FINAL REPORT July 2016

SAINT JOHN'S ABBEY CHURCH

CONSERVATION RESTORATION PRESERVATION

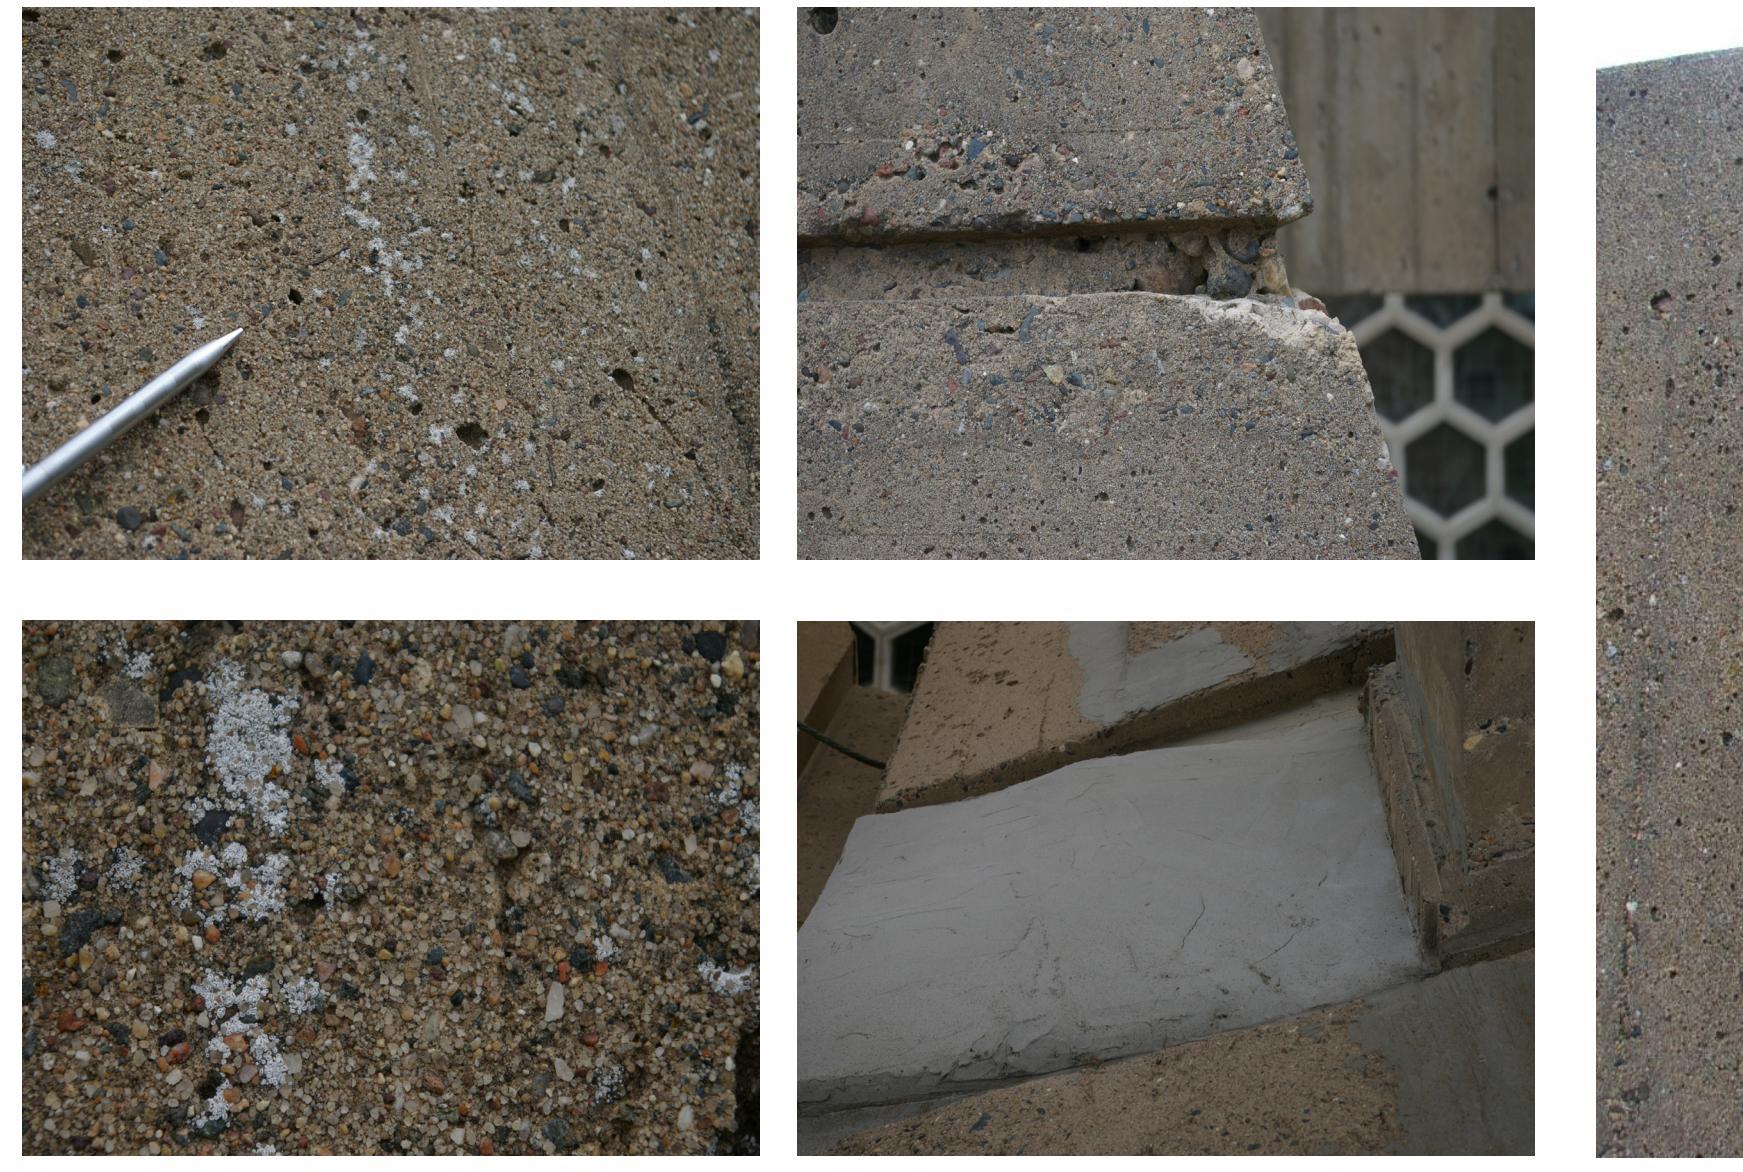
LOWER RIGHT Raw concrete top of the Banner allows moisture penetration of the upper face. A lighting protection leader rests on top.

Remove poor patches and replace with new patch material compatible with original concrete. Provide waterproof solution to top surface of the banner.

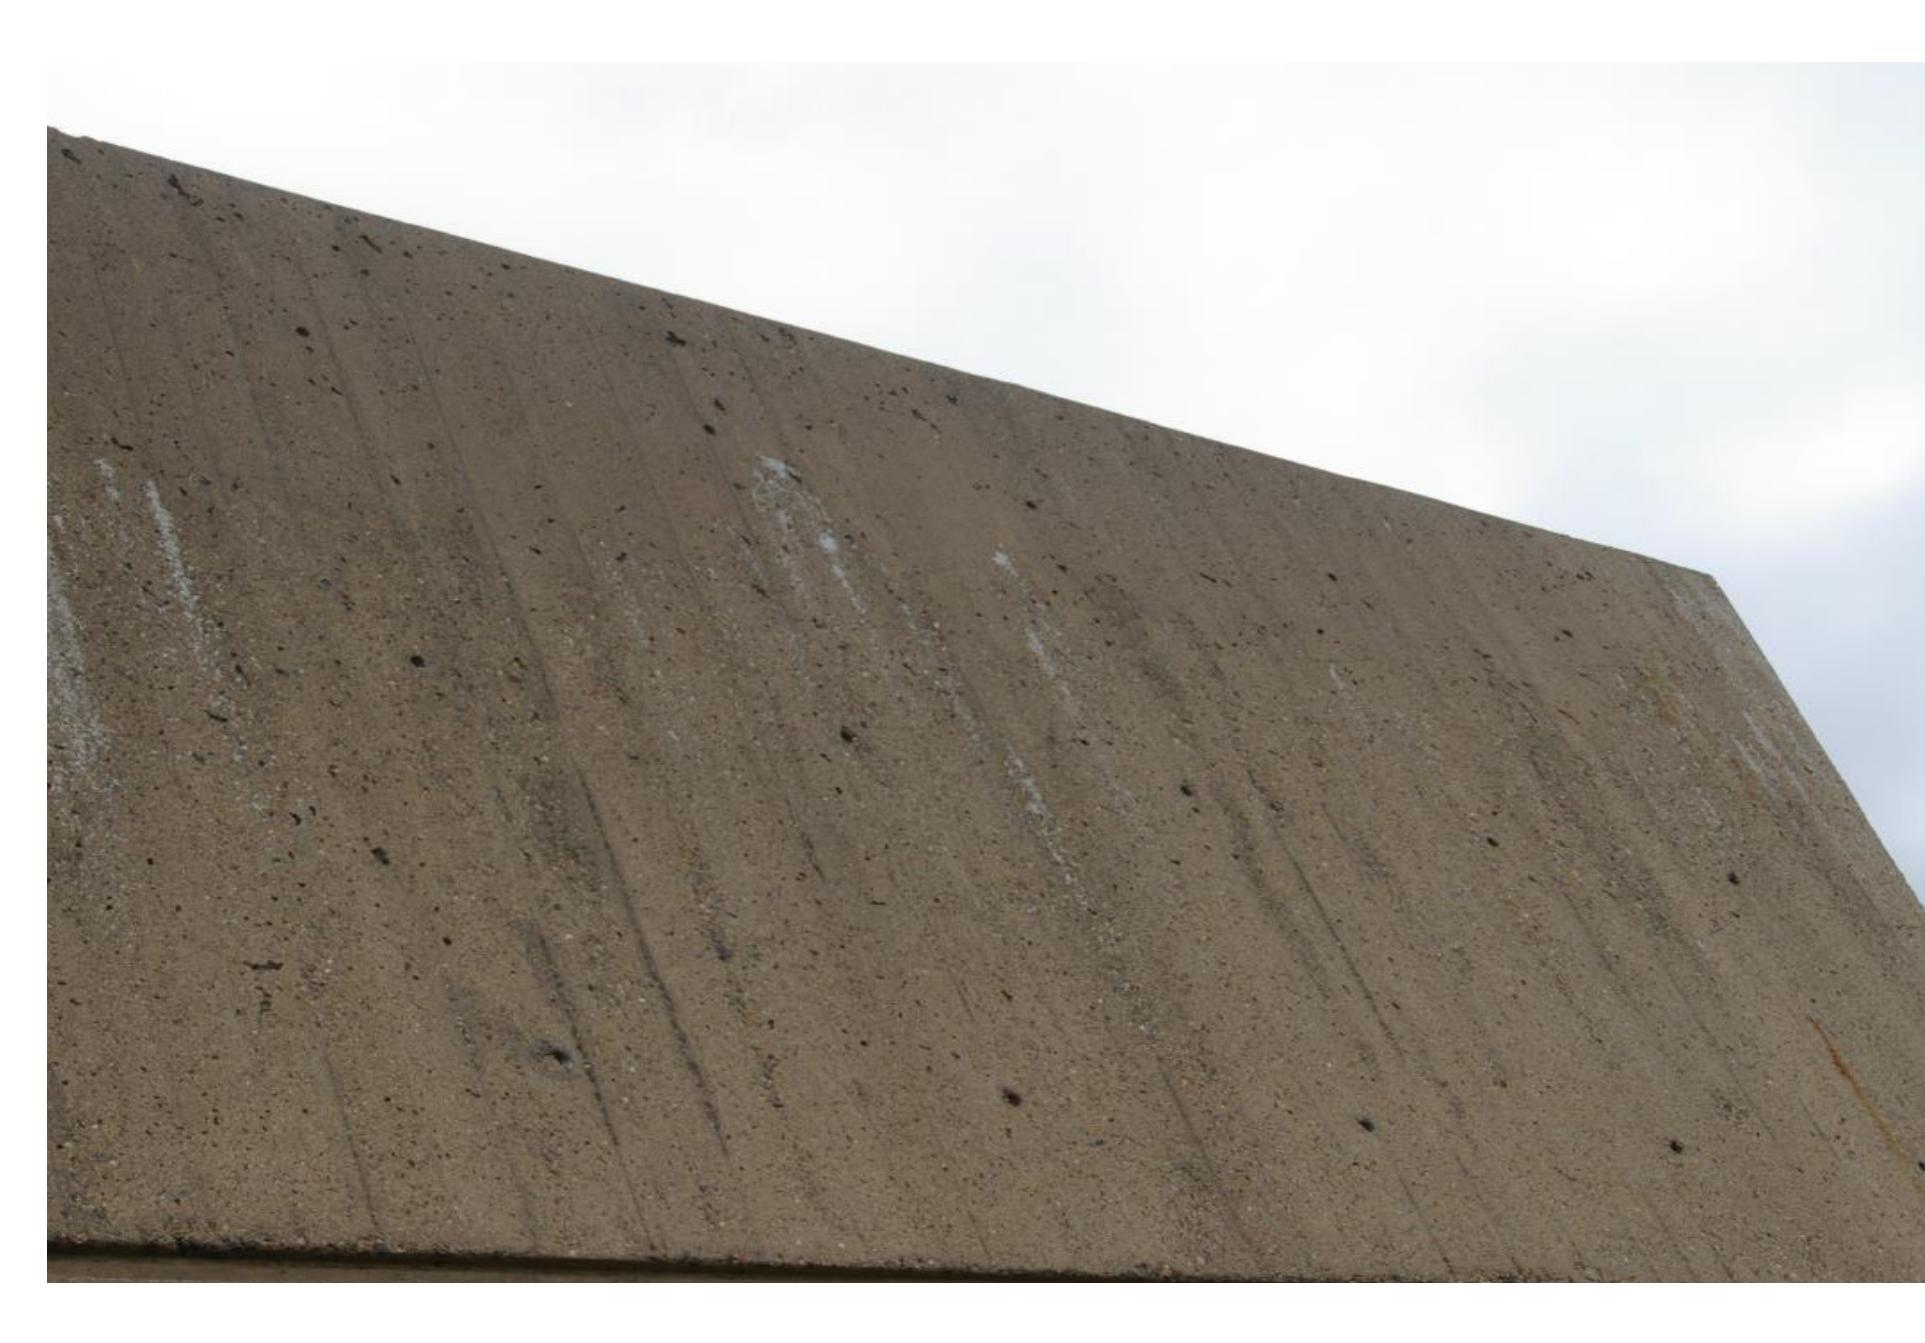
Delamination was noted on the upper right hand portion of the banner as seen from the south. This delamination was identified by hollow sounding areas when sounded using a hammer. Little or no signs of corrosion were noted on the vertical face, although some cracks and rust stains were noted.

The corrosion of reinforcing steel that has resulted in delamination on the banner is due to carbonation of the concrete. Carbonation, a reaction between carbon dioxide in the air and calcium in the concrete paste, reduces the pH below the point where the steel reinforcement becomes de-passivated. Carbonation will not occur in fully saturated concrete or in concrete that is dry; however carbonic acid, created by the solution of carbon dioxide gas from the atmosphere in water, will result in buildup of calcium carbonate.

RIGHT Upper right hand corner of banner where hollow sounding areas (delaminations) were detected

5. In the localized area where delaminations were noted these are repaired by drilling pilot holes into the delaminated area from the top of the banner and applying a urethane bonding agent by gravity flow. Many such materials are optically clear and can be combined with the swarf from drilling to match the color of the concrete.

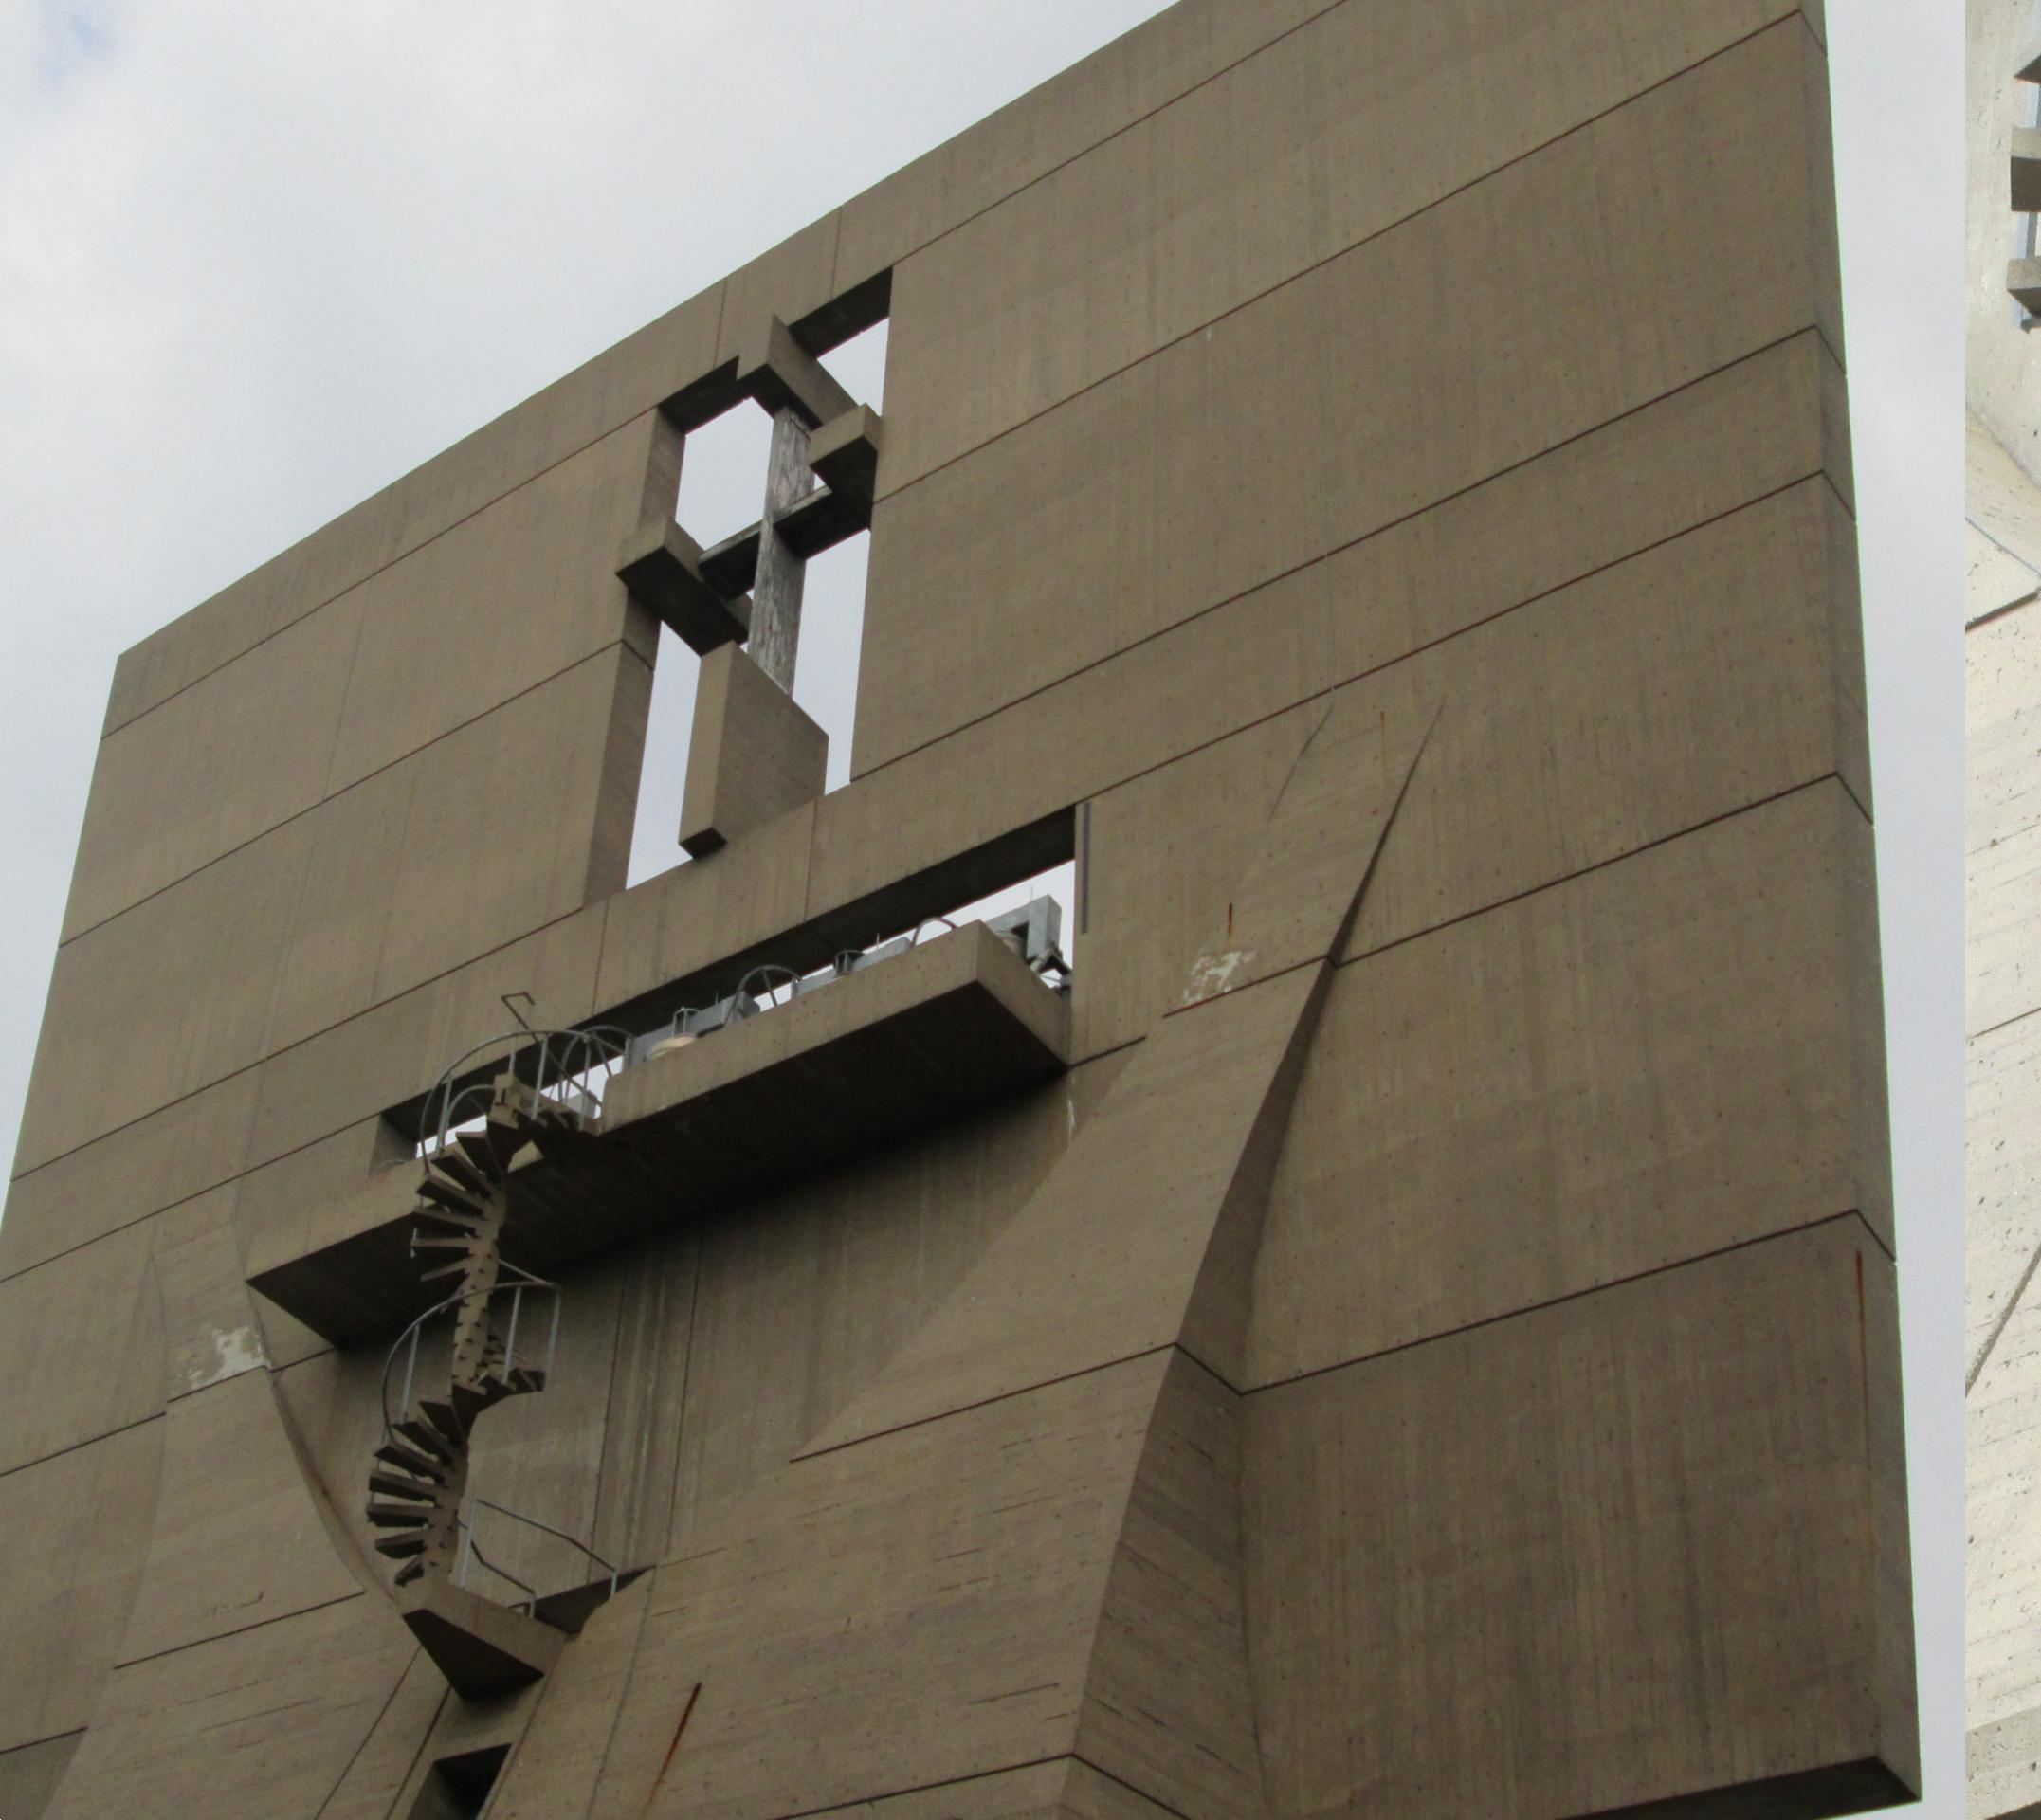
Iron oxide staining

A multitude of small repetitive rust stains on the underside of the arch intrados are clearly observable. The pattern and spacing is indicative of rebar chairs used to support the internal reinforcing steel. Oxidation of the metal chair legs has occurred resulting in the rust stains.

There are a small number of locations with other rust-colored stains. Each stain is typically in a vertical line emanating from a single spot location or a single spot stain. Stains of this appearance are likely the result of iron particle aggregate in the concrete mix rather than reinforcing steel misplacement. The combination of rust staining, spalling or delamination is more likely an indicator of reinforcing steel oxidation issues. Visual inspection did not indicate any observable spalling or delamination of the concrete at rust stain locations.

Options for removal and repair of the exposed reinforcing chair leg ends include precision drilling with micro-tools and introduction of a sealing product to infill the resulting surface cavity.

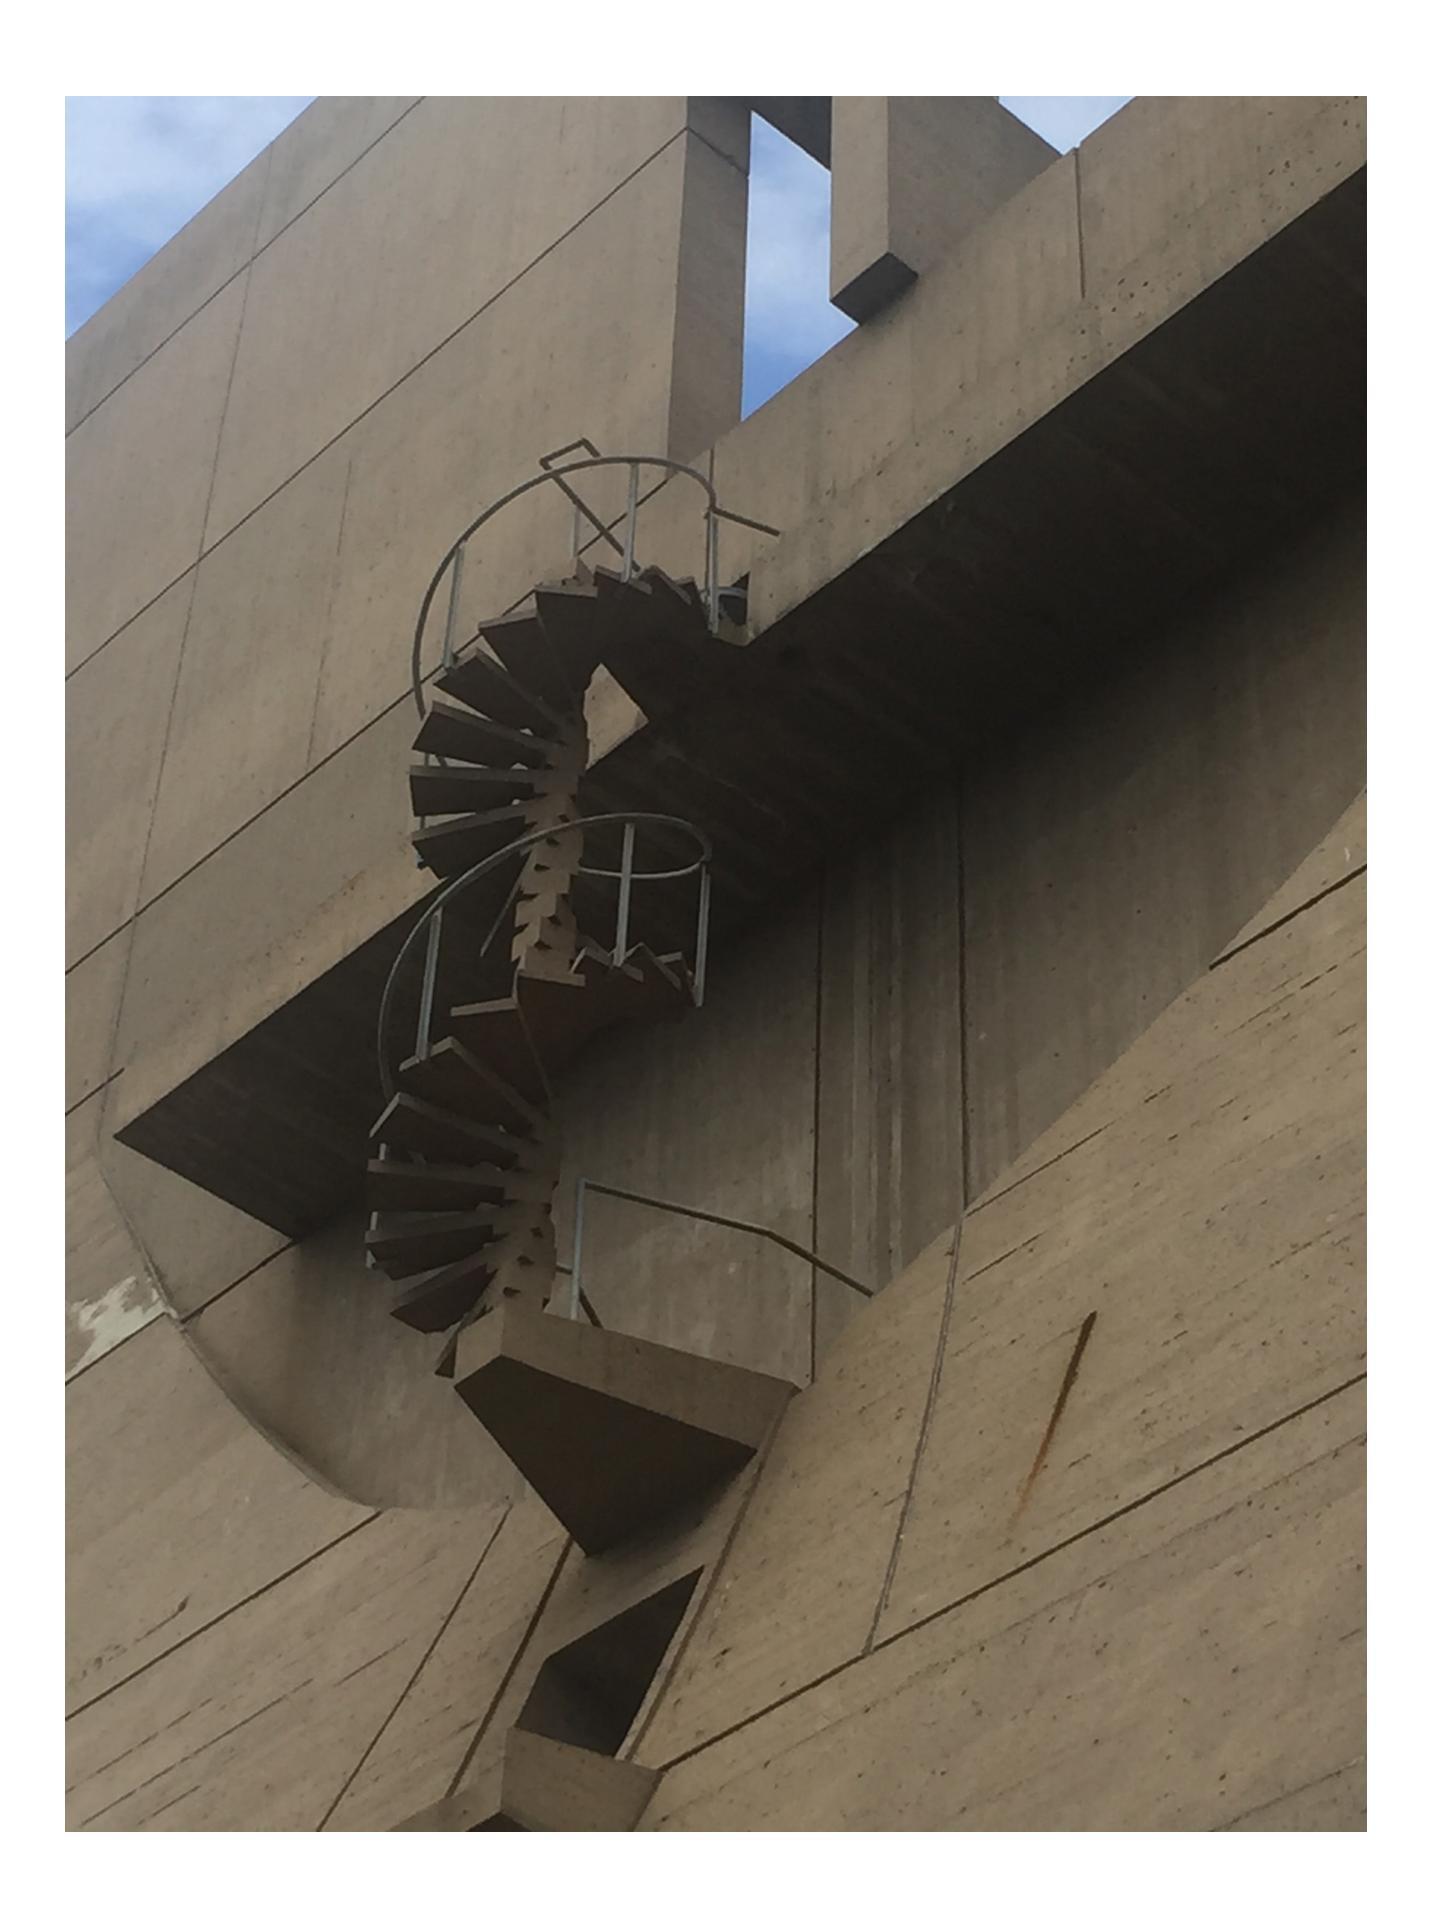
Existing Conditions

The stair has suffered extensive freeze/thaw damage over the years to the extent that sections of the original concrete have spalled off from cracks developing from water ingress into the treads. The water has made its way to the internal reinforcing bars, corroded them and they have expanded in volume considerably, spalling away the concrete cover. Several locations show extensive corrosion of the reinforcing bars and concrete is missing on several tread faces. Close access to the stair and landings via a fire-truck ladder was not possible during our trip to the Campus on 9/17/2015 due to a lightning storm. Assessment of the condition of the upper and lower landings will be performed in Spring 2016. The University closed the stair to any maintenance personnel access in the past (date unknown) due to its dangerous and unsafe condition. Photos 8-17 (p. 110-118) taken by the University in April 2008 show these damaged conditions.

In order to create a stair that matches the historical precedent set by Marcel Breuer it is recommended that the original stair structure needs to be replaced. The extent of the corrosion of the reinforcement in the precast concrete treads is very significant and does not appear to be able to be halted, such that the structural integrity of the treads are essentially irreversibly damaged, dangerous and unsafe. Further investigation (both non-destructive and destructive) could be done to see if the central steel pipe support column is corroded and could be saved, but in order to replace the treads this column needs to be removed anyway so that the new treads could be sleeved over it. This in turn means that the column needs to be extricated from the upper and lower cantilevered CIP concrete landings, meaning that these elements will need concrete repairs after they are carefully, and minimally removed just enough to release the column.

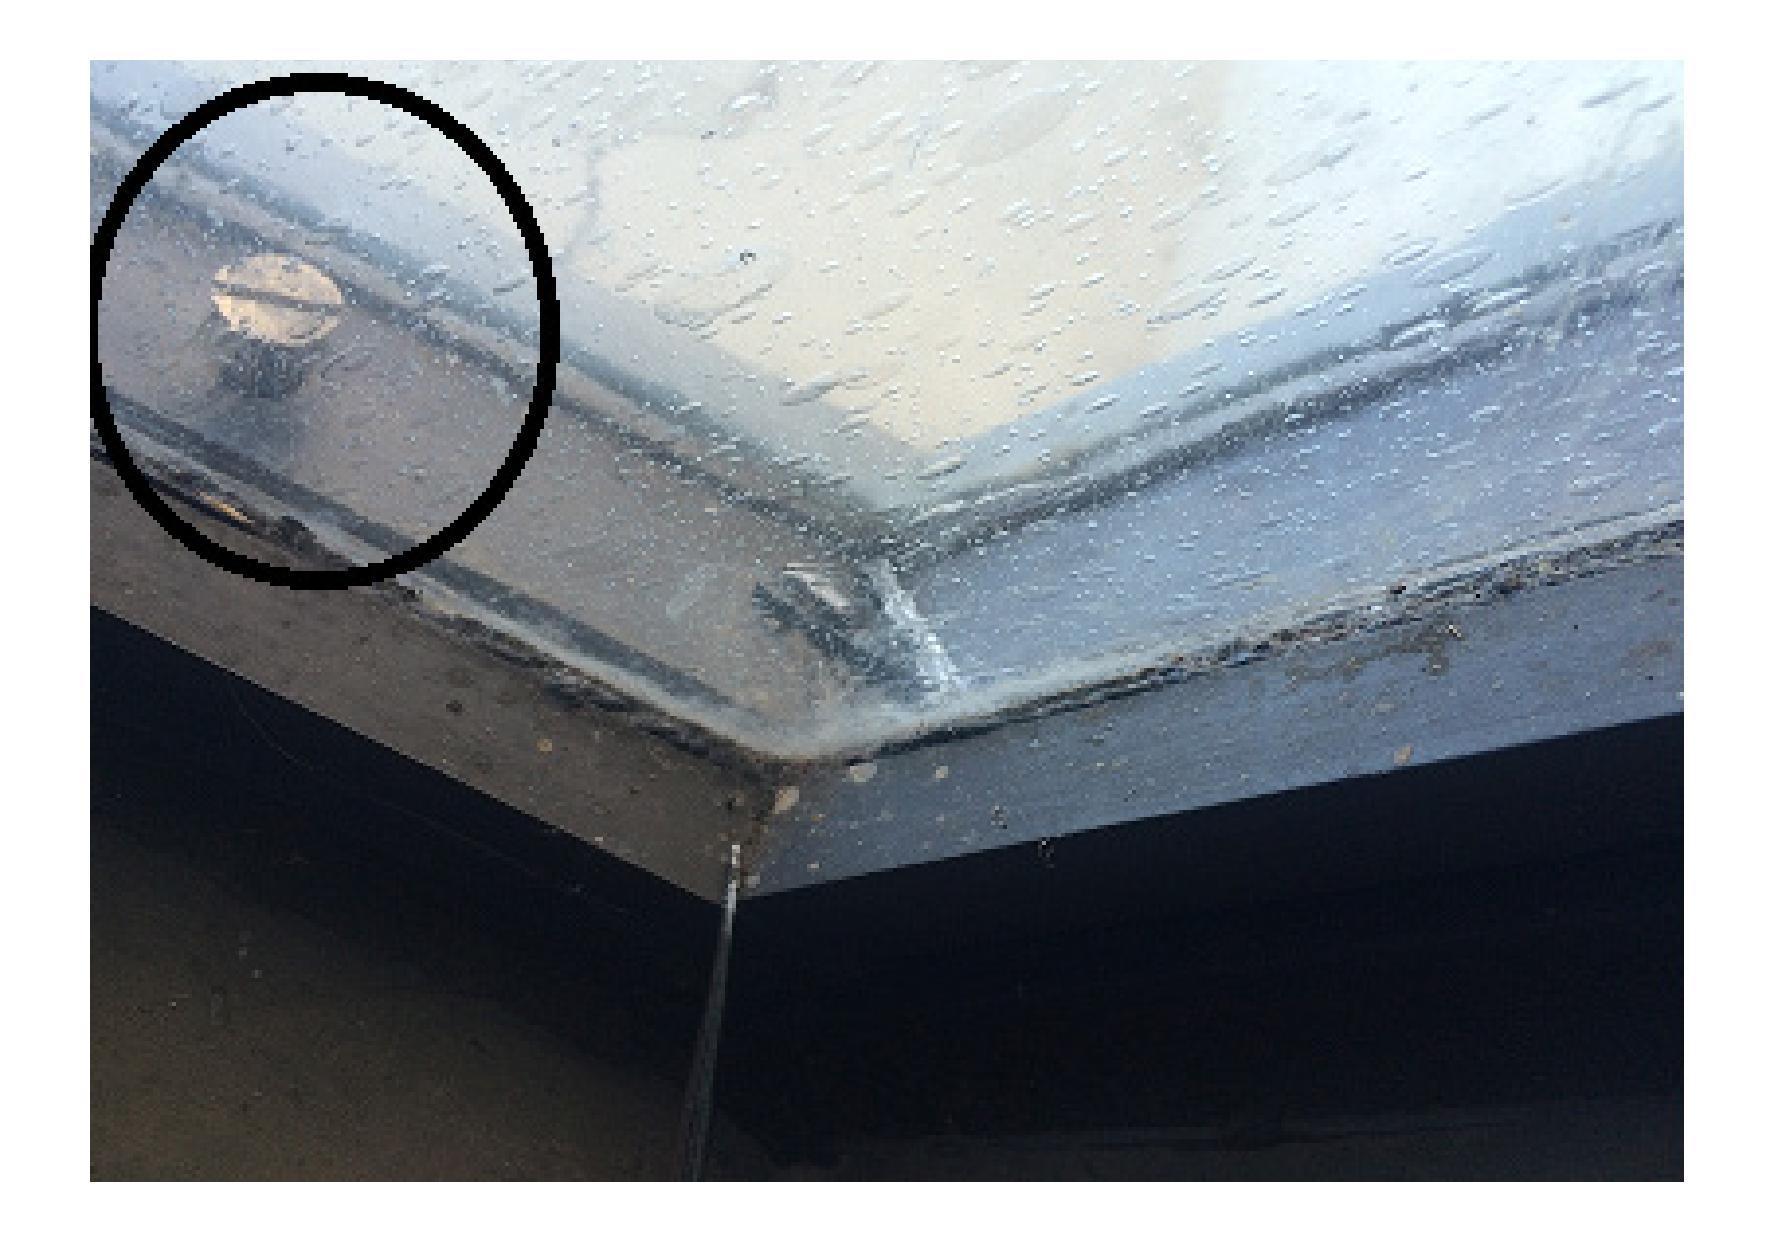
The original protective glazing was heel beaded, taped and cap beaded. The cap bead is deteriorating allowing moisture penetration. (See Photo # 104, 105). Photo (#123) shows the Heel Bead and the recess in the main frame for the leg of the offset glazing stops.

In multiple locations the main frame anchor screws are backing out. (See Photo 111)

North Facade - Create new custom frames to allow for insulated glass. Apply new heel bead to provide moisture seal.

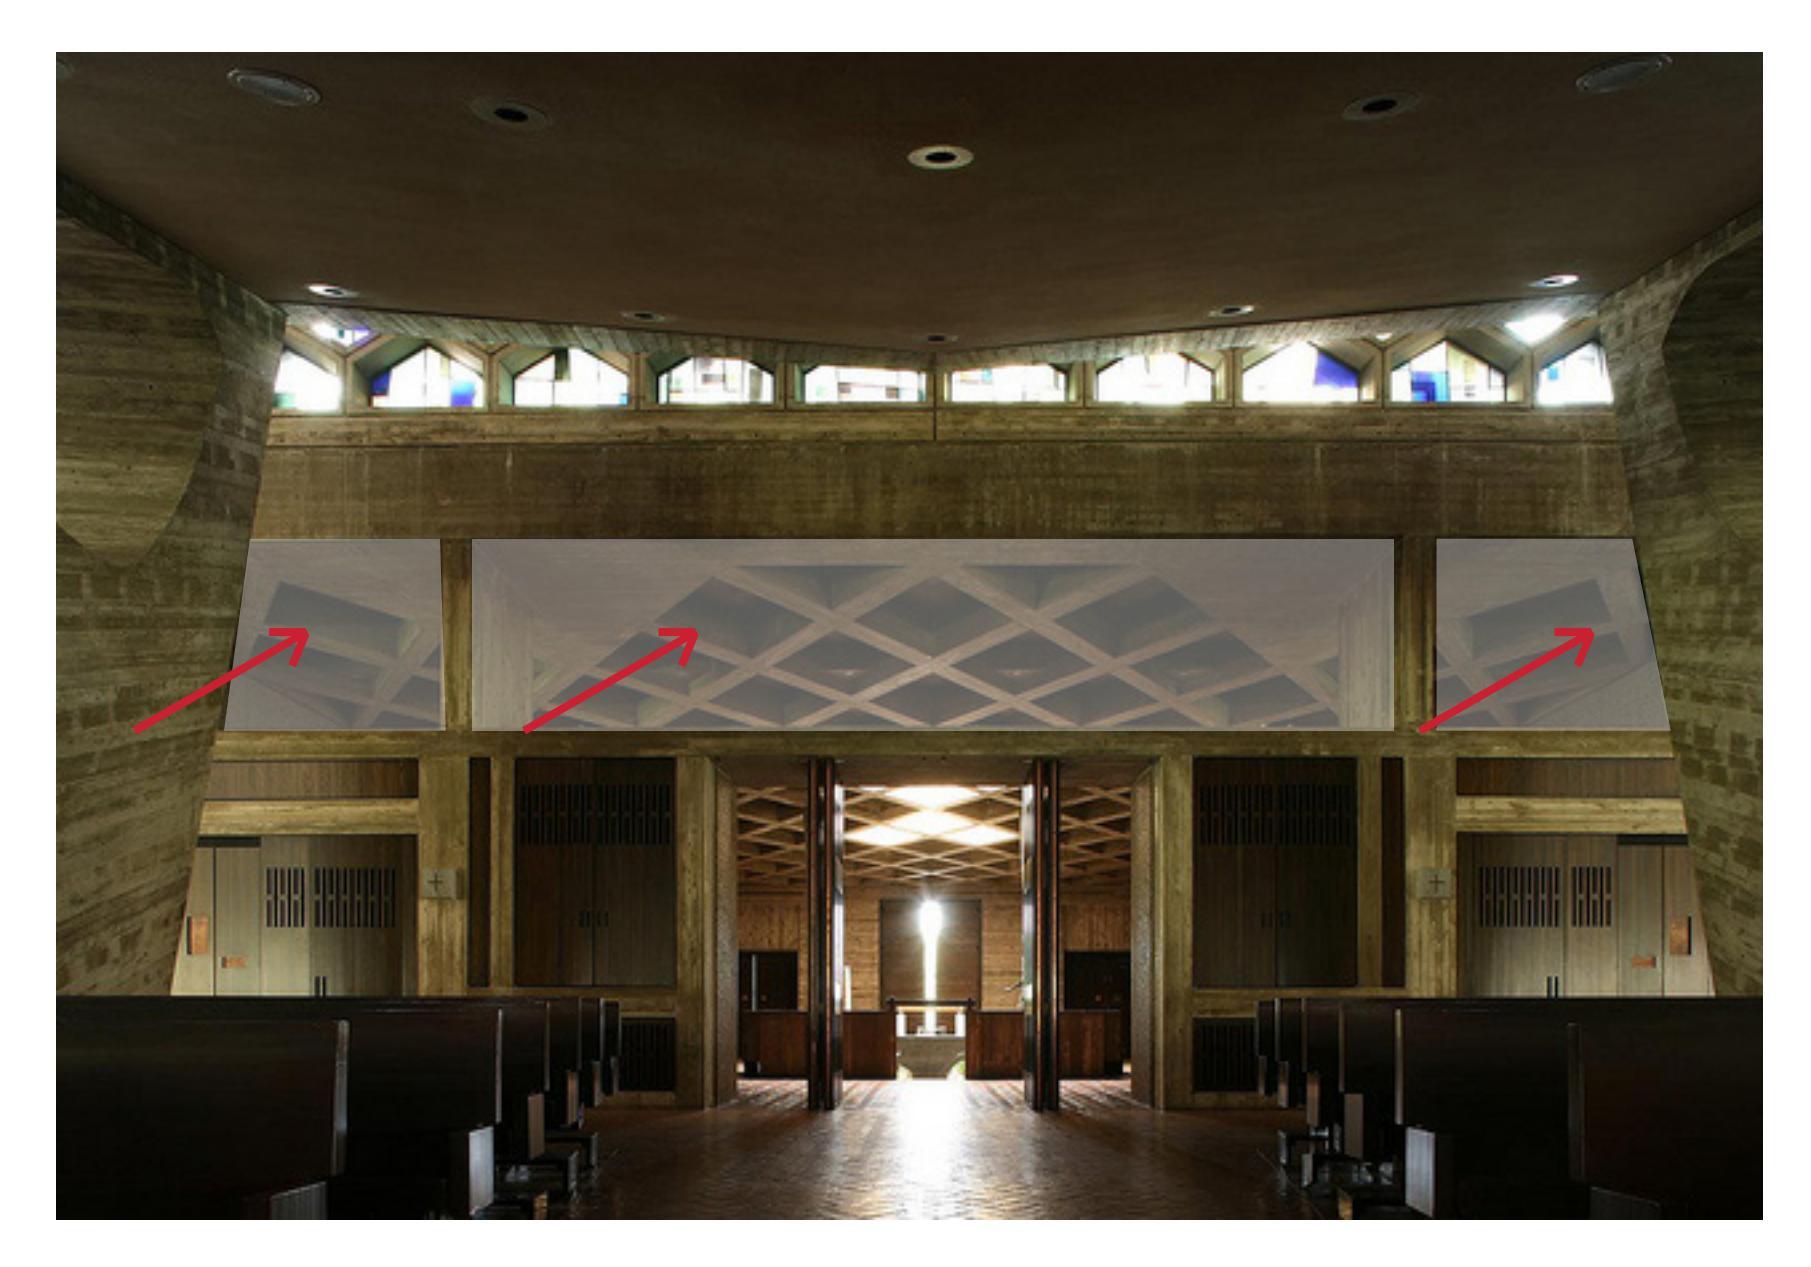
ABOVE A pair of entry doors from beneath the Bell Banner porch into the Baptistry. Light leak is a simile for air infiltration in the winter, which at

ABOVE The Baptistry could provide an air lock for the Abbey Church sanctuary, through infill with clear glass of the openings above the sanctuary doors, storage closets, and confessionals.

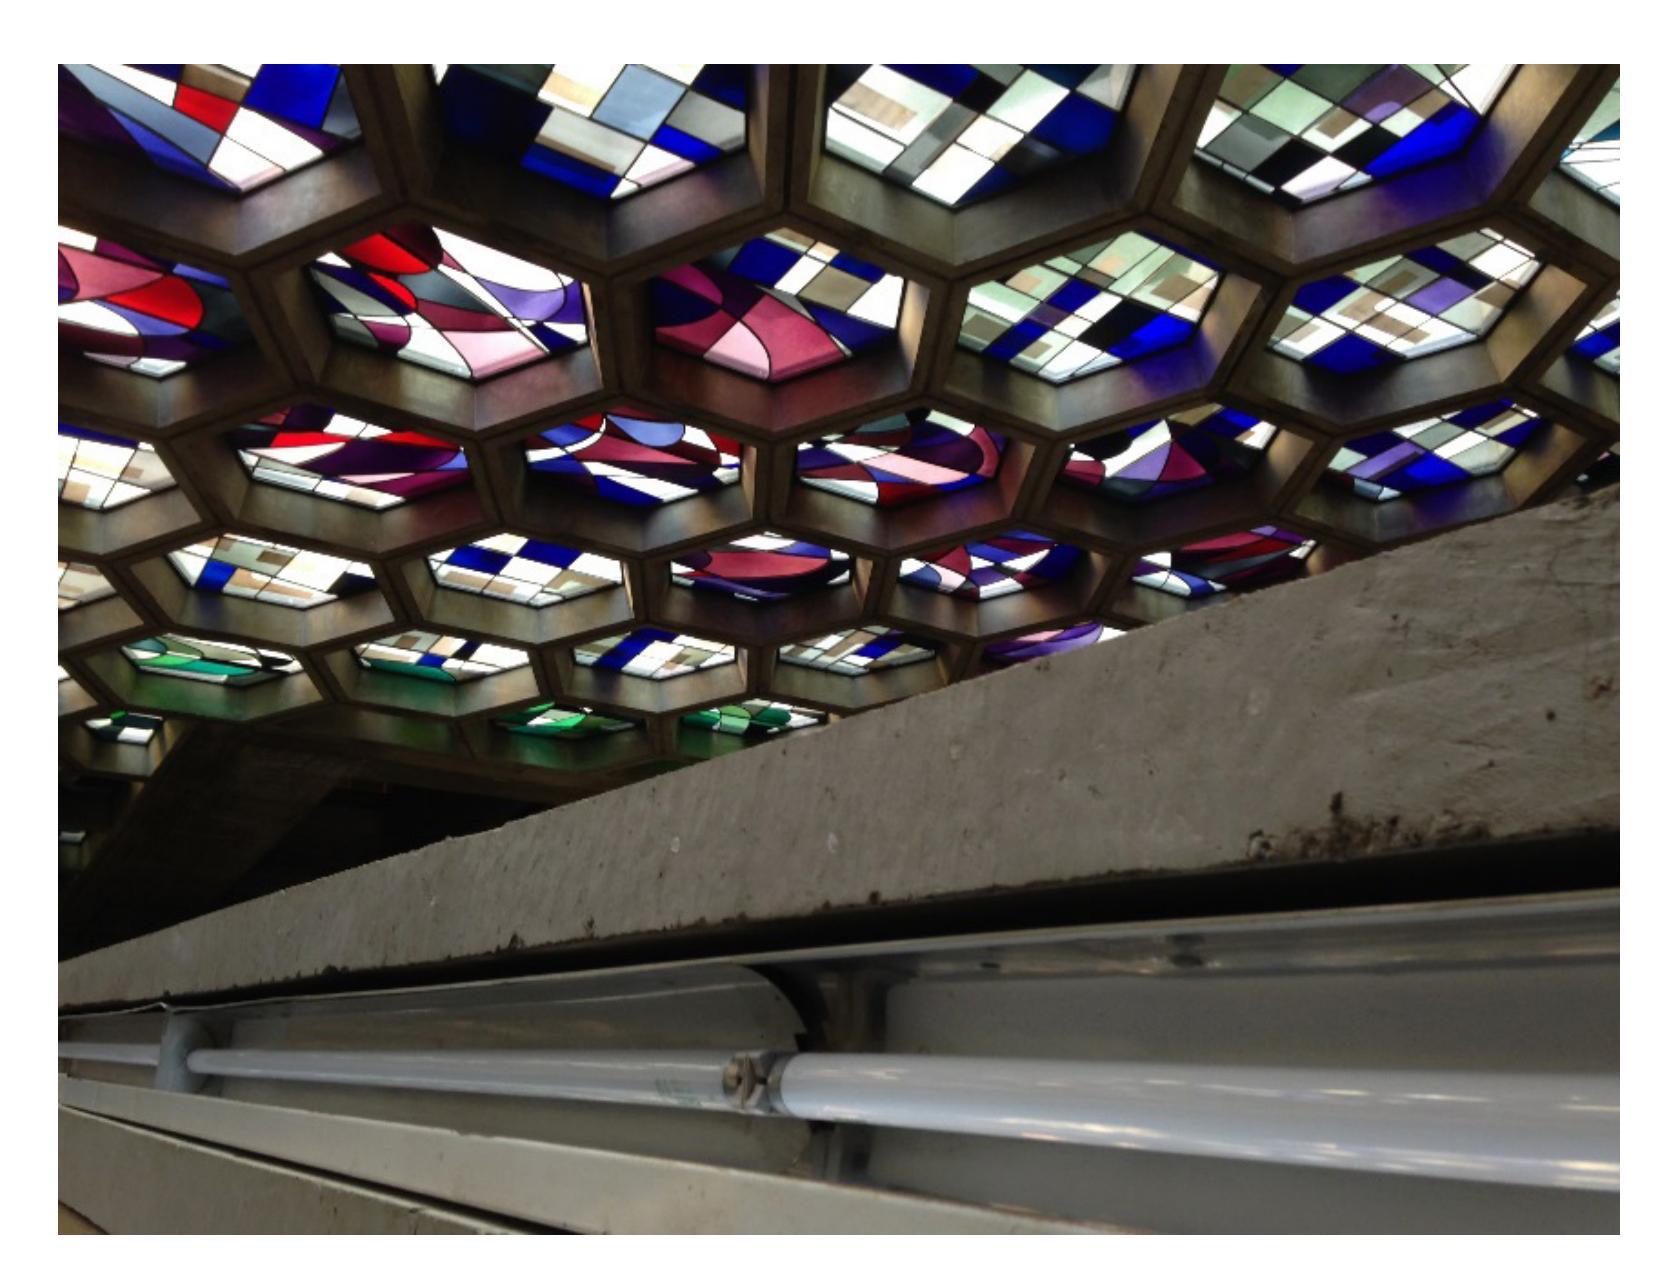
The interior face of the wall is illuminated on select feast days using a row of fluorescent wallwashers at the back of the balcony. These fixtures will be replaced using high-efficiency LED wall wash fixtures.

Type Existing Description Interior up-lighting of North Wall **Proposed Solution** Replace the existing fluorescent units with linear LED striplights

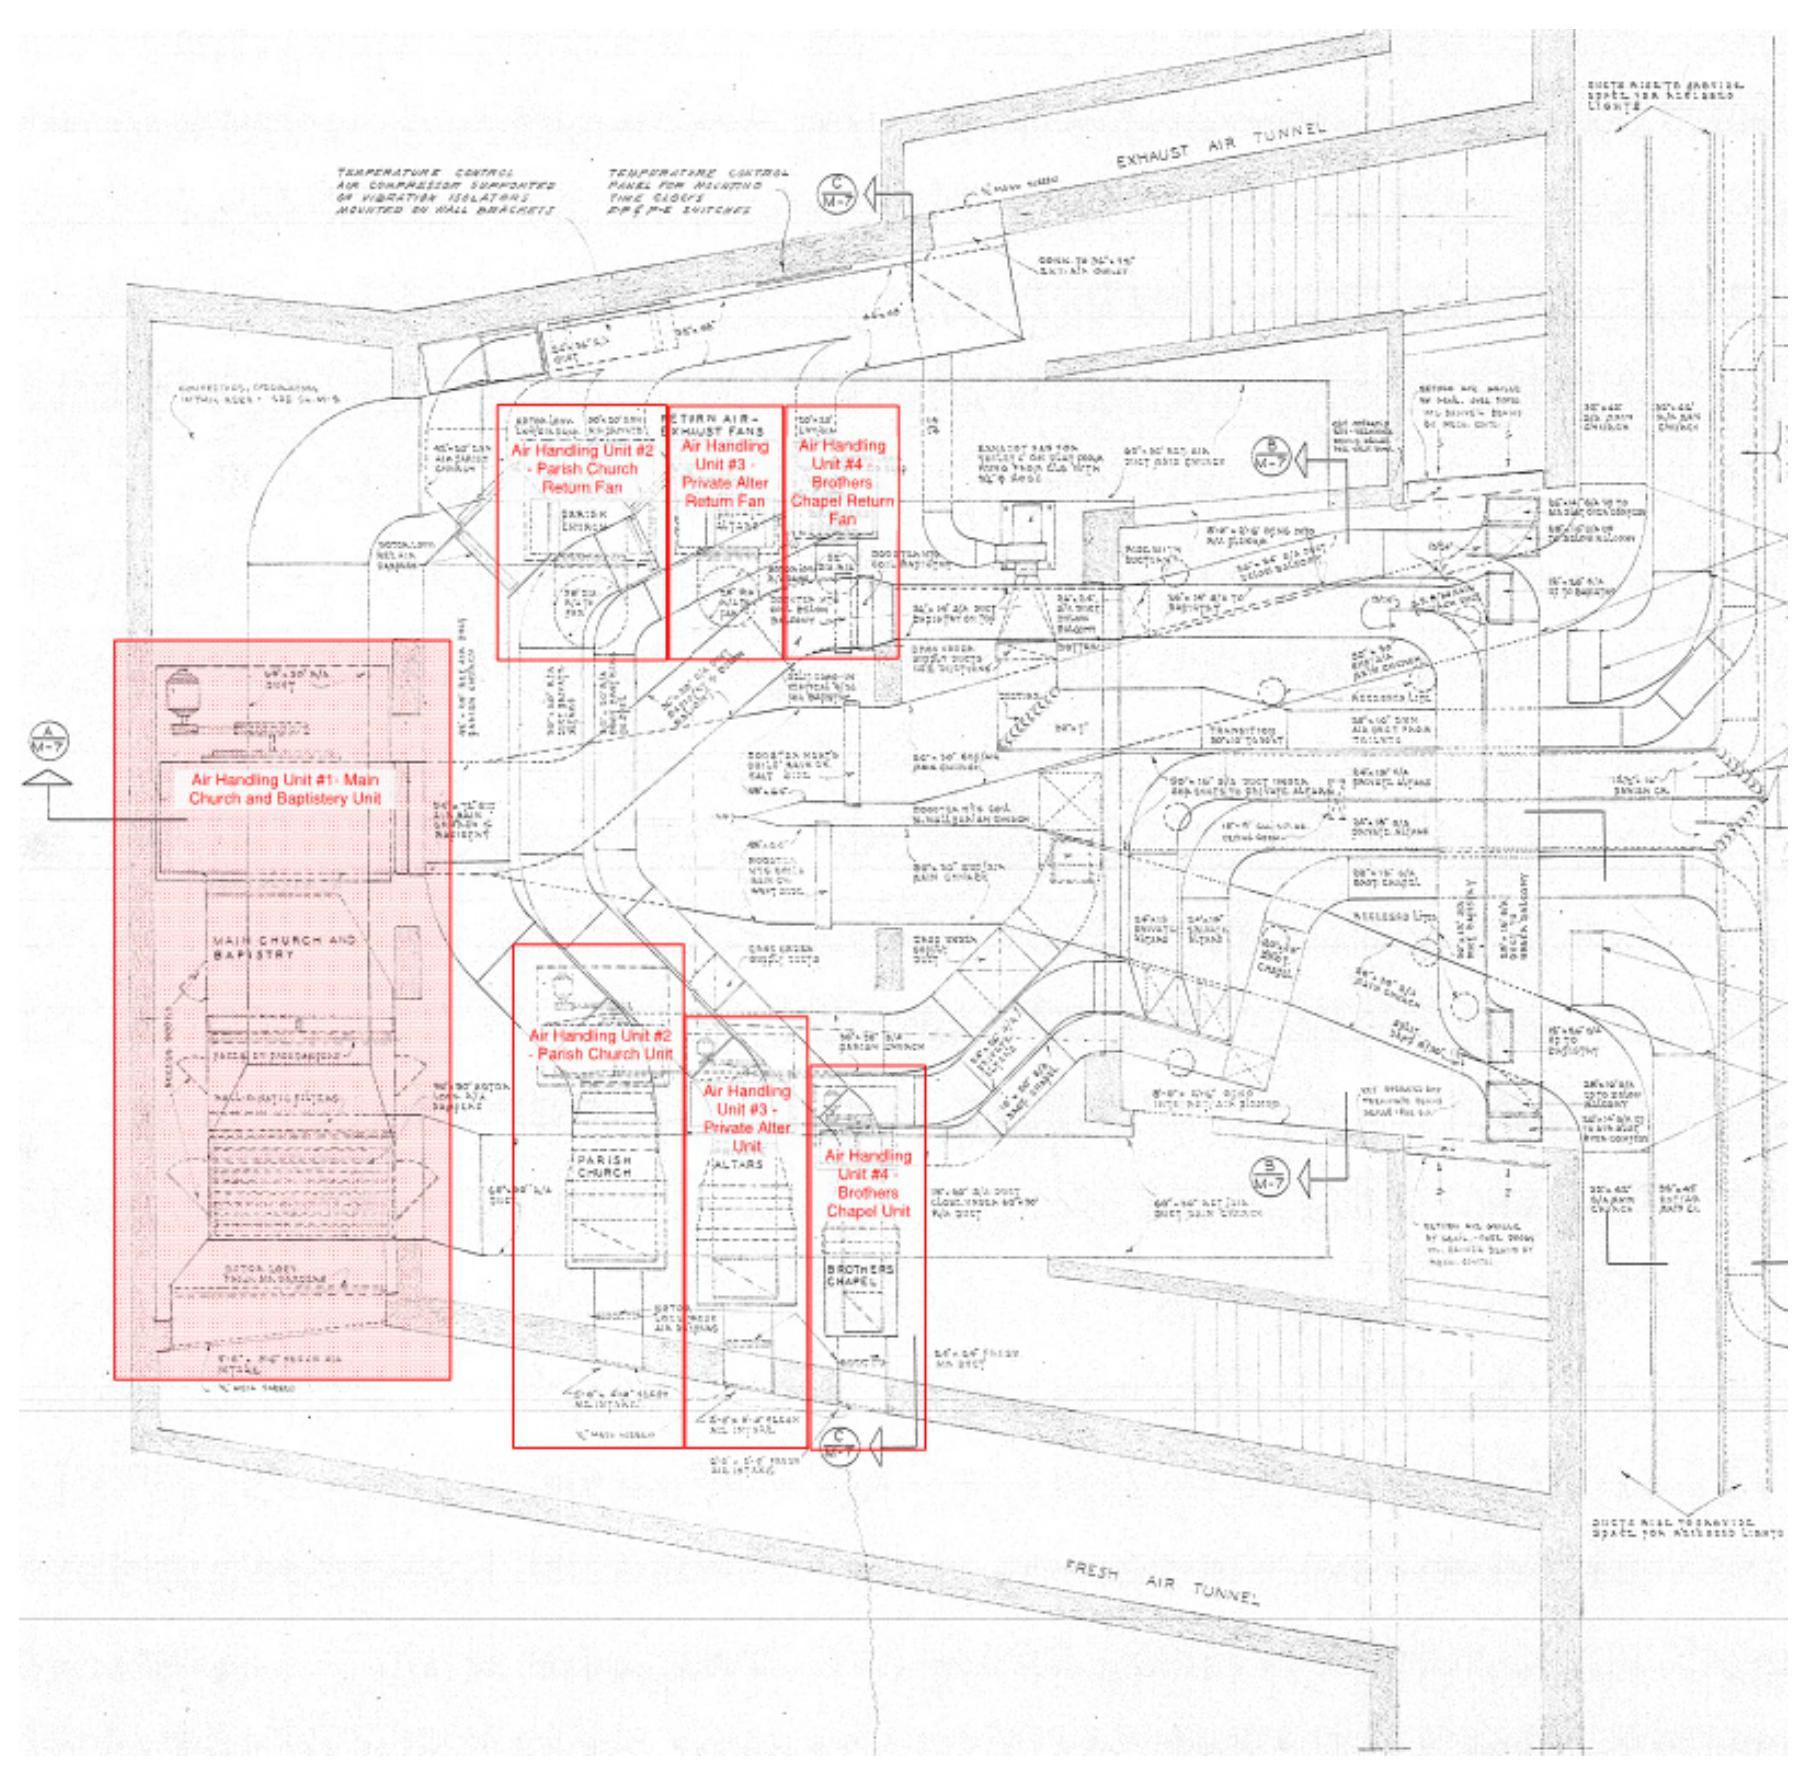
The air handling unit (AHU) is original to the 1957 building placing the unit and the components over 55 years old. This unit consists of a single inlet utility set backward inclined supply fan, pneumatic operated return, relief and outdoor air dampers, fiber media filters, and a steam preheat coil. This unit does not have a return fan, cooling coil for dehumidification or a humidifier. This AHU is a built-up air handling with single wall construction and exposed fibrous insulation exposed in the air stream. The unit is located in the basement mechanical room as highlighted in Figure 1: Mechanical Plan Excerpt
