FINAL REPORT July 2016

SAINT JOHN'S ABBEY CHURCH

CONSERVATION RESTORATION PRESERVATION

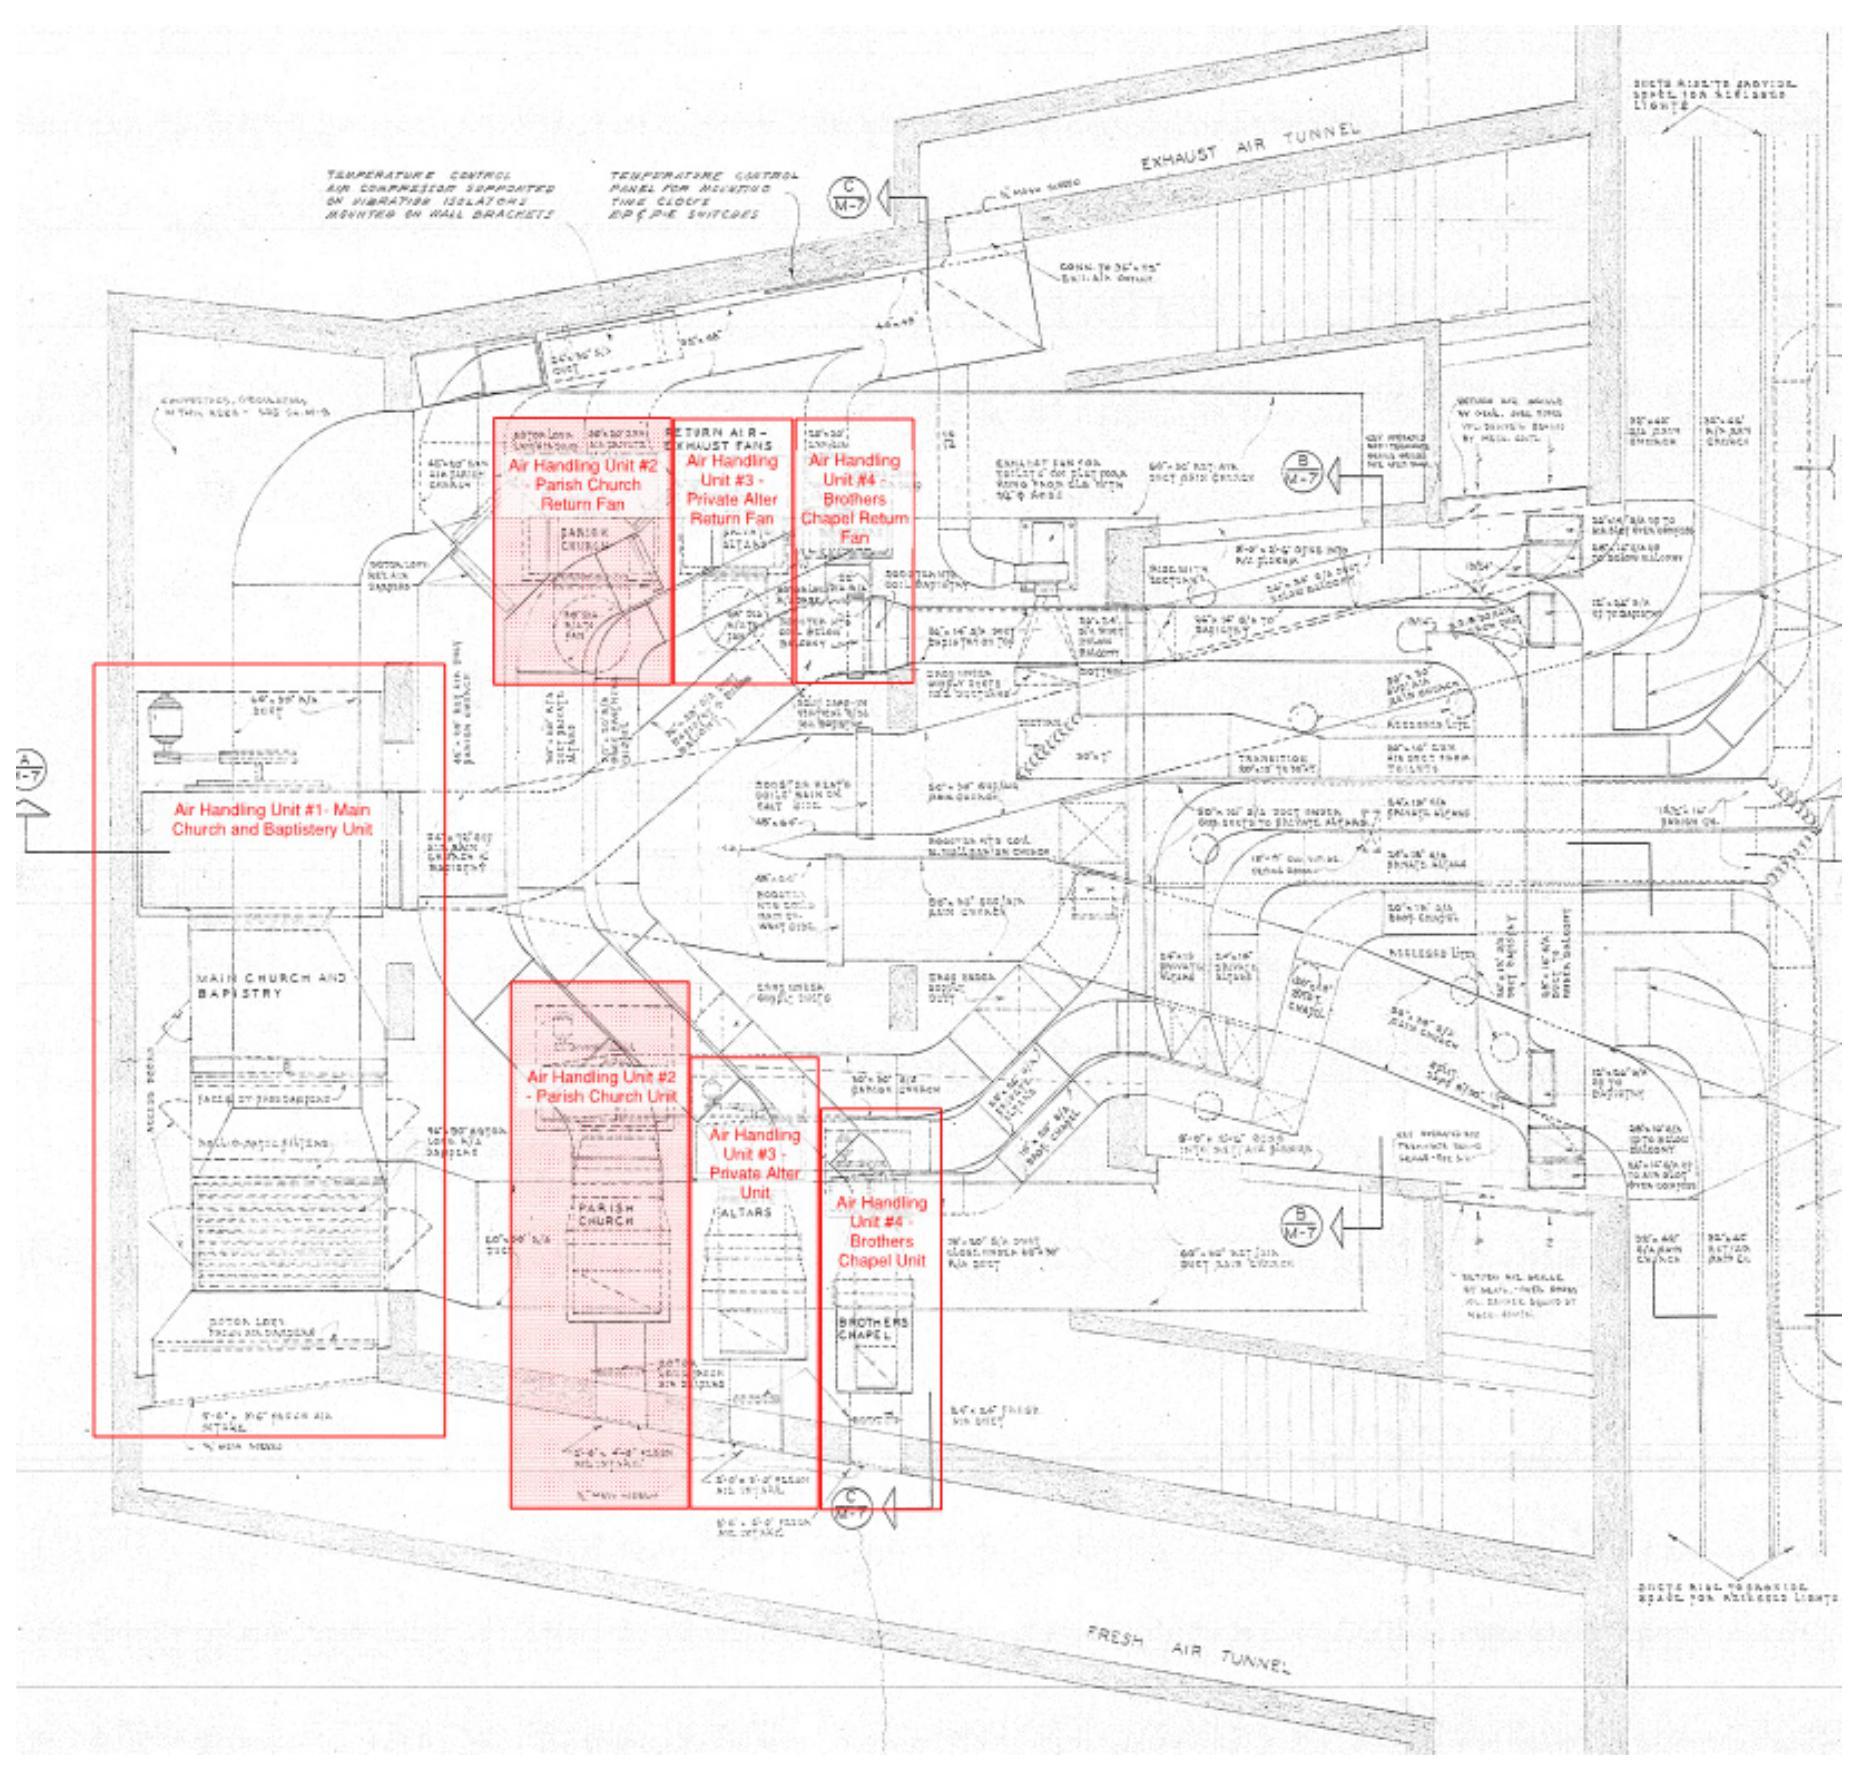
The air handling unit (AHU) is original to the 1957 building placing the unit and the components over 55 years old. This unit consists of a single inlet backward inclined utility set return fan, pneumatic operated return, relief and outdoor air dampers, fiber media filters, steam preheat coil, and single inlet backward inclined utility set supply fan. This unit does not have a cooling coil for dehumidification or a humidifier. This AHU is a built-up air handling with single wall construction and exposed fibrous insulation exposed in the air stream. The unit and associated return fan is located in the basement mechanical room as highlighted in Figure 12: Mechanical Plan Excerpt.

The unit is a constant air volume system that does not meet the current energy code. Energy code requires that a fan system over 5,000 CFM of this size to be able to vary the flow to meet space demand, thereby limiting reheat operation.

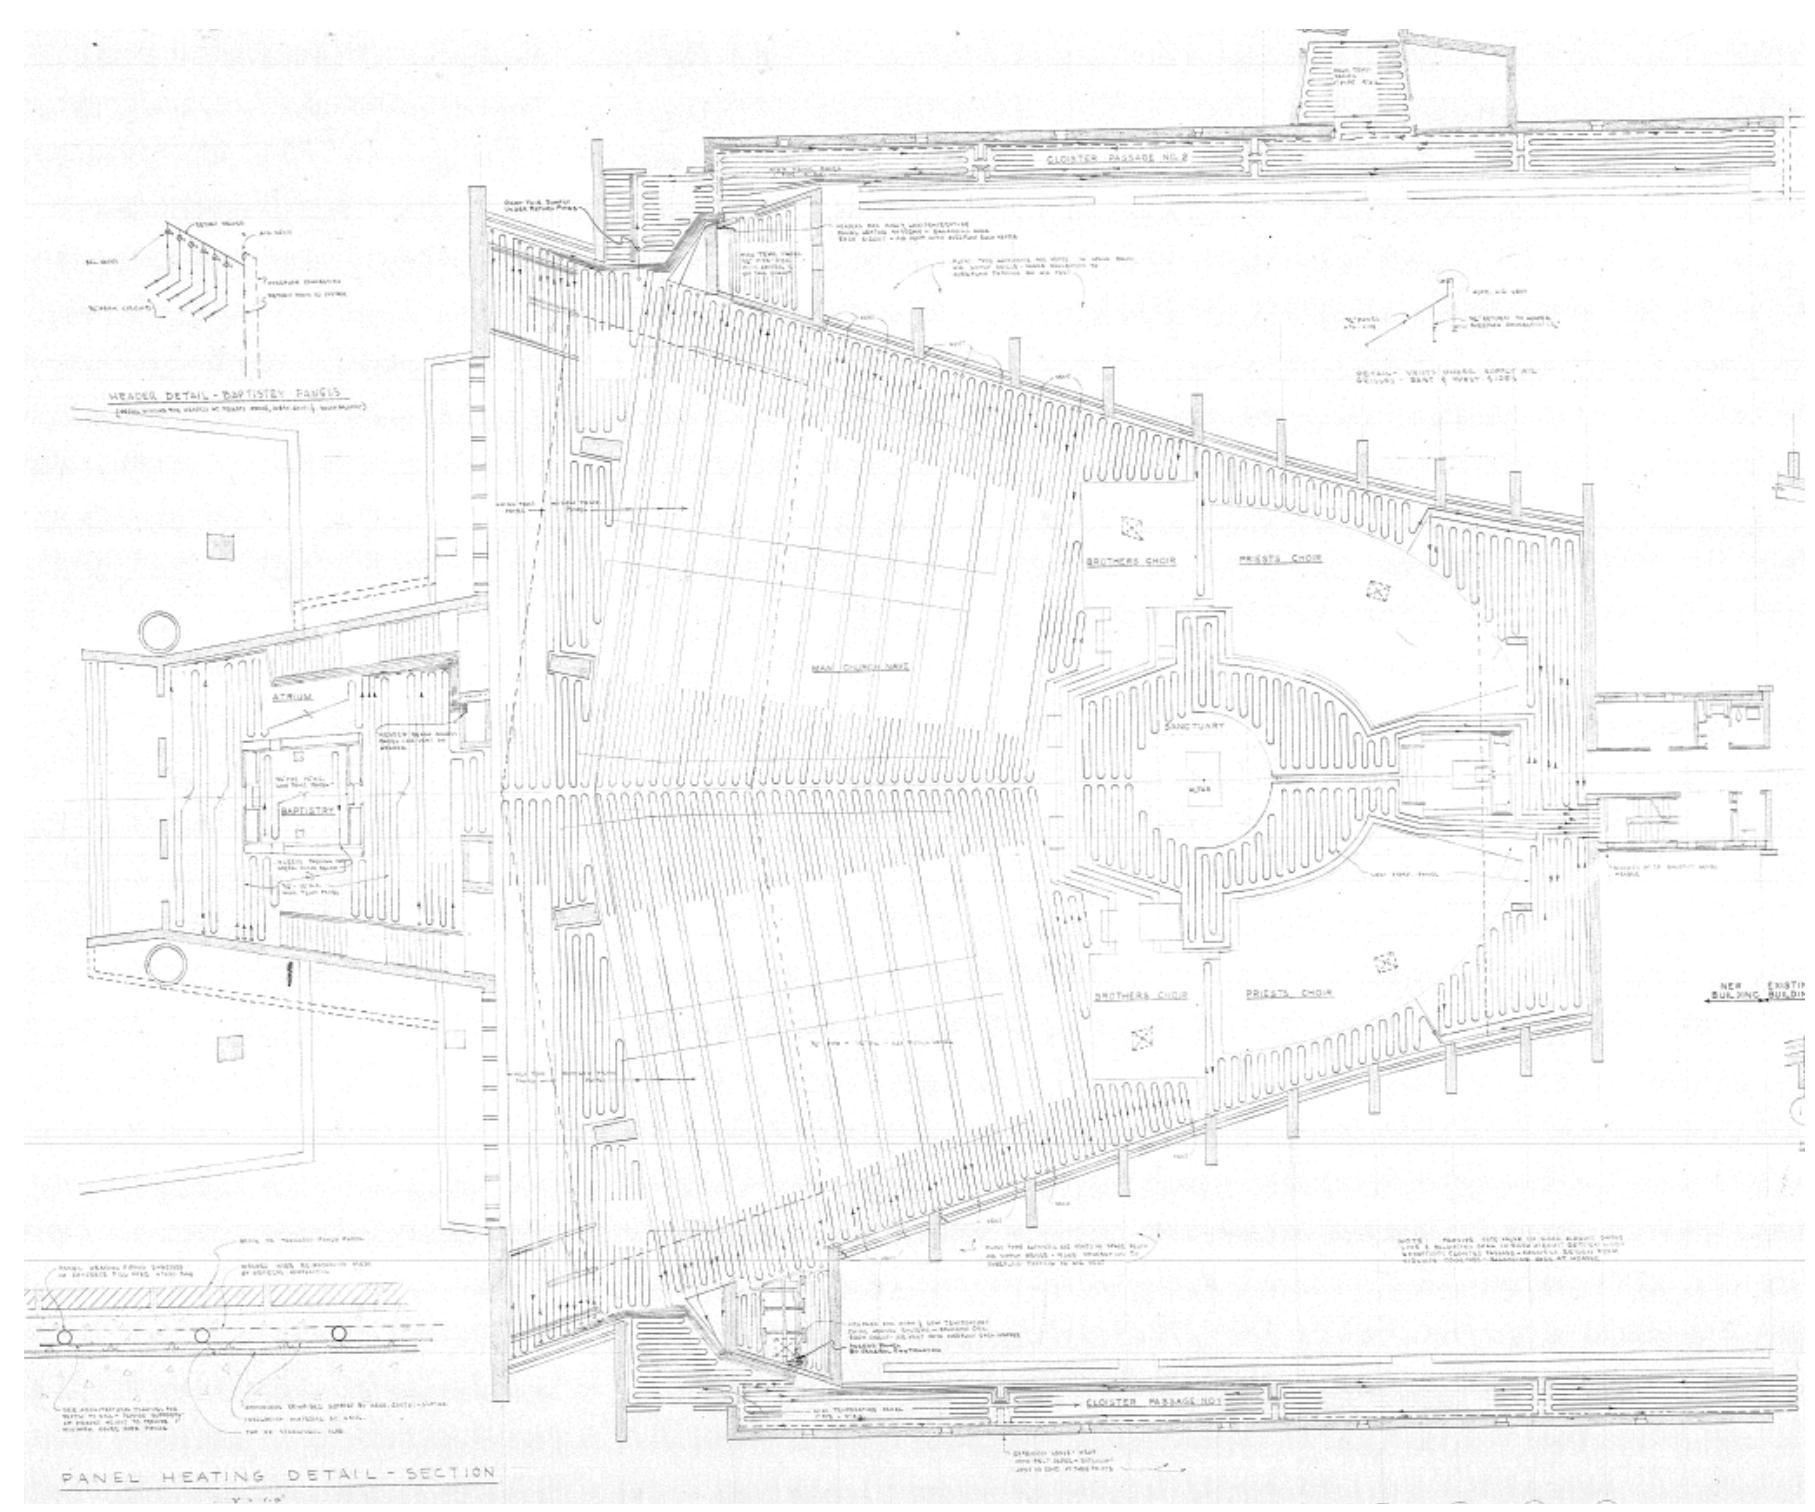
Figure 47: In-floor Heating Zones

The in floor heating system has failed. Only one of the remaining zones is still active, but due to the condition and history of the remaining system the longevity for the system is suspect. The entire system should be replaced.
