Gold Foil, Strip, and Wire in the Iron Age of Southern Africa

A N D R E W O D D Y

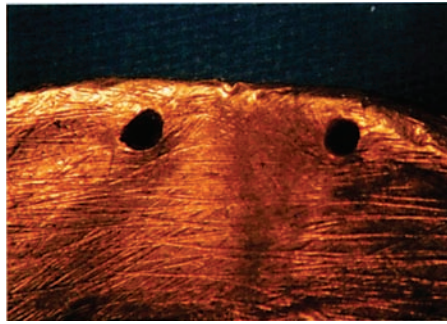
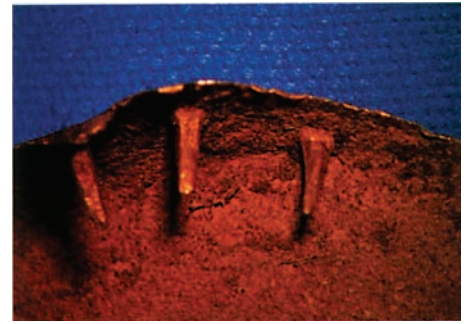
FIGURE 4. Inner surface of gold foil, far right, showing granular texture. Note the presence of small gold nails originally used to attach the gold to a wood former.

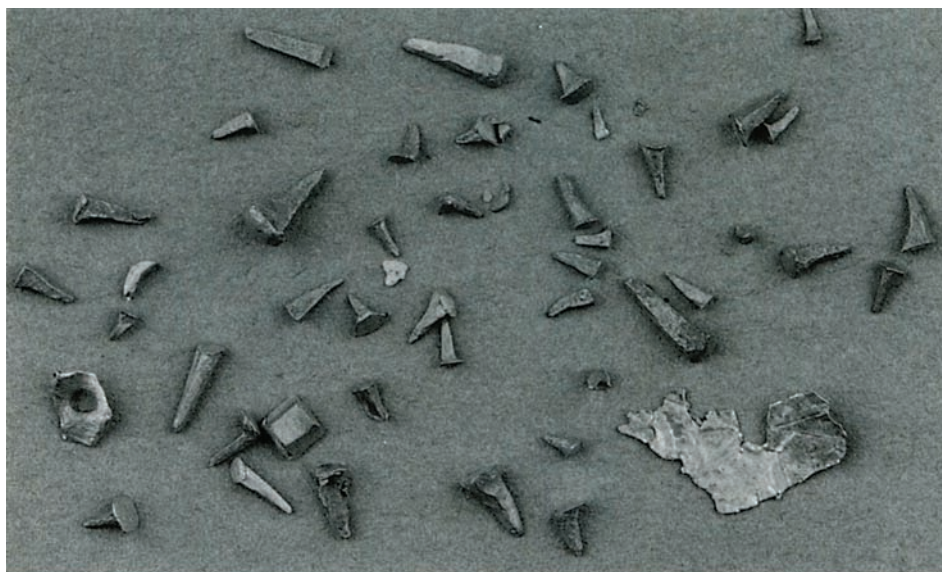
FIGURE 6. *Gold foil-covered scepter from Mapungubwe, below left. Inv. no. DAPU 33.174A.*

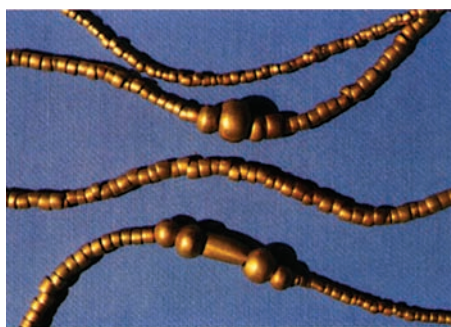
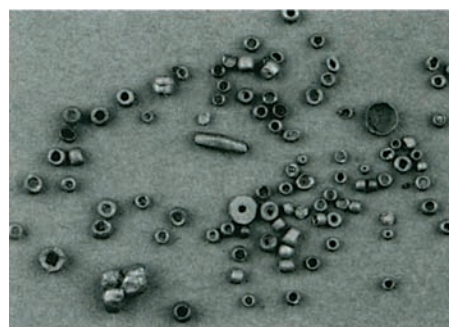
FIGURE 18. Goldsmiths' waste from an unknown site in Zimbabwe. Note the presence of a very small, tubular, gold-foil bead. British Museum, Ethno 1929:12-1(11).

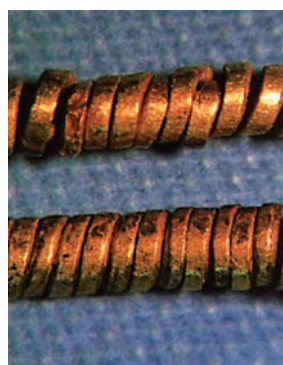
FIGURE 26. Detail of coiled gold-wire bracelets from Mapungubwe. Inv. no. DAPU 33.169 and part of the contents of a cigar box labeled “B Mapungubwe sites S₁, P.S₂.”

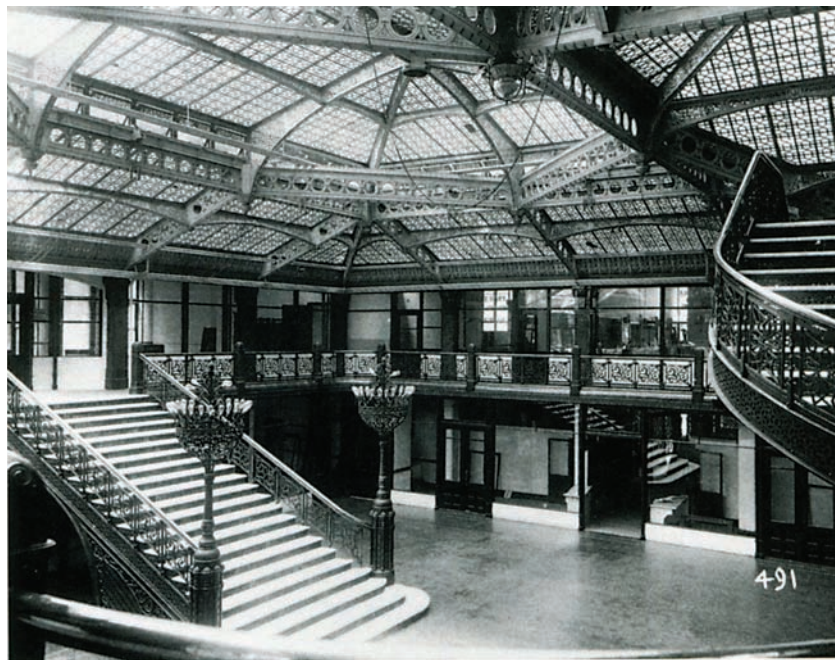
cles and industrial components such as steam engine cylinders, rails, and tram rail plates became common manufactured items. In 1755 Sir John Smeaton employed the first large pieces of cast iron for mill and engine work (Lee 1983:100–1). However, it was not until 1779, when the first major cast-iron structure, the Iron Bridge at Coalbrookdale, was constructed across the Severn River in Shropshire, England, that the tremendous potential for the new material was demonstrated for the first time (Condit 1964:5).

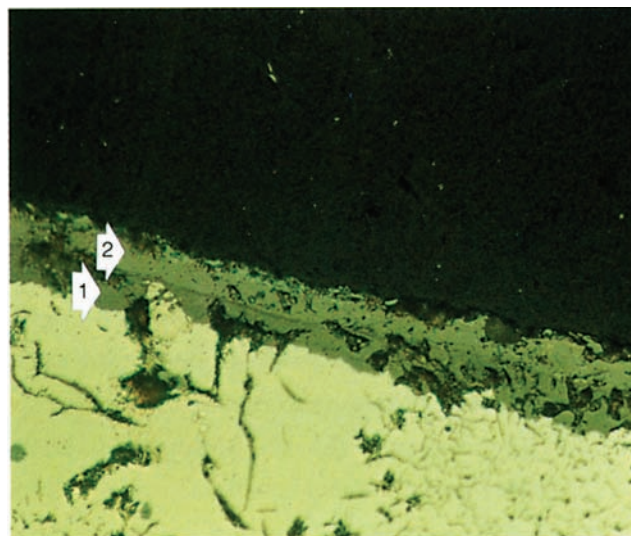
Subsequent modifications in the basic process resulted in a number of patented treatments, including the Wells Process, the Gesner Process, the Bradley Process, the Bontempi Process, and Coslettizing. These commercial processes produced magnetite coatings of better color, uniformity, and thickness for less cost (Wilson 1915:48–49).

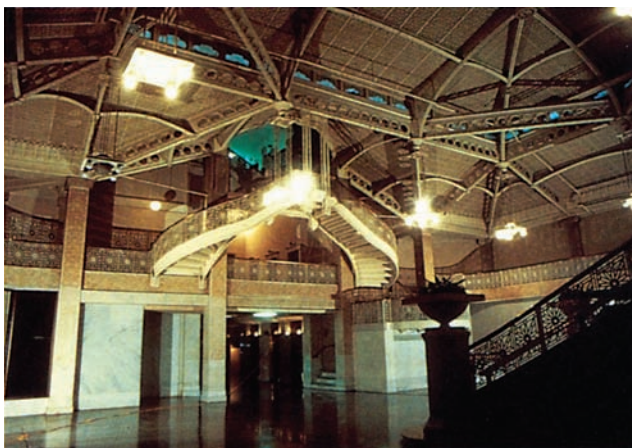
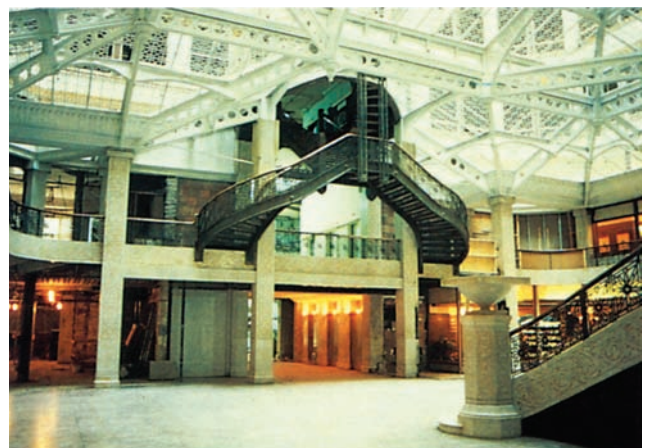
In the case of the Rookery, this effect was largely achieved through the construction of an independent skeleton wall of cast-iron columns joined by wrought-iron spandrel beams, thus maximizing the amount of light entering the inner offices. The architects also made use of light-colored reflective materials—white-glazed bricks and gold-glazed terra-cotta lintels, sills, and copings; gilded cast-iron mullions; and a glossy white-painted skylight and exterior oriel stair. This orchestration of light with highly reflective white, black, and “gold and dark bronze” metallic-colored surfaces must have created a dazzling effect and one which contrasted greatly with the exterior.

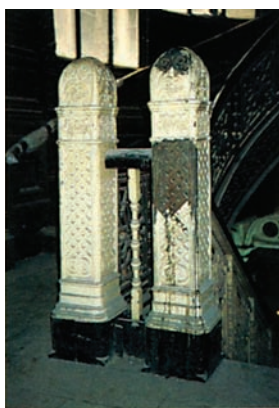
FIGURE 6. *The Rookery, oriel stair newel posts, above, overpainted condition before restoration.*

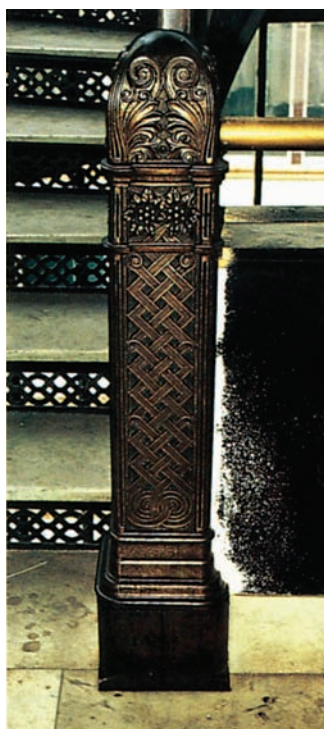
FIGURE 7. *The Rookery, oriel stair, near right, eleventh-floor newel post and stair risers cleaned and lacquered to reveal original patinated copperplate on the newel post black and Bower-Barff finish on the stair risers.*

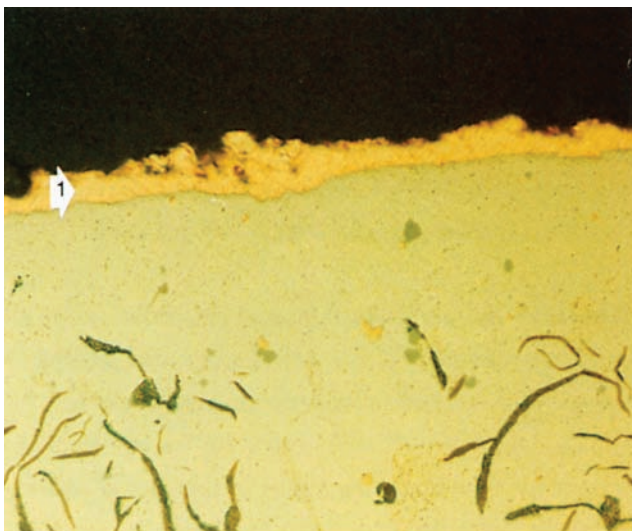
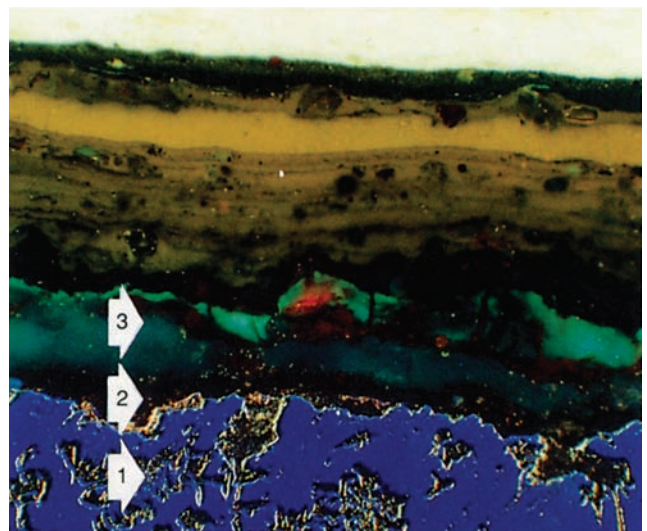
Although it is possible that the thin cuprous layer found above the iron and below the resinous layer is fallout from cuprous “bronzing” powders used in the overlying varnish, it is more likely that the highlighting designated as “gold bronze not too freely used” on the drawings was additional enhancement with tinted varnish of the overall patinated copper electroplate. Such practices employing varnishes, cuprous bronzing powders, or both on both plated and painted iron surfaces were frequently practiced as described in the trade manuals.⁴¹

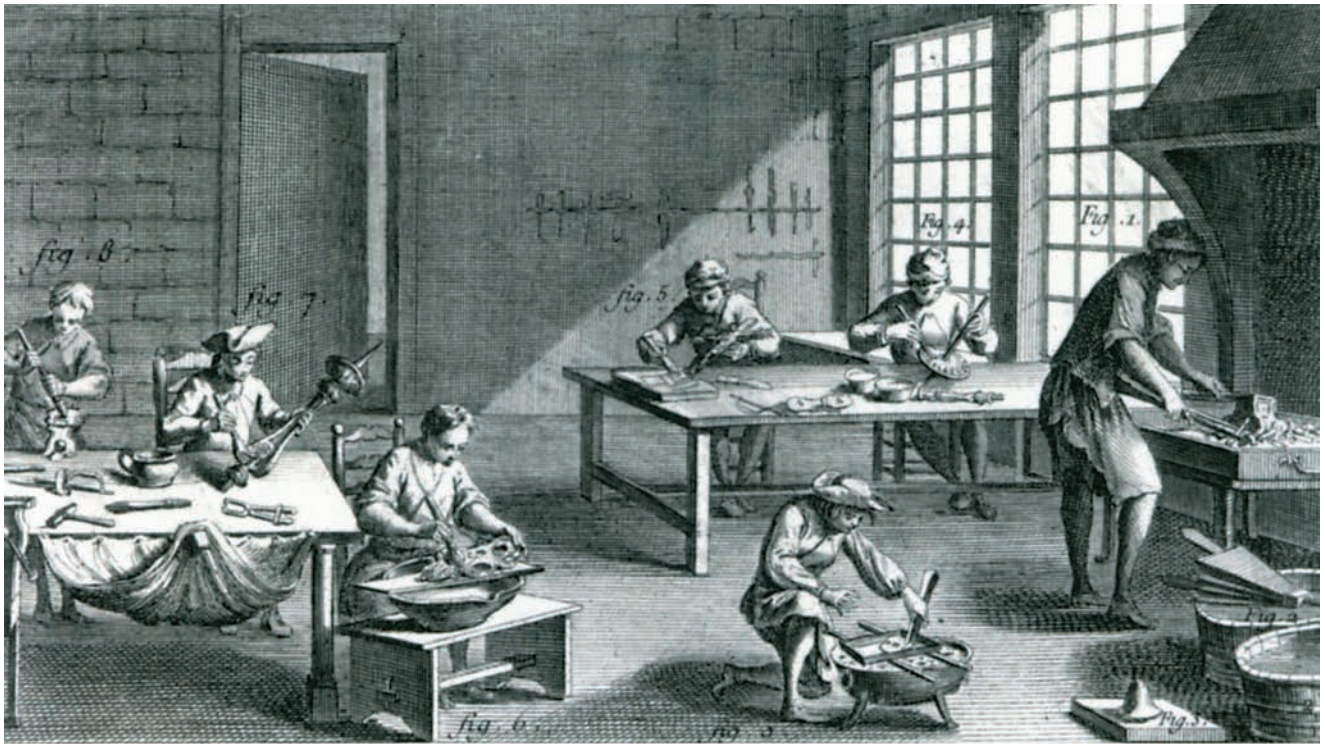
FIGURE 1. *The metal gilder's workshop, detail of plate I from Diderot's Encyclopédie (Diderot and d'Alembert 1751–57).*

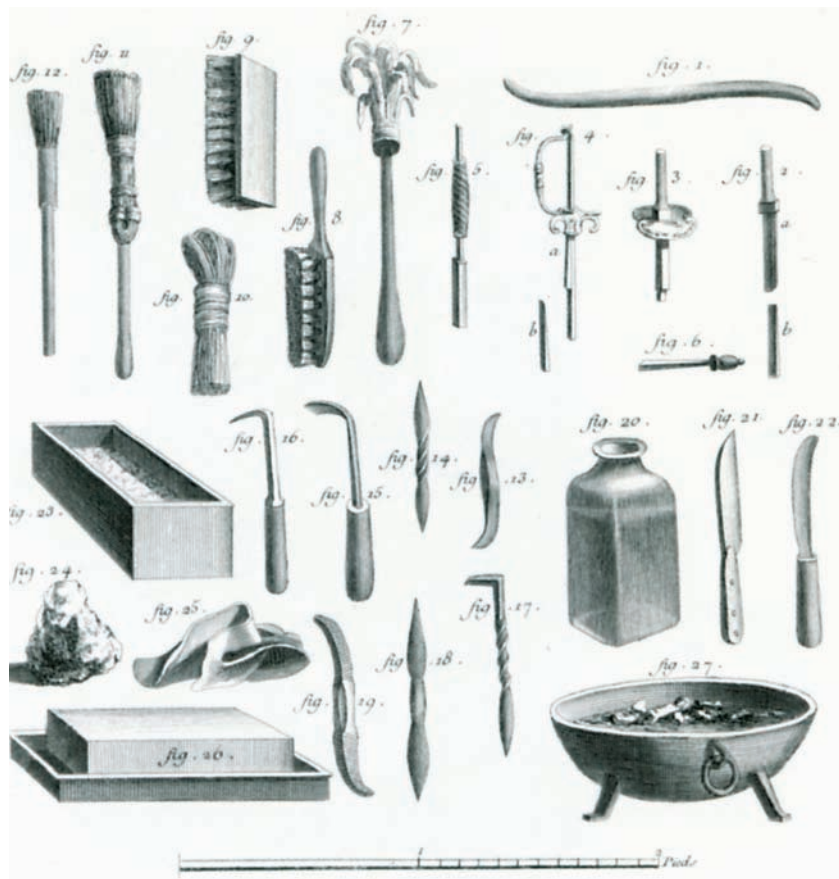
contact with it in England's hat trade during the nineteenth century. Ravrio, a successful manufacturer of gilt-bronze, left a legacy of 3,000 francs in his will to be awarded by the Academie des Sciences to anyone who found a method of gilding that avoided the hazards of mercury. It was awarded to the chemist d'Arcet in 1818 for his adaptation of the muffle kiln to improve chimney drafts and conduct fumes away from the workers. However, the only precautions visible in Diderot's workshop are the hood above the fireplace to collect rising fumes and the door at the back which is left ajar for ventilation (Fig. 1). D'Arcet remarks that more workers were poisoned in winter than in summer, as the doors and windows which created drafts and allowed fumes to escape were often closed in cold weather (d'Arcet 1818:ch. 13).

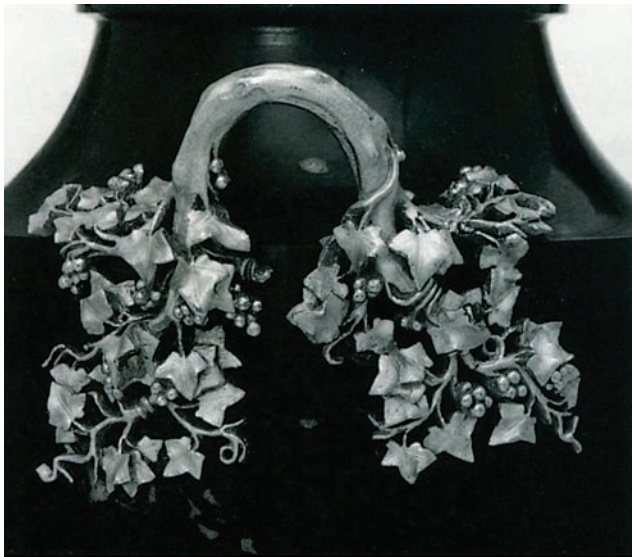
FIGURE 4. *Handle of a vase, detail, above left. Black marble and gilt bronze, France, ca. 1780. This magnified detail shows the use of matt gilding to enhance the naturalistic qualities in the modeling of the ivy branch and leaves. Jones Collection, Victoria and Albert Museum, London, inv. no. 1144-1882.*

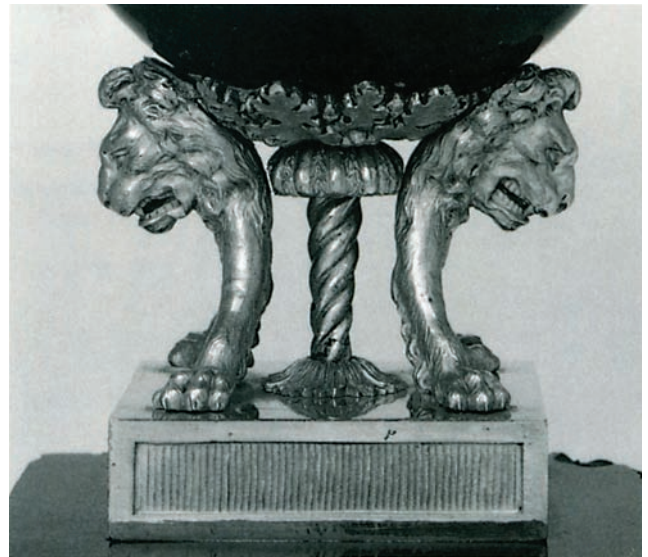
FIGURE 5. *Foot of the vase shown in Figure 4, detail, above right. Note both matt and burnished gilding; matt gilding is applied to the highly modeled faces of the lions, while mirrorlike burnished gilding is employed on the plinth.*

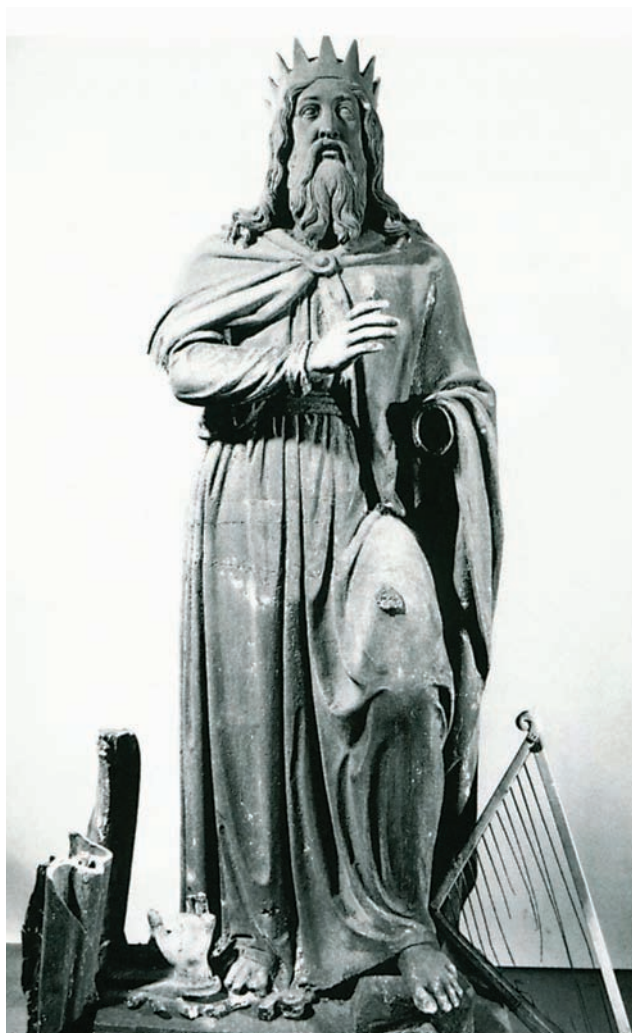
who was also Thorvaldsen's pupil. Christiansborg Castle burned down in 1884, and only fragmentary remnants of this sculpture remain today. In 1852 Borup left Denmark for the United States and settled in New Haven, Connecticut, where he remained until his death. His work in America, if any, is unknown.

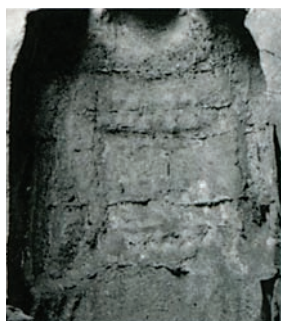
FIGURE 2. *Detail of the inside surface of one of the statues from the church of St. Ansgar.*

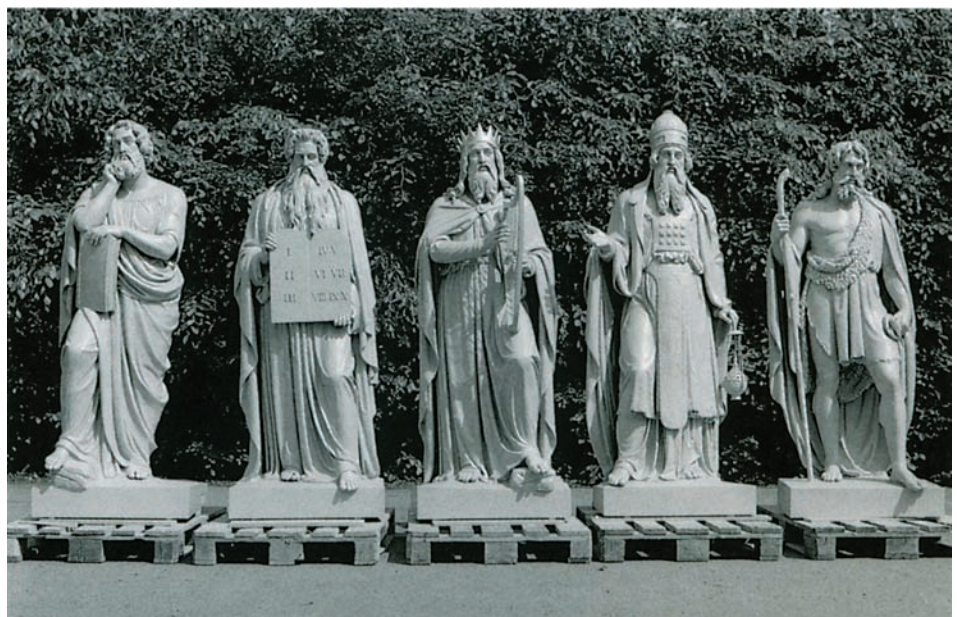
OTHER ZINC CASTING IN DENMARK

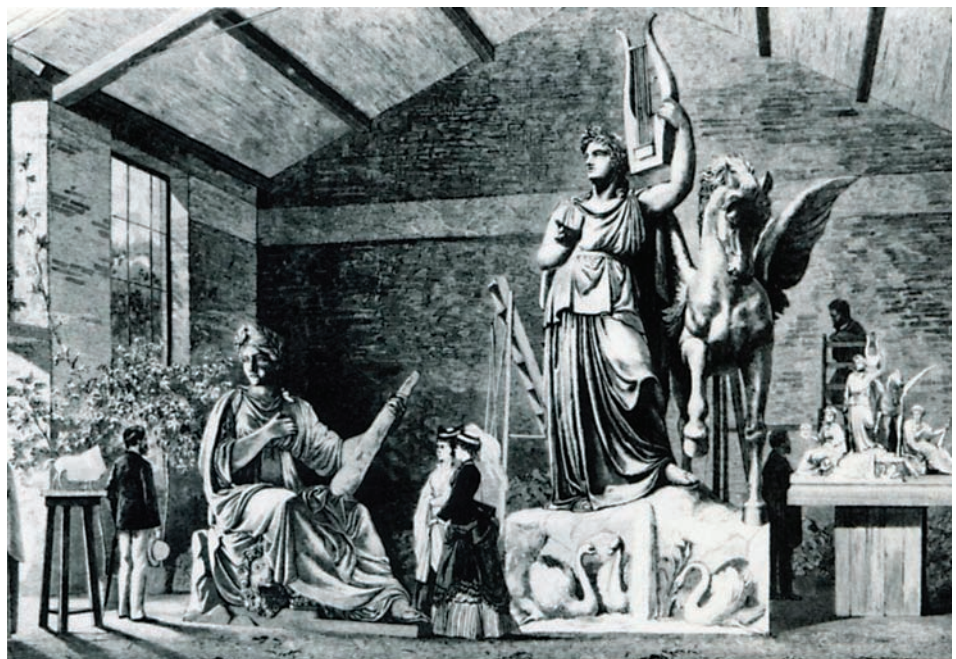
out and the project was canceled. For more than a century the unfinished building stood as a picturesque ruin in the middle of the otherwise fashionable town quarter. Many proposals for renovation were introduced. Finally in 1874 the ruin was bought by Carl Frederik Tietgen, a finance magnate and bank director who hired the architecture professor Ferdinand Meldahl to build a church on the existing foundations.

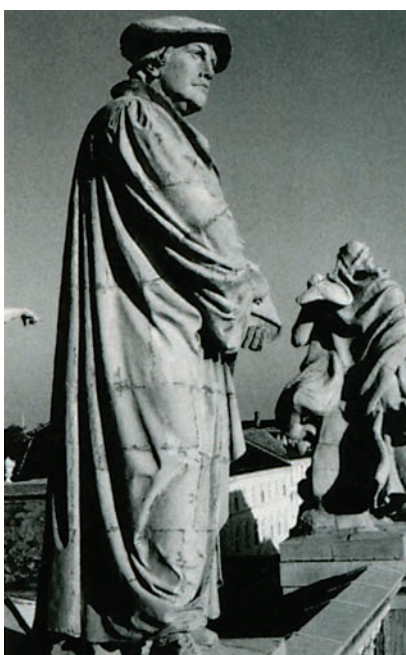
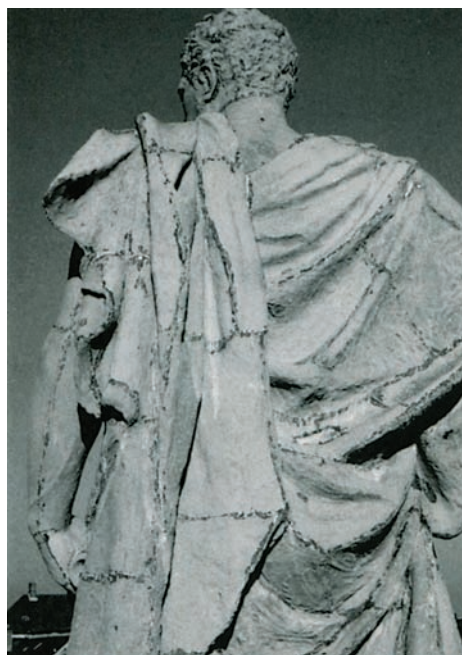
FIGURE 8. *Detail, far right, of one of the figures from Frederiks Church showing tin-solder seams standing out against the corroded zinc surface.*

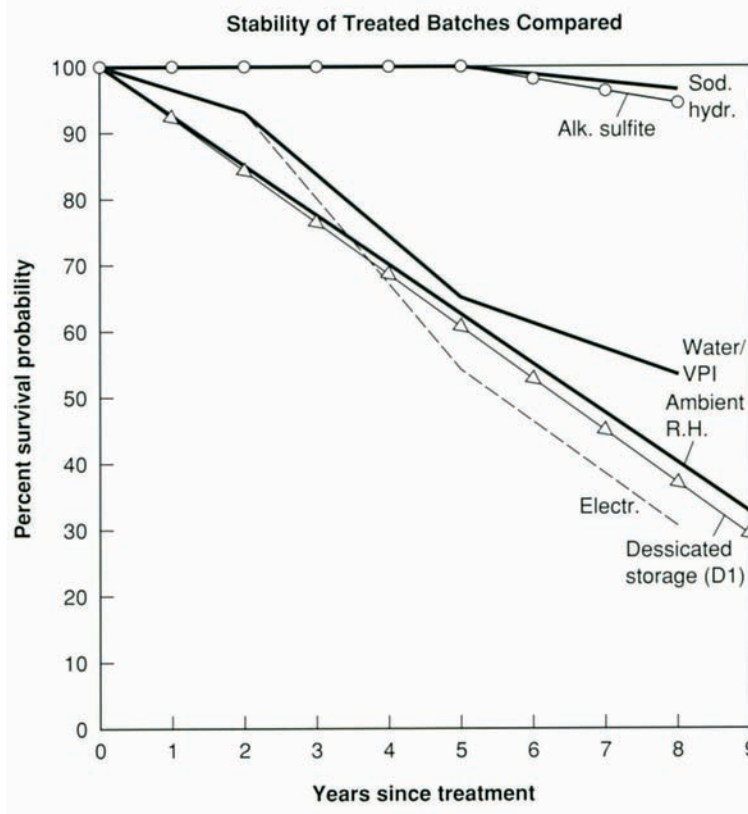
TABLE 4. Percent survival probabilities at Year T for all the assessed batches.

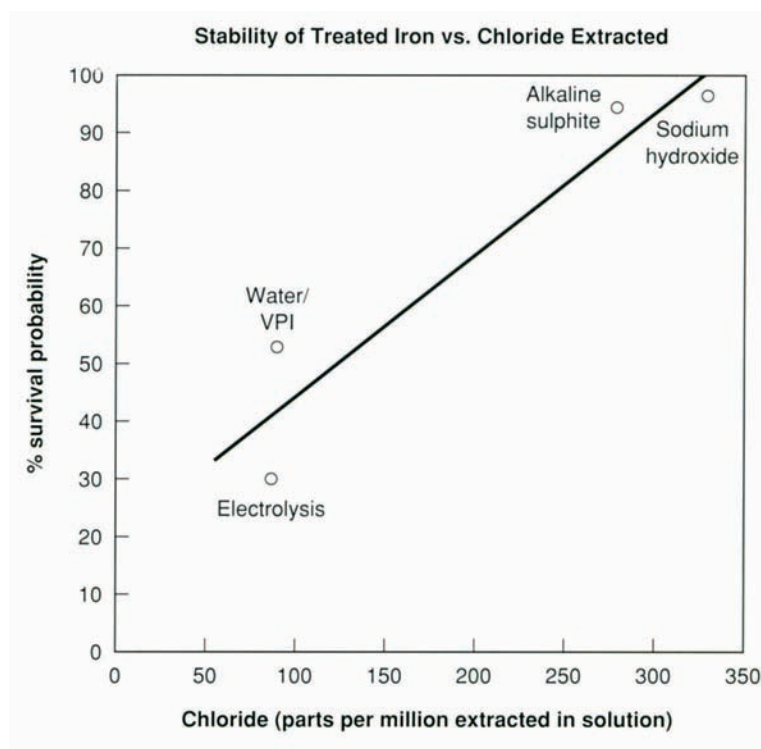
Pretreatment using electrolysis had a markedly adverse effect on the stability of the objects. This procedure was used to make the corrosion layers separate more easily for cleaning delicate, decorated surfaces; and it accomplished this purpose very effectively. It was postulated that electrolysis would make the mineral layers more porous and allow soluble chloride to escape more easily during subsequent soaking. Perhaps this pretreatment also allows oxygen and humidity to penetrate more easily during subsequent storage. If this is the course of its lack of success, then it may be possible to prevent this effect by consolidating the corrosion layers.

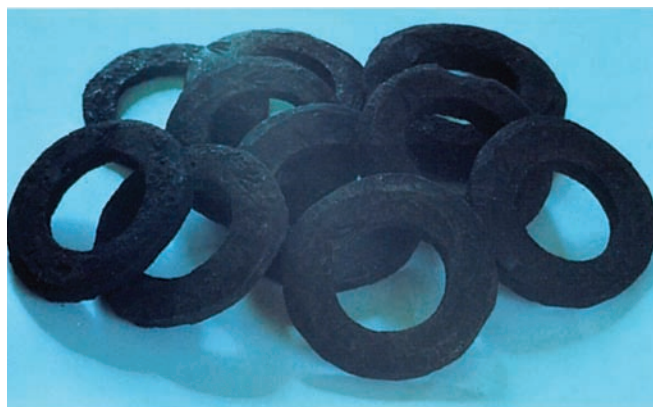
FIGURE 2. Bronze sheathing tacks from the HMS *Sirius*.

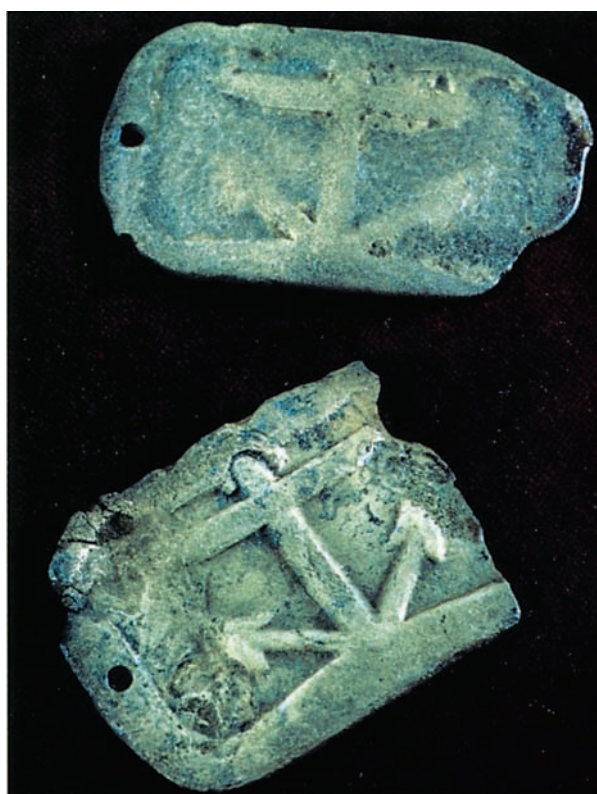
HISTORICAL BACKGROUND

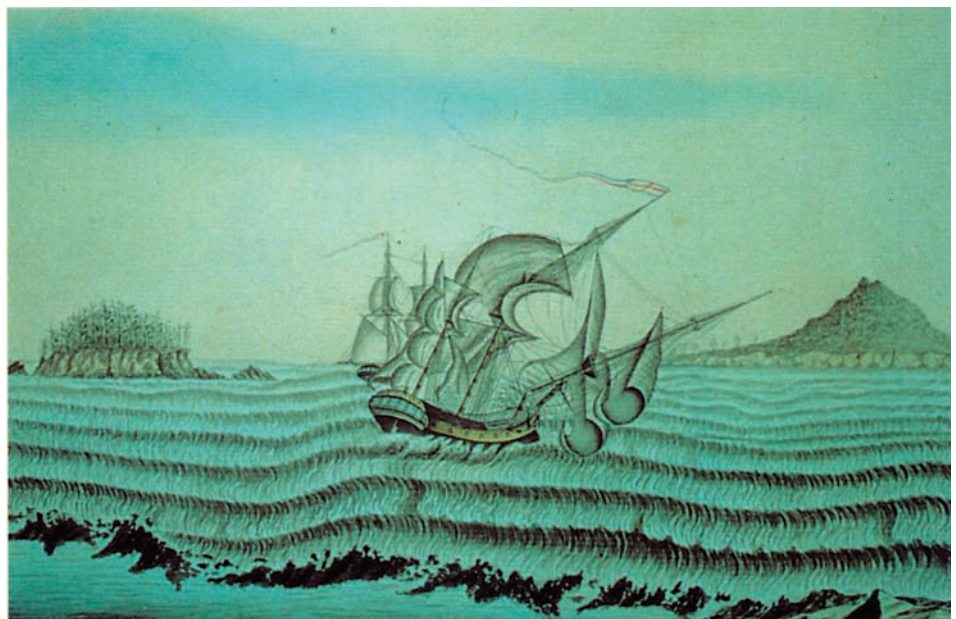
anchors, and one remaining carronade. Smaller artifacts are either trapped within the coralline corrosion matrices or under the ballast. The warm seawater (20.80 ± 1.96 °C), a mean annual salinity of 35.77 ± 0.04 ppt, and dissolved-oxygen levels of 7.7 ± 0.3 ppm constitute a highly corrosive environment for these objects.

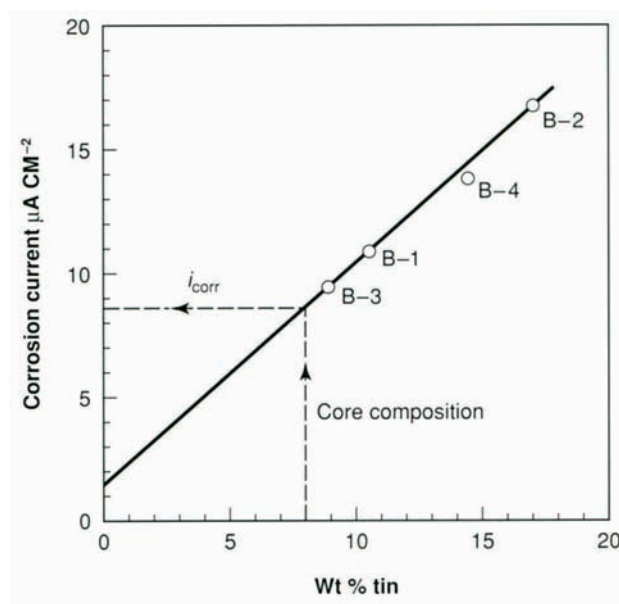
recovered from other less aggressive sites. Interestingly, the corrosion of archaeological bronzes on land sites is similar to that of bronze objects found in marine sites with a low level of oxygenation.

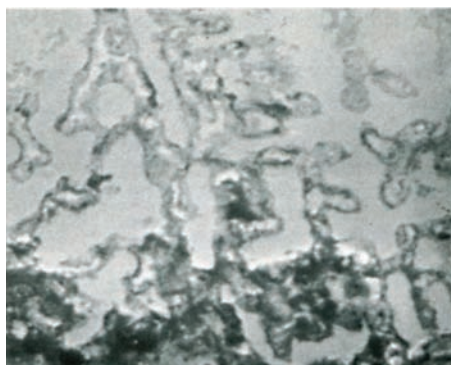
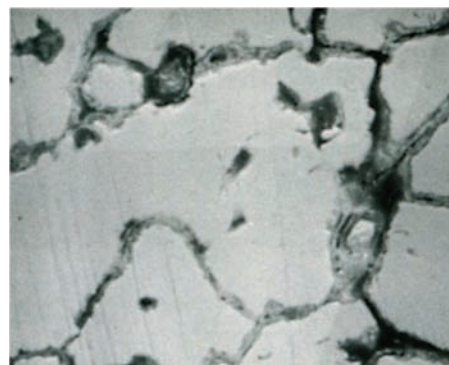
FIGURE 7. A scanning electron micrograph of the intergranular corrosion on a copper clinch ring (SI 254). Full width of the image is 306 μm .

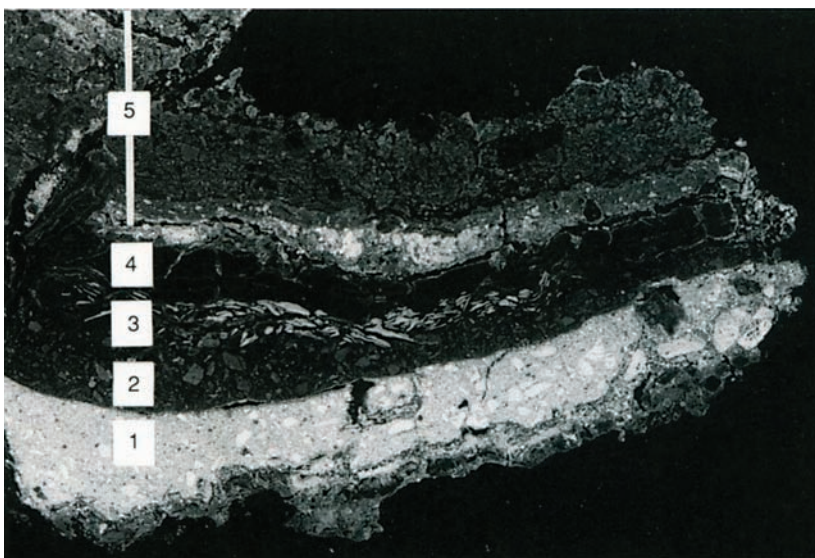
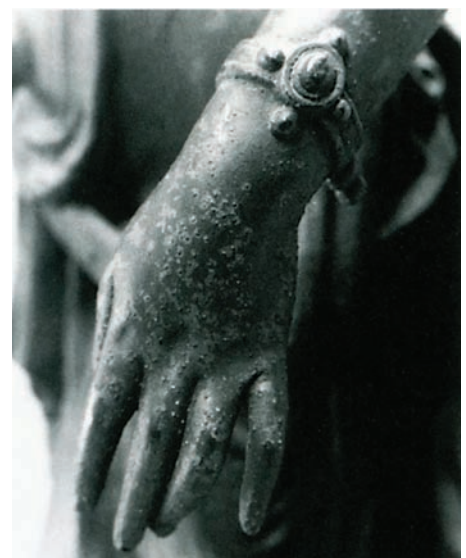
analyzed. On the sculpture of Puck, the leaf gold was applied over a white lead paint (Keck et al. 1983).

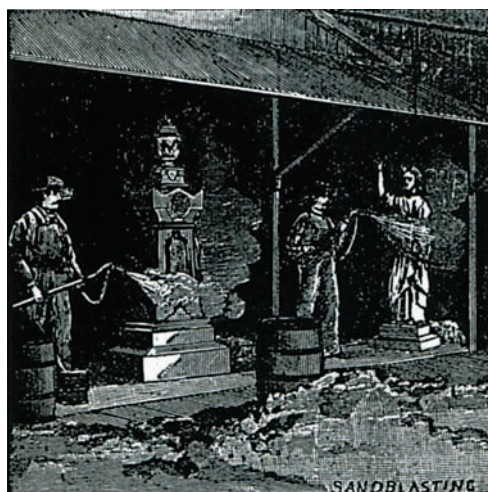
duction of large quantities of zinc sculptures (Servant 1880:7). The molten zinc was poured into open bronze molds and the excess immediately poured back out, leaving a layer of zinc. This process was quick, and many copies could be made that retained fine details from the bronze molds, precluding the need for expensive chasing. However, the process permitted no undercutting within individual castings, and only relatively small sections were produced because the mold size was limited to that which a man could hold and pour. An 1871 advertisement for American show figures notes “a heavy outlay for Design, Moulds &c.” This suggests that metal molds might have been purchased. By contrast, sand molds would have been remade for each casting (Fried 1970:34).

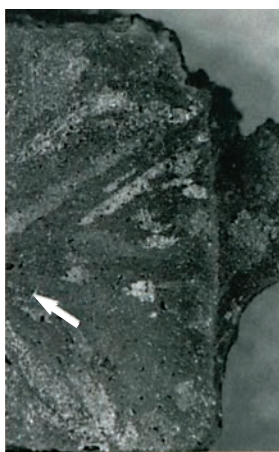
FIGURE 4. *Macrophotograph of a cross section of zinc from Columbia, sculpted by Caspar Buberl, 1890, Smithsonian Institution, Washington, D.C. Note columnar grains in the sand-cast zinc; an iron-zinc intermetallic particle is indicated with an arrow. The sample was taken from the edge of a casting; solder is visible at the right. Magnification $\times 15$.*

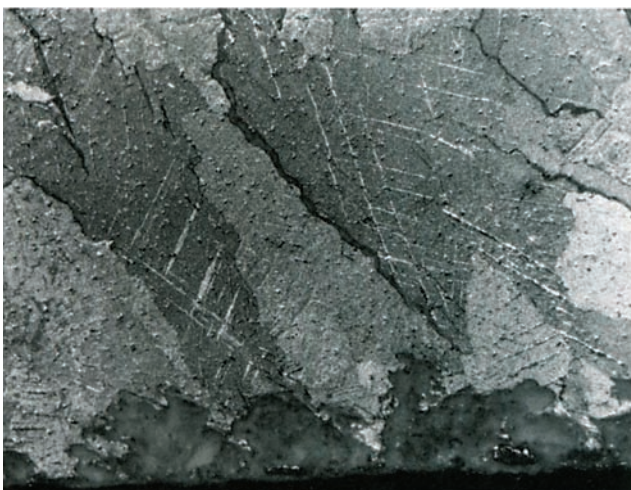
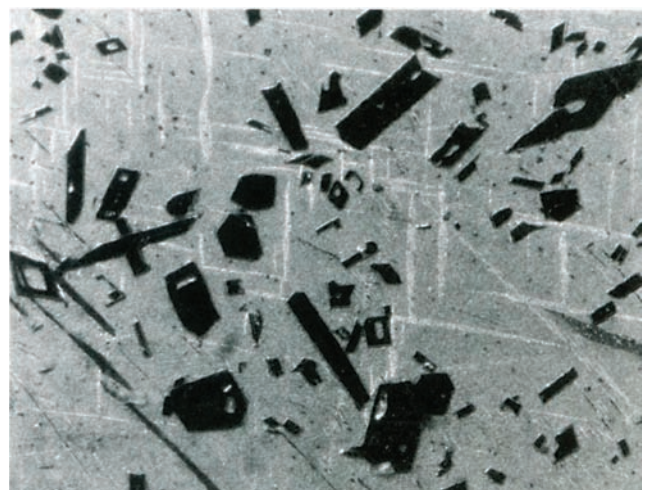
FIGURE 7. *Soldiers' Monument, Winneshiek County Courthouse, Decorah, Iowa, sand-cast and sandblasted by the Western White Bronze Company, 1886.*

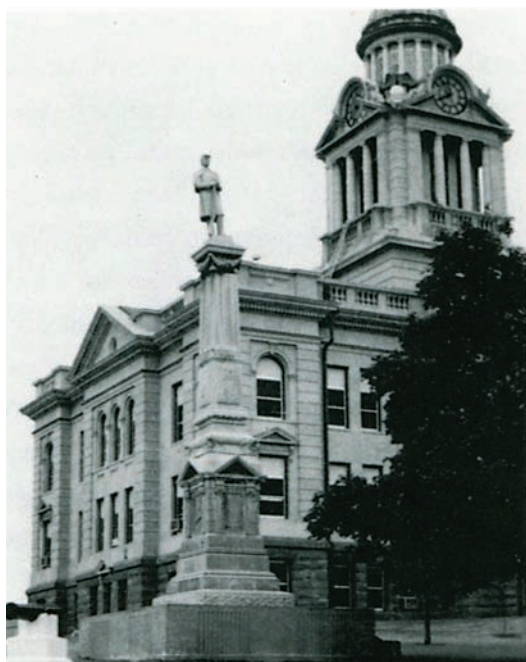
monuments located in rural environments display little apparent surface loss or pitting. However, metallographic examination of sections taken from sculptures such as the Fourth Ohio Infantry Monument at Gettysburg shows some attack at the grain boundaries.

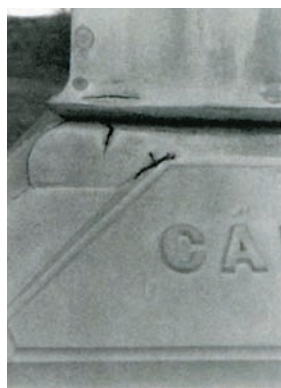
FIGURE 8. *Detail of stress cracks, Fourth Ohio Infantry Monument, Gettysburg National Military Park, Gettysburg, Pennsylvania, sand-cast and sandblasted by the Monumental Bronze Company, 1887.*

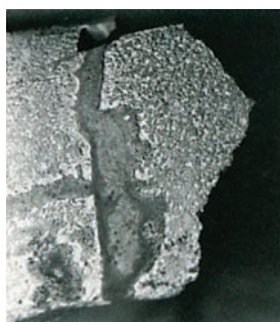
FIGURE 9. Detail of the severely corroded right wrist, Neptune Fountain. Dark material is lead-tin solder.

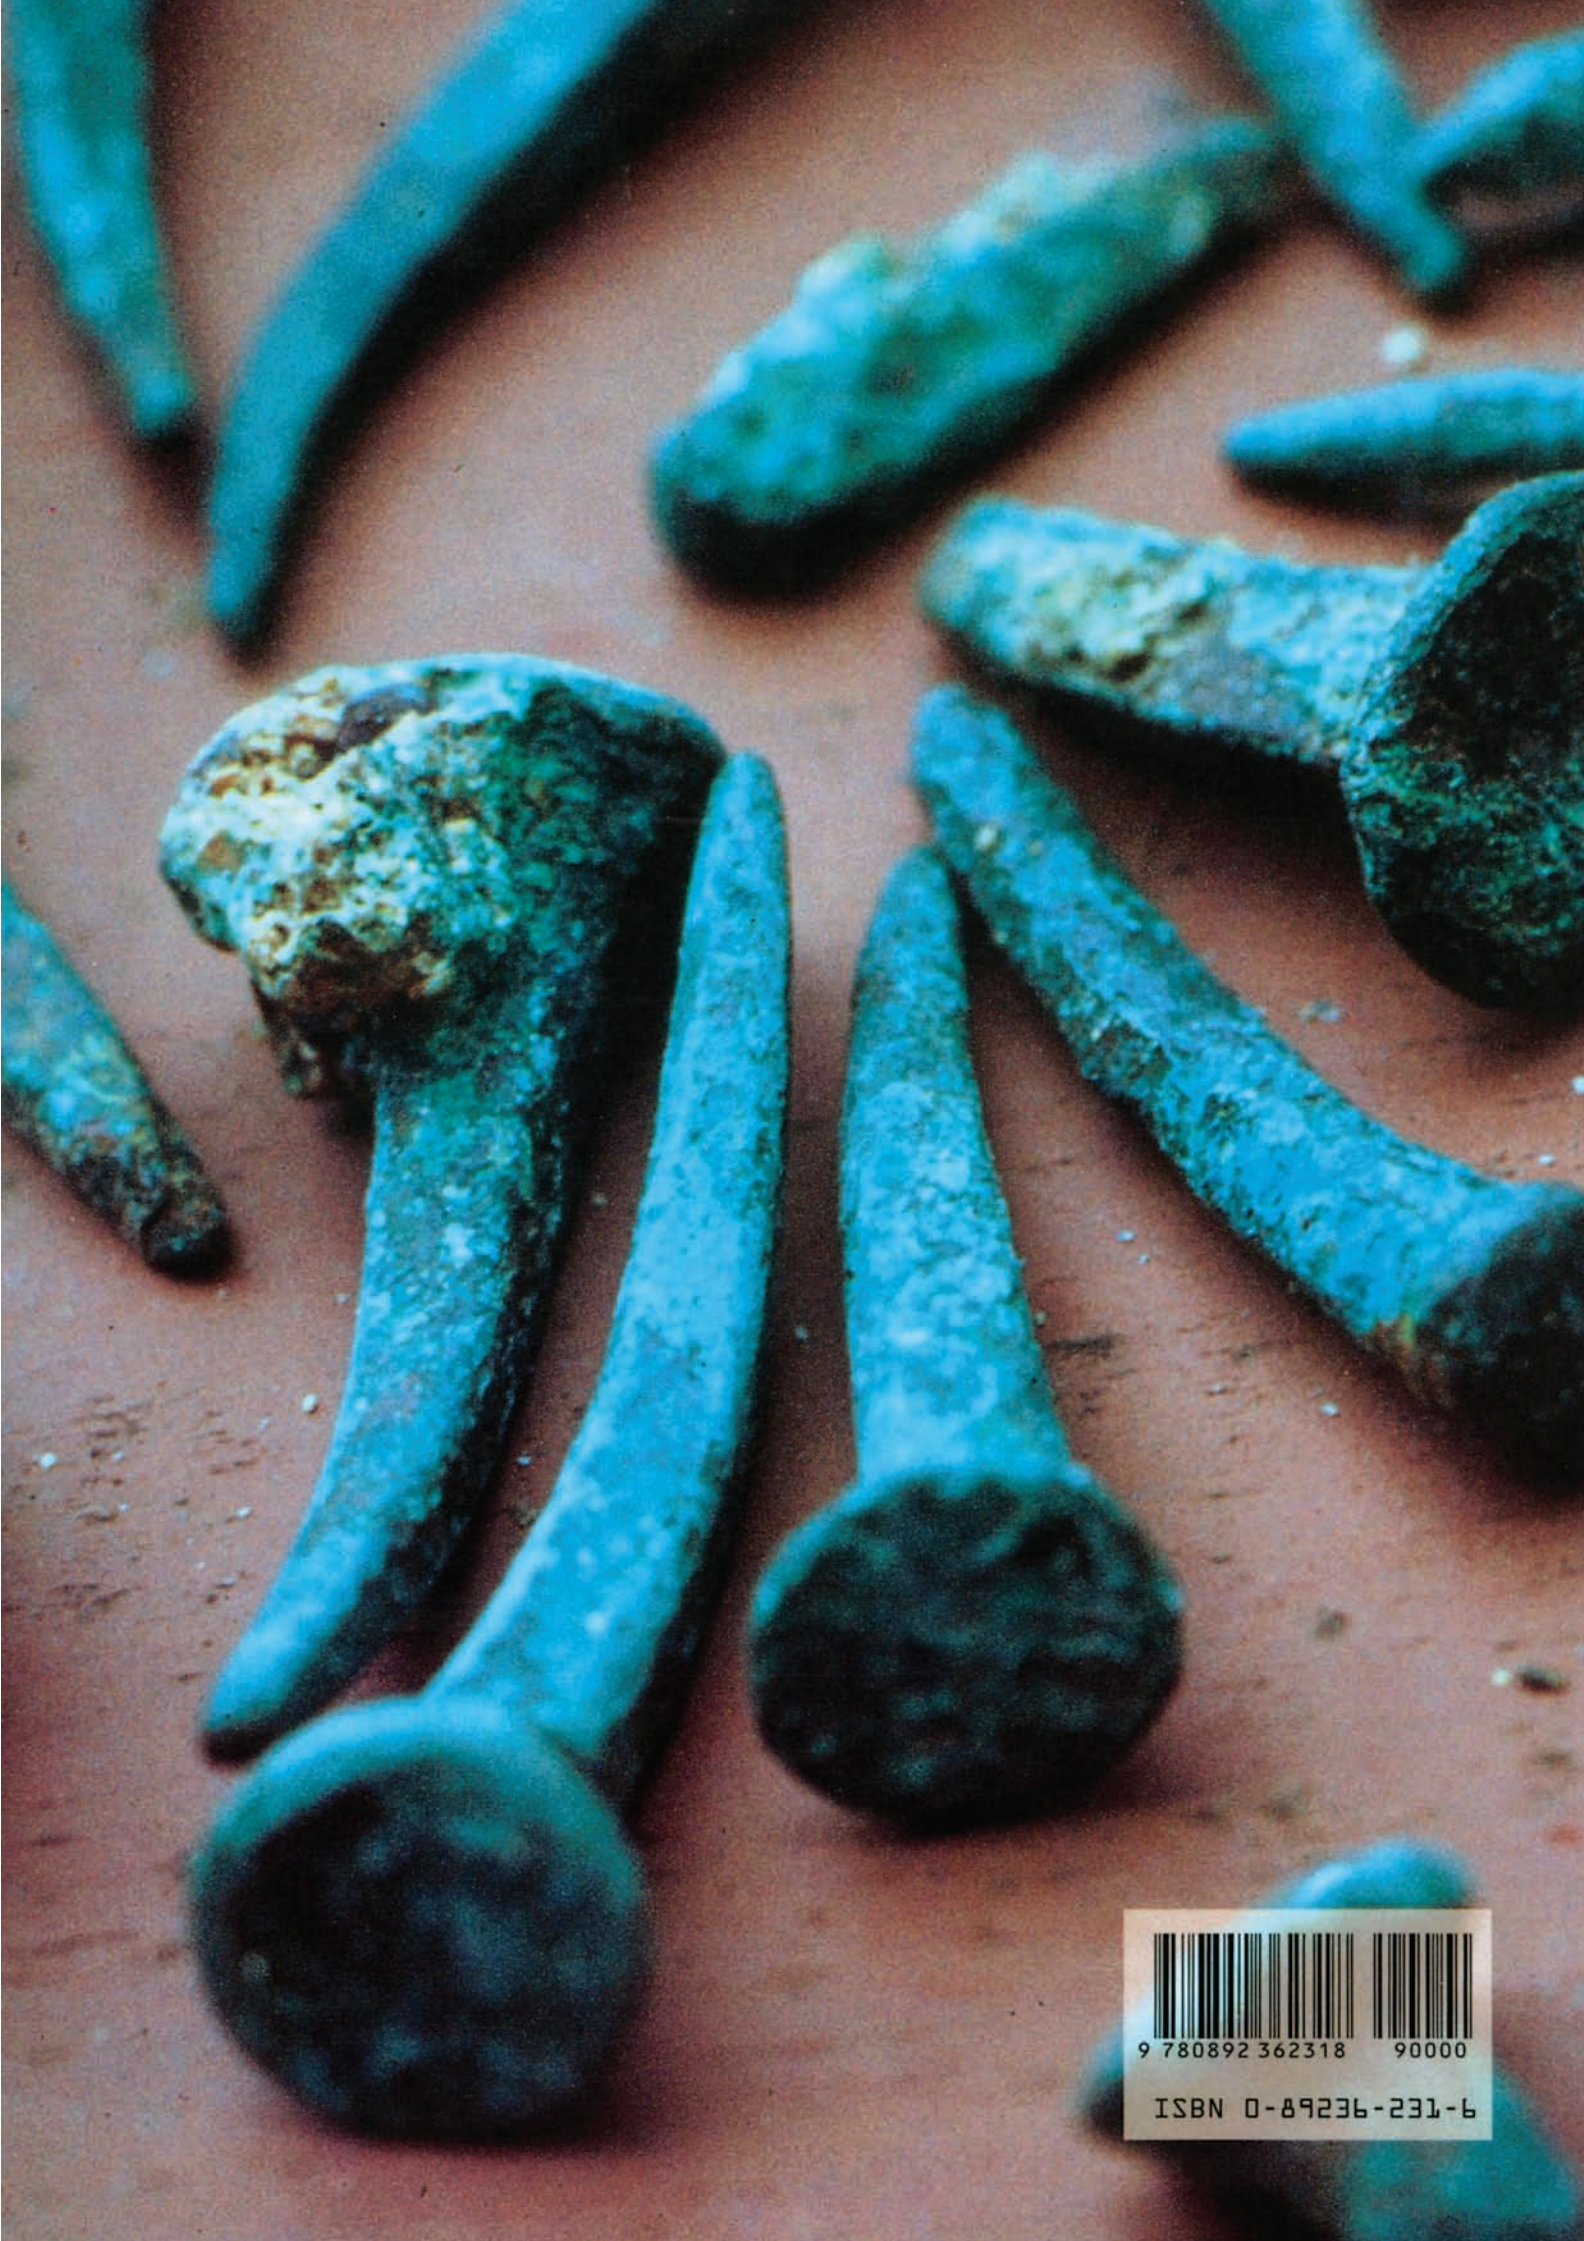
9 780892 362318 90000
ISBN 0-89236-231-6
