BEIRA CENTRAL STATION

CONSERVATION MANAGEMENT PLAN

Elisiário Miranda and Paulo B. Lourenço (coords.)

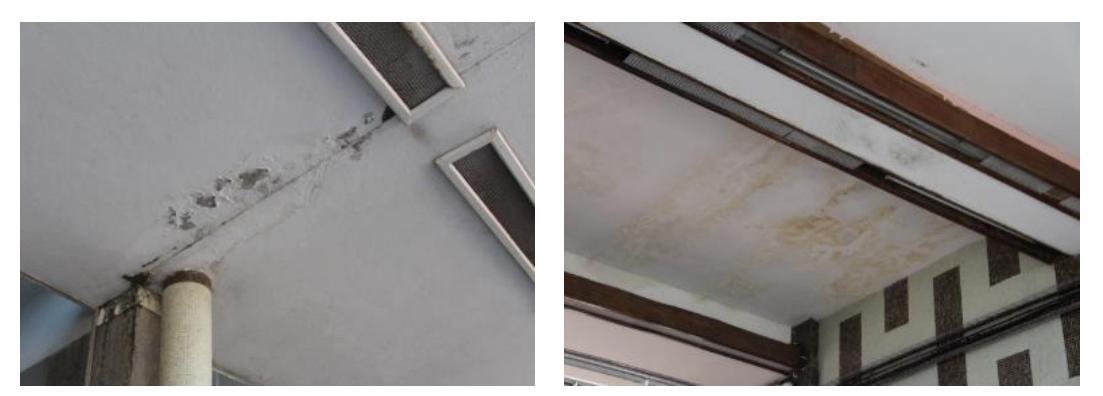
Figure 4.44 Bottom of concrete slab at the transition space between the administration building and platforms' area.

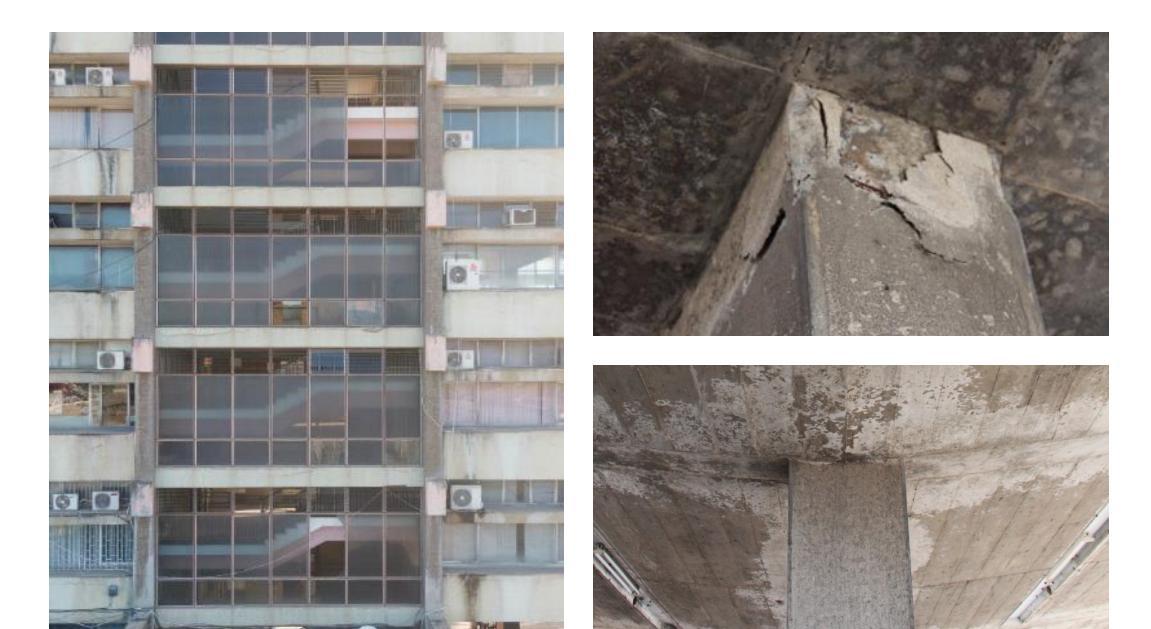
Figure 4.51 Broken glazing on the rear façade of the public atrium.

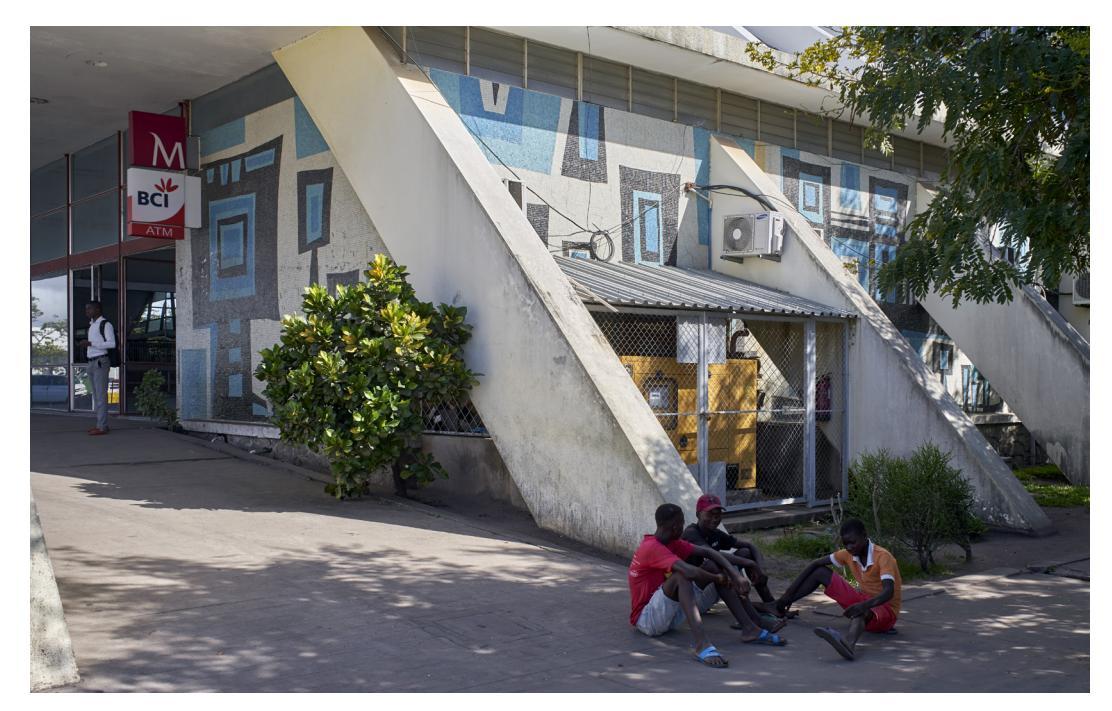
Figure 4.62 Current state of the *Triage* glass mosaic mural in the public atrium block façades (EM, 2020)

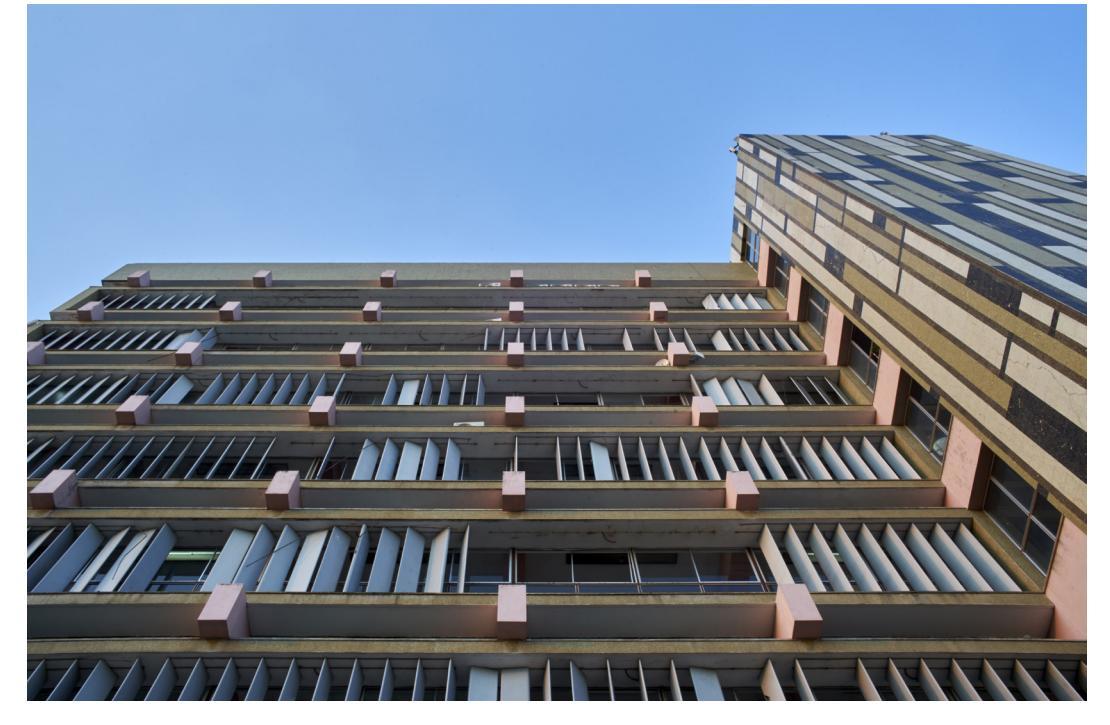
Figure 5.8 Main façade of the administration block showing missing *Brise-soleil* (EM, 2019).

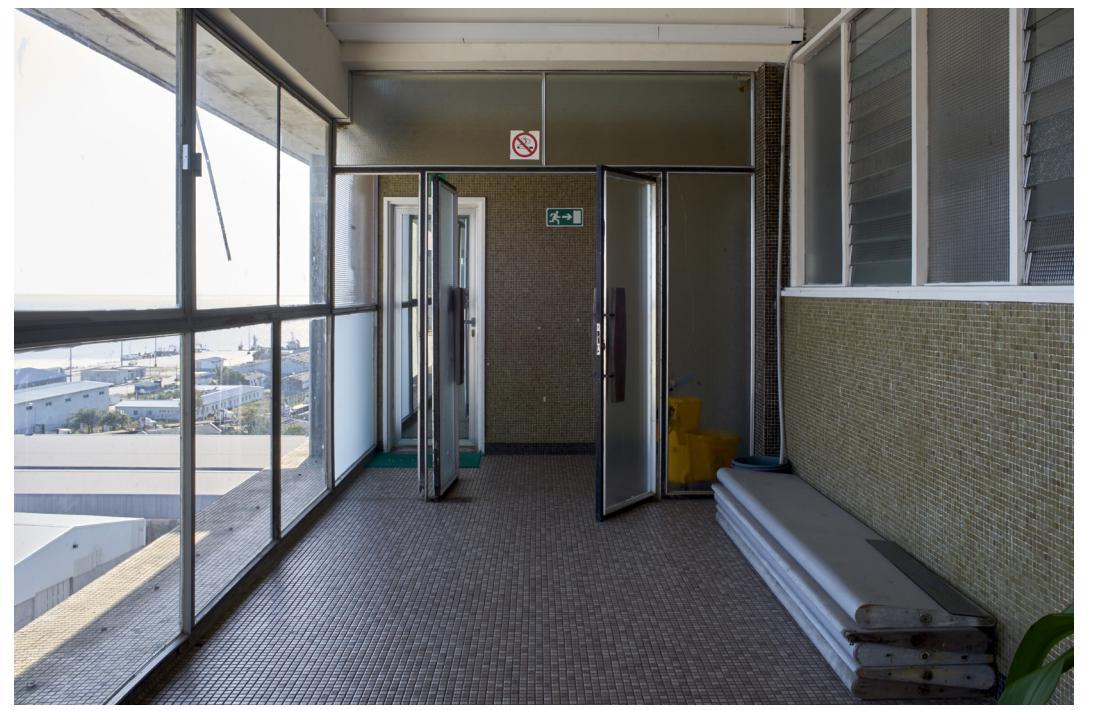
Figure 5.10 *Brise-soleil* from the main façade of the administration block torn off by Hurricane Idai (EM, 2019).
