TBILISI CHESS PALACE AND ALPINE CLUB

CONSERVATION MANAGEMENT PLAN

TBILISI 2021

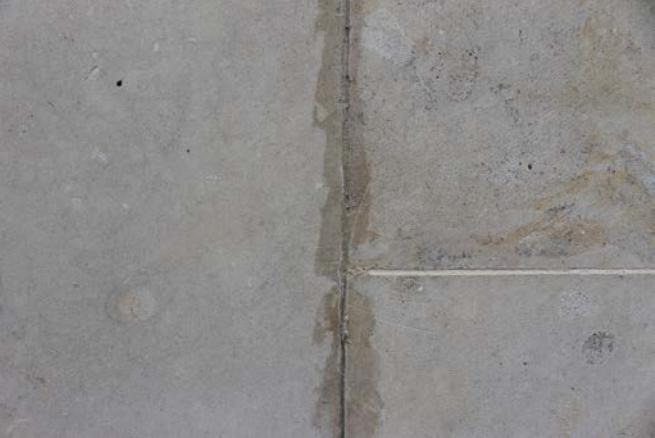
In the process of rehabilitation, the original technique of cladding and pattern of laying the tiles on the façade was neglected. The tiles were attached to the support using cement mortar and small screws. The joints between the tiles

Replaced stone cladding of the façade in 2018.

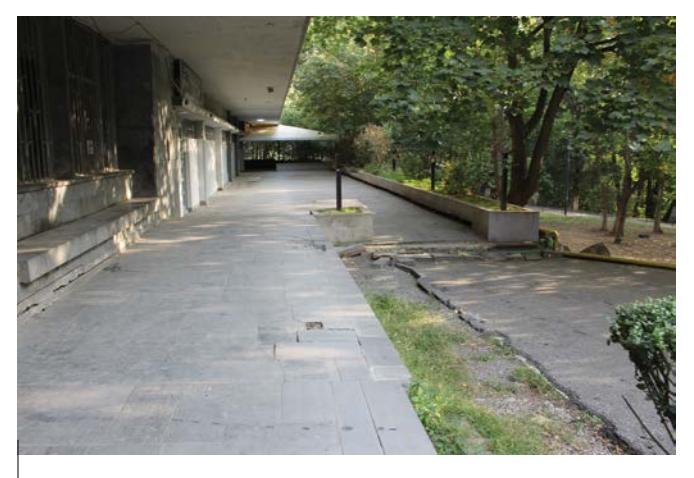
The damage is linked to the infiltration of atmospheric precipitation, caused by the wrong location of water diversion pipes on the roof and balconies, as well as the absence of drainage and runoff water channels.

A Terrace on the Basement Floor. East Side of the Building. 2018

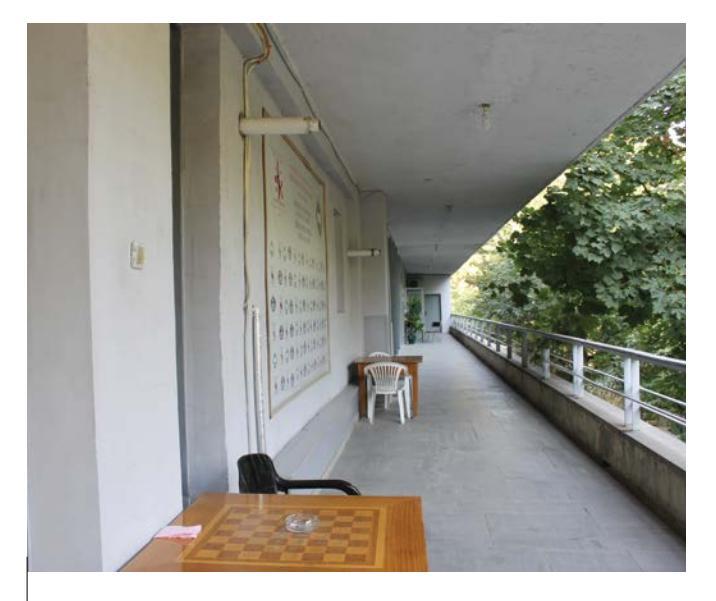
Metal Railing - the balcony's metal railing is slightly deformed, in some places - corroded, and small sections are removed from it.

Balcony on East Façade. 2018

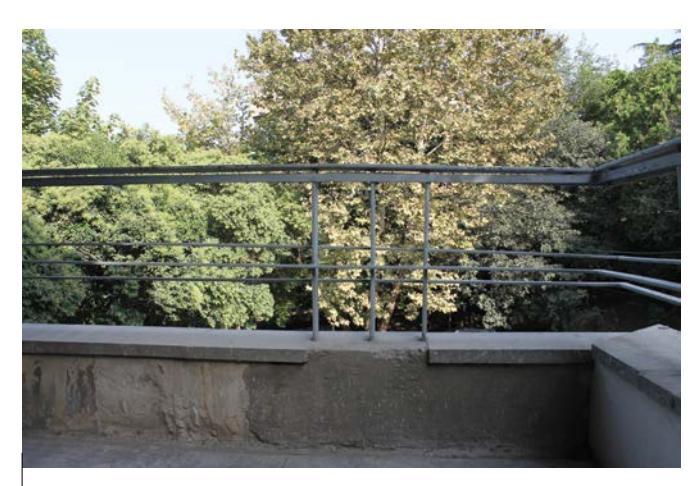
The causes of damage, as in many other cases, is the lack of proper and continuous maintenance and improper repair works. For these reasons, the balconies are not protected against the aggressive impact of environmental factors. One of the reasons for their deformation can be the movement of concrete casting material during construction and soil settlement, another reason presumably is the presence of new additions and the impact of their weight. The traces of rainwater, existing on the ceiling are most likely caused by the absence of the drippers on the edges of balconies and in some cases their incorrect location.

Metal Railing. 2018

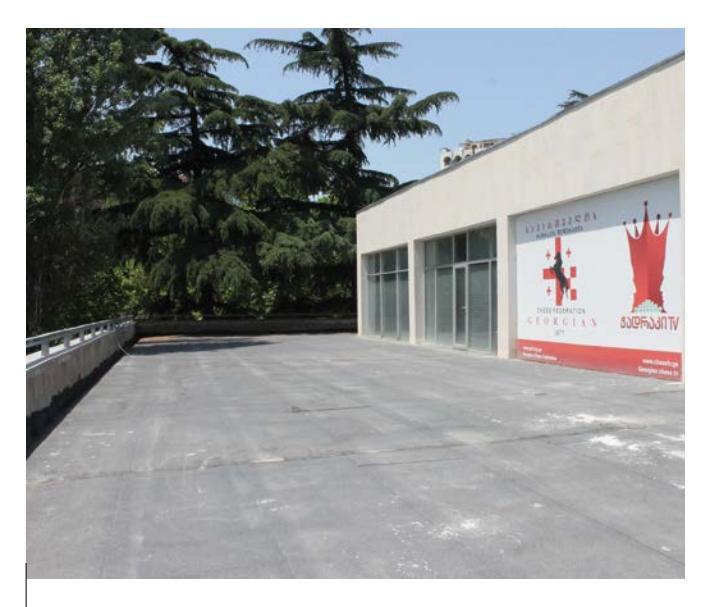
The damages are mainly caused as a result of atmospheric (exposure to water, frost, and sun), as well as mechanical impact and improper use.

Roof Terrace. 2019

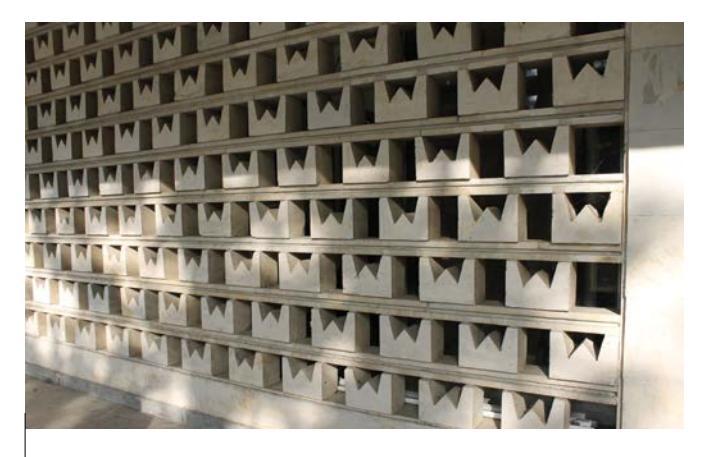
The cause of damage on the decorative limestone wall, in almost all cases, is of mechanical/physical character. Other causes are: Lack of maintenance and vandalism.

Decorative Stone Wall

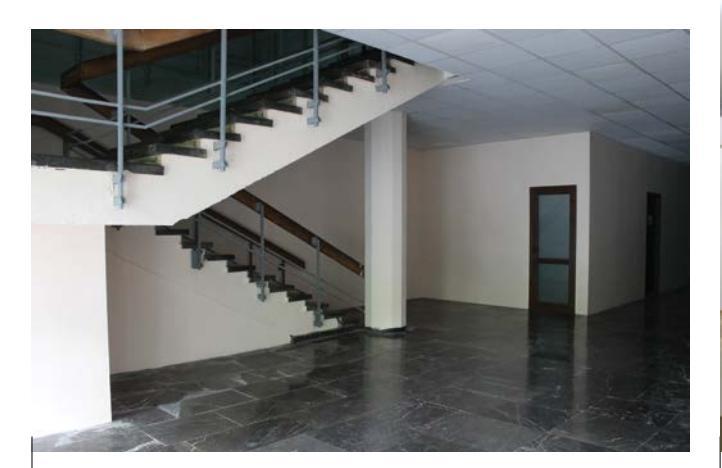
Tuff tiles cladding of the column covered with paint layer. 2018

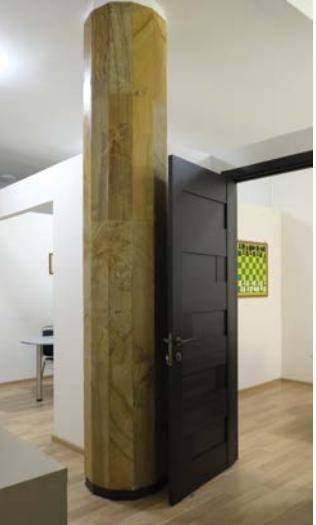
Stone cladding was damaged due to improper use and inadequate intervention. The occurrence and development of damages as a result of the lack of maintenance are also evident.

Tuff tile cladding of the column covered with the layer of varnish. 2018

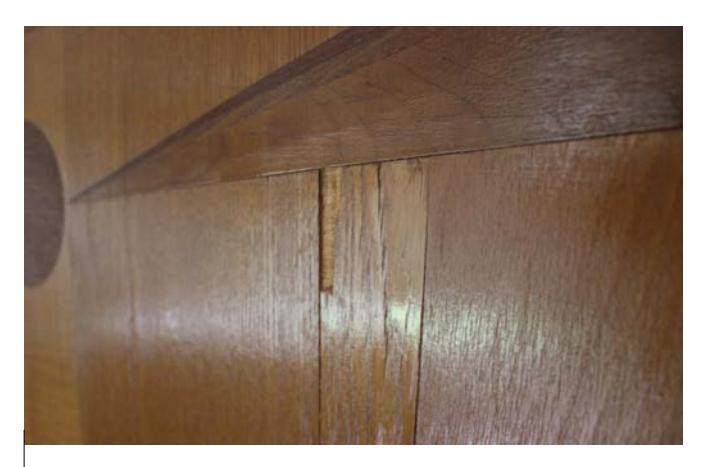
The leading cause of damage to the walls and panels is improper use and inadequate intervention. Failure of the roofing layer and rainwater disposal system caused water infiltration into the walls and led to damage. The traces of mechanical impact are also evident.

Surface Damage on Vertically Slidable Marquetry Panels

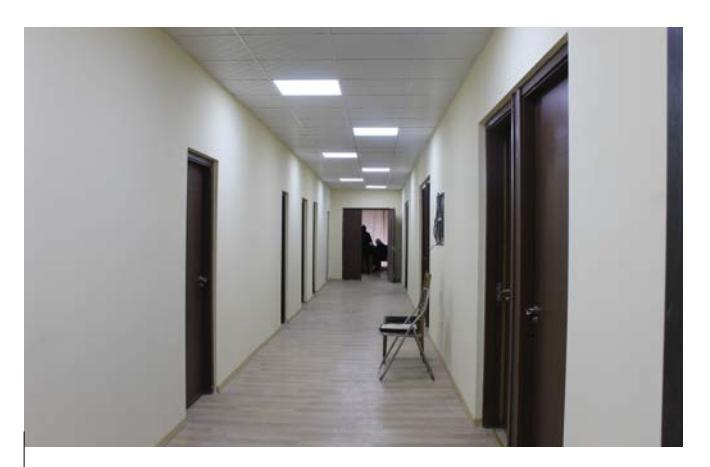
Improper use, lack of adequate maintenance, and inappropriate use of its valuable architectural elements.

Administrative Zone of the First Floor. New MDF doors

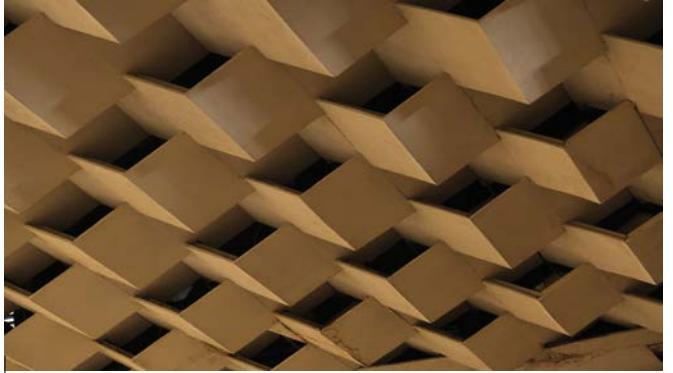
Almost all of the elements and technical details in the Main Hall are in poor physical condition. In some cases, these damages are manifested in alteration of the original appearance of these details, and in other cases – in physical and irreversible damage.

Ceiling of the Main Hall. 2019

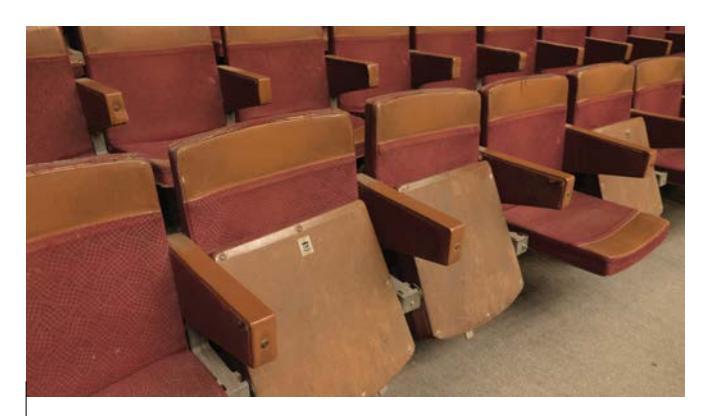
Lack of maintenance, age and wear, and improper exploitation.

Chairs of the Main Hall

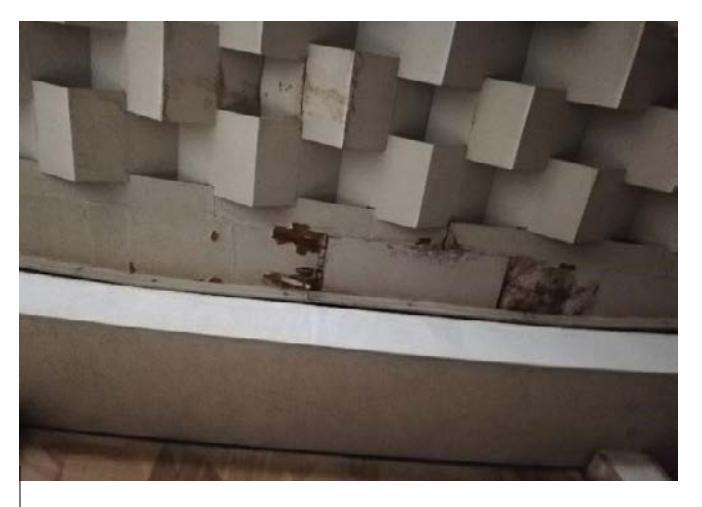
Fig. 21 The suspended ceiling in the Main Hall, damaged by roof leaks

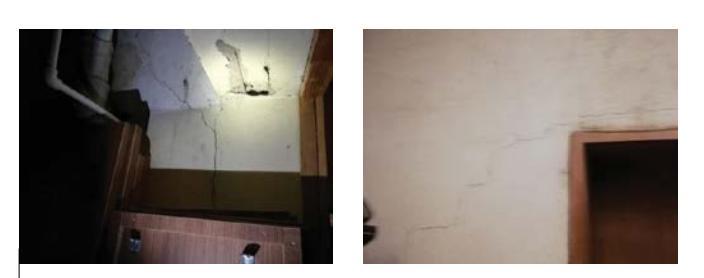
Figs. 11 and 12 Cracks in the walls of the Main Hall

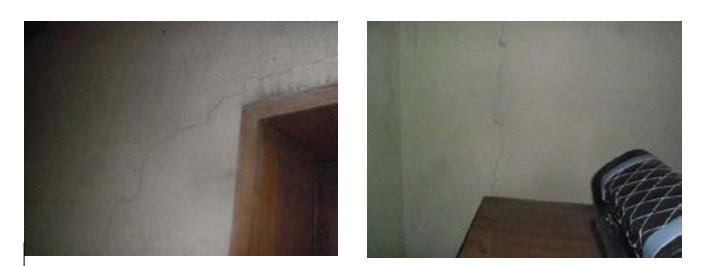
Figs. 13 and 14 Cracks in the walls of the Main Hall

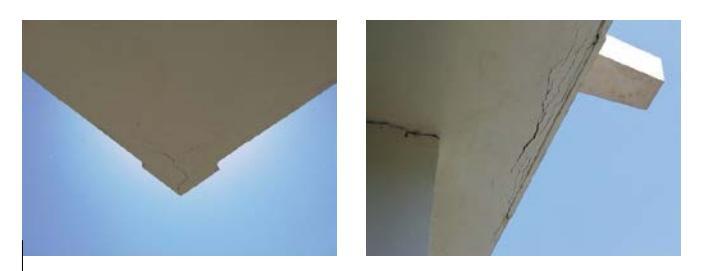
Figs. 15 and 16 Cracks in the recent plastering

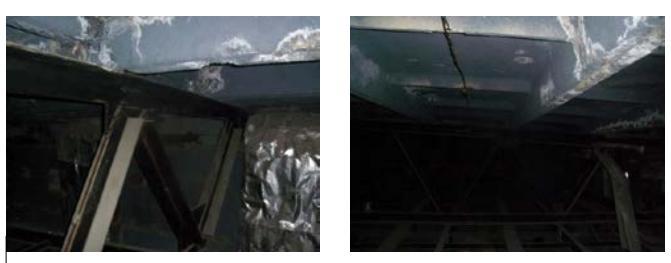
Figs. 17 and 18 Leaching in ribbed prefabricated concrete tiles arranged on metal trusses

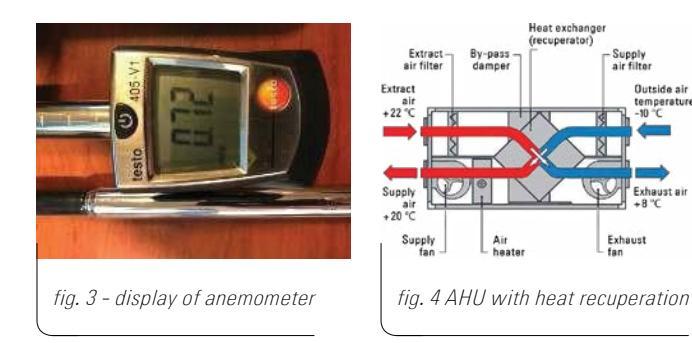
During the test measurements, an average speed of 0.72 m/s was observed in these air ducts

If we calculate this parameter, per hour 725m3 of air will enter the building and be lost from the building. When calculating energy, we get only from this one such air duct: Qi = 0,28 * Gi * C * (Tp-Ti) * k = 4,7 kW loss, which can increase 2-3 times in windy weather.
