Managing change with a living architect OCEAN SWIMMING POOL BY ÁLVARO SIZA

CONSERVATION MANAGEMENT PLAN

Teresa Cunha Ferreira (FAUP, University of Porto)

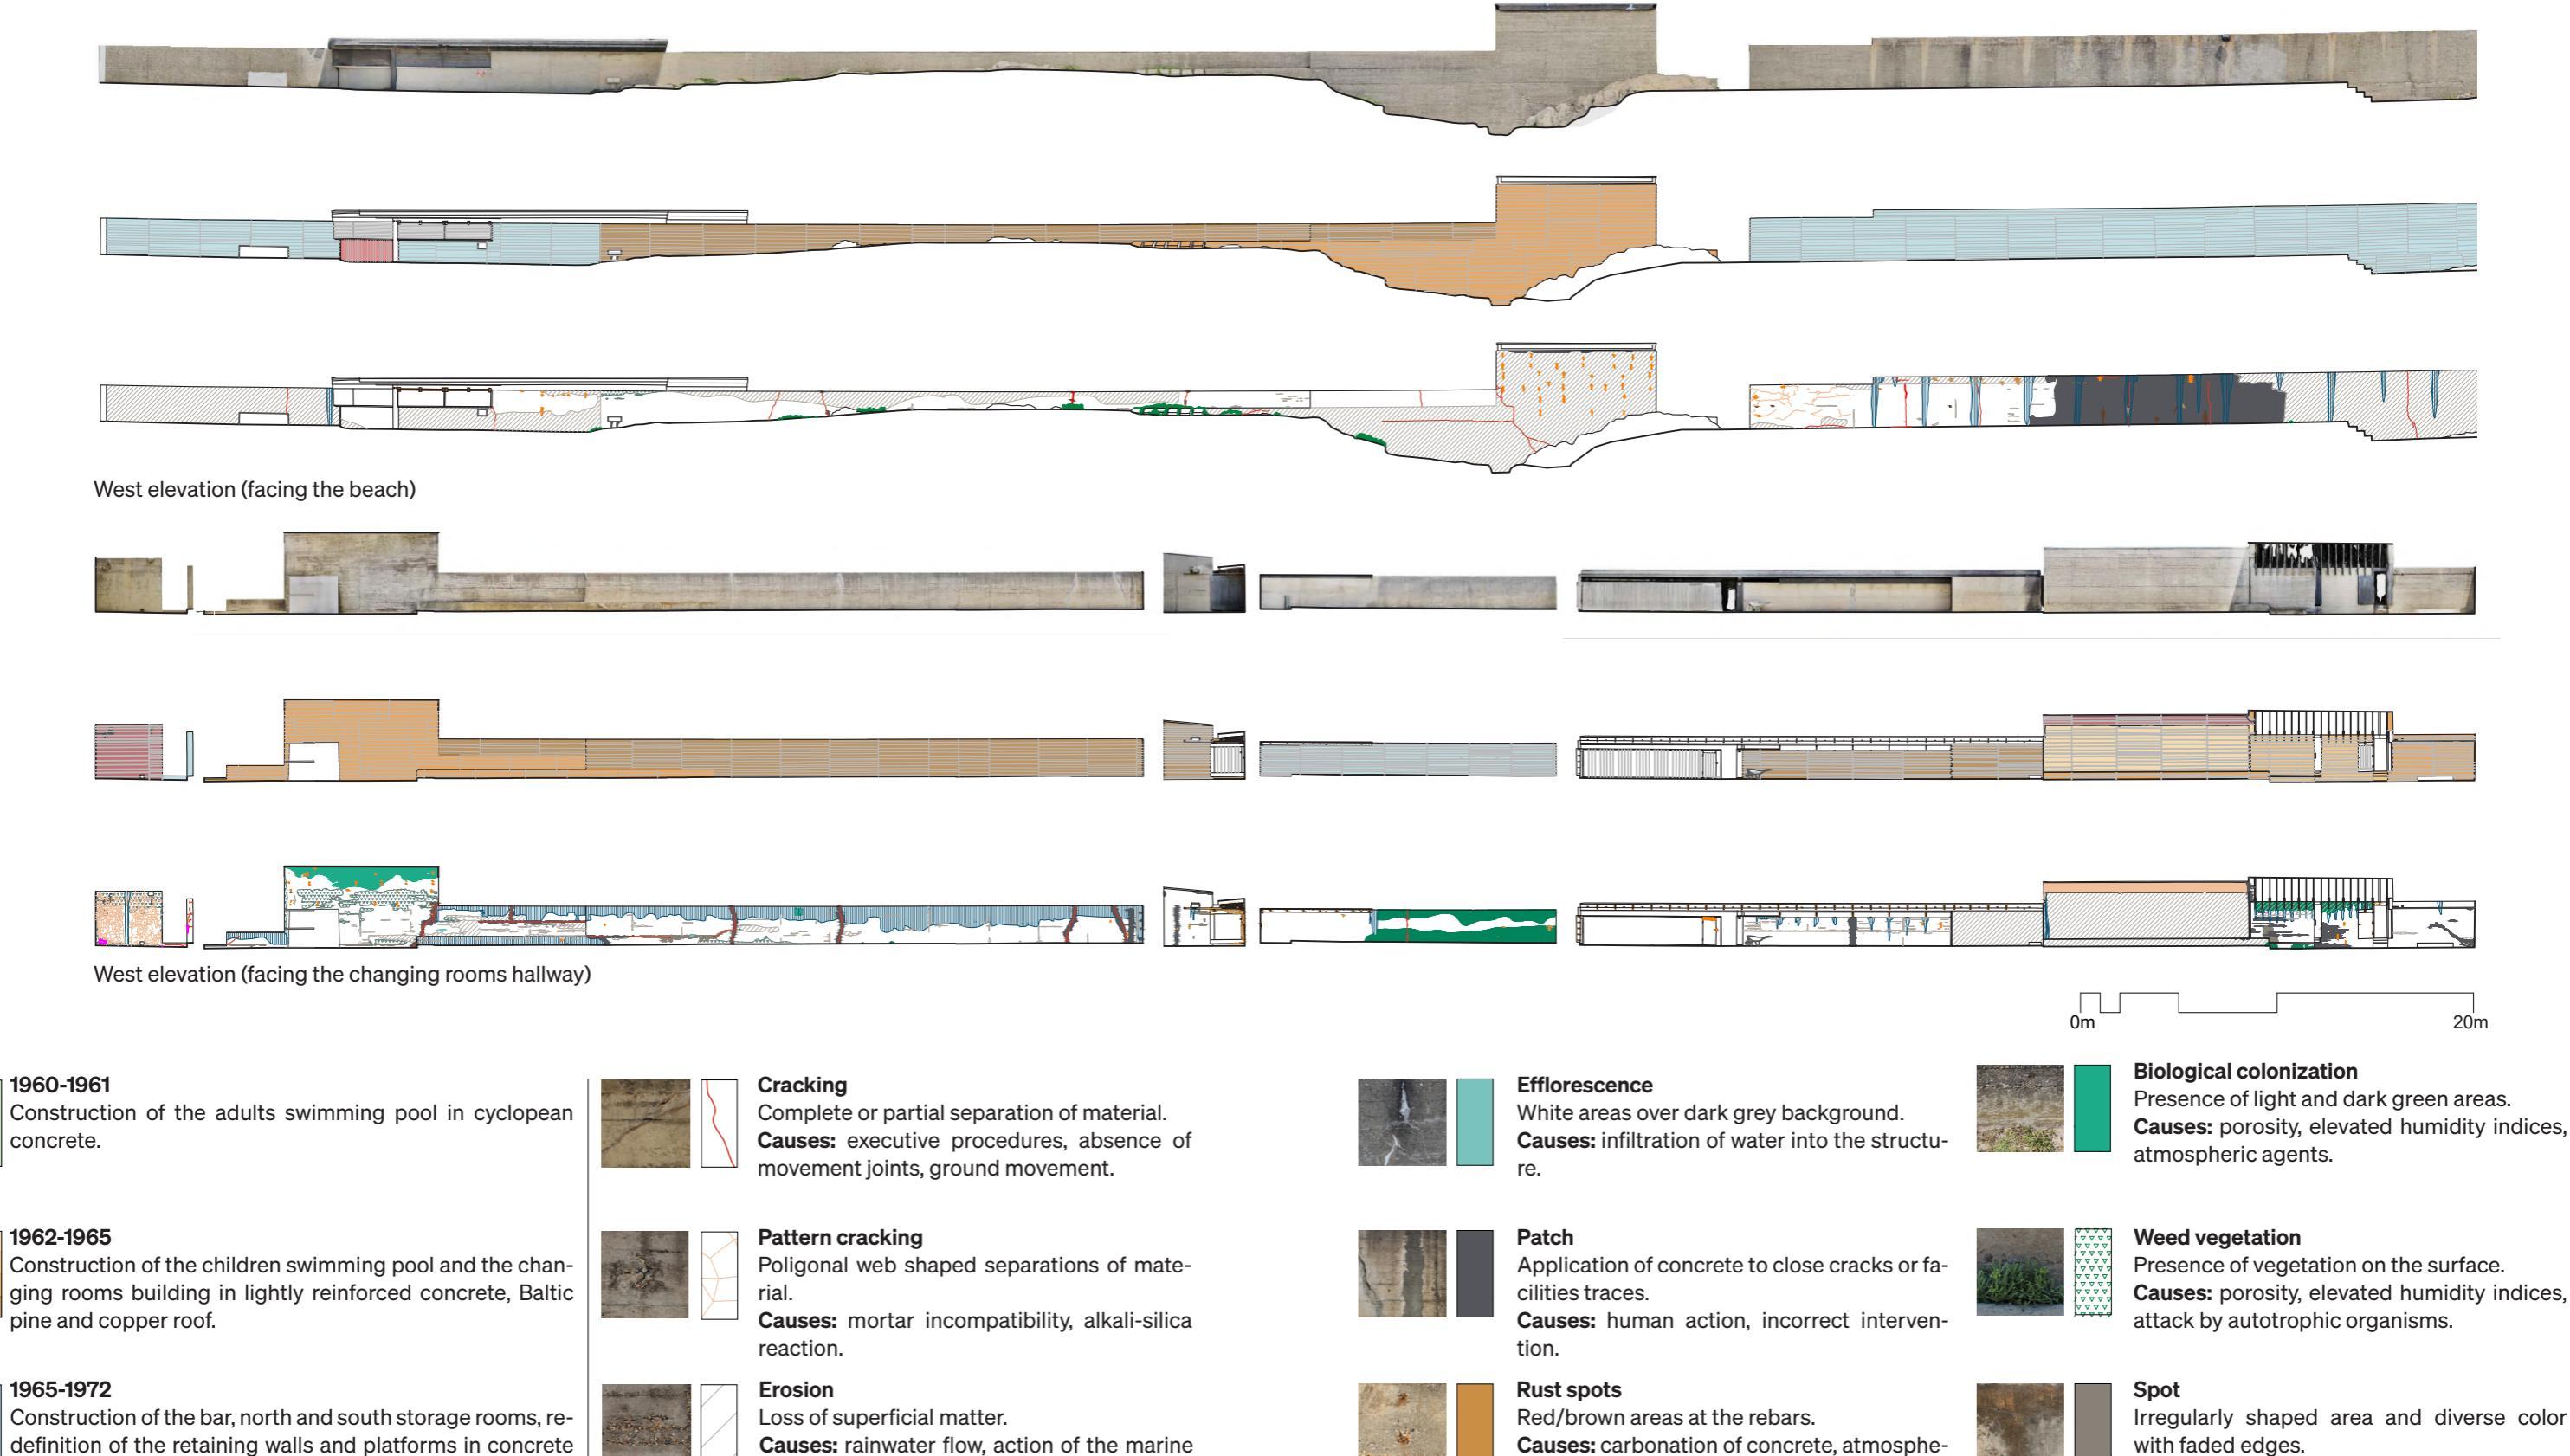
Superficial vertical tracks of diversified color. Causes: building morphology, atmospheric agents, air pollution.

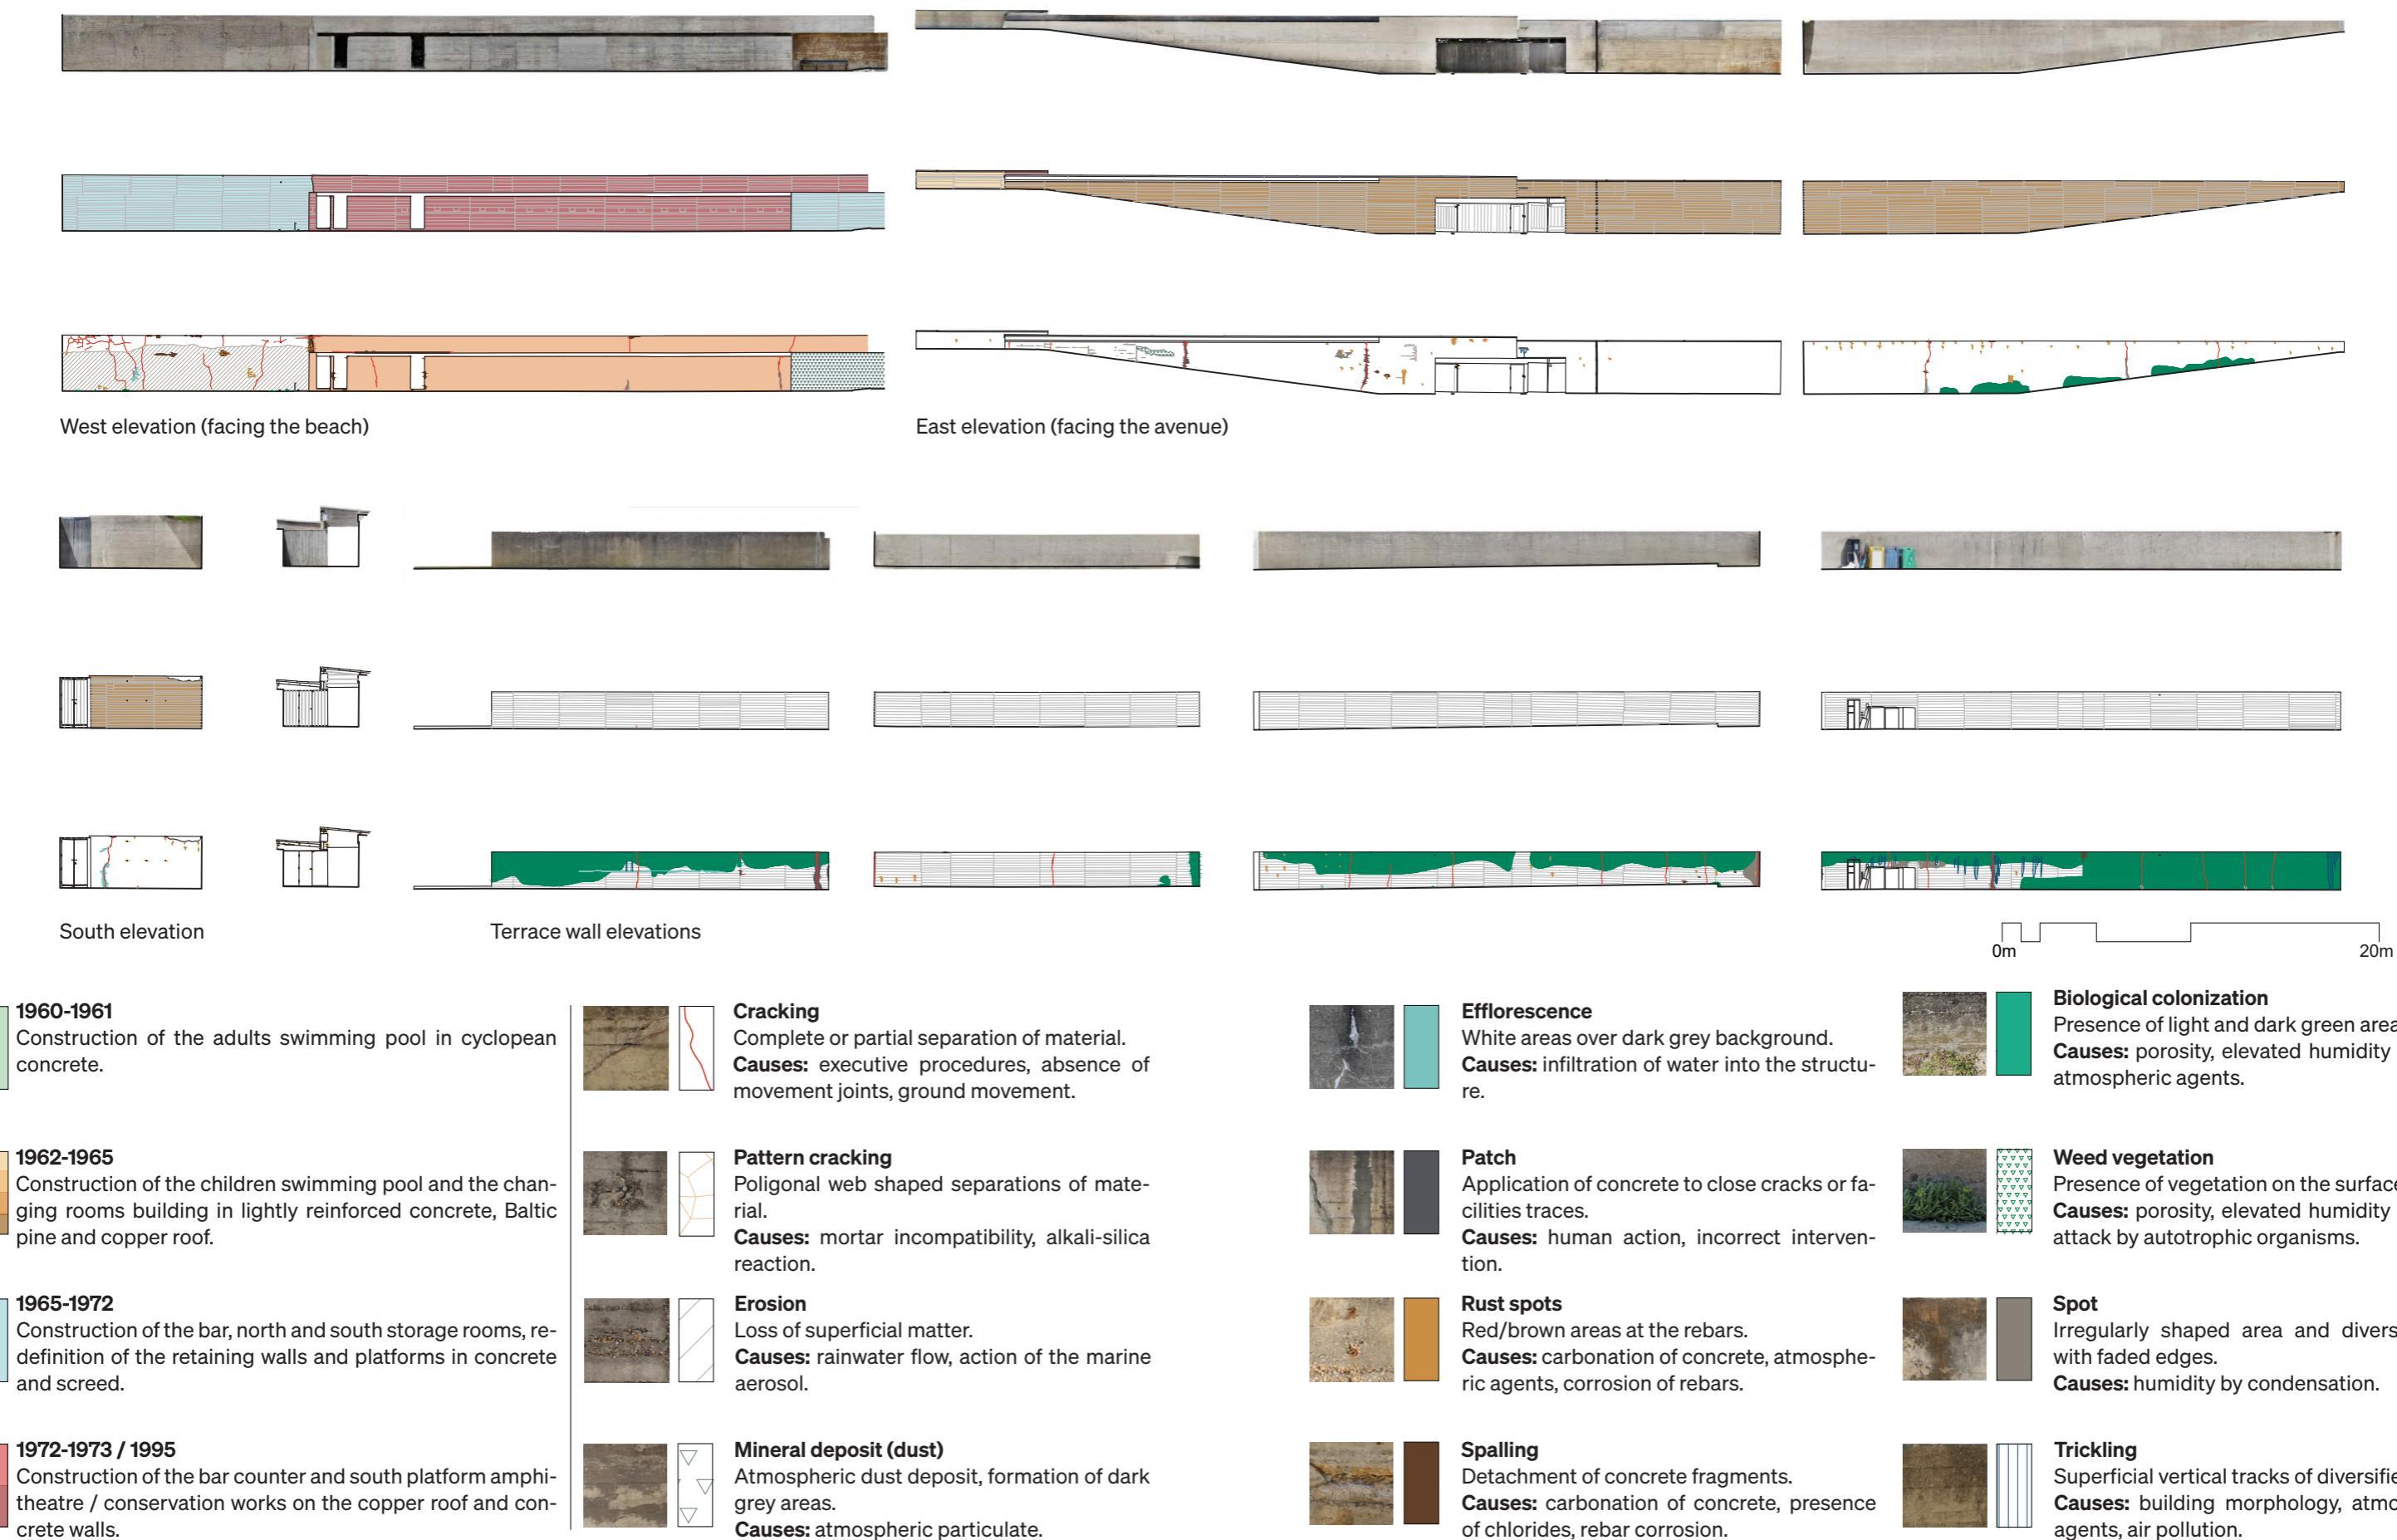
Presence of light and dark green areas. Causes: porosity, elevated humidity indices,

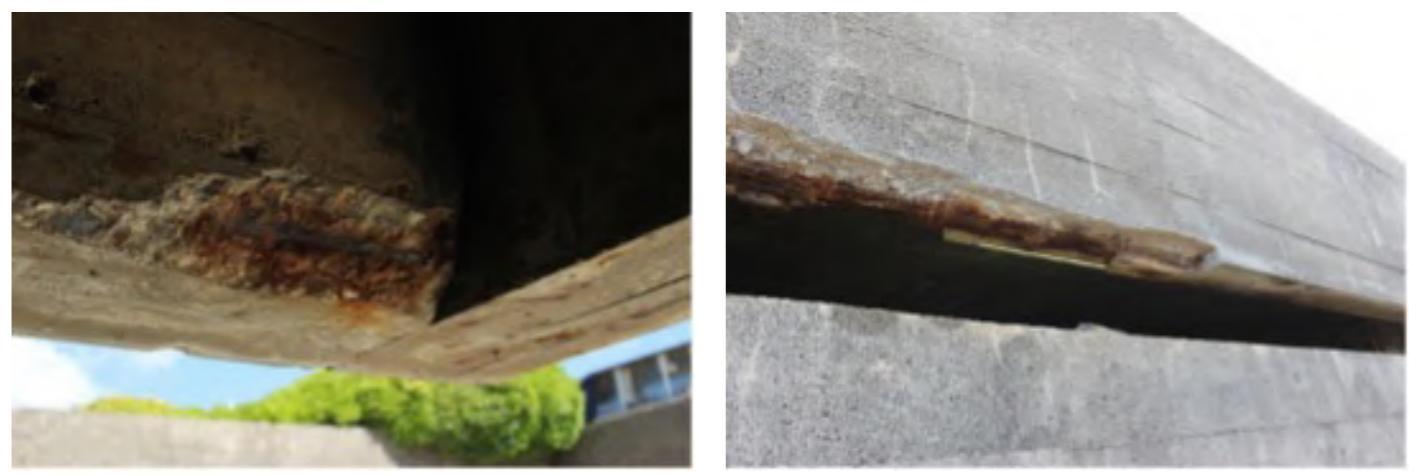
Fig. 34 – Examples of spalling caused by reinforced steel corrosion in beams.

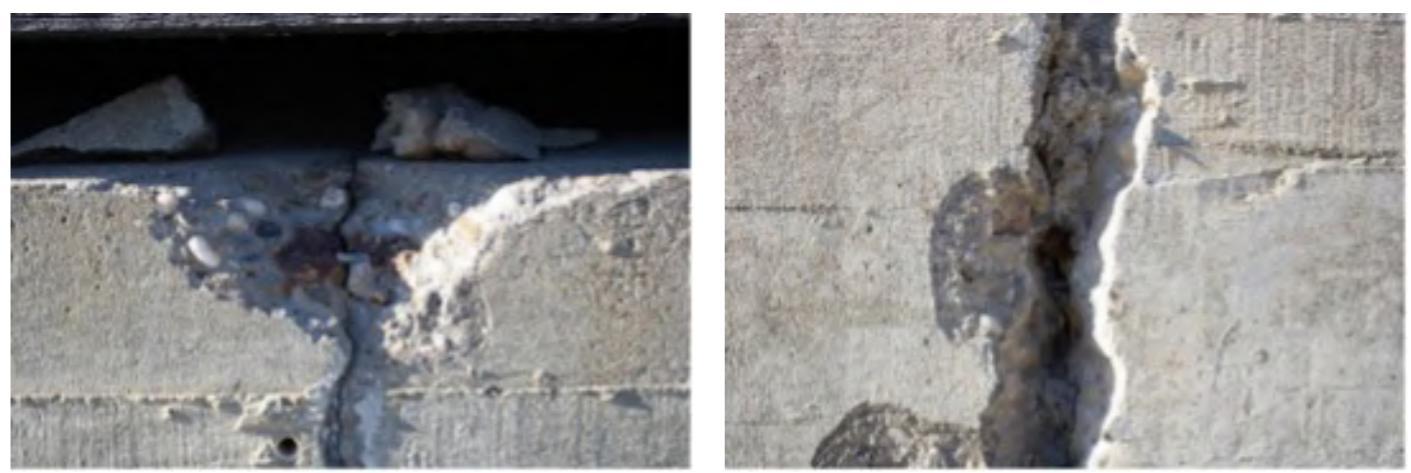
Fig. 35 - Details of vertical cracks.

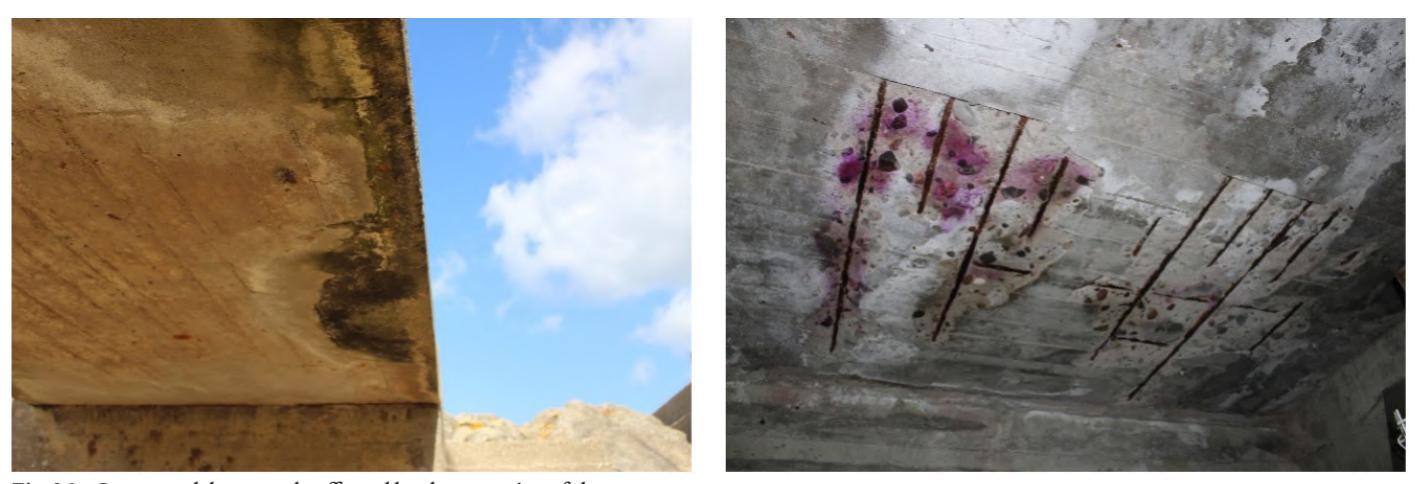
Fig. 36 – Concrete slabs severely affected by the corrosion of the reinforced steel.

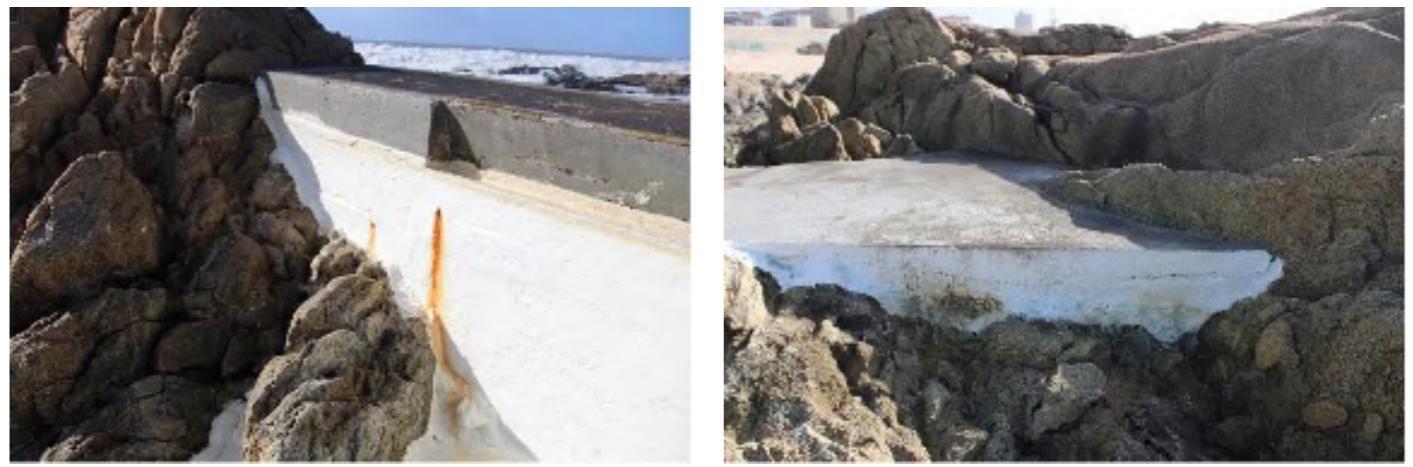
Fig. 42 – Spots and biological colonization in the adults' tank .

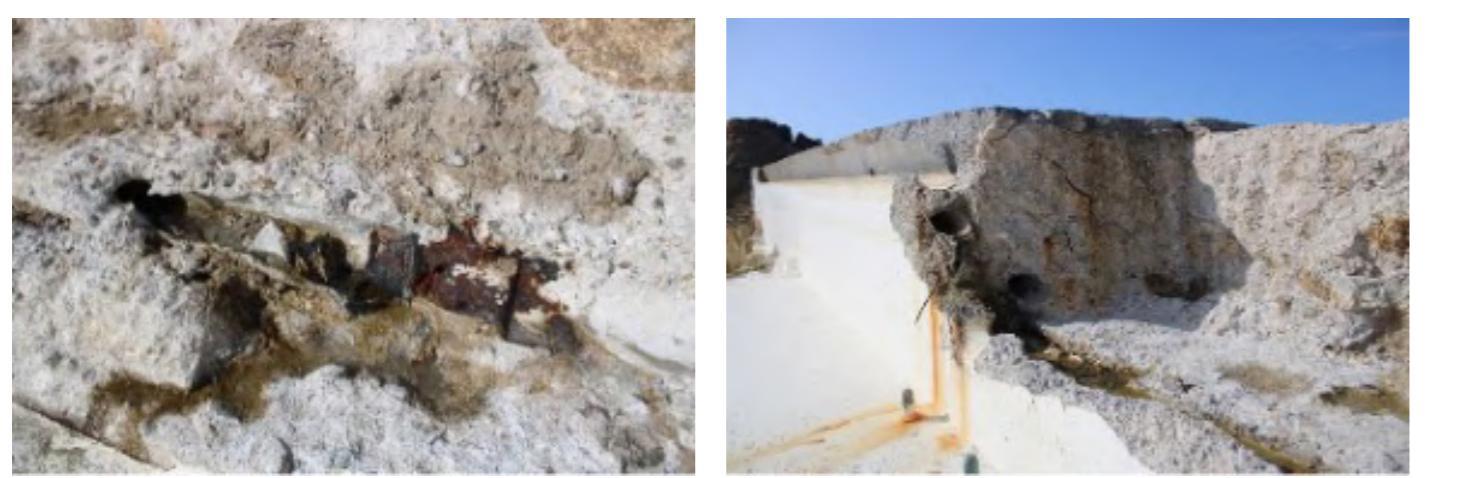
Fig. 44 – Corroded pipes of the water system.

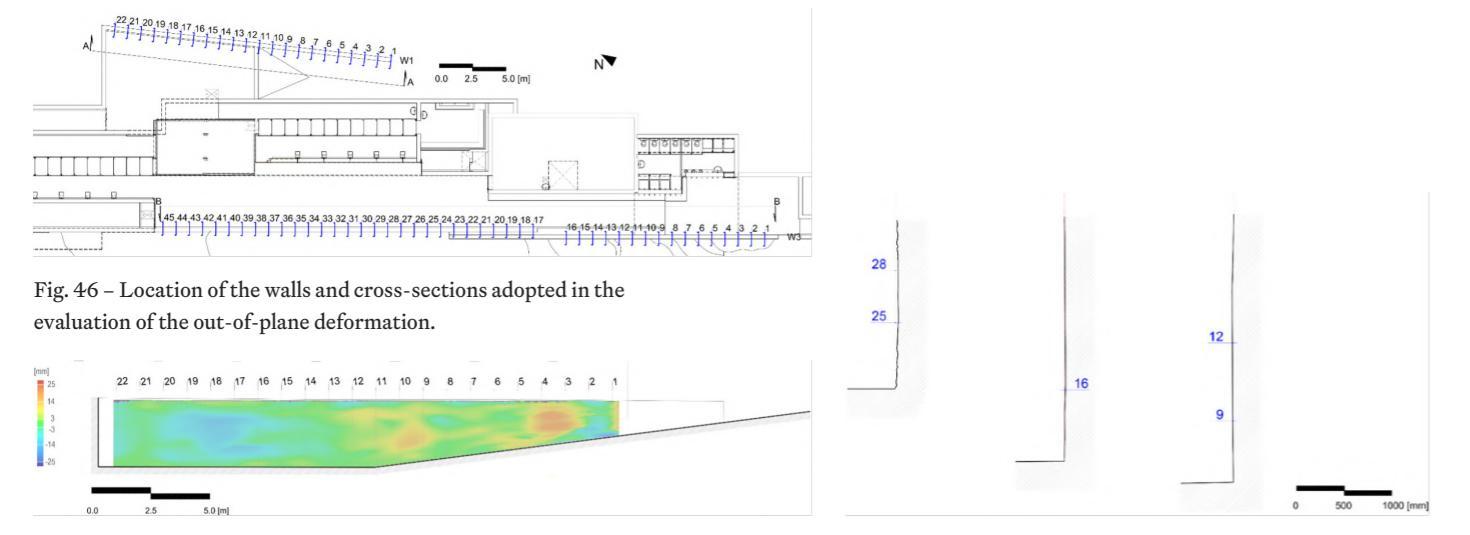
Fig. 47 - Colormap of the out-of-plane deformation of the retaining wall (Section AA).
