CONSERVING MODERN HERITAGE

Concrete

Case Studies in Conservation Practice

Edited by Catherine Croft and Susan Macdonald

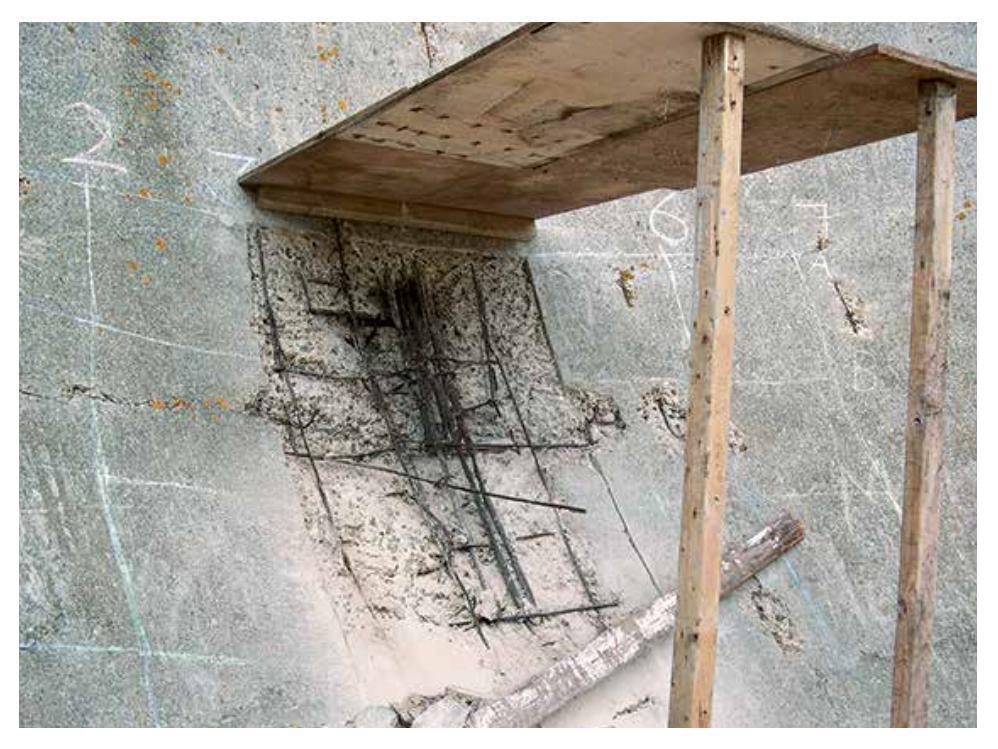
Fig. 1.6. Close-up of the damage to an area of the reinforced concrete cover to the dish of the 30-foot mirror. An area of damaged cover 30 feet (9.14 m) square was mechanically removed for the CP trial.

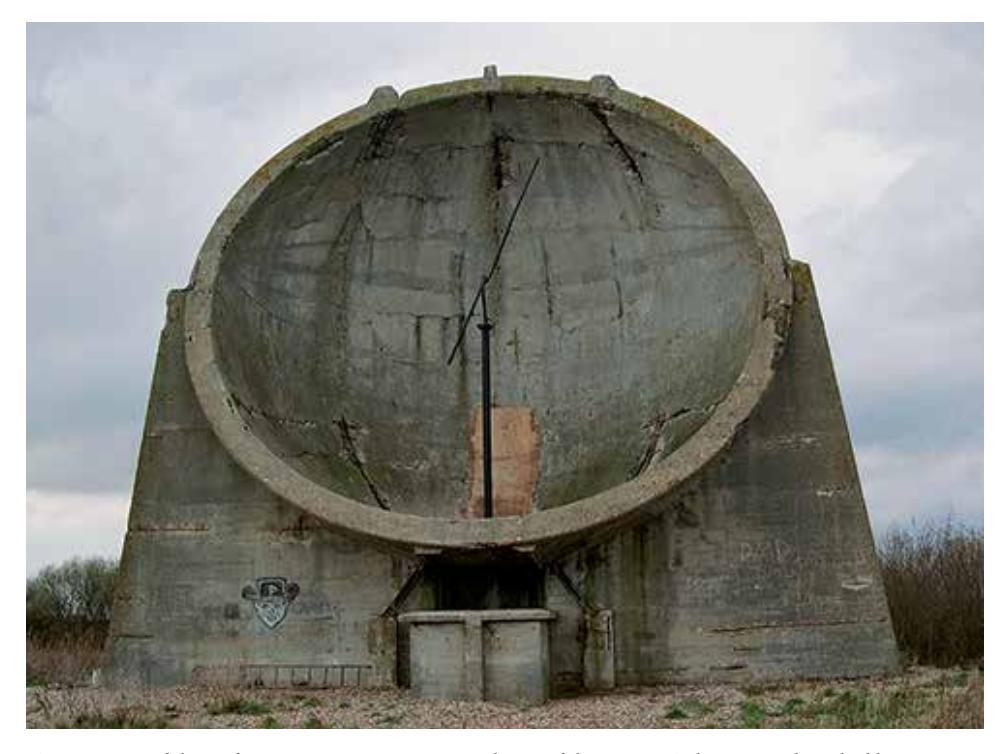
Fig. 1.8. View of the 30-foot Listening Mirror on completion of the project. A thin mortar layer had been applied over the anode mesh to complete the repair. The color match was poor.

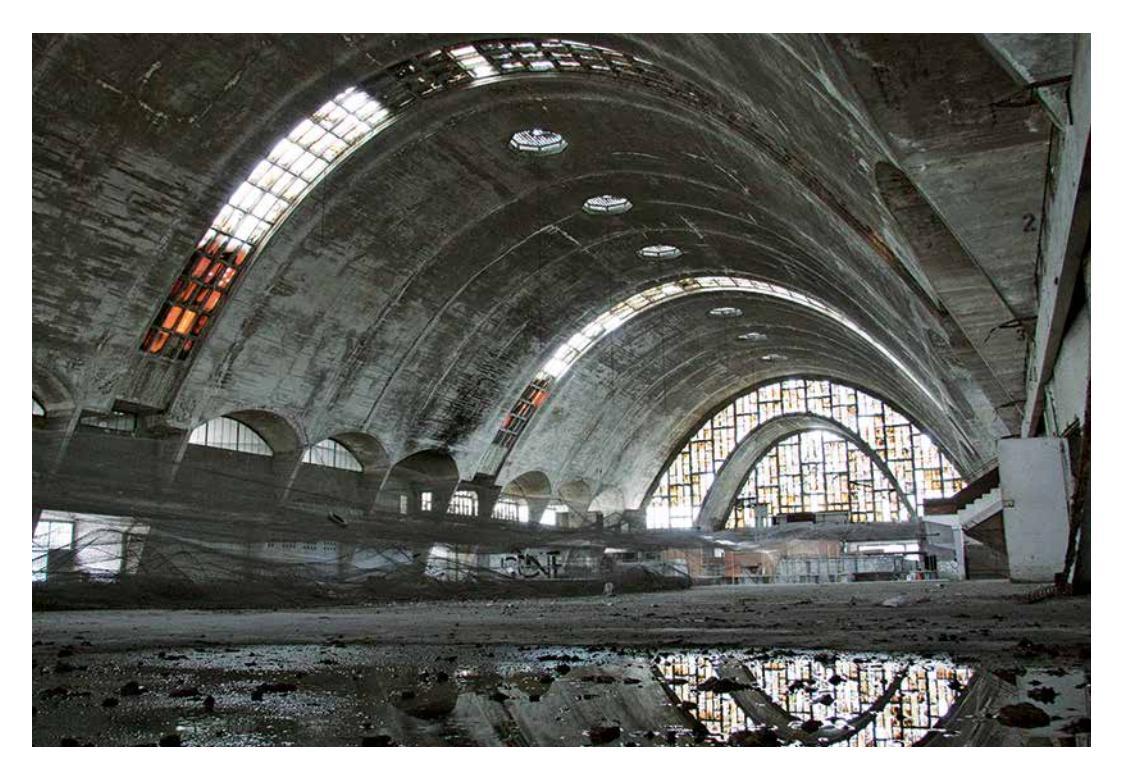
Fig. 2.5. Degradation prior to conservation, 2008. Photo: © Véronique Nosbaum

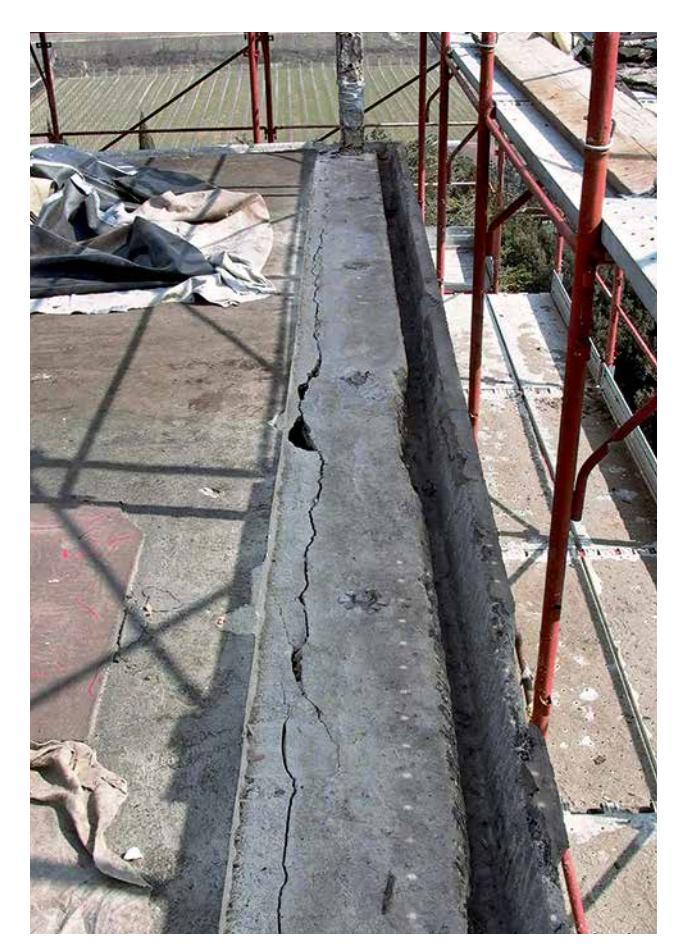
Fig. 3.9. Degradation of the right wing of the rotating part at the roof terrace level, showing cracks in the edge beam, 2003.

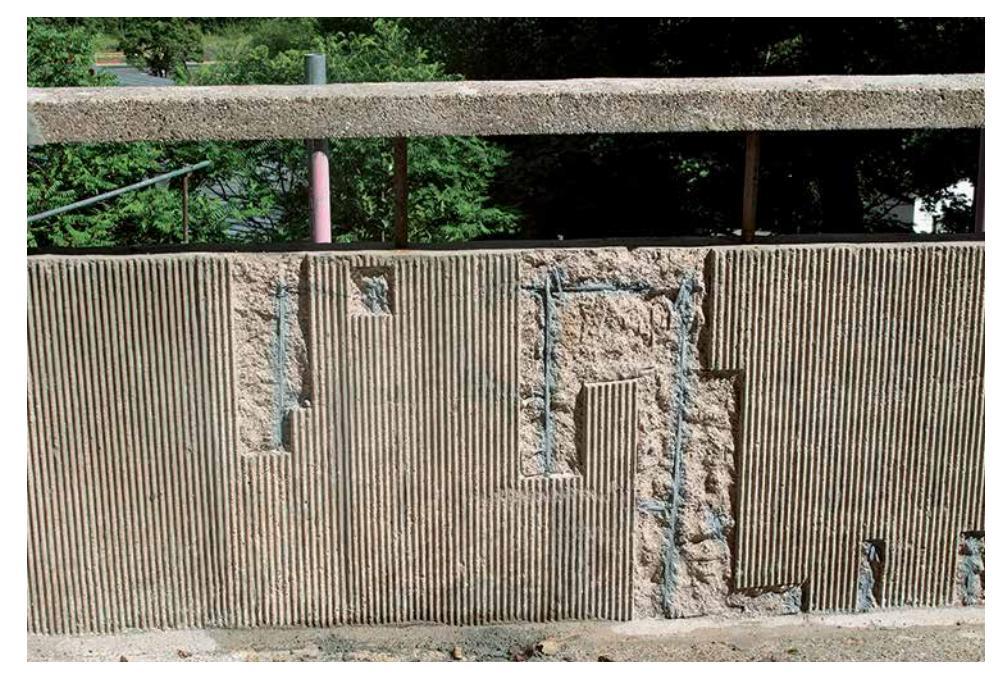
Fig. 4.12. Detail of damaged concrete to the bear ravine's parapet during repairs, 2014.

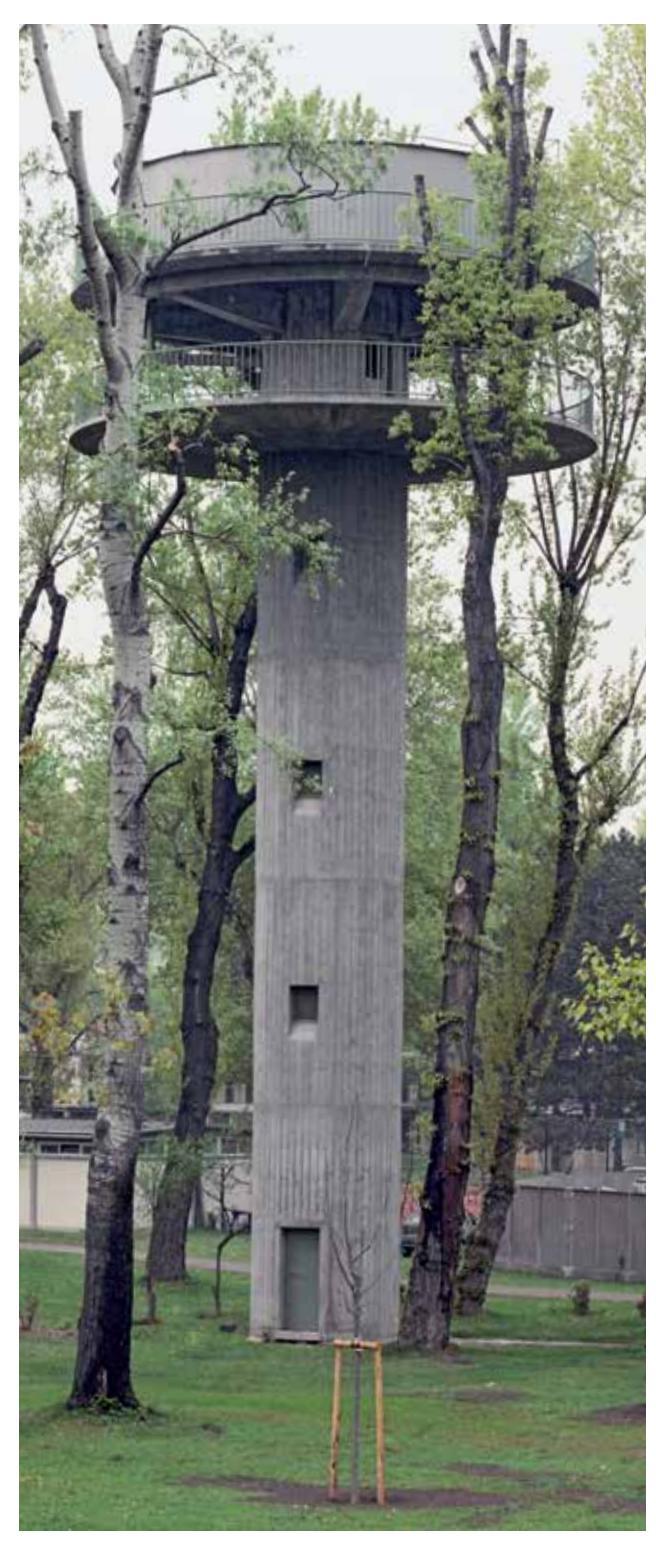
Fig. 7.8. In the projecting upper platform of the water tower, shown here following conservation, cracks and exposed reinforcement were discovered and remediated. Photo: Bettina Neubauer-Pregl / Courtesy of Federal Monuments Authority Austria, Vienna

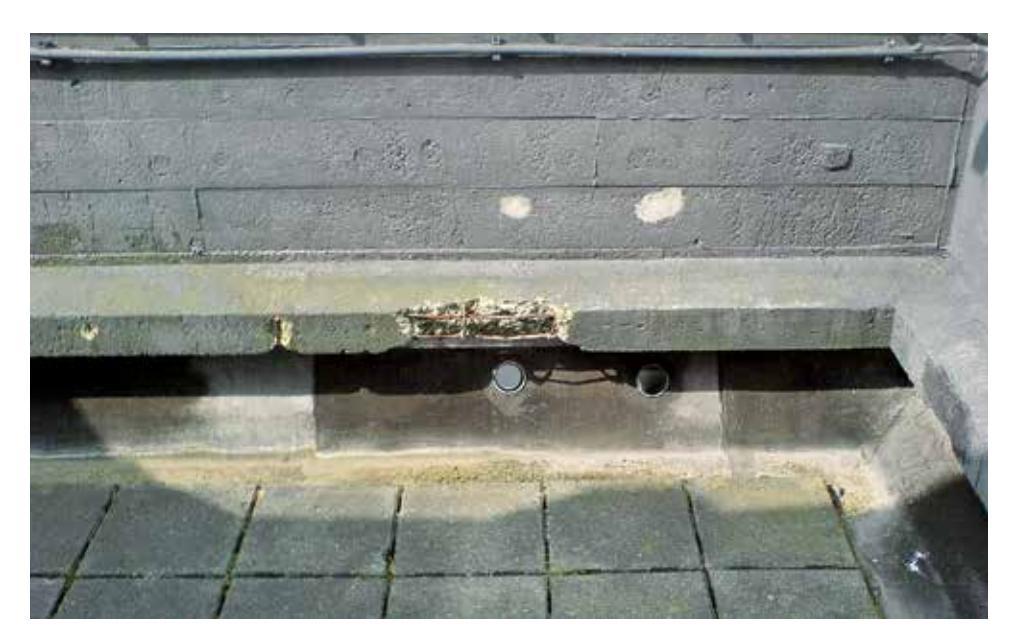
Fig. 9.8. Despite previous repairs, the inside of the concrete roof parapet cast in situ again showed damage and spalling due to corroding rebar. Photo: © Wessel de Jonge Architects, Rotterdam

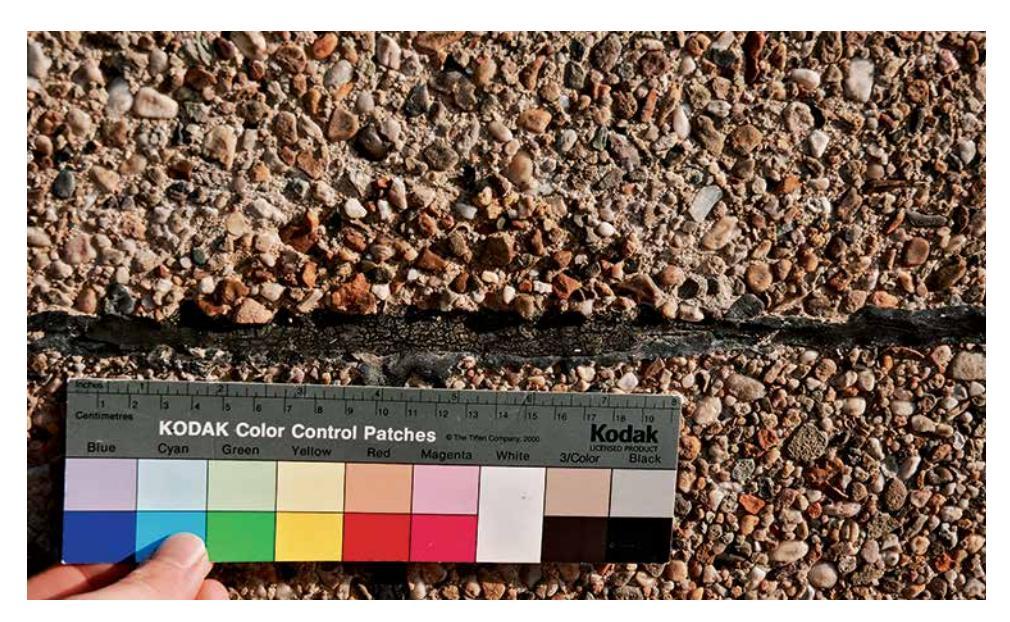
Fig. 9.11. One of the flat 50 mm-thick shockcrete facade panels with a half-moon repair patch (above the color card). After applying an appropriate tone of repair mortar, some selected pebbles and grit were pushed into the wet substance to match the original aggregate component. The bitumen-drenched jute fiber joints were retained. Photo: © Wessel de Jonge Architects, Rotterdam

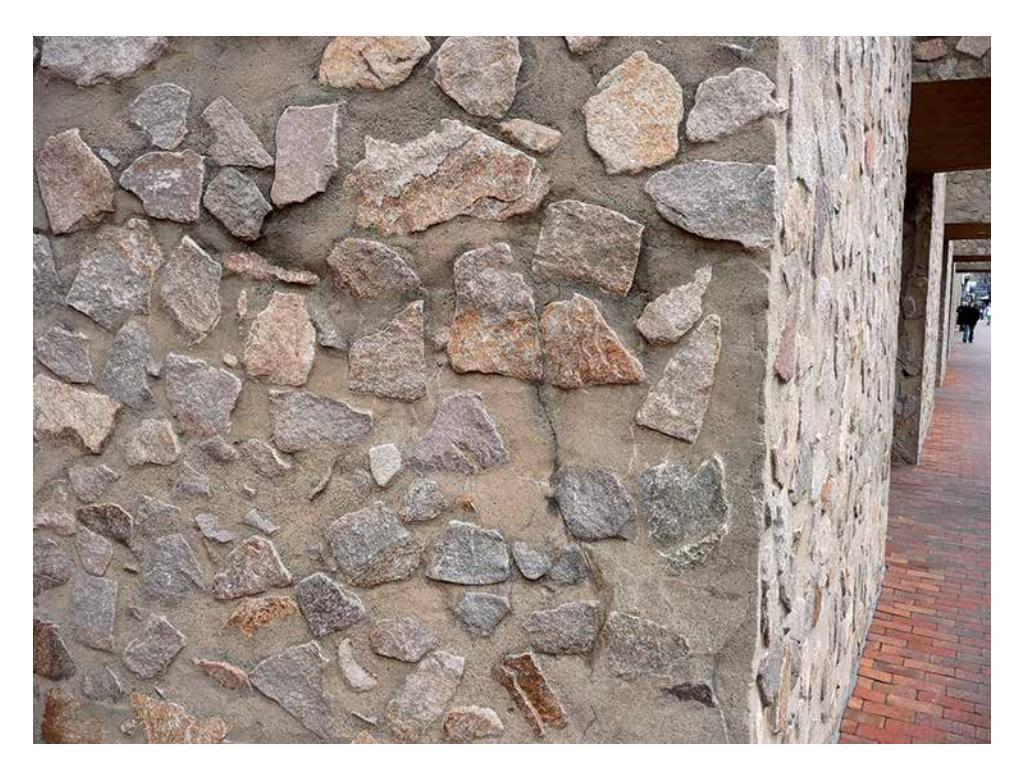
Fig. 10.4. Rubble concrete wall made up of very large granite aggregate surrounded by a cementitious mortar. Note the vertical crack at the right in this photo, as well as light to moderate surface soiling. Photo: Wiss, Janney, Elstner Associates, Inc.

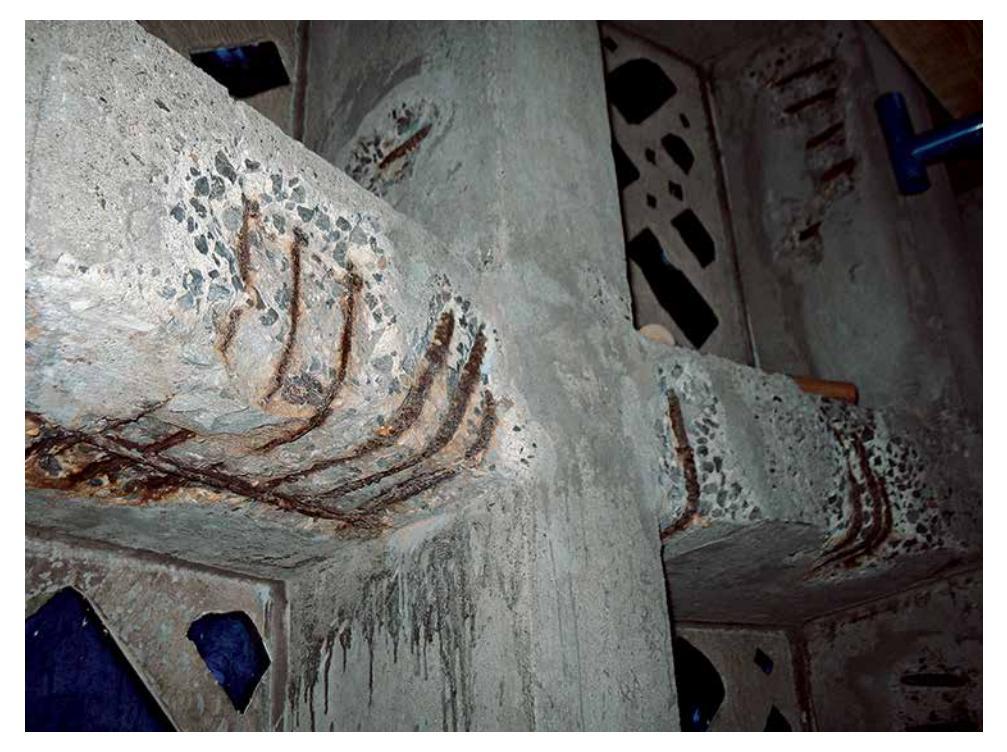
Fig. 11.3. Deterioration at the coffers of freestanding wall, 2009. The conservation contractor removed delaminating concrete with hand tools before chipping the concrete to form the desired patching profile. Photo: Building Conservation Associates, Inc.

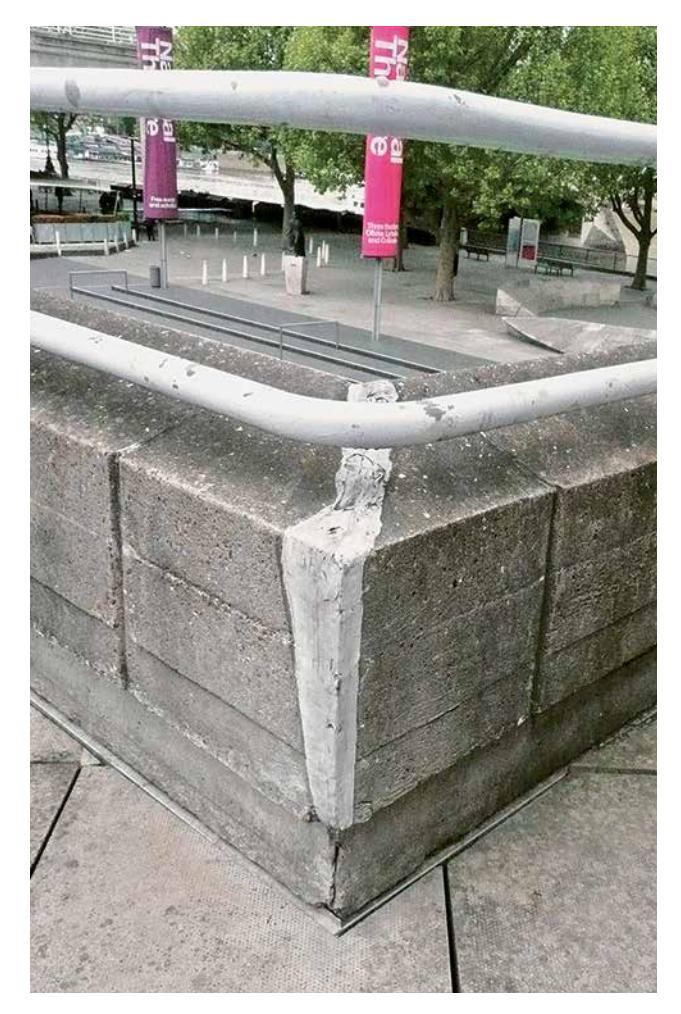
Fig. 12.2. Repair of 1990s using epoxy-based material that has deteriorated, 2013.

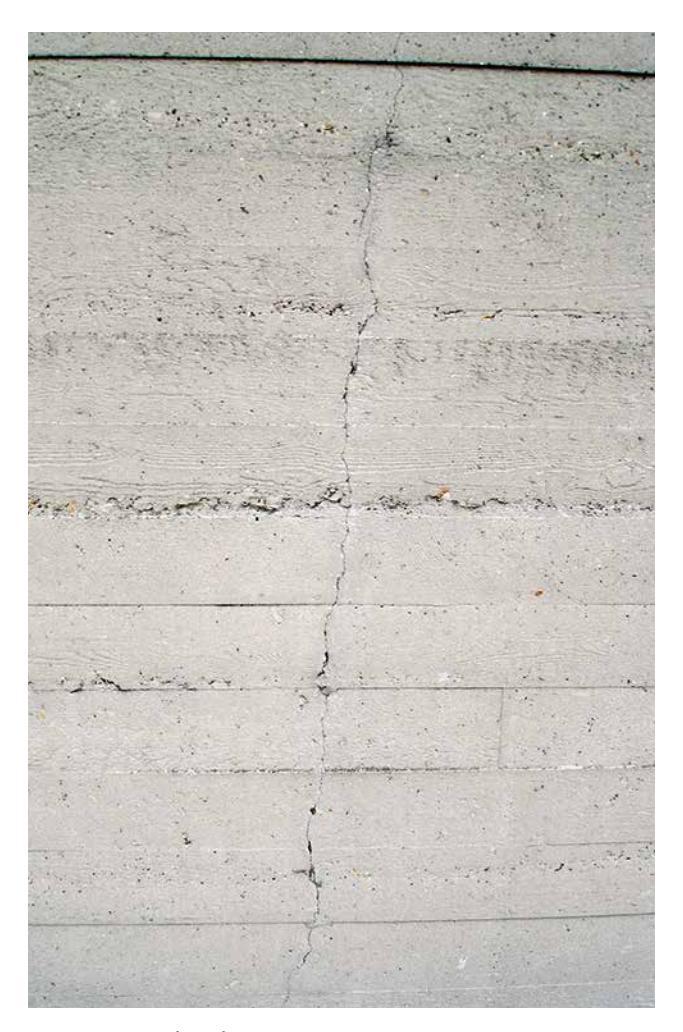
Fig. 12.4. Typical crack, 2013.

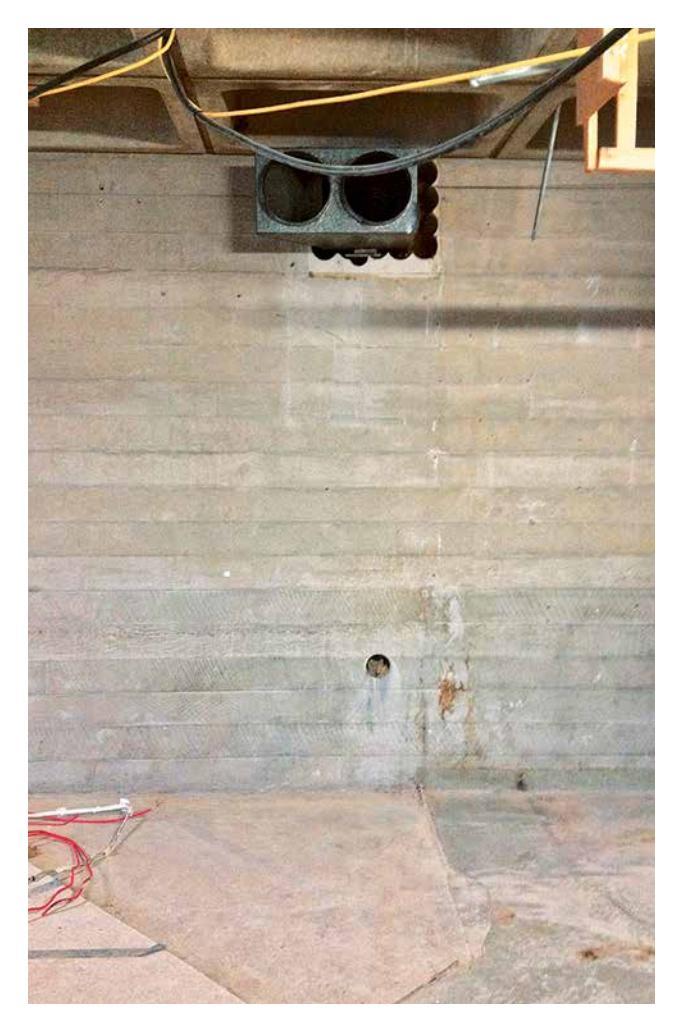
Fig. 12.5. Redundant penetration, 2014.

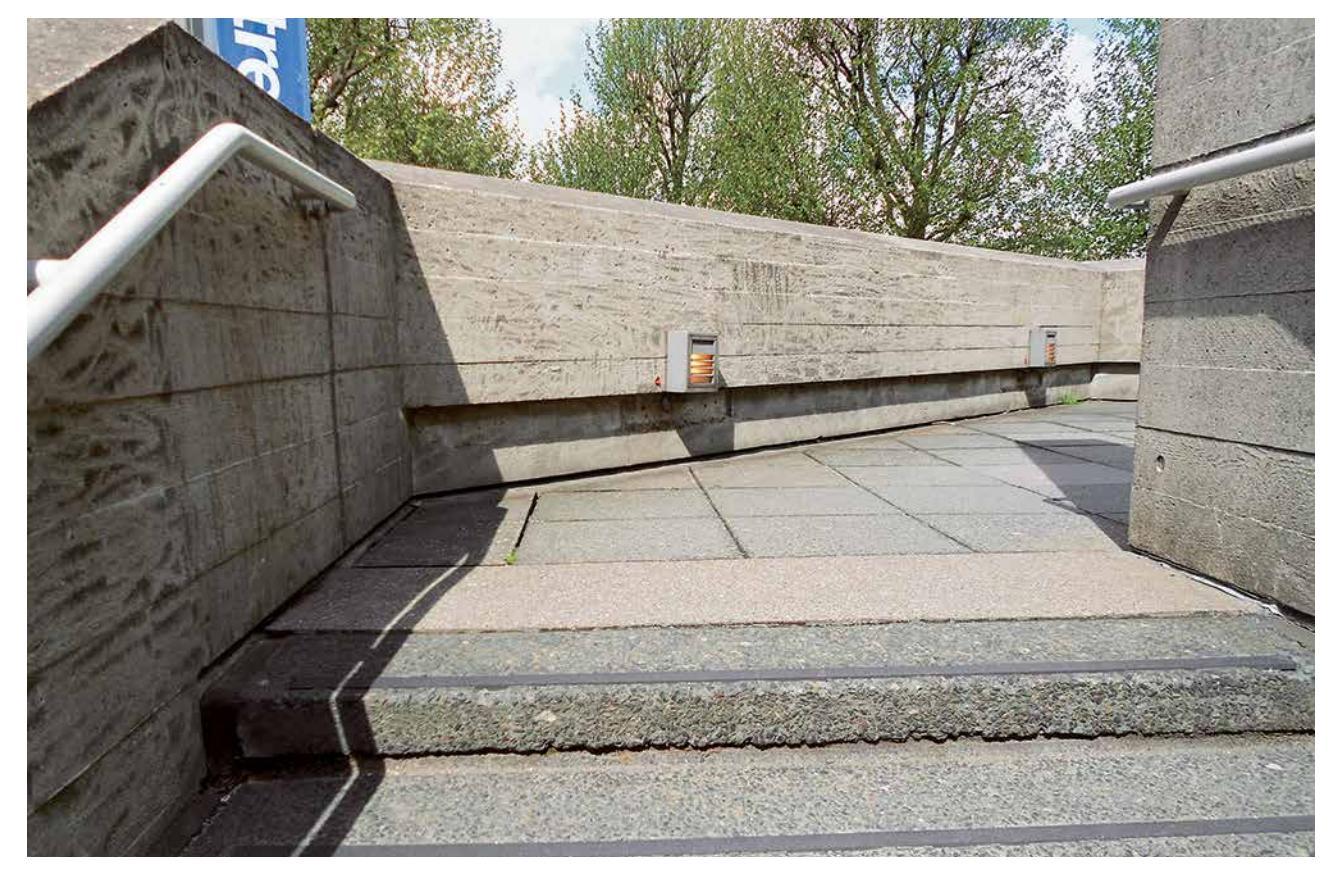
Fig. 12.9. Marks left on concrete following graffiti removal, 2012.
