Terra 2008: The 10th International Conference on the Study and Conservation of Earthen Architectural Heritage

Edited by Leslie Rainer,
Angelyn Bass Rivera,
and David Gandreau

Proceedings of the 10th International Conference on the
Study and Conservation of Earthen Architectural Heritage,
Bamako, Mali, February 1–5, 2008

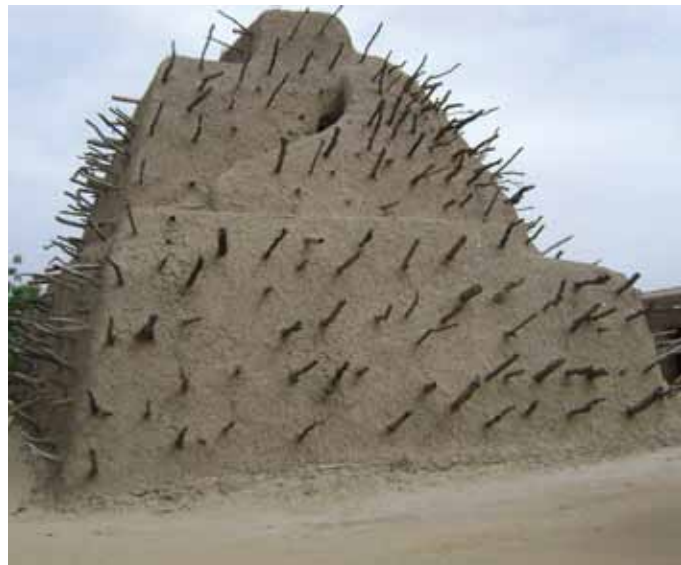
FIGURE 2 Vue d'ensemble du Tombeau des Askia. (DNPC 2006)

- le Tombeau des Askia, imposant monument en architecture de terre, inscrit sur la Liste du patrimoine mondial de l'UNESCO (fig. 2) ;

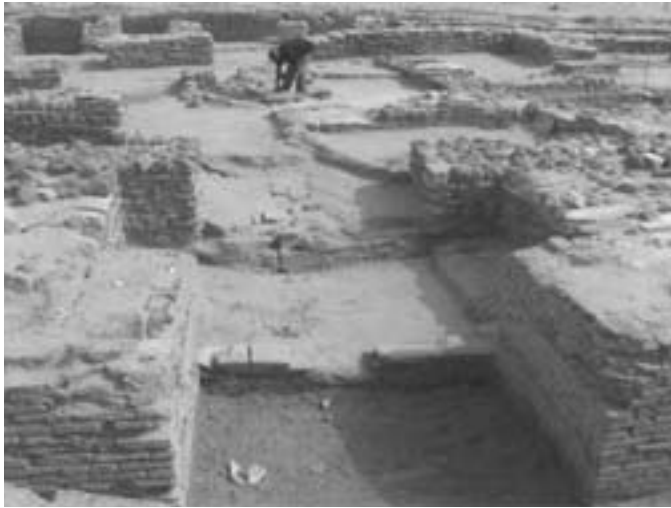
FIGURE 3 Aire principale de fouille, secteur sud-ouest : entrée, couloir principal et pièces. (DNPC 2004)

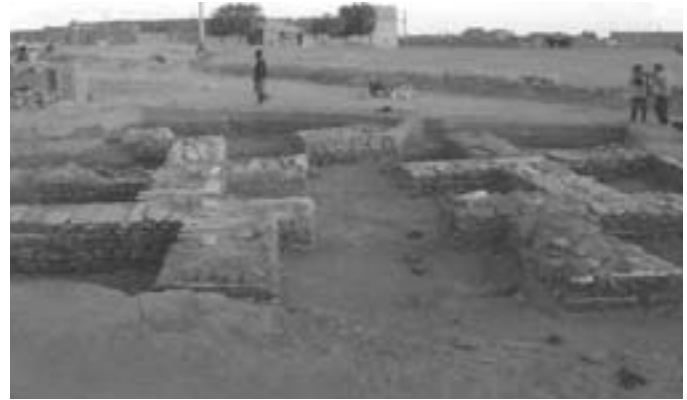
FIGURE 4 Secteur Est, entrée secondaire, couloir et pièces. (DNPC 2007)

terre crue. Dans le secteur sud, le couloir le plus important (sud-est/nord-ouest) mesure 22 m de long sur 1,15 m de large. Il donne de part et d'autre sur une douzaine de pièces de dimensions inégales.

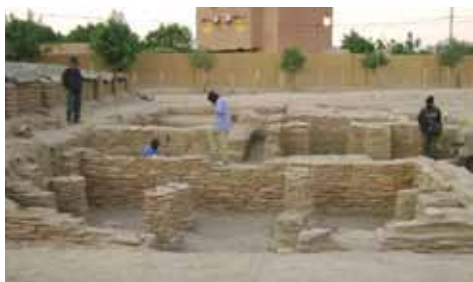
Dans le secteur nord, un gros bâtiment rectangulaire constitué de murs en pierres (grès dur) de 9 m sur 6,15 m est exhumé. L'entrée est bien circonscrite à l'est. Trois rangées de deux piliers chacune, également en pierres, sont dressés ; ils ont servi de support pour la toiture du bâtiment. Le même bâtiment est contigu à l'ouest à un autre également rectangulaire (une chambre ?) dont le mode de construction dénote qu'il s'agit d'une structure relativement plus récente (utilisation de plus de mortiers et de blocs de pierres moins massifs). Une sorte de plancher en pierre massive (schiste) de forme rectangulaire (1,40 m de long sur 0,80 m de large) dont l'usage reste encore énigmatique a été mis au jour dans l'angle nord-ouest de cette pièce.

FIGURE 5 Secteur Nord, grande pièce rectangulaire avec piliers en pierres. (DNPC 2007)

Cependant la tradition orale ne devrait pas être muette sur ce site qui se singularise par un style architectural unique dans la région avec une maçonnerie très élaborée et parfaitement mise en œuvre (symétrie, netteté des angles, droiture des murs), qui n'a rien à envier à celle des temps actuels. Il s'agit d'une œuvre gigantesque ayant nécessité le déploiement d'une main d'œuvre importante à la fois pour l'extraction et le transport des pierres qui ne se trouvent pas sur place (fig. 5).

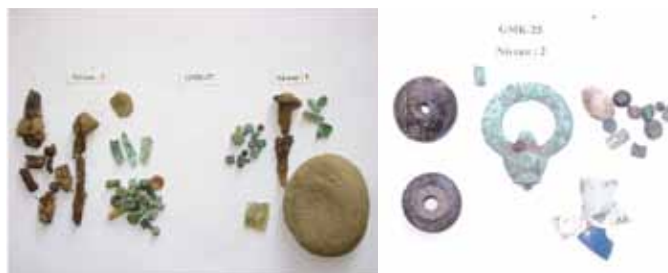
FIGURE 6 Objets mobiliers (perles, fusaïoles, fragments de verre) découverts lors des fouilles. (DNPC 2005)

Ce matériel riche et varié est pour la plupart issu du commerce transsaharien, en particulier les fragments de céramique vernissée, les objets en cuivre, les perles en cornaline et en verre. D'ailleurs, il n'est pas exclu que ces dernières aient fait l'objet d'une fabrication locale à partir du verre provenant du bassin méditerranéen. Une situation similaire est observée à Gao-Saney, la grande agglomération voisine du XI^e siècle, située seulement à 7 km. Cette hypothèse se justifie par la quantité importante de perles inachevées trouvées sur place (fig. 6)³.

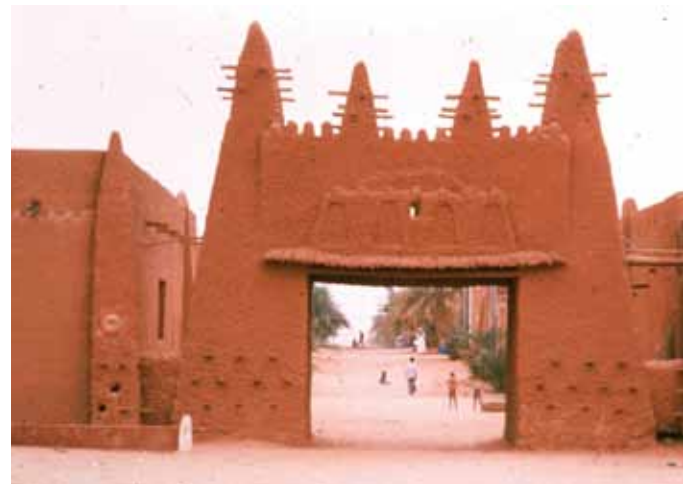
FIGURE 1 Ville nouvelle de Timimoun (Algérie) : porte de style soudanais. Photo : Mauro Bertagnin. © Mauro Bertagnin

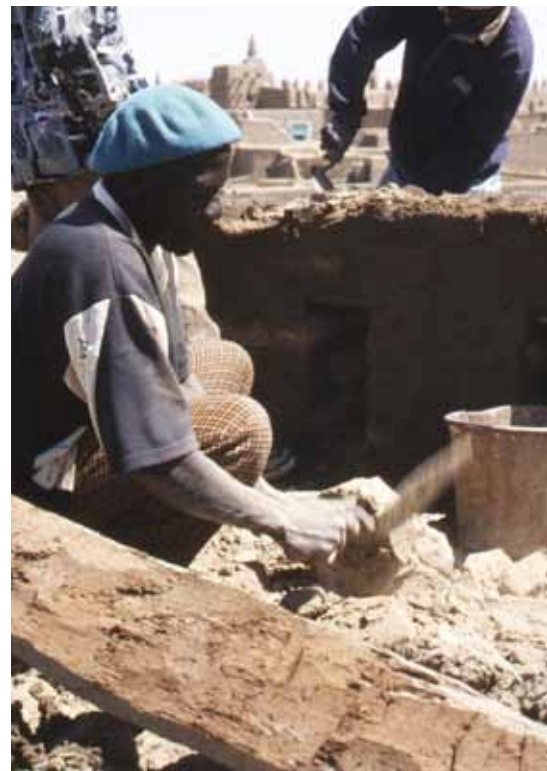
FIGURE 3 Masons and apprentices constructing the monumental parapet of a Djenné house. Photo by T. H. J. Marchand

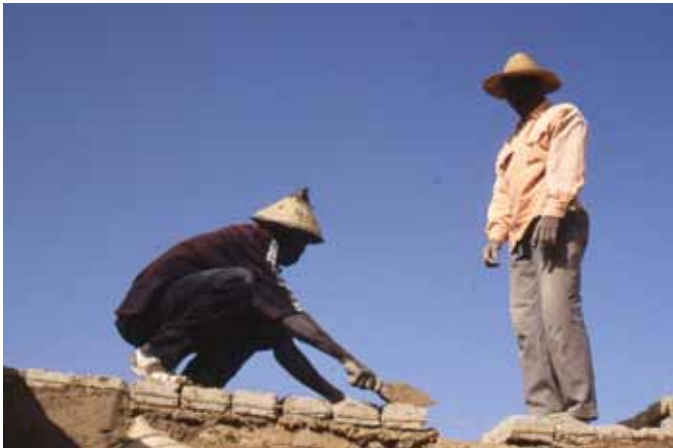
FIGURE 4 Masons constructing a brick wall.
Photo: T. H. J. Marchand

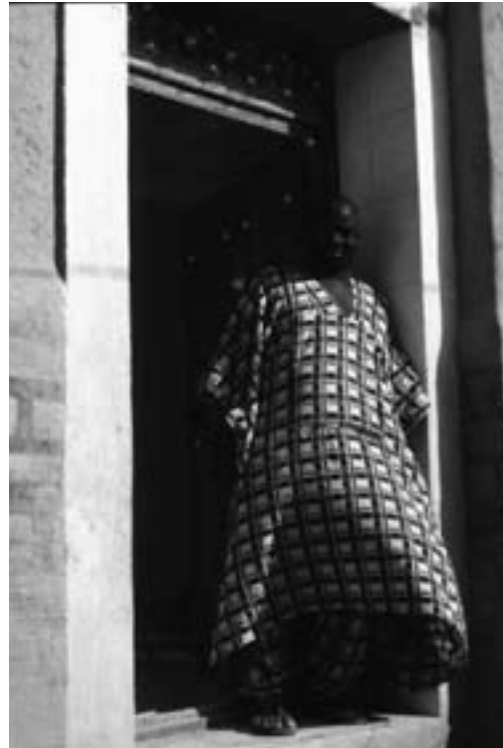
FIGURE 5 A Djenné resident standing in the front door of his new house. The house features new materials, including glazed ceramic tile surfaces, cemented floors, and an Italianate balustrade along the roofline. Photo: T. H. J. Marchand

tools and materials serves to inculcate practical knowledge of possibilities and limitations that guides his structural experimentation. His introduction to client negotiations concerning design and budget, as well as his immersion in the array of current masonry methods and practices, serves to shape his aesthetic sensibilities and his judgment of quality, proportion, and composition. Ultimately, master status depends on one's ability to conceive of a project holistically—from design and planning to construction—and to coordinate all the resources and activities necessary for its realization. The combination of structural and aesthetic principles, together with an accretion of practical experience, enables trade masters to creatively expand the existing repertoire of built forms and decorations in a way that is deemed both traditional and innovative by their colleagues and the public (Marchand 2009b) (fig. 5).

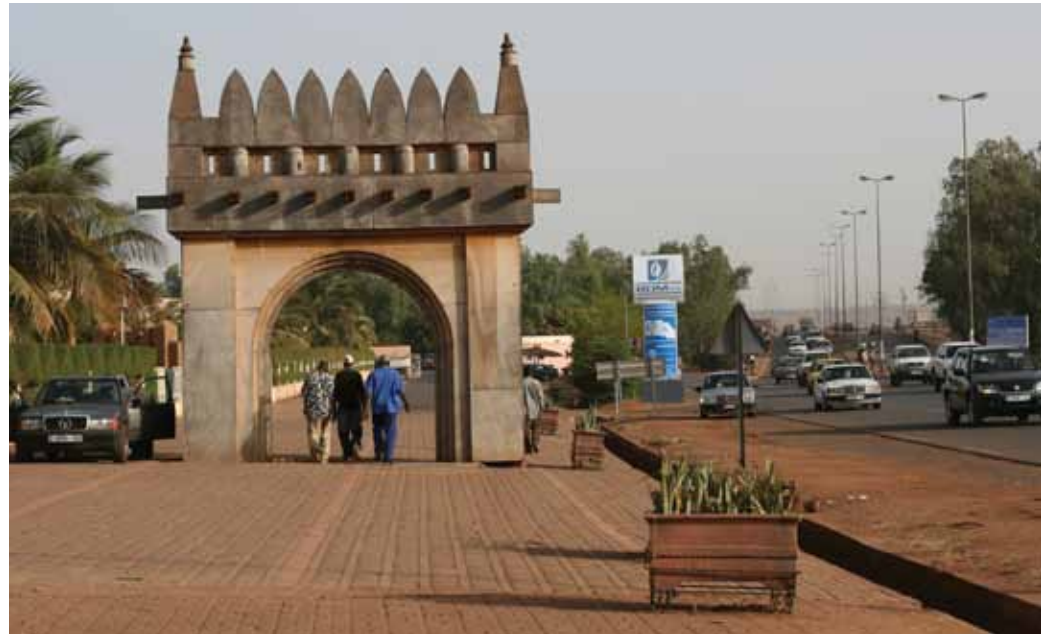
FIGURE 6 Reconstruction of a Djenné-style monumental arch in plywood sheeting on a main road in Bamako. Photo: T. H. J. Marchand

called by French administrators and promoted at turn-of-the-century colonial exhibitions (Prussin 1986)—is set to infiltrate Anglophone regions of West Africa (fig. 6).

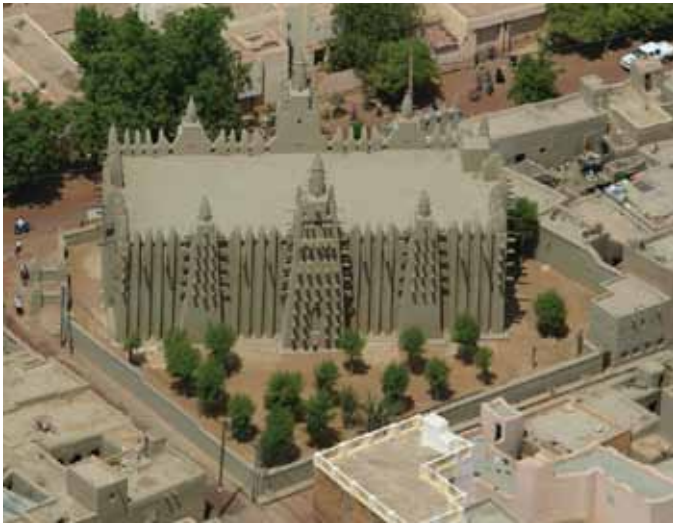
FIGURE 1 Aerial view of the restored Great Mosque of Mopti in late 2006. Photo: AKDN, Bamako

The Great Mosque of Mopti, also known as the Komoguel mosque, is a relatively late structure built between 1936 and 1943 on the site of a previous mosque. It is modeled after the Great Mosque of Djenné, built in 1907. It is a symmetrical, rectangular structure supported by massive pillars. The exterior is defined by slender pillars topped by pinnacles and two symmetrical minarets flanked by two lower towers on each side (fig. 1). The minaret on the eastern facade corresponds to the interior prayer niche. Restoration work started in October

2004 and ended in June 2006. This work included the removal of the cement and reconstruction of the upper part of the building; replacement of the structural timber and roof slab; renovation of the earthen brick walls, minarets, and towers; and the reintegration of the protective plaster. Inside the building, the cement flooring and woodwork were replaced, together with the electrical and speaker systems (fig. 2).

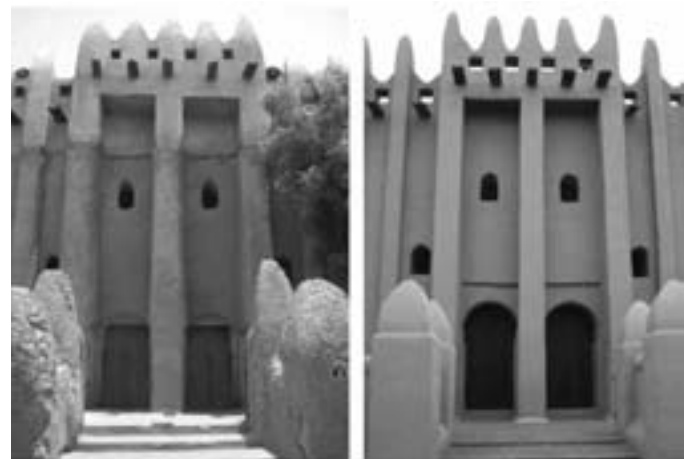
FIGURE 2 The south entrance of the Mopti mosque before and after restoration. Note the damage caused by the cement structure constructed on top of the building prior to restoration of the structure. Photos: AKTC, G. Devreux and G. Taxil

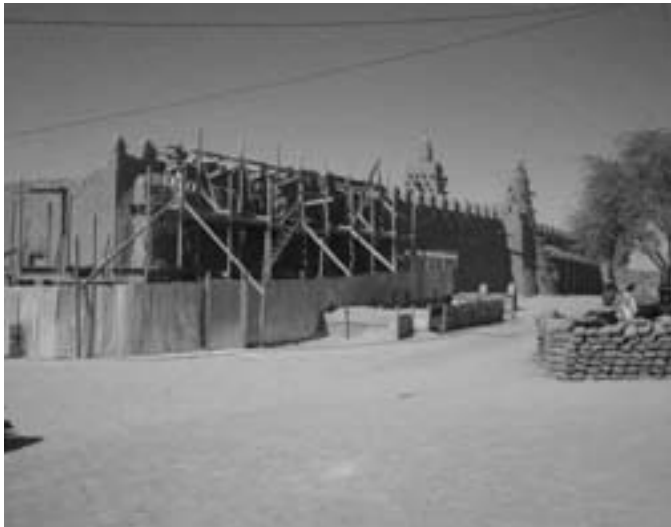
FIGURE 3 View of the Djingareyber mosque under restoration.
Photo: AKTC, L. Blanco

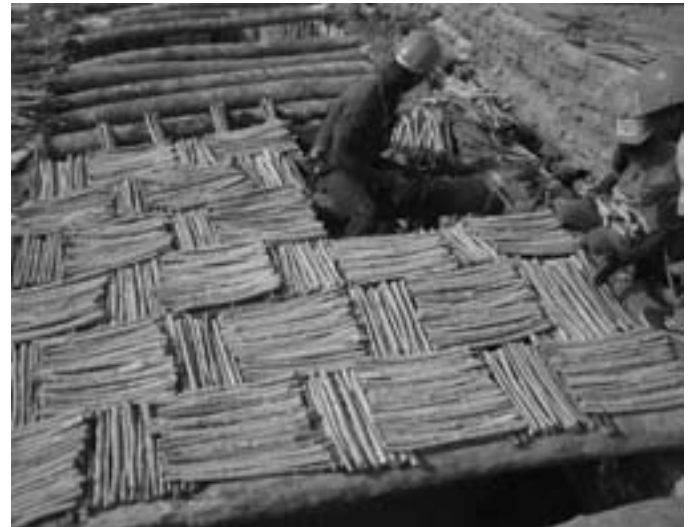
FIGURE 4 Installation of the ceiling made of *goettes* arranged in a geometric pattern, part of the work on the roof of the Djingareyber mosque. Photo: AKTC, M. Sy

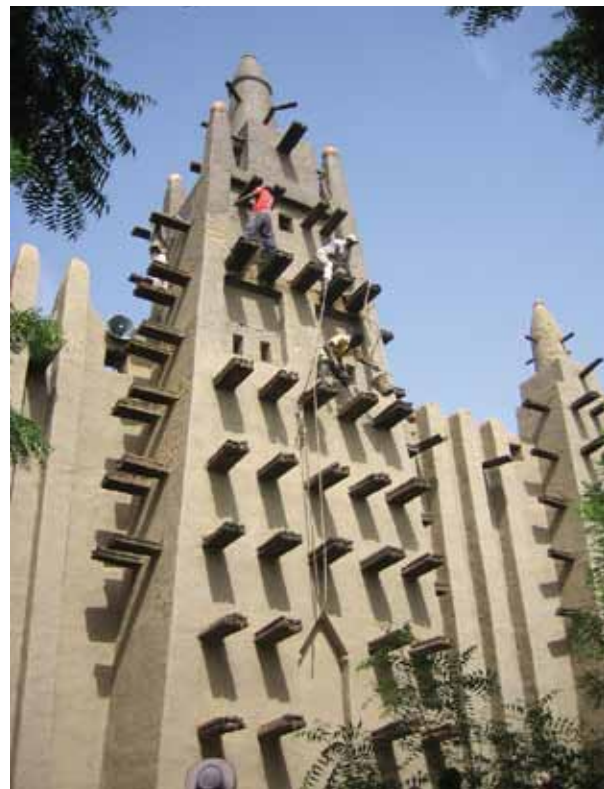
FIGURE 6 The first yearly *crépissage* in the Mopti mosque following restoration of the building in 2006. Periodic maintenance is of paramount importance for extending the life of earthen structures. Photo: AKTC, G. Taxil

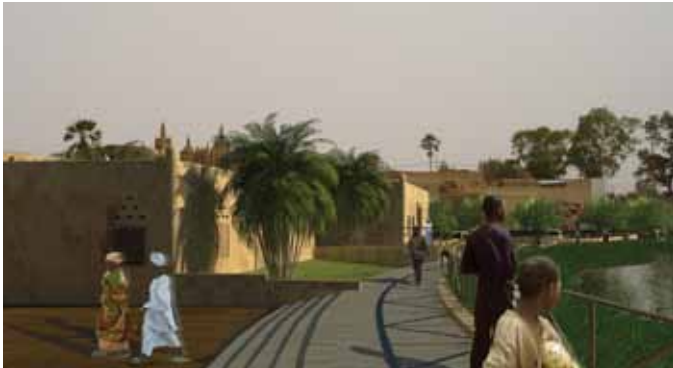
FIGURE 8 The proposed visitor and community center in Mopti will introduce the use of traditional earthen technologies in new construction, as well as provide a community space and source of revenue for the maintenance of the nearby mosque. The project is part of the rehabilitation of the Komoguel neighborhood in Mopti. Photo: AKTC. Design: F. Siravo. Rendering: E. Trapani

Together with these physical improvements, effective legislation for urban areas and settlements needs to be introduced. The DNPC has already developed draft guidelines for Mopti. Another excellent set of guidelines has been proposed for Gao, but they have not yet been translated into statutory town plans. This legal passage, however, is quite important: experience in other parts of the world shows that in order to be effective, these guidelines need to be integrated into the local planning and building bylaws under the control of the local government authorities. Further, implementation of conservation actions and the reintroduction of traditional building practices should become part of the day-to-day responsibility of local planning offices (fig. 8).

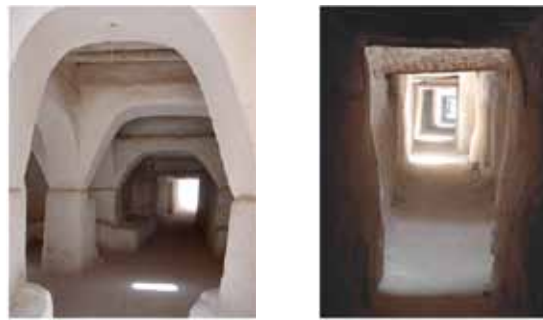
FIGURE 1 Unique architectural features of Ghadames: arches and covered streets. Photos: A. Abufayed

To overcome the harsh climate, streets are narrow, winding, and covered completely except for lighting and ventilation openings spaced almost regularly along them (fig. 1). Consequently, the city's buildings form an extensive monolithic structure with one large roof. This roof is used exclusively by women and children for socializing and trade during the daytime. Moreover, it optimizes adaptations to the harsh environment by minimizing exposed areas and maximizing the area per unit volume. This feature, along with proper selection of isolating local building materials, gives houses in Ghadames superior thermal qualities.

The two-tiered streets have an almost uniform height of about 10 meters, slightly lower than the maximum heights of palm trees so as to ensure protection from the frequent sandstorms and to minimize loss of agricultural land area. Having more than fifteen hundred buildings, Ghadames sustained a high population density of over a thousand persons per hectare. The city's architecture is characterized by its unique, organic form, morphology, covered streets, and unique arches (see fig. 1).

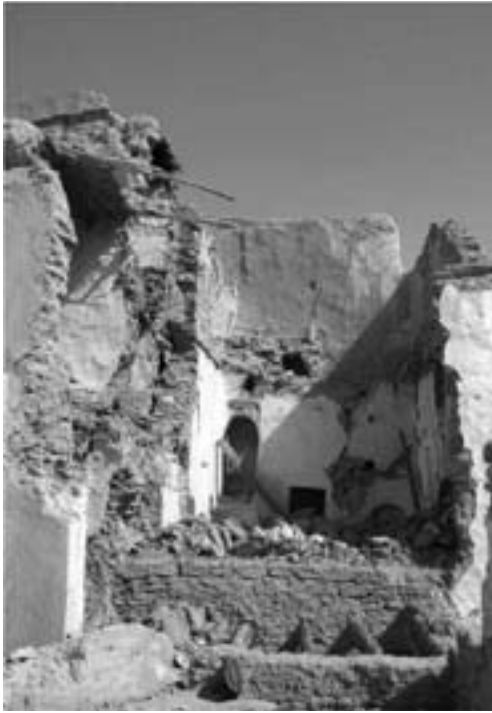
FIGURE 2 Deterioration of adobe structures in Ghadames. Photo: A Abufayed

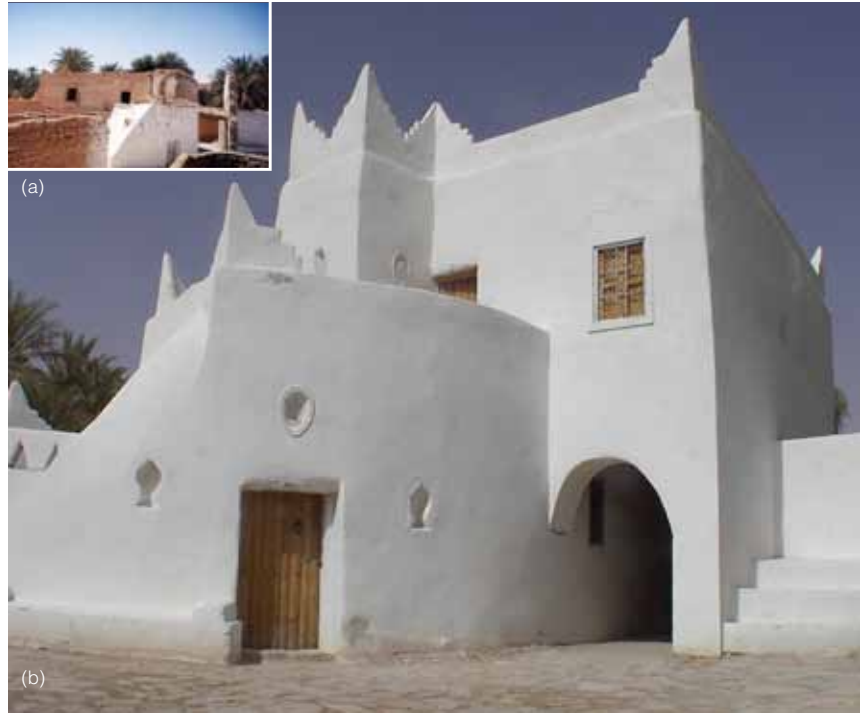
FIGURE 3 Project for the rehabilitation of Ghadames Tylawaan school (a) before and (b) after. Photo: A. Abufayed

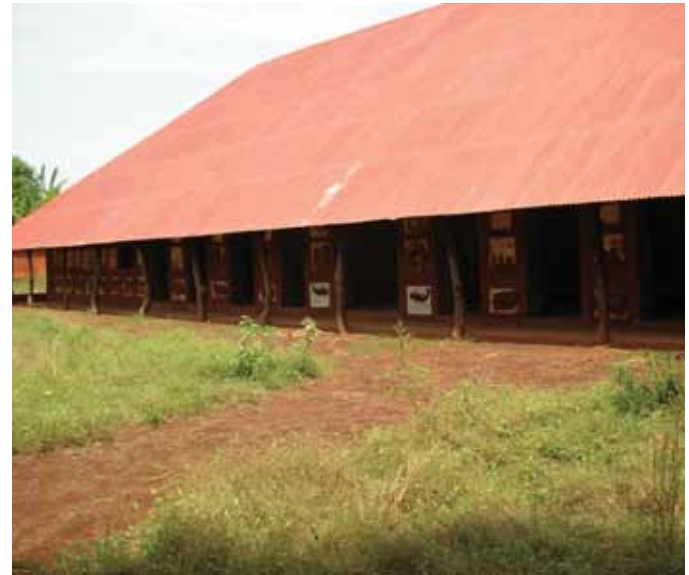
FIGURE 3 Palais de Béhanzin, restauré en 2003. Photographie : Francesca Piqué, 2006

Dowome, palais du roi Béhanzin, n'a jamais été achevé à cause de la guerre, le suzerain ayant passé quatre ans à défendre l'intégrité de son royaume contre les colonisateurs. L'effort entrepris par les familles royales n'a pu aboutir, faute de moyens, le palais faisant plus de huit hectares. Finalement, grâce à l'aide du gouvernement japonais et de l'UNESCO, ce palais construit en terre a été restauré (fig. 3).

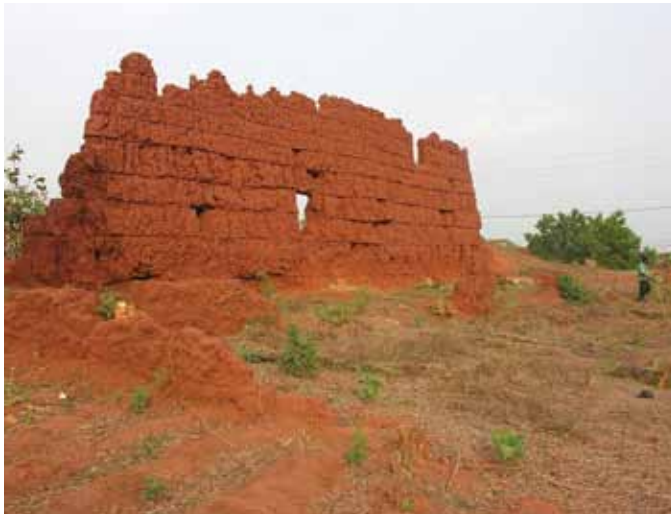
FIGURE 7 Mur vestige de la case à étage du roi Akaba, un des seuls éléments complètement authentique des palais, dont il faut donc prendre le plus grand soin.

La situation des palais n'en demeure pas moins fragile et le gestionnaire du site devra constamment veiller à ce que le plan de conservation, de gestion et de mise en valeur du site soit bien appliqué (fig. 7). Le Comité du patrimoine mondial devra régulièrement évaluer les avancées réalisées. Quant au Gouvernement du Bénin, il devra rester mobilisé et poursuivre son effort de financement régulier.

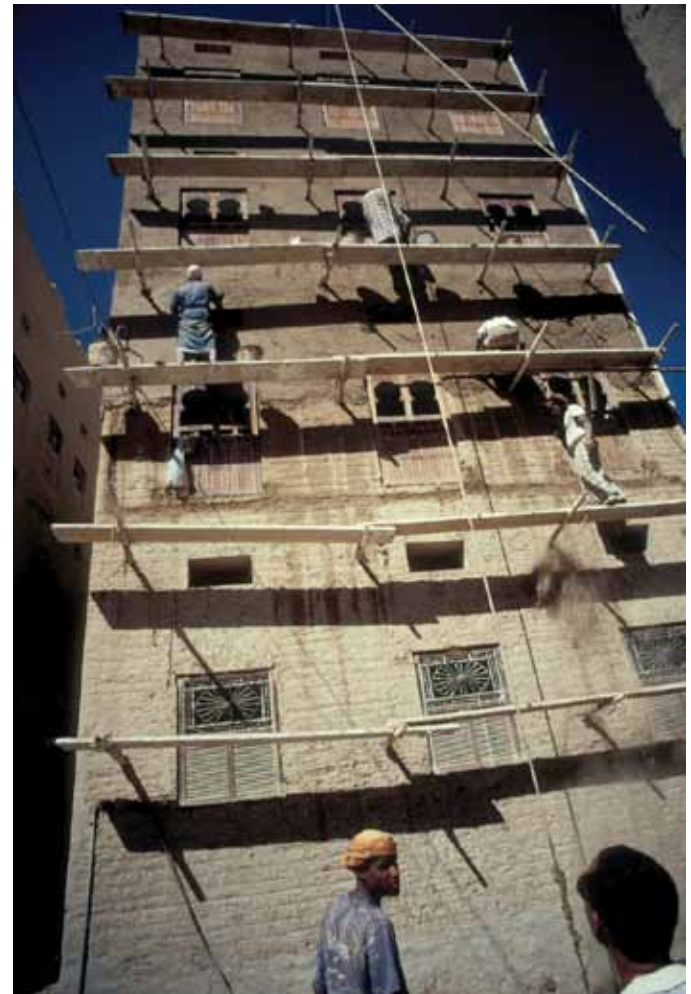
FIGURE 4 Traditional builders applying a coat of mud plaster. Photo: Pamela Jerome. Courtesy of the Visual Media Center, Columbia University

These stories tell us of Tarim's significance as both a socioeconomic and a spiritual center. One may trace the transnational culture of the al-Kafs through the hybrid architectural fabric of Tarim. Hadhrami masons and lime-plaster craftsmen were highly skilled and flexible (fig. 4). They incorporated the architectural languages of Neoclassicism, Rococo, Mughal,

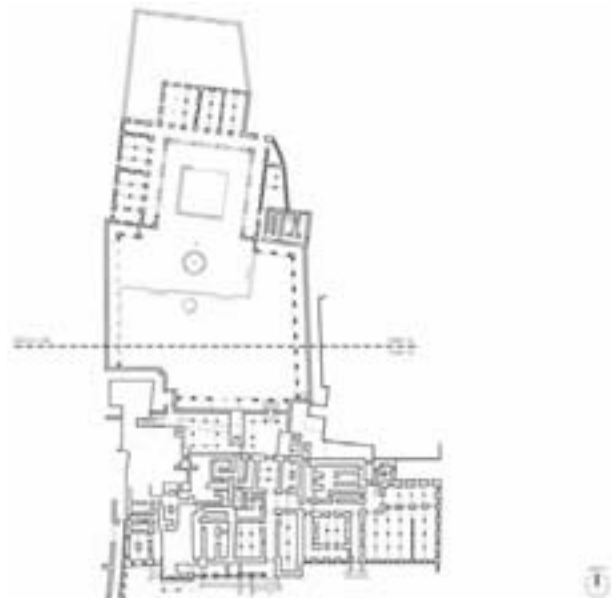
FIGURE 6 Qasr 'Abd al-Rahman bin Sheikh al-Kaf. Plan drawn by Sara Lardinois. Courtesy of the Visual Media Center, Columbia University

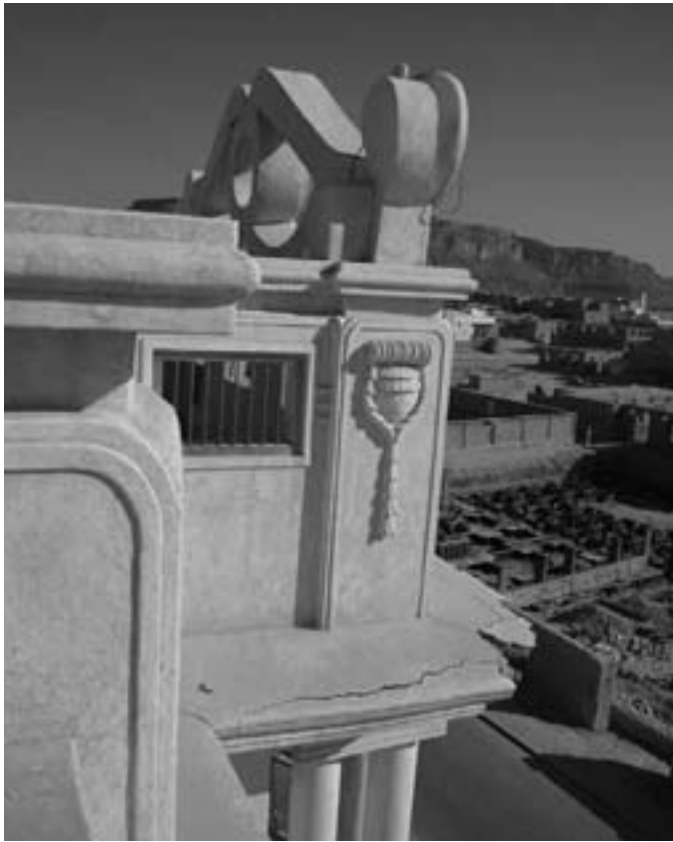
FIGURE 8 Unsympathetic concrete construction in front of Dar al-Salam. The building in question is a much-needed hospital, so conservation becomes the challenge of managing change to ensure that the past has a role in the future while not hindering access to needed services. Photo: James Conlon. Courtesy of the Visual Media Center, Columbia University

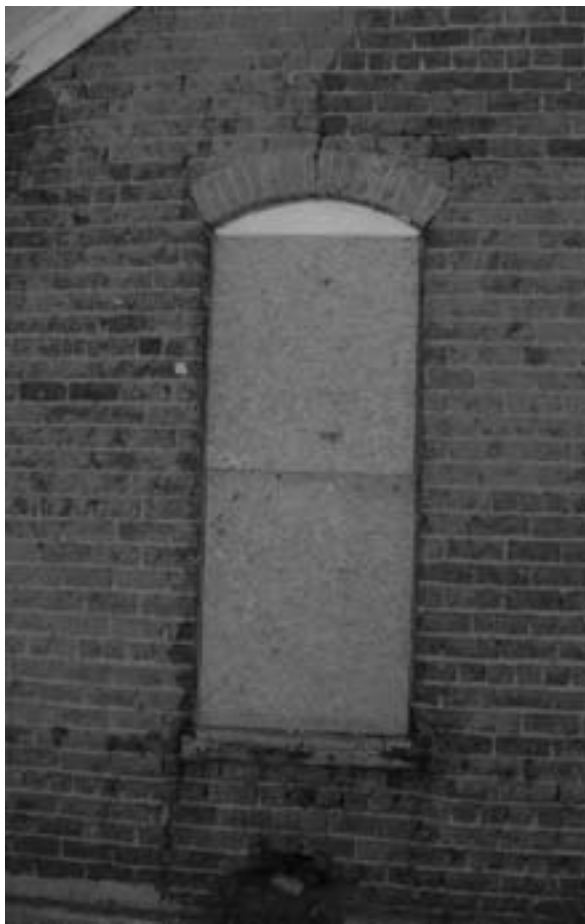
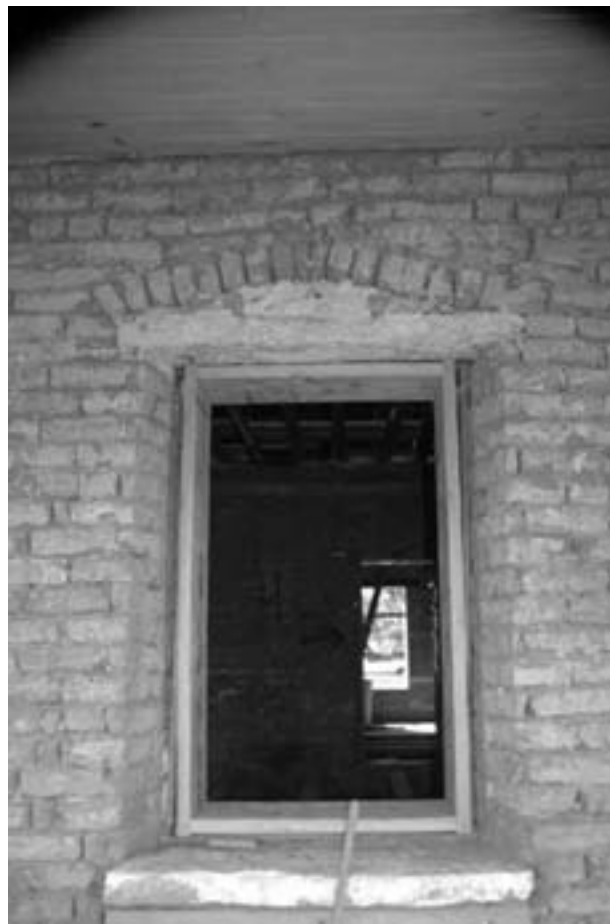
FIGURE 1 Costilla County Courthouse, San Luis, Colorado (a), and Otto Franc House, Pitchfork Ranch, Meteetsee, Wyoming (b). Photos: Edward Crocker

Our solution was to contrive a lathing system that is reversible without damaging the adobe walls. We used 4-by-10-foot sheets of expanded metal lath attached using quarter-inch through bolts and low-profile nuts. The interior will be plastered with earth for permeability, and the exterior, reflecting the desires of the builders 120 years ago, will have a thin coat of thoroughly modern portland cement.

In a rather remarkable turn of events, we had not yet finished with the first phase on the Costilla County Courthouse when we were confronted by its apparent prototype in northwestern Wyoming. Aside from the unlikely presence of an adobe ranch house in northern Wyoming, there was an uncanny resemblance between the adobe masonry style in the Otto Franc von Lichtenstein homestead (1878) and the Costilla County Courthouse. Again, the walls are on fieldstone footings, the size and proportions of the adobes are more akin

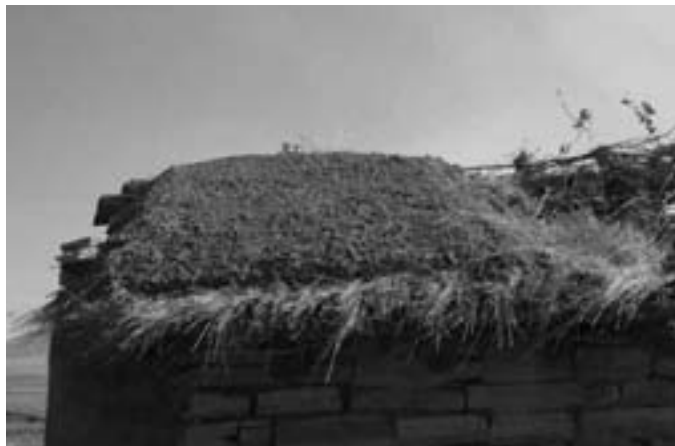
FIGURE 2 Hutmacher Farm, Killdeer, North Dakota. Photo: Edward Crocker

When I arrived at the Hutmacher Farm in North Dakota (built in 1928), I simply had to stand in amazement and ponder the temerity of a family of German immigrants building a pitched mud roof in the Great Plains, where the onslaught of wind, rain, snow, sleet, and hail made for incessant maintenance.

Naturally, there were reasons the Hutmakers built as they did. First, they were limited by the natural resources available to them. Second, and more profoundly, they were replicating a traditional architectural form that has its roots in the Black Sea region of the Ukraine and was brought to North Dakota by people of German-Russian descent. The building tradition they carried to the Great Plains called for building with pitched roofs, but the tradition did not prescribe the

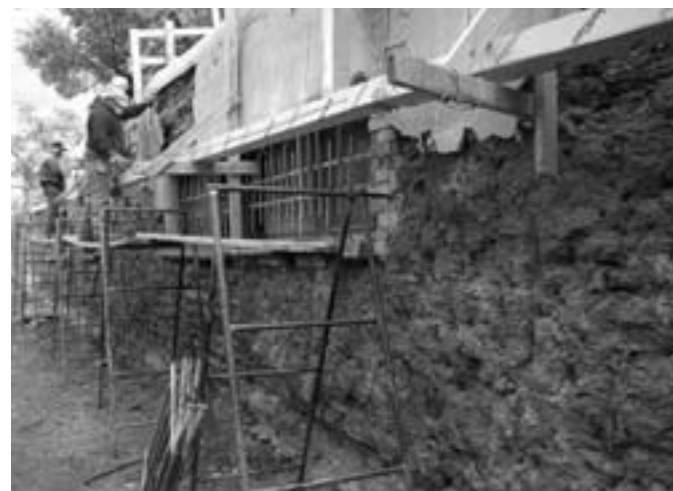
FIGURE 3 Palace of the Governors, Santa Fe, New Mexico. Photo: Edward Crocker

We proposed and installed a series of three seismographs and sixteen crack monitors in strategic locations throughout the Palace/History Library complex. Then, weeks before the demolition began, we took daily readings of both sets of indicators to establish the baseline data. The monitoring allowed us to judge when to halt work and when to recommend a different approach. The system worked admirably, and the Palace survived unscathed. But what if the monitoring, or another event, requires a response?

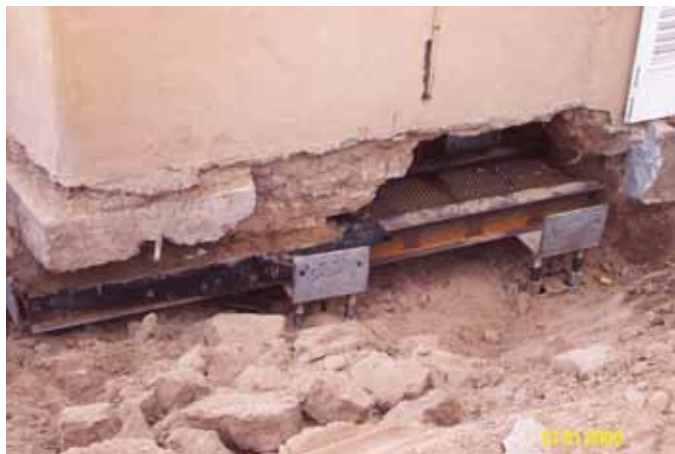
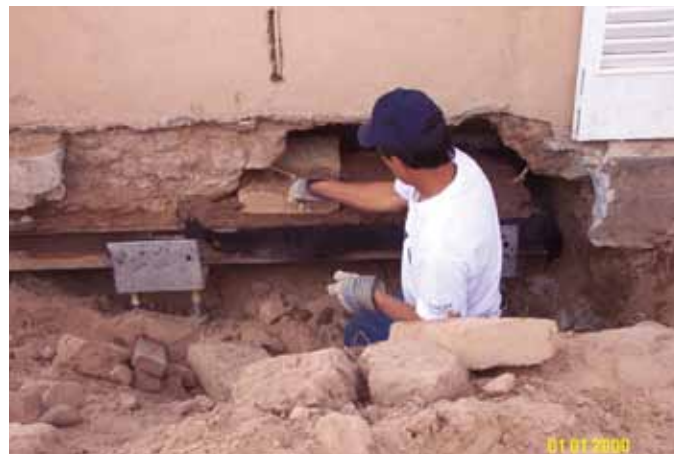
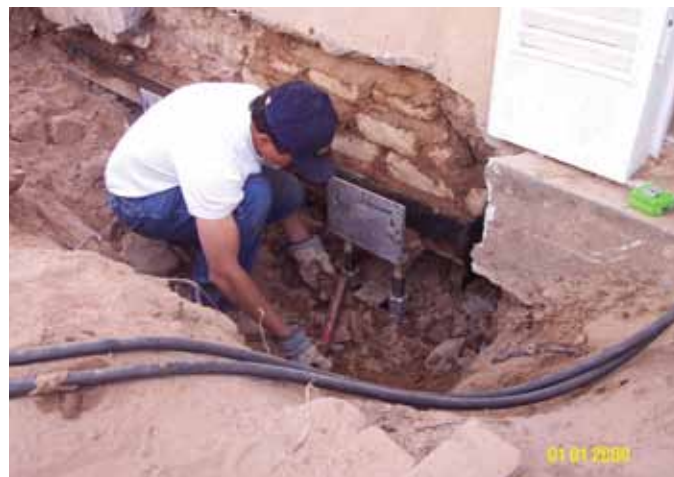
FIGURE 4 Installation of adobe baskets.

One of the more challenging aspects of dealing with historic adobe and stone buildings is deriving a method of structurally underpinning while being true to the preservation tenets of minimal intervention and reversibility. We have developed hardware to underpin even the most difficult situation. Perhaps the most innovative approach is the use of “adobe baskets.” These are steel elements, engineered to specific

My son, who is not known for piety, seemed to receive a nearly divine enlightenment when he came up with “adobe cages” to tame this beast. Essentially, he welded 1-inch channel iron into frames with sufficient bracing to make them rigid,

then welded a heavy-gauge expanded metal over the frames. The dimensions of the frames fit sections of the wall and were intended to encase the bottom 3 feet. By mixing a lime-rich mud and piling it into the damaged wall and filling the low-profile cage with the same material, he could through-bolt two cages together, one inside and the other outside, with minimal interference to the original wall. The resulting sandwich served the purpose brilliantly: it was structural, reversible if necessary, completely vapor permeable because of the expanded metal, and of such low profile that we could later plaster directly over the cages.

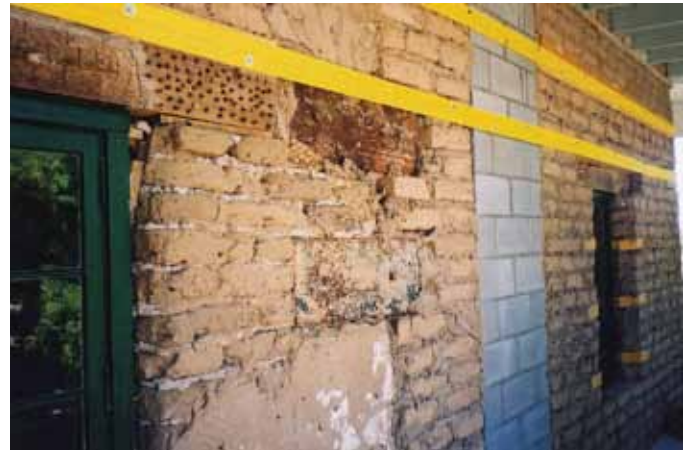
FIGURE 5 Polyester strapping in place at Los Luceros Hacienda, Alcalde, New Mexico. Photo: Edward Crocker

Because the walls of the building had been so compromised by “maintenance,” collapses had already occurred, and some very large and threatening cracks had appeared. We recommended and designed a system to bind the walls together. In keeping with the principles of reversibility and minimal intervention, we specified the use of polyester strapping to wrap the entire structure at several levels (fig. 5). The strapping is 3 inches wide and about one-eighth of an inch thick and has a test strength of 30,000 pounds. Importantly, it will only stretch about 5 percent before reaching its limit, which is why we use polyester over nylon, which can stretch up to 30 percent before failing.

The strapping was run in one piece around the full circumference of the building at window and door lintel height and again at the wooden bond beam separating the stories, hitting as much exposed wood as possible. Grommet holes were melted in and brass decking screws with washers were used to affix it to the wood as well as to the adobe. The strapping was pulled taut mechanically before it was screwed to the walls.

Interior walls were treated as well, with the strapping installed in such a manner as to bind them to the peripheral walls.

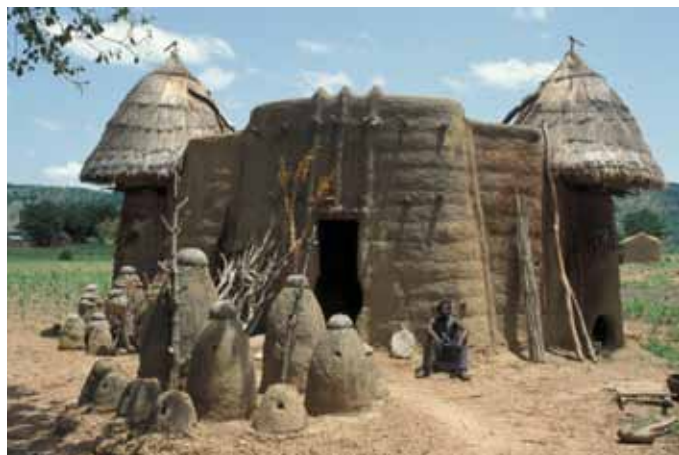
FIGURE 1 Une *takienta* et ses autels extérieurs. Photo : CRATerre-ENSAG, Joffroy, Thierry

Le toponyme *Koutammakou* signifie littéralement « le territoire où l'on bâtit avec la terre » et le nom *batammariba*, « ceux qui façonnent la terre », « les maçons de terre » ou encore « ceux qui construisent avec la terre » (fig. 1).

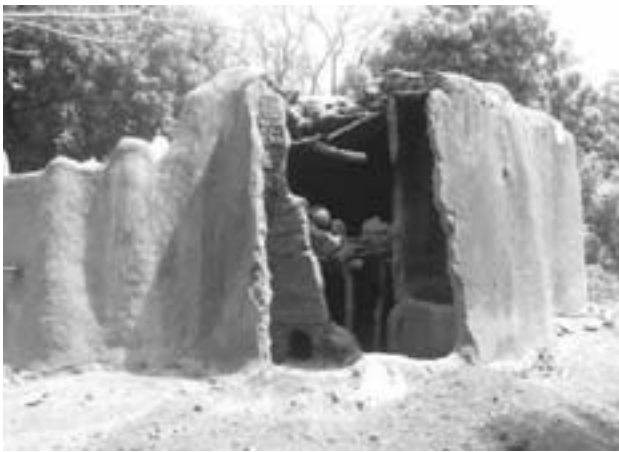
FIGURE 7 Une *takienta* abandonnée. Photo : Direction du patrimoine culturel du Togo

- La principale menace afférente à la *takienta* réside dans l'abandon de plus en plus visible de son édification. Sur le site, cinq situations se présentent (fig. 7) :
 - construction de simples cases rondes à côté des *tatas* familiaux,
 - mutation de la structure circulaire en forme carrée ou rectangulaire avec substitution de la tôle à la paille,
 - développement des agglomérations et de petits centres urbains avec des constructions modernes,
 - construction de la *takienta* en parpaings de ciment (fig. 8),

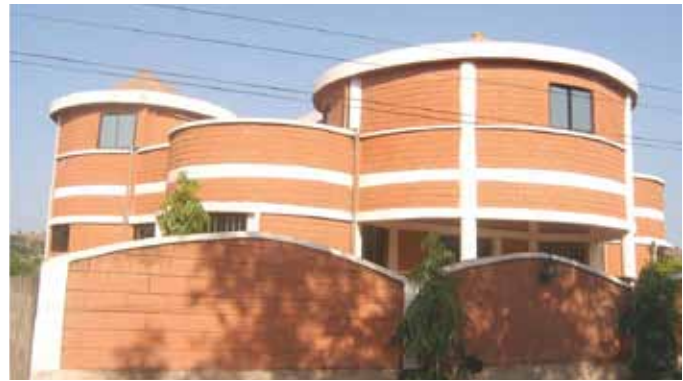
FIGURE 8 Une *takienta* en parpaings de ciment. Photo : Direction du patrimoine culturel du Togo

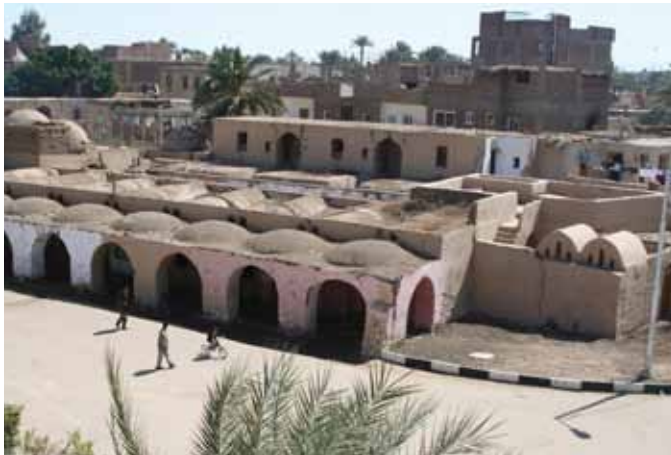
FIGURE 4 A view of part of New Gournna from the minaret of the mosque in 2008. Mud buildings that were built by Hassan Fathy are in a bad state of conservation. Many buildings were replaced by new reinforced concrete blocks. Photo: Hossam Mahdy

Most inhabitants of New Gourna have neglected their mud buildings or replaced them with reinforced concrete block buildings (fig. 4). Authorities on the local, regional, and national levels have turned a blind eye to the gradual loss of these architectural masterpieces. Furthermore, many of the traditional houses in the old village of Gourna were bulldozed in 2006 to gain access to the archaeological layer of ancient tombs (fig. 5). Some of the demolished houses were fine examples of vernacular heritage of the Nile Valley. They also were important for the integrity of Thebes, a World Heritage Site.

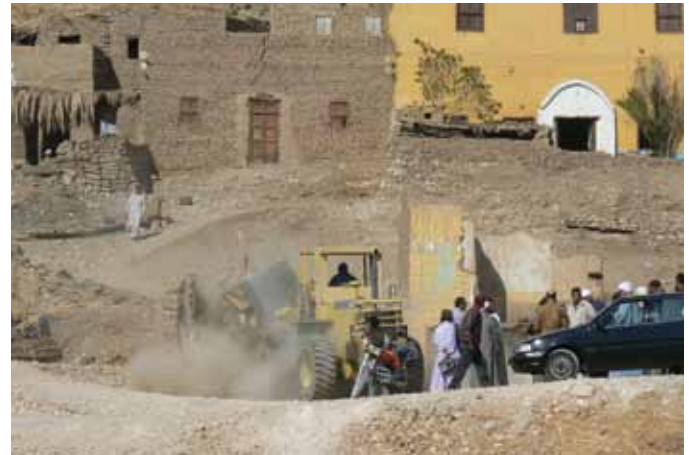
FIGURE 5 The demolition of the old Gournna traditional mud houses in 2006. Photo: Sameh Zaki

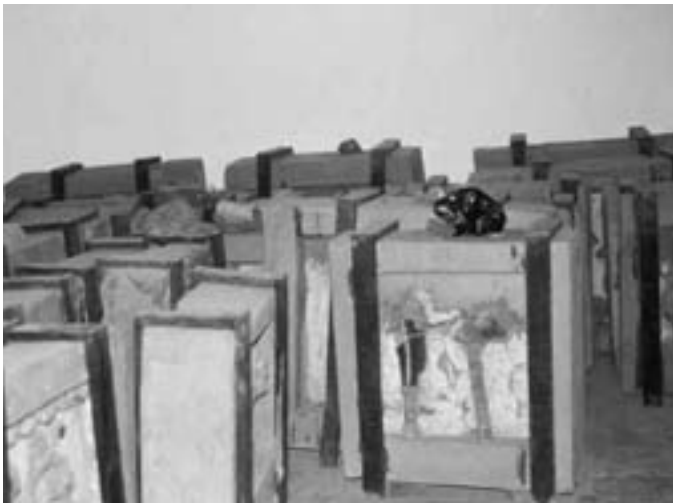
FIGURE 2 From 1988 to 1993, prior to the start of the Abomey Project, the bas-reliefs detached from the Ajalala of King Glélé were stored in different parts of the museum and were in various states of disrepair. Photo: Leslie Rainer. © J. Paul Getty Trust, 1993

when the building was razed and reconstructed. Of the fifty-six bas-reliefs originally on the facade, fifty were found in various states of disrepair and six had been lost (fig. 2).

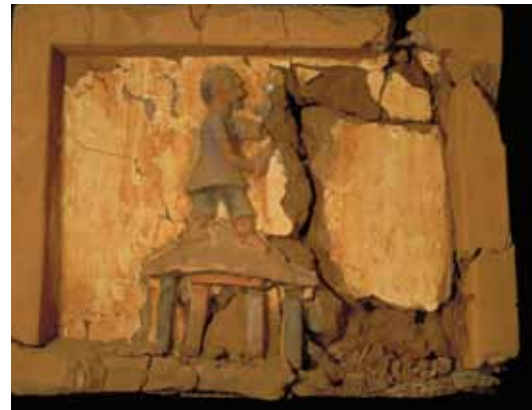
FIGURE 3 Example of a bas-relief, before (a) and after (b) treatment. The broken base of the frame is an indication that the principal cause of damage was the transport of these heavy objects following their detachment. Photo: Susan Middleton. © J. Paul Getty Trust, 1995 (a) / 1997 (b)

Initially the principal cause of damage to the largest bas-reliefs was their aggressive detachment from the facade of the Ajalala of Glélé in 1988. At that time the panels were manually cut out of the walls and encased in heavy cement and earthen frames to stabilize them. The reinforced panels weighed 300 kilograms on average. The detachment process not only caused significant structural damage but also contextually and physically transformed the panels, from integral architectural elements of the palace facade into isolated museum objects. Subsequent transport of the heavy detached bas-reliefs between storage areas aggravated their fragile condition (fig. 3).

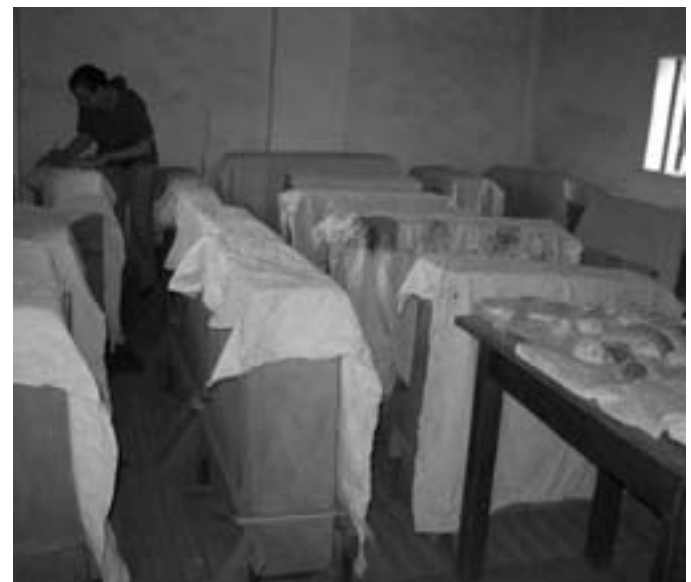
FIGURE 5 Most bas-reliefs in long-term storage were placed upright in rows. Individual wooden base supports, constructed locally, were fabricated to provide stability for each panel. The supports rest on metal sheeting placed over the bare floor to prevent animal and insect attack from the ground (e.g., termites). The bas-reliefs were then covered with cloth and plastic to reduce dust accumulation. Photo: Leslie Rainer. © J. Paul Getty Trust, 2006

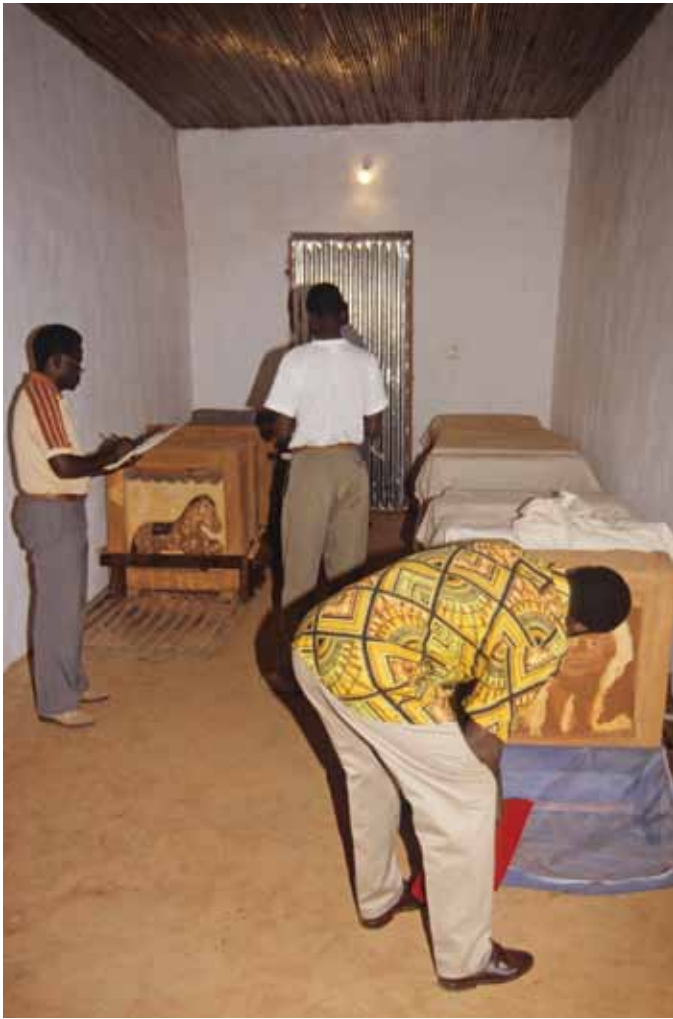
FIGURE 6 The Beninois team members and three of the Abomey Museum staff were trained to carry out regular inspections between campaigns during the project. These inspections included not only the bas-reliefs but also the storage buildings to ensure that there was no damage due to water infiltration, animal attack, or other causes. Photo: Valerie Dorge. © J. Paul Getty Trust, 1996

As part of the Abomey Project, the conservation team developed long-term monitoring and maintenance protocols for the bas-reliefs to be carried out regularly by trained staff of the Historical Museum of Abomey (MHA) (fig. 6). The inspection forms were simple and consisted of checkboxes with additional space for notes and included a field indicating “actions to be taken.” These monitoring inspections were to be followed by maintenance activities involving surface cleaning, as well as repair and stabilization of damage incurred in the interim. The suggested frequency of inspections was twice a year in conjunction with the rainy seasons, when most damage was likely to occur.

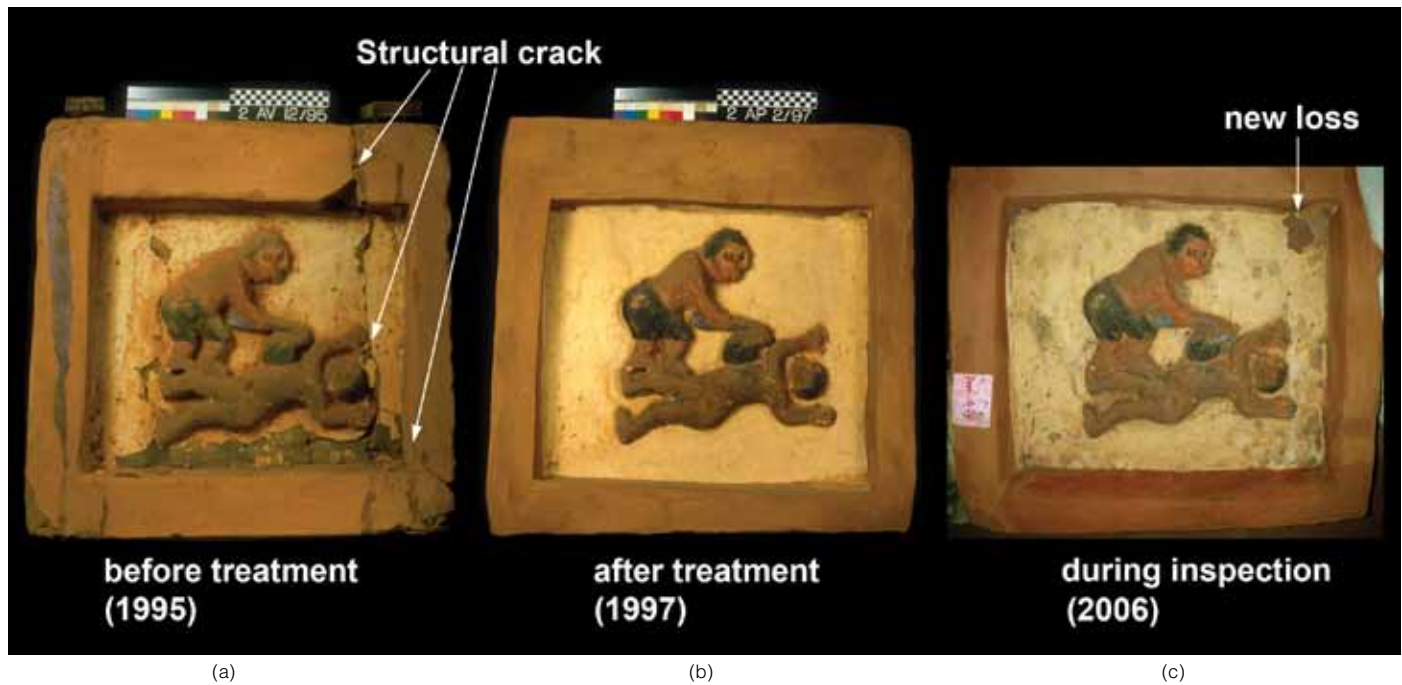
FIGURE 7 The changes observed included not only dust and dirt deposition but also loss of a portion of the background. This new loss runs along an existing structural crack that was filled and reintegrated in 1997. This bas-relief is large and heavy and is one that had been moved to a different storage location after completion of the project. It is likely that transport caused stress along the structural crack, which caused a portion of the painted background to delaminate. Photos: Susan Middleton (a, b) and Francesca Piqué (c). © J. Paul Getty Trust, 1995 (a) / 1997 (b) / 2006 (c)

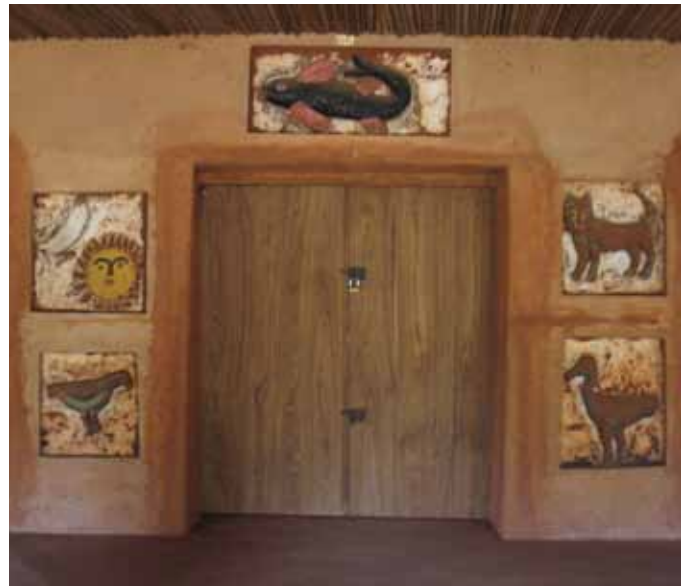
FIGURE 8 Following the Abomey Project, the bas-reliefs from the Ajalala of King Behanzin were conserved by the former site conservator, one of the conservation technicians trained on the Abomey Project, with assistance from local youth. The conservation of these bas-reliefs followed the approach used for the conservation of those from the Ajalala of King Glélé. Photo: Leslie Rainer. © J. Paul Getty Trust, 2006
