Terra 2008: The 10th International Conference on the Study and Conservation of Earthen Architectural Heritage

Edited by Leslie Rainer,
Angelyn Bass Rivera,
and David Gandreau

Proceedings of the 10th International Conference on the
Study and Conservation of Earthen Architectural Heritage,
Bamako, Mali, February 1–5, 2008

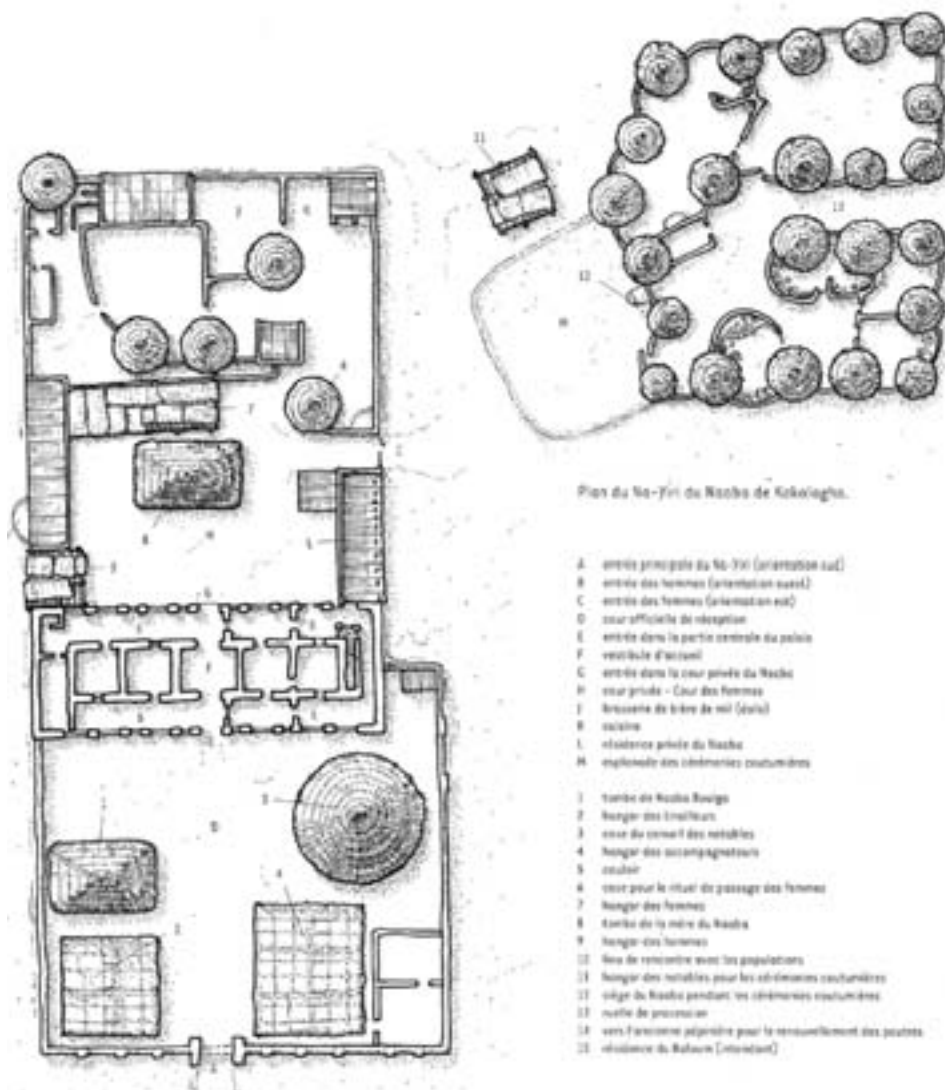
FIGURE 2 Le plan du *na-yiri* de Kokologho. B. Rakotomamonjy et A. Misse. © CRAterre-ENSAG

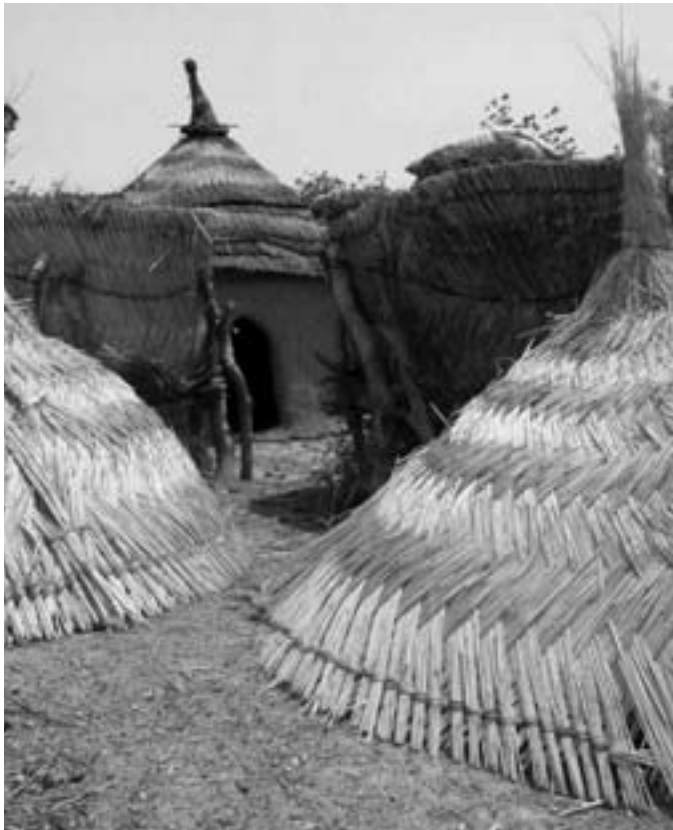
FIGURE 4 Les matériaux utilisés. © CRAterre-ENSAG.
B. Rakotomamonjy

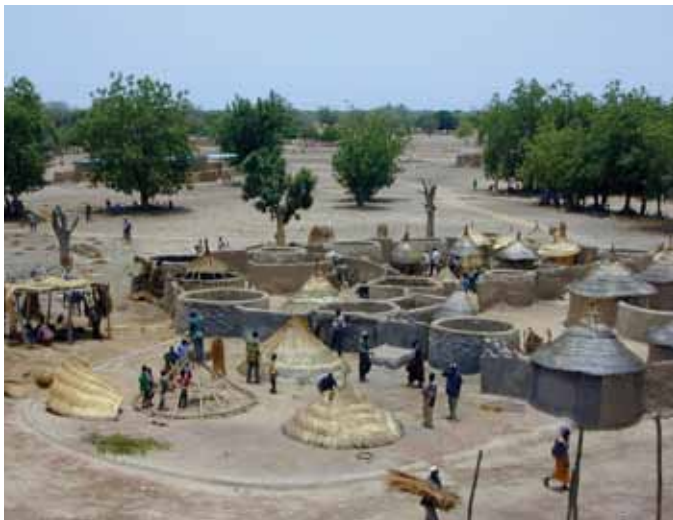
FIGURE 6 Le *soukpilli*, entretien traditionnel des toitures de la cour coutumière. © Direction générale du Patrimoine culturel du Burkina Faso. B. Kaboré

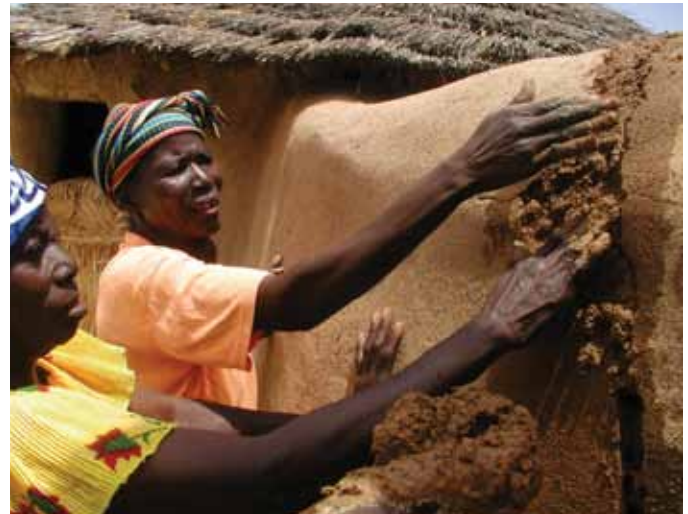
FIGURE 5 L'entretien des murs avant la fête du *Ran Gnouga*.
© Direction générale du Patrimoine culturel du Burkina Faso.
B. Kaboré

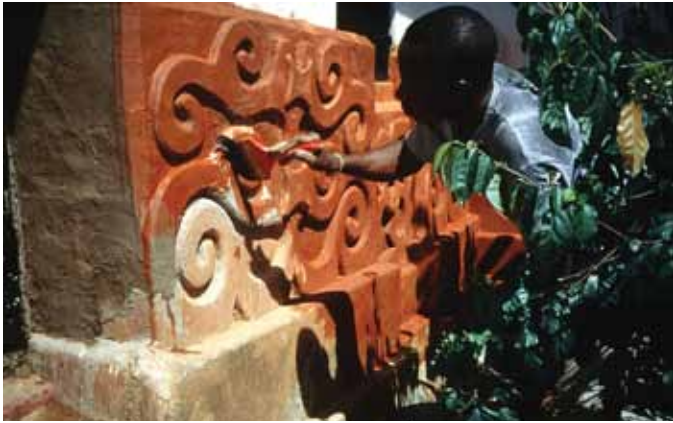
FIGURE 2 An example of an Akan domestic dwelling enhanced with high-relief sculptural semiotics. Photo: Bakorina Rakotomamonjy, CRATerre-ENSAG

However, a more elaborate semiotic symbolism and decoration rooted in the earthen architectural legacy is echoed in Akan architecture, in Ghana (fig. 2). In addition to its elaborateness in terms of function and building technology, Akan architecture is a reflection of native architectural forms and design principles and an embodiment of the spirit of independence of these Ghanaian people. In this regard the Akan use architectural semiotics and symbolism to portray their beliefs about, relation to, and attitudes toward God and his creation. These symbols are used as bas-reliefs or plinths, banisters, and walls in their architecture.

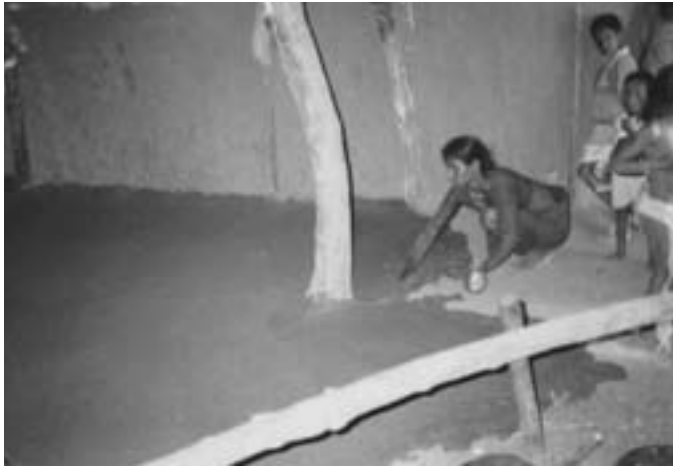
FIGURE 3 Woman plastering a floor.

Outside the house an *otla*, or platform, is built (fig. 2). Here the family works and receives guests. Children also play and study on the *otla*. Children learn to process bamboo and prepare baskets and other items by observing their parents at work. In addition, important kitchen equipment—grinding stone, pestle, tongs—is stored on the *otla*. Water is kept in earthen pots in summer and in steel pots in winter. After every rainy season the house is fully maintained and repaired. The woman of the house plasters (*lipna*) the floor every month (fig. 3).

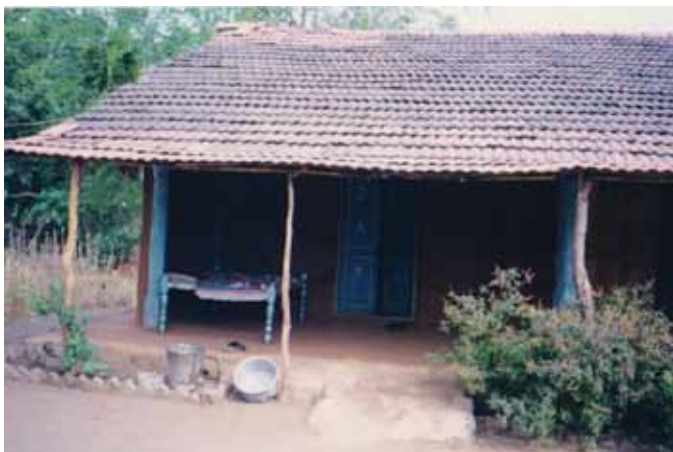
FIGURE 4 Front of an earthen house.

The roof is slanted to prevent rain from entering the house. To cover the roof, bamboo is arranged in such a way that a gap of 2 to 3 inches may remain. The roof is covered with palm leaves and on them *naliyas* (half pipe, 18 inches long), or Mangalore tiles are arranged in such a way that rainwater does not stay on the roof. Water is the constant enemy of a mud wall, so it must be protected against rain and dampness with extended roofs (fig. 4).

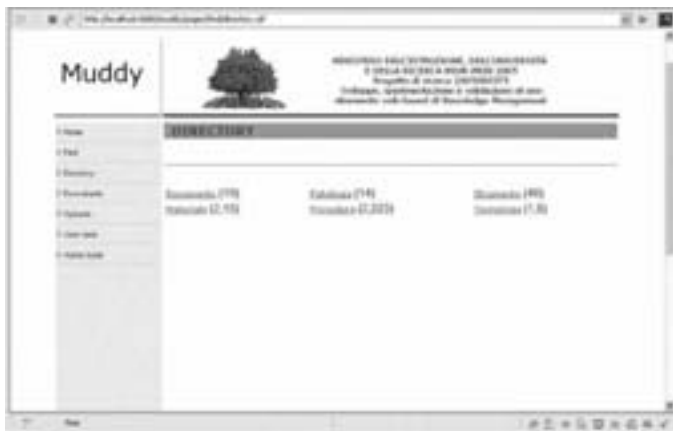
FIGURE 3 Directory page.

Once the user has accessed the main page, he or she can start navigating the knowledge base by means of different search criteria. The first one is the Directory page (fig. 3): at first glance, the portal has a weblike organization, where pages are organized in a taxonomic tree structure and the list

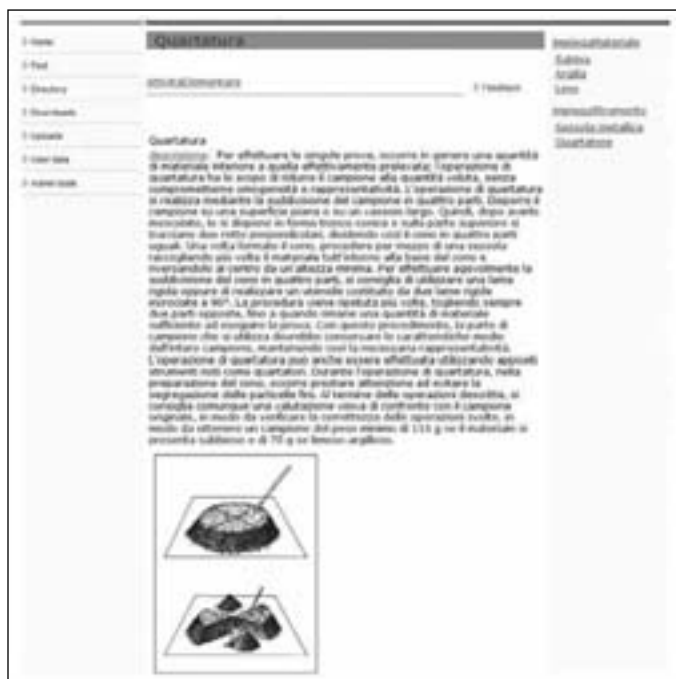
FIGURE 4 Resource page.

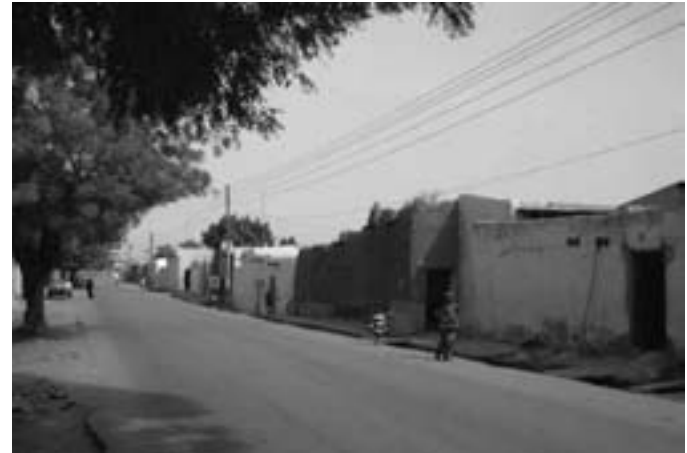
FIGURE 2 Street scene in Daura, January 2008. All the buildings on this street are of earth, plastered over with cement mortar. Photo: Ishanlosen Odiua

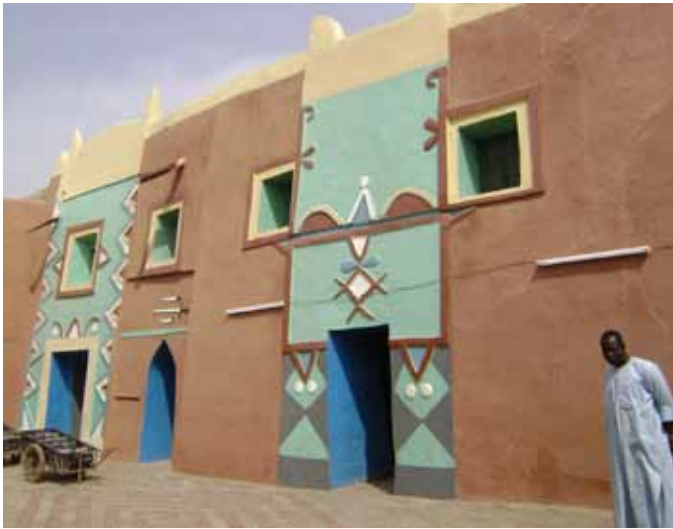
FIGURE 3 Courtyard within the Daura palace complex, January 2008. The paints applied on the wall are of industrial origin. Photo: Ishanlosen Odiaua

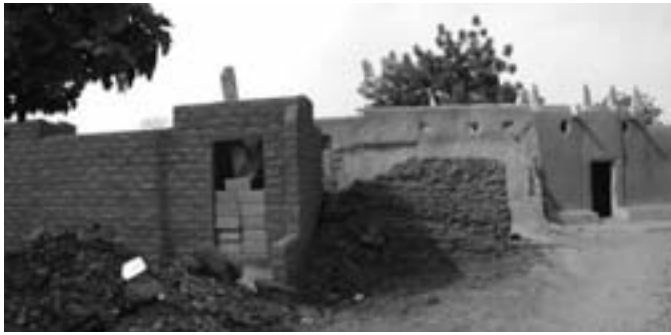
FIGURE 4 New and old buildings in Daura. Note the use of cellular concrete bricks for aeration purposes to the top left of the building under construction. Photo: Ishanlosen Odiava

One of the reasons for the vibrant earth building culture in Daura is also the enduring institution of the *magina*, or traditional builder. It is interesting to note that with the increasing use of cement blocks and the abandonment of the *tubali*, most bricklayers in Daura are judged by their ability to lay mud blocks rather than cement blocks (Isaka, pers. com.), and any builder worth his salt must be proficient in the laying of mud walls before he can be considered a good mason. It is not unusual to see buildings in which there is a mixture of earth and concrete elements, and new buildings often rise out of the ruins of the old (fig. 4).

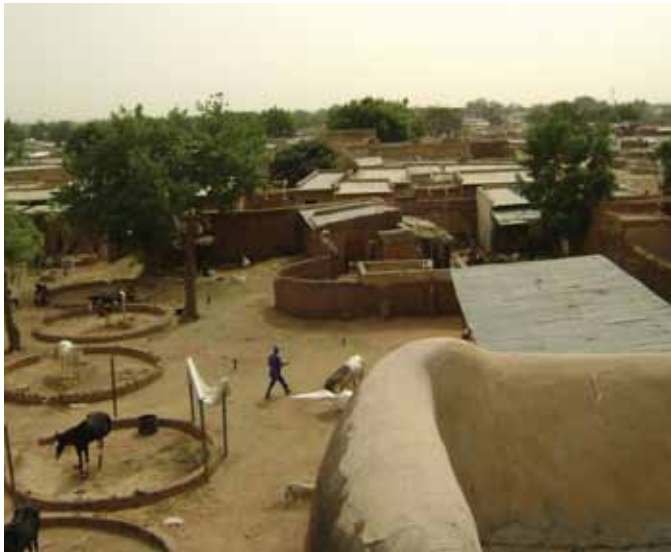
FIGURE 5 View of the palace complex from the top of a palace building. All earth roofs have been replaced with corrugated iron roofing sheets, surrounded on three sides by parapet walls (detail in foreground). Photo: Ishanlosen Odiava

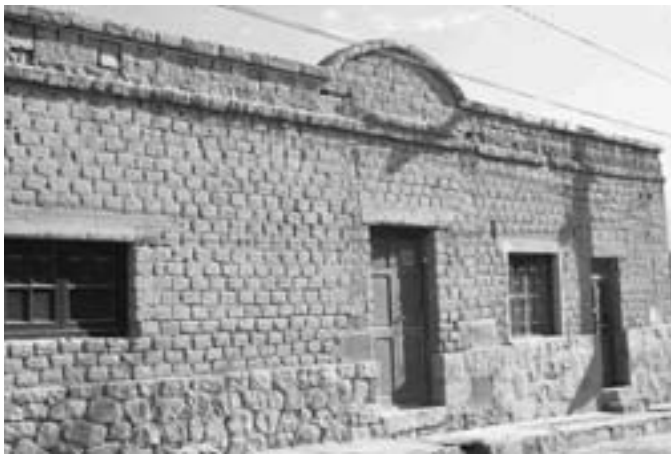
FIGURE 2 Façade d'une demeure traditionnelle du village de Tilcara, Quebrada.

L'expression architecturale de la période coloniale résulte d'un processus de synthèse fondé sur trois facteurs fondamentaux : l'habitant natif avec son savoir faire culturel et technologique, l'Espagnol avec son savoir architectonique, et le milieu naturel. La confrontation des modèles architectoniques et des savoir-faire européens avec la culture constructive locale a abouti à une volumétrie pure et des formes simples caractérisées par des murs épais et bas, et des toitures plates légèrement pentus pour s'adapter à la pluviométrie de la région. La connaissance de la technologie constructive adaptée au milieu naturel (géographie et climat), a déterminé la conception architecturale de cette époque. Jusqu'à la moitié du XX^e siècle et dans quelques régions encore, la terre comme principal matériau de construction définit le caractère et l'expression des constructions (fig. 2).

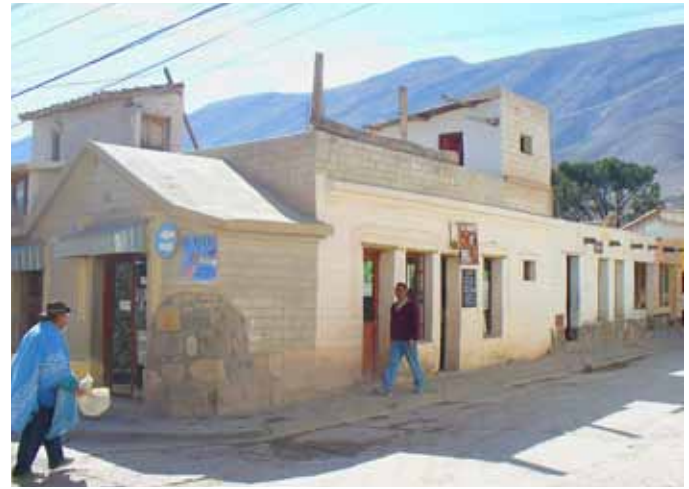
FIGURE 8 Les nouvelles façades ne respectent pas la tradition locale.

où ils sont bâtis. D'autres enfin sont construits sans maîtrise des technologies de la terre comme matériau de construction, et sans en considérer les qualités ni les limites. Ces nouvelles constructions ne s'intègrent pas bien à l'architecture locale car elles ne font pas le lien avec le patrimoine existant et ne tiennent pas compte de la valeur culturelle des sites lors du choix des emplacements (fig. 8).

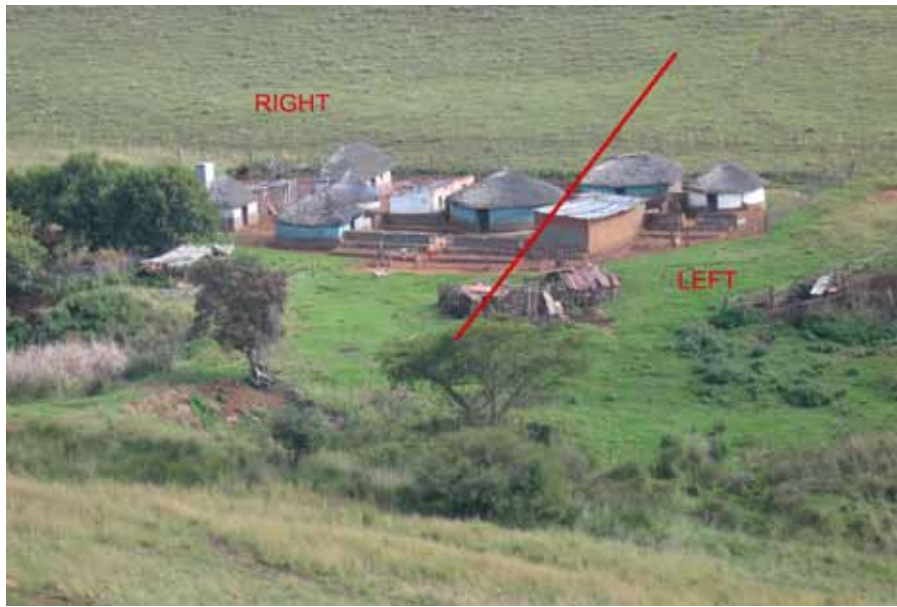
FIGURE 1 Linear-shaped Ndebele homestead near Stoffberg, Mpumalanga. Typical left/right dichotomy indicated. Photo: C. J. van Vuuren

The early Ndebele homestead was divided into two halves along the 12:00–6:00 axis if one compares it with a watch. These halves are invisible and consist of a right-hand side (*ububene*) and a left-hand side (*ikhohlo*) (fig. 1). The Ndebele determine right and left by turning the back on the 12:00 position of the homestead, thus facing the main entrance. The house (*indlunkulu*) of the principal wife is placed at the 11:00 position and that of the second (*ikhohlo*) wife at the 1:00 position. Third, fourth, and lower-ranked wives are placed on either side of the abstract line, thus third and fifth wives right (10:00 and 09:00 positions) and the fourth and sixth wives on the left-hand side (2:00 and 3:00 positions) (Van Vuuren 1983: 43). This orientation dualism is not uncommon in the South African homestead, especially among Nguni-speaking communities such as the Zulu, Swazi, and Xhosa (Kuper 1980).

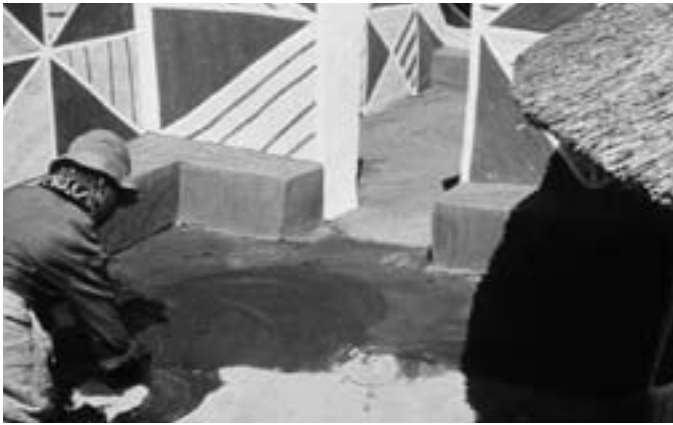
FIGURE 3 Example of a corridor (*umkgothana*) between the front and rear courtyards. The woman who kneels in the frontal section is applying cow dung to the floor. Photo: C. J. van Vuuren

Interlinking courtyard walls between houses are accessed by several corridors and thoroughfares, called *imikgothana* (fig. 3). To the ordinary person, these corridors obviously provide mobility for residents between sectors. From an intangible perspective, these corridors arrange for the flow and maintenance of the *ukuhlonipha* rule in Ndebele society. According to the *hlonipha* principle in Nguni society (Krige

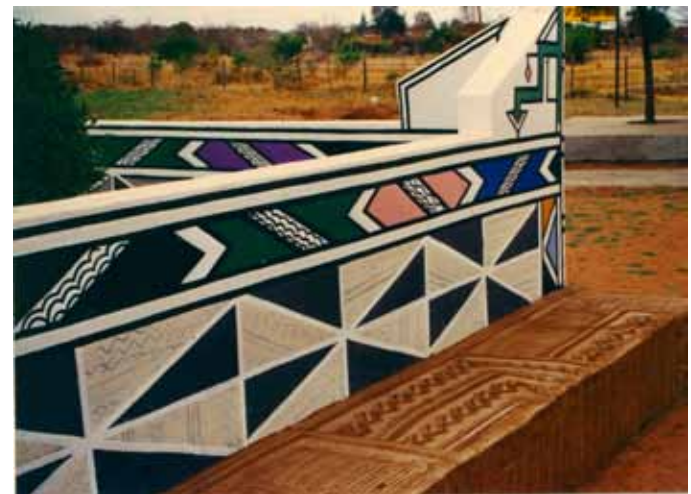
FIGURE 6 Modern mural art accommodates both earthen pigments and commercial paints. Note the lamppost design on the corner wall. Photo: C. J. van Vuuren

Ndebele mural art has earned this community a distinguished cultural identity (Schneider 1985: 62). Ndebele women and their daughters paint their houses and courtyard walls according to their *isikhethu*, that is, “ours” or “our culture.” This style has also become contrasted with modern tendencies in style variation mostly advocated by younger Ndebele women. It has become a generation identity. Since the 1883 diaspora of the Ndebele and the introduction of the farm life period (roughly 1883–1970), regionality in style, particularly motif, color, and paint, has become a clear marker of differentiation (Schneider 1985: 62–63; Van Vuuren 1983: 60–68). Modern acrylic paints were introduced in areas closer to the urban fringe, while earthen pigments are still used in rural areas (Van Vuuren 1983: 165) (fig. 6).

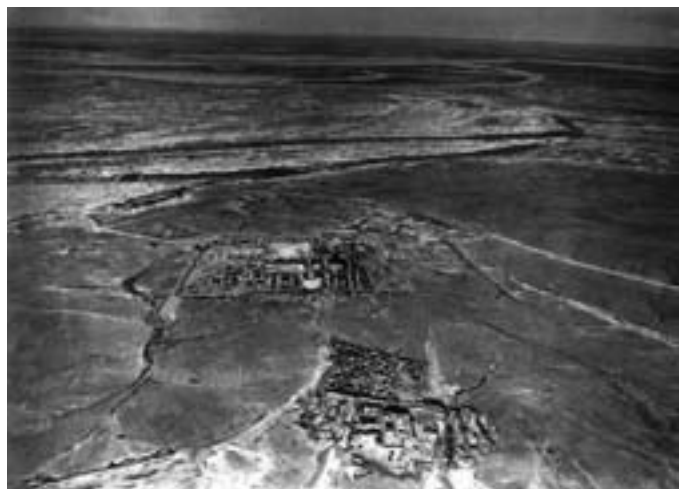
(a)

FIGURE 2 Dégagement du Grand Palais Royal de Mari par André Parrot en 1937 et Plan du Grand Palais Royal de Mari, projet de restauration du secteur de la salle du trône.
© Mission Archéologique Française de Mari

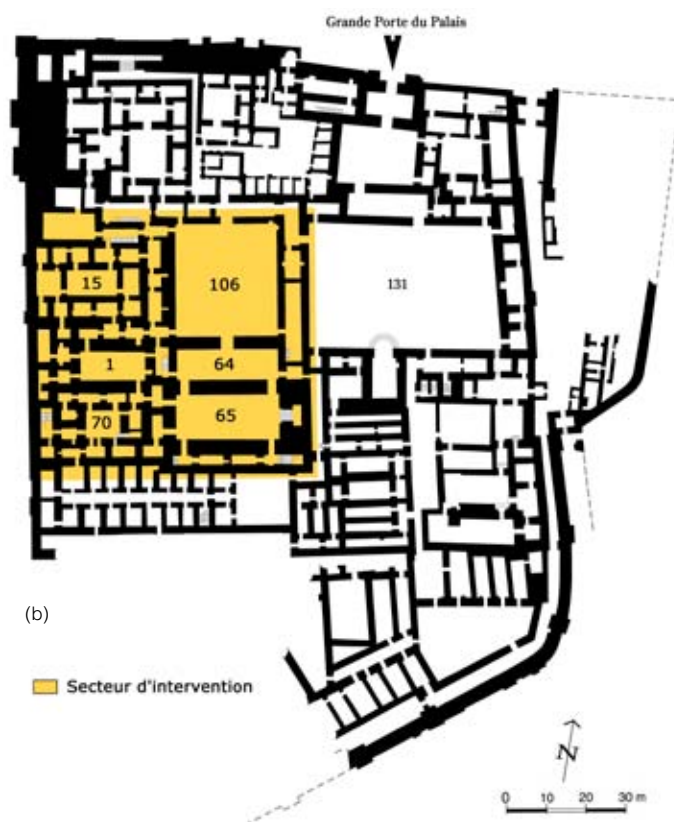
(b)

FIGURE 3 Secteur de l'Enceinte Sacrée du palais du III^{ème} millénaire av. J.-C. protégée par une couverture. © Mission Archéologique Française de Mari

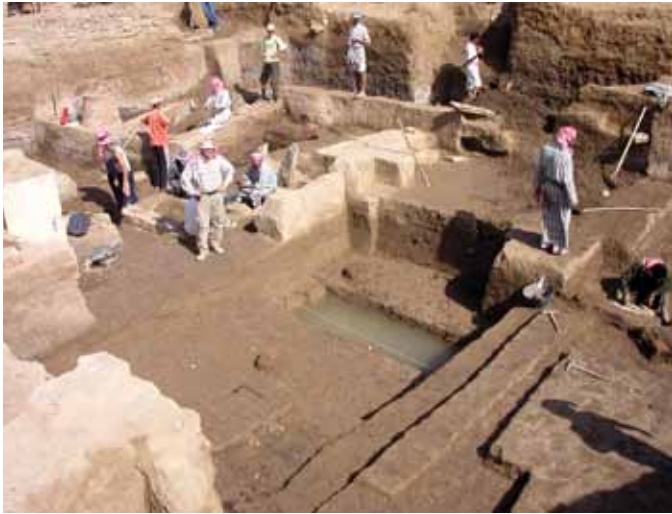
FIGURE 4 Travaux de fouille dans le chantier L avec apparition de l'eau de la nappe phréatique. © Mahmoud Bendakir. CRATerre-ENSAG

L'étude hydrologique a révélé que le principal facteur d'érosion à Mari est lié à la présence permanente d'humidité dans le sol et le sous-sol du tell (fig. 4). Sa localisation non loin de l'Euphrate, dans une vallée actuellement très irriguée, explique cette omniprésence d'humidité. De plus, l'élévation du tell à 14,5 m au-dessus du niveau de la plaine, son exposition au soleil et au vent, offrent les conditions idéales pour l'évaporation des eaux ascensionnelles.

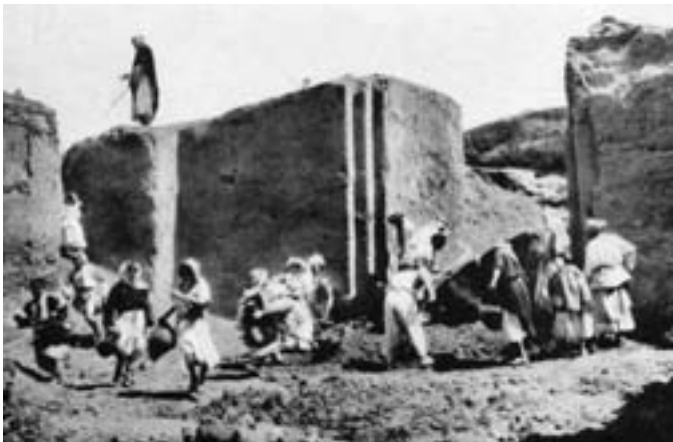
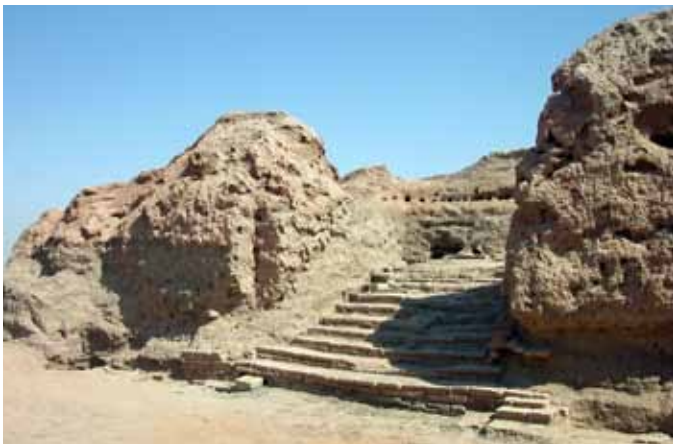
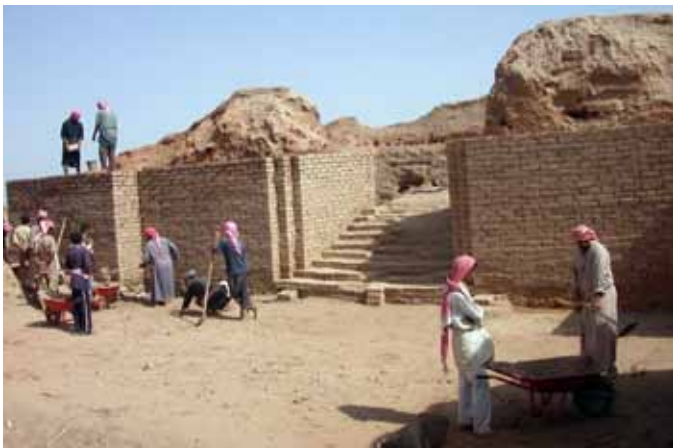
FIGURE 7 La tribune de la salle du trône du Grand Palais Royal du II^{ème} millénaire av. J.-C. État avant et après les travaux de restauration. (a) Mission Archéologique Française de Mari ; (b) et (c) © Mahmoud Bendakir. CRATerre-ENSAG

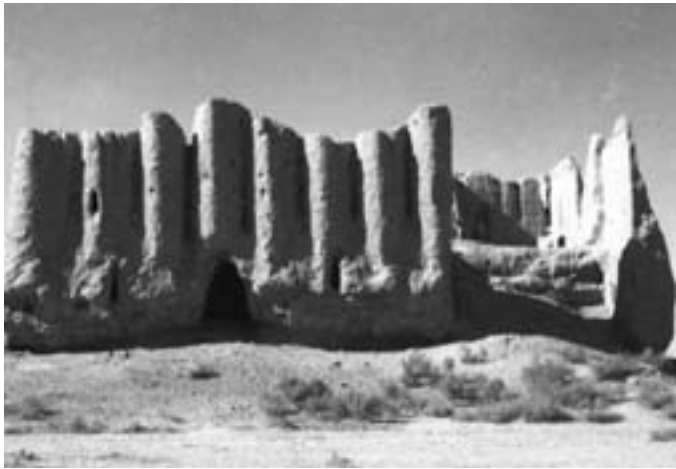
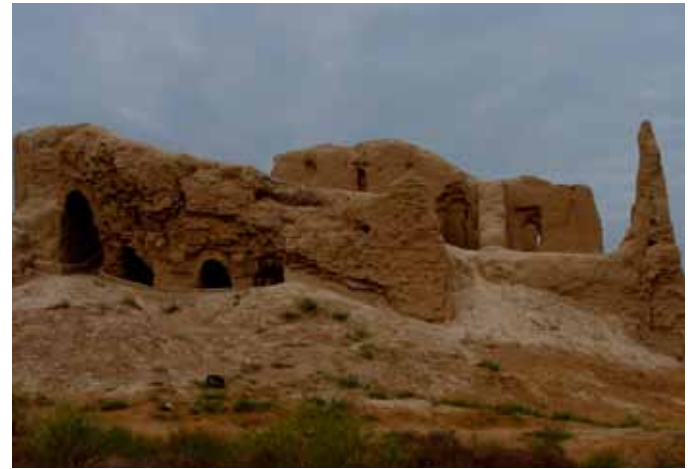
FIGURE 1 (a) Eastern facade of the Little Kyz Kala in 1954, photographed by a member of the YuTAKE team. Courtesy of the Ancient Merv Project, Institute of Archaeology, University College London; (b) Eastern facade of the Little Kyz Kala in 2003. Photo: L. Cooke

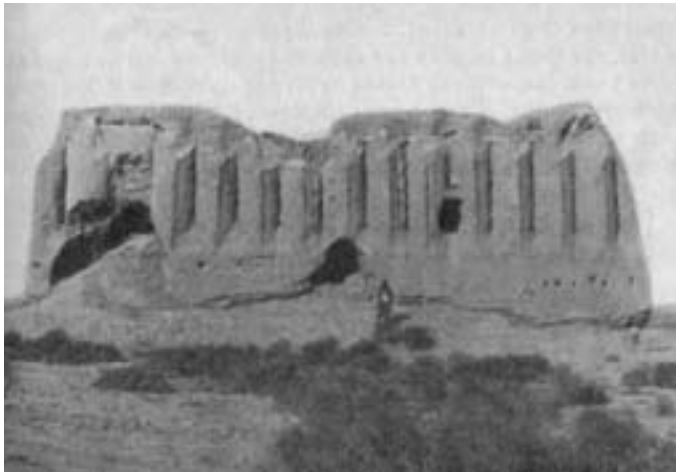
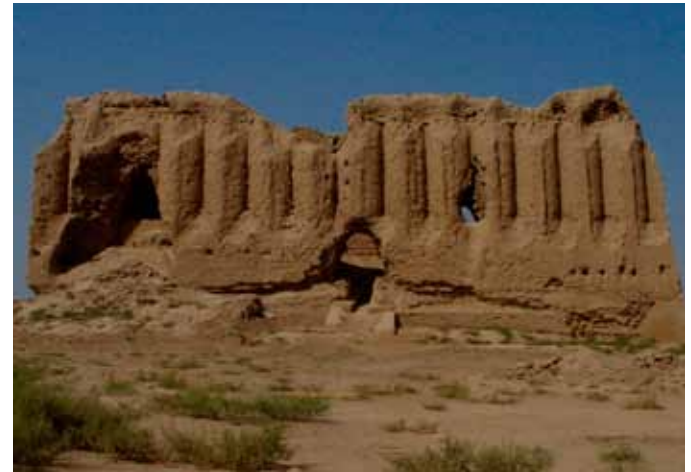
FIGURE 2 (a) Eastern facade of the Kepter Khana in 1958. Photo: G. Pugachenkova. Courtesy of the Ancient Merv Project, Institute of Archaeology, University College London; (b) Eastern facade of the Kepter Khana in 2003. Photo: L. Cooke

Figures 2a and 2b show the east facade of the Kepter Khana. Comparison of the 1958 and 2003 photographs shows an overall loss of definition. Also, the void covering the first

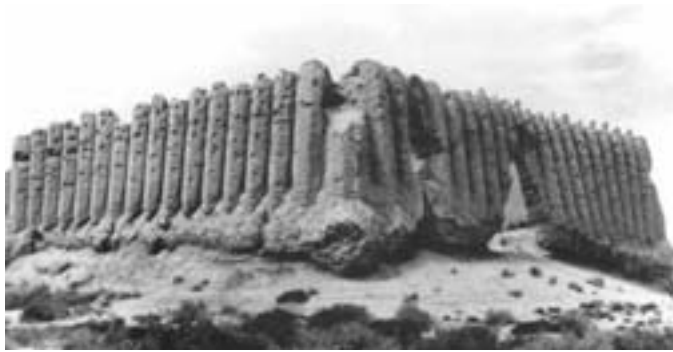
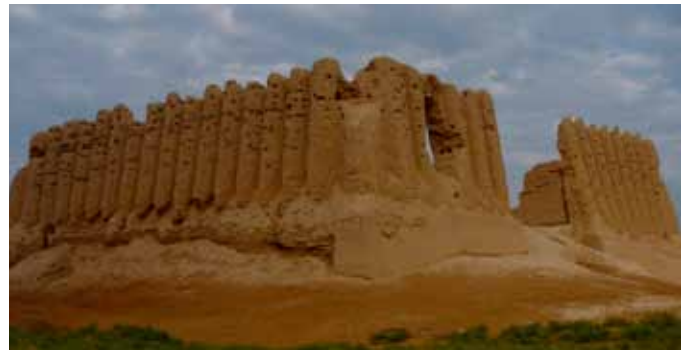
FIGURE 3 (a) The southern and eastern facades of the Great Kyz Kala in 1971. Photo: V. Pilyavsky. Courtesy of the Ancient Merv Project, Institute of Archaeology, University College London; (b) The southern and eastern facades of the Great Kyz Kala in 2003. Photo: L. Cooke

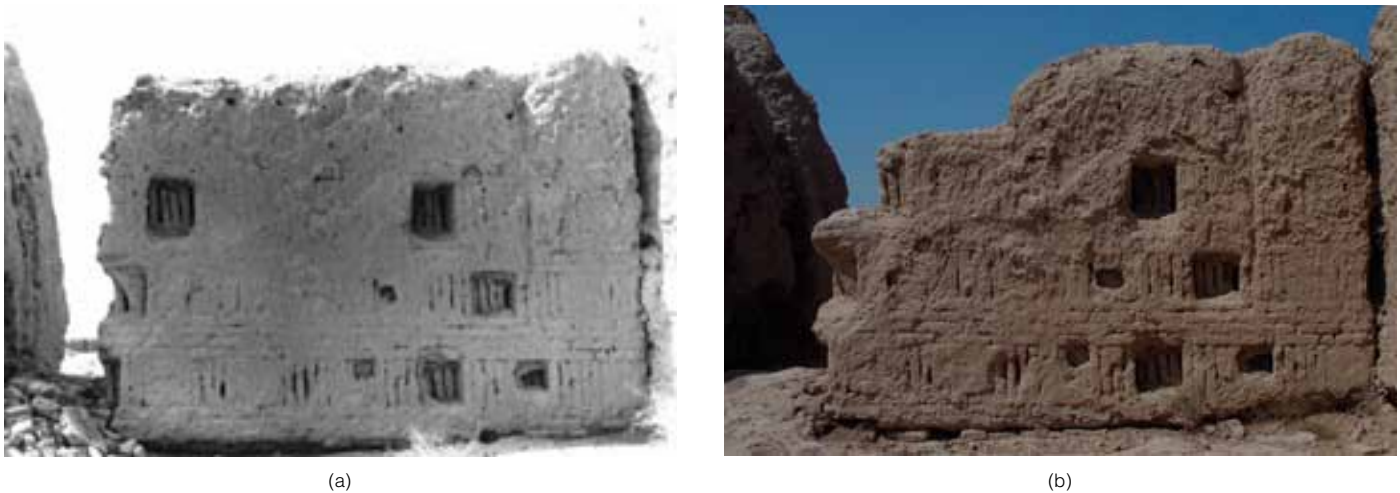
FIGURE 4 (a) The west wall of room 23 of the Palace in Shahriyar Ark in 1990. Photo: IMP team member. Courtesy of the Ancient Merv Project, Institute of Archaeology, University College London; (b) The west wall of room 23 of the Palace in Shahriyar Ark in 2003. Photo: L. Cooke

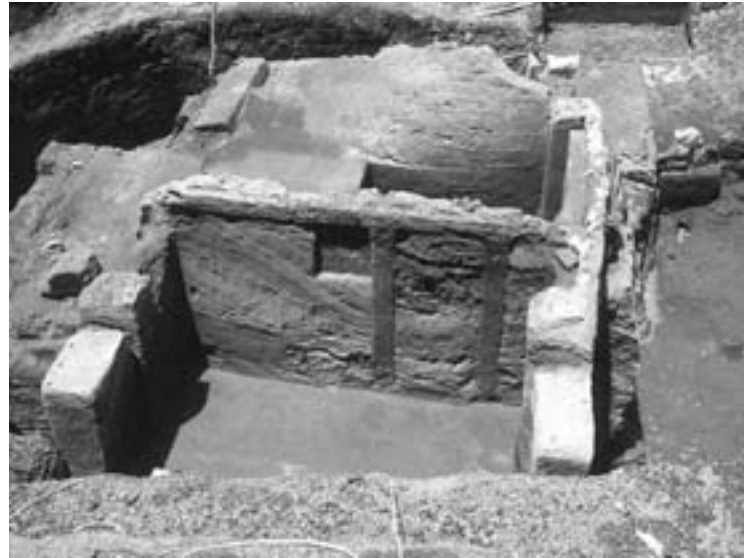
FIGURE 3 Analyse des techniques, des matériaux de construction et de l'état de conservation. Photo : Payson Sheets. Graphique : Elvia Arango. © J. Paul Getty Trust

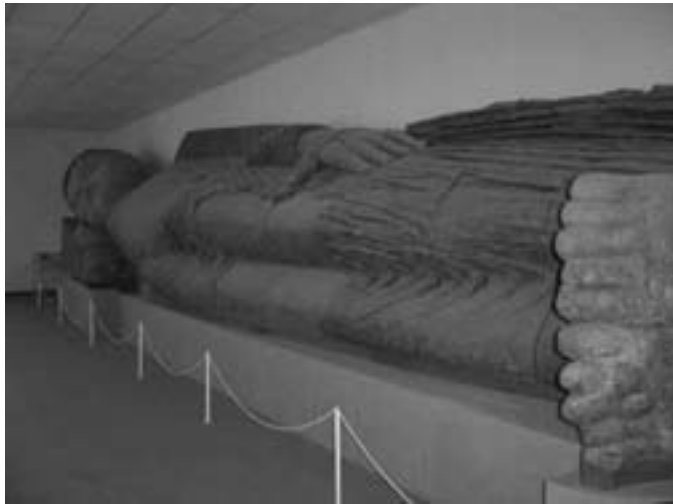
FIGURE 3 The 13 m long Buddha in *paranirvana* was discovered in one of the corridors of Ajina Tapa. The statue, made of soil, was cut into pieces and transported to the National Museum of Antiquities in Dushanbe, where it was conserved by experts from the Hermitage Museum of St. Petersburg. Spring 2005. Photo: Enrico Fodde

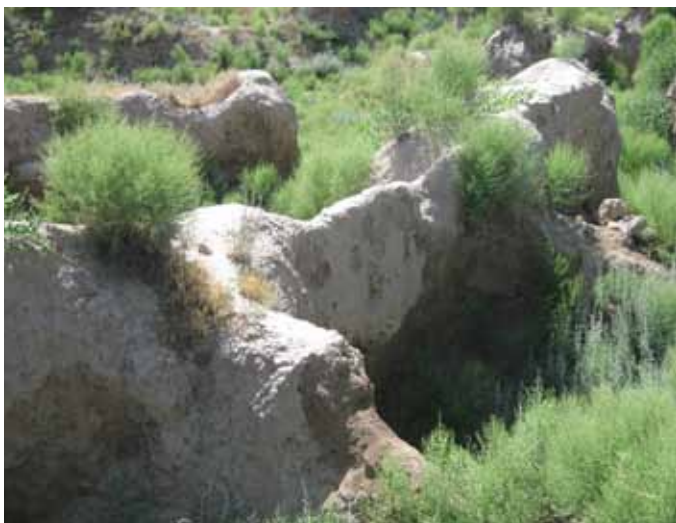
FIGURE 4 Vegetation is one of the main deterioration factors for the earthen walls of Ajina Tapa. Deep roots (up to 1.5 m) expand while growing and cause collapse of parts of the wall. Spring 2006. Photo: Enrico Fodde

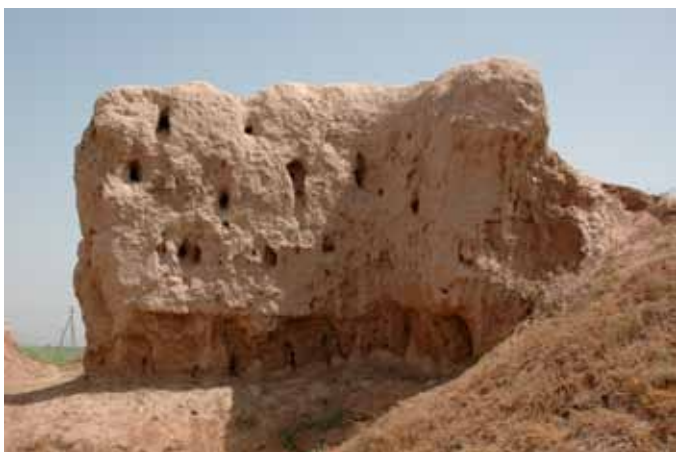
FIGURE 5 One of the tallest earthen walls after removal of vegetation showing decay caused by bird nesting. Spring 2006. Photo: Enrico Fodde

Before the start of the project, the condition of the monastery was similar to that of other Tajik sites excavated in the Soviet period (figs. 4, 5). The earthen walls were left to decay without conservation, which also occurred at Qhulbuk (ninth–eleventh

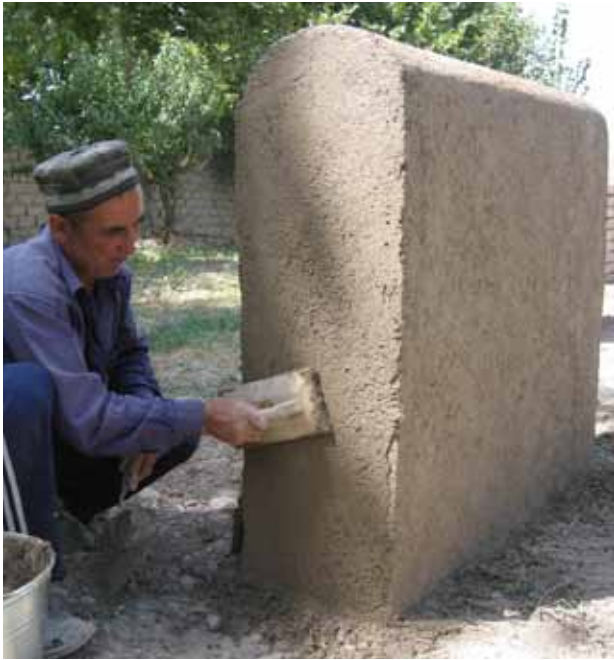
FIGURE 6 Test wall construction. Fall 2006. Photo: Enrico Fodde

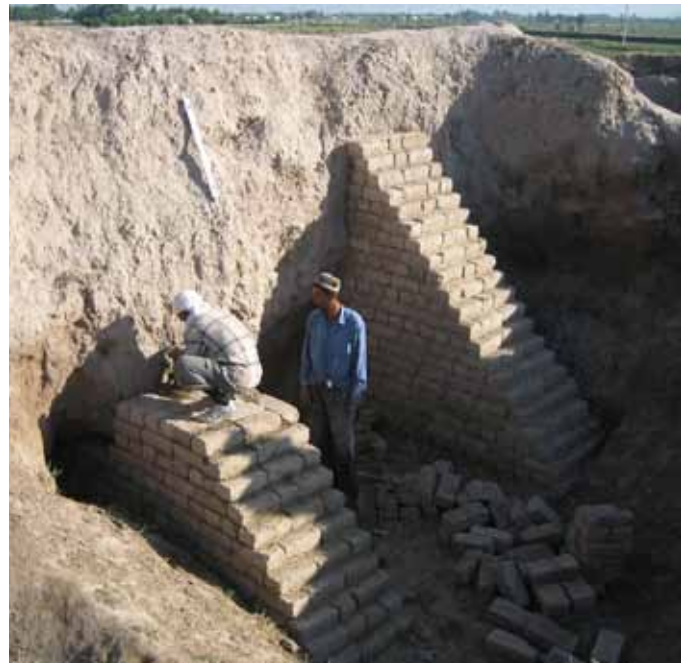
FIGURE 7 Construction of buttresses for the consolidation of leaning walls. Spring 2007. Photo: Enrico Fodde

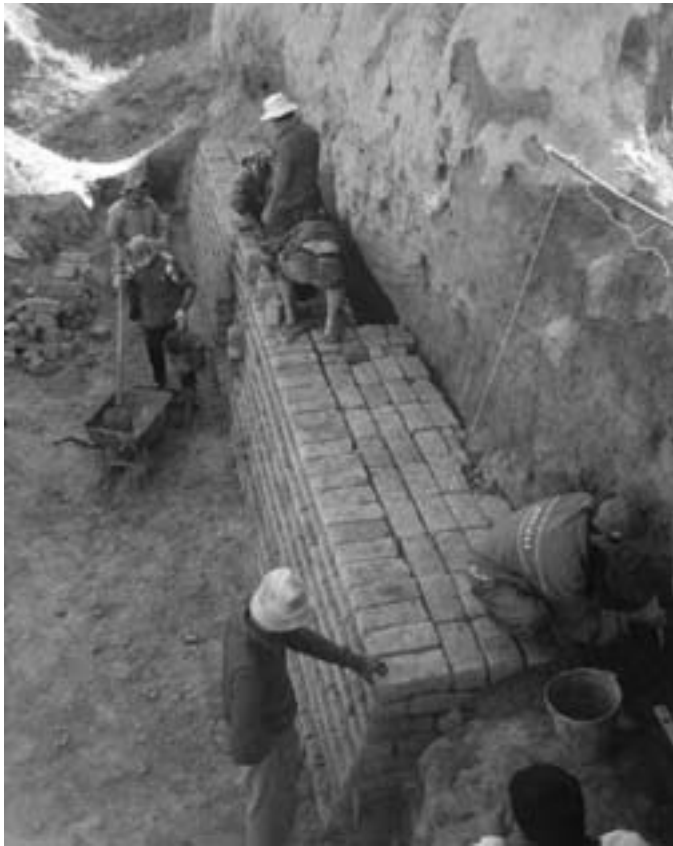
FIGURE 8 Construction of shelter wall against erosion. Spring 2007. Photo: Enrico Fodde

low trench (20 cm deep) was dug along the wall and filled with a conglomerate of gravel and sterile soil. This mix was rammed in place to give a solid ground for the shelter wall masonry. The shelter wall was constructed so that the mud brick is clearly legible as a modern intervention. The gap between the mud-brick skin and the historic fabric was filled with dry soil, and then the area was fully plastered with a mix of soil and straw. In some cases, “windows” were left to expose the historic fabric; this was done for a didactic purpose, to demonstrate our approach to shelter walling.

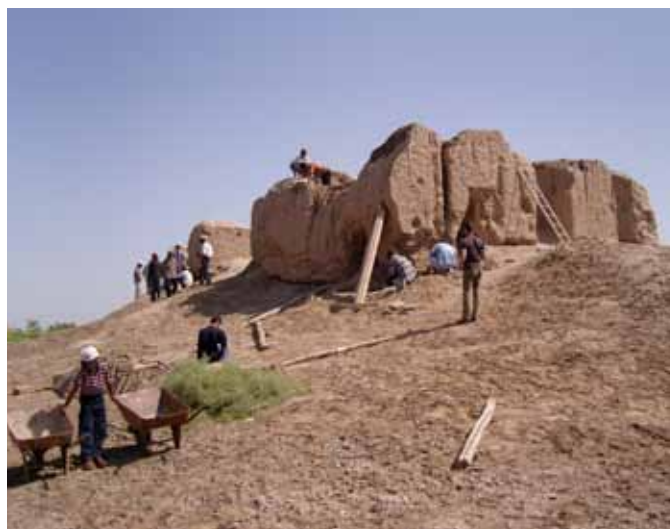
FIGURE 6 Différents procédés de conservation préventive mis en œuvre à Merv. © CRA Terre-ENSAG / David Gandreau

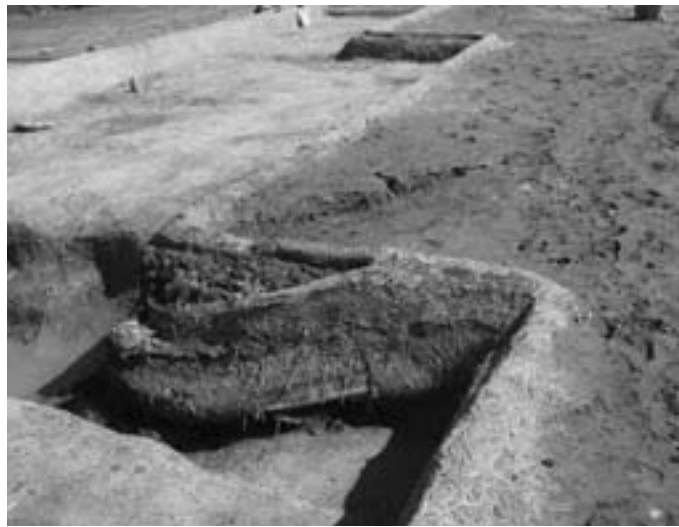
FIGURE 3 The use of adobe plaster on jute textile. Photo: Manijeh Hadian, RCCCR

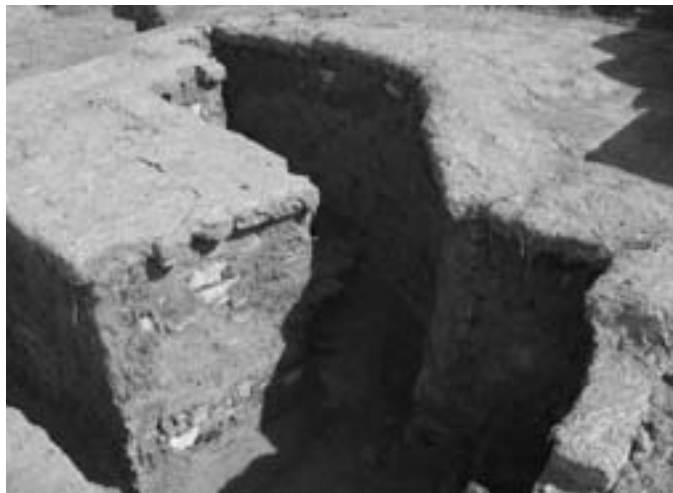
FIGURE 4 The raising of brick walls covered with adobe plaster as a means of protecting the main walls. Photo: Manijeh Hadian, RCCCR

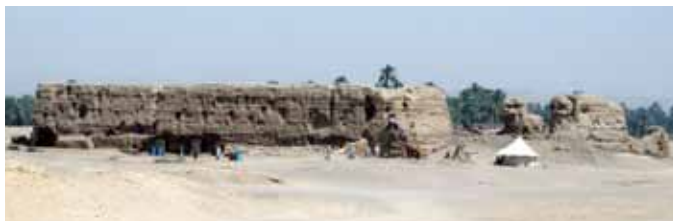
FIGURE 2 (a) View of the south and west walls of the enclosure and repairs made in 2006. Photo: R. Friedman; (b) View of the south and west walls of the enclosure in 1905. Photo: © Garstang Museum of Archaeology, Liverpool University; Garstang Archive Negative H102

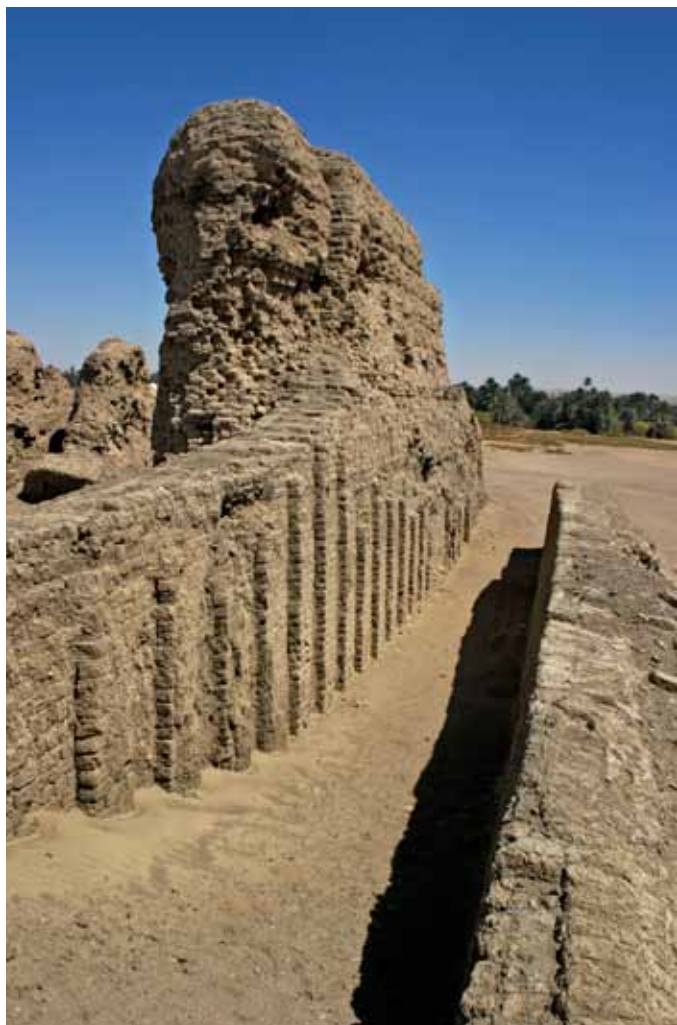
FIGURE 3 Decorative pilasters preserved on the south wall of the enclosure. Photo: James Rossiter

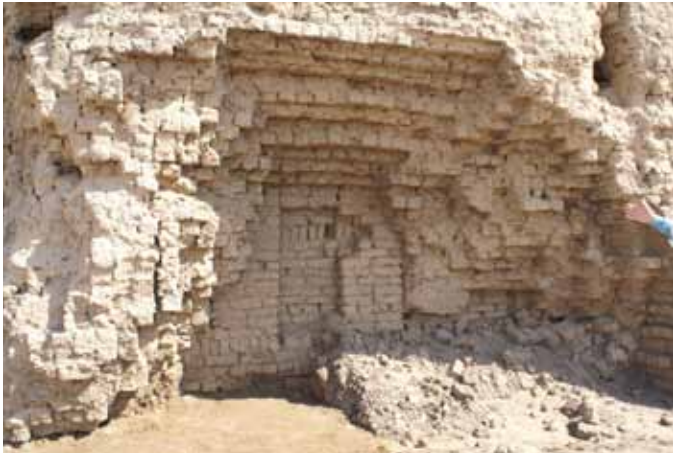
FIGURE 4 The pilasters and exterior facade of the first-phase construction visible within the core of the west wall and partly repaired foundations in 2007. Photo: R. Jaeschke

The collapse of the corners, though tragic because of the extensive damage it caused, allowed us to detect two distinct building phases. At the core there is an inner and obviously earlier phase of construction, which was finished with pilasters (fig. 4). It had only reached a height of about 2.4 meters when plans apparently changed. In a subsequent second phase, an additional 1.5-meter-thick cover of mud brick was added on the exterior and 1.2 meters on the interior. The upper walls were then built up to their full height of over 9 meters as one fully bonded construction. The bricks used in the first phase of construction are slightly paler in color and are about 2 centimeters thinner than those from the second phase that cover them, making them easy to detect in all four walls of the main enclosure (Friedman 2007).

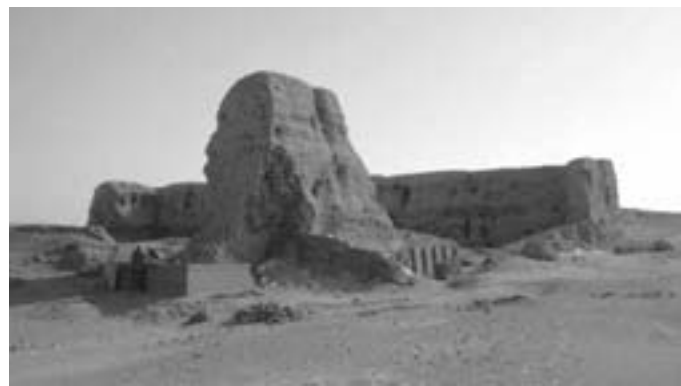
FIGURE 5 View of the northeast corner, which collapsed in 2002, and ongoing repairs in 2007. Photo: R. Jaeschke

bonding not only causes the outer walls to fall away, exposing the vertical face of the inner core wall, but also leaves the monolithic masonry of the upper walls teetering on a small base. This can be seen clearly at the northeast corner, which collapsed in 2002, leaving a precarious section of brick overhanging and threatened with further collapse (fig. 5).

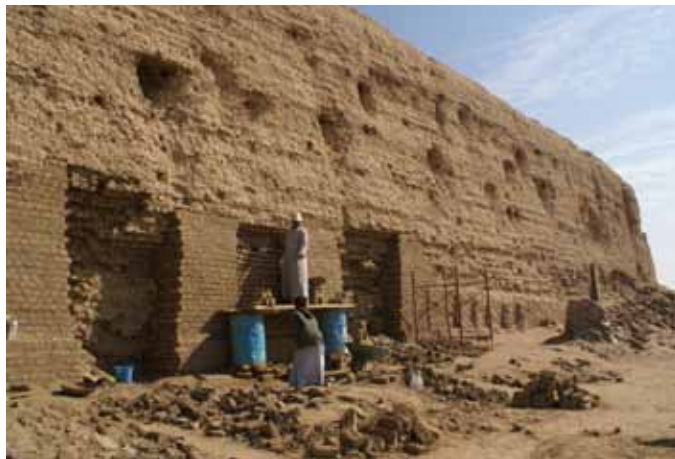
FIGURE 6 Repair of the exterior west wall with a series of buttresslike constructions that were later interbonded. Photo: R. Friedman

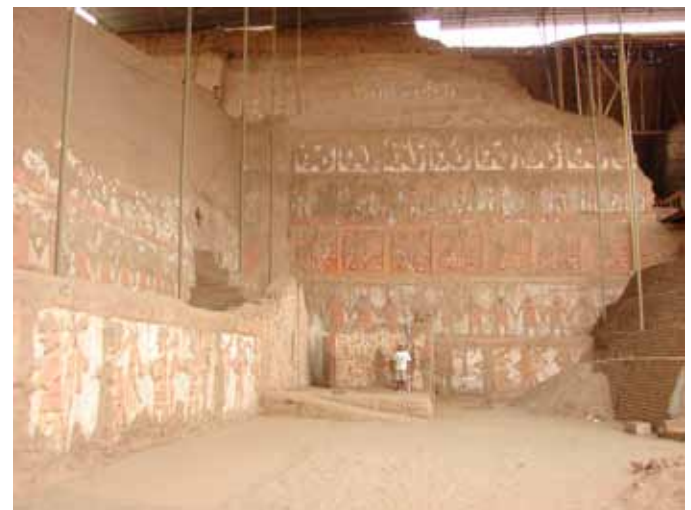
FIGURE 3 Facade of the Temple of the Moon, with complex iconographic narrative in relief. Red, white, black, yellow, brown, and blue are inorganic pigments mixed with organic binder, of exceptional artistic expression.

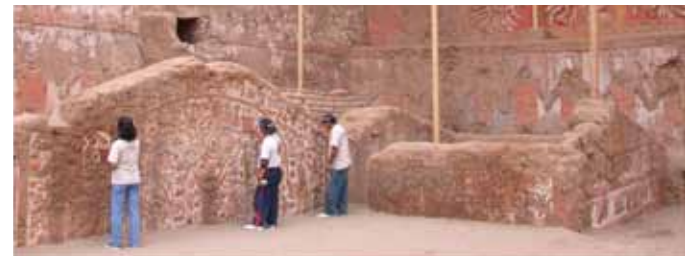
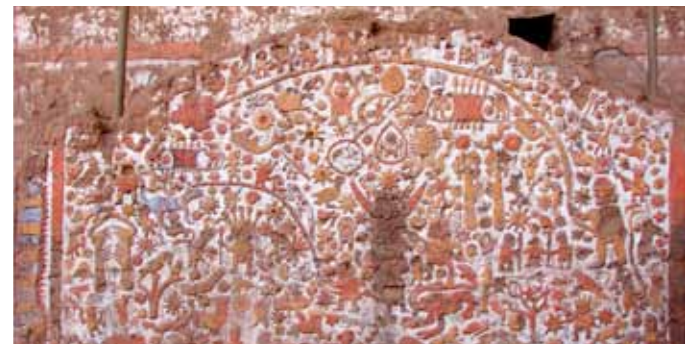
FIGURE 4 Sequence of wall treatment: (a) discovery, (b) cleaning and consolidation, and (c) aesthetic presentation.

adhered to the polychrome surfaces are removed manually (fig. 4b). They are also removed because the clay can expand and contract with hygrothermic fluctuations and cause irreversible damage (Stubbs 1984). This intervention is carried out with cotton swabs dipped in distilled water and ethyl alcohol, binocular magnifying glasses, scalpels, and soft paintbrushes. The last step of this process is to use breadcrumbs (which have been successfully used since 1977) to remove the thin clay layer remaining on the polychrome surface, leaving it in optimal condition for consolidation (fig. 4c).

Consolidation of the earthen surfaces is carried out by spraying a solution of Ethyl Silicate 40 and absolute ethyl alcohol on the relief. The proportion used is a half-liter ethyl silicate to one liter of absolute ethyl alcohol for each meter of treated surface. This consolidant has proven effective in similar cases, for instance, at Chan Chan, where it has been used since 1975. With this treatment the entire wall and decorated surface behave uniformly, that is to say, show improved resistance to erosion, capillarity, high humidity, and weathering (Alva and Chiari 1984).
