Terra 2008: The 10th International Conference on the Study and Conservation of Earthen Architectural Heritage

Edited by Leslie Rainer,
Angelyn Bass Rivera,
and David Gandreau

Proceedings of the 10th International Conference on the
Study and Conservation of Earthen Architectural Heritage,
Bamako, Mali, February 1–5, 2008

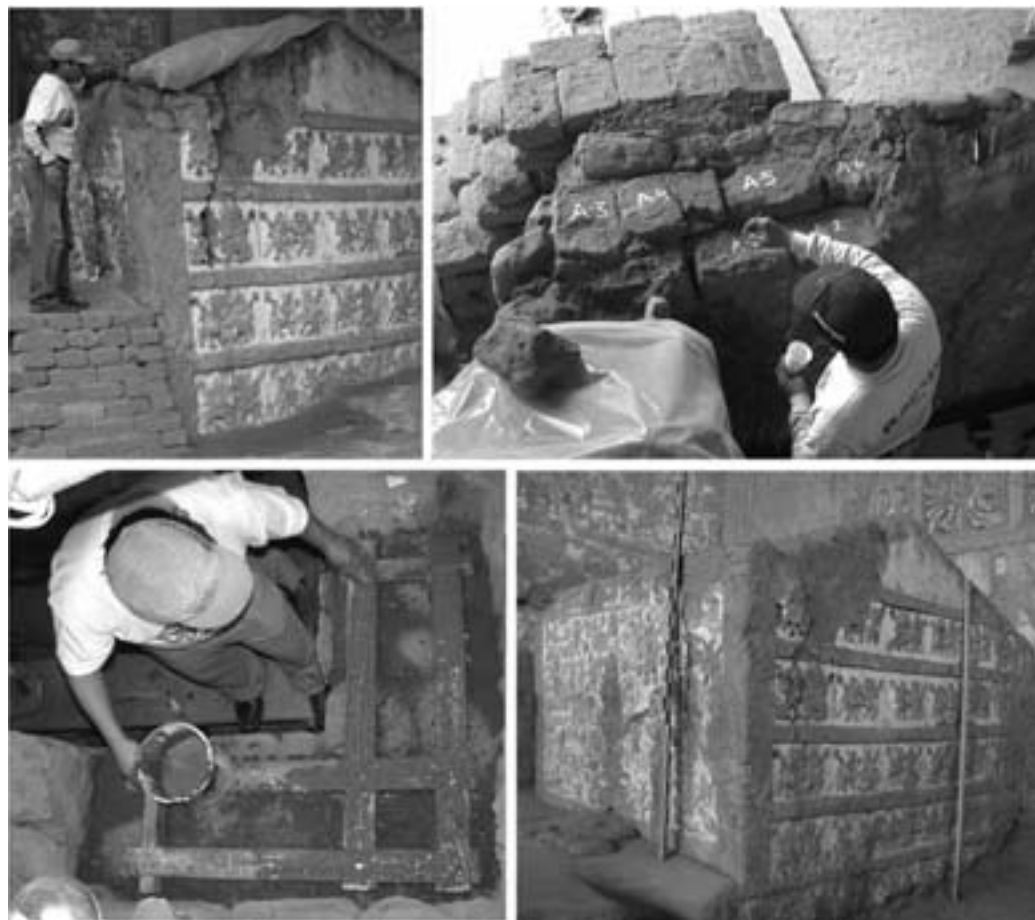
FIGURE 5 Structural reinforcement in walls affected by seismic activity in archaeological times.

Anastylosis consists of removing architectural elements affected by structural movement, fractures, or settling of the wall and restoring the missing elements. To do this, the sector to be treated is first documented with instant photographs and drawings to facilitate the subsequent task of repositioning the feature without affecting its previous appearance. Then the deteriorated adobe masonry is physically removed until a stable sector of the wall is reached. After the structural problem has been solved, the wall is reconstructed with previously consolidated and/or selected adobe blocks (fig. 5).

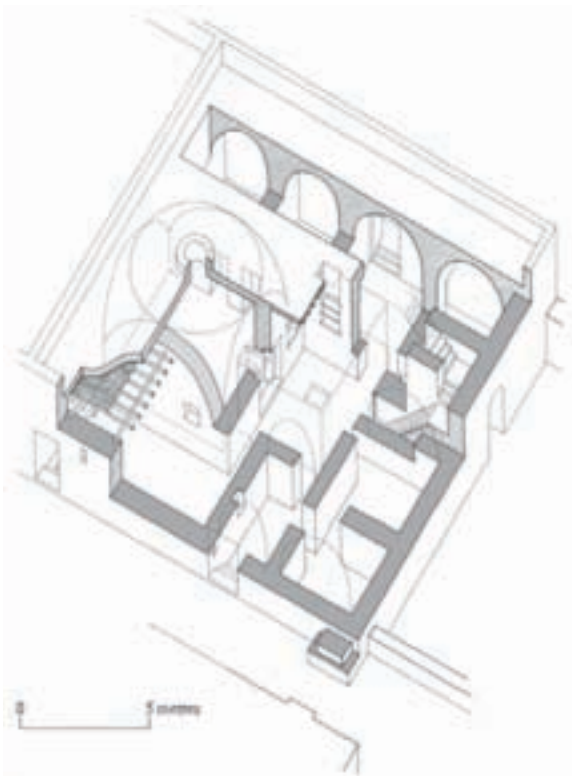
FIGURE 1 Plan of the house of Serenos. © Columbia University, New York University–Columbia University Excavations at Amheida

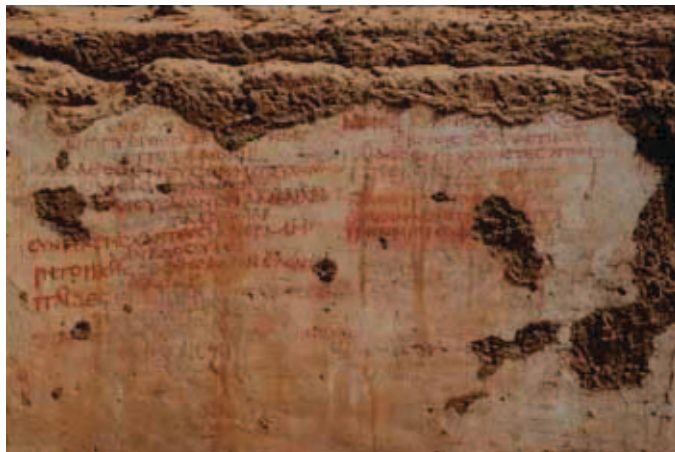
FIGURE 4 Amheida: The classroom in the house of Serenos. The inscription is a unique surviving rhetoric lesson in Greek, executed in tempera paint on mud plaster. © Columbia University, New York University–Columbia University Excavations at Amheida

a classroom with a unique rhetoric lesson in Greek written in red paint on the white plaster (fig. 4).

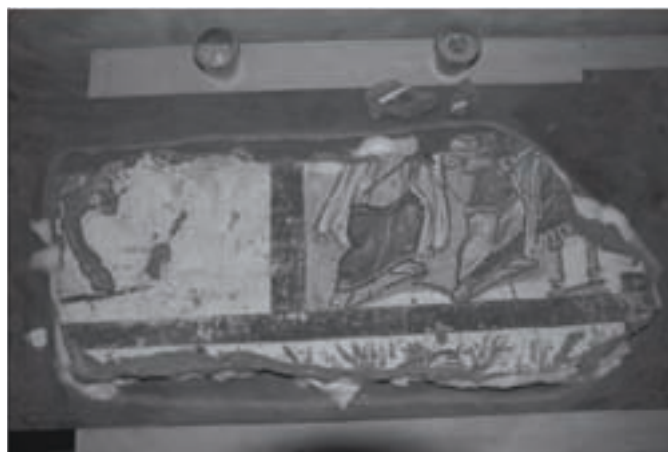
FIGURE 5 Amheida: A large masonry block with an important mural painting scene. Cracking occurred following consolidation with Conservare OH, an ethyl silicate consolidant. © Columbia University, New York University–Columbia University Excavations at Amheida

The test results were excellent. Specifically, the plaster and paint were hardened with no change in the color of the constituent materials. However, when this method was used at the site on large blocks, unpredictable and random cracking occurred (fig. 5). Some of the cracking occurred in all layers; other cracking occurred only in the ground layer. In all instances, the cracks are quite clean and sharp, facilitating repairs. Small cracks in the ground layer were treated with injections of an acrylic dispersion adhesive, Jade™. The larger cracks, which go through all the layers, will be treated when the large blocks eventually are mounted for museum display.

Ethyl silicate consolidants have been used successfully to treat similar mud-plaster murals.⁷ However, cracking of mud-based materials using some ethyl silicate consolidants has been noted by researchers.⁸ The exact reason of this negative side effect remains unclear, but there seem to be two probable causes. One cause may relate to inadequate amounts of water in the mud plaster and an insufficiently low relative humidity during consolidation. However, a more likely vector is the clay component in the mud plaster, because some clays can cause shrinkage during consolidation, leading to cracking.⁹

No fragments will be treated until further research is undertaken on consolidants, to avoid the cracking that occurred during the treatment of the large blocks.

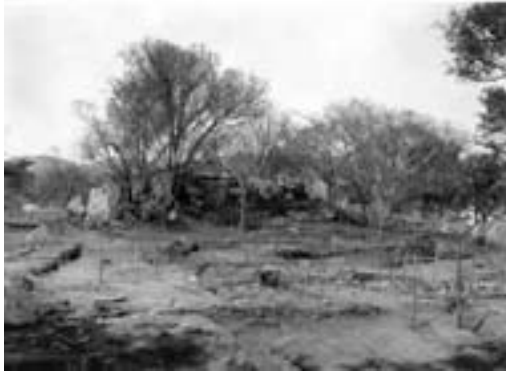
FIGURE 2 Early excavation by amateur archaeologists at Domboshaba stripped the soil that covered the daga structures. Photo: Ashton Sinamai

Zimbabwe sites were among the first to be excavated in southern Africa. Many of these excavations were carried out by treasure hunters whose main concern was to recover gold artifacts that could be melted and sold on the open market. This was an especially serious problem in Zimbabwe, where the Ancient Ruins Mining Company dug up numerous daga structures in its search for precious metals. Sites such as Khami, Regina, Dhlodhlo, and Nalatale suffered extensively from the activities of this company. Individual prospectors also caused havoc at isolated sites such as Domboshaba in Botswana (fig. 2).

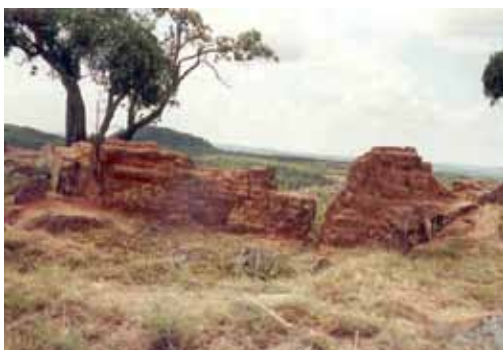
FIGURE 3 Effects of both wind erosion and rain on a daga wall at Nalatale National Monument, Zimbabwe. Photo: Ashton Sinamai

and surface water runoff. Wind carrying dust particles can erode the surface of the walls, as shown by the example from Nalatale (fig. 3). Excess rain runs over the surface, carrying suspended soil particles and causing channeling.

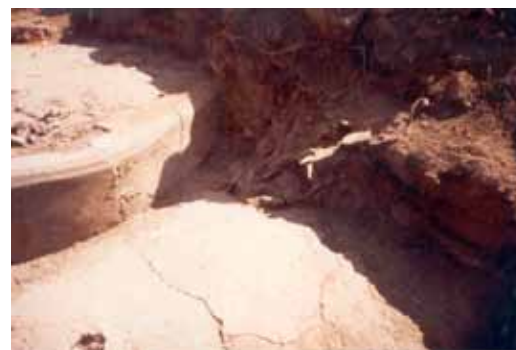
FIGURE 4 When daga structures are exposed the surface cracks almost immediately. These cracks, which were not visible on the structure when it was excavated, appeared after one hour of exposure, Kagumbudzi, Zimbabwe. Photo: Ashton Sinamai

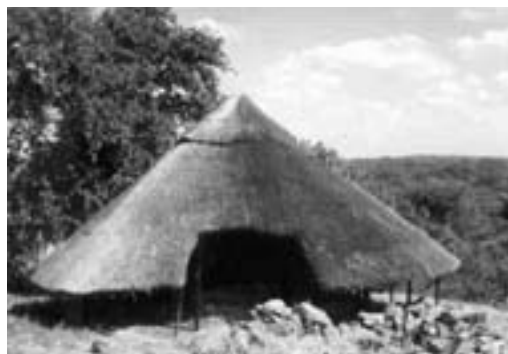
FIGURE 5 Roofing of the structure eliminates the threat of rain and direct sun but not the problem of humidity. Photo: Ashton Sinamai

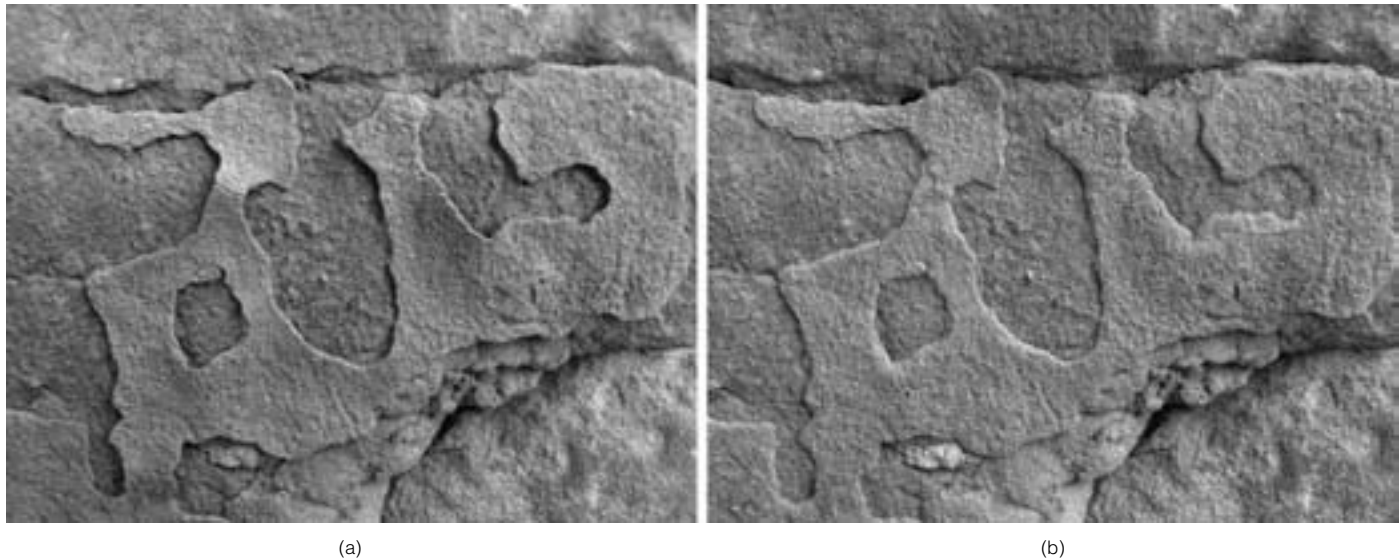
FIGURE 1 Before (a) and after (b) gelatin-glycerin reattachment treatment of earthen surface finishes at Mesa Verde National Park.

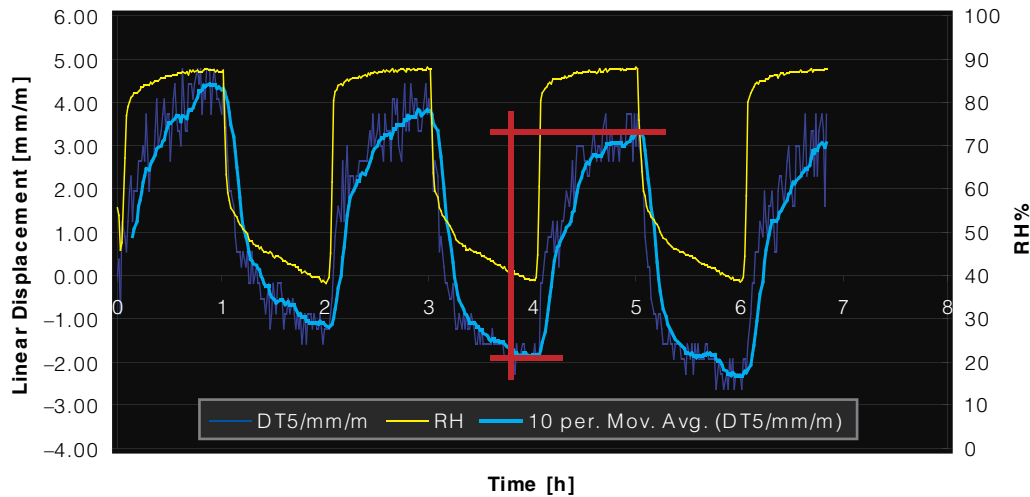
FIGURE 3 LVDT results for an untreated sample (number WD-1-1). Relative humidity fluctuations are seen in yellow, dimensional change in dark blue, and the calculated running average in light blue. Dimensional change for one period is indicated by the red markings.

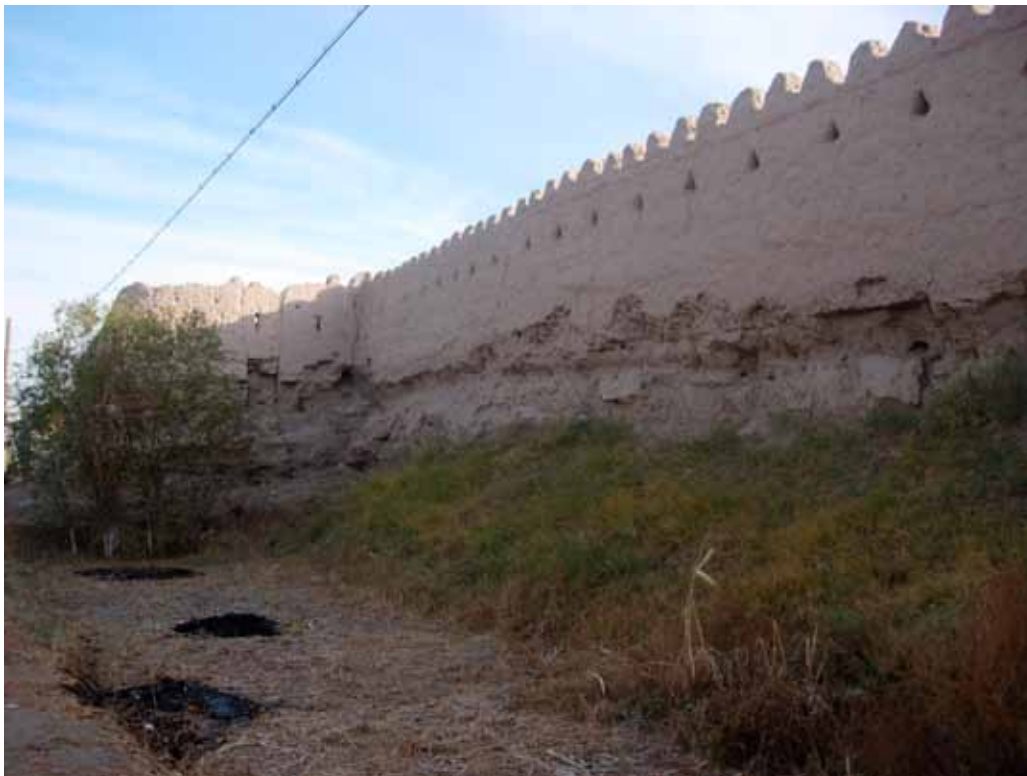
FIGURE 2 Vue du côté externe de la
muraille de Deshan Kala. Le sillon
de dégradation est bien visible à la
base du mur. © LTHE

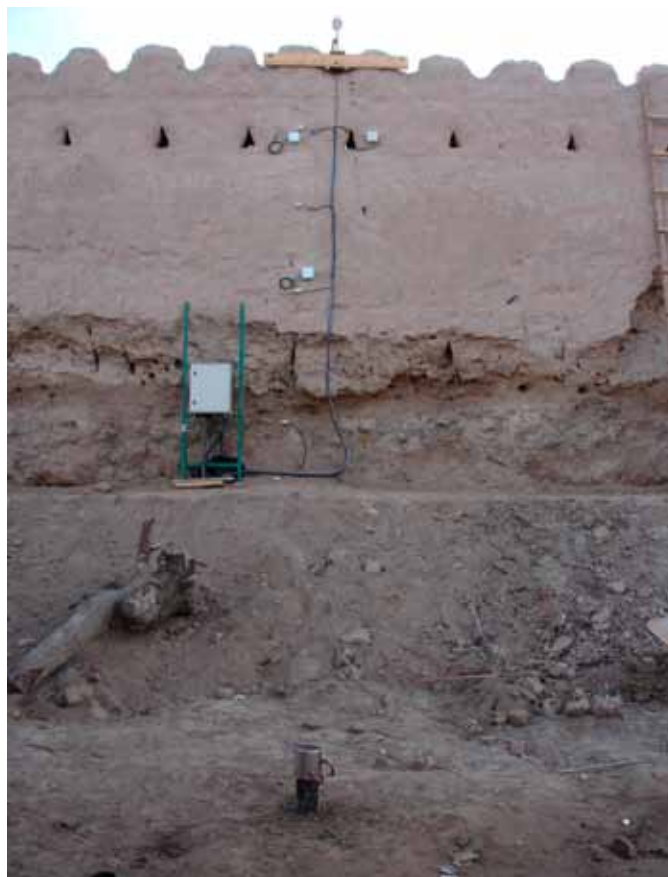
FIGURE 3 Vue du site d'étude. La station météorologique est installée au sommet du mur. Les capteurs d'humidité et de température placés dans le mur sont visibles, alors que ceux placés dans le sol sont enterrés. Au premier plan se trouve le piézomètre contenant les instruments mesurant le niveau et la salinité de la nappe. Tous les capteurs sont reliés à la centrale d'acquisition abritée dans le boîtier blanc qui stocke des données. © LTHE

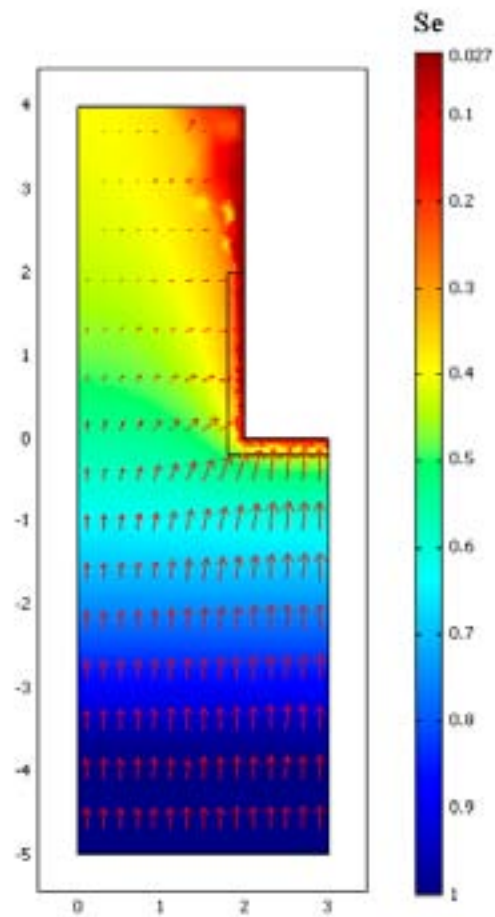
FIGURE 7 Vue en coupe du taux de saturation en eau (couleur) et visualisation des flux d'eau liquide (flèches) dans le sol et le mur. Ce résultat de simulation montre un assèchement important du haut du mur et de la surface proche. Le flux d'eau de la nappe vers l'atmosphère est clairement dévié vers la base du mur, ce qui est conforme aux observations.
© LTHE

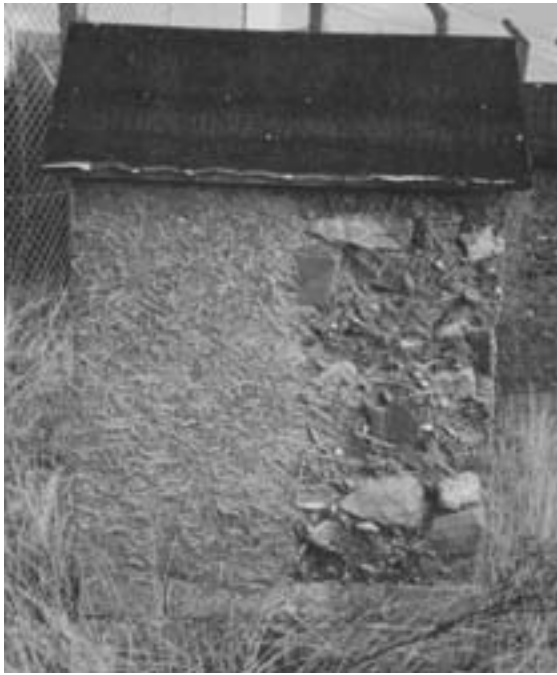
FIGURE 2 ESRP earth-rendered wall: showing only washing away of surface fines after seven years of exposure.

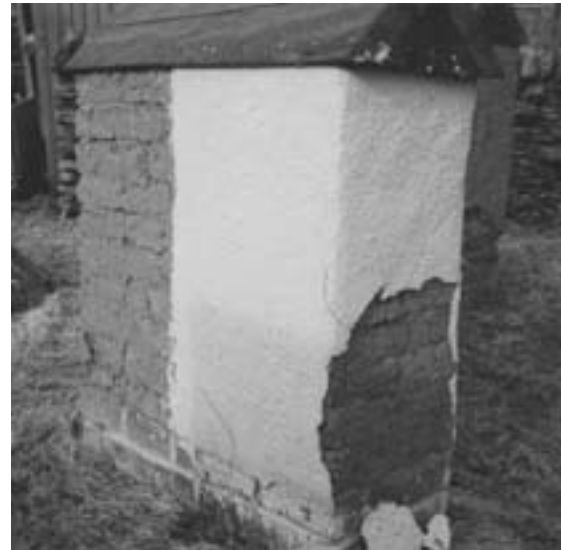
FIGURE 3 ESRP lime-rendered wall: showing loss of bond but not damage to the earth wall.

A different problem seems to occur with lime renders. Here strong initial suction allied to later differential hygro-thermal movements appears to result in a weakening of the lime undercoat, causing loss of bond to the earth substrate, though the lime topcoat surface remains in good condition, especially if regularly limewashed (fig. 5). Where an earth wall is just limewashed, rather than rendered, there does not seem to be the same problem, as burnishing in the limewash creates a more flexible composite lime/clay interface layer.

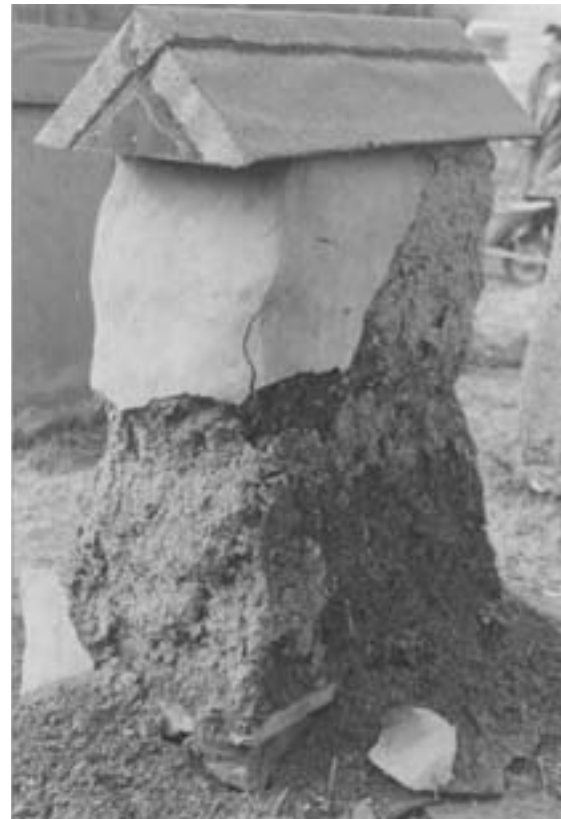
FIGURE 4 ESRP cement-rendered wall: showing major damage that subsequently led to collapse of the wall.

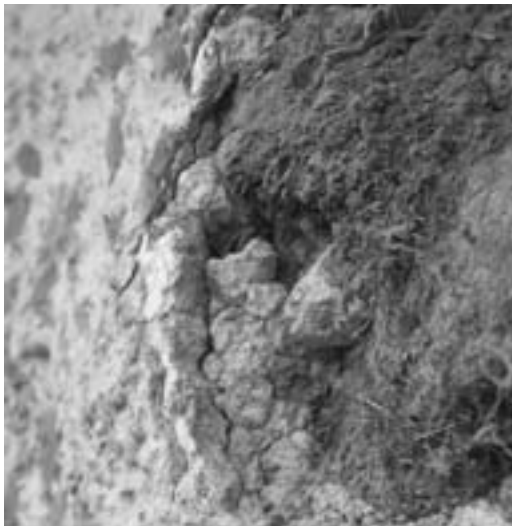
FIGURE 5 Cottown Schoolhouse: the lime base coat has lost coherence, while the topcoat and limewash remain sound.

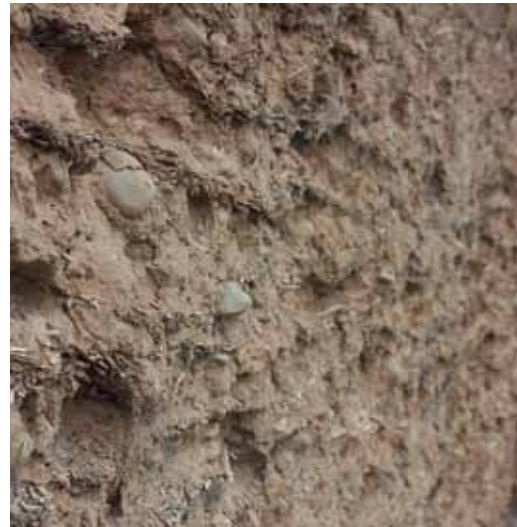
FIGURE 6 Moorhouse Washhouse: removal of cement render revealed a coarse mud wall with lines of straw layers.

In formulating suitable external finishes for earth walls that have been degraded by cement renders, the earth wall face material can be significantly different. At Moorhouse the large stones and straw banding provided a good mechanical key (fig. 6), while at Cottown the silty material of the cob (or mud

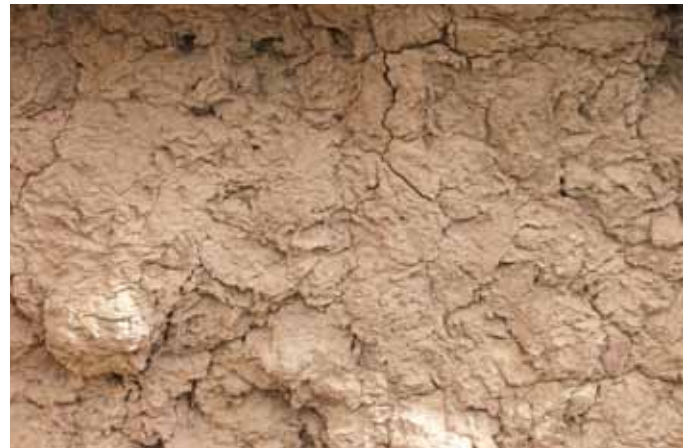
FIGURE 7 Cottown Schoolhouse: the surface was highly degraded, silty, very friable, and lacking in stones or straw.

wall) was highly degraded and first had to be stabilized with limewater (fig. 7). This was followed by a 40-millimeter-thick lime-stabilized clay undercoat, then by a traditional two-coat lime harl, about 10 millimeters thick in total, and seven coats of limewash (fig. 8). We were unable to source suitable whey as an additive.

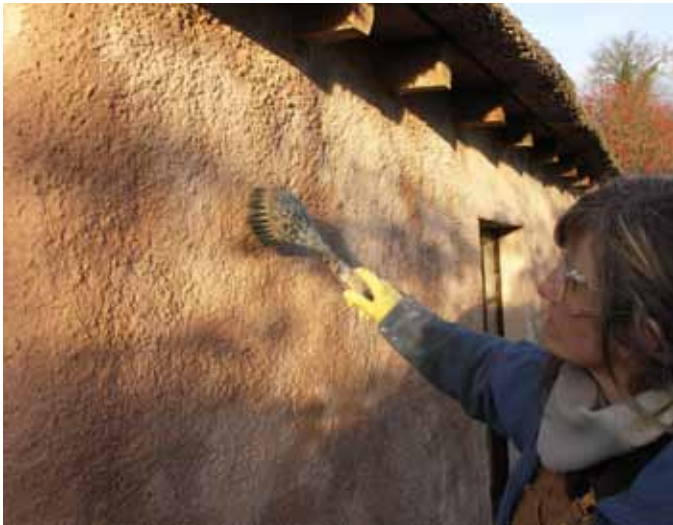
FIGURE 8 Cottown Schoolhouse: application of the final limewash.

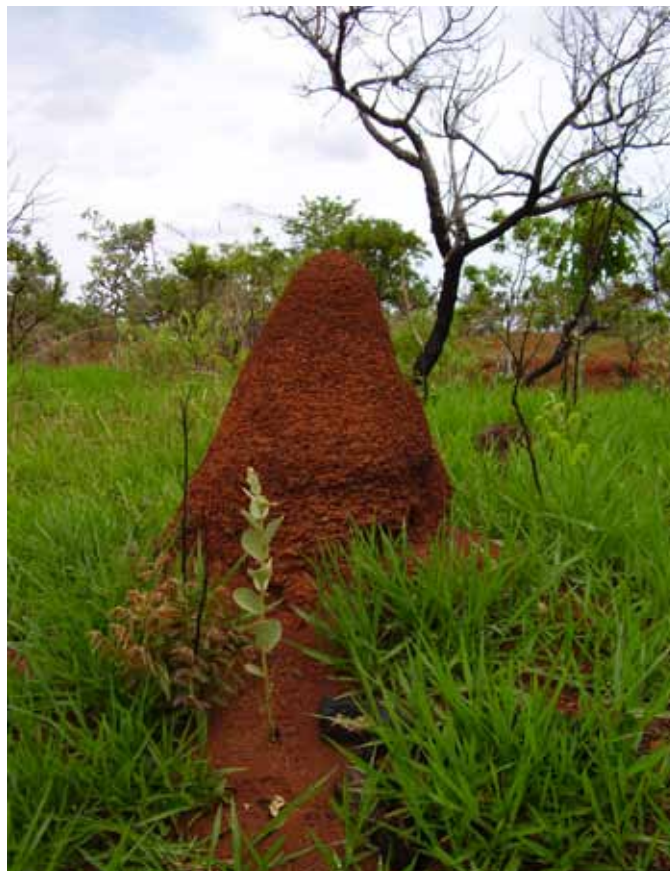
FIGURE 2 A *Cornitermes cumulans* mound near Coromandel, Brazil. *C. cumulans* is considered a keystone species in Cerrado (Brazilian savanna). To build this mound, *C. cumulans* added silt and removed sand from the soil. In the mound top, K, N, and OM increased. In the interior, Al, CEC, and OM increased. Photo: © Honório Nicholls Pereira

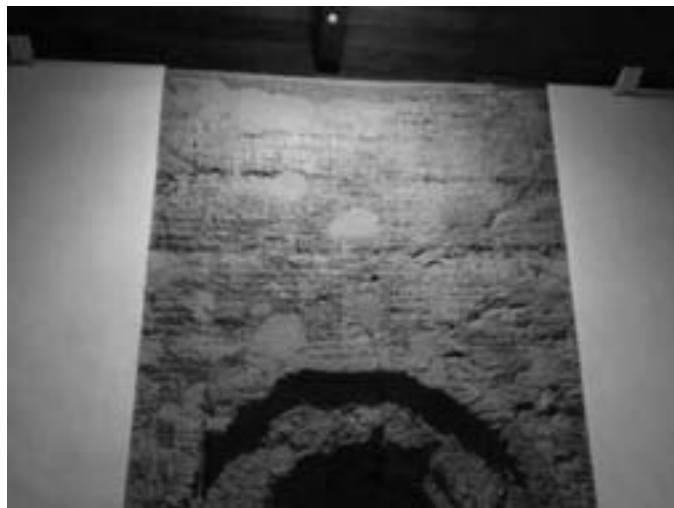
FIGURE 5 Detail of the top of a rammed earth wall after treatment with saliva de cupim. Photo: © Honório Nicholls Pereira

their application; they are brighter, and there are white stains, probably caused by salts or hydrated lime, which was used as an additive.

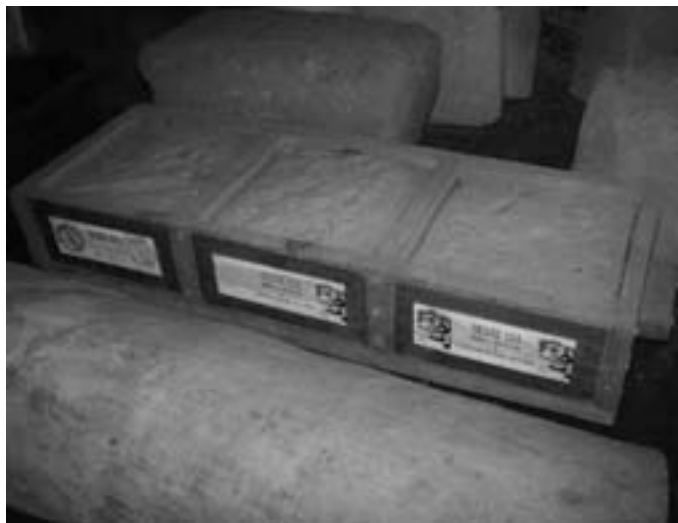
FIGURE 6 Adobe samples amended with hydrated lime and saliva de cupim. Photo: © Honório Nicholls Pereira

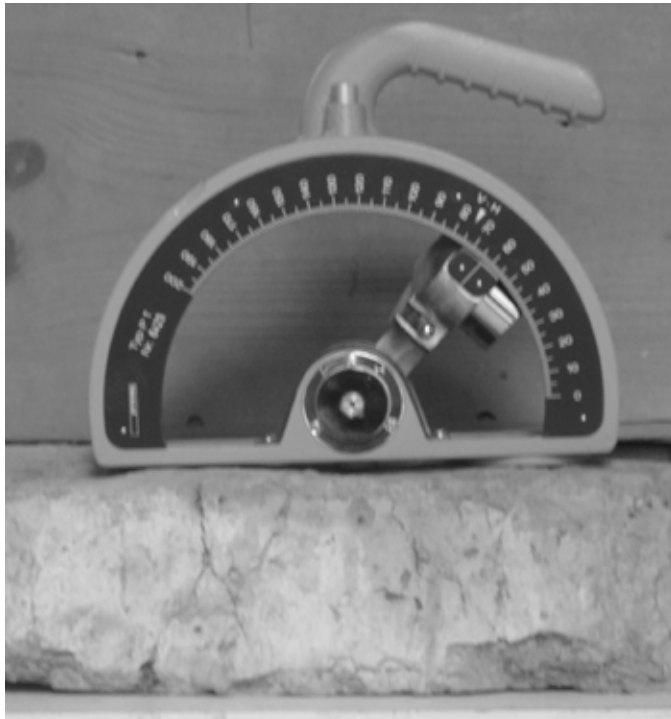
FIGURE 2 Sclerometric test.

In order to compare different compressive strength evaluation methods, the following mechanical tests were performed on each adobe sample (figs. 2–4): first the sclerometer; then the three-point bending; and finally uniaxial compression tests on the remaining pieces obtained from samples broken in the three-point bending tests. Experimental analysis was carried out on six samples ($14 \times 10 \times 26$ cm—base \times height \times length) taken from a restored building in Lamezia Terme and on twenty-four samples produced in the laboratory using earth from the same site.

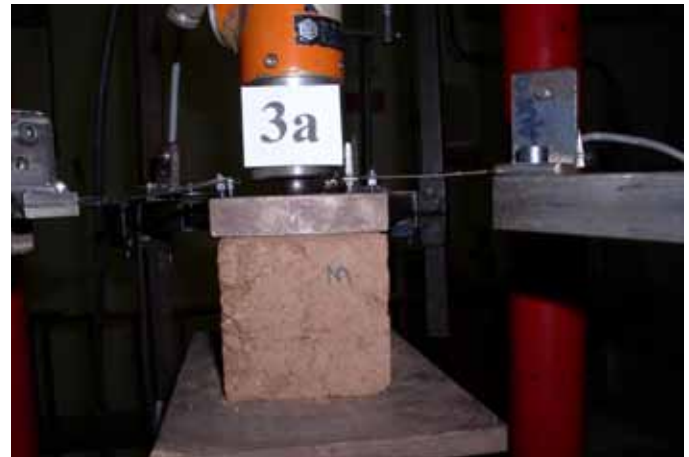
FIGURE 4 Compression test.

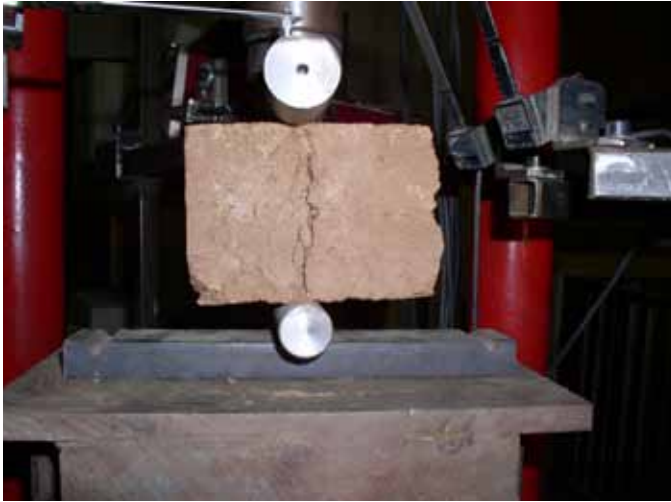
FIGURE 8 Indirect tensile test (Brazilian or splitting test).

In Italy earthen construction is characterized by a large variability in building techniques, and there are many types of adobe whose H/L ratio is not always acceptable for using the three-point bending test. For shaped adobes, there are more suitable indirect tests for determining tensile strength. A reliable test is the “indirect tensile test” (Brazilian or splitting test) in which the results are not affected by geometrical dimensions (fig. 8). Furthermore, this test is easily applied in

the construction yard. However, it is useful to remember that when using the Brazilian test, traction strength is about 1.5 times the direct tensile strength (in the three-point bending test, strength is about 2 times).

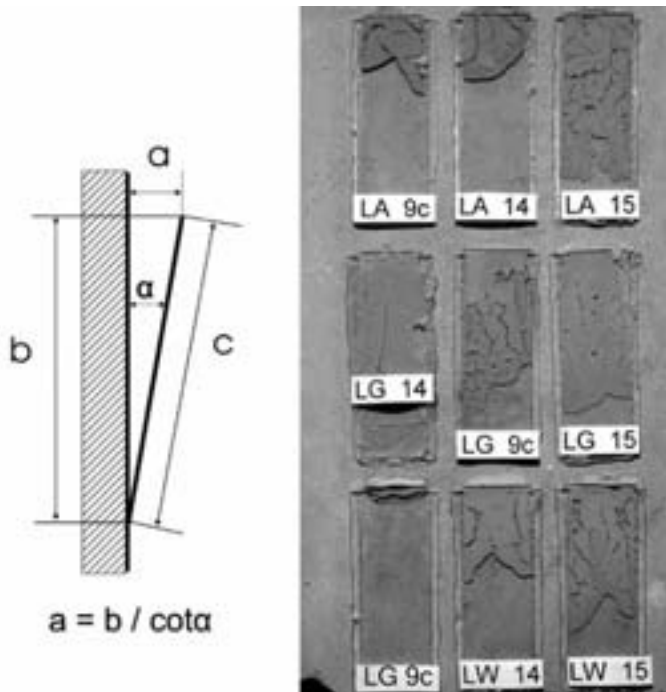
FIGURE 3 Test for the determination of penetrated crack width.

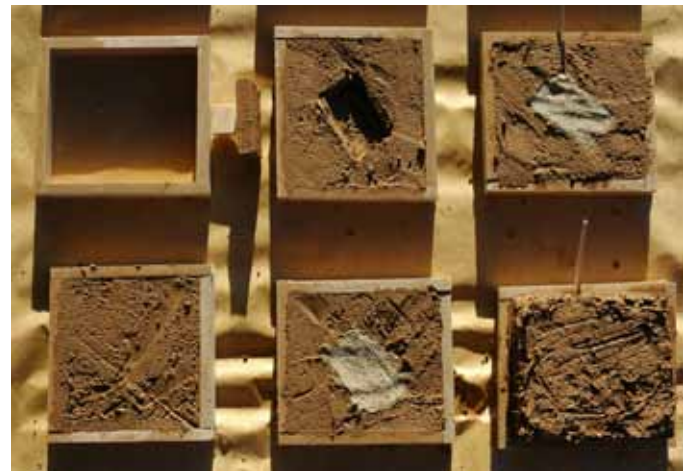
FIGURE 4 Preparation of the mock-up.

To evaluate the behavior of the grouts in the cavity, mock-ups were prepared. The mock-up represents the plaster and underlying earth structure in two layers and contains a void. The void was first marked and later filled with sand (fig. 4). The mock-ups were dried and the sand removed before the grouts were injected through a little outlet at the upper edge of the mock-up. After drying, the mock-ups were cut perpendicular to their surface, and the degree of filling and shrinkage cracks was evaluated.

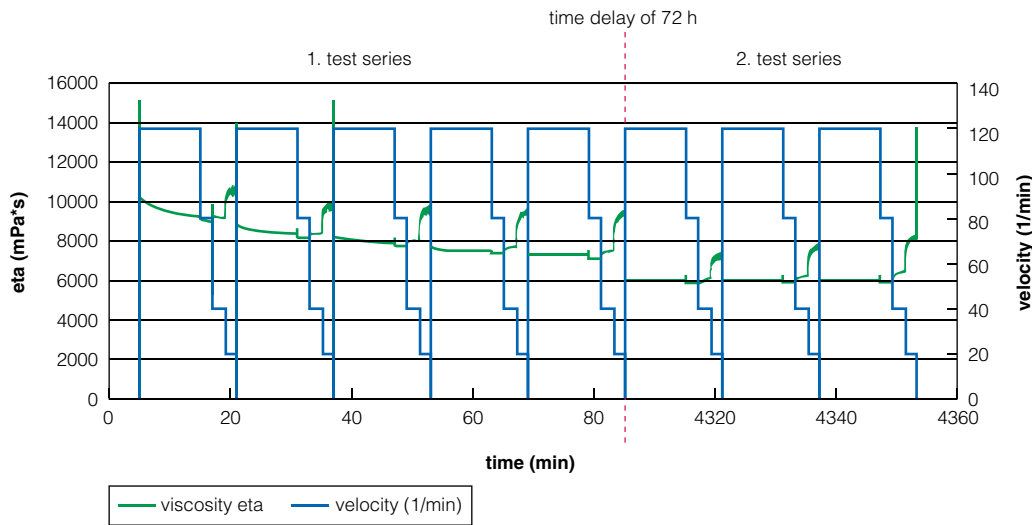
FIGURE 5 Viscosity behavior of injection grout (green); shear rate in blue.

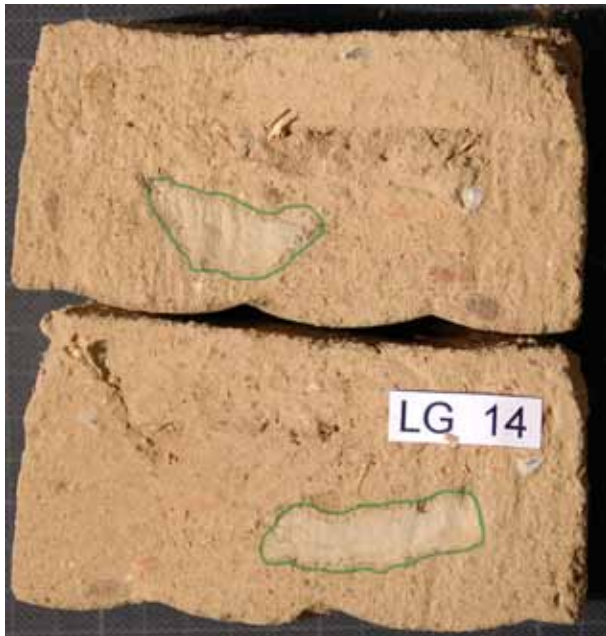
FIGURE 6 Grout behavior in the cavities.

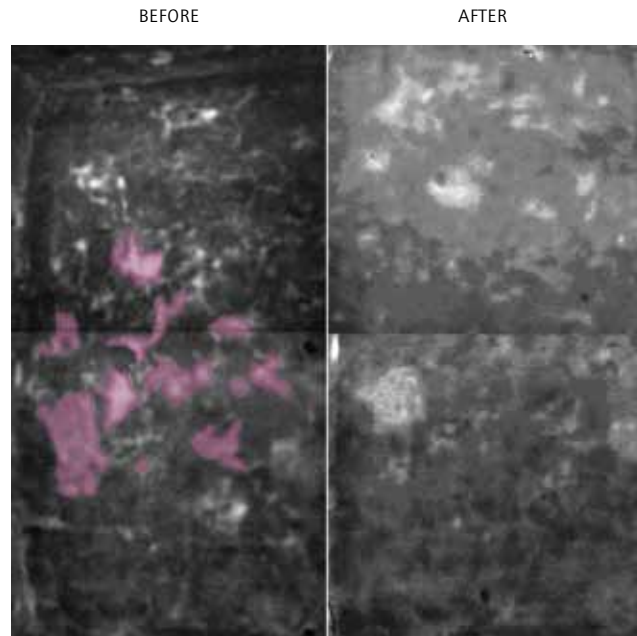
FIGURE 7 Infrared thermography of test wall.

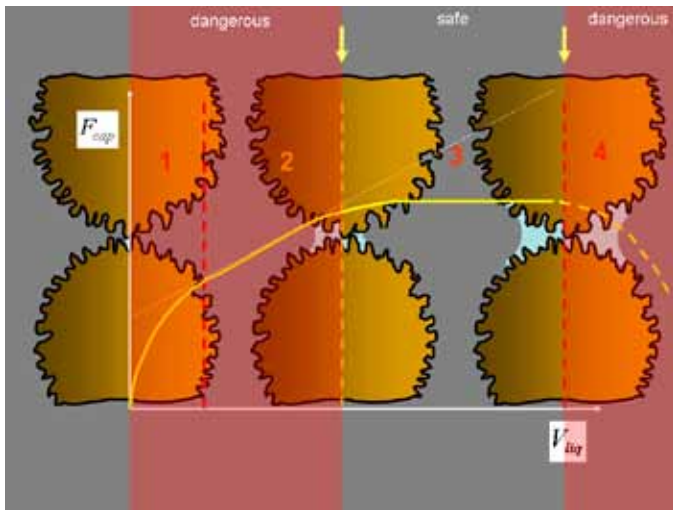
FIGURE 2 La force de cohésion capillaire entre deux grains n'est maximale et indépendante de la teneur en eau que dans un domaine limité. En dessous d'une humidité minimale et au dessus d'une valeur maximale (flèches jaunes), la cohésion décroît. Le même phénomène se produit pour une population de grains. Sur ce graphe, F_{cap} est la force de cohésion capillaire et V_{liq} est la quantité d'eau. © CRATerre-ENSAG

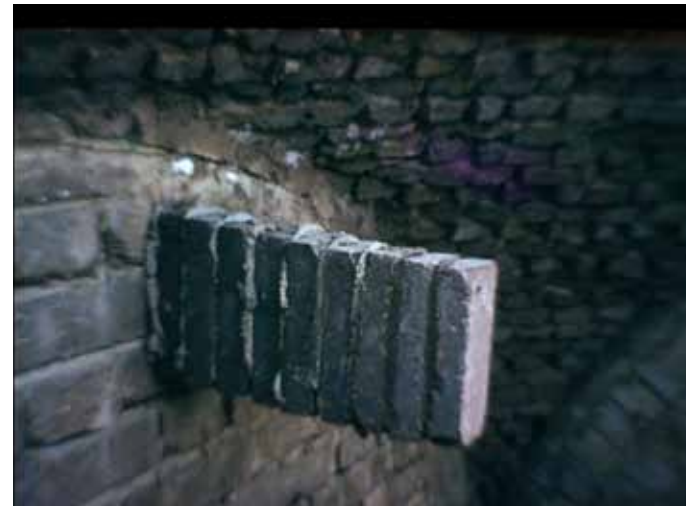
FIGURE 5 La boue est une colle remarquable qui permet de réaliser temporairement, tant qu'elle contient assez d'eau, des assemblages étonnants comme ici, pour la démonstration, neuf briques collées à l'horizontale sur un mur vertical.

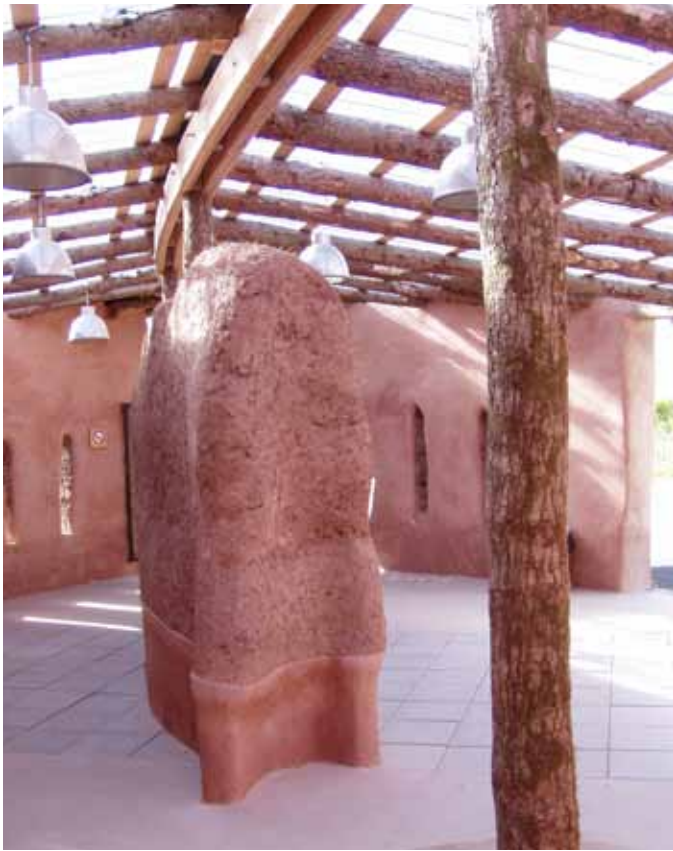
FIGURE 1 Modern cob building, Eden project, Cornwall.
Photo: P. Walker

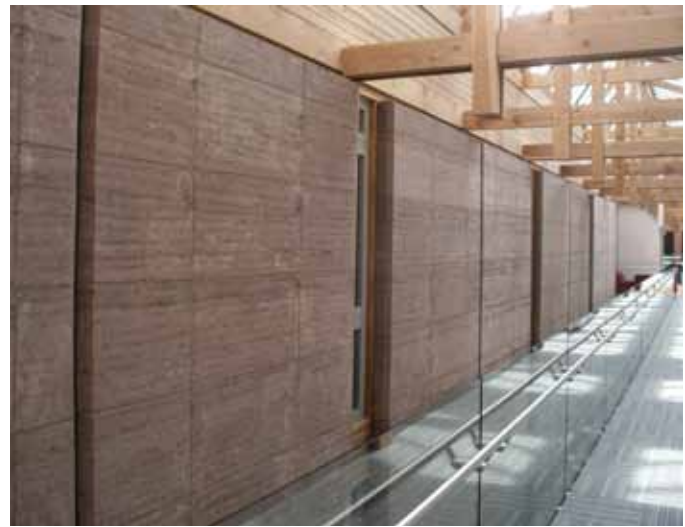
FIGURE 2 Rammed earth wall, Rivergreen Centre, Durham.
Photo: P. Walker

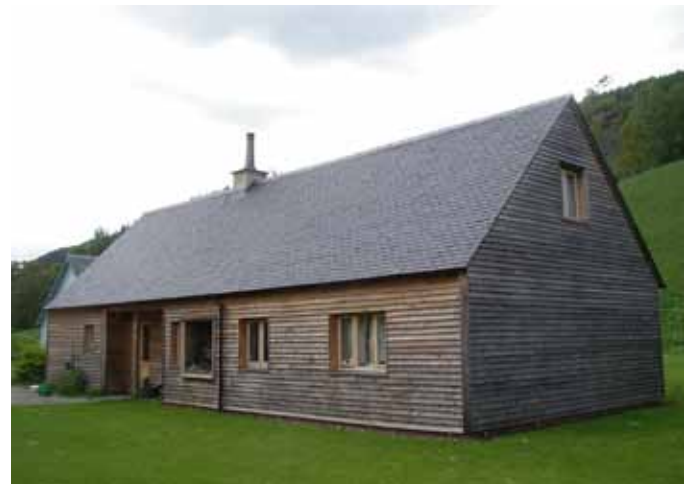
FIGURE 3 Modern timber frame and unfired clay brick building, Dalguise, Scotland. Photo: P. Walker

where a timber frame infilled with bricks will slow construction and require different trades working in the same location on-site. To move unfired clay masonry into mainstream markets where thin, freestanding walls are used will require increased bond strength to give the required structural performance. Successful recent projects include a domestic house in Dalguise, Scotland, by Arc Architects (fig. 3).

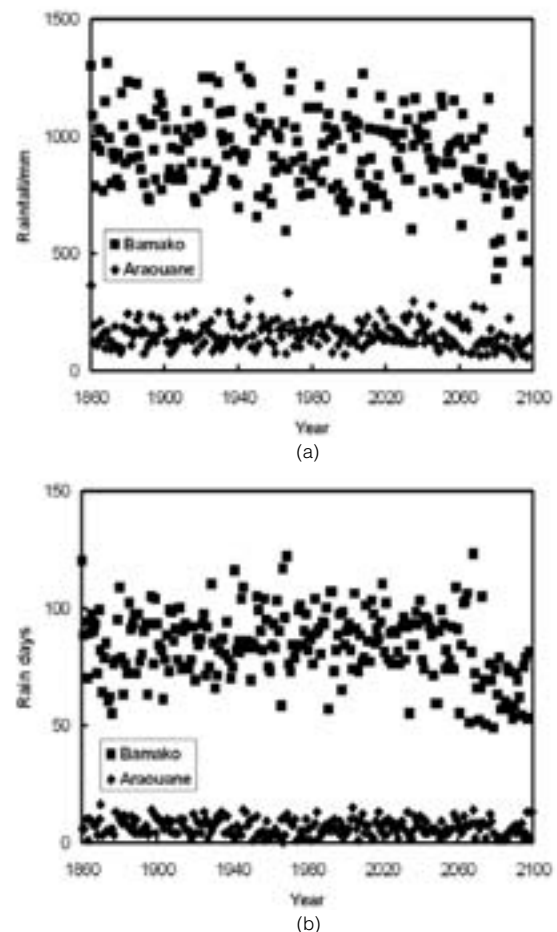
FIGURE 3 (a) Output from HadCM3a2 model for annual precipitation in the Bamako region (squares) and Araouane in northern Mali (diamonds). (b) Output from HadCM3a2 model for number of rain days each year (>0.1 mm) in the Bamako region (squares) and Araouane in northern Mali (diamonds).

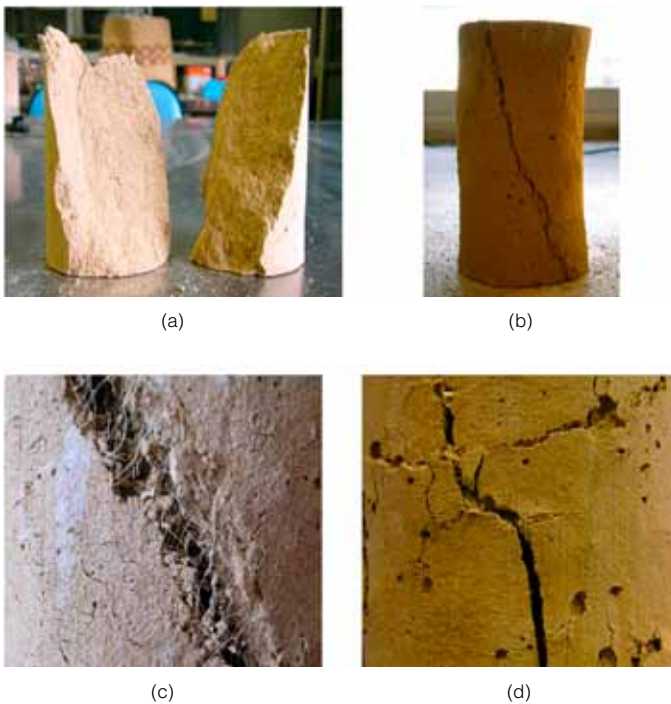
FIGURE 4 Photographs showing failure pattern of (a) unreinforced and (b) jute-reinforced block. Close view of shear band of (c) jute-reinforced and (d) straw-reinforced specimens.

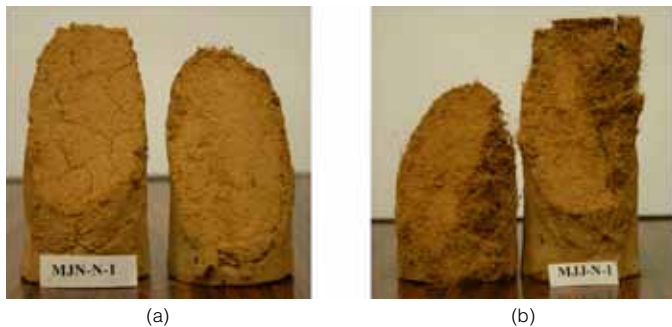
FIGURE 6 Photographs showing failure pattern of sandwich specimens prepared with (a) unreinforced and (b) jute-reinforced mortar.

Failure patterns of the sandwich specimens are presented in figure 6. Shrinkage cracks in the unreinforced mortar (fig. 6a) are the primary cause of poor seismic performance. Cement is not effective in preventing shrinkage cracks in the mortar. Jute alone and jute and cement together are both effective in preventing shrinkage cracks in the mortar (fig. 6b) and at improving bond and mortar strength.

- Shrinkage cracks in the unreinforced mortar, which are associated with drying, are the main cause of poor seismic performance.
- Jute alone and jute and cement together are similarly effective at preventing shrinkage cracks in mortar and in doing so are also effective at improving bond and mortar strength.

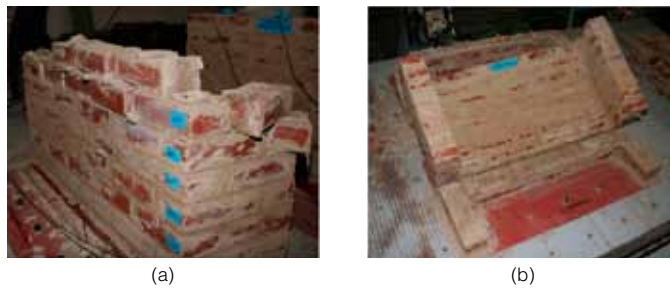
**FIGURE 7** Failure pattern of (a) model L-1 and (b) model L-2.

- jute fiber improves mortar and bonding strength; and
- jute fiber in the mortar is not effective at preventing the sudden bending failure of adobe structures.

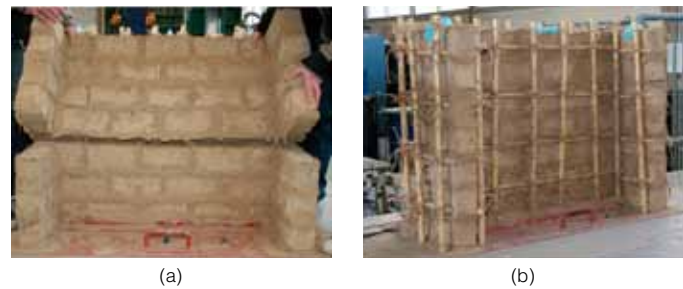
**FIGURE 8** Failure pattern of (a) model L-3 and (b) model L-4.

Bamboo grid: The composition of the blocks and mortar of the models is presented in table 2. Models L-3 and L-4 were subjected to a unidirectional sinusoidal wave (15.0 Hz) parallel to the short dimension of the models. Separation occurred between the block and mortar of model L-3 when the input base acceleration reached 450 Gal, as shown in figure 8a. Model L-3 was removed from the table and the test continued at increasing acceleration levels. Separation occurred between the block and mortar between the first and second courses of model L-4 when acceleration levels reached 850 Gal. Input levels were increased to 1,200 Gal, but model L-4 did not collapse. However, the test was discontinued because of the limitations of the shake table capacity. The bamboo grid effectively improved the strength of the model, and the model proved to have sufficient ductility to withstand the maximum acceleration input levels available for this shake table (fig. 8b).

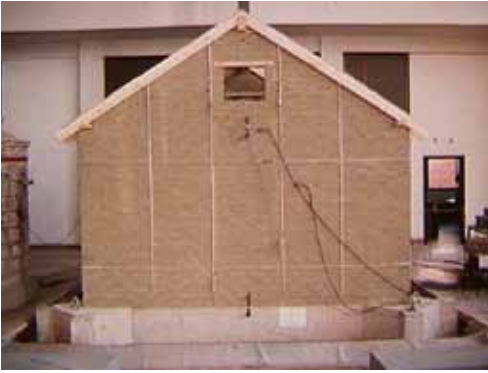
FIGURE 2 Large-scale model building tested as part of the GSAP research program. From Tolles et al. 2000

of retrofitting techniques. Nine small-scale models and two large-scale models were tested on shaking tables to investigate the efficacy of a variety of seismic retrofit techniques (Tolles et al. 2000). The general goal of this research was to develop strengthening and conservation techniques that were structurally effective, minimally invasive, and cost-effective. A photograph of the large-scale, retrofitted model building that was tested in Skopje, Macedonia, is shown in figure 2. The final product of the GSAP research effort was a set of guidelines to assist in both the planning and the engineering design for the seismic retrofit of historic adobe buildings (Tolles, Kimbro, and Ginell 2002).

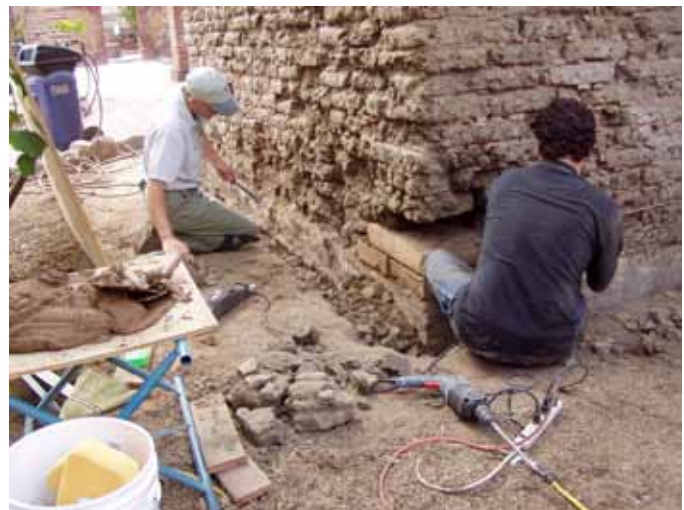
FIGURE 4 Maintenance of the base of adobe walls is critical to their seismic performance.

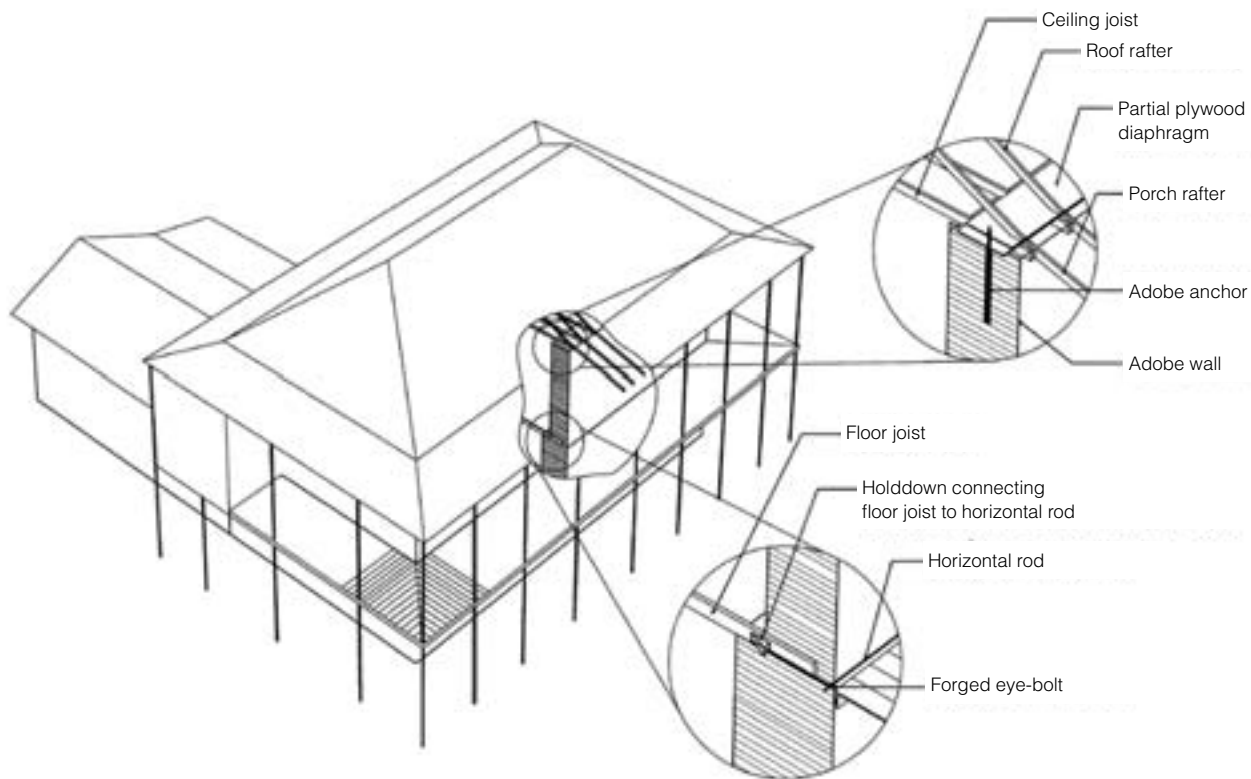
FIGURE 5 Retrofit details at the Las Flores Adobe in Camp Pendleton, California. Details for connections at the roof and floor levels and partial plywood diaphragm. Courtesy of ELT & Associates, 2002

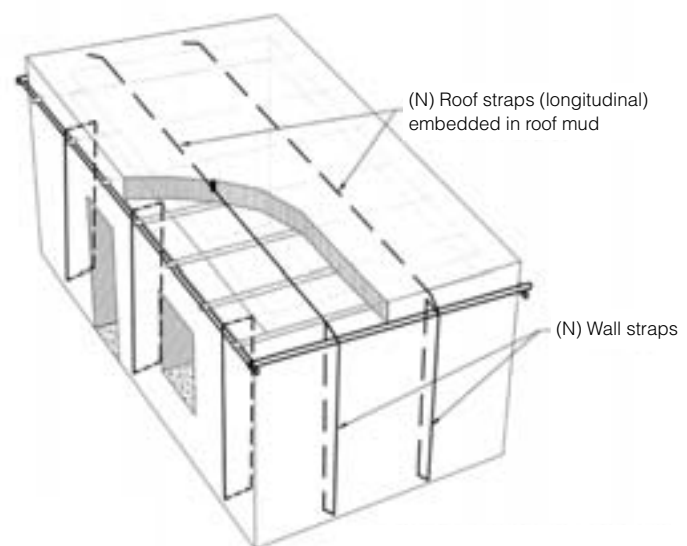
FIGURE 6 Proposed retrofit design for flat-roofed adobe houses in Iran. The primary reinforcing elements are tension-only elements made of steel wire/cable or synthetic materials. Courtesy of ELT & Associates, 2007
