Terra 2008: The 10th International Conference on the Study and Conservation of Earthen Architectural Heritage

Edited by Leslie Rainer,
Angelyn Bass Rivera,
and David Gandreau

Proceedings of the 10th International Conference on the
Study and Conservation of Earthen Architectural Heritage,
Bamako, Mali, February 1–5, 2008

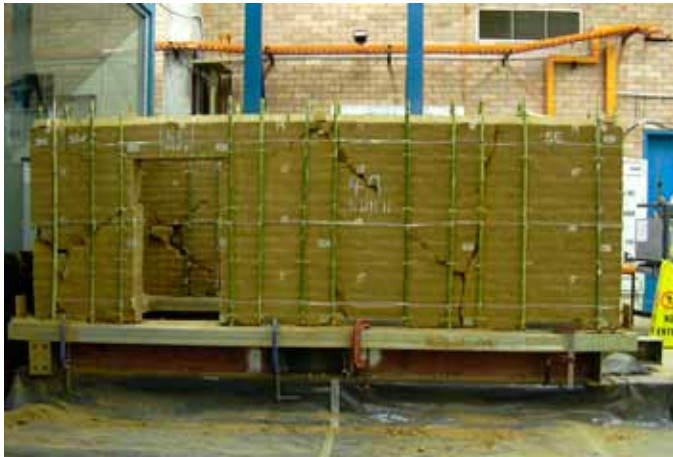
FIGURE 7 1:2 scale adobe house, damaged but intact after a series of severe shake table tests. Courtesy of University of Technology, Sydney, Australia, 2005

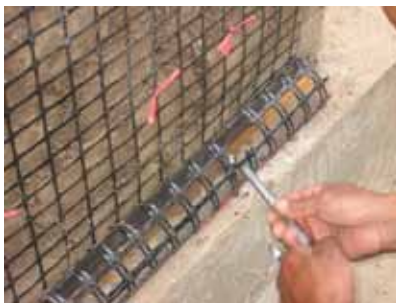
FIGURE 1 Piece of geo-grid. Photo: Daniel Torrealva

The reinforcing geo-grid requires standard properties of strength and stiffness. The grid tested (fig. 1) is fabricated from high-density extruded sheets punched with a precise and regular pattern of circular holes. The grid is then stretched in both directions at controlled temperature and tensile force in order to obtain a biaxial grid with square openings, rigid joints, and flexible ribs.

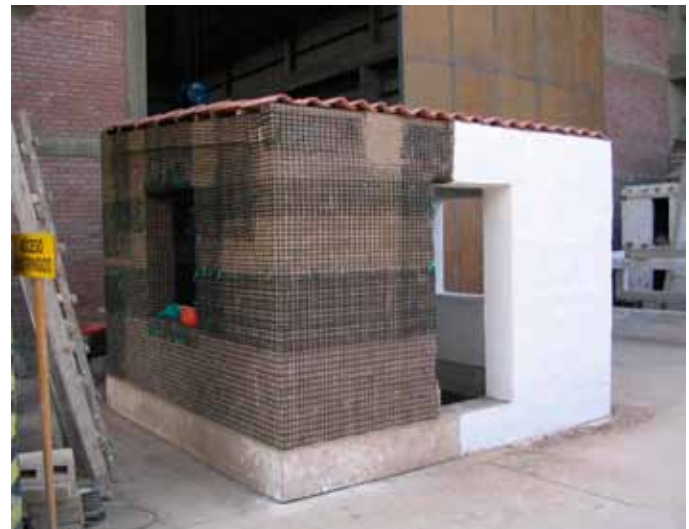
FIGURE 2 Square house reinforced with geo-grid, with mud plastered on one half of the module and not on the other half. Photo: Daniel Torrealva

polyester twine. It is not necessary to fill the holes after tying. Commercially available geo-grids come in rolls 3 to 4 m wide by 50 to 75 m long. The geo-grid must be placed on the walls in such a way that it covers the wall surface continuously in the horizontal direction. Finally, the grid must be covered with a mud-based plaster. In the test model only half of the house was plastered to determine the influence of the plaster on performance (fig. 2).

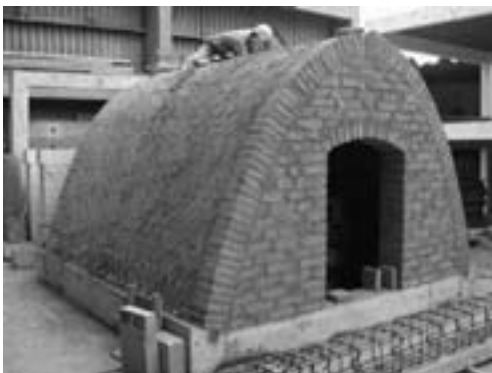
FIGURE 3 Nubian vault, without reinforcement of geo-grid and without mud stucco. Photo: Daniel Torrealva

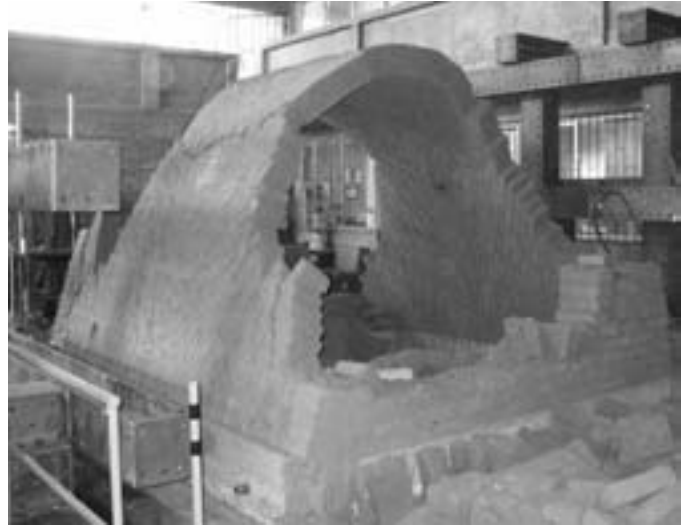
FIGURE 4 Nubian vault without reinforcement of geo-grid and without mud stucco after seismic simulation test.

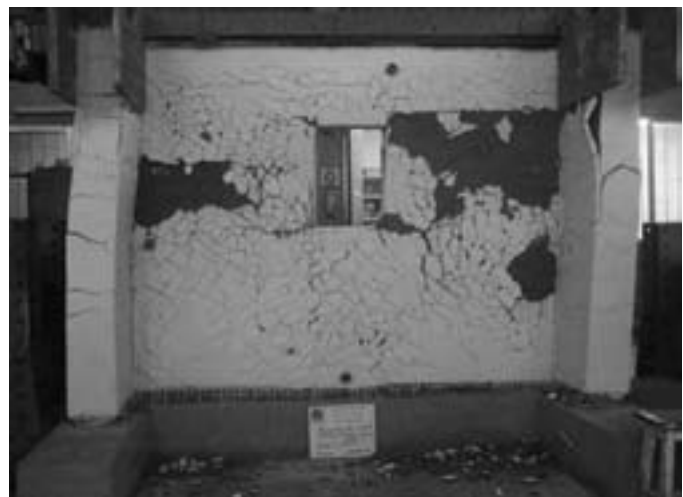
FIGURE 5 Wall with reinforcement of geo-grid and plastered with mud stucco. After cyclic shear test.

configuration were tested in different projects. Blondet et al. (2005) reported on comparative tests of a bare wall and a grid-reinforced wall without plaster. A third wall was tested in 2007 with grid reinforcement and plastered with mud (fig. 5). The results show that reinforcing the wall with geo-grid and mud plaster resulted in an increase in initial strength of 40 percent

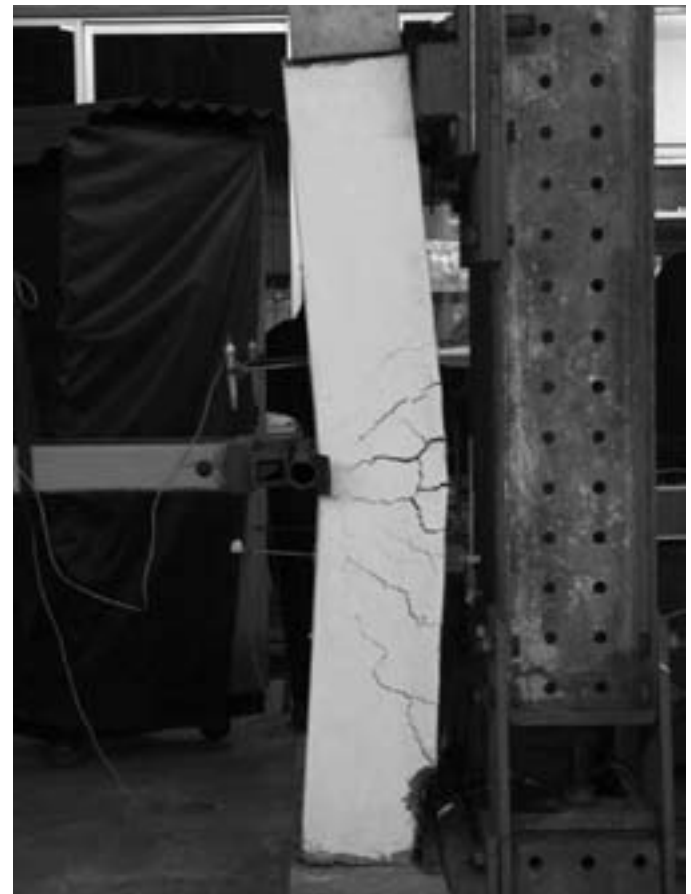
FIGURE 7 Wall tested in flexure out of plane, last phase. Photo: Daniel Torrealva

Another important structural characteristic of an adobe wall is its out-of-plane bending capacity, which can be measured by conducting out-of-plane horizontal force tests. Three 0.80 by 1.60 m walls with a thickness of 0.25 m were subjected to loading and unloading tests. The walls were horizontally supported at the bottom and top, resulting in a simply supported bending type of behavior. The tests confirmed that the grid embedded in the plaster creates a composite material where the adobe wall takes the compression forces and the grid takes the tension forces (fig. 7); these work in unison until detachment of the plaster, which occurred at the ultimate stage of testing. The reinforced panel can undergo twenty-five times more horizontal displacement than the unreinforced panel (fig. 8). In addition, there is a significant increase in bending capacity.

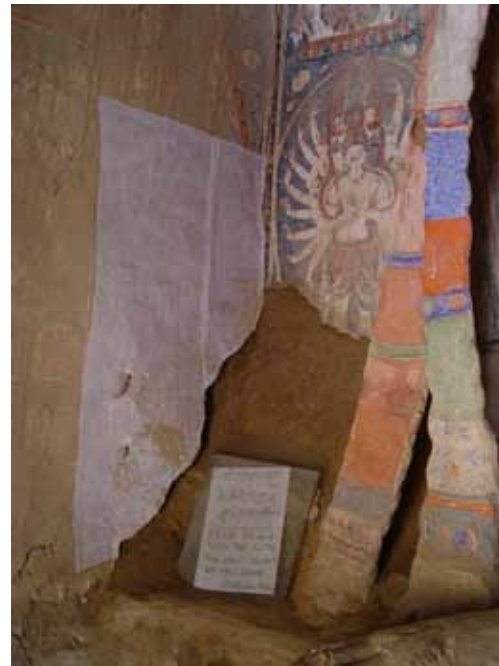
FIGURE 3 Erosion at the base of the wall. Photo: Bhawna Dandona

upper part of the wall and affects the wooden structure of the roof, which could lead to wall collapse. Furthermore, moisture from capillary rise weakens the bases of the walls (fig. 3).

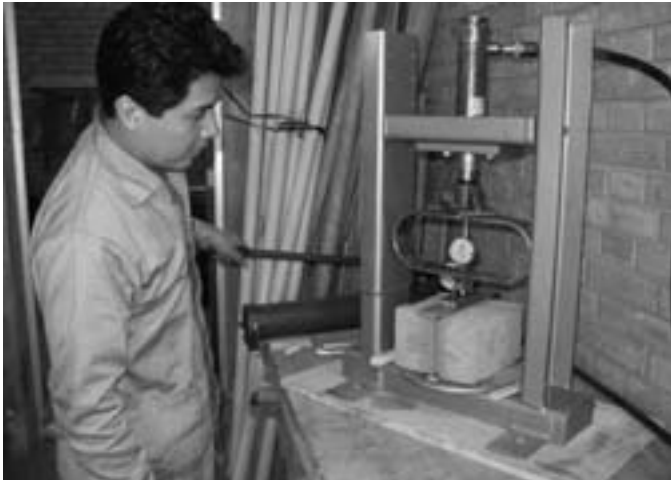
FIGURE 4 Indirect tension test.

The indirect tension test consists of vertical compression of a sandwich of two adobe blocks joined by mortar, forming a vertical and centered joint (fig. 4). The force applied causes fairly uniform tension stresses at the mortar-block interface. The tensile strength of a sandwich is expressed by $\sigma_t = \alpha (P/A)$, where P is the breaking force, A is the area of the mortar interface ($A = lh$, where h is the height and l is the length of the sandwich), and α is a dimensionless factor to estimate the maximum tension stress at the interface (fig. 5).

The results of indirect tension tests revealed that assemblies cured for seven days and made with thinner mortars achieved greater strength. It was difficult to make assemblies with mortar joints less than 2 mm thick because they failed due to the irregular faces of the block. To understand the influence of mortar thickness on the strength of adobe masonry, an additional series of assemblies were built with thinner mortars. After forty-eight hours, the samples were disassembled and the number and width of cracks were recorded. Results showed that the number of cracks was approximately the same in all the opened assemblies, but crack width was narrower in thinner mortars (fig. 6).

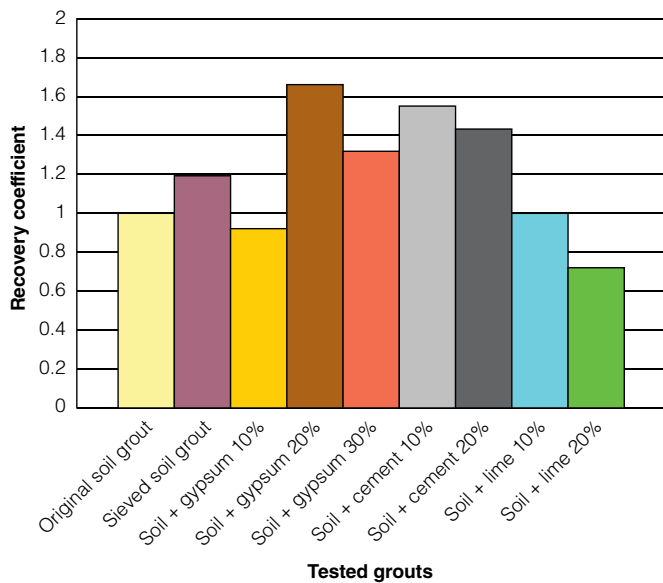
FIGURE 9 Results of the diagonal compression test of repaired small square adobe masonry walls with different soil-based grouts.

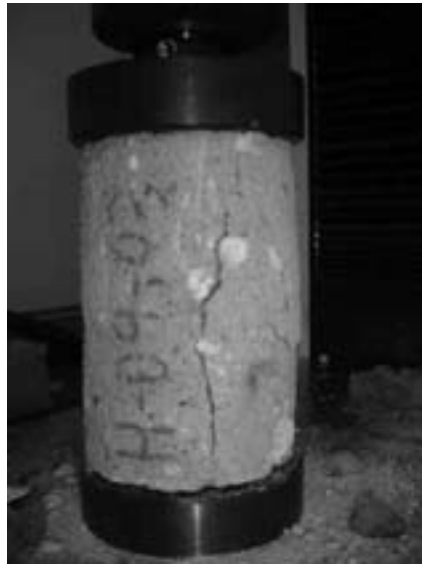
For the experimental testing program, a set of adobe samples was collected from eight houses and eight boundary walls in different locations in the Aveiro district. Cylindrical cores, with diameters ranging between 60 and 95 mm, were extracted from the collected adobe samples. These cylindrical cores had a height approximately two times their diameter. A total of 101 cylindrical specimens, 51 collected from houses and 50 collected from boundary walls, were subjected to mechanical tests. Eighty-three specimens were tested in compression (figs. 2, 3) and 18 in splitting tests.

FIGURE 2 Compression testing of an adobe specimen. Photo: Pereira, 2008

Tests results revealed that the adobe specimens varied significantly in compressive strength, with values varying from 0.32 to 2.46 MPa. In general, tensile strength was found to be equal to approximately 20% of the compressive strength. Results also indicated that samples with larger fractions of small-dimension particles were consistently stronger in com-

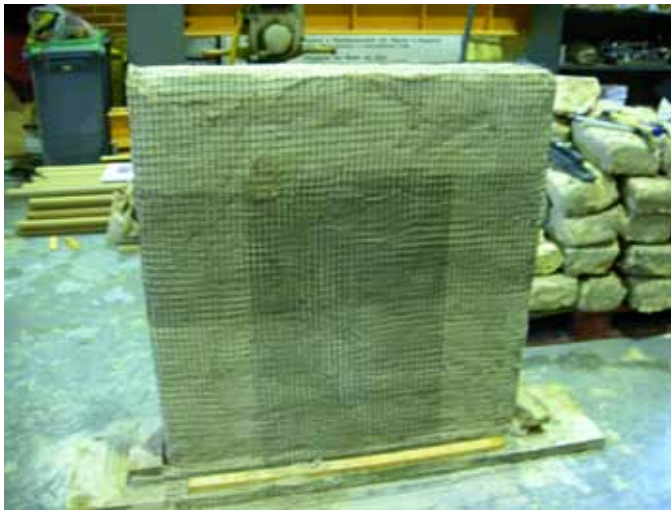
FIGURE 8 Strengthening of an adobe wall with a polymeric mesh and a coat of traditional earthen plaster. Photo: Pereira, 2008

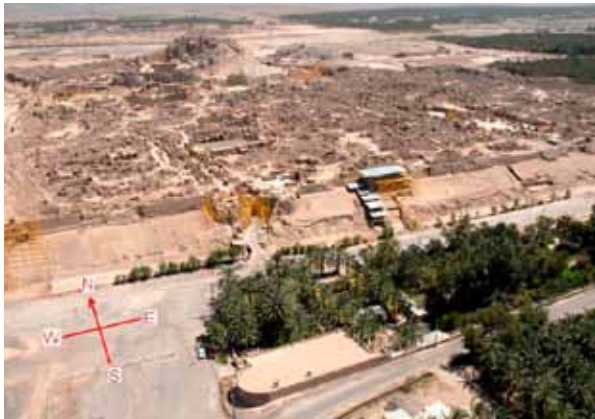
depending on the building type, the direction of the ground movement, and other factors. Since then, the consolidation and reinforcement of the historic structures thus destabilized and damaged have been among the main activities of the Bam Cultural Heritage Recovery Project (fig. 2). This paper describes and analyzes the earthquake-damaged historic structures of Bam and the Citadel. It also briefly introduces engineering and technical issues encountered in the Bam project, the types of structural damage affecting the damaged buildings, and the latest methods for stabilizing these structures. The final part of the paper draws conclusions from the research and discusses the knowledge and experience gained in the years after the earthquake.

FIGURE 2 The Bam Citadel, aerial image, July 2007. Conservation measures after the earthquake.

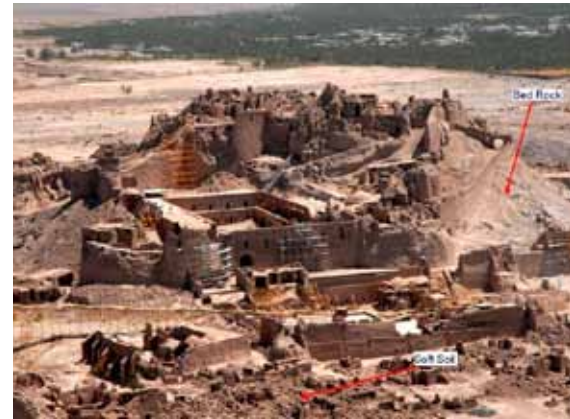
FIGURE 3 Differing extent of destruction in various parts of the Citadel and diverse dynamic behaviors in the bedrock and structures built on soft soil (Caravansarai, Stable, and Payambar mosque).

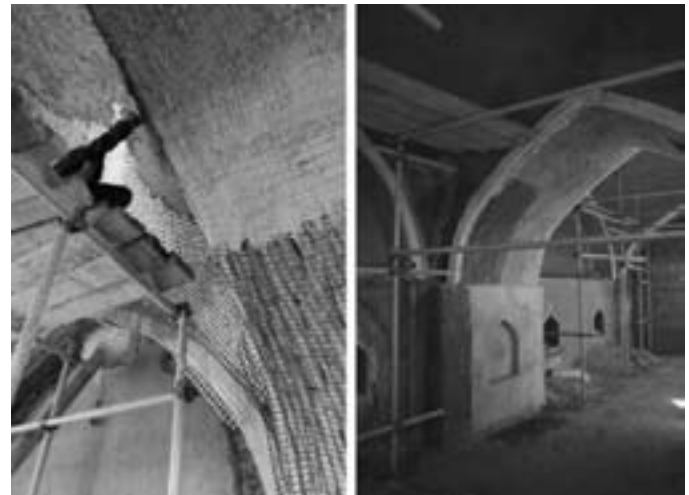
FIGURE 4 Reinforcement of the internal surfaces of the dome and walls in the Stable of the Citadel with geo-grids.

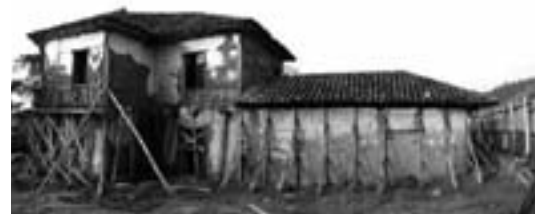
The earthen house is constructed of wattle and daub. It was in very poor condition due to lack of maintenance (fig. 2). It had structural problems, collapsed walls in the interior patio, invasive vegetation, and decay of the wood floors and roof. To stabilize the structure we repaired the interior patio and added perimeter walls with adobe buttresses. In addition, the existing adobe and wattle-and-daub walls were reinforced, new adobe walls were added, and the roof and floors were replaced. Last, perimeter drains were installed around the structure to control surface water runoff.

FIGURE 2 The Quinta Bolívar before restoration. Photo: Lourdes Abad R., 2004

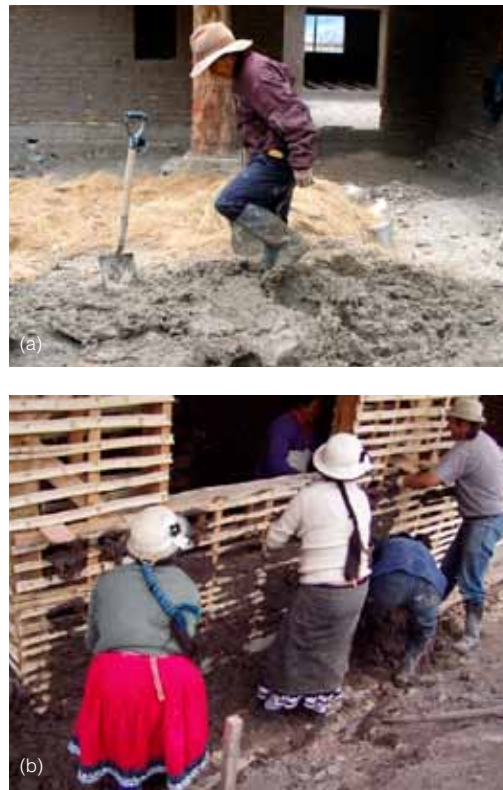
FIGURE 3 The Cañar House, constructed of wattle-and-daub, a mixture of mud and straw packed into a wooden latticework. Photos: Lourdes Abad R., 2006

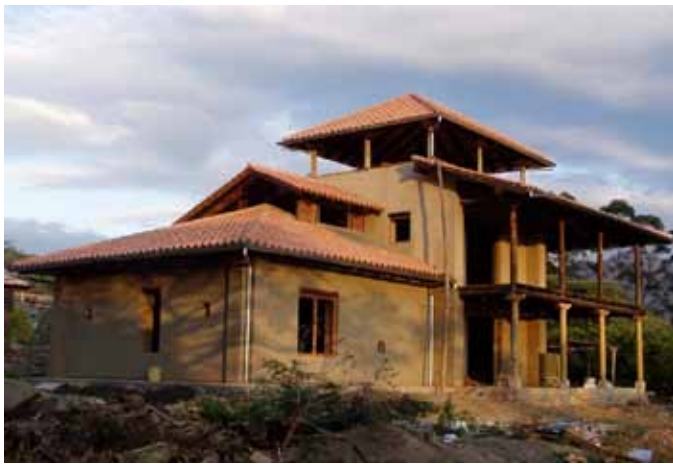
The house design incorporates a passive system of climate control that uses the insulating properties of the adobe, wind direction, and solar orientations to its advantage (fig. 4). The house is constructed primarily of adobes, with the third floor in *bahareque*. Fortunately, there was good soil for adobe

FIGURE 4 The Yunguilla House during construction. Photo: Lourdes Abad R., 2005

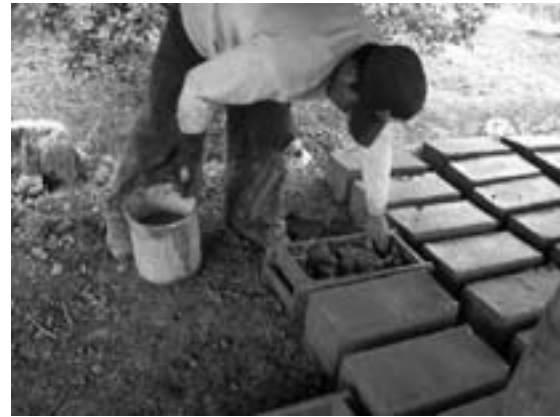
FIGURE 5 The Yunguilla House, making the adobes. Photo: Lourdes Abad R., 2006

available nearby. Analysis of the soil revealed it to be generally composed of 65% sand, 12% silt, 15% clay, and less than 3% organic matter. We added straw and 2% asphalt to stabilize the mix (fig. 5).

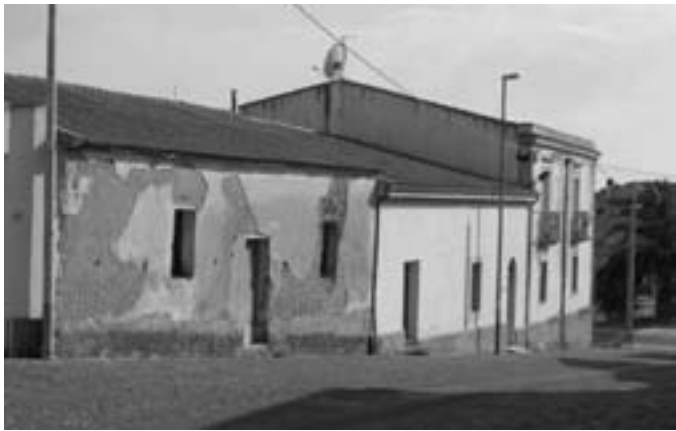
FIGURE 3 Casa Sanna in Solarussa. Photo: Department of Architecture, Faculty of Architecture of Cagliari.

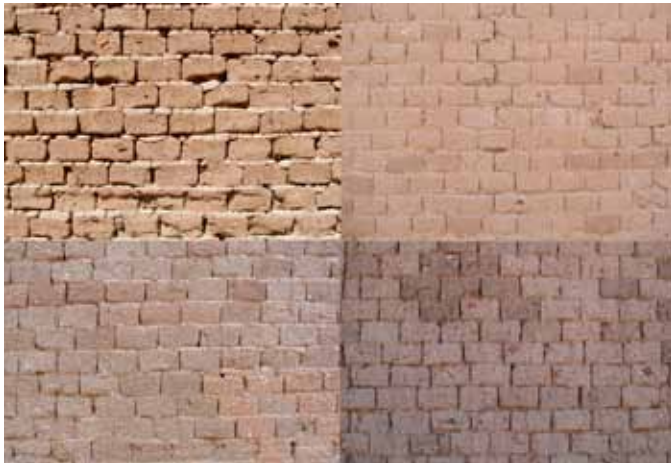
FIGURE 7 Different walls, same textures. Photo: Department of Architecture, Faculty of Architecture of Cagliari.

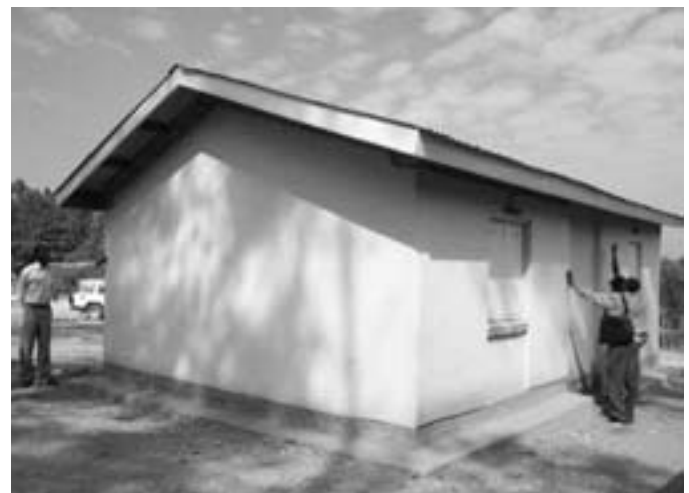
FIGURE 4 Prototype de construction contemporaine en torchis à Bushenyi, Ouganda, 2005. Photo : Olivier Moles. © CRATerre

Le projet a permis de proposer une réponse conforme aux standards de l'Ouganda en termes d'exigence de qualité, de durabilité et d'entretien des bâtiments publics (figs. 4-6). Les résultats les plus remarquables sont :

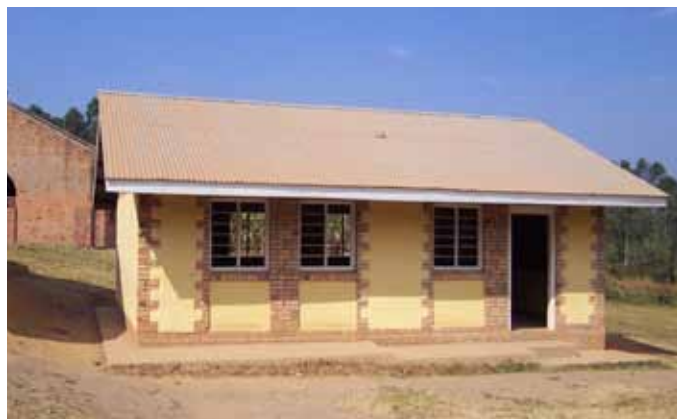
FIGURE 5 Prototype de construction contemporaine en adobe, Bushenyi, Ouganda, 2005. Photo : Olivier Moles. © CRATerre

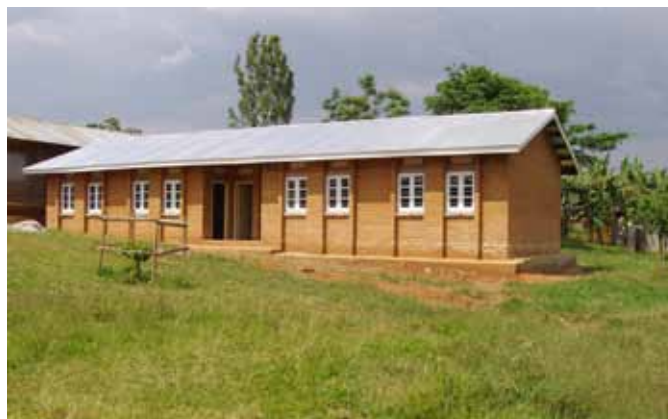
FIGURE 6 Prototype de construction contemporaine en blocs de terre comprimée, Bushenyi, Ouganda, 2005. Photo : Olivier Moles. © CRATerre

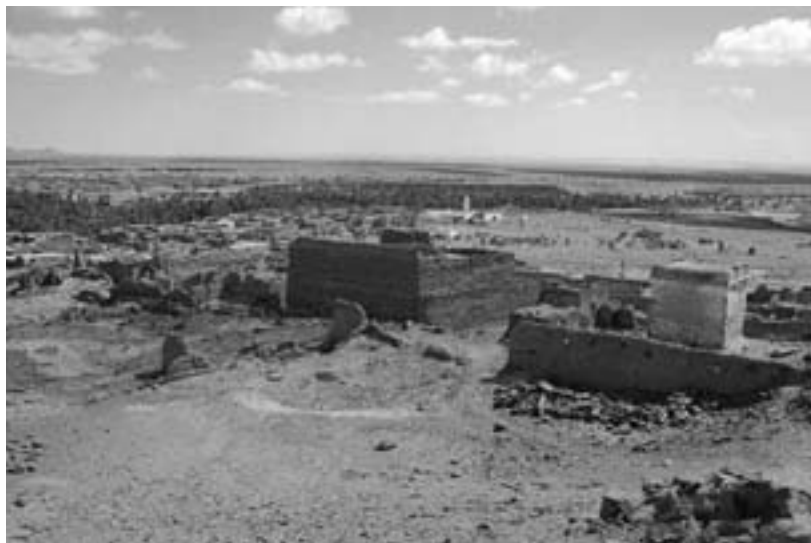
FIGURE 1 État des lieux avant intervention et pré-inventaire. A : restauration des parties collectives (patrimoine sacré, remparts, curetage ou calepinage). B : mise à niveau urbaine. C : porteurs de projets privés identifiés pour la première phase. Plan de situation © S. Naji, architecte en chef du projet

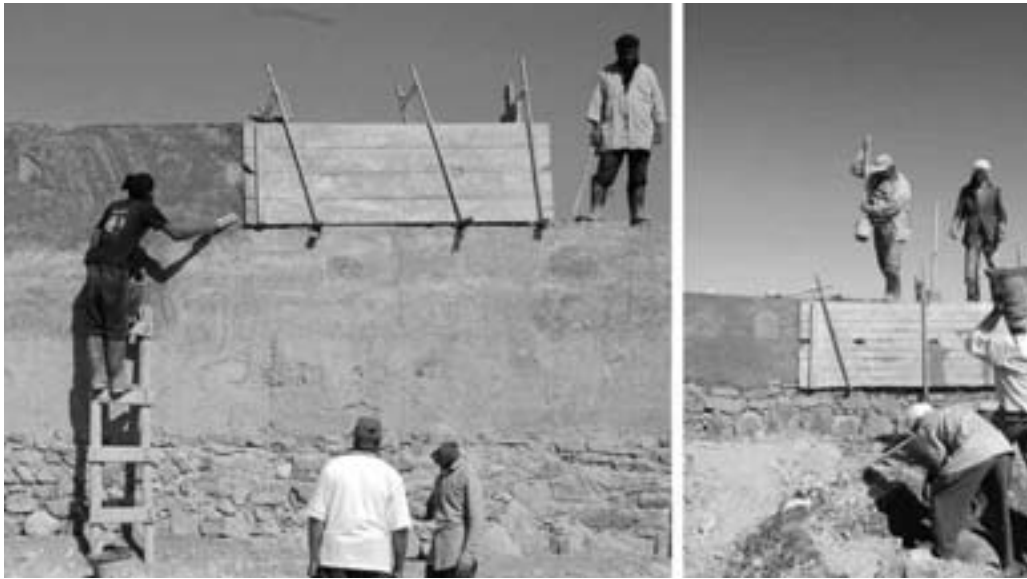
FIGURE 3 Restitution de l'ancien rempart, double paroi en pierre et en pisé. Mise en œuvre du pisé d'Assa : damage dans la banche sur assise de pierres. Photo © S. Naji

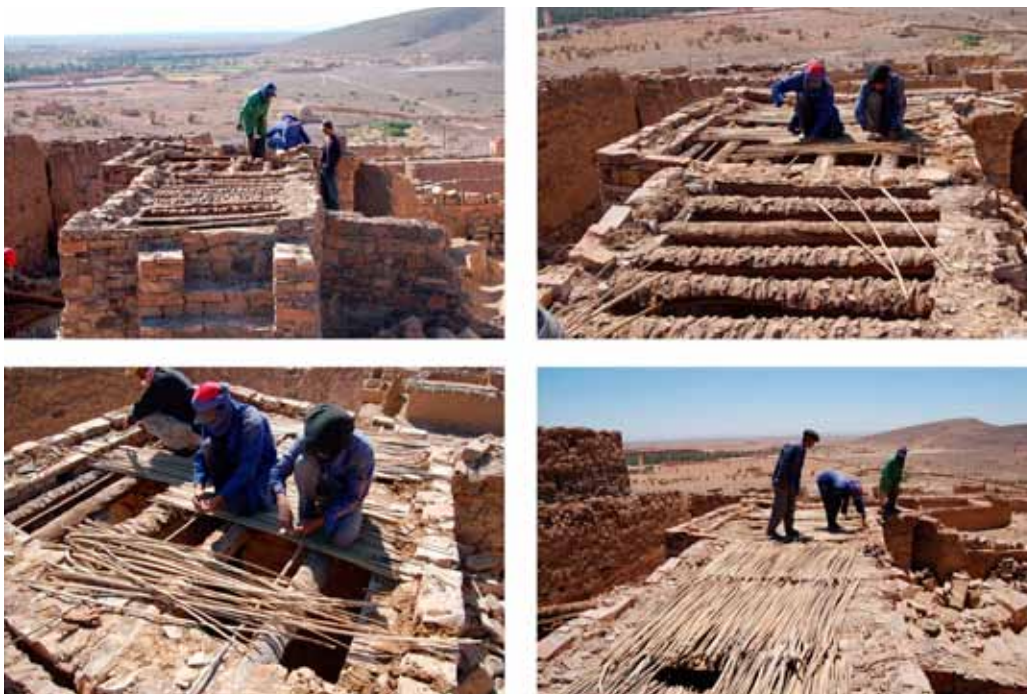
FIGURE 4 Compétence d'édifier, retrouver les gestes. La charpente très simple est constituée de stipes de palmier de section rectangulaire ou triangulaire, très rapprochées. Ces solives portent perpendiculairement au mur, le voligeage est constitué de tiges de palmes. Un lattis serré de branches de laurier ou de palmes sèches est ensuite recouvert de palmes entières fraîchement cueillies, apportées et déposées sur cette structure, de sorte que le mortier final, répandu au-dessus ne passe à travers. Une fois les interstices ainsi comblés, on peut répandre le mortier de couverture, préalablement malaxée au pied. Photos © S. Naji

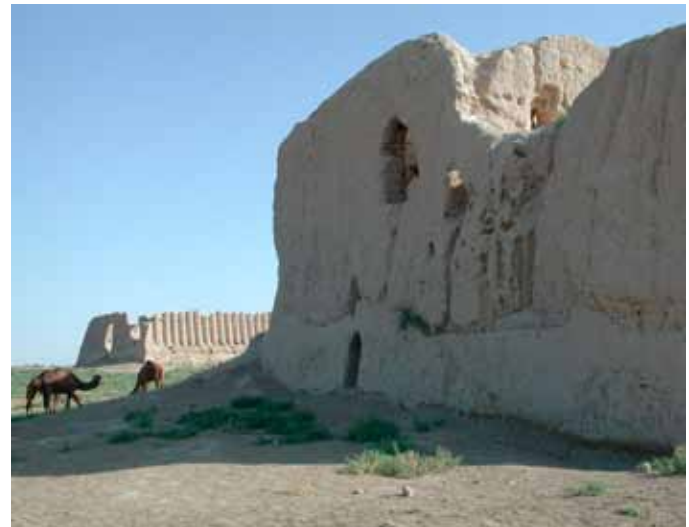
FIGURE 1 The greater and lesser Kyz Kala in Merv, Turkmenistan. Note the repairs at the base of the walls. Photo: Gaetano Palumbo. © World Monuments Fund

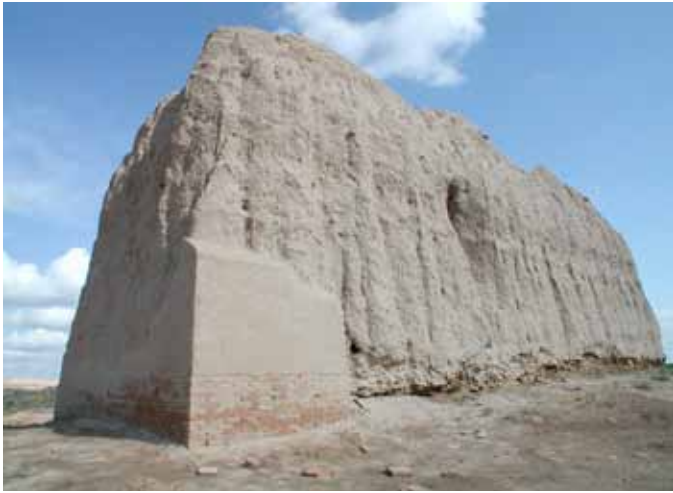
FIGURE 2 Kepter Kana in Merv, Turkmenistan. Corner repair using the traditional building technique of fired bricks at the wall base. Photo: Gaetano Palumbo. © World Monuments Fund

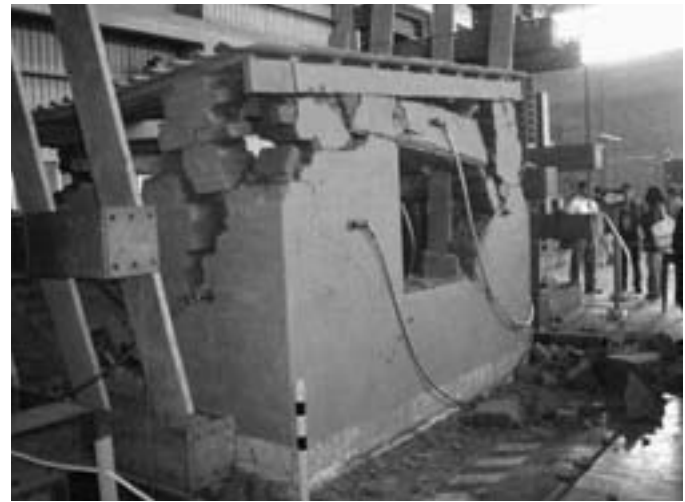
FIGURE 1 Seismic retrofitting tests performed during SismoAdobe 2005, held at PUCP, Lima, Peru, in May 2005. Photo: Mariana Correia

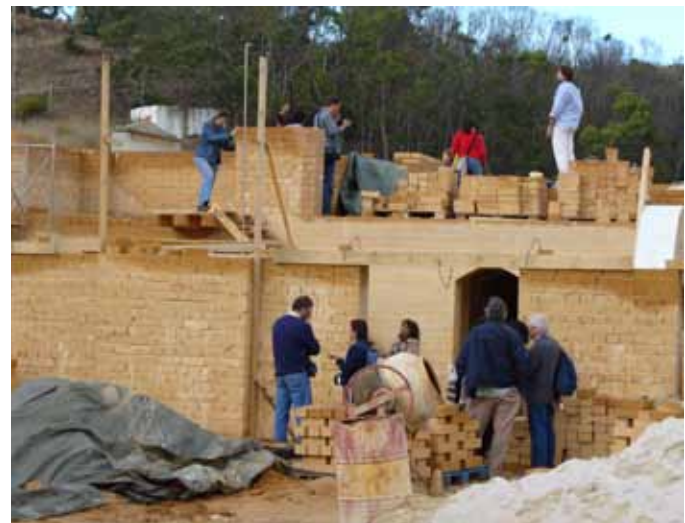
FIGURE 2 CEB construction in Carrapateira, Algarve. Visit during the IV SIACOT, held in Monsaraz, Portugal, in October 2005. Photo: Mariana Correia

The great majority of the earth construction techniques applied in Brazil are basically compressed earth bricks (CEBs), but monolithic panels molded in place are also used. During the 1990s a movement to use debris from the fabrication of bricks and CEBs began (fig. 2).

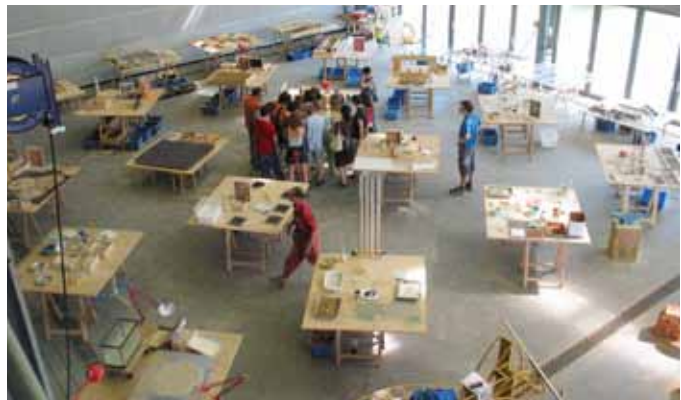
FIGURE 1 L'atelier scientifique « Grains de bâtisseurs® » pour lequel plus de cent cinquante expériences ont été développées et qui se déploie sur 400 m². © CRATerre-ENSAG

ron 400 m² (fig. 1) et l'atelier scientifique est associé en aval à l'atelier technique qui se développe en même temps sur environ 800 m² (fig. 2). Les expériences sont en libre-service individuel et elles peuvent également être pratiquées collectivement, mais dans tous les cas la présence d'un(e) médiateur(trice) scientifique est obligatoire. De nouvelles expériences sont développées constamment au fur et à mesure de l'évolution des connaissances qui sont produites par les programmes de recherche en cours et des nouveaux besoins pédagogiques identifiés. En amont, l'atelier « Grains de bâtisseurs® » est précédé par un ensemble intégré d'exercices analytiques théoriques (fig. 3) et pratiques (fig. 4) impliquant les cinq sens et

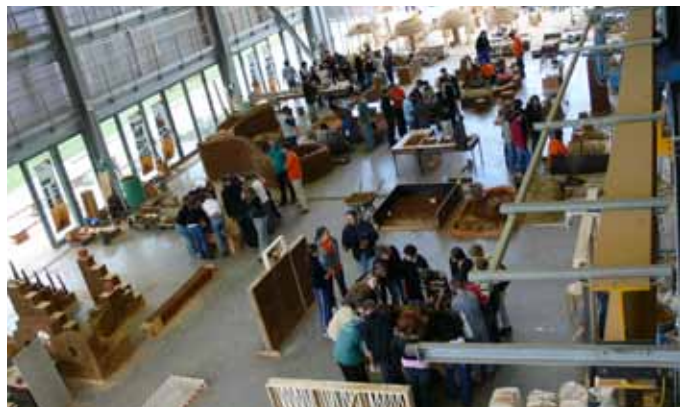
FIGURE 2 L'atelier technique de 800 m² qui accompagne l'atelier scientifique « Grains de bâtisseurs® ». © CRATerre-ENSAG

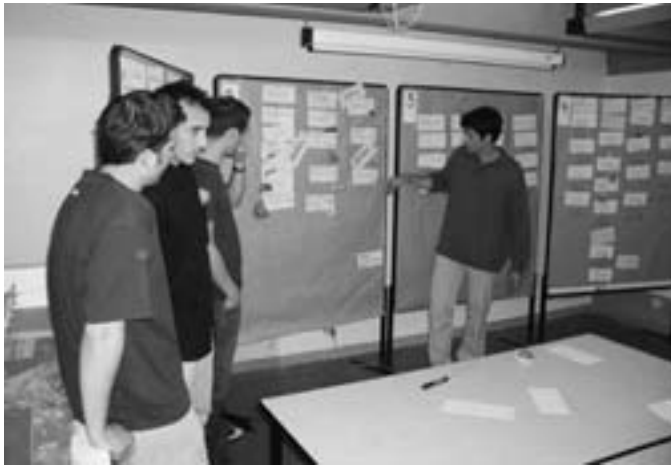
FIGURE 3 Exercice de classification des composants et élaboration d'un modèle théorique de la nature triphasique de la matière terre. © CRATerre-ENSAG

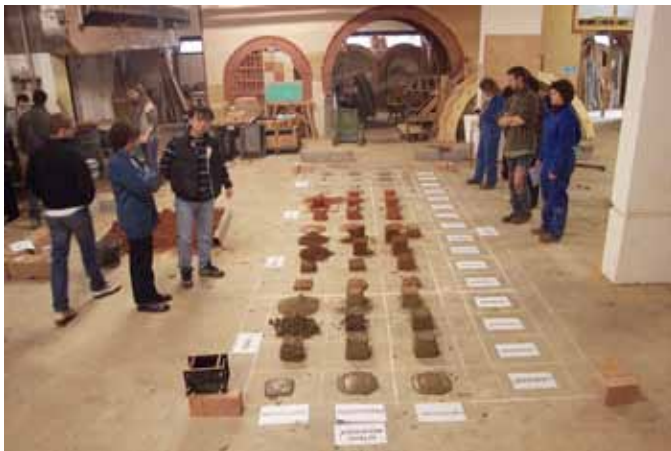
FIGURE 4 Exercice de synthèse des variations paramétriques des interactions triphasiques de la matière terre. © CRATerre-ENSAG

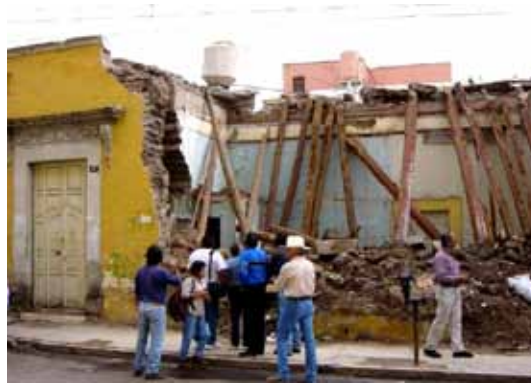
FIGURE 1 The lack of interest in salvaging the historic adobe architecture in Historic Durango is evident in this ruined adobe building. Photo: Francisco Uviña, 2003

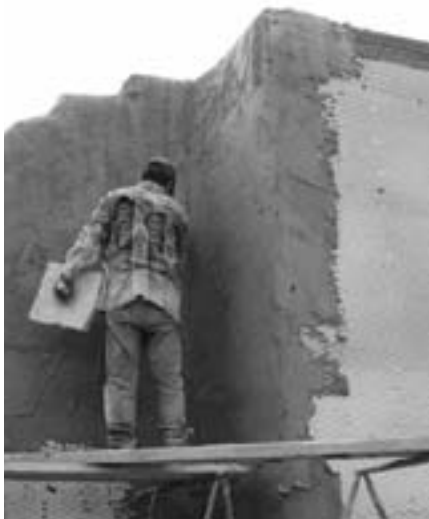
FIGURE 2 The application of cementitious plaster over wire lathe in Santa Fe, New Mexico, showing the lack of use of traditional plasters. Photo: Luis Fernando Guerrero Baca, 2006

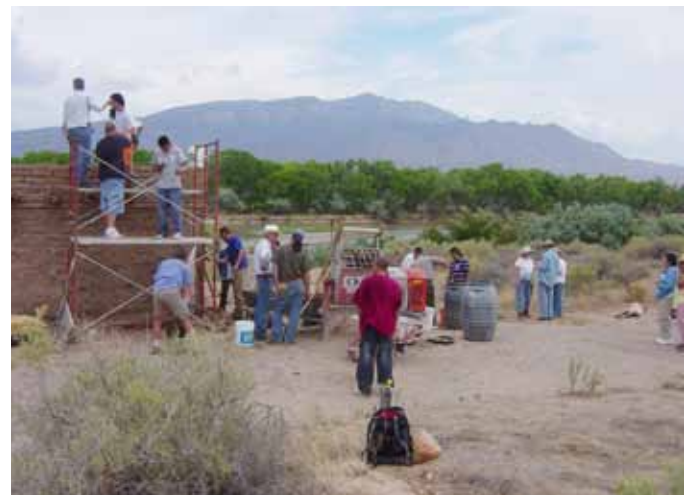
FIGURE 4 Work on a small building at the Coronado State Monument and the application of mud plaster. Photo: Francisco Uviña, 2006

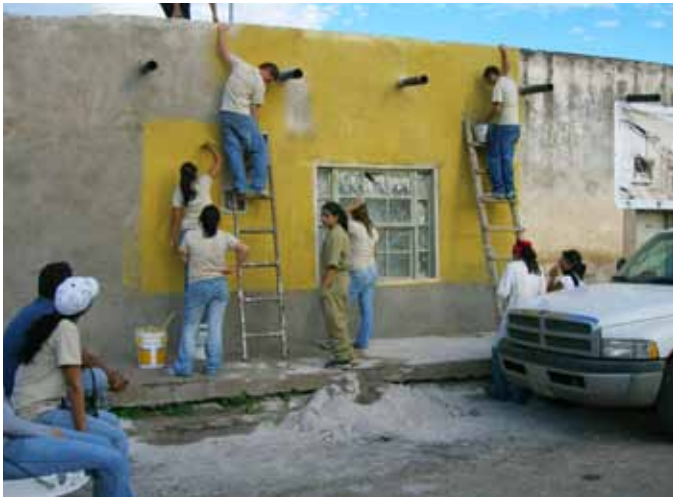
FIGURE 5 Architecture students applying the traditional lime paint, Ciudad Guerrero, Chihuahua, Mexico. Photo: Francisco Uviña, 2006

roofs and alum waterproofing of the lime-plastered roofs, an old technology still practiced in Mexico. Lime-based paints were also applied when the lime plasters were completed.

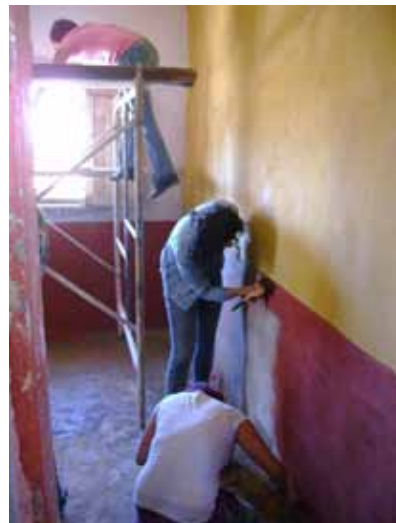
FIGURE 7 Students applying the traditional lime paint in the interiors, El Sauz, Chihuahua, Mexico. Photo: Luis Fernando Guerrero Baca, 2007
