TECHNICIAN TRAINING FOR THE CONSERVATION OF MOSAICS

PART 1
THE CONSERVATION OF IN SITU MOSAICS

Archiving documentation

House « of the two peristyles »
ID: HE/H2P/25

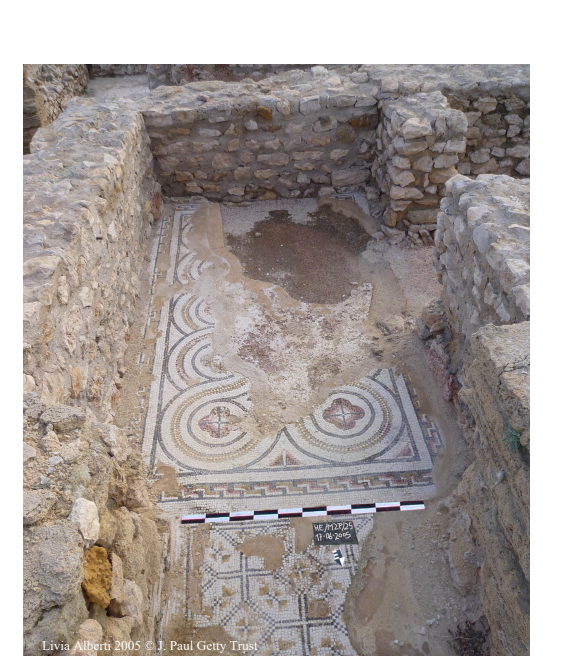
HE-H2P-25_2005-06-17_ID_GeneralPhoto

Pavement in Opus Tessellatum, polychrome geometric tesserae in white, black, green, yellow, pink, and red limestone. Dimensions of the tesserae: 0.80cm x 1.00cm; 1.00cm x 1.00cm; 1.20cm x 1.00cm

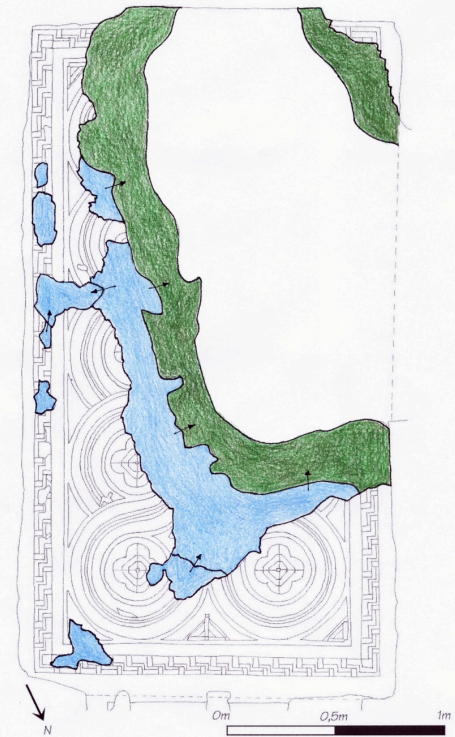
TITLE: Previous Interventions Map

Mortar repairs

- Infilling of lacunae
- Edging repair
- Outline
- Overlap
- Filling of

Reintegration of lacunae

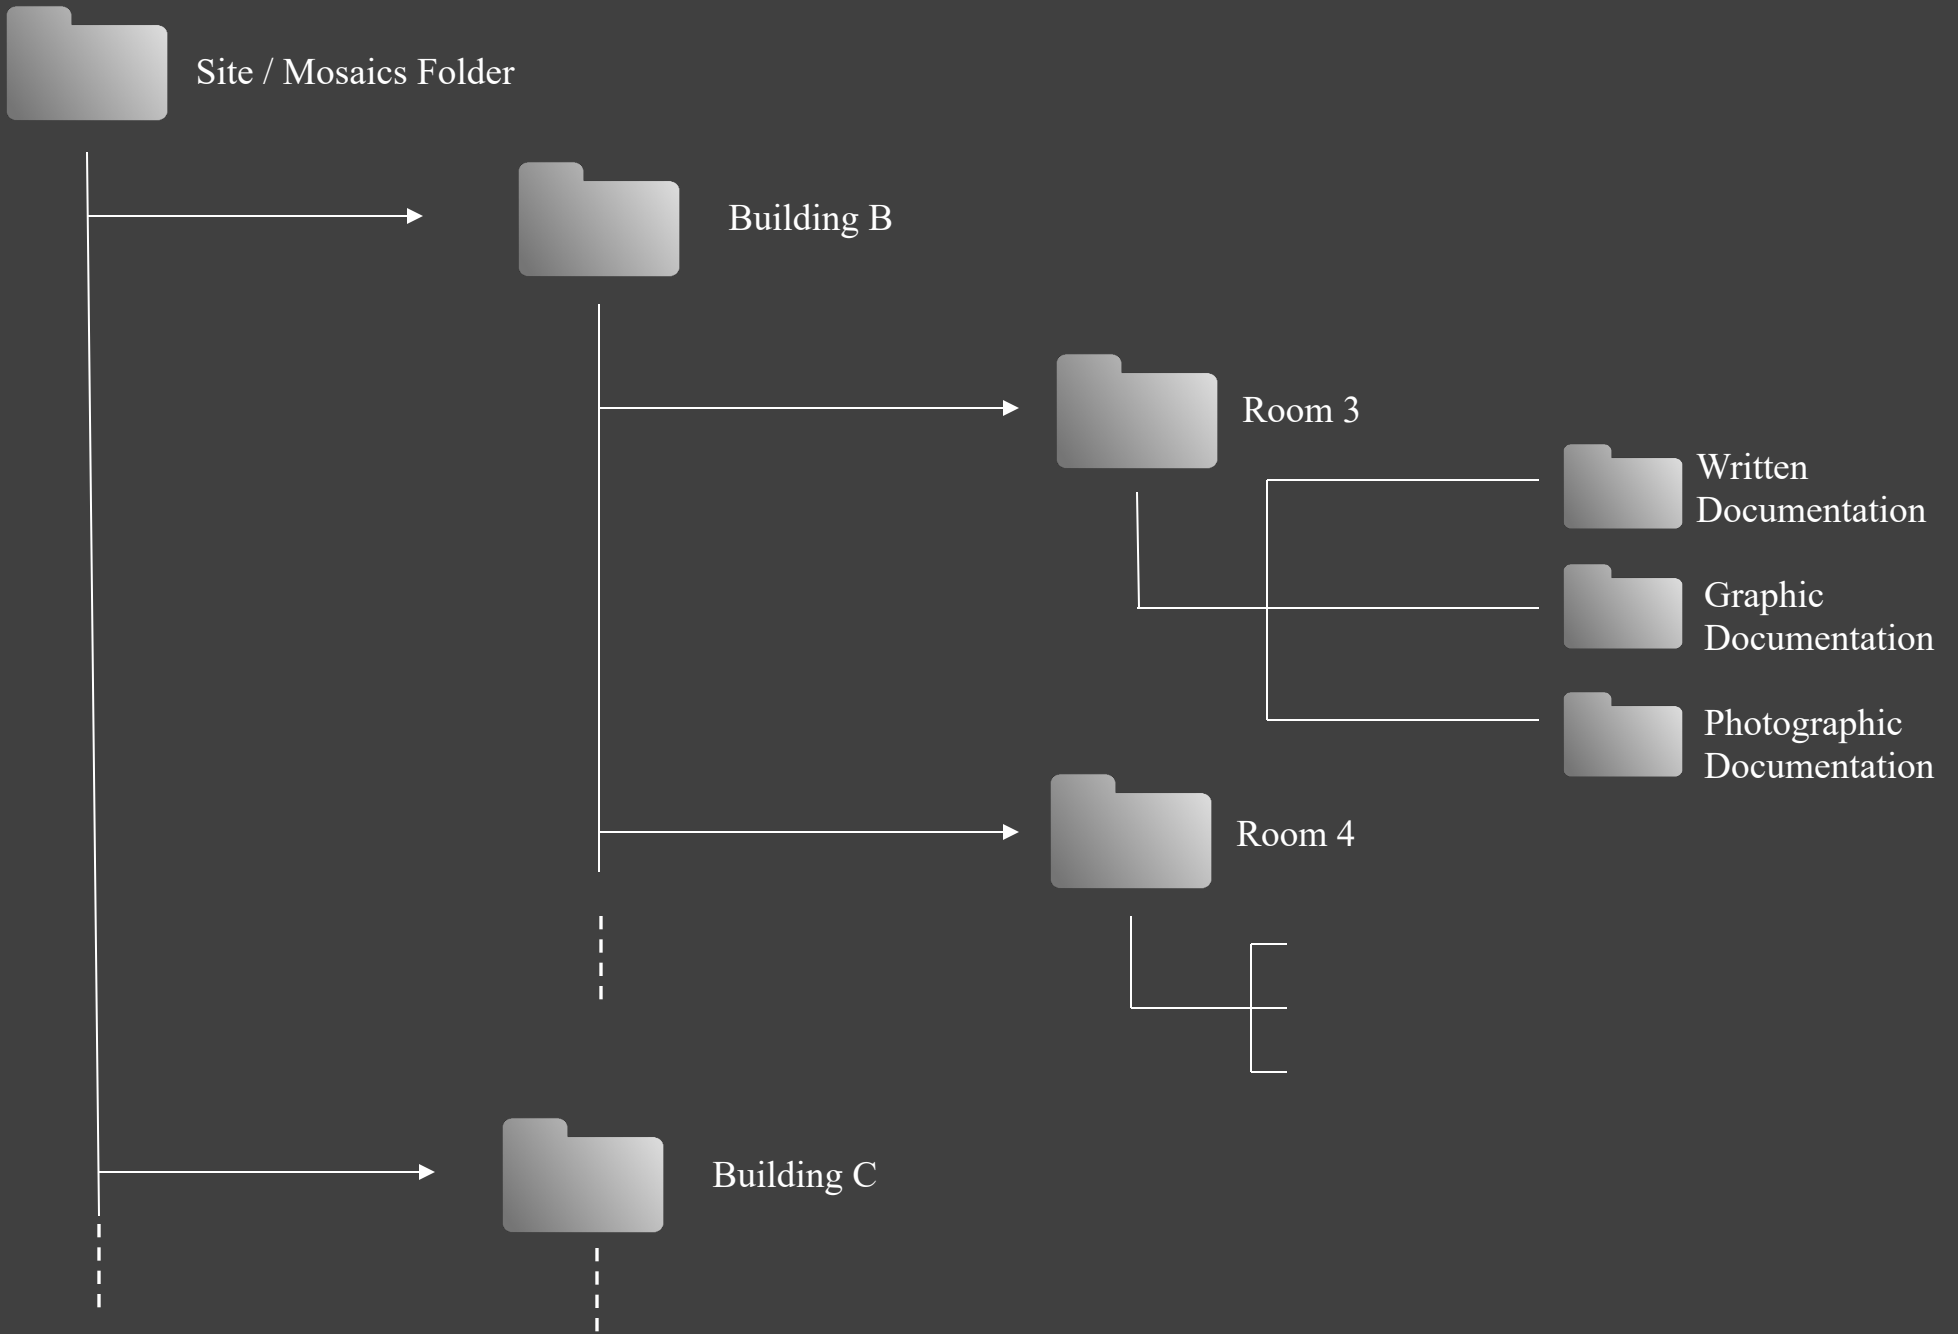
Organization of digital folders

Mosaic ID	Date	Subject		Number
		Category	Note	
Site – Building – Room - Division	yyyy-mm-dd	<ul style="list-style-type: none"> • 1ID (Identification) • 2PI (Previous Interventions) • 3CA (Condition Assessment) • 4PL (Planning) • 5CI (Current Interventions) • 6WA (Working Aid) 	(Use the technical vocabulary found in the map legends and the <i>Illustrated Glossary</i>)	(If two files share the same ID, date, subject and format)
Example				
DG – Th1 – 11 – 2	2006–05-10	3CA	DetachTess	04
