TECHNICIAN TRAINING FOR THE CONSERVATION OF MOSAICS

PART 2
THE CONSERVATION OF DETACHED MOSAICS

The conservation of mosaics kept in storage

Livia Alberti, Ermanno Carbonara, Thomas Roby

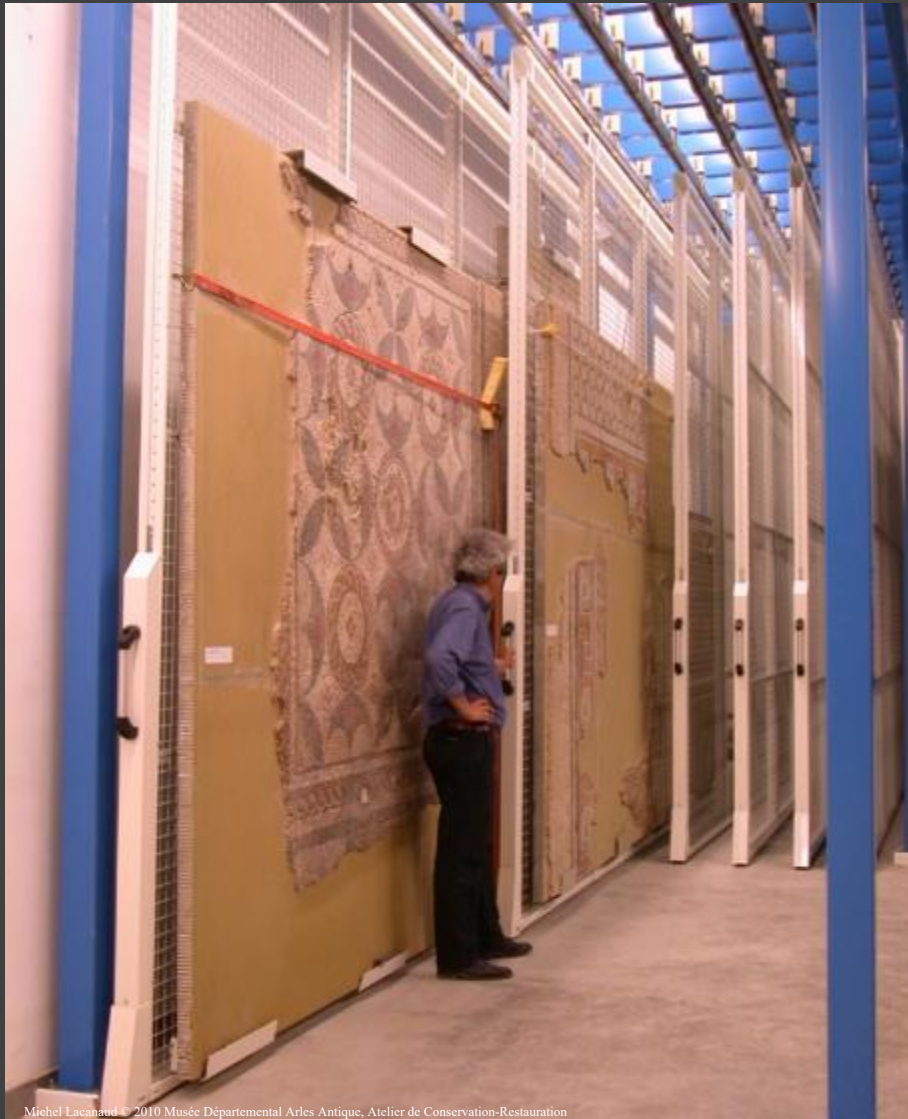
Honeycomb aluminum panel

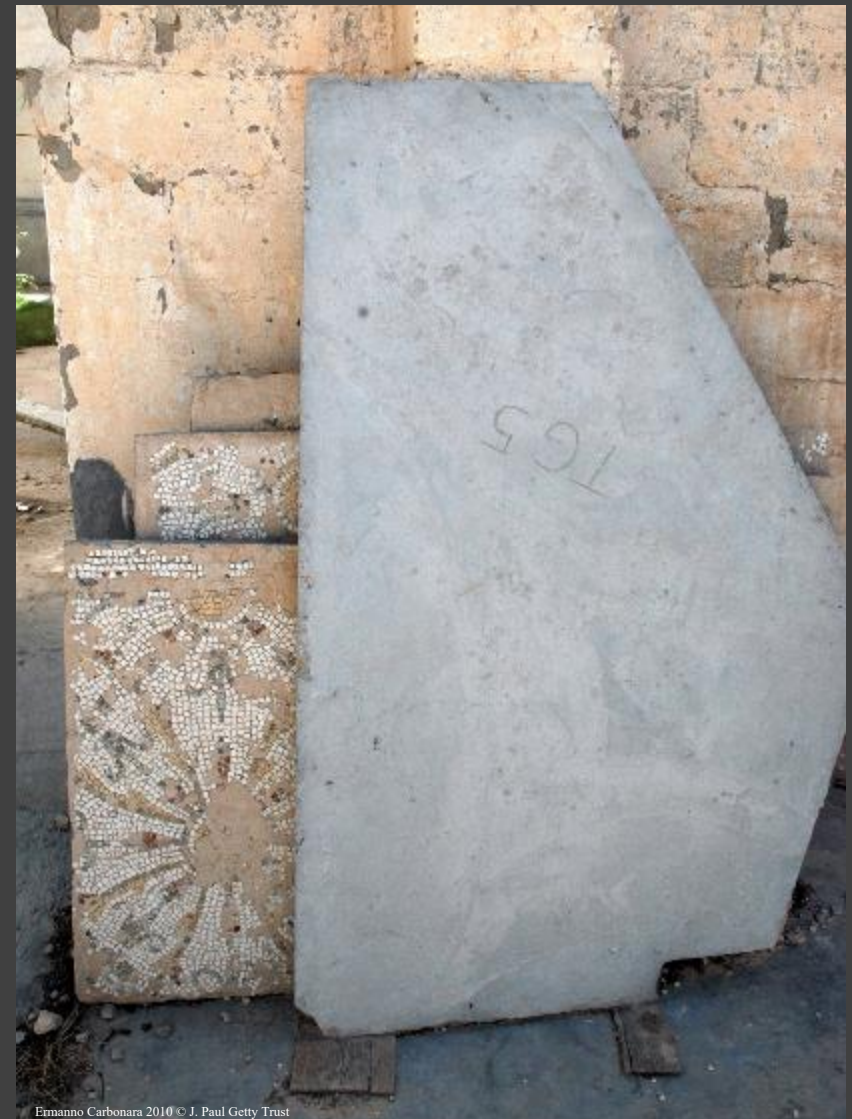
Reinforced concrete panel

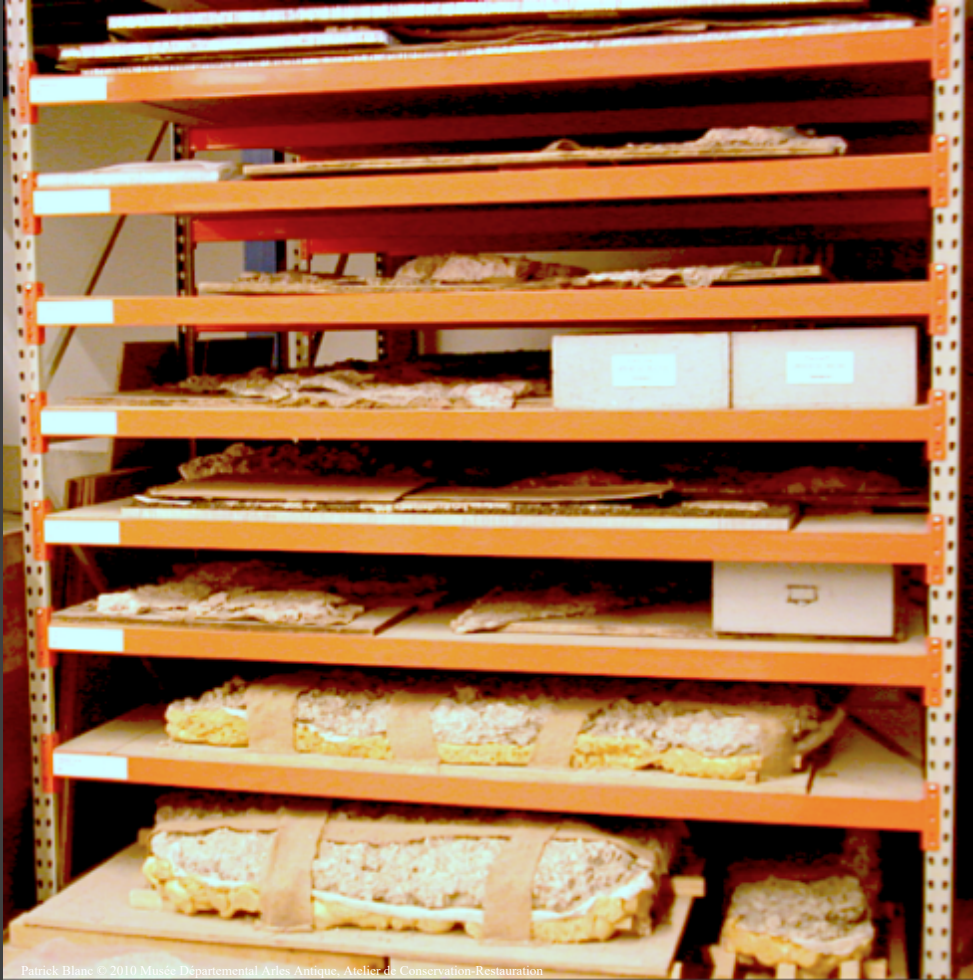
On metal shelves

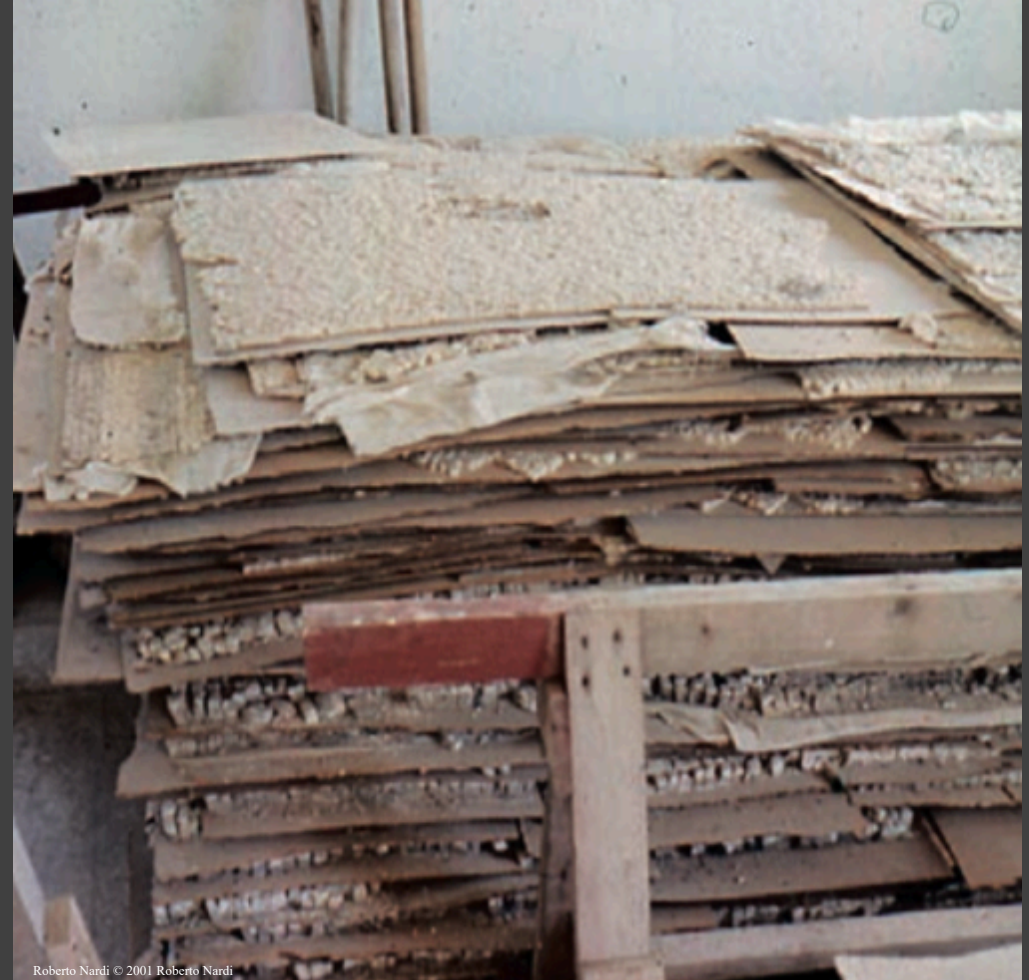
One on top of another

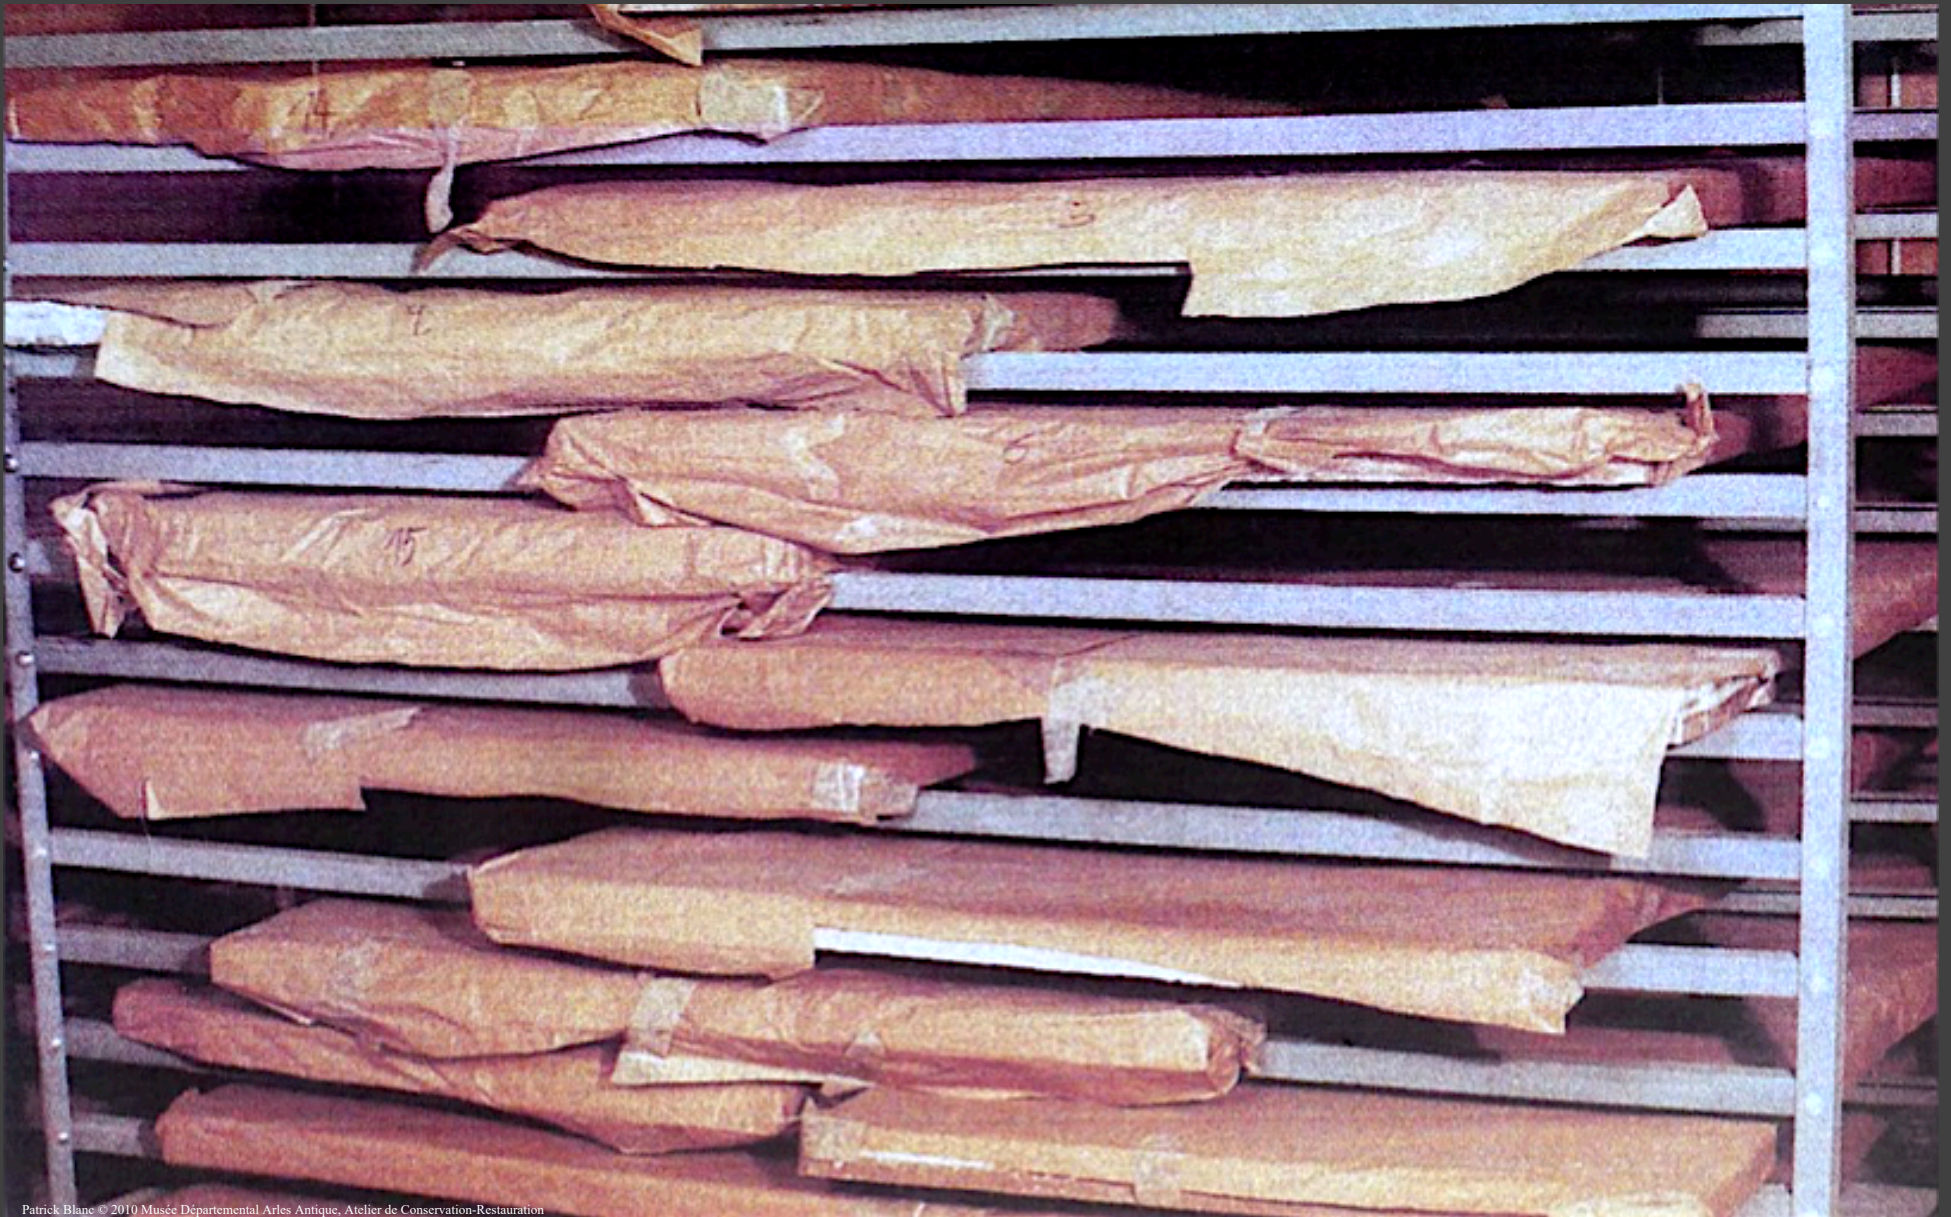
Mosaics put in storage on metal shelves on plywood panels

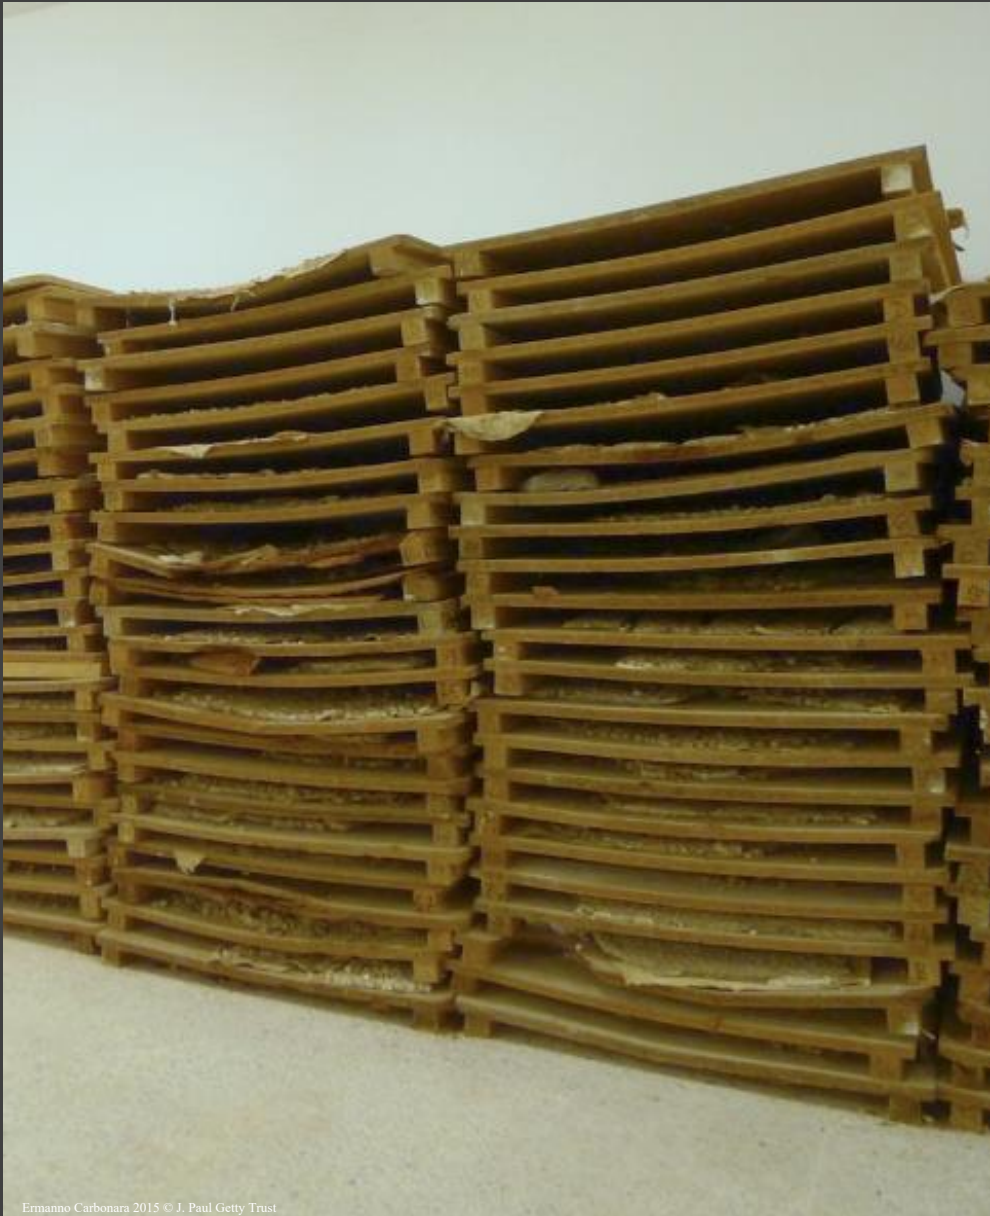
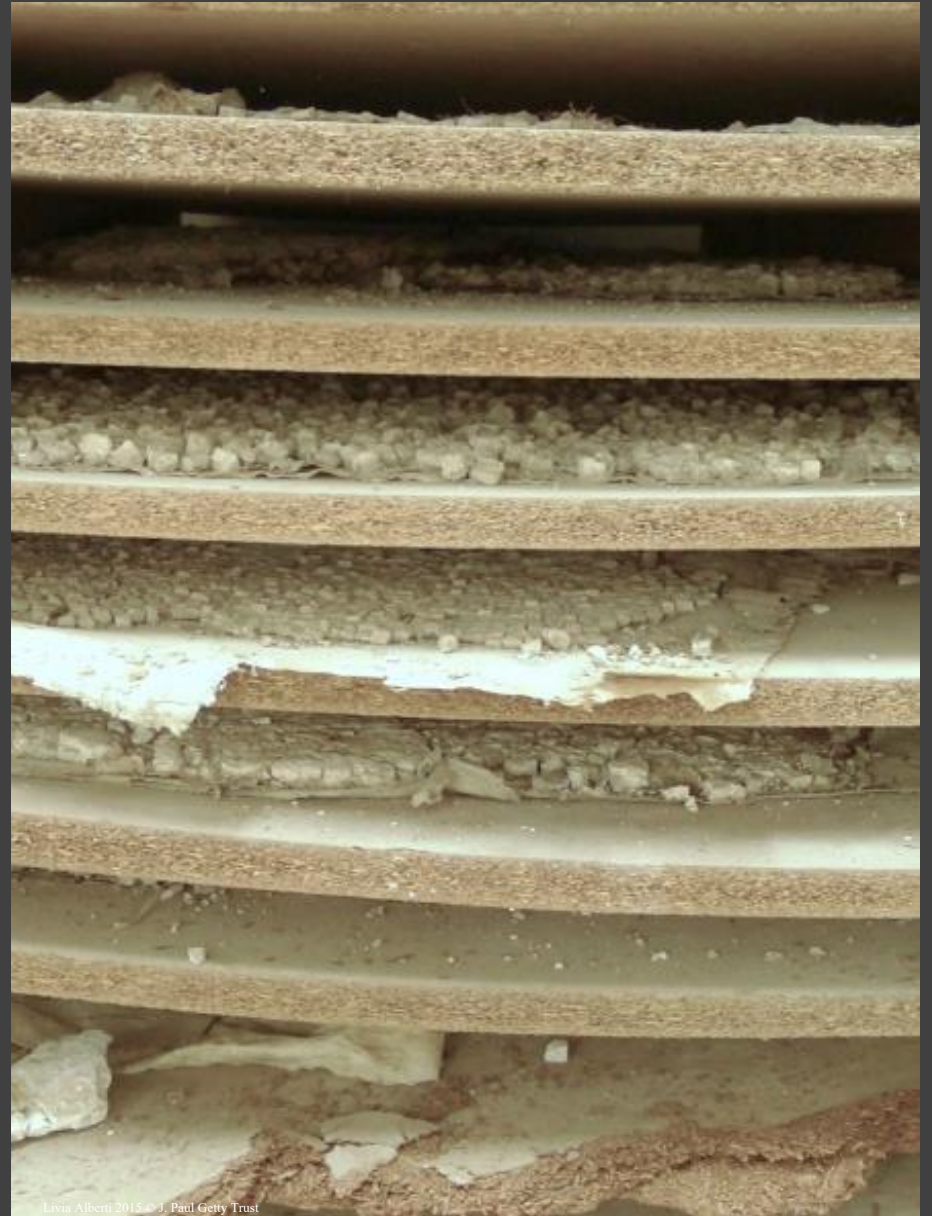
Mosaics put in storage one on top of another on particleboard panels

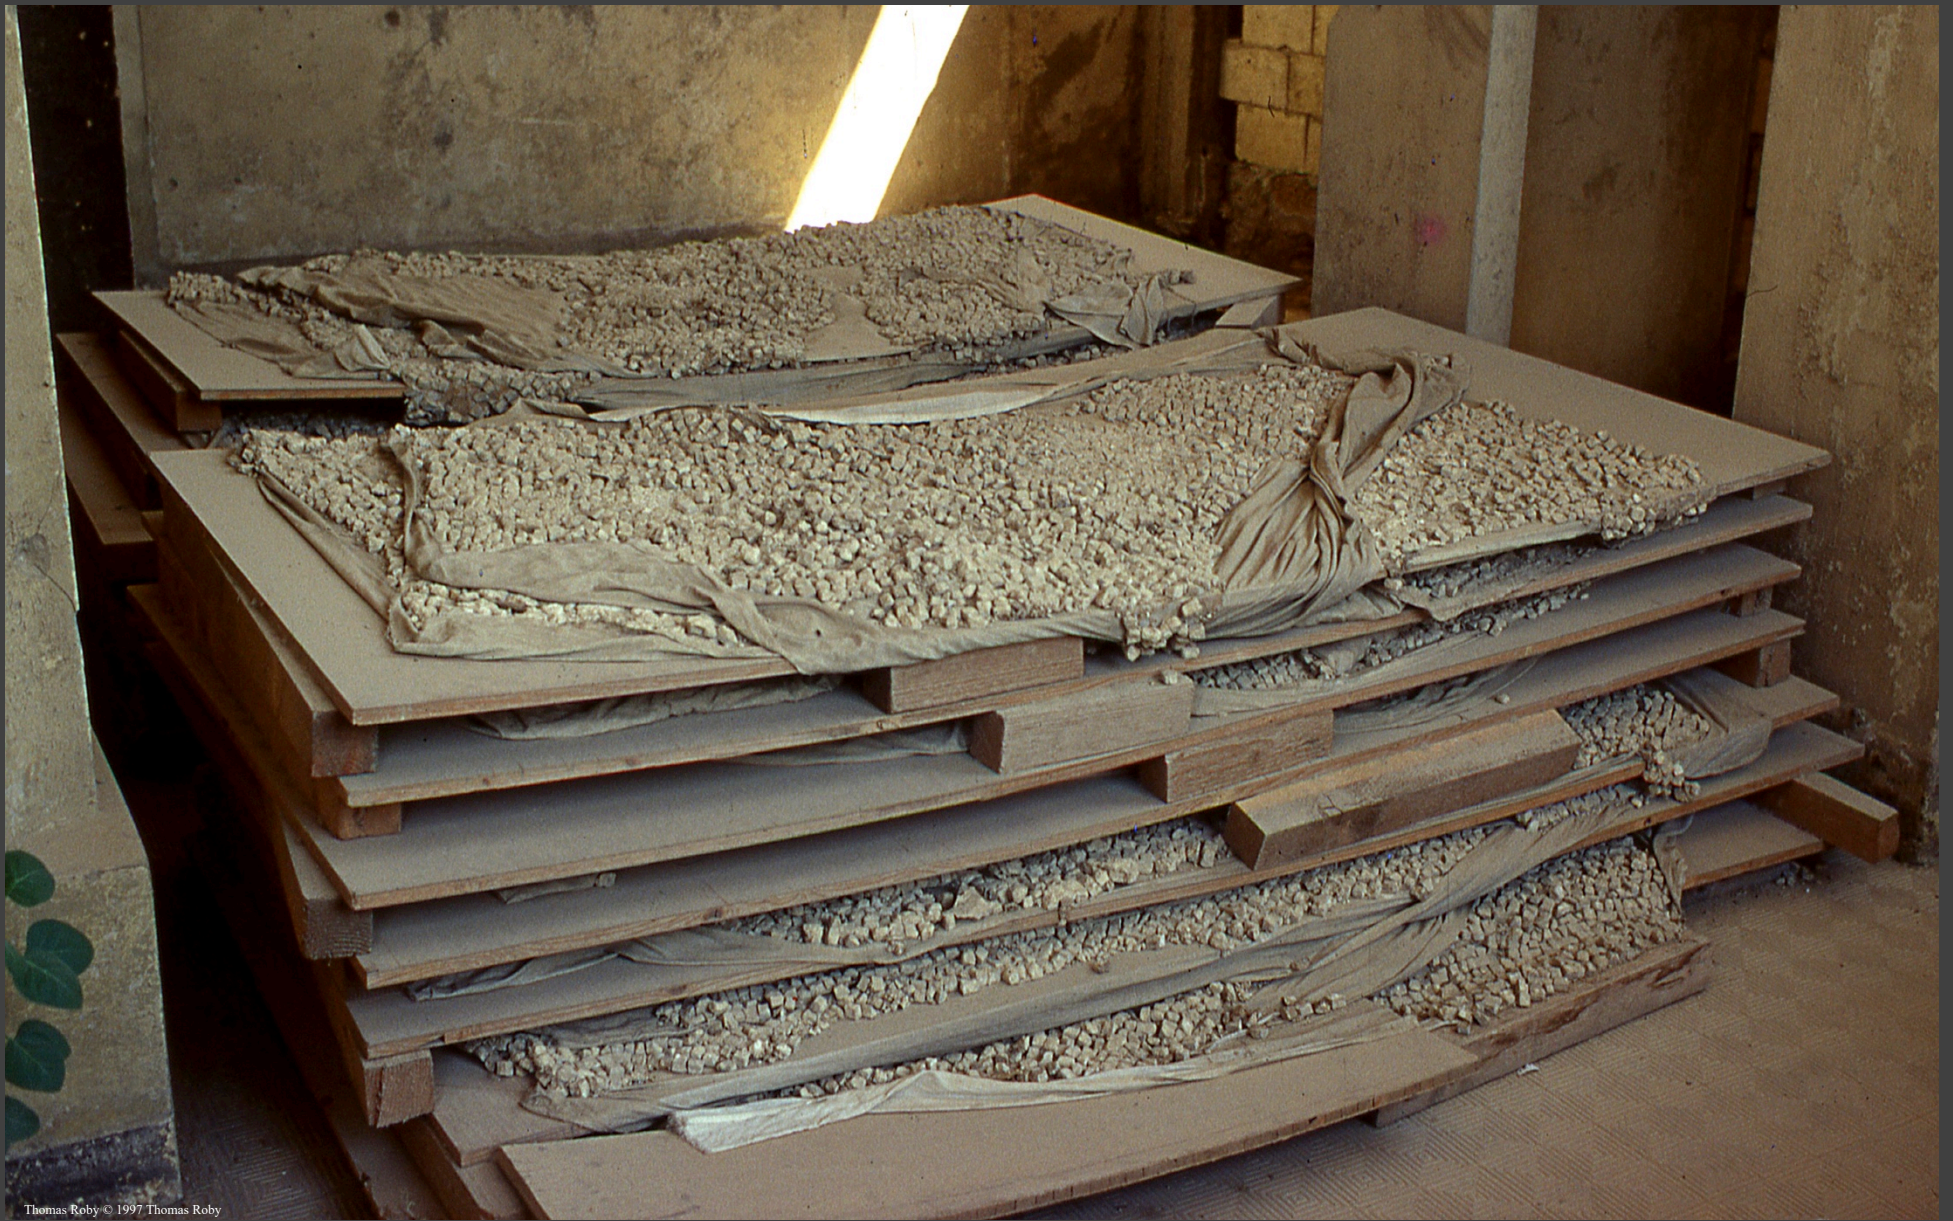
Mosaics put in storage one on top of another on plywood panels

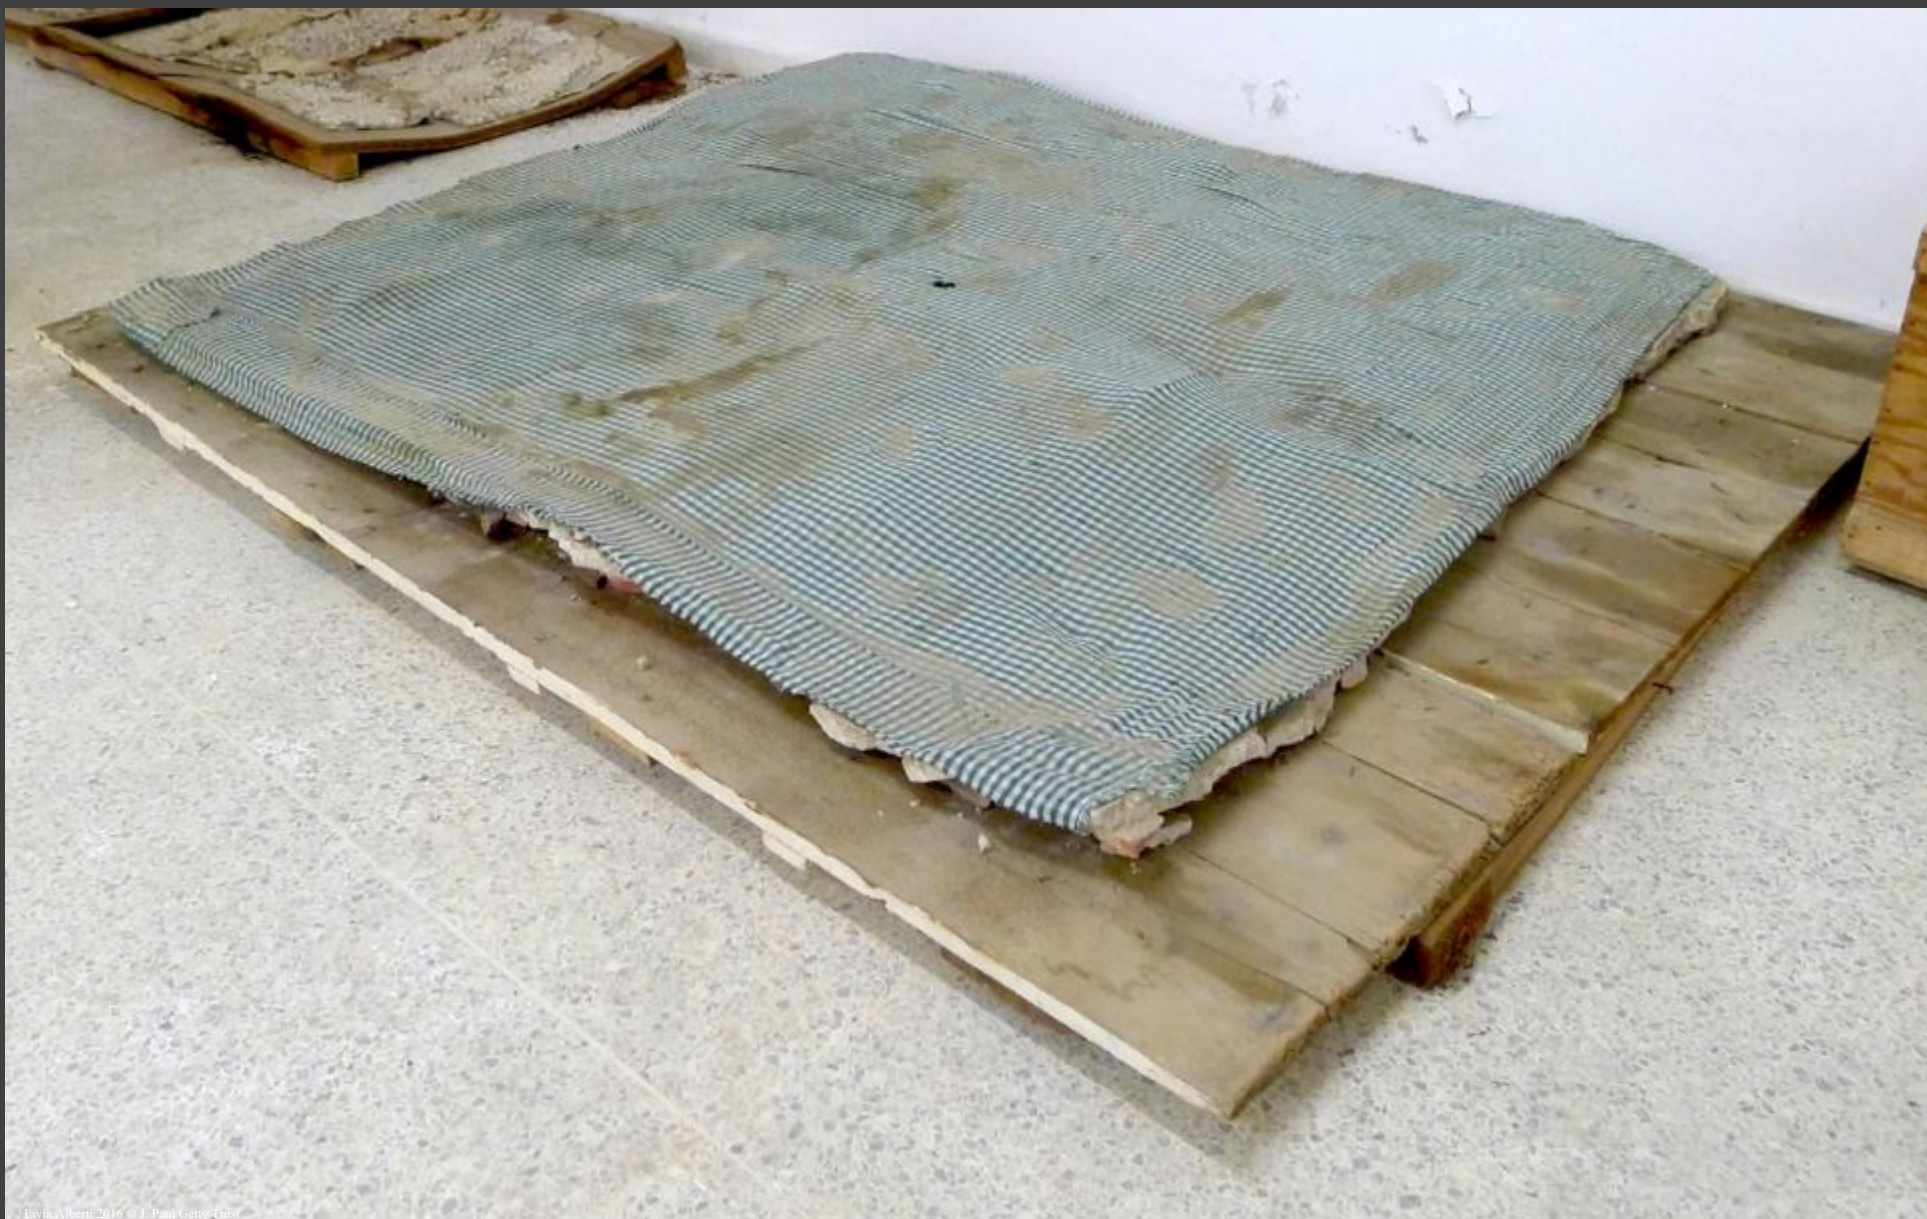
Mosaics put in storage on a wooden plank panel

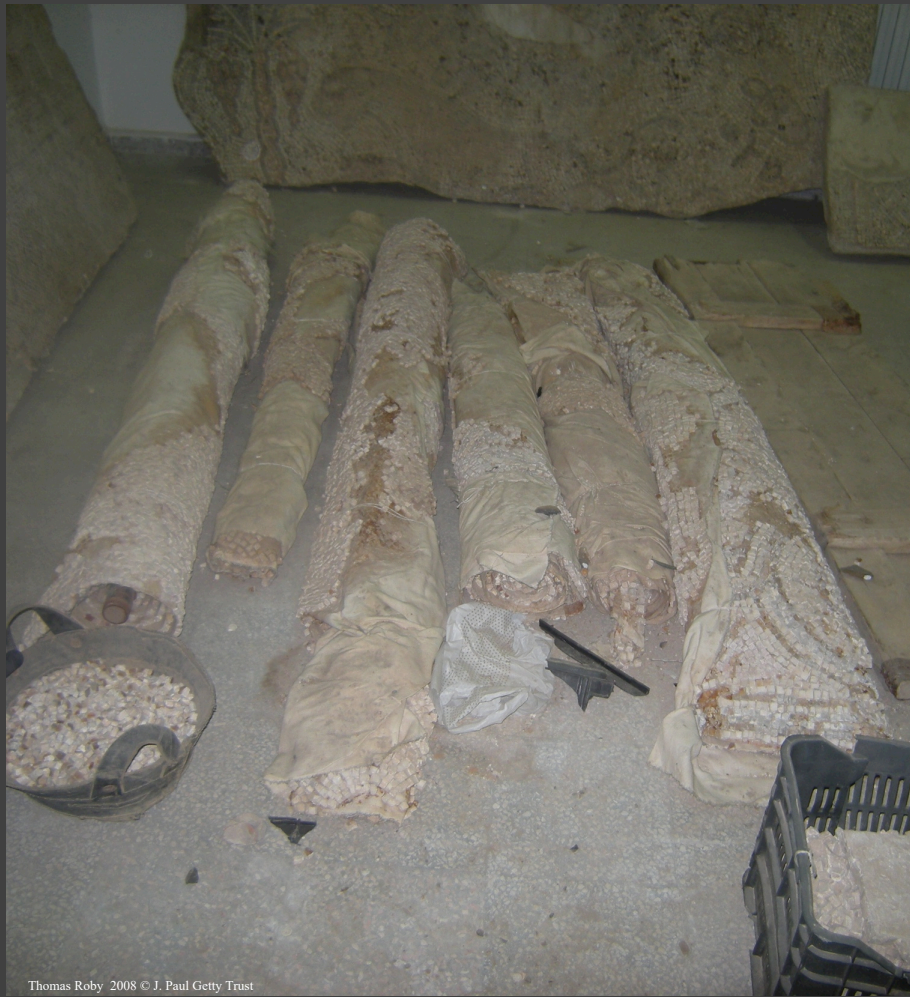
Mosaics put in storage without any support structure

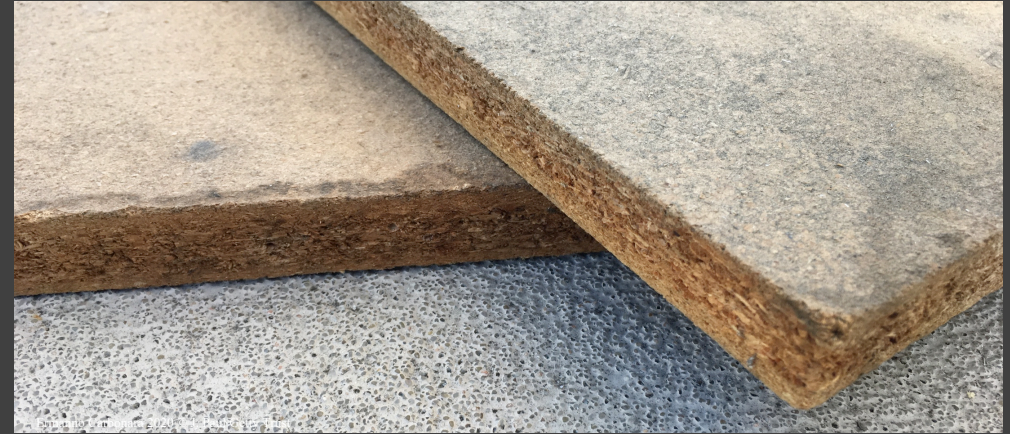
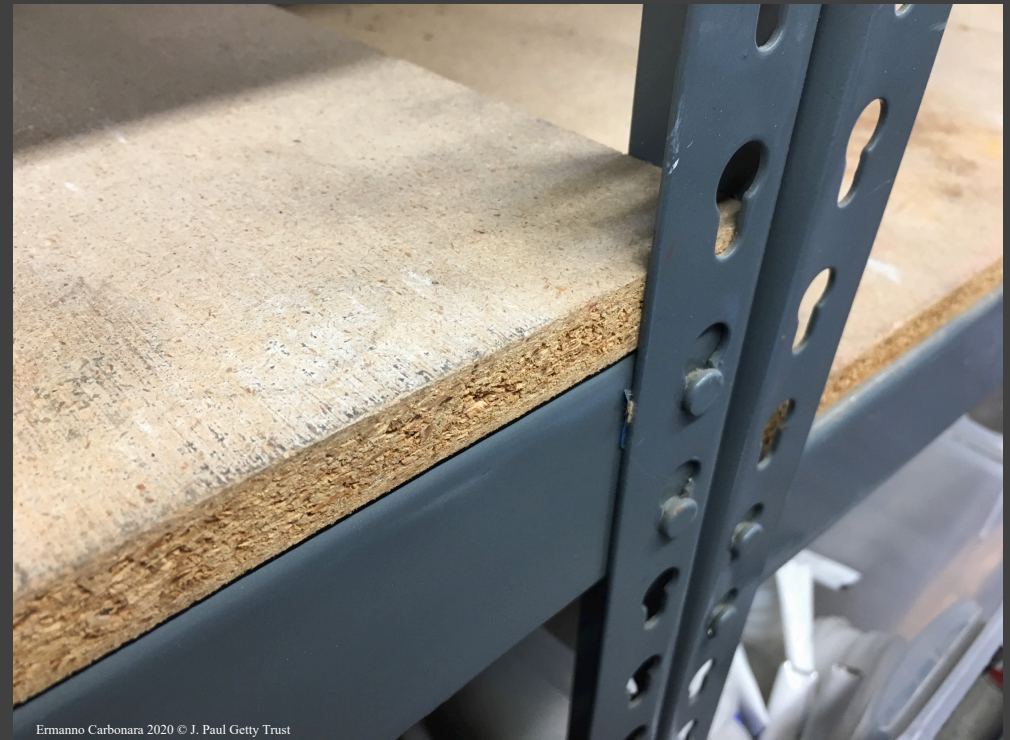
Particleboard panels

- Inexpensive
- Readily available

- Easily deformed in the short term
- Low stability to humidity
- Low weight-bearing capacity
- Maintenance needs

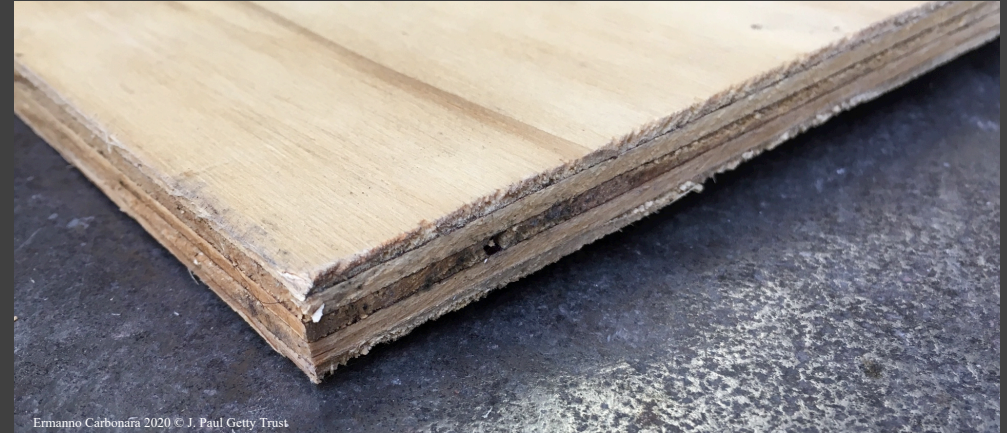
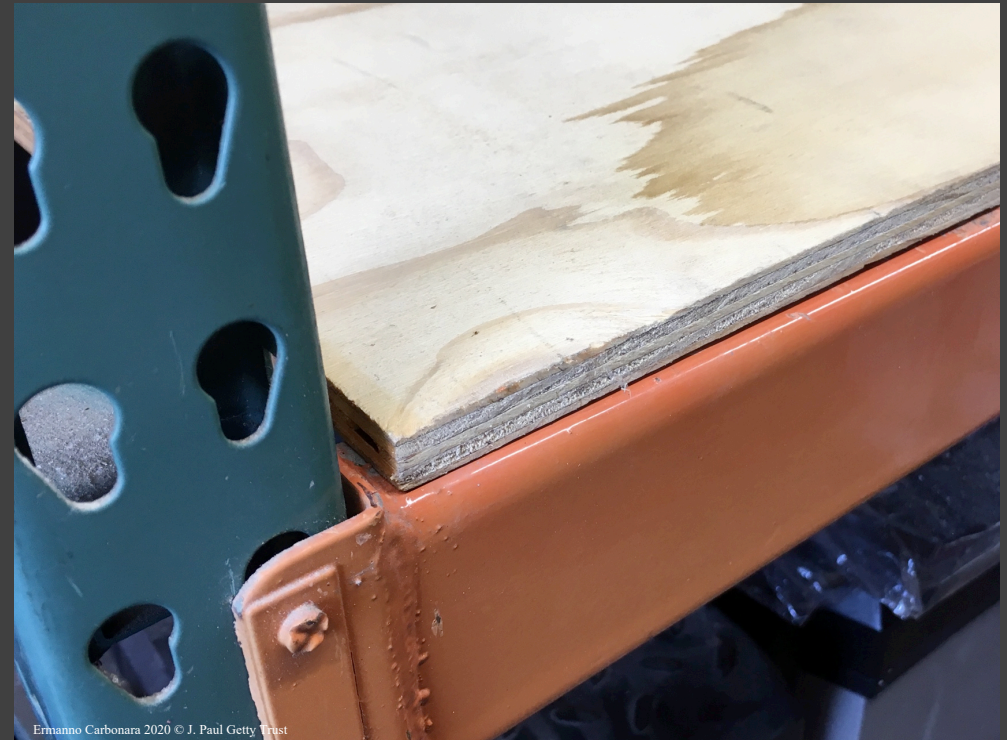
Plywood panels

- Inexpensive
- Readily available
- Good weight-bearing capacity

- Easily deformed in the medium term
- Low stability to humidity
- Maintenance needs

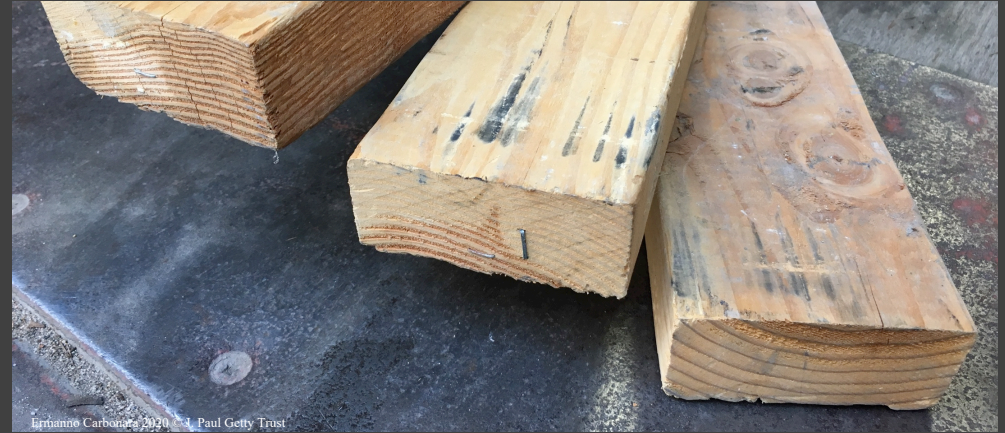
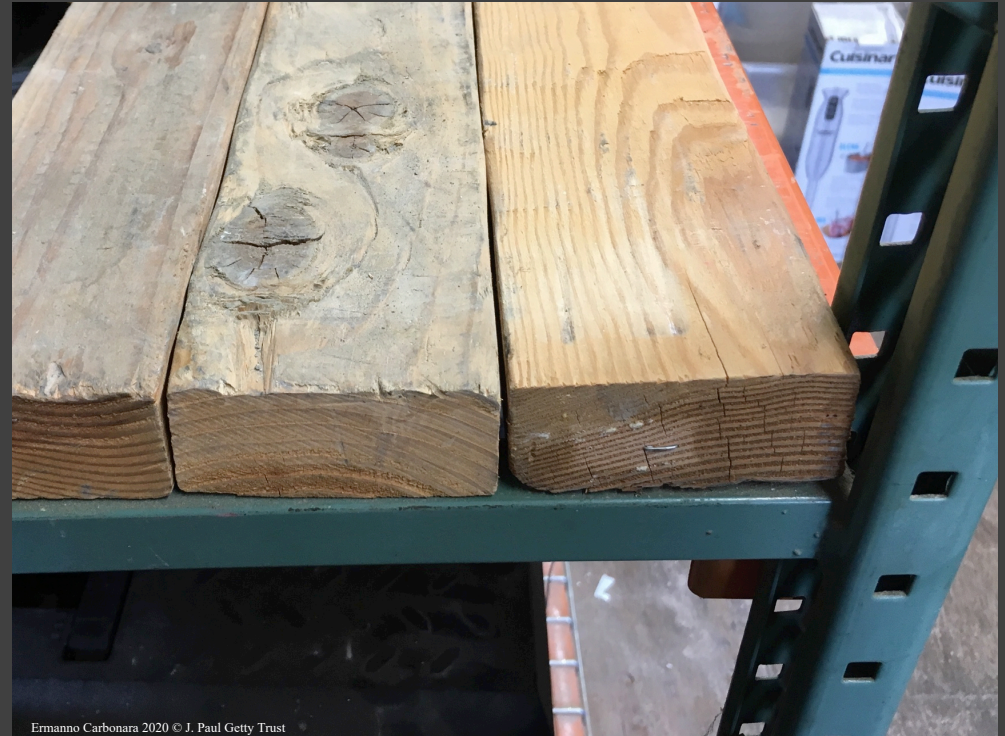
Wooden planks

- Readily available
- Good weight-bearing capacity

- Expensive
- Easily deformed in the medium term
- Low stability to humidity
- Maintenance needs

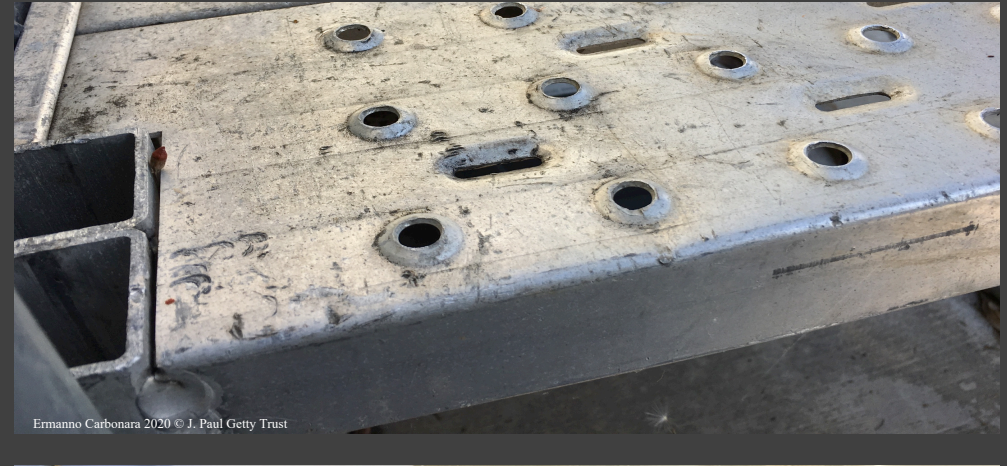
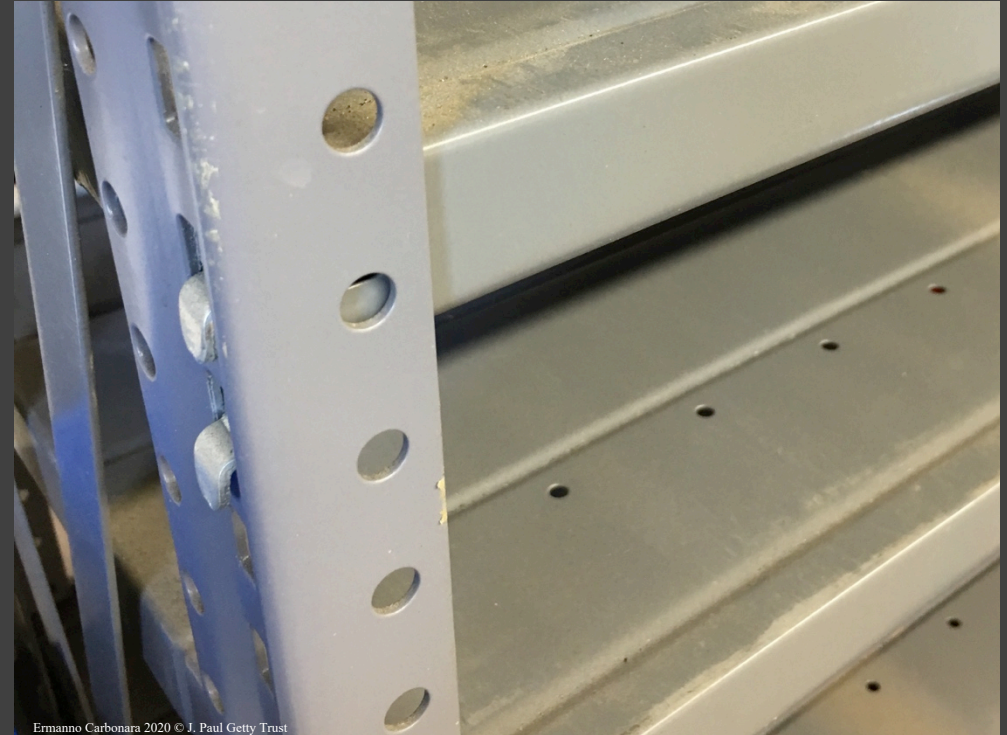
Painted or galvanized iron

- Good stability
- Not easily deformed
- Very good weight-bearing capacity
- Low maintenance needs

- Expensive
- Not readily available

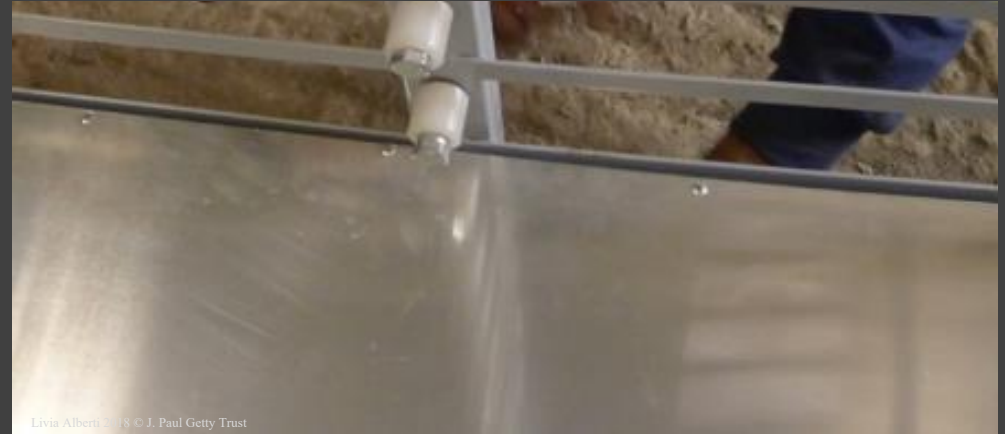
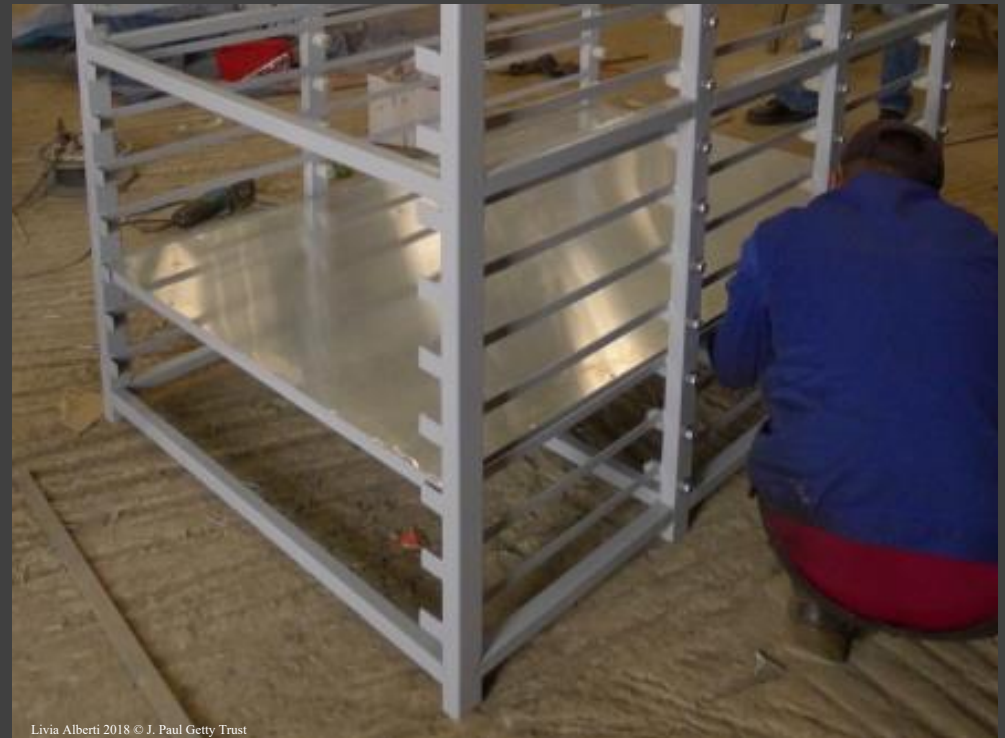
Aluminum

- Stable
- Not easily deformed
- Very good weight-bearing capacity
- No maintenance needs

- Expensive
- Not readily available

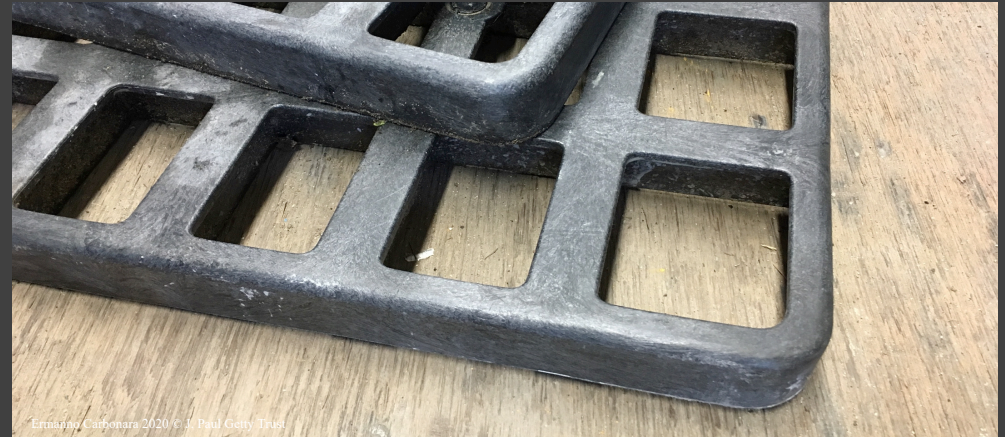
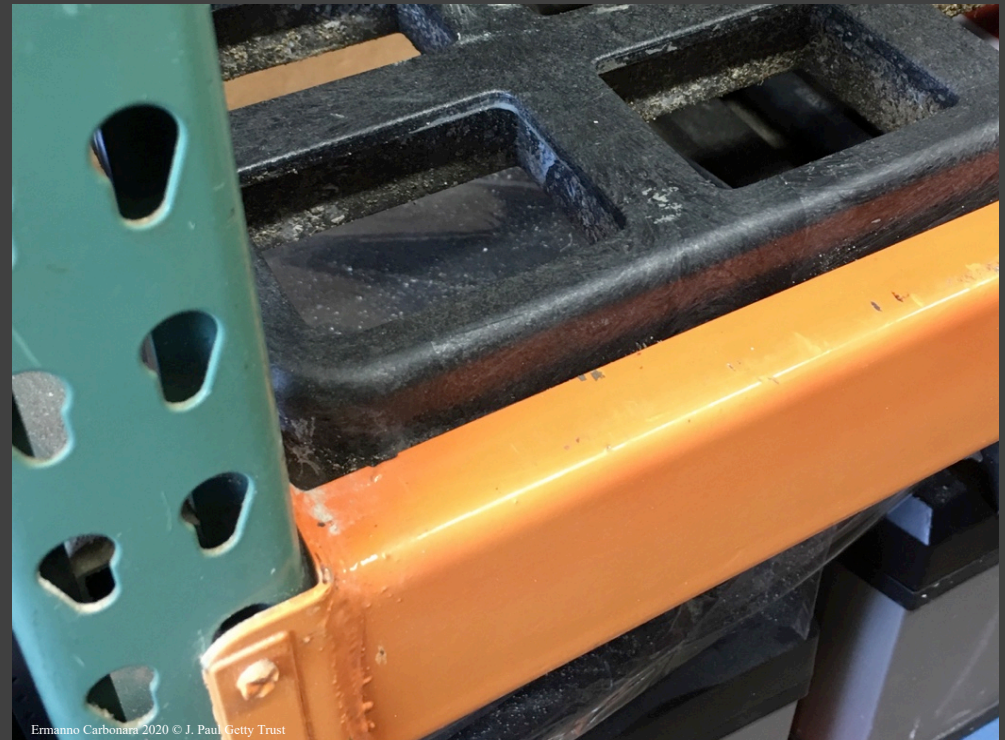
Polyethylene

- Stable
- Not easily deformed
- Good weight-bearing capacity
- No maintenance needs

- Expensive
- Not readily available

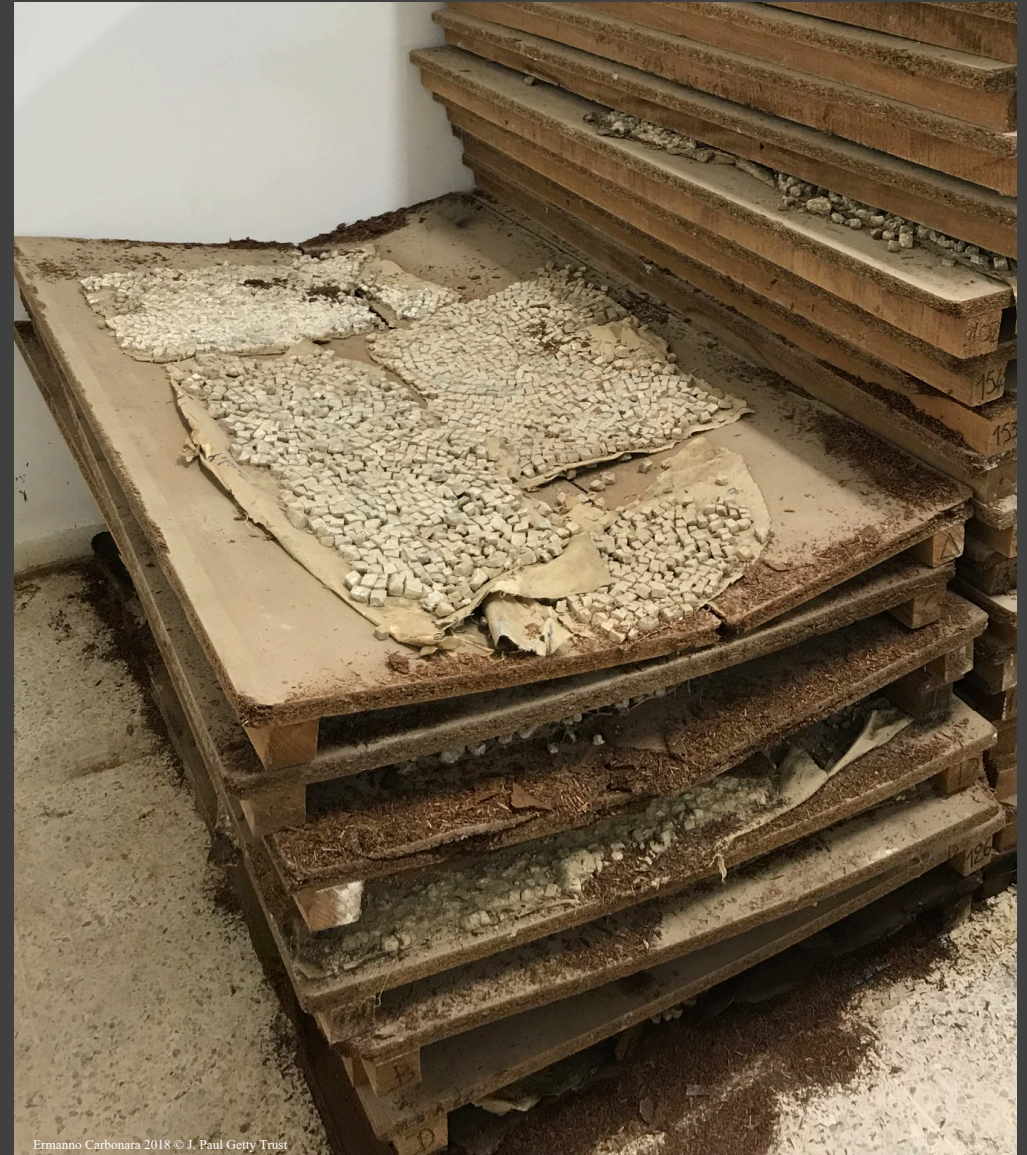
- Deformation of sections
- Detachment of tesserae
- Growth of micro-organisms
- Tearing of the fabric/paper
- Disintegration of the fabric/paper

- Inappropriate support materials for sections/fragments
- Inappropriate storage structure
- High humidity
