TECHNICIAN TRAINING FOR THE CONSERVATION OF MOSAICS

PART 2
THE CONSERVATION OF DETACHED MOSAICS

The conservation of mosaics kept in storage

Livia Alberti, Ermanno Carbonara, Thomas Roby

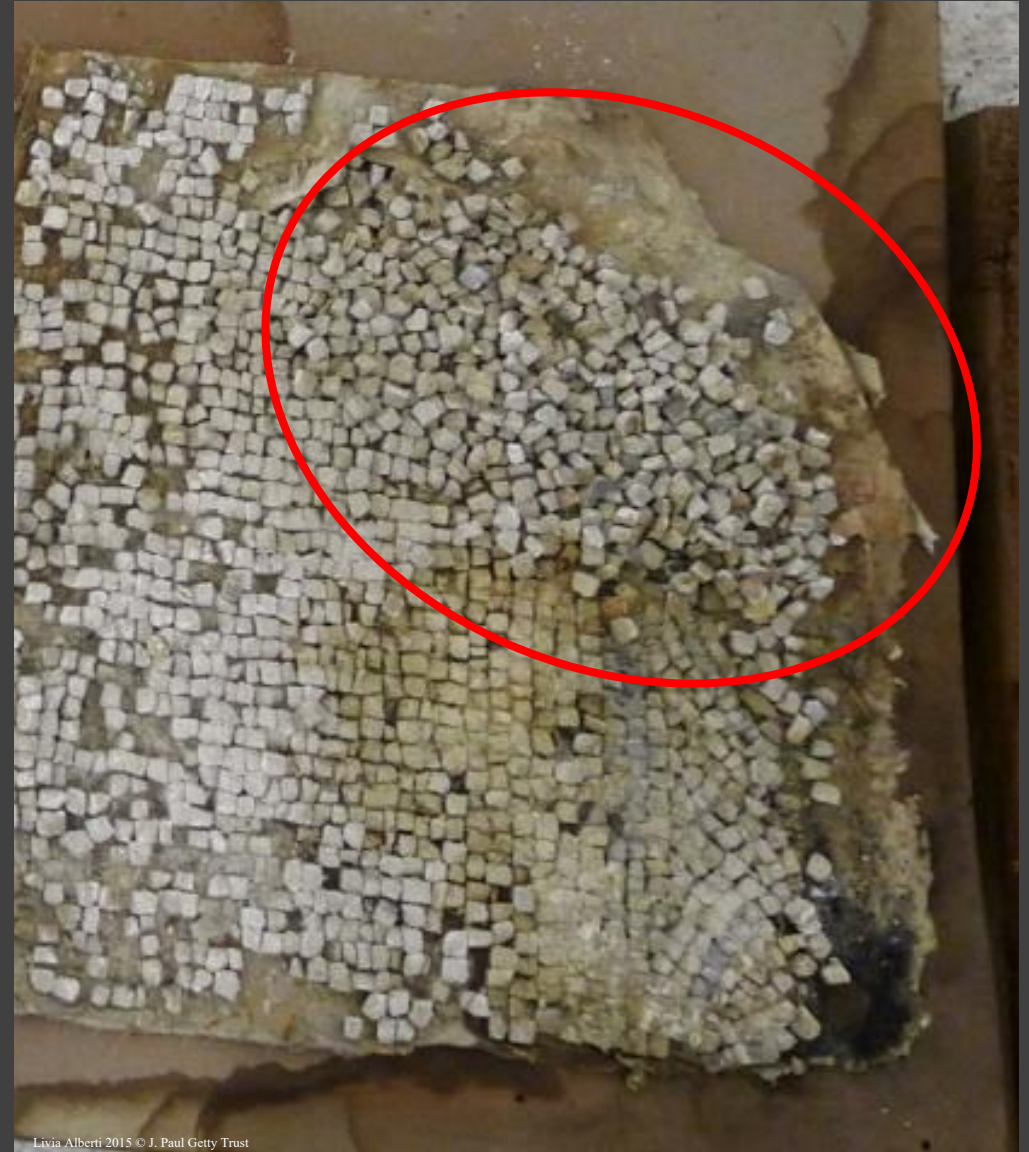
- Deformation of sections
- **Detachment of tesserae**
- Growth of micro-organisms
- Tearing of the fabric/paper
- Disintegration of the fabric/paper

- High humidity
- Presence of light (ultraviolet)
- Variations in temperature and humidity

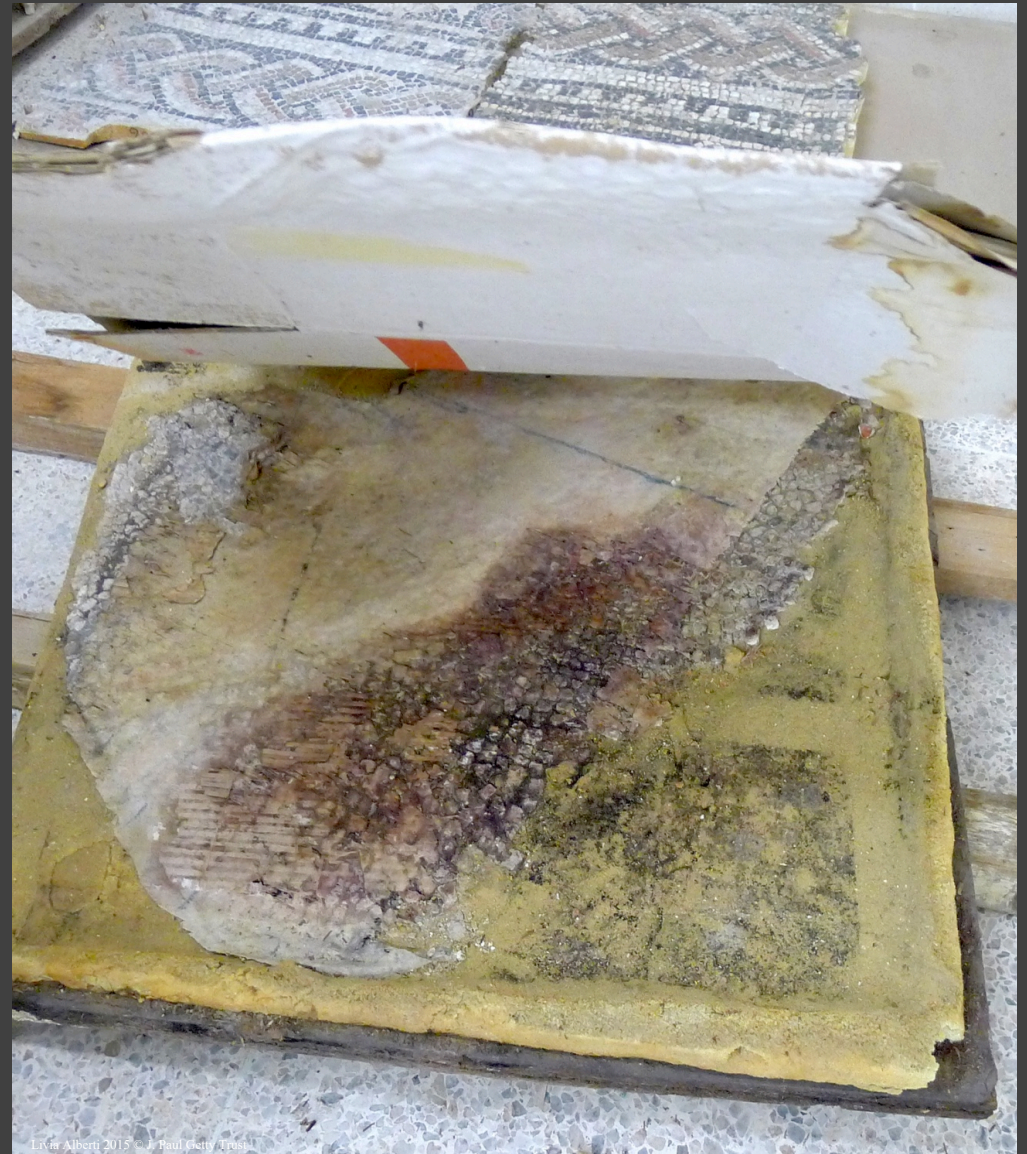
- Deformation of sections
- Detachment of tesserae
- **Growth of micro-organisms**
- Tearing of the fabric/paper
- Disintegration of the fabric/paper

- High humidity
- Presence of light (ultraviolet)

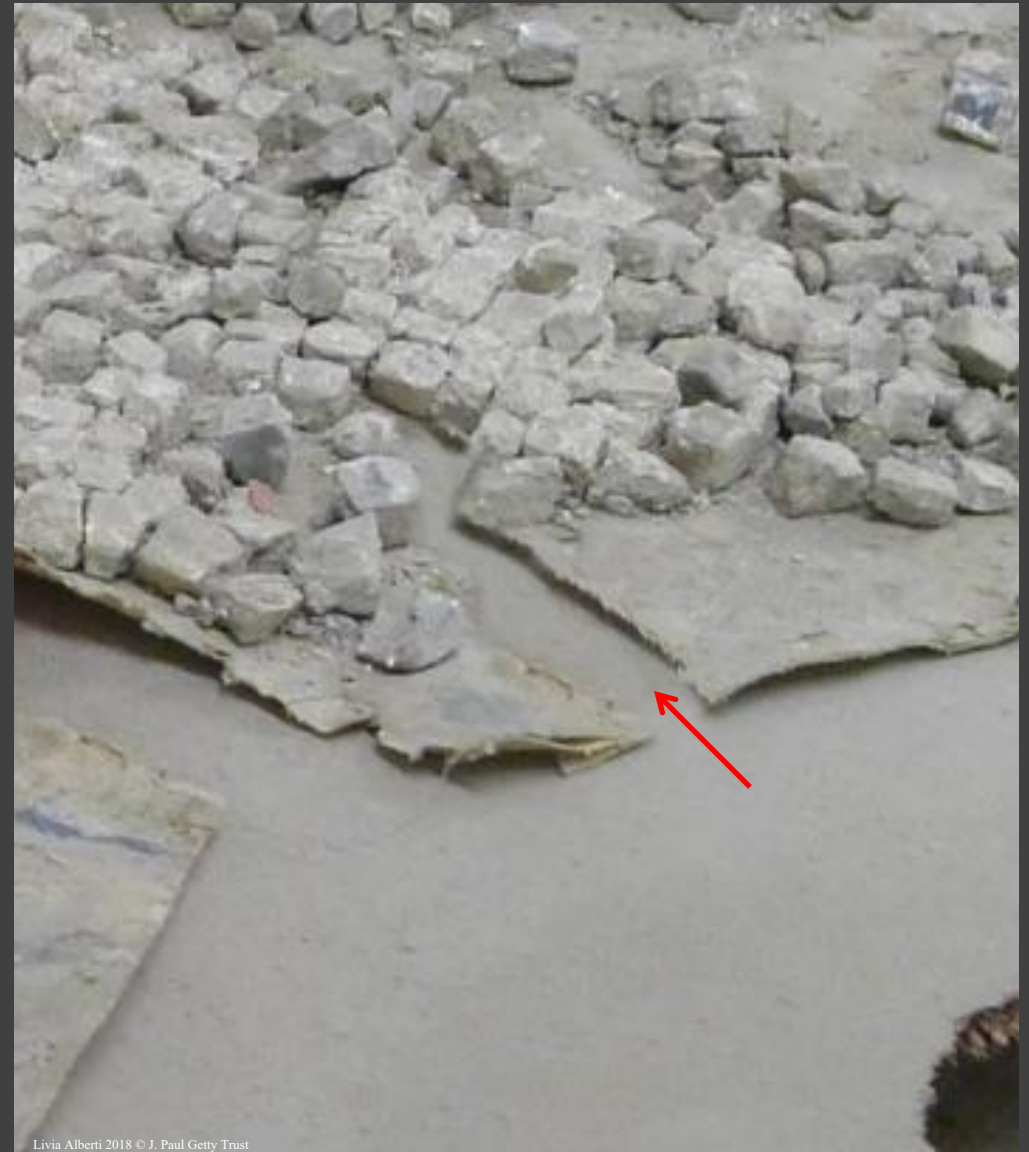
- Deformation of sections
- Detachment of tesserae
- Growth of micro-organisms
- Tearing of the fabric/paper
- Disintegration of the fabric/paper

- Inadequate removal procedure and materials
- Incorrect manipulation of sections during storage

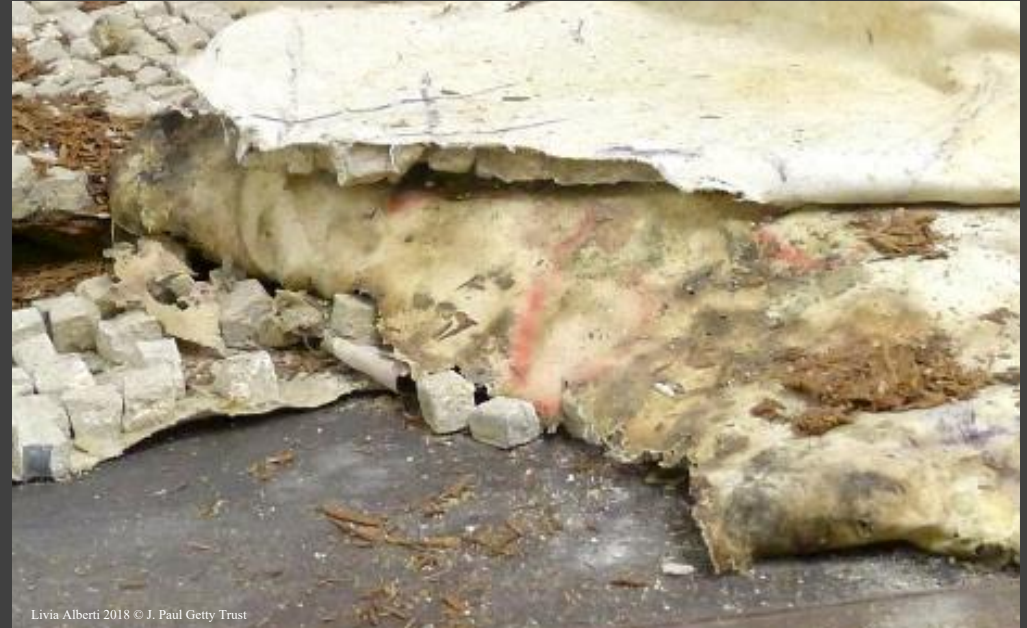
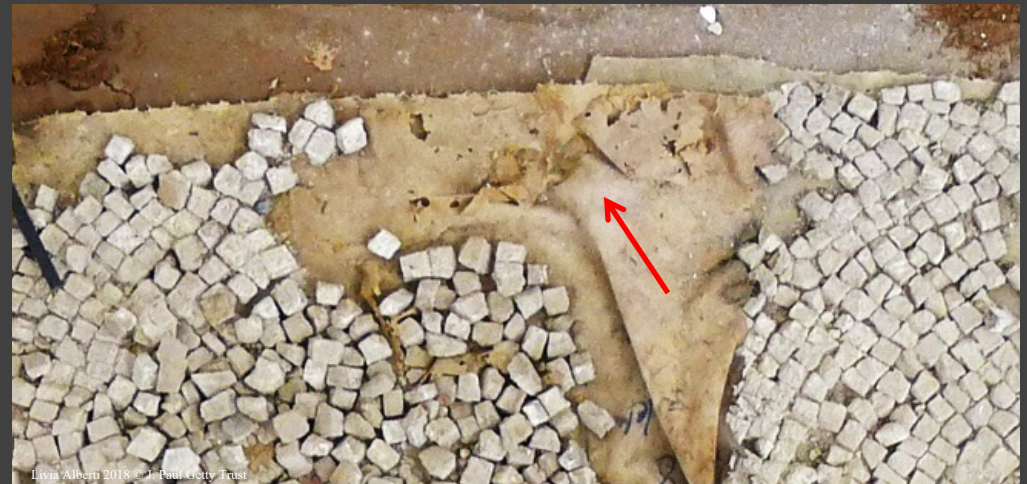
- Deformation of sections
- Detachment of tesserae
- Growth of micro-organisms
- Tearing of the fabric/paper
- Disintegration of the fabric/paper

- High humidity
- Presence of light (ultraviolet)
- Variations in temperature and humidity
- Inadequate removal materials and procedure
- Presence of animals in the repository

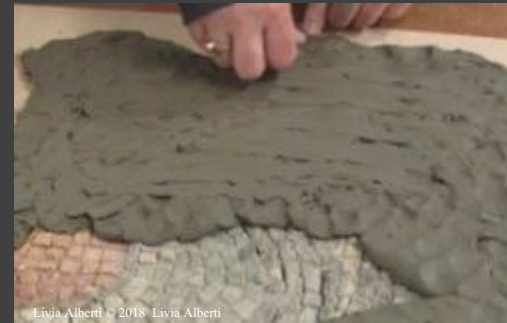
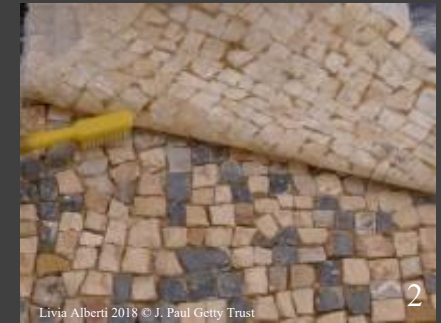
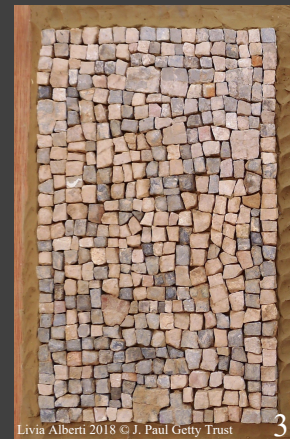
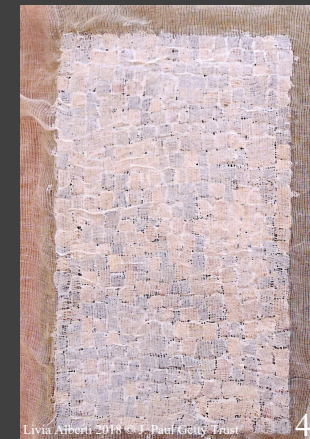
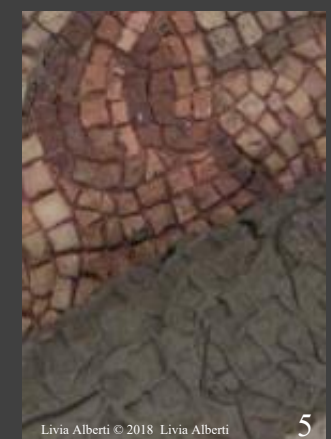
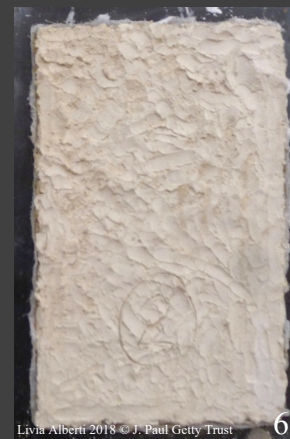
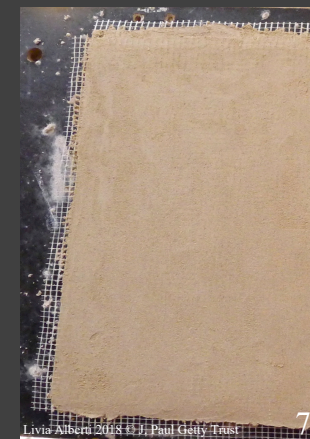
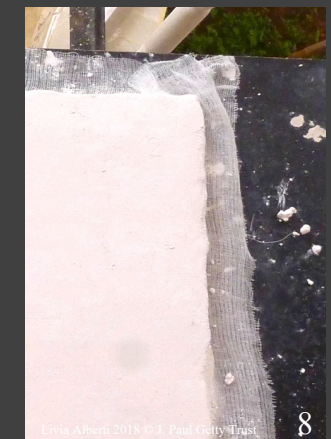
3. Creation of a new temporary support

- Apply a layer of clay to the back of the sections/fragments and invert them (Photo 1).
- Dissolve the facing adhesive with an appropriate solvent, depending on the type of adhesive used and remove the facing fabric, verifying that the tesserae do not detach from the clay bedding layer (Photo 2, 3).

- Apply a new facing fabric layer (one or more) to the surface of the mosaic using an appropriate adhesive (Photo 4).
- Invert the mosaic sections/fragments and remove the clay layer (Photo 5).

- Apply an initial layer of a weak lime-based mortar to the back of the tesserae (Photo 6).
- Apply a second layer of mortar reinforced with natural fibers (hemp, cotton, horse hair) or synthetic fibers (polyester, carbon) (Photo 7).

- Apply a layer of wide weave natural fabric (cotton gauze or fabric) or synthetic fabric (polyester) with an adhesive (acrylic or vinyl) with aggregates, if necessary (Photo 8).
