病害状况与成因

Condition and Causes of Deterioration

病害调查与诊断

Investigation and Diagnosis

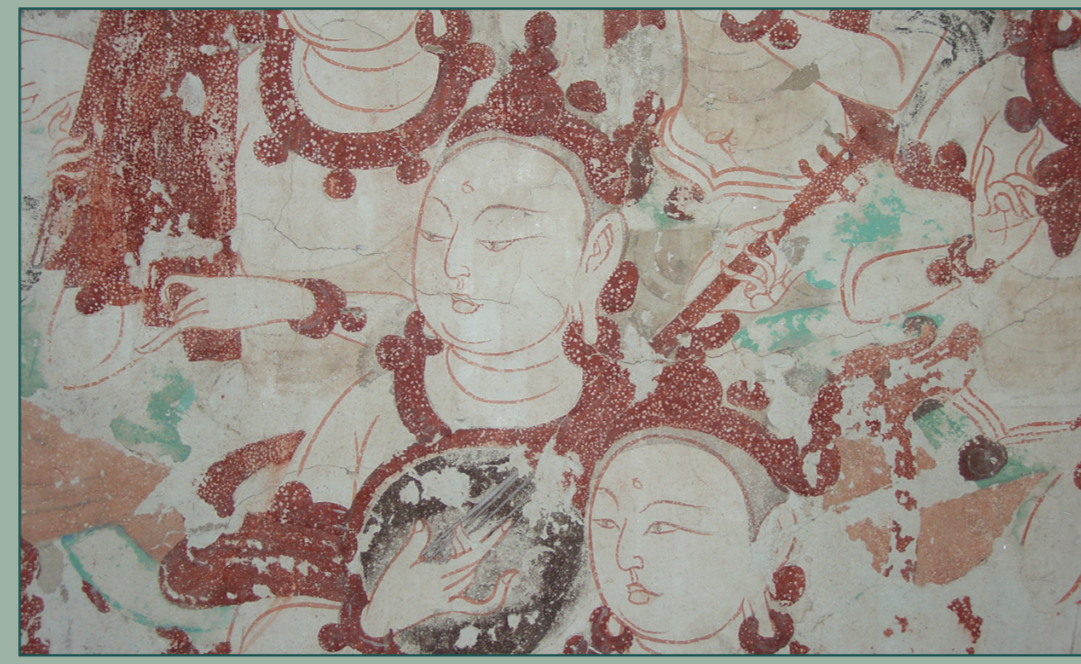
85窟后部区域盐害造成颜料层的点状脱落。
Salt deterioration is the cause of the small point-like losses in the paint layer in areas toward the back of the cave.

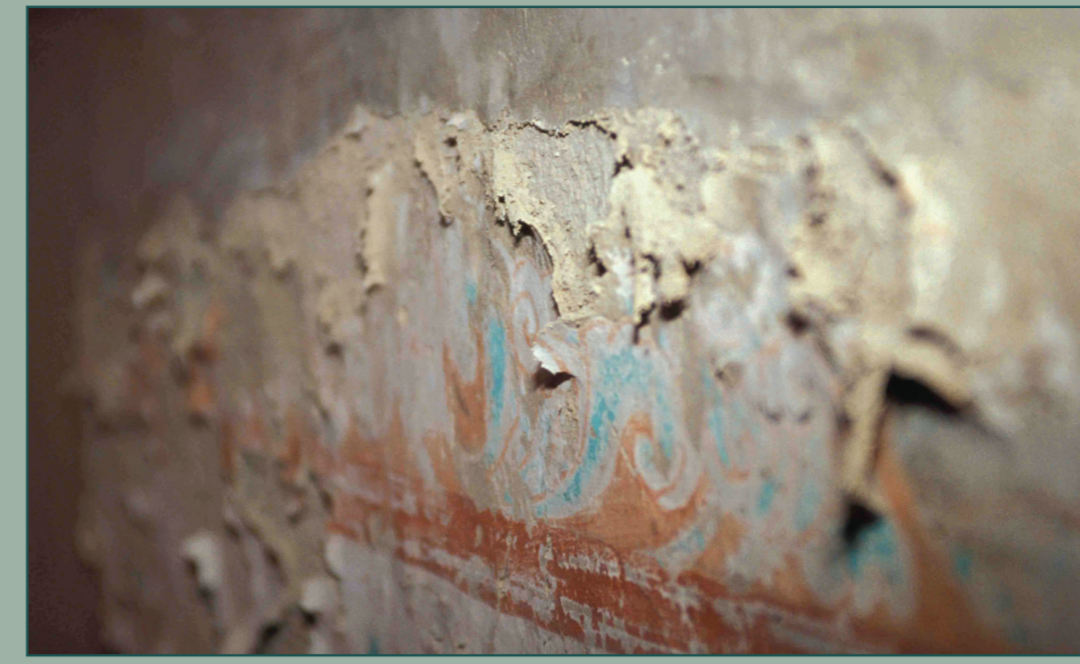
颜料层起甲与酥碱起甲。
Flaking and exfoliation of the paint layer.

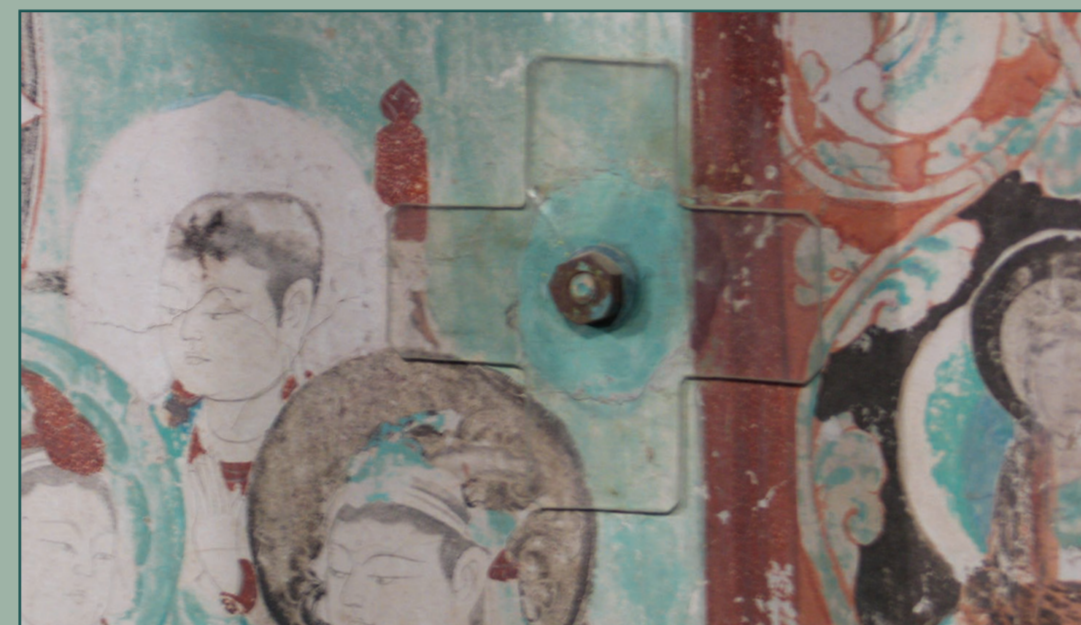
20世纪70年代，为防止壁画脱落进行了壁画锚固。上图显示仍然保留在主室北壁的锚固与垫板。
Anchors and bolts were inserted into the walls in the 1970's to secure areas of detachment. The anchor shown above was left in place on the north wall of the main chamber.

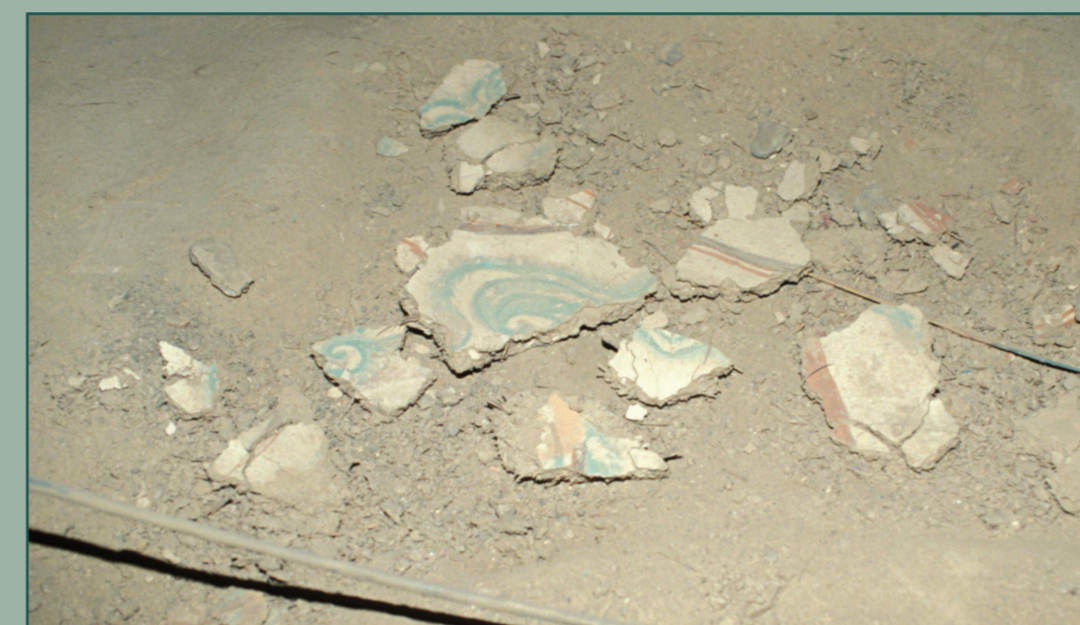
锚固只是用来对付壁画仍然继续脱落的一个权宜之计。1996年的残片脱落是在一段时间的高湿度之后发生的。
The anchors were only a temporary solution as areas of painted plaster continued to be lost. These fragments fell in 1996 after a period of high humidity.

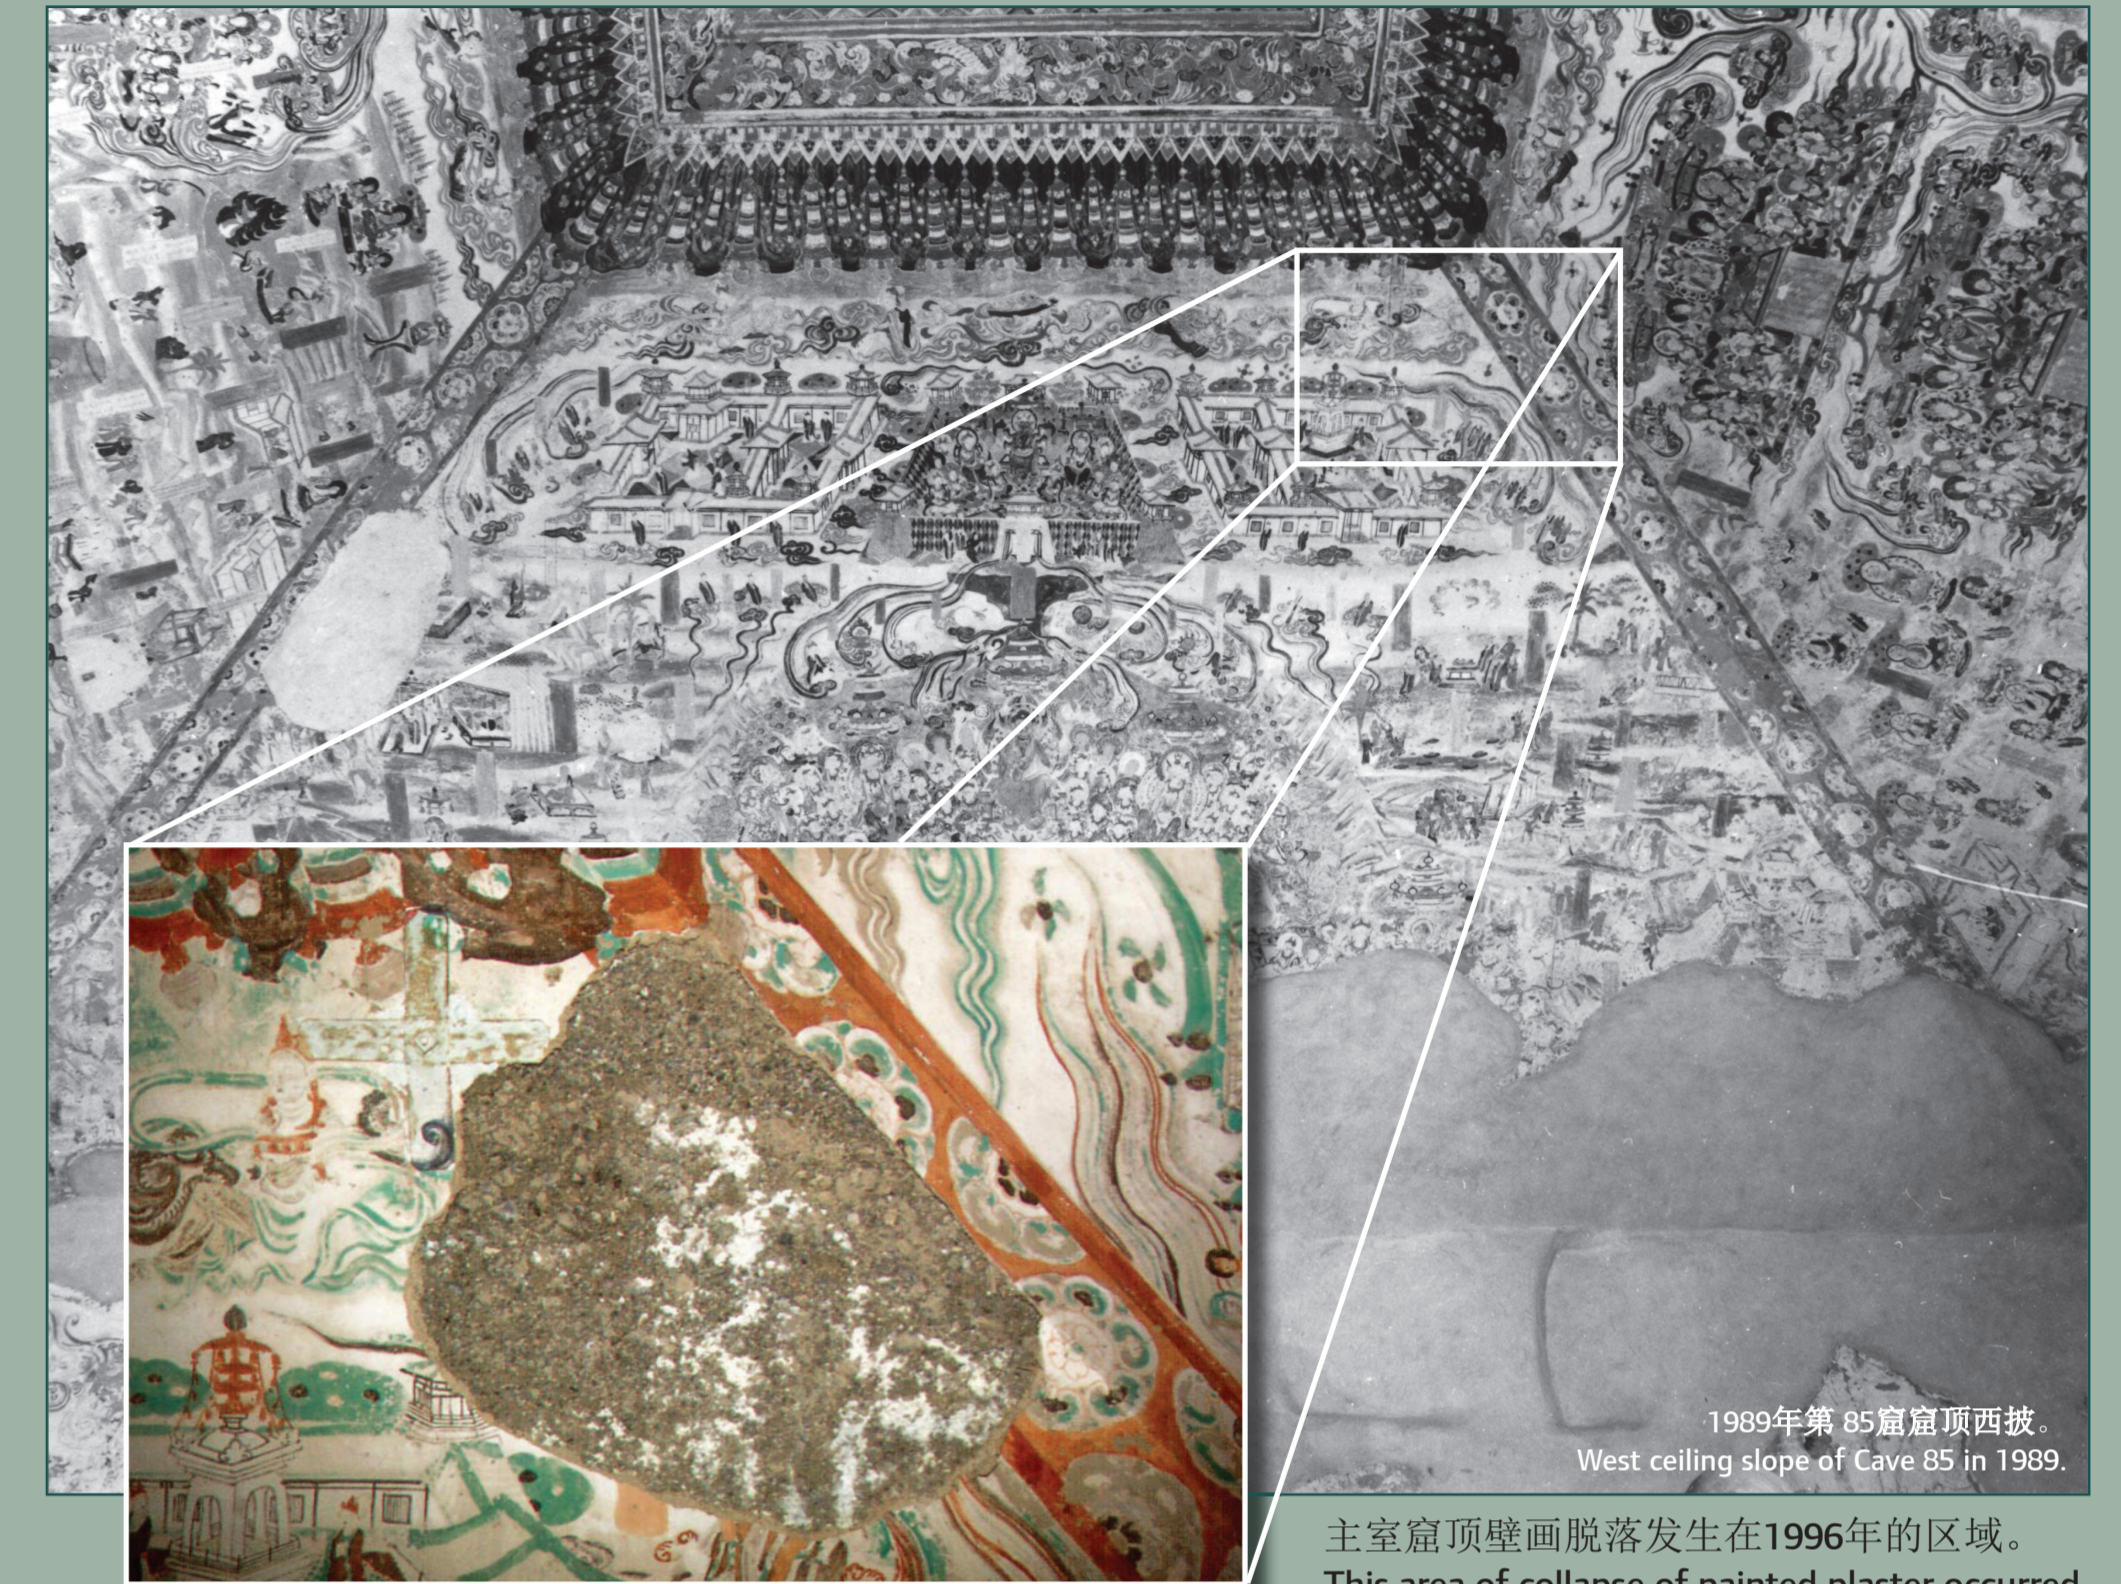
1989年第85窟窟顶西披。
West ceiling slope of Cave 85 in 1989.
主室窟顶壁画脱落发生在1996年的区域。
This area of collapse of painted plaster occurred on the ceiling of the main chamber in 1996.

壁画病害包括盐害、起甲、地仗层与砂砾岩层之间失去粘结力后造成的空鼓脱落等。后者为最严重的病害。在85窟发现大量的壁画空鼓有脱落的危险。最近一次壁画脱落发生在1996年，有一大片壁画从主室西披脱落。

The paintings suffered from salt deterioration, flaking, and loss of adhesion between the conglomerate rock and the earthen plaster. The latter problem was the most serious, as substantial areas of the painted plaster were found to be detached and susceptible to collapse. Most recently, a large piece of painted plaster fell from the west slope in 1996.

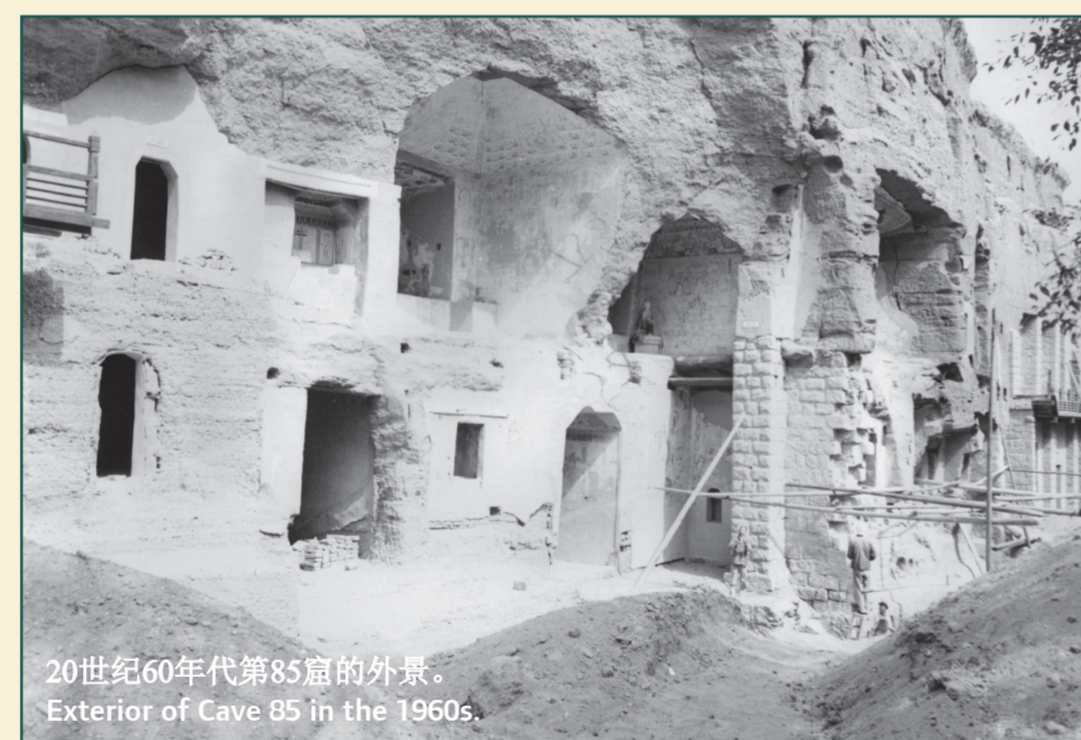
20世纪60年代第85窟的外景。
Exterior of Cave 85 in the 1960s.

莫高窟在被废弃后的数百年里，洞窟一直暴露在外，崖面风化、风沙和水的侵蚀是壁画和塑像产生病害的主要原因。The cave was open to the exterior for many centuries after the abandonment of the site. Erosion of the cliff face, windblown sand and water were responsible for much of the deterioration of the cave wall paintings and sculpture.

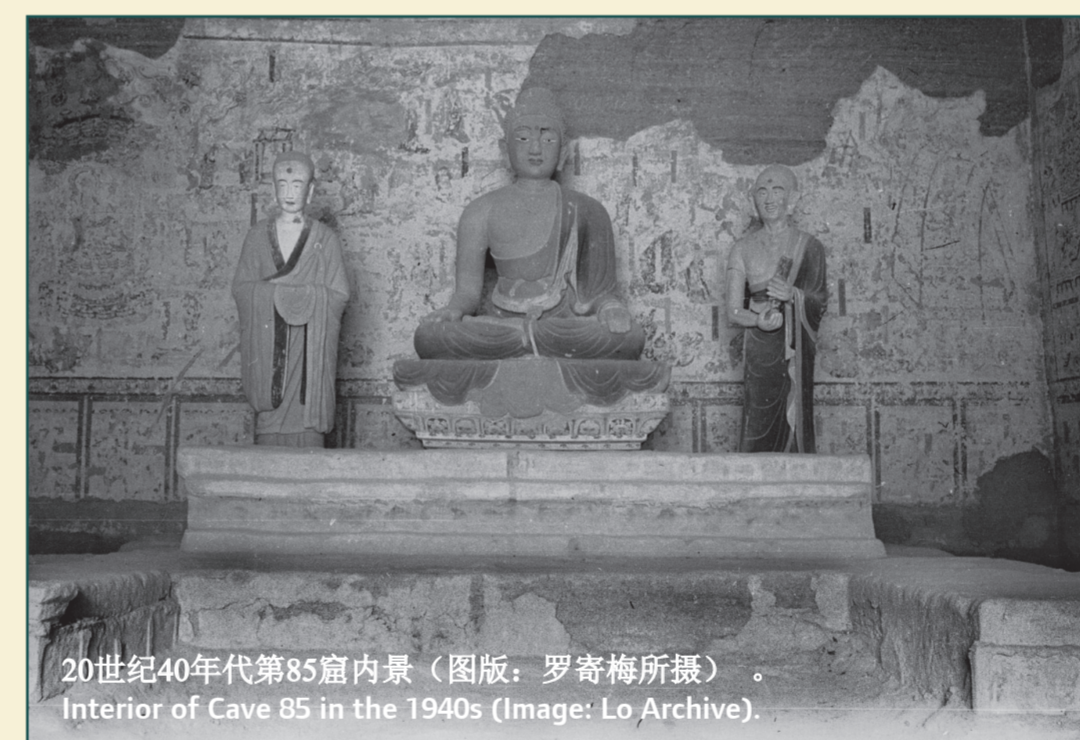
20世纪40年代第85窟内景（图版：罗寄梅所摄）。
Interior of Cave 85 in the 1940s (Image: Luo Jimei Archive).

壁画大量脱落是由于四壁下部遭到湿气侵入及上层地仗层的坍塌。The paintings have suffered large losses at the base of all walls from moisture ingress and collapse of upper areas of plaster.

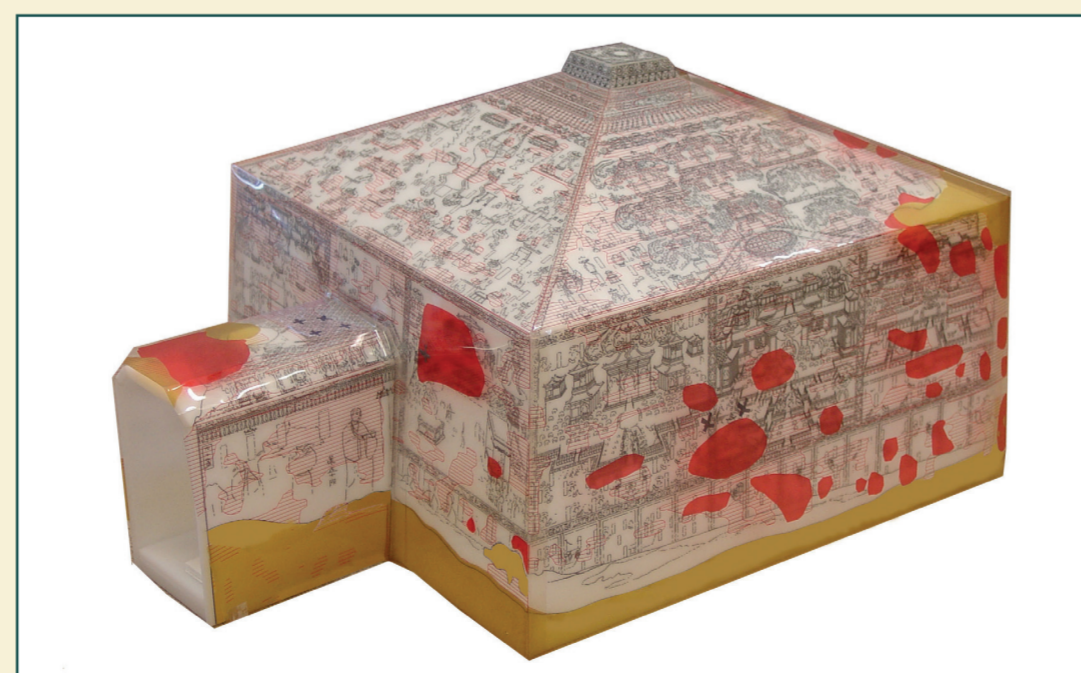
85窟病害分布3维模型显示了85窟的病害模式。壁画脱落区域（黄色）集中于四壁下部和后部，窟顶角落；壁画空鼓区域（红色）在整个窟都有发现，但主要集中于石窟后部。
A 3D cave model shows patterns of deterioration found throughout the cave. Areas of loss of painted plaster (yellow) were concentrated at the base of walls and toward the rear, upper corners of the cave; areas of detachment (red) were found throughout but were also concentrated toward the back of the cave.

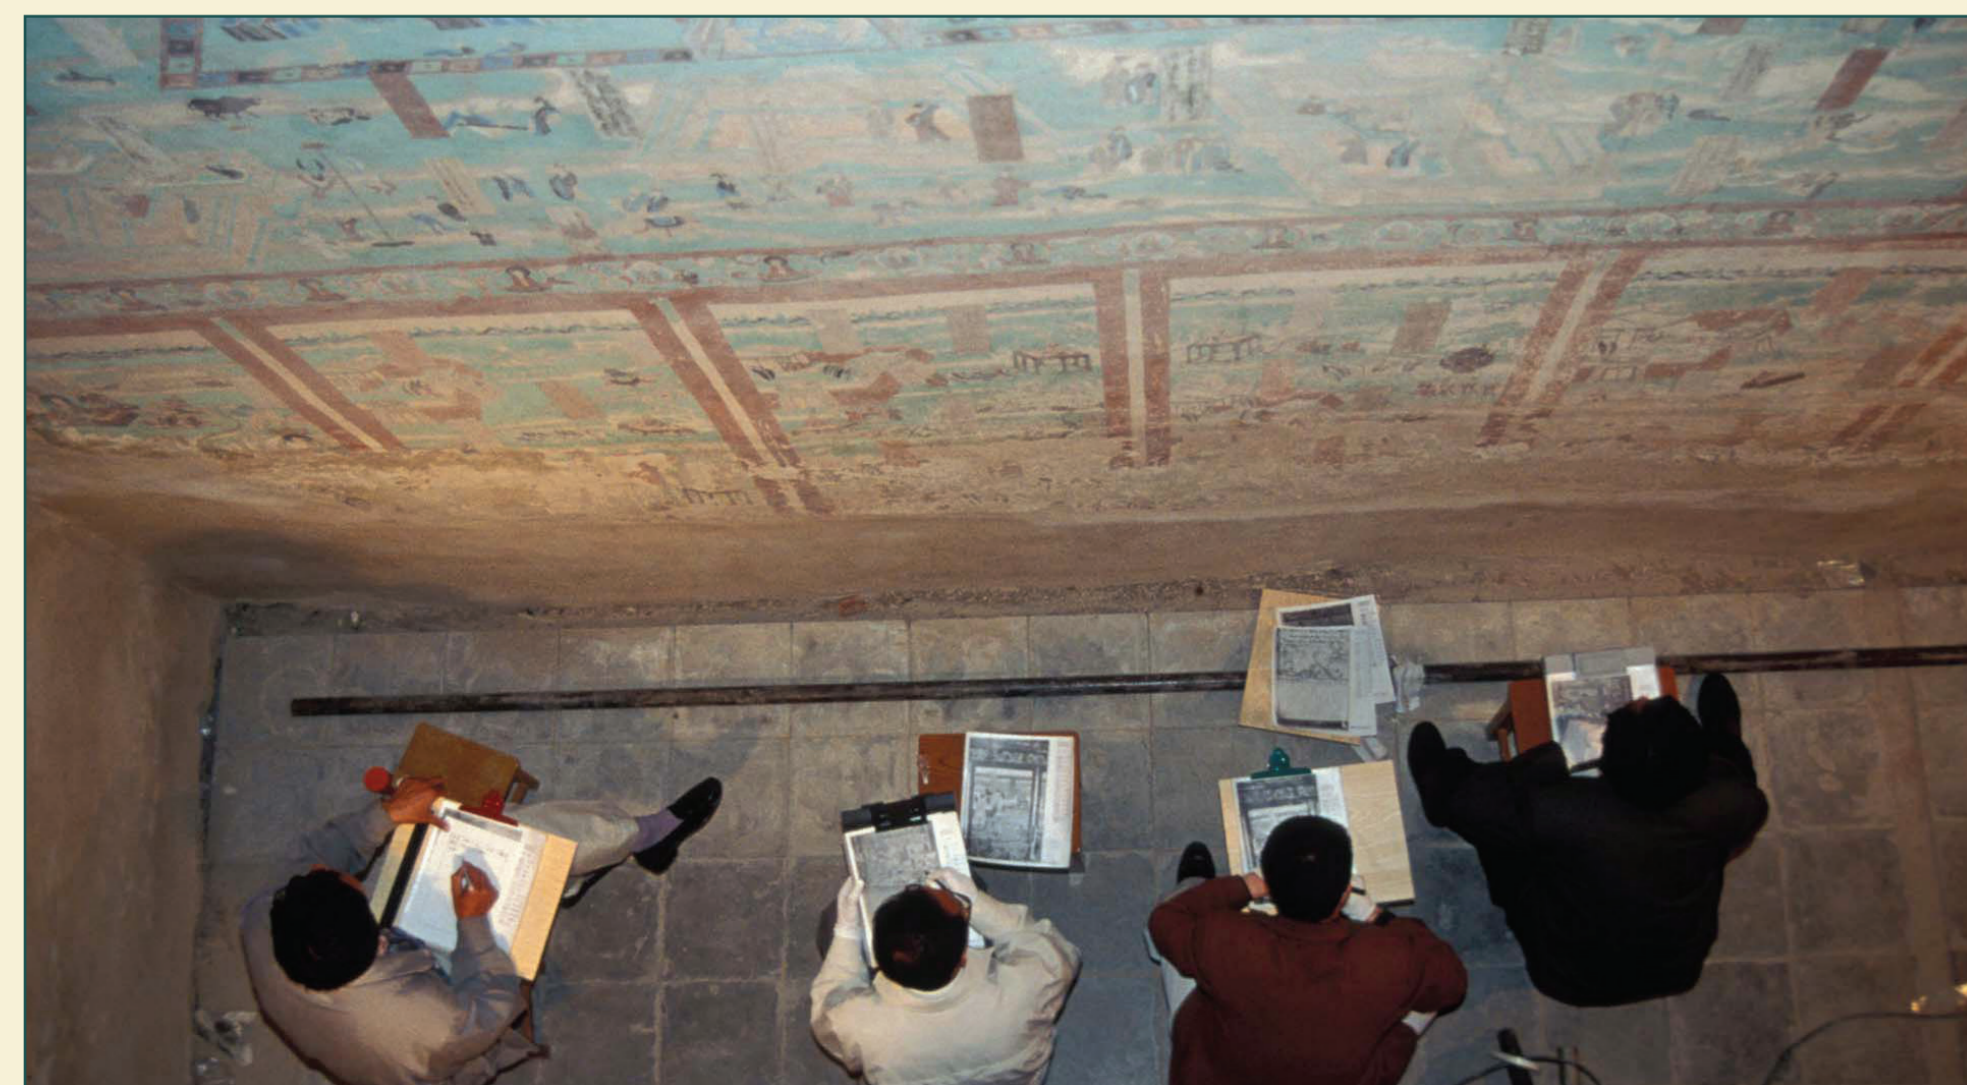
项目开始时进行的状况调查记录。
Condition recording was undertaken at the start of the project.

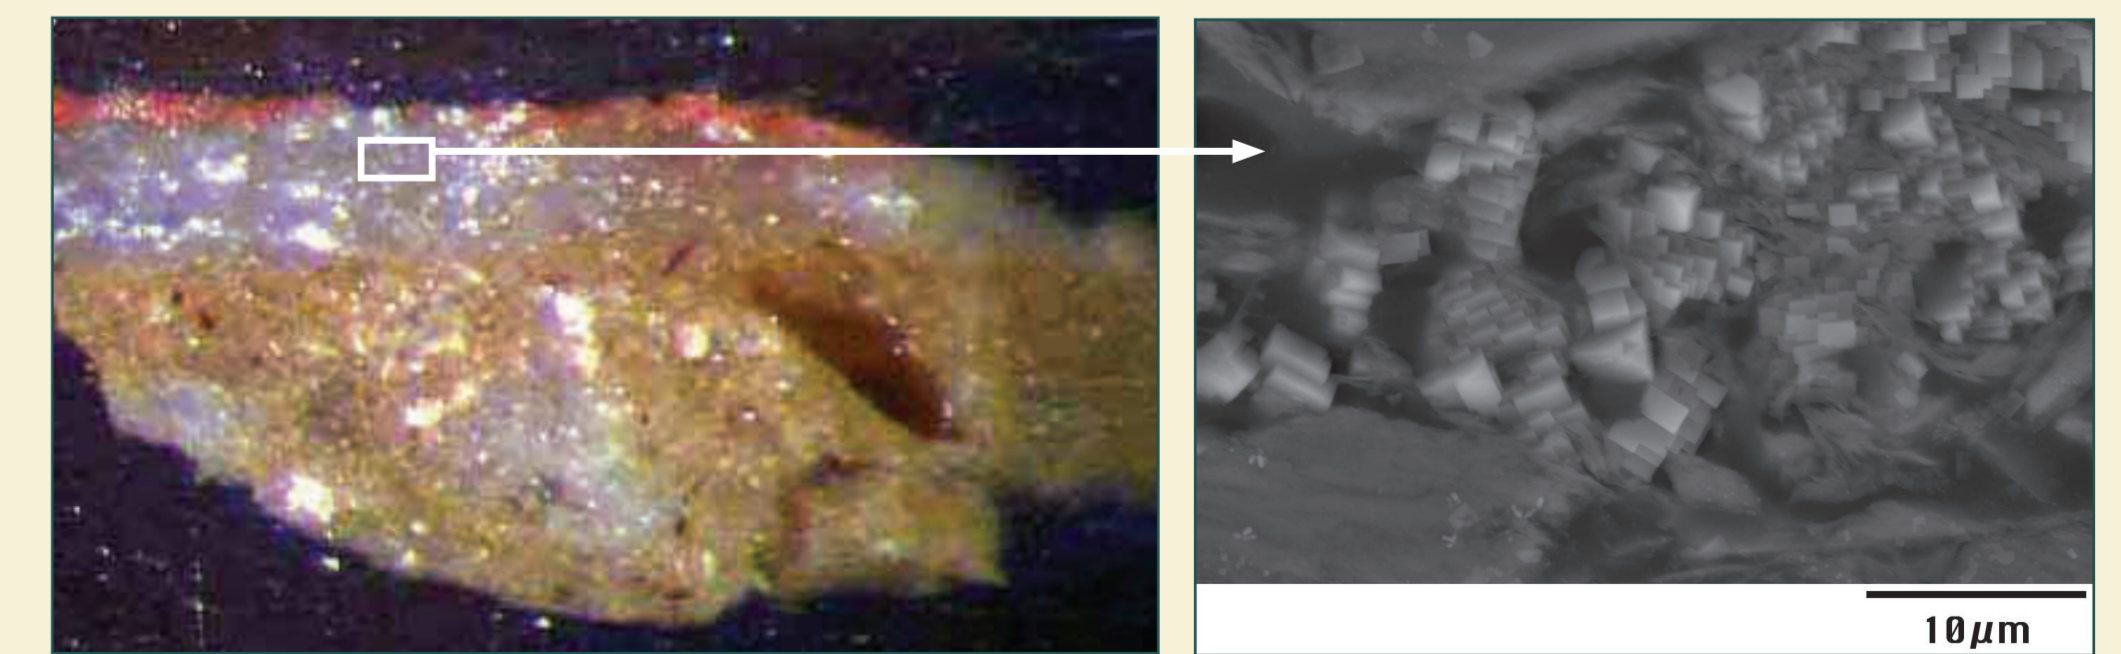
壁画层的剖面图（左上）和高倍放大的氯化钠（普通食盐）的晶体推挤颜料层（右上）。盐是大部分病害的主要原因，诸如造成颜料层脱落、地仗层酥碱以及壁画空鼓等。
A cross-section of painted plaster (above, left) and a highly magnified image of NaCl (ordinary table salt) crystals pushing through the paint layer (above, right). Salt is responsible for much of the deterioration such as loss of the paint layer, disruption of the plaster, as well as contributing to detachment of the painted plaster.

过去洞窟内病害的原因有立即性的与逐渐性的：湿气侵入四壁下部导致原来材料发生物理化学性变化以及盐份的活动导致病害发生。我们可以减低大部分的病害原因，但是无法移除壁画中的所有盐份。因此，了解盐害发生的过程，制订预防性与保护性的措施，是降低病害发展速度的基本手段。

Past causes of deterioration in the cave have been both immediate and gradual: moisture ingress at the base of walls, physicochemical changes of the original materials, and deterioration caused by salts. We can reduce most of these causes, however, we cannot remove all of the salts present in the painted plaster. Therefore, understanding the processes of salt deterioration was the basis for developing conservation and preventive measures to slow the rate of deterioration.
