A PROJECT OF SEISMIC IMPORTANCE

SRP BUILDING PROTOTYPES

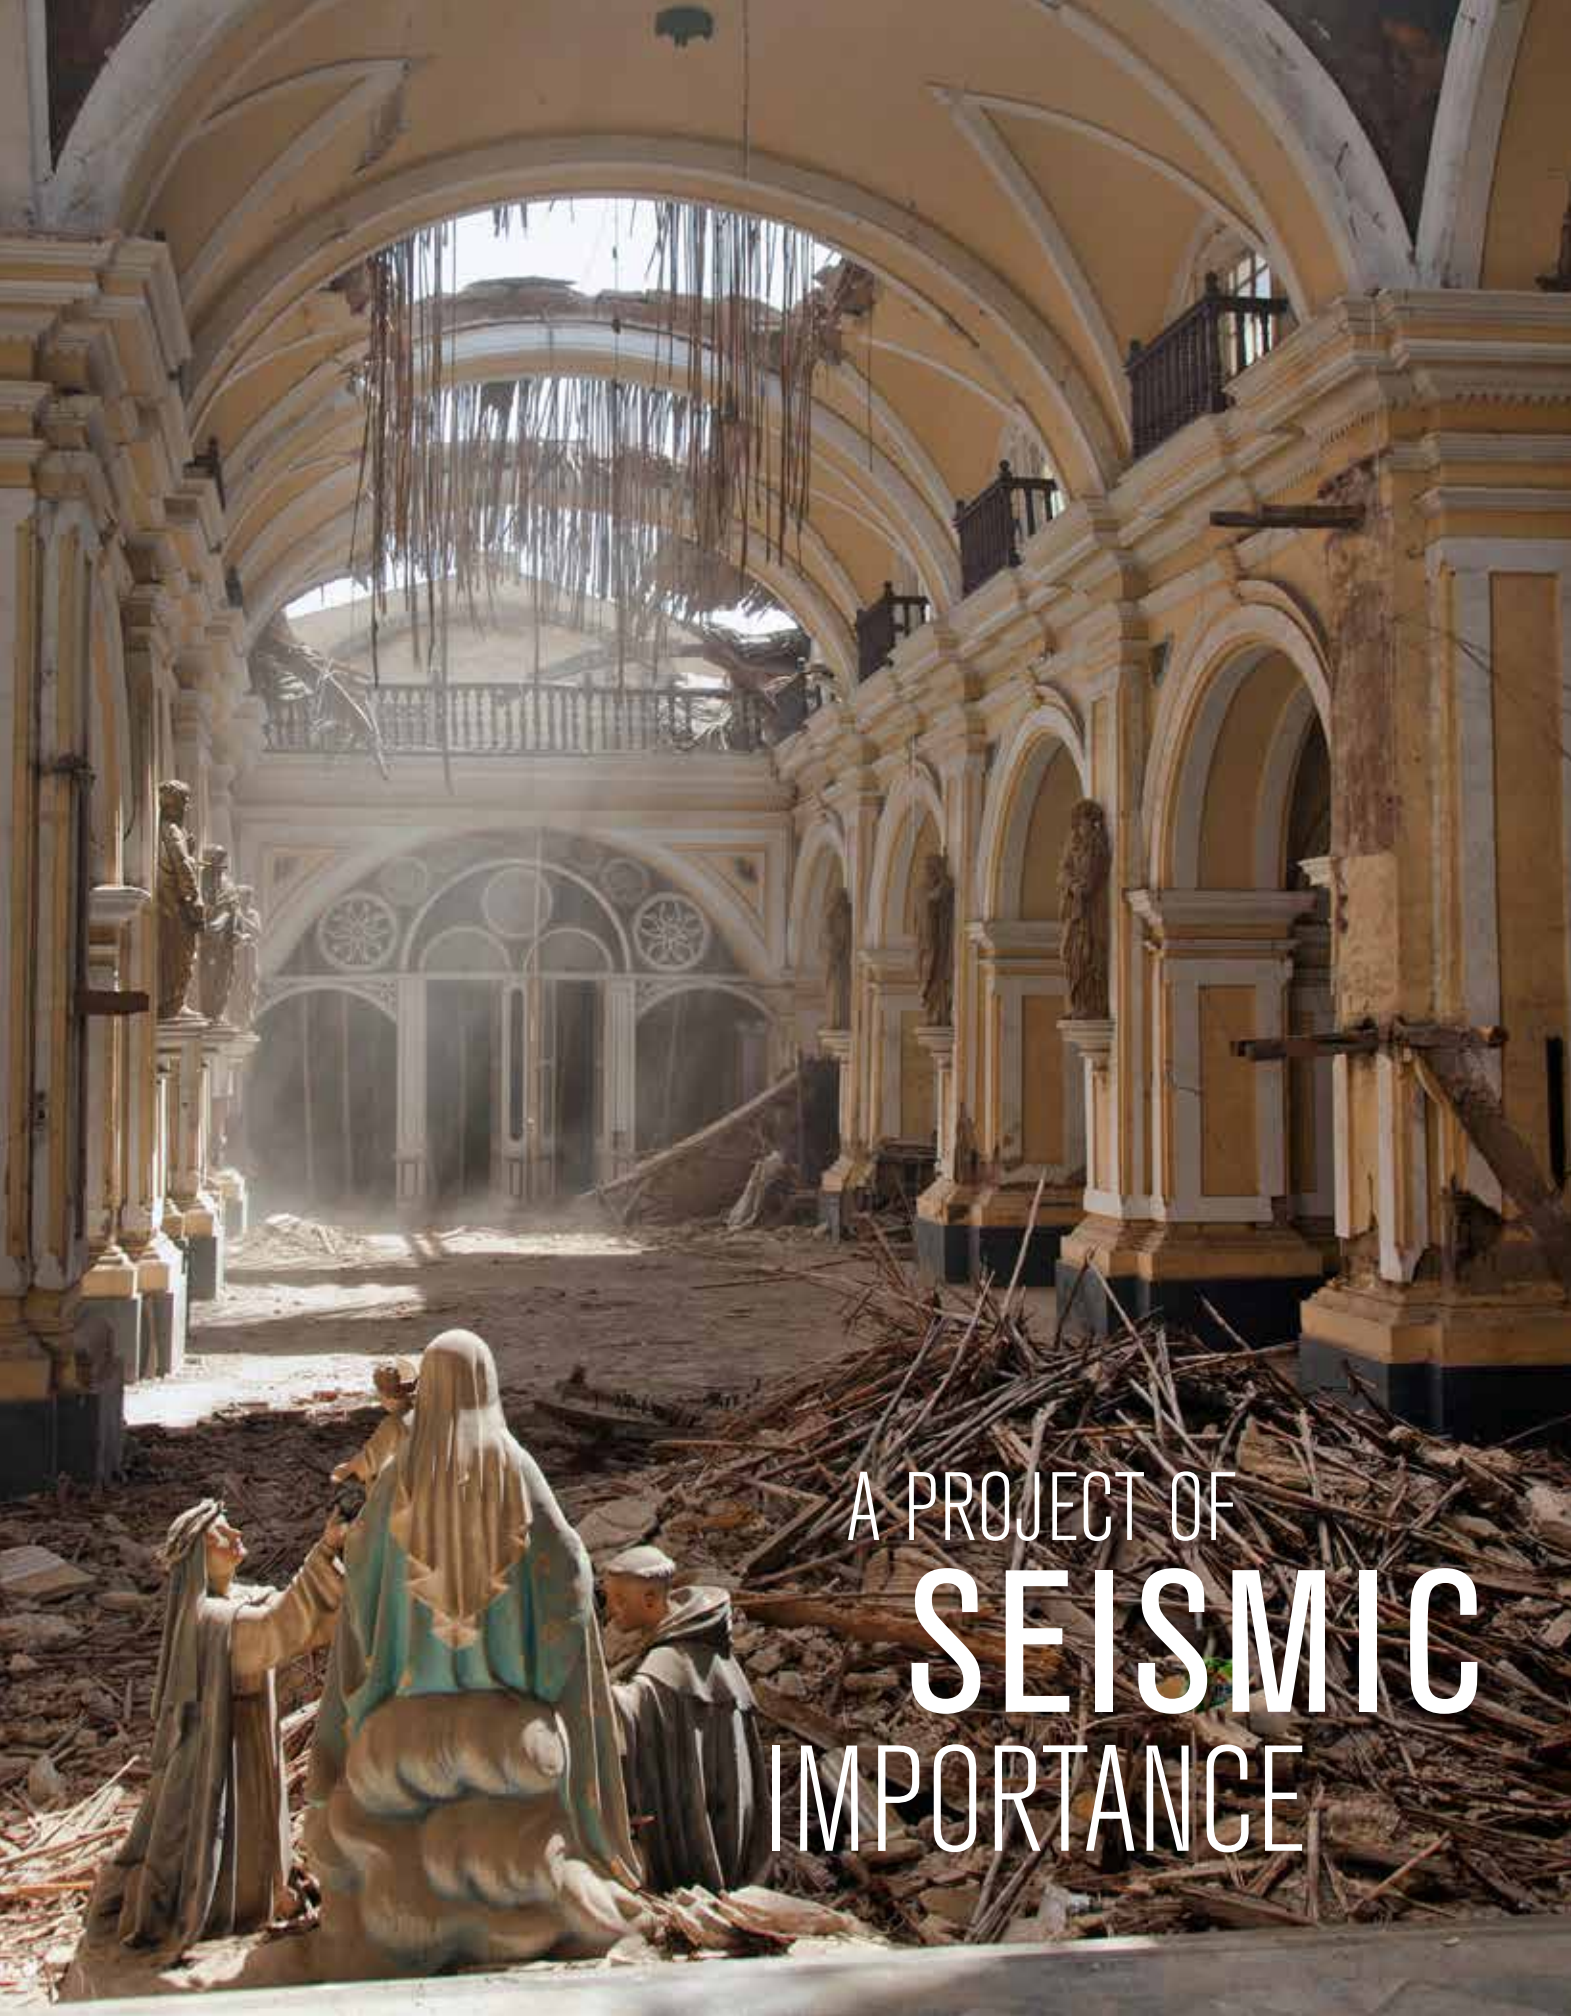
Left: View of the central nave of Ica Cathedral after the 2007 Pisco earthquake. Photo: Scott S. Warren, 2011

Located on the coast of Peru, the Cathedral of Ica was originally built in 1759 by the Society of Jesus and was used as a place of worship until it was damaged in the 2007 Pisco earthquake.

The thick lateral walls are constructed with mud brick masonry over a fired brick base course and stone foundations. The side aisles are separated from the central nave by a series of hollow quincha (wattle and daub) pillars and arches covered with painted plaster. The barrel vault and domes are also constructed with wood arches or ribs and quincha.

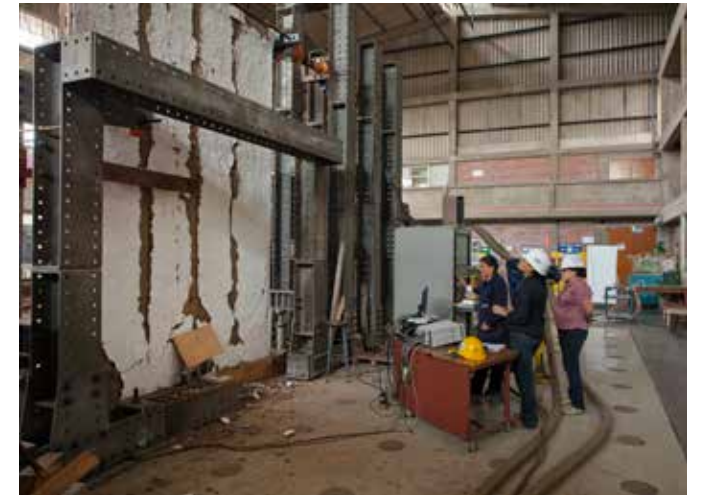
Above: Shear strength tests via lateral displacement of mock up of a quinchá panels, a vernacular building technique, at the Pontificia Universidad Católica del Perú. Photo: Scott S. Warren

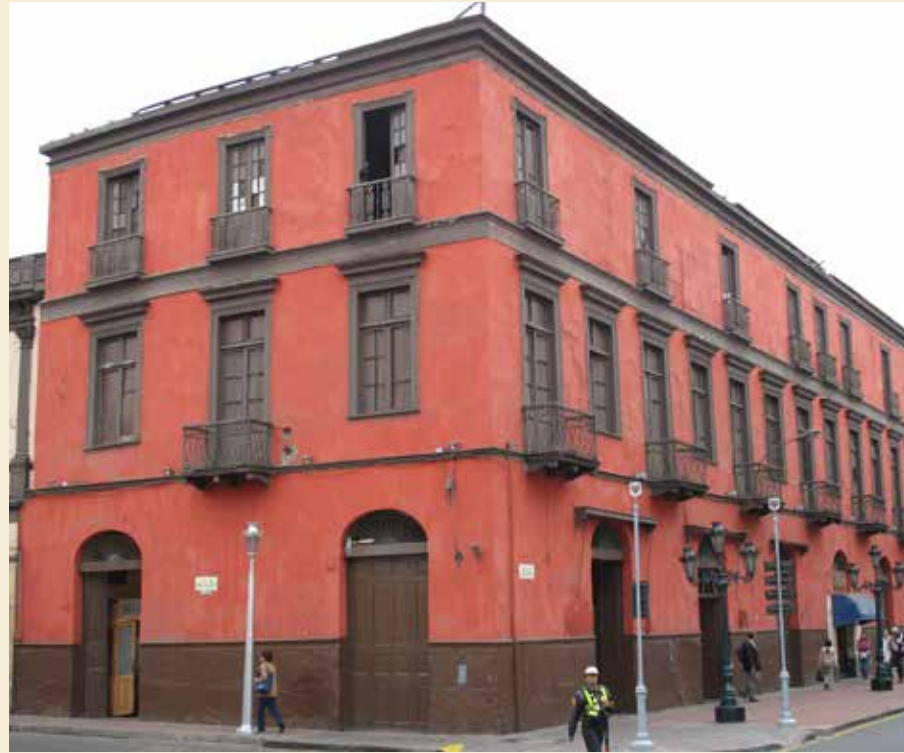
Hotel Comercio:

The Hotel Comercio is located in the historic center of Lima. The site was first developed in the sixteenth century; however, the current structure dates to the middle of the nineteenth century. Hotel Comercio is representative of a typical courtyard or "patio" building, known as a casona. The three-story building consists of 131 rooms arranged around two interior patios.

Hotel Comercio is constructed with rubble stone foundations, a fired brick masonry base course, mud brick masonry walls at the first floor, and quincha panels at the second and third floors.

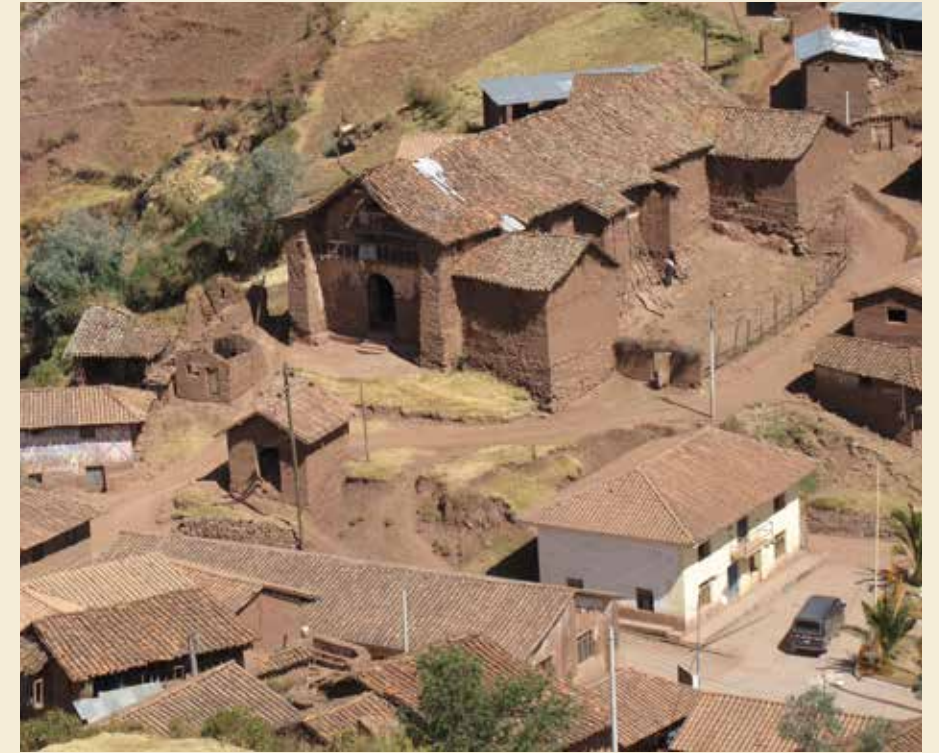
Kuño Tambo Church:

The Church of Santiago Apóstol of Kuño Tambo, located in a remote Andean village, has been in continuous use as a place of worship since its construction in the seventeenth century. Remarkably, it still retains much of its original configuration and materials.

Constructed with thick adobe walls and buttresses over a rubble stone masonry base course and a wood-framed gable roof "par y nudillo," the church exhibits many of the design features and materials typical of churches in small villages established by the Spanish across Latin America. The church, including the beautiful wall paintings that decorate the interior, are being conserved with support of Friends of Heritage Preservation.

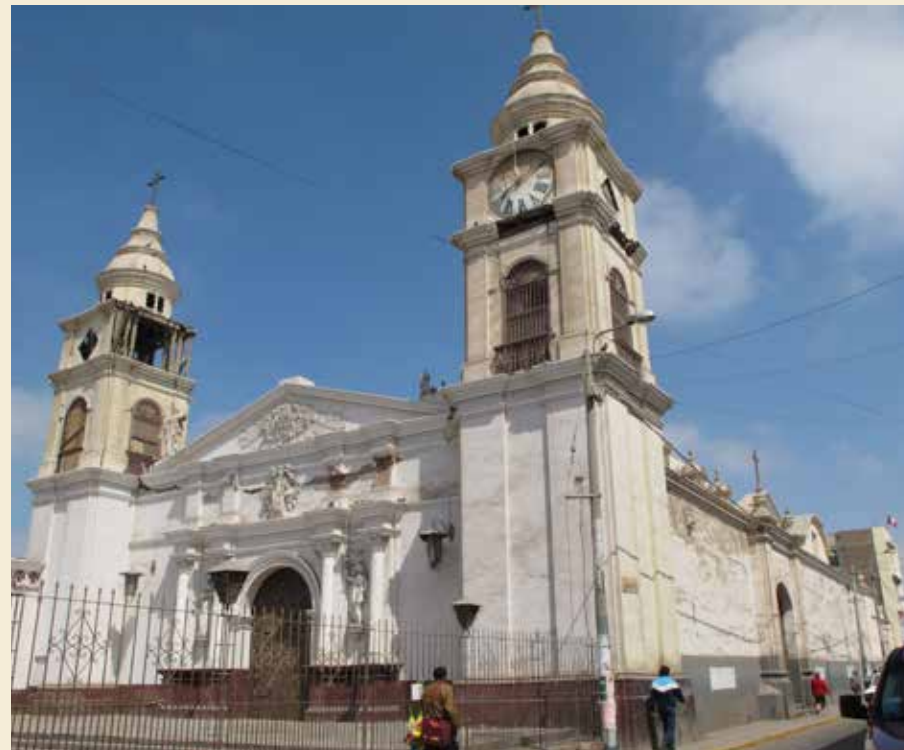
Ica Cathedral:
