## **Providing Safe and Practical Environments for Cultural Property in Historic Buildings—and Beyond**

By Richard L. Kerschner

Kerschner  
**Providing Safe and Practical Environments for Cultural Property in Historic Buildings—and Beyond**  
Contribution to the Experts' Roundtable on Sustainable Climate Management Strategies, held in April 2007, in Tenerife, Spain

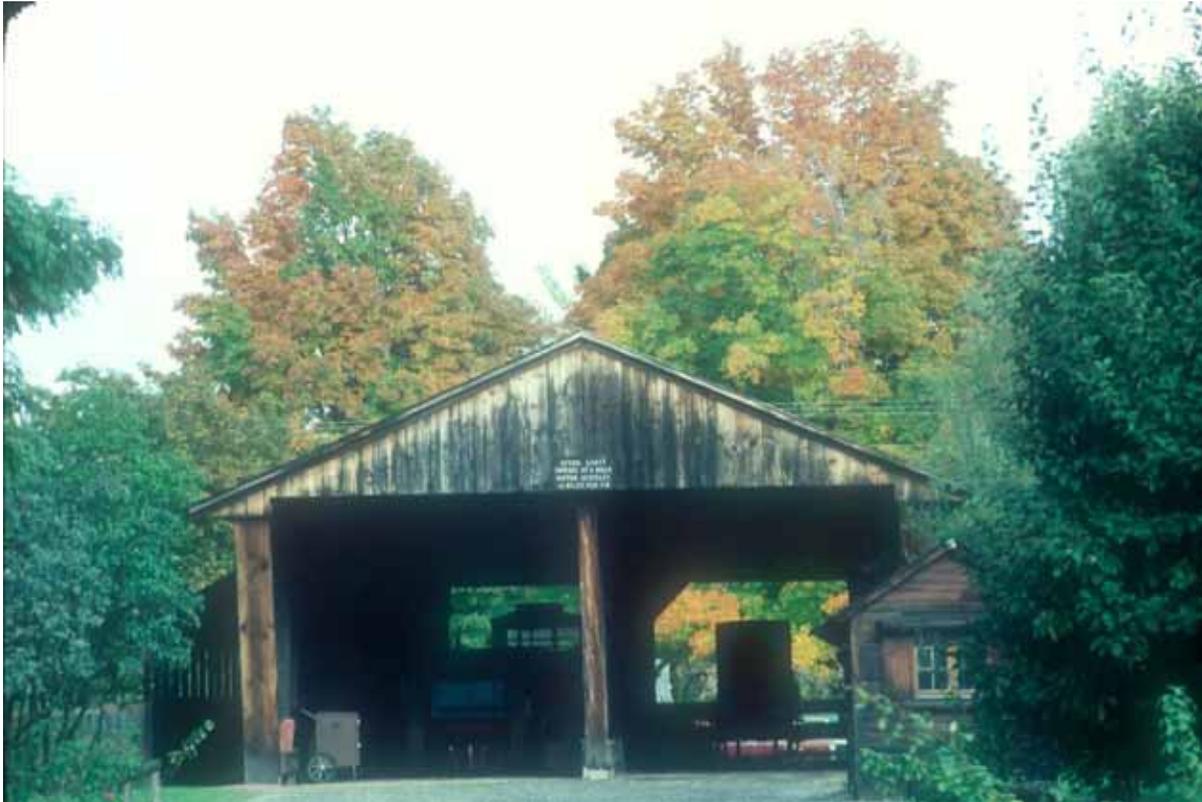
Figure 1

The Cambridge Covered Bridge, a class 1 building. Photo: © Shelburne Museum, Shelburne, Vermont.

- *Class 1* buildings are open structures such as covered bridges or open sheds. These structures have little potential for environmental improvements, although they sometimes protect important artifacts from the harsh elements (fig. 1).

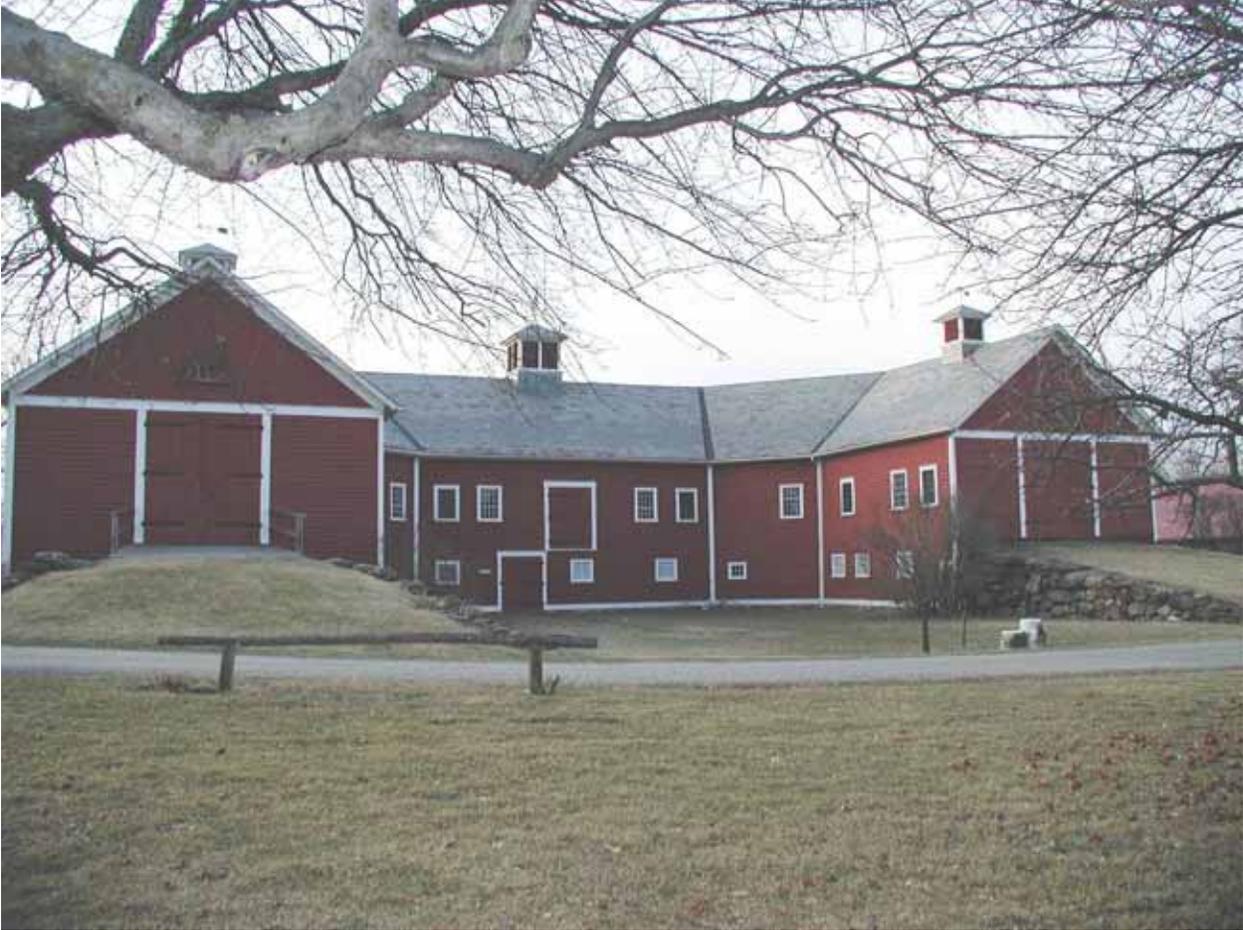
Figure 2

The Horseshoe Barn, a class 2 building. Photo: © Shelburne Museum, Shelburne, Vermont.

- *Class 2* buildings are sheathed post-and-beam structures, such as barns. The only reasonable climate improvement for such buildings is ventilation to reduce heat and moisture accumulation (fig. 2).

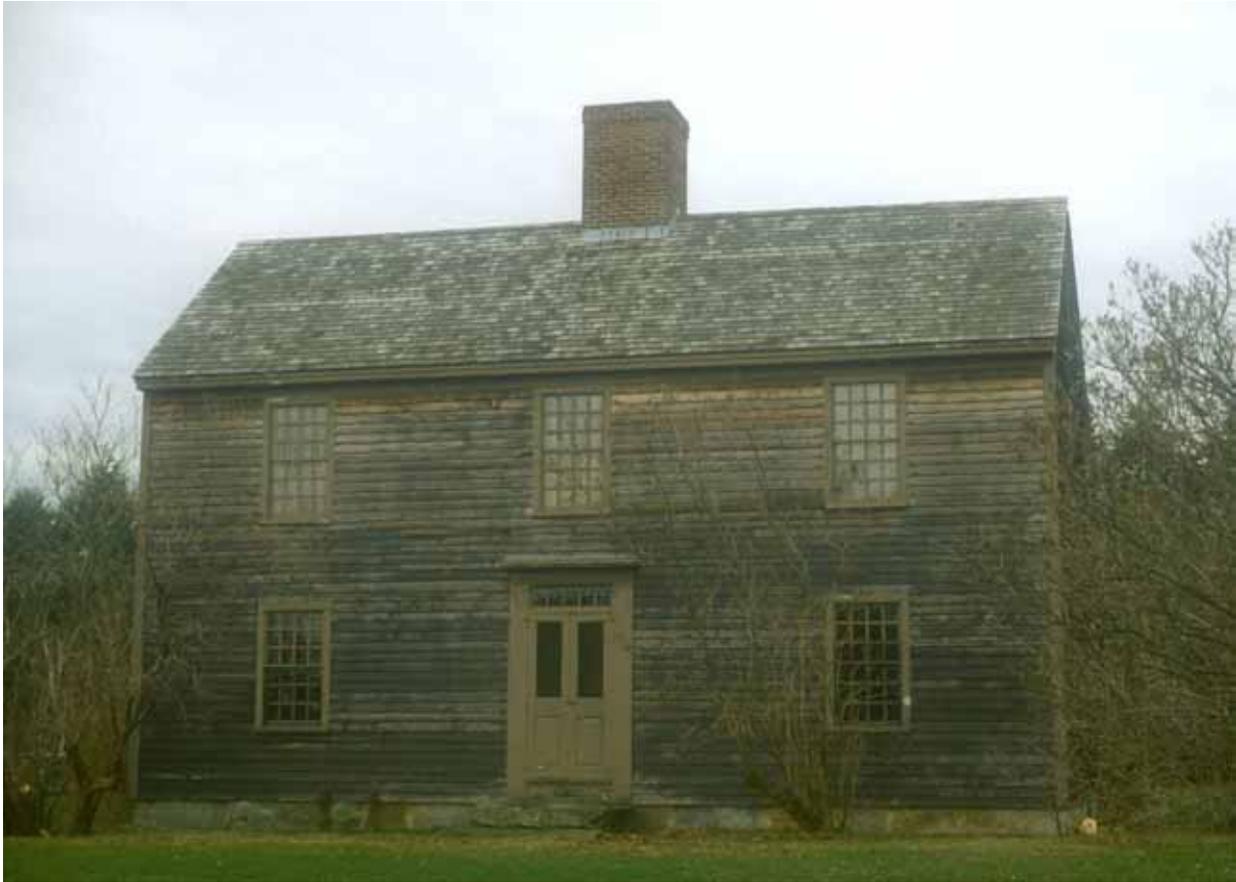
Figure 3

Prentis House, a class 3 building. Photo: © Shelburne Museum, Shelburne, Vermont.

- *Class 3* buildings are wooden structures with framed and sided walls and single-glazed windows, or un-insulated masonry structures—essentially a basic historic house. In these structures, one can use low-level heating to reduce high humidity levels, and employ summer exhaust ventilation (fig. 3).

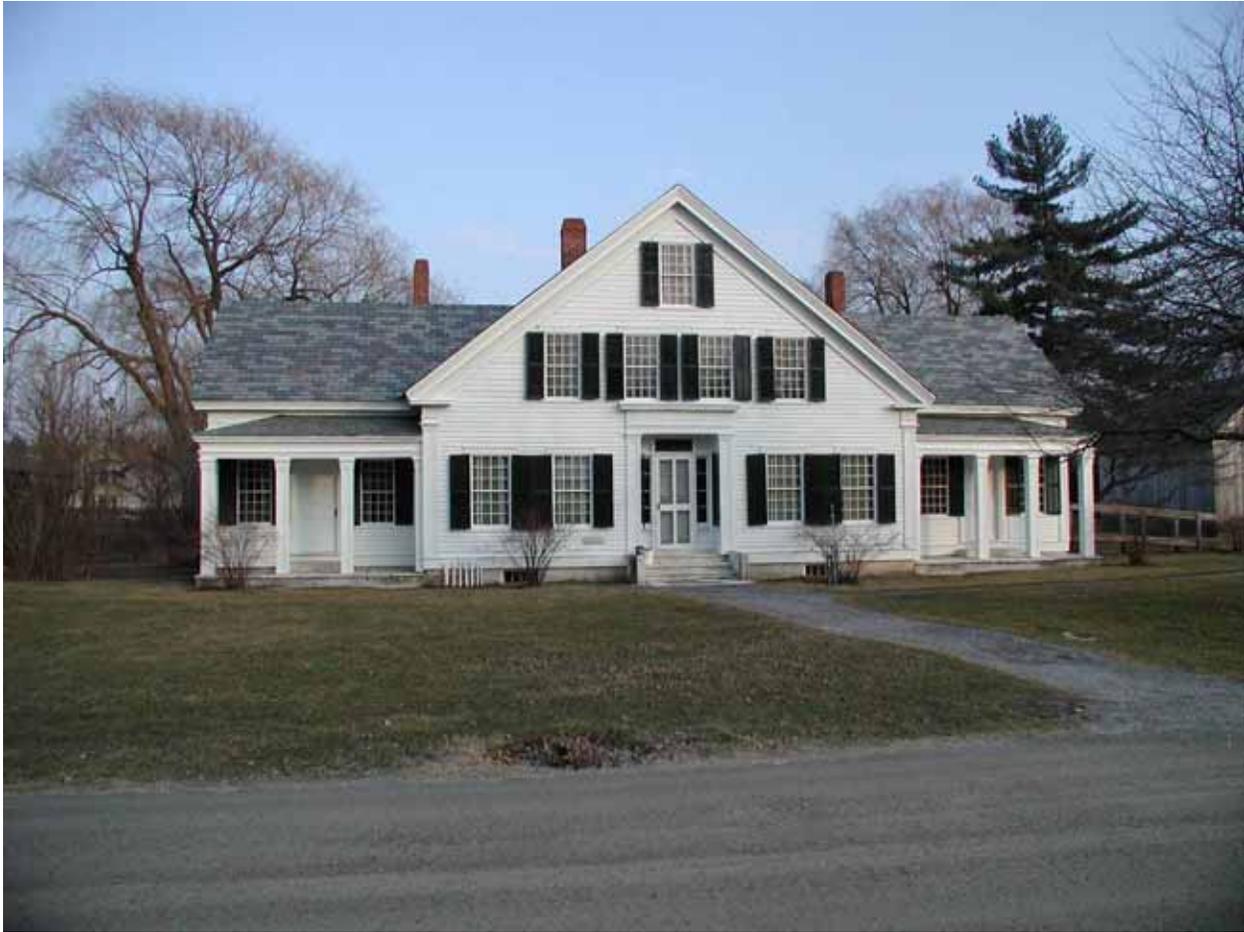
Figure 4

Dorset House, a class 4 building. Photo: © Shelburne Museum, Shelburne, Vermont.

- *Class 4* buildings are tightly constructed wooden structures with composite plastered walls and storm windows, or else they are heavy masonry structures, typical of high-quality historic houses. These buildings can support low-level heating and humidification in the winter and cooling and reheating for dehumidification in the summer (fig. 4).

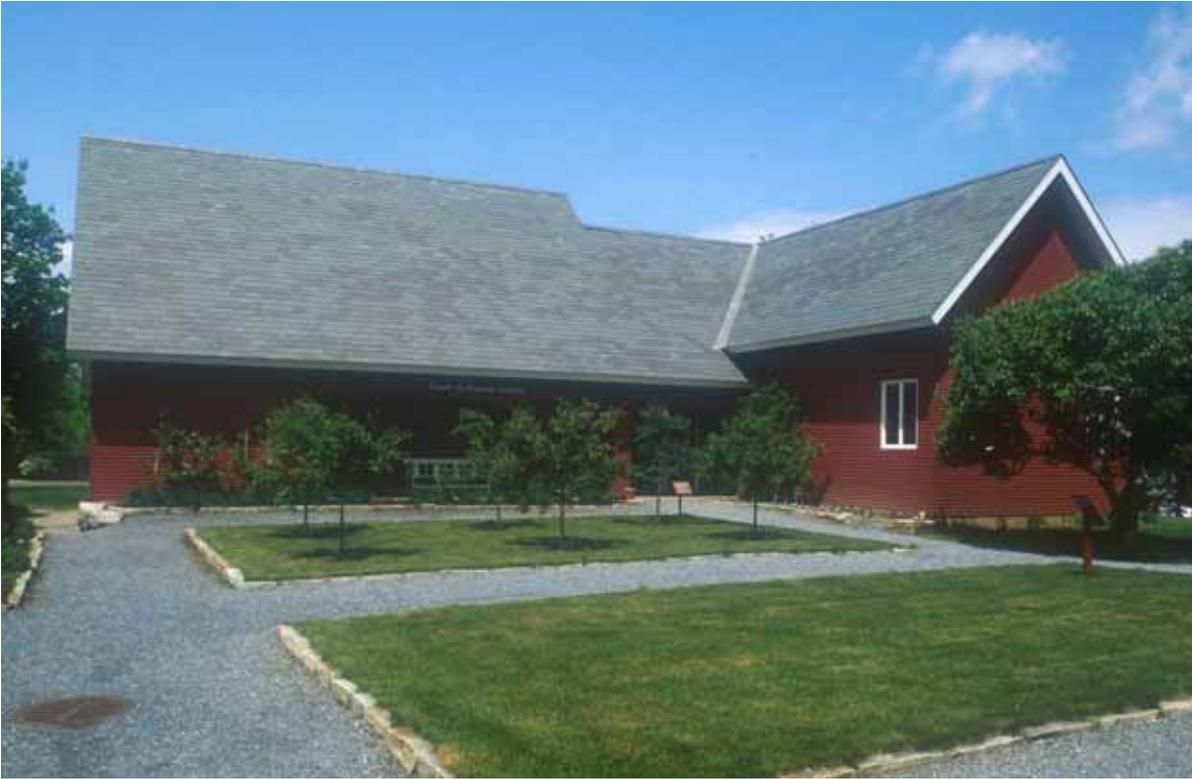
Figure 5

The Pleissner Building, a class 5 building. Photo: © Shelburne Museum, Shelburne, Vermont.

- *Class 5* buildings are new-built structures with insulated walls with vapor barriers and double-glazed windows. These buildings can support complete HVAC systems with winter comfort heating and humidification, and summer cooling and reheating for dehumidification (fig. 5).

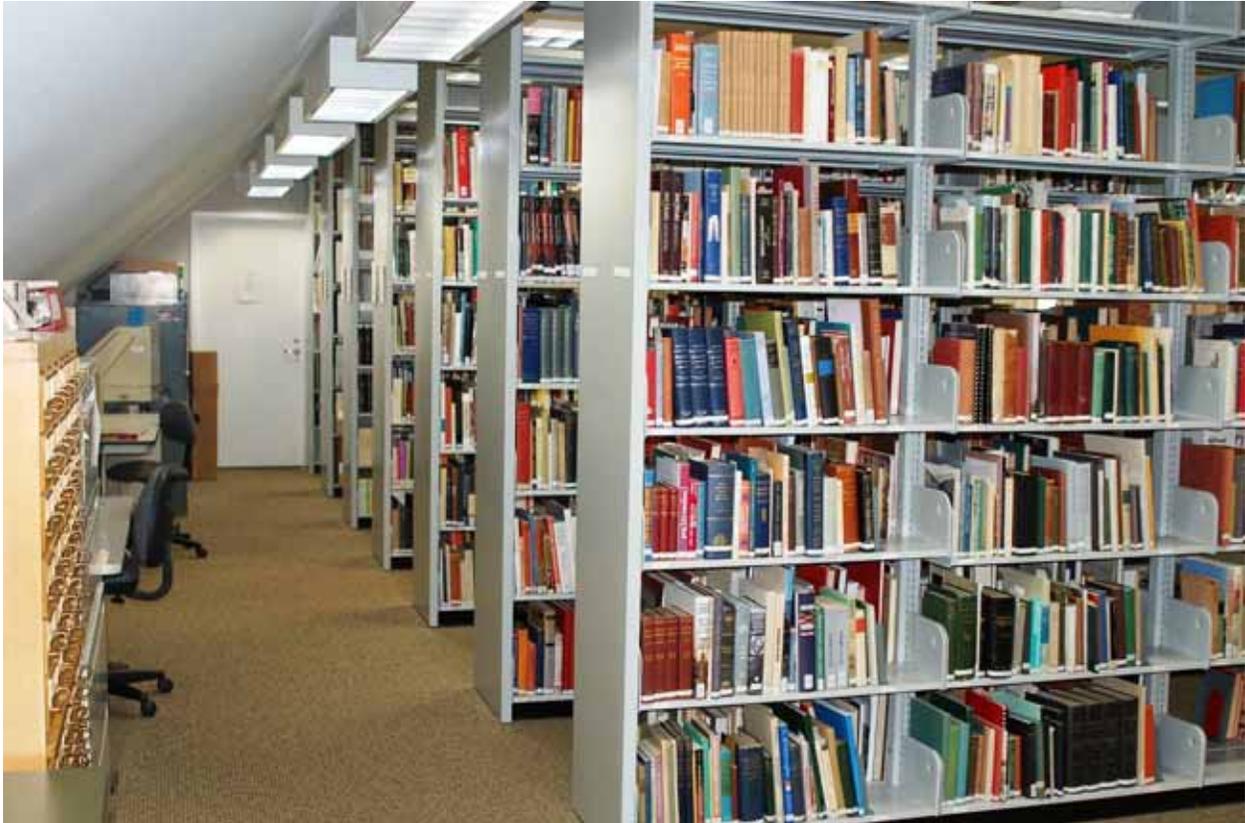
Figure 6

The Shelburne Museum Library, a class 6 building. Photo: © Shelburne Museum, Shelburne, Vermont.

- *Class 6* structures are rooms-within-a-room, double-wall constructions with insulated and sealed walls, such as storage vaults specially built to support precision controlled heating, cooling, and RH control systems (fig. 6).

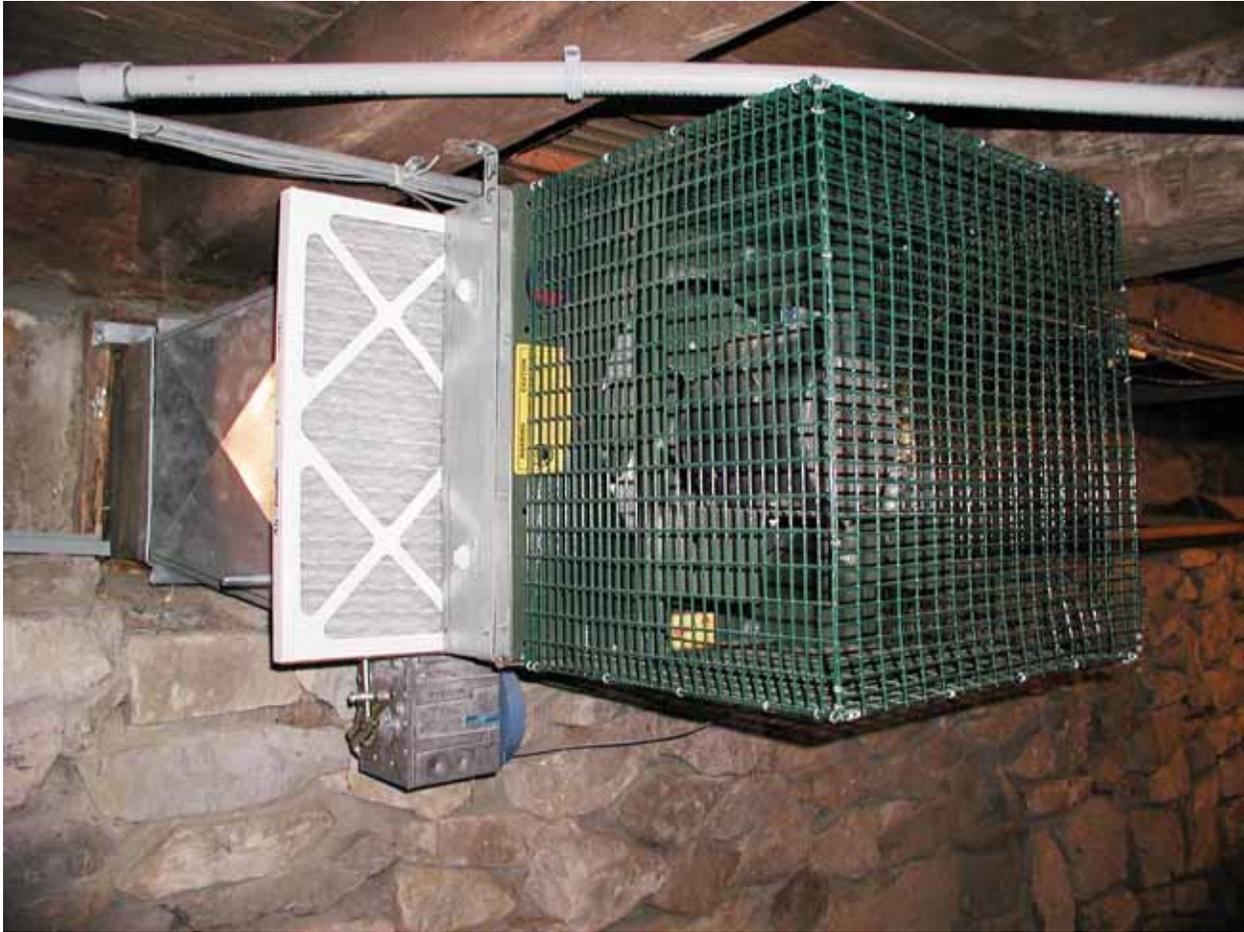
Figure 7

A basement intake fan assembly with dust filter. Photo: © Shelburne Museum, Shelburne, Vermont.

Conservation ventilation employs fans controlled by a humidistat rather than by a thermostat. When the inside temperature exceeds 18°C (65°F) and the inside RH is higher than the outside RH, the fans are activated, and the hot, moist interior air is replaced by cooler, drier air from outside. This practical environmental control system was installed in nine of our class 2 barnlike structures, since it was apparent that during the summer, heat and RH levels inside these structures exceeded outside conditions, especially on upper levels on hot afternoons. A consulting engineer calculated that it would require about seven air changes an hour to effectively exhaust the hot, humid air and replace it with cooler, drier air from outside. However, simply installing and operating whole-house exhaust fans would solve one problem but create another—by introducing seven times as much dust into the collections areas. This problem was solved not only by exhausting air through the attic but also by using fans to draw air into the first floor or basement of the building through filters that trap the dust (fig. 7). Because the fans drawing air into the building are larger than the exhaust fans, the entire building is slightly overpressured, a condition that discourages dust from entering when

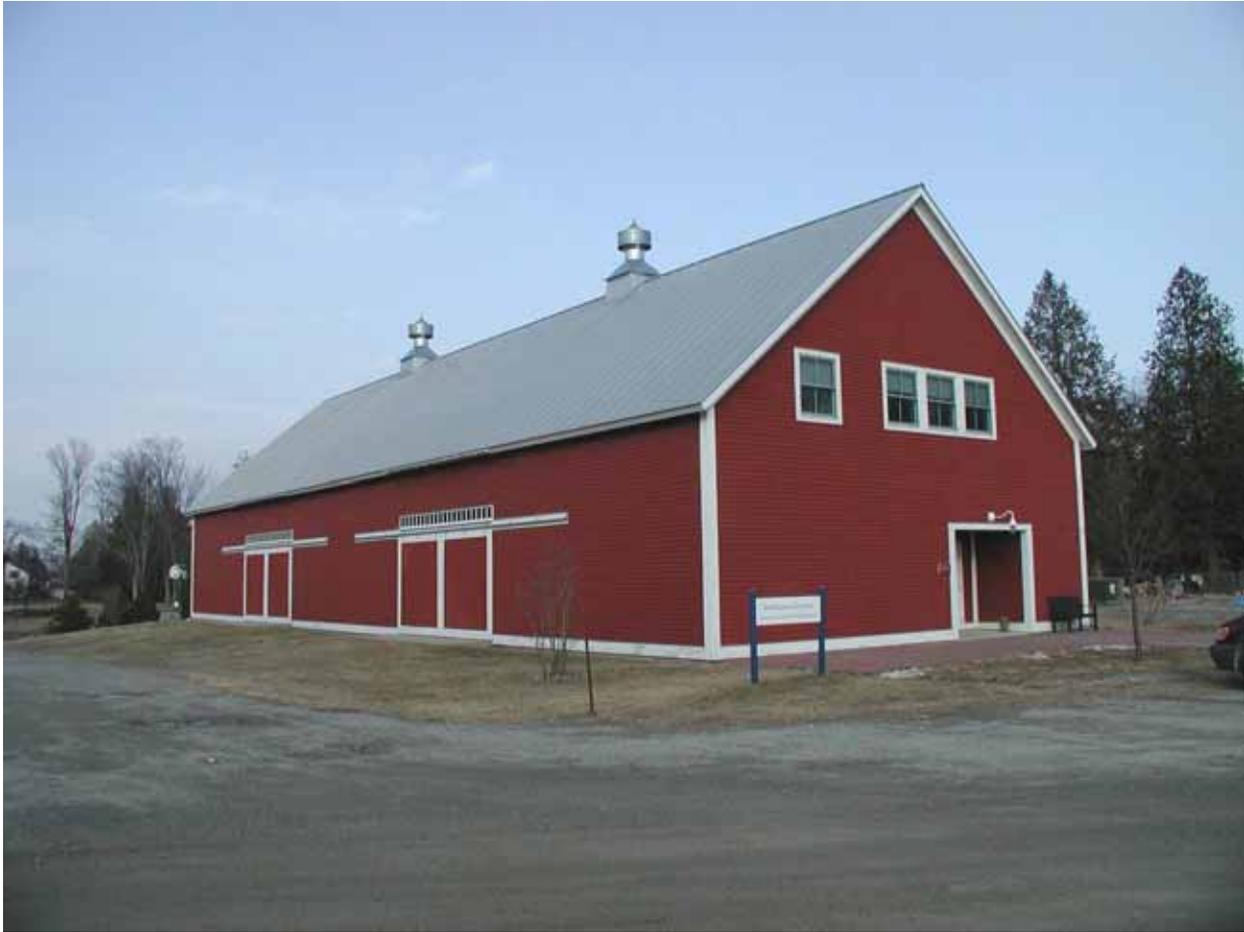
Figure 8

Collections Management Building. Photo: © Shelburne Museum, Shelburne, Vermont.

In 2000, planning began for construction of a new 930 m<sup>2</sup> (10,000 sq. ft.) two-story storage building (fig. 8), the Collections Management Building. A well-insulated, modern, barnlike building was proposed for construction on a well-drained site. The building was originally designed to utilize the practical environmental control principals and systems successfully employed in our historic collections buildings—i.e., conservation heating and ventilation. During the planning process, our director decided to include a library and collections management space on the second floor, introducing people into the structure and reducing storage space by 40%. Since conventional winter humidification and summer air-conditioning were now required for the occupied space, an aluminized polyester film vapor barrier was added to the building specifications. Conservation heating and ventilation were still deemed sufficient to maintain a safe environment for the carriages, furniture, wood sculpture, metals,

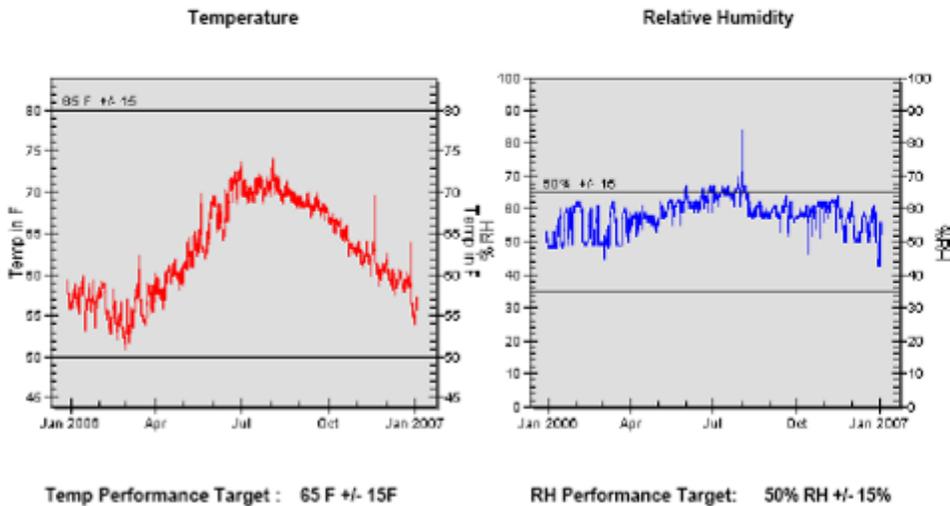
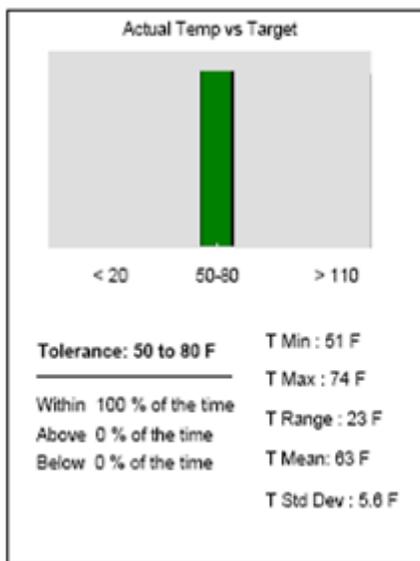
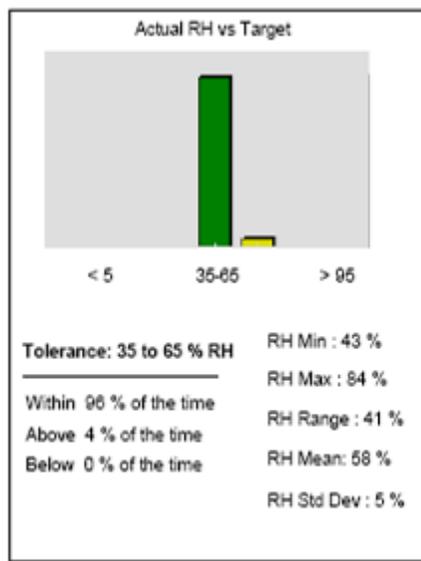
Figure 9  
 2006 Climate Notebook "Engineer's Report" for the Collections Management Building storage area. Report: Climate Notebook software, © 2000, Image Permanence Institute, Rochester Institute of Technology.

However, as the year progressed, we found that when the conservation heating and ventilation system serving this storage area was completely shut down, the temperature and RH levels were steady and safe, changing only gradually with outside conditions. The storage area RH seldom exceeded 60% during the winter, spring, and fall, and summer temperatures remained below 24°C (75°F), with summer RH levels topping out at 65%. By installing a steam humidifier to introduce some moisture into the space during the coldest winter months, we are able to maintain a safe environment that ranges from 45% RH in the winter to 60% RH in the summer, at temperatures ranging from 10°C (50°F) in the winter to 24°C (75°F) in the summer. We can maintain these favorable conditions so efficiently because this well-sealed and insulated first-floor storage space is sandwiched between the ground, with a year-round temperature of about 10°C (50°F), and the fully conditioned space above, and it is filled with large wooden artifacts that act as a significant humidity buffer. The “Engineer’s Report” generated by Climate Notebook analysis software shows temperature and humidity measurements for 2006 in this storage space (fig. 9).

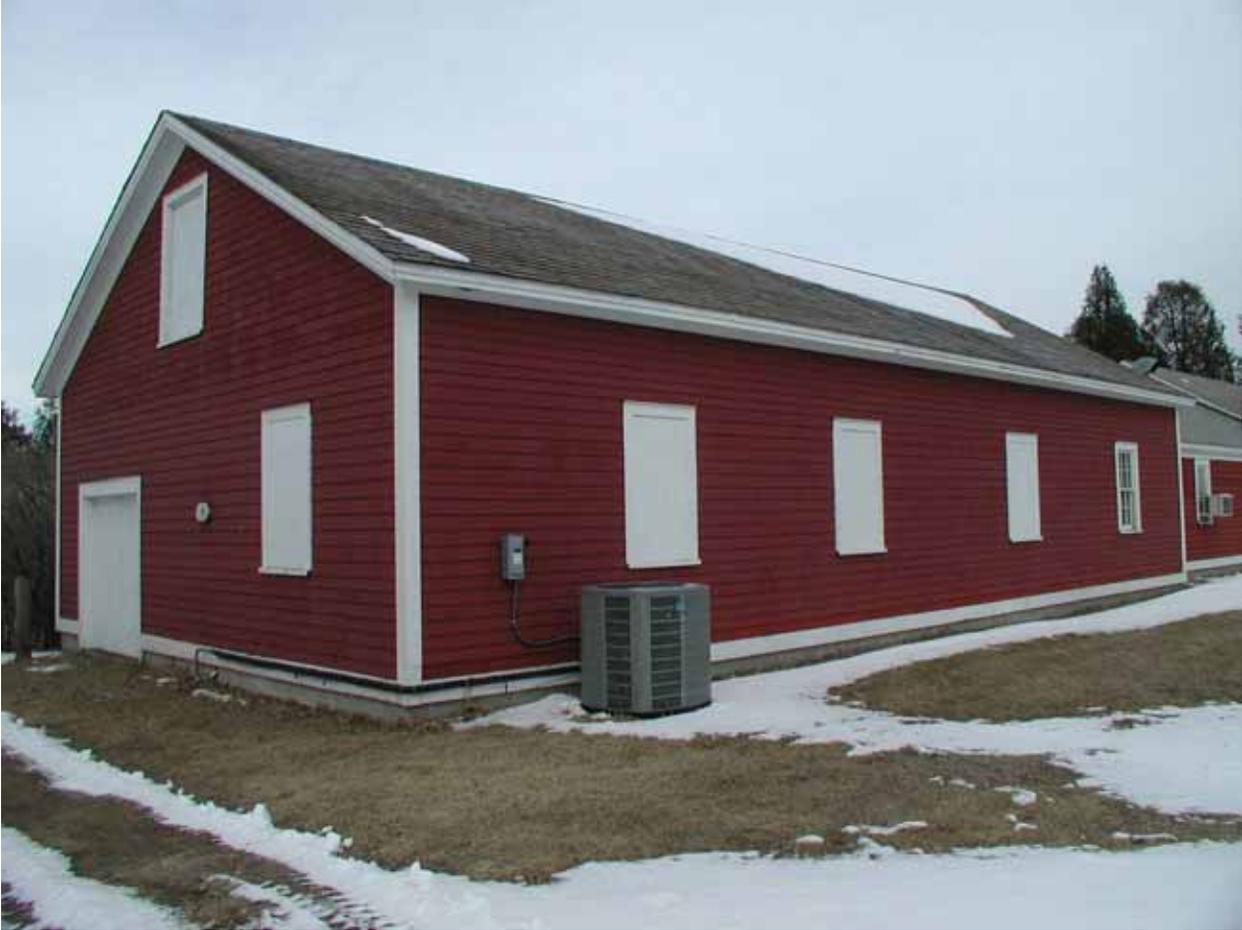
Figure 10

Decorative Arts Storage Building. Photo: © Shelburne Museum, Shelburne, Vermont.

Our most recent innovation is controlling RH in the 300 m<sup>2</sup> (3,200 sq. ft.), infrequently accessed Decorative Arts Storage Building (fig. 10), using only conservation heating and direct refrigerant expansion (DX) cooling, as opposed to expensive supercooling and reheating, which requires running air-conditioning and heating at the same time for three seasons of the year. The Climate Notebook “Engineer’s Report” (fig. 11) shows the temperature and RH in Decorative Arts Storage for 2003, the year before environmental improvements were made. The histograms show the temperature and RH measurements that fall within the established “safe” zones. Note the high RH, indicated in blue on the right chart, especially during the summer.

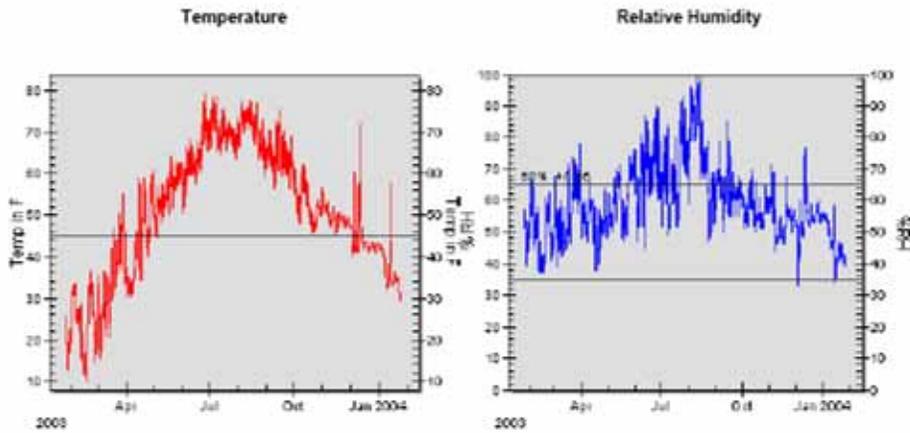
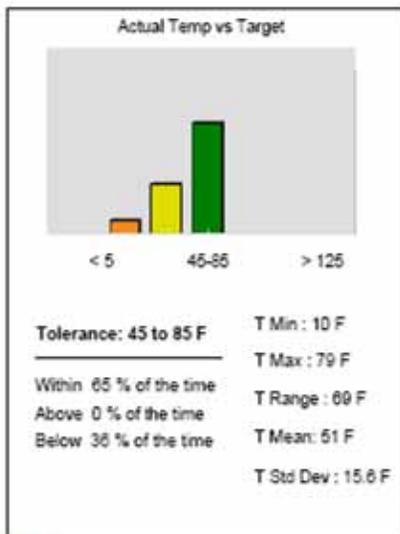
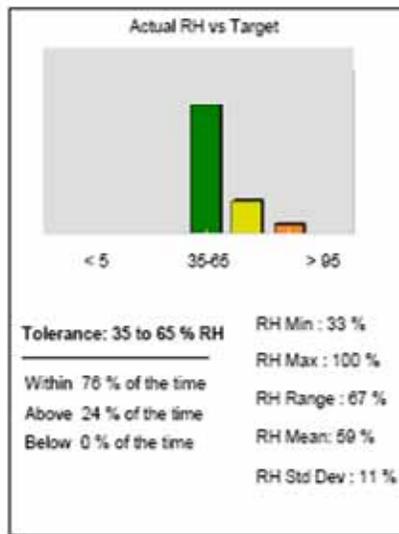
Figure 11  
 2003 Climate Notebook "Engineer's Report" for the Decorative Arts Storage Building prior to environmental improvements. Report: Climate Notebook software, © 2000, Image Permanence Institute, Rochester Institute of Technology.

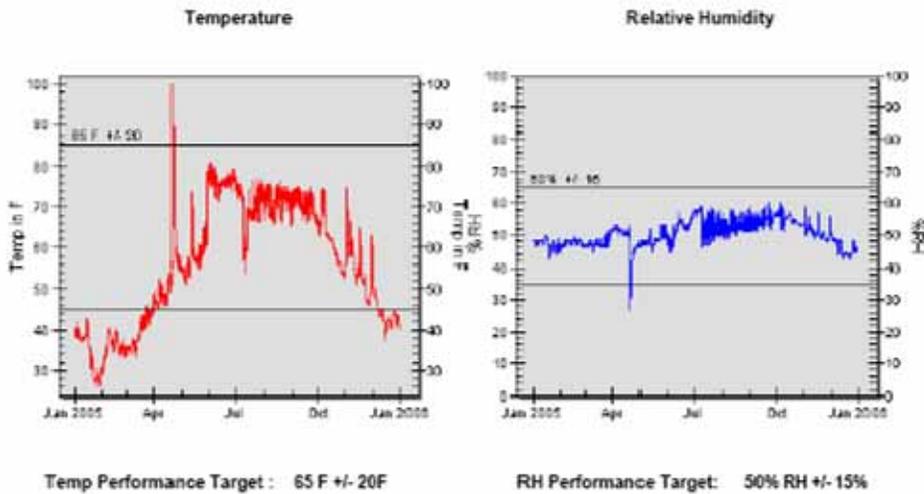
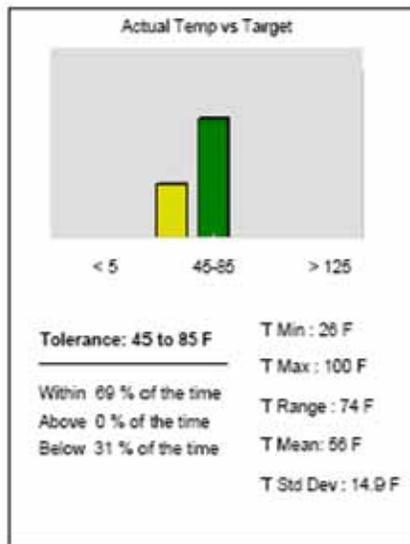
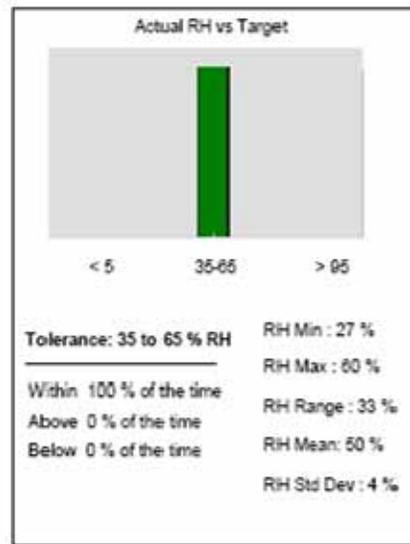
Figure 12  
2005 Climate Notebook "Engineer's Report" for the Decorative Arts Storage Building after environmental improvements. Report: Climate Notebook software, © 2000, Image Permanence Institute, Rochester Institute of Technology.

below freezing. When the temperature is above 22°C (72°F), DX cooling dehumidifies the space. With the exception of one brief equipment failure, temperature and humidity levels remained very steady during 2005, topping out at 27°C (80°F) and 60% RH in the summer and decreasing to 2°C (28°F) and 42% RH in the winter (fig. 12). The equipment failure during April 2005 is a good reminder that even practical climate control systems require constant and careful monitoring to ensure that safe conditions are maintained. Outside temperature and humidity conditions for 2004 are included for comparison (fig. 13).

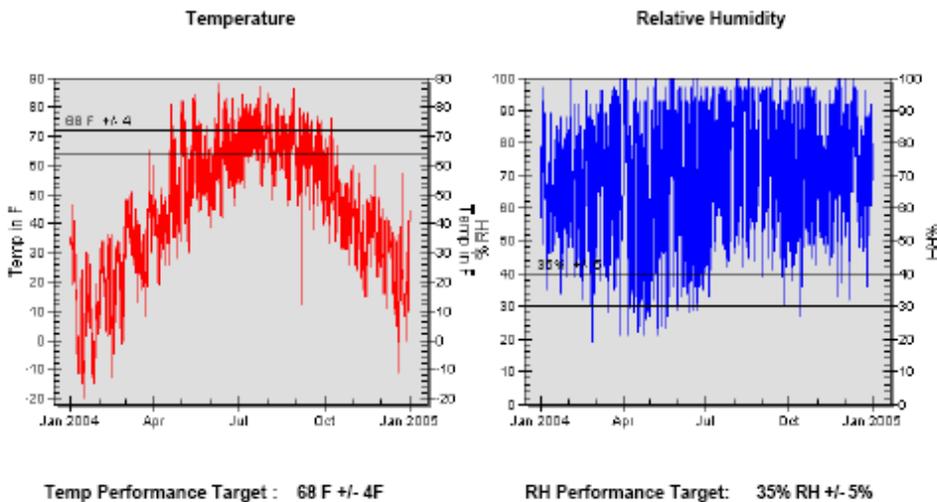
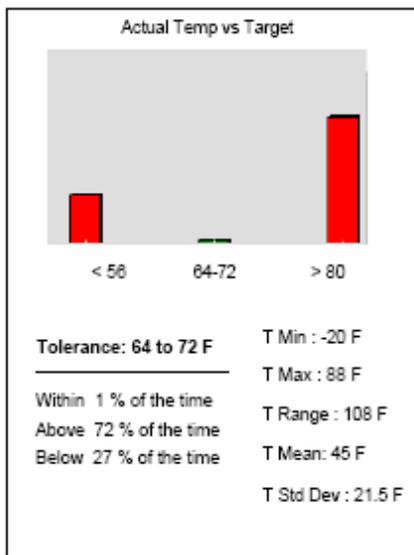
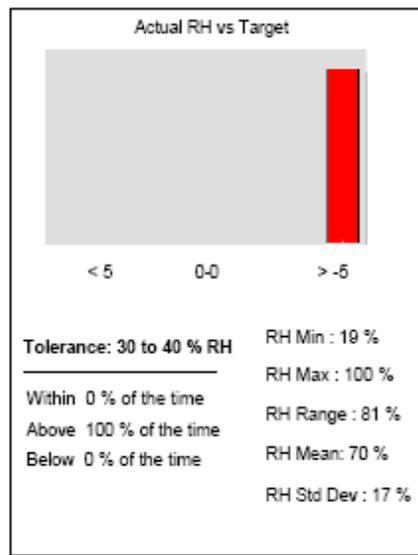
Figure 13  
 2004 Climate Notebook "Engineer's Report" for outside temperature and relative humidity for Burlington, Vermont. Report: Climate Notebook software, © 2000, Image Permanence Institute, Rochester Institute of Technology.
