Original Painting Techniques and Materials Used in the Tomb of Nefertari

STEPHEN RICKERBY

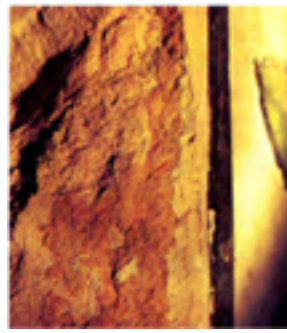
FIGURE 2. STRATIGRAPHY OF CLAY-STRAW PLASTER LAYERS ON THE SOUTH FACE OF COLUMN II. THE LEVELING PLASTER IS COARSER AND DARKER THAN THE UPPER LAYER.

Two layers of clay-straw plaster are often present in Nefertari's tomb: a coarse lower layer, and a finer upper layer (Fig. 2). Nile silt usually consists of a mixture of very fine sand and clay with calcium carbonate and gypsum. Analysis of fragments of the leveling plaster from the tomb supports this observation, although it appears crushed limestone was also added as a filler, contributing to the plaster's coarseness (Stulik, Porta, and Palet, this volume). *Hib* silt is composed of a natural mixture of clay and very

fine limestone, the latter giving the applied plaster a much lighter color. This is noticeable in the upper plaster in the tomb of Nefertari, indicating that *hib* silt was probably employed.

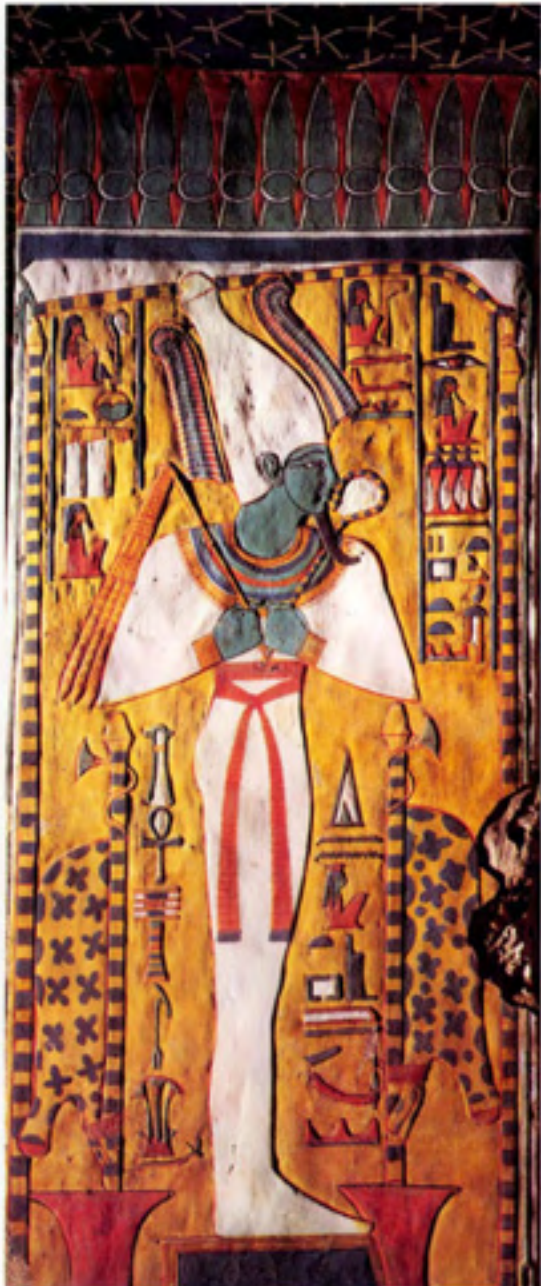
FIGURE 5, FAR RIGHT. CHAMBER K, WEST WALL, WITH AREA OF UNFINISHED HIEROGLYPHS.

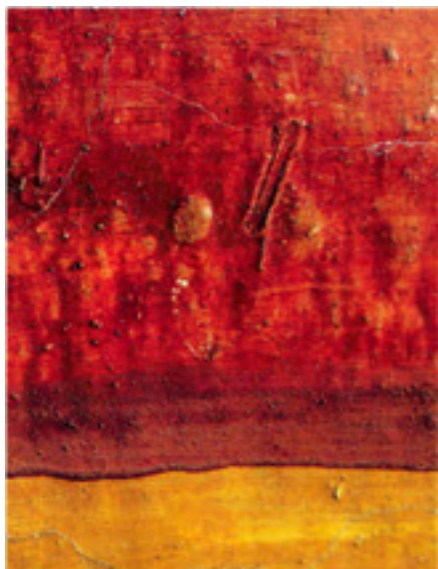
FIGURE 6, RIGHT. DETAIL OF *DJED* PILLAR SHOWING DISTINCT AREA OF SHINY AND MATTE PAINTING, PROBABLY THE RESULT OF SELECTIVE VARNISHING.

Distinct areas of shiny and matte painting certainly exist in Nefertari's tomb, and in many instances these can be attributed to the varying effects between different pigments and their medium. However, compelling evidence also suggests that other areas of painting, reds and yellows in particular, were sometimes selected to receive the enhancement of a varnish as well. On the *Djed* pillars that decorate one side of the columns in the burial chamber, for example, horizontal bands of red and yellow have a shiny appearance, but are separated by matte red lines applied on top (Fig. 6). Closer examination reveals how paint from the horizontal bands was accidentally extended beyond the defining edges of the relief work (Fig. 7). In comparison, these paint traces are matte and lacking in saturation, presumably because they escaped being varnished (Stulik, Porta, and Palet, this volume).

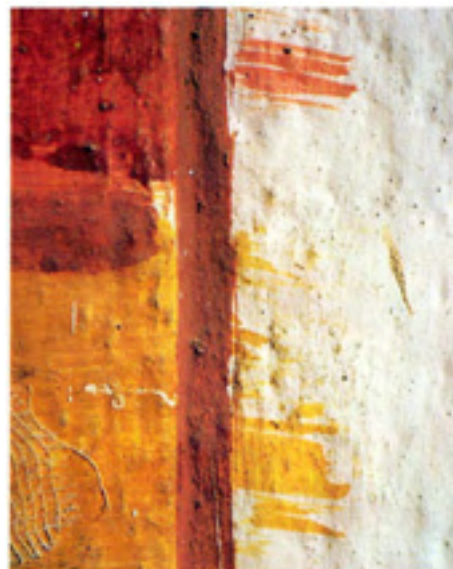
FIGURE 7, FAR RIGHT. DETAIL OF *DJED* PILLAR SHOWING ACCIDENTALLY EXTRUDED TRACES OF PAINT. THESE APPEAR MATTE, PROBABLY BECAUSE THEY WERE NOT VARNISHED.

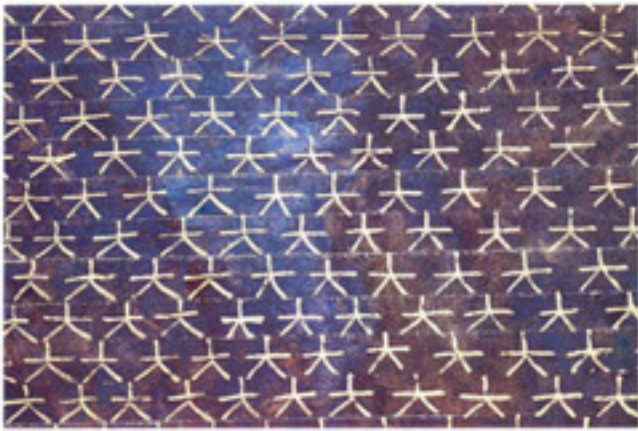
FIGURE 9, TOP LEFT. THE INTENSE COLOR OF THE CEILING IS ACHIEVED BY APPLYING EGYPTIAN BLUE OVER A LAYER OF BLACK. TYPICALLY THE APPEARANCE IS PATCHY.

Areas painted with Egyptian blue, the synthetic pigment characterized by its large particle size and glassy appearance, were nearly always applied over an underlying layer of black to create a dark blue color. In the few areas where black has been omitted as an underlying layer, Egyptian blue takes on a much more brilliant and lighter color (Tite et al. 1988:297–301). On the ceilings, which are entirely painted in the first manner, there are noticeable regions of patchiness where the black shows through the thin covering of blue, or fails to be covered at all (Fig. 9). It is improbable that these were deliberately intended effects, but were likely the result of rapid painting techniques. These shortcomings did not inhibit the painting of the superimposed yellow stars, which are laid out along parallel guidelines snapped onto the ceiling from taut cords dipped in white

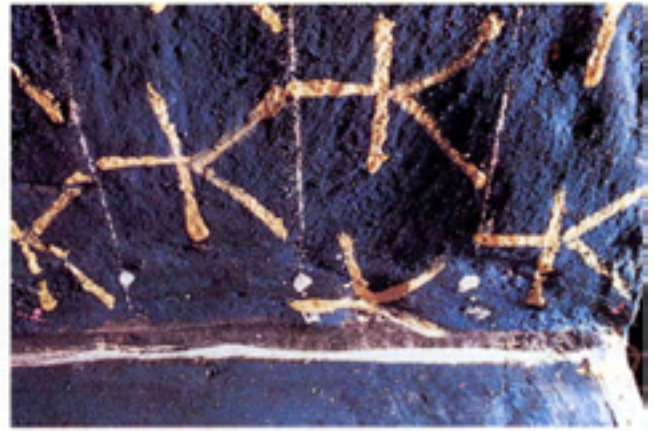
FIGURE 10, TOP RIGHT. DETAIL OF SNAPPED GUIDELINES ON THE CEILING. PAINT SPLATTERS AND FINGERPRINTS ARE CLEARLY VISIBLE FROM THIS PROCESS.

paint (Fig. 10). This process left clearly visible paint splatters, together with smudges and fingerprints where the cords were held and stretched in place.

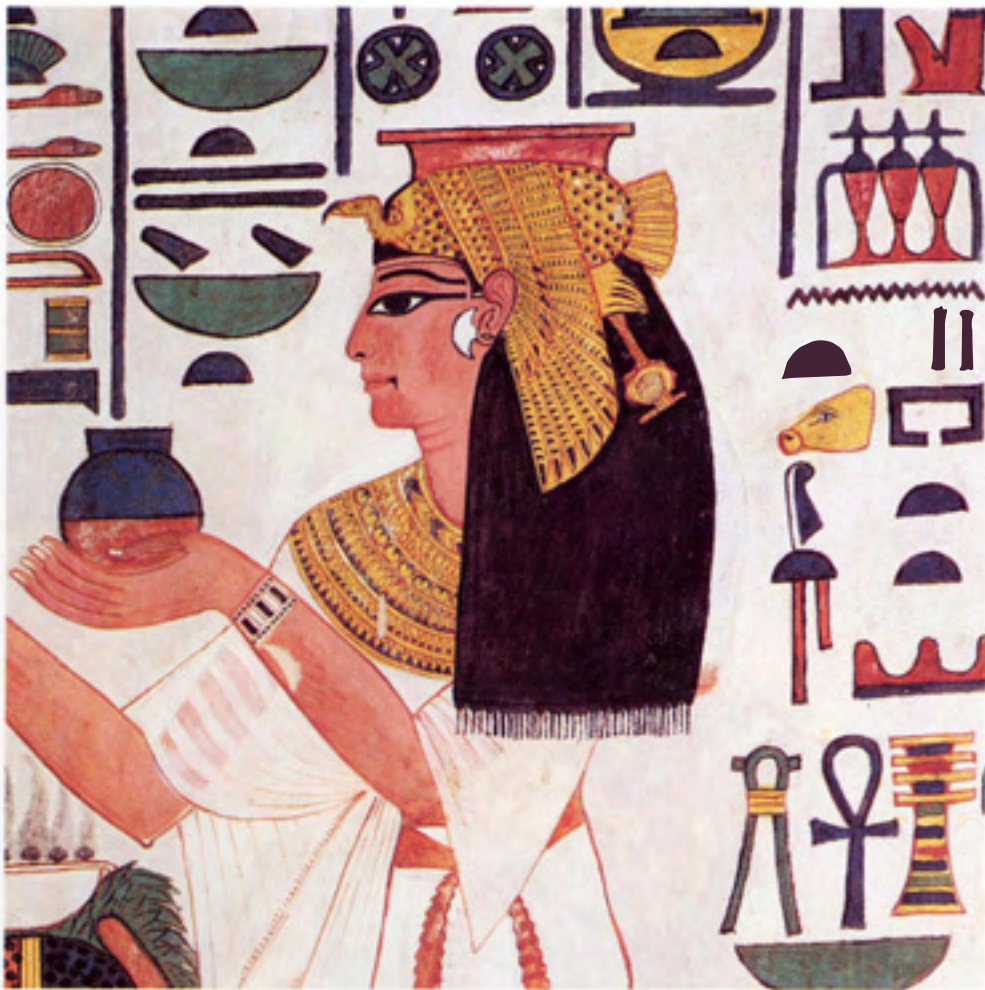
FIGURE 13. STAIRWAY, EAST WALL. DETAIL OF NEFERTARI SHOWING HOW THE PAINTING OF HER WIG DIVERGES FROM THE INITIALLY INTENDED EDGE OF THE RELIEF WORK.

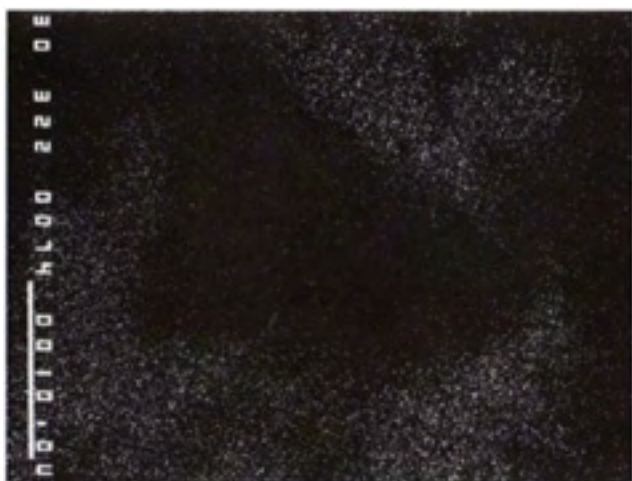
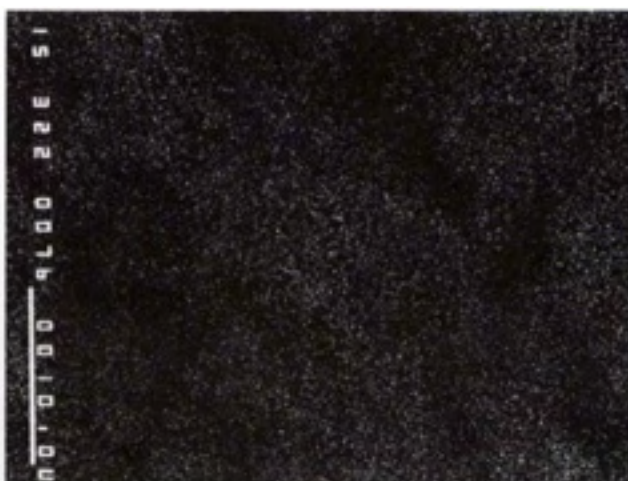
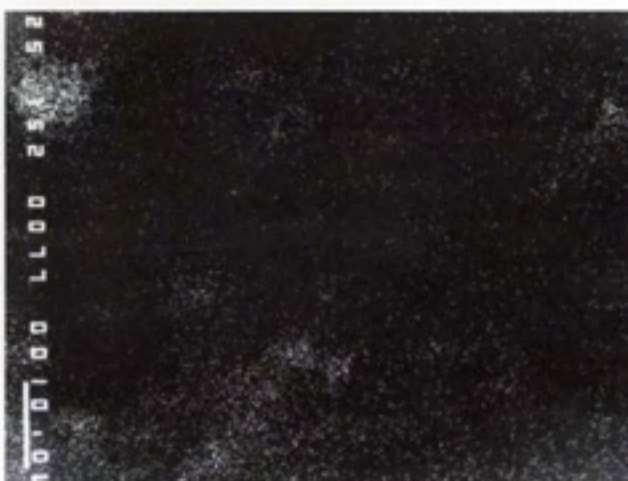
FIGURE 9A, BOTTOM LEFT. ELEMENTAL DISTRIBUTION MAP FROM A CROSS SECTION OF A RED PAINT LAYER. DOT MAP OF ARSENIC.

FIGURE 9B, BOTTOM RIGHT. ELEMENTAL DISTRIBUTION MAP FROM A CROSS SECTION OF A RED PAINT LAYER. DOT MAP OF SULPHUR.

sodium chloride peak pattern in the xrd diffractograms. Qualitative dot maps produced by an electron microprobe tuned to arsenic and oxygen peaks (Fig. 8a, b) show that the arsenic is bound to oxygen. Dot maps on a cross section of the red pigment sample show a lack of correlation between the distribution of arsenic and sulfur (Fig. 9a, b). The electron micrograph in Figure 9a shows that arsenic-rich crystallites lie parallel to the pigment layer and appear to have precipitated in place. This confirms the PLM results, which excluded the presence of arsenic-based pigments in the red pigment layer. The question of the origin of the arsenolite in the paint remains unresolved. One possibility may be that during a previous restoration attempt, the restorers treated the paintings with an arsenic-based chemical as a means of protecting them from microbiological growth.

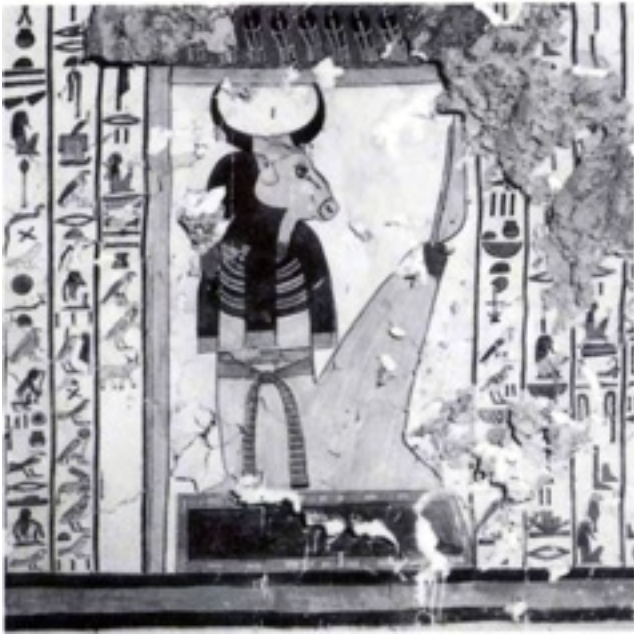
FIGURE 2A. DETAIL, CHAMBER K, EAST WALL, CA. 1920. PHOTO: COURTESY OF THE METROPOLITAN MUSEUM OF ART.

Comparisons of the cumulative photographic documentation, from 1904 to the present, reveal widespread deterioration of the tomb paintings and a notable increase in the number of fallen pieces of plaster (Fig. 2a, b). These conditions probably were due more to natural factors than to the deleterious effects of earlier visitors to the tomb or to the inadequacy of previous restoration attempts. Harmful effects include the migration of salts and their consequent recrystallization on the surfaces, and the formation of small pustules corresponding to the borders of reinforced lacunae and in those zones that had been previously consolidated with injections of unsuitable materials. In addition, disordered fragments were found to be overlapping one another under the gauze that had been applied to secure the paint in place.

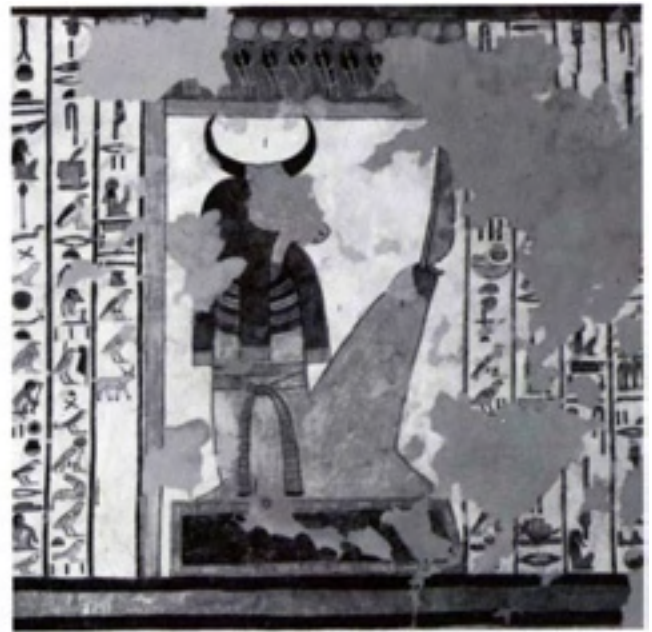
FIGURE 2B. DETAIL, CHAMBER K, EAST WALL, OCTOBER 1989.

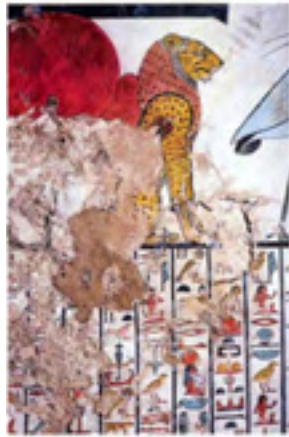
FIGURE 4, TOP LEFT. FLAKING PAINT.

sist of: (1) lack of cohesion of the painted layer, manifested as a tendency toward pigment pulverization; (2) detachment of the pictorial layer with flaking of the paint (Fig. 4); (3) loss of the pictorial layer (Fig. 5); (4) abrasion due to mechanical damage and wear (Fig. 6); (5) macular or spotty chromatic alterations, where paint smears were evident; (6) layers of dirt caused by a variety of factors; and (7) natural deposits on the surface in the forms of earth sediment, dust, and the remains of spider webs and insect nests (Fig. 7).

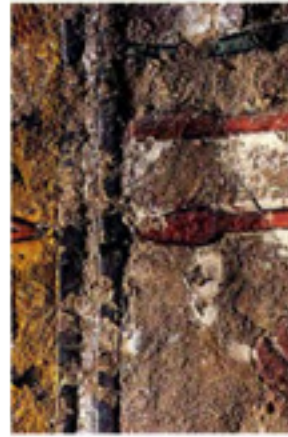
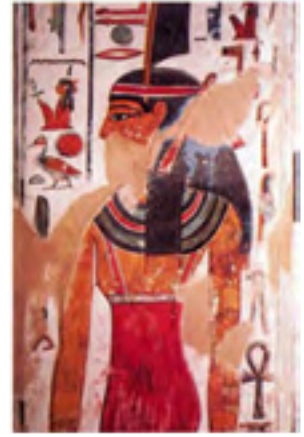
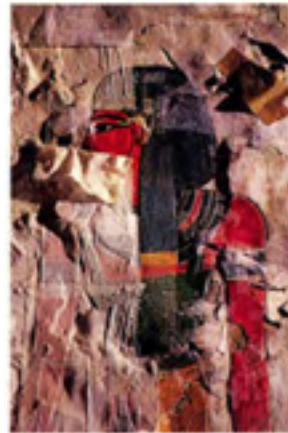
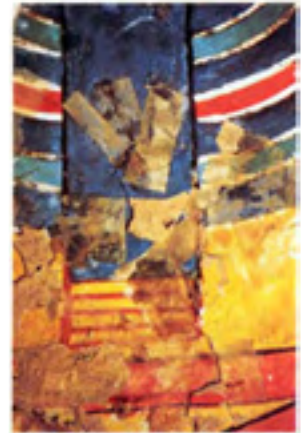
FIGURE 5, TOP RIGHT. LOSS OF PICTORIAL LAYER.

FIGURE 7, ABOVE RIGHT. INSECT NESTS.

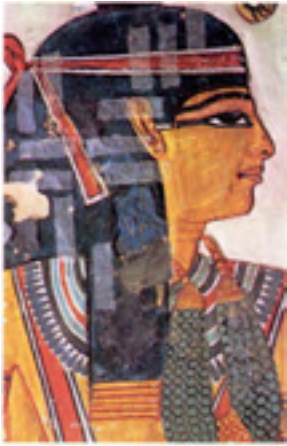
FIGURE 11, ABOVE. FINE-GRAIN PAPER APPLIED TO WALL SURFACES.

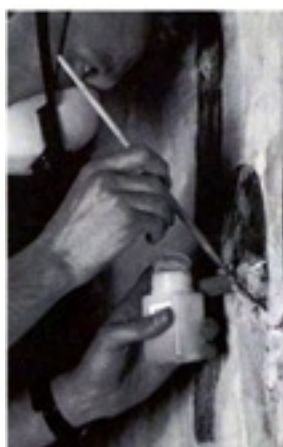
FIGURE 13. REMOVAL OF OLD GAUZE FACINGS.

Because removal of the facings often revealed badly disintegrated plaster, interim emergency repairs were frequently necessary. These were made while the facings were being removed using strips of polyamide tissue paper to temporarily secure loose and endangered areas. An acrylic resin in solution (10% Paraloid B72 in lacquer thinner) was used to apply these strips.

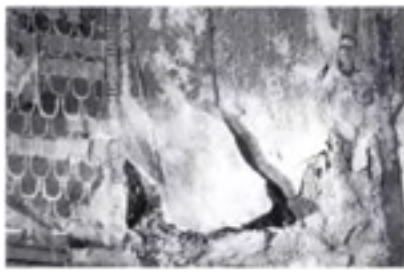
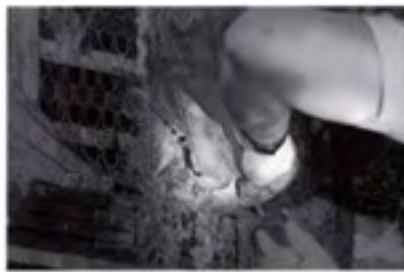
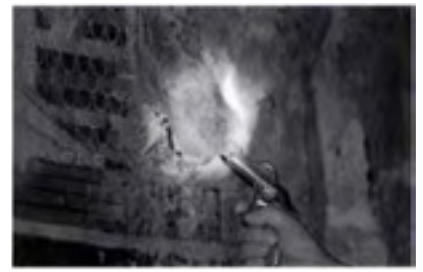
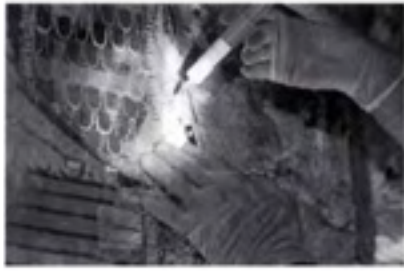
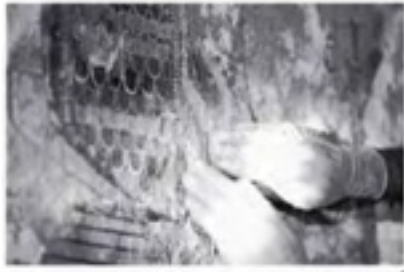
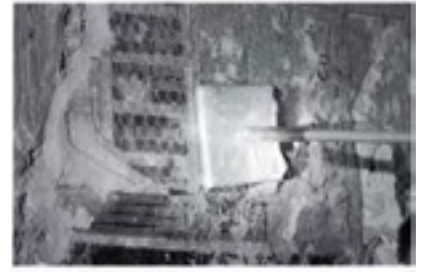
FIGURE 14. OSIRIS'S FOOT, CHAMBER K, NORTH WALL, 1987.

Once cleaned, all the fragments were impregnated with a 3% Paraloid B72 in lacquer thinner solution and correctly positioned and reattached using a drier, pliable, and dough-like mortar mixture composed of the same ingredients as the consolidation mortar described previously, but in a one-to-one proportion to accelerate the drying time. This mixture prevented the rock from absorbing water and subsequently releasing salts back into the plaster. In 48 hours, after the mortar was dry, the protective facing was removed from the reattached fragments (Fig. 14a–h).

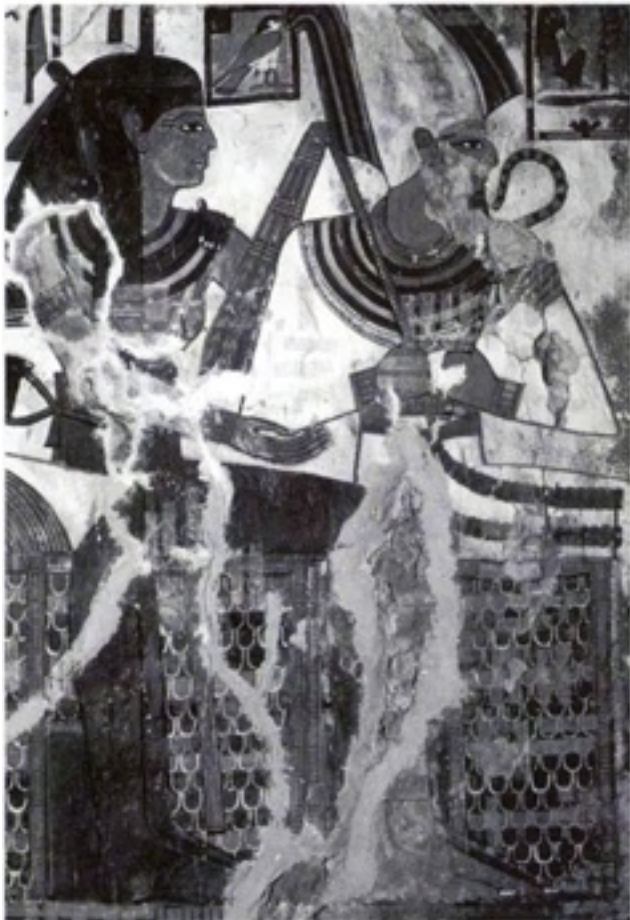
FIGURE 15. OLD FILLS OVERLAPPING ONTO ORIGINAL PAINTING.

Removal of the old fills and borders of the reinforced sections was particularly difficult because the plastering material used for the fills was pure gypsum, which is much harder than the original plaster, and because the plastering was not limited to the lacunae and to the borders alone but overlapped onto large areas of the original painting (Fig. 15). The removal of this material was made even more arduous and time consuming because the mechanical elimination of the old fills had to be done centimeter by centimeter and needed to be preceded, in some cases, by moistening with a solvent mixture (Table 1, solvent No. 4).

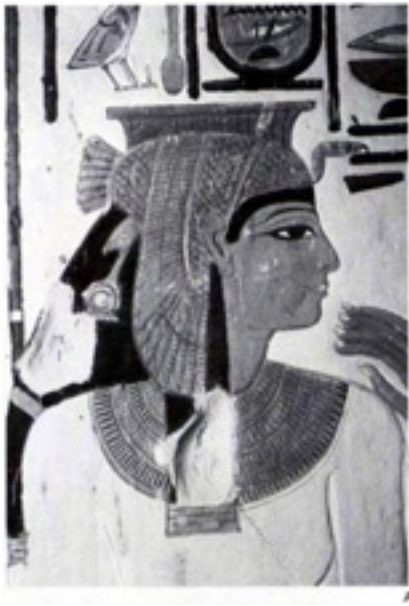
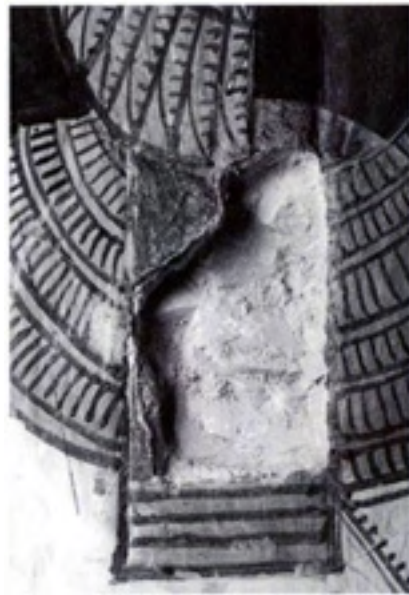
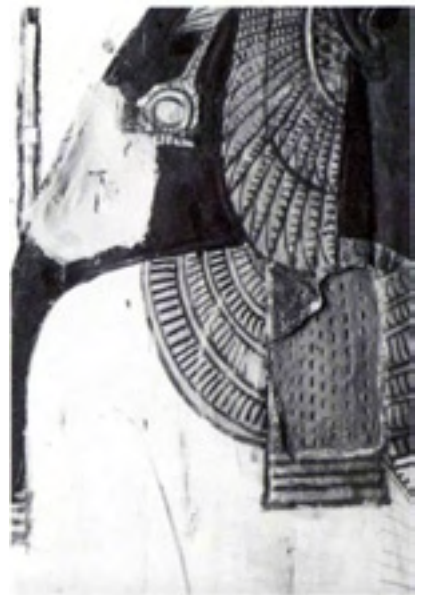
FIGURE 16A. OLD FILLING OF LACUNAE.

FIGURE 16D. SURFACE STIPPLED FOR TEXTURE.

specially prepared instrument made from a fine point of wood. In every area with lacunae this procedure produced a perfect homogeneity between the layer of original mortar and the reintegrated areas. Finally, stippling with a pointed instrument made the repairs visually less obtrusive (Fig. 16a–d).

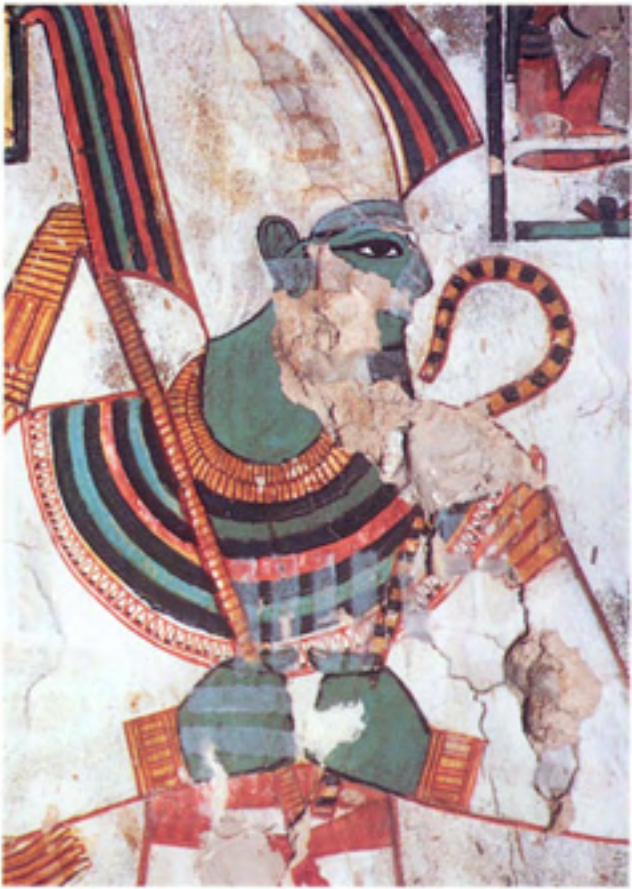
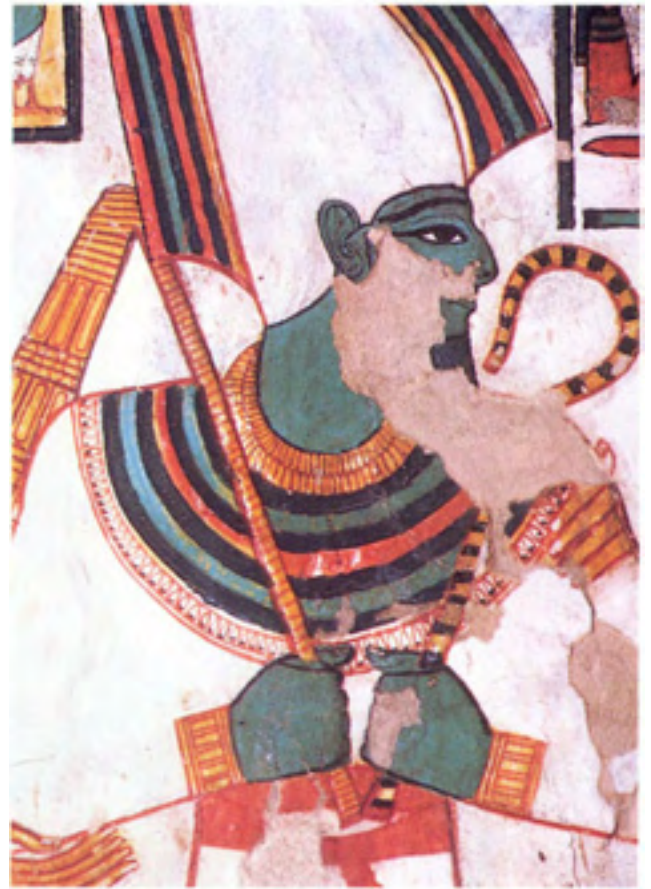
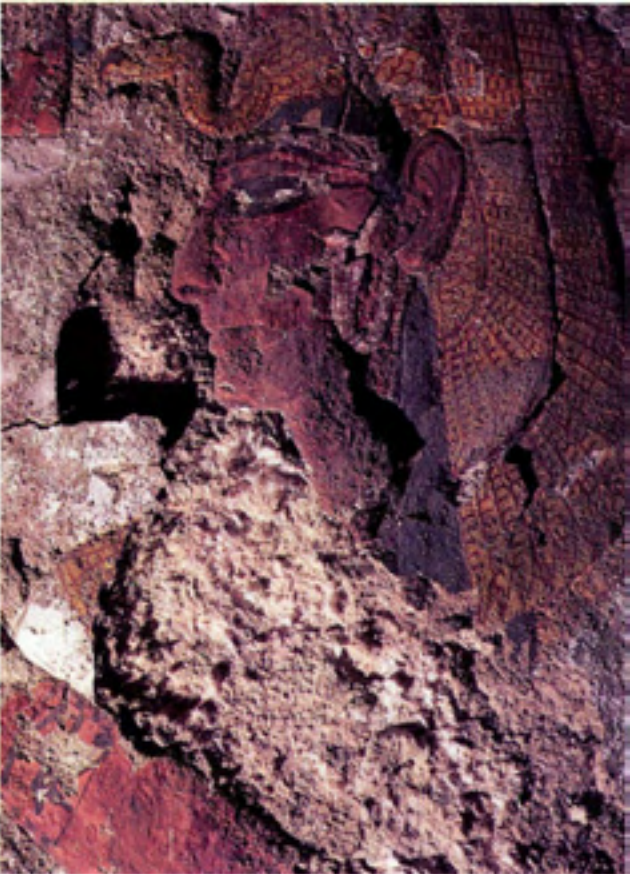
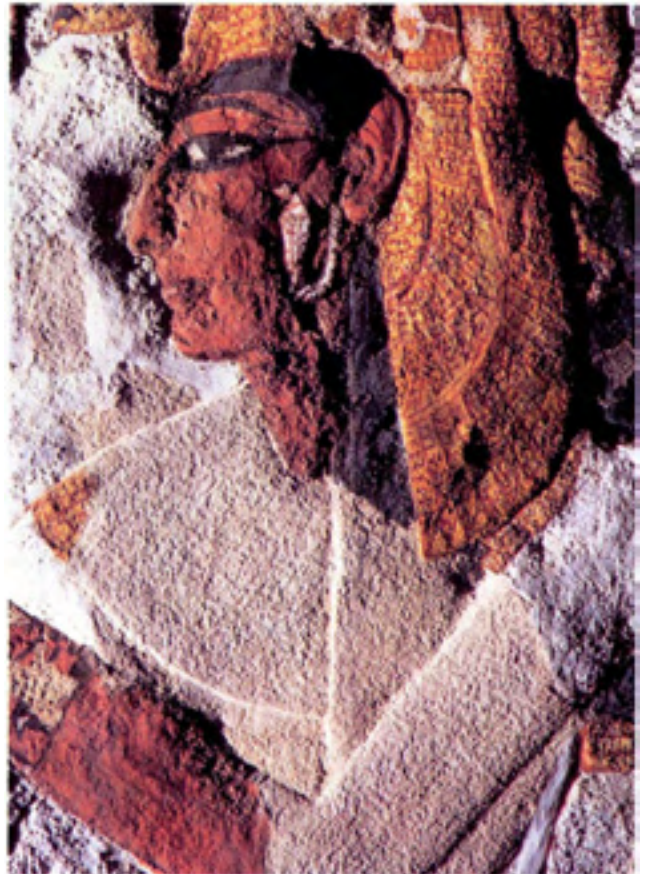
FIGURE 16B. OLD FILLING REMOVED.

FIGURE 16C. LAYER OF NEW MORTAR FILLING.

mals, it was necessary to fill some lacunae with a mortar similar to that used by the ancient Egyptians. The lacunae were then filled with a more compatible mortar so as not to create differential tensions between the new and the old materials. This consisted of the principal mortar mixture without the addition of Primal AC-33, as follows: three parts local sand to one part gypsum plus water to the consistency required. Because the composition of the mortar included a small quantity of water, the internal edges of the lacunae were preventively impregnated with 3 to 4% Paraloid B72 in lacquer thinner solution, to preclude the migration of salts. For the same reason, the mortar was applied in thin, successive layers allowing time for drying out between one layer and the next. Lower levels were additionally bulked out with small stones inserted for the same reason. The new fills were installed up to the level of the surrounding original plaster, in such a way as to imitate the surface wear of the original mortar, using a

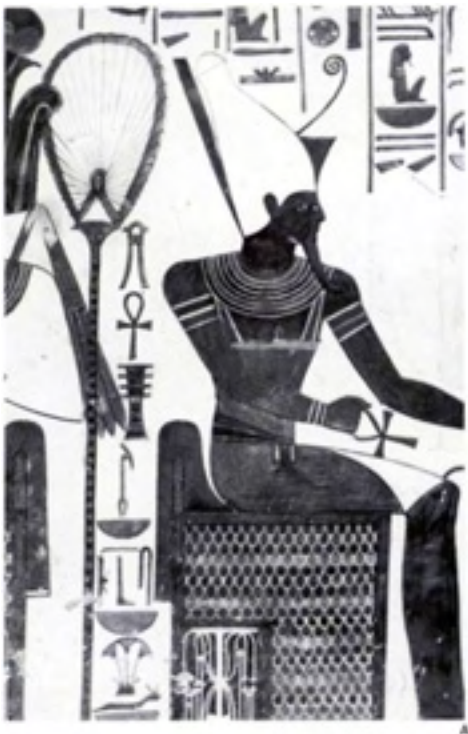
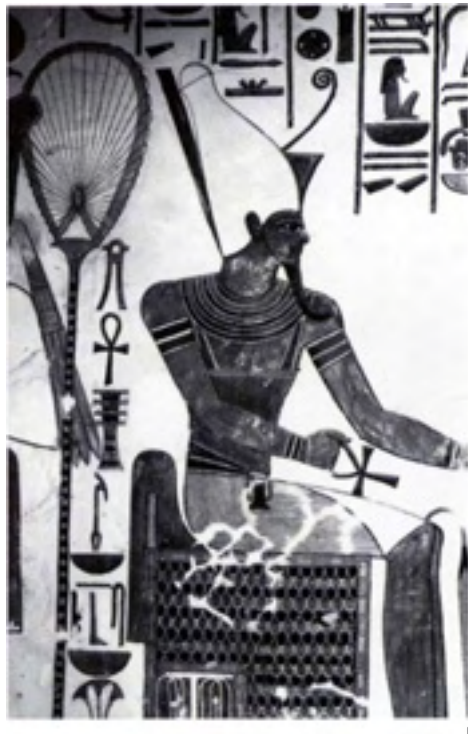
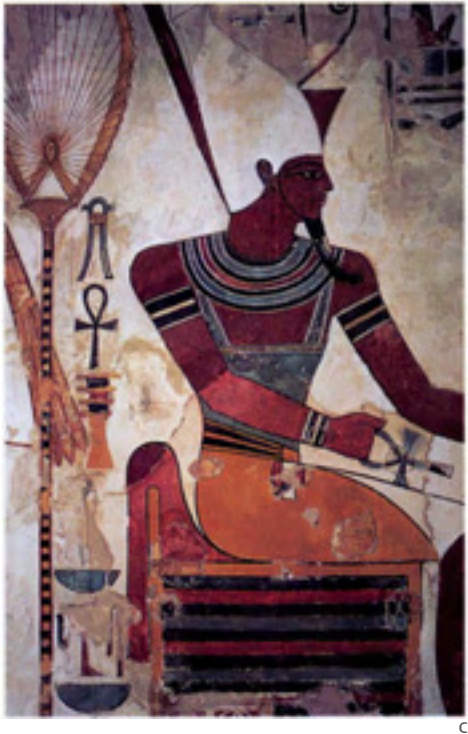
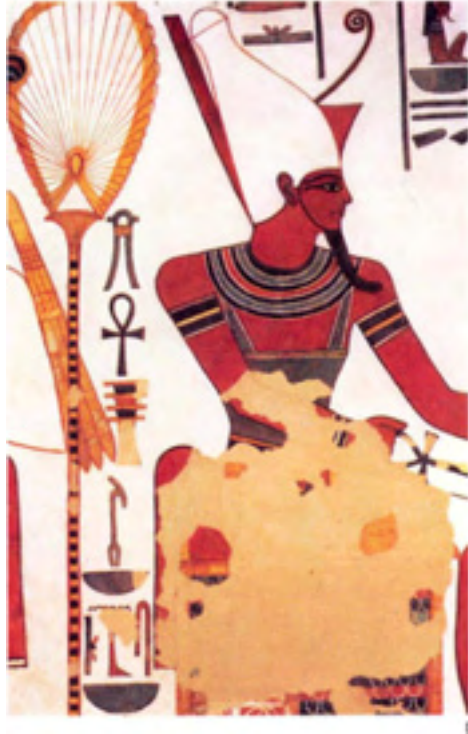
FIGURE 20A. DETAIL OF THE GOD ATUM, CHAMBER G, EAST WALL, CA. 1904.

FIGURE 20B. CA. 1920.

FIGURE 20C. OCTOBER 1986.

FIGURE 20D. APRIL 1992.

The numerous and crude repaintings of original painted surfaces found throughout the tomb (Fig. 19) were removed with applications of dimethylformamide in lacquer thinner and water (solvent No. 4) using Japanese paper and subsequent mechanical action, or a *secco* application. One relatively large area of inpainting in the central portion of the east wall of chamber G posed a dilemma. The question was whether to remove the previous restoration which was not too unsightly, or to leave it in place. Photographic evidence showed that the inpainting had been done in the early 1950s. The argument for retaining it was that the area had appeared in this form in all subsequent photographs, which formed part of the tomb's recent history. But the restoration was visually inconsistent with the rest of the tomb and with the project's philosophy of preserving the original without alterations to its surface. The final decision was to retain the inpainted layer but to cover it with unpainted mortar filling that could be removed without damaging the previous inpainting should this be considered desirable in the future (Fig. 20a–d).

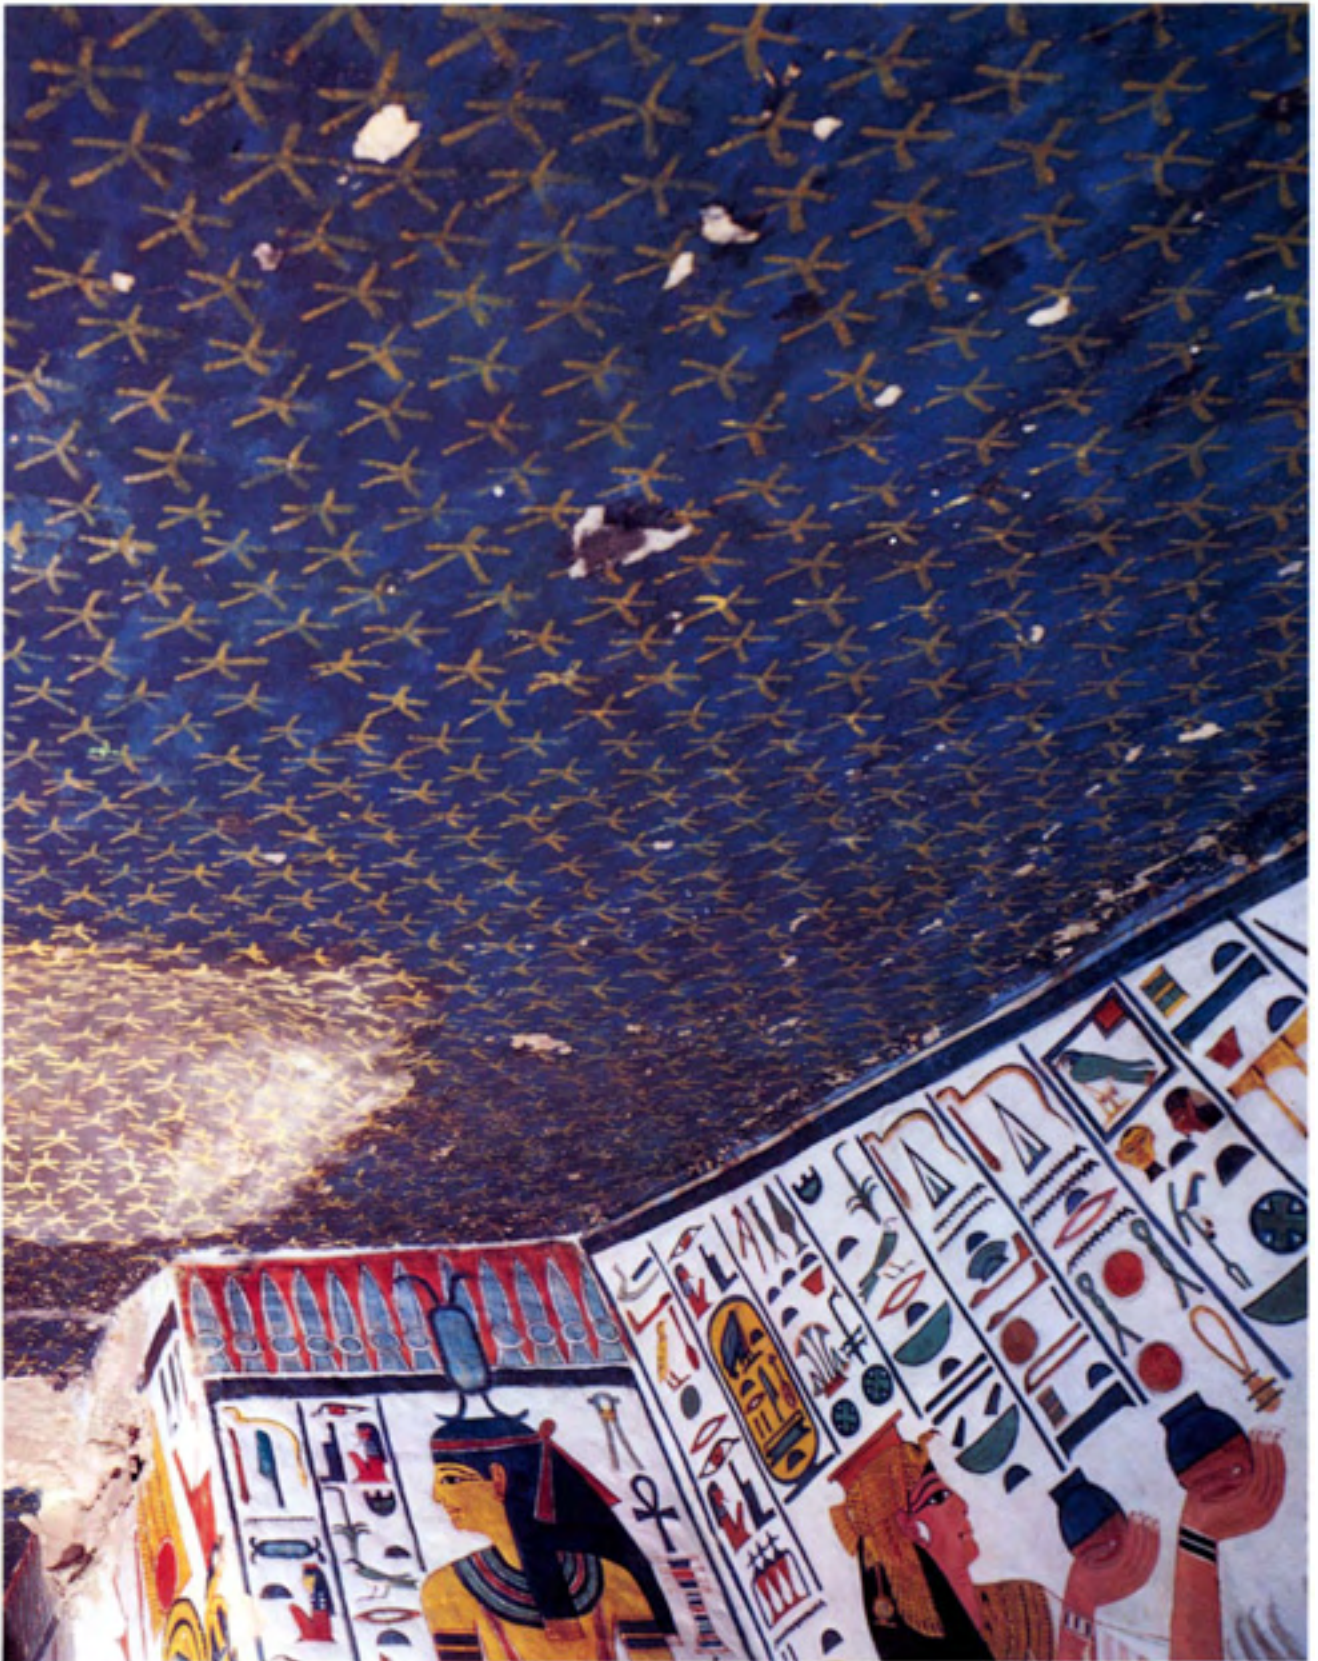
CEILING OF STAIRWAY I, LOOKING SOUTHWEST TOWARD CHAMBER C SHOWING EVIDENCE OF DAMAGE. THE LIGHTER AREA MAY INDICATE AN EARLY ATTEMPT AT RESTORATION.

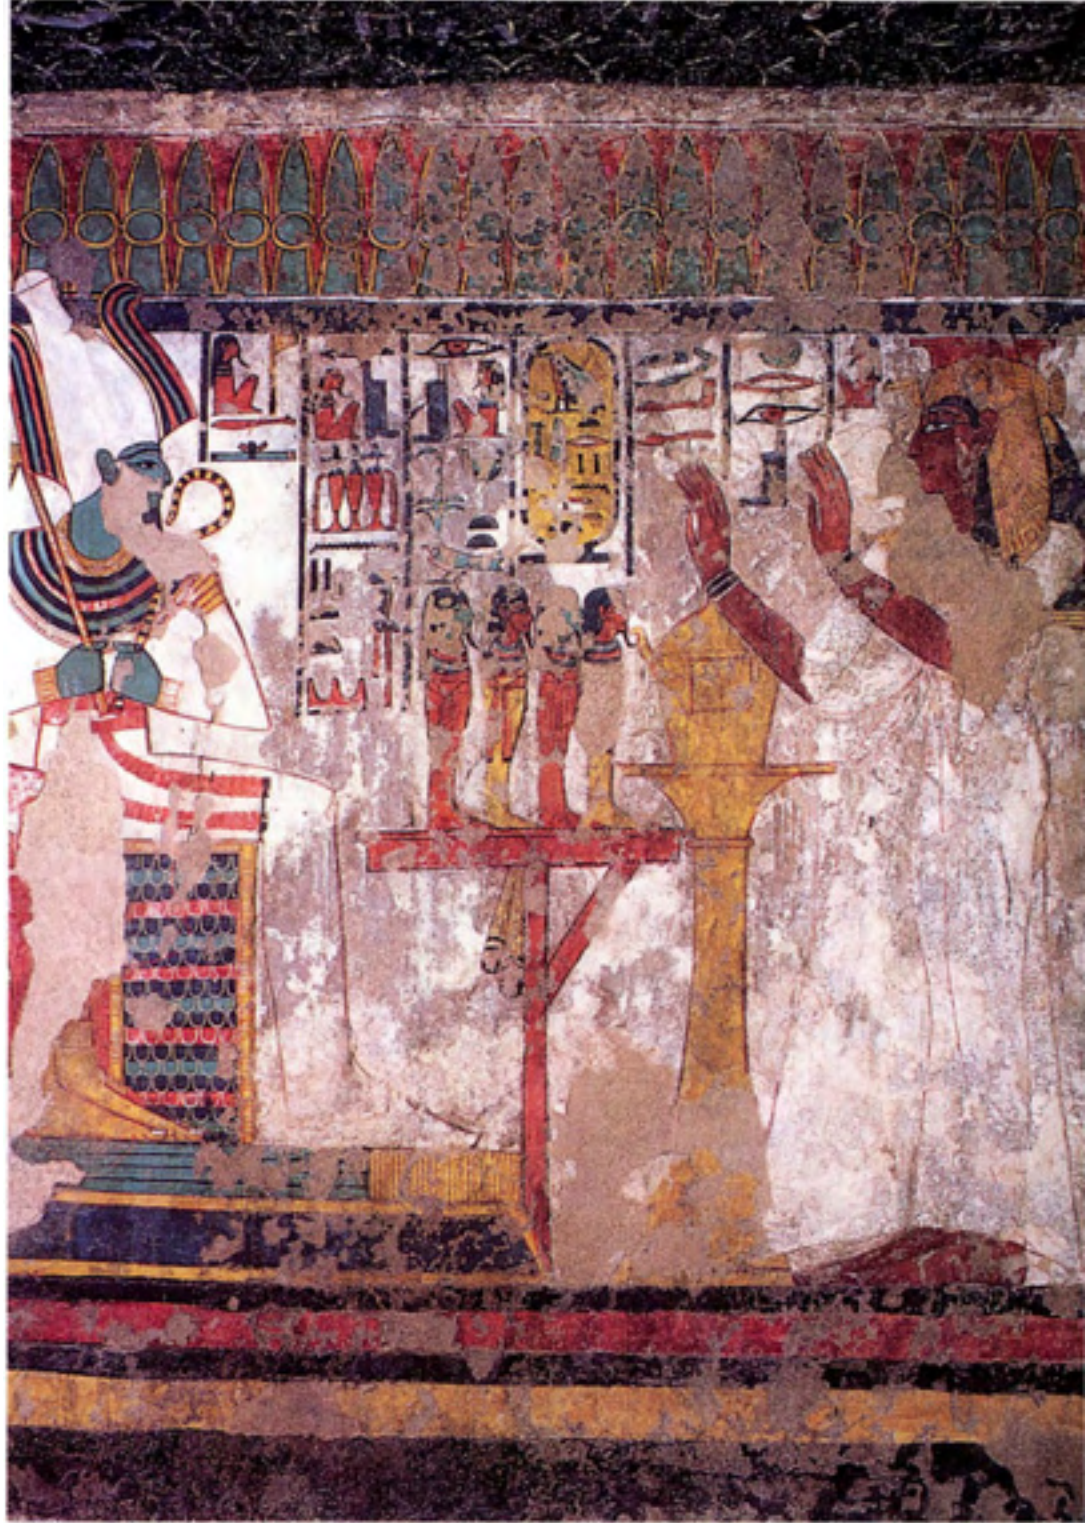
FIGURE 2A, RIGHT. VIEW OF CHAMBER K, NORTH WALL, EAST SIDE, AFTER TREATMENT, SHOWING AREAS WHERE THE CLEANING PROCEDURE WAS EVALUATED. FIGURE 2B, BELOW. DETAIL OF FIGURE 2A BEFORE FINAL TREATMENT.

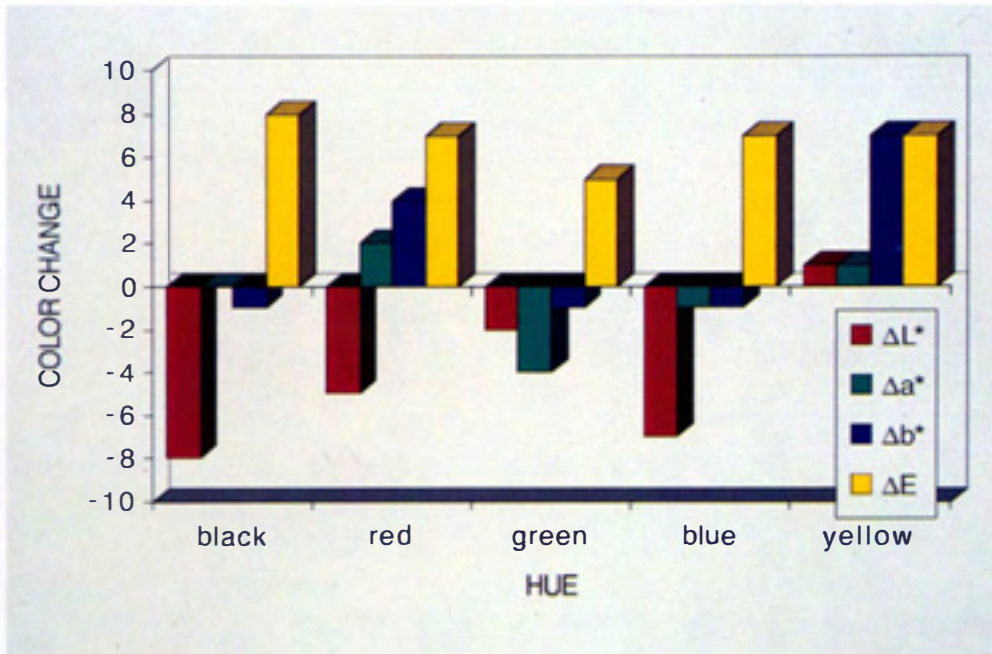
FIGURE 5. BAR GRAPH OF DATA FROM FIGURE 2, SHOWING MAGNITUDE OF COLOR CHANGES DUE TO CLEANING.

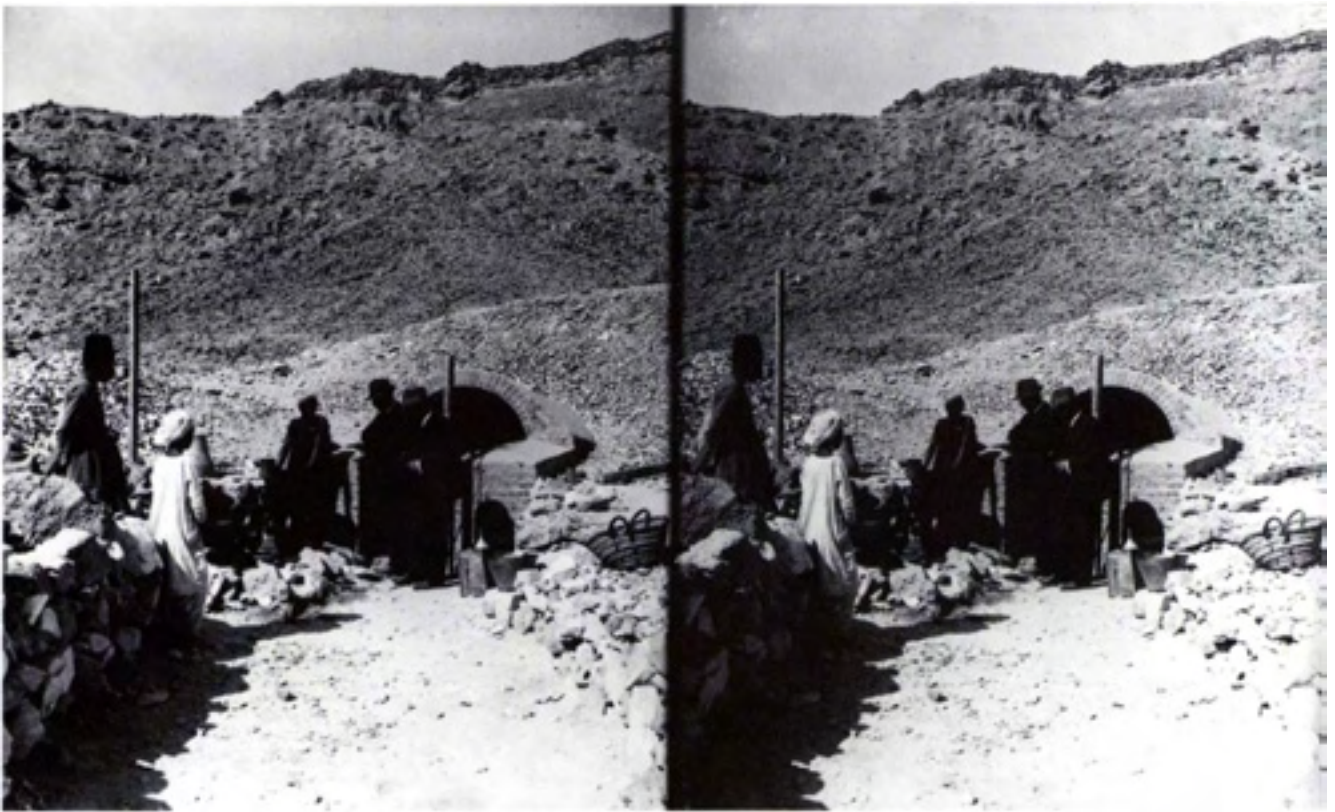
OPPOSITE. PROOF SHEET OF GLASS-PLATE NEGATIVES OF THE TOMB OF NEFERTARI PRODUCED BY E. SCHIAPARELLI, CA. 1904. COURTESY OF THE MUSEO EGIZIO, TURIN.

The earliest record of black-and-white photographs of the tomb of Nefertari is a collection of some 132 glass-plate negatives, taken under Ernesto Schiaparelli’s directorship after his discovery of the tomb in 1904. With the exception of negative E621 which is 20 x 30 inches, details of interior walls are all in a 13 x 18-inch format, while exterior and general views of the site, totaling about twenty images, are 18 x 24 and 20 x 30 inches (Fig. 1). The original plates are housed in the photo archives of the Museo Egizio in Turin and are classified as: *Scavi Schiaparelli—Valle delle Regine e tomba di Nefertari—album 2 e 3*. They were taken by a member of Schiaparelli’s mission,¹ Don Michele Pizzio (Figs. 2, 3),² in collaboration with the Egyptologist Francesco Ballerini (Fig. 4; Schiaparelli 1923). Don Pizzio was also responsible for making the architectural plans, as well as the model of Nefertari’s tomb which is housed in the Museo

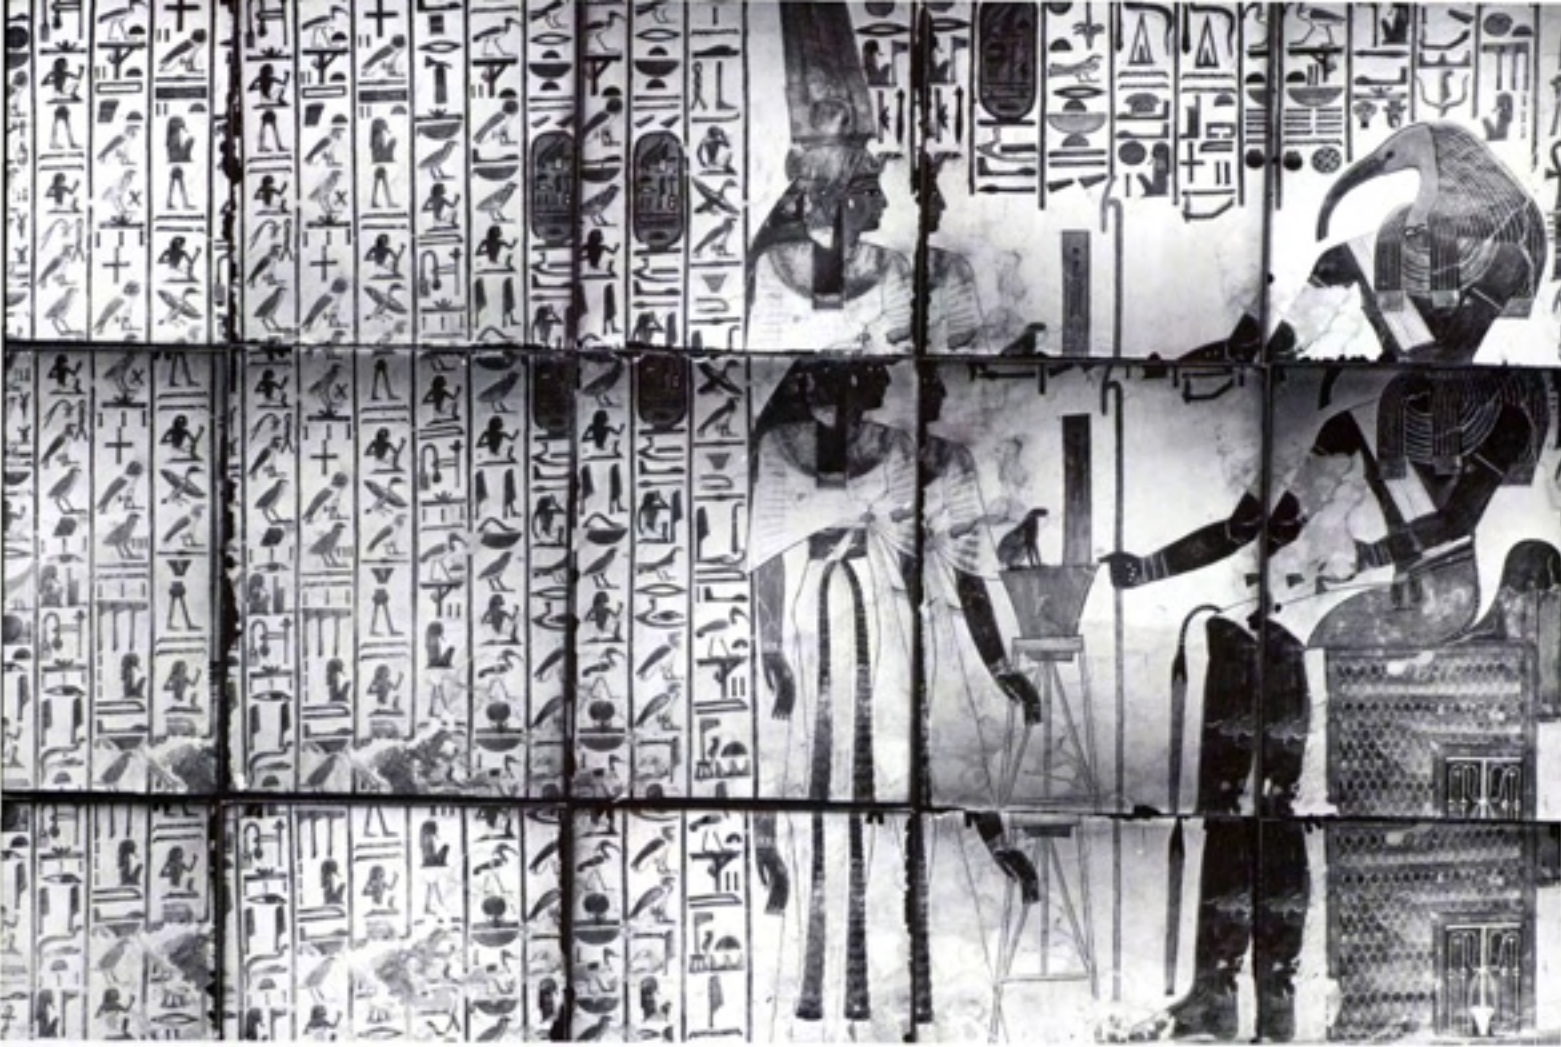
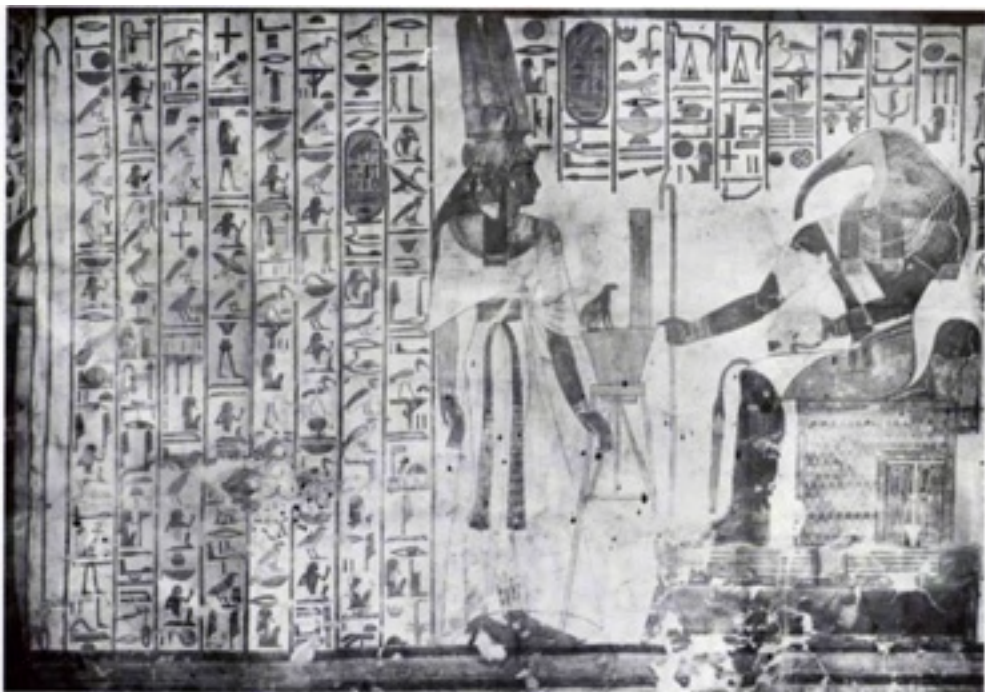
FIGURE 6A, ABOVE. ROBERT MOND'S MOSAIC PHOTOGRAPHS OF THE EAST WALL OF CHAMBER G, CA. 1914–1916.

FIGURE 6B, LEFT. MOND'S RECONSTITUTED PHOTOGRAPH OF THE SAME WALL. PHOTOS: COURTESY OF THE GRIFFITH INSTITUTE, OXFORD UNIVERSITY.
