Original Painting Techniques and Materials Used in the Tomb of Nefertari

STEPHEN RICKERBY

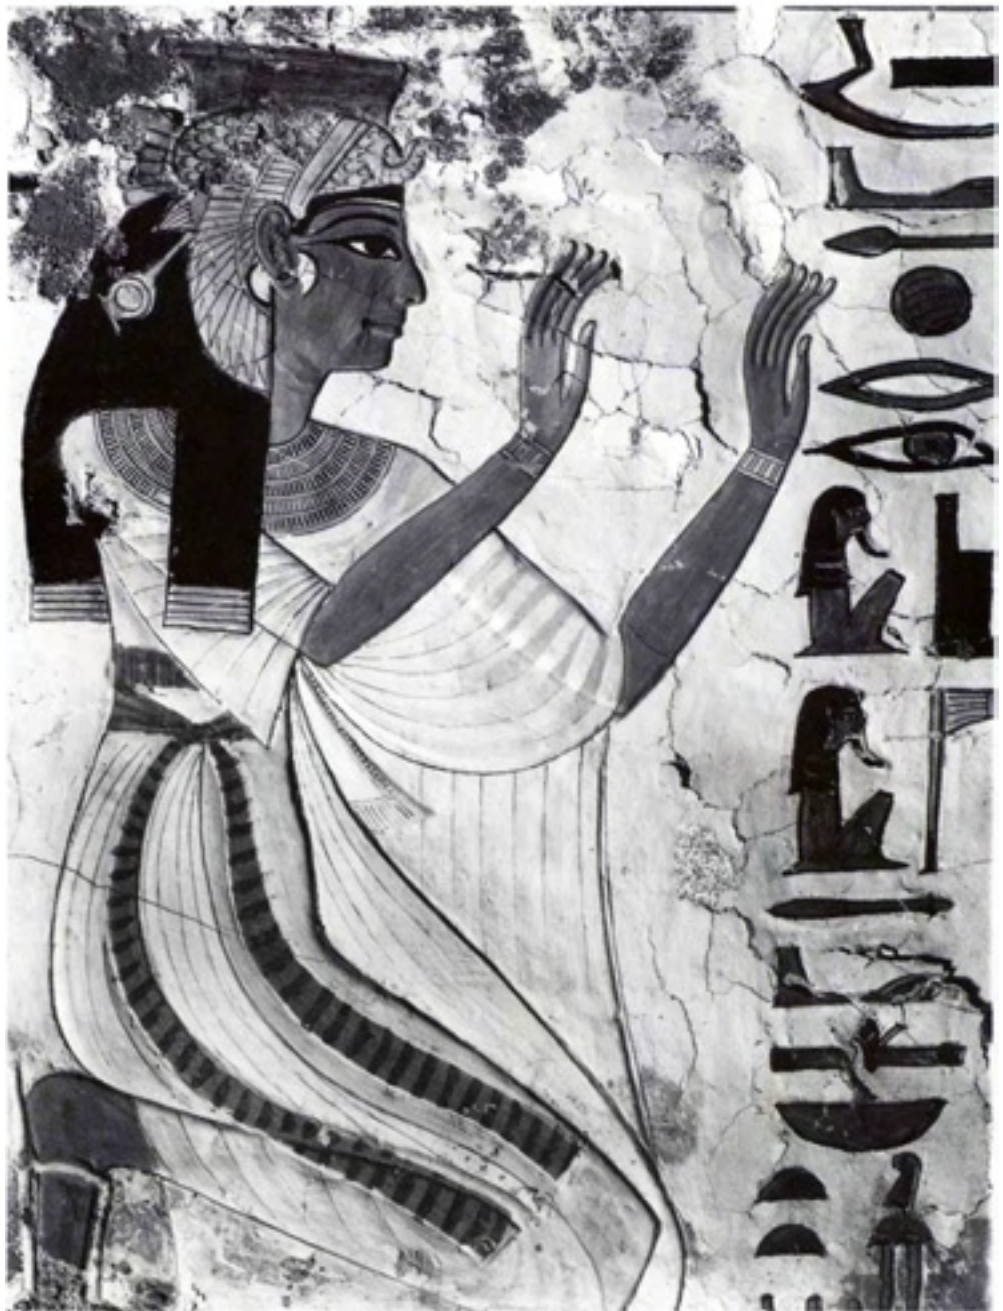
FIGURE 7. DETAIL OF THE SOUTH WALL OF CHAMBER C. BURTON'S PHOTOGRAPHS ARE EXCEPTIONALLY CLEAR RECORDS OF THE CONDITION OF THE WALL PAINTINGS IN THE EARLY 1920S. PHOTO: COURTESY OF THE METROPOLITAN MUSEUM OF ART, NEW YORK.

The Metropolitan Museum of Art's Egyptian Expedition resulted in a collection of more than sixty photographs of exceptional quality taken by another Englishman, Harry Burton, from 1920 to 1923 (Fig. 7). Burton was an experienced fieldworker who had a penchant both for objectivity and aesthetic worth. He was also a proven improviser and is known to have hung blackout curtains in empty tombs which he used as darkrooms! His original 18 x 24-inch glass-plate negatives are stored at the museum's Egyptian Department archives in New York. The exterior photographs are marked M524, M525, and T278. Interior views are marked as follows: 1920/21: T855–874; 1921/22: M4147; and T1038–1078 (Burton 1923).

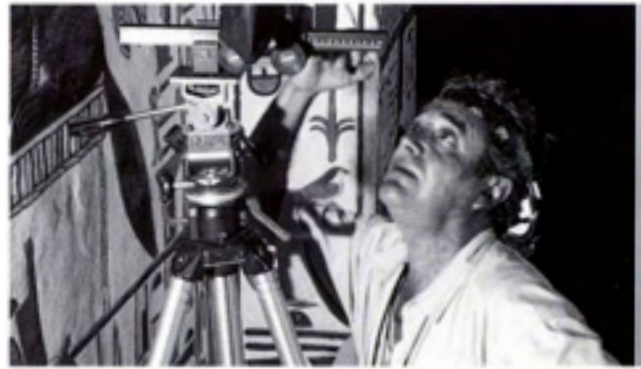
FIGURE 8. ALDANA DOCUMENTED THE NEFERTARI CONSERVATION PROJECT IN MORE THAN 7,000 PHOTOGRAPHS FROM 1986 TO 1992.

film documents the condition of the wall paintings in 1987, and contains related archaeological, historical, and scientific information. Its main focus is the Getty Conservation Institute/Egyptian Antiquities Organization Nefertari conservation project. A short version of the video running about eleven minutes was produced on the occasion of the exhibition *In the Tomb of Nefertari: Conservation of the Wall Paintings*, that opened at the J. Paul Getty Museum on November 12, 1992. The exhibition was a collaborative venture between the Getty Conservation Institute and the J. Paul Getty Museum. Nefertari photographs used for didactic purposes and in the exhibit catalogue were the work of the Mexican photographer Guillermo Aldana, who was also responsible for the full-scale photographic reproduction of chamber G displayed at the exhibit (*In the Tomb of Nefertari* 1992; Fig. 8).

As an integral part of the Getty Conservation Institute’s conservation project, Aldana has produced the most extensive and systematic collection of photographic documents of the Nefertari wall paintings to date. The documentation covers the conservation problems—including past restorations—as well as the methods and techniques used by the GCI conservation team throughout the six years. Taken together with the earlier historic photographs, these sources provide invaluable data regarding the kind and quality of damage sustained by the wall paintings over the eighty years that separate the tomb’s discovery and the recent conservation of its wall paintings.

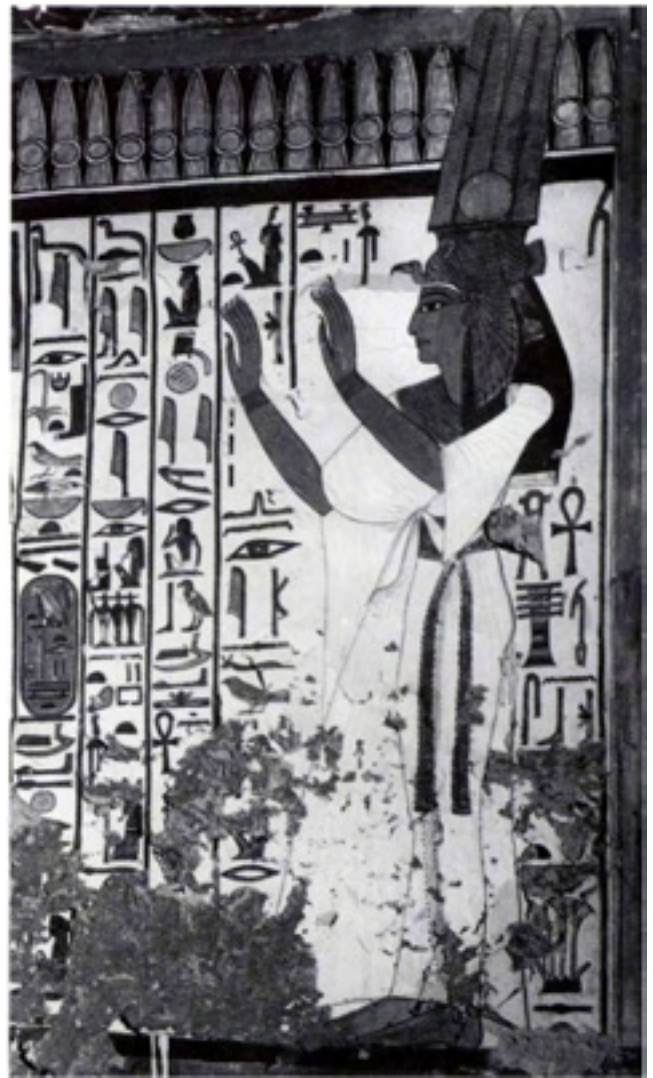
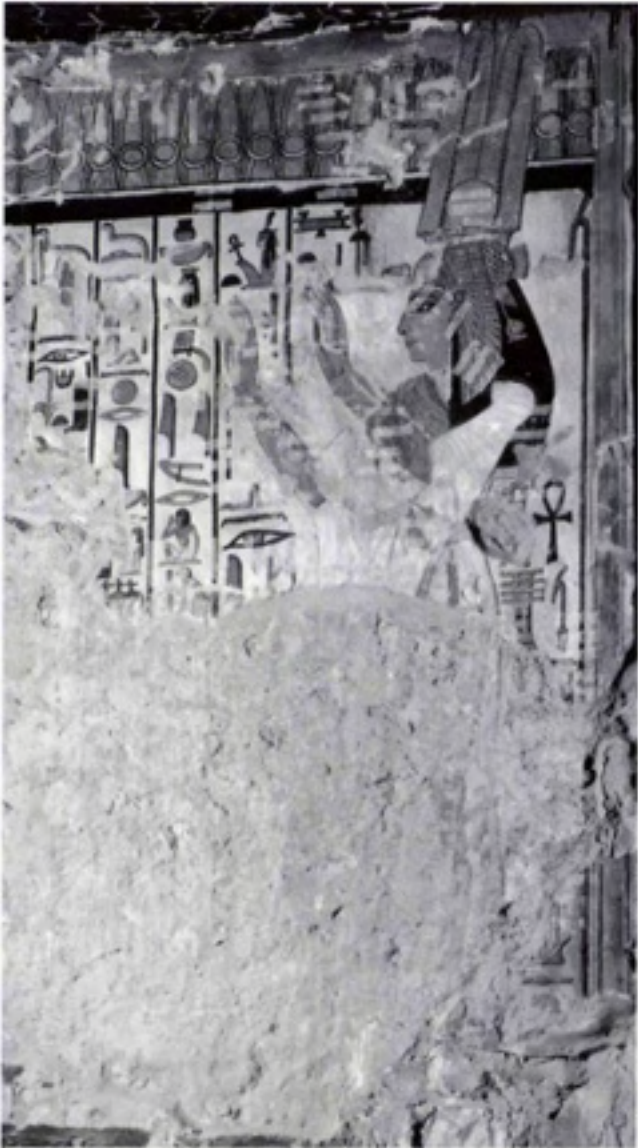
CHAMBER K, SOUTH WALL, EAST SIDE. ABOVE, SCHIAPARELLI MISSION, CA. 1904. OPPOSITE, EAO-GCI PROJECT, CA. 1989. PHOTOGRAPHS ARE A RICH SOURCE OF INFORMATION ON THE RATE AND TYPES OF DETERIORATION.

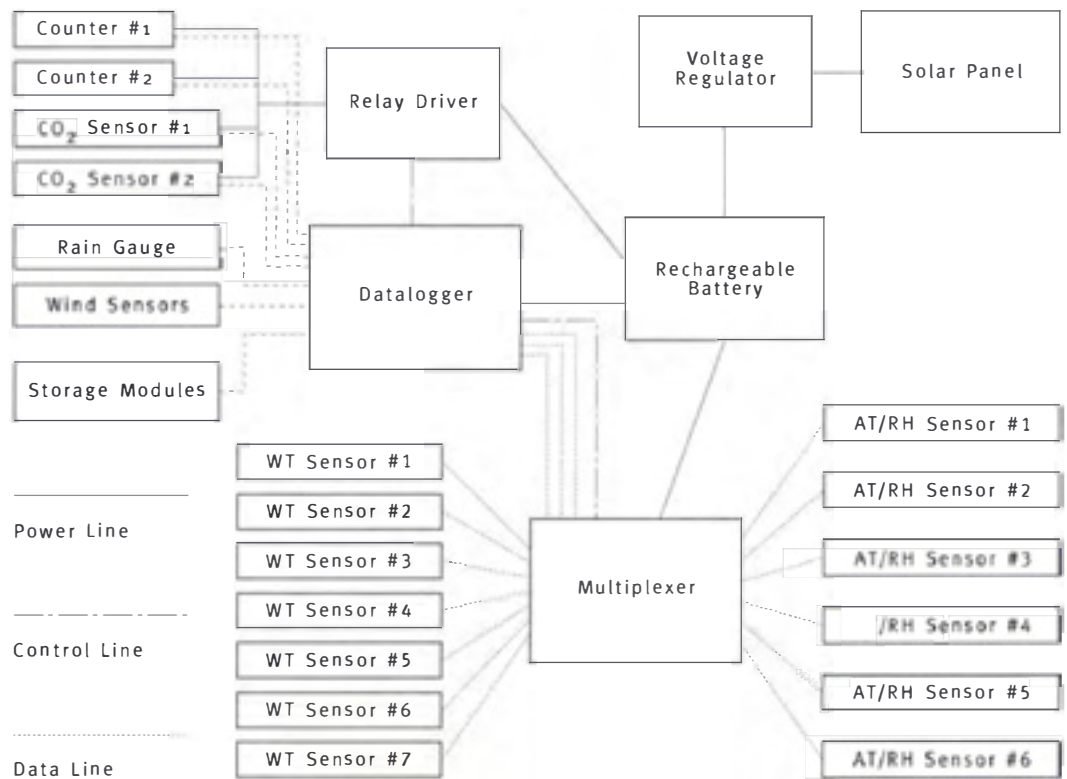
FIGURE 2. SCHEMATIC OF THE ENVIRONMENTAL MONITORING SYSTEM.

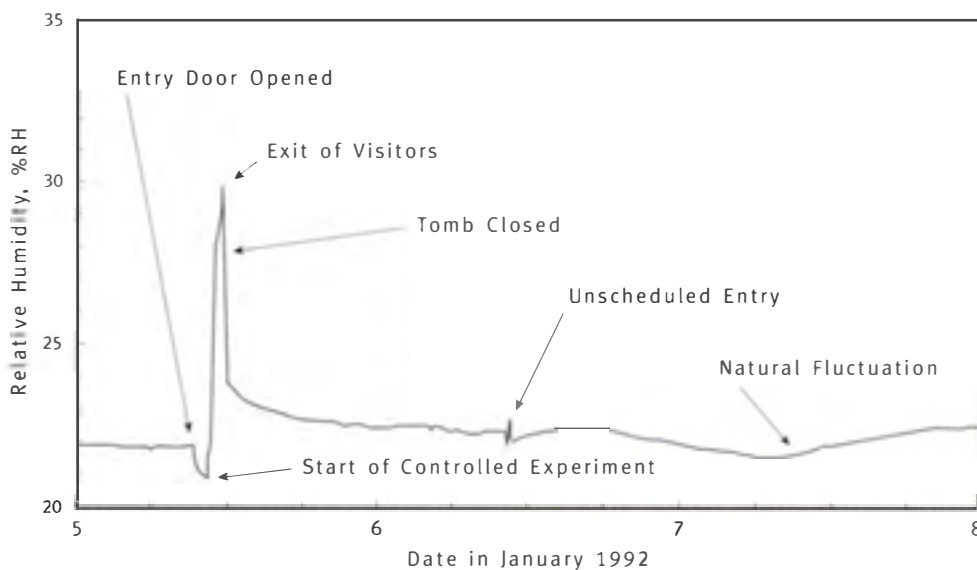
FIGURE 16, BELOW. RELATIVE HUMIDITY DECAY IN THE BURIAL CHAMBER IN WINTER.

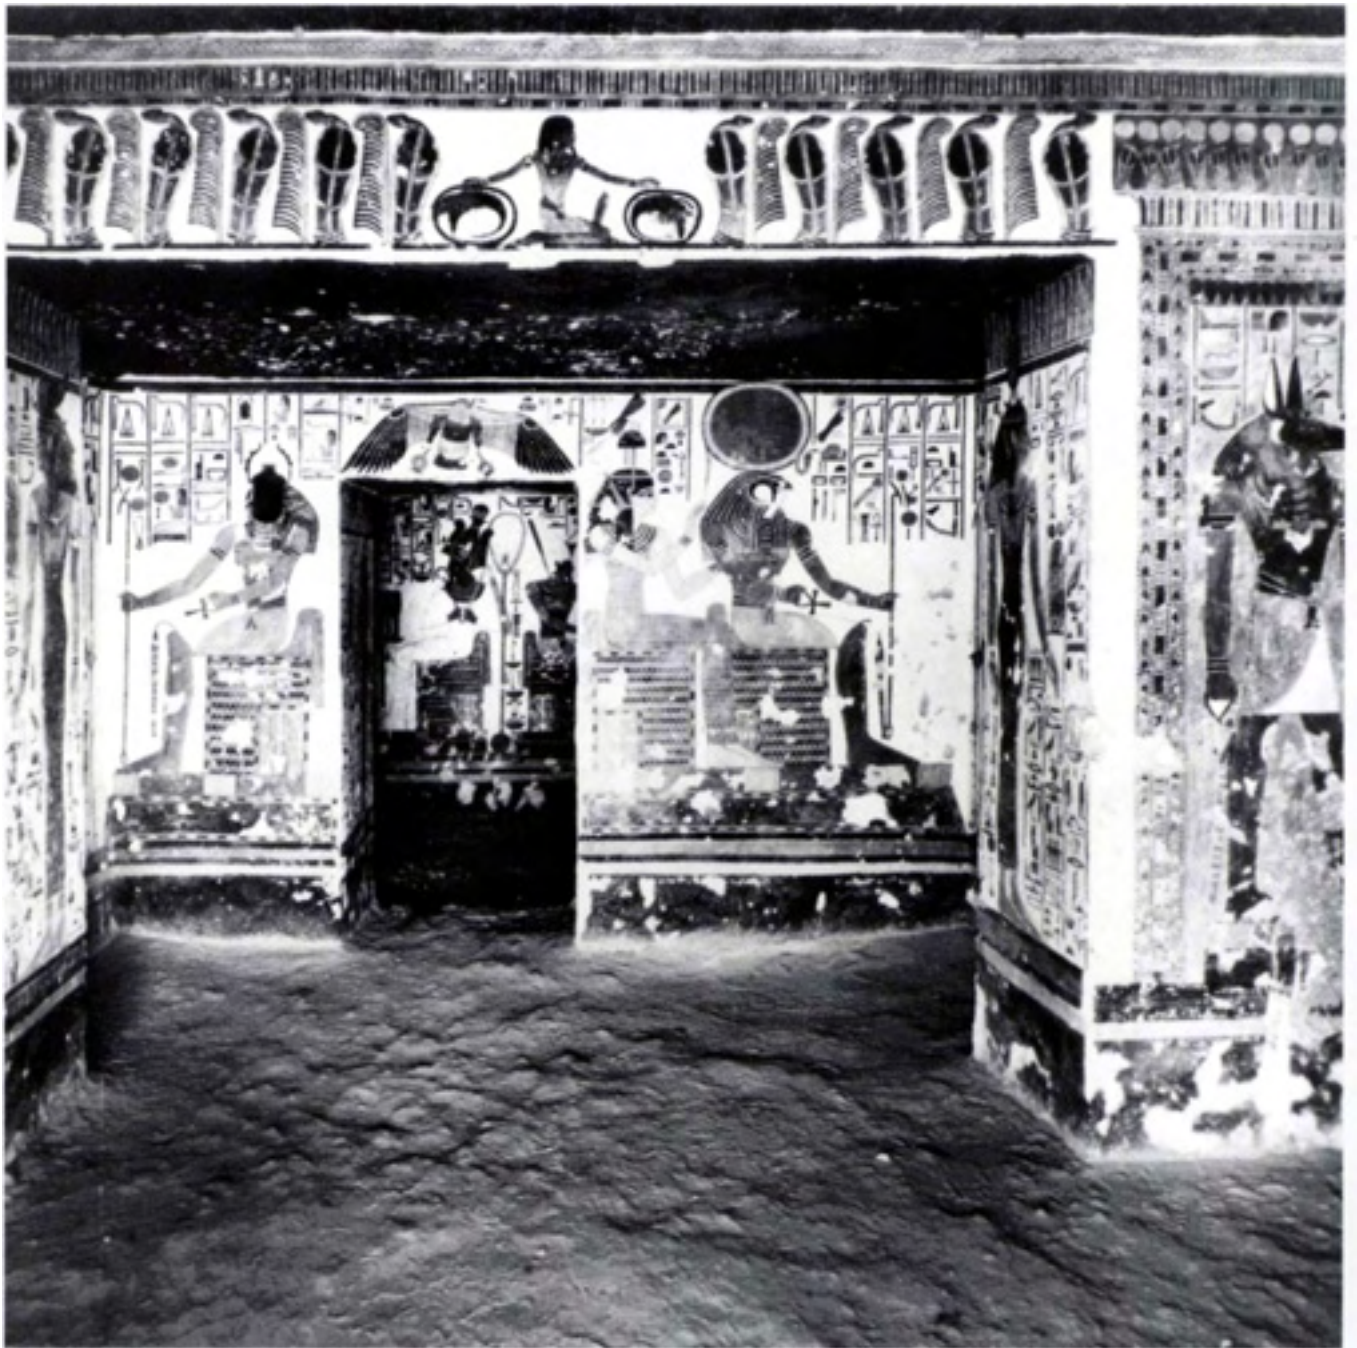
CHAMBER E, SHOWING THE STATE OF THE TOMB PAINTINGS IN THE EARLY 1920S WHEN THEY WERE PHOTOGRAPHED BY H. BURTON. PHOTO: COURTESY OF THE METROPOLITAN MUSEUM OF ART.
