# Low-Cost and Low-Tech Reinforcement Systems for Improved Earthquake Resistance of Mud Brick Buildings

*Dominic M. Dowling and Bijan Samali*

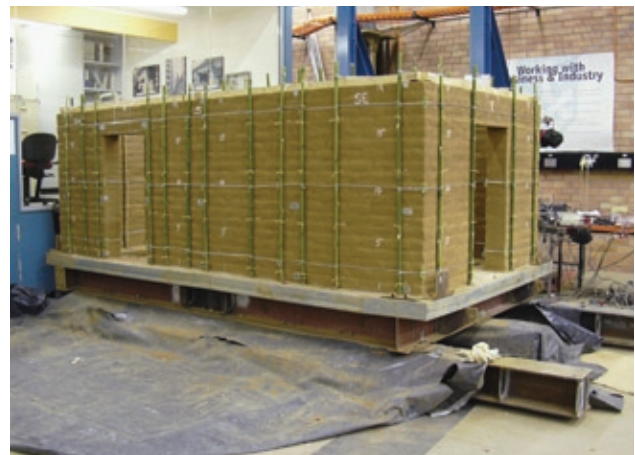
FIGURE 2 Model house 4A prior to testing; south and east walls are visible.

A model house (1:2 scale) was constructed, retrofitted, and tested on the UTS shake table (fig. 2). Its dimensions were  $3.53 \times 1.84$  m ( $11.6 \times 6.0$  ft.), with a wall thickness of 0.15 m (5.9 in.) and a height of 1.2 m (3.9 ft.). The model house featured two doors and one window; the direction of shaking was north–south, perpendicular to the long walls.

The sequence of construction and retrofitting of the model house was: (1) construct unreinforced house and allow to dry; (2) mark and drill holes in rows at top, middle, and bottom of each wall; (3) insert polypropylene string loops through holes; (4) fill holes with mud, allow to dry; (5) place timber ring/crown beam on top of wall and connect with bamboo dowels

and wire; (6) place external vertical bamboo (inside and outside house), tied with through-wall polypropylene string ties; (7) place and tension galvanized fencing wire horizontally between bamboo poles (top, middle, and bottom); and (8) connect bamboo poles and ring beam with wire loops.

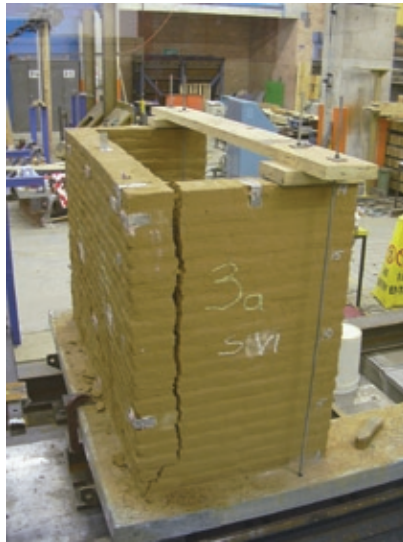
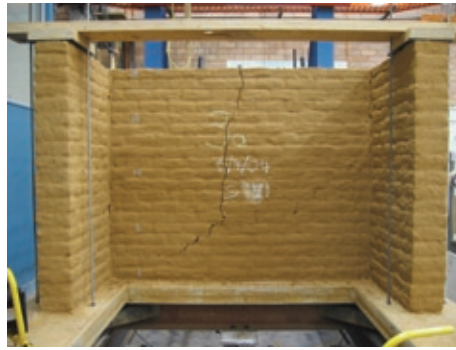
FIGURES 3A AND 3B Specimen 3A after simulation S6 (75%). The in-plane wall and corner connection (a) and the out-of-plane wall (b) are shown.

Specimen 3A represented a common, unreinforced adobe structure. Sudden, brittle failure occurred during the moderate, 75% intensity simulation, S6 (figs. 3a and 3b). The primary failure modes for the unreinforced

specimen 3A (and lightly reinforced specimens 3B, 3C, and 3D) were: (1) vertical corner cracking at the intersection of orthogonal walls; (2) midspan vertical cracking in the out-of-plane long wall; and (3) horizontal and diagonal cracking in the out-of-plane long wall, with a propensity for overturning of the affected panel. These damage patterns are consistent with common damage to real houses subjected to real earthquakes. This feature confirms that the selected specimen configuration, boundary conditions, and input spectra

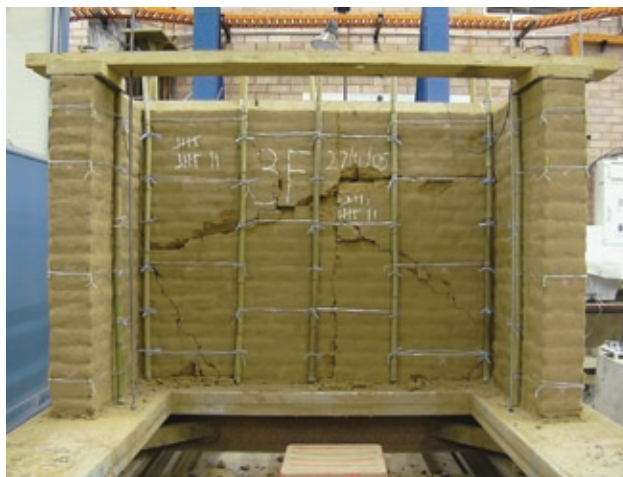
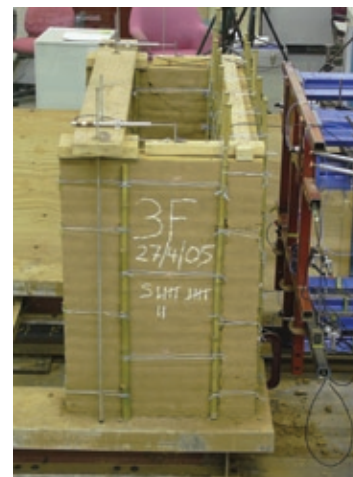
FIGURES 4A AND 4B Specimen 3F after simulation S12 (100% repeated). The out-of-plane wall (a) and the in-plane wall and corner connection (b) are shown.

Specimen 3F was built as a common, unreinforced structure (as was specimen 3A); it was then retrofit-strengthened with external vertical bamboo poles, external horizontal fencing wire, and a timber ring beam (using the same procedure as described above for the model house). Specimen 3F performed extremely well. The reinforcement system was

observed to delay the onset of initial cracking and reduce the severity of cracking, even during the series of high-intensity simulations (figs. 4a and 4b).

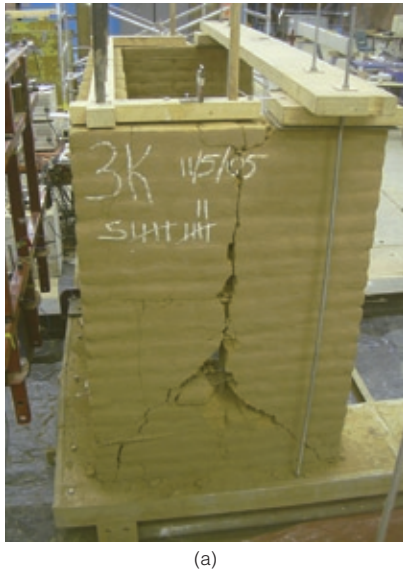
FIGURES 5A AND 5B Specimen 3K after simulation S12 (100% repeated). The in-plane wall and corner connection (a) and the out-of-plane wall (b) are shown.

Specimen 3K included internal vertical reinforcement (25 mm [1 in.] diameter timber broom poles), plus internal horizontal chicken wire mesh reinforcement. This method and derivations thereof have been widely promoted as an effective earthquake strengthening

Concerns also exist about the durability of the natural materials commonly used as internal vertical reinforcement (e.g., bamboo, reeds, timber), which cannot be checked or replaced when encased in the structure. Despite these practical limitations, specimen 3K performed well during testing (figs. 5a and 5b). The reinforcement acted to reduce the severity of cracking, although it was observed that the internal vertical poles introduced discontinuities to the structure, evidenced by vertical cracking concentrated

around the location of the vertical poles. This feature may be attributed to a difference in dynamic response between the stiff adobe wall and the flexible timber poles, as well as the reduced cross-sectional area of the wall around the poles.

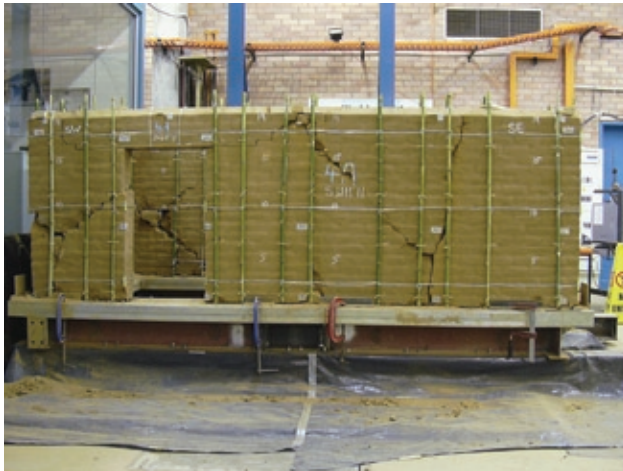
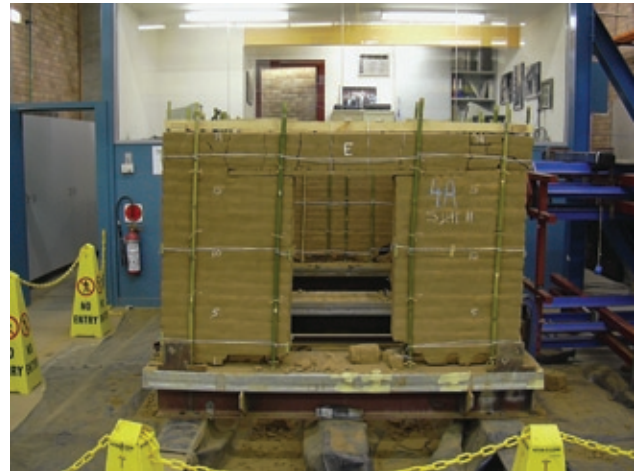
FIGURES 11A AND 11B Model house 4A: damage after simulation S8 (shakedown). The south wall (a) and the east wall (b) are shown.

house 4A increased during subsequent simulations. Figures 11a and 11b show the condition of the house after simulation S8 (shakedown). Despite being severely damaged, the structure resisted collapse, even after the series of severe earthquake tests.

The reinforcement system acted as a netting to contain the structure, even after significant damage. Cracking was distributed around the structure, with major damage occurring around the window and door openings. Vertical cracking at the corner intersections was largely prevented. This represents a major positive

outcome, as one of the main failure modes of adobe houses is vertical corner cracking, which often results in the overturning of the walls and the collapse of the roof (as discussed above). There was no evidence of failure or breaking of the bamboo, string, or wire during testing.
