“To Do No Harm”: Conserving, Preserving, and Maintaining Historic Adobe Structures

Steadie R. Craigo

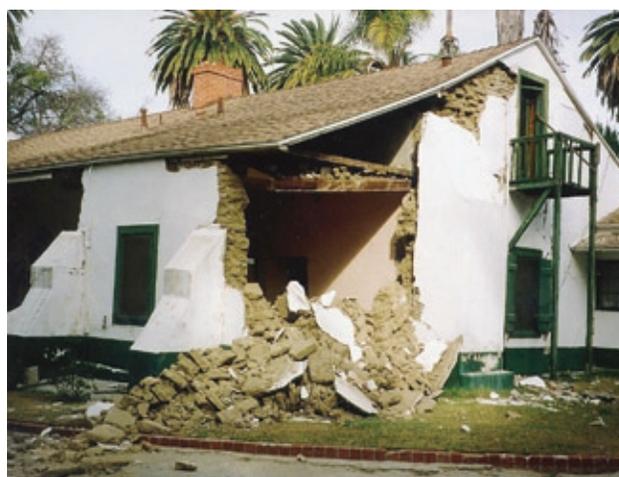
FIGURE 1 Main House, Rancho Camulos, damaged during the 1994 Northridge earthquake. Photo: E. Leroy Tolles, ELT and Associates.

Adobe is one of the most natural and organic of building materials. Simple earthen structures can last centuries with appropriate maintenance and repair. Unfortunately, efforts to enhance seismic resistance can be invasive, jeopardizing the material integrity and authenticity of historic adobe structures. In seismic-prevalent regions, such as California, there is a need to retain these important historic buildings and to improve the seismic resistance of the structures (fig. 1).

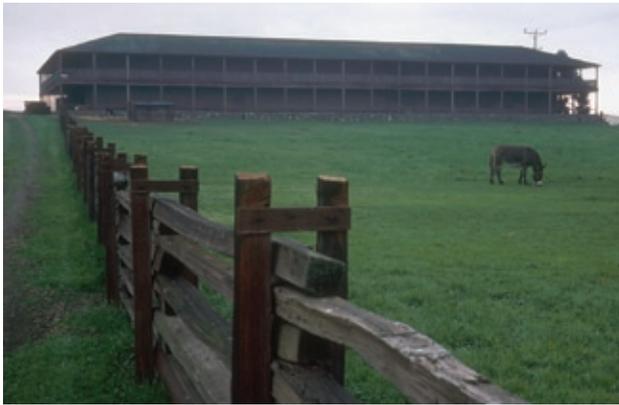
FIGURE 2 Petaluma Adobe State Historic Park. This large two-story adobe residence was the central feature of General Mariano G. Vallejo’s rancho outside of Sonoma, California, the town that he founded. It was one of the largest and most important private ranchos in Alta California. Photo: California State Parks, © 1969.

(towns), *asistencias* (sub-missions), and, later, *ranchos* (ranches). The structures were largely constructed of adobe, although some fired brick and stone materials were also used. Following secularization of the churches by Mexico in 1834, after independence was won from Spain, the mission lands were mostly divided into private ranchos (e.g., fig. 2).

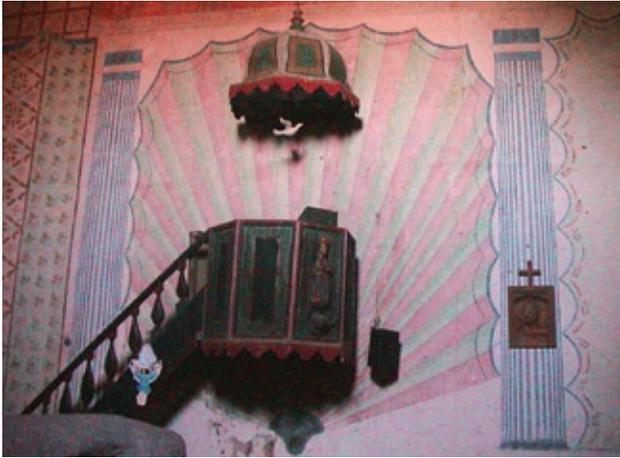
FIGURE 3 Interior of Mission San Miguel Chapel after the 2004 San Simeon earthquake. The decorative interior wall finishes were badly damaged. Photo: E. Leroy Tolles, ELT and Associates.

In the United States, the term *conservation* is more narrowly defined. As the narrative at the Colonial Williamsburg Research Division Web site (no longer available) stated, “the field of architectural conservation emerged out of the historic preservation movement as a new and distinct discipline in the late 1960s.” Considered a subset of the field of historic preservation, conservation is closely allied with object or art conservation, with a focus on material science and preservation theory. Architectural or material conservation is considered to be treatment of building fabric and elements, including the stone foundations, clay roof tiles, adobe walls, and earthen coatings of historic adobes (figs. 3 and 4).

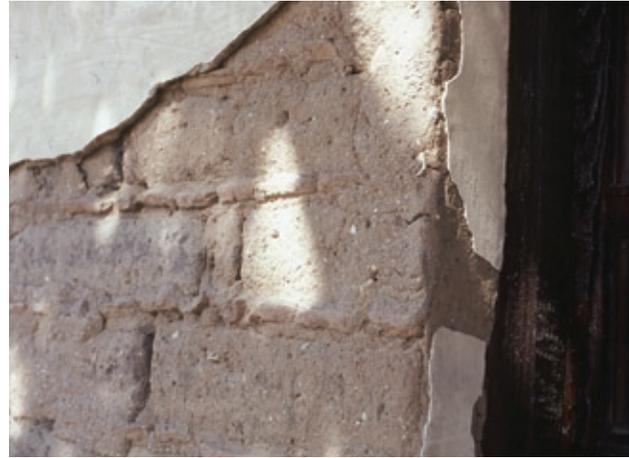
FIGURE 4 Adobe garden wall at Cooper-Molera State Historic Park, Monterey, California. Freestanding adobe structures are difficult to maintain and retrofit seismically.

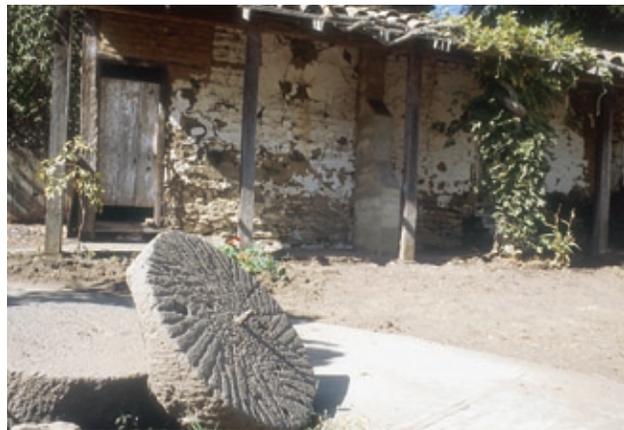
FIGURE 5 Don Jose Antonio Bolcoff Adobe, ca. 1840, Wilder Ranch State Park, near Santa Cruz, California. The Bolcoff Adobe's deteriorated condition is the result of deferred maintenance. Photo: California State Parks, © 1988.

ance clearly reveals some physical deterioration (fig. 5). The current historic appearance would be challenging, if not impossible, to retain if the building materials were properly conserved.

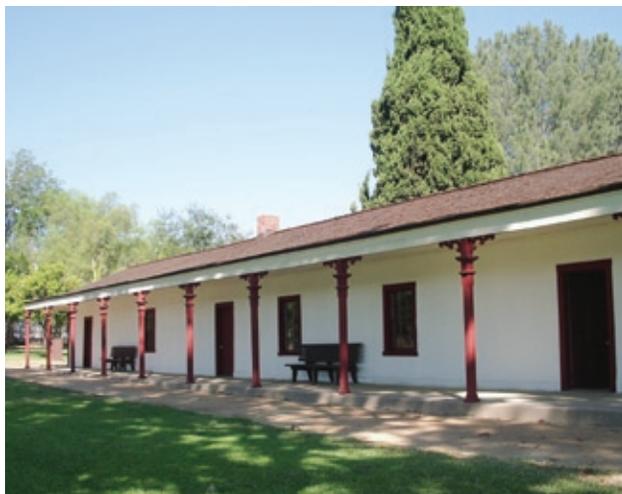
FIGURE 6 Exterior of de la Ossa Adobe, Los Encinos State Historic Park, Encino, Los Angeles. The adobe was damaged by the 1994 Northridge earthquake. Photo: Courtesy of Karen Hildebrand, California State Parks.

The de la Ossa Adobe, now part of Rancho Los Encinos State Historic Park, was constructed about 1849 in the San Fernando Valley area of Los Angeles (fig. 6). The adobe was heavily damaged during the 1994

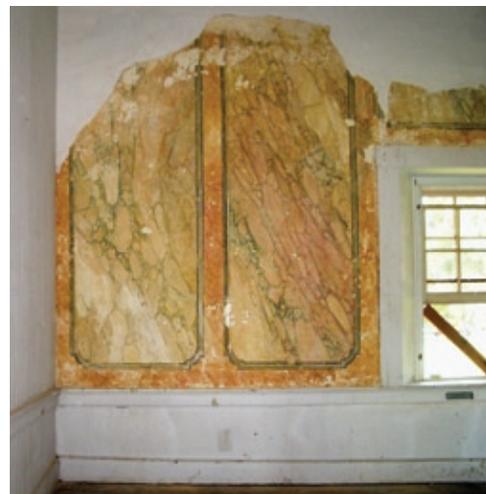
FIGURE 7 Conserved *sala* wall, de la Ossa Adobe, Los Encinos State Historic Park. This decorated surface was discovered beneath later paint layers. Photo: Courtesy of Karen Hildebrand, California State Parks.

Northridge earthquake. An interior faux stone wall treatment was discovered during the planning process for the adobe’s repair and seismic retrofit work (fig. 7). While inspecting the earthquake-damaged interior wall surfaces, State Archaeologist Karen Hildebrand and the project architect, Senior Architect Maria Baranowski, both of California State Parks, noticed varying colors in a deep crack that had exposed wall layers in Room 4B, the former *sala*. Conservation scientist Frank Preusser examined the room and found that the walls of the entire *sala* had been decorated in this manner during the ownership of the Garnier brothers. Conservator Molly Lambert performed the conservation work.

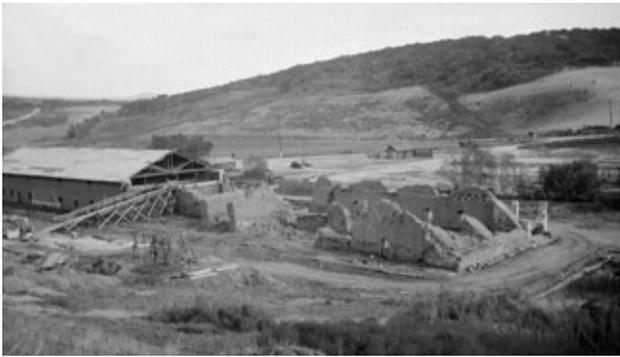
FIGURE 8 The Convento of La Purisima Mission, Lompoc, California, in 1935. The structure was in ruins prior to reconstruction by the Civilian Conservation Corps. Photo: Courtesy of California State Parks, 2007.

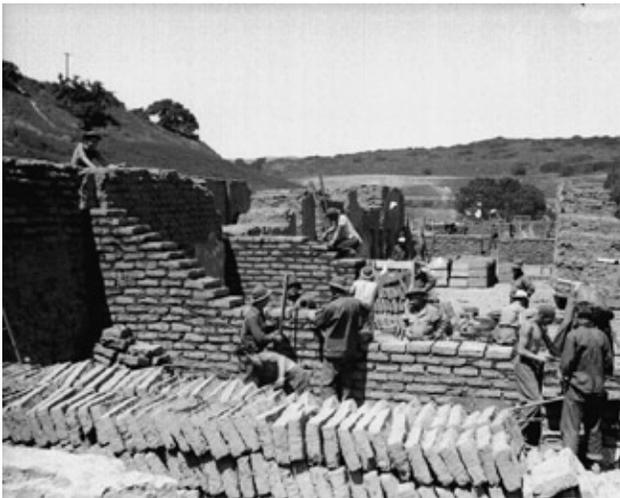
FIGURE 9 The Convento of La Purisima Mission, under reconstruction in 1935. The Civilian Conservation Corps documented building materials and structural work photographically. Photo: Courtesy of California State Parks, 2007.

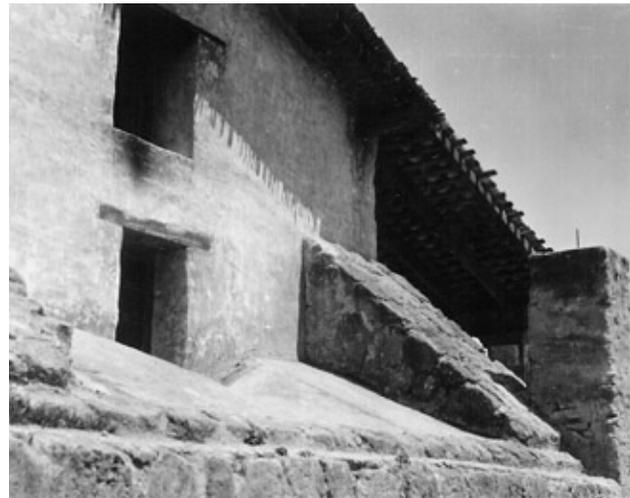
FIGURE 10 The southwest end of the Convento of La Purisima Mission, after reconstruction, ca. 1937. Note the buttresses in photos prior to and after reconstruction (compare fig. 8). Photo: Courtesy of California State Parks, 2007.
