DATA MANAGEMENT: ANALYZING INFORMATION

Structural Assessment

Gorun Arun

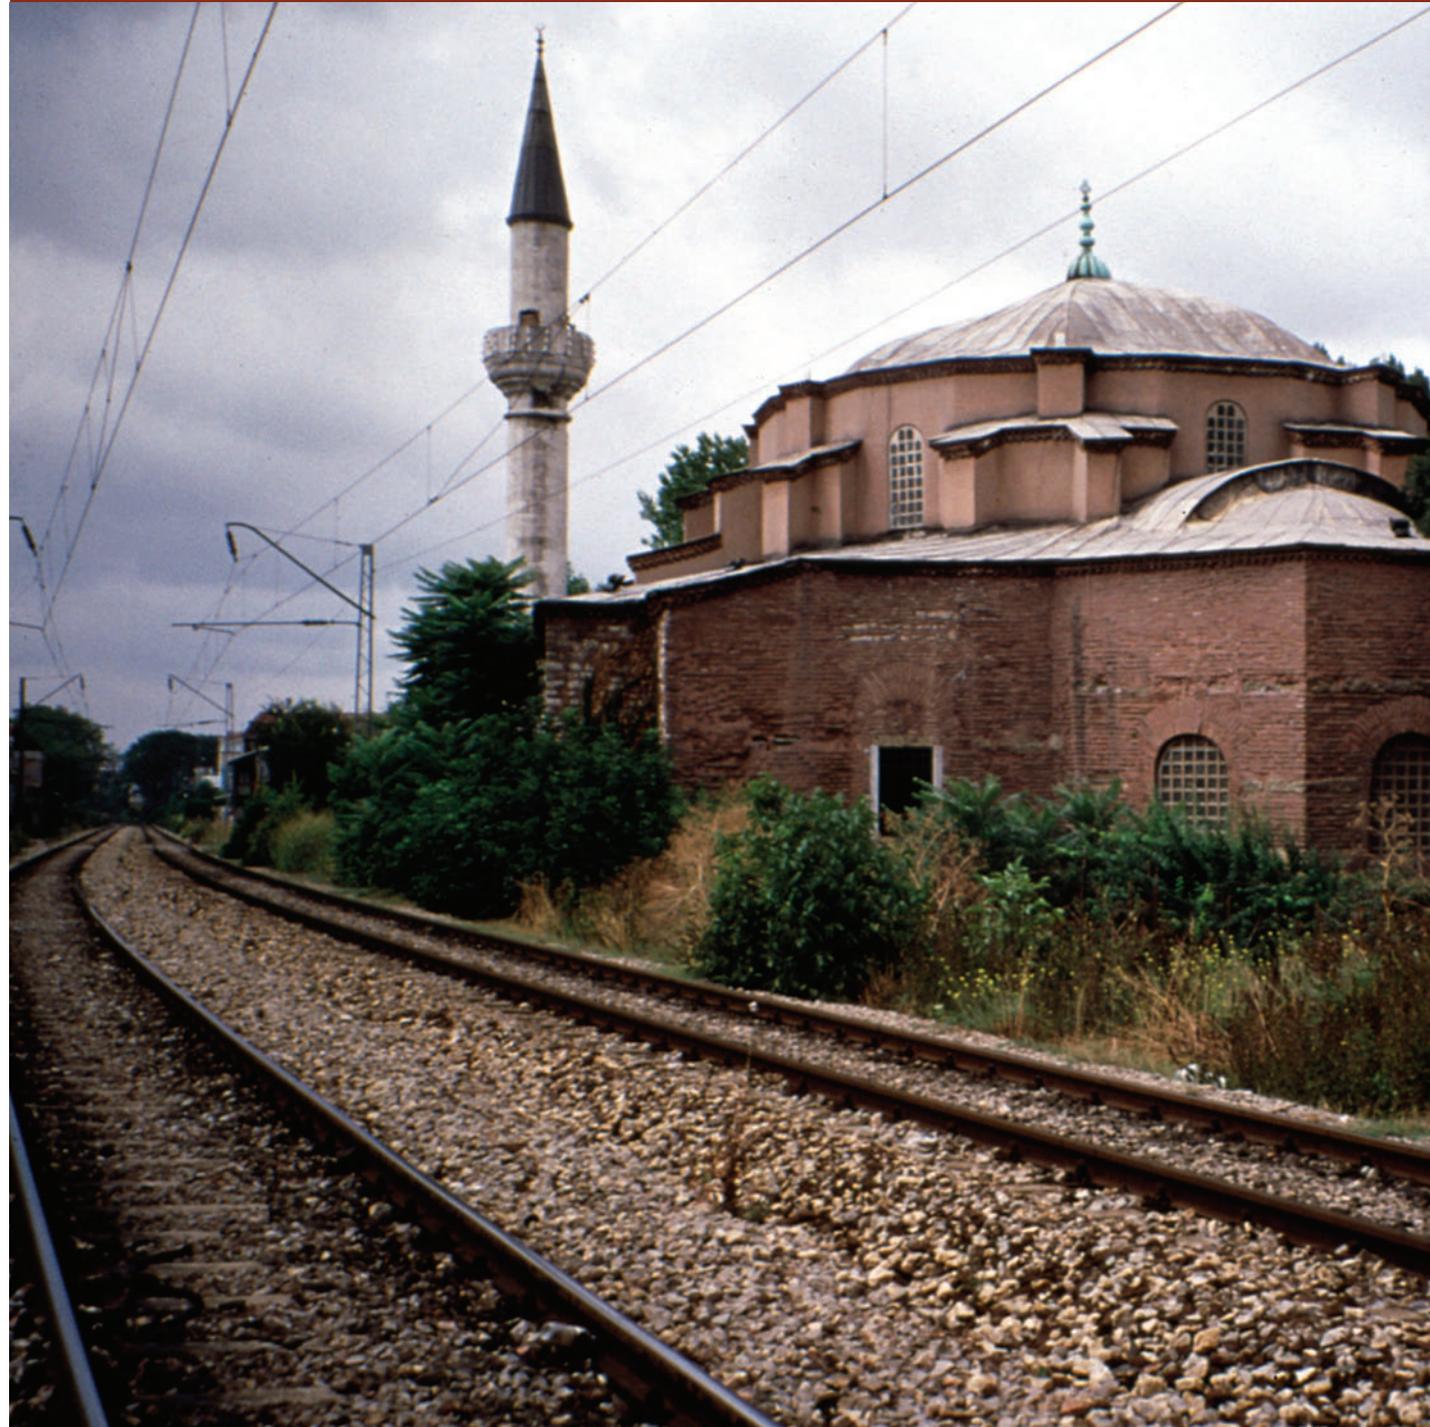
Küçük Ayasofya Mosque, in Istanbul, showing the railroad tracks in the foreground. The active tracks are only 5 meters from the building. Photo: © World Monuments Fund.

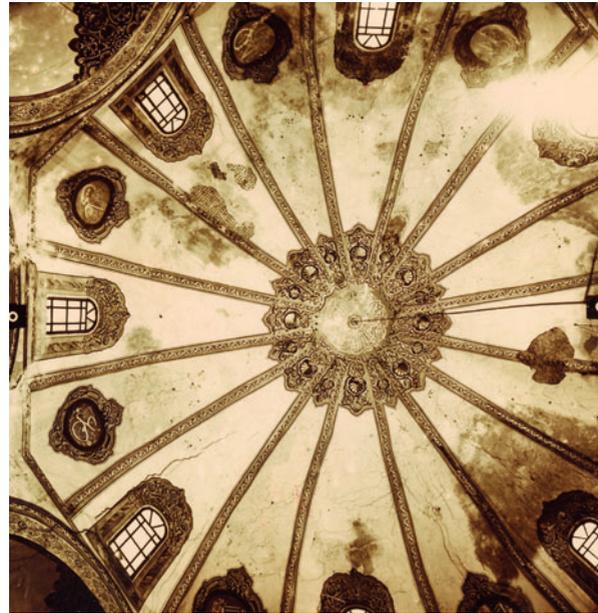
A pair of stereographs of the dome, taken looking straight up. Note the large number of cracks. Photo: A. Alkiş © Küçük Ayasofya Project.

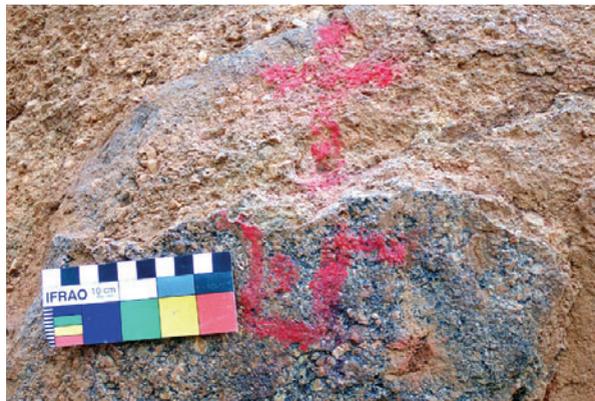
Red graffiti obscuring rock art at Uluru.
Photo: © Mick Starkey.

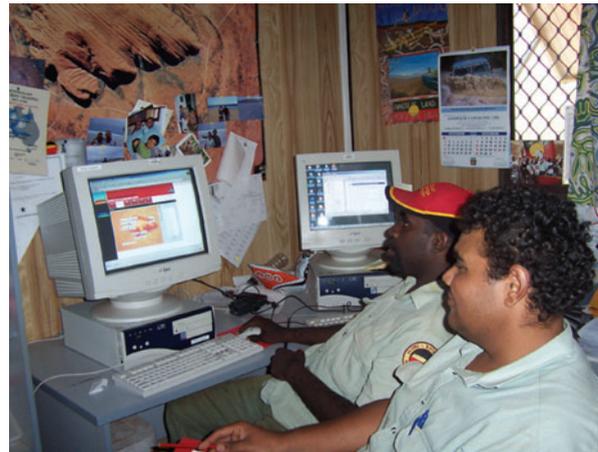
A team member (*foreground*) instructing an Anangu park ranger on the use and management of the database system.
Photo: © Mick Starkey.

A cultural site management system (CSMS) was built upon Microsoft Access, a common database software program. The database used at Uluru is a collection of various types of data, including photographic images, sketches and measurements, condition assessments, and other pieces of information stored in a systematic way for security and easy retrieval. Individual records or data are separated into sets, themes, and fields, with unique identifiers to allow the data to be linked together and queried in various ways. The database can connect the separate pieces of information together. For example, in all photographs the names of the people depicted are included so that data can be searched by name. This may appear unimportant, but under tjukurpa, images of deceased people cannot be seen during mourning; when appropriate, any material related to these individuals can be moved to the “sorry box”—an area of the database where information is unavailable for retrieval—until it is approved for release.

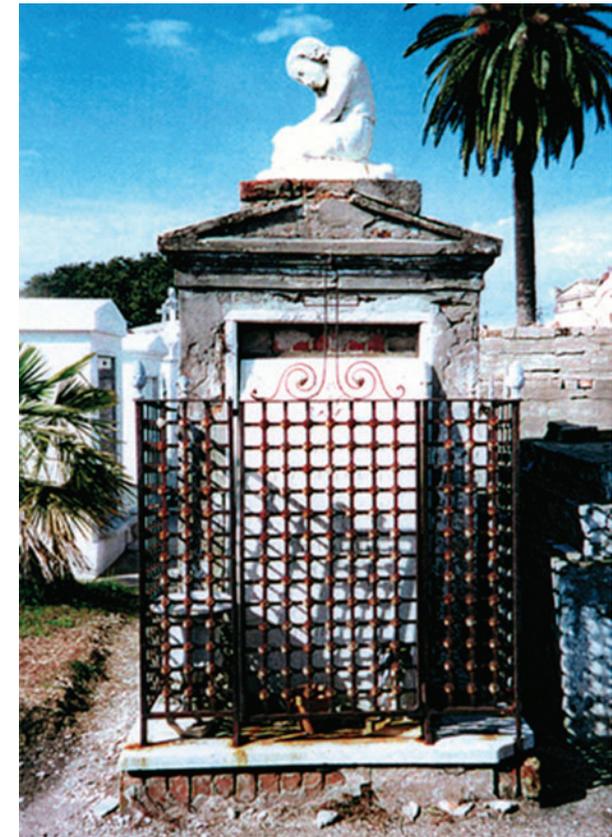
The Bergamini tomb, dated 1865, showing areas of loss as well as soiled and weathered marble. Photo: Frank Matero
© University of Pennsylvania Architectural Conservation Laboratory.

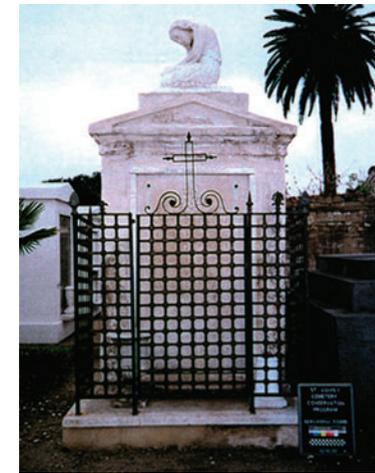
The Bergamini tomb, after restoration. The masonry and associated stone and metalwork were stabilized and conserved. Photo: Frank Matero © University of Pennsylvania Architectural Conservation Laboratory.

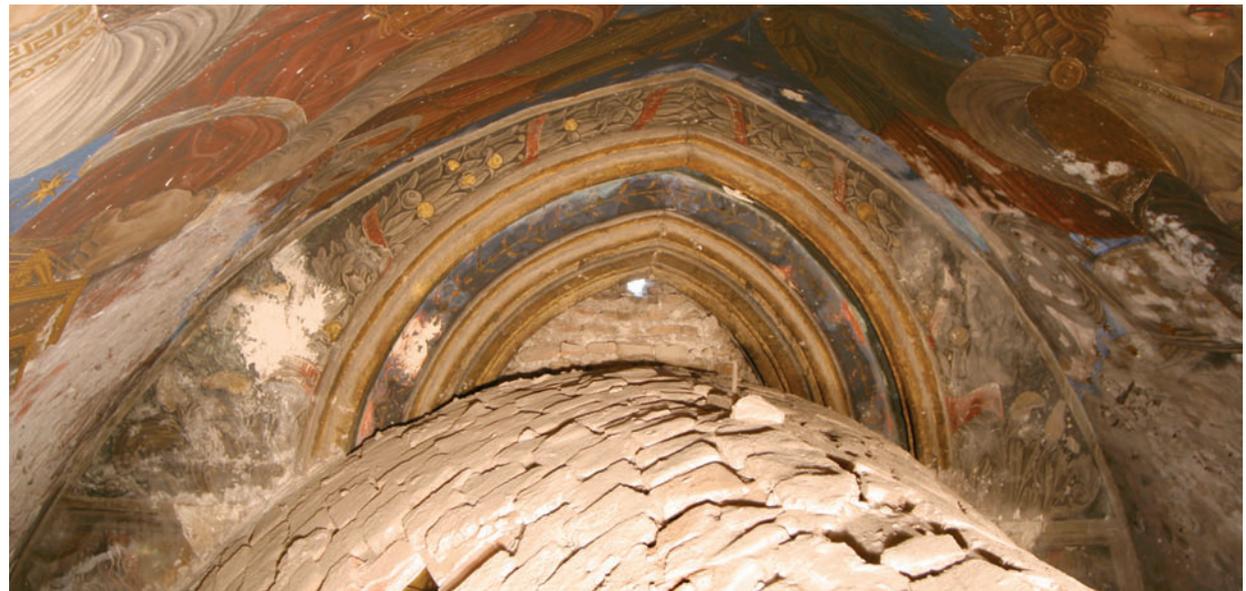
The void between the domes inside the cathedral. The space was too narrow to view the paintings in their entirety. A camera inserted into the space was able to capture multiple details for later compositing of the entire scene.
Photo: © José Luis Lerma.

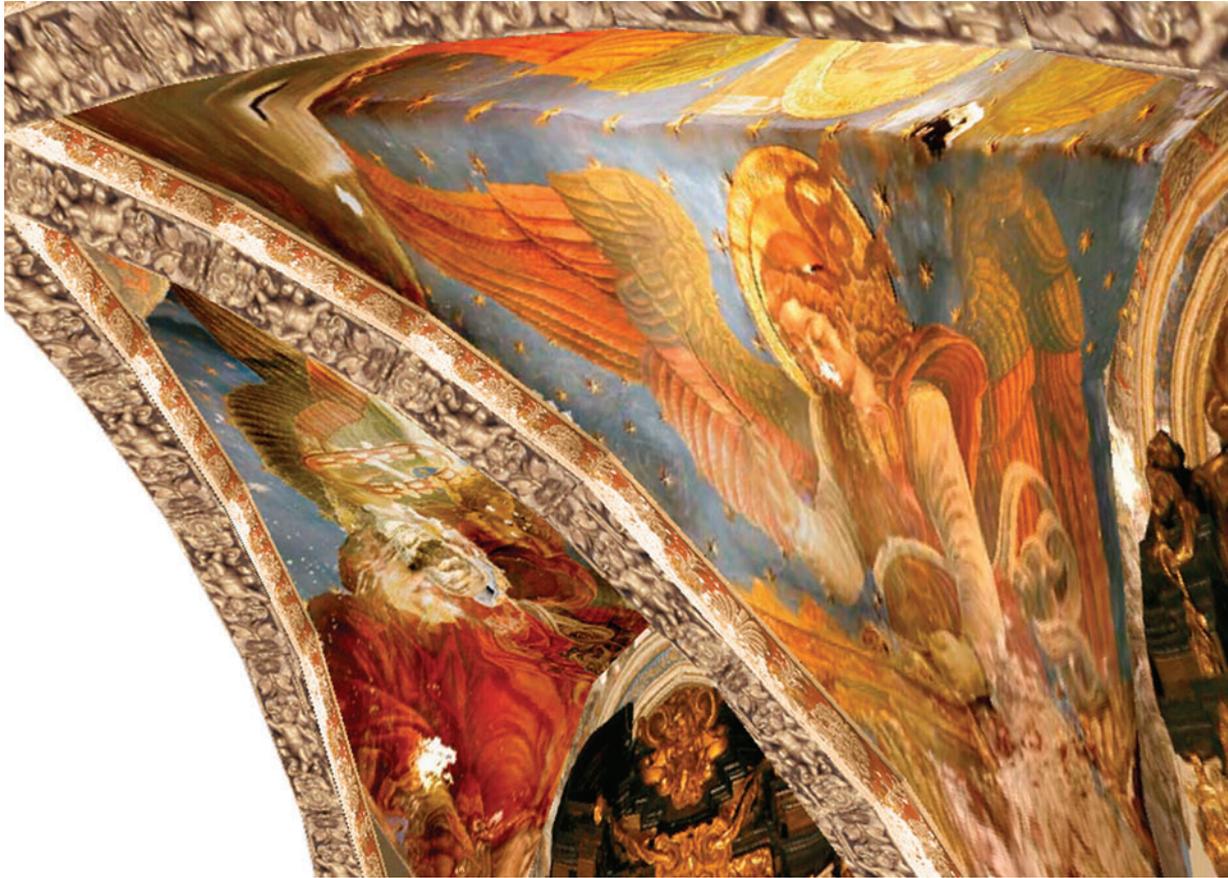
Construction of the 3-D digital model required mapping the images to their positions on the digital structure. Photo: © José Luis Lerma.

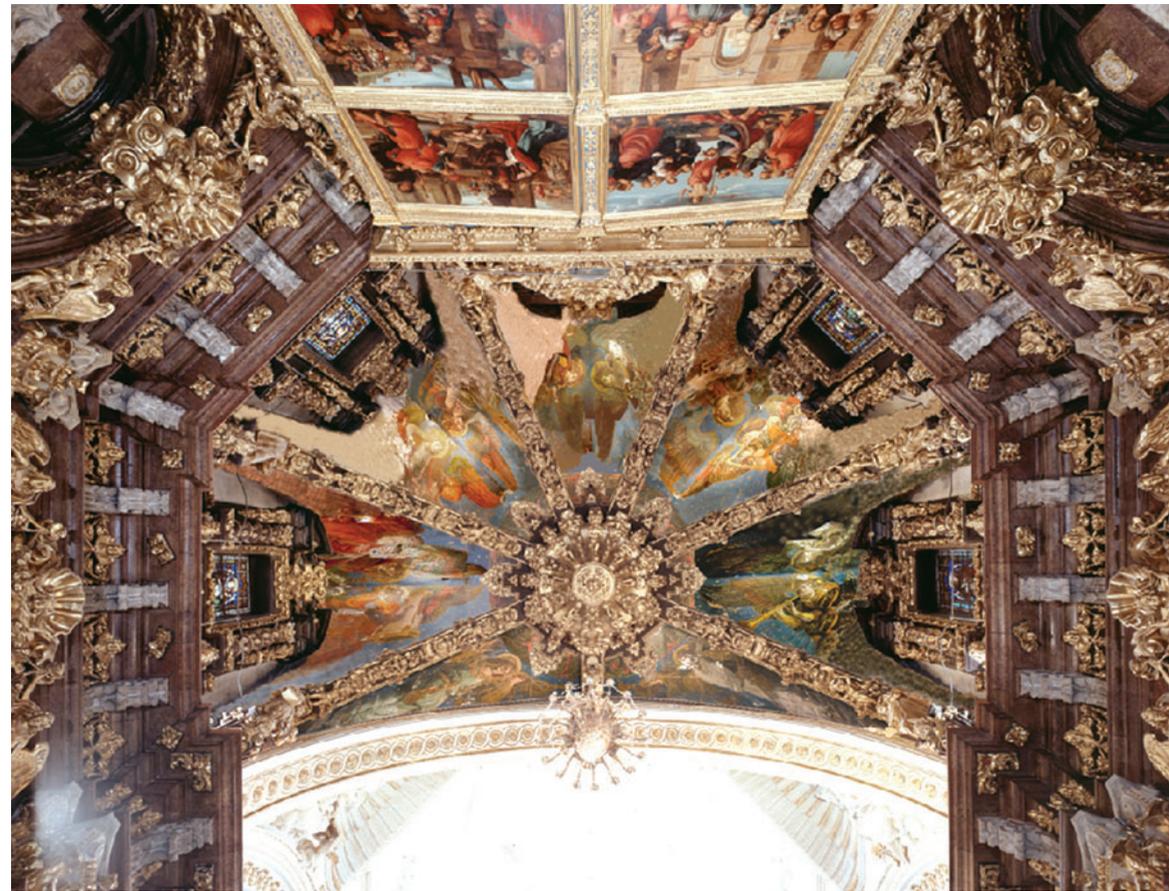
On-site work was carried out during two full days and included image collection and point measurements. A 6.3-megapixel digital single lens reflex (SLR) Canon D60 camera and a Sigma® 15mm super wide-angle lens were used. The camera was mounted on a tripod to avoid blurring. All the pictures of the Renaissance ceiling were taken at a fixed distance and at convergent angles. When possible, normal images of the baroque vault were also captured. An on-site calibration was per-

formed to determine all the orientation parameters. 3-D coordinates for the targets were measured with a reflector-less total station theodolite. Therefore, angle and distance measurements were obtained for the targeted points to create a stable coordinate system.
