三号区 AREA 3

会乘殿至清凉楼的假山 The Rockery between Huicheng Hall and Qingliang Building

3号区
Area 3

殊像寺
Shuxiang Temple

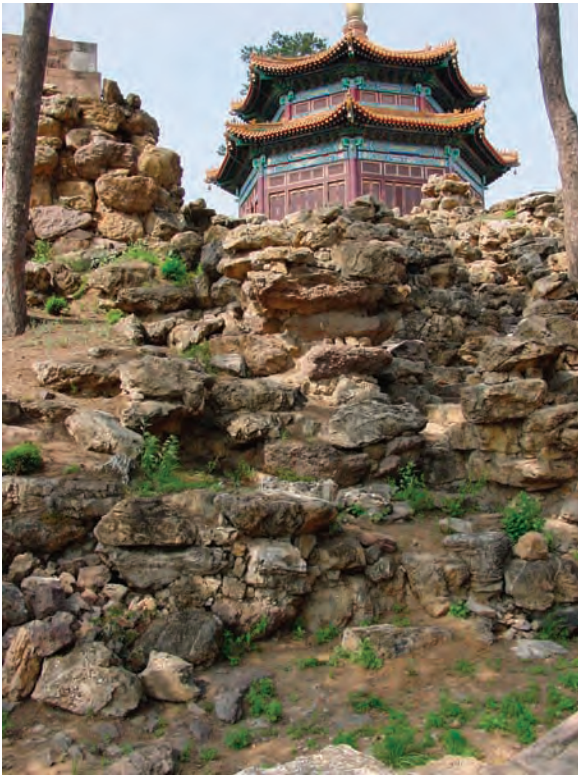
80. 会乘殿后边假山（朝东南方向的宝相阁）
Rockery behind Huicheng Hall, looking NE to Baoxiang Pavilion

会乘殿后的假山由黄石堆砌而成，用以象征五台山清凉界。蜿蜒的小道与洞桥通向山顶上的宝相阁及云来、雪净二殿（照片80-84）。宝相阁建在山顶的一块平台上。宝像阁四周为叠起的假山，阁前方的东、西两侧建有吉晖殿和慧喜殿，北面是清凉楼。假山在慧喜殿西侧继续延伸（照片83）；吉晖殿东面的假山因未经清理而范围不清，但推测应与慧喜殿西侧假山的范围相同（假山详见附件3）。

Behind Huicheng Hall is a large free-flowing, 'ornamental mountain' made from jagged rocks, which was meant to represent Qingliang Peak in Wutai Mountain. Through winding paths, small rock caves and bridges, the rockery leads to Baoxiang Pavilion and Yunlai and Xuejing Halls (Photos 80-84). Toward the summit of the rockery one reaches the platform on which Baoxiang is situated. The rockery wraps around Baoxiang and follows the rising terrain toward Jihui and Huixi Halls to the east and west, and Qingliang Building to the north. The rockery continues west of Huixi Hall (Photo 83) and presumably east of Jihui Hall, although this area has not been cleared to verify its full extent (see Appendix 3 for details of this and the other rockeries).

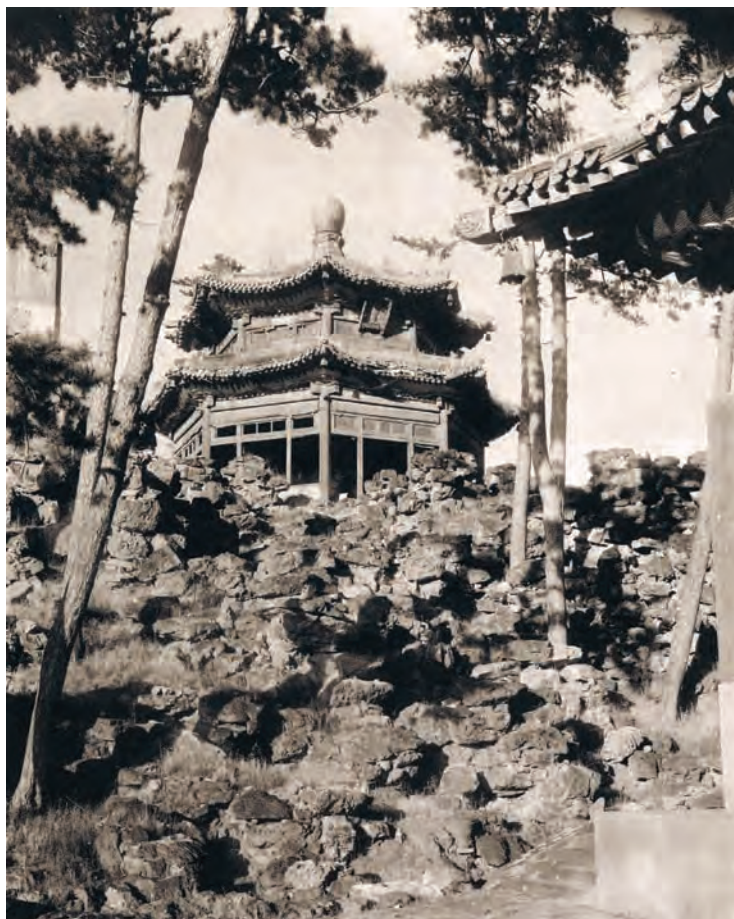
85. 从会乘殿西南角望宝相阁（1933年）
Baoxiang Pavilion from the NW corner of Huicheng Hall (1933)

宝相阁（也称作“净名普贤”阁）是一座八面的亭式建筑，位在假山正中的平台之上。1933年所摄的宝相阁虽未坍塌，却是残败不堪，所有的门窗隔扇均已缺失（照片85-86）。1959年曾对宝相阁进行了修复，包括屋顶的修复（照片89）。根据档案记载，宝相阁在1967年落架移入库房。从1981年（或是1979年）的照片上所见到的宝像阁仅存槛墙及塑像底座（照片90-91）。2002年至2003年宝相阁及塑像在原址重建（见《殊像寺干预史》，附件2）。重建的宝相阁为八边形重檐，黄琉璃瓦带绿剪边，四面辟正交菱花隔扇门，另四面设菱花隔扇窗的建筑。阁内文殊骑狮的塑像仿五台和香山的文殊像，木骨泥胎（高11.6米；比五台文殊像高出2米），立于雕刻精美的鸚鵡岩底座上（图片87-88）。狮两侧各有护法神像。重建的塑像使用了一些原始塑像的残存部分。阁内原有的柱帘匾额现已不存（关于对联的详细叙述，见卷二《殊像寺价值评估综合报告》）。

Baoxiang Pavilion (also referred to as *Jingming Puxian*, 'Pure Name Samantabhadra'), is an eight-sided pavilion on a leveled area in the middle of the rockery. The 1933 photos show the Pavilion still standing, but in deteriorating condition (all of its latticed windows and doors are missing) (Photos 85-86). Photographs from 1959 show restoration work being carried out, including repair of the roof (Photos 89). Archival records indicate that the pavilion was dismantled and removed to storage in 1967. Photographs from 1981 (and possibly 1979) show only the sill walls and statue base in situ (Photos 90-91). The pavilion and the statues were recreated on the original site in 2002-2003 (see History of Interventions, Appendix 2). As reconstructed, the pavilion has an octagonal double-eave roof, covered in yellow tiles with green border tiles. It has four foliated/cross-hatched lattice doors alternating with four lattice sill windows. Inside the Pavilion is a wood and clay replica of the Wutai and Xiangshan [Fragrant Hills] Manjusri (*Wenshu*) riding a lion (11.6m high; 2m taller than the one at Wutai Mountain); the statue sits on an elaborately carved tuff stone base (Photos 87-88). On either side of the lion are statues of guardian attendants. The reconstructed statues incorporate the few remaining fragments of original sculpture. The pillar couplet that was inside Baoxiang Pavilion no longer exists (see Vol. 2, *Assessment of Significance* for explanation of couplet).

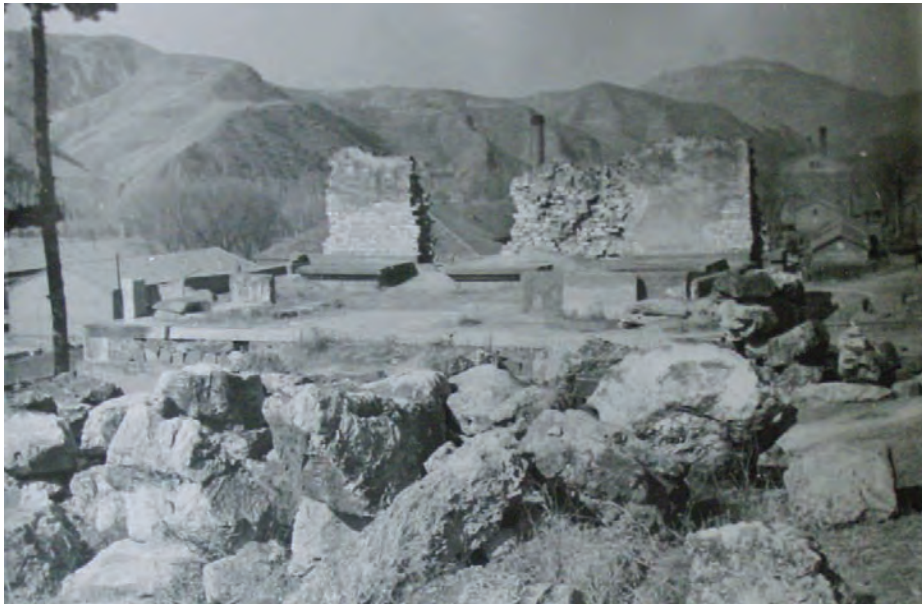
92. 1981年雪净殿，（朝西）
Xuejing Hall in 1981, looking west

雪净殿后的地势急剧下降至倚云楼区（照片96）。该殿建在红砂岩条石砌筑的高台上（照片95）；殿体部分倒塌并被掩埋。殿址尚未经过发掘，上层表土仍在。高台的四壁为假山石所环抱（照片95-96）；经过假山的踏步石可以到达现存的殿址（照片93）。高台东面（正面）两侧的角柱石为鸚鵡岩。雪净殿正面仍然保留着部分的槛下墙和正面檐墙倒塌后的块状鸚鵡岩石材，墙的其余部分则使用红砂岩。殿内尚存原来的三座红砂岩塑像底座。西面的砖砌后墙保存量较大，内墙仍有粗糙的抹灰（无彩饰）（照片92-94）。

The terrain drops off steeply behind (west of) Xuejing Hall to the Yiyun complex (Photo 96). The high retaining walls of the platform are of red sandstone ashlar blocks (Photo 95). Xuejing Hall survives in a state of partial collapse and burial; its ruins have not been cleared of accumulated soil. The rockery hugs the sides of the platform retaining wall (Photo 95-96). Access is via rough stone steps from the rockery (Photo 93). Tuff stone is used on the corners of the east (main) facade of the platform. The sill wall is partially preserved with tuff blocks on the exterior main facade (now collapsed); red sandstone is used elsewhere. Three statue bases of red sandstone survive. Extensive remnants of the brick wall above the sill remain on the west wall, with remnants of coarse interior plaster (no paint) (Photos 92-94).

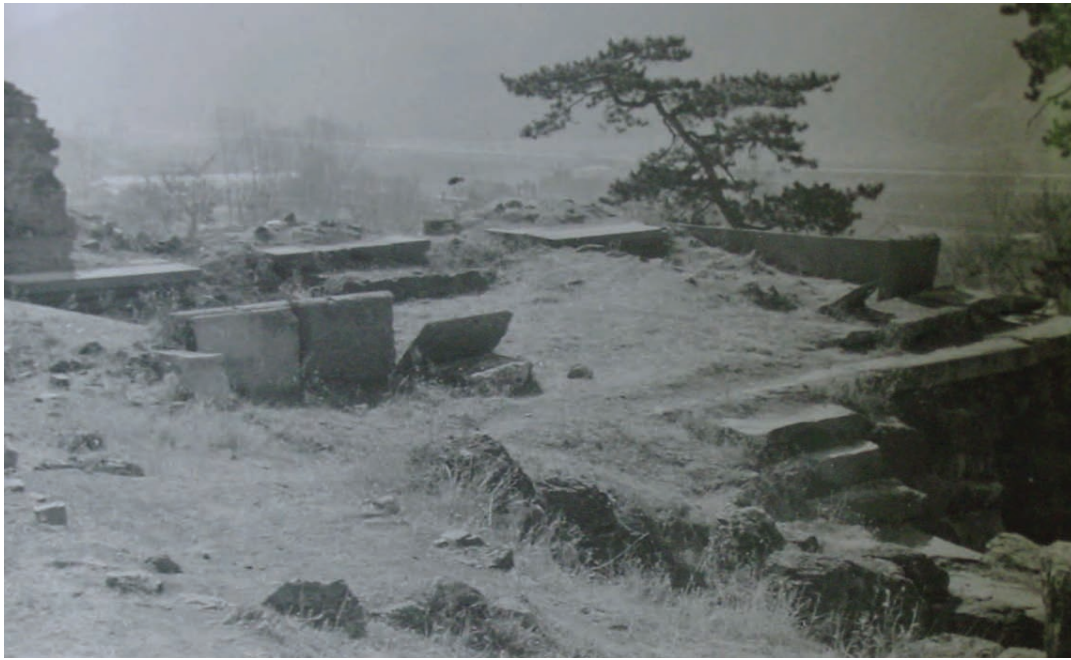
97. 1981云来殿（朝东南）
Yunlai Hall in 1981, looking SE

云来殿也未经挖掘；由于近期在其北端设置了石灰搅拌池，该殿遭到了部分的破坏（照片99）。台基使用了鸚鵡岩及红砂岩；墙下碱部分倒塌并被掩埋。如雪净殿建制，云来殿的西墙外部用鸚鵡岩，内部用红砂岩构筑；南墙及东墙使用了块状砂岩（北墙痕迹不清或已被石灰搅拌坑破坏）。目前殿内有两座砂岩塑像底座；第三座可能被建造石灰池时留下的废弃物掩埋，这三个底座在1981年所摄的照片中依然清晰可见（照片97）。与雪净殿不同，云来殿后墙（东墙）不是用砖而是由毛石砌筑。

Yunlai Hall, partially destroyed by a recent lime-mixing pit at its north end (Photo 99), has also not been excavated. The platform comprises both tuff blocks and red sandstone. The sill walls are partially collapsed and buried, but also utilized tuff stone on the exterior, and sandstone on the interior of the main (west) facade wall; sandstone blocks are used on the south and east (the north wall is obscured or destroyed by the lime-pit). Two of the red sandstone statue bases are visible; the third may be buried under debris from construction of the lime pit (the base is visible in the 1981 photo, Photo 97). Unlike Xuejing, the superstructure of the east (rear) wall is built of rubble masonry (Photo 100), rather than brick.

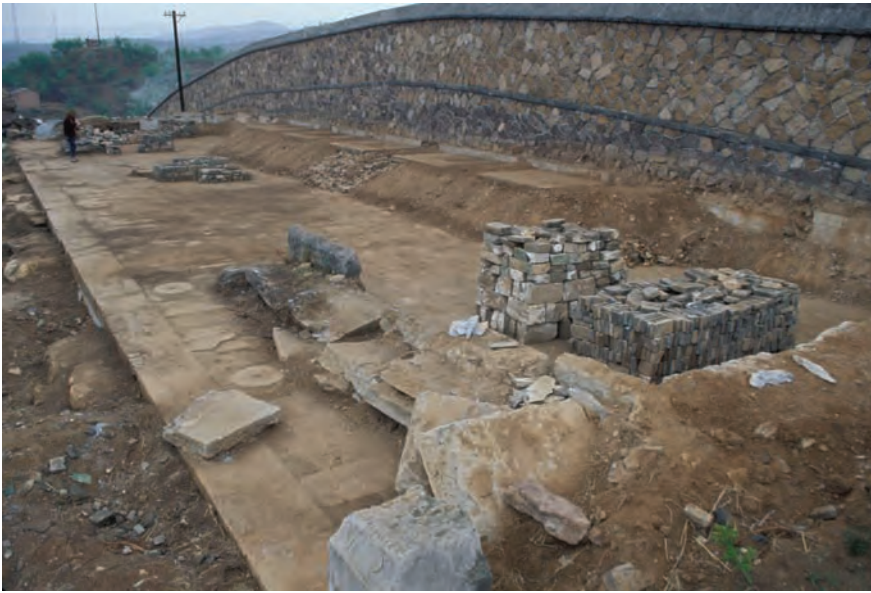
101. 发掘后的清凉楼（朝西）
Qingliang Building after excavation, looking west

清凉楼基址在2003年11月曾经过正式的考古发掘（照片101、104）。发掘揭露出由鸚鵡岩构筑的台基、墙下碱、柱顶石及方形地砖。西、北、东三面的墙下碱大部份保存完整，但建筑所用的鸚鵡岩石块上多有严重的裂隙（照片103）；南墙基本无存或坍塌。考古发掘中发现了经过火烧并带有绿色彩绘的灰色砖块（照片105），推测它们原来是建筑室内隔墙的材料。北墙下仍有五座经过雕琢的鸚鵡岩塑像底座（照片102）。20世纪80年代重修殊像寺北围墙时，将其直接建在原清凉楼的墙之上。另外，为了固定古松而设的钢缆和现代混凝土破坏了基址的原地面。建筑遗址已在2004年12月回填了。

Today, the building survives as a ruin, revealed through archaeological investigation in November 2003 (Photos 101, 104). The platform, sill wall, column bases, and square floor pavers are all of tuff stone. Sill walls of the west, north and east walls are largely intact, though the tuff often exhibits severe fissuring (Photo 103); the south sill wall is largely missing or collapsed. Fired grey bricks painted with green patterns (Photo 105) were found during archaeological investigations, presumably from the interior partitions. Against the north wall are five carved statue bases, also in tuff (Photo 102). The north wall of the temple complex's perimeter wall was rebuilt in the 1980s directly on the sill wall of the north wall of the building. A mass of modern concrete, for steel cabling to anchor one of the ancient pines, has damaged the floor. The building was reburied in December 2004.

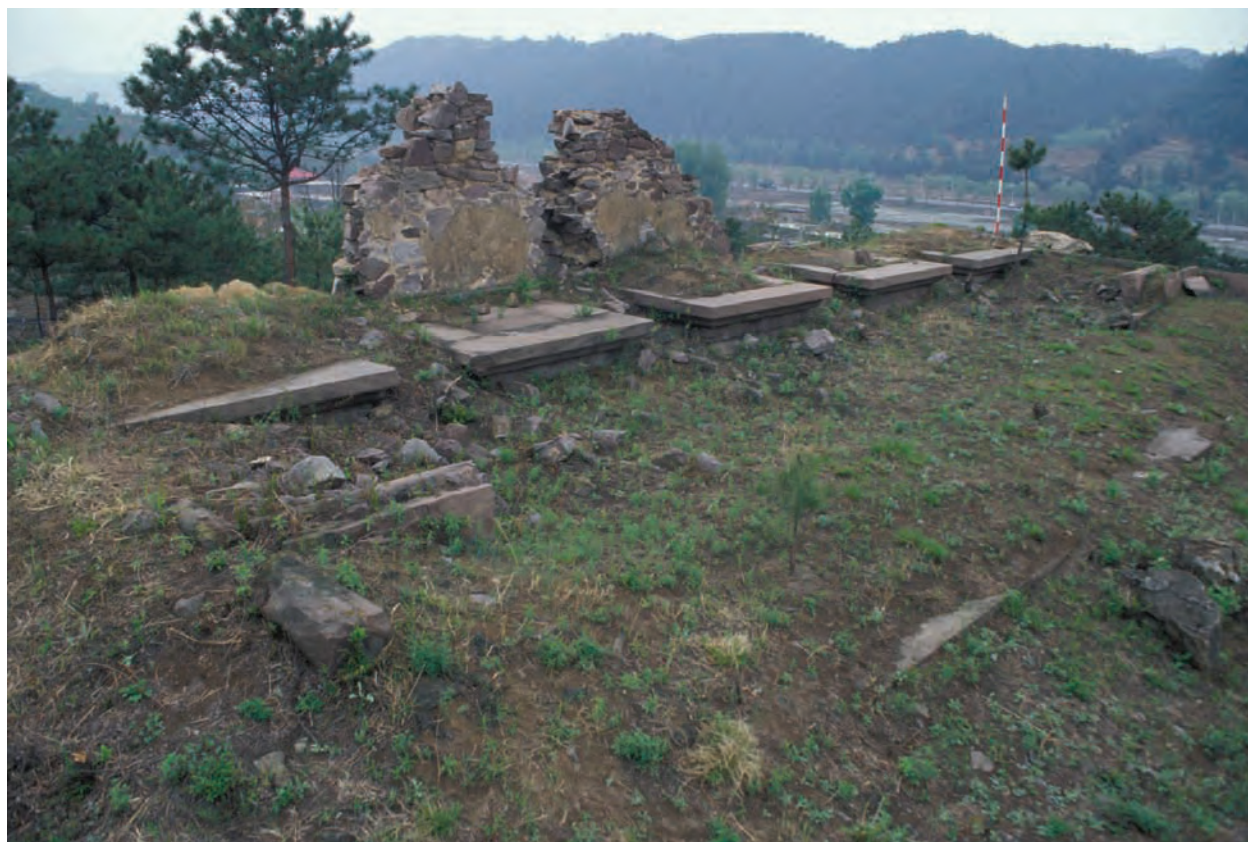
106. 吉晖殿（朝东南）
Jihui Hall, looking SE

吉晖殿仅有部分露出地表以外（照片106）；保存的墙下碱部分由于覆土掩盖而难以分辨。东侧墙下碱之上尚存带有抹灰饰面的毛石墙残断。吉晖殿内仍然保存着五座红砂岩塑像底座。在两殿址均没有发现使用鸚鵡岩石材的痕迹。

Jihui Hall is only partially exposed (Photo 106). Sill walls are partially preserved, but obscured by soil covering. Above the east sill wall is a section of rubble masonry wall with patches of plaster facing. There are 5 red sandstone statue bases preserved in Jihui Hall. There was no evident use of tuff stone in either hall.

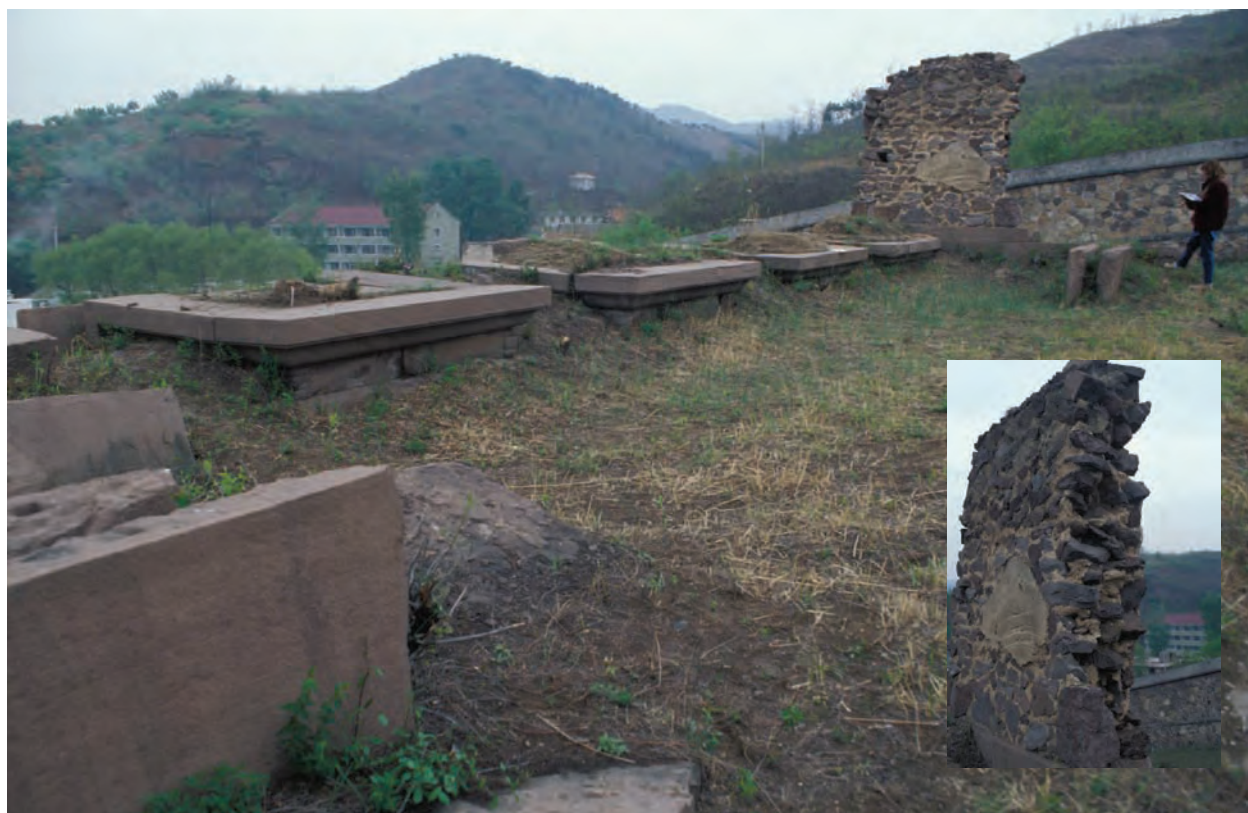
107. 慧喜殿及其毛石砌筑墙的细部（朝西北）
Huixi Hall, looking NW, with detail of rubble masonry wall

慧喜殿尚存台基，但台基西侧有局部坍塌（照片108）；殿墙的北、西及东面尚存大部分墙下碱（南面台基坍塌部位无墙体留存）（照片107-109）。北墙保存着大段毛石墙体上身。五座红砂岩塑像须弥座临西墙而立。

Huixi Hall preserves its platform, partially collapsing on the steep, west side (Photo 108), and most of its sill wall on the north, west and east (no wall survives on the south where the platform is collapsing) (Photos 107-109). A large section of rubble masonry superstructure is preserved on the north wall (Photo 107). Five red sandstone statue bases survive against the west wall.

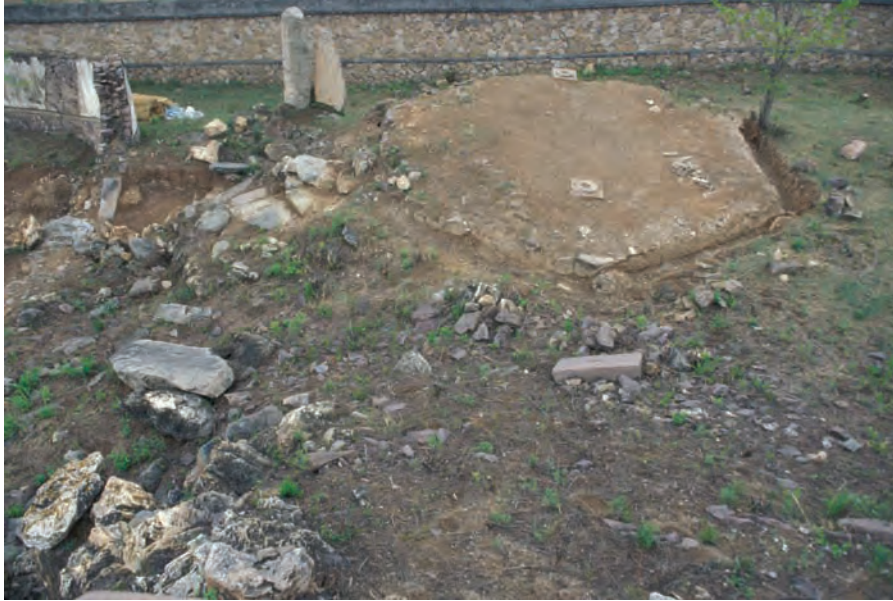
110. 从慧喜殿看六方亭（发掘后）
Hexagonal Pavilion, looking
down from Huixi Hall, after
excavation

2003年11月对六方亭进行了部分的考古发掘。发掘揭露出亭的基址，包括台基埋头石（照片110-111）。在倒塌的西墙上可以见到三个尚存的柱顶石和砖砌的礅墩（照片112）。由六方亭南侧的假山台阶可达香林室建筑群（照片113）。

Partially excavated in November 2003, the pavilion preserves only its foundations, including the corner ashlar blocks (Photos 110, 111). Where the west wall is collapsing one can see the brick pillars that supported column bases (Photo 112), three of which survive. A path of rough stone steps leads from the Hexagonal Pavilion south through a rockery to the Xianglin Complex (Photo 113).

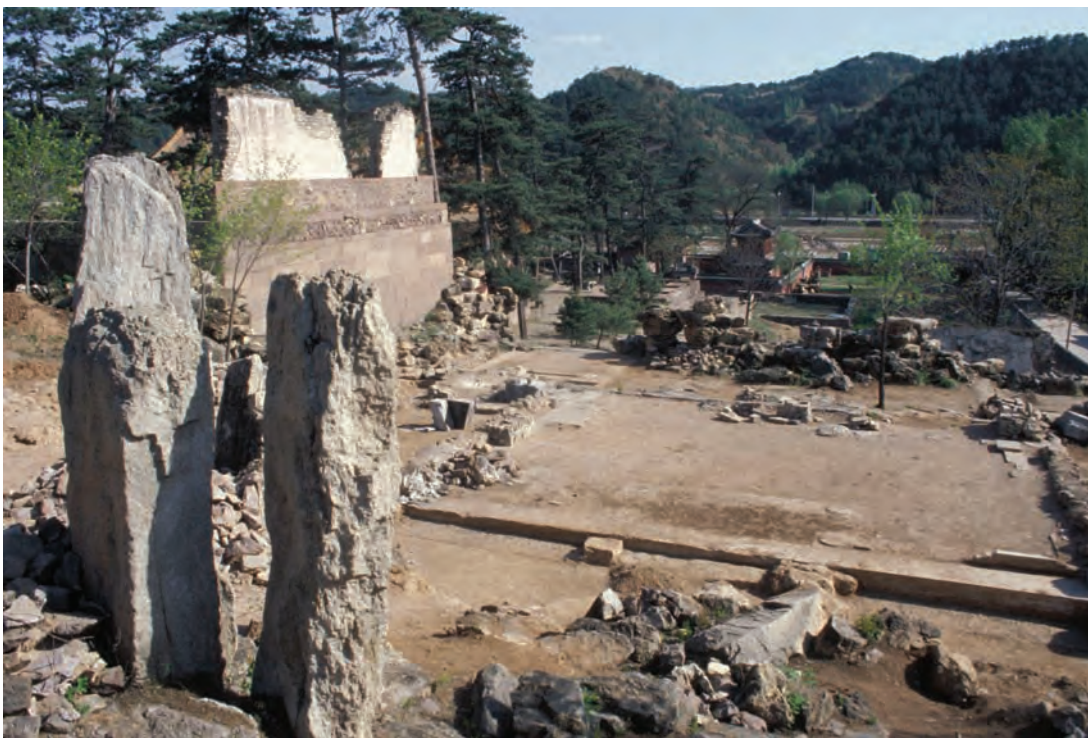
116. 香林室建筑群及假山（朝南-左边前景）
Xianglin Complex, looking south, with large standing blocks in rockery (left, foreground)

雪净殿的正西侧是一组由三座建筑组成的庭院，2003年11月对此进行了发掘，在2004年12月回填了（照片114-116）。建筑群北部尚存部分曲形围墙，墙中部设门，可见鸚鵡岩石门槛和门框的残迹（照片117）。半圆形的院落中有假山遗迹。围墙西部保存完好，其余部分仅存墙基。建筑群南端有一段东西走向的围墙，部分墙身在发掘前就露于地表（照片118）。

Directly west of Xuejing Hall is a complex of three buildings with courtyards, excavated in November 2003 and reburied in December 2004 (Photos 114-116). The complex is enclosed on the north by the remains of a curved wall, with an opening at its center; remnants of tuff threshold and door jambs survive in the opening (Photo 117). There are also remnants of a rockery in the hemispherical courtyard created by the enclosure wall. The western part of the enclosure wall is well preserved; the rest survives as foundations only. The southern limit of the complex is defined by a wall on an E-W axis, part of which preserves its superstructure and was visible above ground prior to excavation (Photo 118).

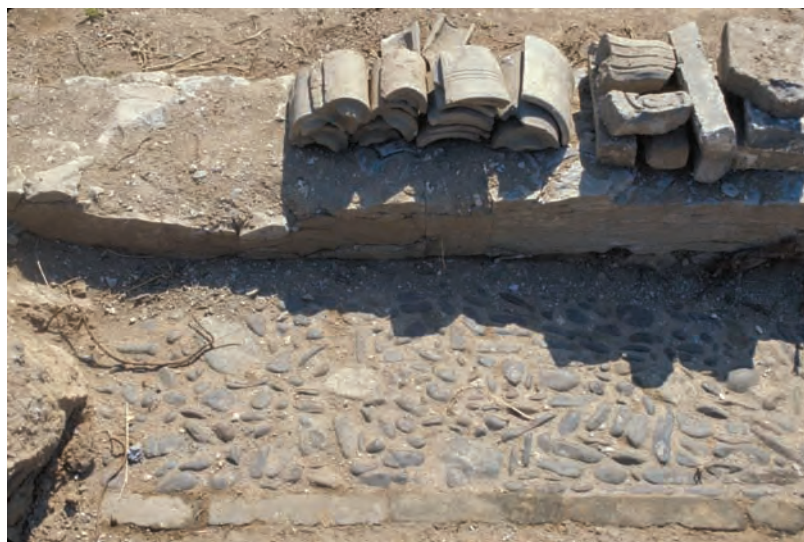
119. 建筑周围的卵石散水
Pebbled drip-line pavement surrounding buildings

香林室是这组建筑中的主要建筑，面宽3间，毛石台基，上覆横向铺设的鸚鵡岩阶条石；另有局部保存的毛石墙体（照片115）。墙体与阶条边缘留有约10厘米宽的金边。南、北两面居中设门。建筑四周卵石散水保存完好（照片119）。

Xianglin Room is the main building of the complex, three-bays wide (Photo 115). It was constructed with a rubble masonry platform, capped by horizontally laid ashlar blocks of tuff and a superstructure of rubble masonry, inset approximately 10cm from the edge of the ashlar. There are centrally placed entrances in the south and north walls. Pebbled drip-line paving is well preserved on all sides of the building (Photo 119).

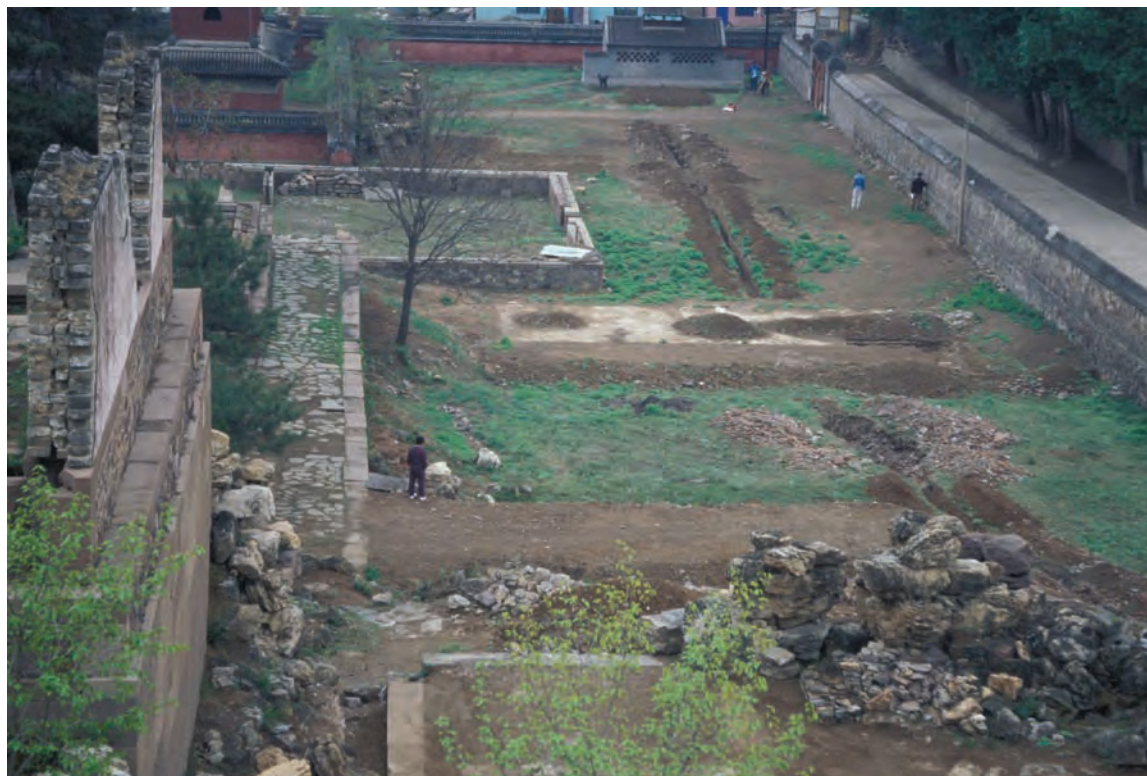
122. 2004年四号区全景，（朝南）
General view of Area 4 in 2004, looking south

位于殊像寺西边的四号区没有现存的古建筑（照片122）。该区原有僧房可能在1947年被国民党部队拆毁，也可能在1954年或1972年在这里建小学校舍时被拆除（见《殊像寺干预史》）。1979年的寺庙平面图在4号区南部标出了僧舍的位置。2003年11月进行考古发掘时，曾经发现可能属于原来建筑的房基（照片123）。现在四号区内有厕所等现代建筑，西南角有大门、菜田以及原校舍遗迹（水泥铺面）（照片124）。

Area 4, along the west side of the temple complex, contains no standing buildings with original fabric (Photo 122). Monk's quarters were originally located in this area; these may have been destroyed in 1947 by the Kuomintang (KMT) army and/or by the construction of school buildings in 1954 and 1972 (see History of Interventions). A 1979 site plan shows one building labeled as monks' quarters in the southern portion of Area 4. Archaeological trenches excavated in November 2003 (Photo 123) revealed foundations of structures that may be from the original buildings (see *History of Interventions*, Appendix 3). Currently, the area contains modern constructions such as toilets, the gate in the SW corner, garden plots, and remains of the schoolhouses (cement pavements) (Photo 124).

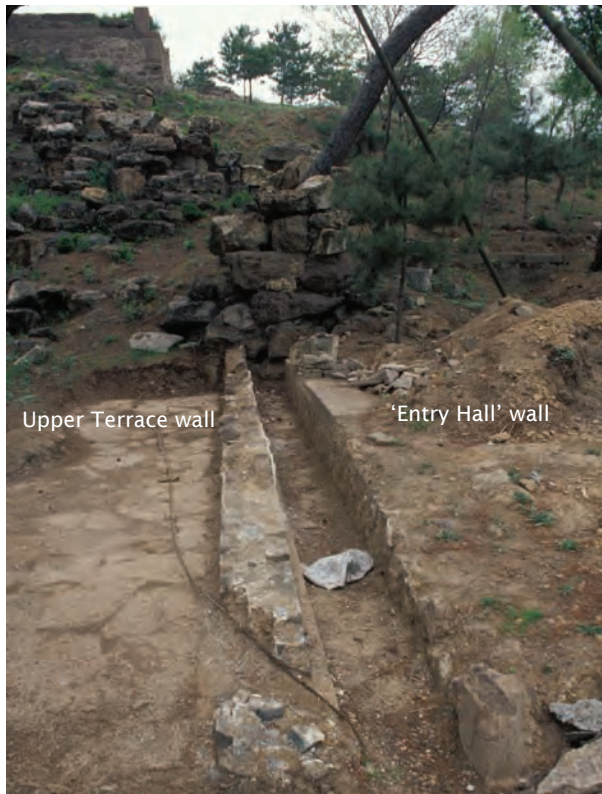
125. 2003年发掘时上层月台左边的护坡墙、‘值房’西墙
Upper Terrace wall (left) and west wall of 'Entry Hall'
(right) as excavated in 2003

‘值房’建制不清。在上层月台东侧之处发掘出了两堵平行而且相近的墙（照片125）。据早期寺庙的平面图，最西的墙段原来可能是和‘灶房’对称的一个建筑物的墙（参看图13-15），但第二堵墙的功能目前仍然难以确定（这堵墙是2003年扩建蓄水池后发现的）（照片127）。此墙的墙基很深（约1.50米），由毛石砌筑，条石压顶，其准线与位于南部的一条很长的墙段相同，因此，很可能是这堵墙的延续（见下面内容）。

The ‘Entry Hall’ is poorly defined. Two walls in close proximity and parallel to each other were excavated to the east of the Upper Terrace (Photo 125). The westernmost wall may define a room, symmetrically placed in relation to the ‘Imperial Kitchen’, as shown on earlier plans of the site (see Plans 13-15). The function of a second wall, revealed in the large water reservoir pit (which was enlarged in November 2003) (Photo 127) is not understood. This wall has deep foundations (approx. 1.50m) of rubble masonry capped by horizontally placed ashlar blocks. It is on the same alignment as a long stretch of wall further south and may be a continuation of it (see below).

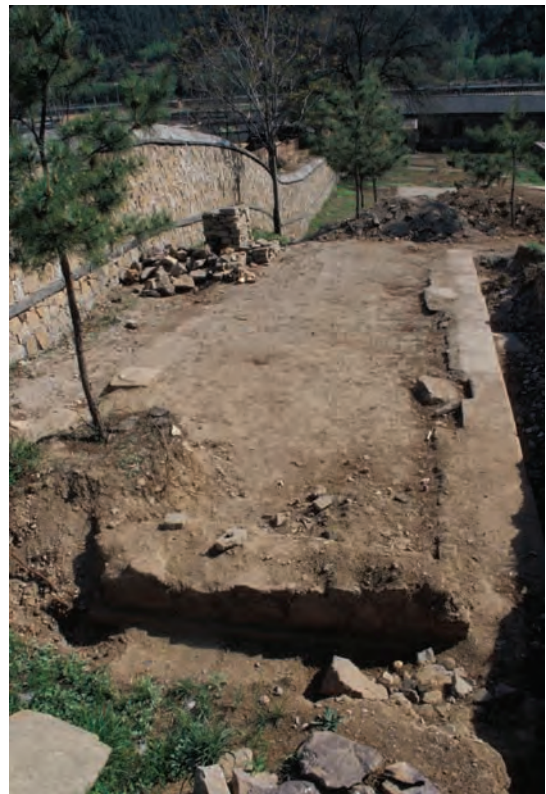
126. ‘灶房’（朝南）
The 'Imperial Kitchen,' looking south

‘灶房’位于‘值房’东侧，临近寺庙的围墙（照片126）。发掘后只能看到北墙的横向条石、六层墙砖（内墙）、条石上头的毛石外墙、地砖及柱顶石，但下面的墙基看不到。根据该建筑的位置及出土遗物，特别是出土的明代陶瓷碎片，这座建筑被初步确定为御灶房。

The ‘Imperial Kitchen’ is located to the east of the ‘Entry Hall’ and adjacent to the perimeter wall of the temple complex (Photo 126). Excavation has revealed only the horizontal ashlar blocks (the foundation below is not visible) and six courses of brick (interior) and rubble masonry (exterior) construction above

the ashlar survive on the north wall. Remnants of a brick floor and column bases were also revealed. This building is tentatively identified as a kitchen facility because of its location and associated finds, especially remains of fine Ming Dynasty pottery shards.

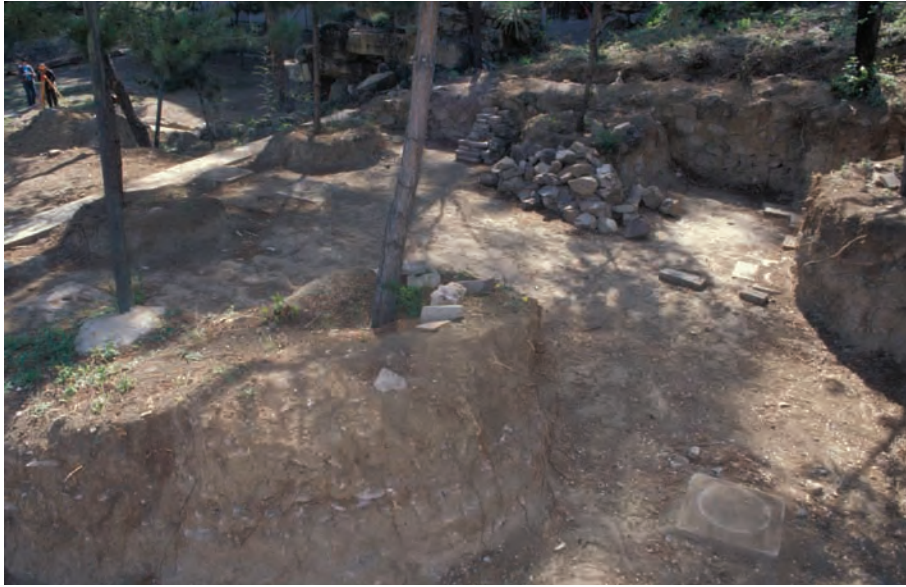
128. 2003年对‘上房’基址进行发掘的情景
Remains of ‘Dining Hall’ as excavated in 2003

由于‘上房’基址被现代机动车出入道路所压，因此考古工作者仅在道路东、西两侧对‘上房’进行了部分发掘。发掘的部分显露出部分山墙墙体（外墙为条石，内墙为毛石）及山墙上部毛石砌筑墙残段。发掘以前在上房原址上种的八棵幼松连同其四周的土包被保留下来（照片128）。

The ‘Dining Hall,’ partially excavated only on the west and east sides of the modern access road that runs over the structure, preserves remains of its sill wall (ashlar on the exterior and rubble masonry on the interior) with a remnant of rubble masonry wall above. Eight young pine trees planted prior to excavation within the area of the building stand on unexcavated mounds of soil (Photo 128).

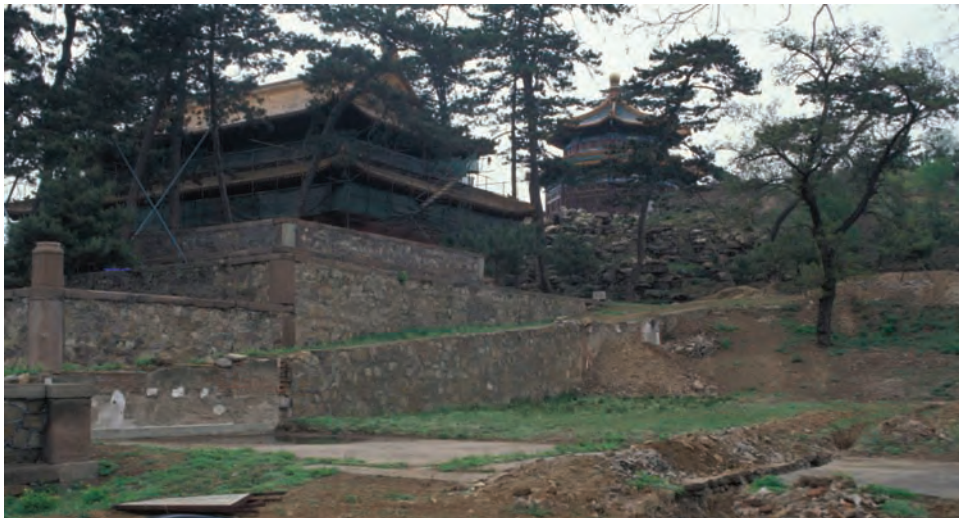
129. 2004年五号区内南北随墙，现在为机动车道的护坡墙
N-S running wall in center part of Area 5, now serving as a retaining wall for access road (2004)

四号区中间有上面所提到的一条很长的墙（照片129），其功能和时期不清。假如为原墙，那么近期一定经过修缮。现在这堵墙是机动车出入道路的护坡墙。

In the middle part of Area 4 is a long stretch of wall (Photo 129), mentioned above, whose date and function is not clear. If it is original, there have been modern repairs to it. It currently functions as a retaining wall for the access road.

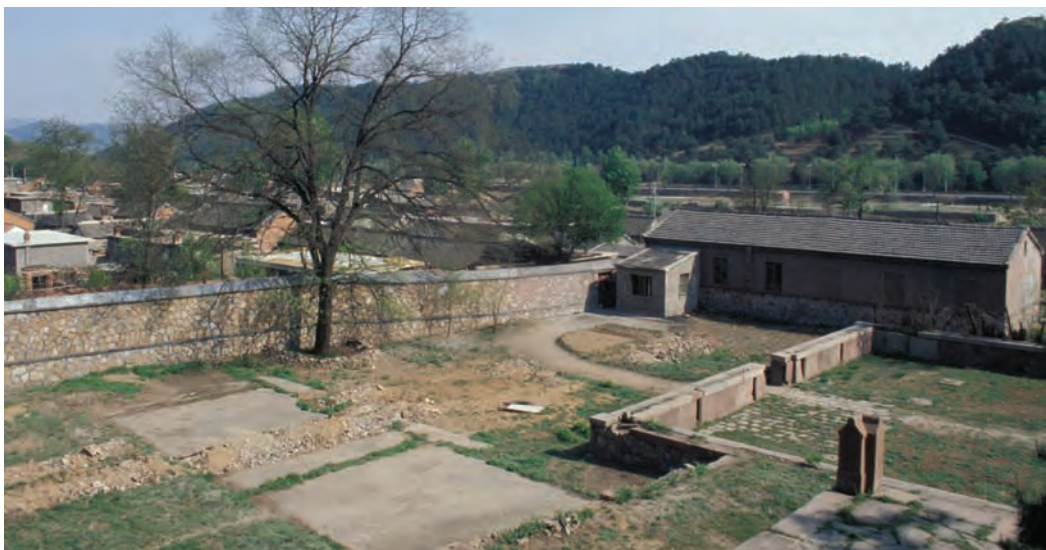
130. 五号区中部的校舍水泥平台
Center part of Area 5 with cement pavement from school building

建造小学校舍时（可能于1972年，见《殊像寺干预史》），五号区南段的大部分古建筑被毁坏，如今仅存原僧房一栋（照片133）。目前还可以见校舍的水泥房基（照片130）。该区新建了文保所的办公室、狗窝及菜田（照片130）。现存的文保所办公室西侧的墙可能是古墙（照片132）。

At the southern end of Area 5 most of the original buildings were destroyed when school buildings were constructed here (possibly in 1972, see *History of Interventions*). Of the original lodgings for the monks, only one now survives (Photo 133). Remains of the school buildings are visible in the form of cement platforms (Photo 130). New constructions in this area include an office for the site custodian, dog kennel, and garden plots. The custodian’s office is adjacent to what may be historic walls, visible to the west of the building (Photo 132).
