MUSEUM AMSTELKRING IN AMSTERDAM

Advisory report, indoor climate control

BPS-report 05.20.K
Sub department BPS
March 2006

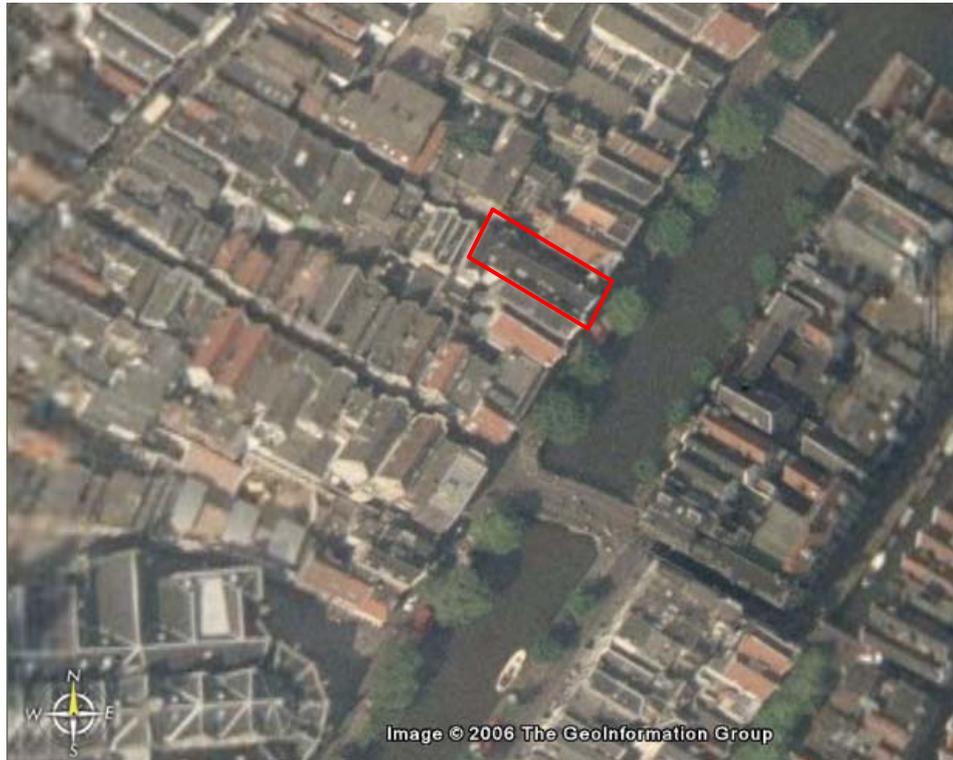
Figure 2 Satellite photo of the building. The facade of the building on the canal-side faces south-east.

The main entrance of the building on Oudezijds Voorburgwal faces south-east. See Figure 2 for a graphic presentation of the building orientation.

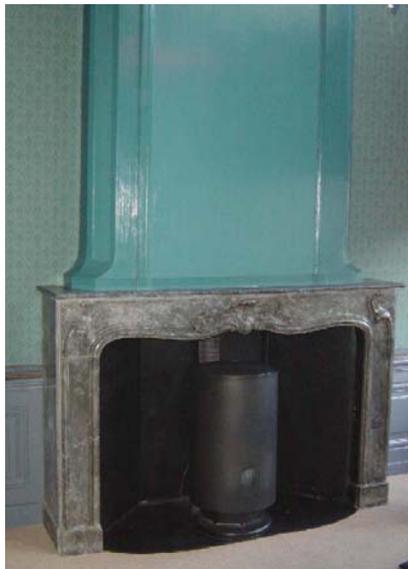
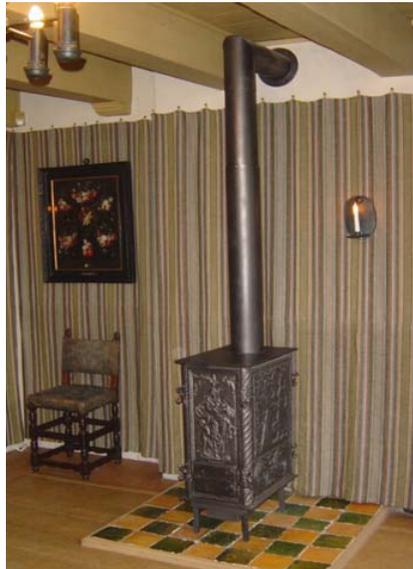
Figure 3 The gas stoves installed in the antechamber (left) and the Canal room (right).

Gas stove in the antechamber: Pelgrim Bambino type
Output 9.4 kW
Manual controls
Open device

There are 2 gas stoves installed in the museum, i.e., in the antechamber on the ground floor, and on the 1st floor in the Canal room. The oxygen the stoves require for combustion is removed from the ambient air. The flu gases are removed by ductwork through a structural shaft, and vented above the roof.

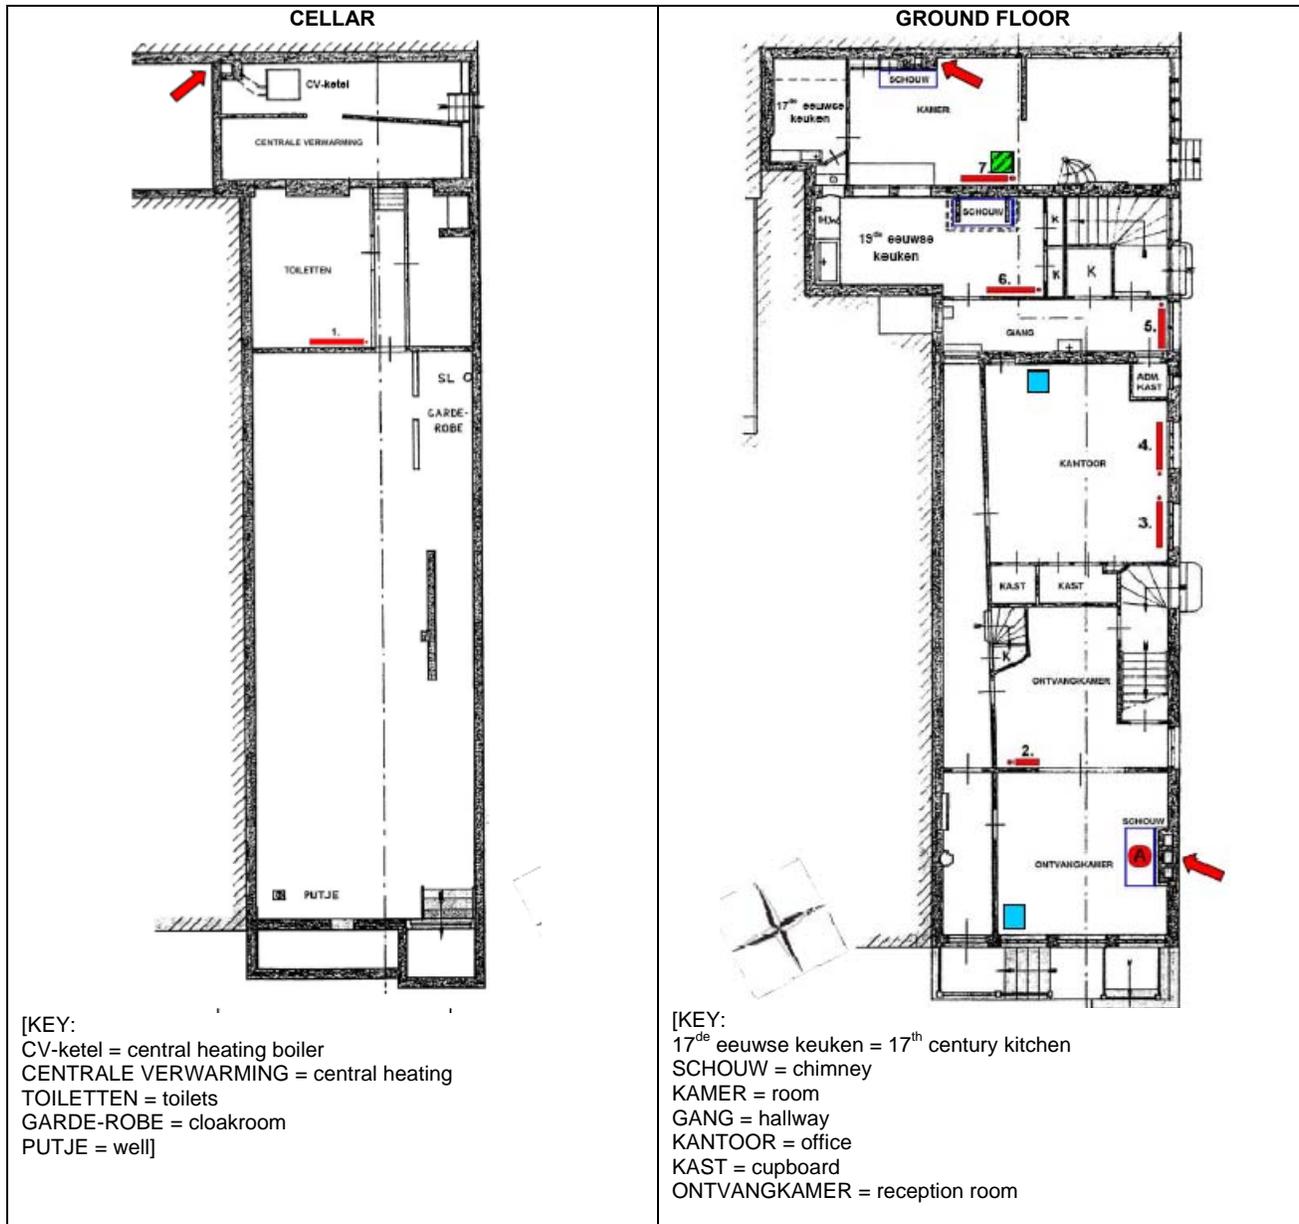
Number	Type*	Dimensions h*w [mm]	Output [W]	Type of radiator valve
1	Plate radiator type 10	1000 x 800	980	Thermostatic, mfg. Danfoss
2	Plate radiator type 22	1800 x 580	3800	Thermostatic, mfg. Herz
3	Flanged radiator 30 vanes	450 x 1230 x 150	2100	Thermostatic, mfg. Danfoss
4	Flanged radiator 30 vanes	450 x 1230 x 150	2100	Thermostatic, mfg. Danfoss
5	Flanged radiator 25 vanes	450 x 1250 x 220	2350	Thermostatic, mfg. Danfoss
6	Veha Plate radiator type 20	1010 x 1090	2200	Thermostatic, mfg. Danfoss
7	Eres Flanged radiator 15 vanes	1080 x 620 x 100	1500	Thermostatic, mfg. Danfoss
A	Gas stove		9400	n.a.
* Type 10 = 1 plate radiator Type 20 = 2 plate radiator Type 22 = 2 plate radiator with 2 convectors		[blue square] = humidifier [green square] = dehumidifier ↗ = shaft location

Figure 4 Floor plan of the cellar (1) and the ground floor with installed heating elements, humidifiers and a gas stove (A) in the reception room (Antechamber). The outputs of the installed radiators are given in the table with a 90/70/20°C water-supply/return/room temperature system. The outputs are estimated from data provided by the manufacturer or by comparison with similar products.

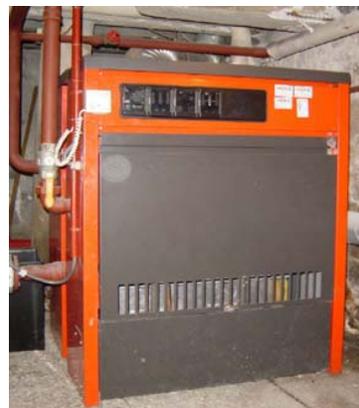
- Remeha type Gas 3C
- 7 sections
- closed system
- nominal output 138 kW
- year of manufacture 1991

The air comes in via a grate in the door to the furnace room. The flu gases are removed via a flu gas duct which exits the roof. Furthermore, the storage area is provided with a gas detection system with 3 sensors, mfg. Bieler & Lang type LS 7014-2.

Figure 8 Central heating boiler Remeha Gas 3C.

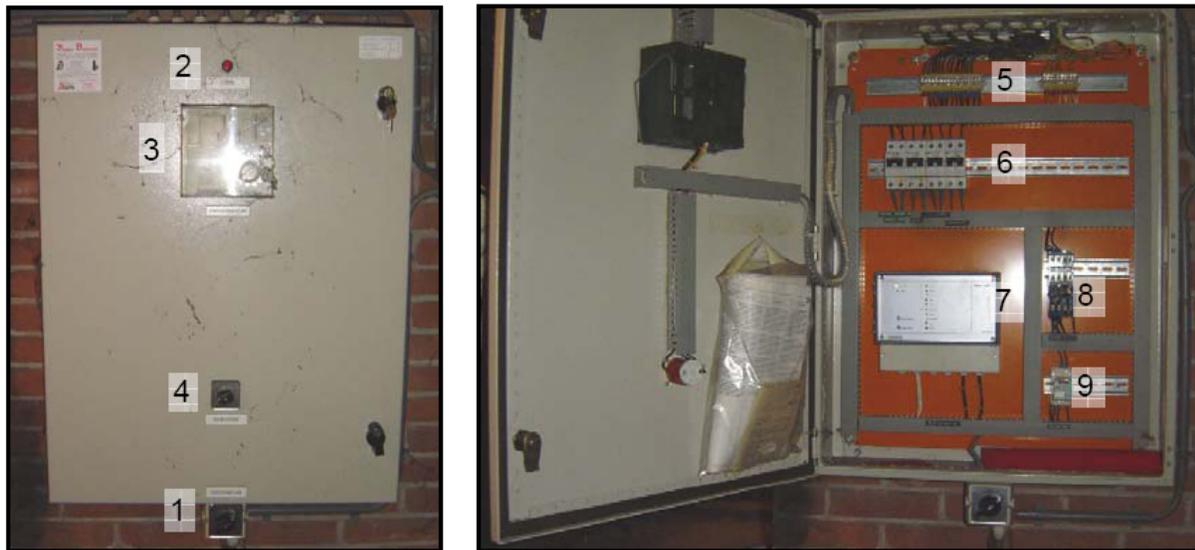
Figure 10 The switch box closed (l) and open, with the components numbered.

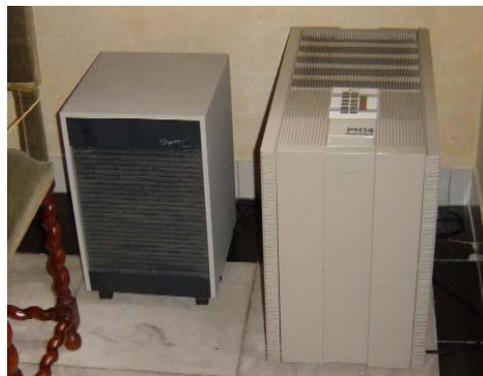
Figure 12 The dehumidifier and humidifier units used in the Sael.

The humidifier units also have activated charcoal air filters. The humidifiers are set for 50% RH. The capacity settings are set at III in the winter and I in the summer.

The dehumidifiers are set at 50% and work on the principle of cool drying with subsequent heating by the condenser.

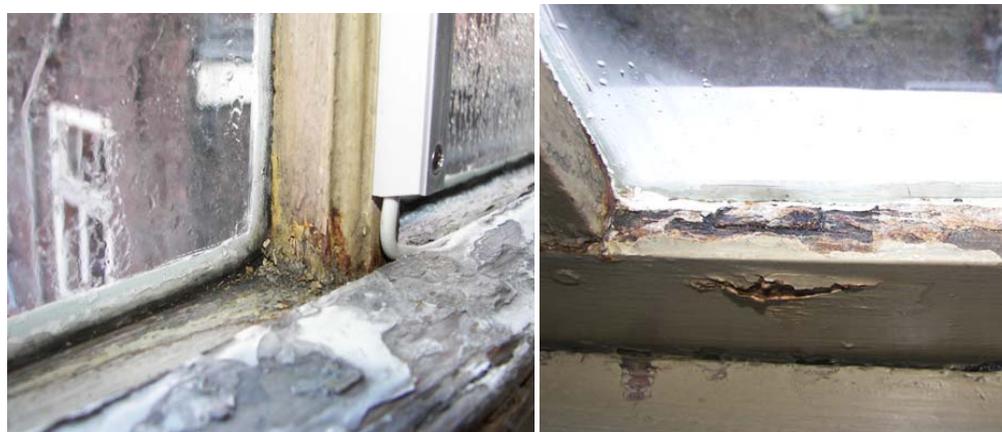
Figure 14 Two damaged areas on the window sills on the north-east wall of the Church resulting from surface condensation and high relative humidity at the surface.

See Figure 51 in Appendix B. Condensation often forms as a result of the low surface temperatures of the single-pane glass in the winter and the high absolute humidity in the church. The consequences of this surface condensate for wooden window sills are clearly visible.

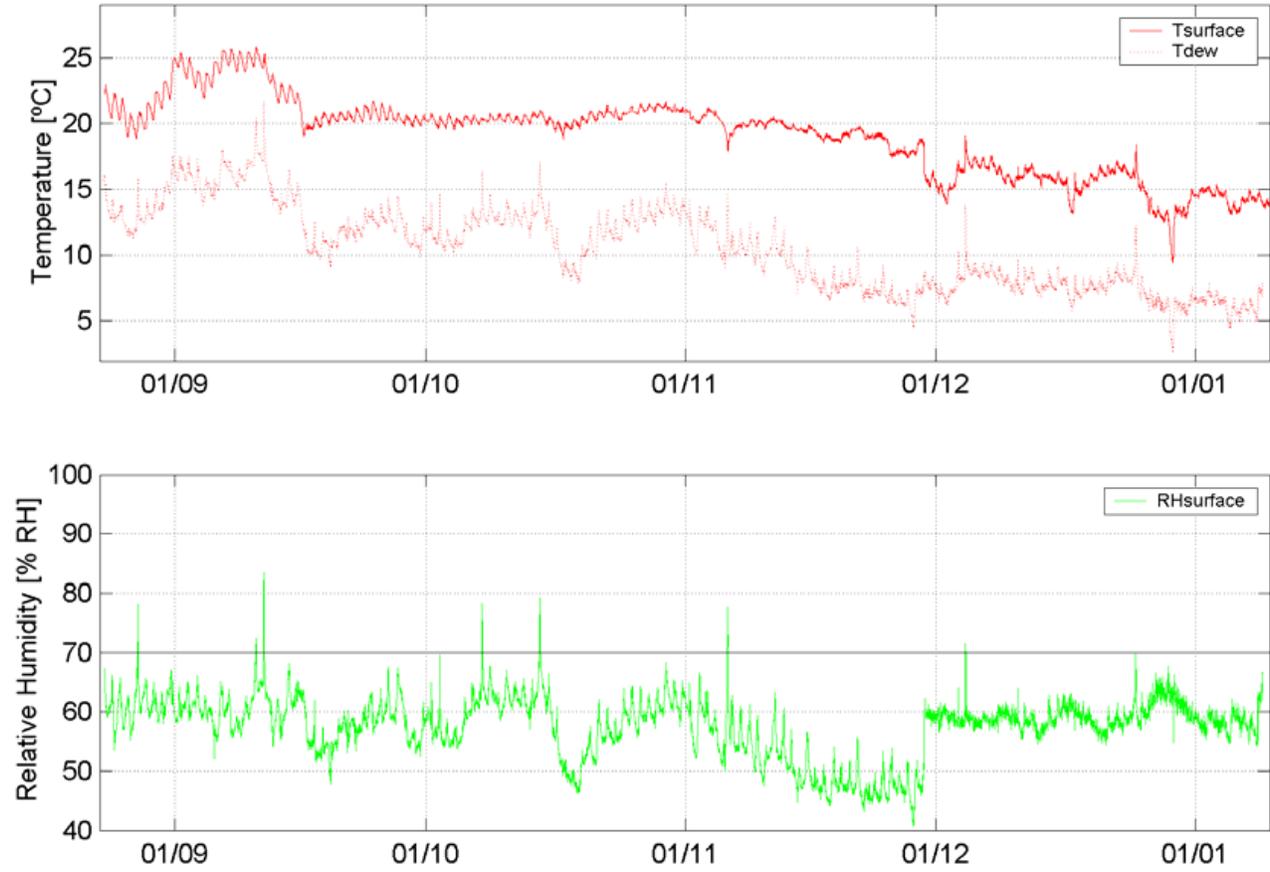
See Figure 52 in Appendix B. During the measurement period, there were no potential mold problems found on the window sill surface.

Figure 52 The graph above plots the measured T and the calculated RH versus time of the surface of the window sill on the north wall of the church. The lower graph also shows the 70% line of increased risk of microbial growth.

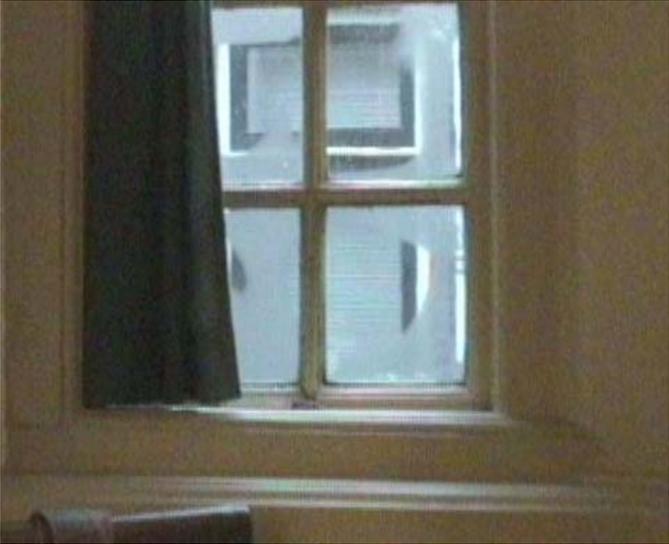
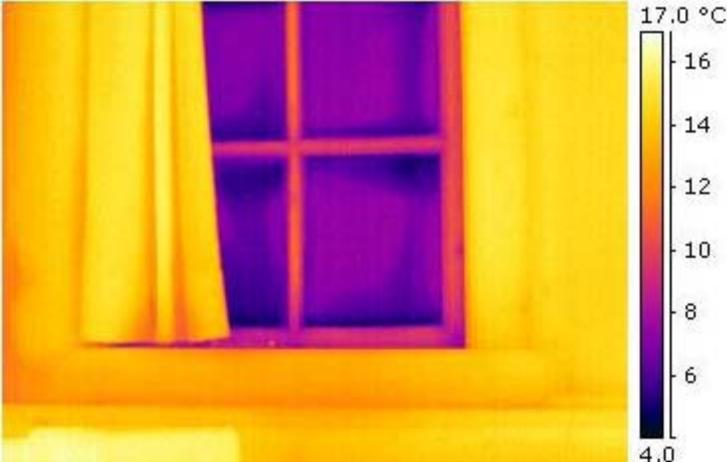
Single pane glass with condensation.

See Figure 54 in Appendix C which shows the condition of the window on the north wall, where condensation on the glass can be easily seen. The surface temperature of the coldest parts of the glass is about 4°C. Since this is below the dew-point temperature of the indoor air, condensation will form.

Figure 54 Ordinary, thermal and hygrographic images of a window with condensation on the 2nd floor in the exhibit room.

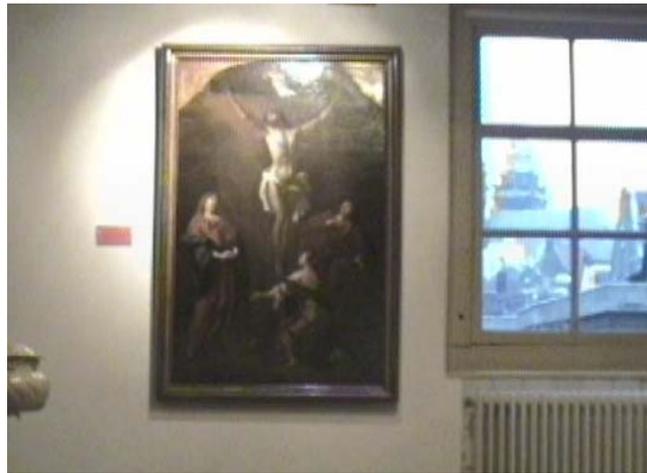
Painting against a cold wall and a window sill

See Figure 55 in Appendix C. This painting is hung on an outside wall. The RH at the wall near the painting is approximately 70%. Behind the painting, the RH is probably even higher because of decreased airflow. There is condensation on some of the glass and the window sill.

Figure 55 Ordinary, thermal and hygrographic images of a painting on the outside wall on the 3rd floor, in the hallway behind the altar.

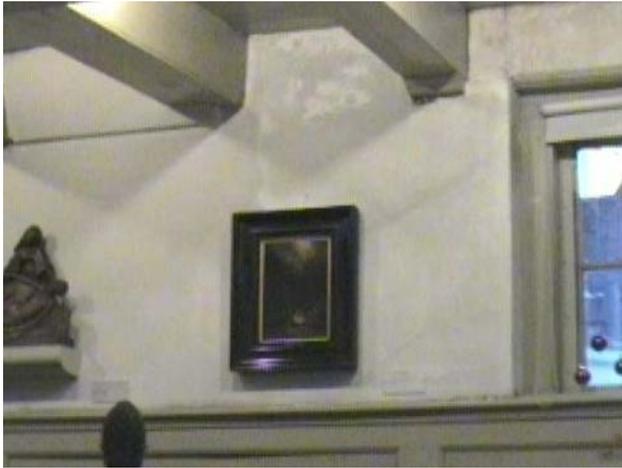
Painting against a cold wall

See Figure 56 in Appendix C. This painting is also hung on an outside wall. The photographs clearly show where the division is between the outside wall and the inner wall. In the vicinity of the painting the RH is approximately 70%, which could be even higher behind the painting due to the lower temperature.

Figure 56 Ordinary, thermal and hygrographic images of a painting on a southern outside wall on the 3rd floor of the Church near the altar.

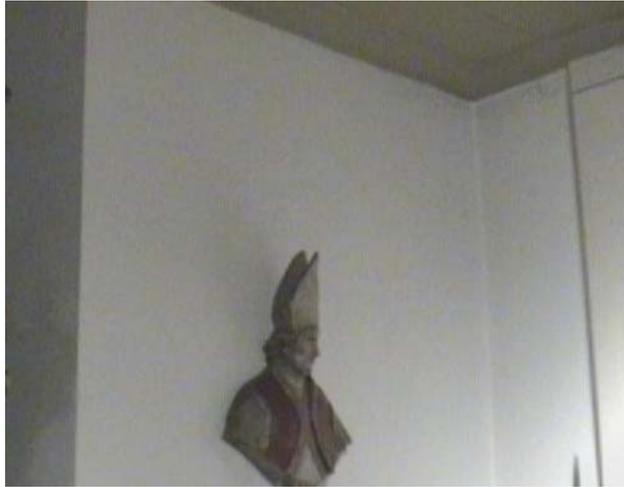
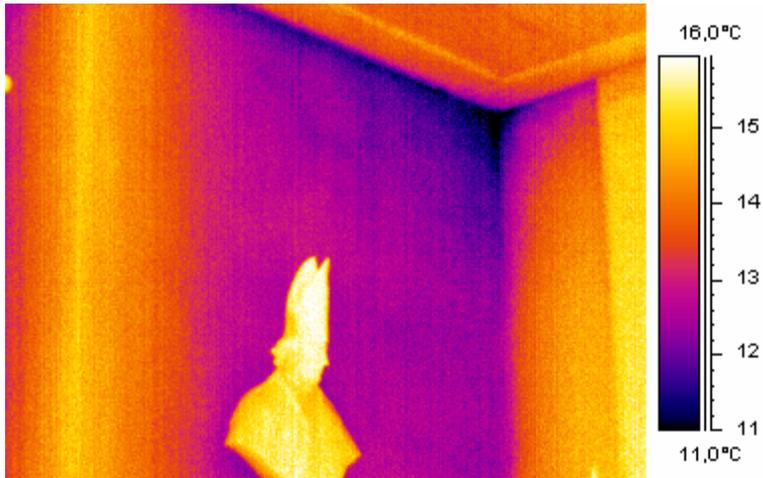
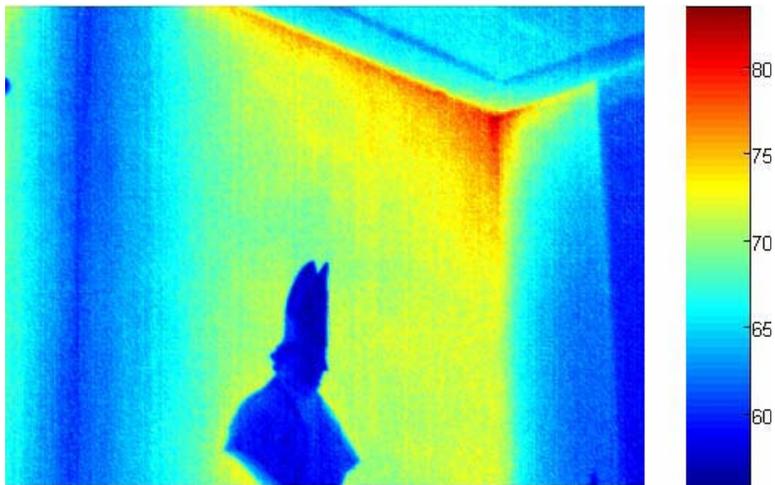
Art object against a cold outside wall

See Figure 57 in Appendix C. At the point that the art object touches the wall, the RH exceeds 70%, which could be even higher behind the object due to lower temperature.

Figure 57 Ordinary, thermal and hygrographic image of an art object against a cold outside wall. Location: 3rd floor behind the altar.

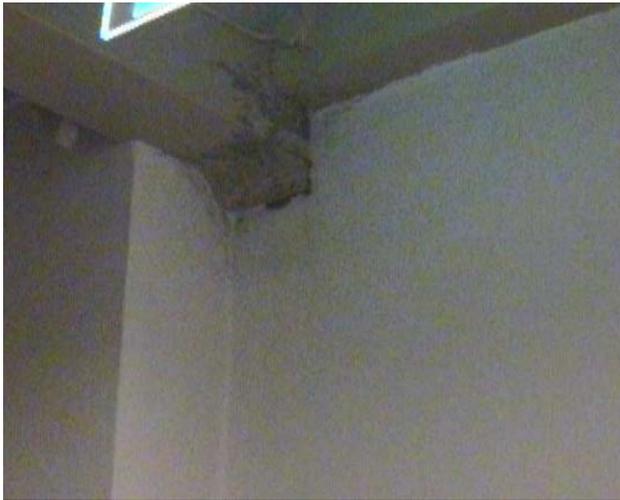
Restored beam head

See Figure 58 in Appendix C. This regards readings of a recently restored beam head. The low surface temperatures at the wall-joint are clearly visible. During the conditions indoors at the time the photograph was taken, the maximum RH at the surface of the beam head was about 80%. This high RH value means a higher risk of microbial growth and condensation on the beam head, which can lead to its rotting away. Because the temperatures inside the wall are probably lower still, it is quite possible that there will be condensation inside the wall where the beam head is located.

Figure 58 Ordinary, thermal and hygrographic images of a restored beam head. Location: 4th floor behind the altar near the stairs.

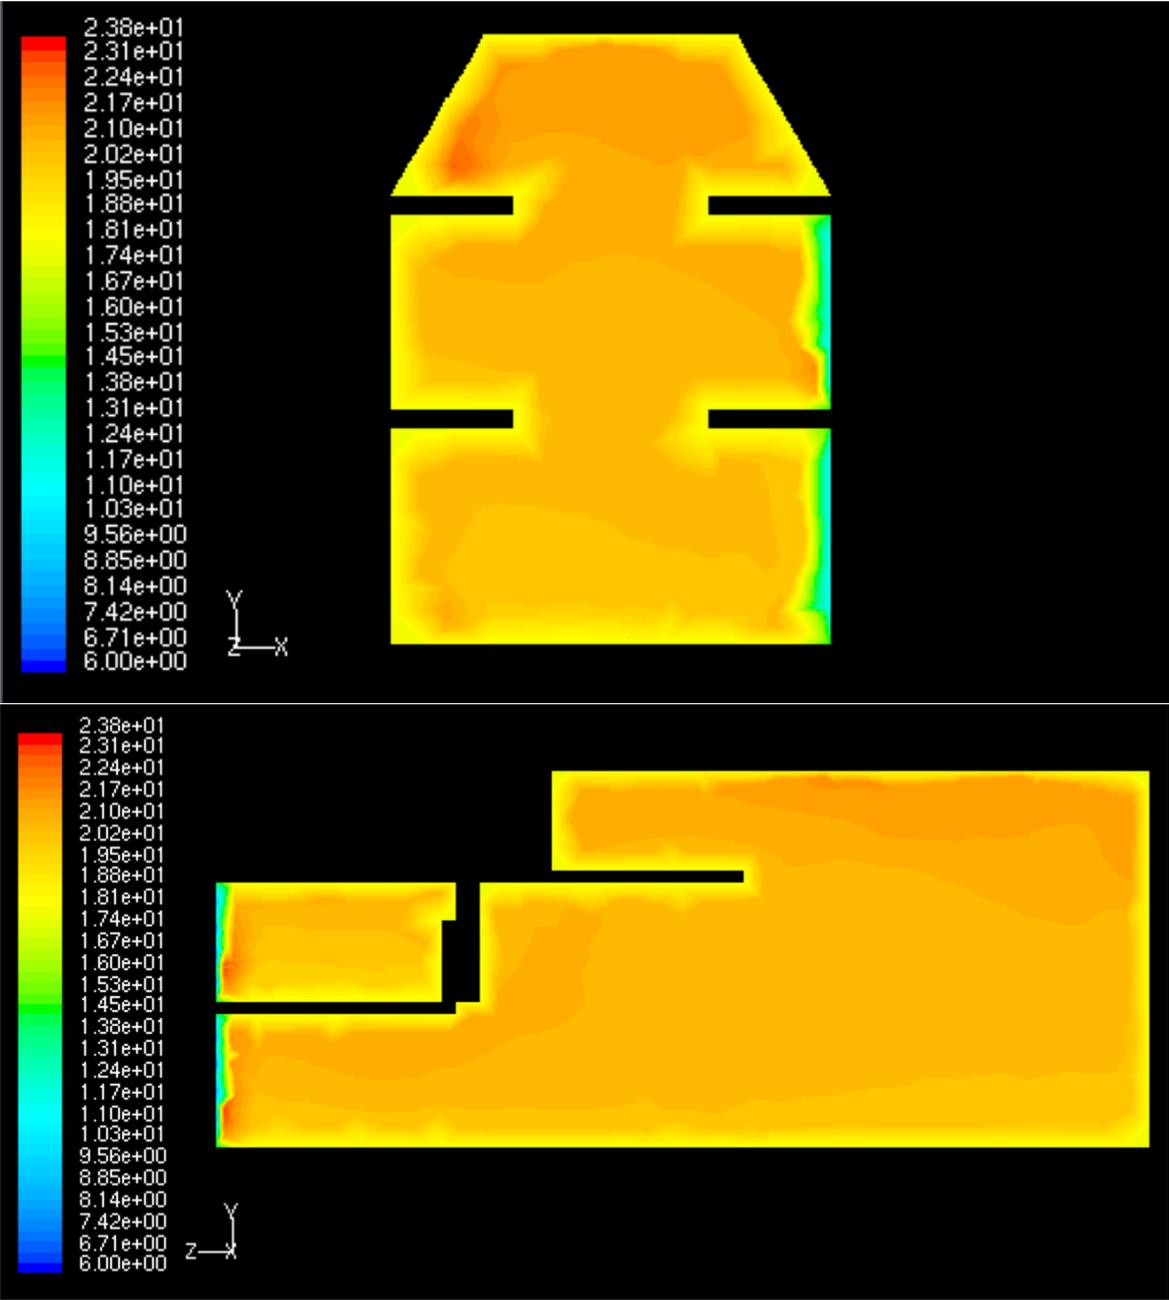
Figure 72 Simulation results of variant 1: the temperature distribution over the width and length of the Church during the winter.
