Assessment report 'Museum Our Lord in the Attic'

Part II – Assessments

7 Indoor climate research

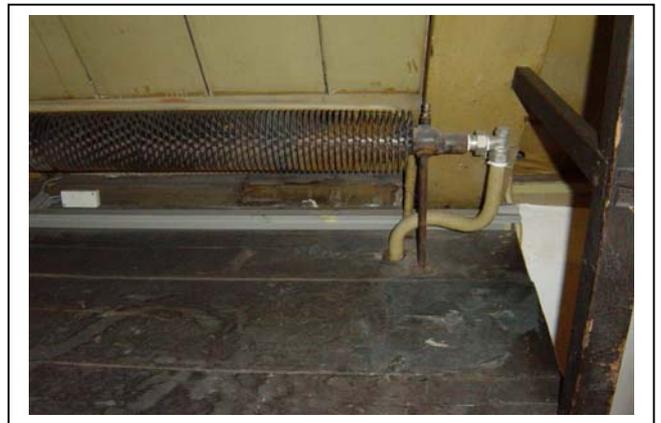
Heating at the base of the fixed church benches (photo: TU/E)

In 1938 it is recorded that central heating was installed in the building. Where exactly (recorded are 'Regentenzaal', 'bibliotheek' – then Canal Room and 'voorzaal') and what it may have looked like remains unclear. It is mentioned that the generated heat was comfortable throughout the building.¹ The heating at the bottom of the fixed benches for dignitaries in the church may date back to this period.

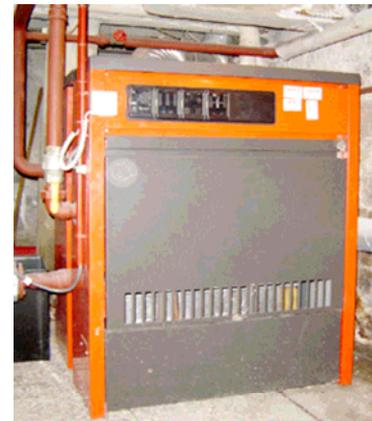
The boiler (photo TU/E)

The air supply is located in the door of the basement. Smoke/fumes are extracted through chimneys in the building leading to the roof. The basement space has a gas detection system.

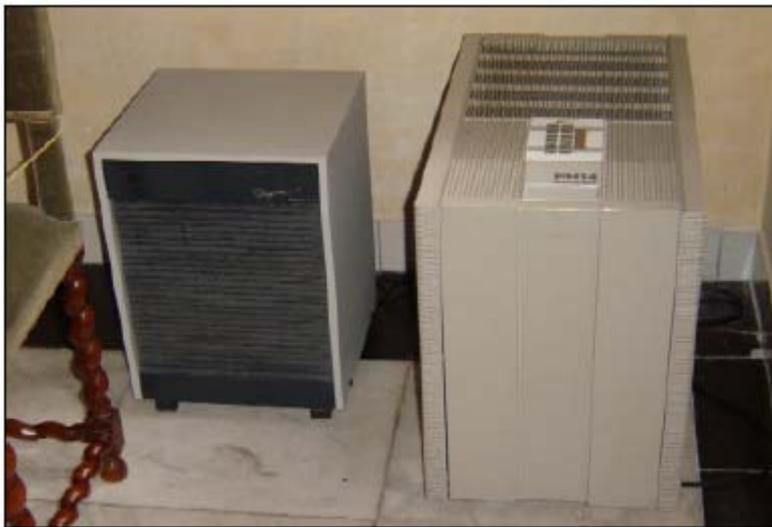
Humidifier and dehumidifier in the Sael. (photo: TU/E)

The humidifiers (Defensor P14, cold evaporation type) are equipped with active carbon filters that filter the air and remove pollutants. Their setting is 50% RH. Their capacity is set in winter at level III and in summer at level I.

The dehumidifiers are set at 50%; they are of the cooling dehumidifier type.

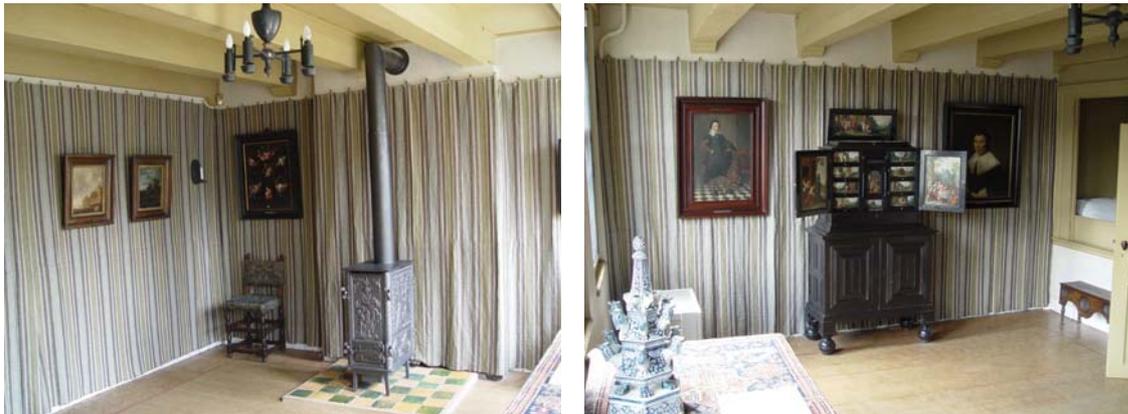
The Canal Room (photos: ICN)

The Canal Room is a historic interior with a few objects: several paintings (on canvas and on panel), several pieces of furniture (including a painted cabinet), a ceramic vase and some metallic lamps. The cupboard bed is made up with bed linens.

There is no local (de)humidifier present in this room.

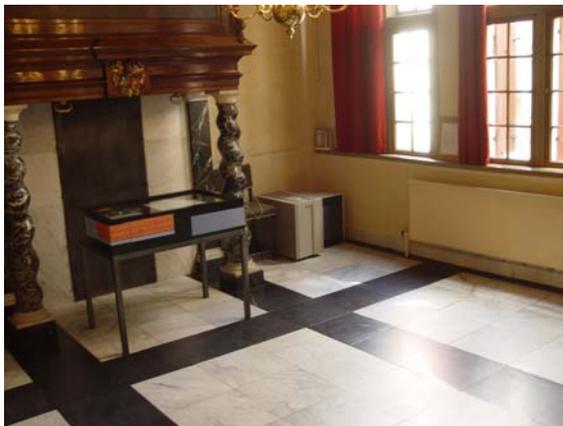
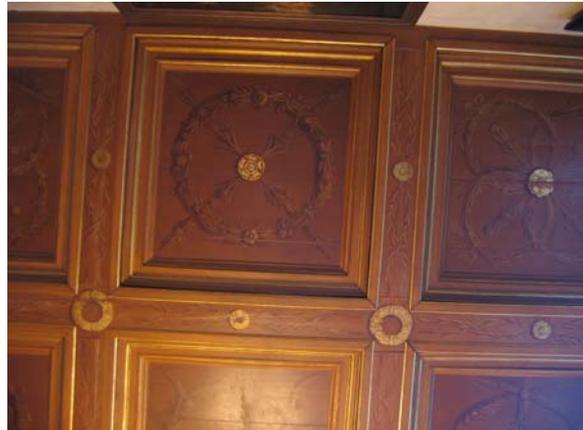
The Sael and the wooden ceiling (showing a crack in the lower panel) (photo: ICN)

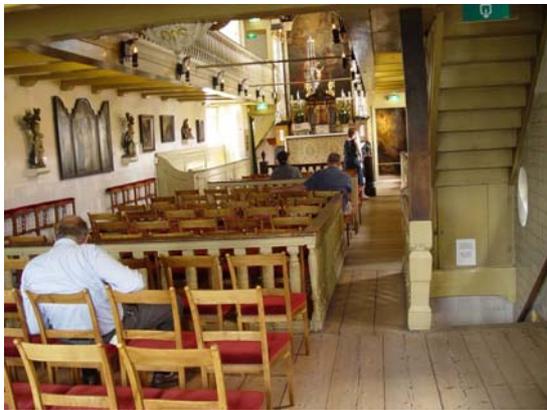
A variety of objects, such as paintings (both on canvas and on panel) and wooden sculptures (many are polychrome), are on open display. Some (precious) metal objects are exhibited in showcases.¹ The most valuable object, in terms of cultural value, is a painted wooden Maria sculpture (just behind the altar, in a separate room referred to as the Lady or Mary Chapel), which is thought to have been in the Church since its beginning.

The Church (photos: ICN)

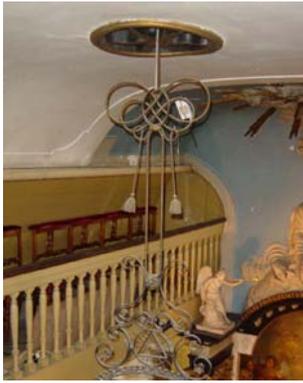
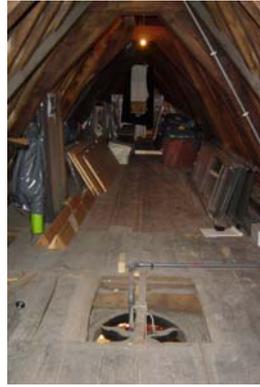
The 'Lamp of God' seen from the Church and from the attic

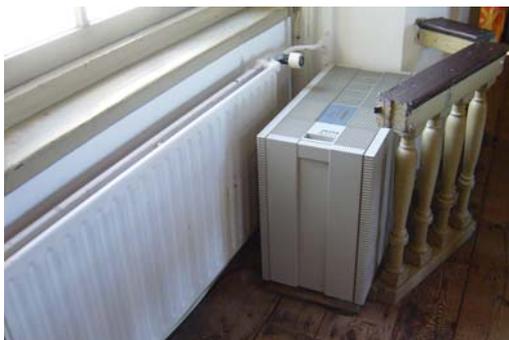
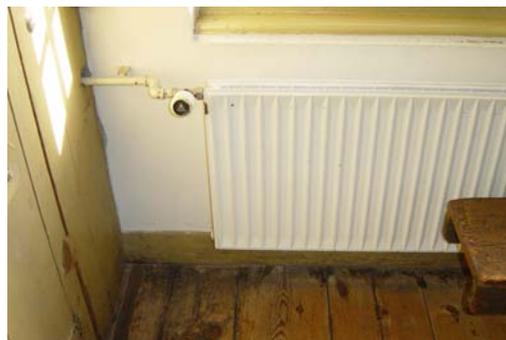
Humidification and central heating in 2006 (photos: TU/e)
