## PHYSICAL STRATEGIES – STRUCTURAL ANALYSIS AND INTERVENTIONS

*This session was created by Tony Crosby and modified by Claudia Cancino.*

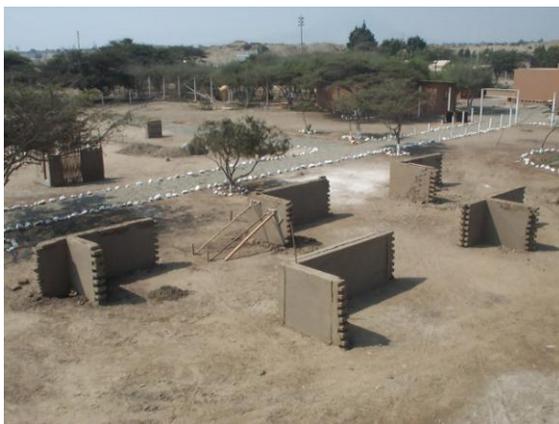
Figure 5.3.1 (left) and 5.3.2 (right)  
Left: View of field exercise walls to be repaired  
Right: PAT instructor discusses the damage and proposed solutions to PAT students  
PAT course, 1999 © J. Paul Getty Trust

The field exercise will be undertaken at the constructions used earlier to demonstrate failure patterns. The five groups will each work on a separate construction and each group will be given a specific reintegration assignment, in addition to a common exercise for all of the participants. The common assignment will be the stitching together of two portions of an adobe wall separated by a structural crack.
