TECHNICIAN TRAINING FOR THE CONSERVATION OF MOSAICS

PART 2
THE CONSERVATION OF DETACHED MOSAICS

Mosaics detached and relaid in situ on
reinforced concrete:
their deterioration, in situ maintenance treatments
and documentation

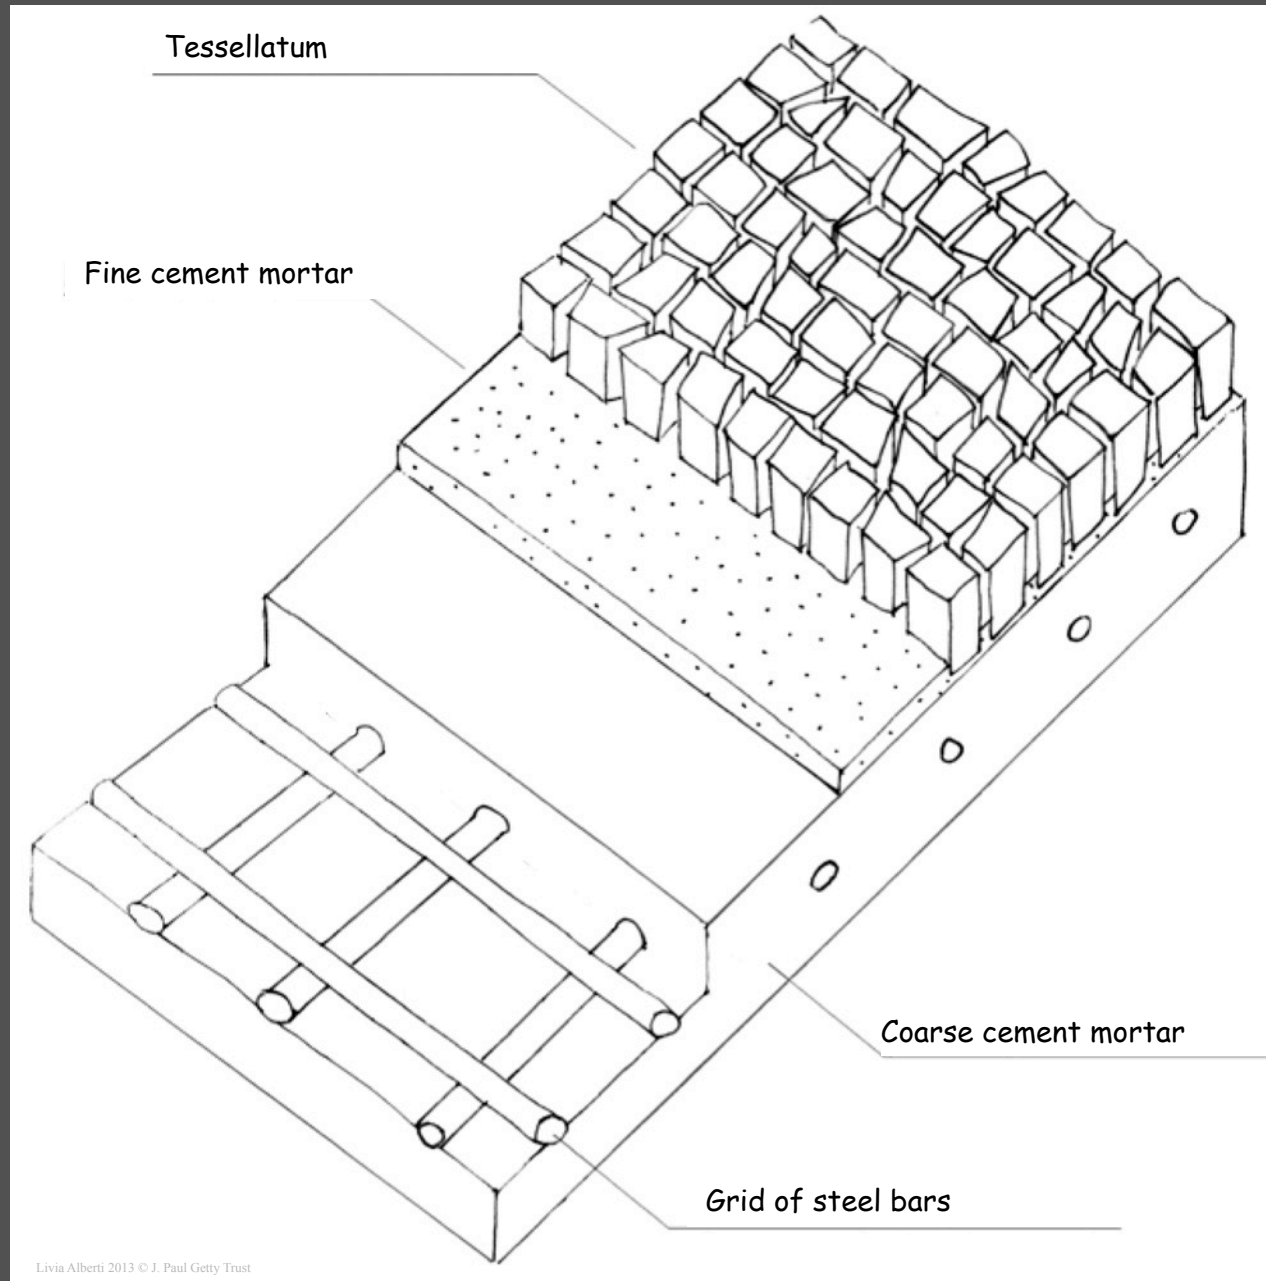
Panel reinforced with steel bar grid

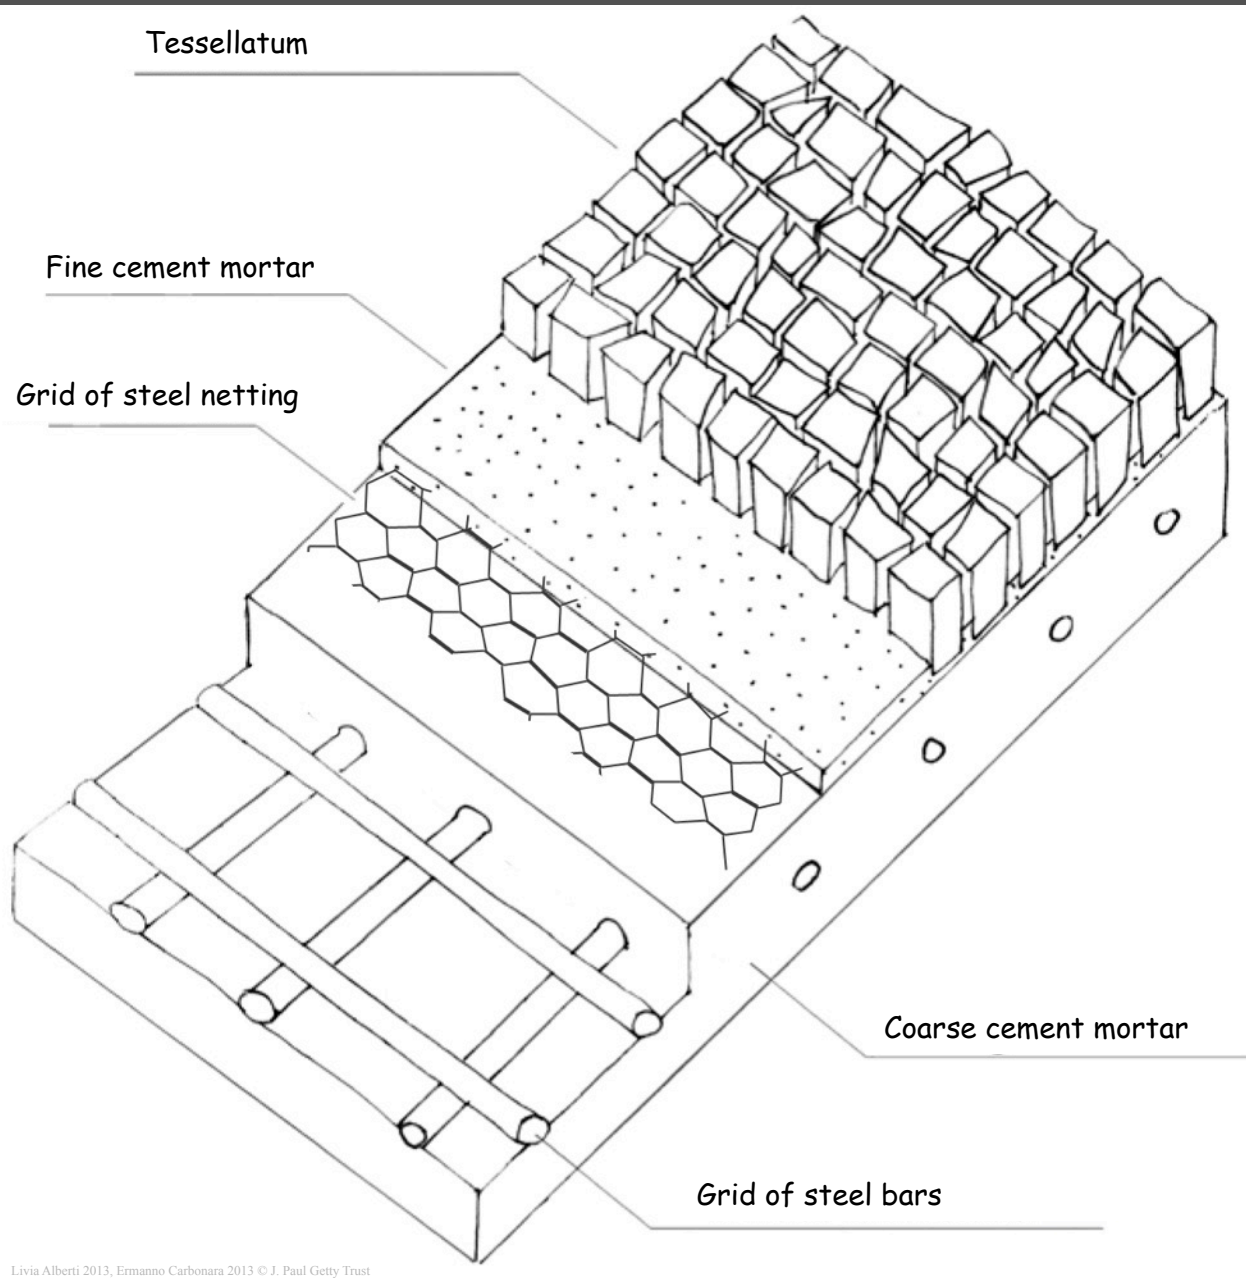
Panel reinforced with steel bar grid and wire

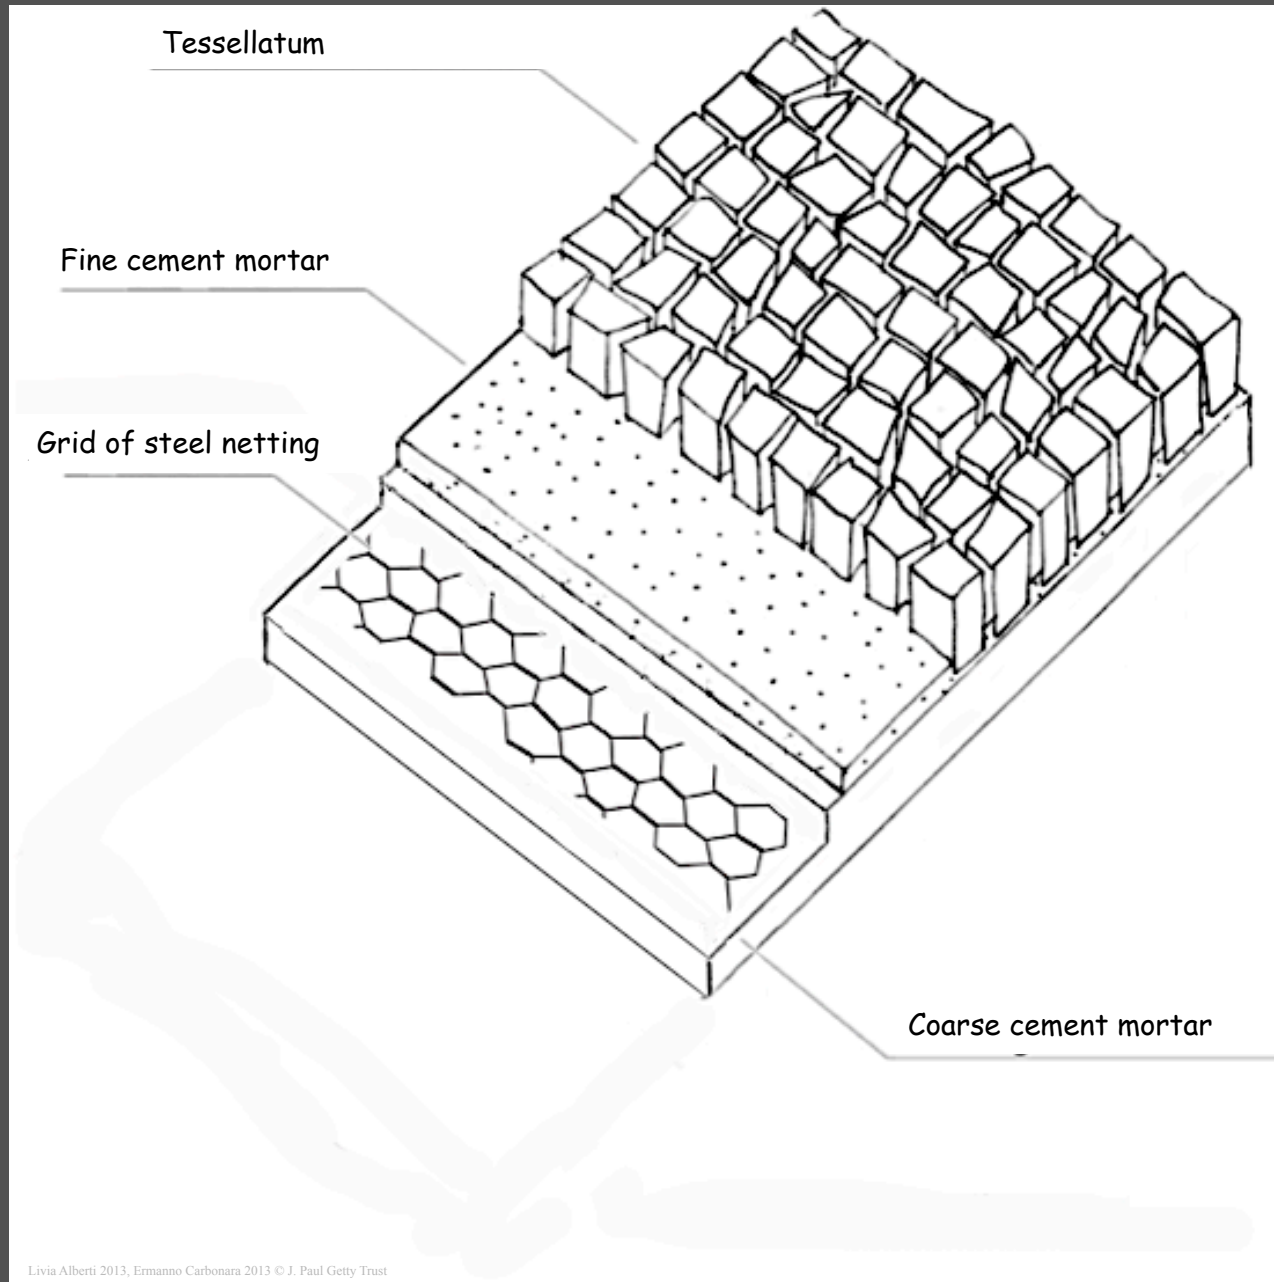
Panel reinforced with steel wire

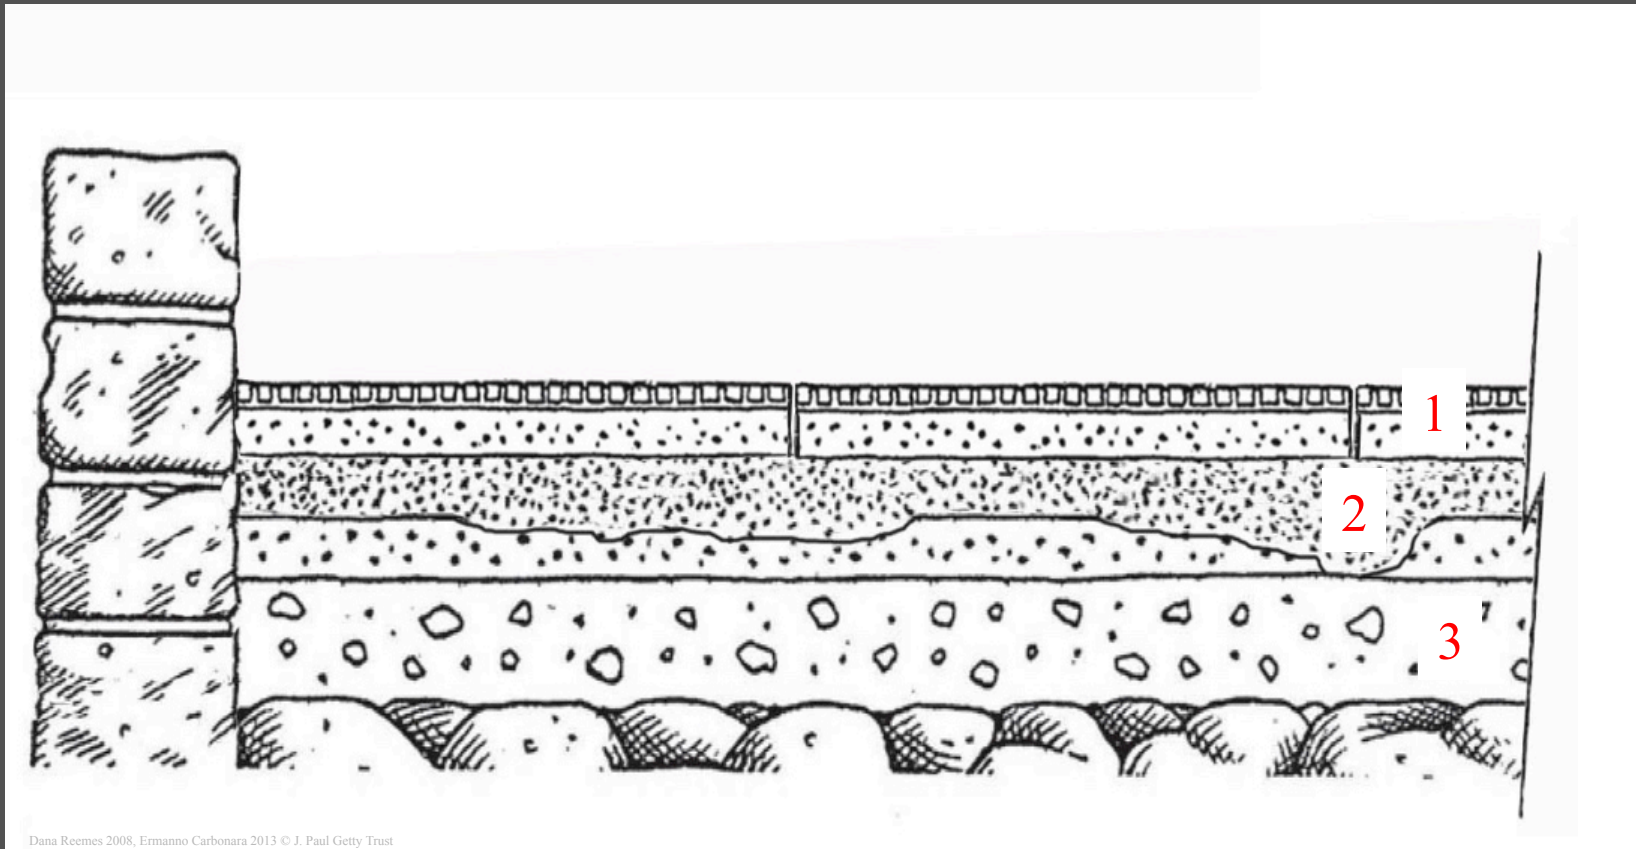
Example of on-site installation of reinforced concrete panels

- 1 Mosaic panels
- 2 Layer of sand
- 3 Original preparatory layers of mortar

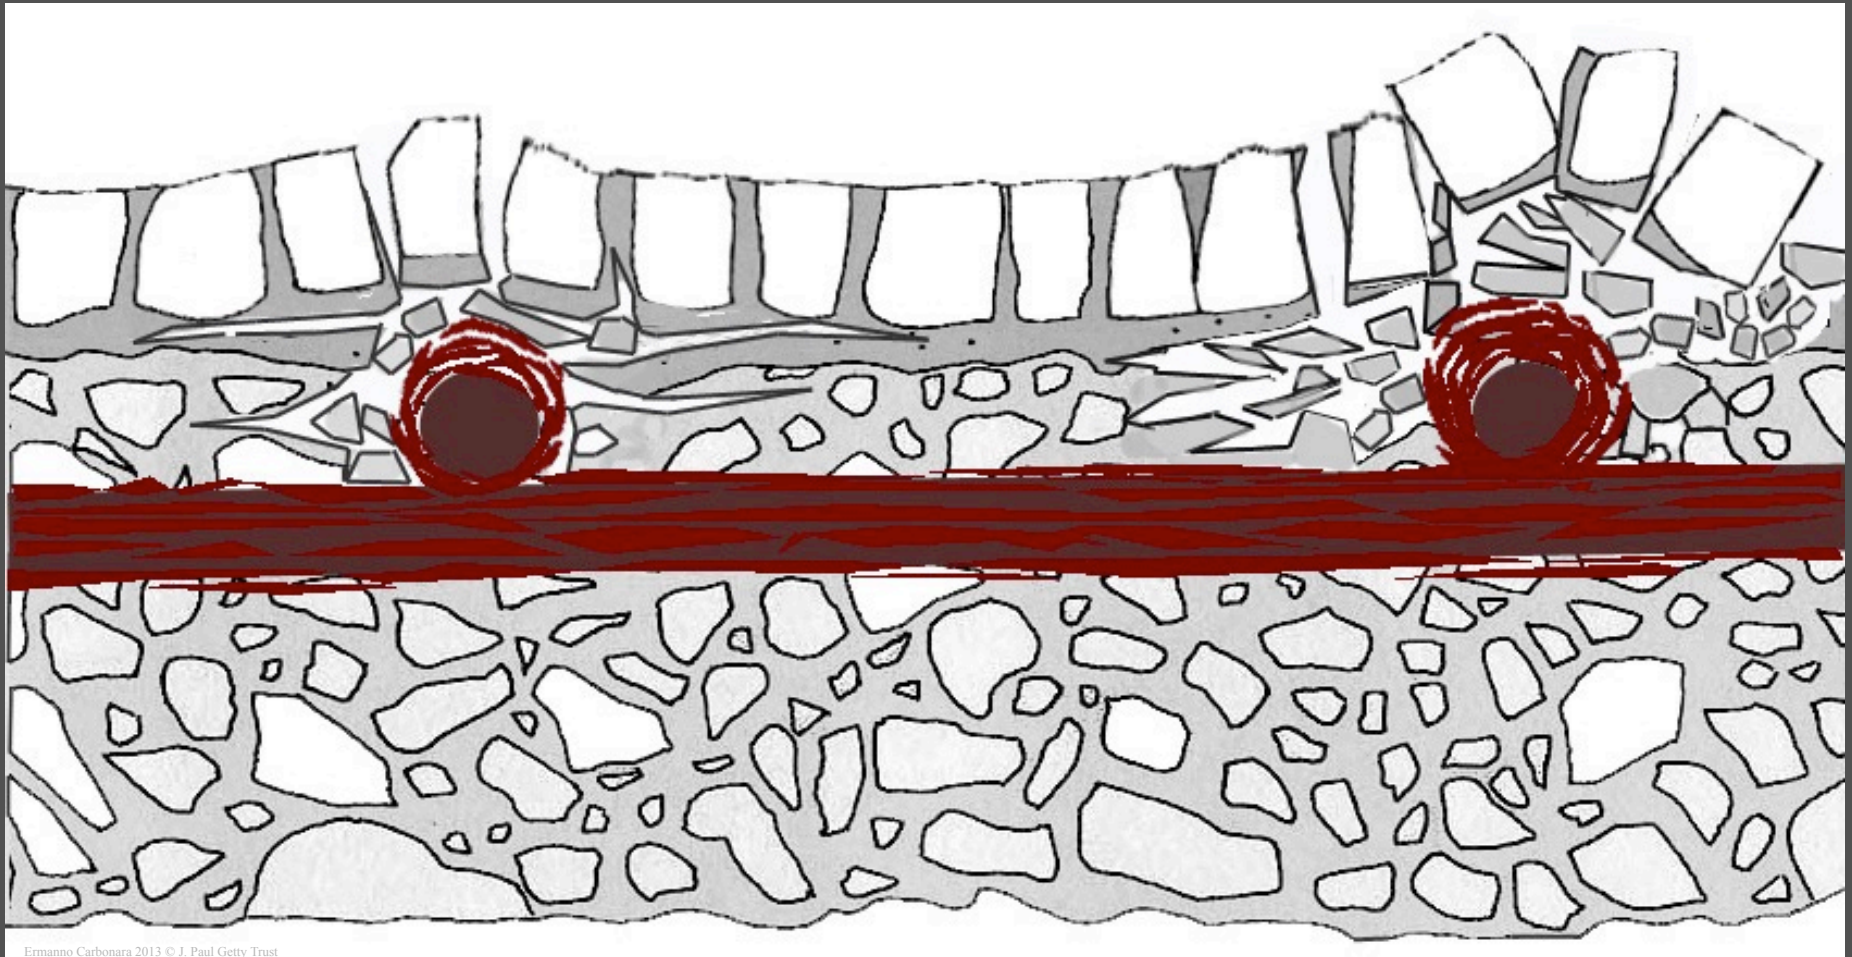
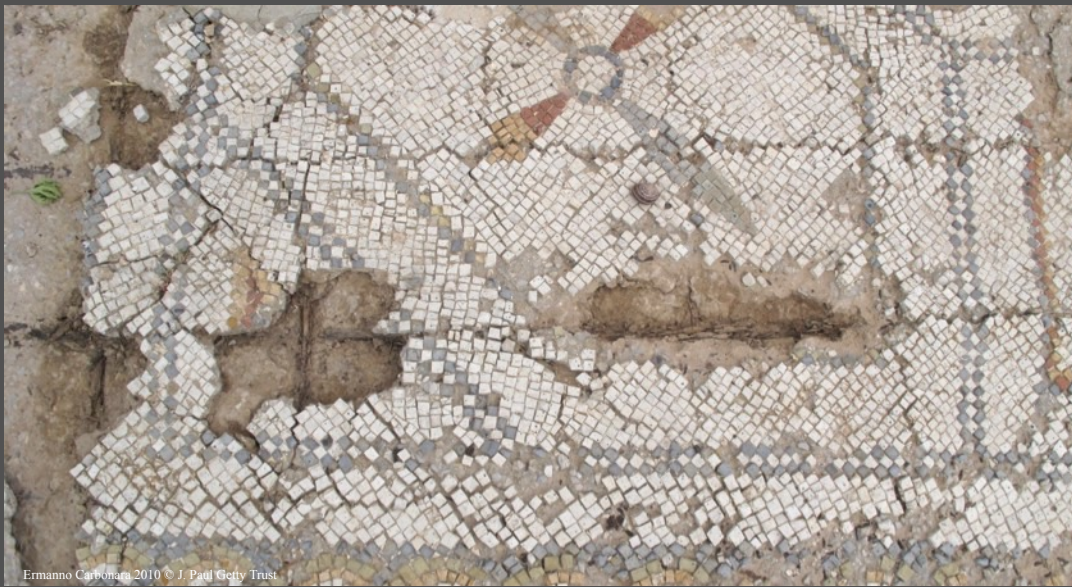
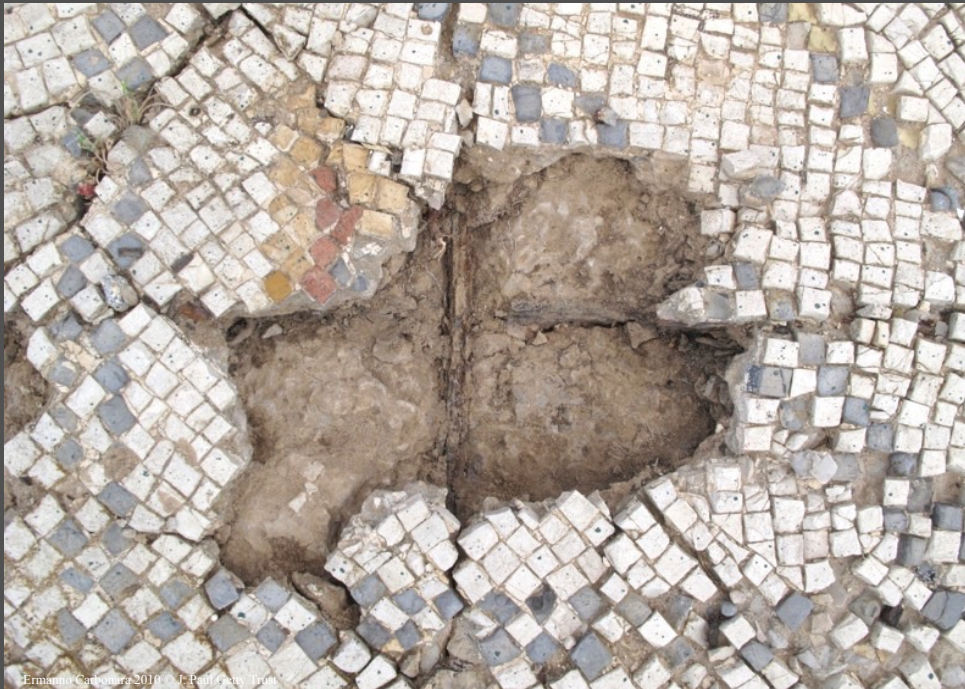
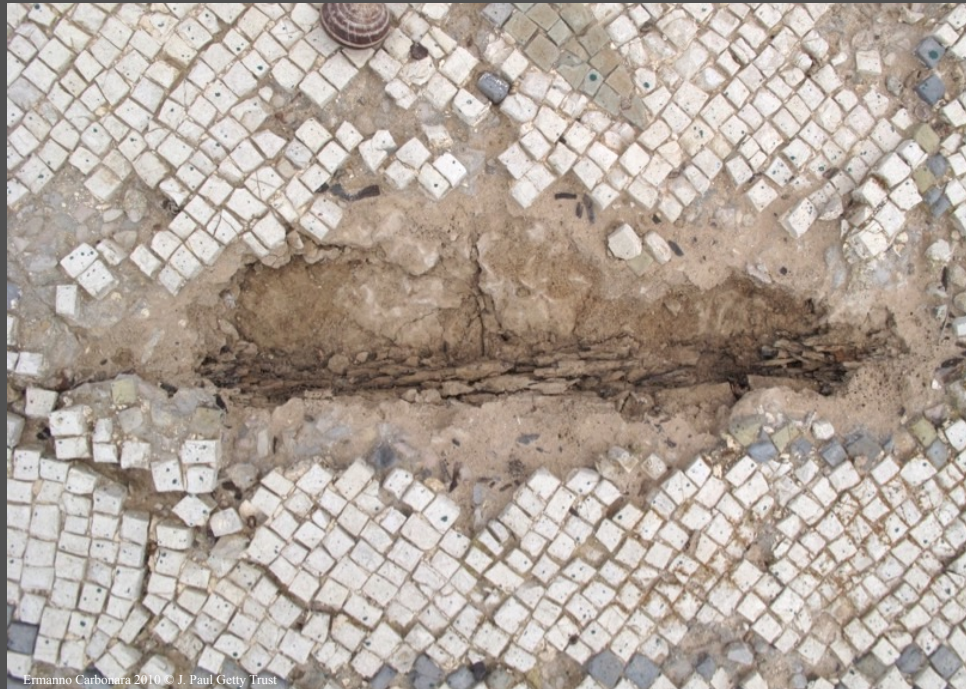
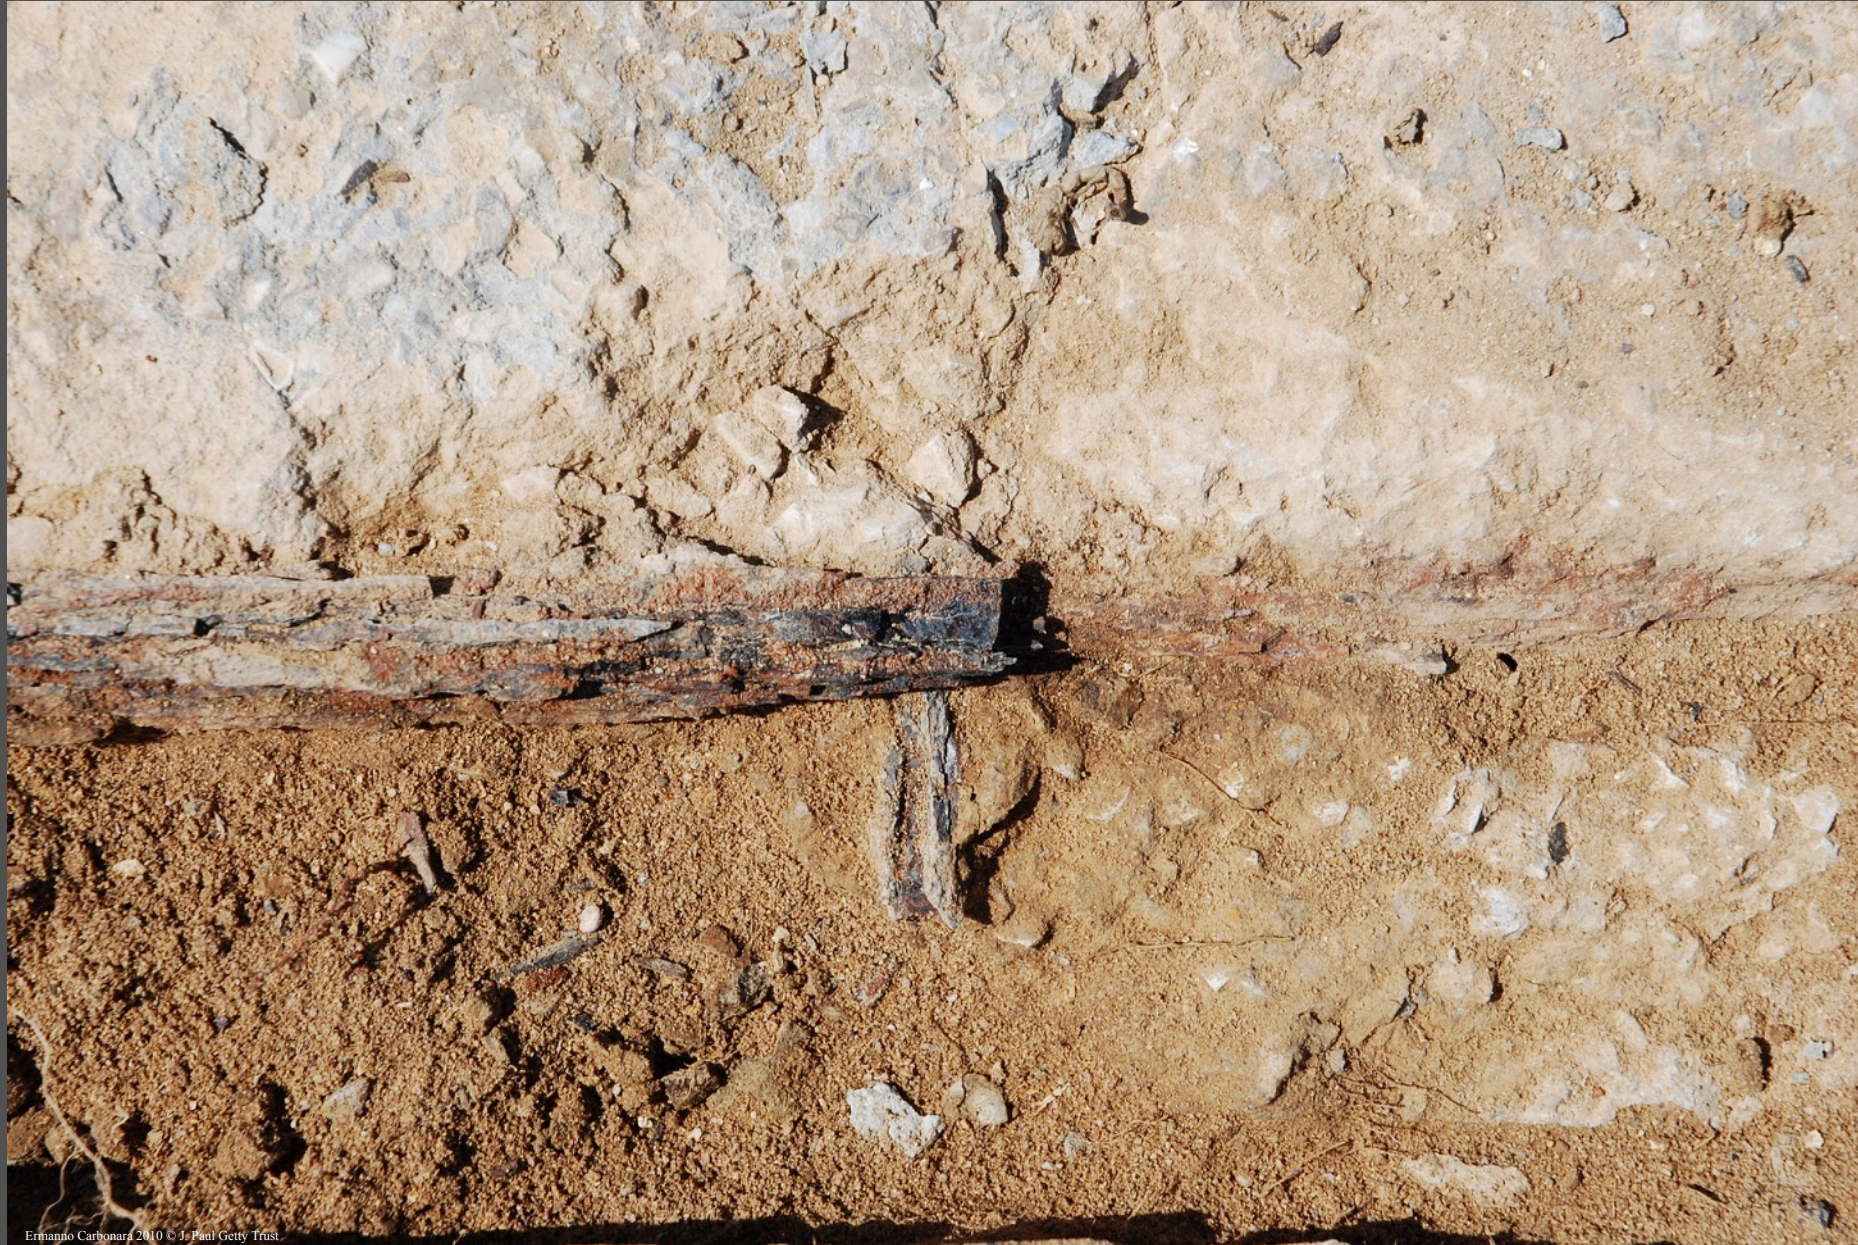
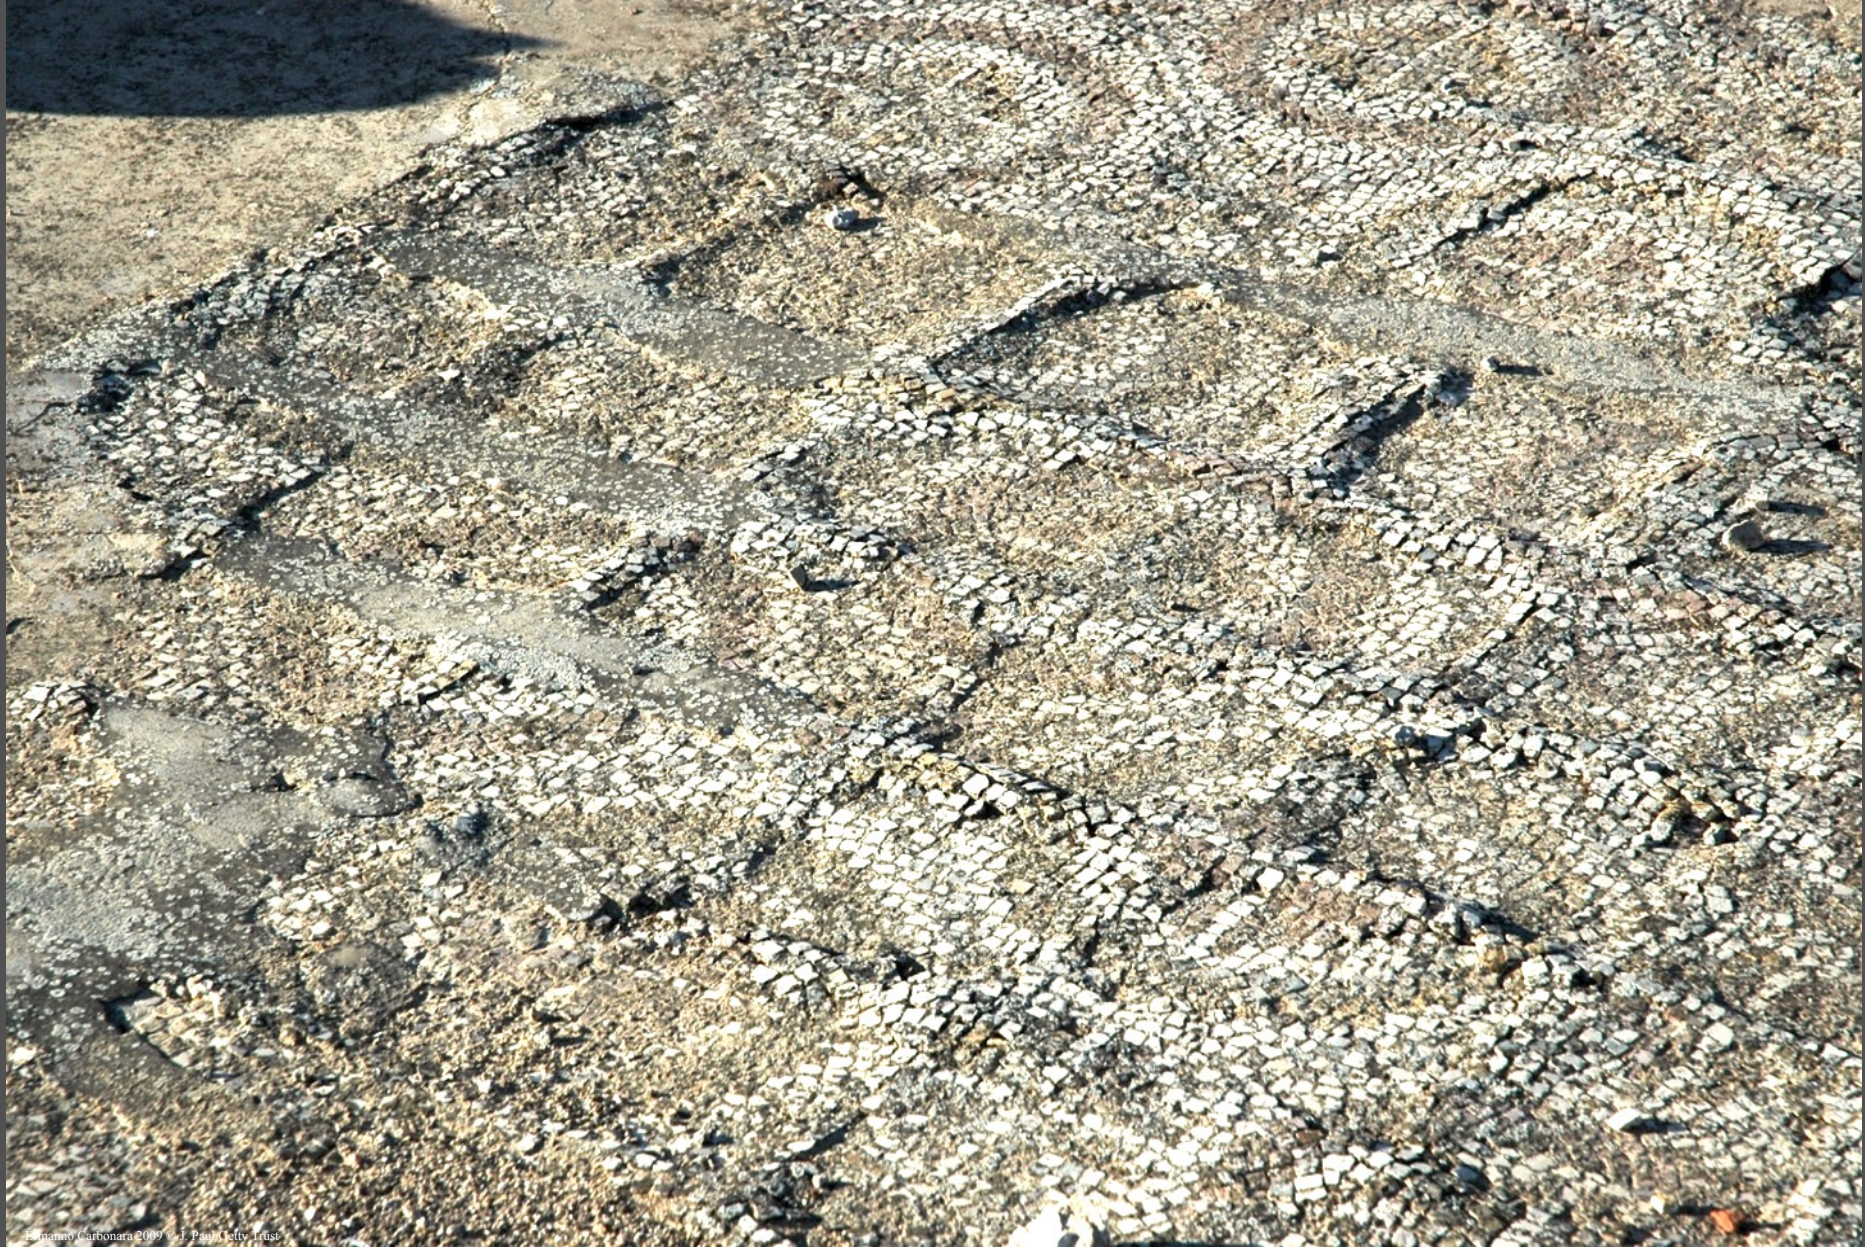
Corrosion of steel bars in the concrete

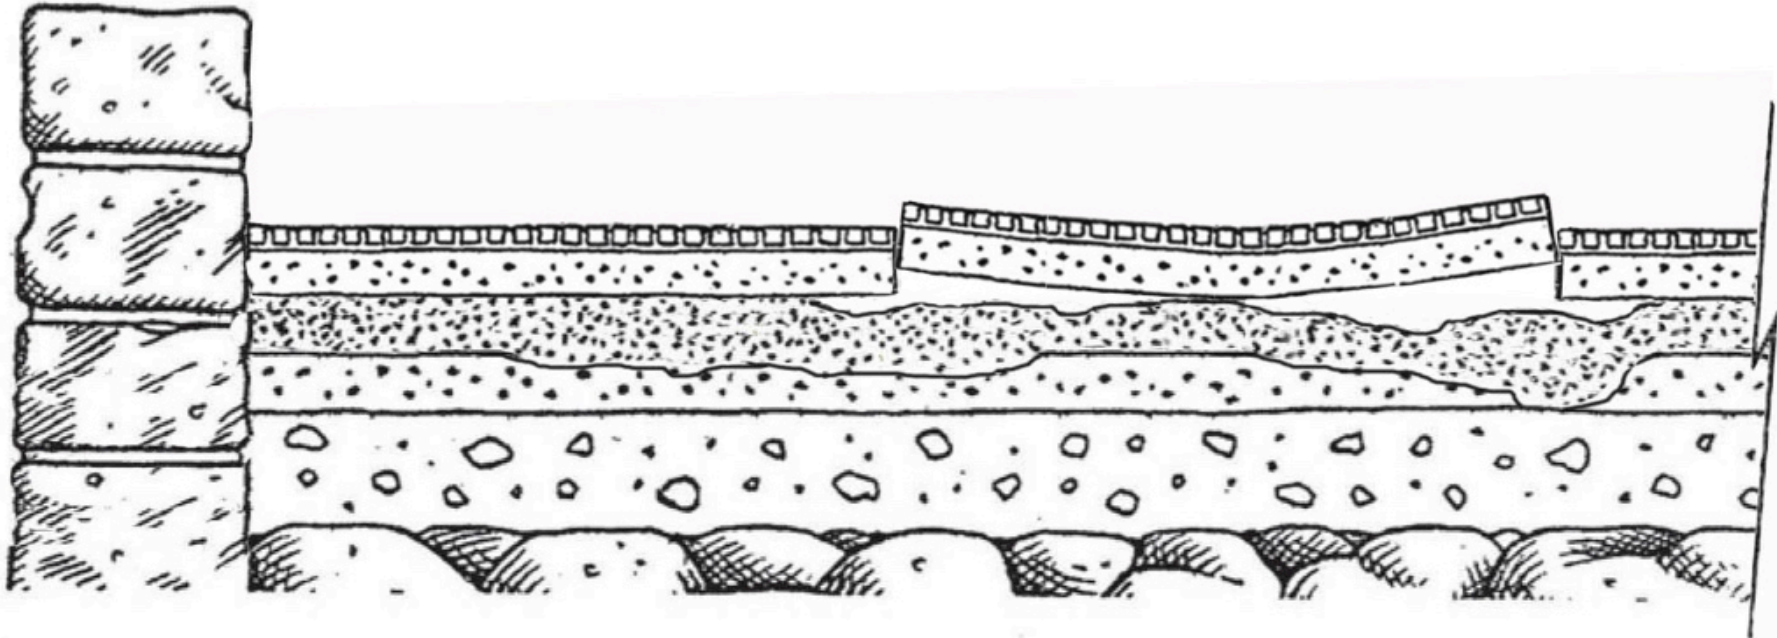
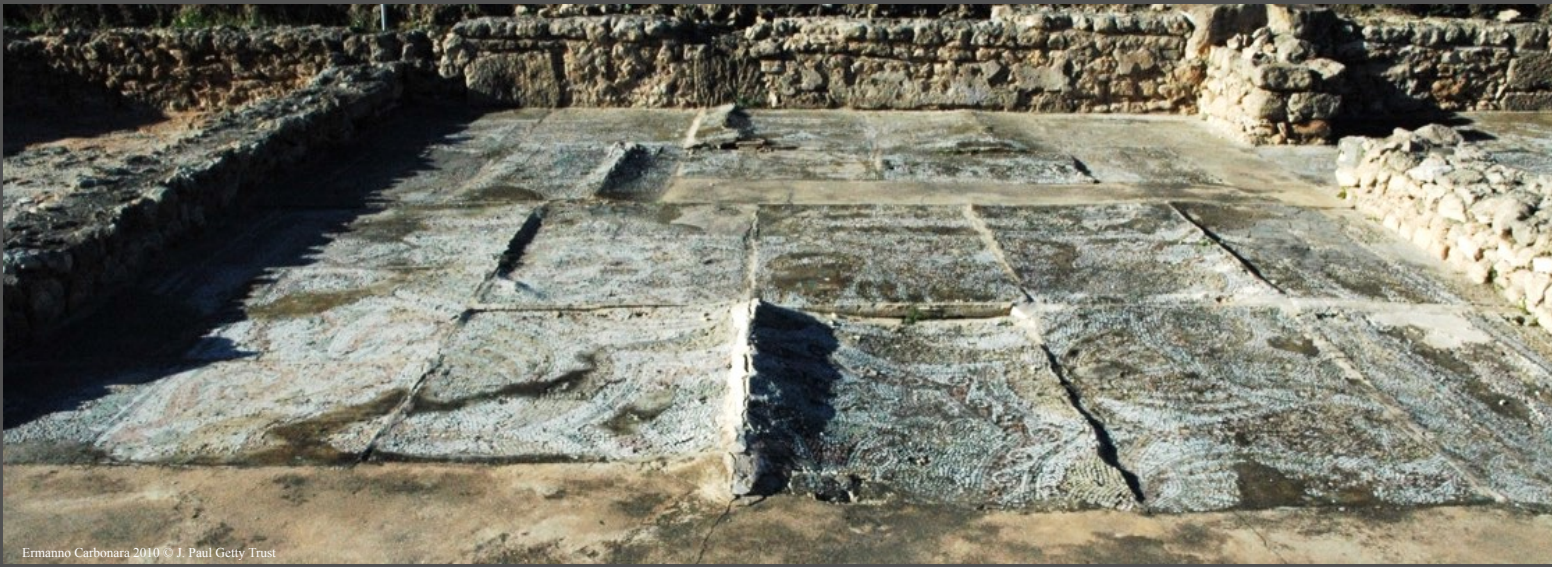
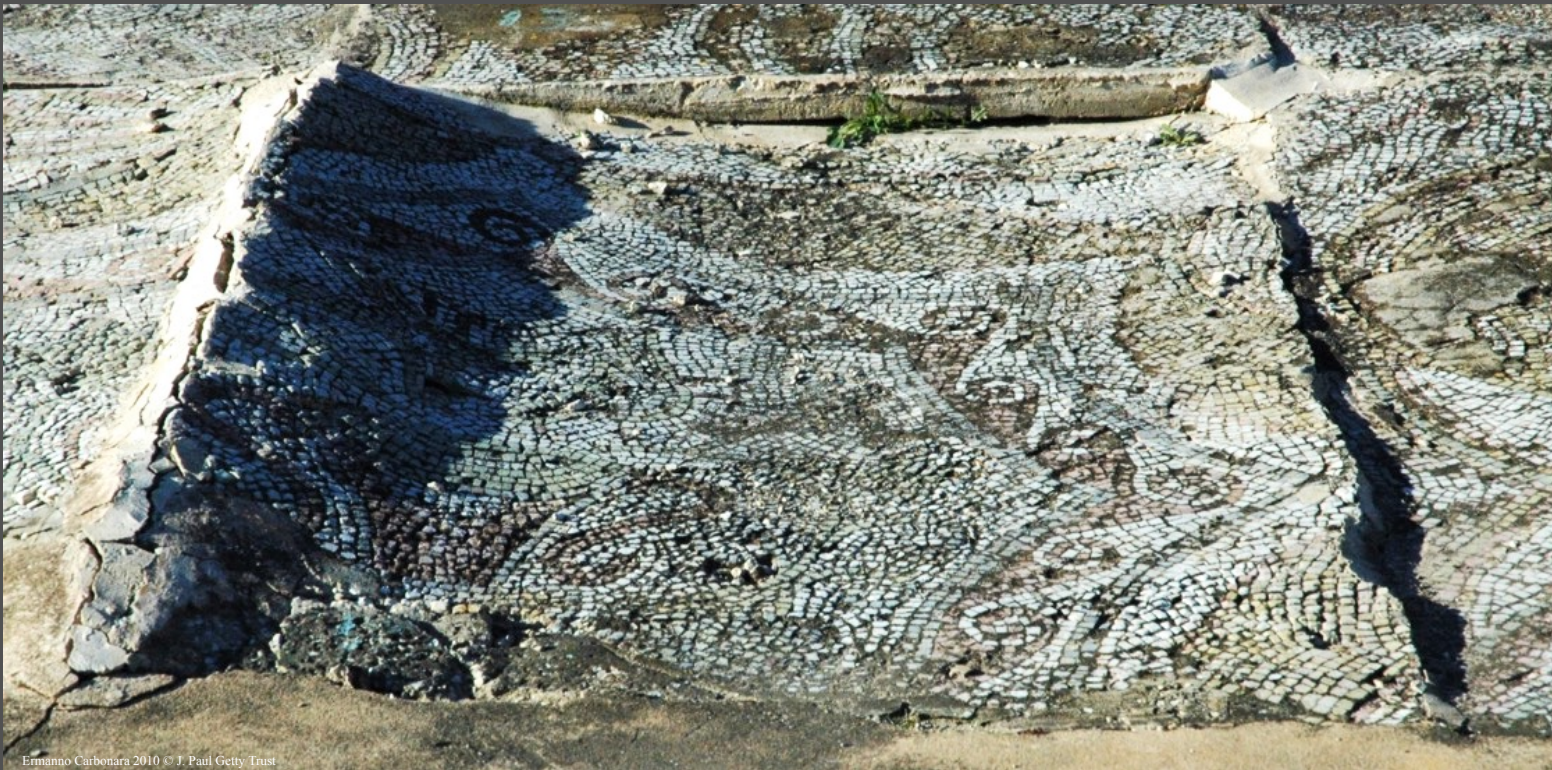
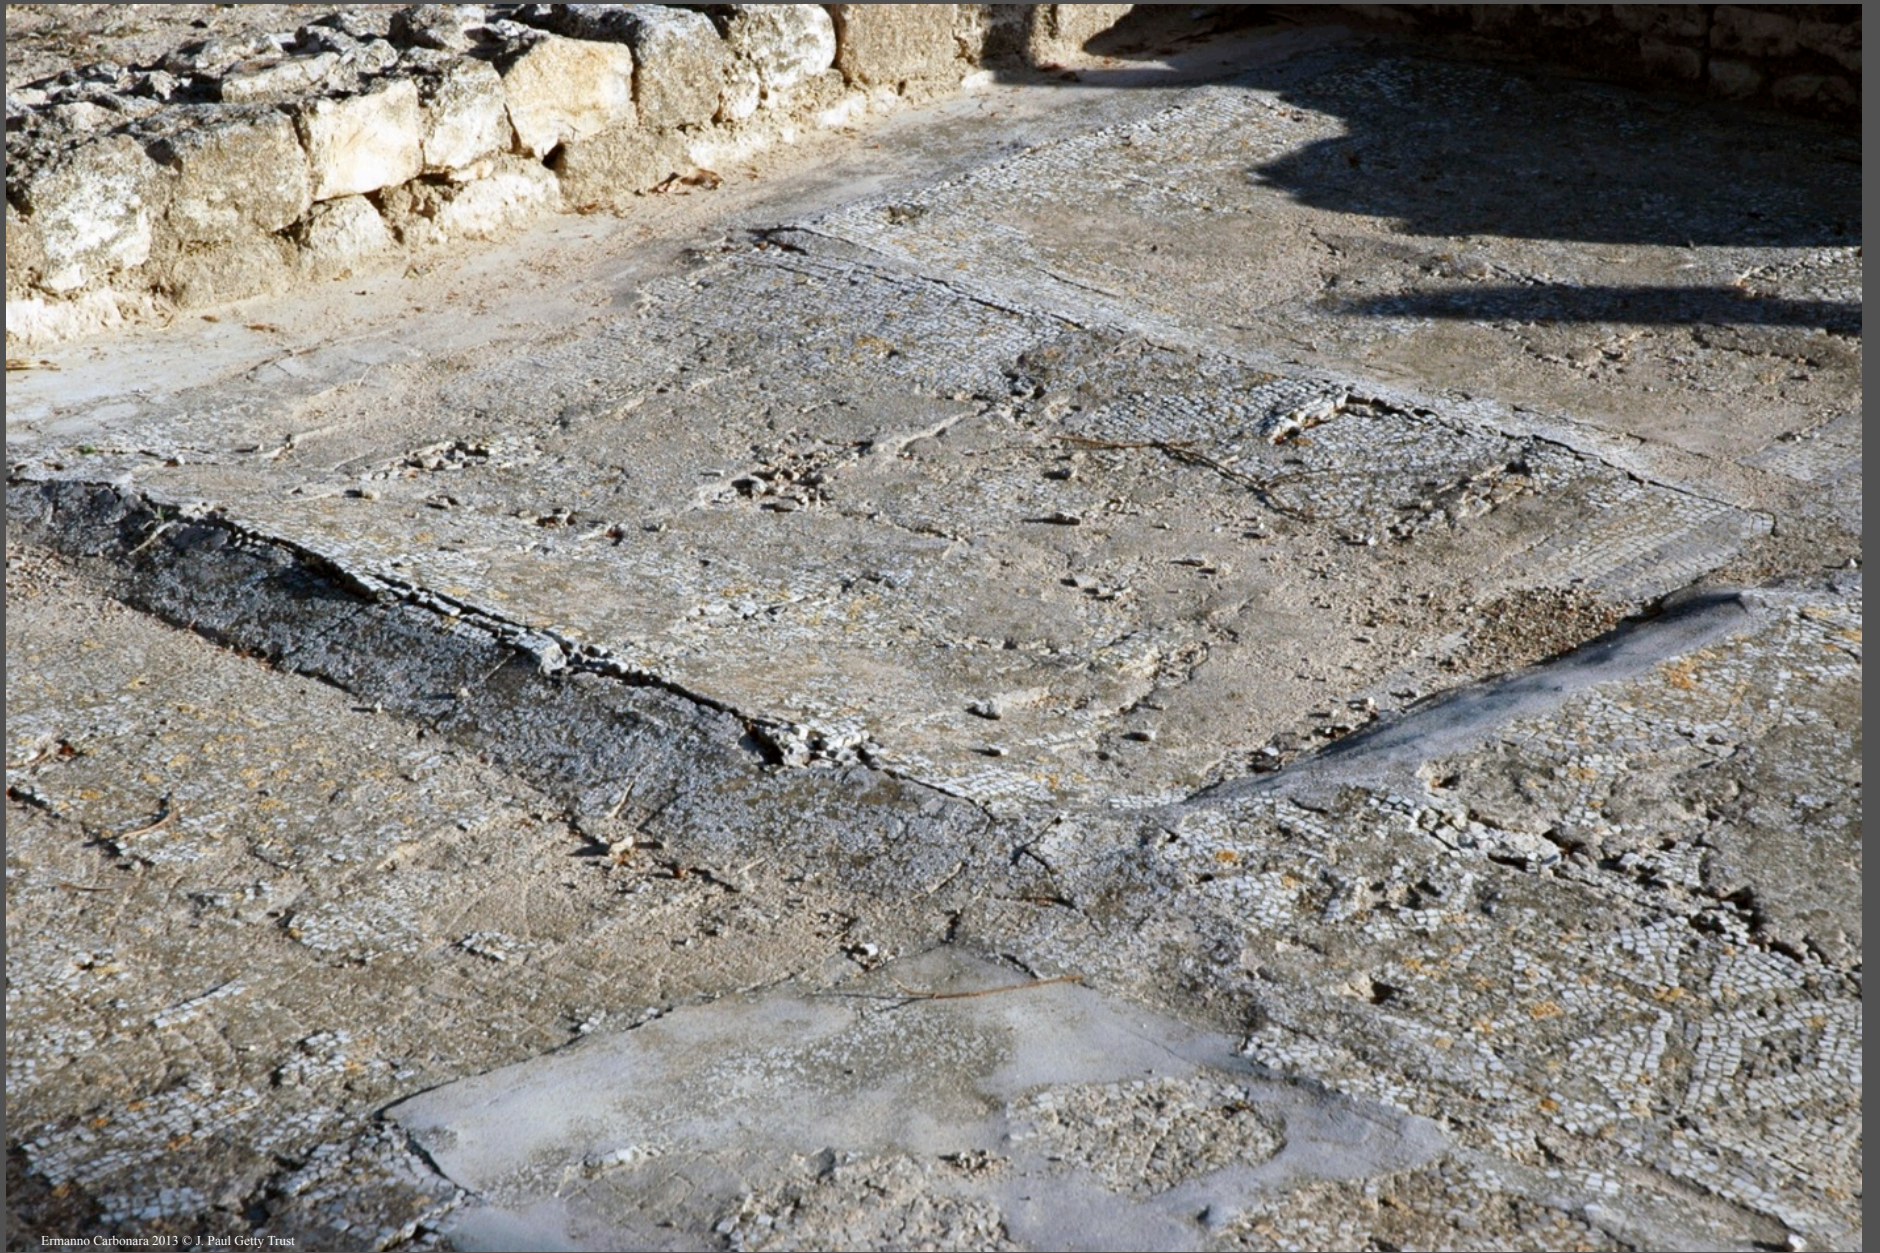
Deformation of mosaic support panels

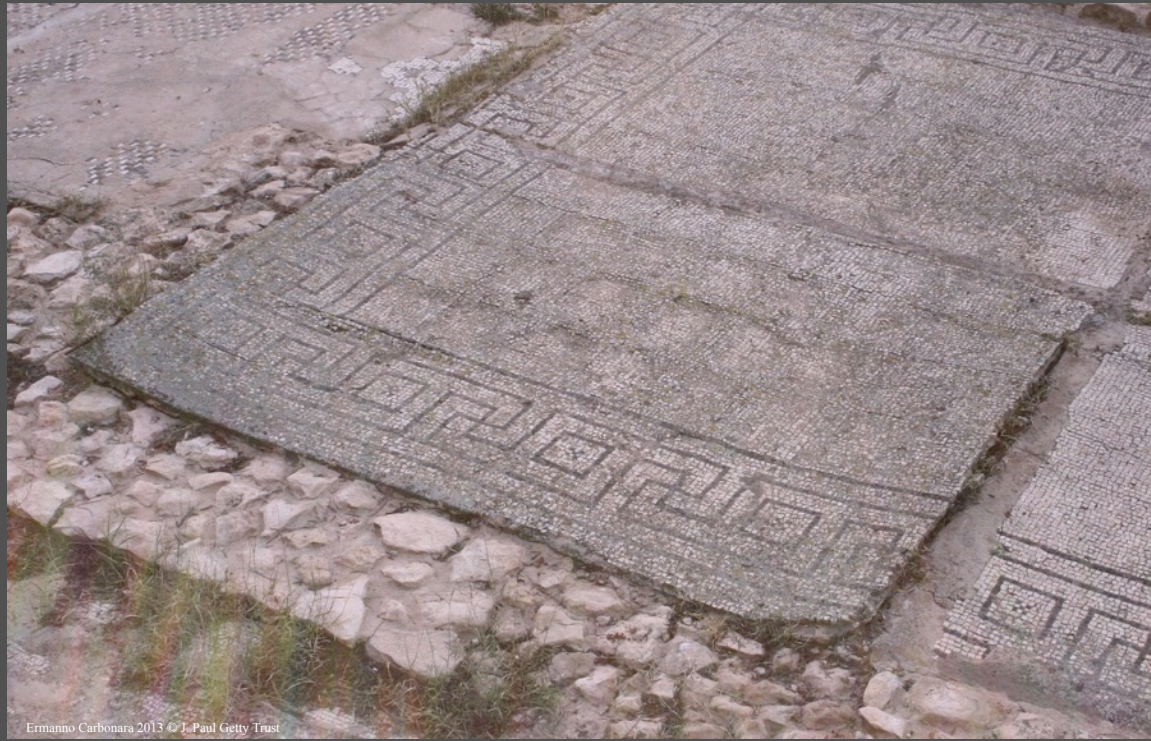
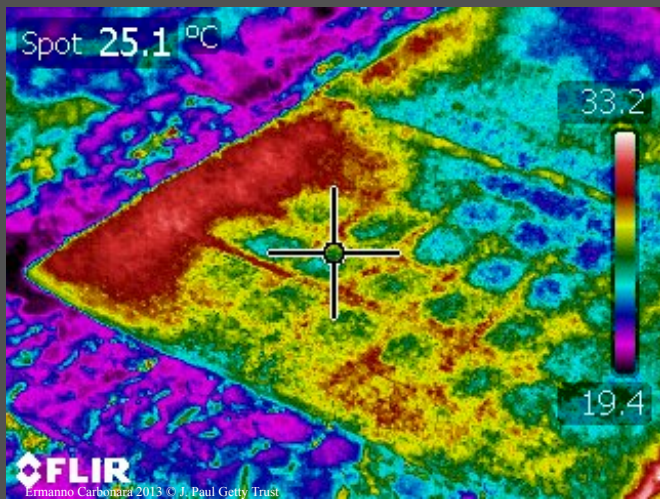
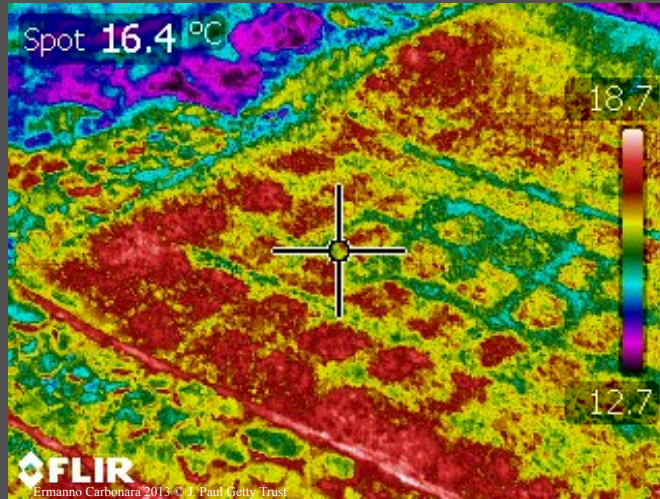
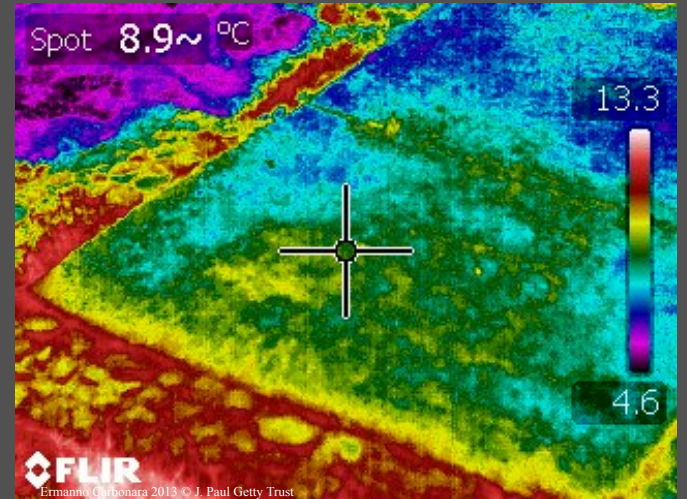
The effects of solar radiation on deteriorated and exposed panels of mosaics relaid on site.
