TECHNICIAN TRAINING FOR THE CONSERVATION OF MOSAICS

PART 2
THE CONSERVATION OF DETACHED MOSAICS

Mosaics detached and relaid in situ on
reinforced concrete:
their deterioration, in situ maintenance treatments
and documentation

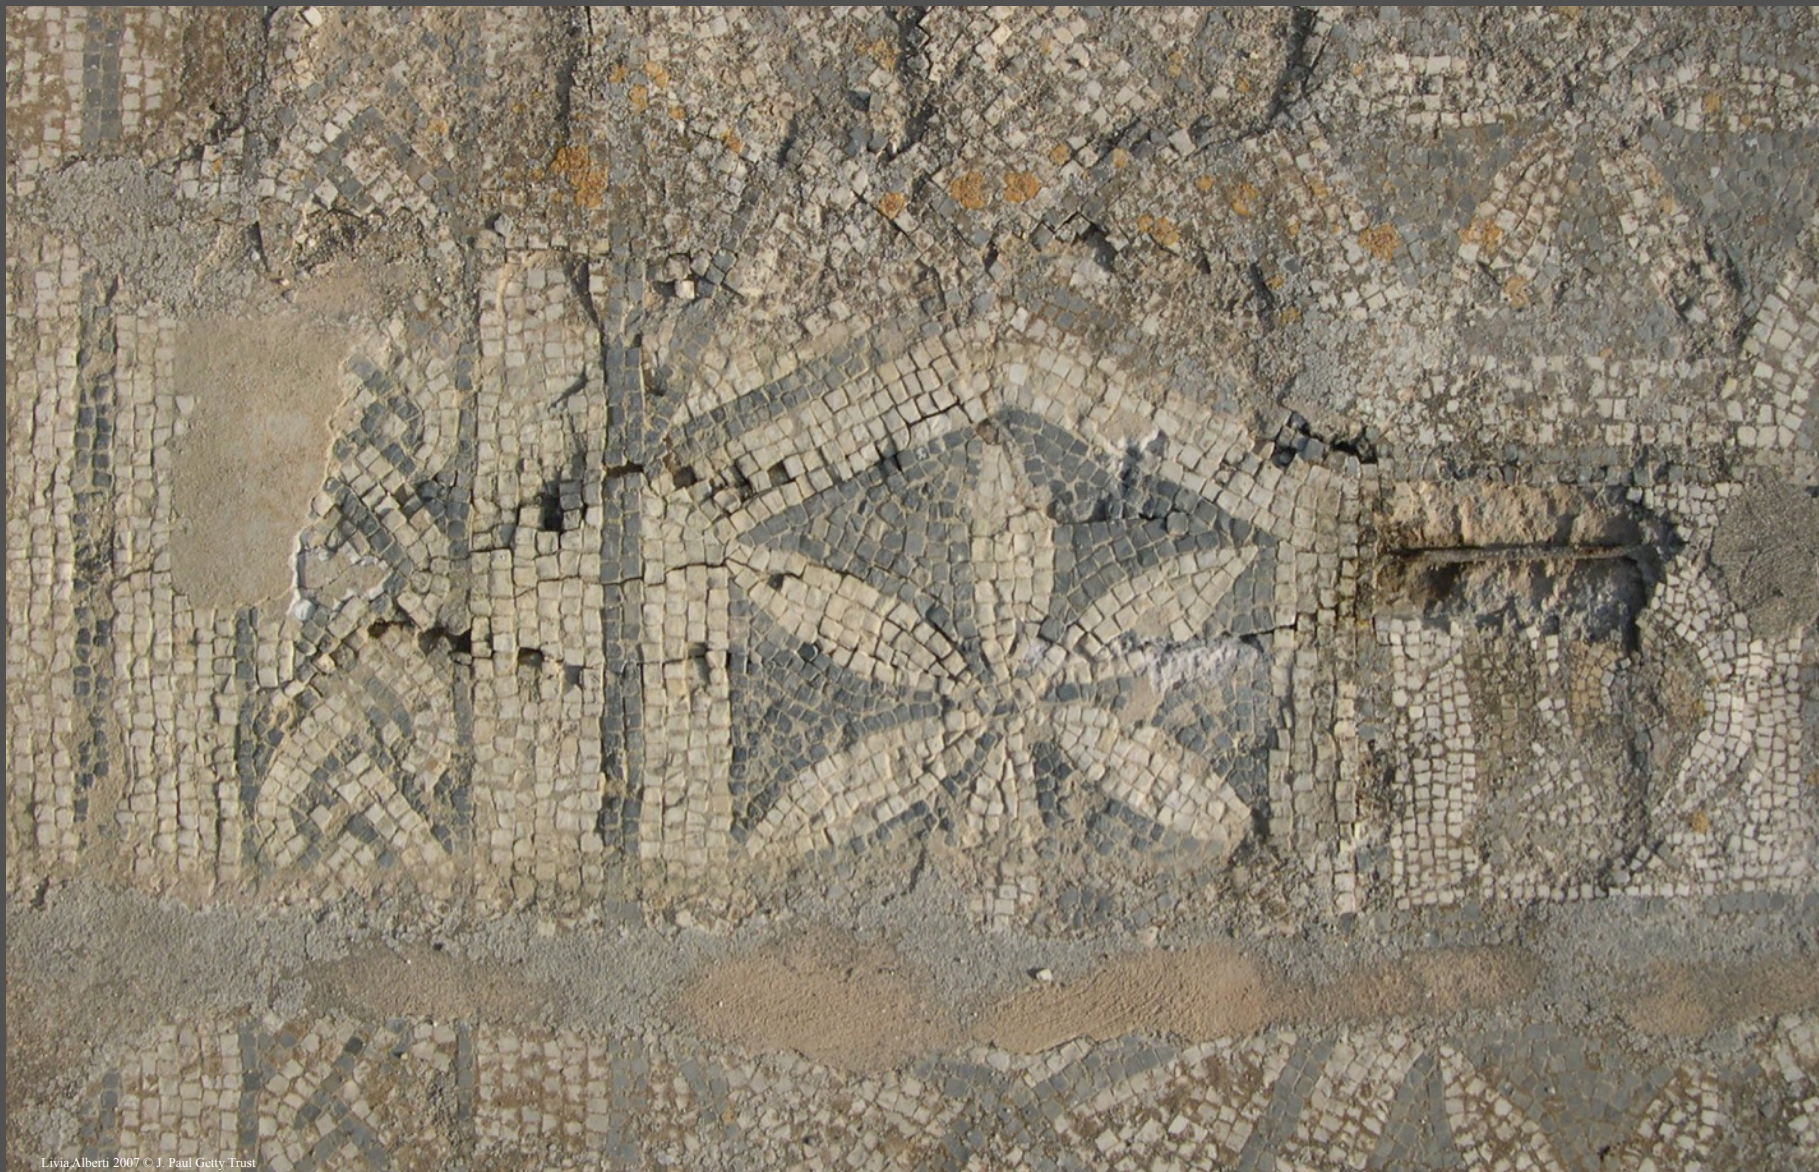
Before stabilization

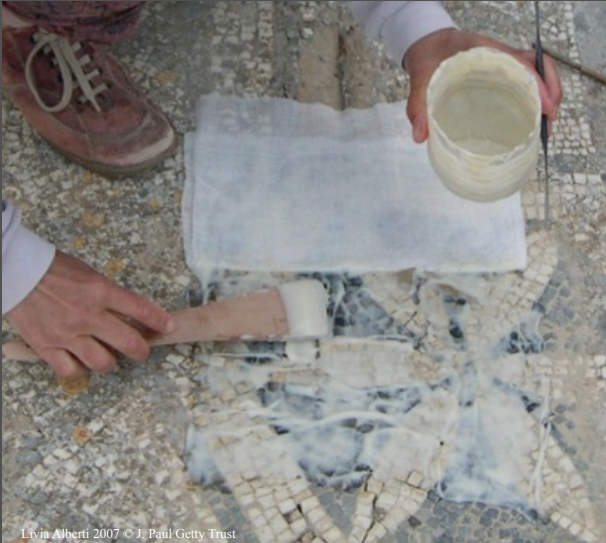
Complete cleaning of the area of the mosaic panel affected by corrosion of rebar

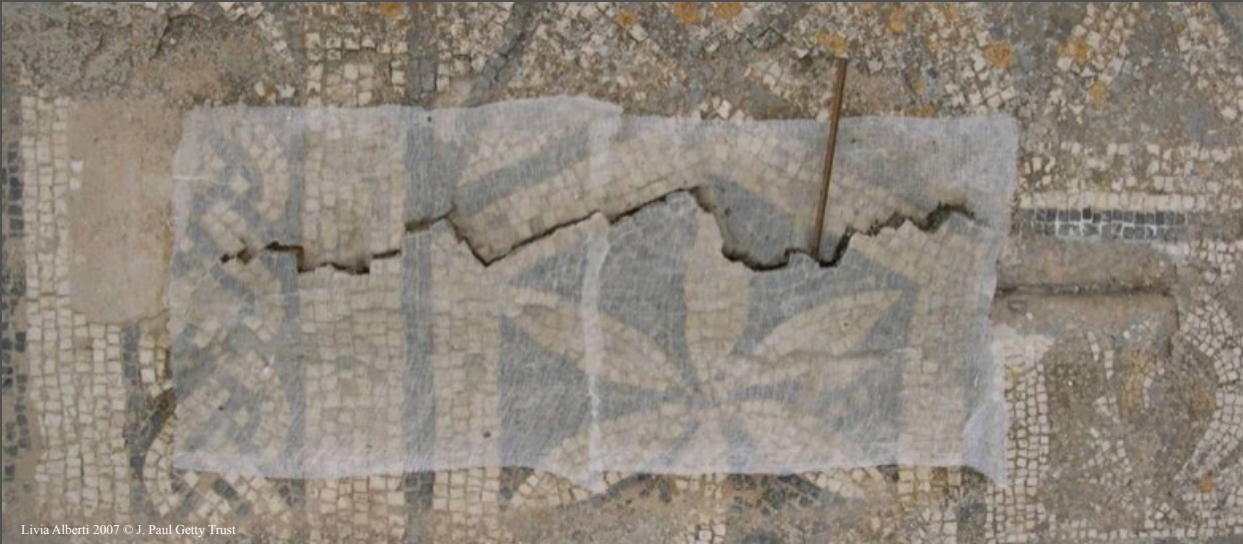
Protection of the area with facing

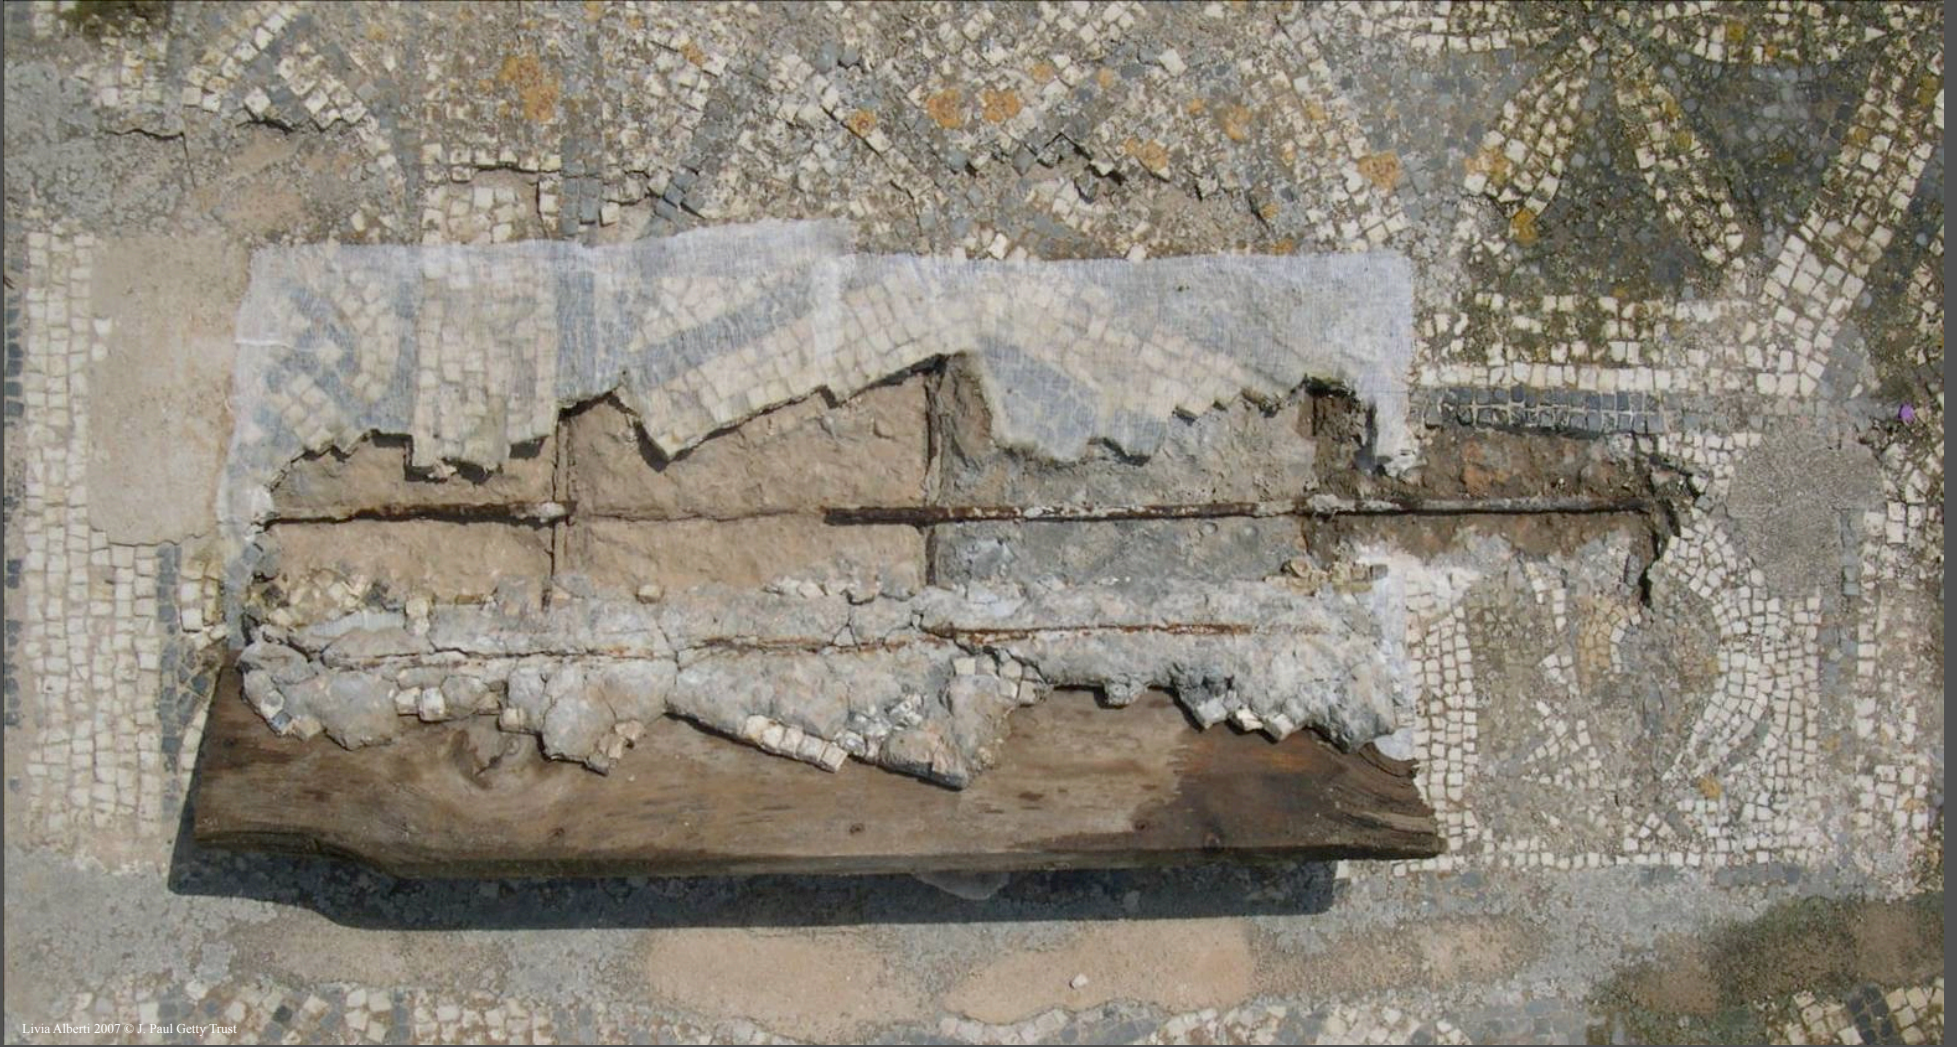
Temporary removal of the section of tessellatum located above the corroded bar

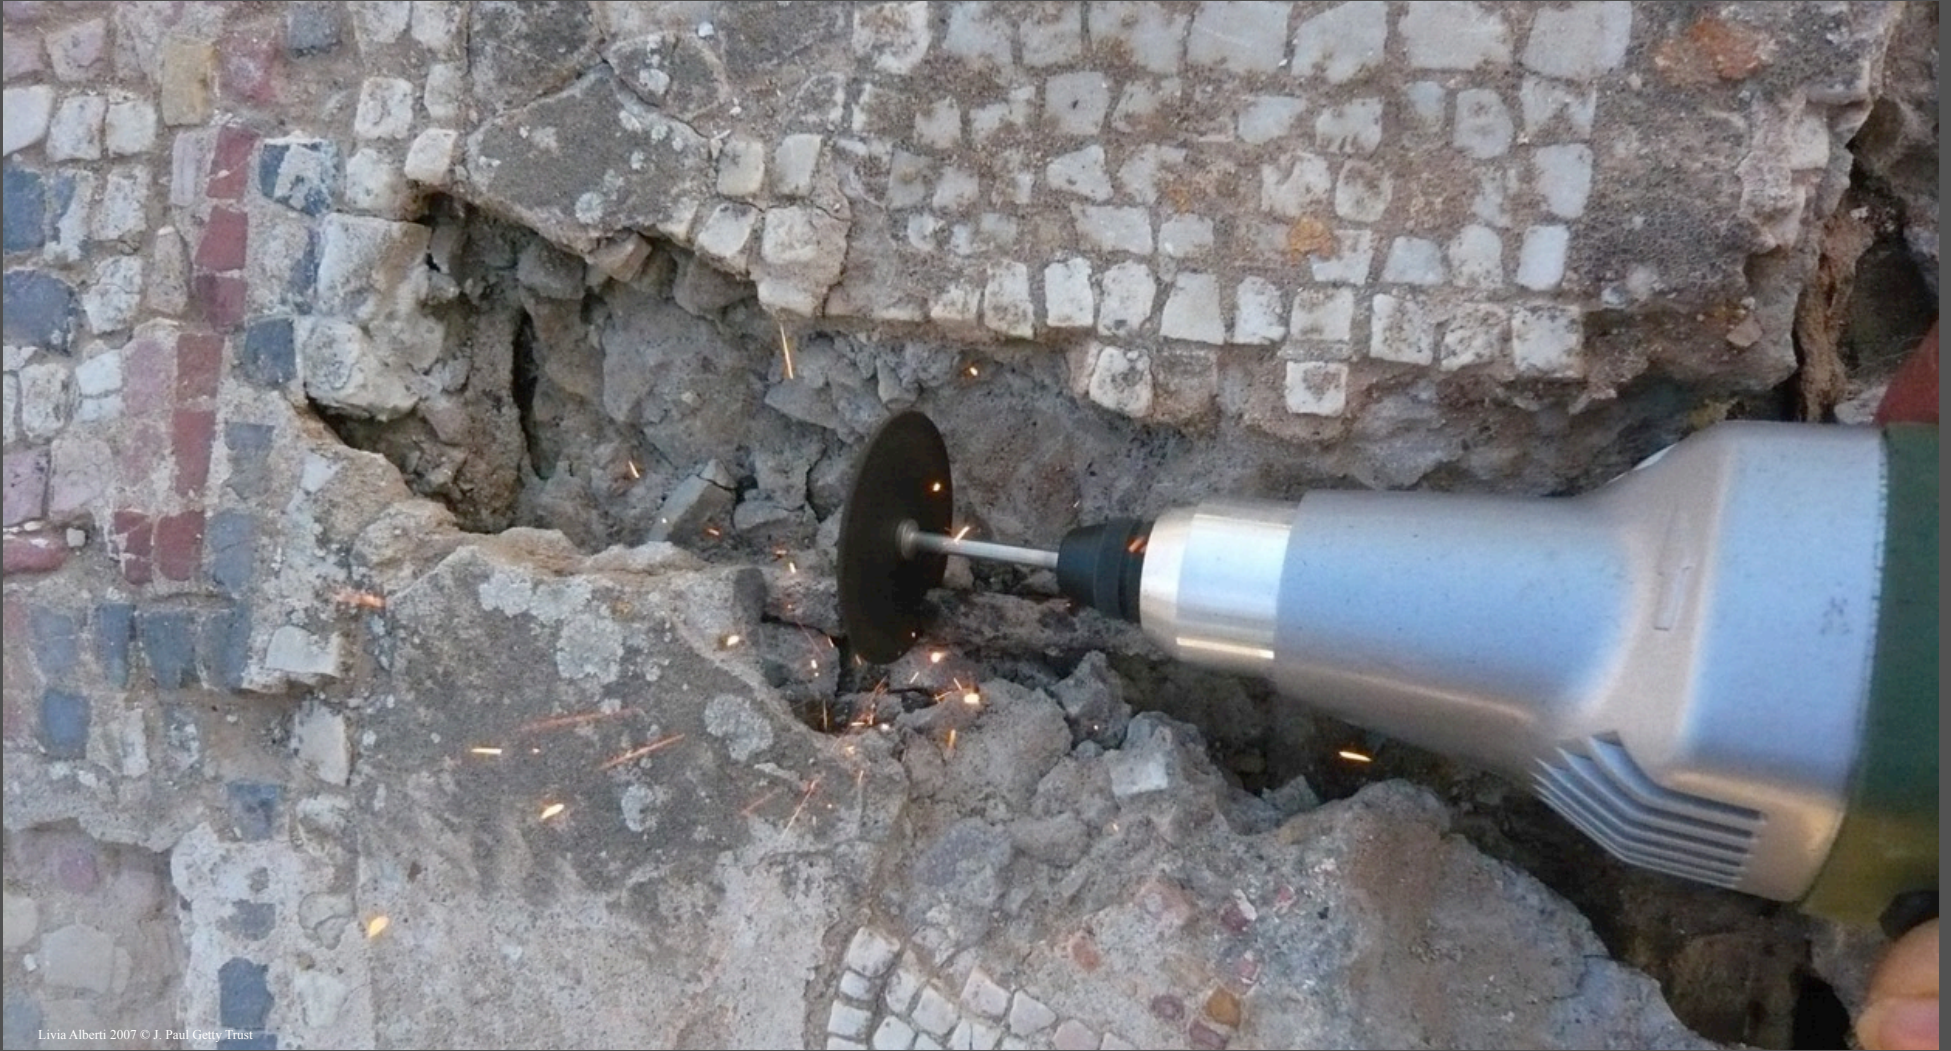
Removal of the bar remains and cleaning of the area to remove debris

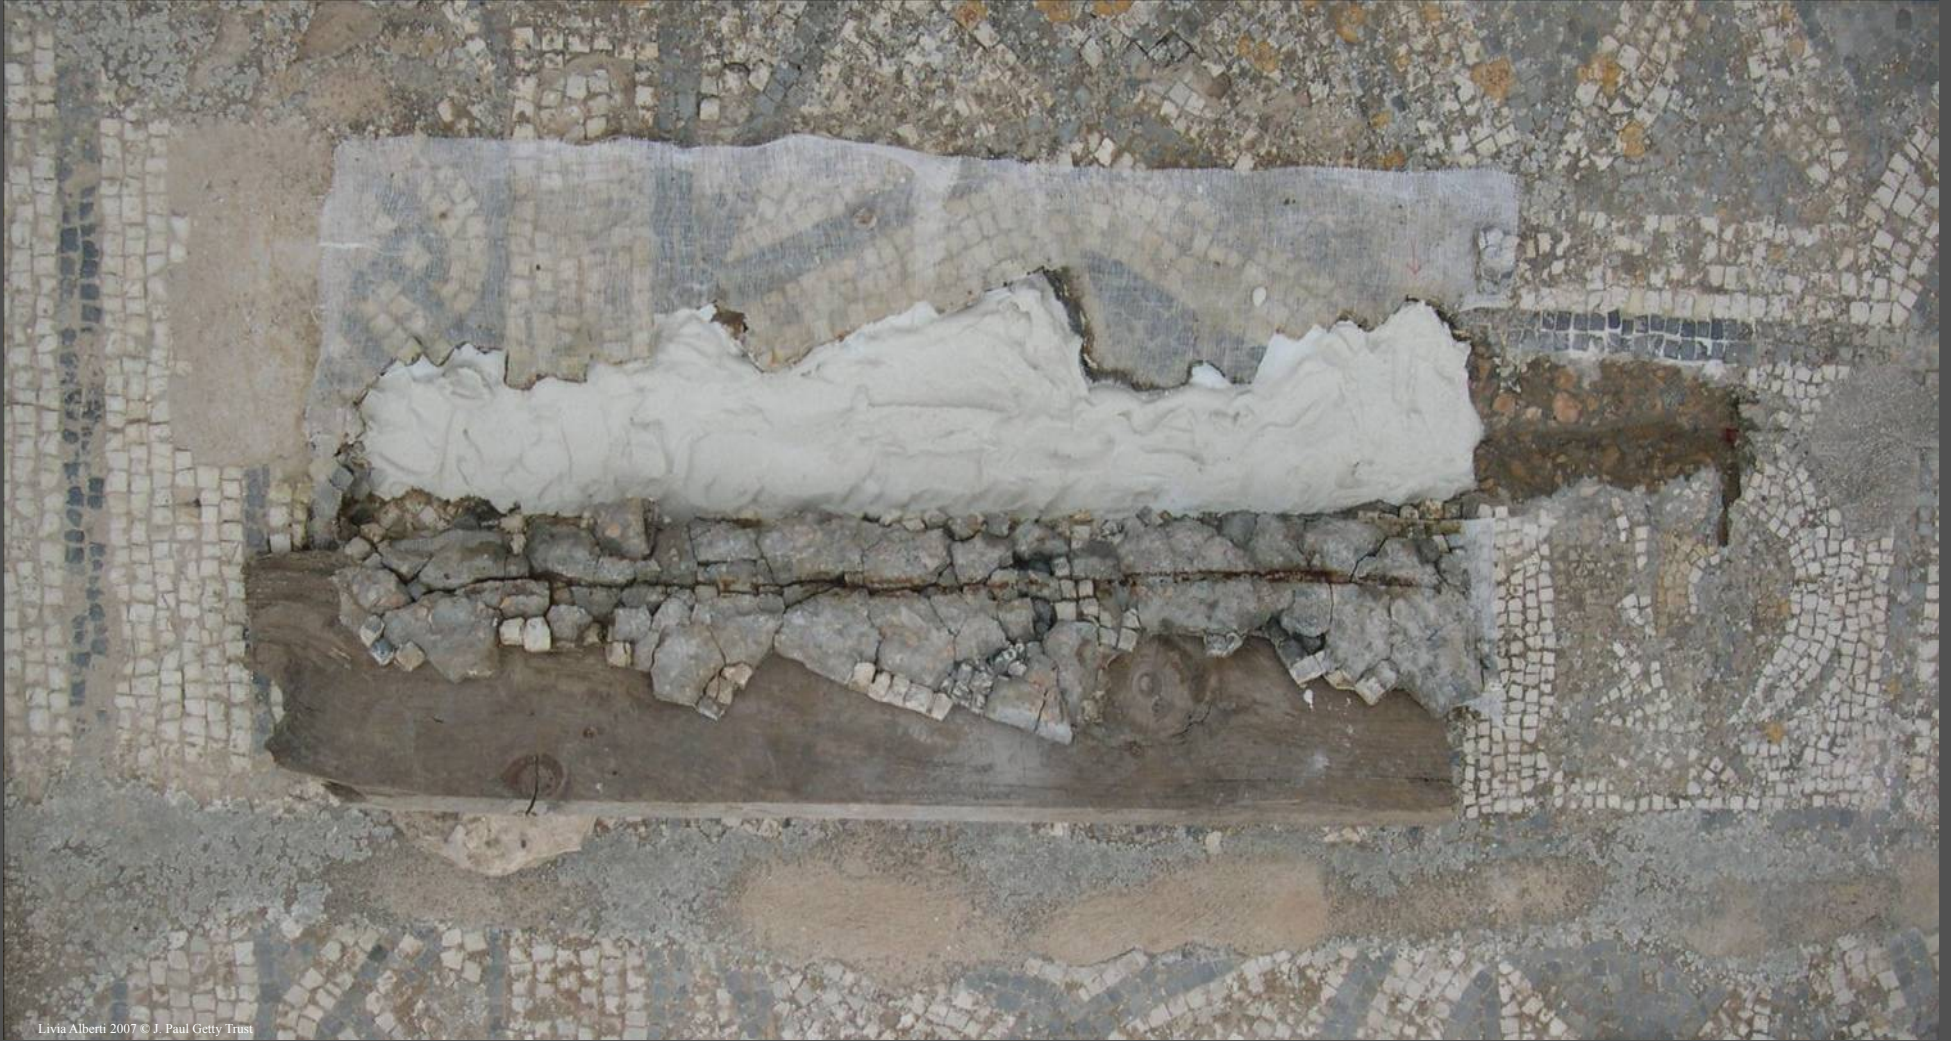
Cutting the steel bar

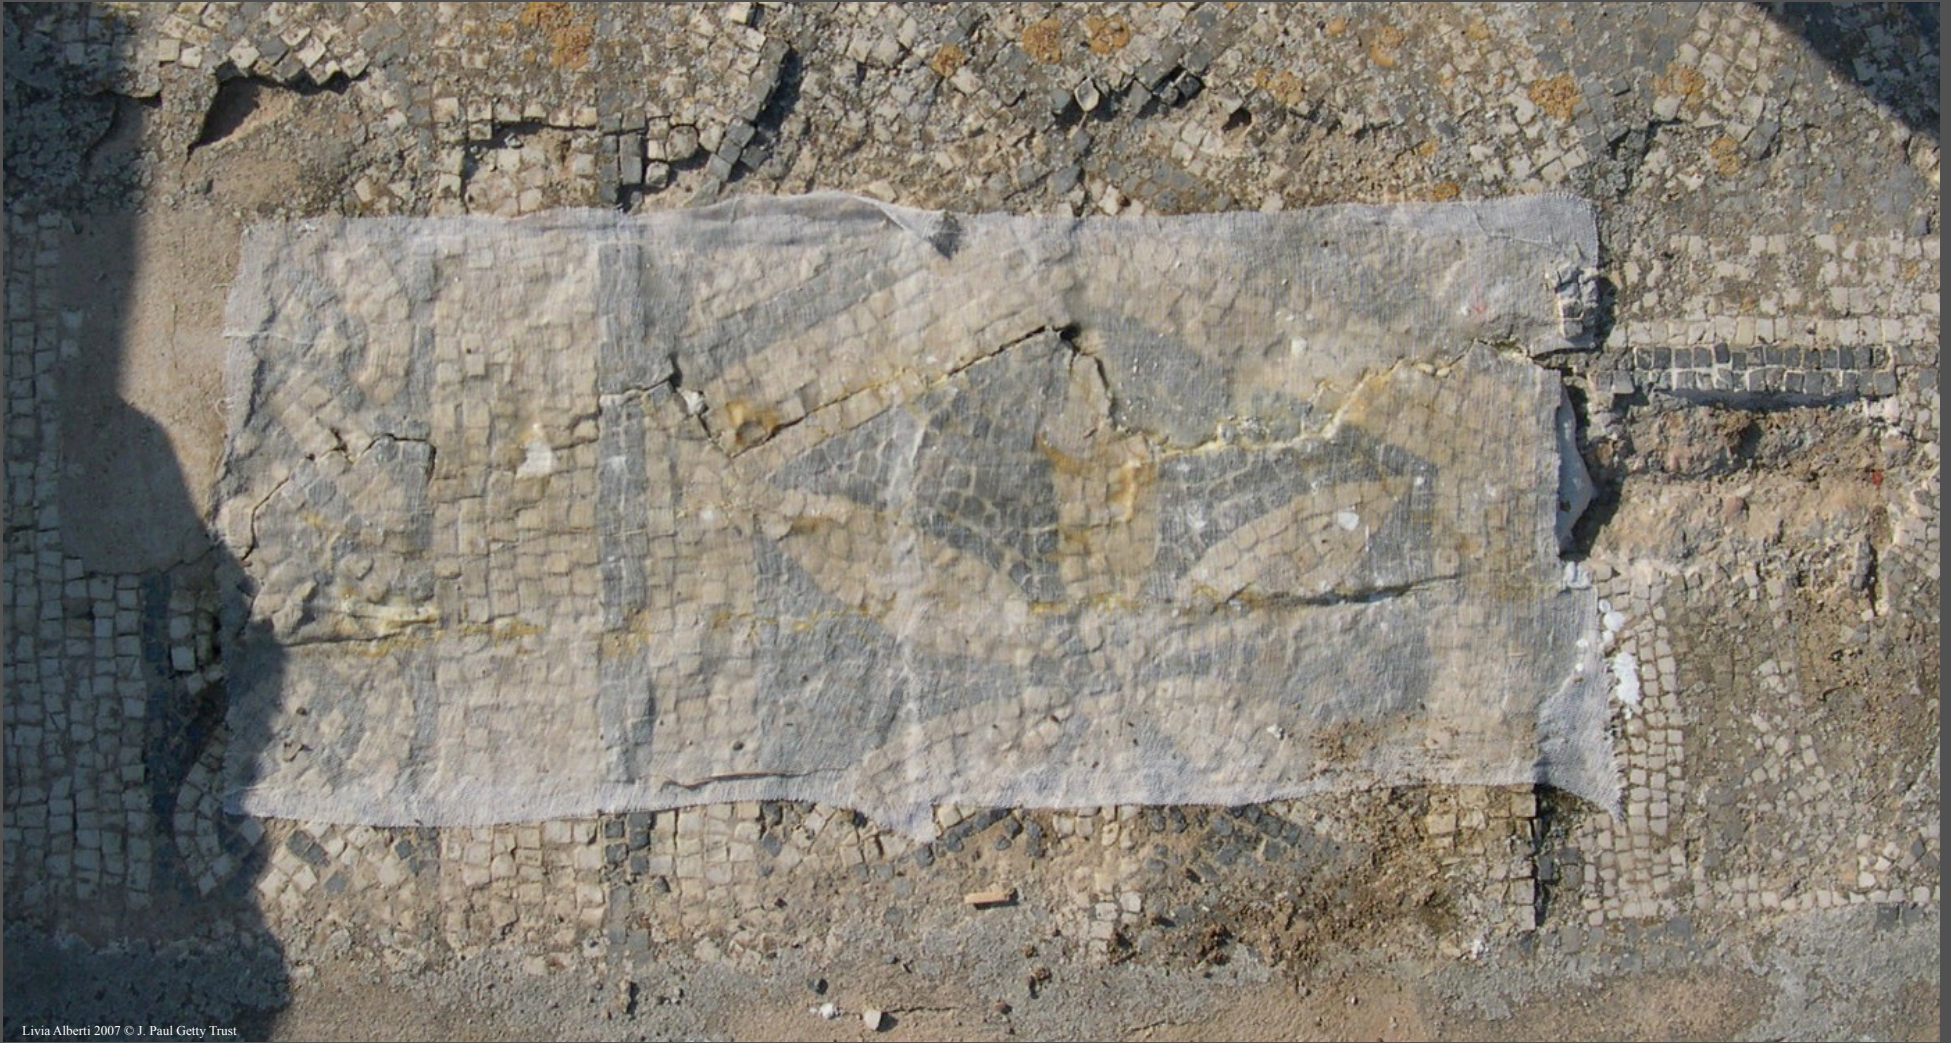
Filling with mortar the space left by the removed bar and concrete debris

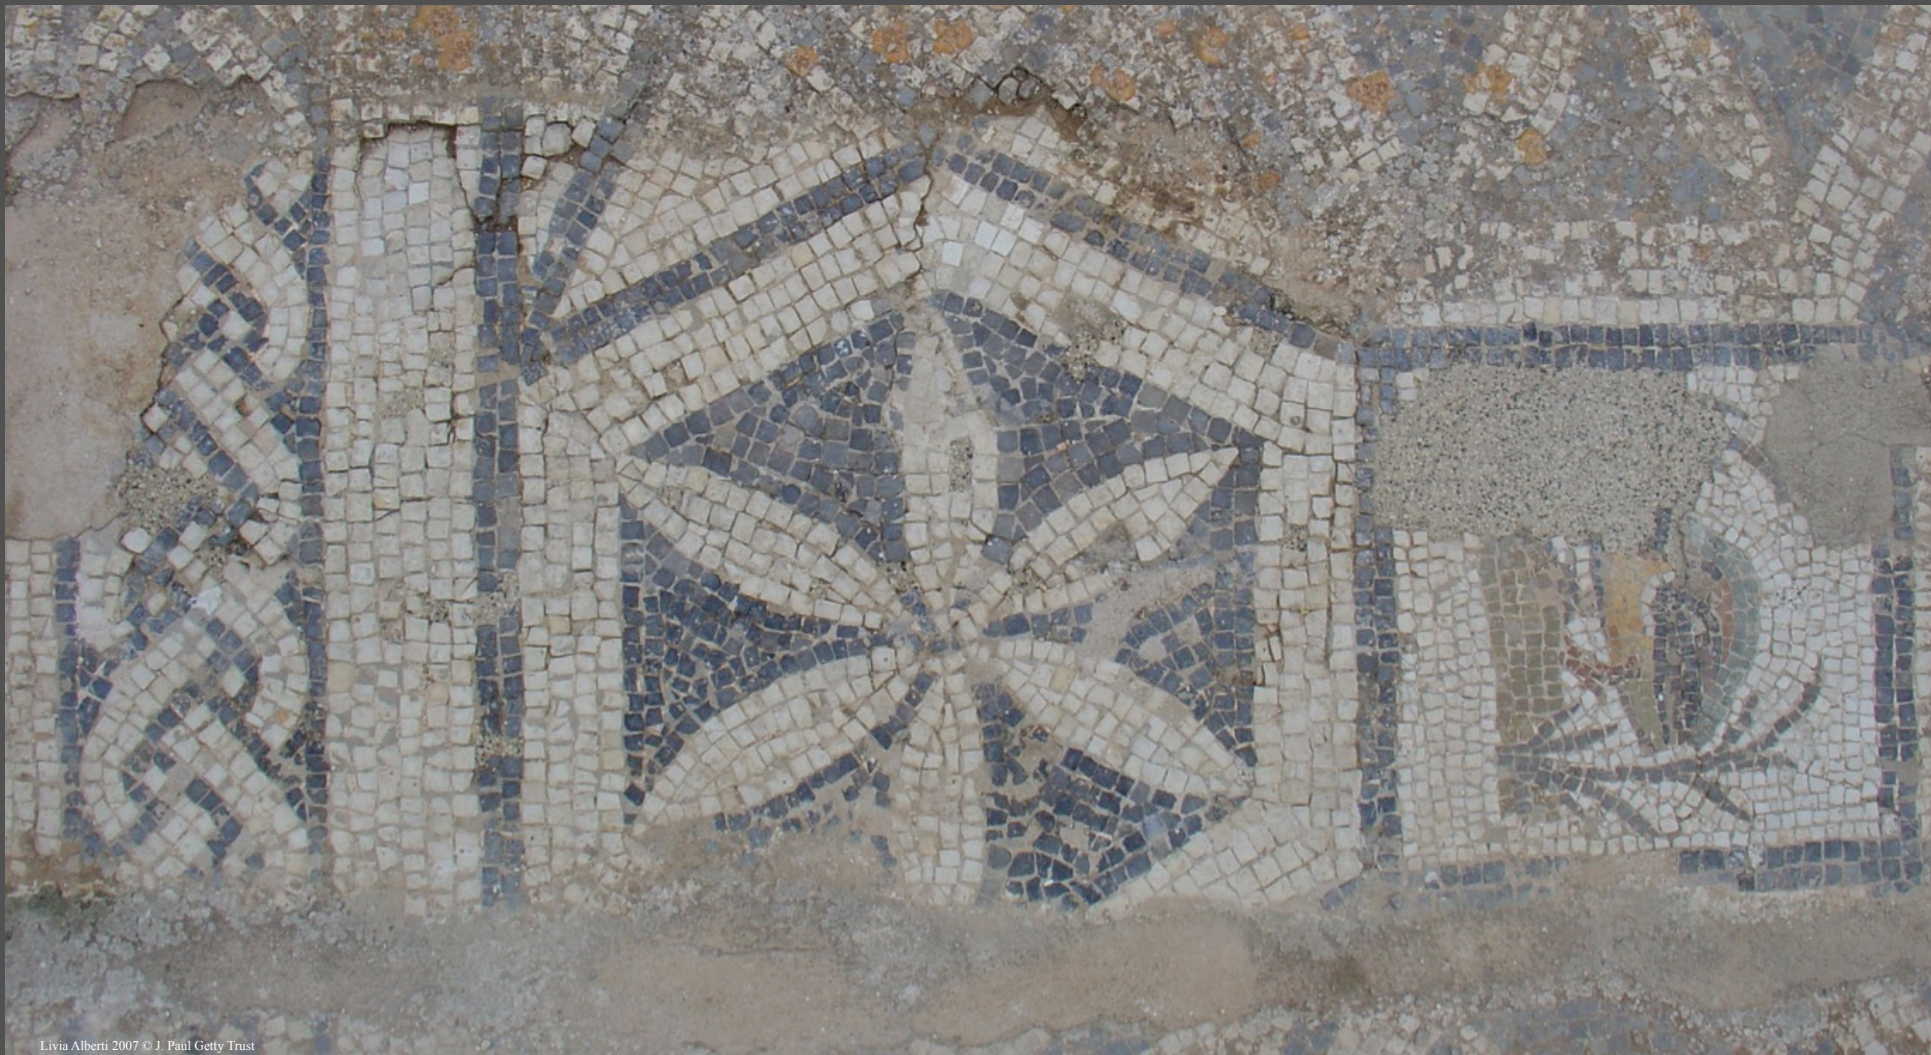
Resetting the previously removed tessellatum section

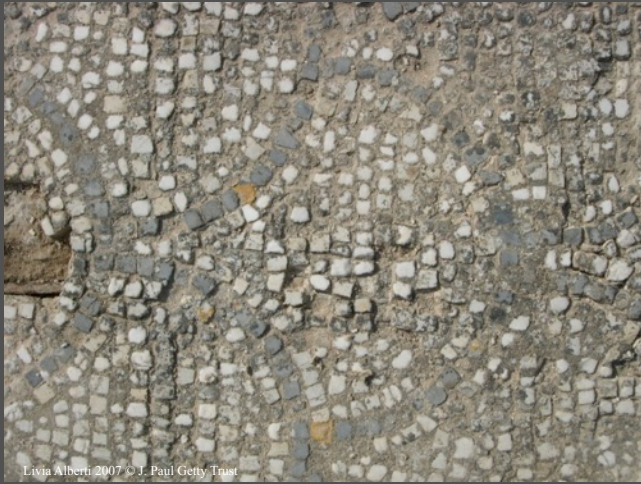
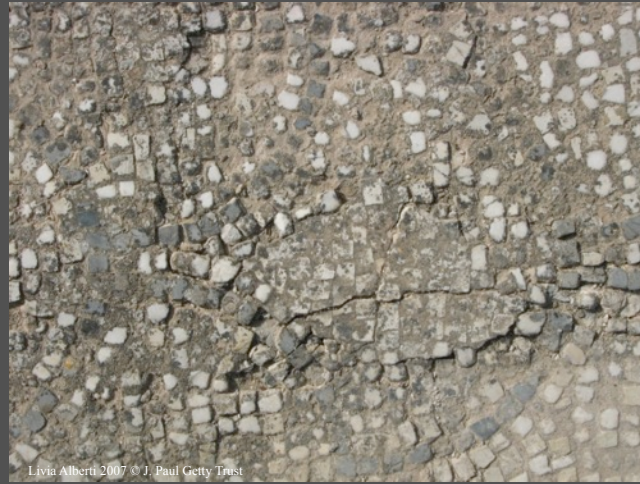
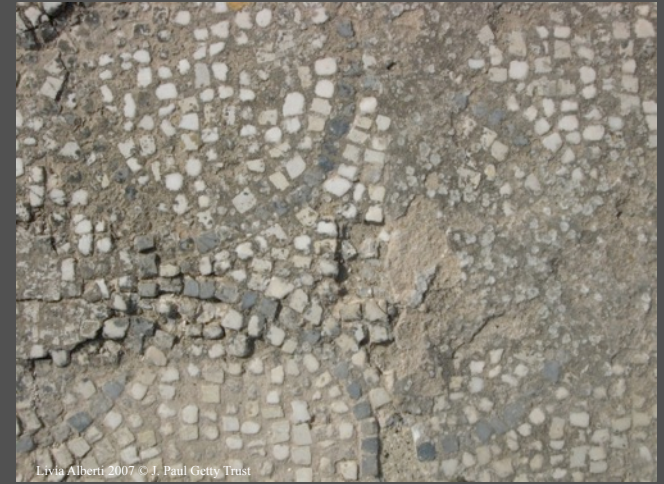
Before stabilization

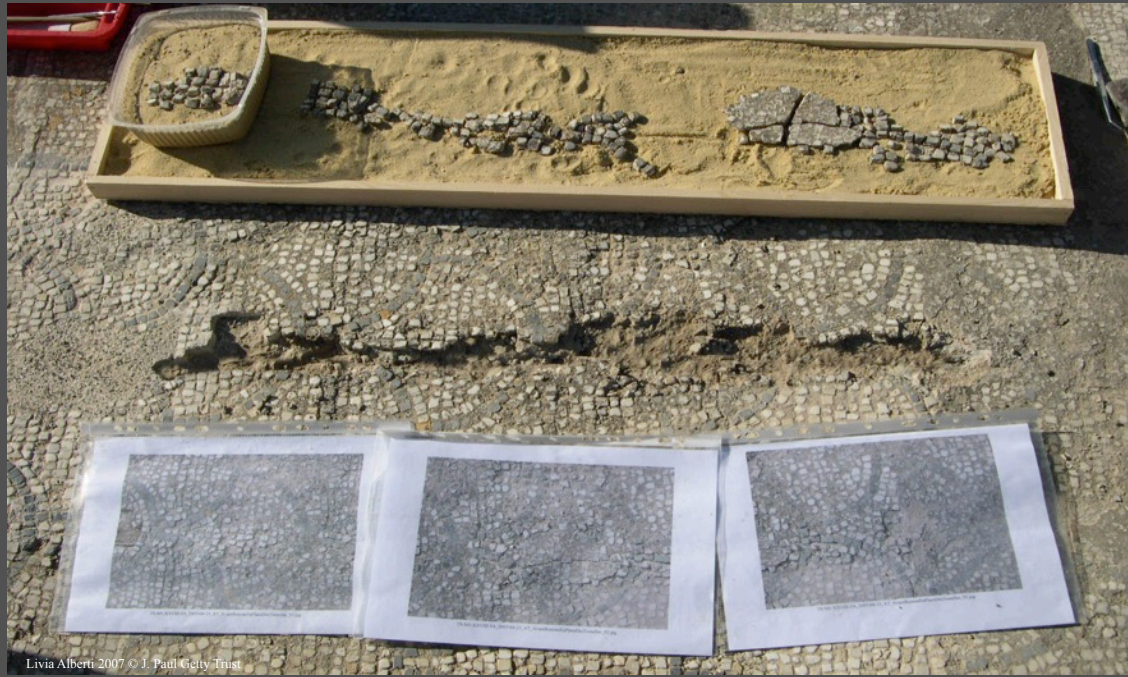
Removing and placing the detached tesserae on temporary sand bedding

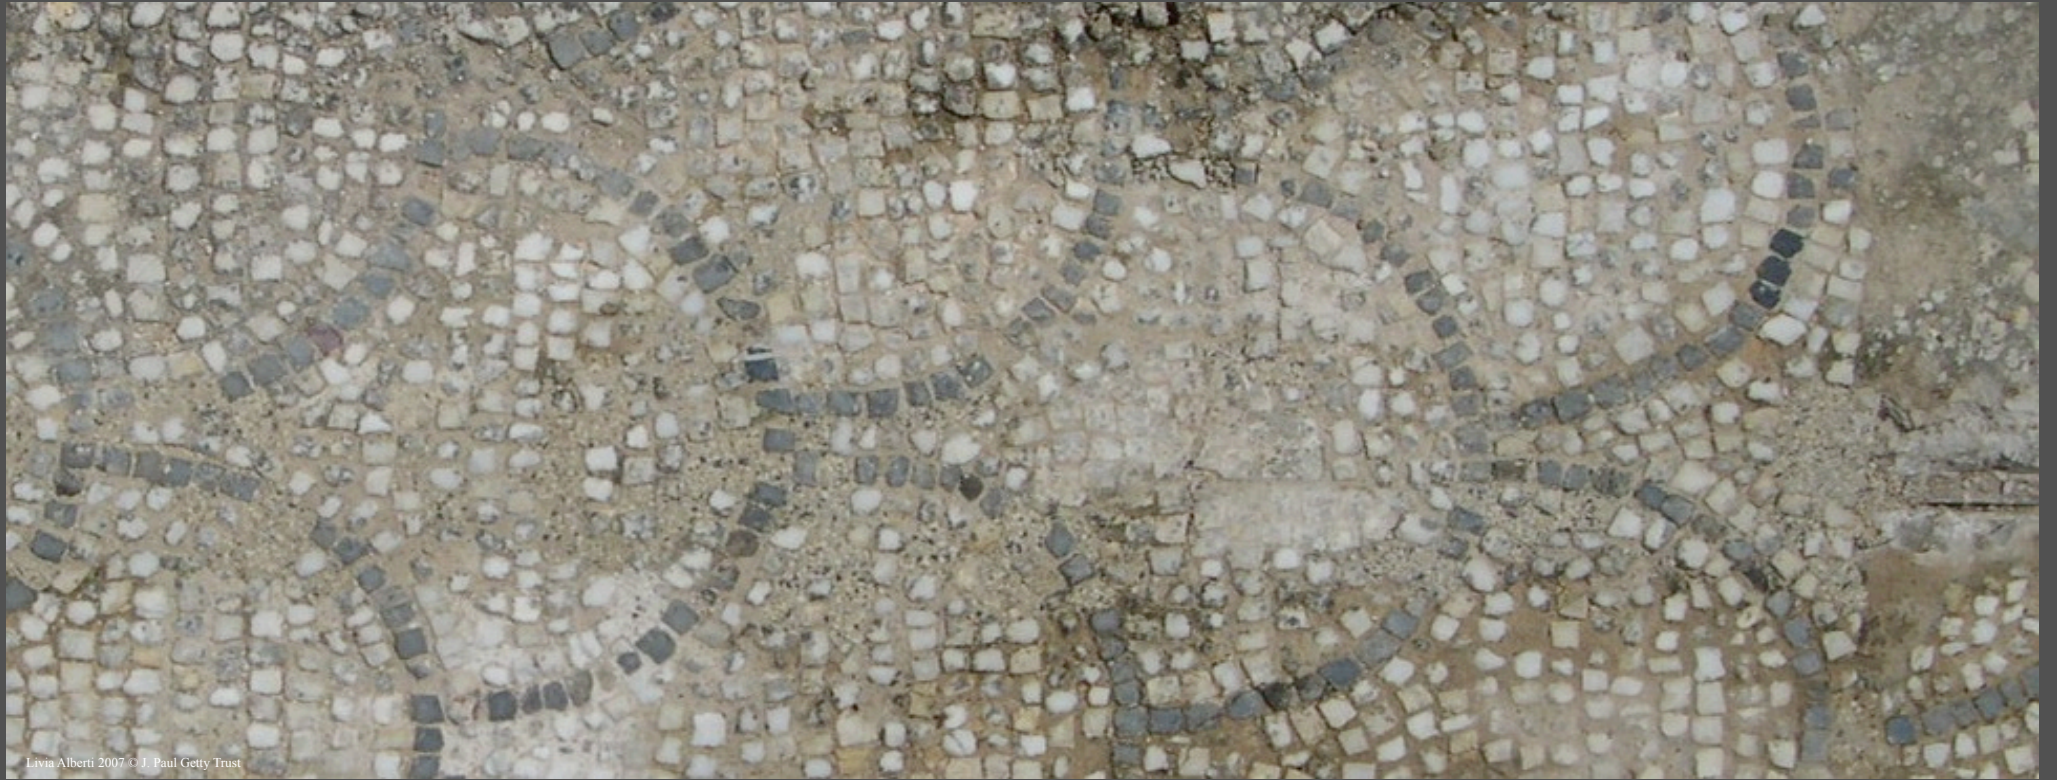
Using a “working aid” photograph

Resetting the tesserae, filling interstices, cracks and lacunae with mortar
