TECHNICIAN TRAINING FOR THE CONSERVATION OF MOSAICS

PART 2
THE CONSERVATION OF DETACHED MOSAICS

Mosaics detached and relaid in situ on
reinforced concrete:
their reinstallation in situ and documentation

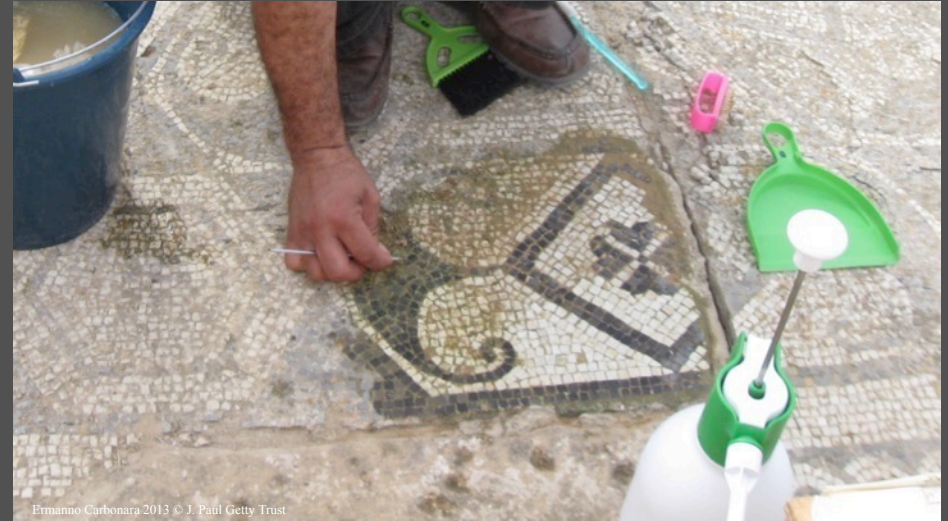
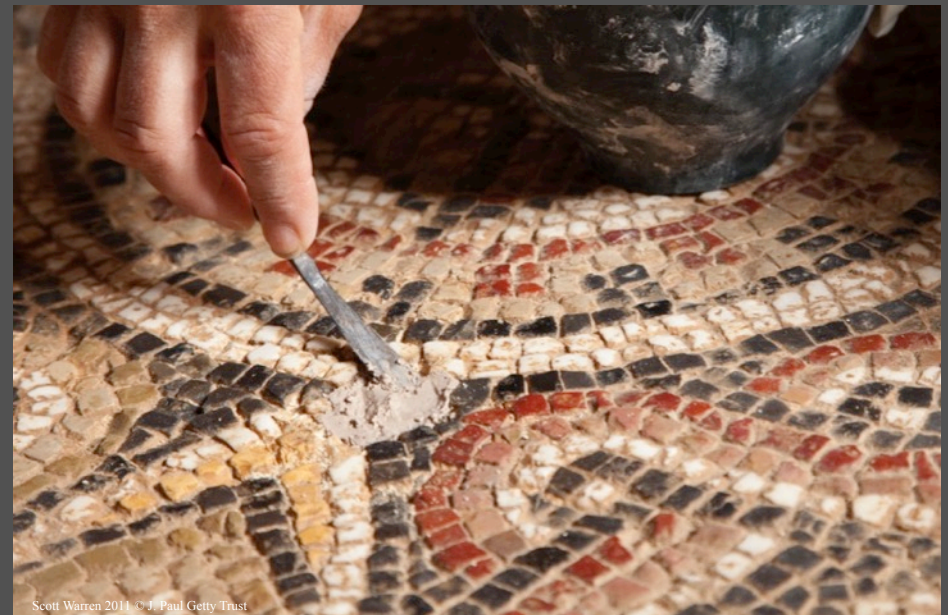
Cleaning of deposits of dirt and debris without water.

Cleaning of micro-organisms with water.

Resetting of detached tesserae using a weak mortar.

Filling lacunae with a weak mortar.

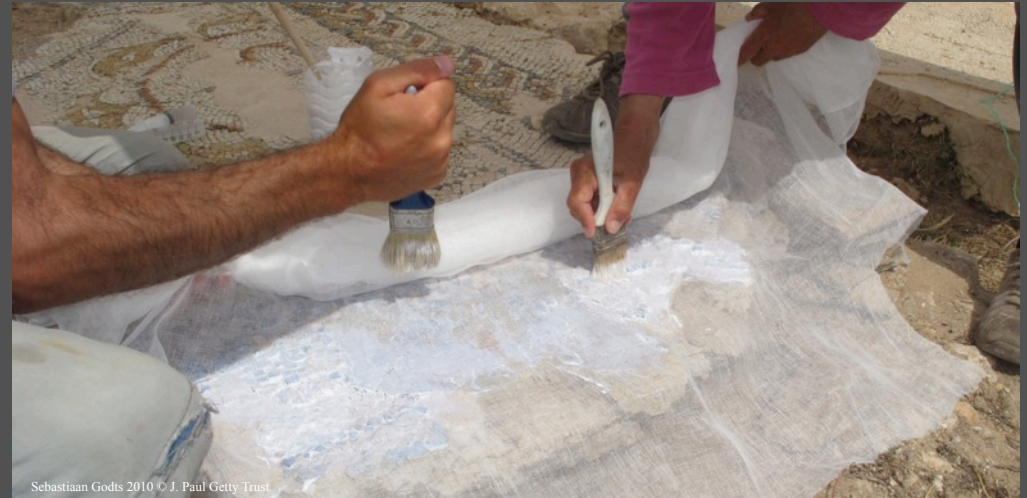
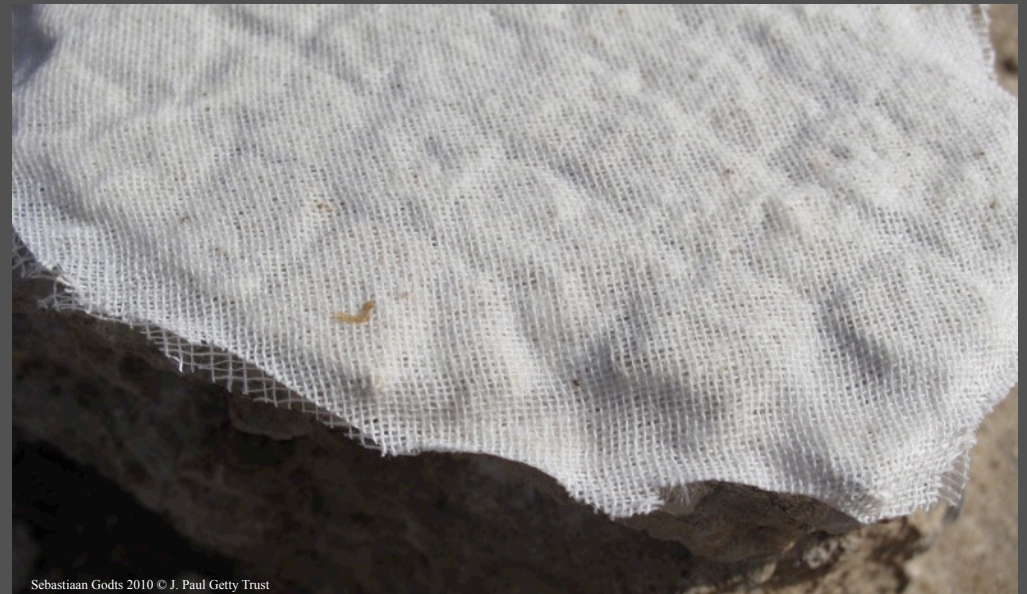
Apply one or more layers of fabric to the surface of the mosaic using an adhesive.

Characteristics of the adhesive to be used:

Able to be removed without damaging the mosaic.

Compatible with the fabric.

Adequate adhesion.

Adequate vitreous transition temperature.

Appropriate for the mosaic's humidity conditions.

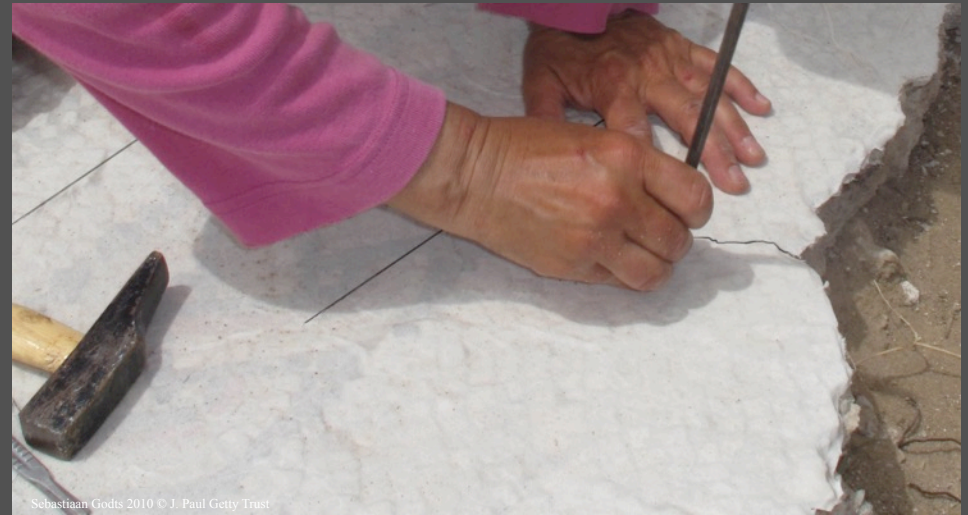
Mark and number the profiles of each section on a map and on each of the sections themselves.

Mark the reference lines between each of the sections.

Create a reference system separate from the mosaic.

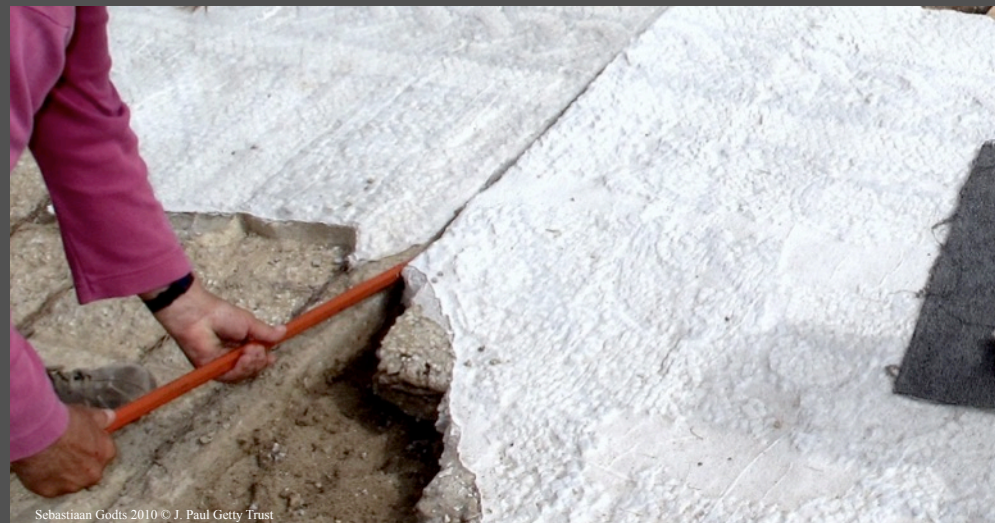
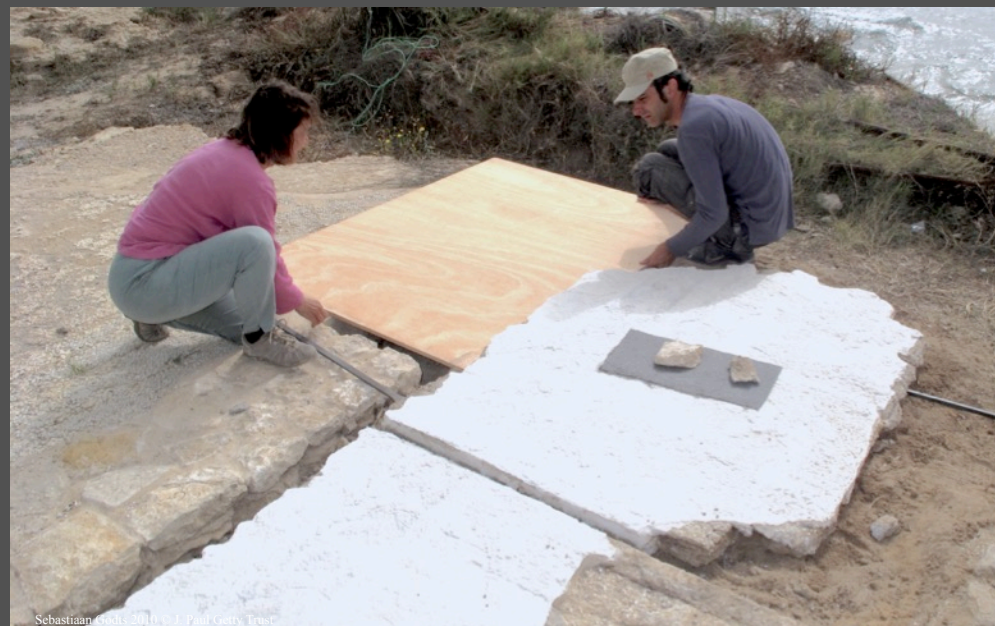
Detach and lift the sections using long, flat bars and/or a lever.

Slide the sections onto rigid plywood panels.

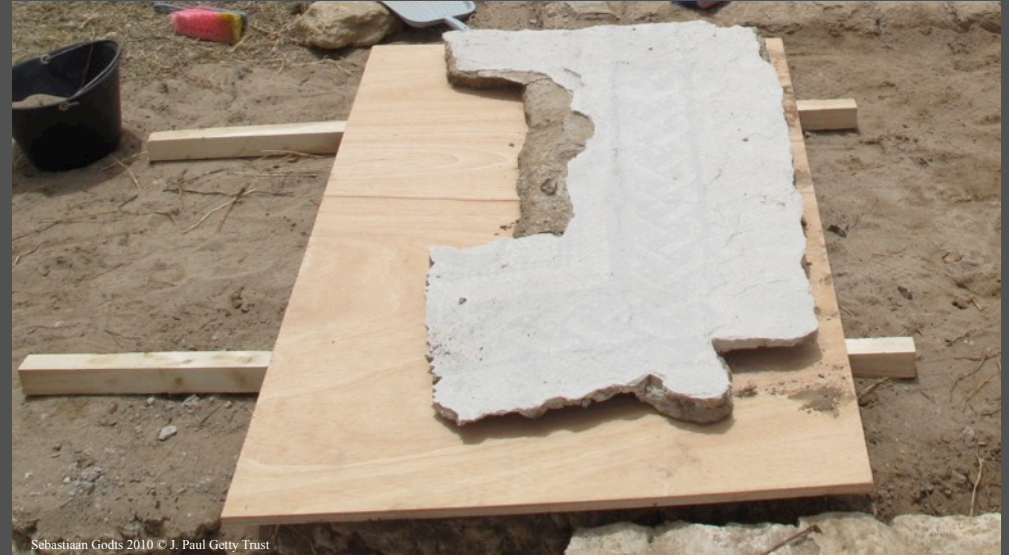
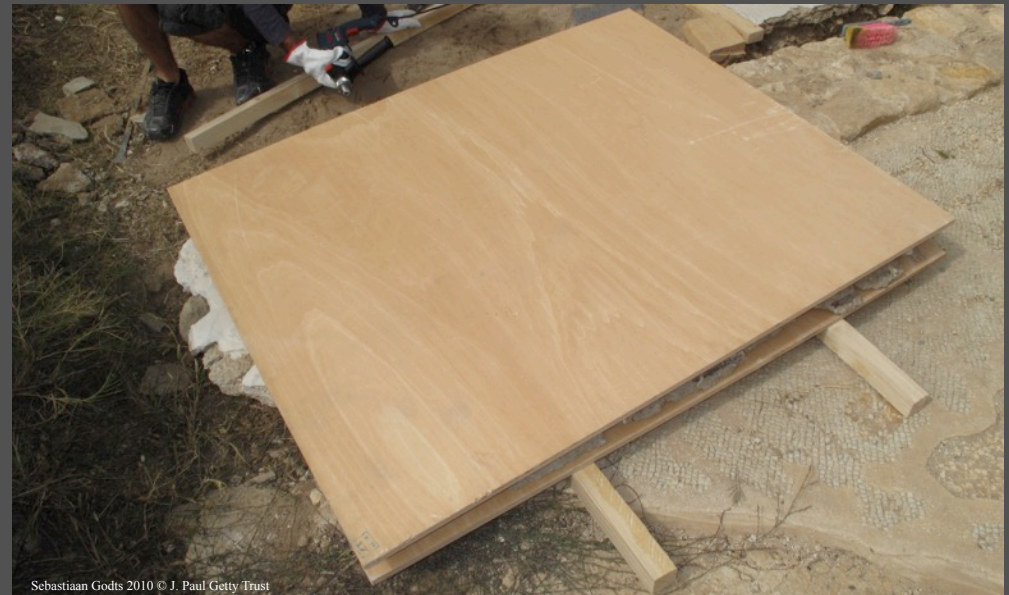
Place a plywood panel on the surface of the section.

Hold the two panels together using rigid braces.

Invert the mosaic section.

Secure the panels with the mosaic section, if necessary.

Transport the panels manually or by other means, depending on the weight.

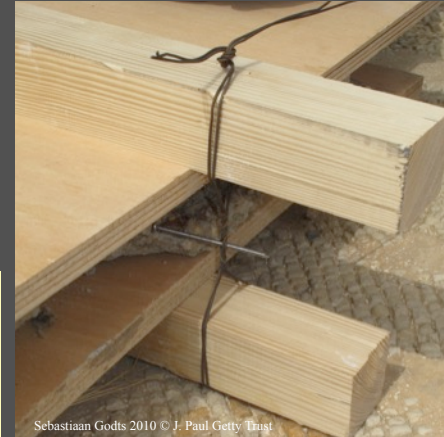
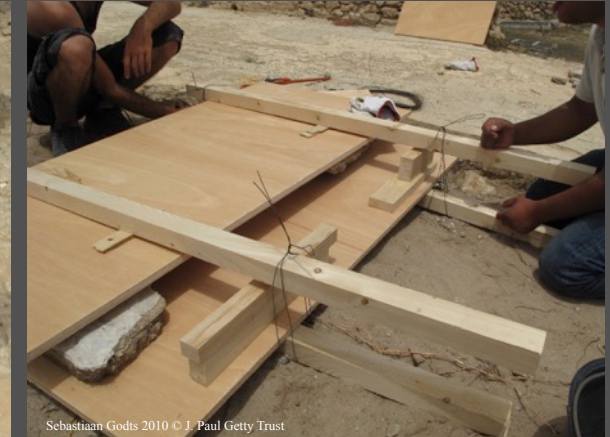
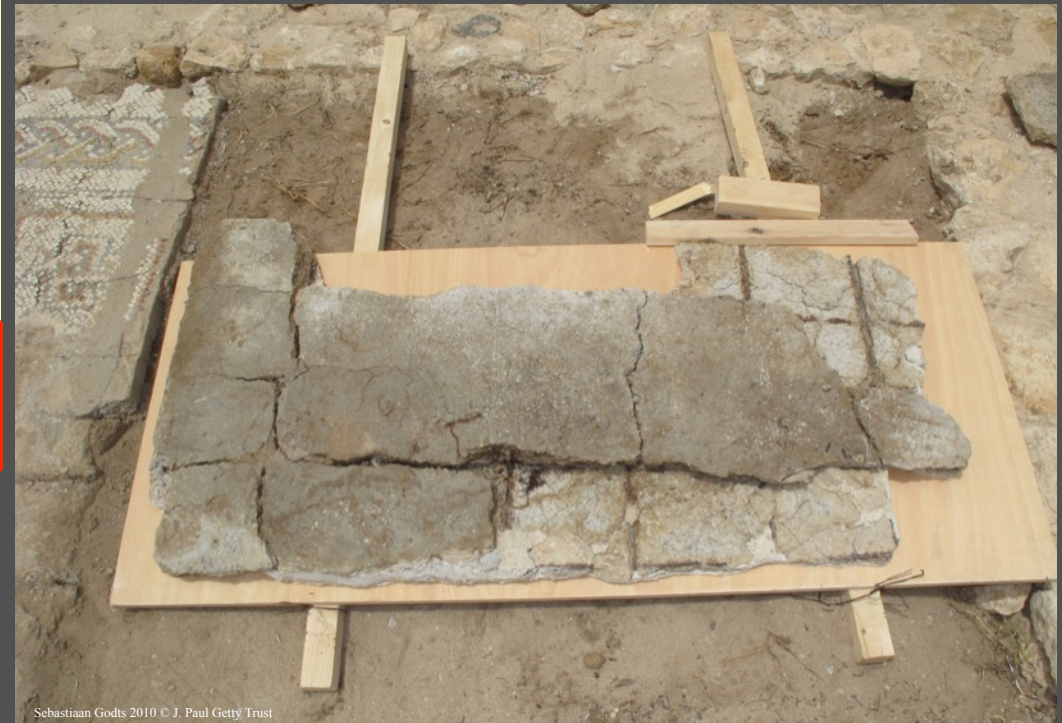
1. Detachment of mosaic panels

- Cleaning and Stabilization
- Facing of the surface with one or more layers of fabric and adhesive
- Numbering of sections to be removed and reference placement for reinstalling sections
- Separation and detachment of panels
- Inversion of panels and transport to the laboratory

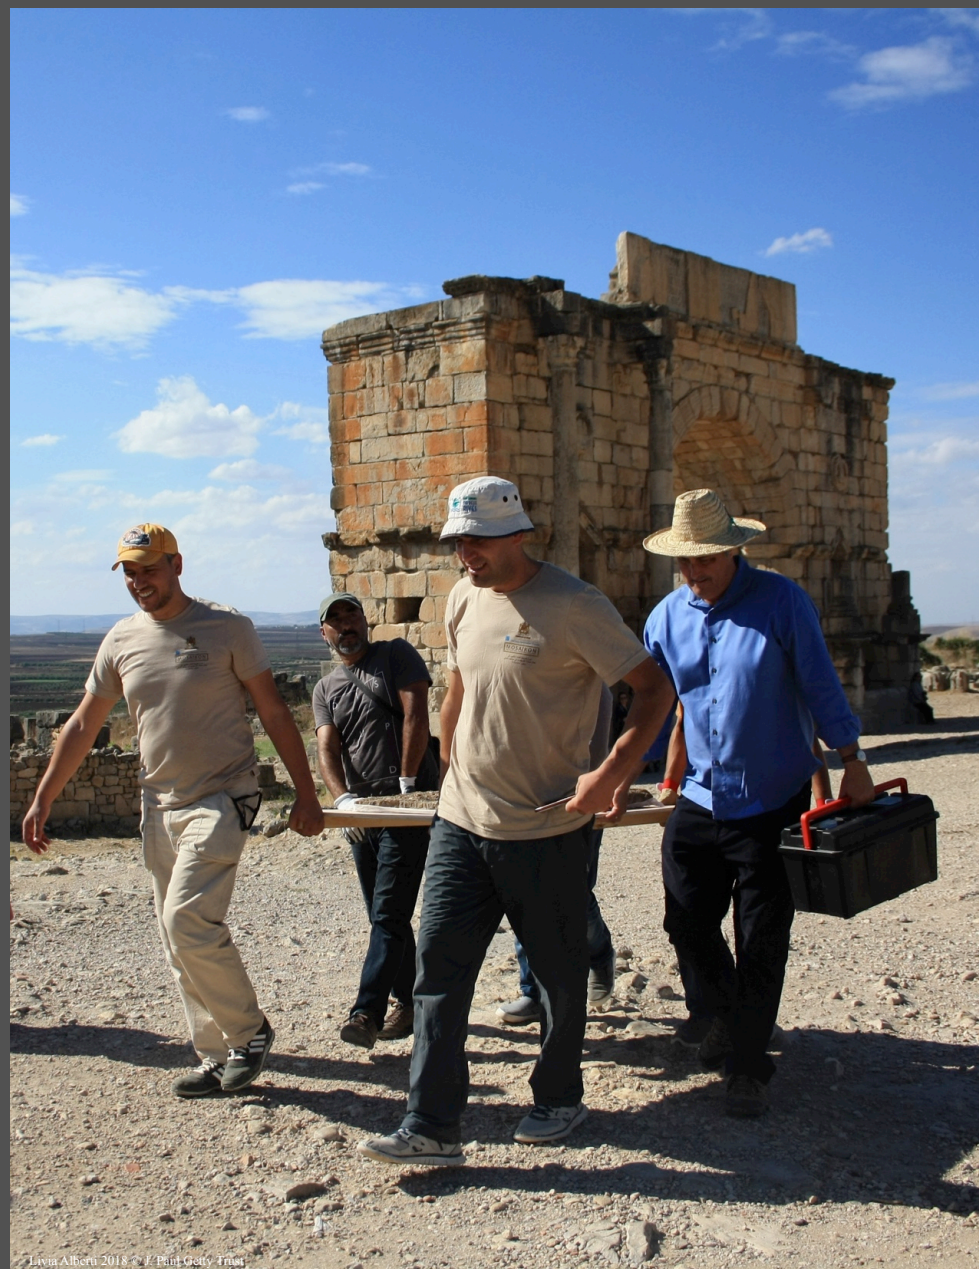
1. Detachment of mosaic panels

- Cleaning and Stabilization
- Facing of the surface with one or more layers of fabric and adhesive
- Numbering of sections to be removed and reference placement for reinstalling sections
- Separation and detachment of panels
- Inversion of panels and transport to the laboratory

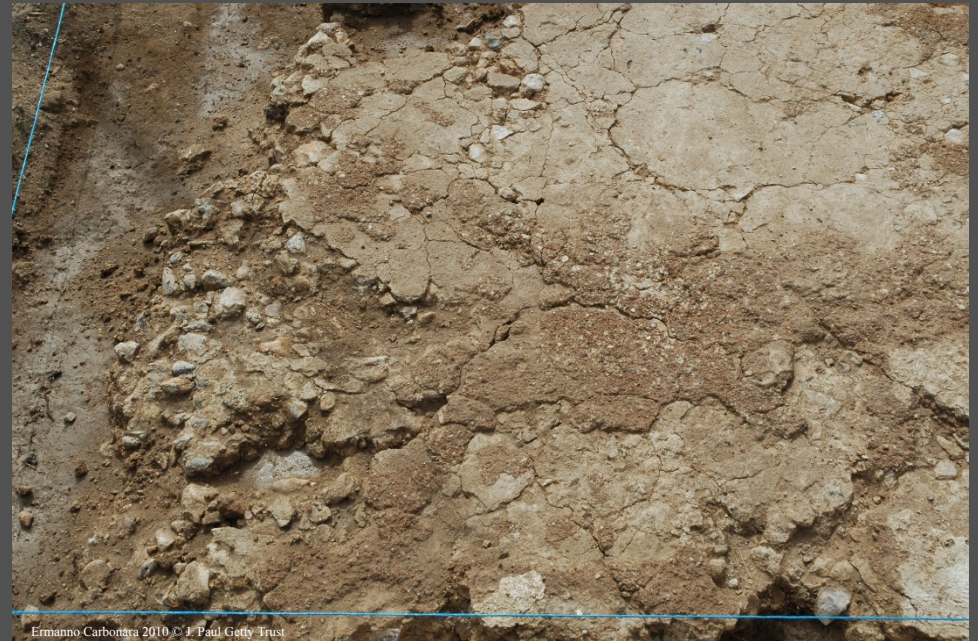
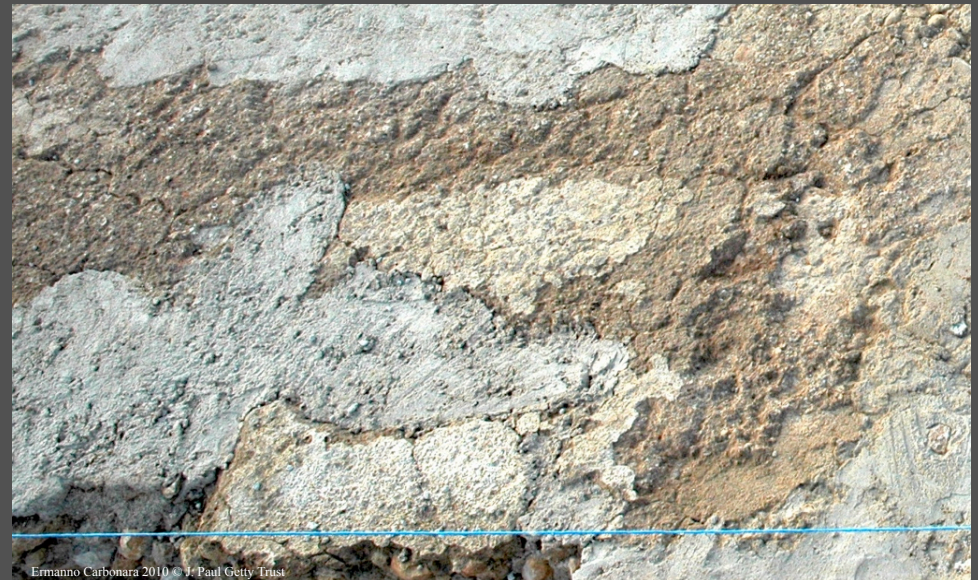
Cleaning loose dirt and debris without water.

Cleaning compact dirt with water, if necessary.

Fill lacunae and cracks with lime putty or hydraulic lime-based mortar similar to the original layer to be stabilized.

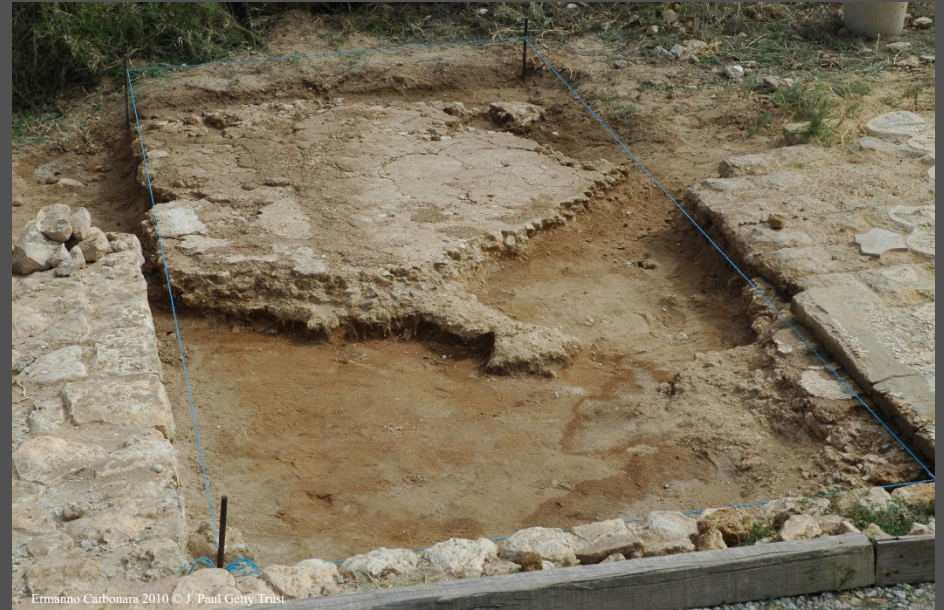
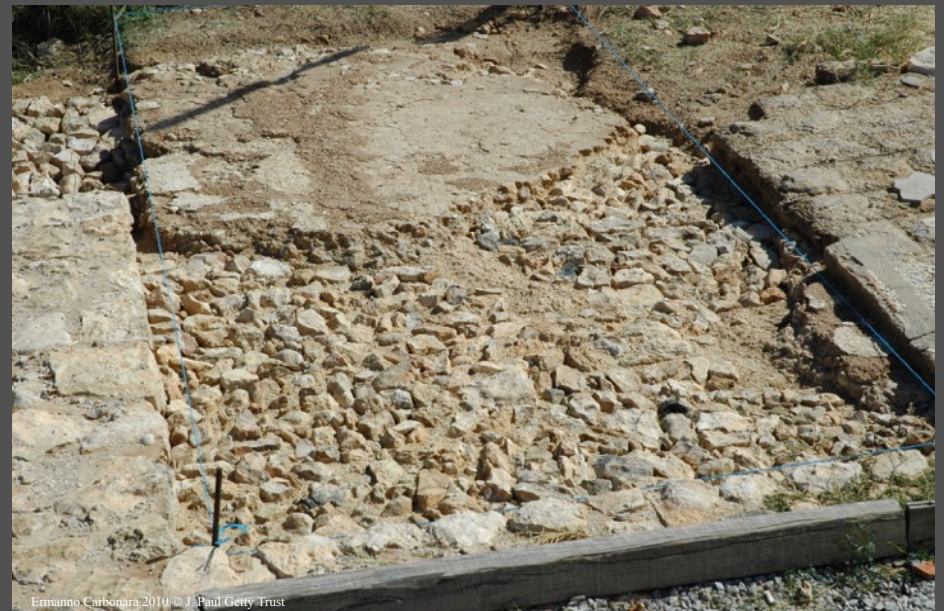
Create mortar samples for the various preparatory layers to be integrated.

At the correct level, reconstruct the missing parts of each original preparatory layer, excluding the bedding layer for the tesserae.

Consider the slope for draining rain water from the room and determine the placement of a water drainage opening, if necessary.

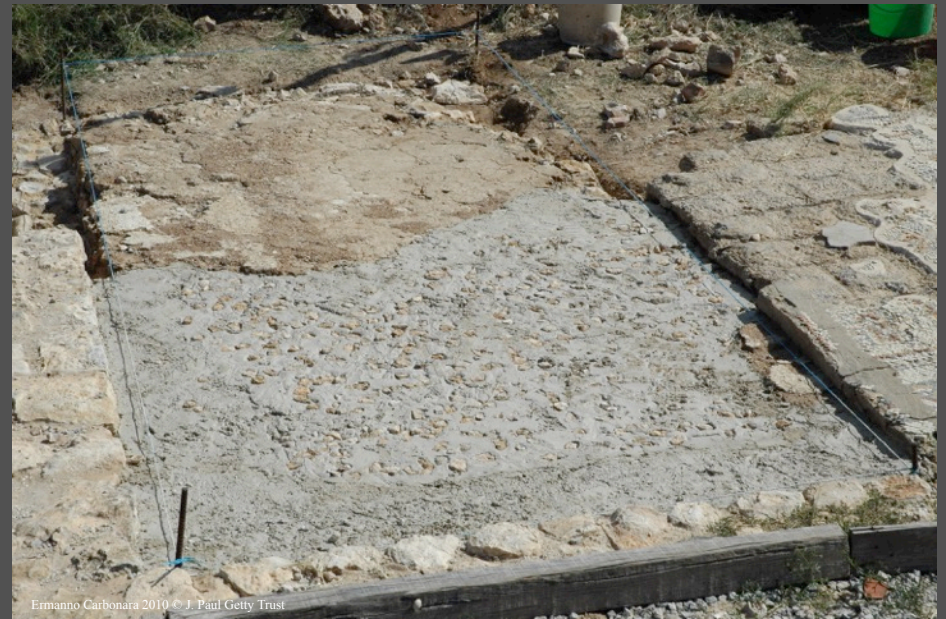
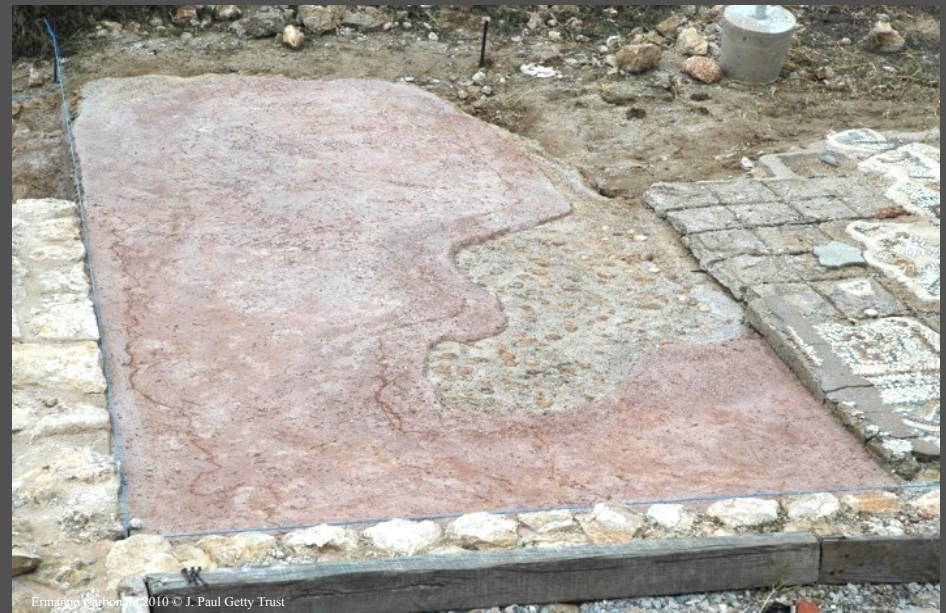
2. Preparation of reinstatement area for sections

- Cleaning and stabilization of each original preparation layer
- Reconstruction of each preparation layer

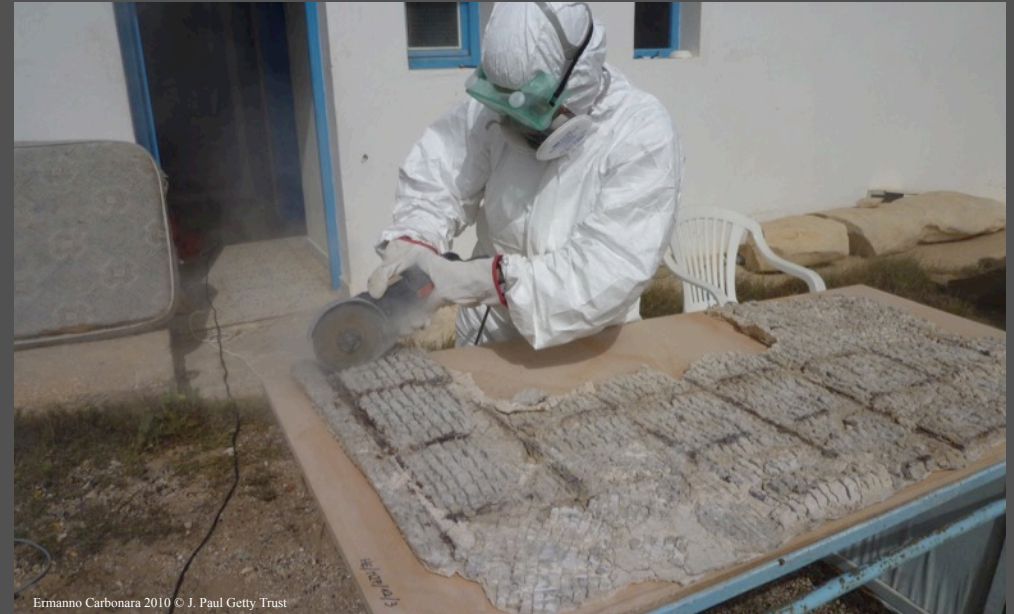
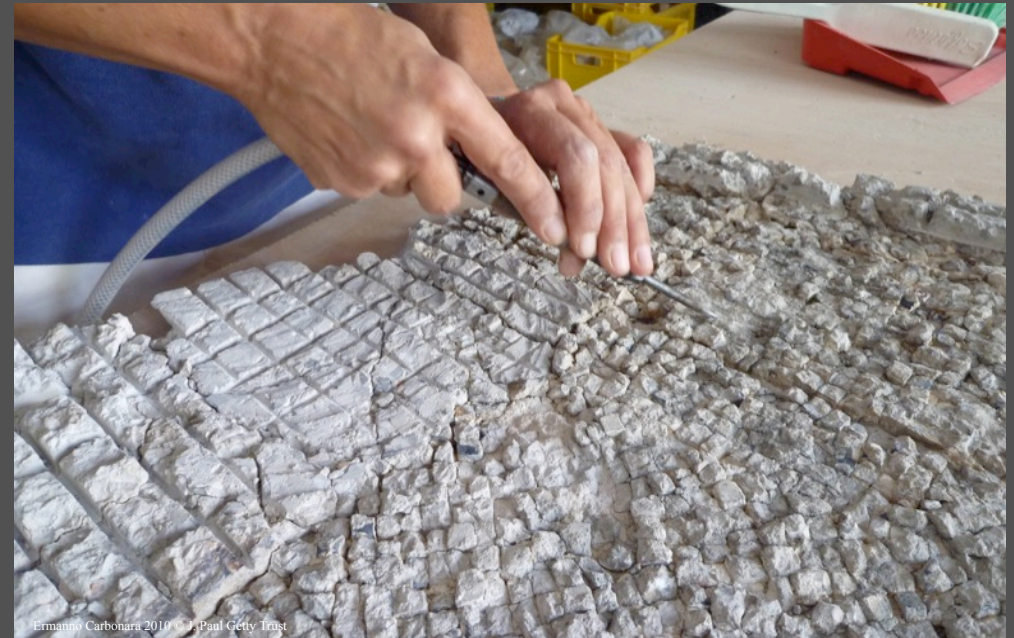
Make close parallel cuts in the panel using a disc grinder.

Remove the concrete ridges left behind by the cuts, using a hammer and chisel.

Clean the back of the tesserae with micro-chisels, micro-engravers, scalpel, etc.

Attach again with an adhesive any detached tesserae to the fabric, if necessary.

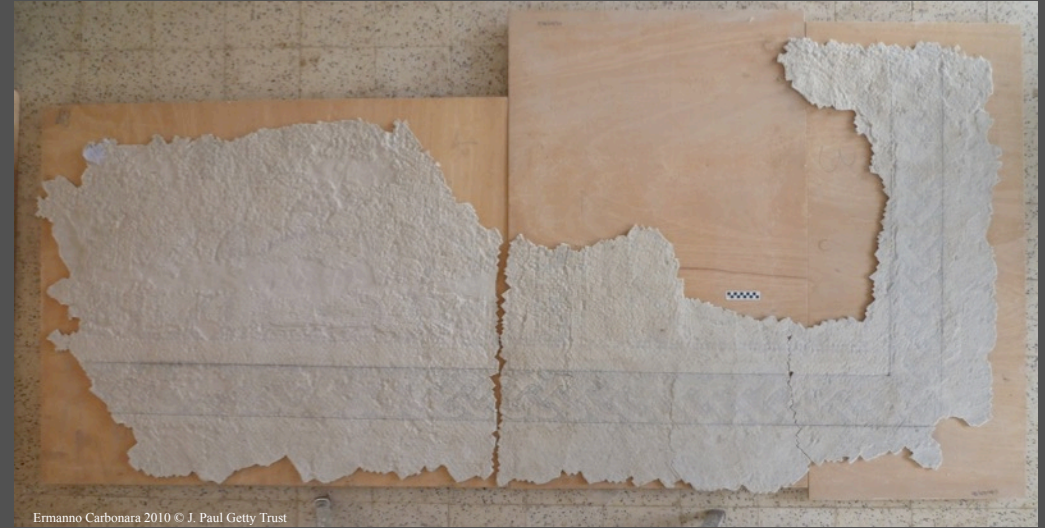
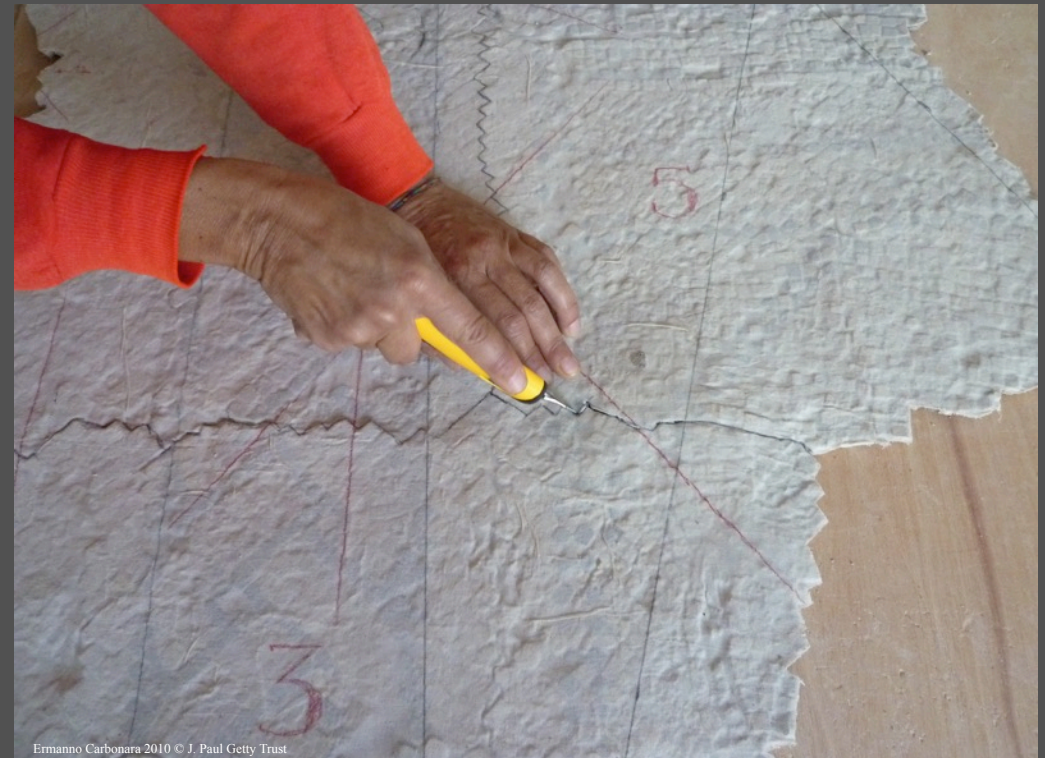
Procedure to follow in the event of minimal panel deformation:

Verify the connection between the sections, correct their position and mark the new reference lines if errors are detected in the alignment from the previous positioning.

Create new section cuts in the mosaic, if necessary.

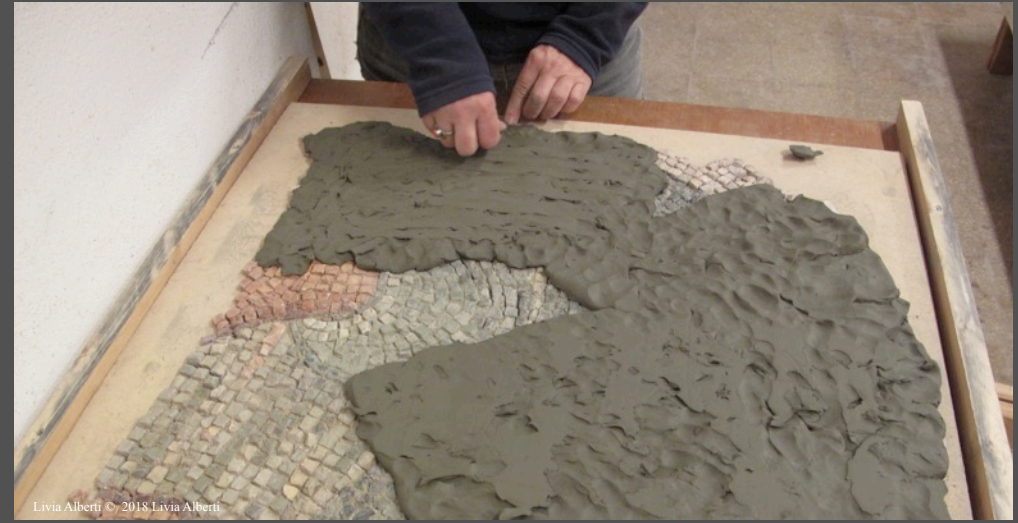
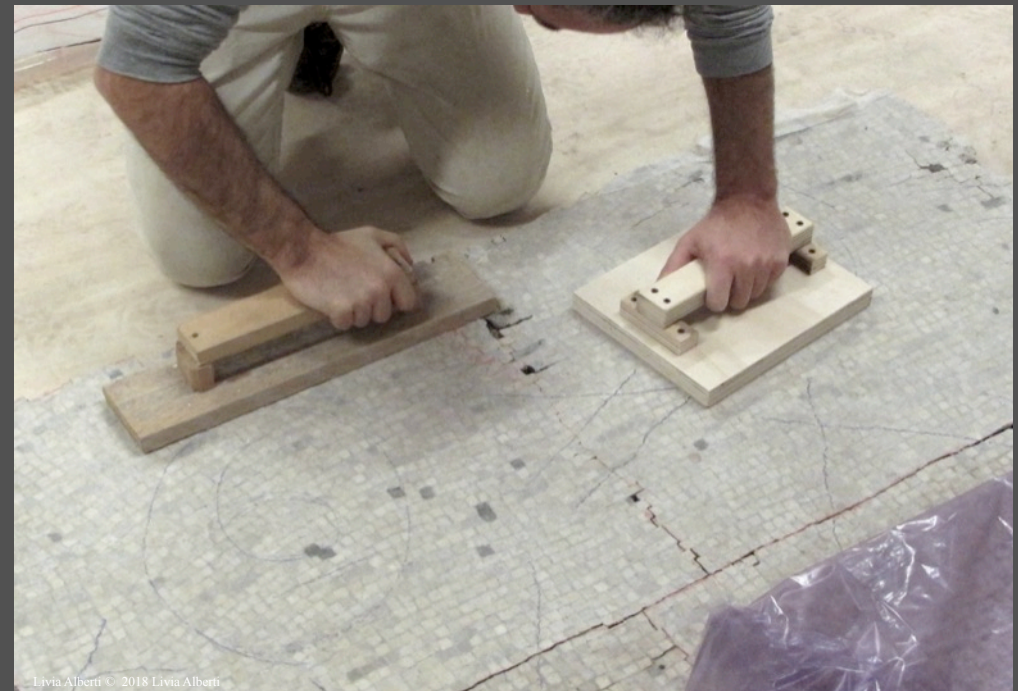
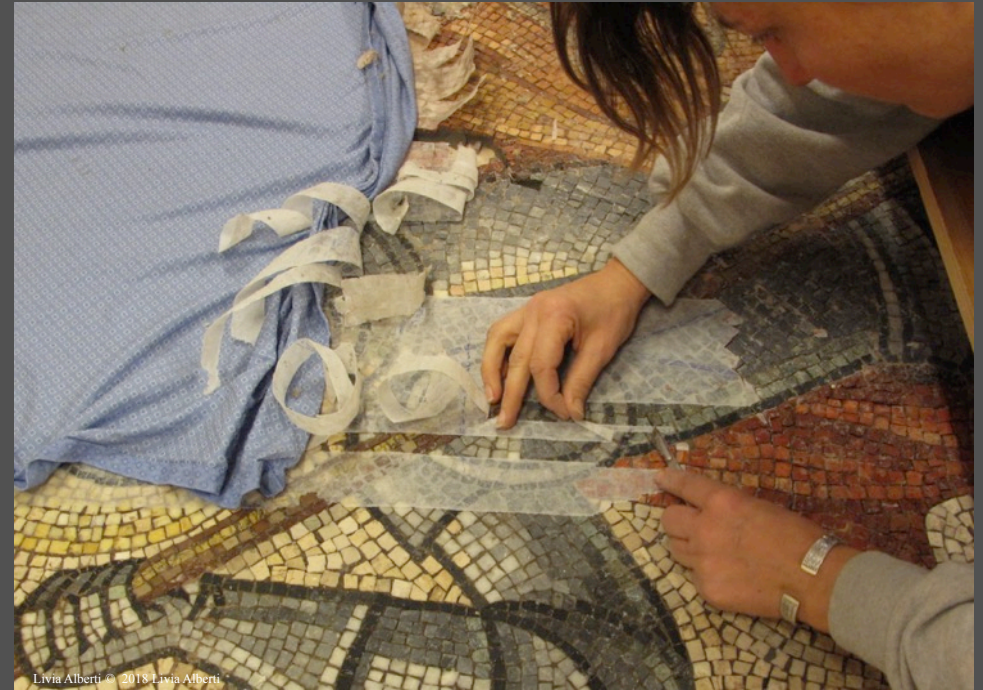
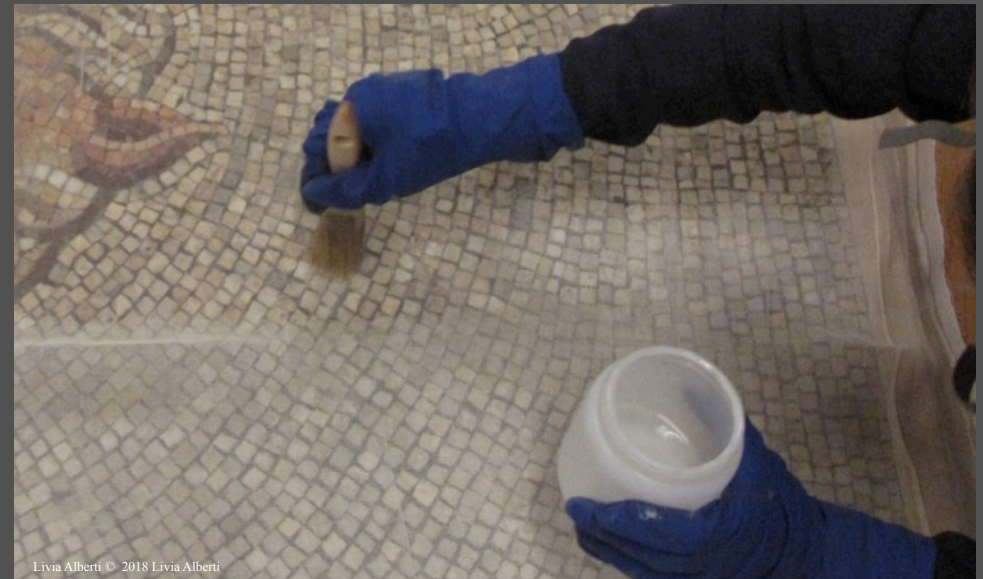
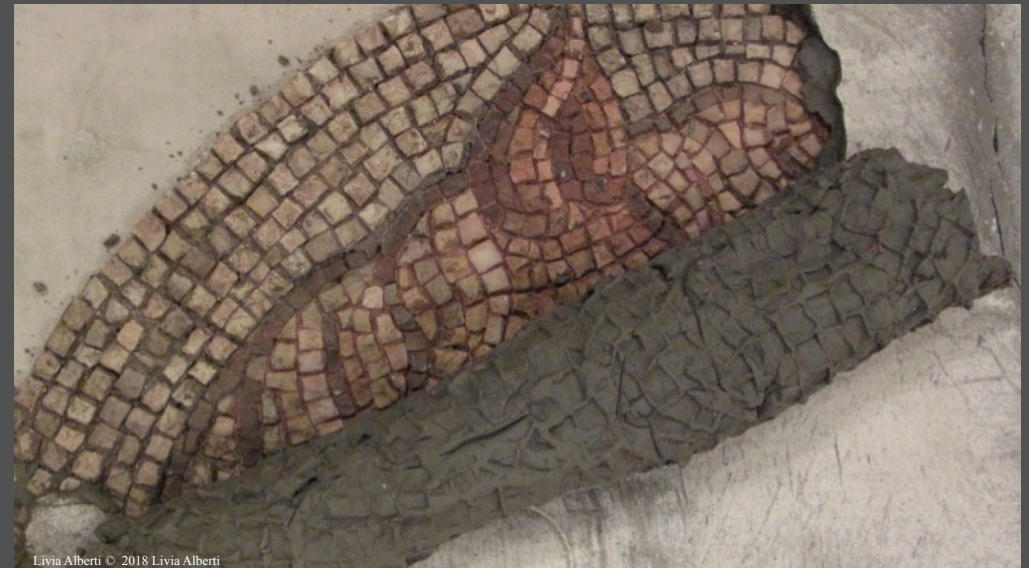
Procedure to follow in the event of significant panel deformation:

Apply a layer of clay to the back of the sections and invert them.

Tap the surface of the mosaic while the layer of clay is fresh to bring the sections together and correct the deformation of the mosaic, referring to the lines and motifs of the mosaic decoration itself.

Dissolve the facing adhesive with an appropriate solvent, depending on the type of adhesive used, and remove the fabric, verifying that the tesserae do not detach from the clay bedding layer.

Apply a new fabric layer (one or more) to the surface of the mosaic using an appropriate adhesive.

Mark and number the new sections on the map and on each of the sections themselves.

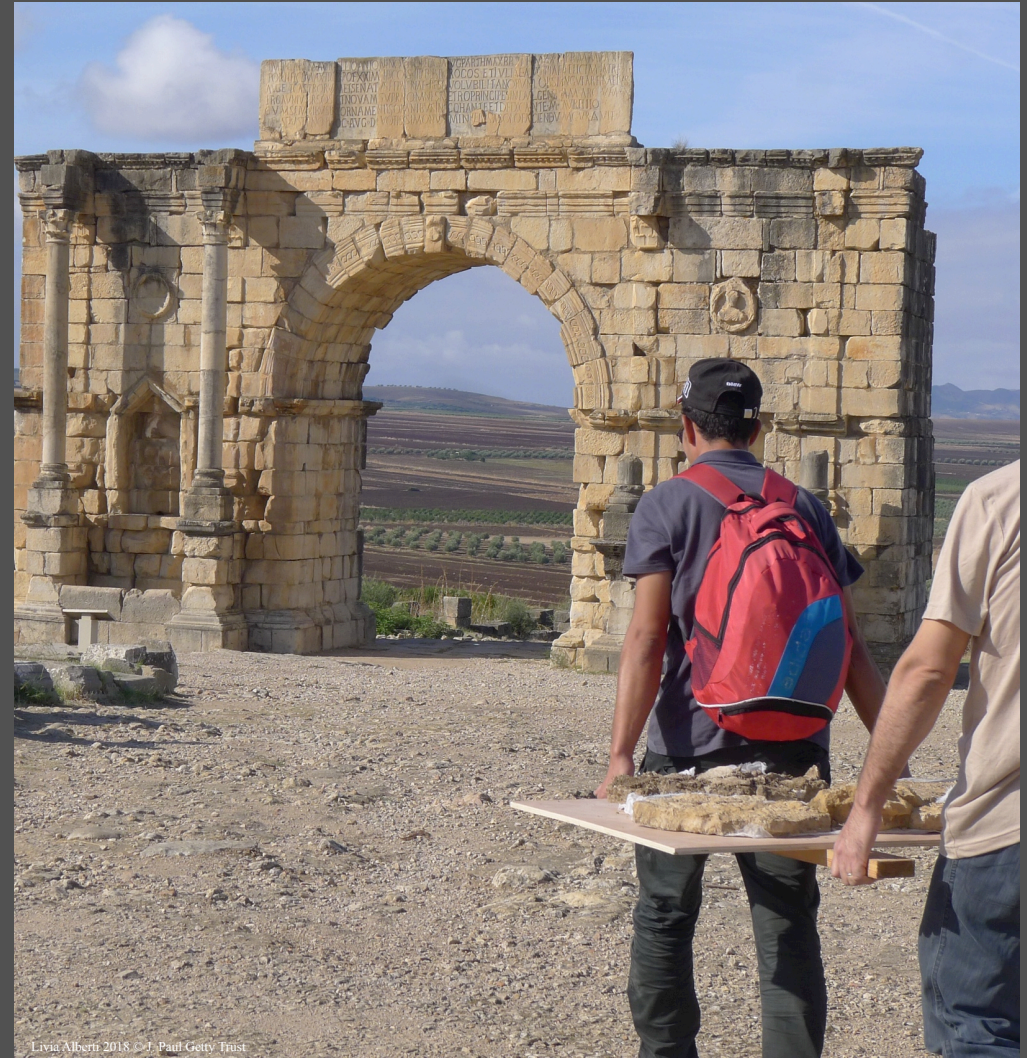
3. Removal of old panel supports

- Removal of reinforced concrete
- Temporary assembly of mosaic sections
- On-site transport of sections

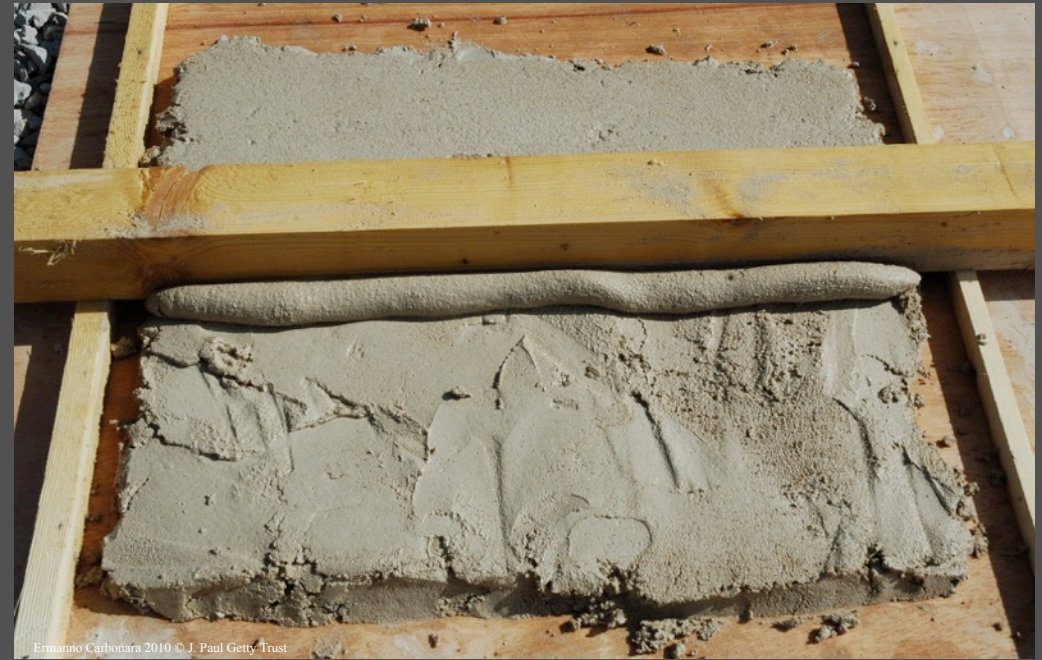
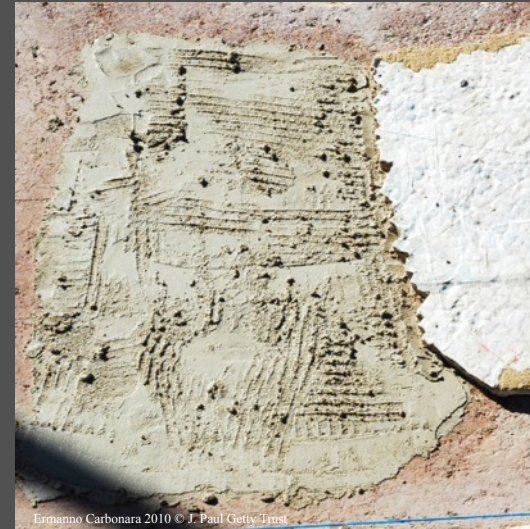
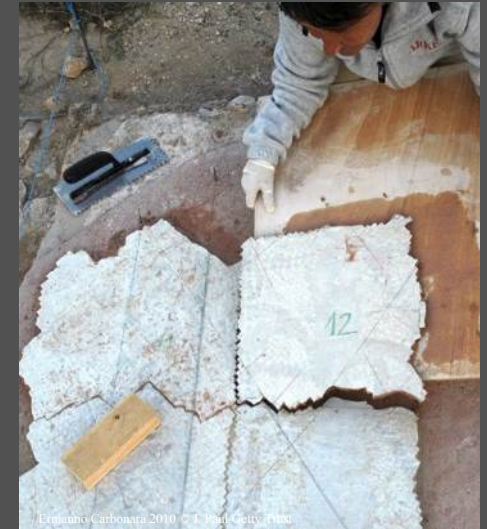
Apply the lime-based mortar on the tesserae and the section reinstallation area.

Reposition the sections one at a time by sliding them onto the mortar beds that are still freshly applied to the section reinstallation area.

Verify the position of the sections using the reference lines between the various sections and the reference systems previously set up around the mosaic.

Tap the surface of the mosaic while the mortar is still soft to bring the sections together and correct deformations, if necessary.

Apply weight to the surface of the mosaic while the mortar is setting.

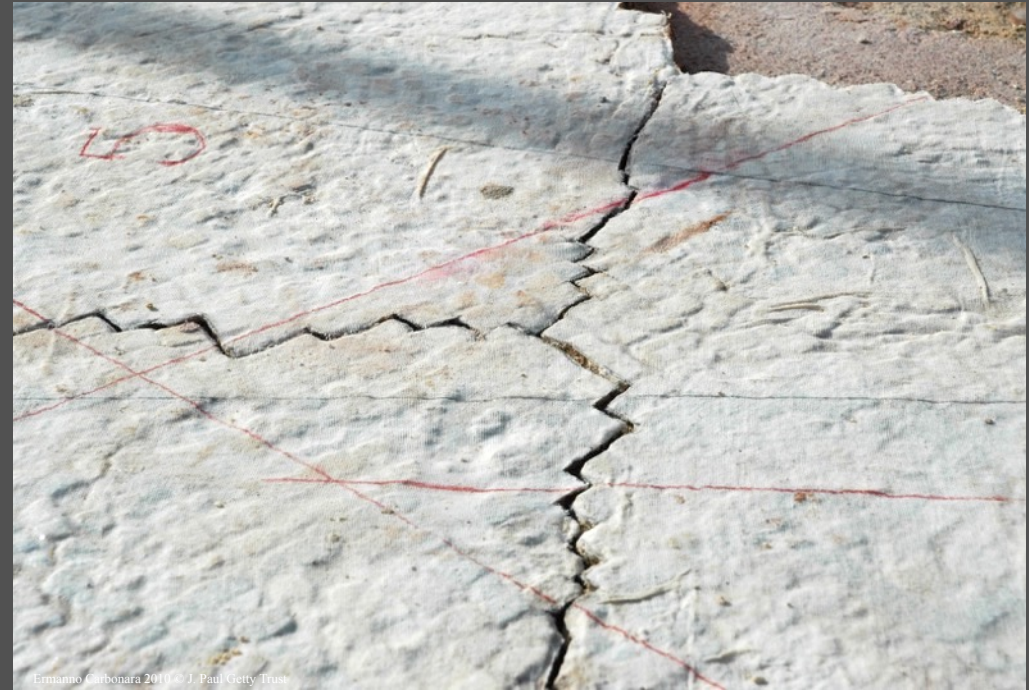
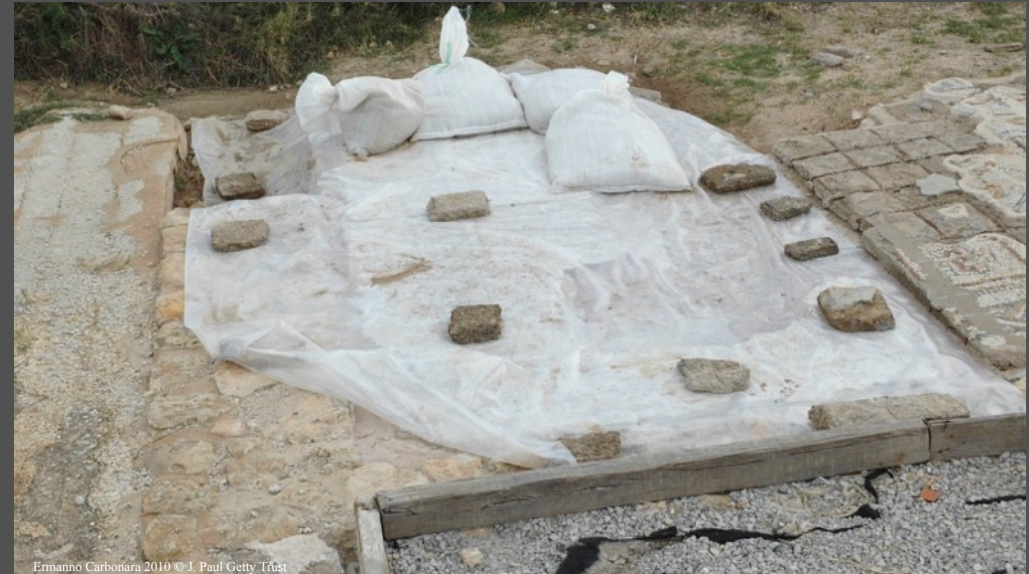
4. Reinstallation and presentation of the mosaic

- On-site reinstallation of mosaic sections
- Removing the fabric and cleaning the adhesive
- Stabilization of the tessellatum

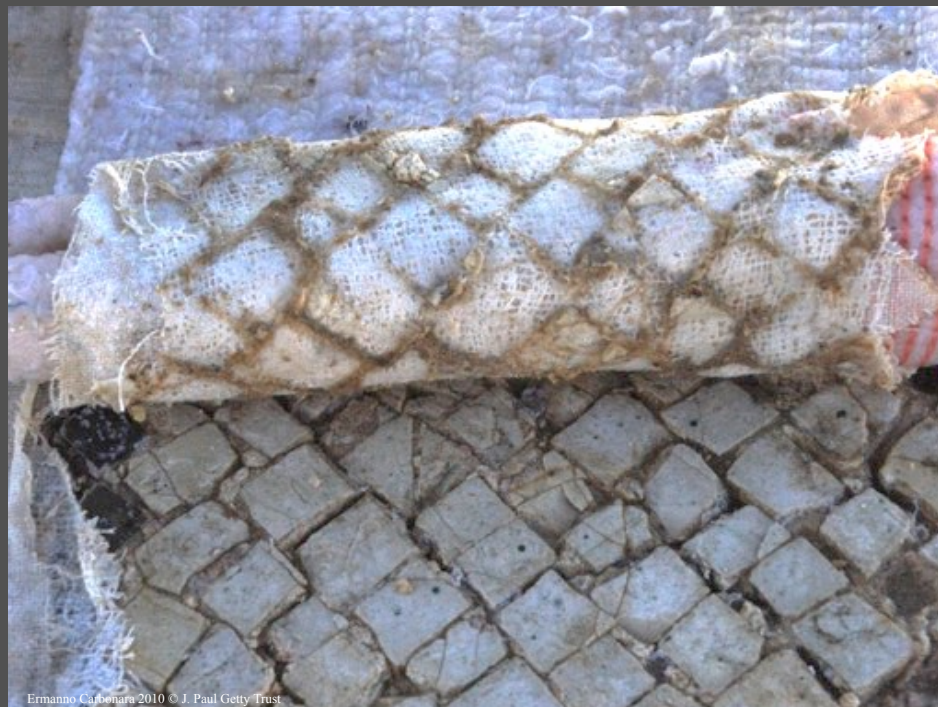
Dissolve the adhesive with an appropriate solvent, depending on the type of adhesive used.

Remove the fabric one small area at a time, verifying that the tesserae do not detach from the bedding layer.

Clean the adhesive off the mosaic surface with an appropriate solvent.
