TECHNICIAN TRAINING FOR THE CONSERVATION OF MOSAICS

PART 2
THE CONSERVATION OF DETACHED MOSAICS

Mosaics detached and relaid in situ on
reinforced concrete:
their reinstallation in situ and documentation

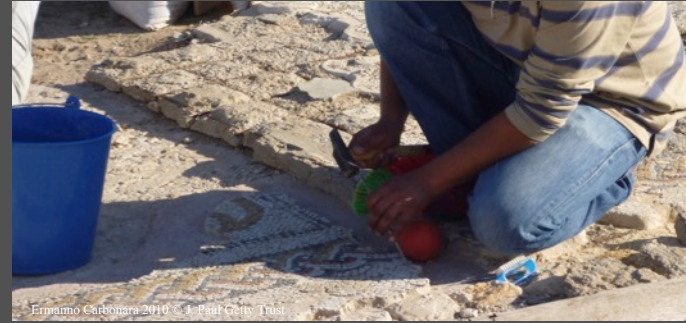
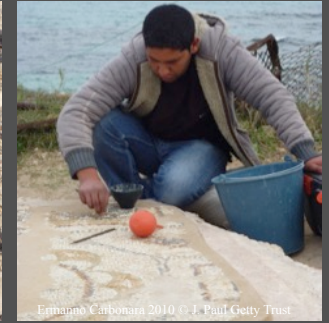
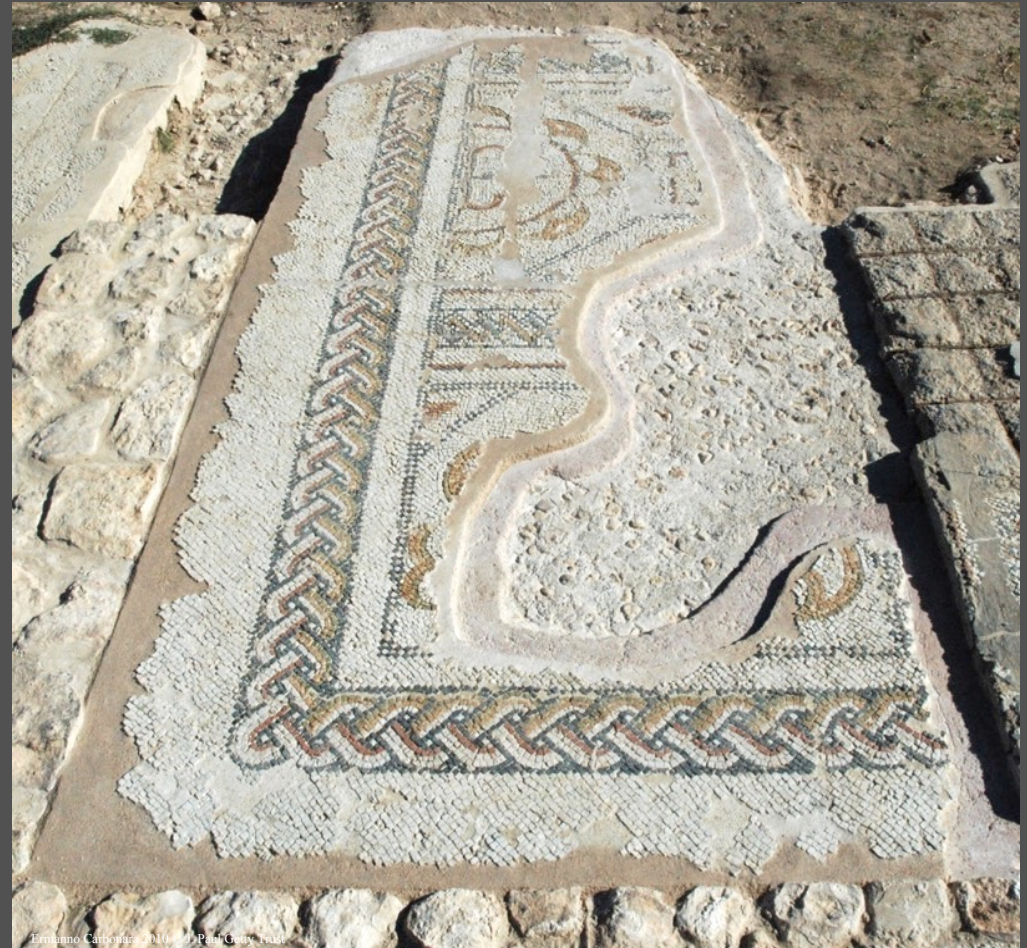
Remove the old mortar in the lacunae and fill them with appropriate mortar.

Fill the interstices between the tesserae where needed.

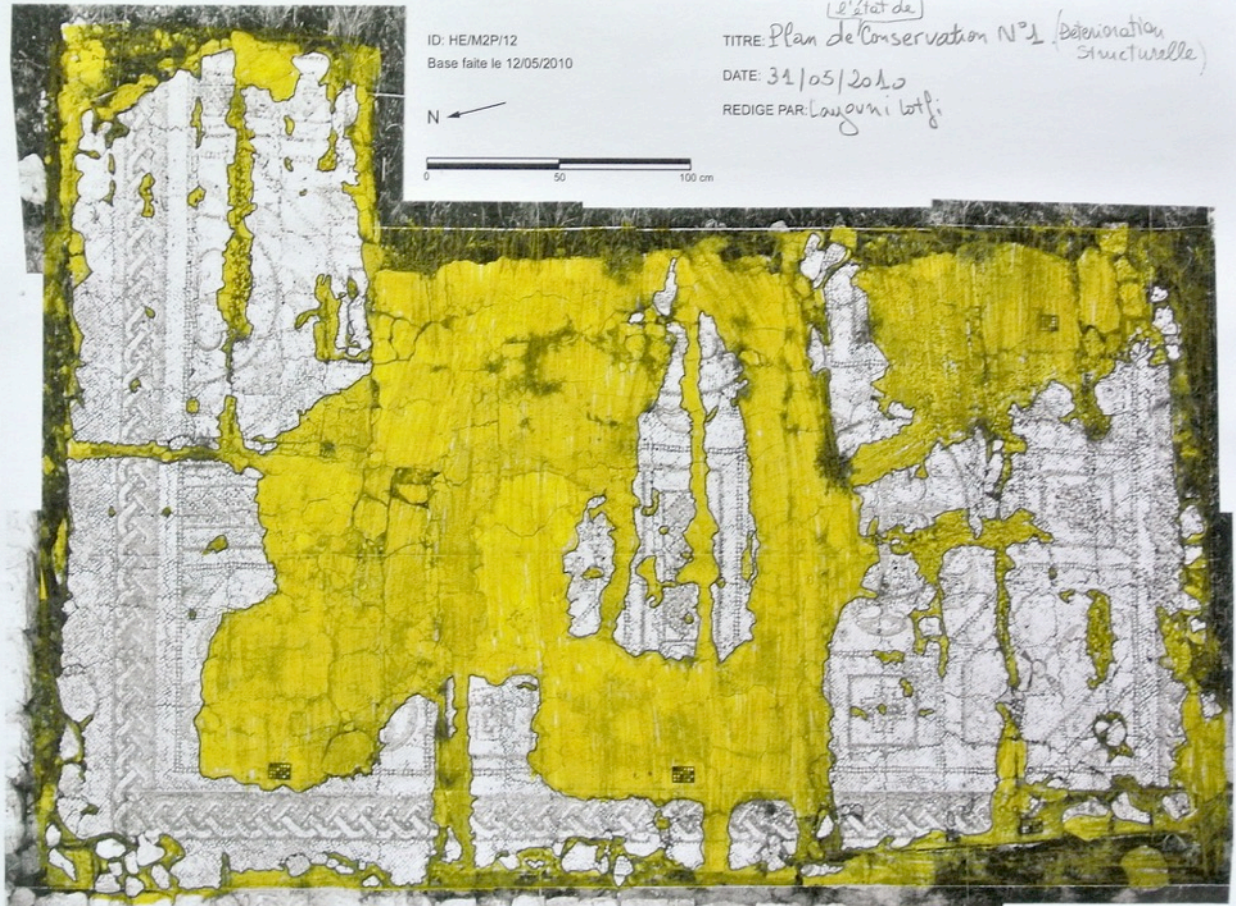
ID: HE/M2P/12

Base faite le 12/05/2010

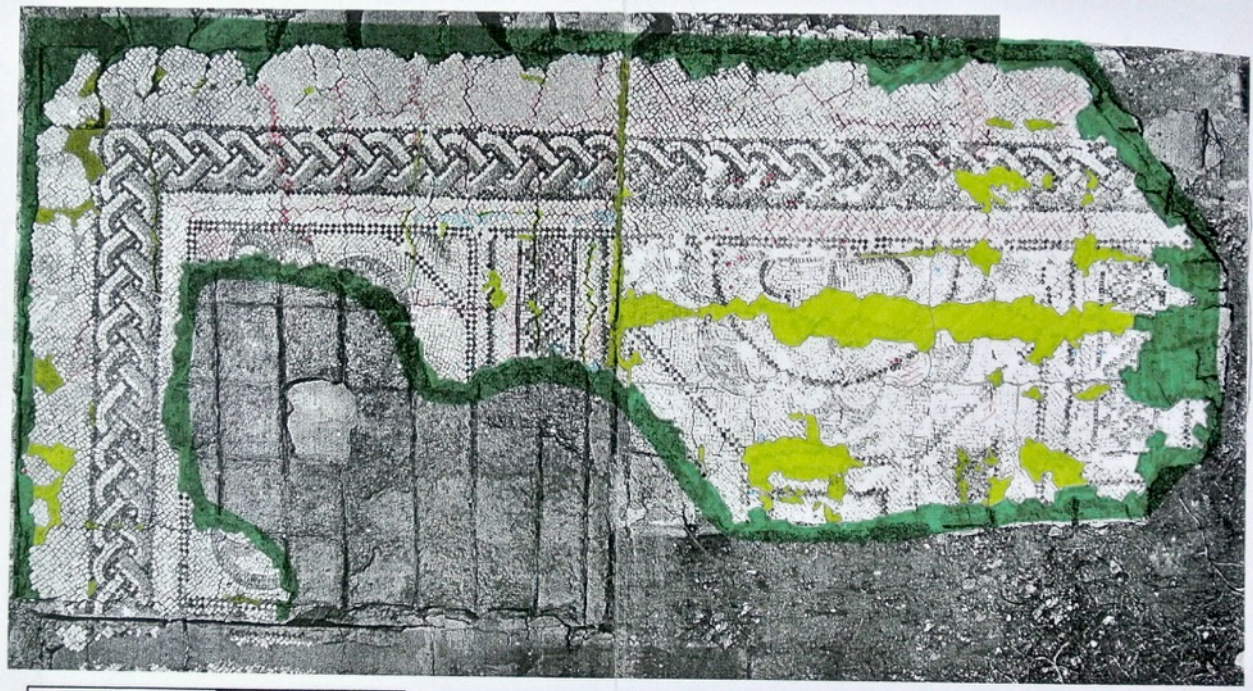
ID: HE/M2P/12 Partie Nord
 Base faite le 12/06/2010

TITRE: INTERVENTION RÉALISÉ
 DATE: 16-22 NOVEMBRE 2010
 REDIGÉ PAR: CARBONARA

- Enlèvement temporaire et remise en place des fragments de mosaïque avec la toile de sécurité
- Reenfouissement
- Bouches de drainage
