## TECHNICIAN TRAINING FOR THE CONSERVATION OF MOSAICS

PART 1  
THE CONSERVATION OF IN SITU MOSAICS

### Deterioration of mosaics

Livia Alberti, Ermanno Carbonara, Thomas Roby

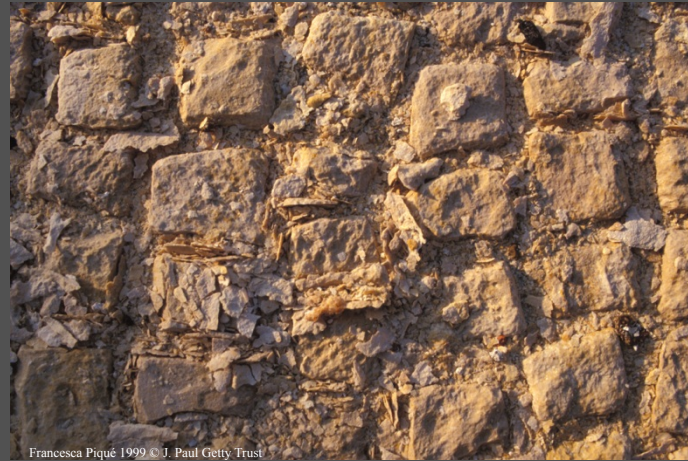
**CONDENSATION**  
when the surface is cooler than the air

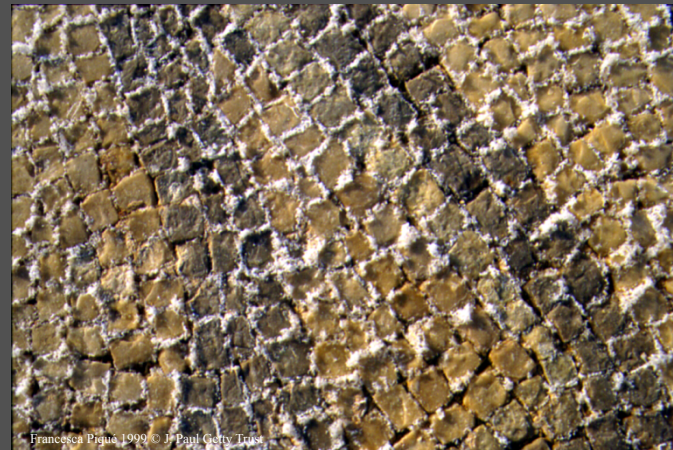
**CAPILLARY RISE OF WATER**

**Efflorescence**

**Incrustation**

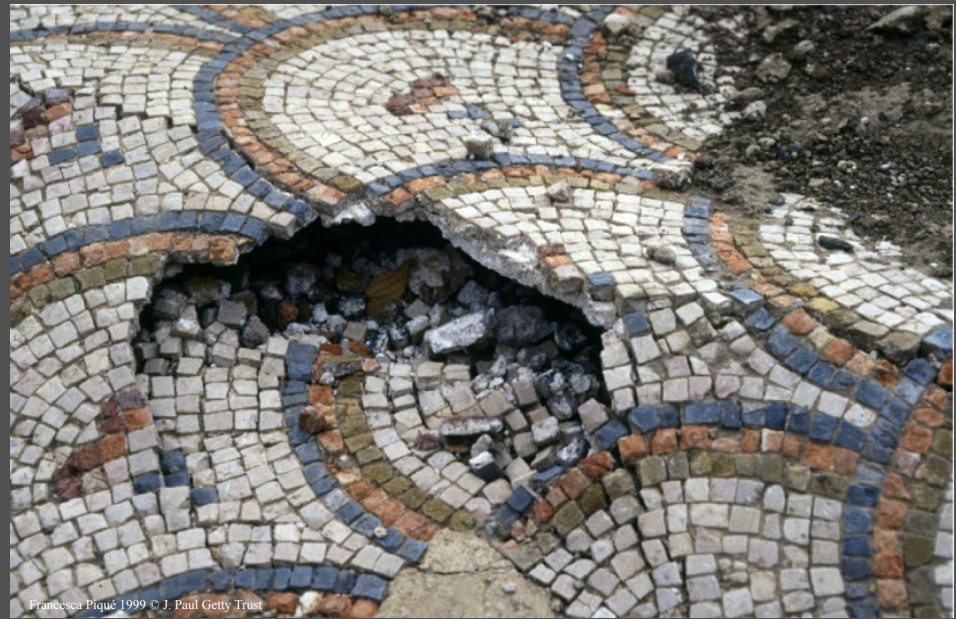
Bulges, Detachments, Cracks, Lacunae, Detached Tesserae

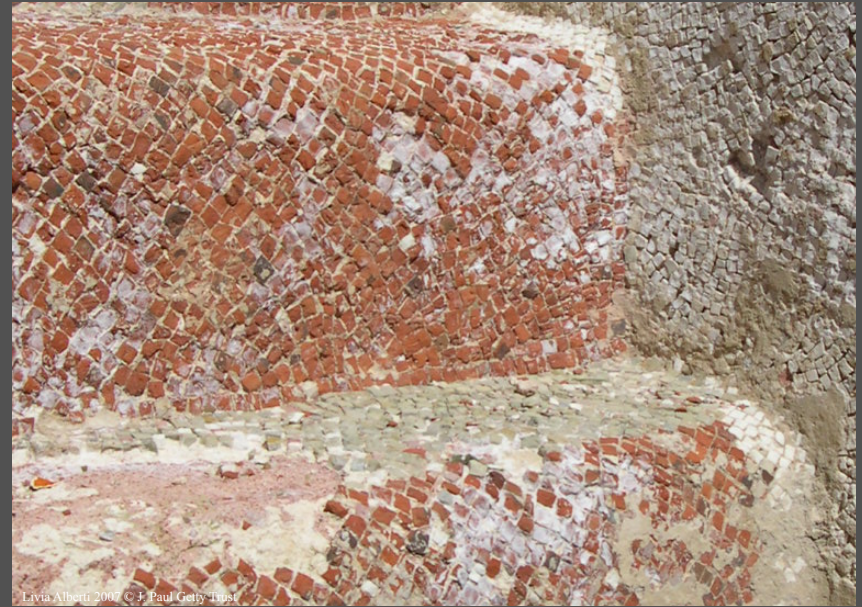
## Efflorescence, Damaged tesserae

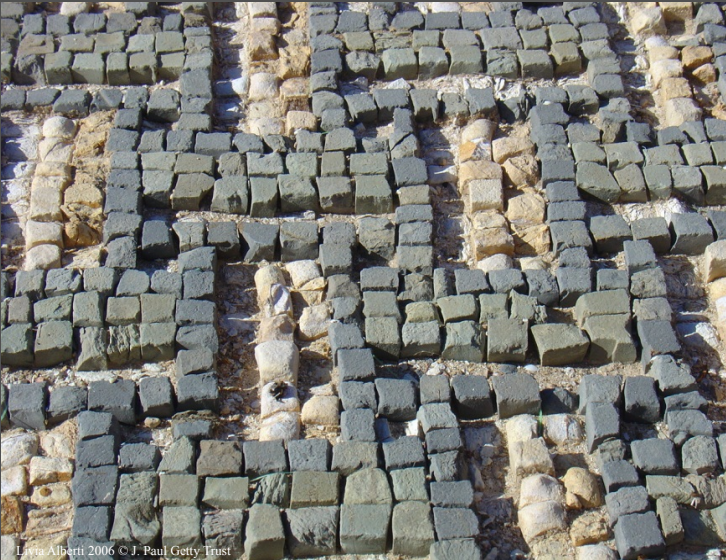
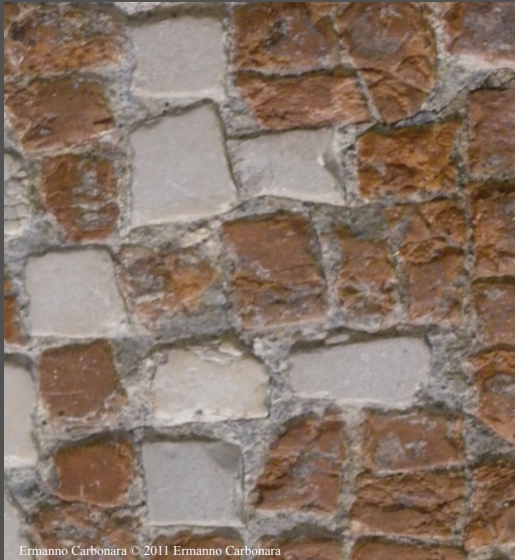
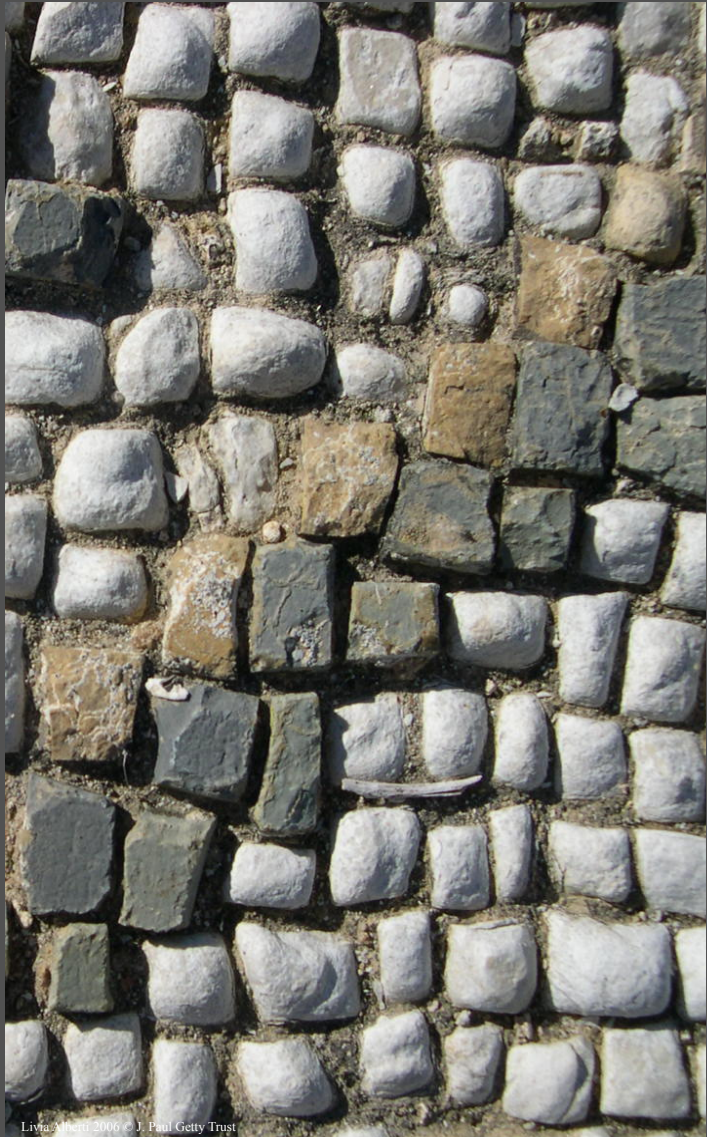
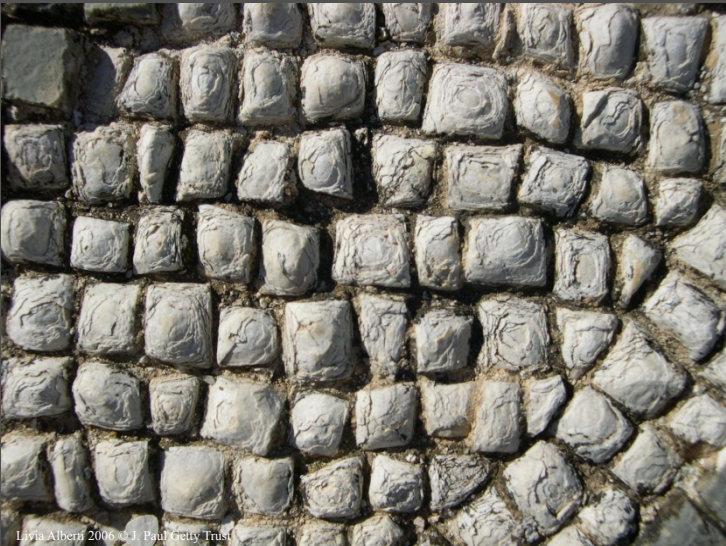
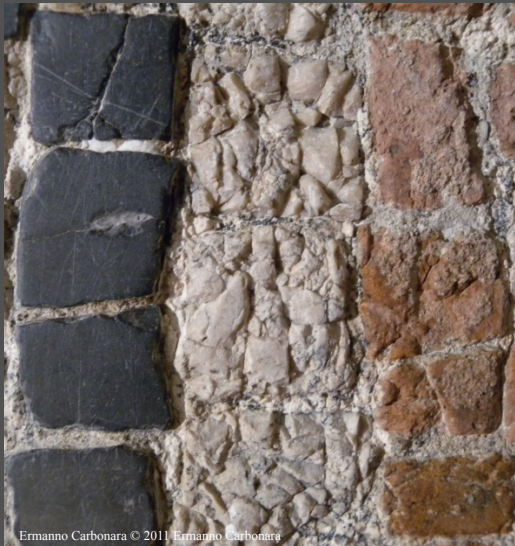
# Particular deterioration phenomena due to the type and quality of the materials

Damaged Tesserae

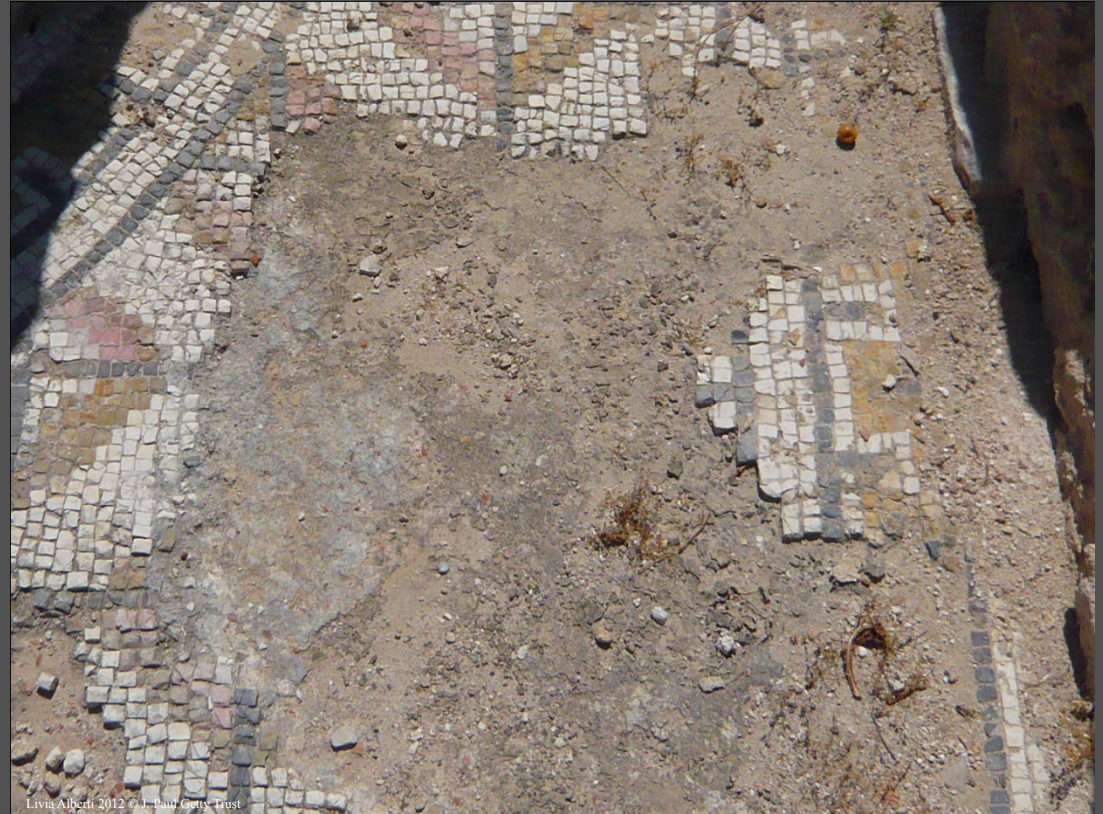
## Tessellatum lacunae

Part of a mosaic where the tesserae layer has been lost.

Different levels of lacunae in a mosaic

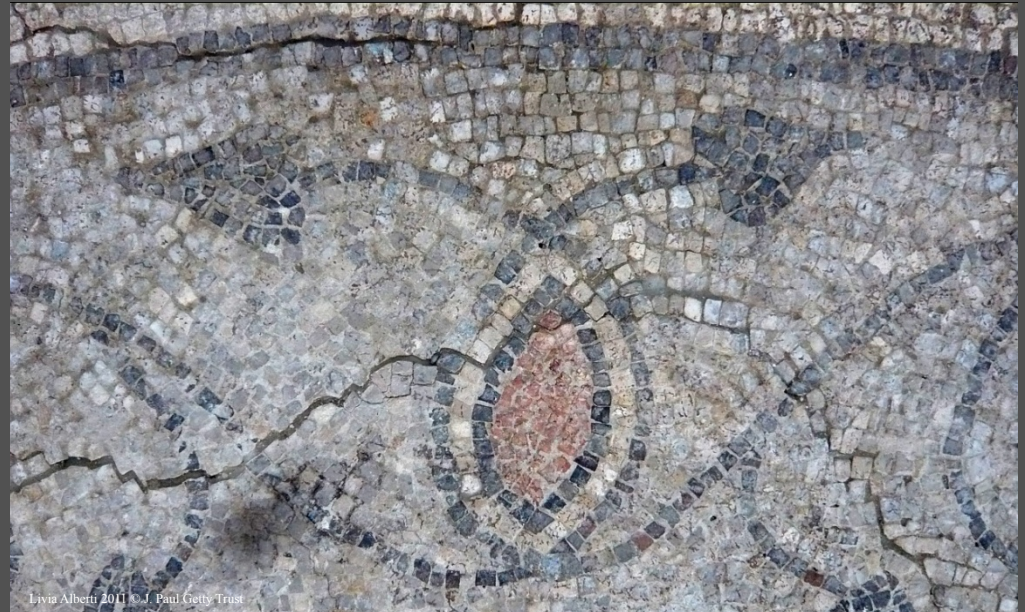
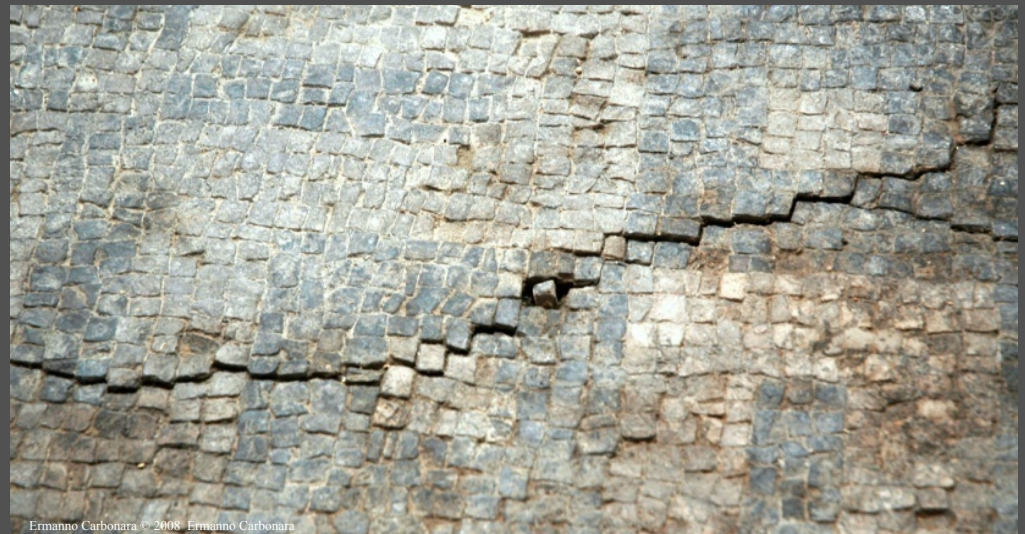
## Cracks

Linear fissure visible on the surface of the mosaic that could also continue into the bedding layers.

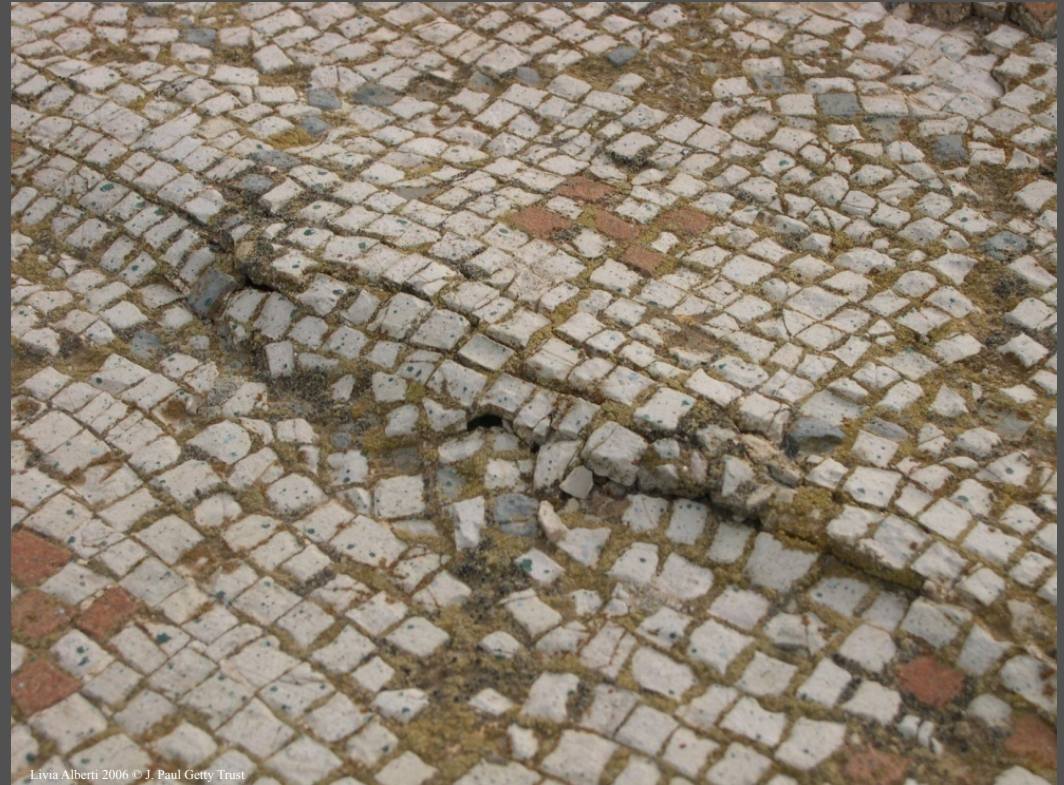
## Bulges

An upward deformation of the mosaic above its original surface level.

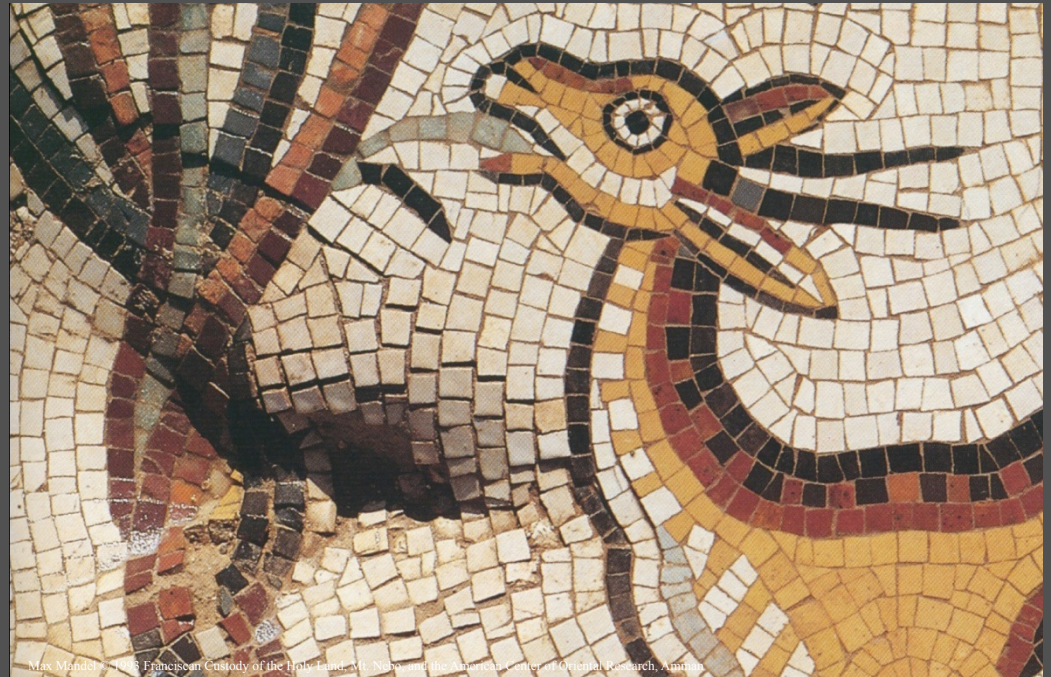
## Depressions

A downward deformation of the mosaic below its original surface level.

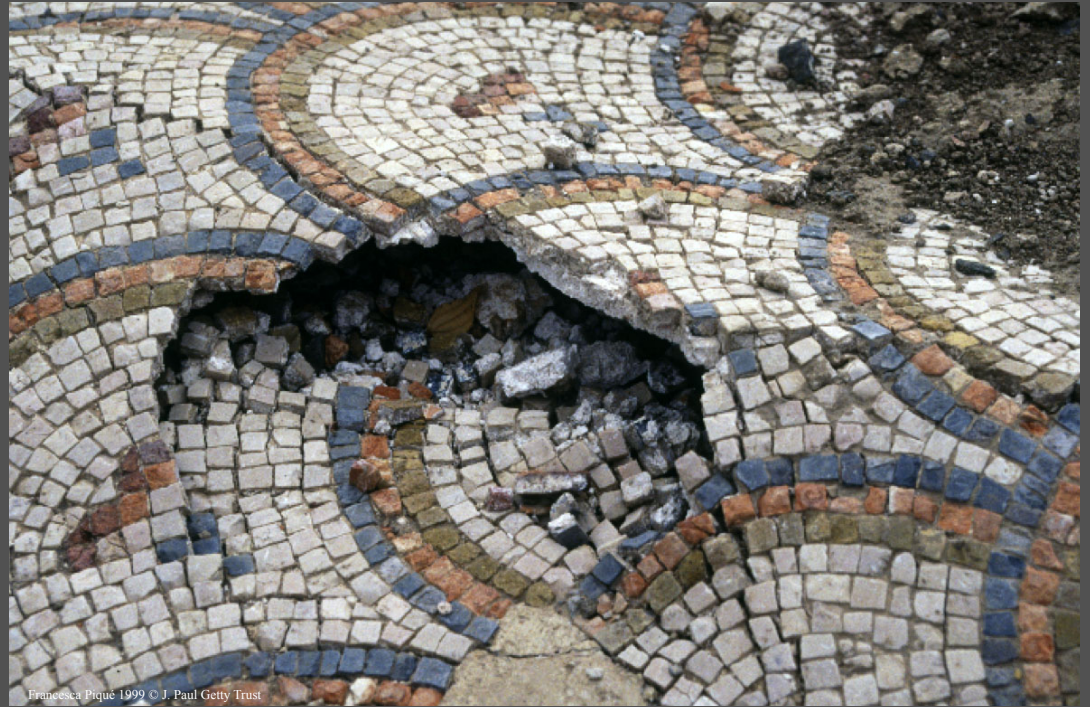
## Detachments between mosaic layers

Separation or void between two layers of the mosaic. A detachment is generally not visible and can be detected by the corresponding hollow sound produced when it is tapped.

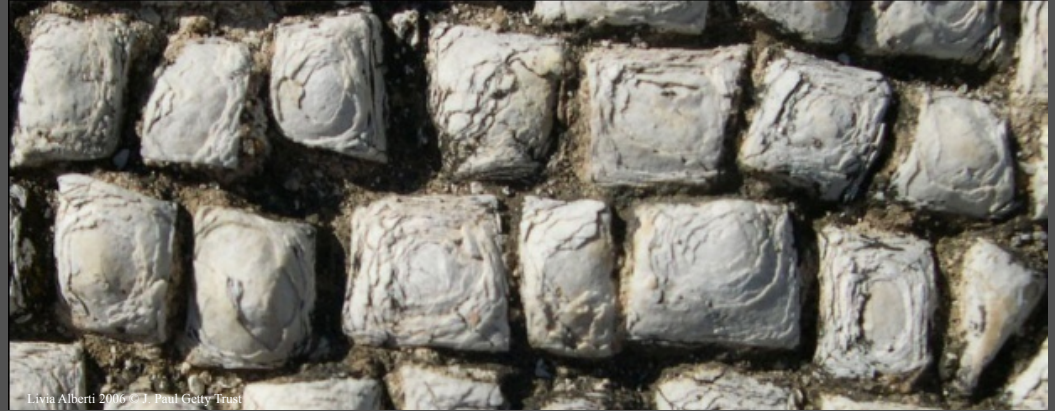
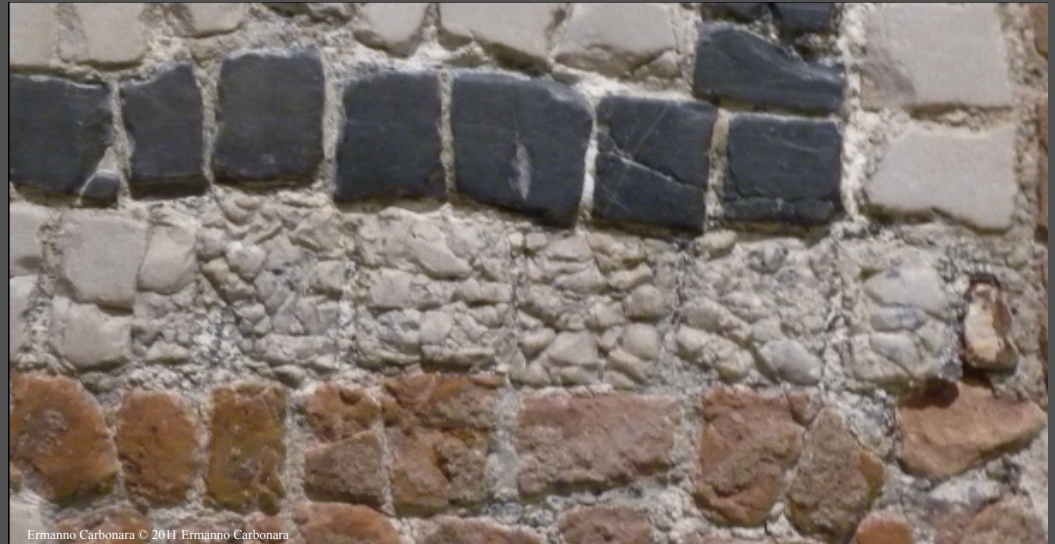
## Deteriorated tesserae

Tesserae that are no longer in good condition. Damaged tesserae can be cracked, eroded, delaminated or show other types of damage or loss.

Disaggregation of tesserae

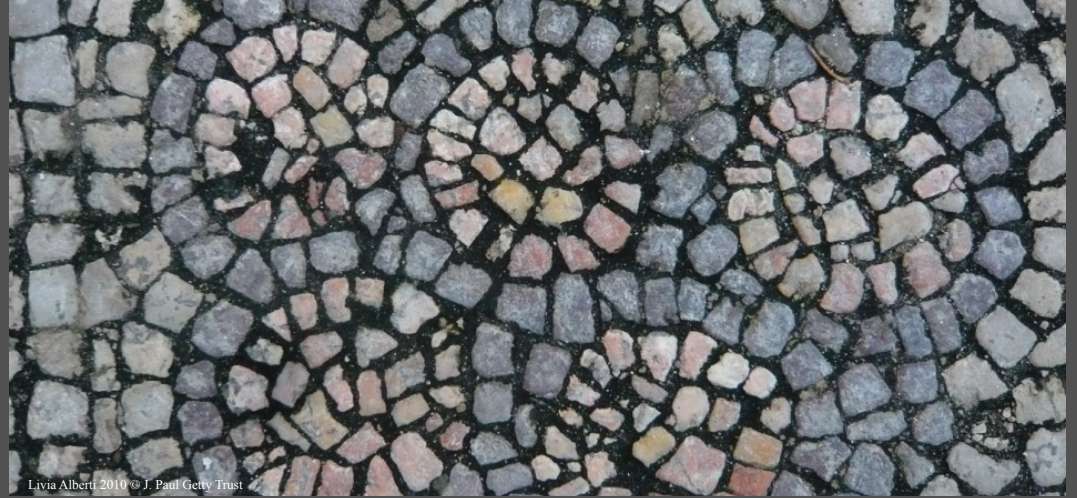
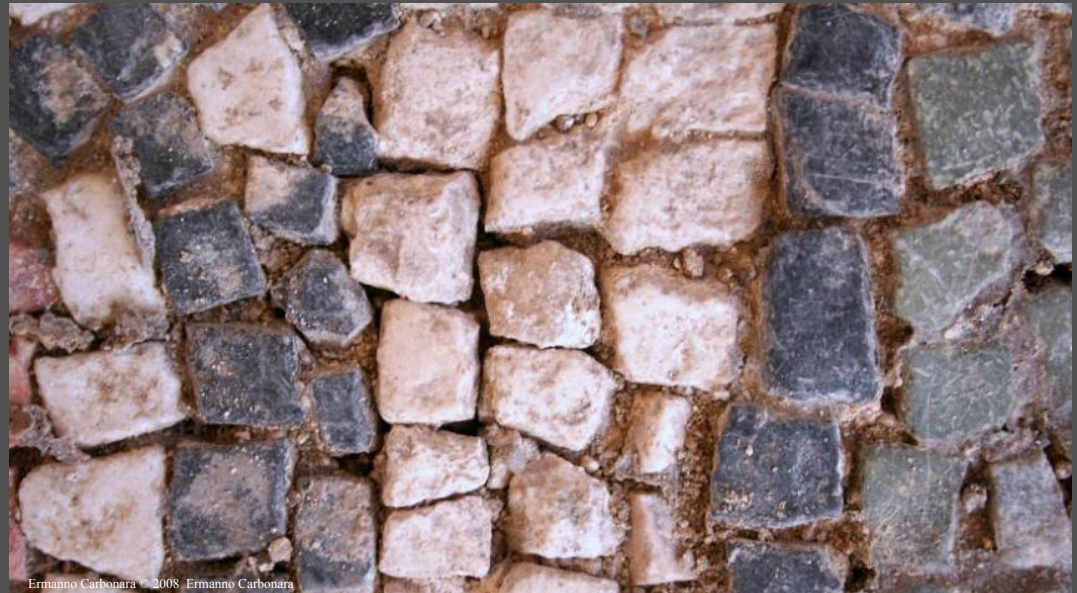
## Deteriorated mortar between tesserae

Mortar located in the interstices between the tesserae that is lost or no longer in good condition.

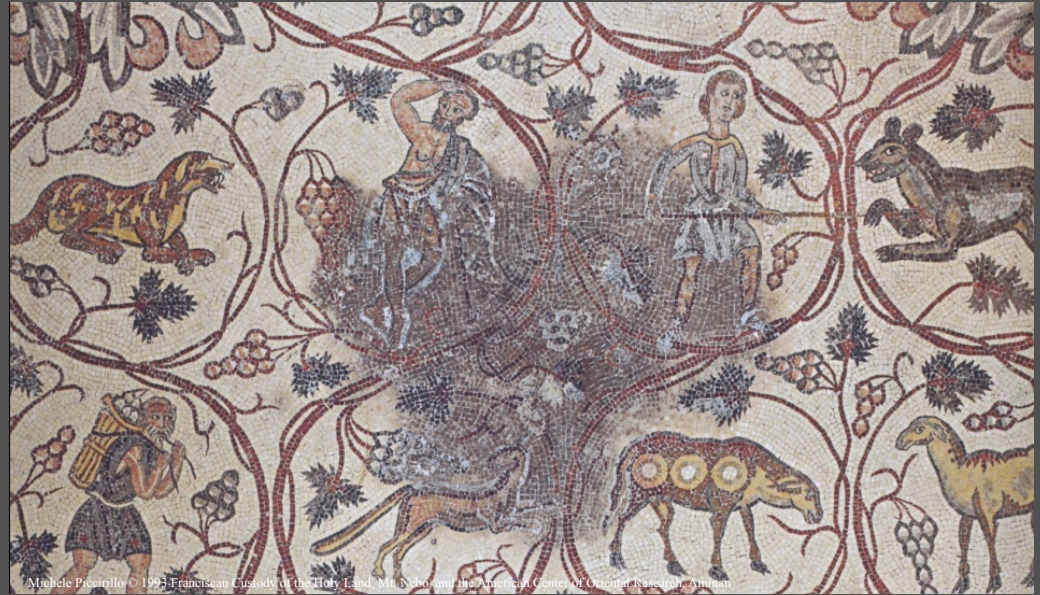
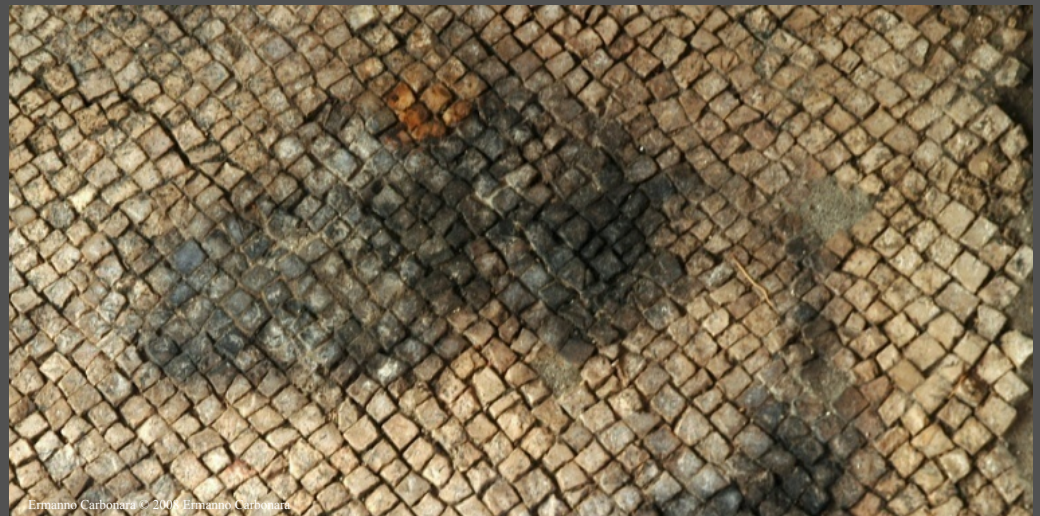
## Stains

Localized changes in color of the mosaic surface.

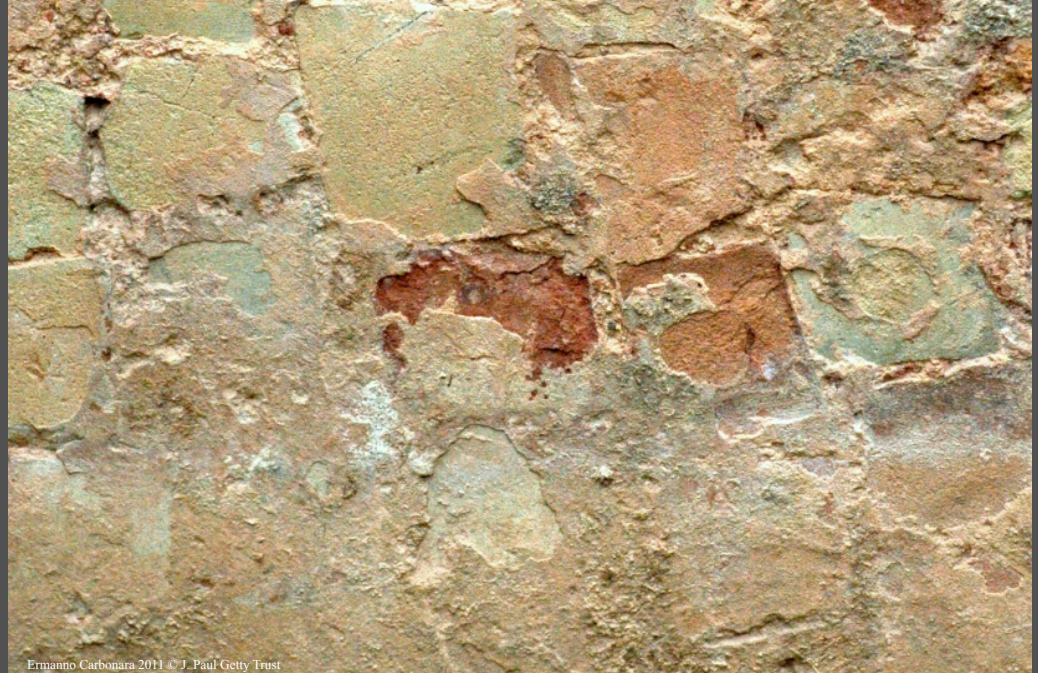
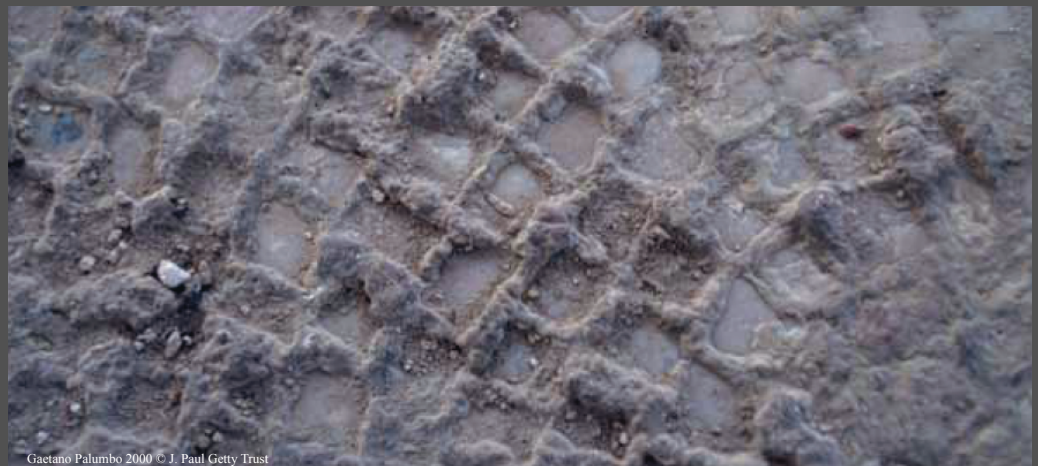
## Incrustations

Mineral crust of variable thickness and area that is often hard and compact, located on the surface of the mosaic.

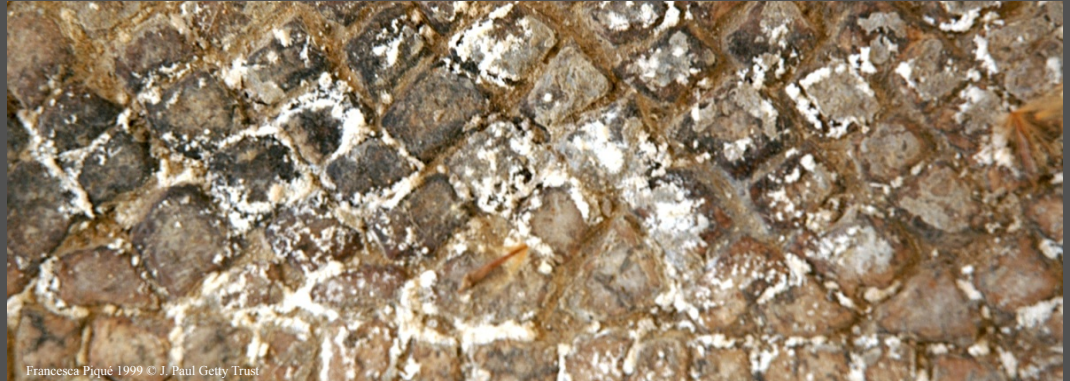
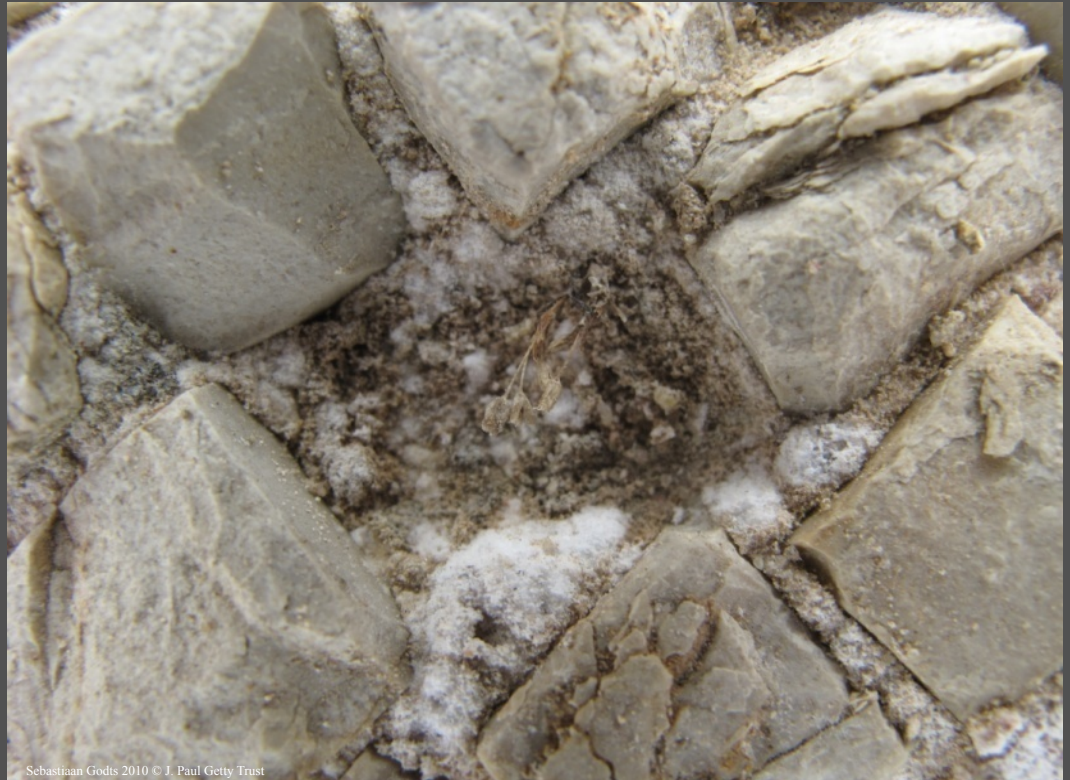
## Efflorescences

Generally a white and crystalline substance, which adheres loosely to the mosaic surface, and is powder-like in appearance.

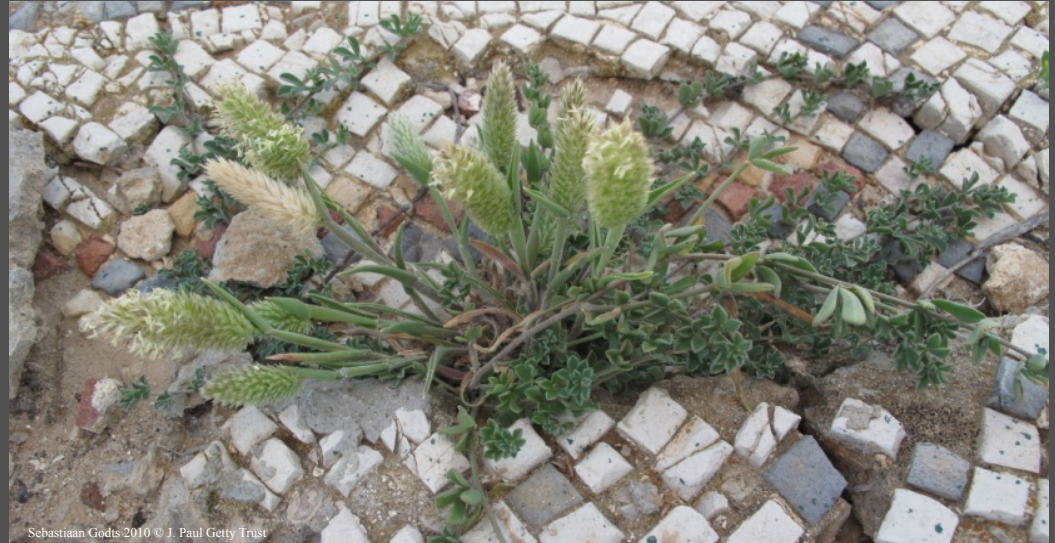
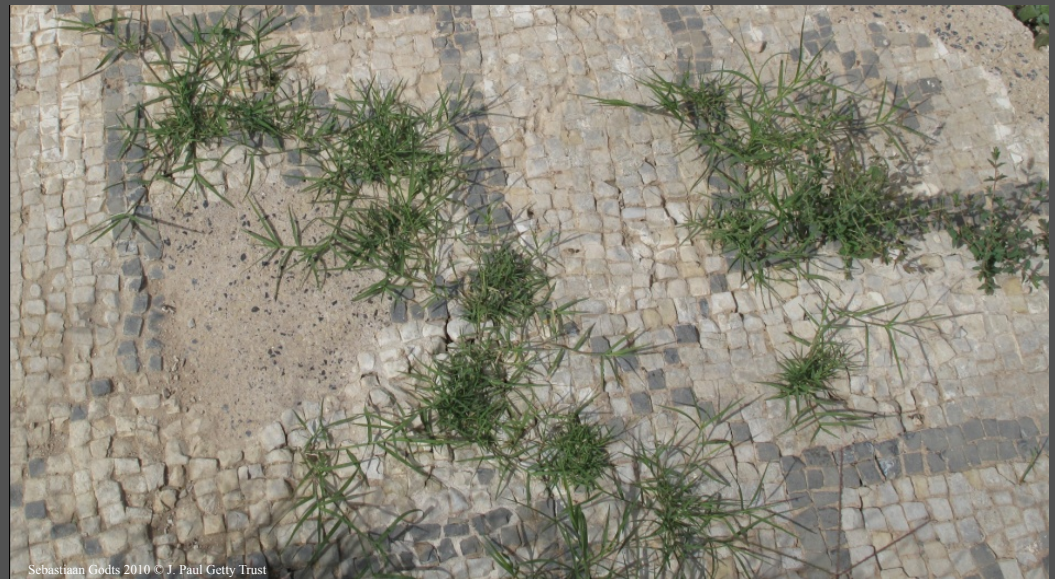
## Vegetation

Plants such as grasses, weeds, bushes, as well as trees and their associated roots growing under, inside, or on top of the mosaic.

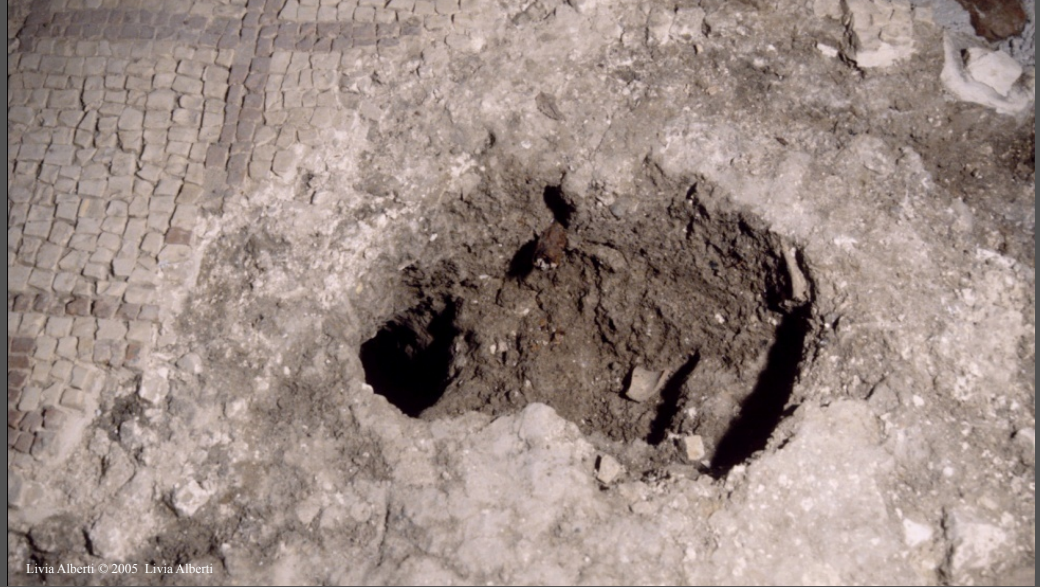
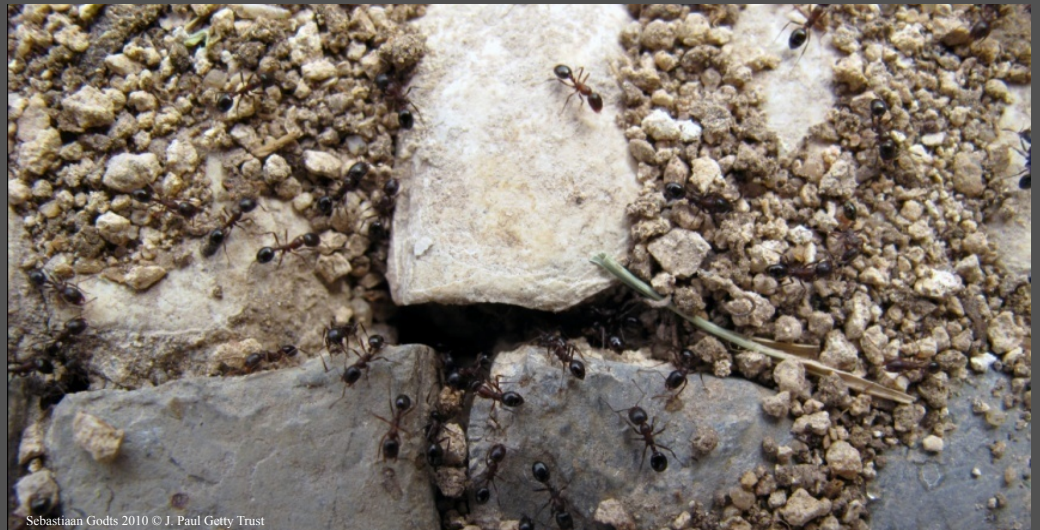
## Tunnel or entrance hole made by insects or other animals

An area of the mosaic where insects or other animals have burrowed.

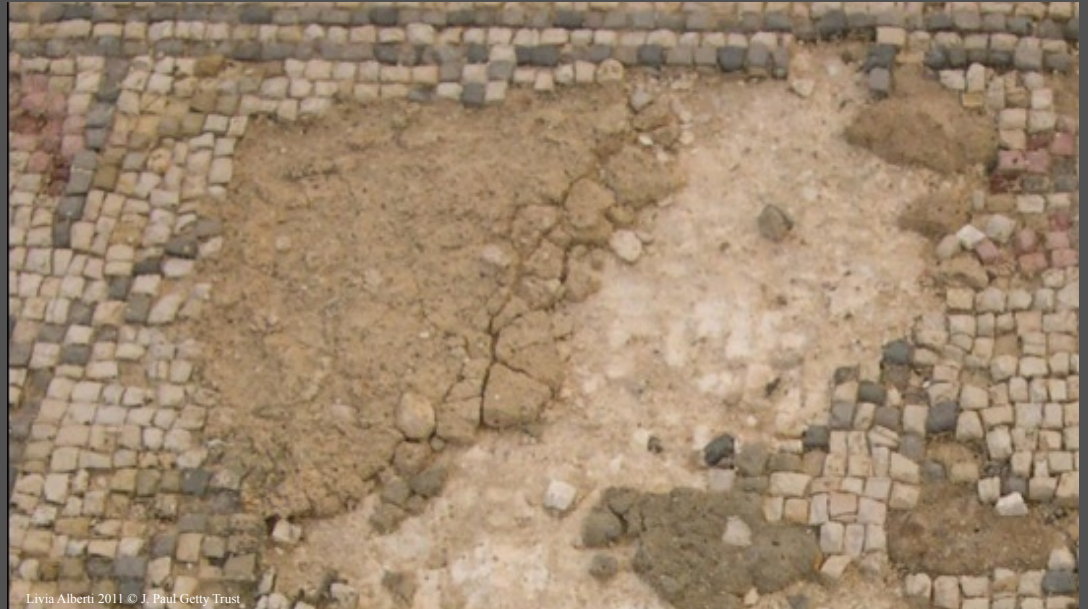
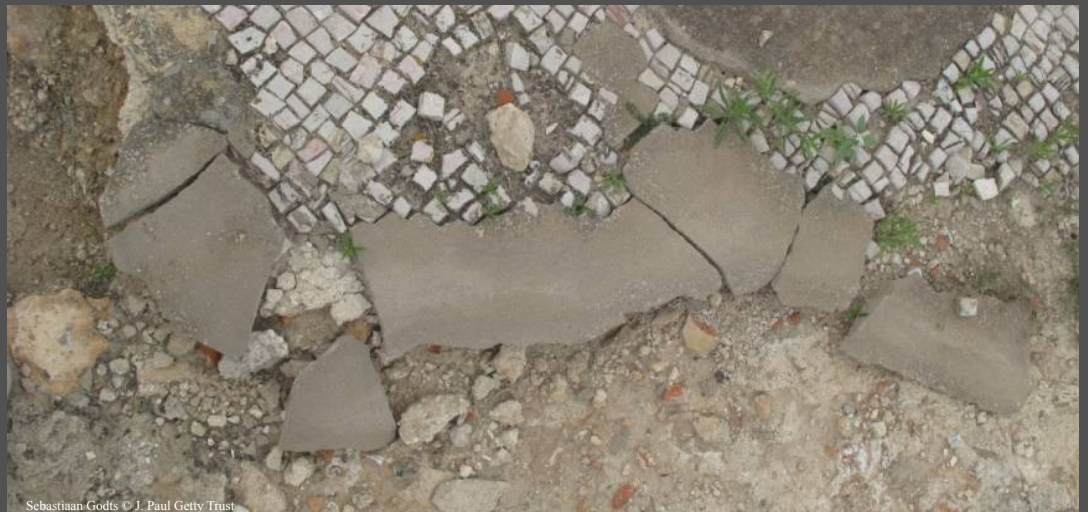
## Deteriorated lacunae fills or edging repairs

Lacuna fill or edging repair between tesserae in poor condition, presenting cracks, erosion or other types of damage.

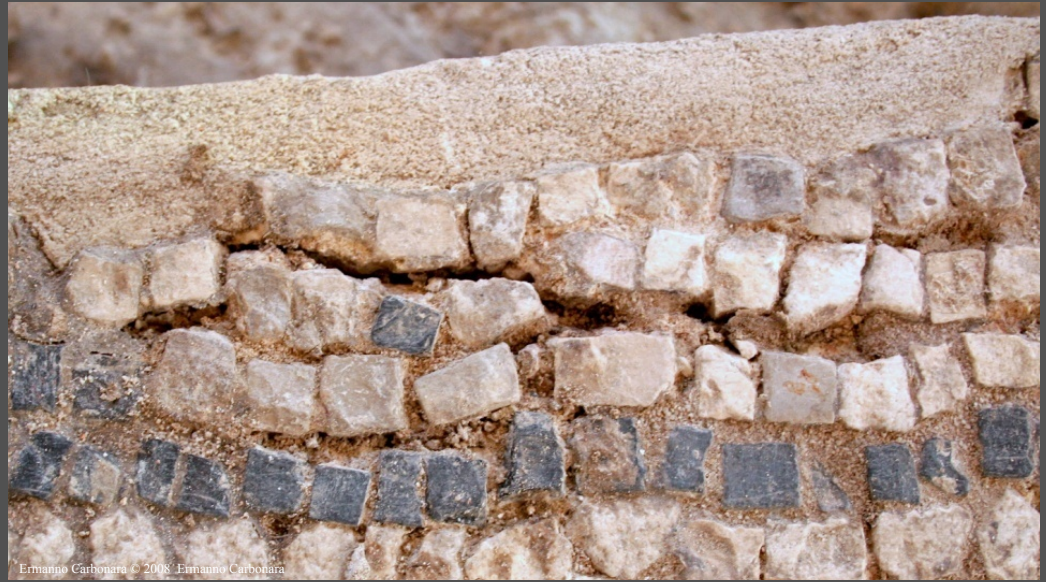
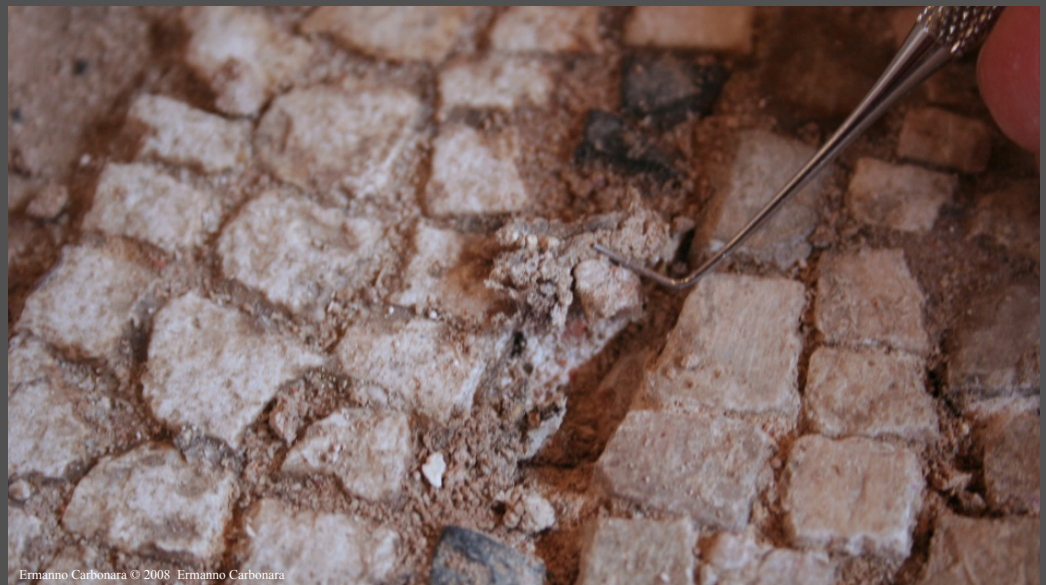
## Deteriorated mortar between tesserae

Mortar fill between tesserae in poor condition, presenting cracks, erosion, or other types of damage.

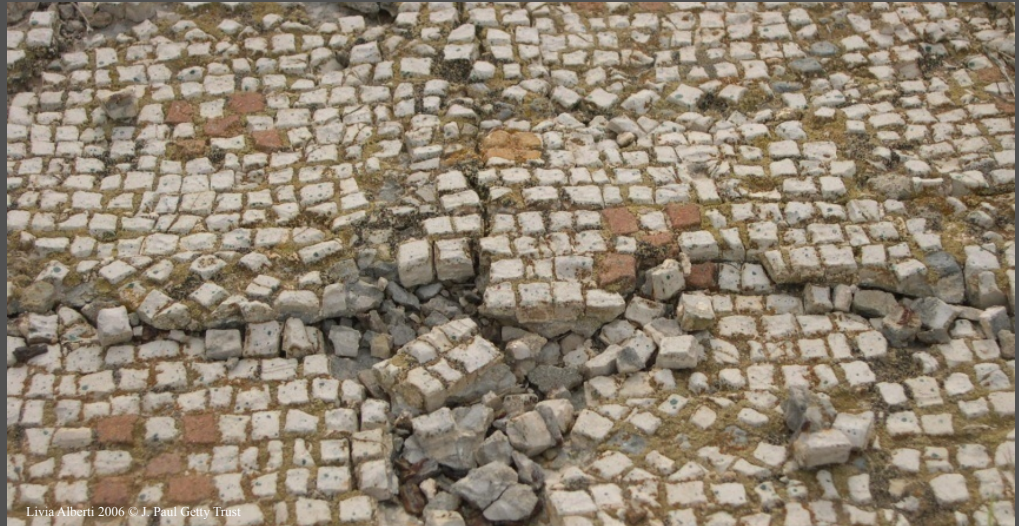
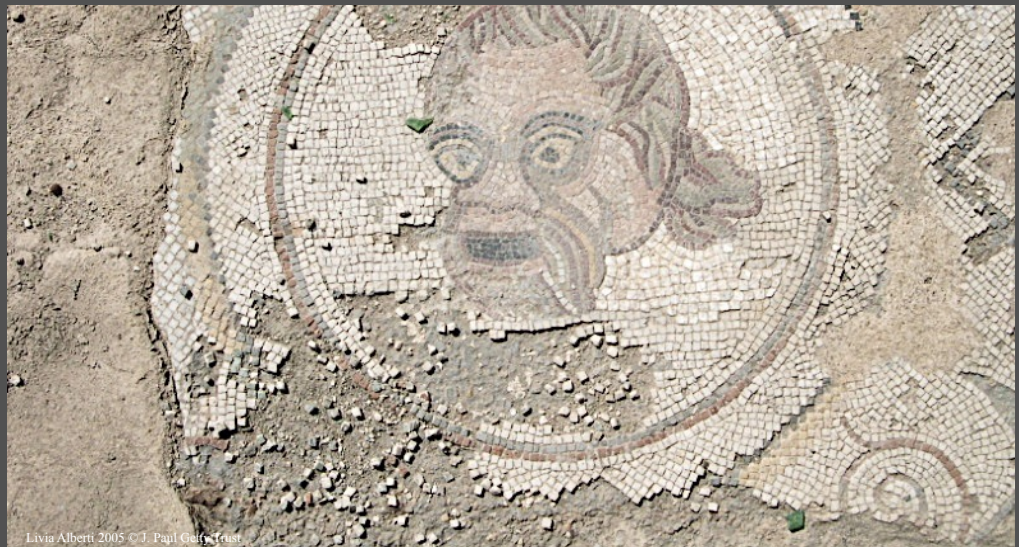
## Re-detached tesserae or detached tesserae of a lifted and re-laid mosaic

Tesserae already reset during a previous intervention that are no longer adhered, or detached tesserae from a section of the mosaic that has been lifted and re-laid on a new support.

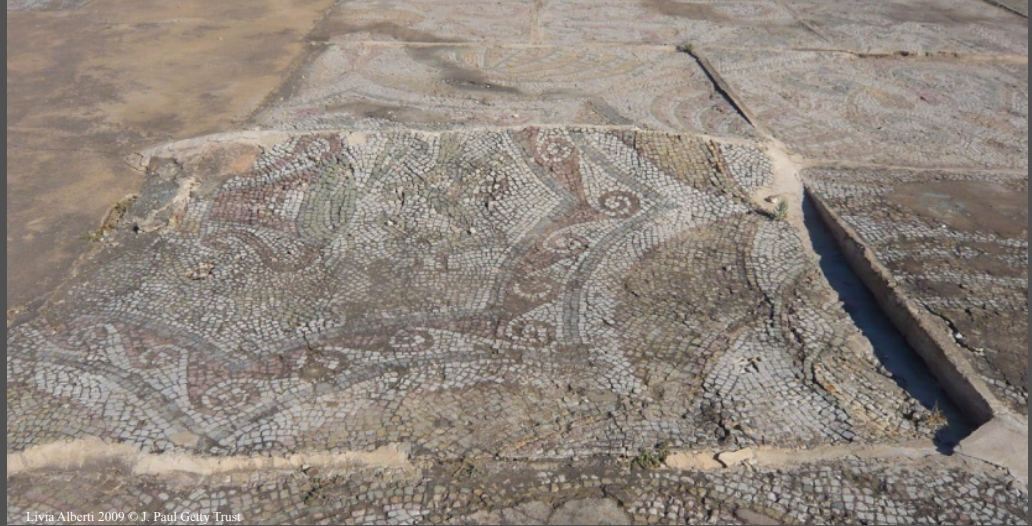
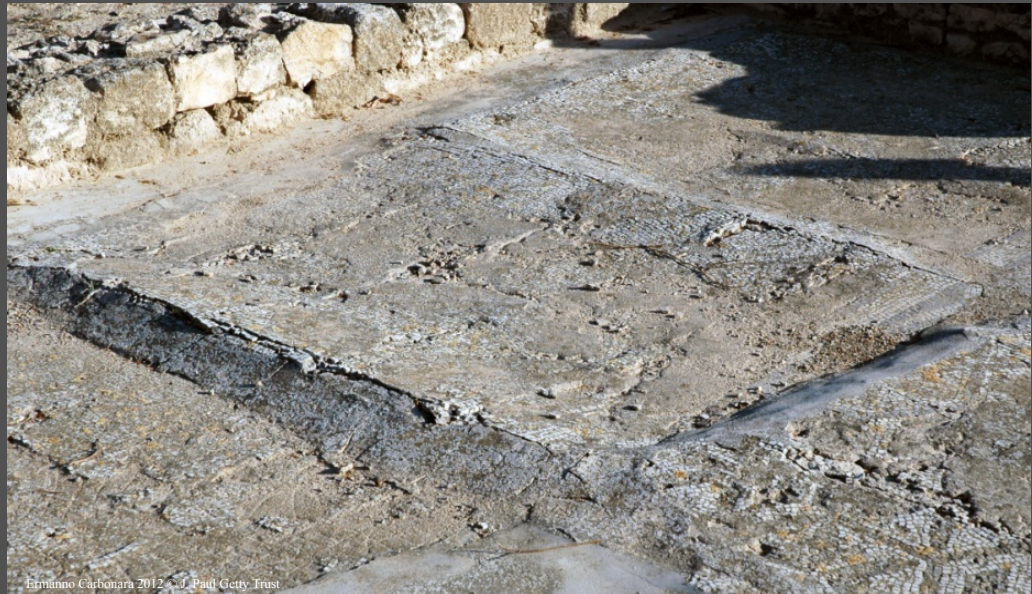
## Deteriorated support panels

**Deformed support panel:** Modern support panel of a re-laid mosaic whose shape has changed, part of its surface being located above or below its original level.

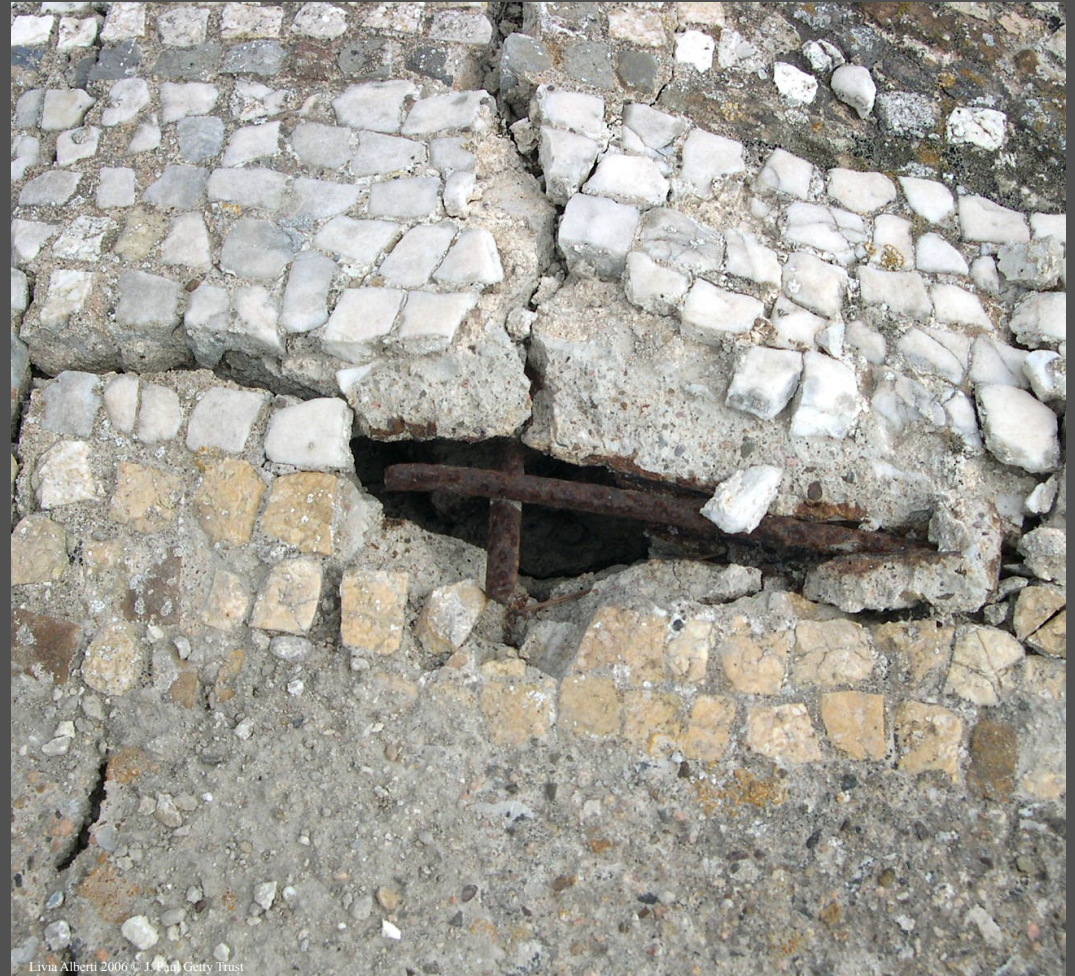
## Deteriorated support metal reinforcements

Structural reinforcement of a support of a re-laid mosaic that is in poor condition.
