## TECHNICIAN TRAINING FOR THE CONSERVATION OF MOSAICS

PART 1  
THE CONSERVATION OF IN SITU MOSAICS

### Deterioration of mosaics

Livia Alberti, Ermanno Carbonara, Thomas Roby

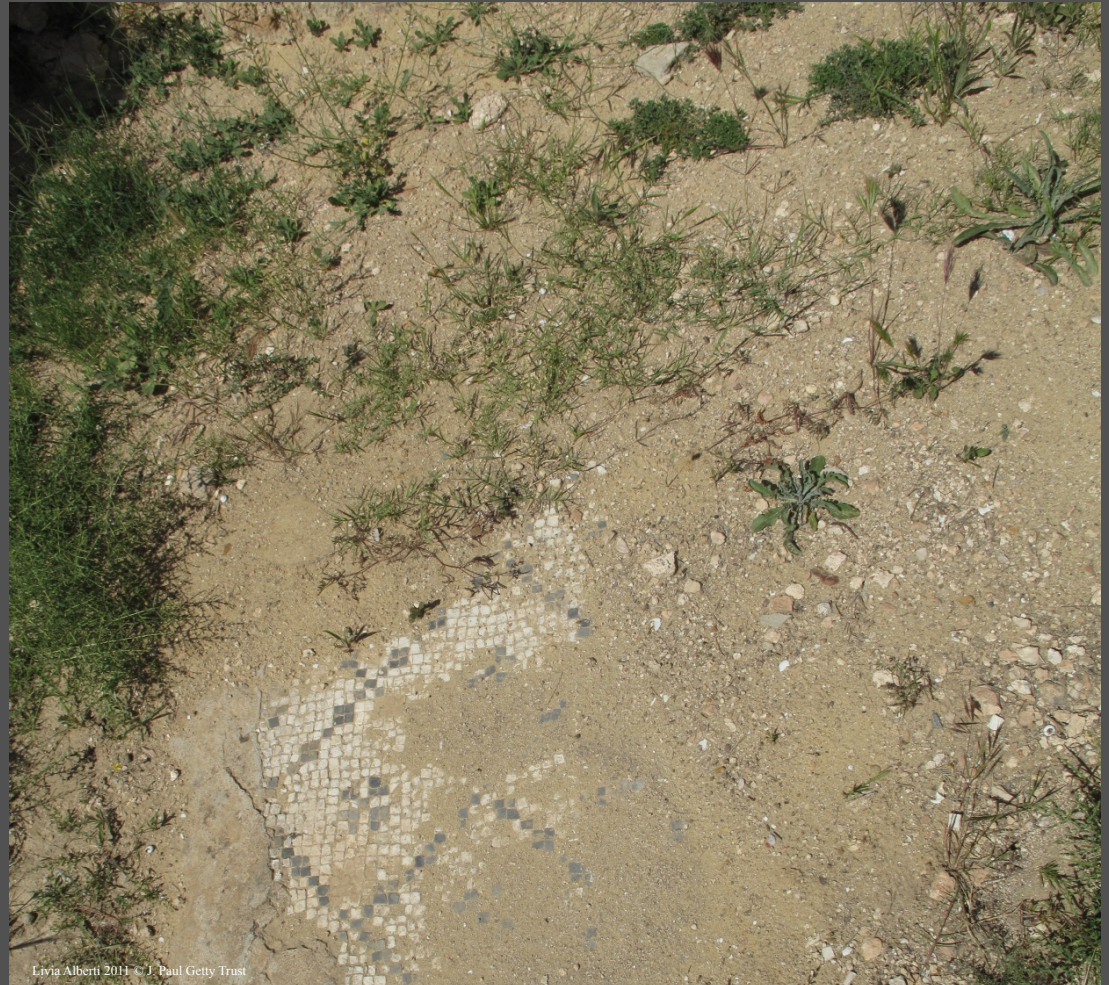
Presence of vegetation and loss of fill materials

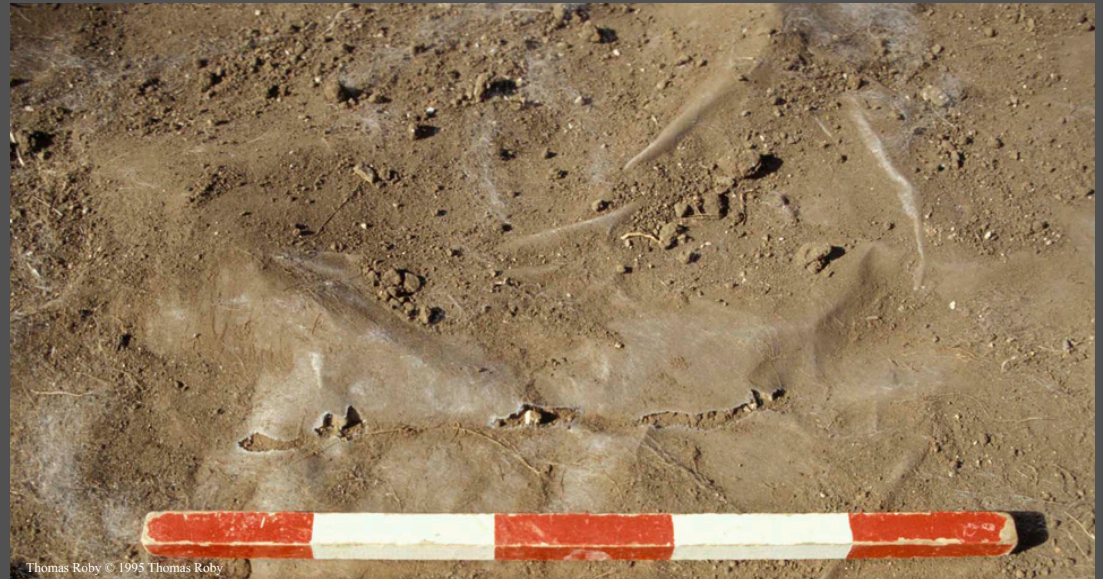
Deteriorated separation membranes

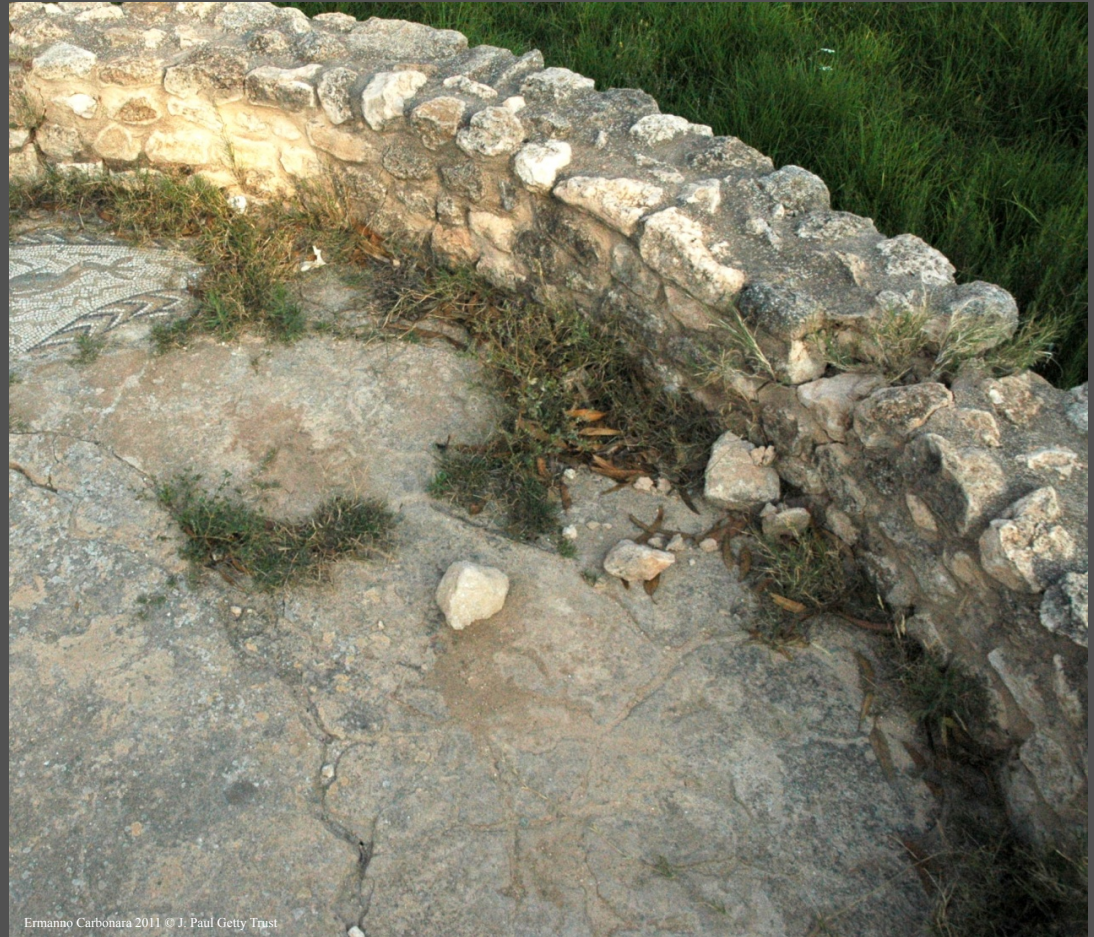
Stabilized walls with new deterioration

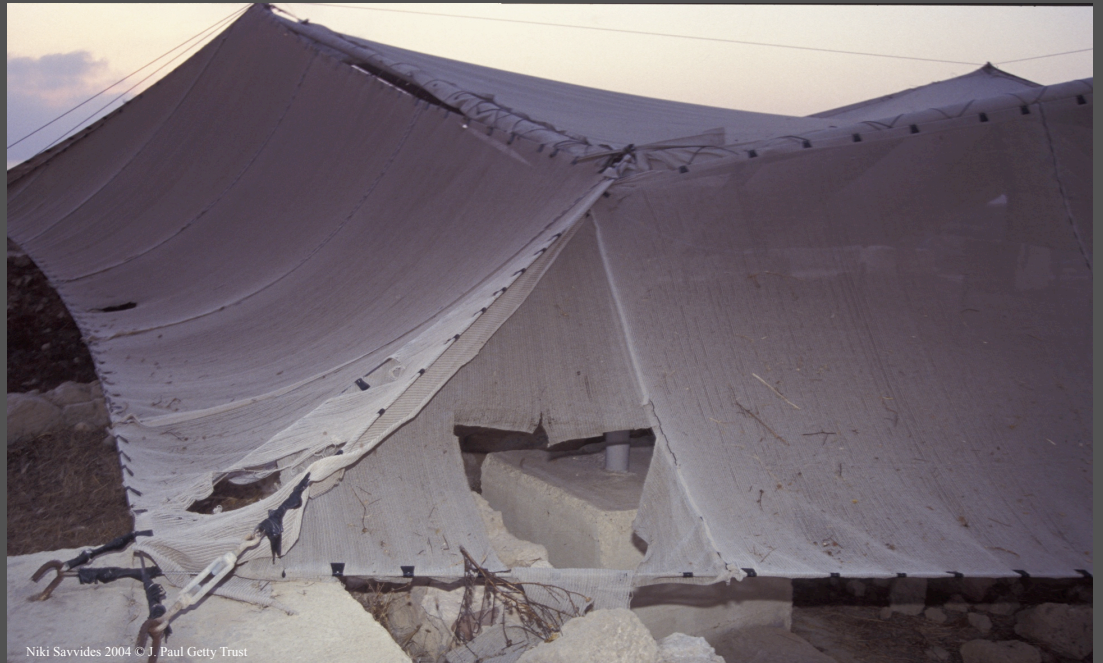
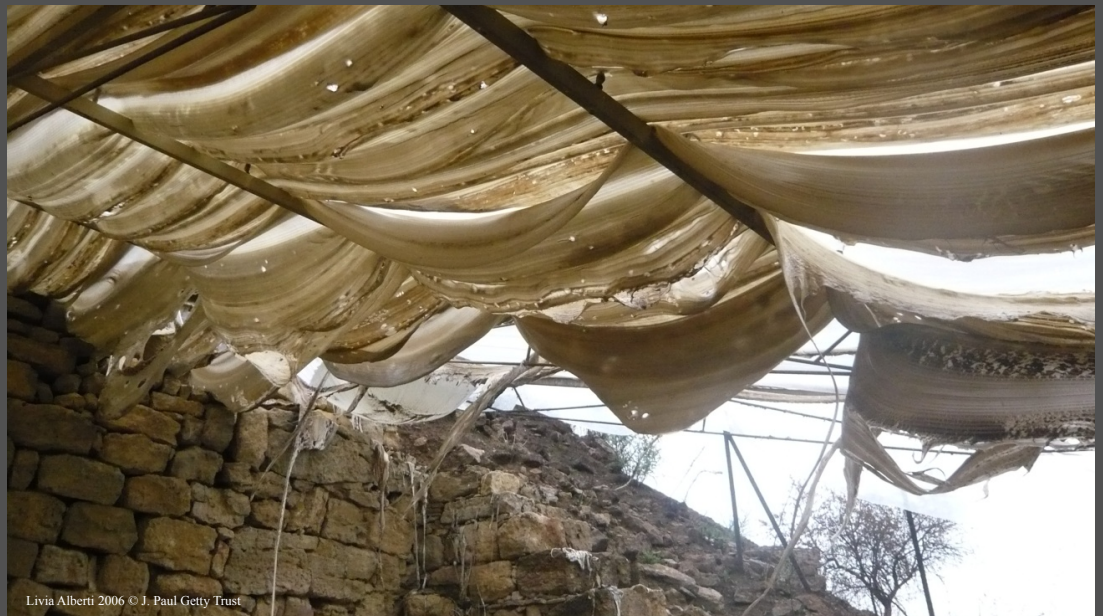
Deteriorated cover or shelter

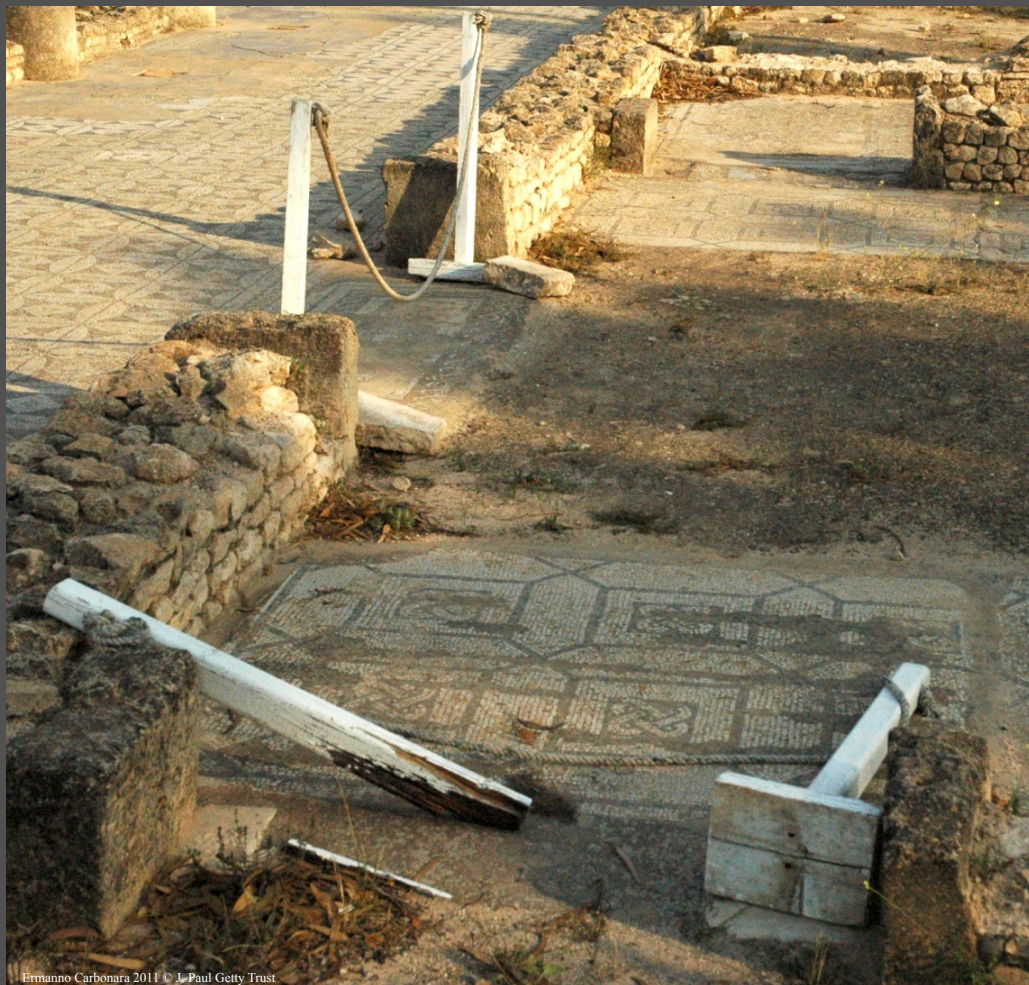
Damaged access barrier

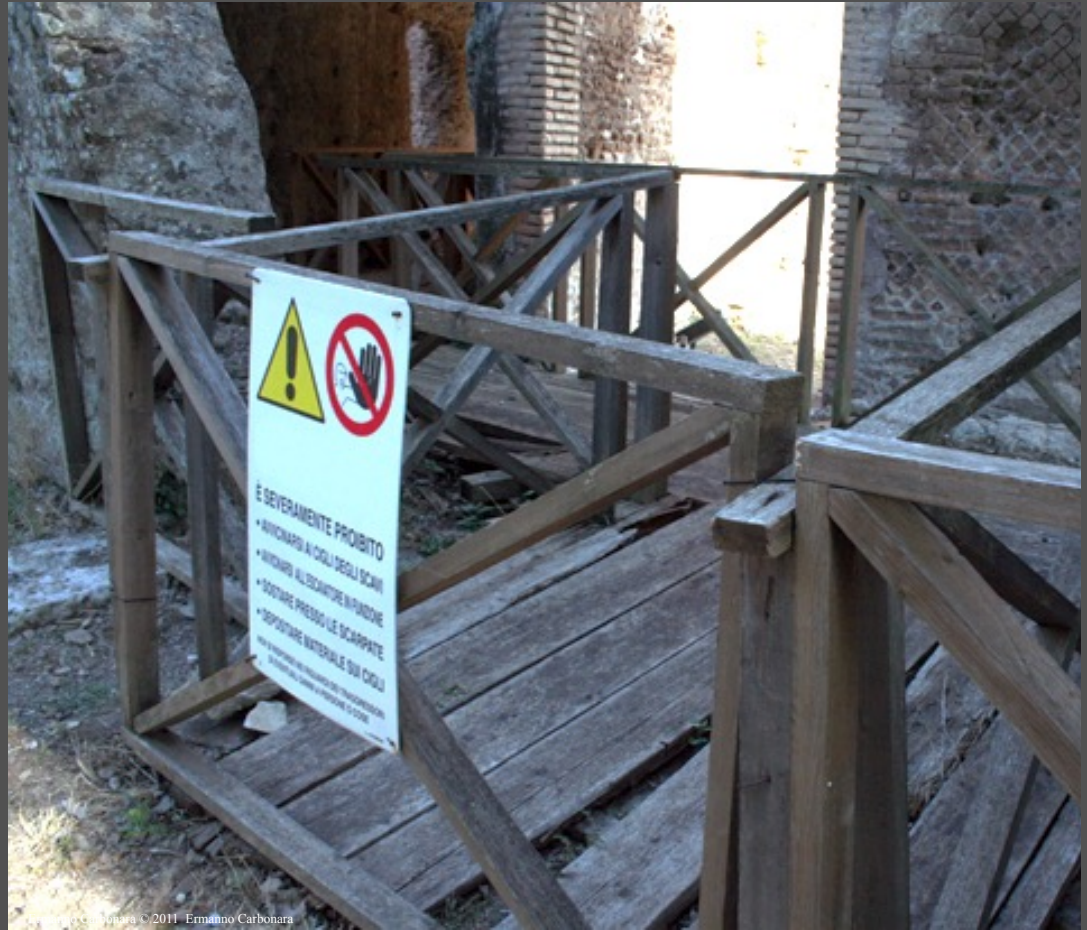
Damaged footbridge
