## TECHNICIAN TRAINING FOR THE CONSERVATION OF MOSAICS

THE CONSERVATION OF ARCHITECTURAL REMAINS AND THEIR DECORATIVE SURFACES

## Structures and decorative surfaces: conditions and their documentation

Livia Alberti, Ermanno Carbonara, Thomas Roby

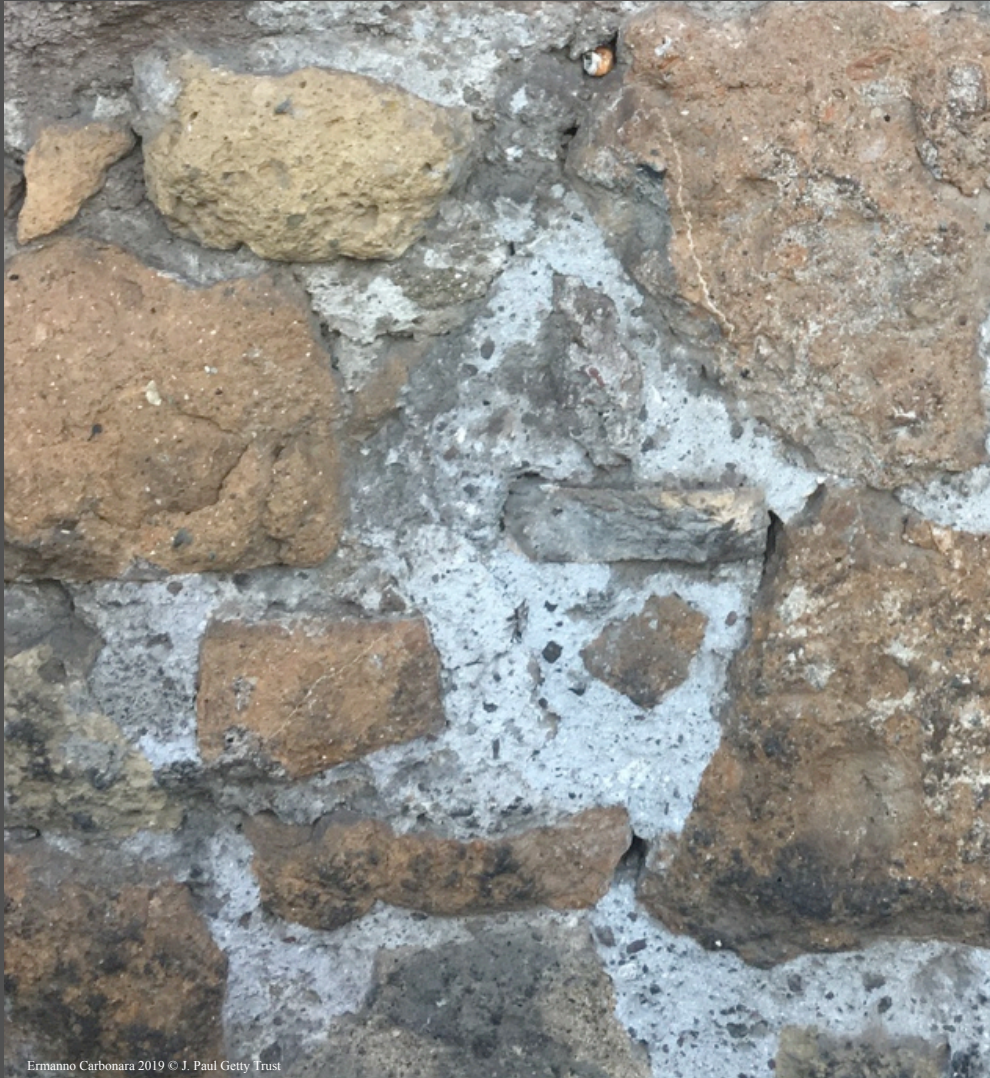
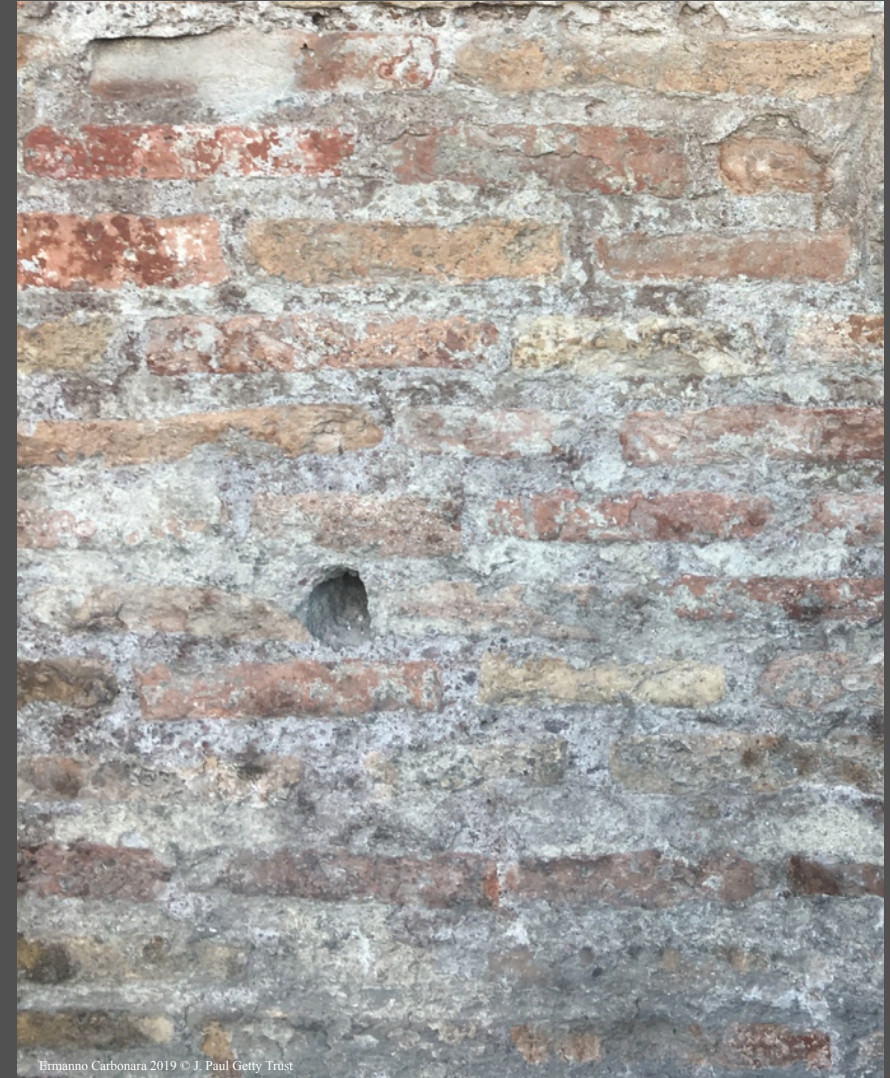
Efflorescences

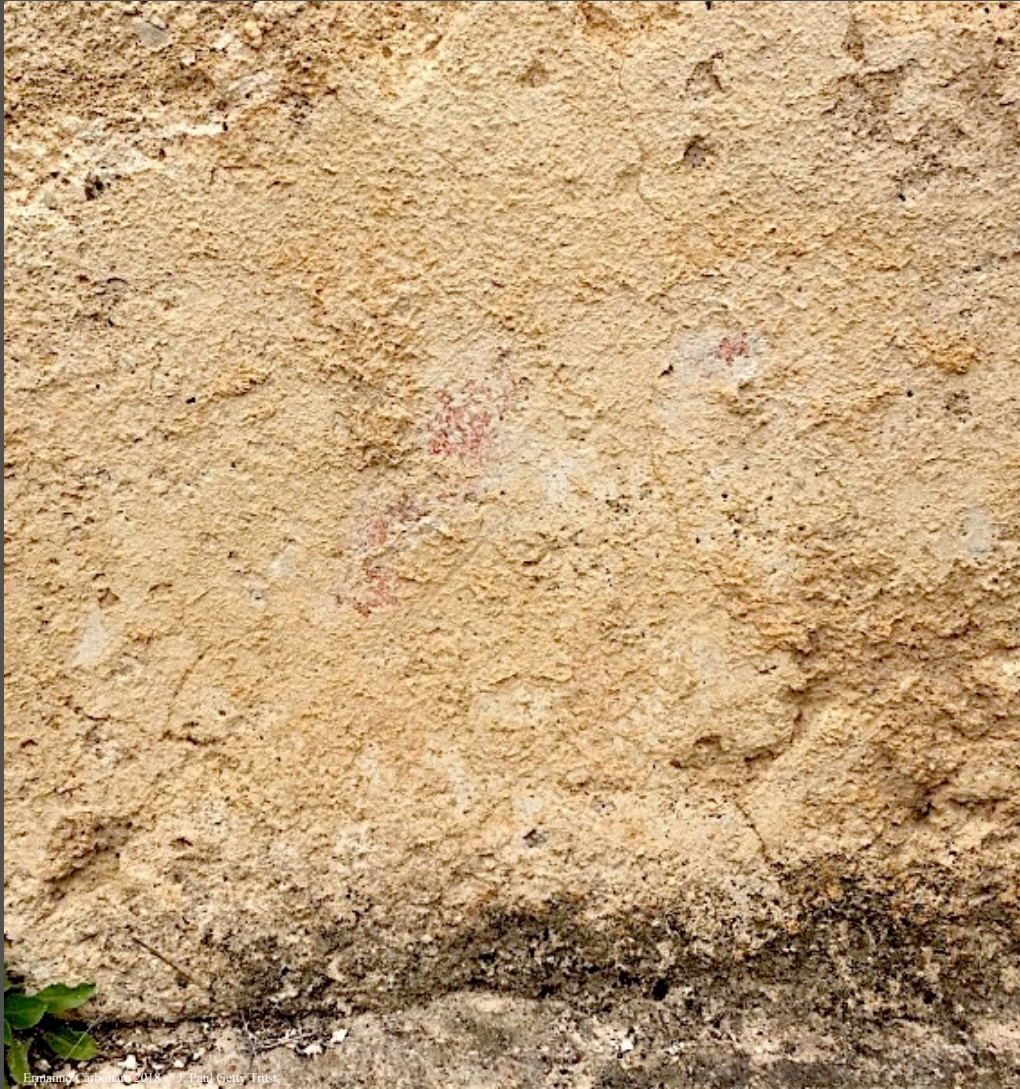
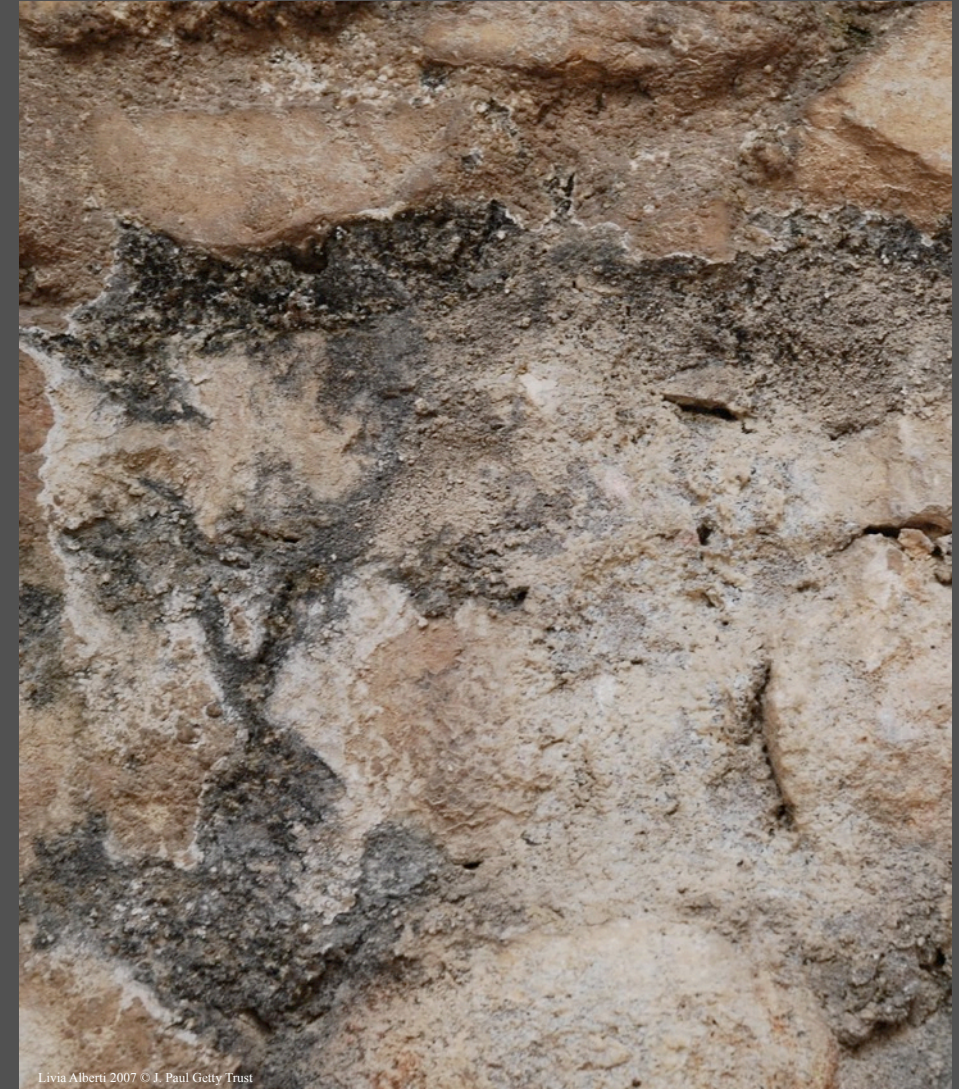
Incrustations

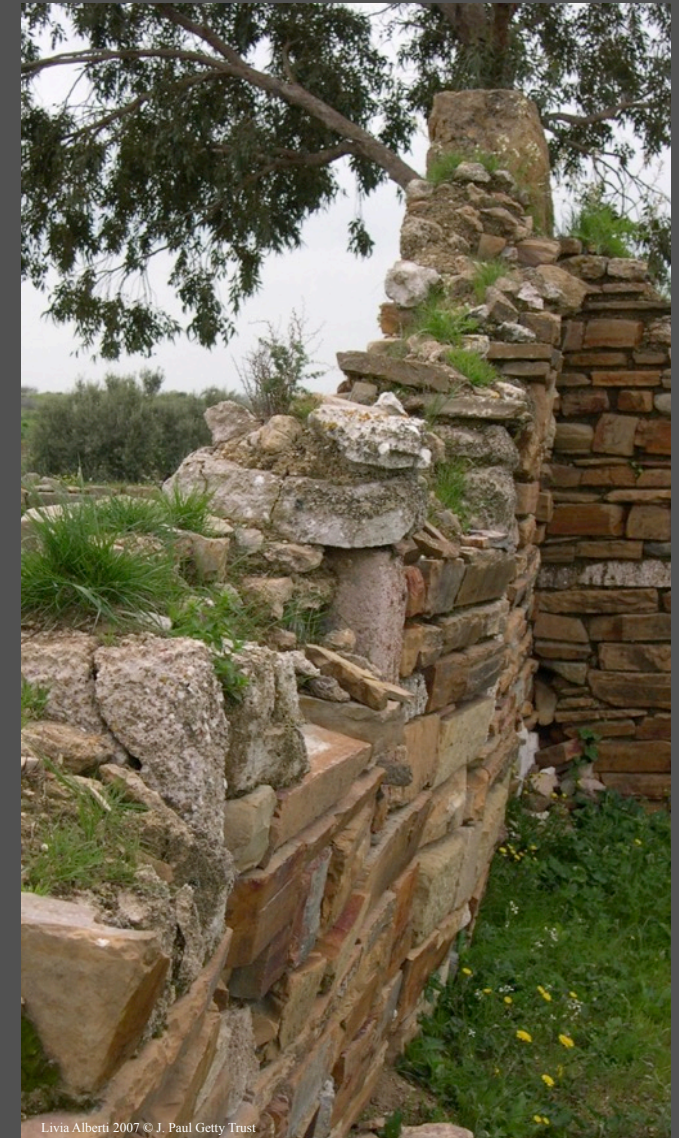
Instability and change of the form of the construction

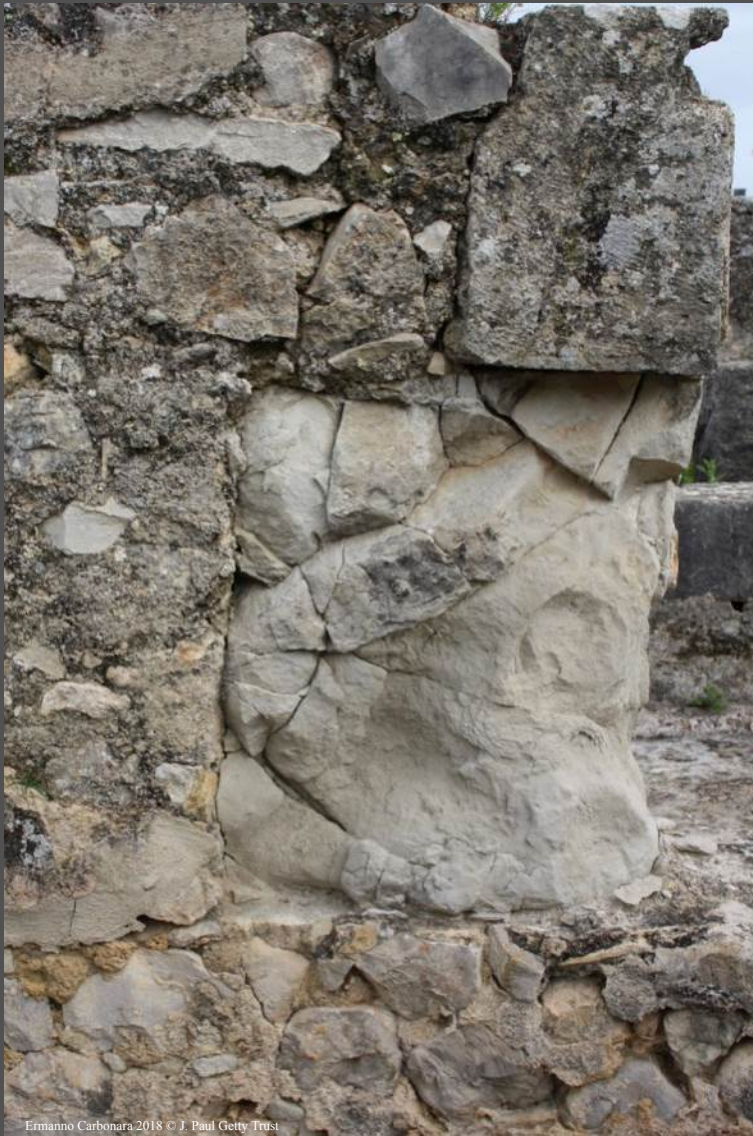
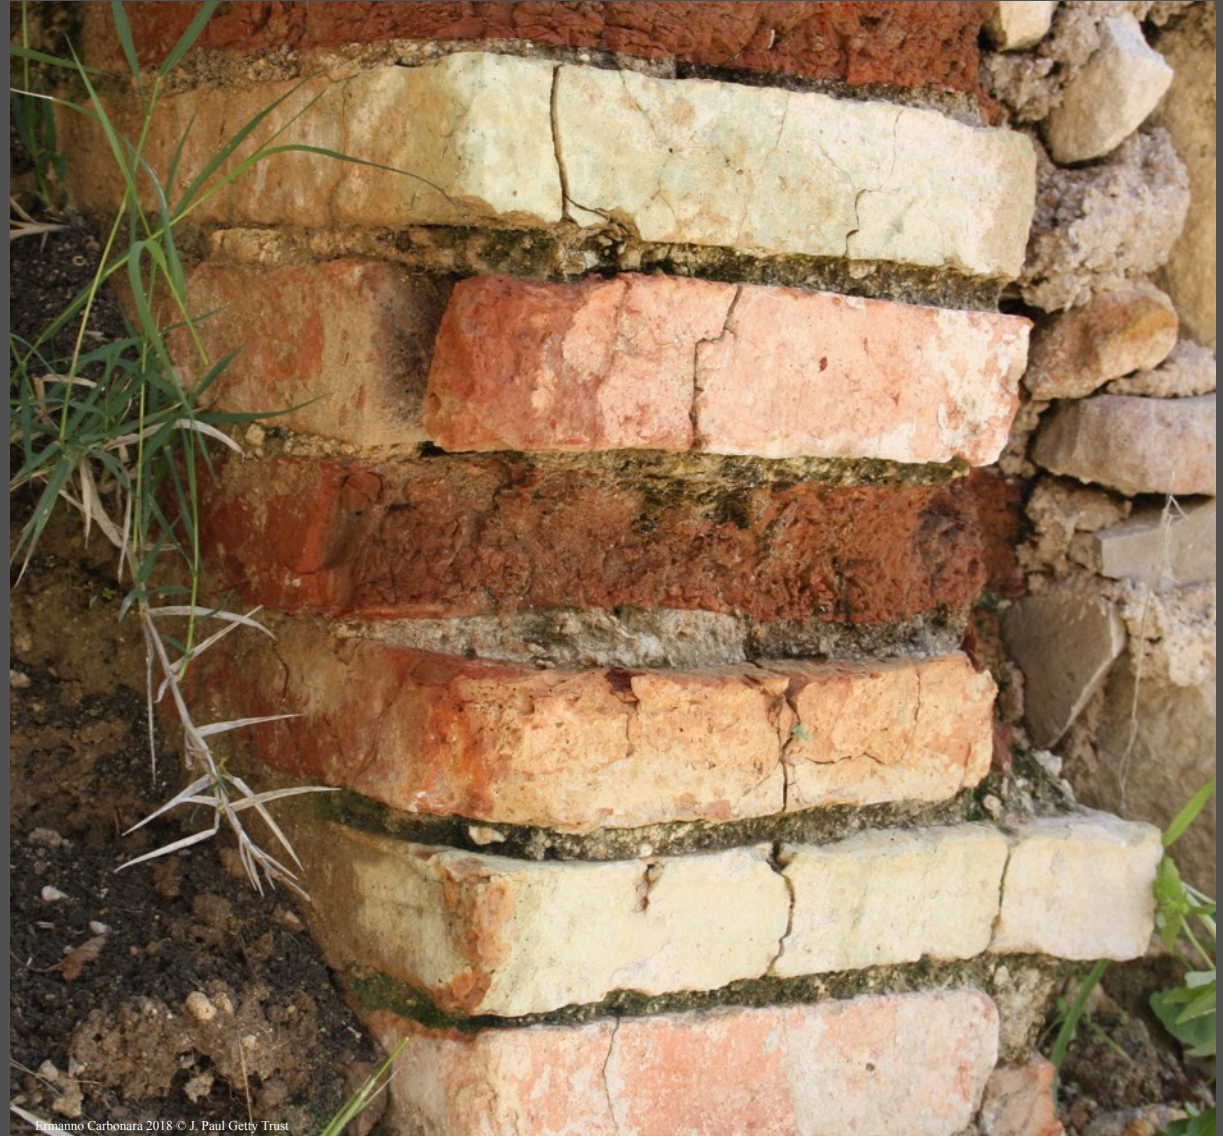
Deteriorated elements of the construction (stones and bricks)

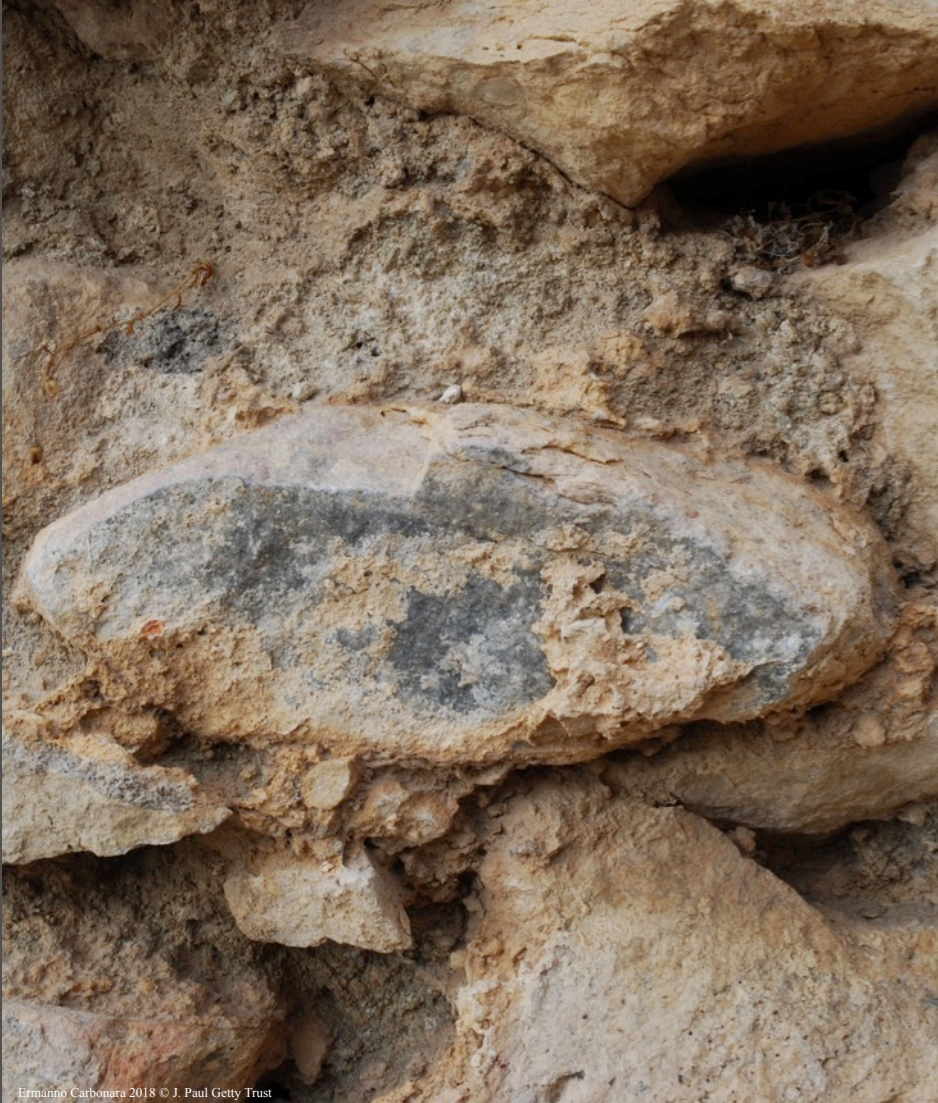
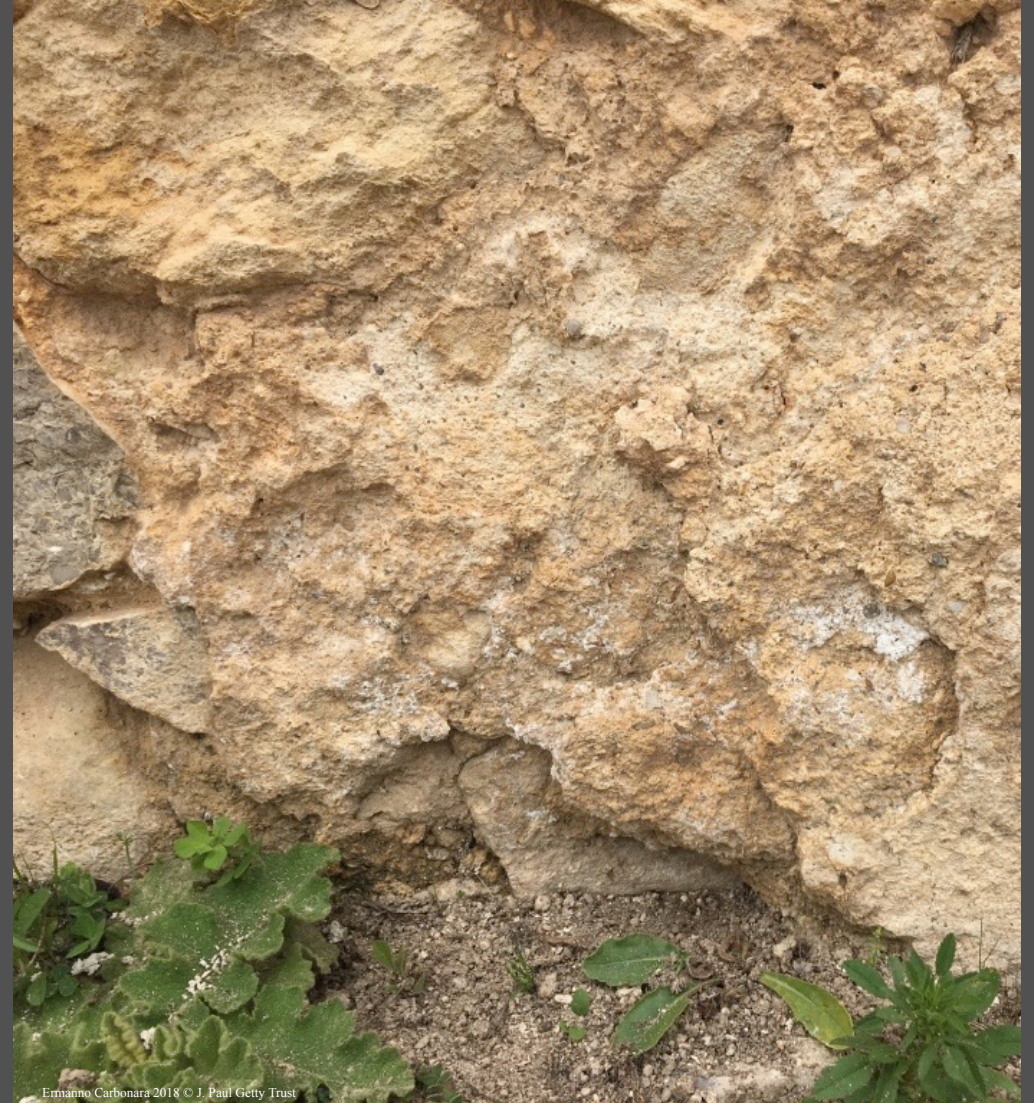
Deteriorated mortar of the construction and decorative surface

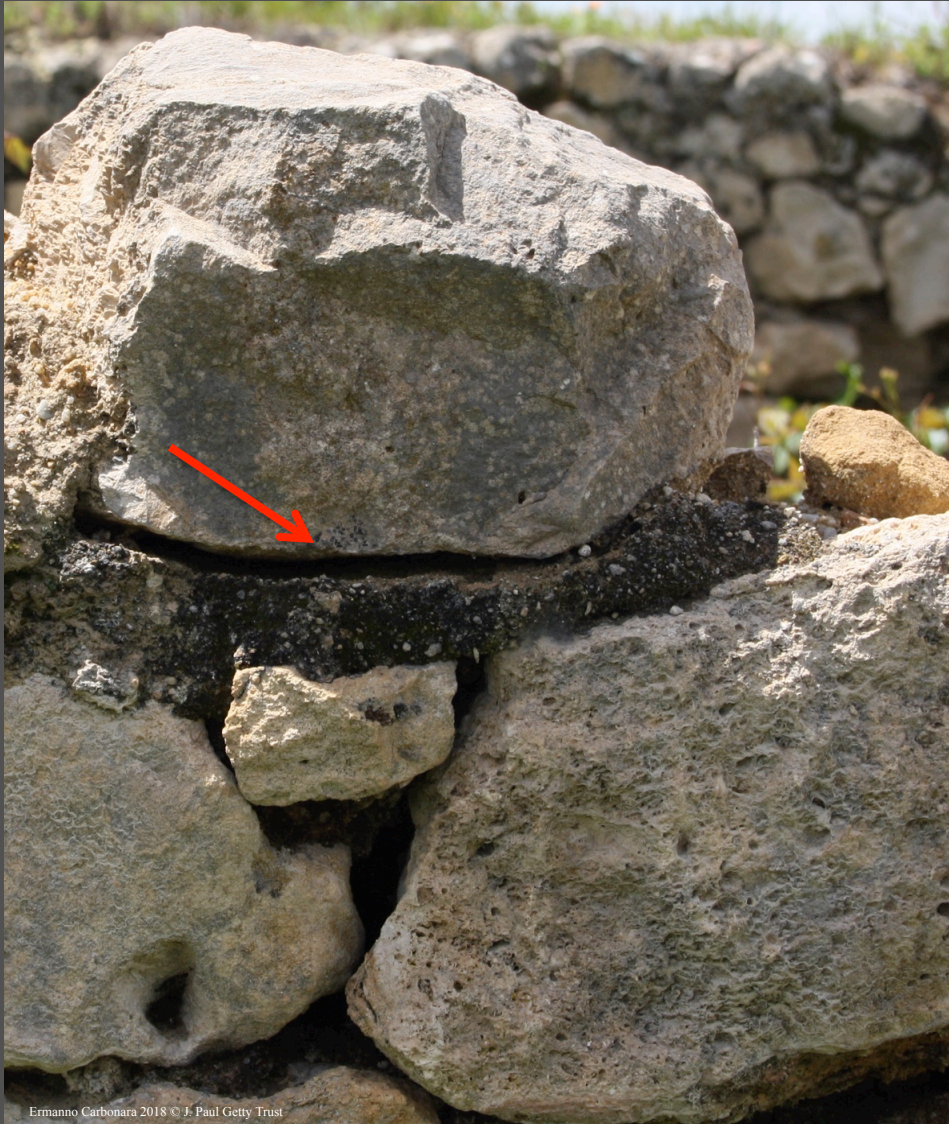
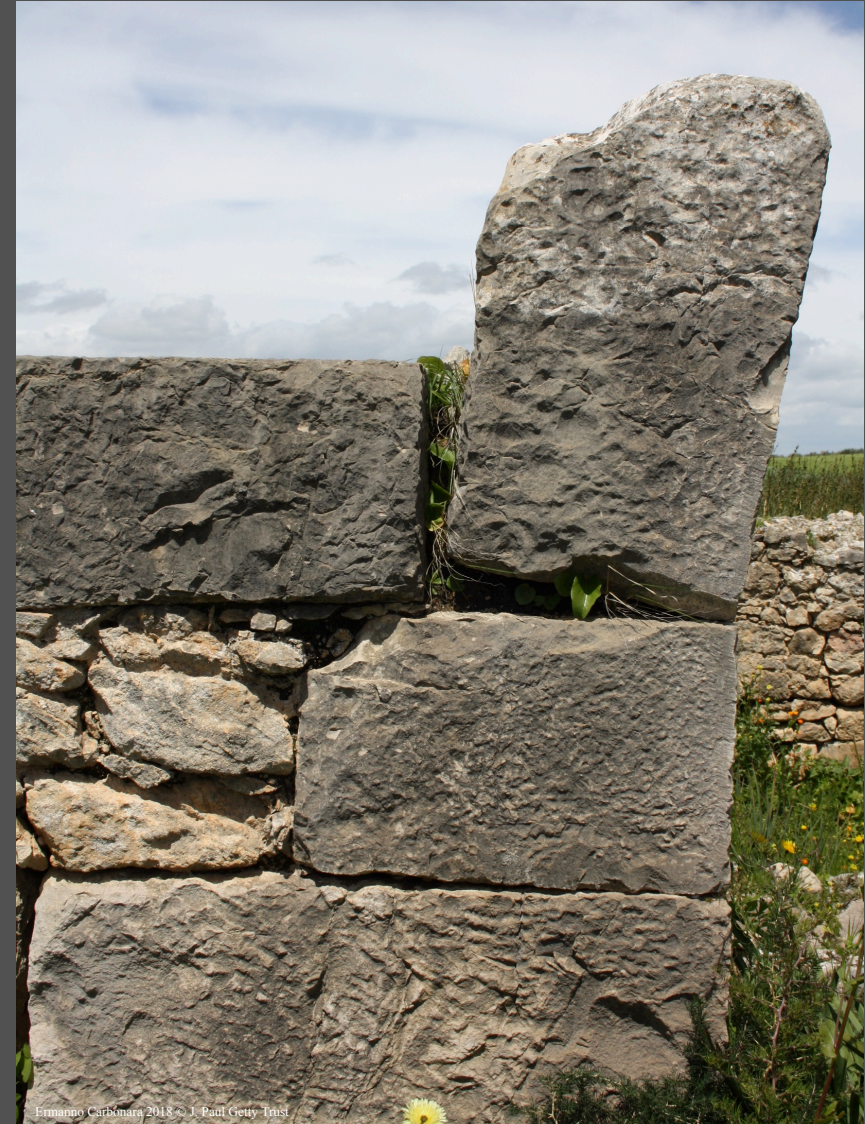
Detachment of elements of the construction

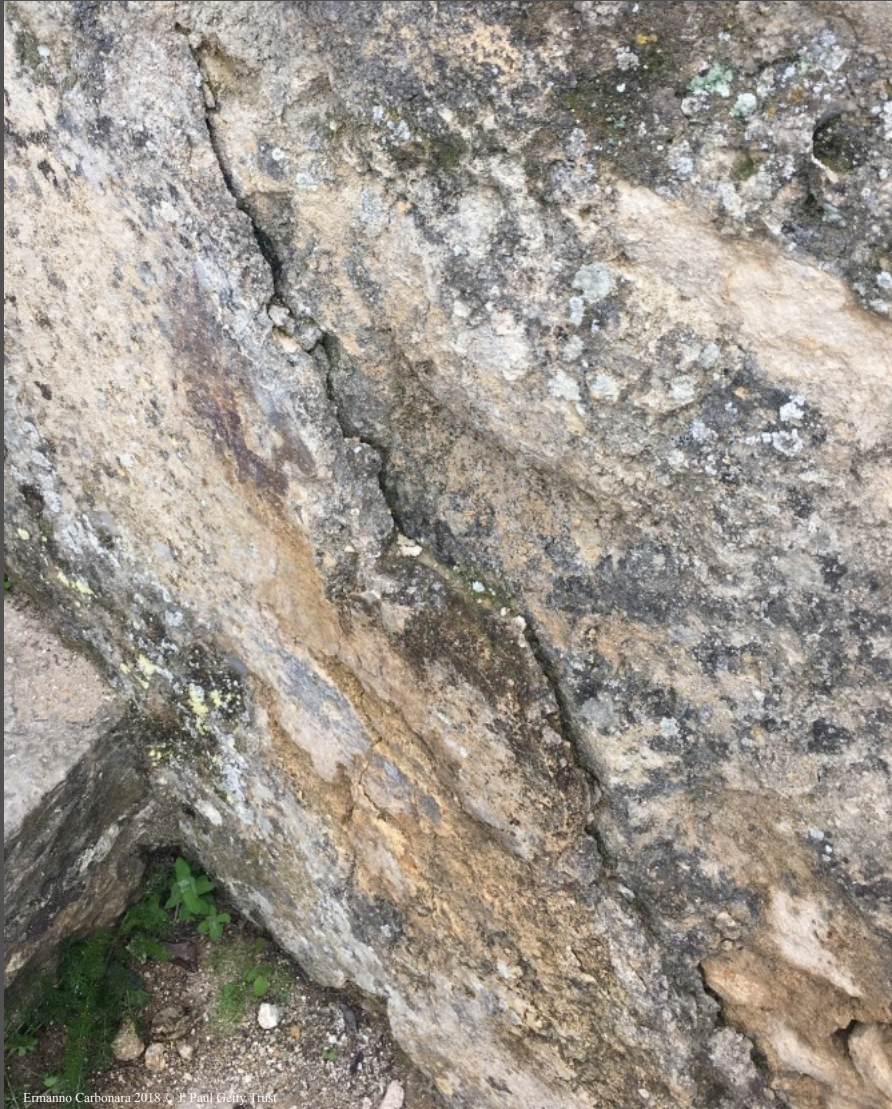
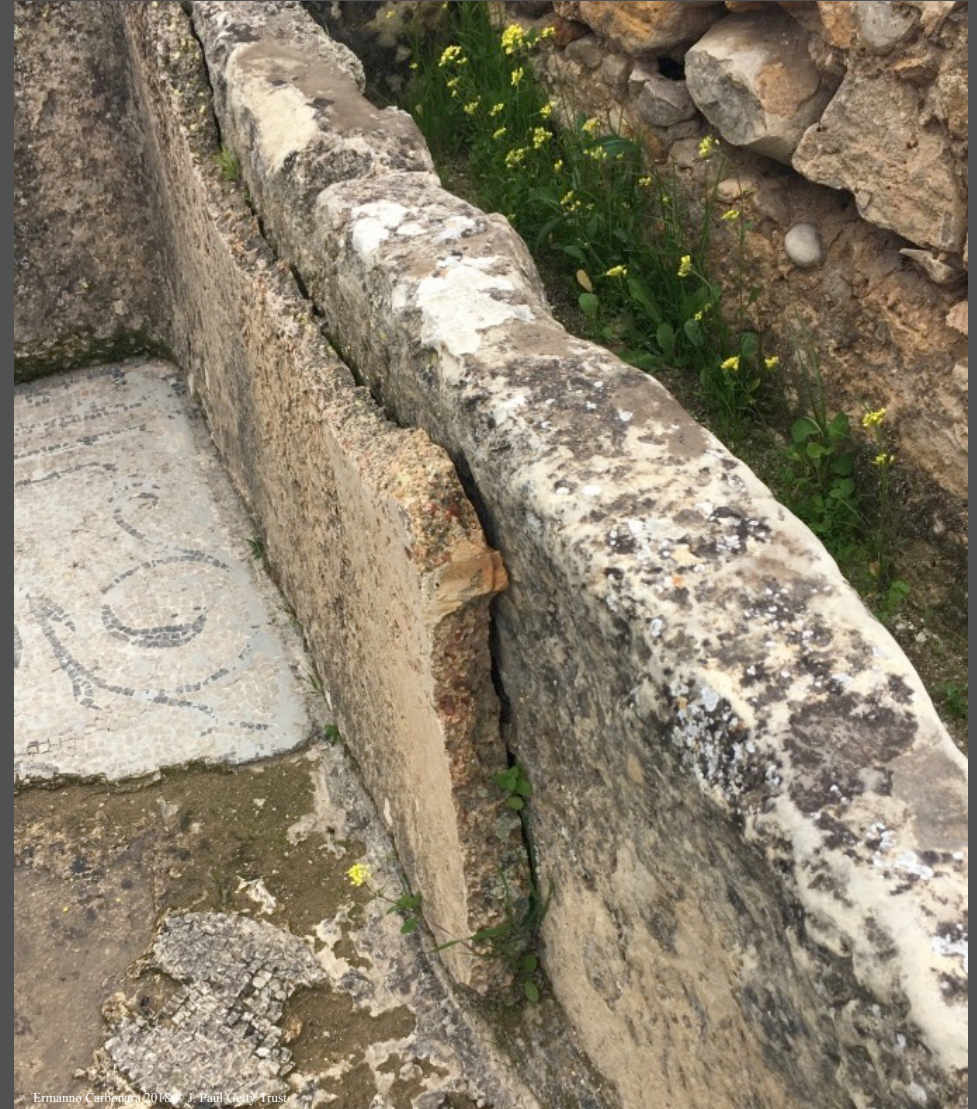
Detachment of the decorative surface

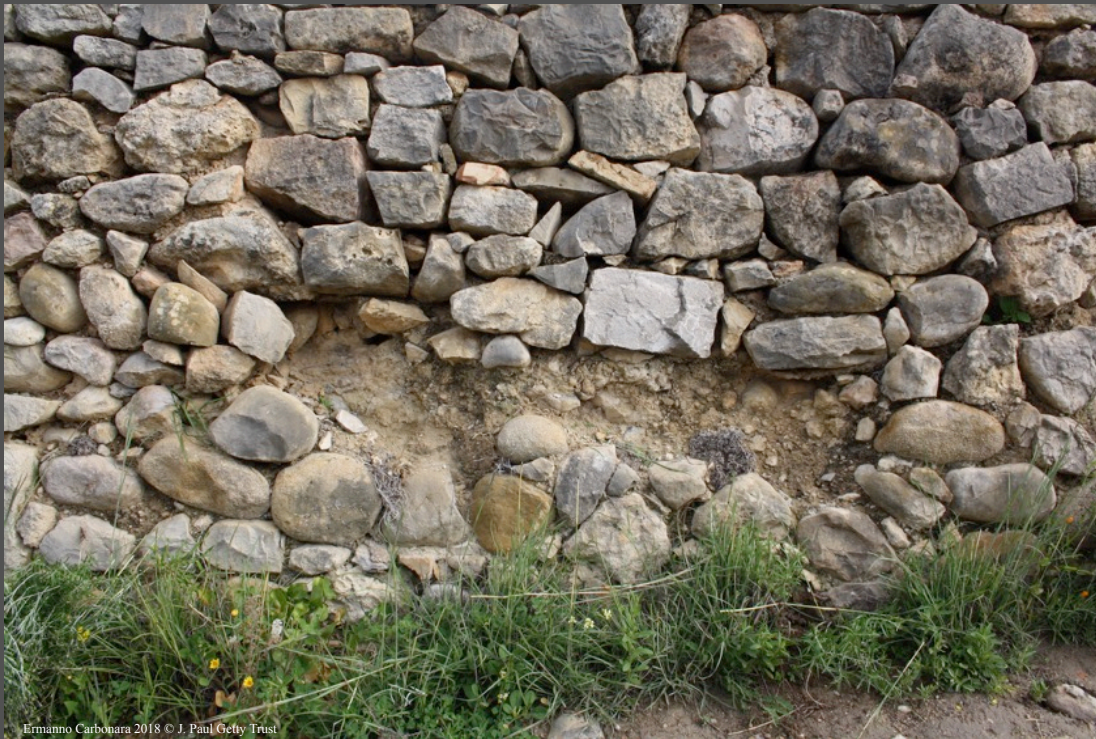
Loss of stones of the construction

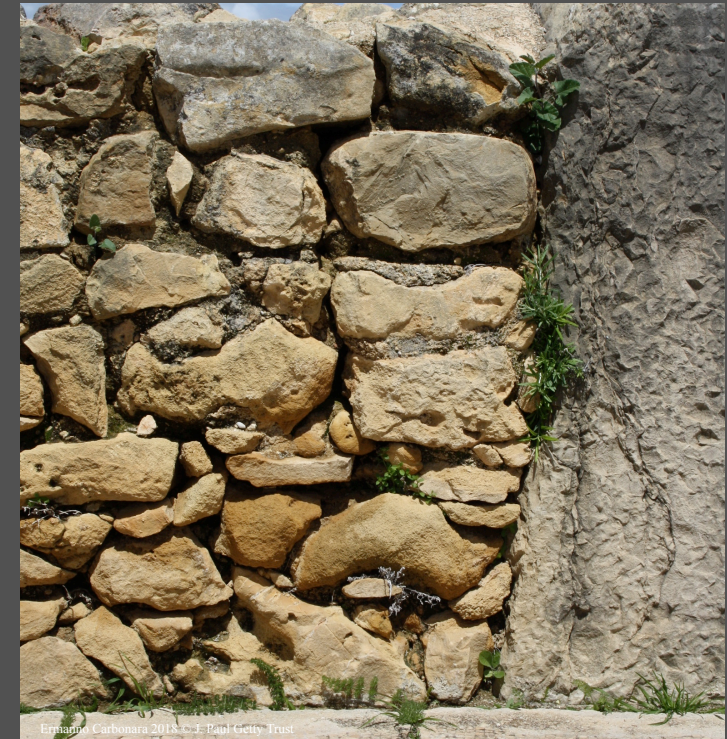
Loss of mortar of the construction

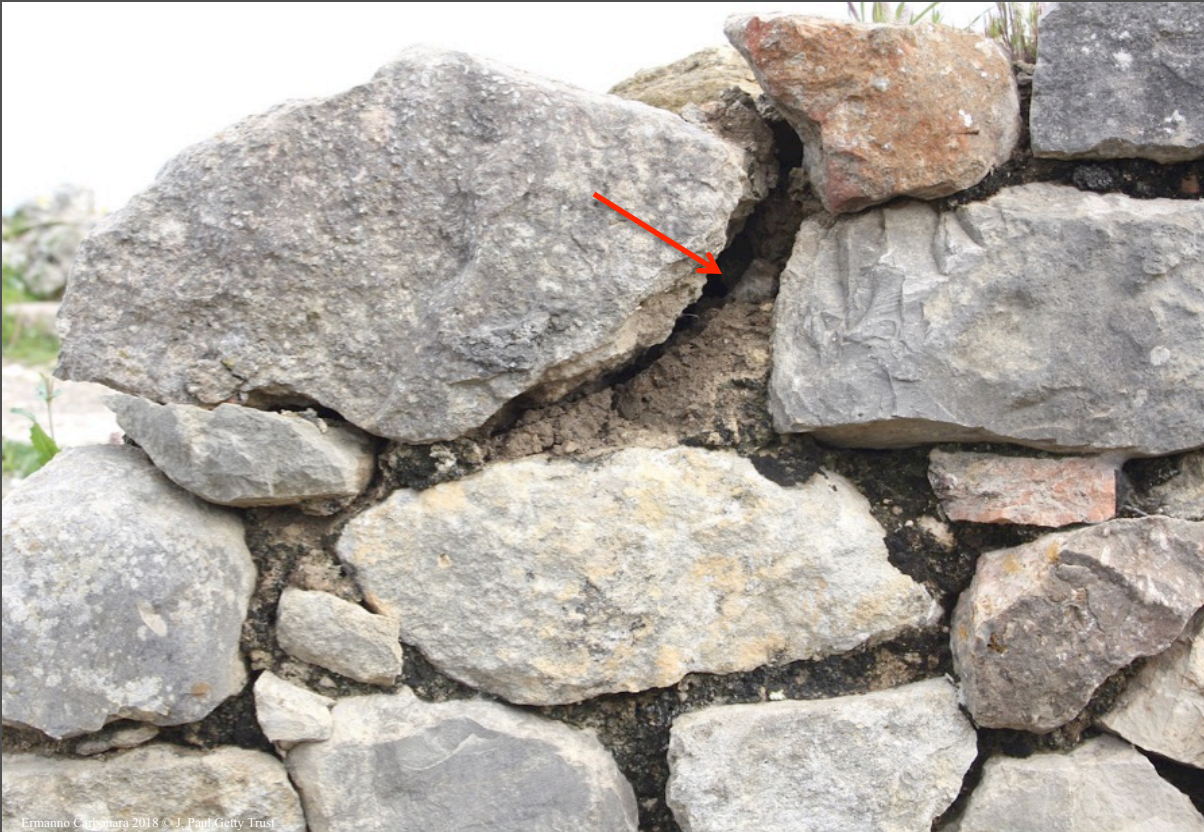
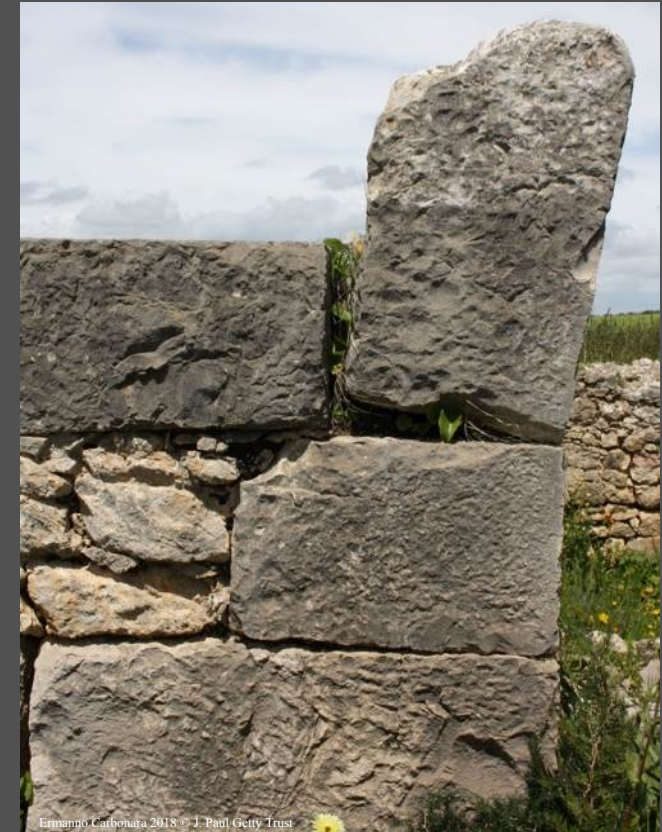
<input type="checkbox"/> Loss of stones or mortar of the structure	<input type="checkbox"/> Cracks
<input checked="" type="checkbox"/> Detached stones of the structure	<input type="checkbox"/> Deformations (bulge or depression)
<input type="checkbox"/> Vegetation	<input type="checkbox"/> Loss of surface decoration of wall or pavement
<input type="checkbox"/> Micro-organisms	<input type="checkbox"/> Detachment of surface decoration of wall or pavement
<input type="checkbox"/> Incrustations	<input type="checkbox"/> Deteriorated surface decoration
<input type="checkbox"/> Efflorescences	<input type="checkbox"/> Deteriorated previous interventions

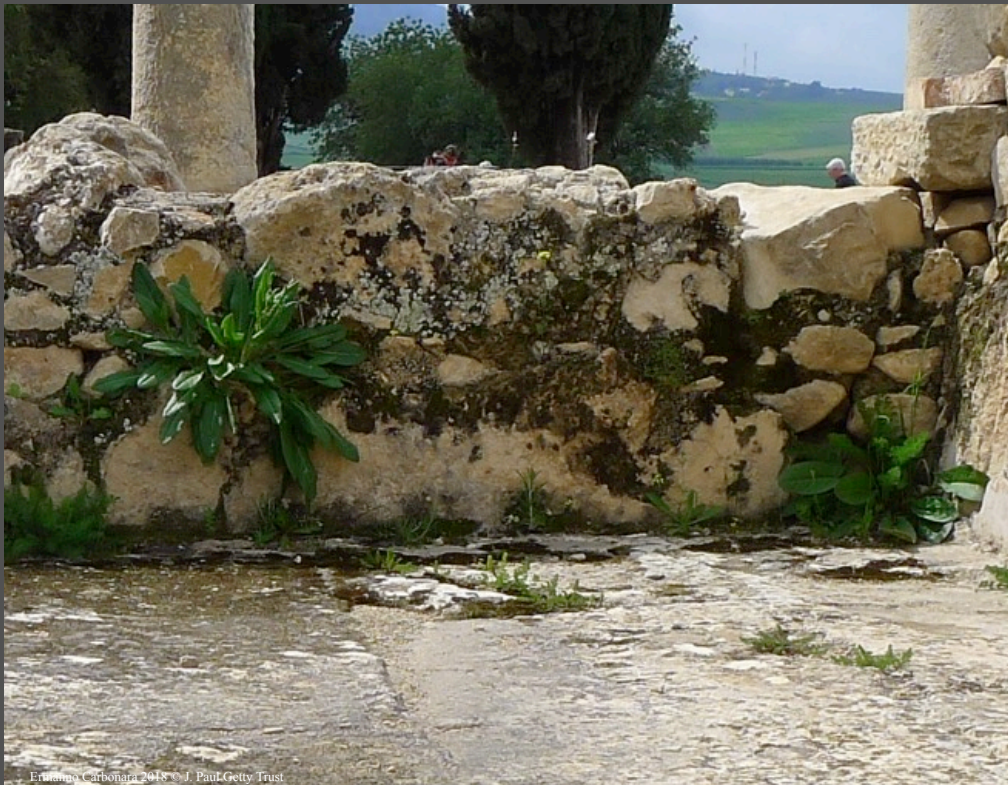
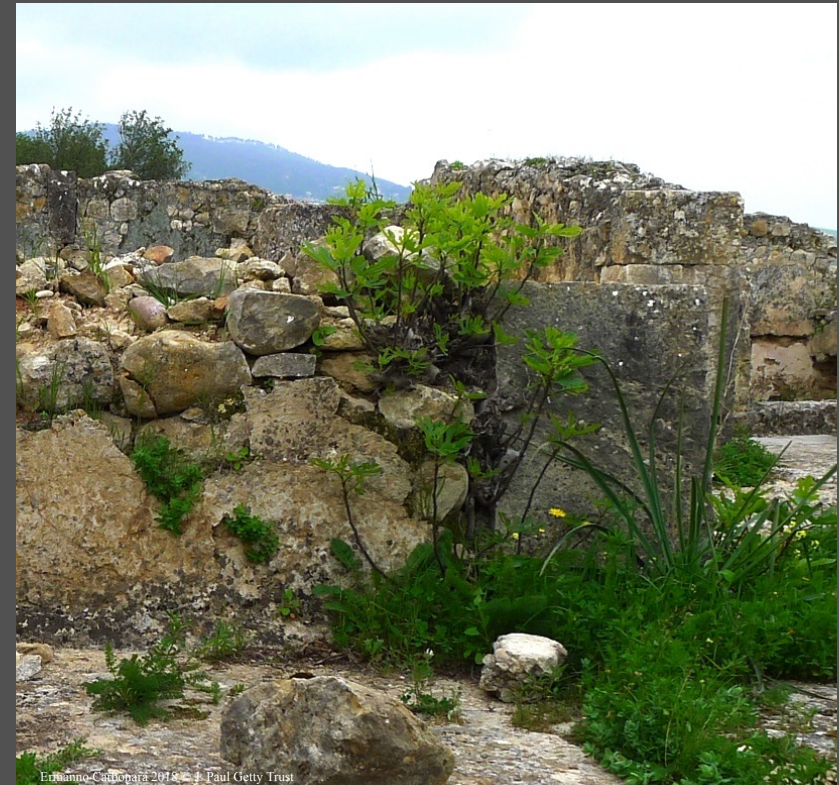
<input type="checkbox"/> Loss of stones or mortar of the structure	<input type="checkbox"/> Cracks
<input type="checkbox"/> Detached stones of the structure	<input type="checkbox"/> Deformations (bulge or depression)
<input checked="" type="checkbox"/> Vegetation	<input type="checkbox"/> Loss of surface decoration of wall or pavement
<input type="checkbox"/> Micro-organisms	<input type="checkbox"/> Detachment of surface decoration of wall or pavement
<input type="checkbox"/> Incrustations	<input type="checkbox"/> Deteriorated surface decoration
<input type="checkbox"/> Efflorescences	<input type="checkbox"/> Deteriorated previous interventions

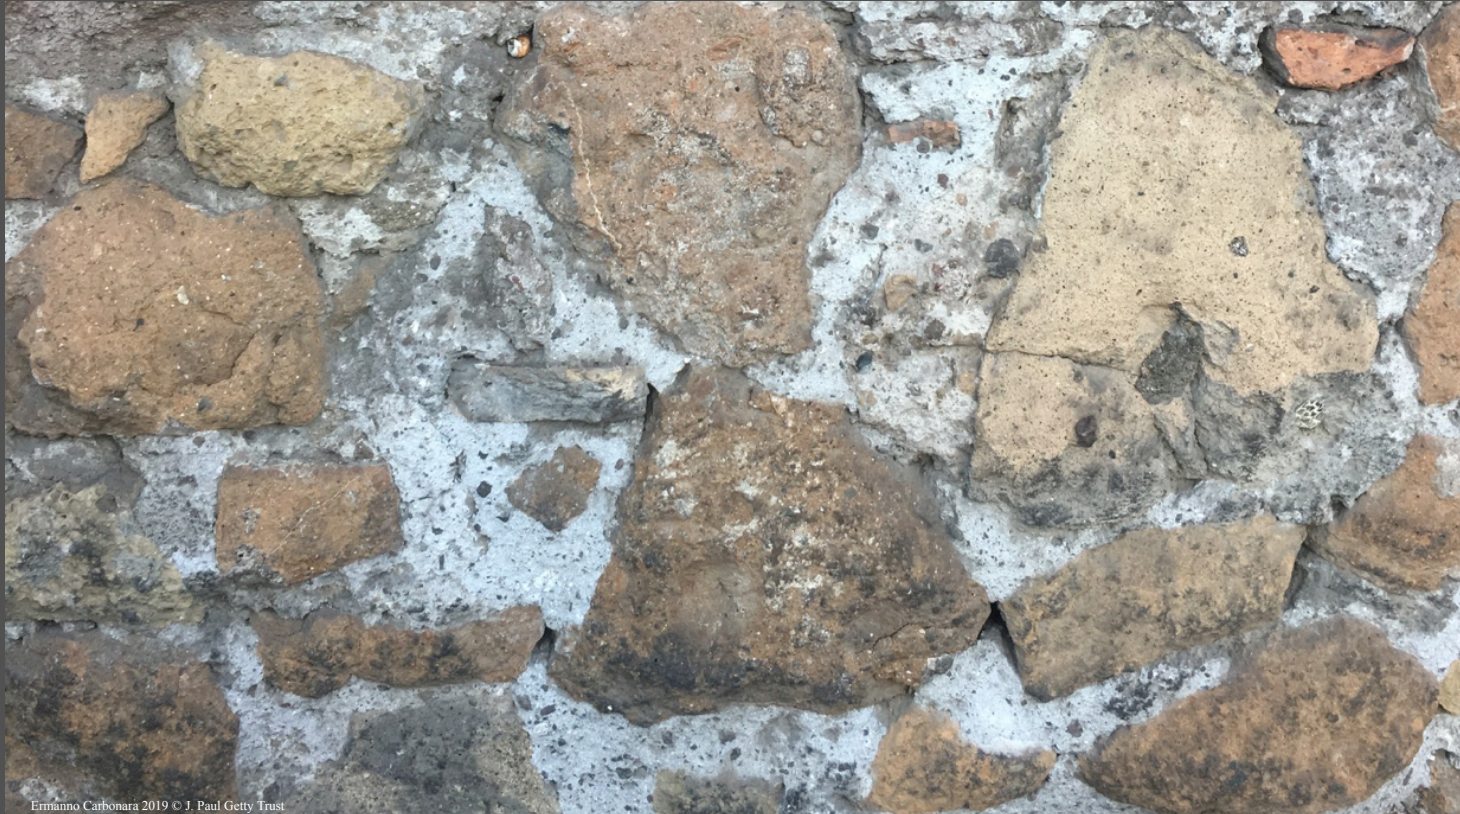
<input type="checkbox"/> Loss of stones or mortar of the structure	<input type="checkbox"/> Cracks
<input type="checkbox"/> Detached stones of the structure	<input type="checkbox"/> Deformations (bulge or depression)
<input type="checkbox"/> Vegetation	<input type="checkbox"/> Loss of surface decoration of wall or pavement
<input type="checkbox"/> Micro-organisms	<input type="checkbox"/> Detachment of surface decoration of wall or pavement
<input type="checkbox"/> Incrustations	<input type="checkbox"/> Deteriorated surface decoration
<input checked="" type="checkbox"/> Efflorescences	<input type="checkbox"/> Deteriorated previous interventions

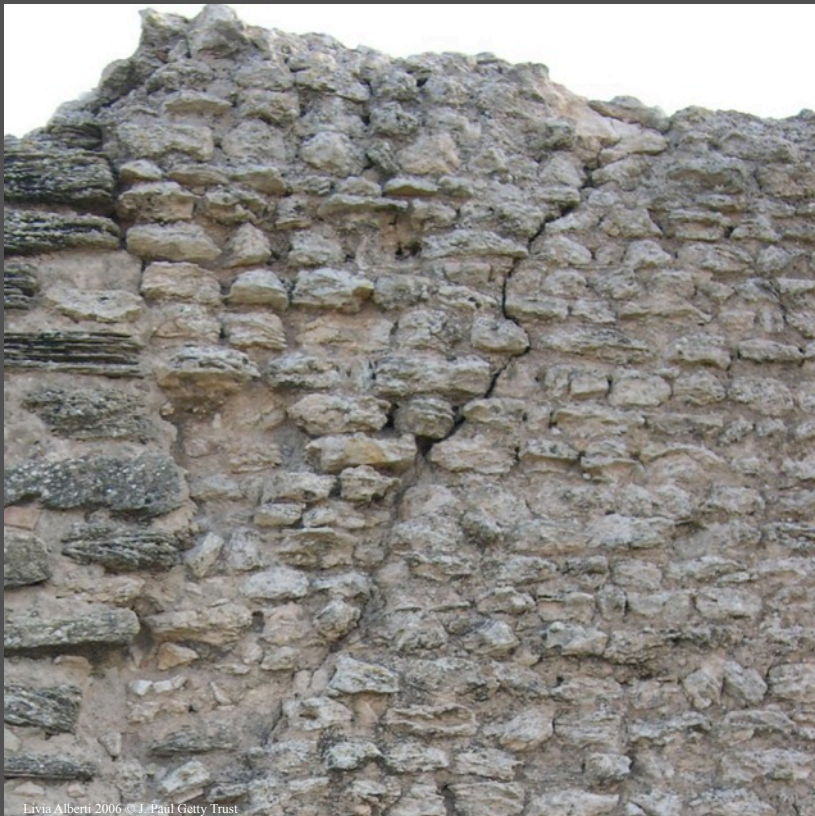
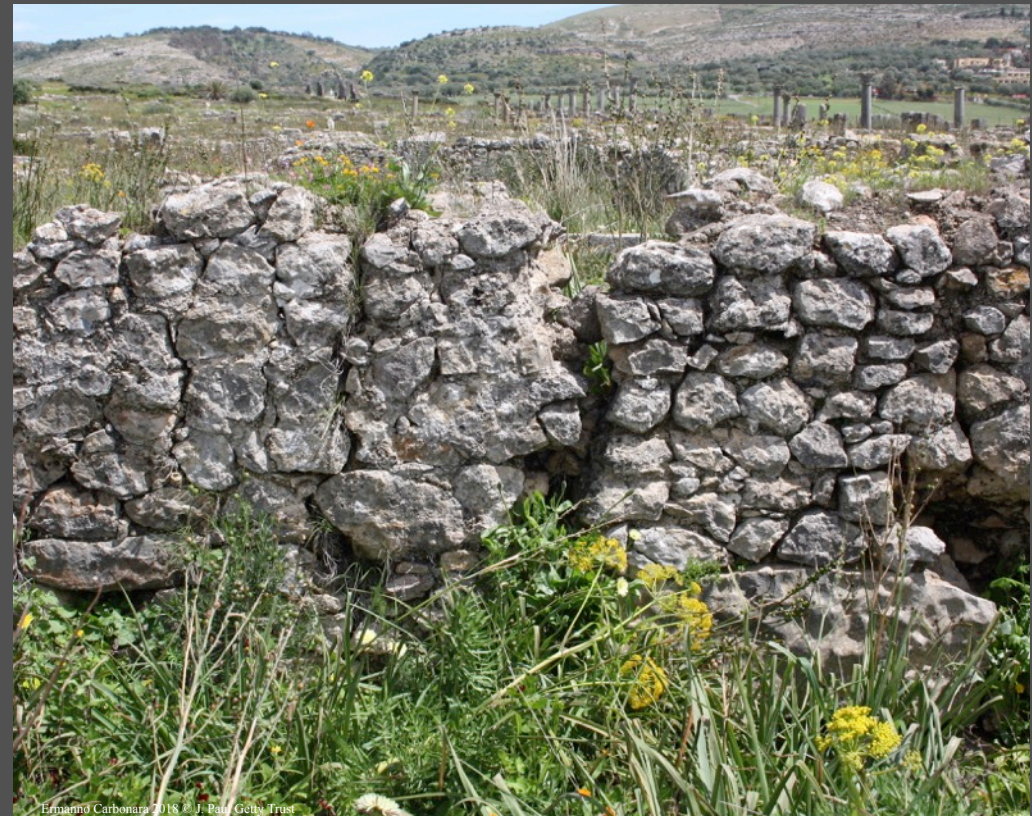
<input type="checkbox"/> Loss of stones or mortar of the structure	<input checked="" type="checkbox"/> Cracks
<input type="checkbox"/> Detached stones of the structure	<input type="checkbox"/> Deformations (bulge or depression)
<input type="checkbox"/> Vegetation	<input type="checkbox"/> Loss of surface decoration of wall or pavement
<input type="checkbox"/> Micro-organisms	<input type="checkbox"/> Detachment of surface decoration of wall or pavement
<input type="checkbox"/> Incrustations	<input type="checkbox"/> Deteriorated surface decoration
<input type="checkbox"/> Efflorescences	<input type="checkbox"/> Deteriorated previous interventions

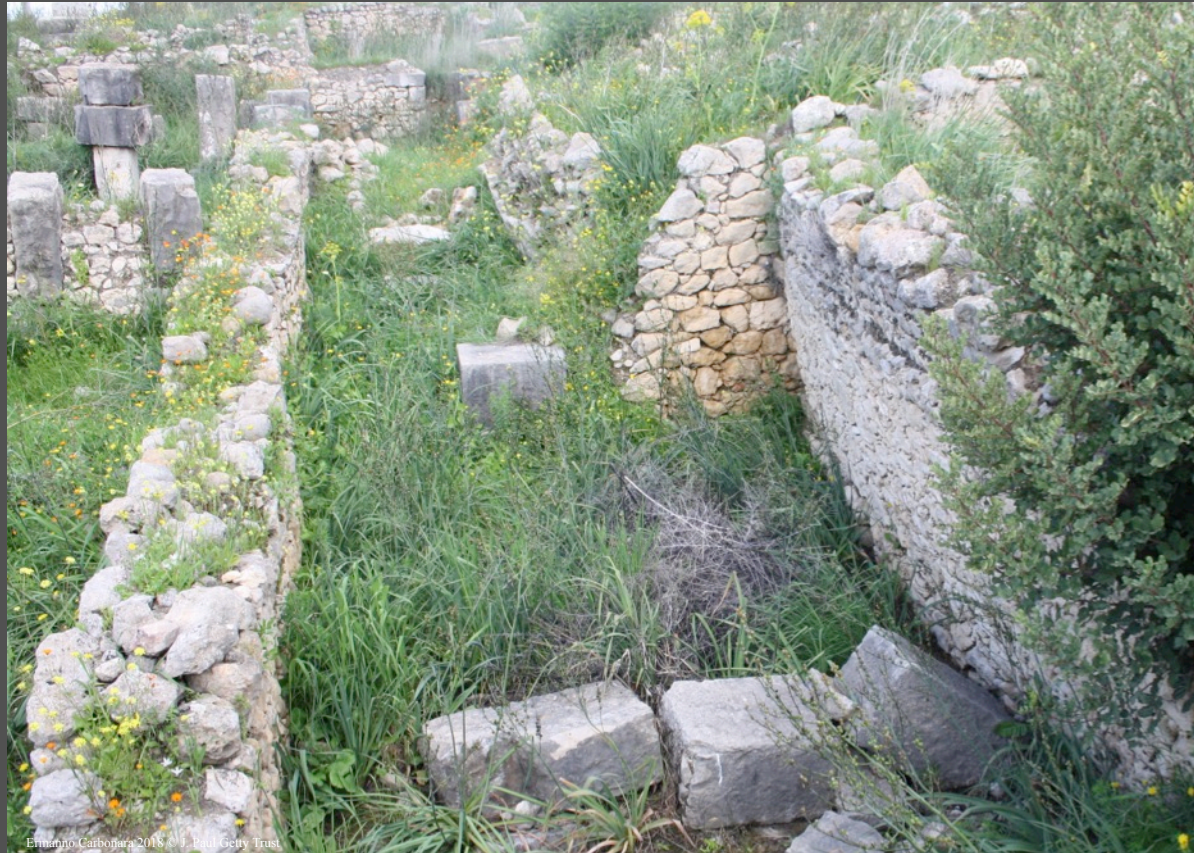
<input type="checkbox"/> Loss of stones or mortar of the structure	<input type="checkbox"/> Cracks
<input type="checkbox"/> Detached stones of the structure	<input checked="" type="checkbox"/> Deformations (bulge or depression)
<input type="checkbox"/> Vegetation	<input type="checkbox"/> Loss of surface decoration of wall or pavement
<input type="checkbox"/> Micro-organisms	<input type="checkbox"/> Detachment of surface decoration of wall or pavement
<input type="checkbox"/> Incrustations	<input type="checkbox"/> Deteriorated surface decoration
<input type="checkbox"/> Efflorescences	<input type="checkbox"/> Deteriorated previous interventions
