## TECHNICIAN TRAINING FOR THE CONSERVATION OF MOSAICS

THE CONSERVATION OF ARCHITECTURAL REMAINS AND THEIR DECORATIVE SURFACES

## Structures and decorative surfaces: conditions and their documentation

Livia Alberti, Ermanno Carbonara, Thomas Roby

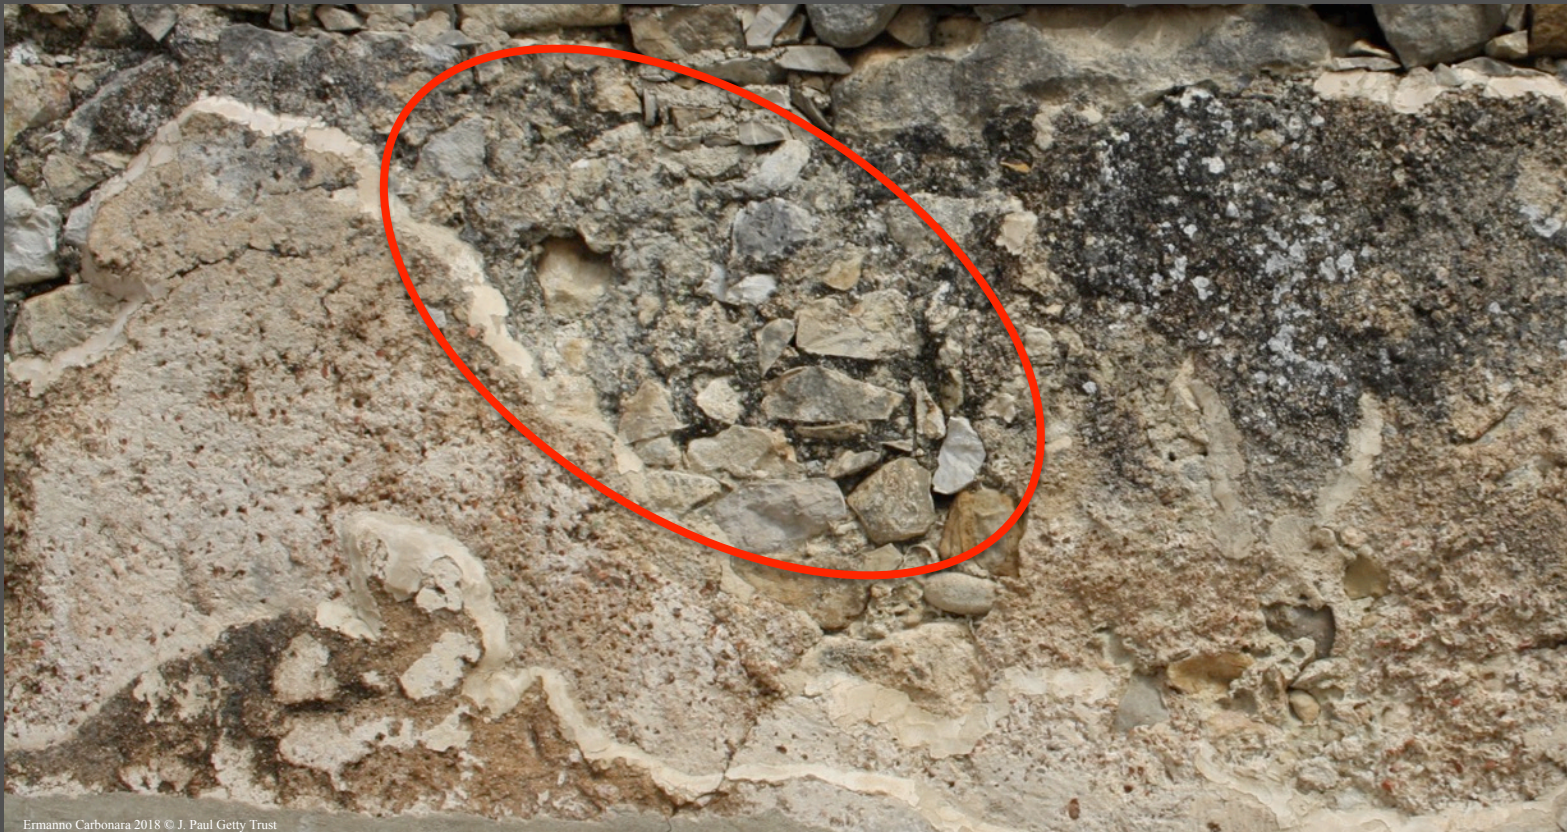
<input type="checkbox"/> Loss of stones or mortar of the structure	<input type="checkbox"/> Cracks
<input type="checkbox"/> Detached stones of the structure	<input type="checkbox"/> Deformations (bulge or depression)
<input type="checkbox"/> Vegetation	<input checked="" type="checkbox"/> Loss of surface decoration of wall or pavement
<input type="checkbox"/> Micro-organisms	<input type="checkbox"/> Detachment of surface decoration of wall or pavement
<input type="checkbox"/> Incrustations	<input type="checkbox"/> Deteriorated surface decoration
<input type="checkbox"/> Efflorescences	<input type="checkbox"/> Deteriorated previous interventions

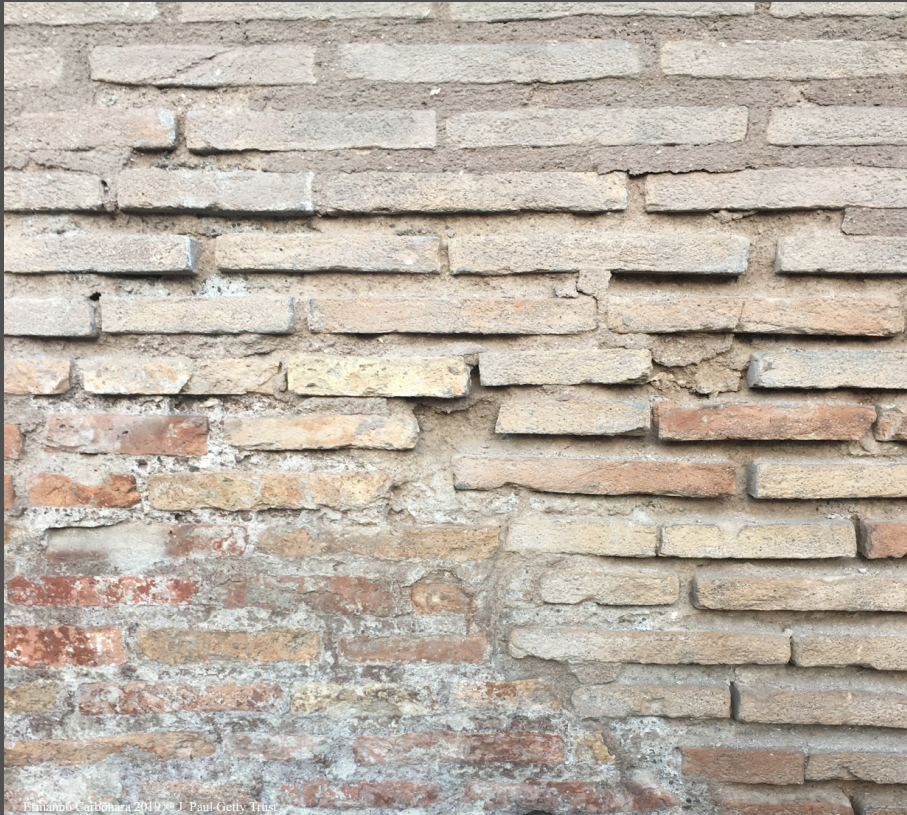
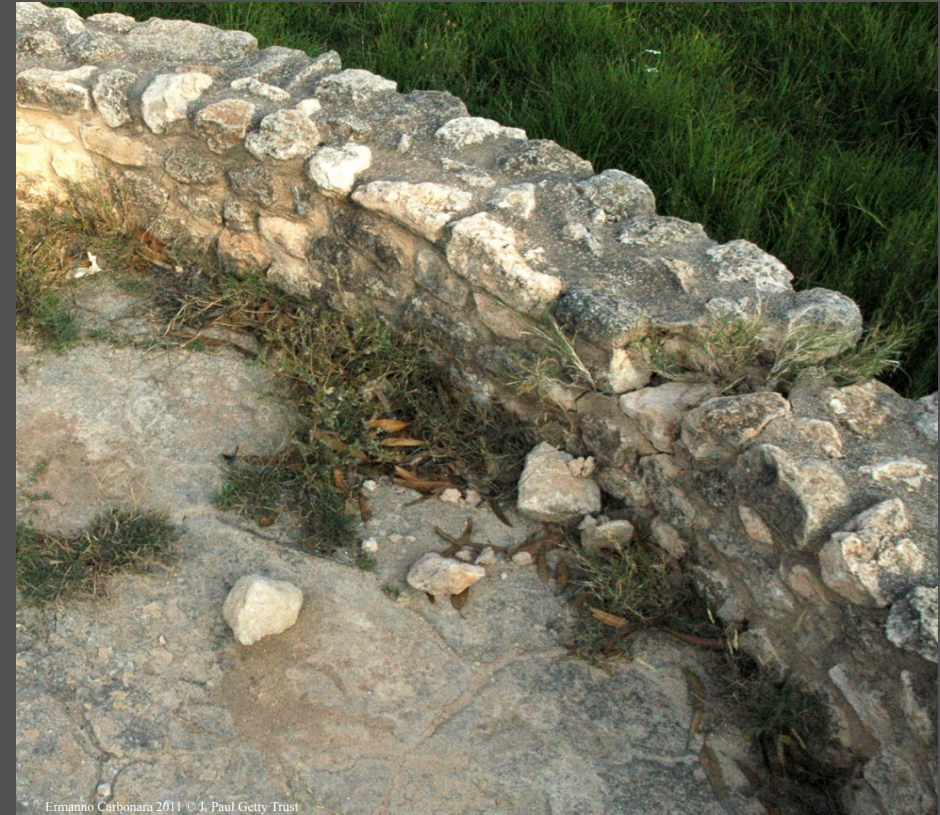
<input type="checkbox"/> Loss of stones or mortar of the structure	<input type="checkbox"/> Cracks
<input type="checkbox"/> Detached stones of the structure	<input type="checkbox"/> Deformations (bulge or depression)
<input type="checkbox"/> Vegetation	<input type="checkbox"/> Loss of surface decoration of wall or pavement
<input type="checkbox"/> Micro-organisms	<input type="checkbox"/> Detachment of surface decoration of wall or pavement
<input type="checkbox"/> Incrustations	<input type="checkbox"/> Deteriorated surface decoration
<input type="checkbox"/> Efflorescences	<input checked="" type="checkbox"/> Deteriorated previous interventions

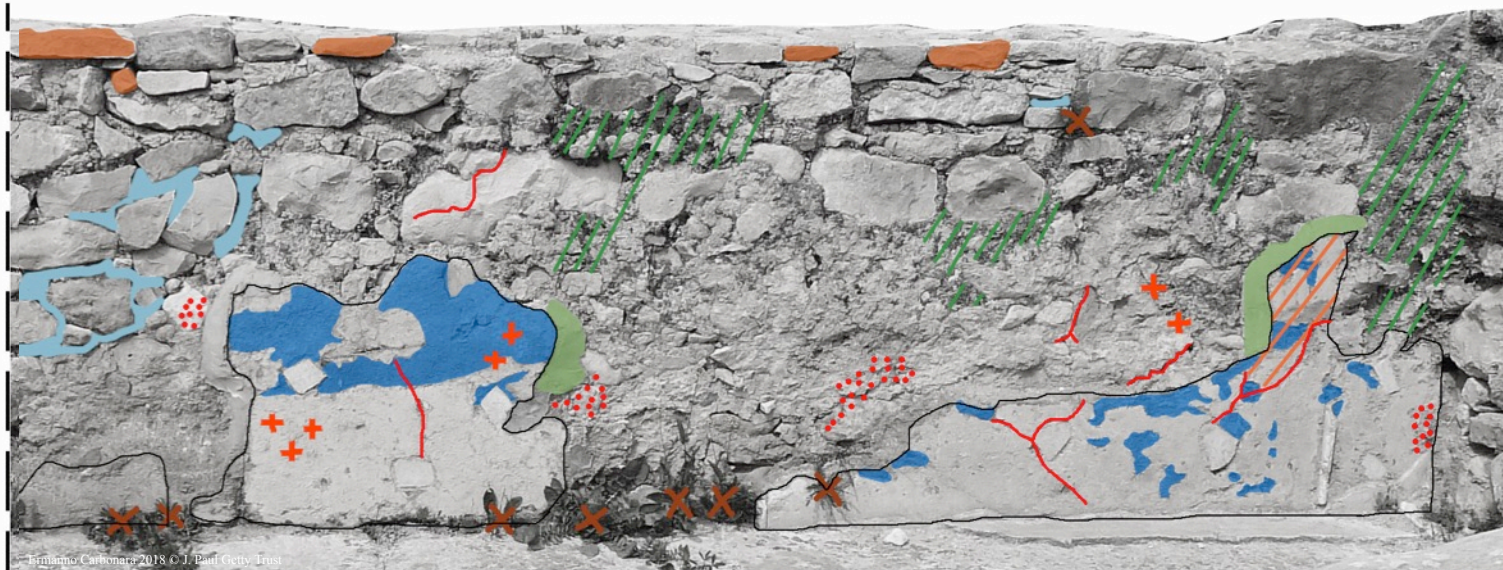
Vol-MOr-02-d-2

TITLE: Condition Assessment Map
