CONSERVATION MANAGEMENT PLAN FOR GANDHI BHAWAN, PANJAB UNIVERSITY

*Funded by the 'Keeping it Modern' Grant Awarded by
The Getty Foundation, Los Angeles, USA*

July, 2017

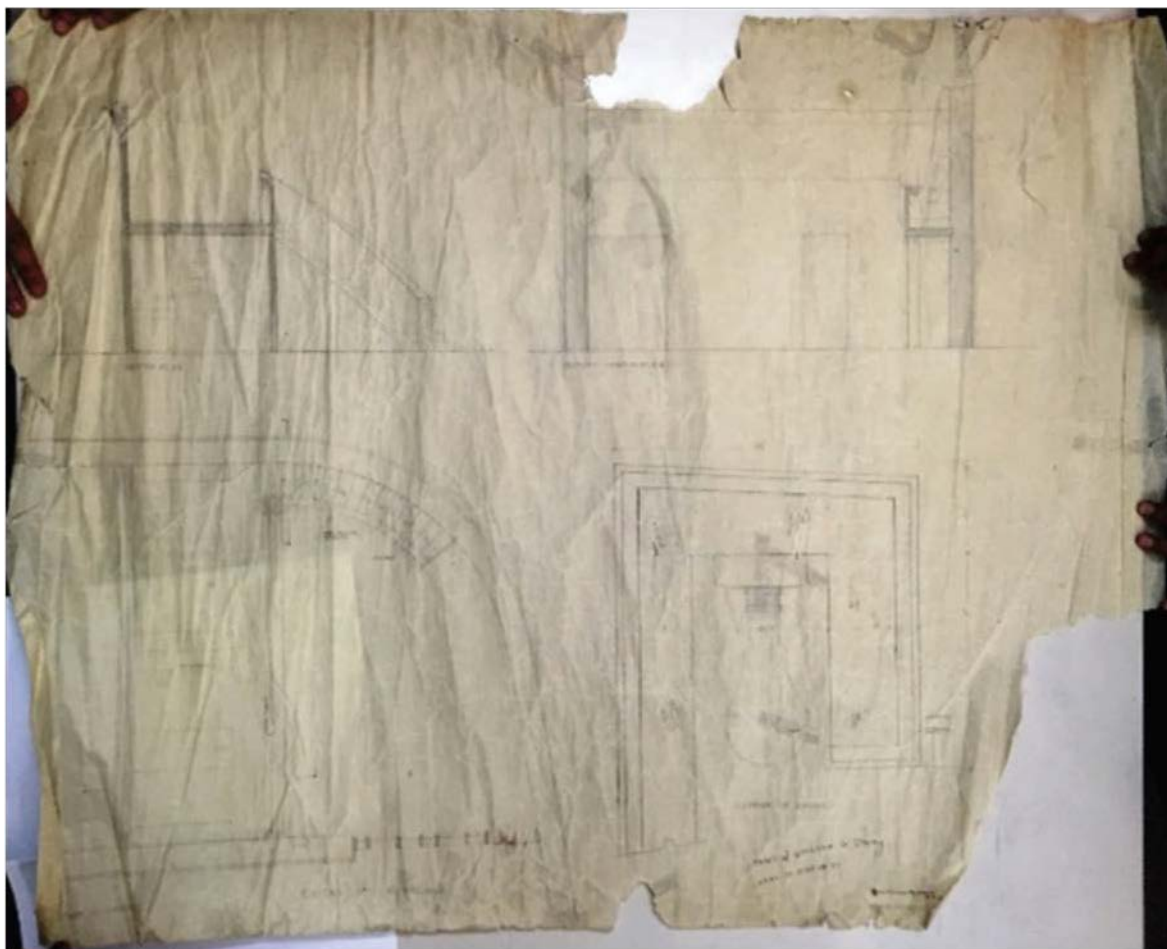
Figure 3. Original drawing of staircase railing and lighting detail currently located at the Architect's Office Panjab University

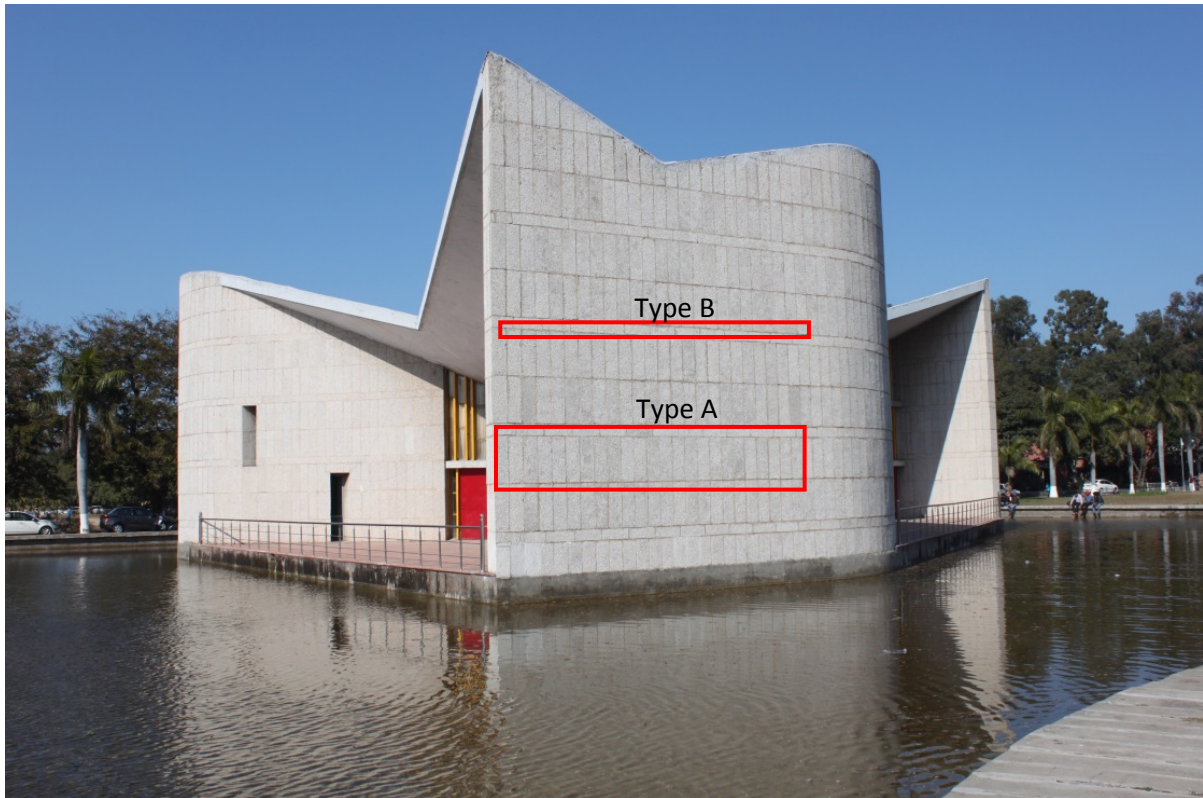
Figure 43. Types of panels used

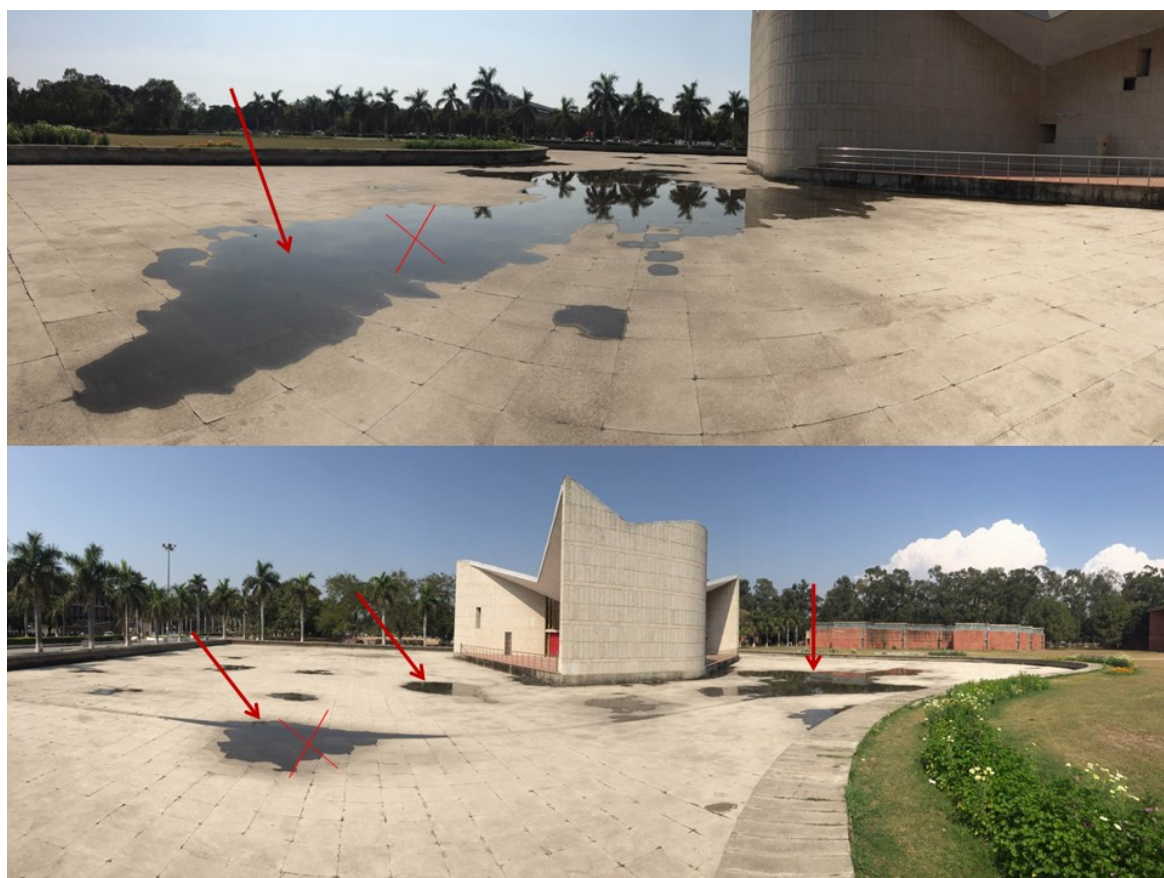
Figure 62 Standing water in empty pool

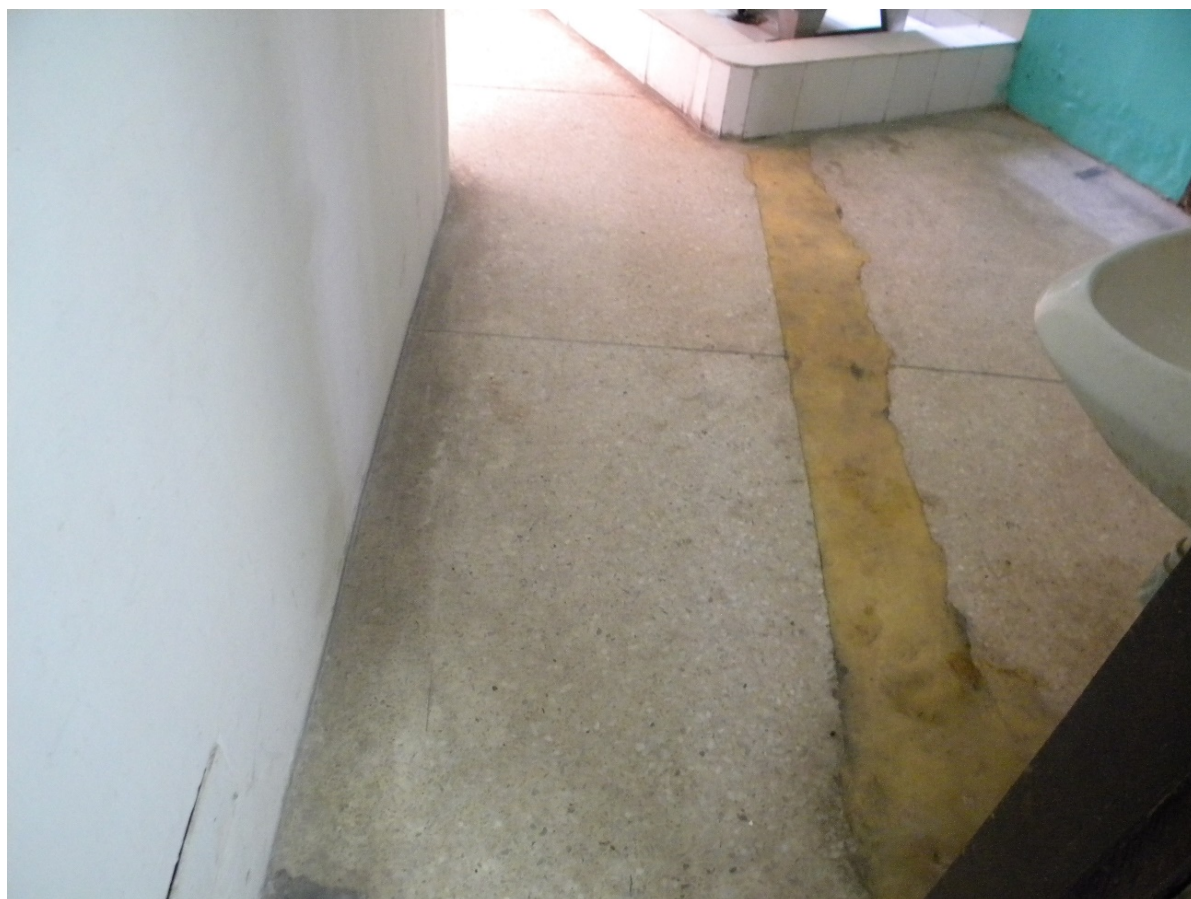
Figure 69 Patch repairs in floor outside the toilets

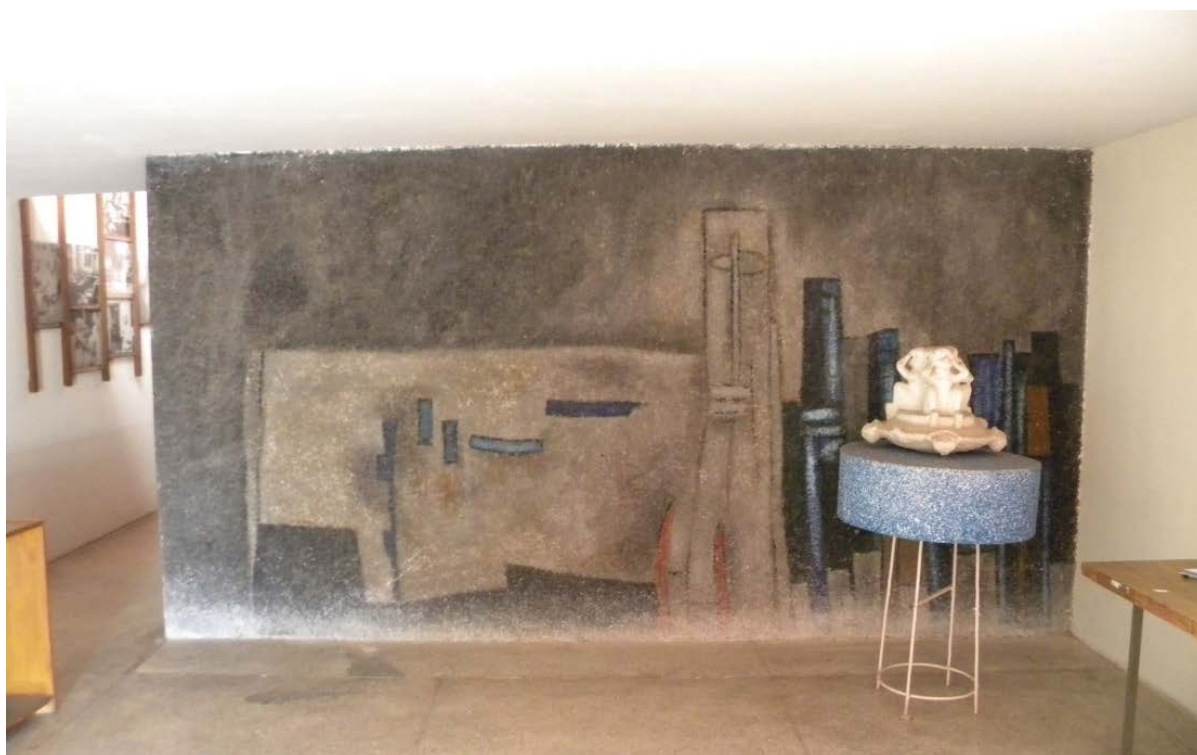
The mural at the entrance by artist Satish Gujral also requires some cleaning/ conservation work since the bottom side is splashed with some paint , overall mural shows signs of scratches and fading of colour in certain areas. The wall mural light fixture was originally installed in the floor and later on it was covered. The grainy textured surface of the mural attracts dust and grime, so the whole mural is covered in a fine layer of accumulated grime.

Figure 70 Mural as seen from the entrance in 2016 shows deterioration and splash of paintwork at bottom

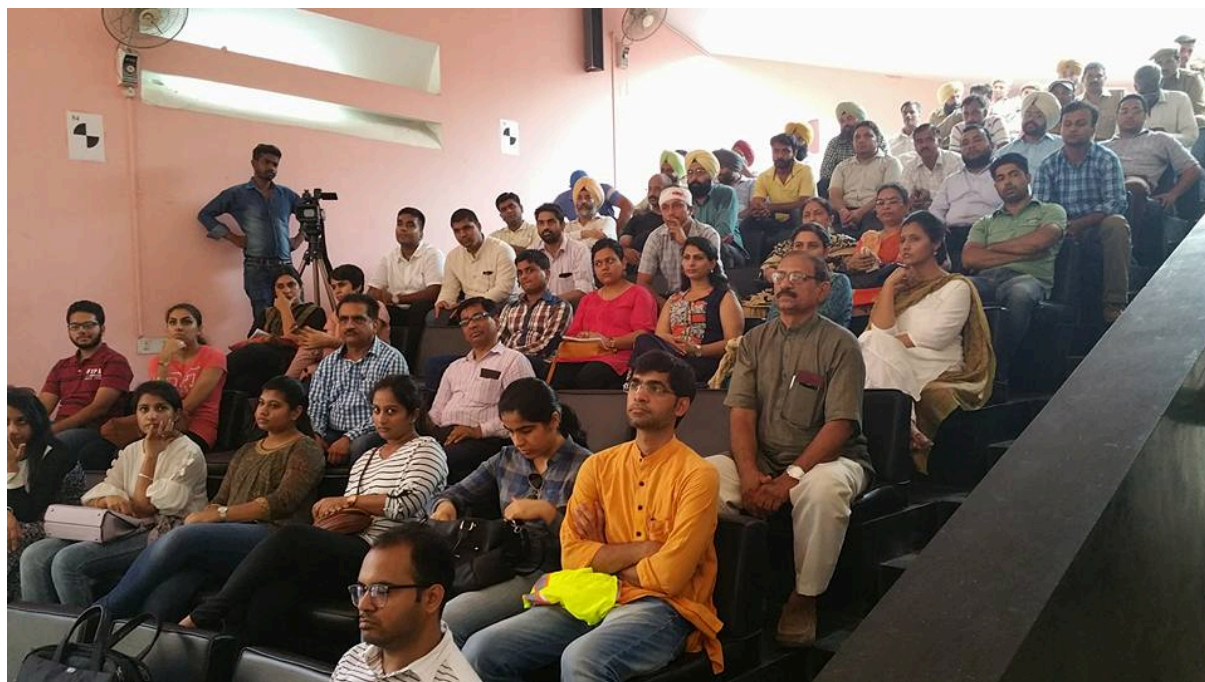
Figure 72 Gandhi Bhawan auditorium being used in July 2016. It has serious issues of audio and lighting for presentations and heat and humidity issues while in use during summer

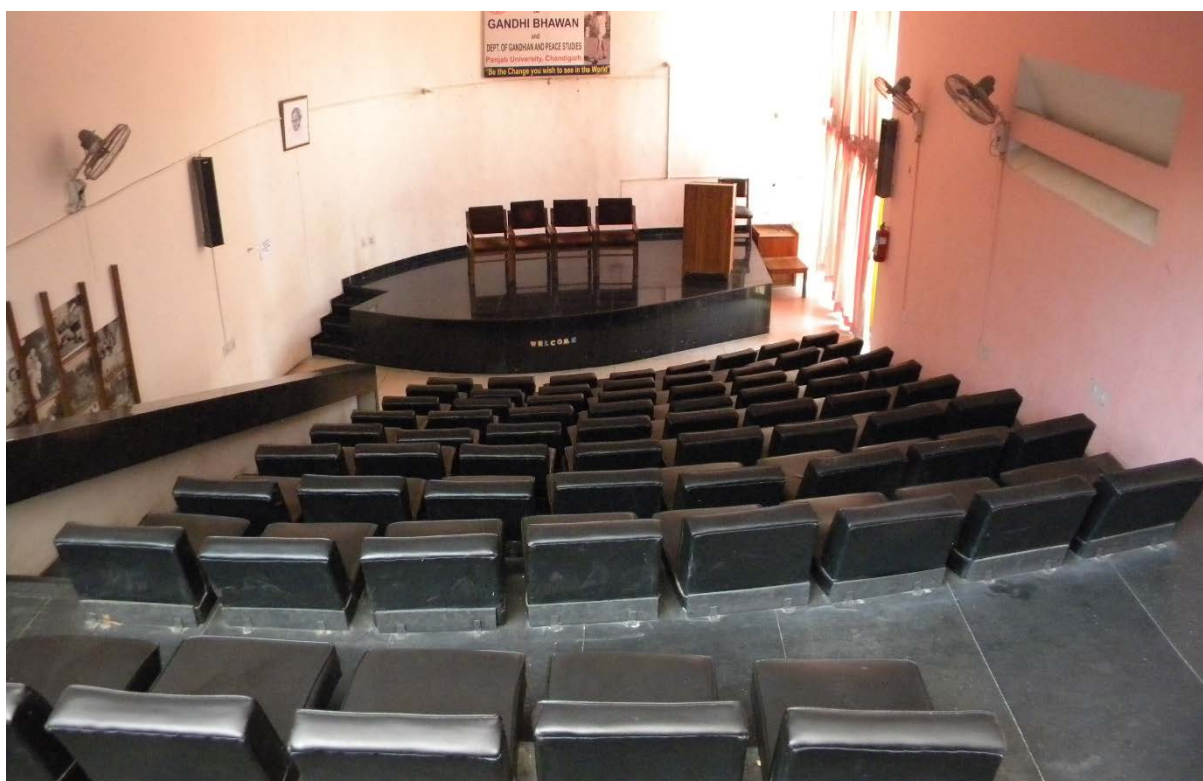
The infrastructure and services at Gandhi Bhawan including rainwater outlets, piping systems, electrical works, and lighting require major changes considering the future use and functionality of the space. State of the art facilities such as speaker system/audio-visuals and air conditioning in the spaces requires serious consideration. Some of the later additions of lights and wall fans are major interventions that disturb the aesthetics of the interior spaces.

Figure 73 Seminar Room and Gandhi Bhawan auditorium showing inappropriate fixtures of lights and fans that are disturbing the interior aesthetics

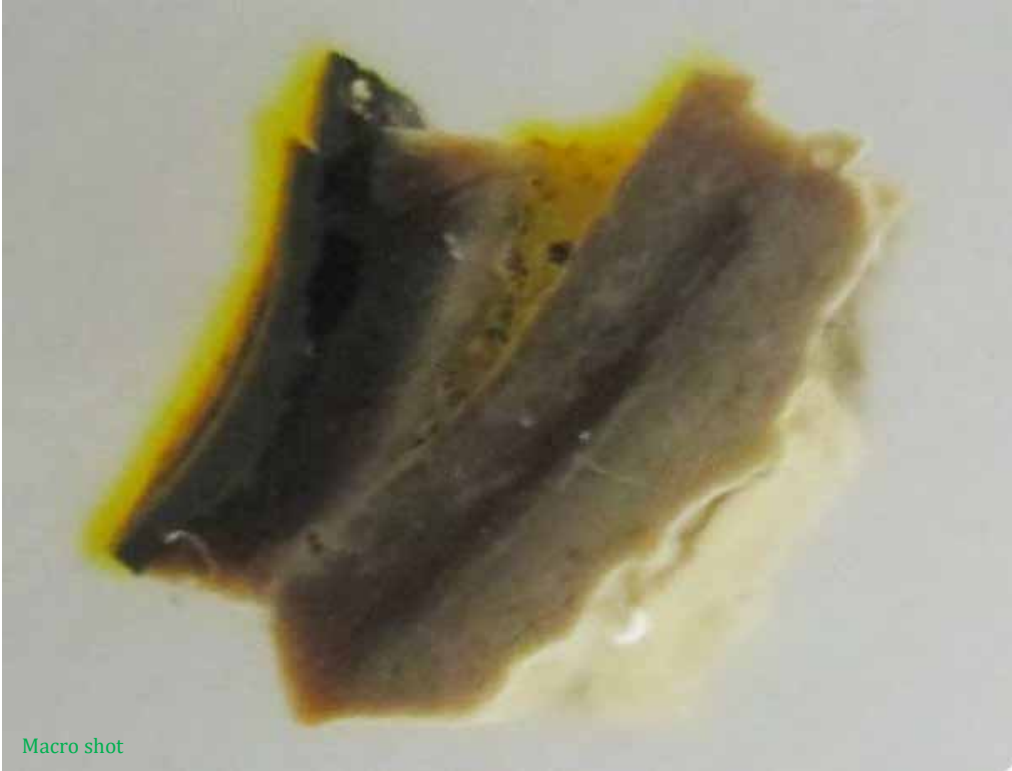
Sample code: GB07

- This sample shows presence of the ground layer over and underneath the older layer of paint.
- Two layers of yellow paint can be seen on both the magnifications.
- This suggests over painting of the area after some repair work was conducted on the particular wall or area.
