MASP's Structure
Conservation Plan

MASP

The Getty Foundation

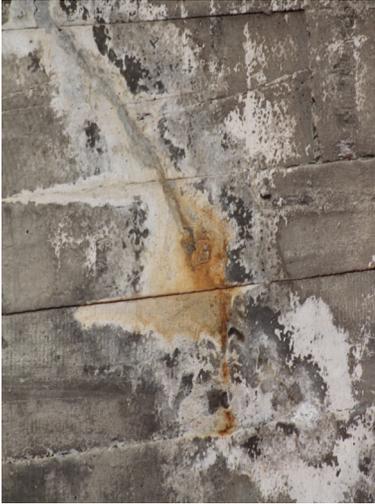
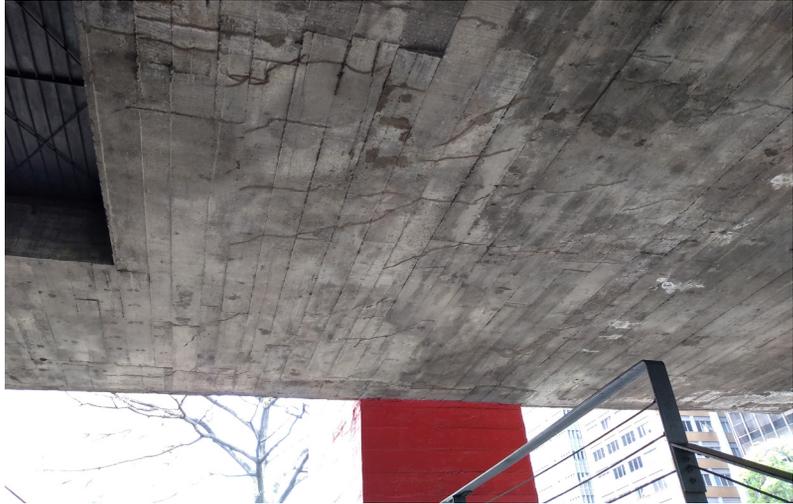
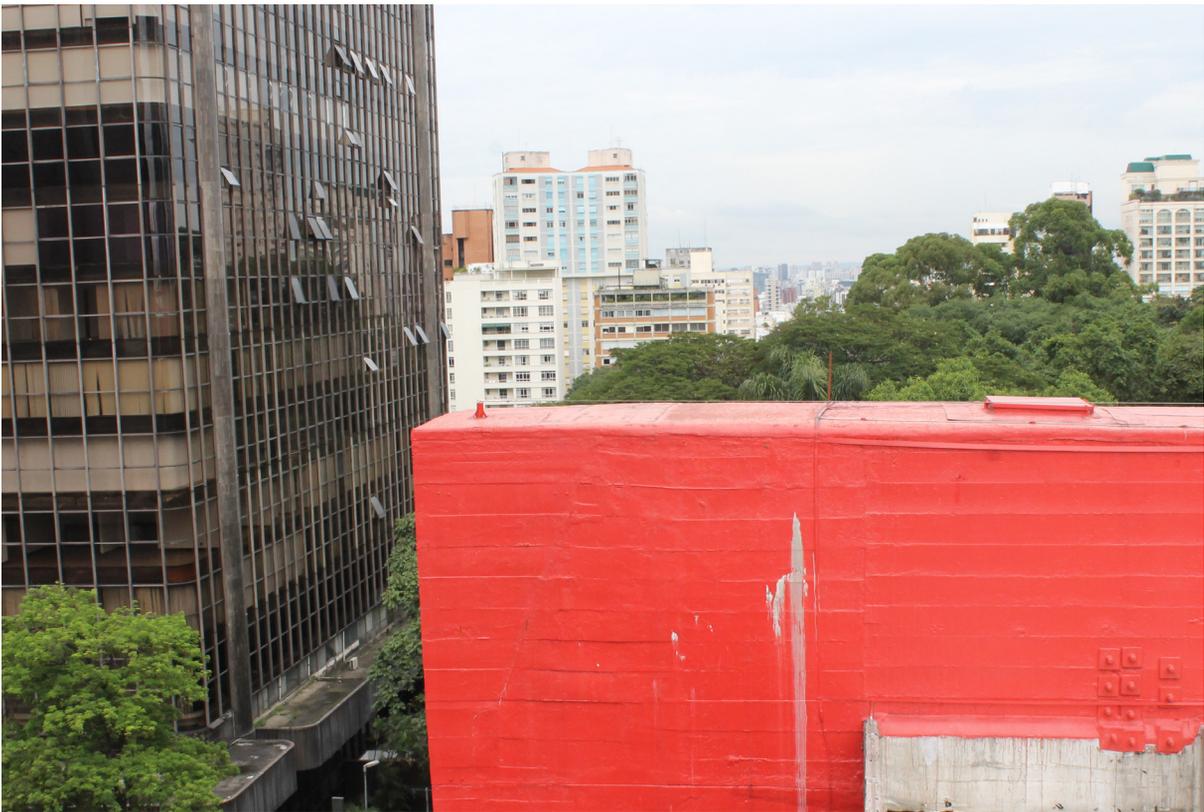
[74] [75] [76] Pathologies in the lower part of the first floor slab (ceiling of the plaza under the free span) and in the roof beam

While on the one hand the mapping of the damages allows for the precise detection of the conditions of the reinforced concrete, in relation to cracks, some points have already been identified that should be monitored – see ACTION 8, 9 and 10 – for determination of its (active or passive) state, and procedure for adequate recovery.

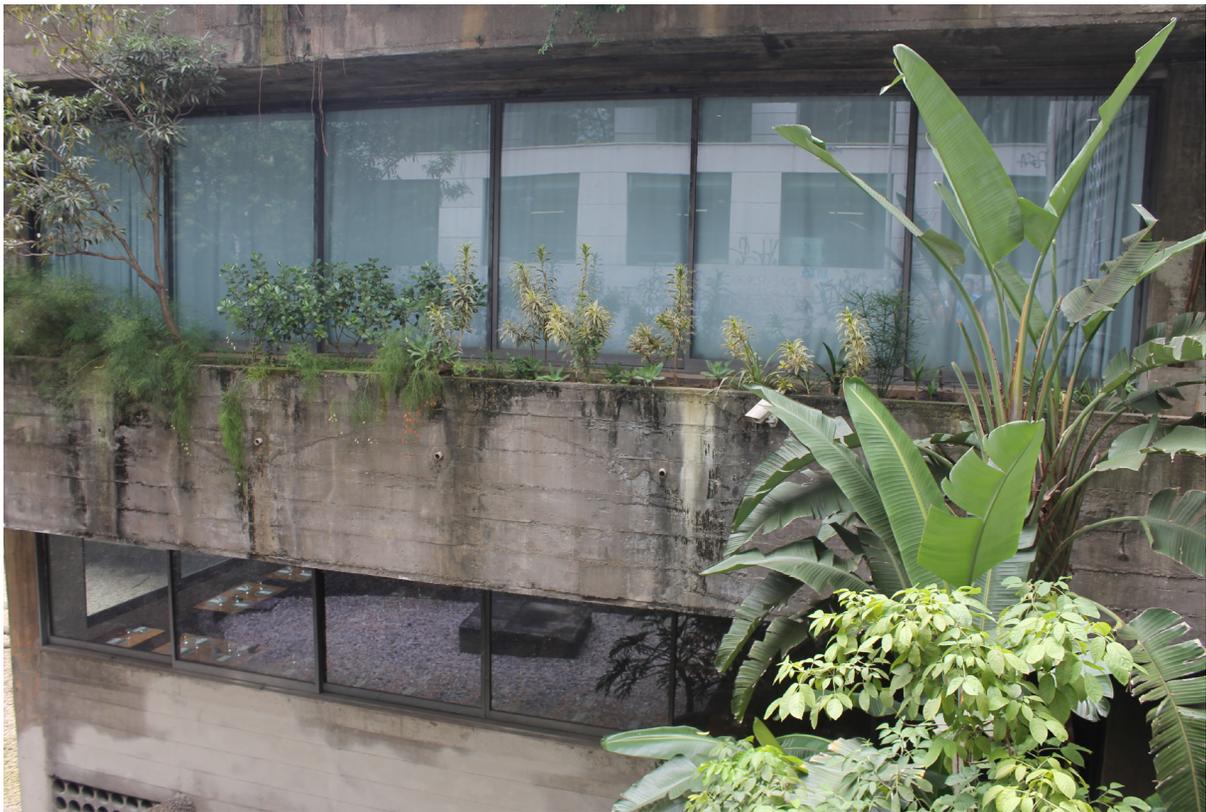
[77] [78] [79] [80] Pathologies in the façades of the lower volume

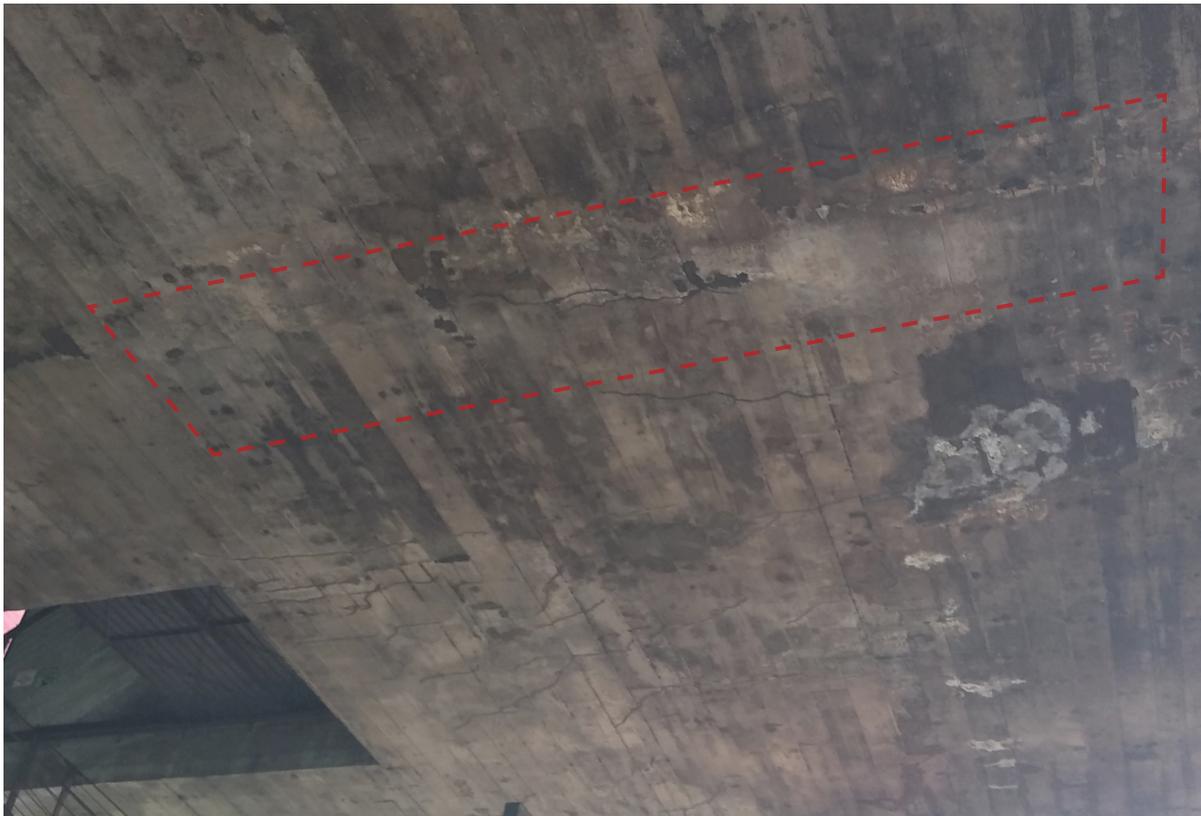
[82] Highlighted: cracks in beam V16

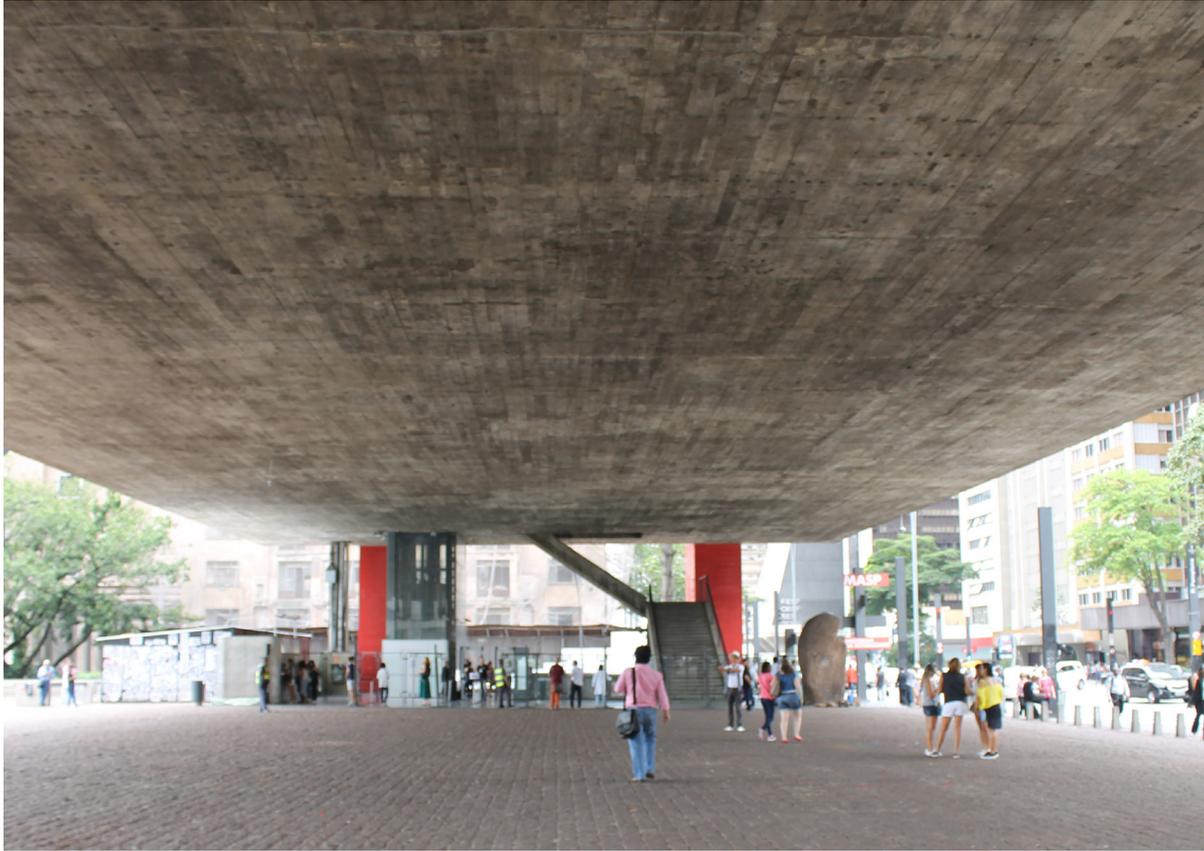
[83] [84] [85] Pathologies in the lower part of the first floor slab (ceiling of the plaza under the free span)

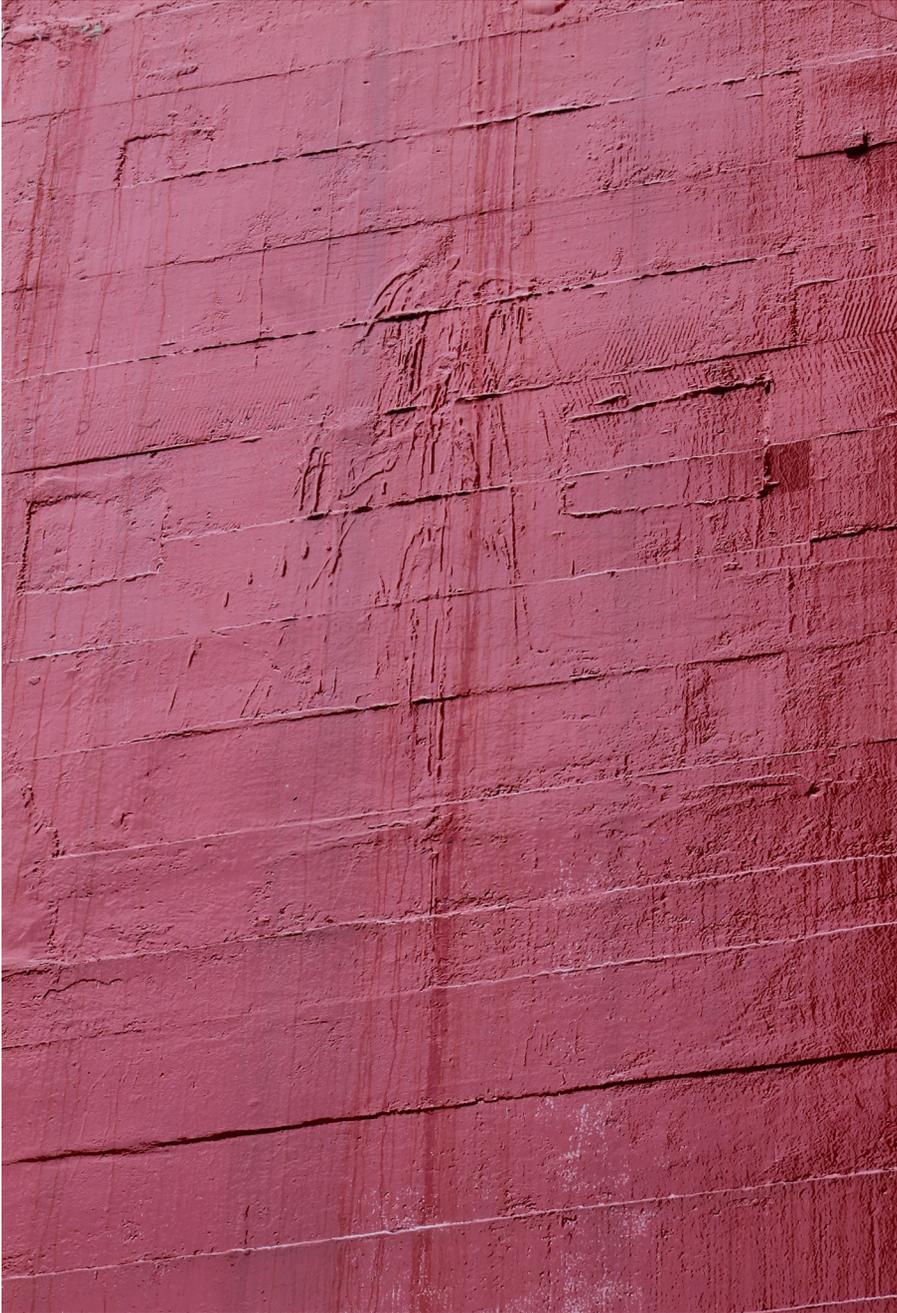
[88] Pathology due to type of paint

The painting of the columns and main beams has the function of protecting them from water and other pathogenic agents. The painting's composition, however, must be appropriate so that it does not also become an agent of degradation. The chemical composition of the current painting limits the exchange of gases of the structure with the surrounding environment, since the moisture already existing within the beams and columns is exuded over time. As a consequence of this process, "passages" arise in the paint that allow for the entrance of moisture, forming zones of carbonation and porosity that contribute to the degradation of the material. A new painting should consider a chemical composition which on the one hand contributes to the waterproofing of the pieces and on the other allows for the exchange of gases with the atmosphere. Considering that for MASP the red painting of these elements is a fundamental part of the building's characteristic expressivity, any change should maintain the color, though it is acceptable if the change in composition leads to the alteration of other aesthetic aspects.

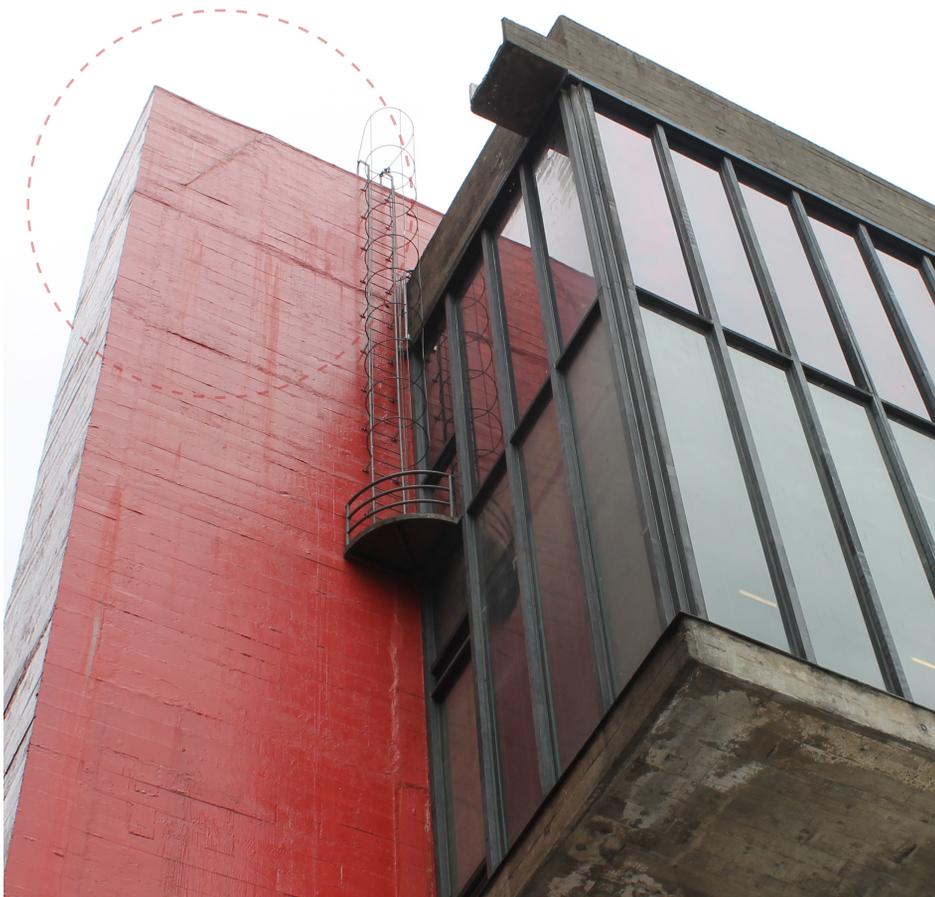
[89] View of completed corner of beam V2 and the expansion joint where the beam meets column P2

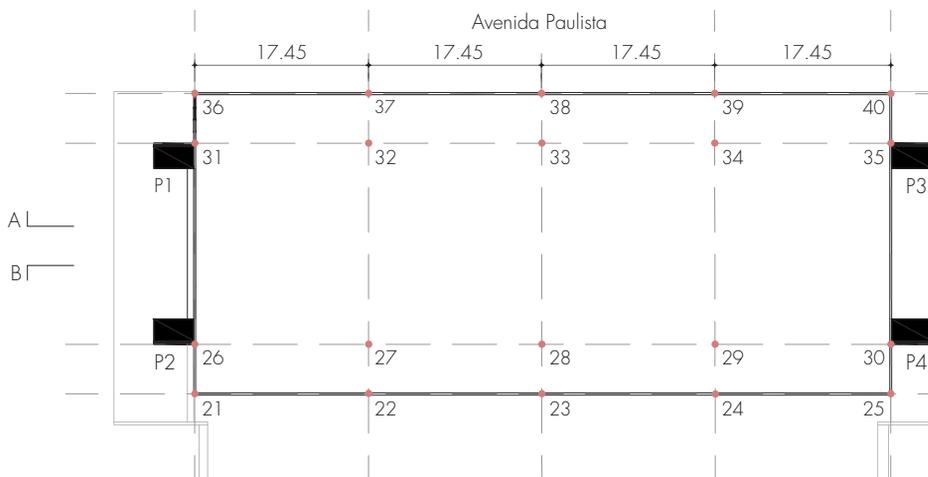
[92] Raised points under the first-floor slab (ceiling of the plaza under the free span)

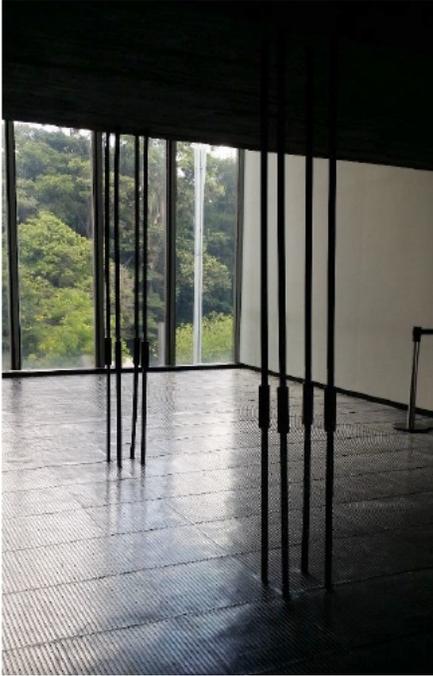
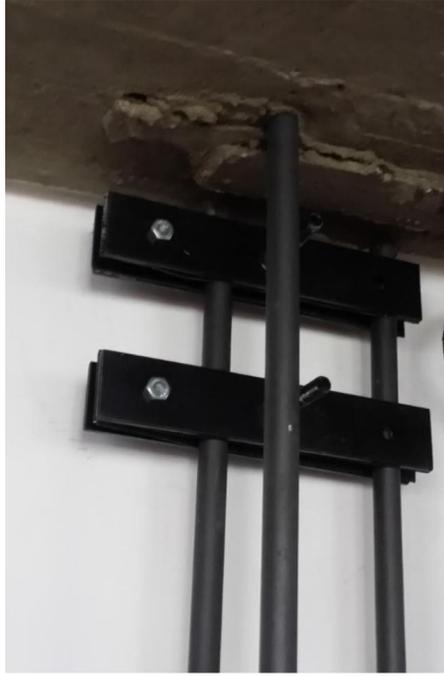
[98] [99] Misaligned or compressed tie rods

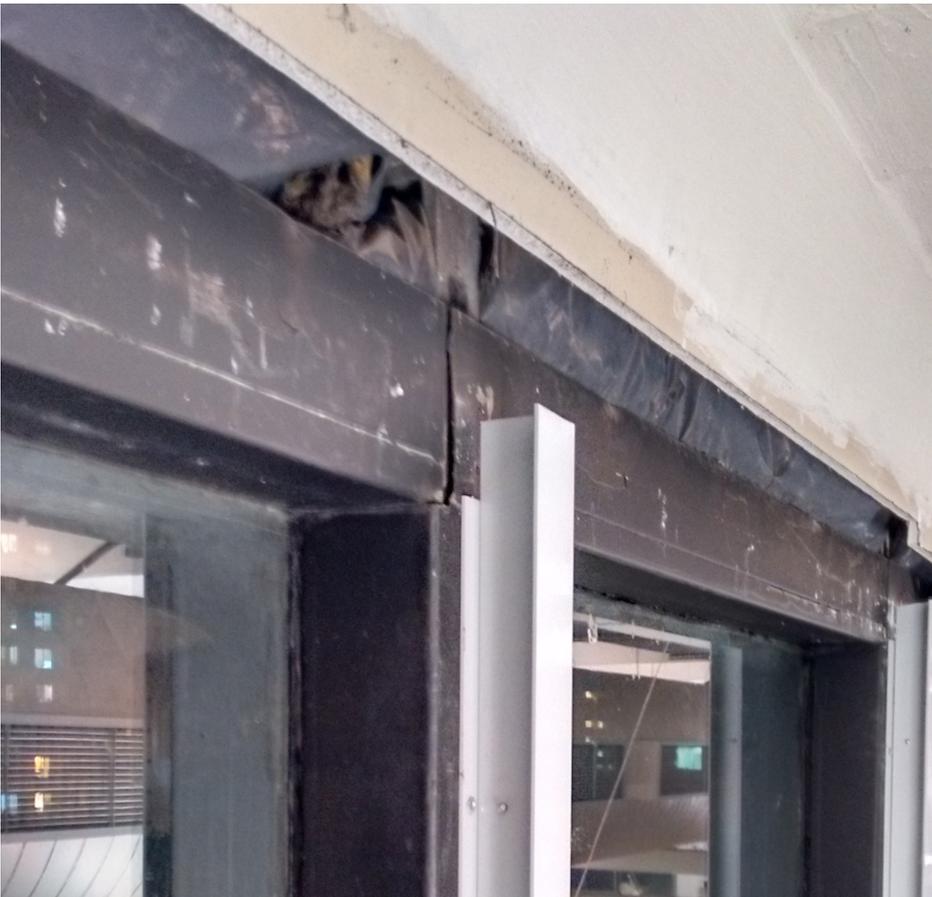
[100] Connection of the window casings with the roof slab

The window casings of the upper volume have a direct interface with the structure, possessing attachment points on the lower surface of the roof slab and on the top surface of the first-floor slab. According to a report made in 1999 by the AEC (Consultores de Arquitetura e Construção Ltda.), the linking of the window casings with the slab is extremely precarious. Thus, the weight of the window casings is totally borne by the first-floor slab, contributing to its deformations. There is also the possibility that this welding was made on the steel reinforcing, which could cause damages. The framework and rigidity of the transversal roof beams indicate that the window casings could be supported by them, alleviating the loading on the beams of the first-floor. Therefore, it is necessary to investigate ways for attaching the window casings and their performance. With an awareness of the need for an intervention in the window casings to meet demands of safety, the research carried out in the digital model can also contribute to establishing parameters such as the maximum loads and deformations on the edges of the slabs and the best ways for attaching the window casings.
