FINAL REPORT

MMS-CONSOL: Concrete Solutions

A standard-setting project for graffiti management, surface cleaning and patch repair of historic concrete, utilizing the Miami Marine Stadium as a test site.

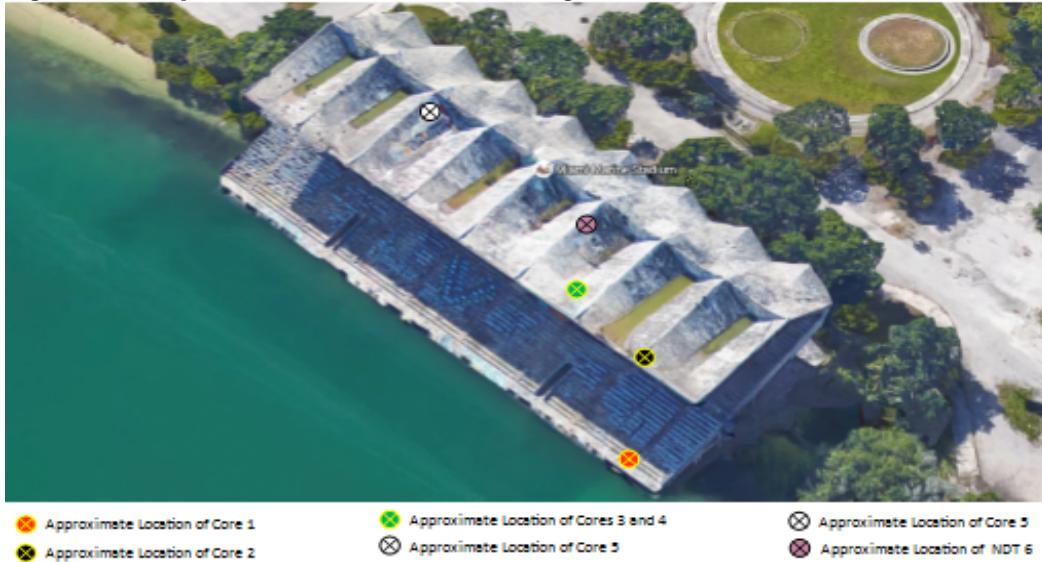
Figure 1: Sample extraction and NDT testing locations

hardened mixture of the *in-situ* concrete surfaces. Core specimens were also obtained in accordance Standard Test Method for Obtaining and Drilling Cores and Sawed Beams of Hardened Concrete (ASTM C42). A summary of tests performed is provided by Table 1.

Table 1: Field Test and Coring Locations

Location ID	Core Count	Tests Performed
1	1	Core Extraction, Rebound Hammer, Windsor Probe
2	1	Core Extraction, Rebound Hammer, Windsor Probe
3	1	Core Extraction, Rebound Hammer, Windsor Probe
4	1	Core Extraction, Rebound Hammer, Windsor Probe
5	1	Core Extraction, Rebound Hammer, Windsor Probe
6	1	Rebound Hammer, Windsor Probe

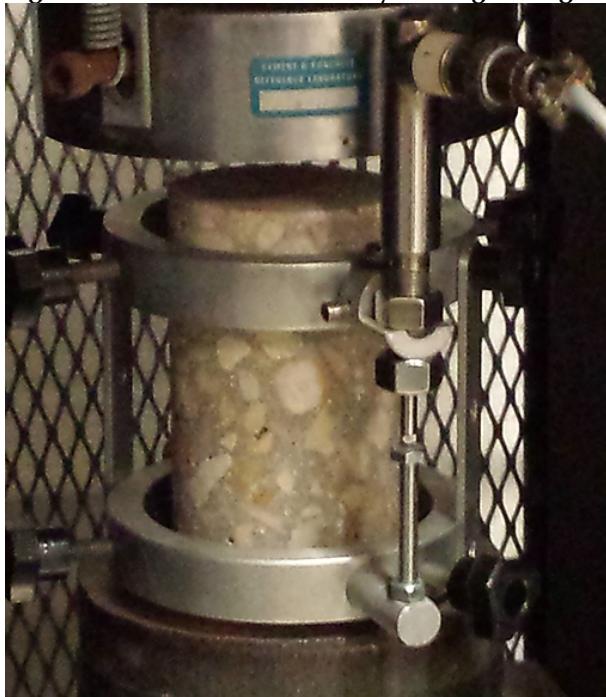
Figure 2: Modulus of Elasticity testing configuration

- 6.18 Typically, the modulus of elasticity of concrete is calculated from compressive strength⁵ ⁶ utilizing data from ASTM C873 Standard Test Method for Compressive Strength of Concrete. However, compressive strength testing of concrete is destructive in nature, requiring many core samples for statistical accuracy. So due to the historic preservation aspects of this project, it was decided to perform testing on the samples obtained that would preserve the integrity of the samples themselves. The modulus of elasticity testing acquired from Sample #5 was approximately 3,880,000 psi. The results are presented in Figure 2.

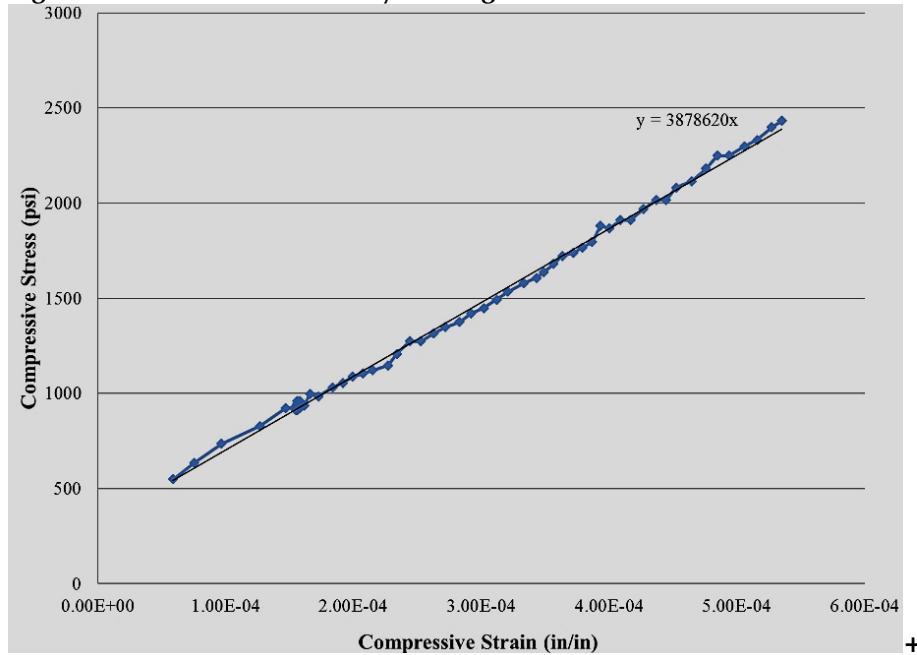
Figure 3: Modulus of Elasticity Testing Results

- 6.19 The results from the modulus of elasticity testing are consistent with a concrete similar to the Class II concrete per the Florida Department of Transportation (FDOT) Standard Specification for Road and Bridge Construction⁷. The compressive strength of Sample #5 is approximately 4,500-5,000psi which is appropriate for its use.

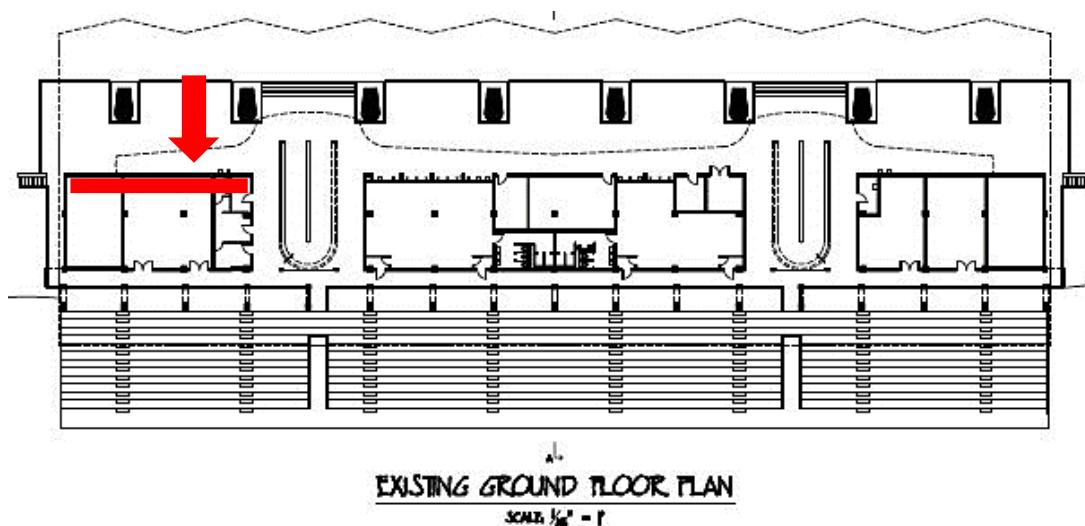
Figure 4: Location of Graffiti Removal, Cleaning & Graffiti Barrier Trials

- 8.5 We intend to set up our cleaning trial area at ground floor level along the graffiti-covered southeast blank wall of the Stadium to the right-hand side of the car park entrance façade (Appendix B, Photo 4). This area is protected from the weather by the overhanging cantilever tie-downs of the hypar roof system, and is on the opposite and less exposed side of the Stadium from the lagoon. As the area remained in use by skateboarders and the graffiti community (site security being poor), we took steps to delineate a safe working area for RLA operatives and planned to temporarily protect our cleaning trials from subsequent attack by vandals.

- 8.6 The treatment specification called for the trial site floor area immediately in front of the test wall to be cordoned off with a 3-4 ins. deep waterproof collection point and 'evaporation pond' of solvent-resistant, 4-6 mil, black-colored polyethylene plastic sheeting to capture surface run-off of rinsing water, wet abrasive aggregates, chemicals and paint residues so as not to pollute the site and adjacent lagoon. The sheeting was to be laid over an edging of Coir fiber rolls (or similar) as used to control spillages on construction sites. The plastic sheet joints were to be sealed with duct tape. All collected residues were planned to dry off naturally by evaporation and then for the solids to be carefully removed from site and safely disposed of, according to city, county, and state ordinances (Appendix B, Photo 5).

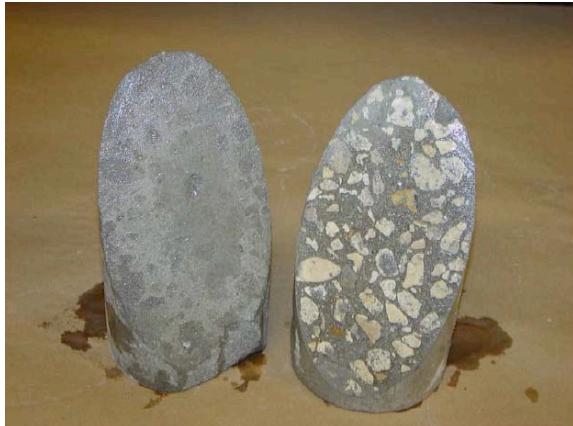
- 8.29 The average of three replicate specimens for each age and testing type is provided by Table 8 below. This provides a summary of the average compressive and bond strength for each repair mixture accordingly. Revisiting Section 6, the physical testing performed in the field, and on the core specimens extracted from the field, indicate that the compressive strength of the concrete used to construct the stadium is approximately 6,000 psi. Based on the results from the compressive strength testing, the concrete mixture we made which is most comparable to the *in-situ* concrete used to build the Stadium is concrete mixture #1. It obtained the highest compressive strength, as well as the highest bond strength.
