**PAIMIO SANATORIUM
CONSERVATION MANAGEMENT PLAN
2016**

Publisher
Alvar Aalto Foundation

The overall goal of the CMP is to guide the future use, care and conservation of the Paimio Sanatorium. The objective in preparing of this CMP has been to produce documents that bring together already existing historical records of the building, including defining of architectural features, physical analysis and the knowledge of the buildings performance over time to create a long-term strategy for decision-makers, contractors and users regarding conservation and maintenance.

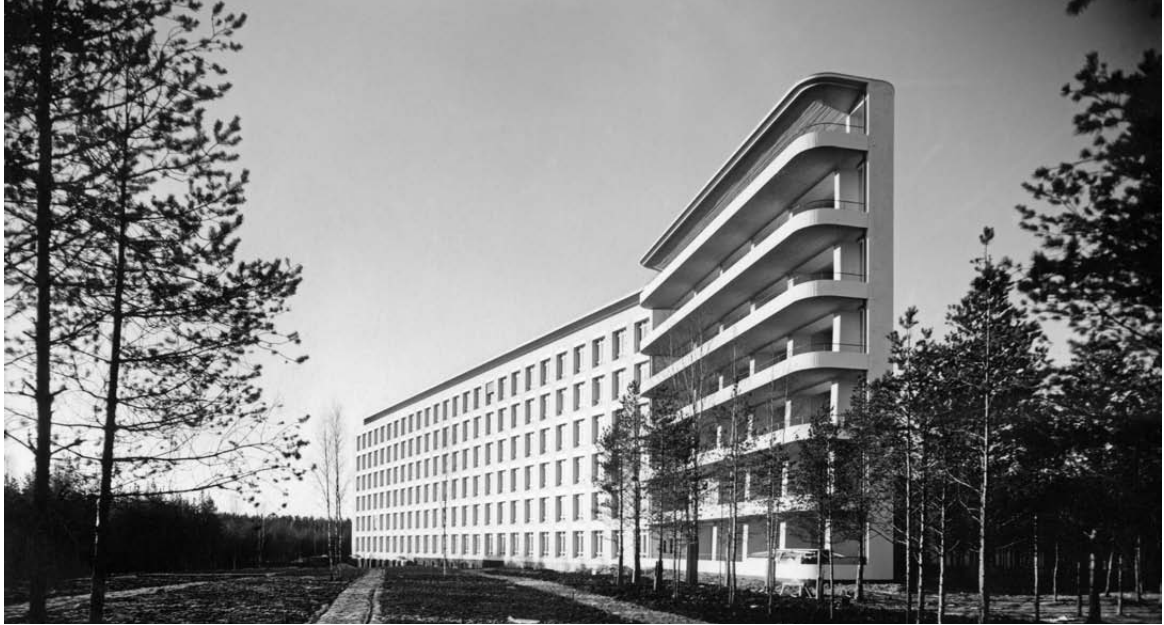
AAM 50-003-096 1930s

The main building of the sanatorium was placed on the highest point of the area, and oriented in a north-south direction. The layout was organised into five independent entries, connected with the main functions – the patient rooms, communal rooms, operating theatre, kitchen services and technical spaces. Each was placed in its own wing and oriented in the most favourable direction with regard to the light. The various wings meet at a central connecting node, where the most important internal circulation routes – the main staircase and lifts – are located. The central entrance porch, with an amoeba-shaped canopy, is also situated in this central core. The glazed lift shaft of the narrow west facade is a reflection of the Aaltos' admiration at that time for the machine age and modernity. This planning principle has produced a unique building offering a dynamic whole with varying views outwards into the landscape, as well as embodying the ideas of the new Functionalist architecture.

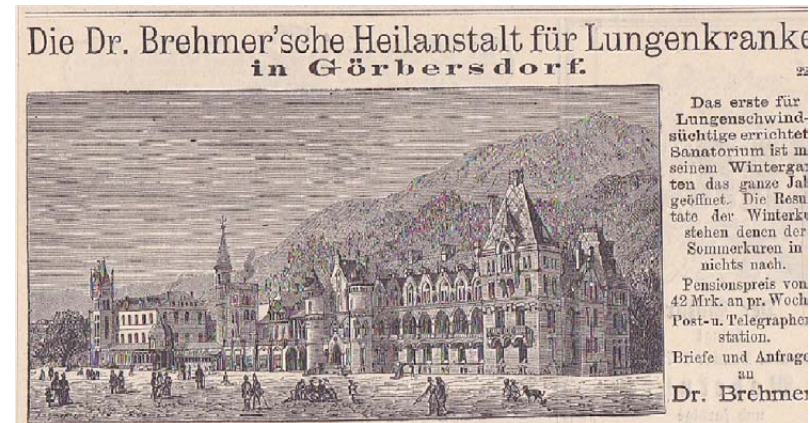
Dr. Brehmer's sanatorium in Görbersdorf, with the neo-gothic "Neue Kurhaus" (1875-78) designed by architect Edwin Oppler. The early newspaper advertisement (circa. 1880) notes that 42 Marks had to be paid per week by the patient. (Eva Eylers' archive)

With its castle-like appearance, Brehmer's sanatorium expressed a romantic belief in the possibility to finally heal and conquer tuberculosis. The neo-gothic employed for Görbersdorf would be the perfect style to express its remoteness and the immunity of the place and at the same time indicate the romantic belief or hope in betterment.

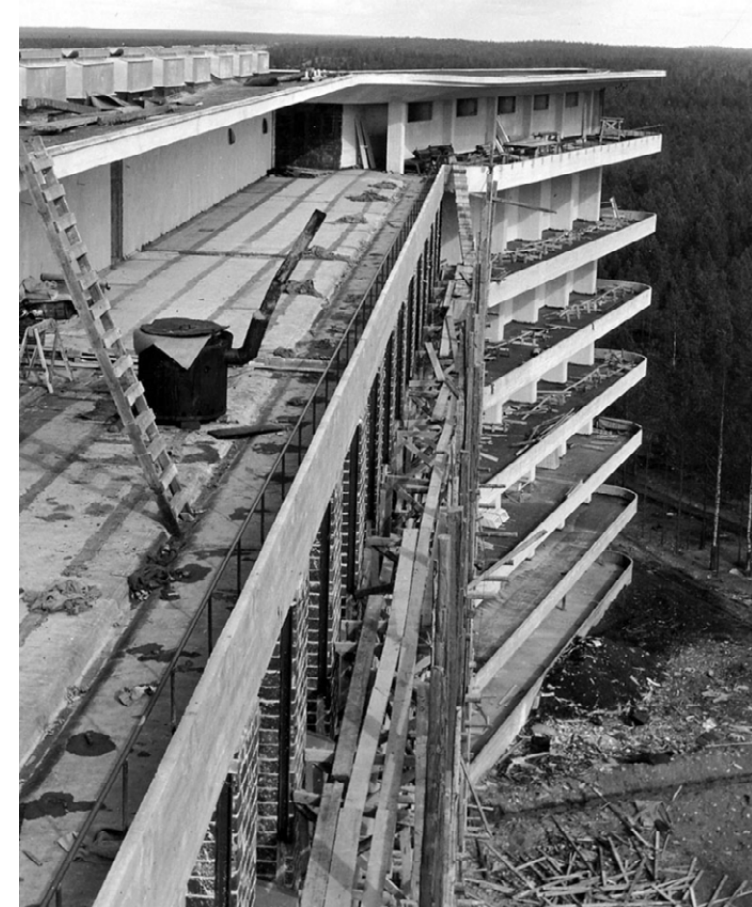
The Paimio construction site (AAM 50-003-079).

¹²⁰ In Finnish: "Rakennusmestari Arvi Ahti on suorittanut tuberkuloosiparantolan betonirungon rakentamisessa "mestarinäytteen". Melkein päätä huimaa, kun katselee päädyistä pilarimaiselle näyttävää betonirunkoa. [--] Sehän näyttää seisovan yhden seinän varassa. Tosiasia kumminkin on, että siinä se seisoo Preitilän nummella, mahtavana luomuksena insinööritaidon ja ammattikätevyyden ilmettynä ihmeenä. Rakennusmestari Ahdin vakuutuksen mukaan on työ suoritettu niin huolitellusti, ettei edes nykyinen korkea työtekniikka pysty parempaa aikaansaamaan. Ja sen me uskomme." (*Turunmaa* 17.6.1933).

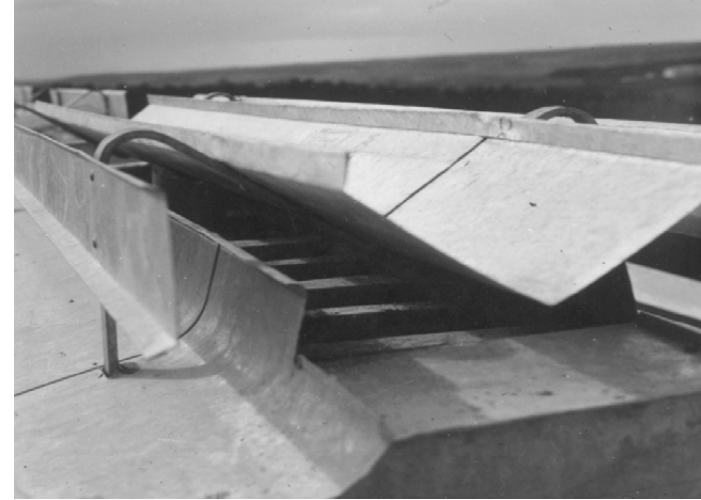
The covers of the A-wing ducts differed from the original design (AAM 50-003-142).

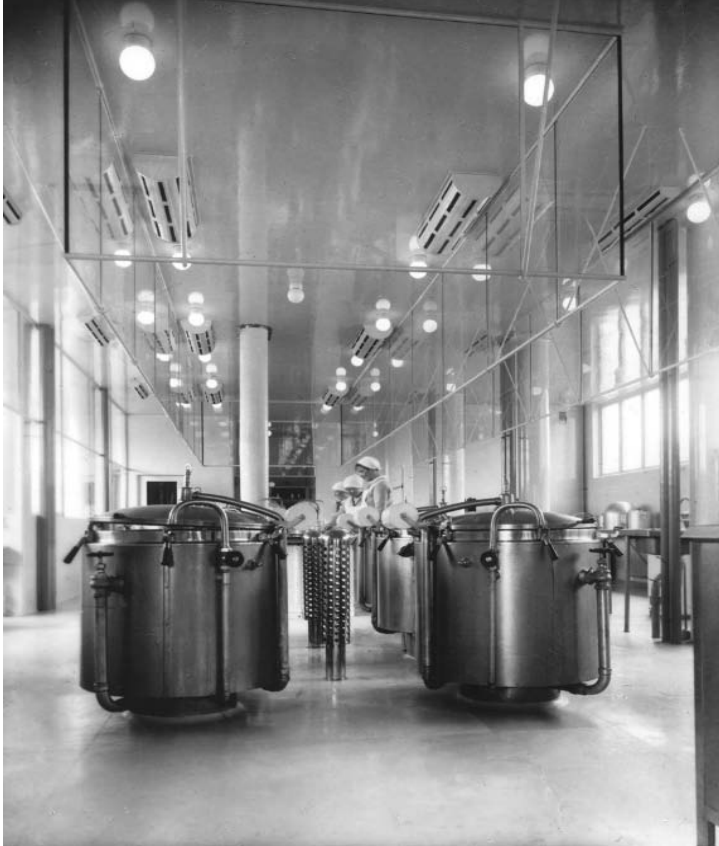
The original kitchen with air outlets and glazed steam collectors (AAM 50-003-402 Gustaf Welin 1933).

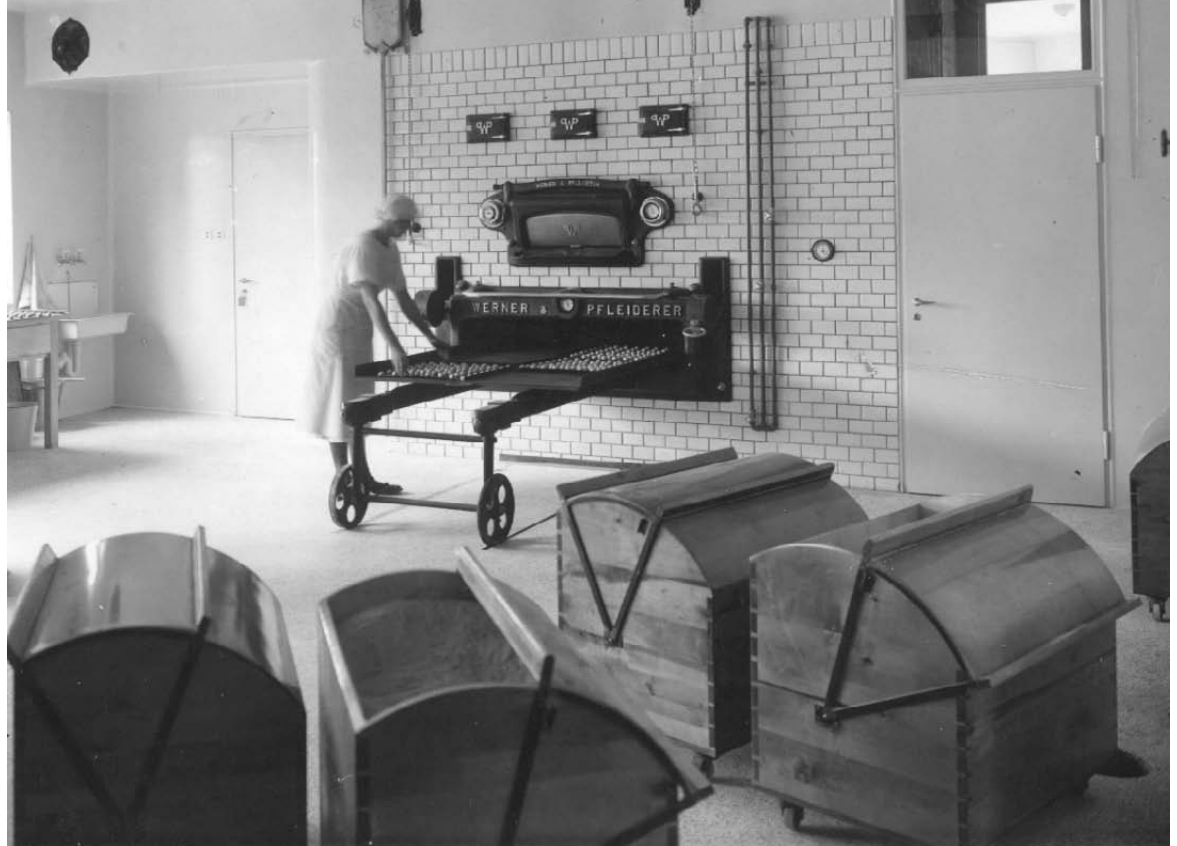
The baking oven on the basement level, an air outlet fan is visible in the far left corner (AAM 50-003-393 Gustaf Welin 1933).

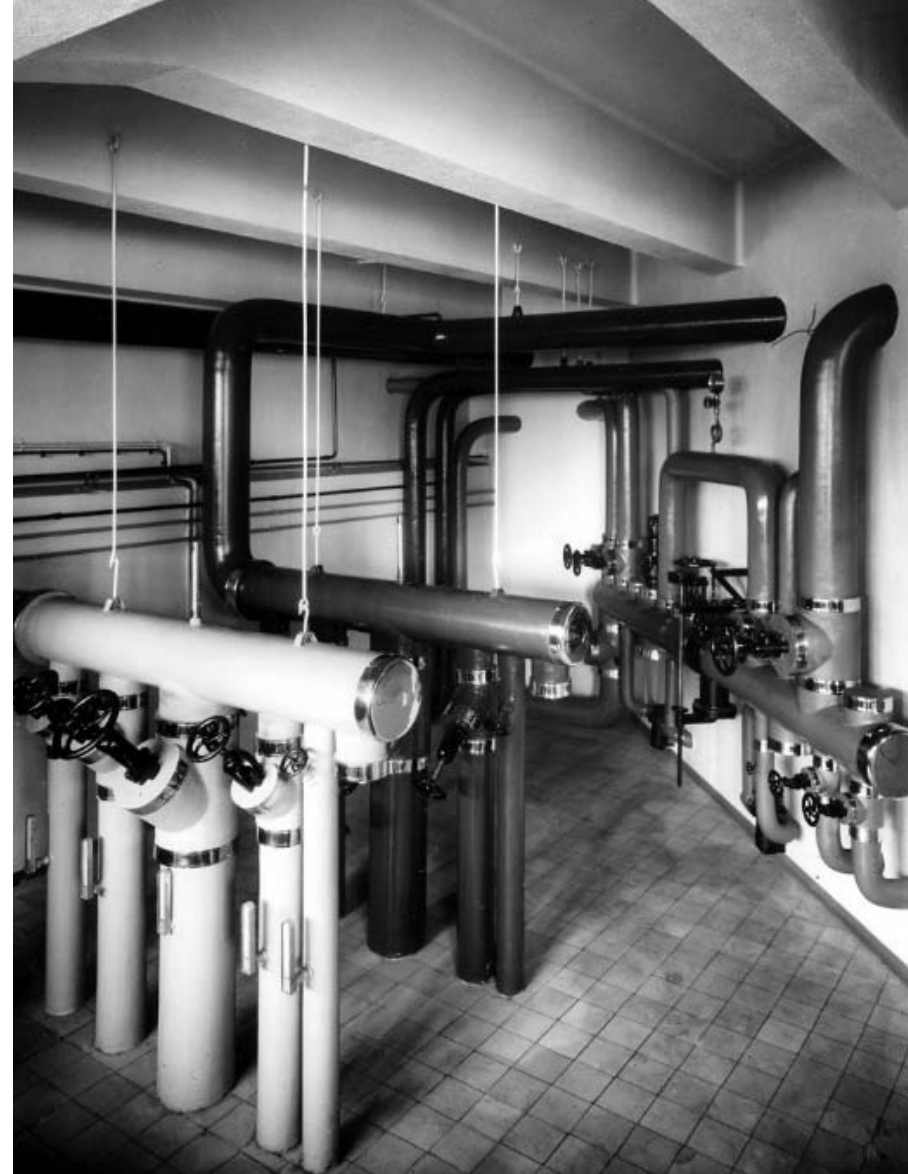
*Different coloured pipes in the control room
(AAM 50-003-411 Gustaf Welin).*

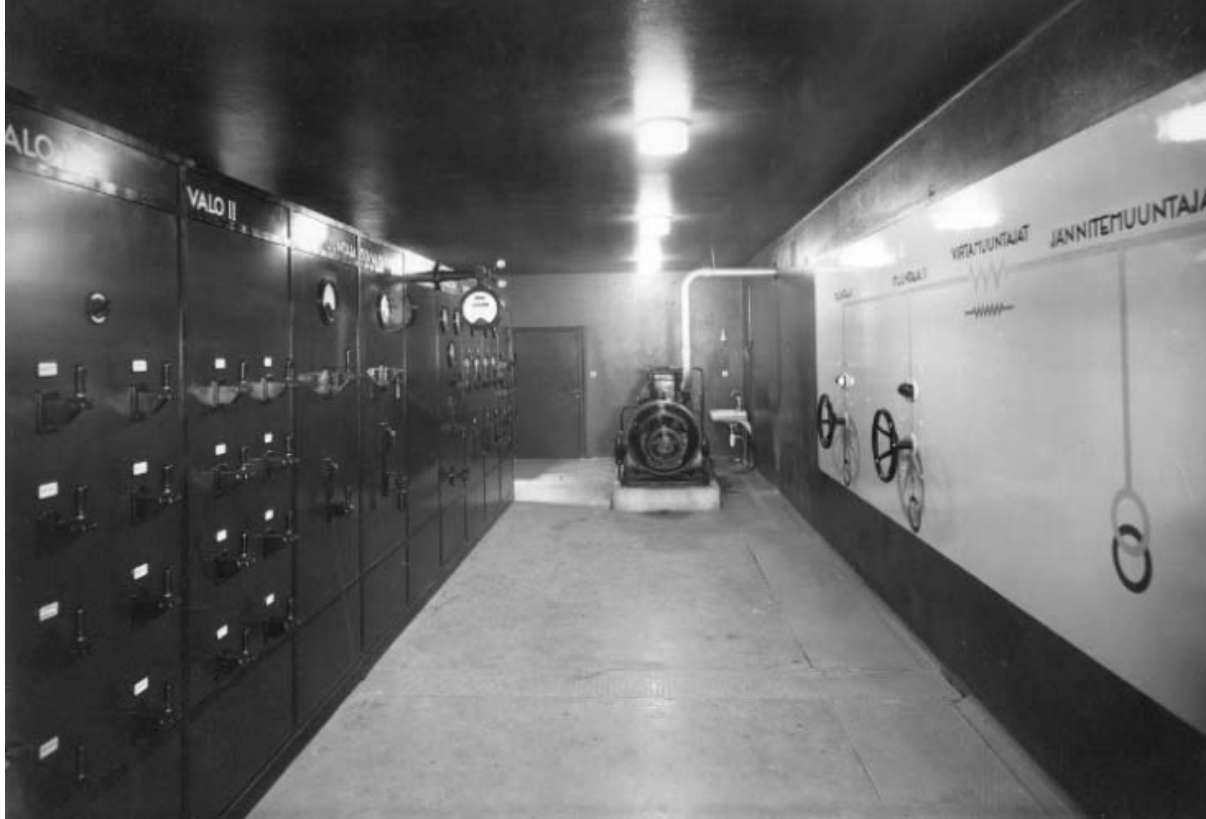
Transformer equipment by Hankkija, the painting work on the wall is by Eino Kauria. (AAM 50-003-405 Gustaf Welin).

The electrical contractor was Keskusosuusliike Hankkija. In the main transformer room the different parts were separated by walls. The niches, holding the electrical installations, were closed off by timber beams in order to prevent accidental touching. The niches were further equipped with drains in case of possible oil leaks. The control room had informative paintings on the wall by Eino Kauria.

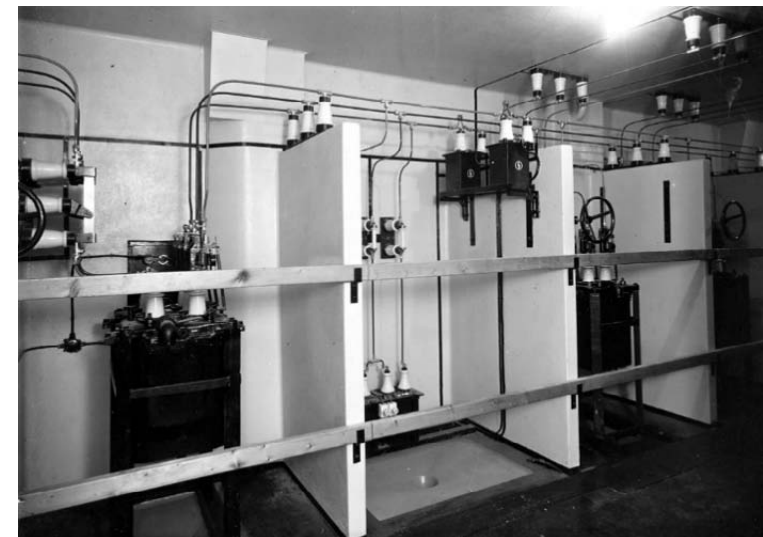
The transformer room, possibly on the other side of the wall from the previous photo (AAM 50-003-506 Gustaf Welin).

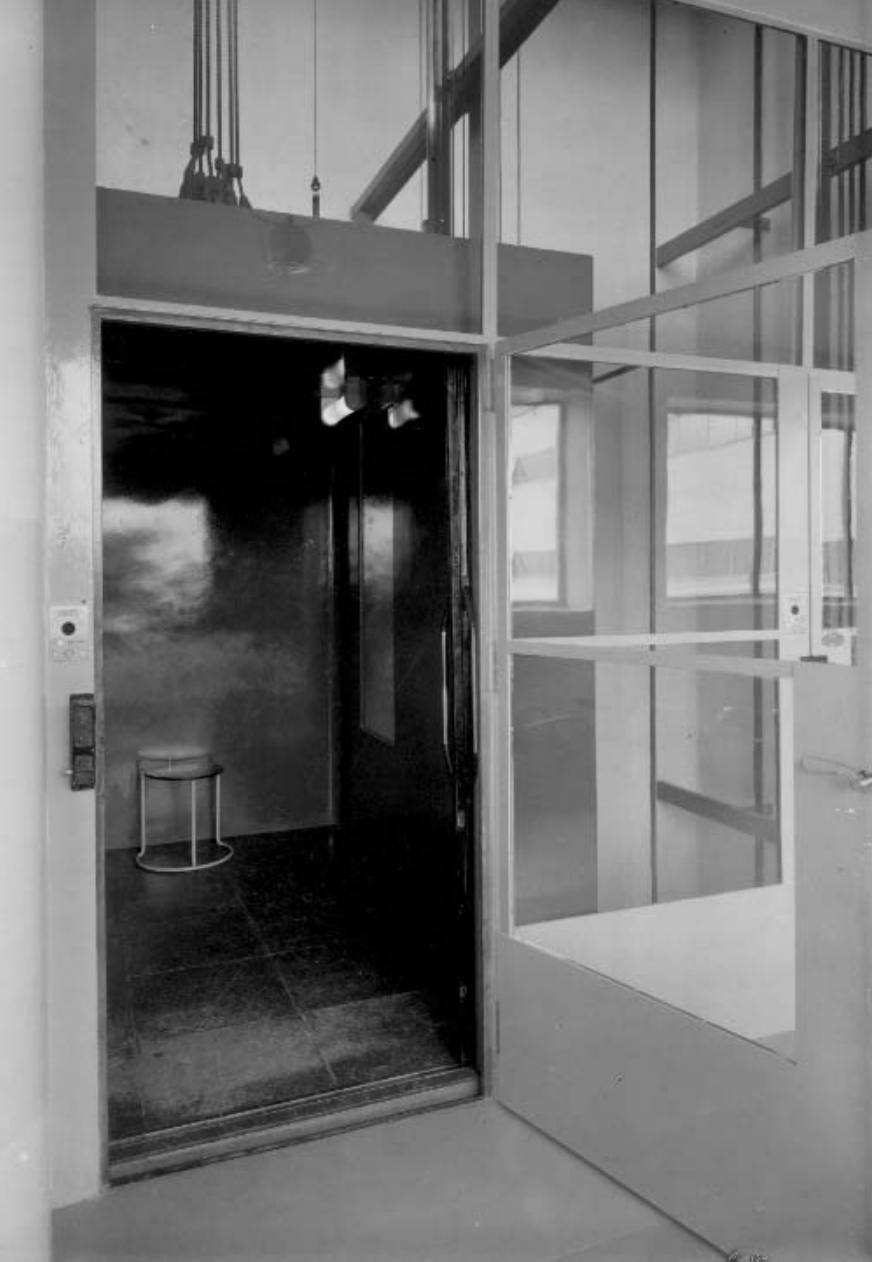
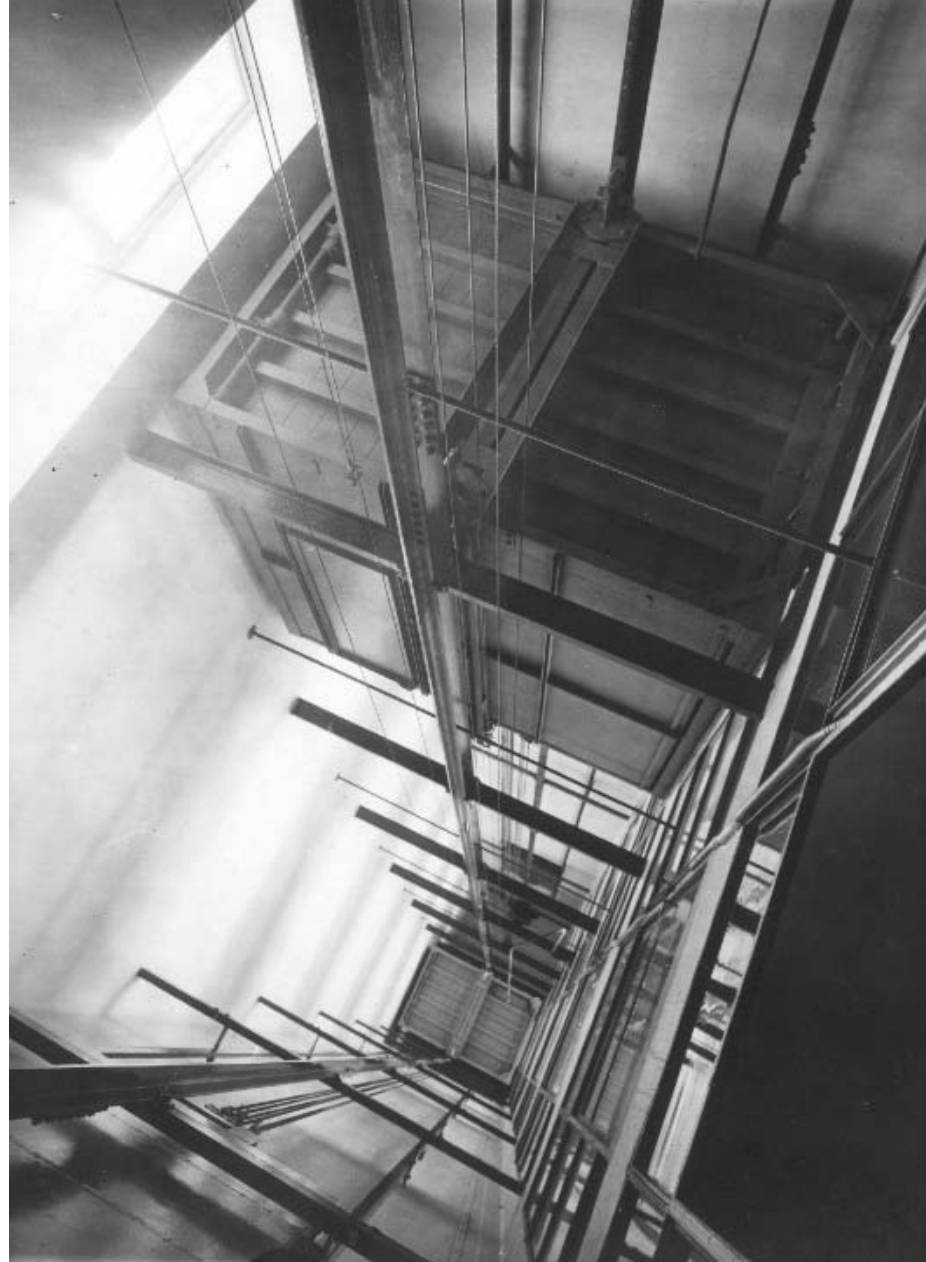
The main elevators were capable of transporting 15 persons at a time over 8 stories. (AAM 50-003-344; AAM 50-003-341 Gustaf Welin).

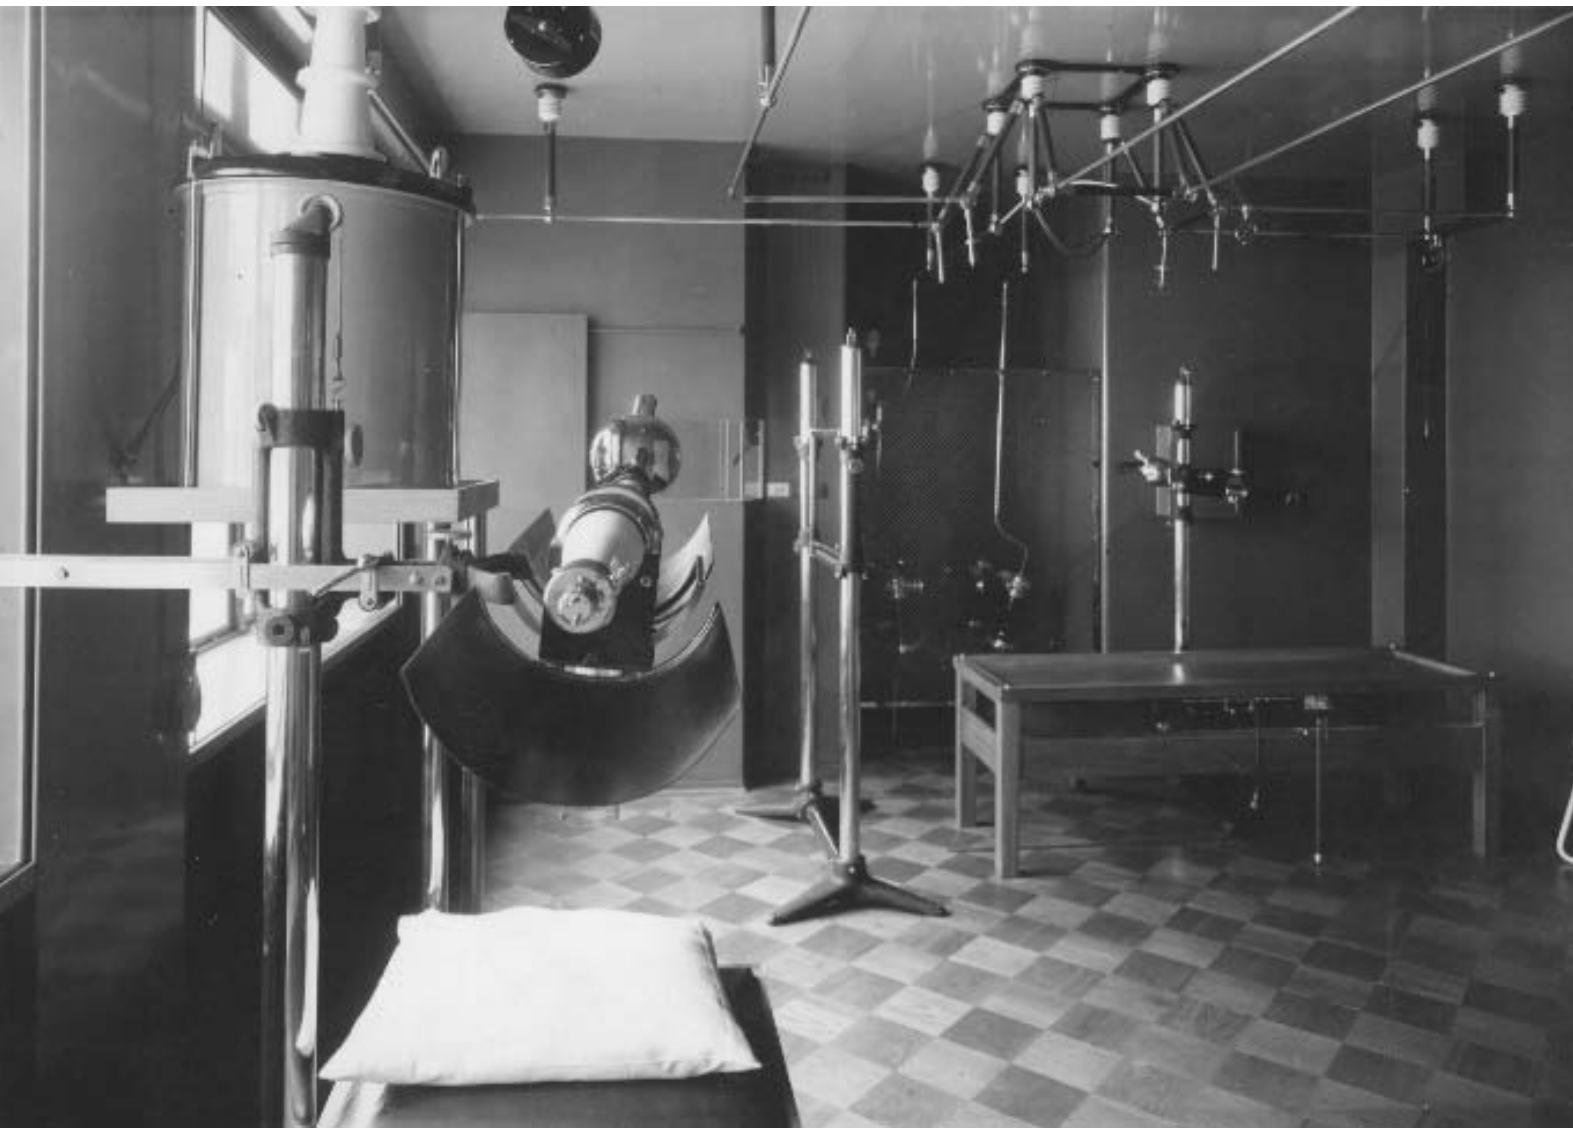
The original X-ray machinery located on the ground floor of B-wing, (AAM 50-003-371 Gustaf Welin).

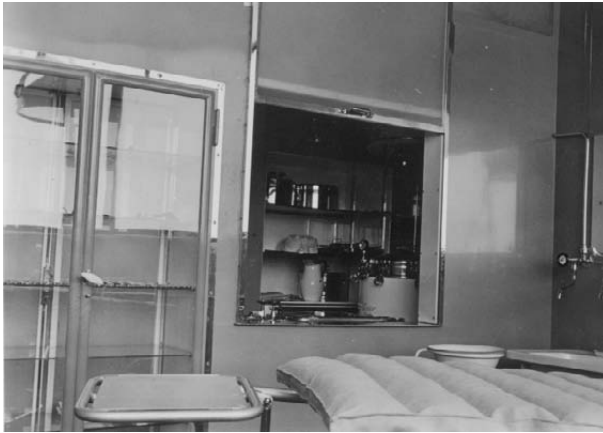
Hatch to the sterilization equipment room from the operating theatre, (AAM 50-003-380).

During the 1930s, the technical installations in the operating theatre included the following features: a roof-light and extensive windows provided abundant daylight in the curved space with the operating table in the centre; next to the operating theatre was a rather small space for the sterilization of the equipment and they could be passed to the theatre via a hatch in the wall.

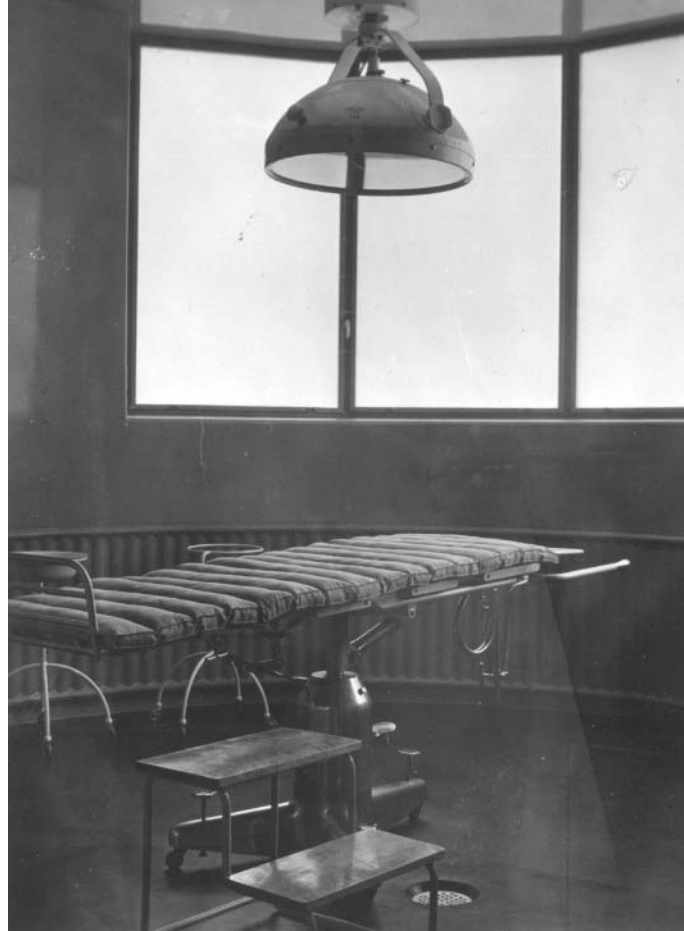
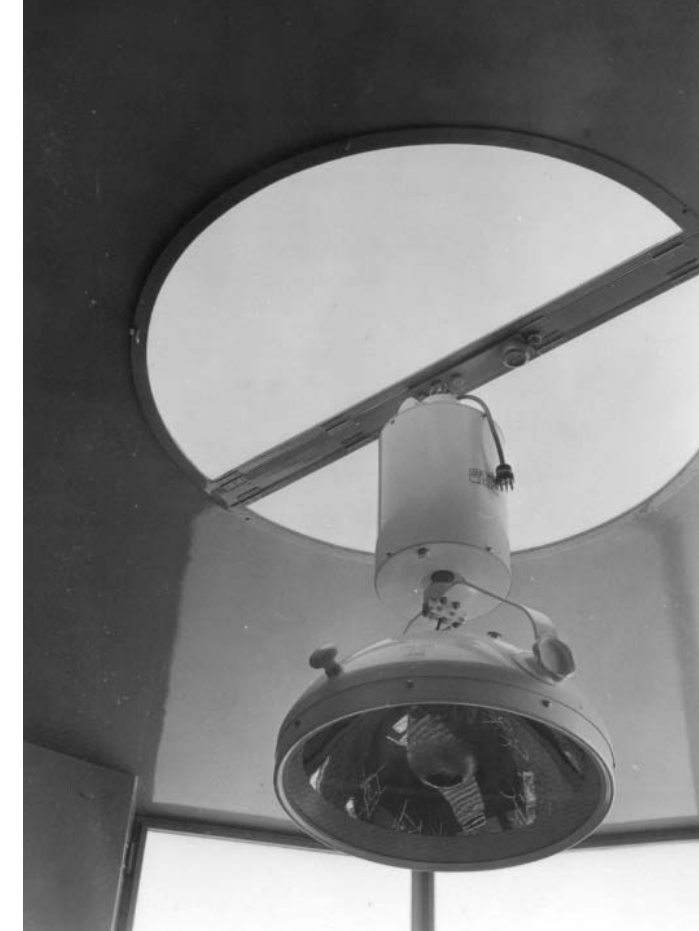
Operating theatre on the ground floor of B-wing, with a curved radiator, (AAM 50-003-374; AAM 50-003-375).

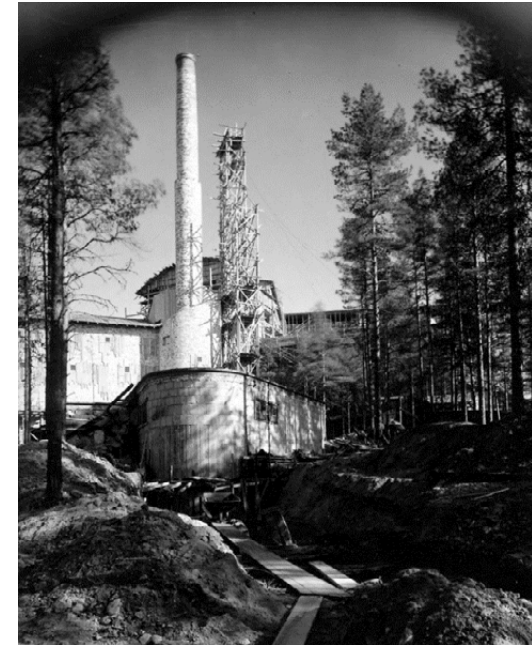
The heating plant, in the foreground, under construction (AAM 50-003-488 Gustaf Welin).

The boilers, located in a separate building, were mostly heated with coal, and the first large shipping of coal for the sanatorium arrived in Turku harbour on November 18, 1932.¹⁶⁸ The type of boiler was chosen so that also wood could be used as the fuel source.¹⁶⁹ During the war time, the heat was gained by burning turf, which was acquired from grounds rented for the sanatorium in March 1942.¹⁷⁰ The use of turf continued during the late 1950s, but was terminated in 1959. In 1960 the turf plant fell victim to a fire caused by lightning, and it was never again put into operation.¹⁷¹

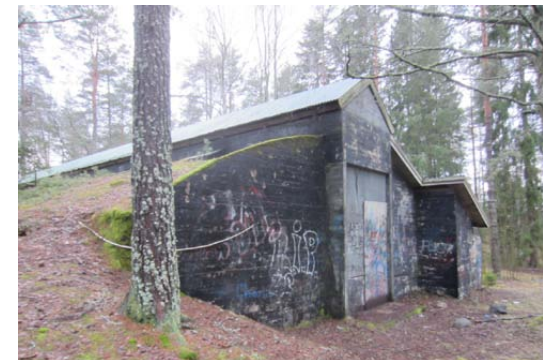
The abandoned water purification plant at Paimio in 2015 (AAM Malmberg).

The drainage was discussed during the design process, as mentioned earlier, and a separate waste-water purification plant was built. The concrete structure, with a long opening strip window at the very top, was an elegant design. The original drawings have not been found, nor is the author of the design known for certain. Thus it is not clear to what extent Aalto was involved in the design, though engineer R. Granqvist was involved in the design.¹⁹⁶

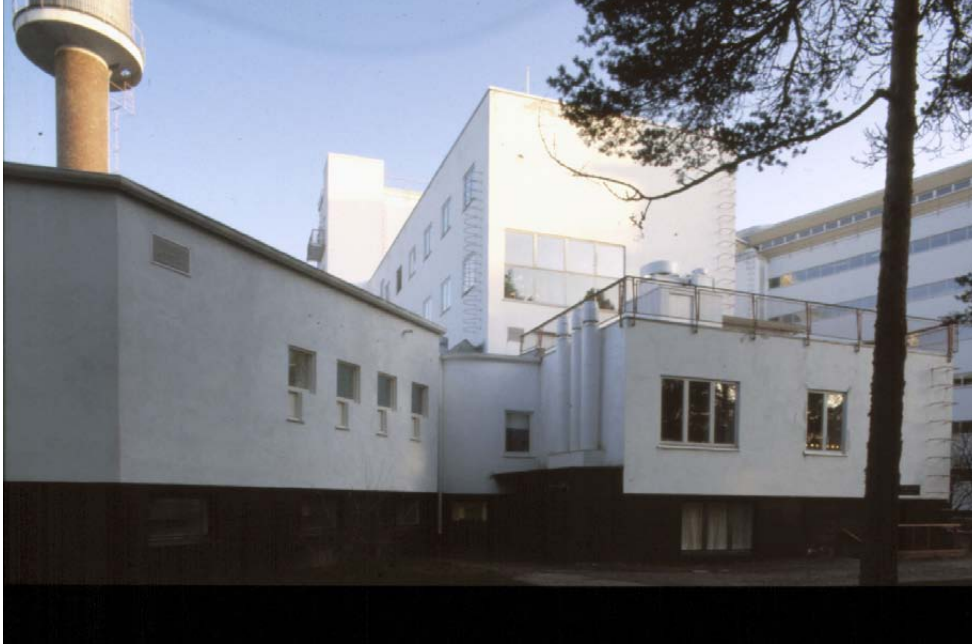
*The operating theatre wing next to B-wing
in the 1970s (AAM 5305 Mikko Merckling).*

OPERATING THEATRE WING

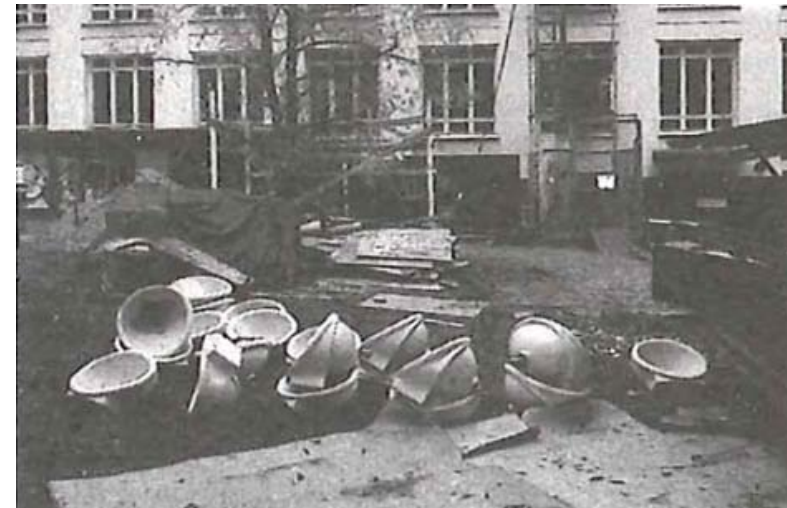
Removed wash basins, designed by Alvar Aalto on the building site during the refurbishment (Arkkitiehti 7/1977, 15).

The patients' rooms in Paimio Sanatorium are to be completely rebuilt, apart from one museumified room. The round cornered cabinets and silent basins are to be replaced with standard models. [--] In widening the doors the original birch plywood doors are to be replaced with painted plywood

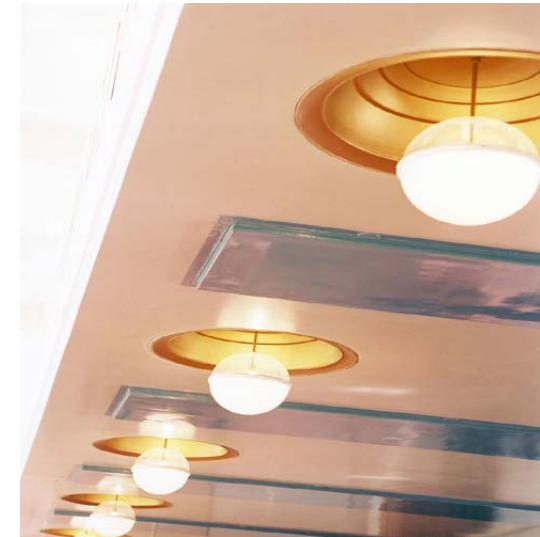
The original heating panels in the dining hall, today unused (AAM L2168 Judith Turner).

The heating panels mounted on the ceilings of the patients' rooms were replaced in the 1970s by regular wall-mounted radiators installed beneath the windows. One assumes that the change was an agreeable one from the users' point of view. This is the only way to eliminate the draught from the windows in the Nordic climatic conditions. The ceiling panels have scarcely been used in Finland since around the 1930s. They have later been used in the electrical heating of single-family houses and since the 2010s more often in cooling and occasionally also in heating systems in contemporary office interiors and warehouses. The choice of heating panels on the ceilings combined with natural ventilation was a very peculiar one in a 1930s sanatorium. According to the minutes of the building committee, the decision-making process was difficult. Instead of the usual concerted decision, they ended up voting on the issue. The arguments for ceiling panels were based on the possibility of having a lower room temperature in the wintertime, as the panels provided the thermal radiation from the ceiling for the objects and patients. Since neither the preserved minutes nor other sources can provide the full insight, it seems obvious that Aalto was very keen to use the unconventional system of the ceiling panels.

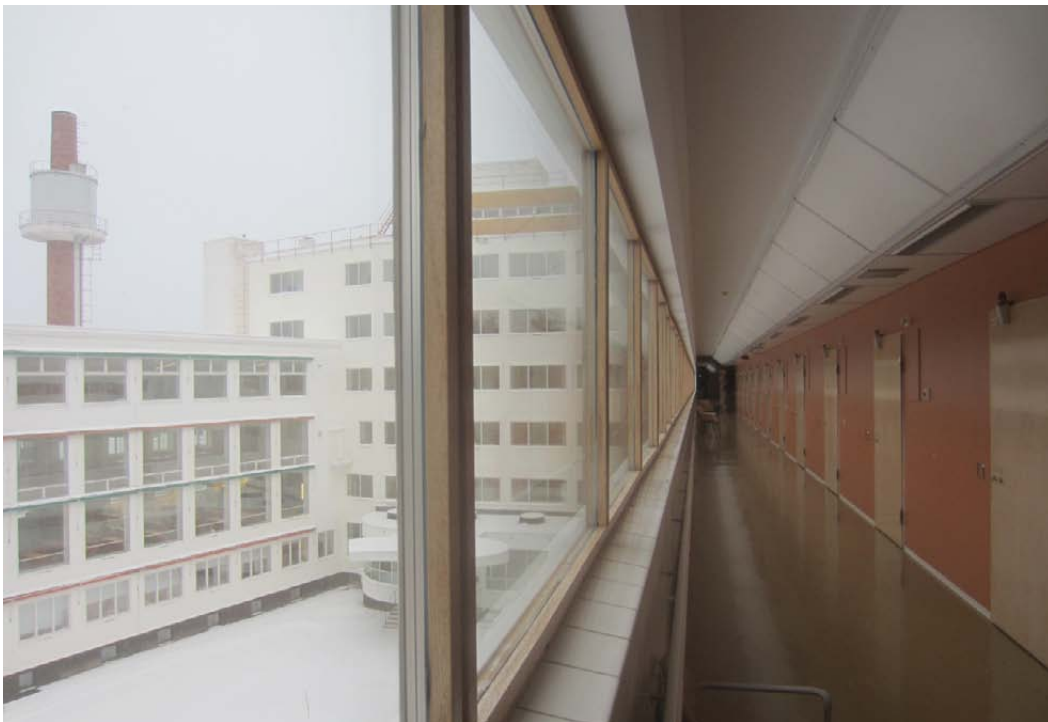
A corridor in A-wing with the partial suspended ceiling (AAM Malmberg).

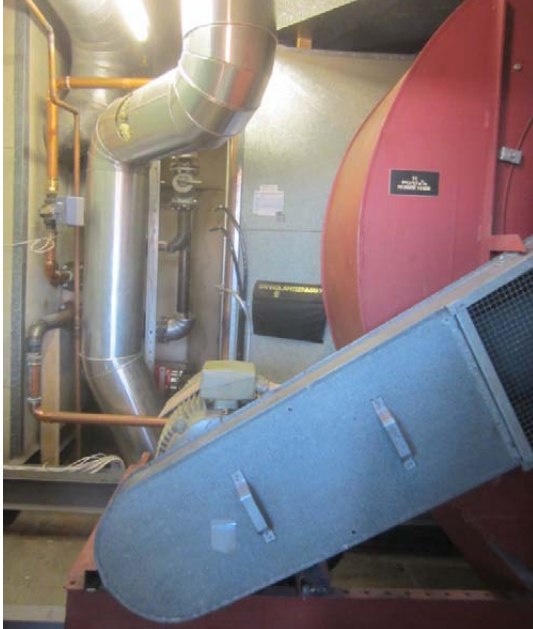
*The ventilation machinery serving A-wing
(AAM Malmberg).*

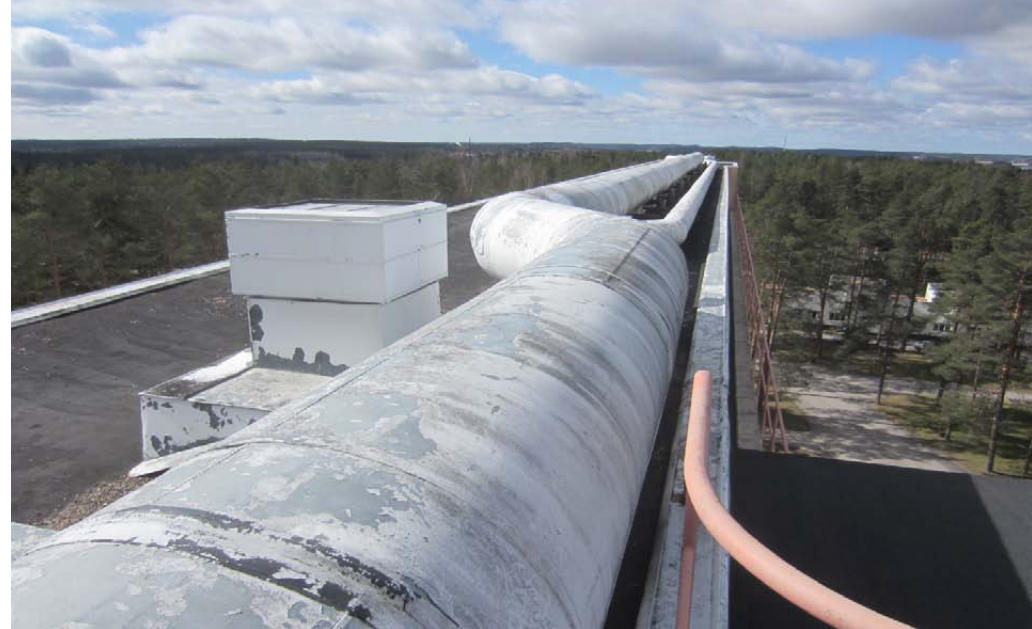
*Installations on the roof top of A-wing
(AAM Malmberg).*

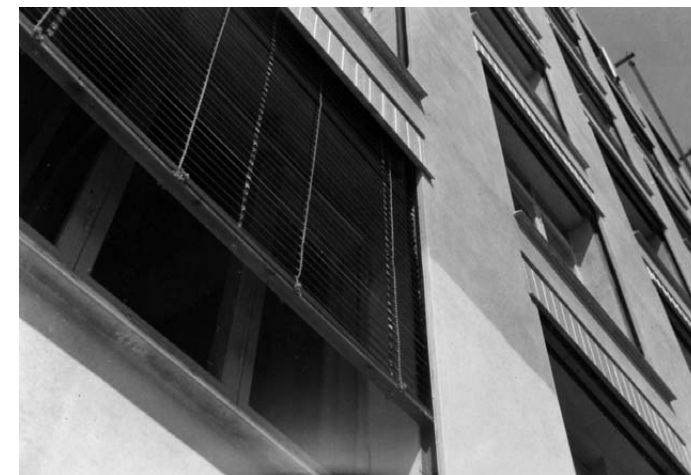
*The wooden blinds were part of the
original equipment of the patients'
rooms (AAM 50-003-250).*

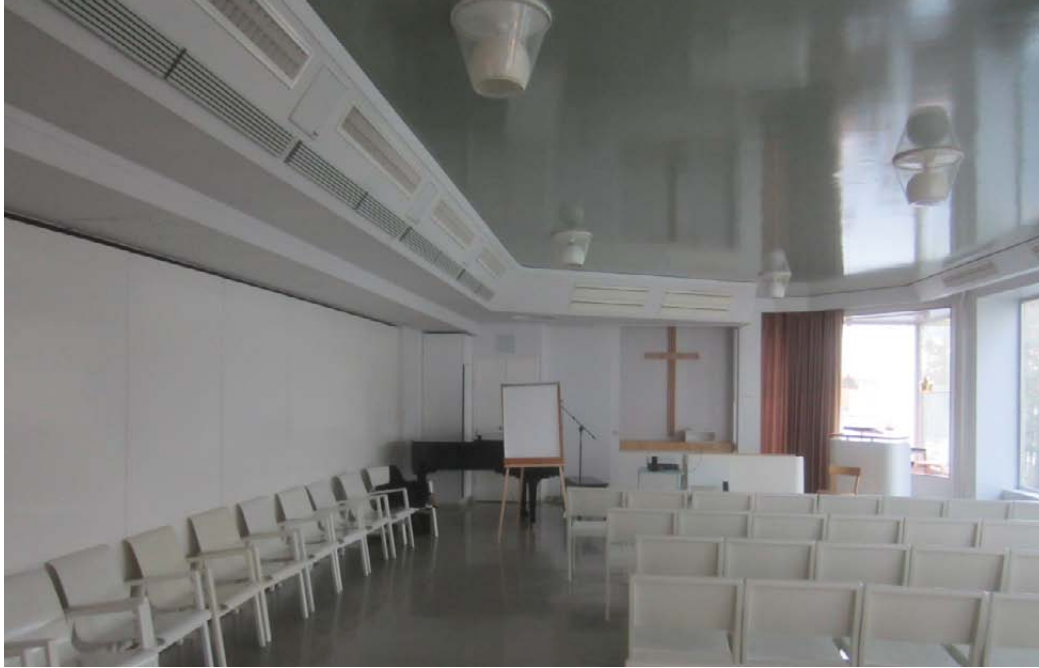
The partially suspended ceilings were installed in the day room in the 1980s (AAM Malmberg).

The refurbishment of A-wing took place in 1974–79 as the treatment of tuberculosis had come to an end. In this renovation the rest of the patients' wing was fitted with mechanical ventilation, which required the partial suspended ceilings in the wards and on the roof terrace. Some of the original terraces were converted into ventilation machinery rooms. Practically the whole of A-wing was ventilated by a single incoming and exhaust air unit, which included a heat recovery unit. It was also equipped with an evaporating moisturizer, which was most likely disconnected soon after its realization. Moisturizing in a 1930s building carried serious threats to the structures and also to the hygiene of the ventilation. In the tight machinery room, the careful cleaning and maintenance required by the system was practically impossible.

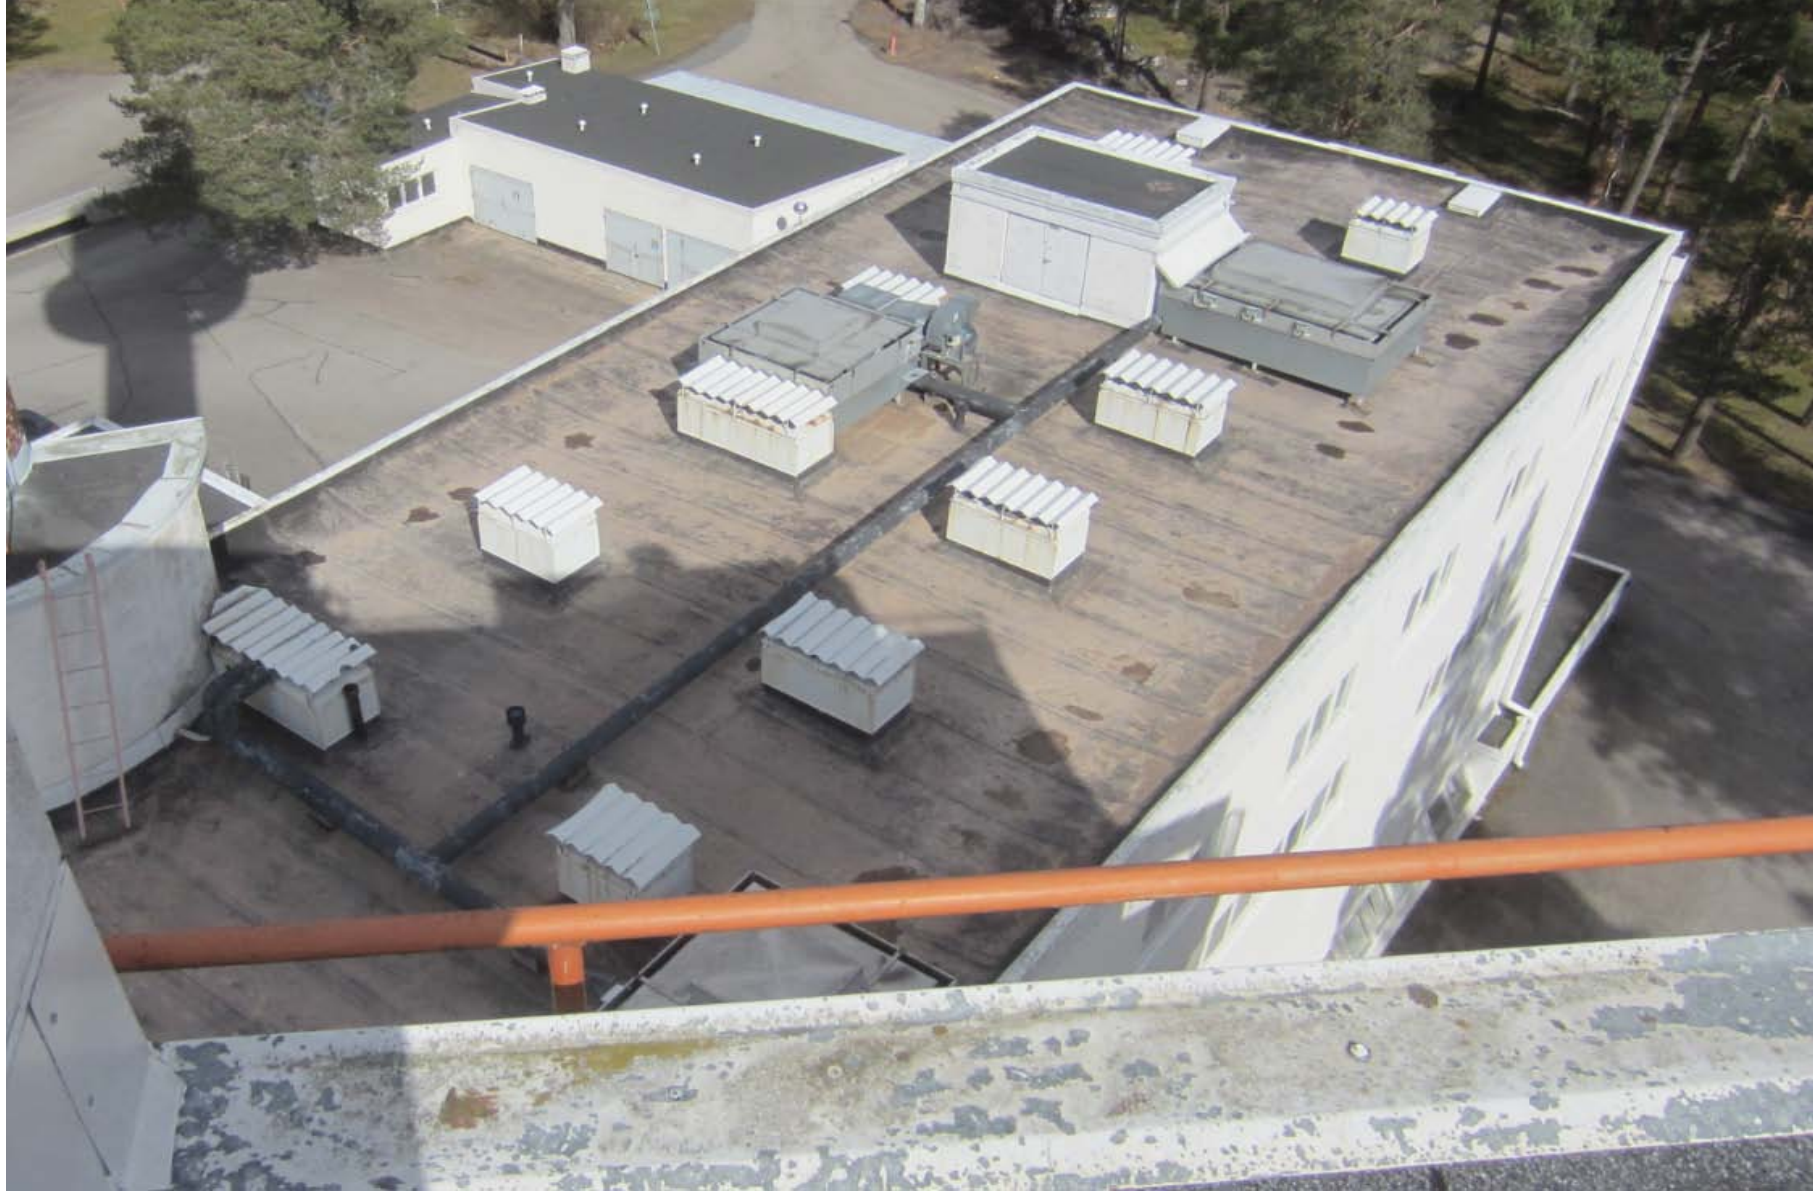
*The roof top of C-wing in 2015
(AAM Malmberg).*

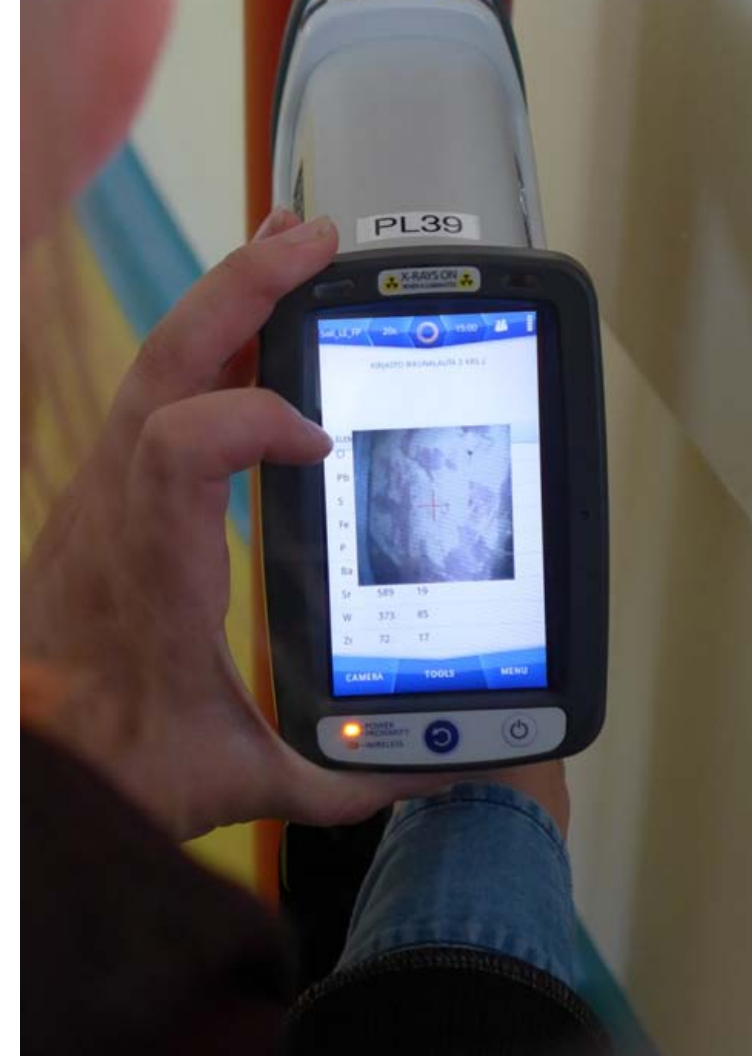
Krista Hackzell, a chemist and lecturer from Metropolia University of Applied Sciences shows the students of interior conservation how to use the X-ray fluorescence instrument (AAM Elina Riksman).

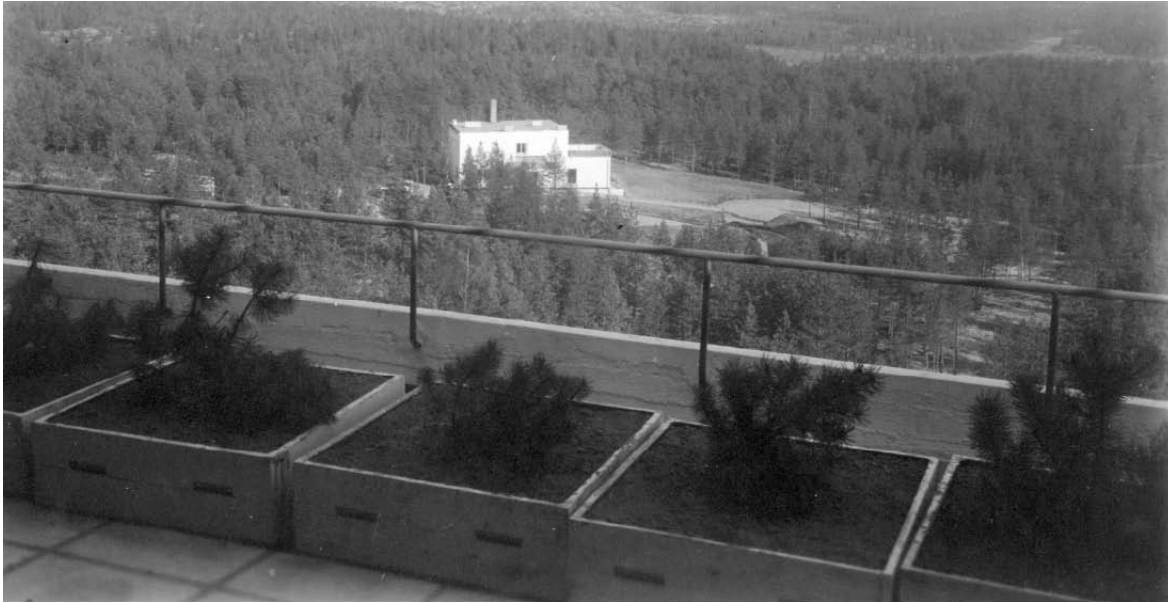
*Planting boxes on the roof terrace of A-wing
(AAM 50-003-262).*

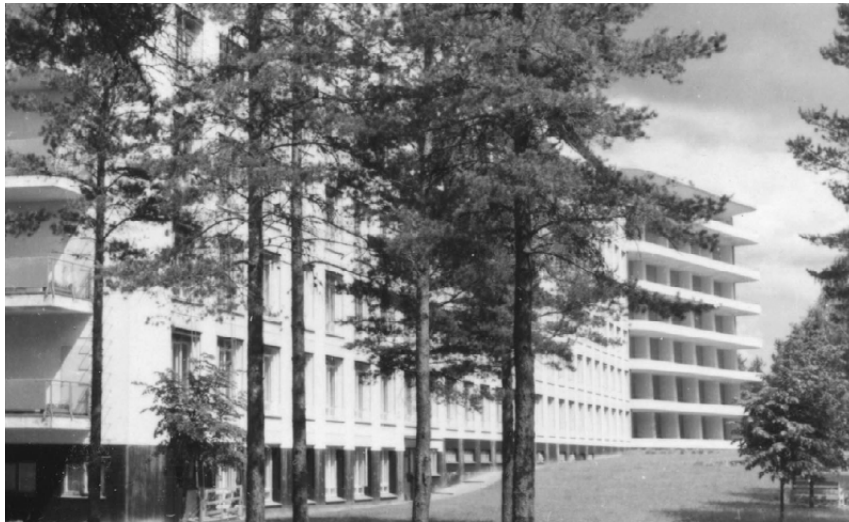
1930–40s: The garden was light and open. There were gravel paths next to the main building and around the fountains. Next to the fountain are two lindens and graminoids (Sukkinen's photo collection).
