**PAIMIO SANATORIUM
CONSERVATION MANAGEMENT PLAN
2016**

Publisher
Alvar Aalto Foundation

The overall goal of the CMP is to guide the future use, care and conservation of the Paimio Sanatorium. The objective in preparing of this CMP has been to produce documents that bring together already existing historical records of the building, including defining of architectural features, physical analysis and the knowledge of the buildings performance over time to create a long-term strategy for decision-makers, contractors and users regarding conservation and maintenance.

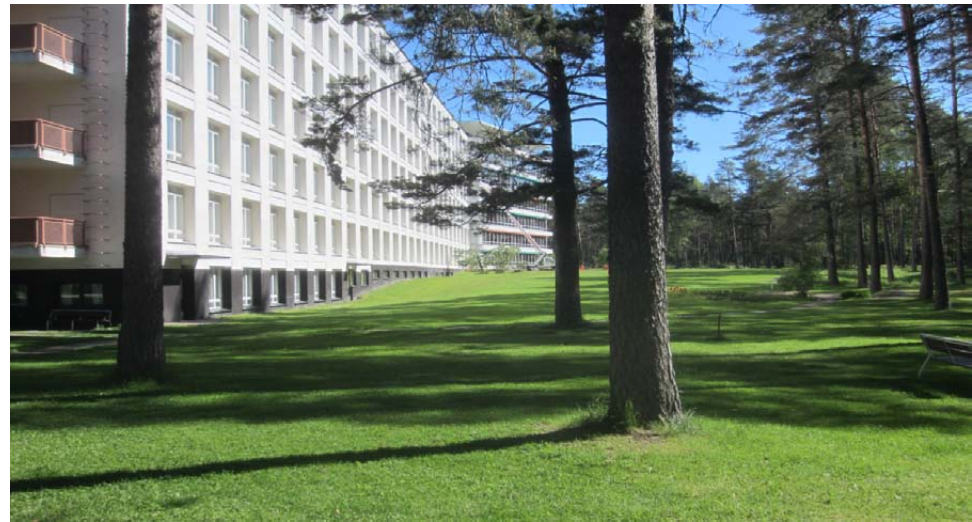
2015: The view is more open than it was in 2006. The other lindens have been cut down. The plants around the preserved fountain resemble the 1940s state. The paths are no longer visible. An asphalt road at the front leads to the 1960s nurses' apartment building. (AAM Malmberg).

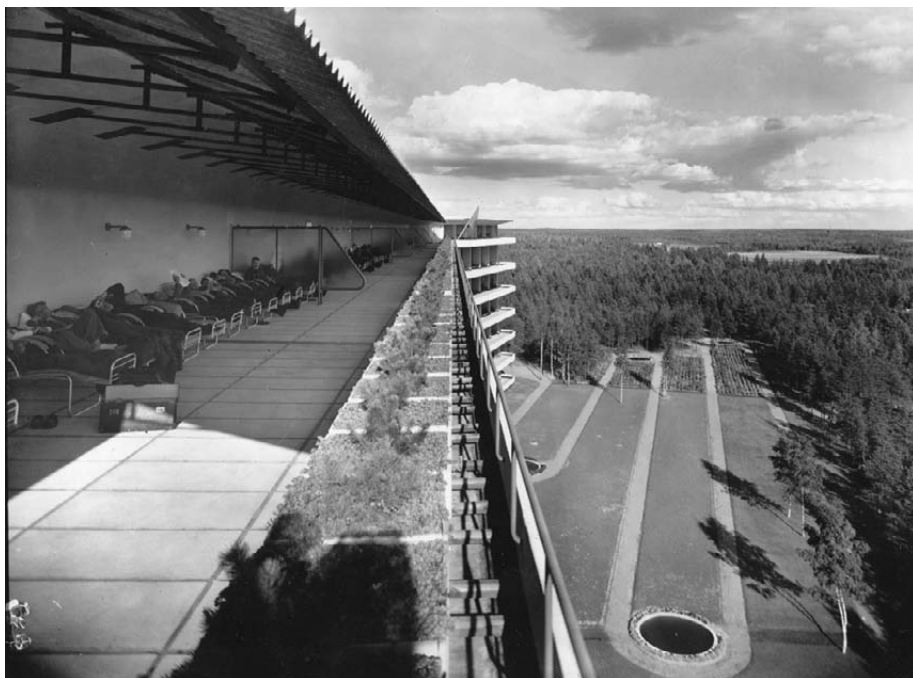
1934: The path with the fountains is completed. Some birches are left next to the walk path. At the east end of the garden the end of the grass lawn is seen (AAM 50-003-266 Gustaf Welin).

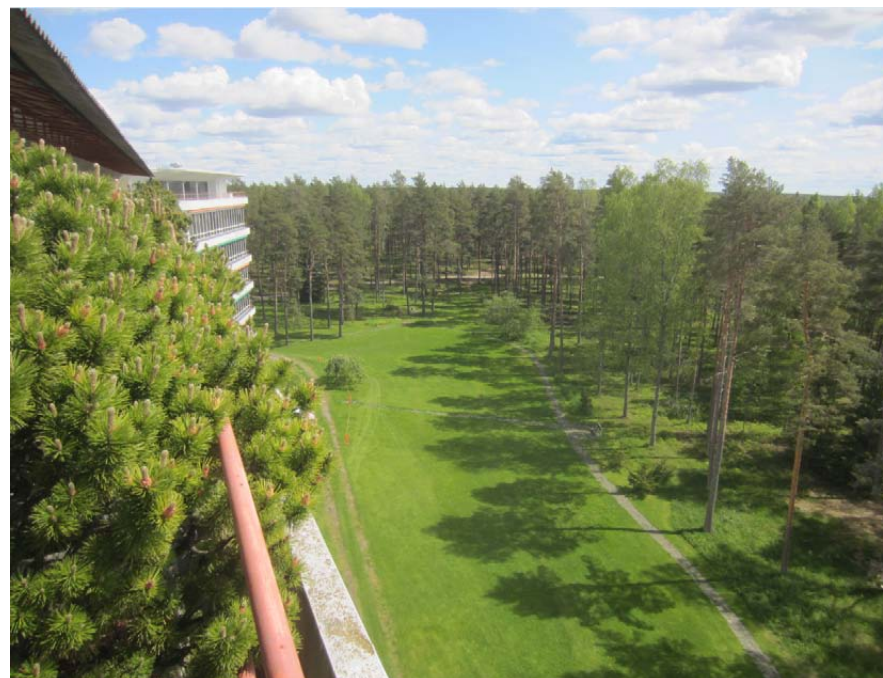
2015: Some of the birches, fountains (except one) and the paths are removed. The mountain pines at the balcony are over grown. The grass lawn covers most of the original garden area. The surrounding forest has grown as well as the survived birches. (AAM Malmberg).

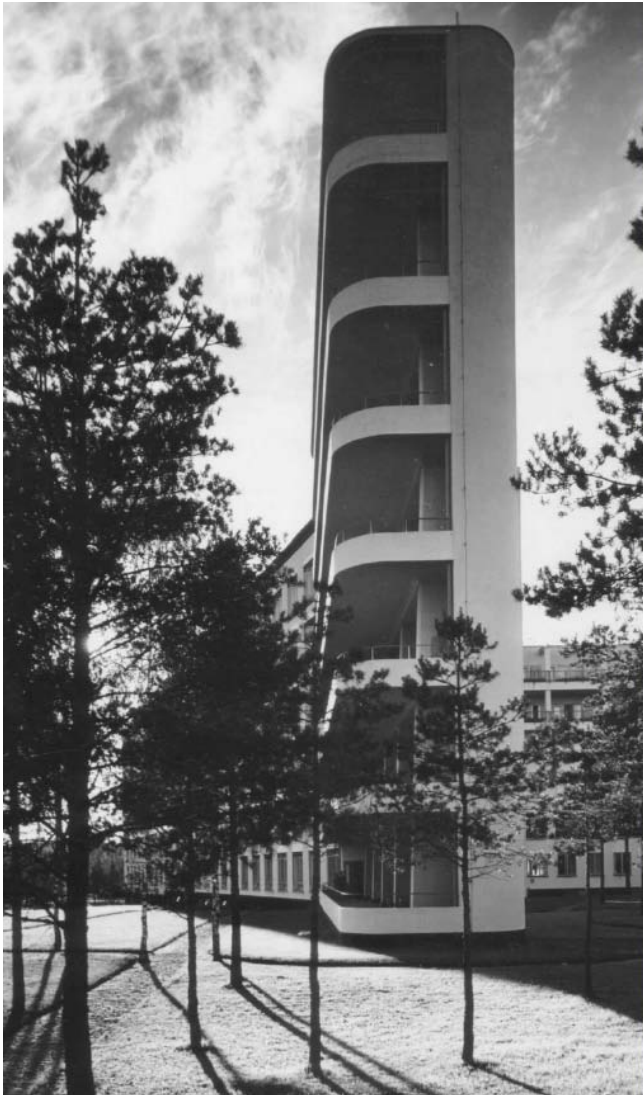
1933–36: Young vegetation around the building, and the lawn is well kept. Gravel paths are linking the building and surroundings. (Pietinen in Saarikko 2007, 56).

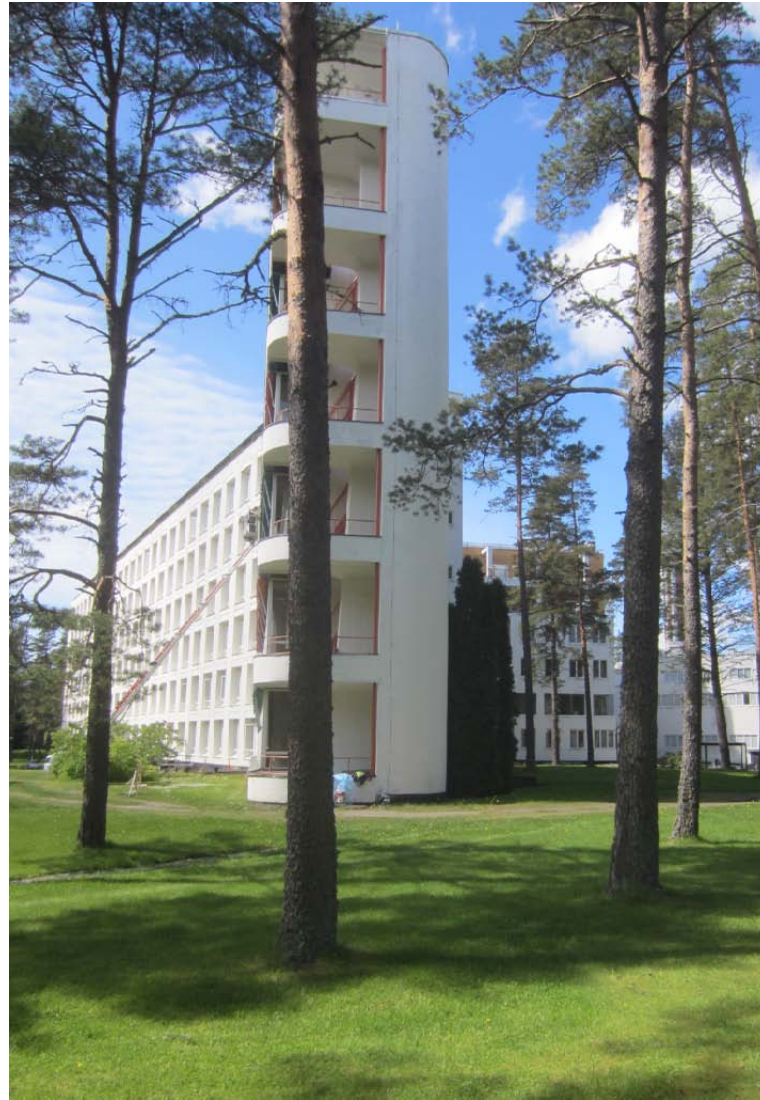
2015: The trees have reached the height of the main building. Garden like plants have been added in the southern side. (AAM Malmberg).

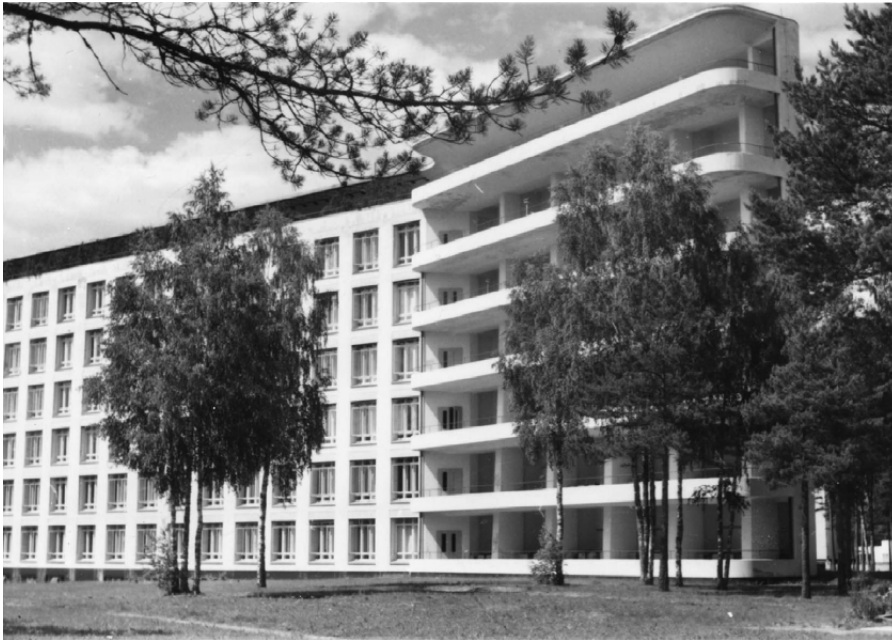
1930s–40s: The birches are approx. 10 meters tall. The garden is still relatively open. (Sukkinen in Saarikko 2007, 57).

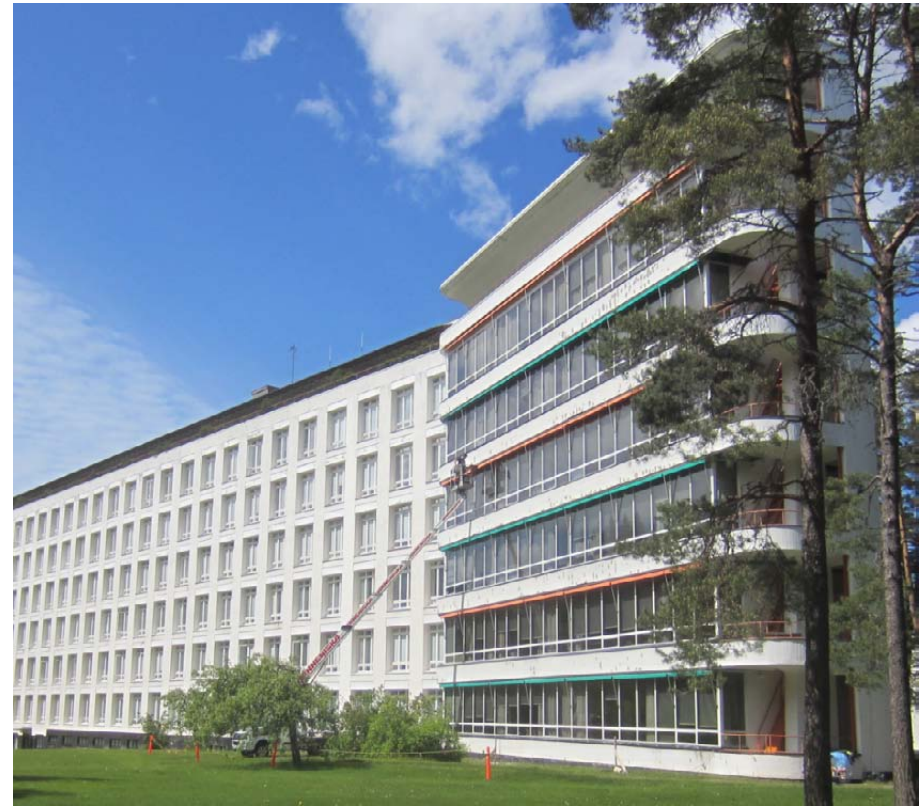
2015: The birches have been cut. The low garden like vegetation in front of the former balcony wing. (AAM Malmberg).

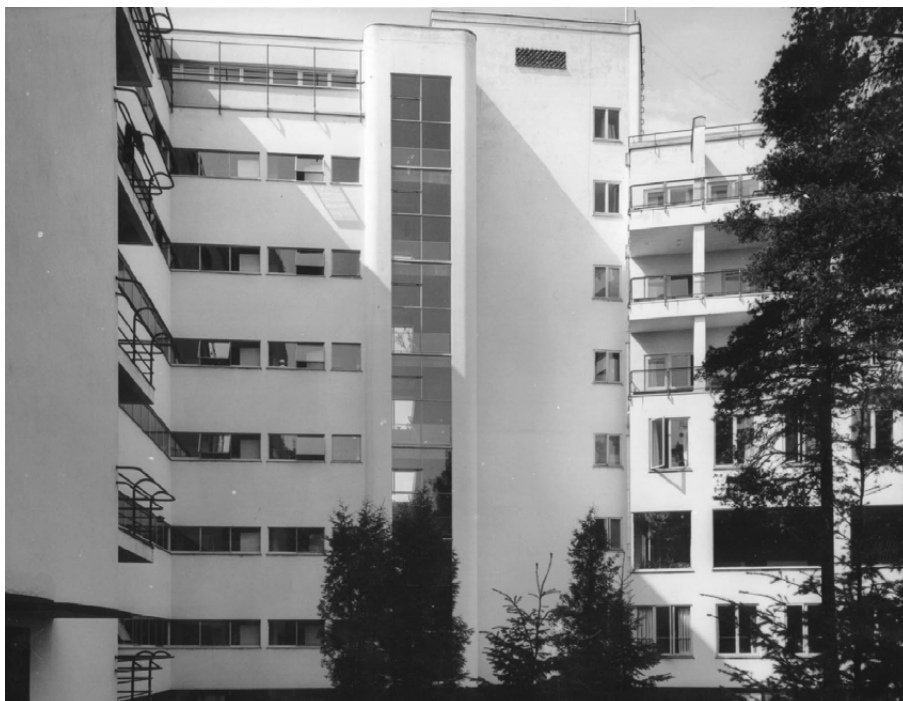
1950s: East side garden relatively open. Douglas firs and cedars are rather young. The view from the main stair case was open. (Jaakkola in Saarikko 2007, 57).

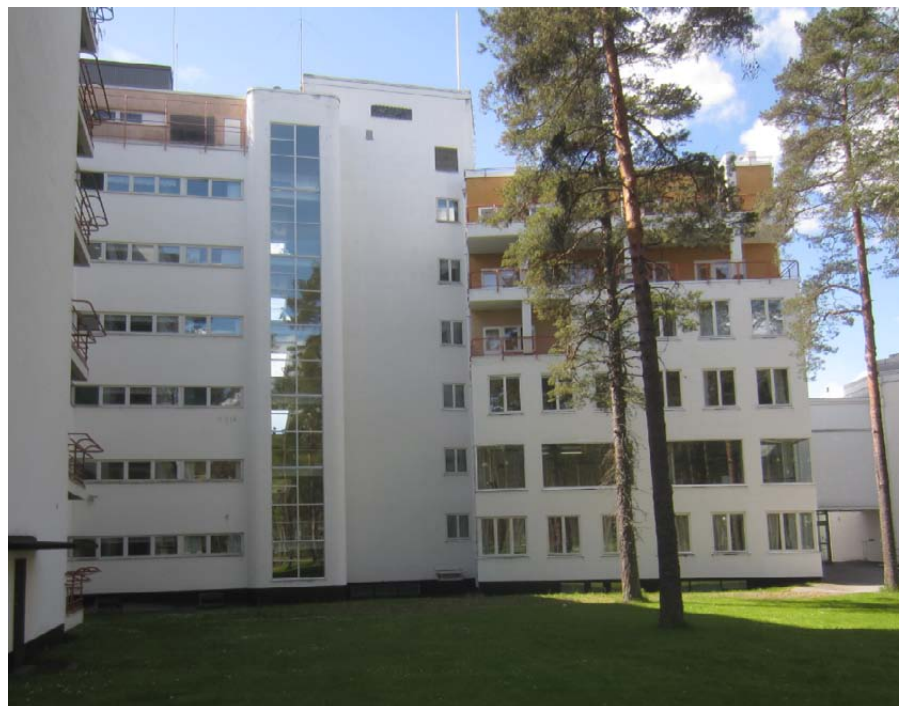
2015: Only few tall pines left, the Douglas firs as well as cedars have been cut. (AAM Malmberg).

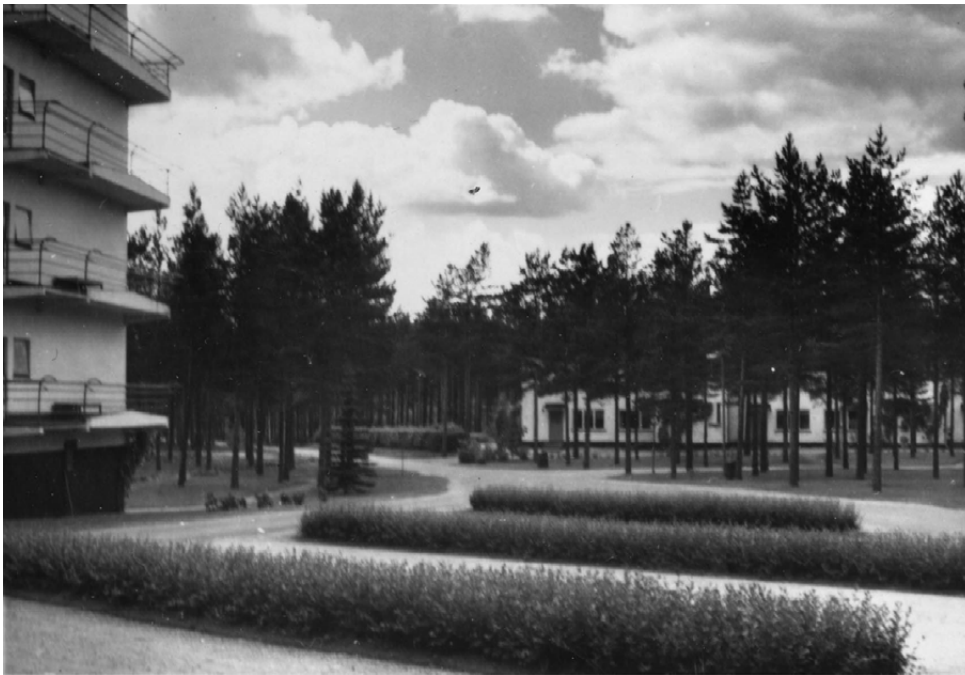
1940s: The court yard and car park in front of the main entrance is of gravel and bushes of one species are planted. (Sukkinen in Saarikko 2007, 58).

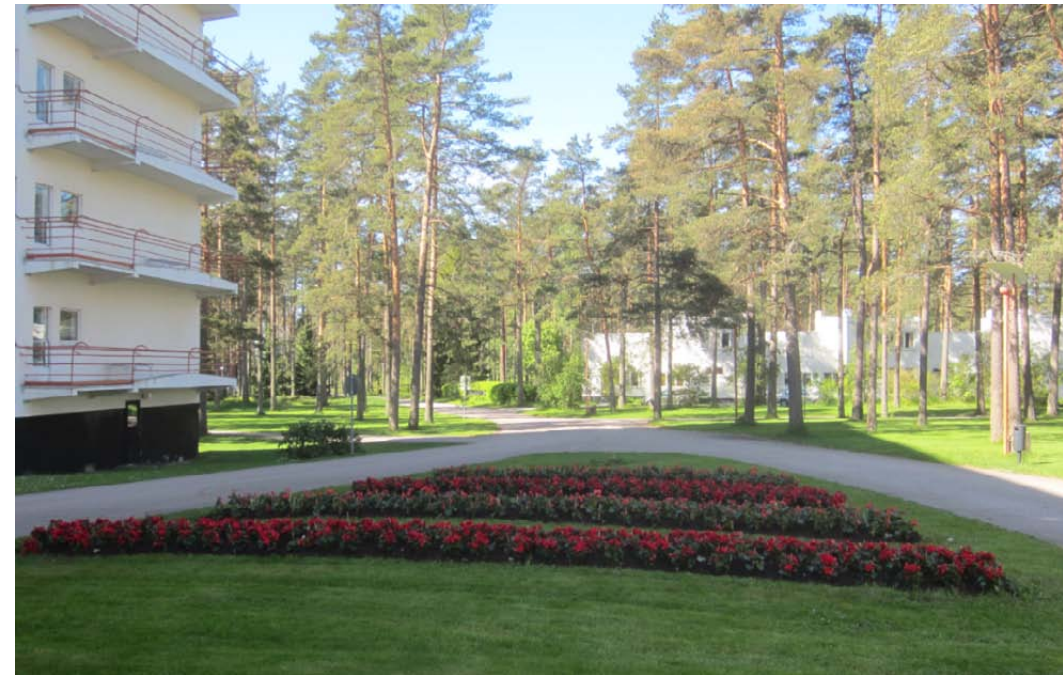
2015: The entrance court yard is without car park, road is widened to be suitable for the large vehicle and paved with asphalt. In the middle of the loop there are rows of flowers. The row house is seen in the back, but more sheltered by the bushes than in the 1940s. (AAM Malmberg).

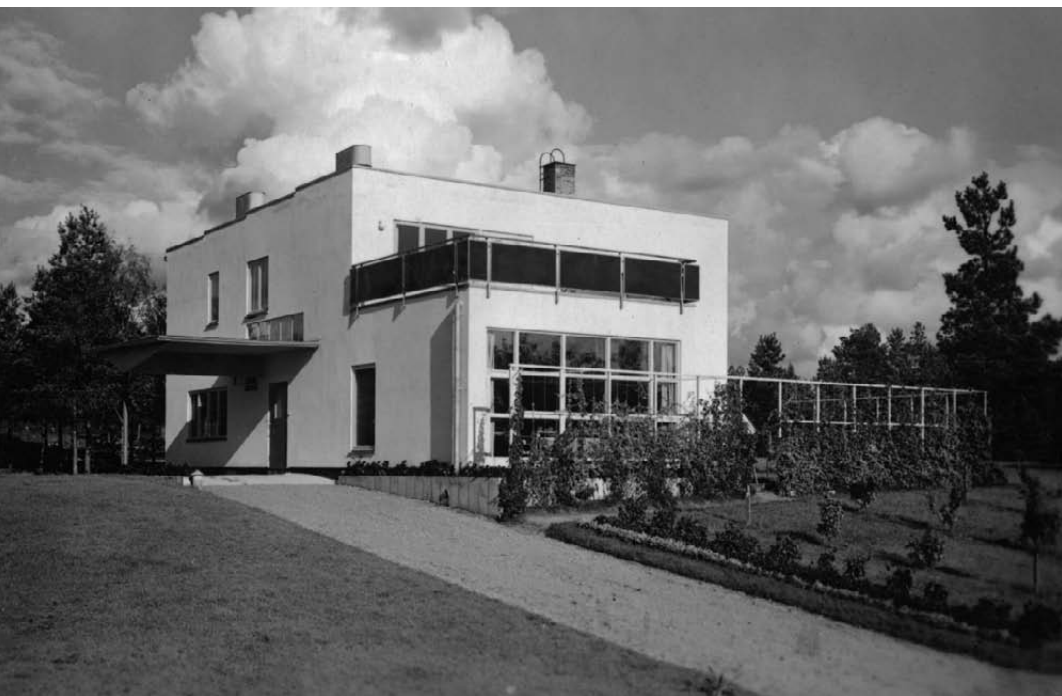
Early 1930s: Chief physician's villa with the fence and the creepers. The grid of apple trees is just planted. (AAM 50-003-466).

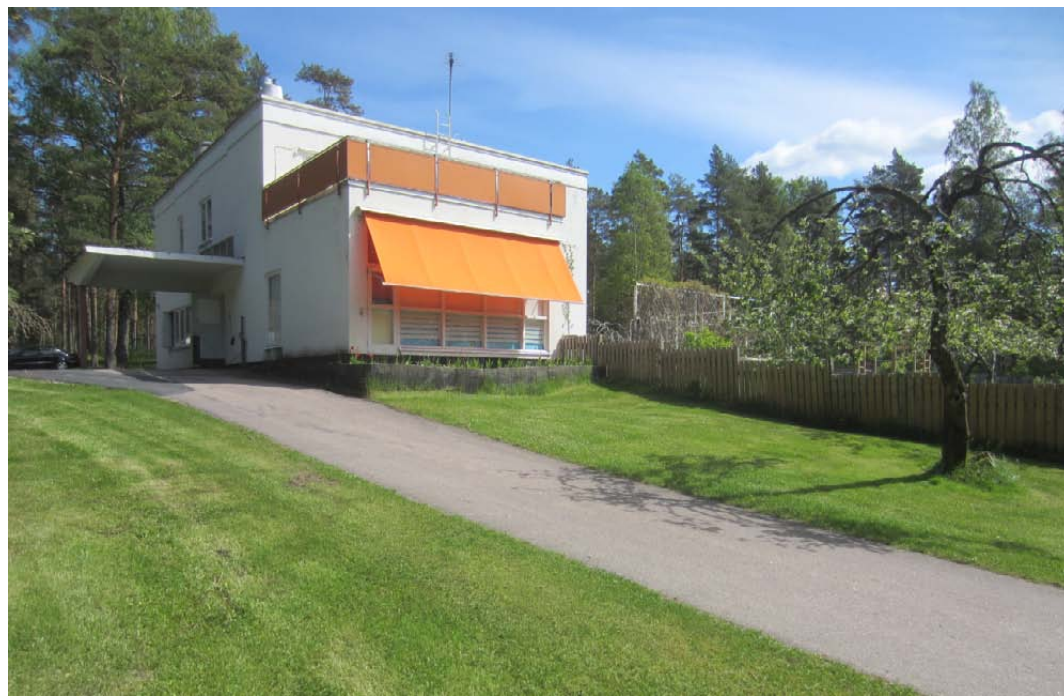
2015: The villa was reused as a kinder garten in the 1970s. New fence has been added since 2006. The fence with creepers has been removed earlier. Many of the apple trees have been cut. (AAM Malmberg).

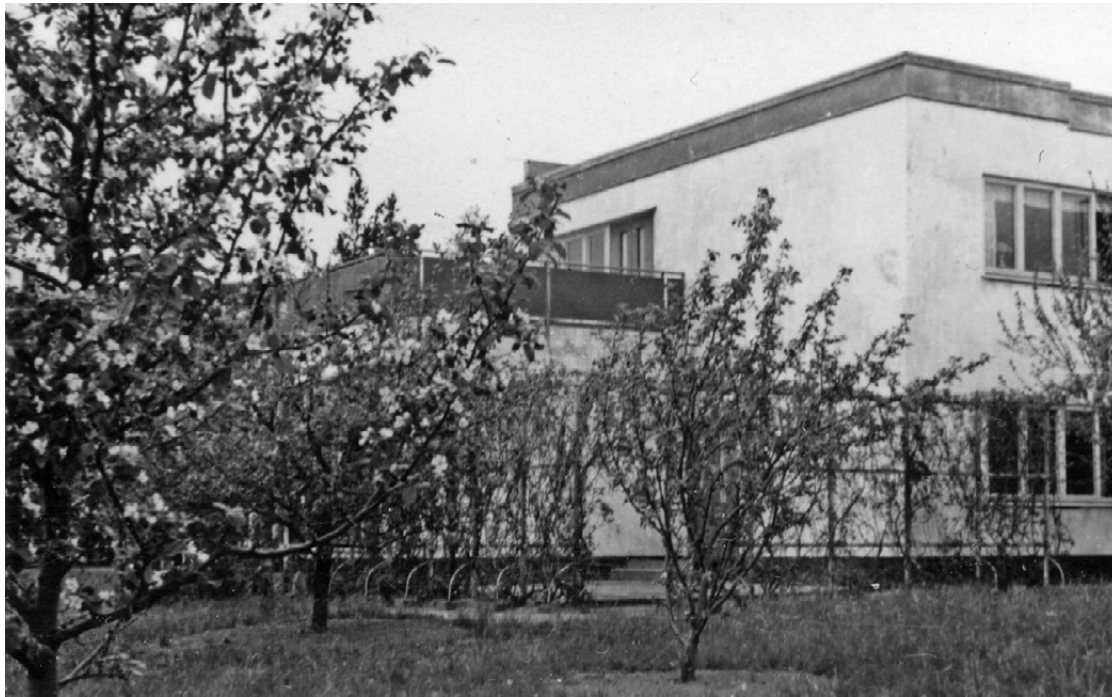
1930s: Chief physician's villa seen from the grid of apple trees, the ground is of grass (Sukkinen in Saarikko 2007, 59).

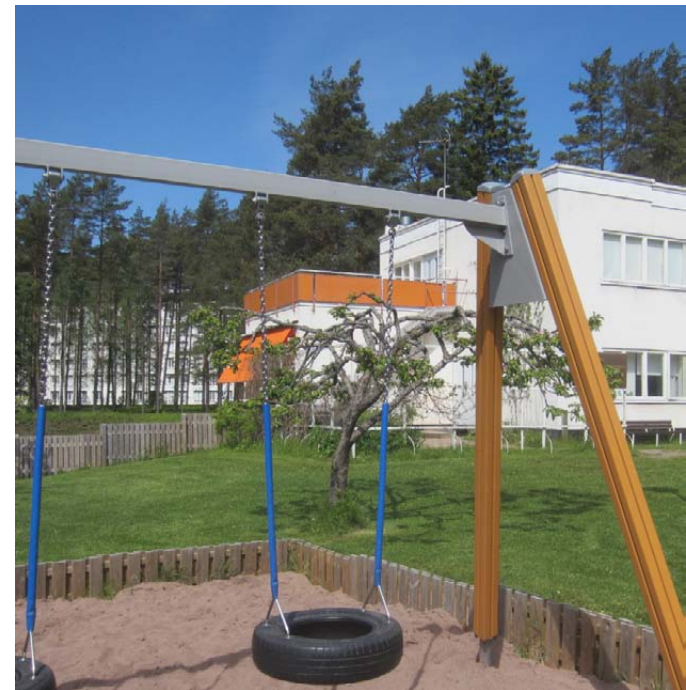
2015: New play ground of the kinder garten has been built since 2007. Only parts of the original fence and low garden wall around the villa have survived (AAM Malmberg).

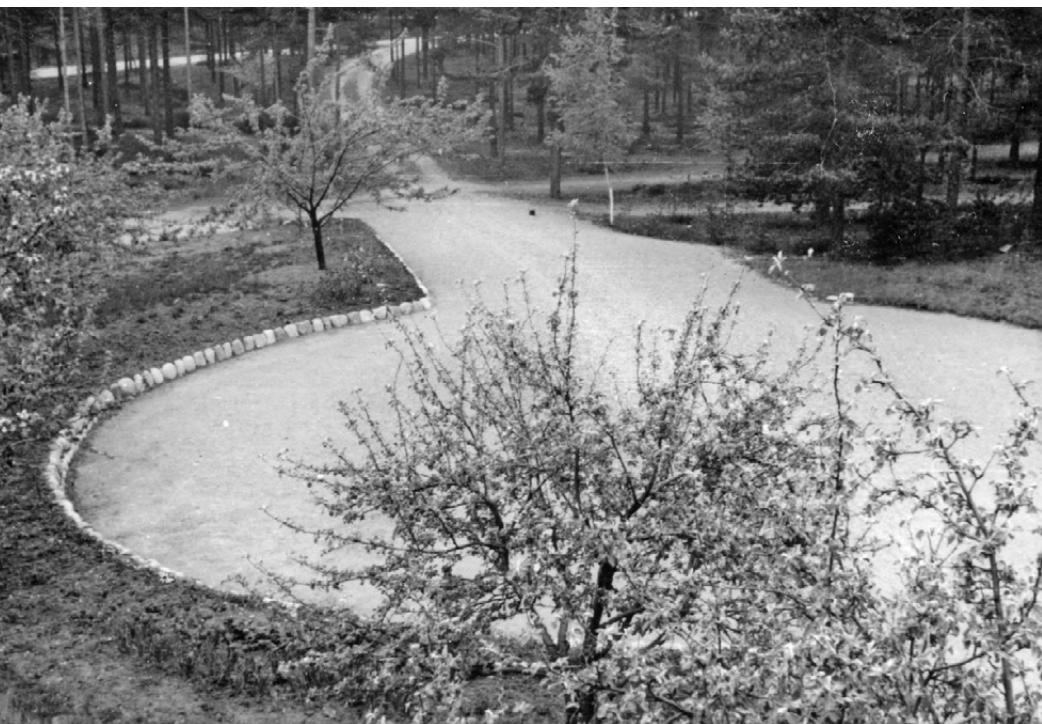
1940s: The view from the roof terrace of the chief physician's villa is dominated by a large round shape, gravel cul-de-sac. (Sukkinen in Saarikko 2007, 59).

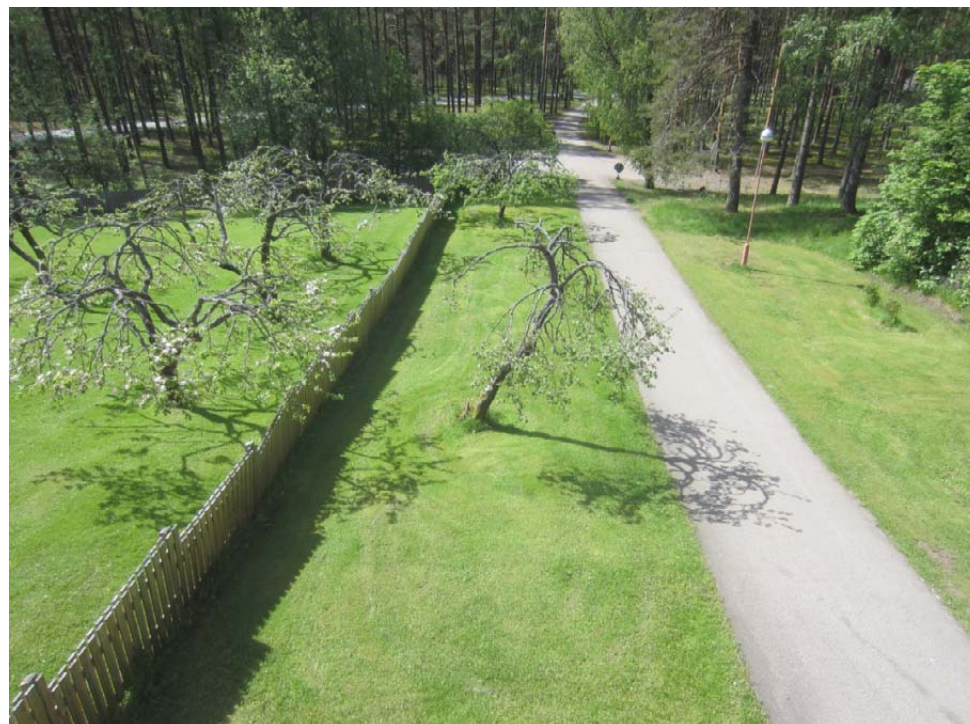
2015: The road is smaller and the round shape has been removed. The is paved with asphalt. A lamp post designed in Aalto's office has been added. (AAM Malmberg).

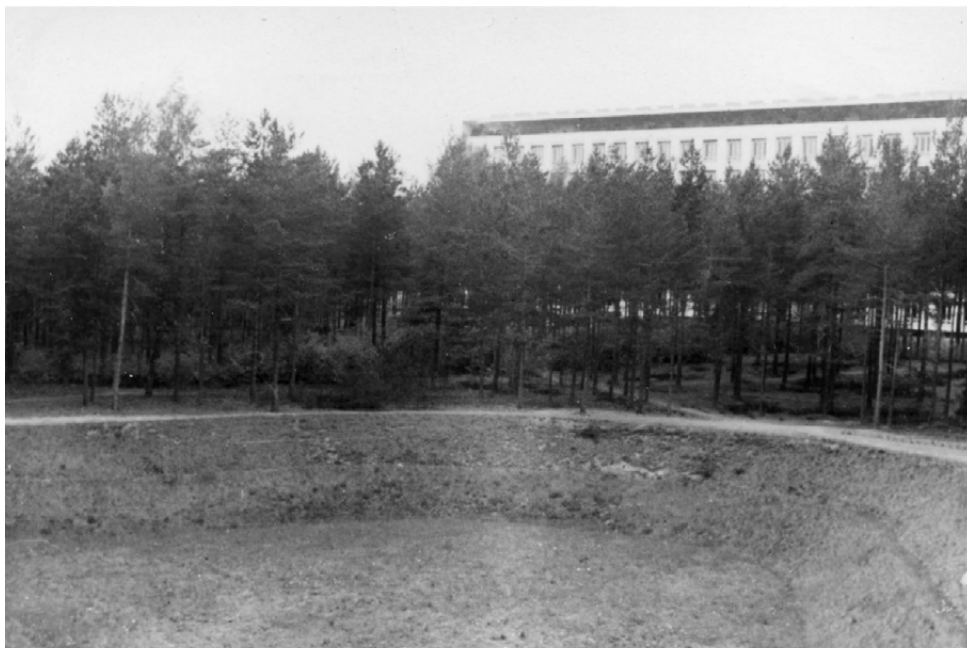
1930s: The ditch that was used for croquet playing seen from the roof terrace. The sanatorium stands behind the relatively young forest. There was a path around the ditch (Sukkinen in Saarikko 2007, 60).

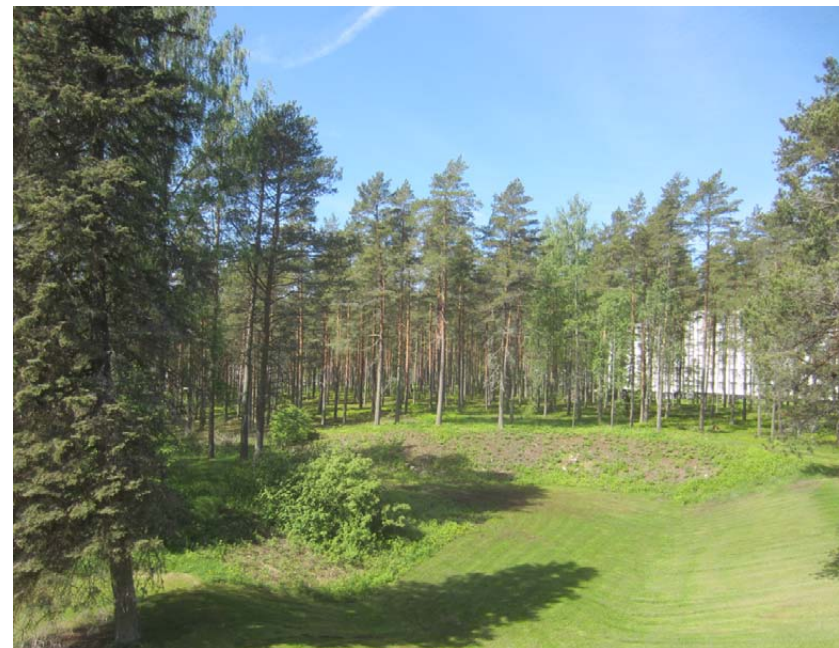
2015: The ditch is well visible, but its' shape has been softened. The path can no longer be seen. A variety of bushes have been removed from the ditch since 2006, but some have been left. (AAM Malmberg).

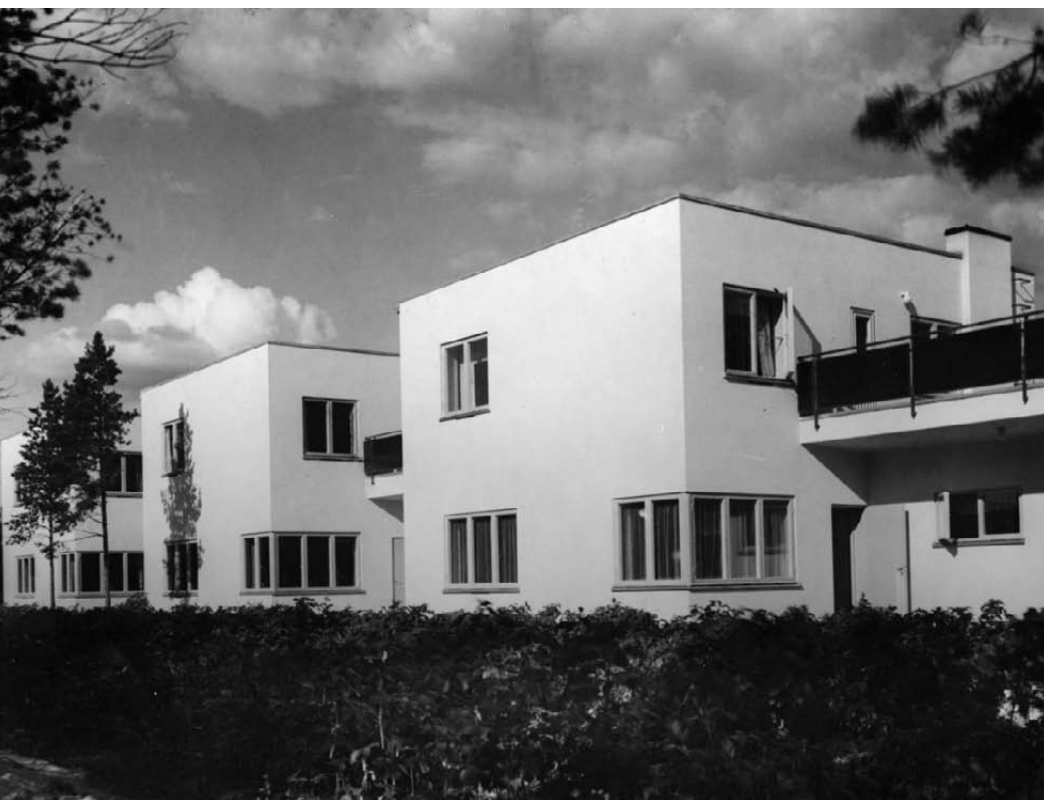
1934: The physicians' row house soon after completion with open courtyards enclosed by a cut hedgerow (AAM 50-003-448).

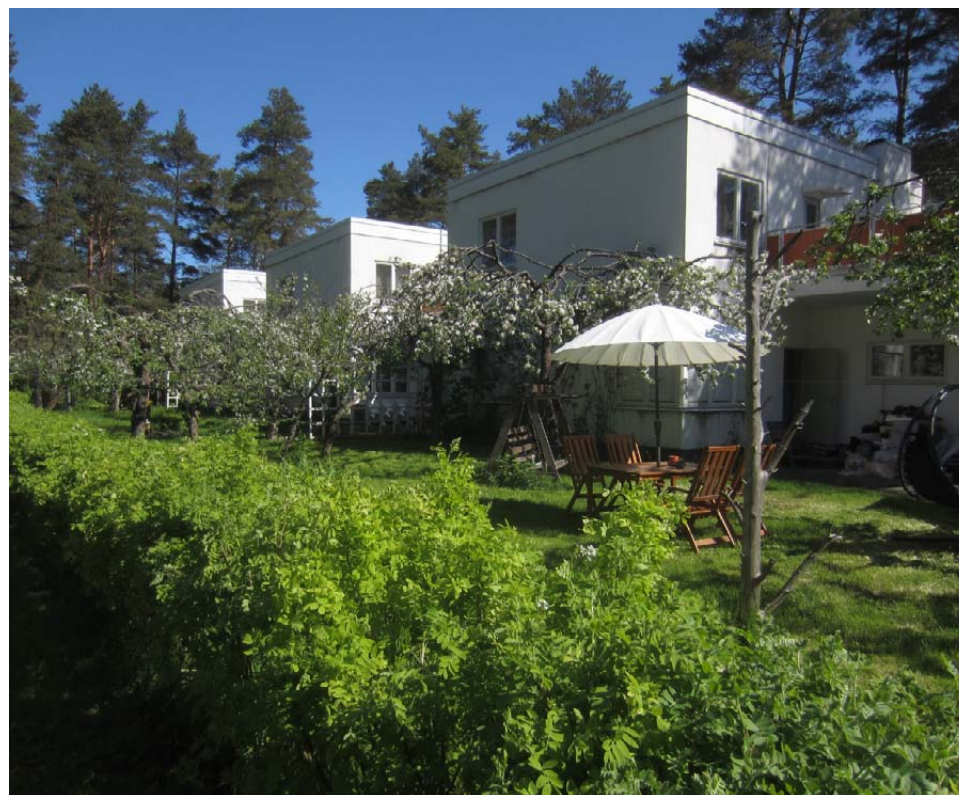
2015: The yards have a variety of trees e.g. cherries and plums. The over view is confused. (AAM Malmberg).

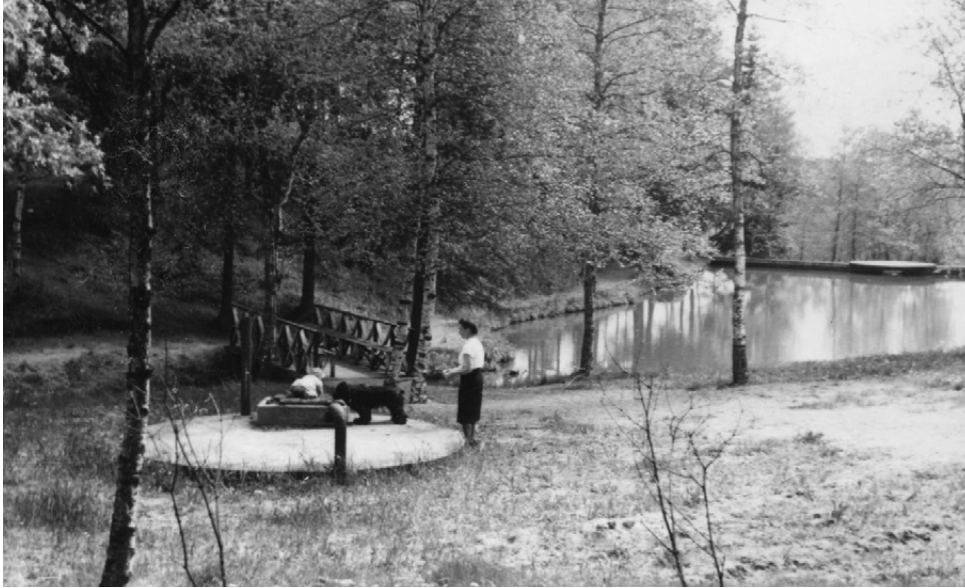
1930s–40s: Lemmenlampi artificial pond was created by a dam. The pond and the concrete structure of the pond are seen behind. The area around the pond was well kept. (Sukkinen in Saarikko 2007, 63).

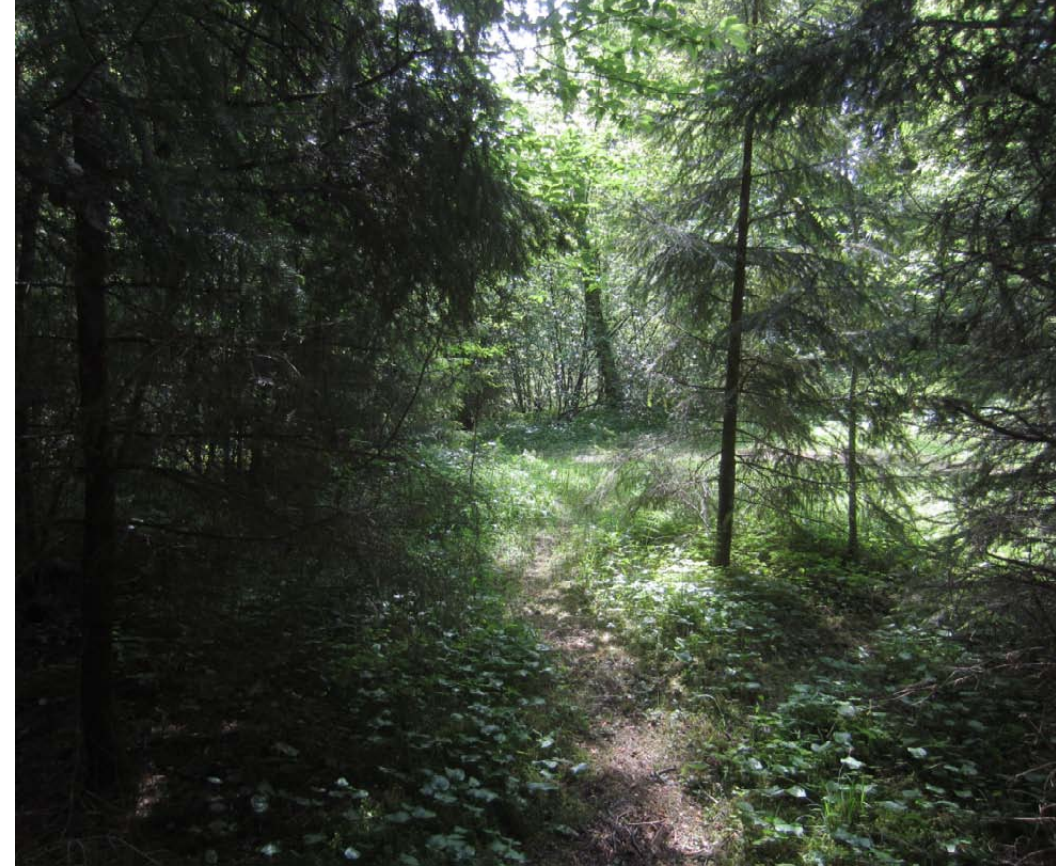
2015: The former pond is grown and can hardly be recognized (AAM Malmberg).

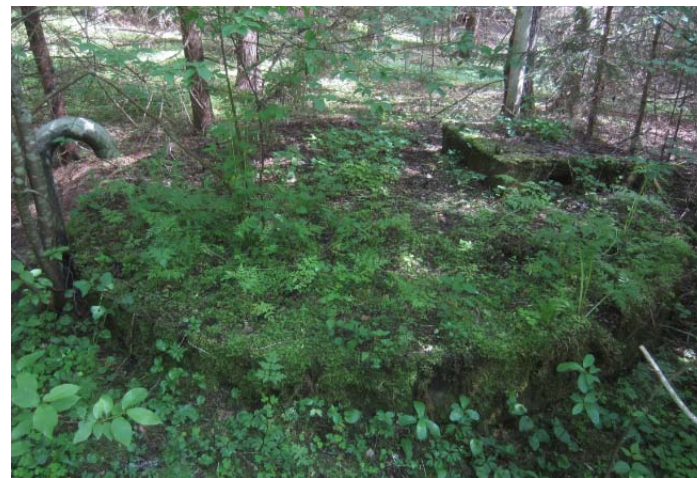
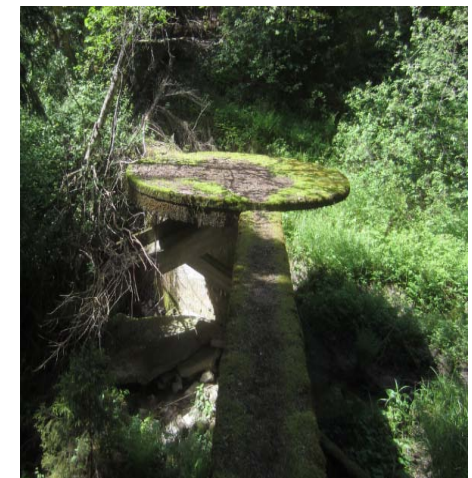
2015: The concrete structures have survived in the forest (AAM Malmberg).

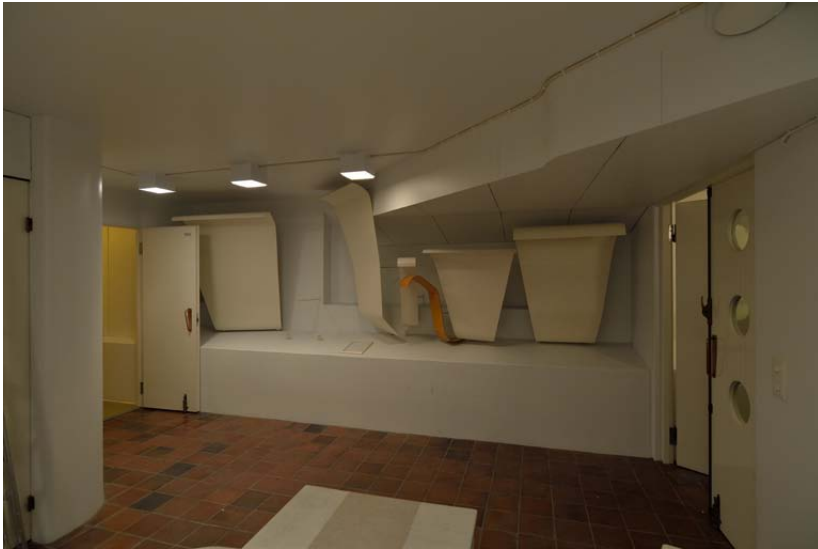
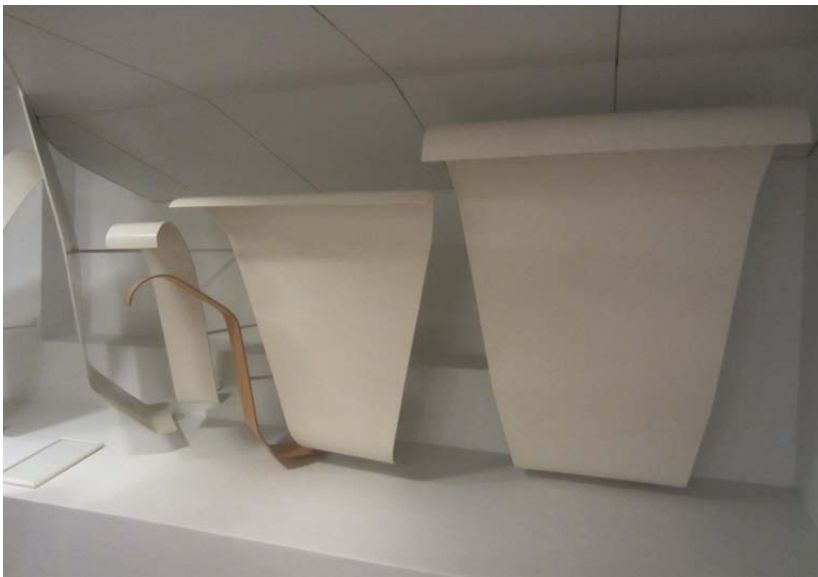
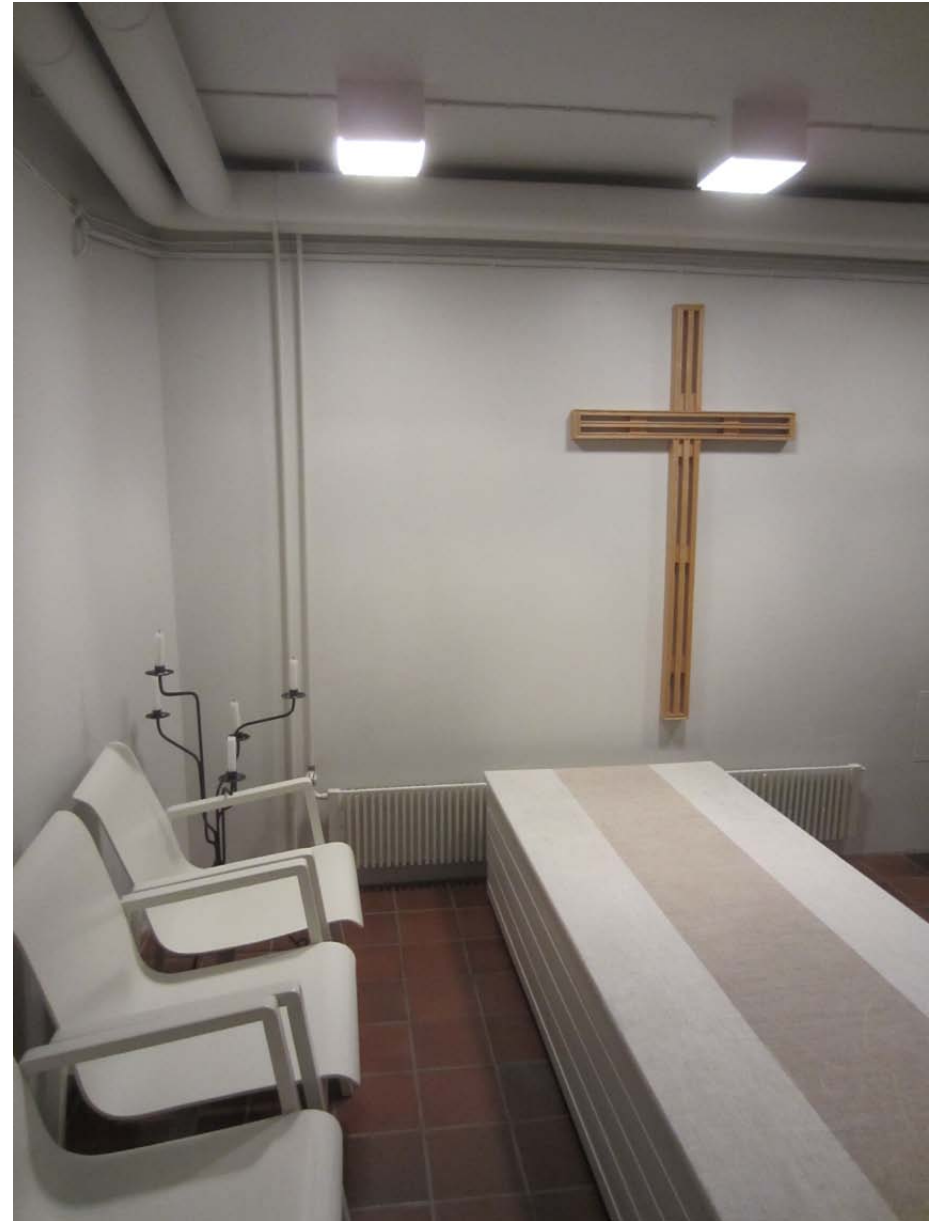
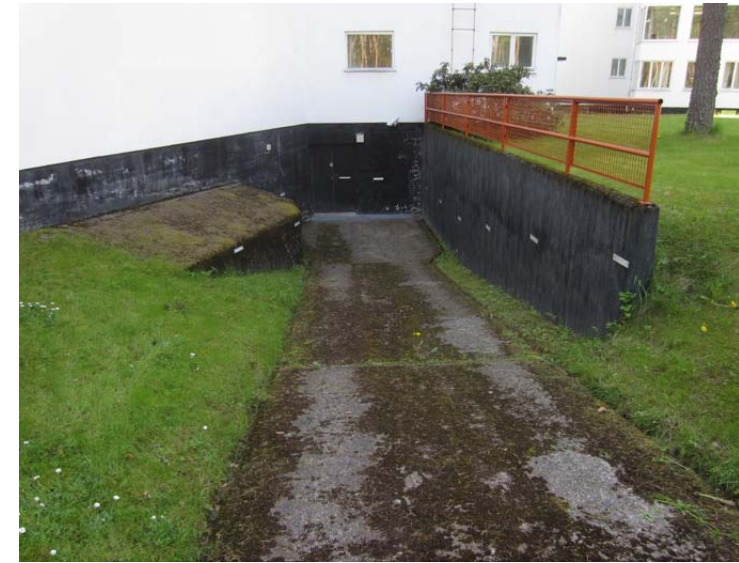
Basement A-wing, chapel (AAM Sakari Mentu)

- The unique and exceptional interior designed under the direction of architect Heikki Tarkka (designs from 1987) was a replacement for the Rose Cellar morgue. The architectural design as a whole was unique but compared to Aalto's 1930s modernism it was hesitant.

- The space has few later additions or layers, so it corresponds with the solutions dating from the original building period. Artwork structures specifically designed for the space were made in the hospital workshop (communication from Reijo Vihervaara).

- The totality, in regard to its use and long design history, has a cultural-historical value. But its potential, for instance, as an architectural attraction is less than that of the central spaces of the sanatorium. The usability of the space is poor.

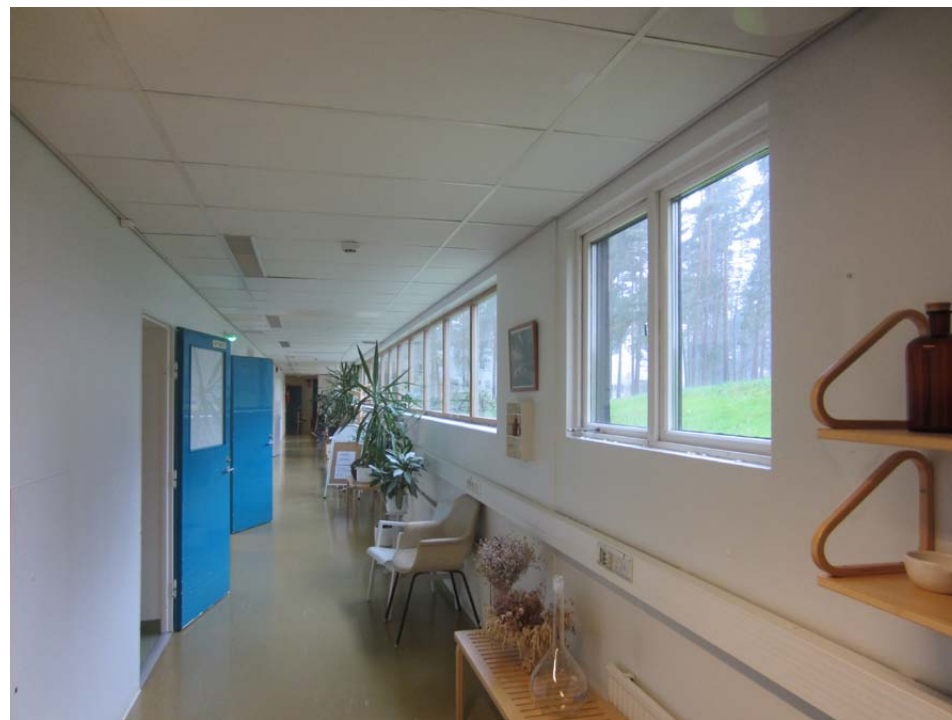
*Basement A-wing: quarantine ward
(AAM Jonas Malmberg)*

- Preserved parts linked to the original building stage include: the load-bearing structures, the side corridor adjacent to the spaces (albeit the end of the corridor is altered and supplied with suspended ceilings) as well as the windows of the rooms, replaced by thermal glazing in the 1980s. The space itself has been changed a lot, and as such has no particular cultural or building-historical significance. A particularly interesting detail is the door openings of the patient rooms, the dimensions and door jambs of which have been preserved but not the doors themselves.
