**PAIMIO SANATORIUM
CONSERVATION MANAGEMENT PLAN
2016**

Publisher
Alvar Aalto Foundation

The overall goal of the CMP is to guide the future use, care and conservation of the Paimio Sanatorium. The objective in preparing of this CMP has been to produce documents that bring together already existing historical records of the building, including defining of architectural features, physical analysis and the knowledge of the buildings performance over time to create a long-term strategy for decision-makers, contractors and users regarding conservation and maintenance.

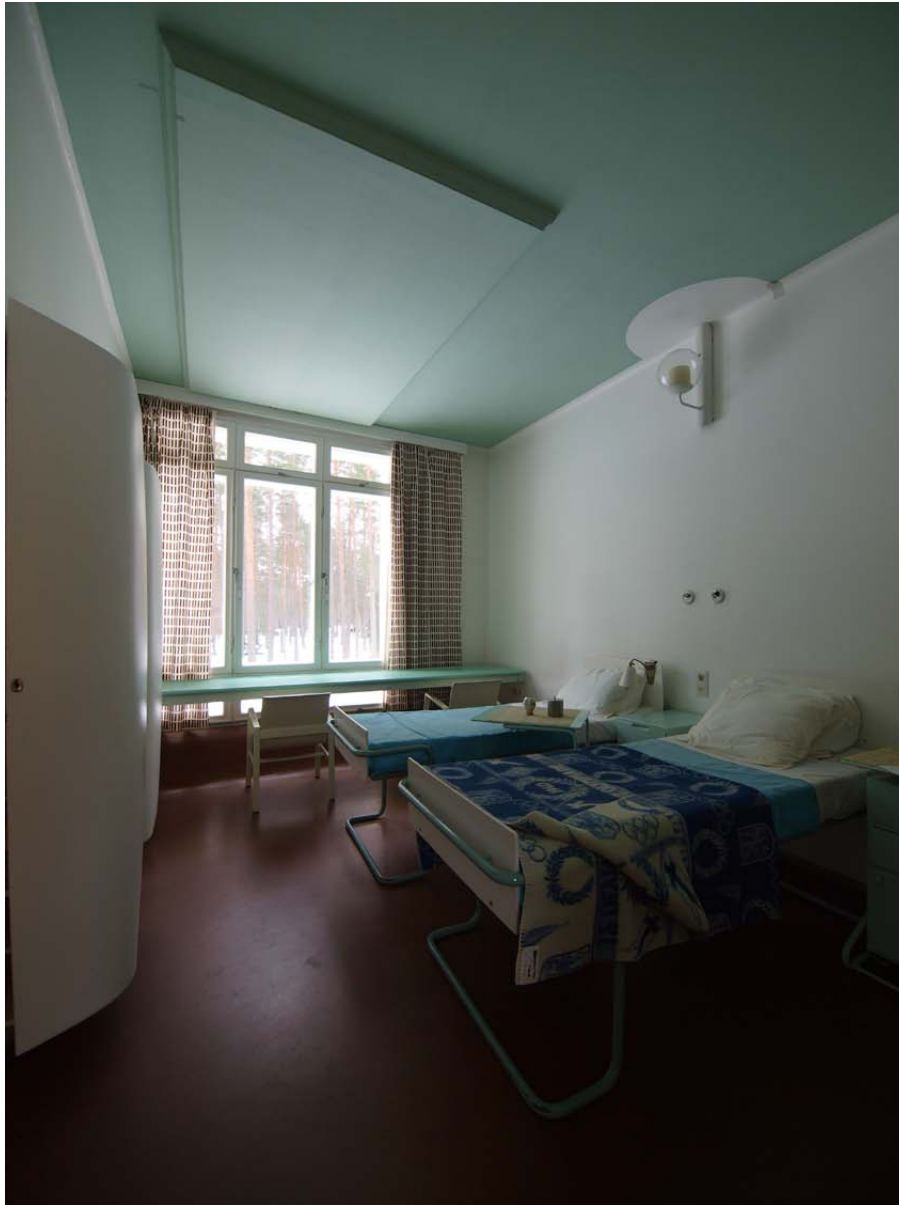
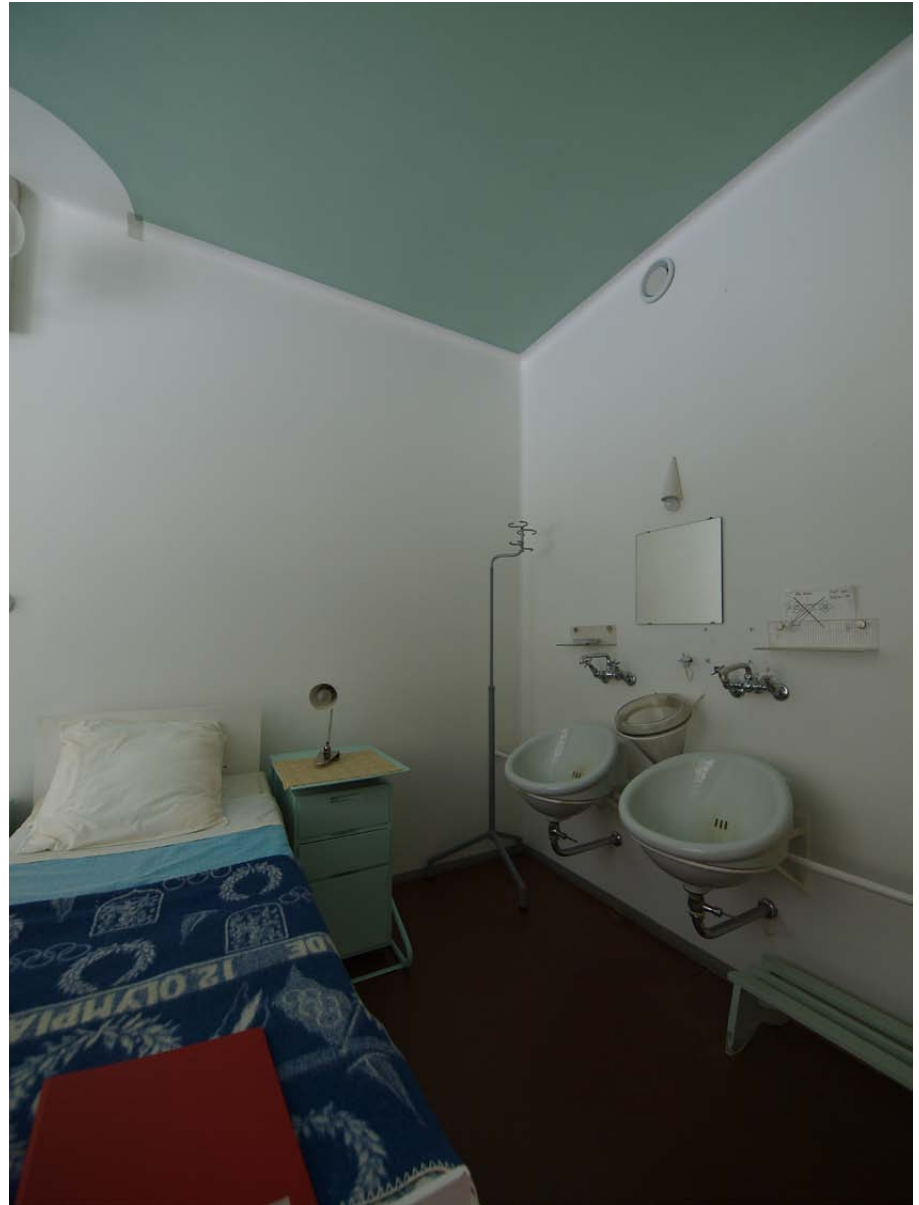
Ground floor A-WING: MUSEUM ROOM

The museum room (AAM Sakari Mentu)

- The original furniture and fittings as well as the door to the patient rooms were preserved in the 1970s renovation. Even after the renovation, the patient room had a use that corresponded with the original one; hence in the renovation it was fitted to, for instance, the hospital's gas system as required for patient use.

- Even by international comparisons, the original furniture and fittings of Paimio Sanatorium have been both well and extensively preserved, also beyond the museum room. Making these more extensively accessible to visitors than at present by means of informative collections is justifiable.

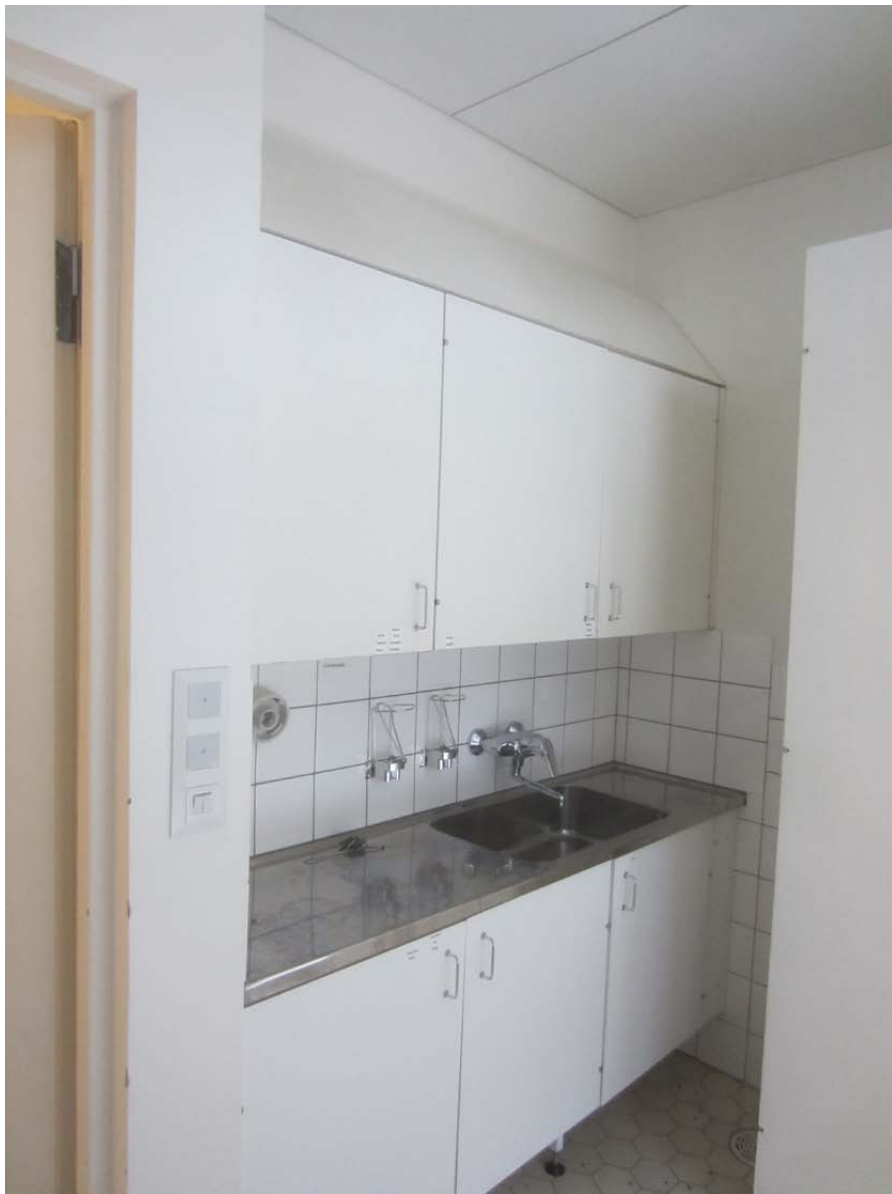
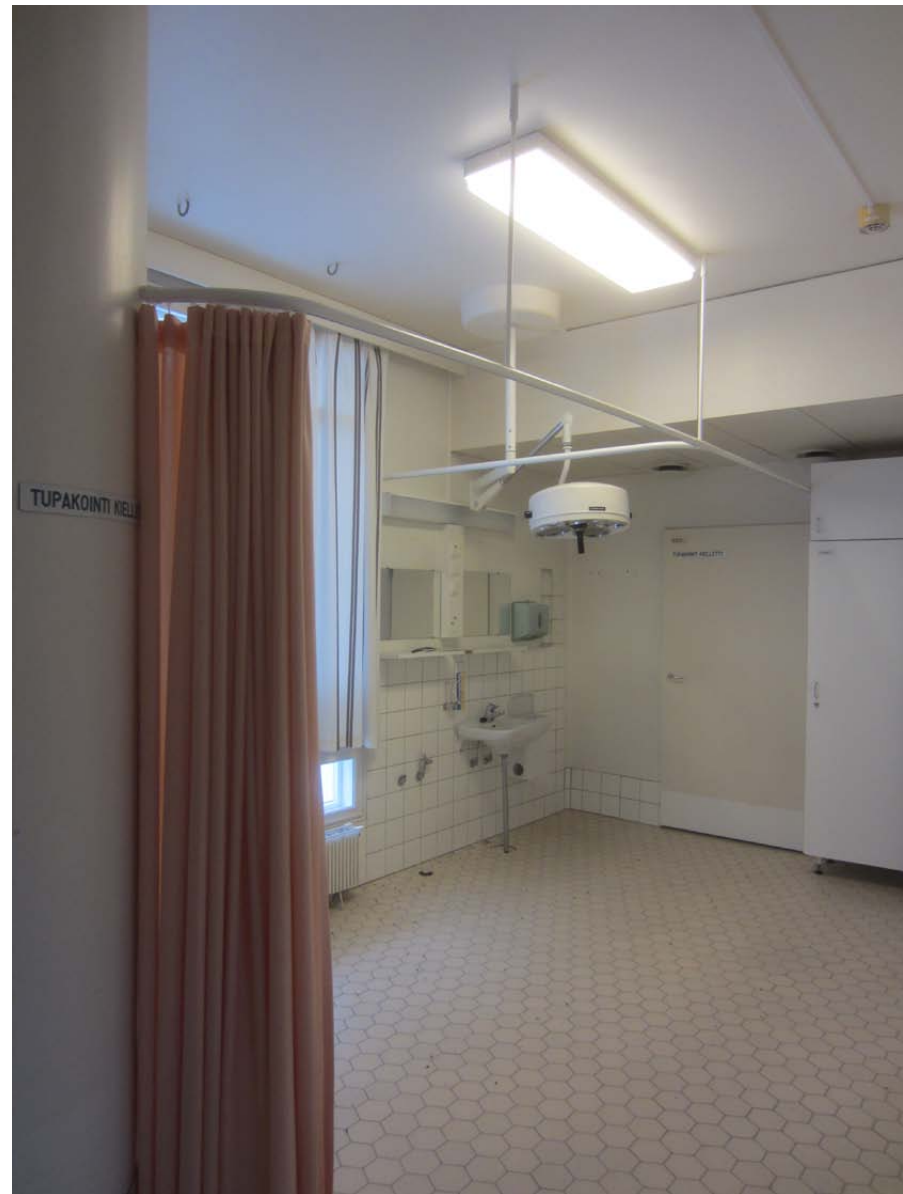
Ground floor A-WING: WARD NURSE'S APARTMENT / WARD WET SPACES

Ground floor A-wing: ward nurse's apartment.
Photo from 3rd floor (AAM Jonas Malmberg)

- The use of the space was changed in the 1970s to toilet and washing facilities, when also the space that had been extended to the adjacent patient room was connected more clearly than previously to the ward corridor. Apart from the balcony, the space no longer conveys the message of dwelling activity, but of a stage in the history of the hospital.

- In recent years, a patient room has been arranged next to the patient room that functions as a museum room, which tells about the 1970s stage, and in place of the former wet space photographs, a scale model, lamps and other objects have been placed that support the exhibition activity.

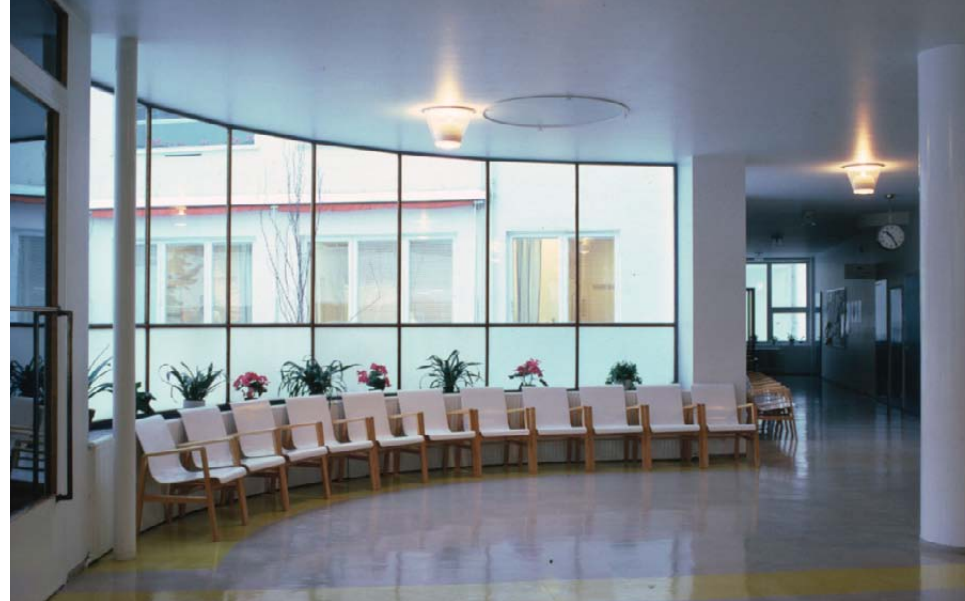
*Ground floor in the 1980s, entrance hall before new
opening at the end (AAM av 818 Martti Kapanen)*

- The corridor running from the lobby to B-wing has also changed spatially: it was originally open via the porter's space towards the direction of the rear yard, and by the widening of the corridor created also a space for a circular telephone booth. The space was more diverse than the present central corridor and it continued without any intermediate doors towards the waiting area in the consultation department and corridor. The corridor is subtly divided from the lobby by the difference in surface materials.

- The largest changes to the lobby were made already in 1958 when a reception desk replaced the area of wooden shelves used for the patients' outdoor footwear, and additionally the fixed furniture has been altered at different stages up until very recently. The reception booth with its free-form glass wall has been fitted tightly around the outline of the original circular skylight. In its detailing, the booth is a carefully considered entity which can be recognised as having an architecture that differs from the original. The present appearance of the booth still mainly corresponds to the 1958 design, but the rear space, where there was originally a posting point, has been altered more than the visible part and the receptionist's space.

- The situation regarding the B-wing ground floor corridor is linked to the situation of the lobby established already during the 1950s. In connection with any future alterations, it is recommended that the opening up of the corridor in the direction of the rear yard should be investigated.

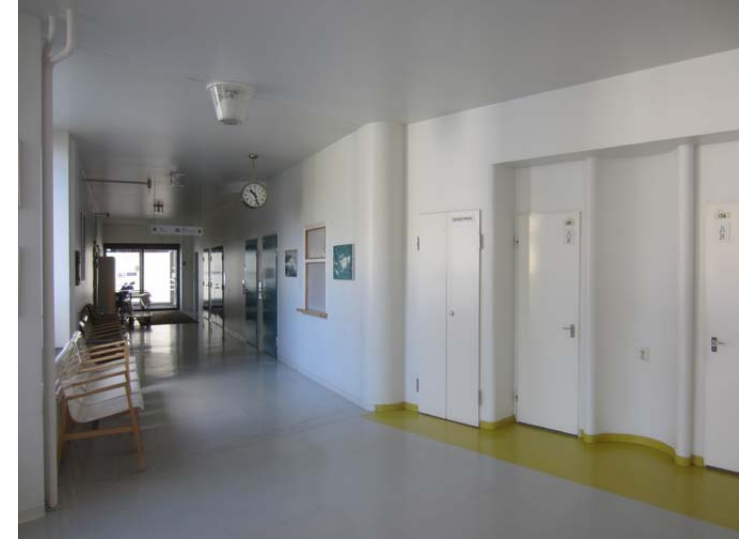
Entrance hall, B-wing corridor
(AAM Jonas Malmberg)

- The corridor of B-wing was altered in 1958 to become a central corridor, at the end point of which the window was opened to become an entrance. Its structures were renewed in the 1980s and most recently in 1998. A trace of the former telephone booth is visible in the ceiling of the corridor.

- Following alterations, the central and open interior space linked to the lobby has lost its transparency. The functionally and architectonically diverse space has become a conventional central corridor. The placement of doors in the corridor was altered in the 1980s when a hatch for the present service point was built. The hatch was later covered with an opaque membrane which is alien to the architecture of the building.

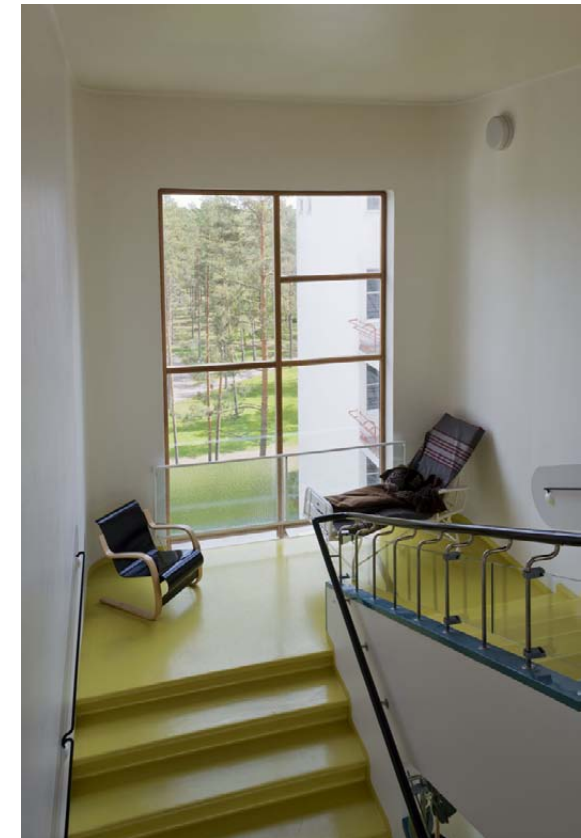
*Main stairs in 2014
(AAM digi 2080 Maija Holma)*

- **Preserving the appearance of the main stairs is of central importance. In terms of lighting fixtures, there is reason to examine the possibility of returning the original lamps (presently in storage) to their original locations. In any future alterations the connection of the main stairs in the direction of B-wing on the different floors should be examined (see 3rd floor workshop, below)**

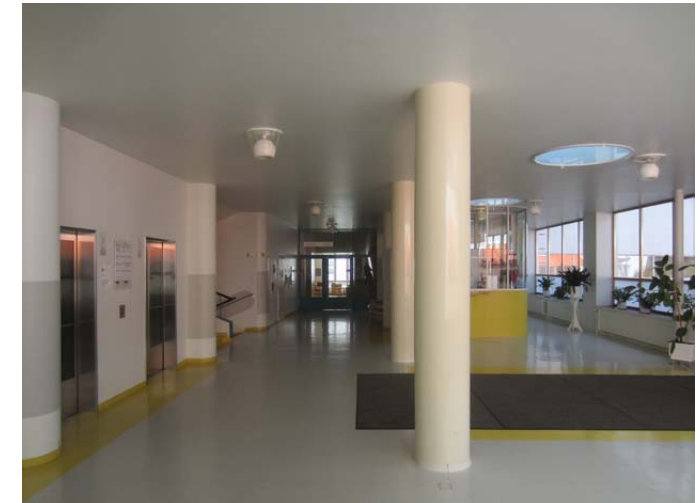
- The lifts connected to the lobby and the different floors of the building have been renewed twice, most recently in 2001. The original ones were substantially transparent and the ceilings and walls were in different colours. According to the patients' magazine and the colour compilations prepared by Eino Kauria, one was blue and the other was red. The metal parts at the front of the lifts are mentioned in a newspaper article (Hahl 1933) as being red, but it has not been possible to confirm this from removed building parts. In some plans a window has been proposed in the exterior wall of the lift shafts, which was never implemented, apart from the window of the machine room that was assembled from the round glass elements of the machine room.

- The present solid lift doors with only small glazed parts, as well as the general appearance of the lifts, conflict with the totality of the lobby.

*Entrance hall, lifts in 2015
(AAM Jonas Malmberg)*

- **In future repairs and alterations to the lifts, the opening of the lift shafts into the lobby and floor landings should be emphasised and the original transparency and machine-romantic atmosphere strived for.**

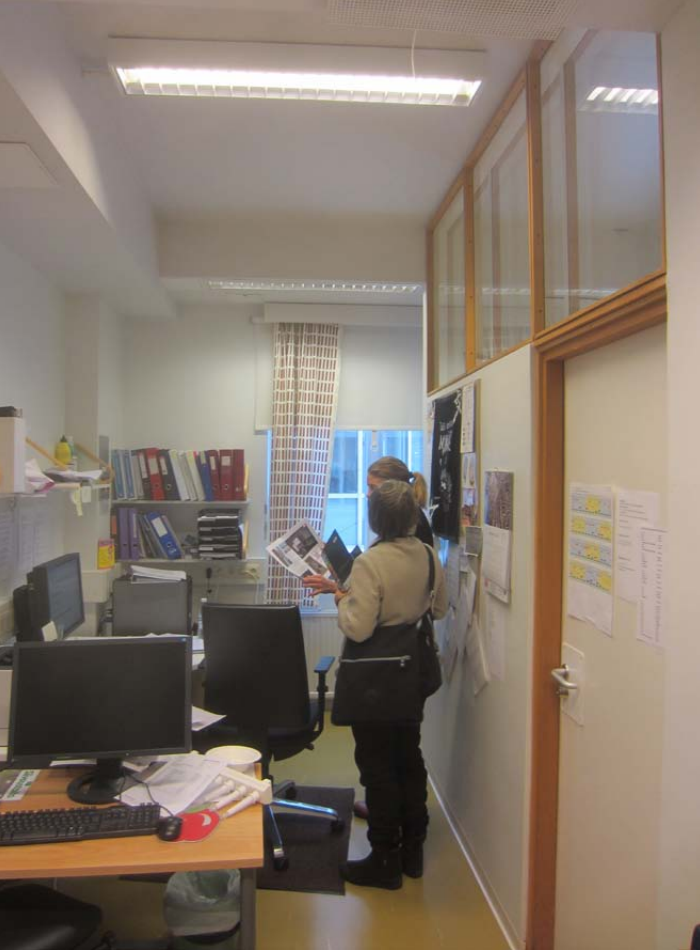
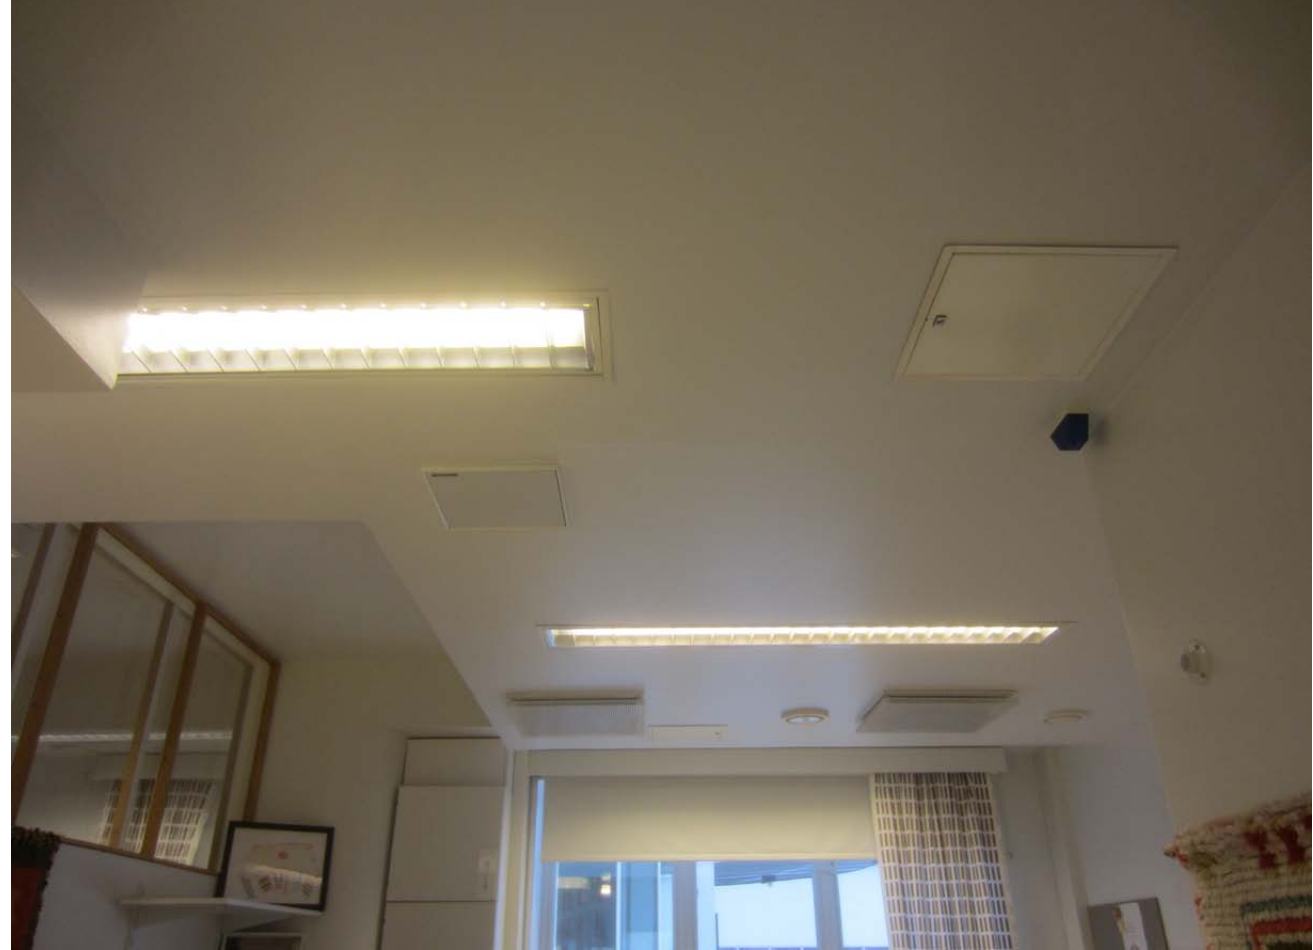
Ground floor B-WING: CHIEF PHYSICIAN'S WORKROOM AND SECRETARIAT

*Chief physician's workroom in 2015
(AAM Jonas Malmberg)*

- In 1983 new facilities were designed on the second floor for the chief physician, when Professor Tala asked architect Heikki Tarkka to take into consideration the fixed and moveable furniture so that they could be utilised in the new space due to the pleasantness and additional value they brought to the interior. Original moveable furniture has been preserved in different parts of the main building.

- The doors have been renewed and thermal glazing has been installed in the windows, probably during the 1980s.
- Nowadays the rooms house the offices of the Mannerheim League for Children Welfare's Foundation for the Rehabilitation of Children and Young People.

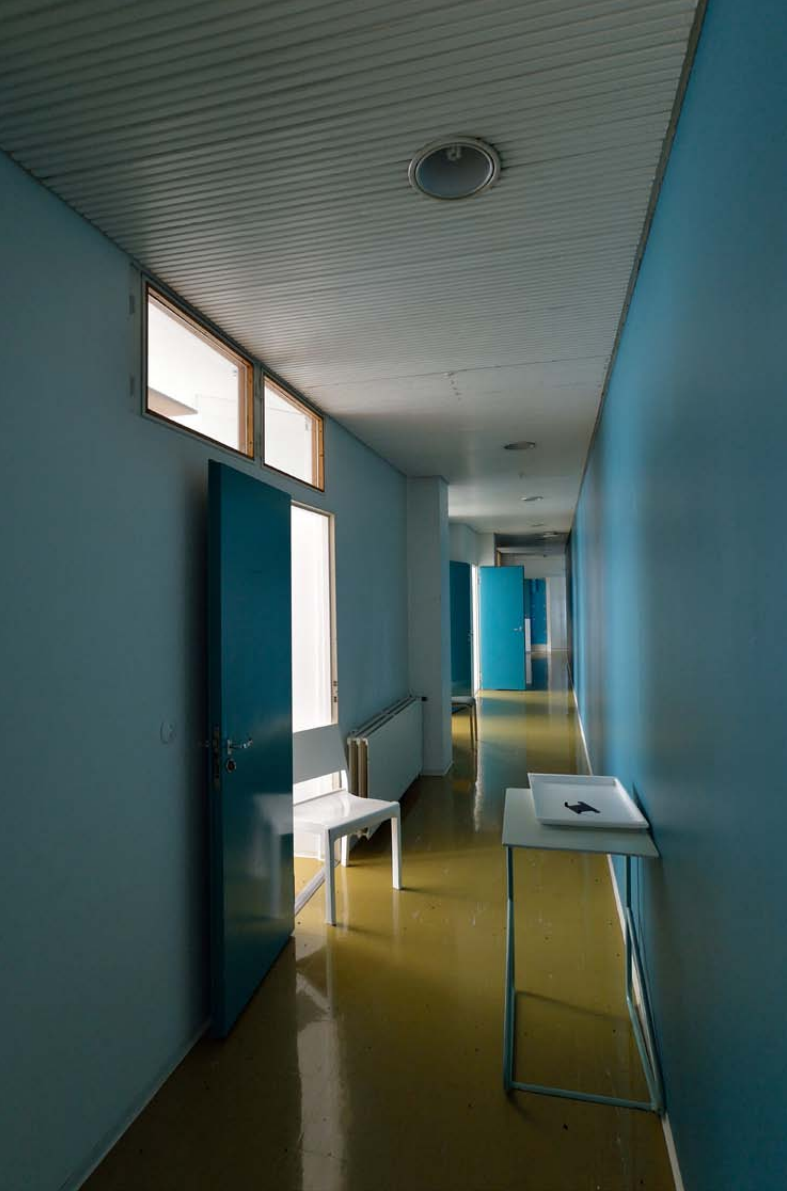
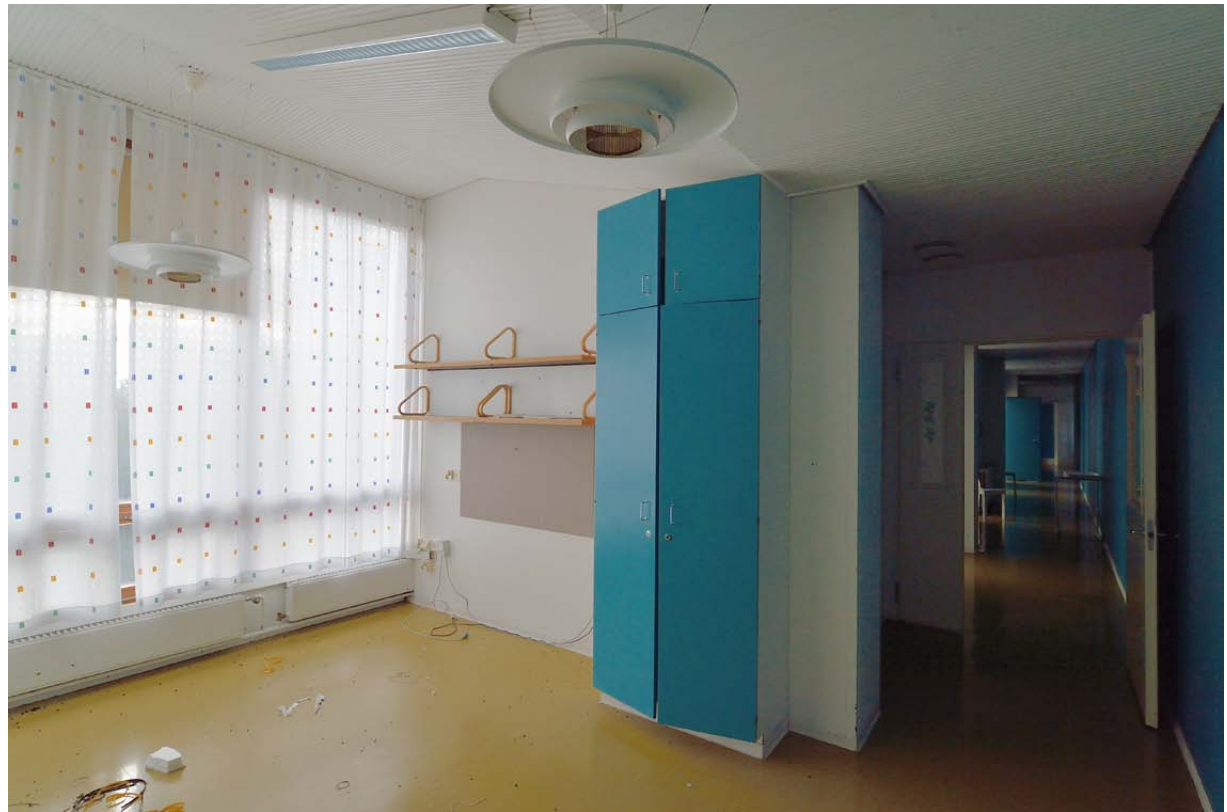
Ground floor to 5th floor A-WING: FORMER SUN BALCONY

*Former sun balcony in 2015
(AAM Sakari Mentu)*

- Nowadays the sun balcony wing, rebuilt as an internal space, is a sign of the change in the treatment of tuberculosis, and ultimately the change of the wards' operations from that of a sanatorium to a hospital. Because of this change the sun balcony wing was preserved in use and the original structure was protected, such that the structure has been preserved (sun balconies that were no longer in use were demolished, for instance, at the Kinkomaa sanatorium in the 1970s)

- In their original use, the sun balcony was the place nearest to the patient ward where the patients could recline. Reclining on the sun balconies was a central generator of social cohesion between the patients, because the several hours long period of reclining was repeated several times a day. When, by the 1960s, the medical and surgical treatments had evolved, the reclining treatment was removed from the available treatments.

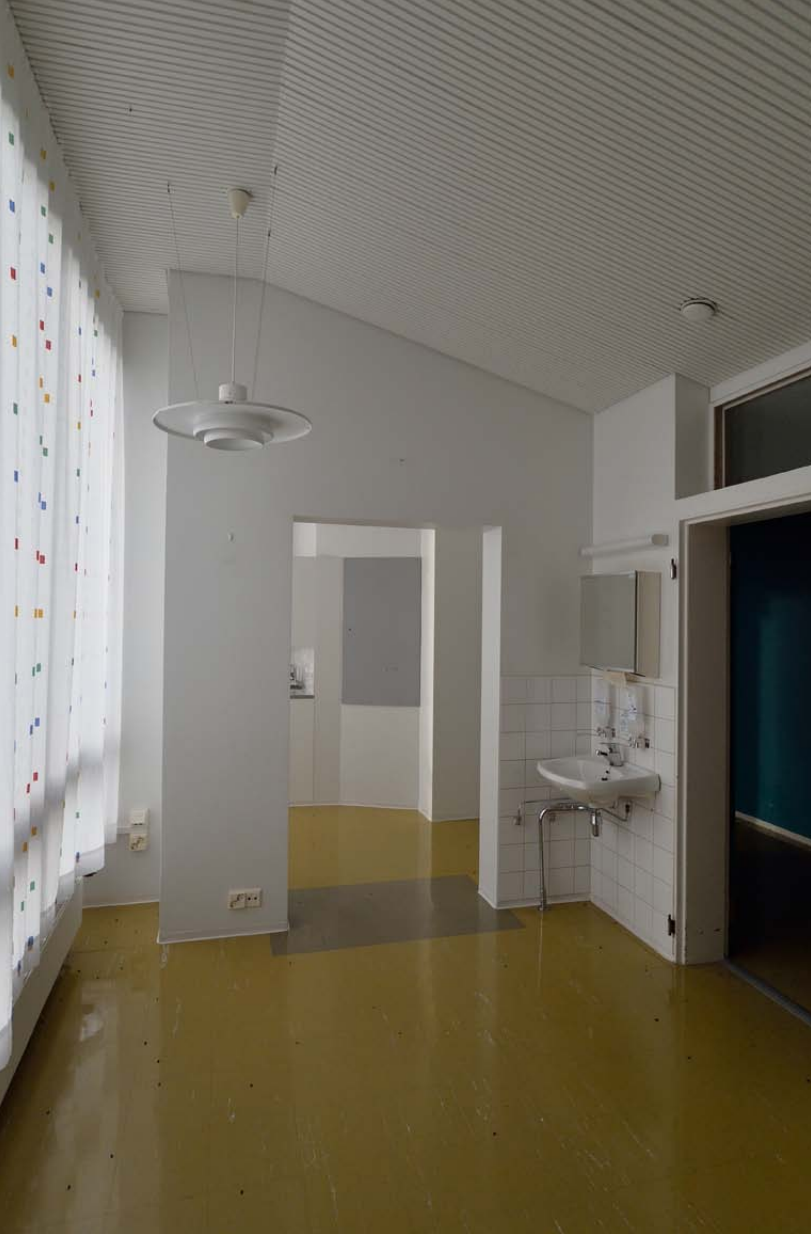
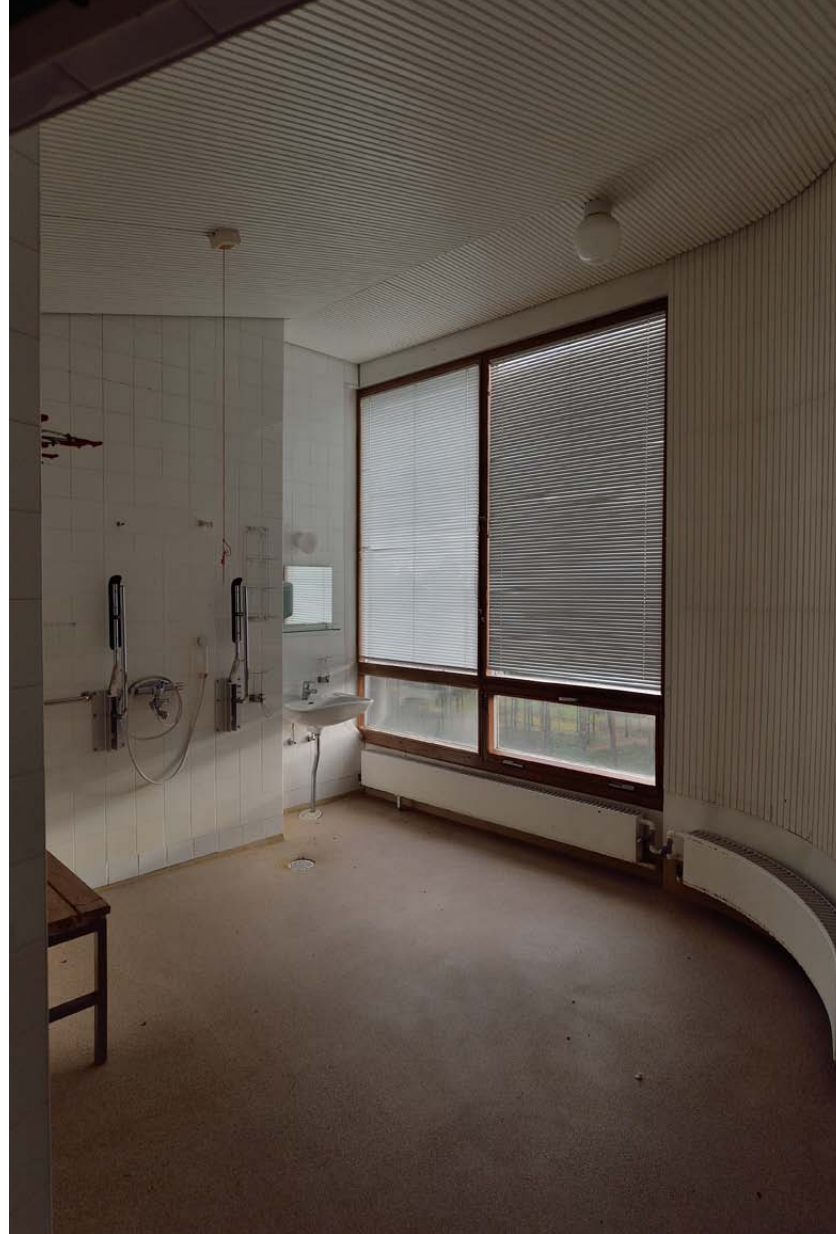
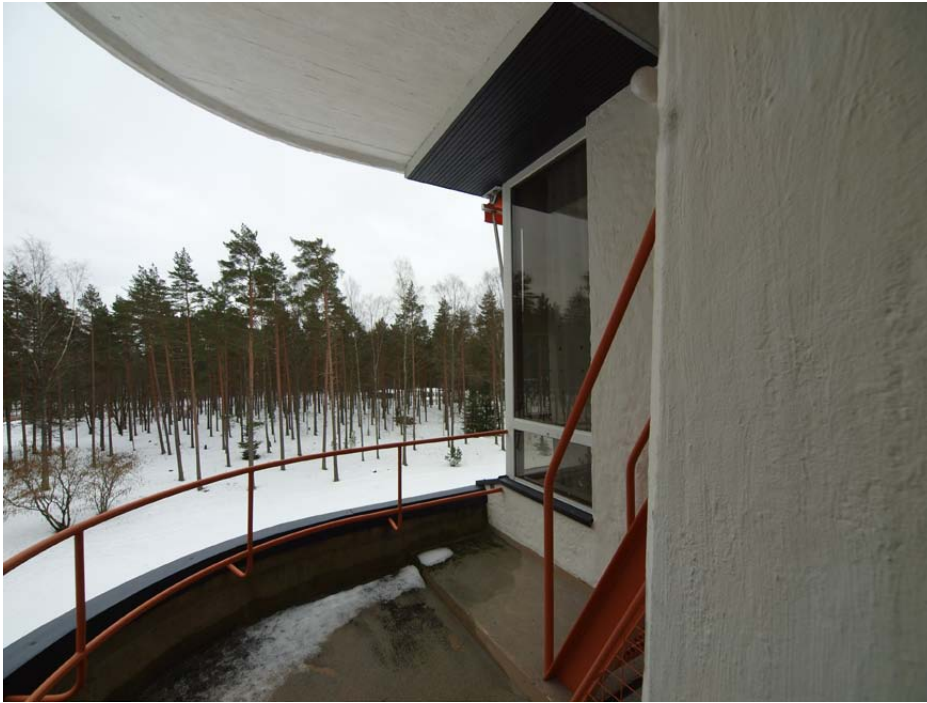
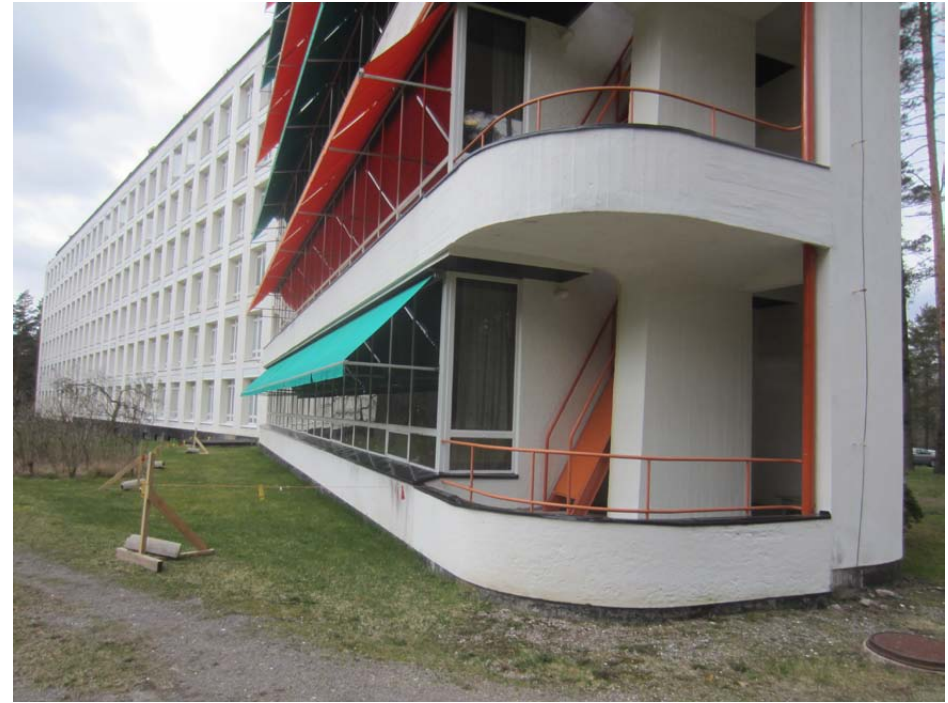
*Former sun balcony in 2015
(AAM Sakari Mentu)*

*Former sun balcony in 2015
(AAM Jonas Malmberg)*

- The sun balconies were converted into internal spaces in 1963-64 when patient lounges, physician's secretariat, staff social spaces, smoking rooms, and wet spaces were placed there. In the alterations, the ends of the balconies were left open and a fire exit stairs was added, the change applying to the wards on each floor. The open balconies at the end of the wing and the roof terrace still demonstrate the original design solution.
- Certain interior spaces were altered slightly with the renovation of the wards in the 1970s, when the physician's room was changed to suit the teaching activities of a university hospital. Amongst the lamps and moveable furniture are pieces from the Artek range from various decades. Preserving them and keeping them in use is justified. The windows were later at least partly renewed.

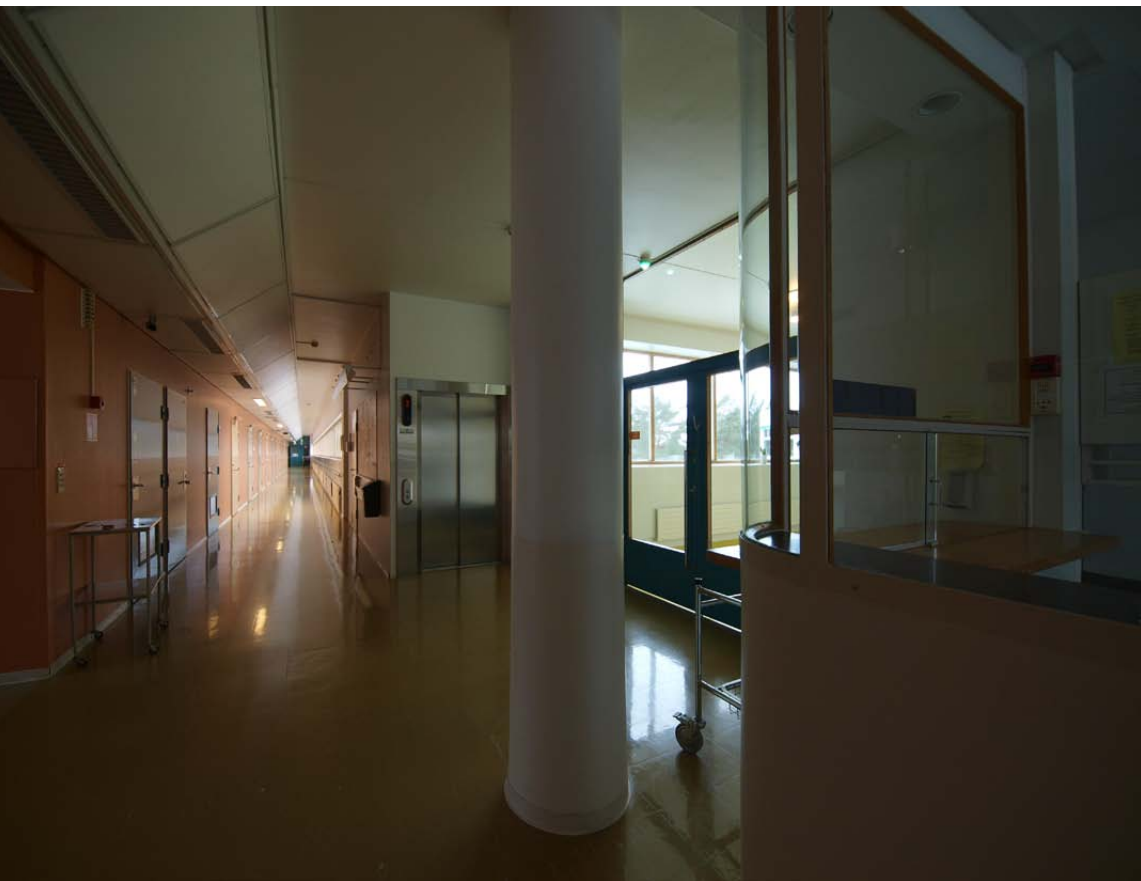
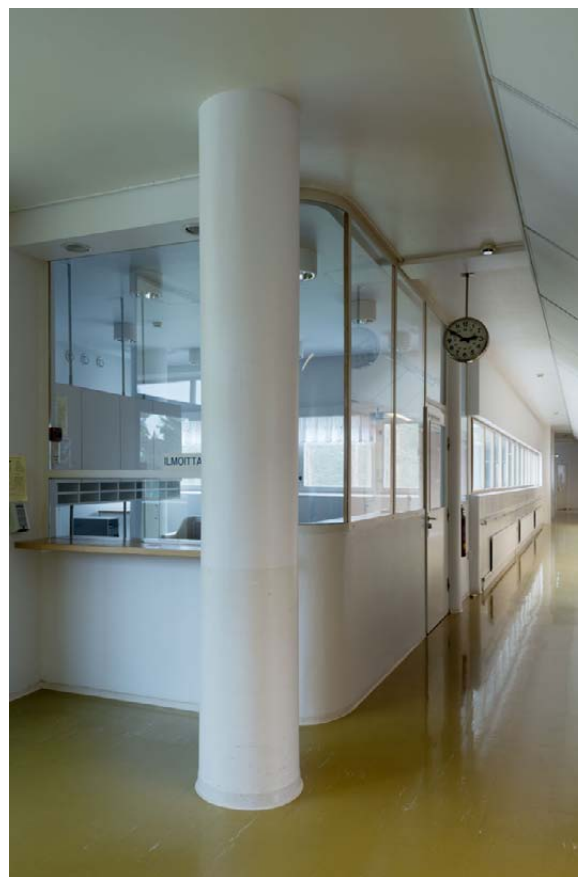
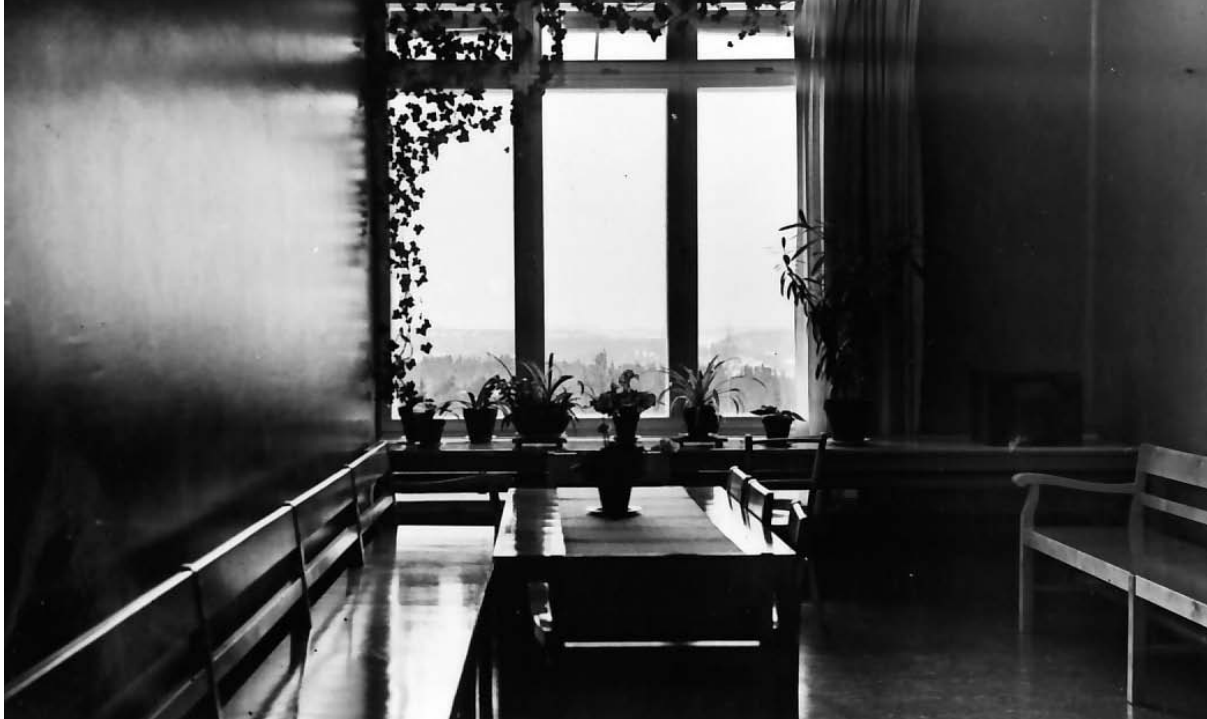
1st to 5th floors A-wing: the patient wing corridor with adjoining spaces

- In 1963-64 a side corridor was continued in place of the sun balconies (see above). A second gable end was opened up in the 1970s renovation when the toilet was removed from the end of the corridor. In the same renovation, the special sputum lift and the hatches linked to it, as well as the adjacent toilet, were removed. Also the glass walls of the office were altered at that time. The doors of the patient rooms that open out into the corridors were widened and the suspended ceiling housing ventilation ducts as well as lamps changed the cross-sectional shape of the corridor. Thermal glass was installed in the windows.

- The dayroom, situated around the middle of the ward, was originally a cloakroom for outdoor clothing and the transparency from the lobby is partly an original motif. The functions of the space were changed probably already in the 1950s, converting it into patient lounges, and telephone booths were added in 1957. In the 1970s renovation, a space was opened up from the kitchen alcove, which had been divided off from the adjacent room. The lounge spaces were renewed in 1996. The technical infrastructure shafts of the patient rooms can be maintained from the corridor side – albeit the hatches have been renewed. At least some of the original signalling lamps of the patient rooms have been preserved behind the suspended ceiling.

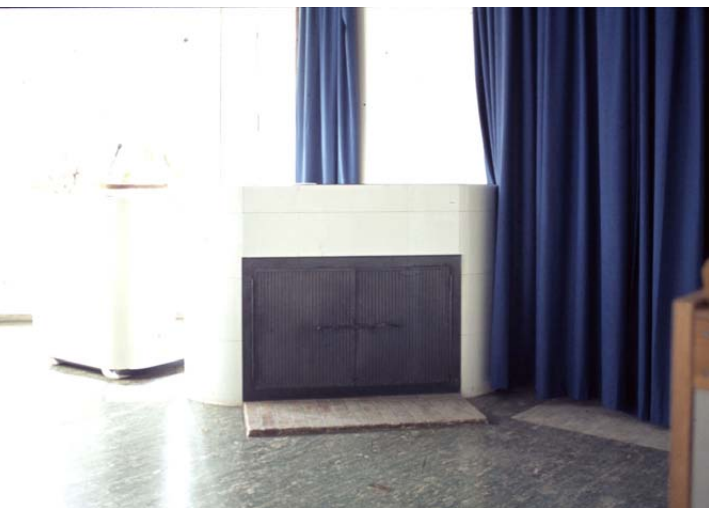
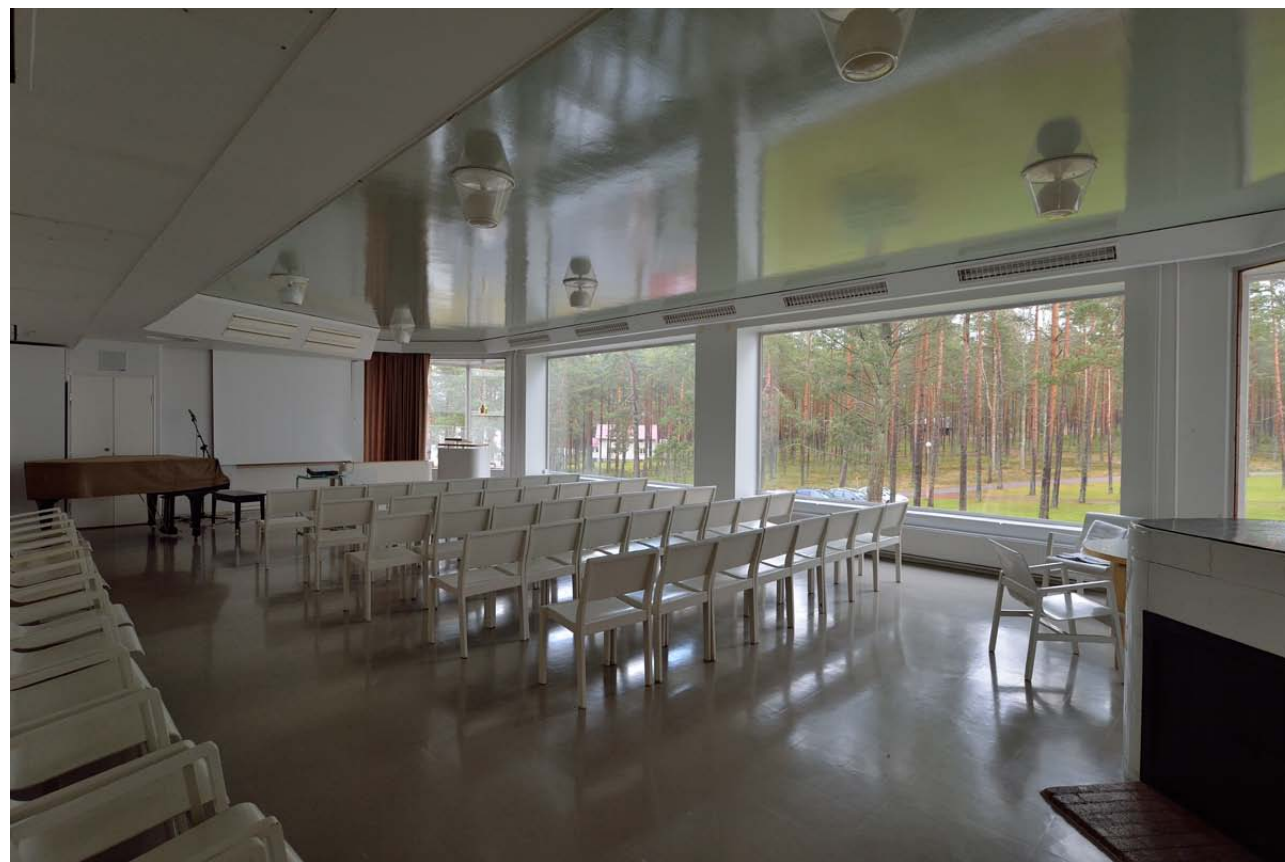
Patients' lounge, 1970s (AAM av 5378 Mikko Merckling)

Patients' lounge, 2015 (AAM Sakari Mentu)

- On the whole, the ensemble has been preserved unchanged. The biggest changes are an alteration in the suspended ceiling that contains the technical infrastructure (carried out in the 1980s), when also the German manufactured folding partition door was renewed. At the same time, the lounge also started to be used as a lecture hall, and furniture and equipment that had been situated in the basement were moved there. One of the tiled stoves was dismantled. The floor material was changed from the original strongly patterned linoleum to a neutral patterned vinyl flooring.

- The original radiators in the upper part of the space have remained in use and the ceiling radiators are also in still place albeit not in use. The original lamps and the most important doors are also preserved, except for the folding partition door. The ventilation window situated next to the door leading to the terrace, the hatches of the projector room in the loft area, and the ventilation installation that ran through the room have all been removed.

- The surfaces of the space have been hard and thus were acoustically challenging already to begin with, but this has been compounded by the fact that tablecloths are no longer used, the floor tiles are harder than linoleum, and by changing the fabric-covered sliding partition doors for ones with a hard surface. Also the surface material of the table tops, which seems to have been changed in the 1960s, is probably harder than the original one. Acoustic boards were added to the walls of the dining room in the 1980s, and the issue was taken up again in 2015. The reverberation problems that presently occur when dining should be studied also in regard to identifying alternative dining spaces.

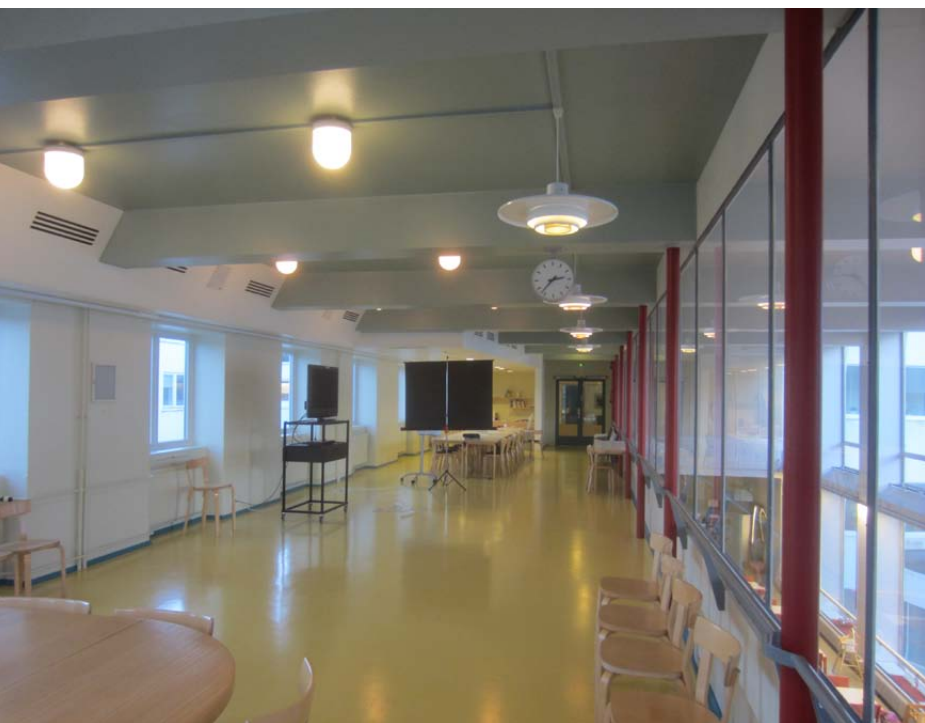
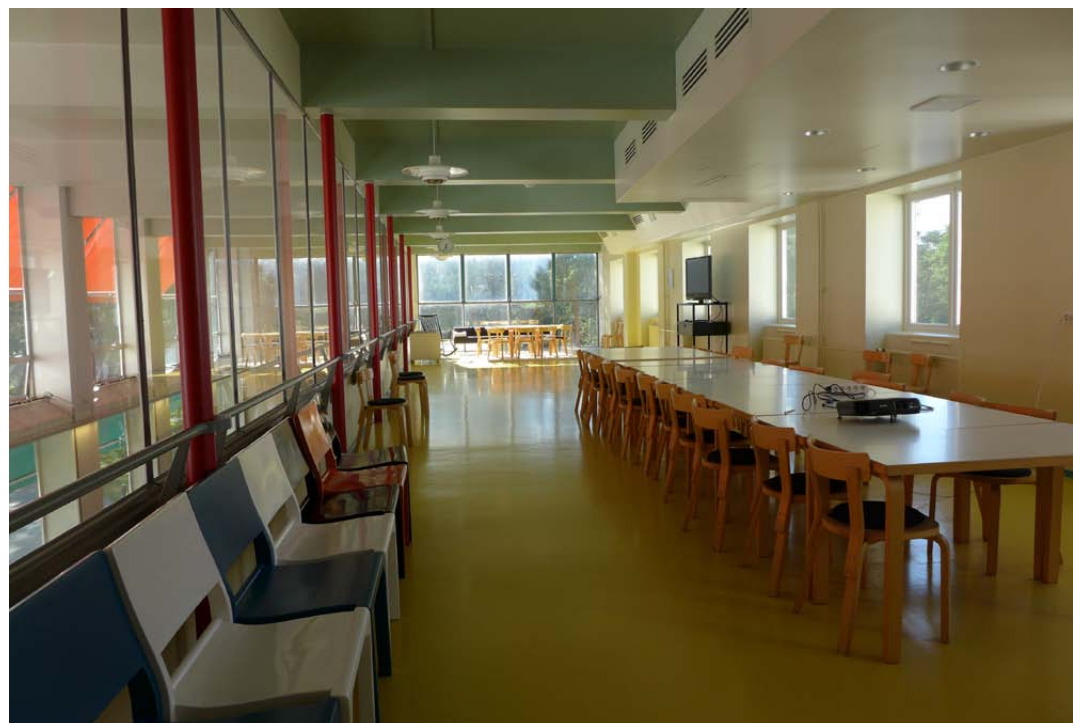
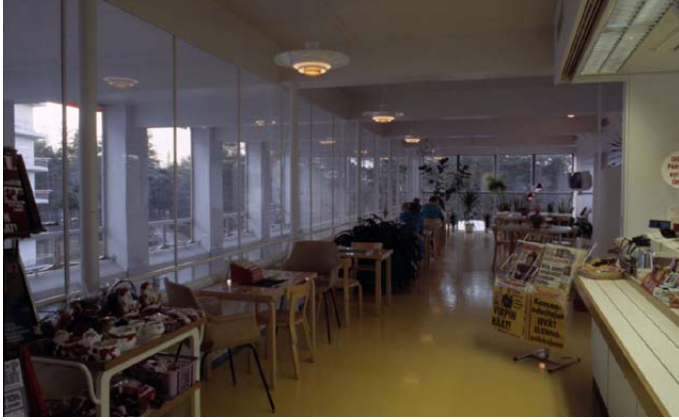
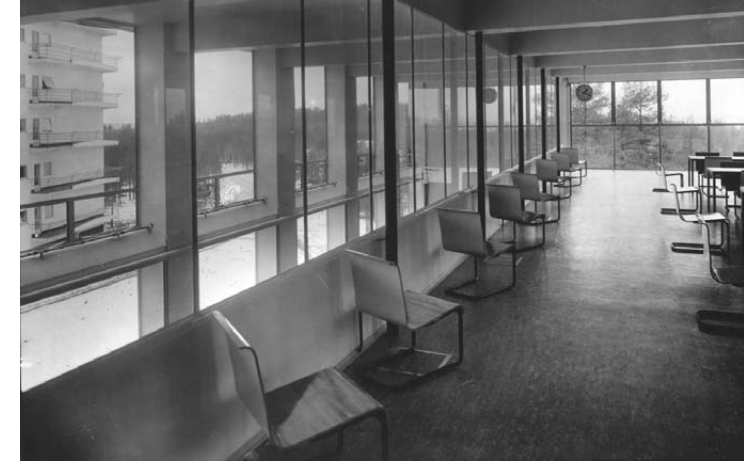
2nd floor B-WING: LIBRARY

Library, 2015 (AAM Jonas Malmberg)

Library, 2015 (AAM Elina Riksmán)

*Library, 1970s
(AAM av 5357 Mikko Merckling)*

Library, 1933 (AAM 50-003-507 Gustaf Welin)

- A rail has been successfully fitted within the overall layout of the window wall (plans from 1975).
- The colour scheme was made in the 2000s, and its historical equivalence, according to the latest colour research, is reasonably good. However, with the next renovations, certain details, such as the boundaries above the dividing wall windows, should be clarified. The installation ducts for the ceiling radiators of the dining hall show traces of the colour coding for the technical infrastructure. The floor material has been changed from a strong patterned linoleum to an evenly coloured yellow linoleum, which gives the space a somewhat disjointed impression.
