**PAIMIO SANATORIUM
CONSERVATION MANAGEMENT PLAN
2016**

Publisher
Alvar Aalto Foundation

The overall goal of the CMP is to guide the future use, care and conservation of the Paimio Sanatorium. The objective in preparing of this CMP has been to produce documents that bring together already existing historical records of the building, including defining of architectural features, physical analysis and the knowledge of the buildings performance over time to create a long-term strategy for decision-makers, contractors and users regarding conservation and maintenance.

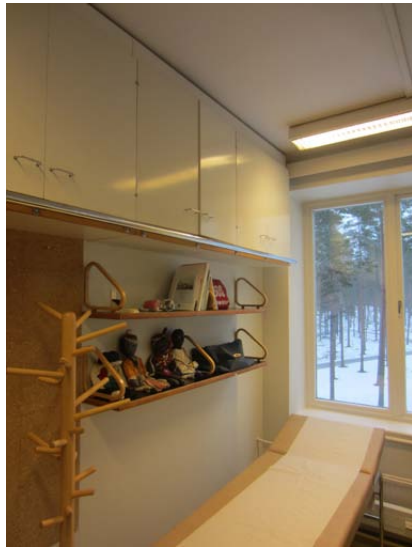
2nd floor B-WING: NURSES' DINING HALL AND LOUNGE, AND GUEST ROOM / CHIEF PHYSICIAN'S OFFICE.

Nurses' dining hall and lounge, and guest room /
chief physician's office, 2015

- The offices built in the 1980s have refined upper windows and other design solutions. Previously used fixed furniture was brought from the chief physician's ground floor office on the specific request of Professor Tala. The totality is in many aspects stylish, and the most elegant of the Paimio interiors realised under the direction of architect Heikki Tarkka.

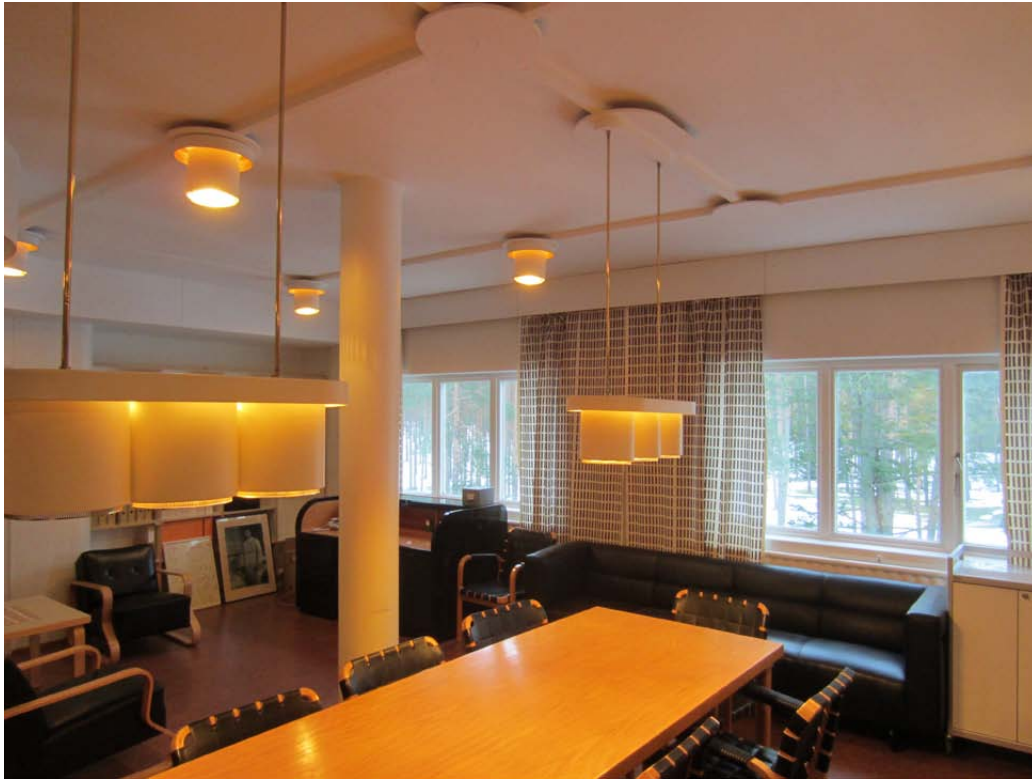
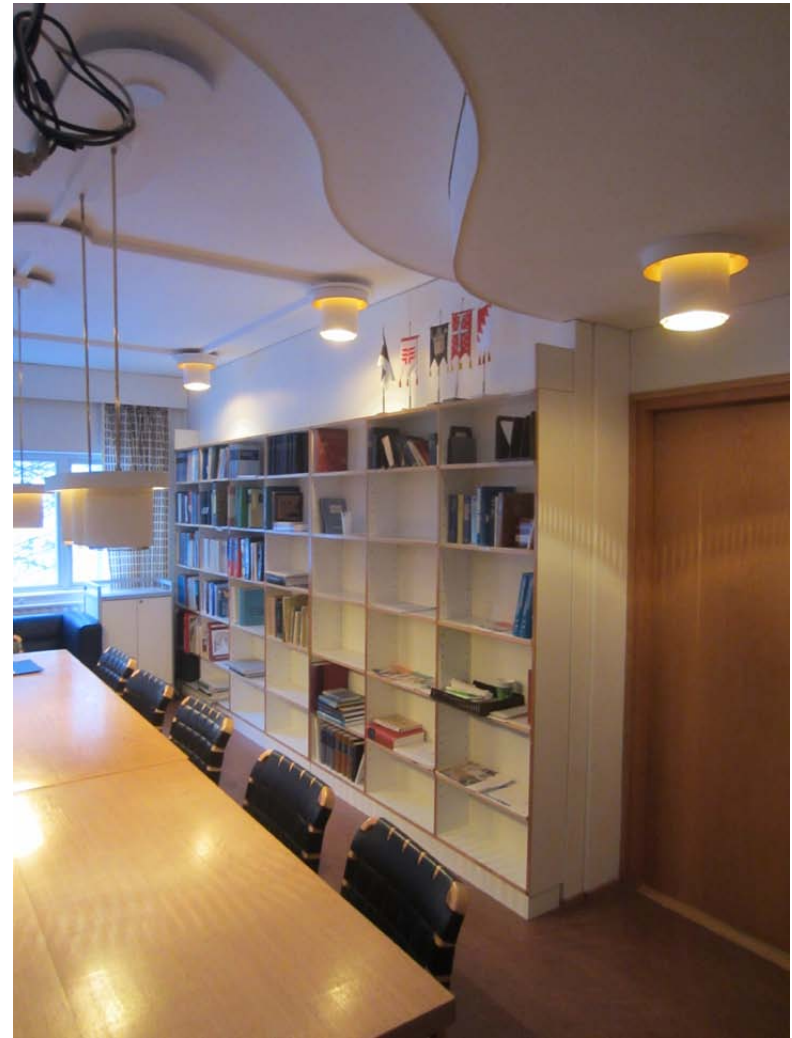
2nd floor C-WING: SANATORIUM BOARD CONFERENCE ROOM / LIBRARY

*Sanatorium board conference room / library, 2015
(AAM Jonas Malmberg)*

- The new space is furnished with refined Artek furniture and ceiling lamps; the space nowadays also contains a collection of original furniture moved here from elsewhere. Particularly the use of the special pieces of original furniture so that they are accessible to visitors can be seen as justified.

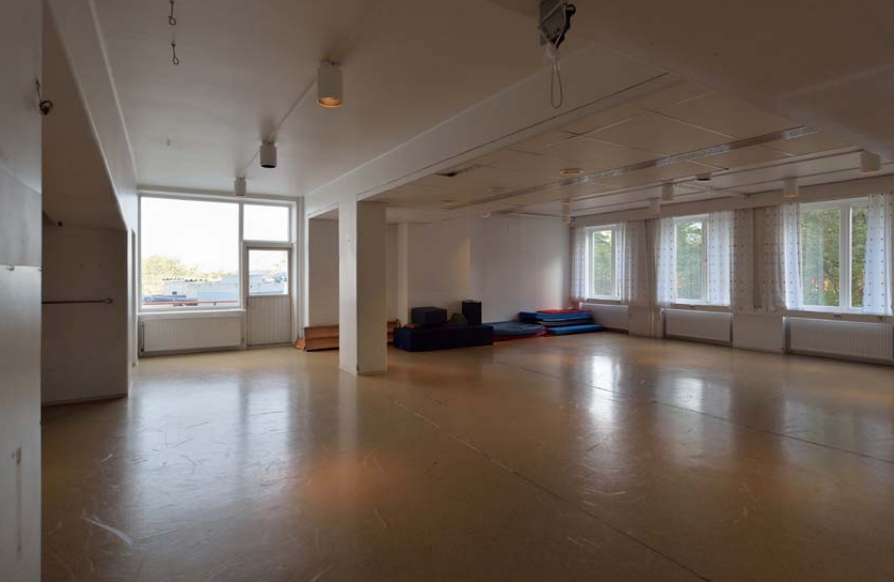
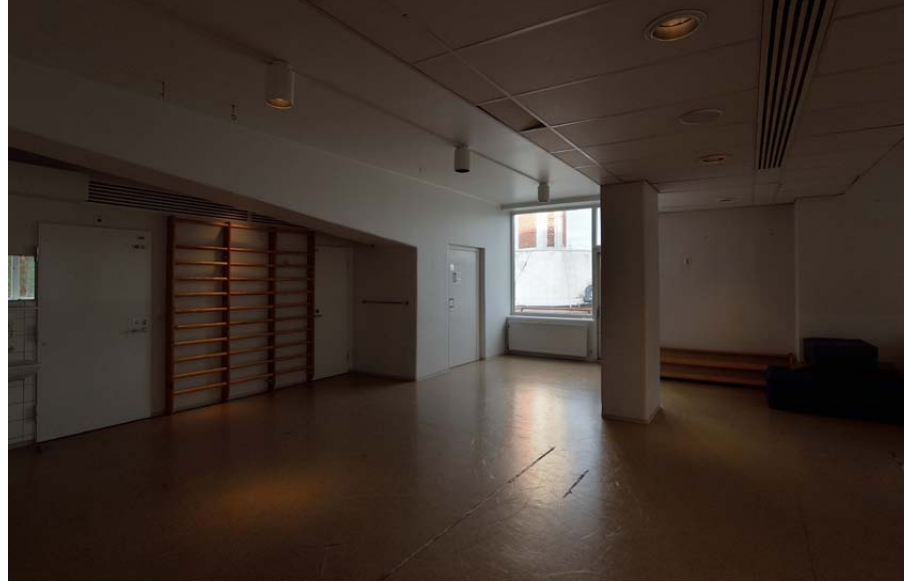
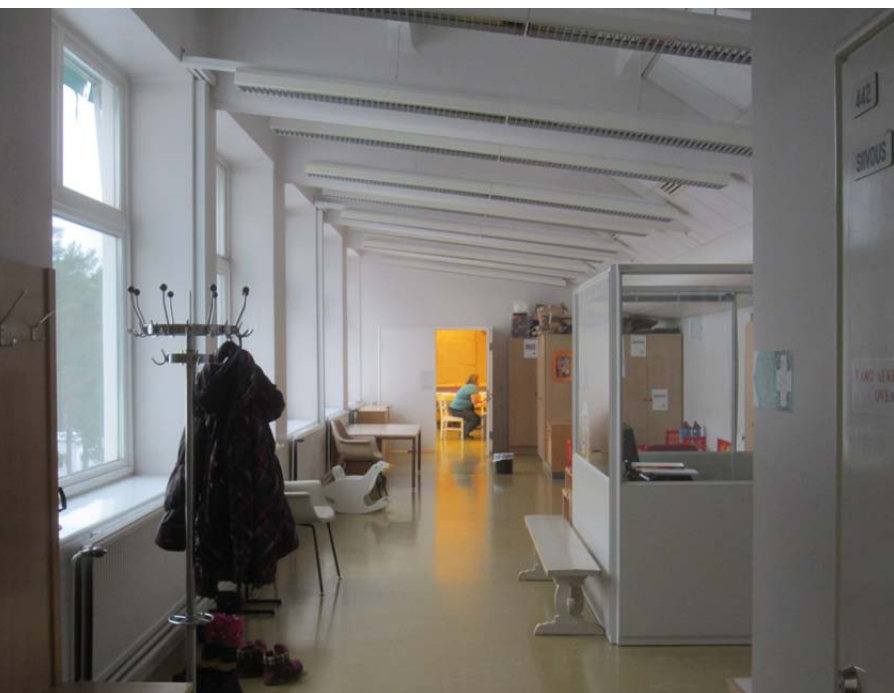
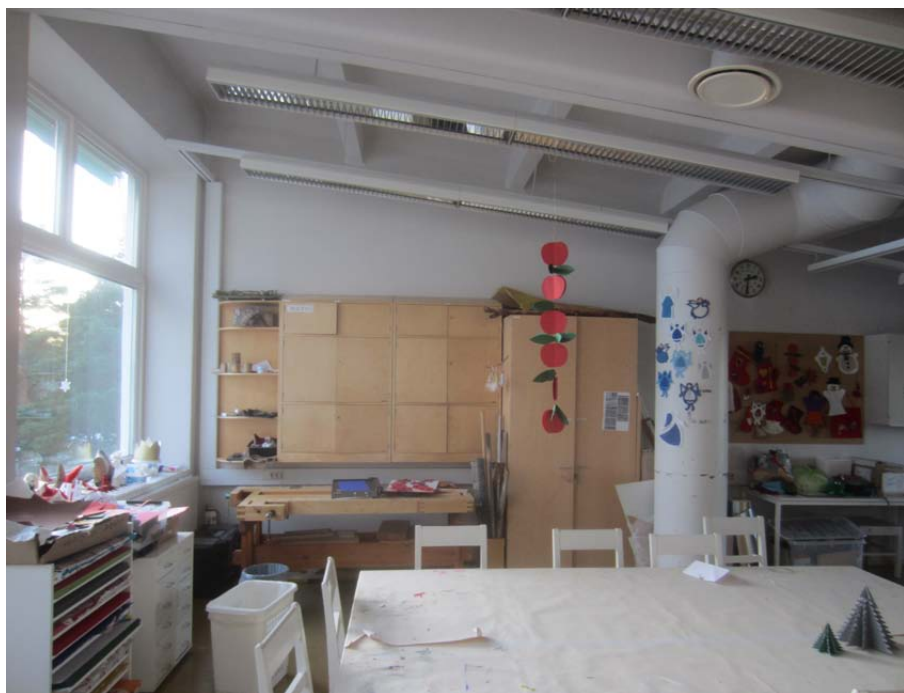
3rd floor B-WING: WORKSHOP, GUEST ROOMS AND ASSISTANT PHYSICIAN'S ROOM
/ ACTIVITY SPACES, GYM HALL, SECRETARY'S OFFICE

Workshop, corridor, guest
rooms / gym hall, 2015
(AAM Sakari Mentu)

Workshop, 2015
(AAM Jonas Malmberg)

- The workshop was divided up, no later than in the 1980s, into small activity spaces and offices, but some parts of it were taken into use already in the 1960s for physiotherapy.

- The gym hall was built in the 1980s in place of the corridor and accommodation, and it cuts off the view from the main stairs towards the balcony at the end of the corridor. The gym hall also spreads over to the location of the former workshop.

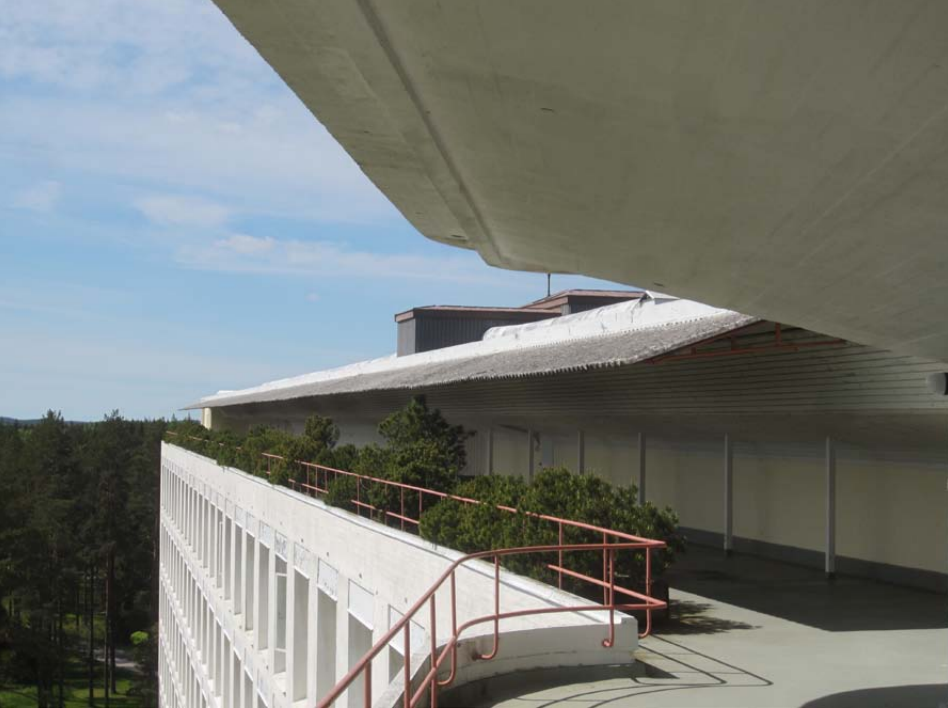
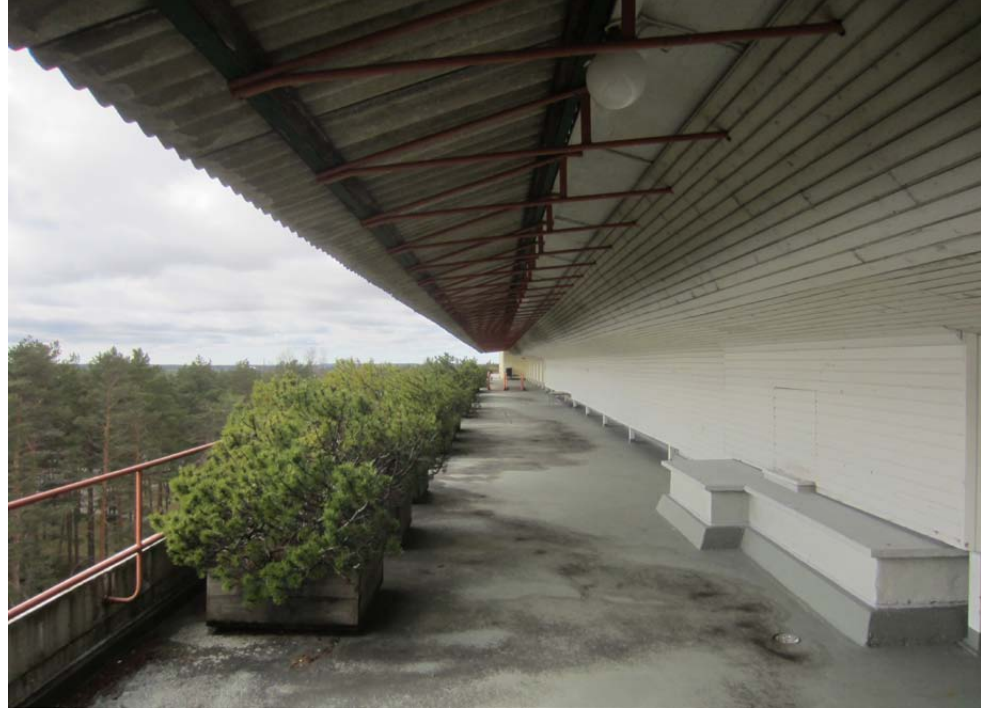
Roof terrace, 2015 (AAM Jonas Malmberg)

- The roof terrace was originally a place where those patients who were in a better condition could recline. On the other hand, it signifies the change in the treatment of tuberculosis. The plant boxes, in accordance with the original idea (the dimensions of the present boxes differ from the original ones), including the dwarf mountain pines, are part of the history (cf. the history of the treatment of tuberculosis and the use of pines, even as potted plants).
- The roof canopy was widened already in 1934. The original glass-steel screens have been removed. The floor has been renewed. From the 1970s onwards, spaces were reserved for the air-conditioning machinery, and suspended ceilings installed. The original lamps have been removed, as has the rail construction for patient rehabilitation which was added in the 1980s.
- The roof terrace is a key sight for visitors.

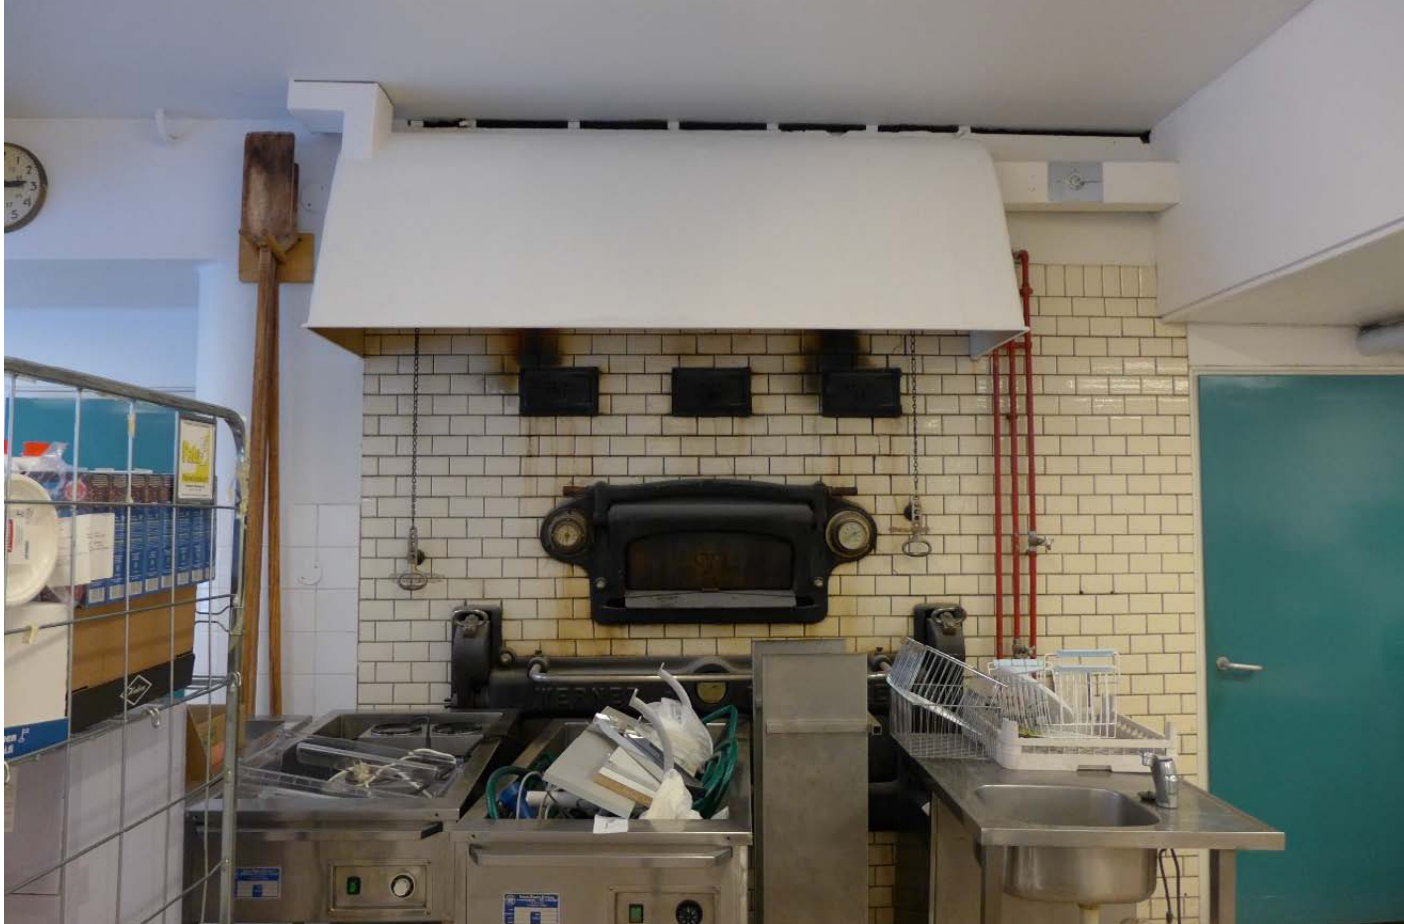
Maintenance of windows of the 6th floor during summer 2015 (AAM Elina Riksmán).

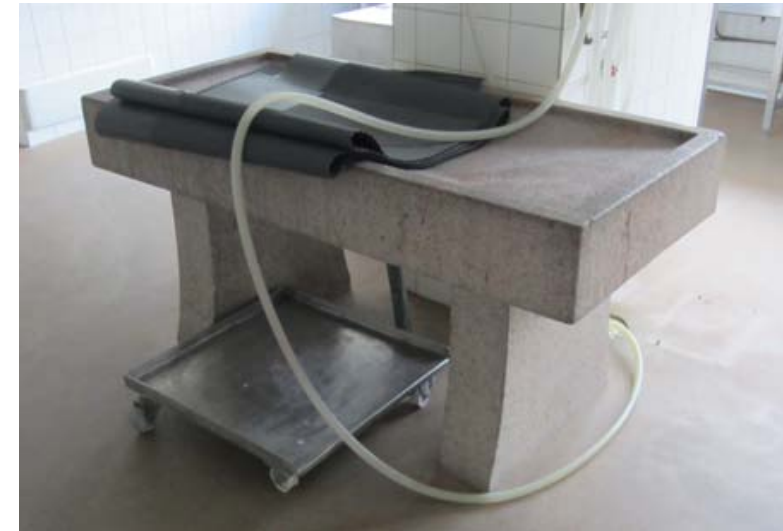
The original kitchen sink on the ground floor of C-wing (AAM Malmberg).

The sanitary equipment has lost their original character as the result of normal wear, decay and refurbishments. There are not too many pieces to be preserved from the original installations. Besides the museum room, there are only a few examples of early sanitary porcelain or other such pieces, which are to be recognized and preserved in forthcoming interventions. All the interesting examples are to be found in technical spaces as well as in the basement of C-wing, which has, for example, an original kitchen sink.

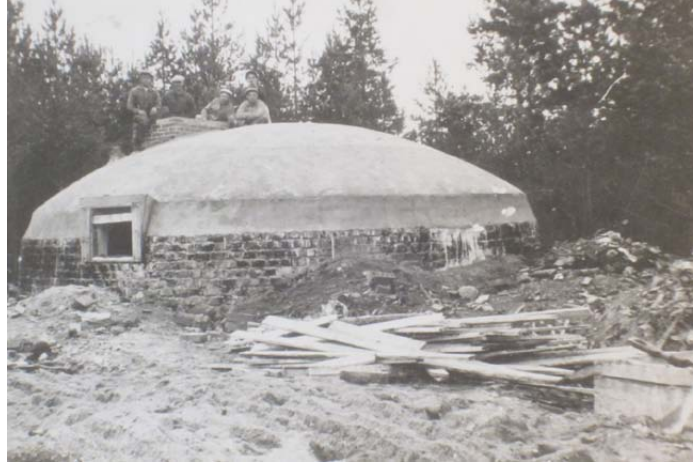
PAIMIO SANATORIUM, ROSE CELLAR

*Rose Cellar under construction
(Sanatorium photo).*

The first preparatory stage for the restoration is to compile a building-historical report on the cellar; in the event that there is a lack of information about the original design and later alterations, the focus would shift towards landscape work, while repairs to the interiors would be limited to only the absolutely necessary ones.

Another essential pre-restoration planning measure is the analysis of the water-proofing that had been later applied by brush to the inside of the cellar. If the insulating material turns out to be creosote,

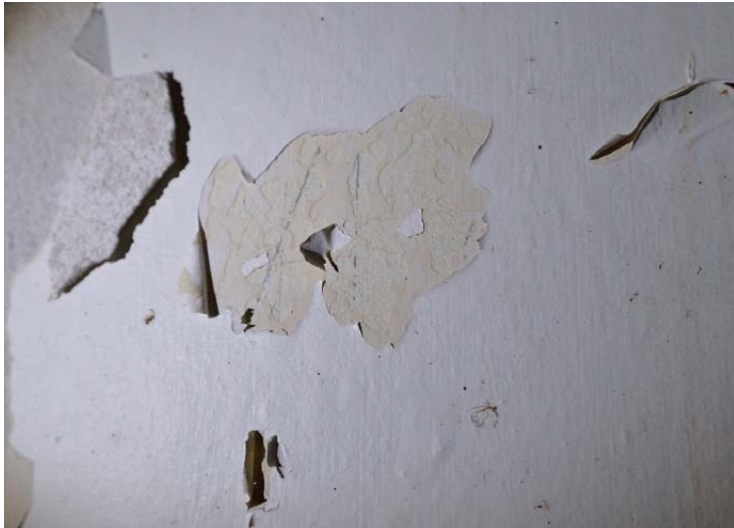
*Kauria's mural is painted over
(AAM Sakari Mentu).*

The original building material must not be damaged during the work, except for the above-mentioned wall surfaces, which are to be removed. Besides technical challenges, the most difficult part of the reconstructive restoration will be the choice of approach when restoring the cellar mural. On the wall are two paint layers in poor condition, about neither of which there is currently sufficient information. During the course of the work, the paintings should preferably be protected from physical damage, and more information should be found about the original situation. If such information is not discovered, the choice of action will be particularly difficult; later surfaces can not be removed without knowing the extent and condition of the painting beneath, the conservation of the present situation will be difficult, and the reconstruction of the later painting could be harmful to the layers of paint beneath.

In the absence of source material, it would in principle be possible to select a minimum intervention, based on the last documented appearance of the interior space. The wall mural would be complemented or repainted so that the earlier painting layers are protected by the new surface layer (if technically possible). The inner shell would be rebuilt, but the creosote substance would be removed or sealed in. The floor would be returned to its previous appearance and the brick floor would be retained beneath it. The original material would be preserved, but the end result would easily end up being rather uninteresting.

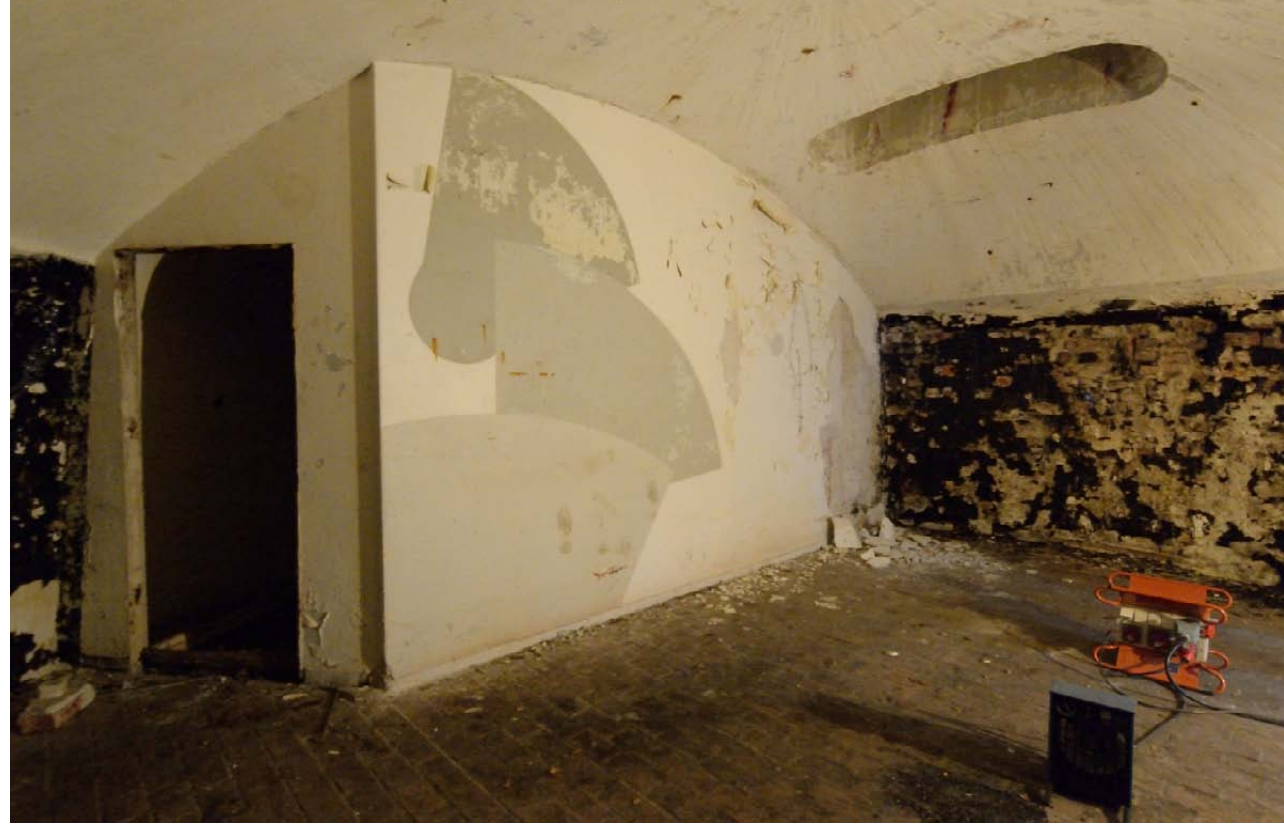
Interior in 2015 (AAM Sakari Mentu).

If the above conditions are achieved, it will be primarily a case of returning the original forms, materials and colours of the interior surfaces. Eino Kauria's mural will be conserved and complemented, the interior brick walls will be re-laid and their surfaces treated, and the exterior earthworks will be redone. The source material for the planning work should be as comprehensive and detailed as possible. If successful, the restoration of an interior close to the original will benefit cultural tourism in Paimio and the presentation of the sanatorium surroundings.

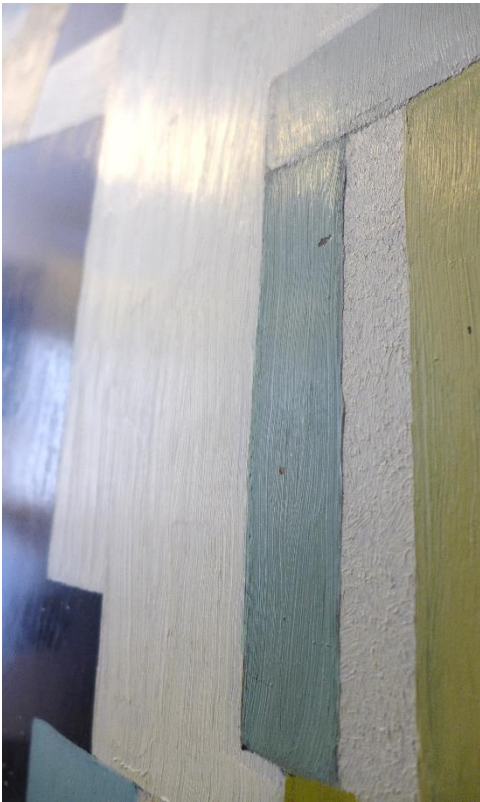
NCS color codes of the color board of Paimio hospital are presented above. This board is at the moment located in Paimio hospital's main building.

The different textures on the color board created by the brush strokes and technique. This pictures presents the textures of the board located in Paimio hospital.

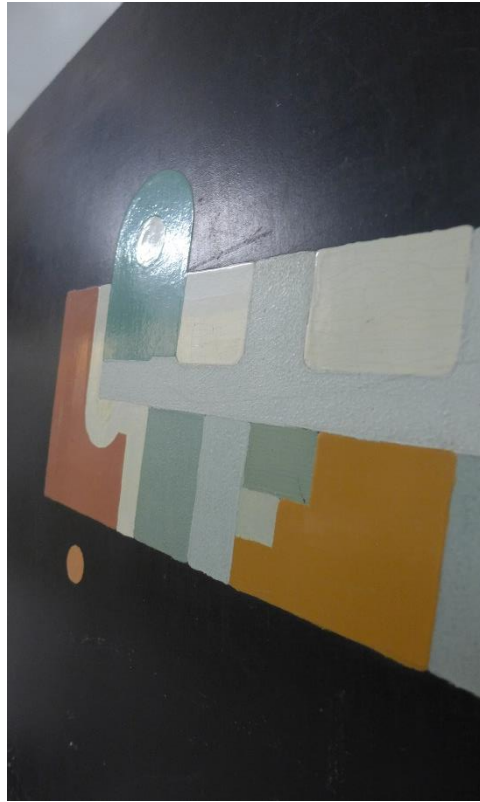
The second board's NCS codes are shown left. This board is presumably the original board painted by Kauria himself. It is in the collections of Alvar Aalto museum, Jyväskylä, Finland.

The presumably original color board of Alvar Aalto Museum collections has high gloss and matt finishes.

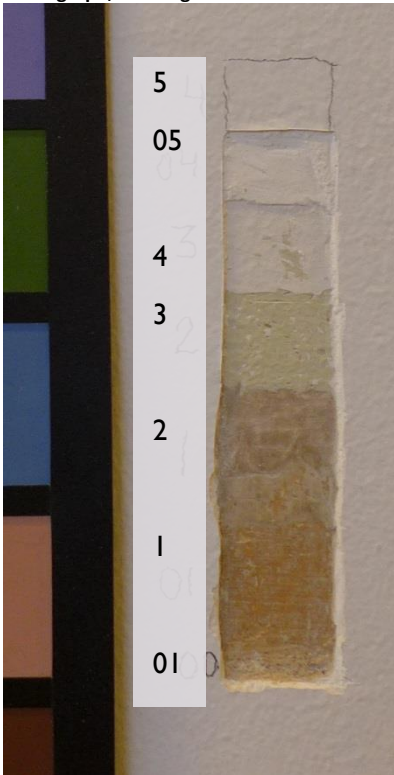
Number of Sample 160	Subject Paimio Sanatorium	Building / Space / Surface Main building Basement Ward Wing Hall way wall	
Architect, building year Alvar Aalto, 1929-33	Researcher, date Elina Riksmann, June-Dec. 2015, Alvar Aalto-foundation		
Most significant repairs and changes of the space, dates 1970's ventilation system brought casing of the pipes and electric cords in the ceiling. Doors and their sizing has changed, broader painted wooden doors have replaced the original wooden doors with lacquered surfaces. The lighting and fixtures have also been replaced.			
Photograph, drawing

Layers of Sample 00 Chalsium based Plaster	
		01 Oil Filler	
		1 Orange paint 3040-Y40R

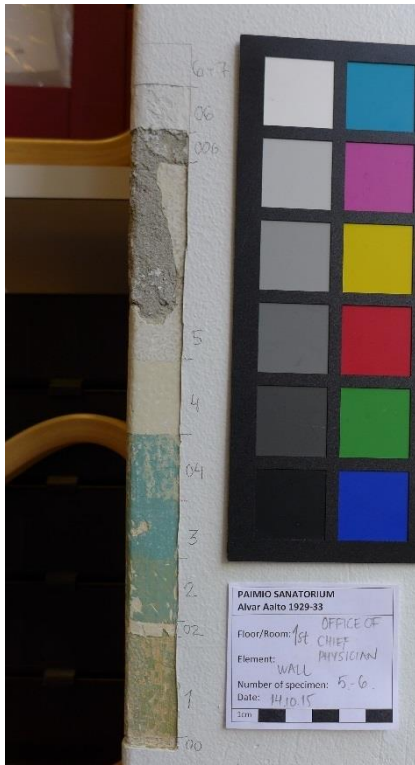
Number of Sample 5-6	Subject Paimio Sanatorium	Building / Space / Surface Main building Ground Floor Chief Physician's office Jamb of window	
Architect, building year Alvar Aalto, 1929-33	Researcher, date Elina Riksmann, June-Dec. 2015, Alvar Aalto-foundation		
Most significant repairs and changes of the space, dates The office has been divided in two separate office spaces with a light structured wall in the 1980's. Also divided a cupboard with its own door to the hallway. Ventilation system built in 1970's, with dropped ceiling structure. New door openings. Sink in opposite corner as in the original office plan.			
Photograph, drawing

Layers of Sample 00 Chalsium based Plaster 01 Oil filler, yellowish 1 Green paint, oil, 3020-G40Y

Technique used to make and take Samples, Circumstance in site, Lighting: Carved color steps on surface, crater technique, daylight + fluorescent lamps	Color chart in use: NCS Teknos 2004 Color codes are written without the NCS prefix.	Type of Sample, Place of Storage: Cross-section sample 5 and 6, Alvar Aalto Foundation Helsinki. Scale 500µm.	Floor plan, Location of Sample

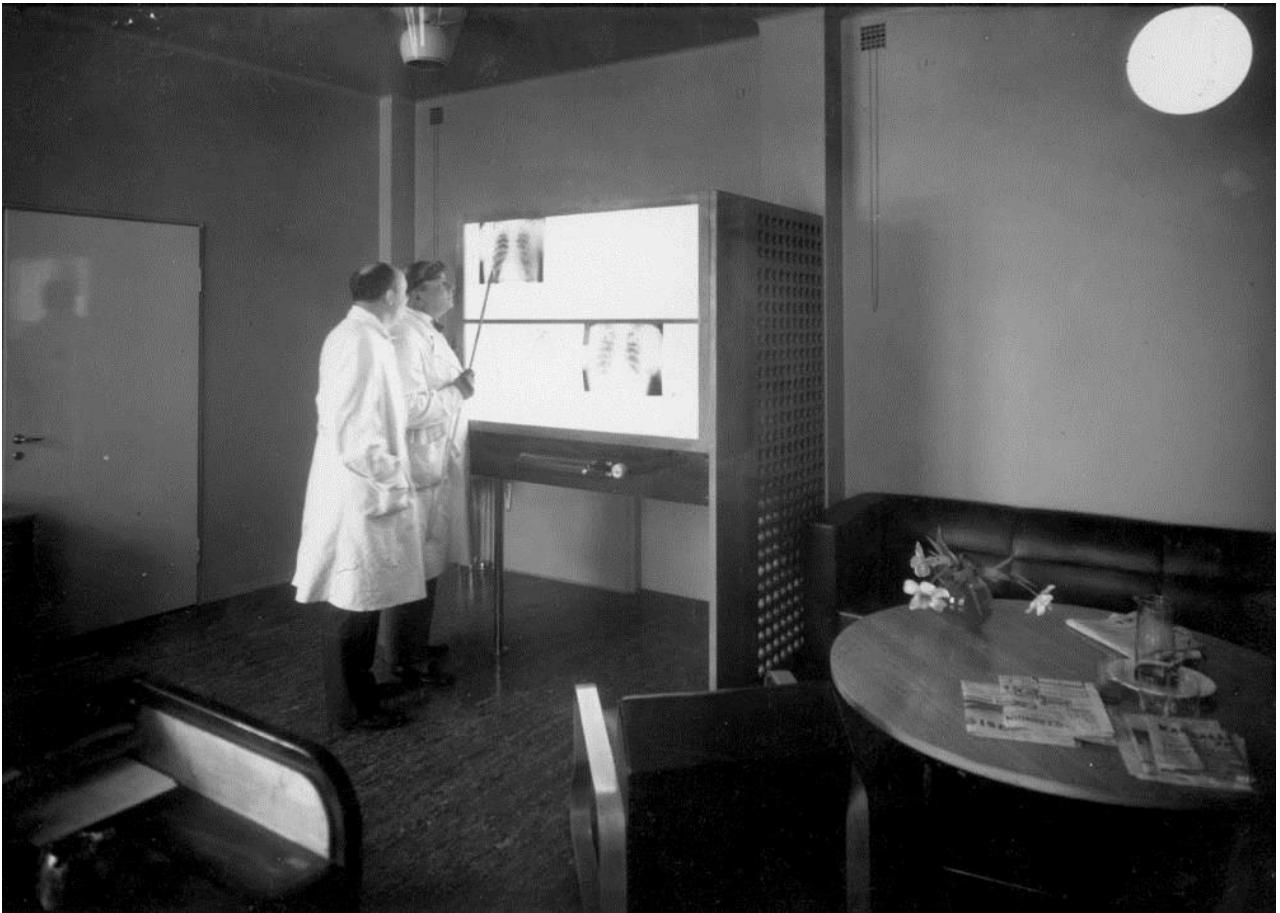
The pilaster where sample 22 (see next page) was taken is behind the gentlemen in the picture. Notice the heavily patterned linoleum flooring. AAM Sign. 50-003-369.

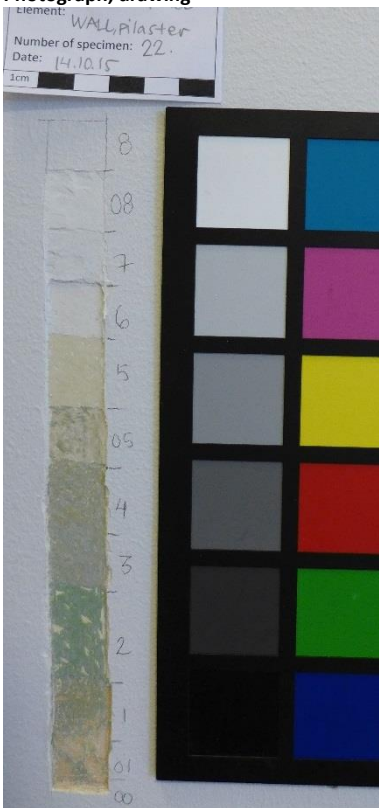
Number of Sample 22	Subject Paimio Sanatorium	Building / Space / Surface Main building Ground floor Former Chief Physician's office (now: offices) Pilaster in the corner of the room	
Architect, building year Alvar Aalto, 1929-33	Researcher, date Elina Riksmann, June-Dec. 2015, Alvar Aalto-foundation		
Most significant repairs and changes of the space, dates The office has been divided in two separate office spaces with a light structured wall in 1980's. Also divided a cupboard with its own door. Ventilation system built in 1970's, with dropped ceiling structure. New door openings. Sink in opposite corner as in the original office plan.			
Photograph, drawing

Layers of Sample 00 Chalsium based Plaster	
		0 Oil based filler	
		1 Grey paint, oil 2005-B80G	
		2 Green paint, oil 3030-G10Y	
		3 Grey paint, between 2005-B20G and 3005-B20G	
		4 Grayish green3010-G70Y	
		5 Glossy, hard paint, Beige 1010-Y10R

6 White paint 0603-G80Y	
		7 White latex paint	
Observations, remarks, e.g. pigment, adhesive, type of paint, material analysis: 1 Öljymaali Most of the surfaces have been stripped down, apparently during the 1970's big renovations. One of the pilasters showed good amount of paint layers in crater excavation of surfaces.		08 White, light weight filler	
		8 White latex	
Technique used to make and take Samples, Circumstance in site, Lighting: Carved color steps on surface, crater excavation technique, daylight + fluorescent lamps	Color chart in use: NCS Teknos 2004 Color codes are written without the NCS prefix.	Type of Sample, Place of Storage: Cross-section sample 22, Alvar Aalto Foundation Helsinki	Floor plan, Location of Sample

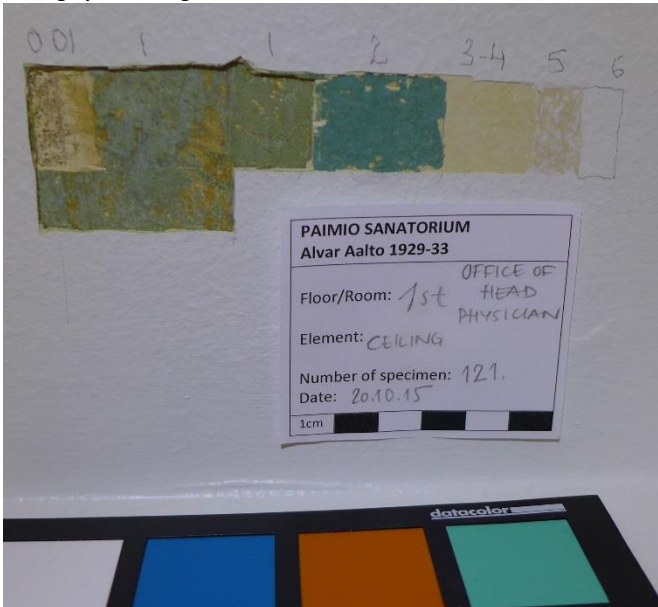
Number of Sample 121	Subject Paimio Sanatorium	Building / Space / Surface Main building Ground Chief Physician's office (now offices) Ceiling	
Architect, building year Alvar Aalto, 1929-33	Researcher, date Elina Riksmann, June-Dec. 2015, Alvar Aalto-foundation		
Most significant repairs and changes of the space, dates The office has been divided in two separate office spaces with a light structured wall with windows in 1980's. Also divided a cupboard with its own door. Ventilation system built in 1970's, with dropped ceiling structure, but not covering the whole ceiling, leaving parts of it bare. New door openings.			
Photograph, drawing		Layers of Sample

00 Chalsium based Plaster	
		0 Oil based filler	
		1 Light turquoise/blue paint, surface scratched with scalpel: 2010-B90G, untouched paint surface 4020-G10Y

5 Beige paint 1005-Y20R			
6 White			
Observations, remarks, e.g. pigment, adhesive, type of paint, material analysis: 1			
Technique used to make and take Samples, Circumstance in site, Lighting: Carved color steps on surface, crater technique, daylight + fluorescent lamps		Color chart in use: NCS Teknos 2004 Color codes are written without the NCS prefix.	Type of Sample, Place of Storage: Cross-section sample 121, Alvar Aalto Foundation Helsinki

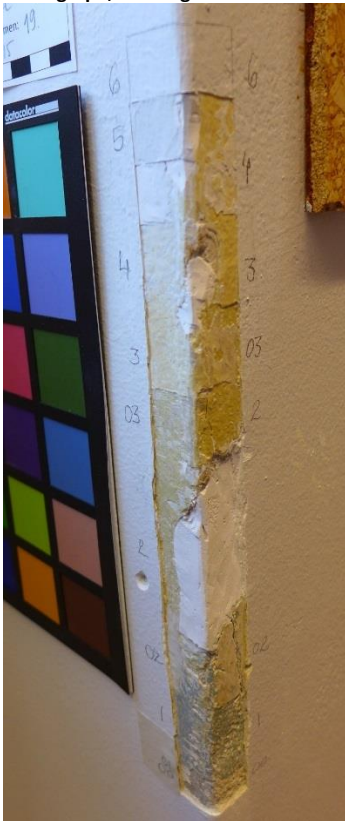
Number of Sample 19	Subject Paimio Sanatorium	Building / Space / Surface Main building Ground Floor Artificial sun treatment room (now: kitchen of staff) Jamb of window, wall	
Architect, building year Alvar Aalto, 1929-33	Researcher, date Elina Riksmann, June-Dec. 2015, Alvar Aalto-foundation		
Most significant repairs and changes of the space, dates Former light treatment room has been divided in three office spaces. Kitchen, used by the staff from 1970's. Ventilation system built in 1970's, with dropped ceiling structure. New door opening.			
Photograph, drawing

Layers of Sample 00 Plaster	
		0 Filler	
		1 Greyish blue oil paint, 3020-B50G

02 Beige filler	
		2 Dark Beige 2030-Y10R	
		03 Light filler / base coat 2010-Y10R	
		4 Beige 0510-Y10R	
		05 Filler, light weight, white	
		5 Grey Latex 2000-N	
Observations, remarks, e.g. pigment, adhesive, type of paint, material analysis: 1st Layer Oilpaint Small crater type excavations were made in the room.		6 White Latex

Technique used to make and take Samples, Circumstance in site, Lighting: Carved color steps on surface, crater technique, daylight + fluorescent lamps	Color chart in use: NCS Teknos 2004 Color codes are written without a prefix.	Type of Sample, Place of Storage: Cross-section sample 19, Alvar Aalto Foundation Helsinki. Scale 500µm.	Floor plan, Location of Sample

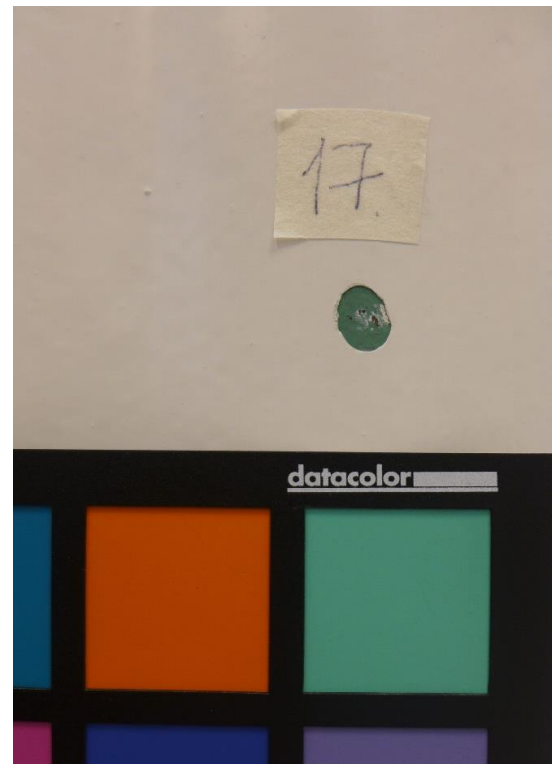
Sample 17 shows the undermost layers of green. The first layer seems to be a blueis, teal kind green.

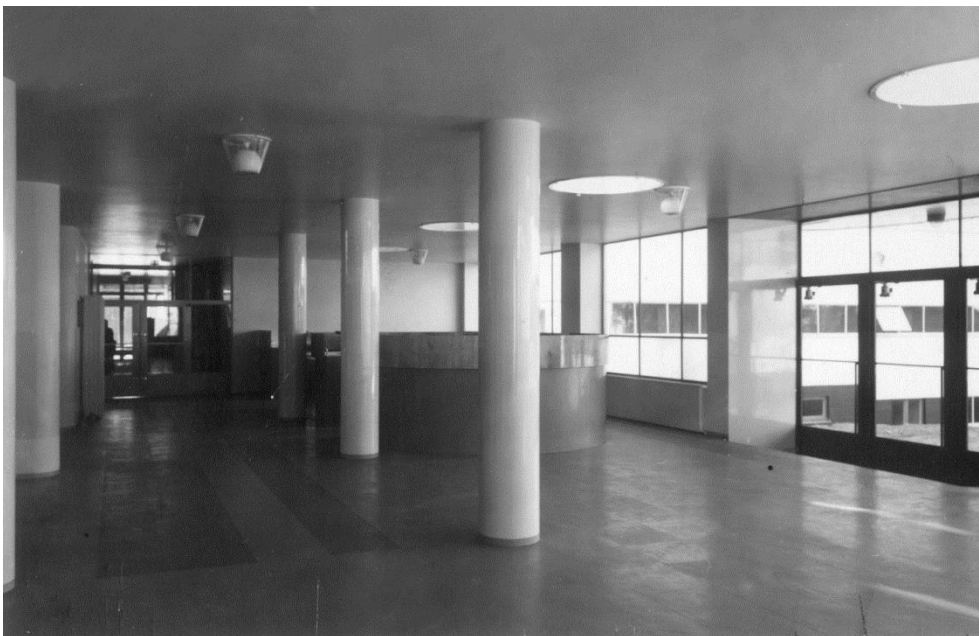
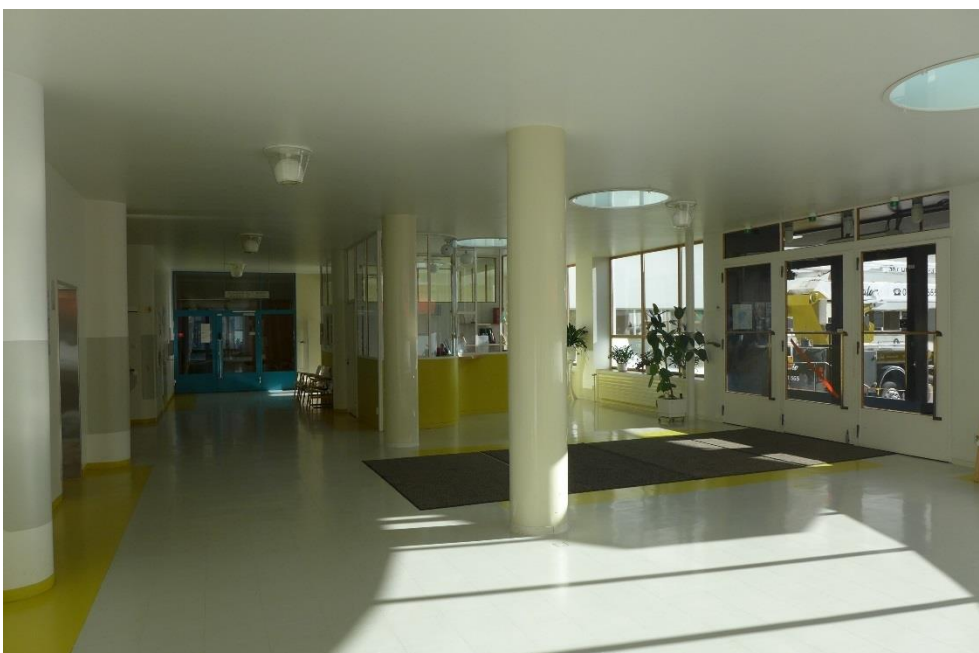
The main lobby of Paimio Sanatorium has gone through several changes. One of the major changes is the change from original front desk to a curved glass cubicle 1958. The change was designed by Alvar Aalto's office. The two elevators have been renewed. The original elevators stood side by side, the structure was a see-through glass-walled shaft. It has been said in a patient statement that one of the elevators was colored red. This was maybe to mark the line of passage for different types of users. All the traces of these color coded elevator cars have been lost during the renovations. The elevator's original technical space at the roof in 6th floor does neither give any hints of color. The Kauria color board marks the elevators bright red and bright blue. The samples and small excavations made in the main hall gave little new information to the facts one can see in the coeval photographs taken after the completing of main building. The ceiling is relatively lightly colored, as the pilasters stand out white and glossy. The main doors seem dark and the cheeks of the doors are light and glossy, as nowadays these cheeks are painted black.

Main hall with the original flooring and front desk. No draught lobby was built at this stage. Below is the current status of the Main lobby. Notice how the light does not pass through the Ground floor ward through the ward doors due to some change, leaving the back part of the lobby dark. AAM Sign. 50-005-308.

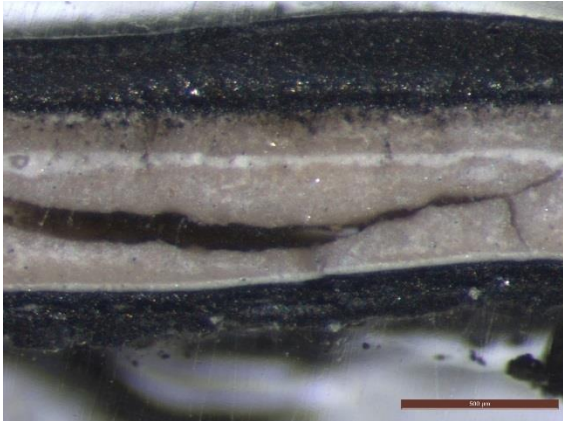
Number of Sample 25	Subject Paimio Sanatorium	Building / Space / Surface Main building Ground Floor Entrance hall Draught lobby (between outer and inner main doors)	
Architect, building year Alvar Aalto, 1929-33	Researcher, date Elina Riksmann, June-Dec. 2015, Alvar Aalto-foundation		
Most significant repairs and changes of the space, dates Draught lobby was built 1958 as the inner doors were added. At the same time the front desk was replaced.			
Photograph, drawing

Layers of Sample 00 Plaster	
		0 Filler	
		1 Black paint	
		2 Light beige or white	
		3 Thick filler	
		4 Black paint	
		5 Black paint	
Observations, remarks, e.g. pigment, adhesive, type of paint, material analysis			
Technique used to make and take Samples, Circumstance in site, Lighting: Carved color steps on surface, crater technique, daylight + fluorescent lamps	Color chart in use: NCS Teknos 2004 Color codes are written without the NCS prefix.	Type of Sample, Place of Storage: Cross-section sample 25. Alvar Aalto Foundation Helsinki. Scale 500µm.	Floor plan, Location of Sample

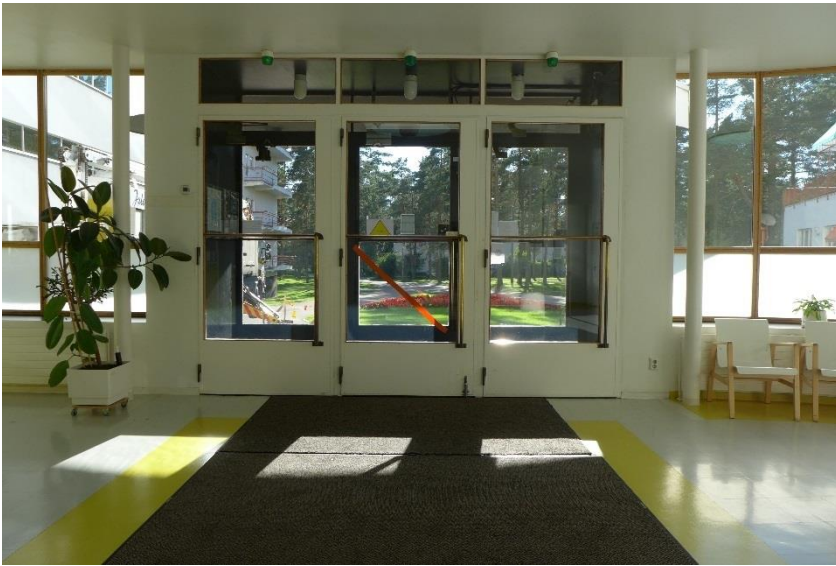
The entrance hall and drought lobby today.

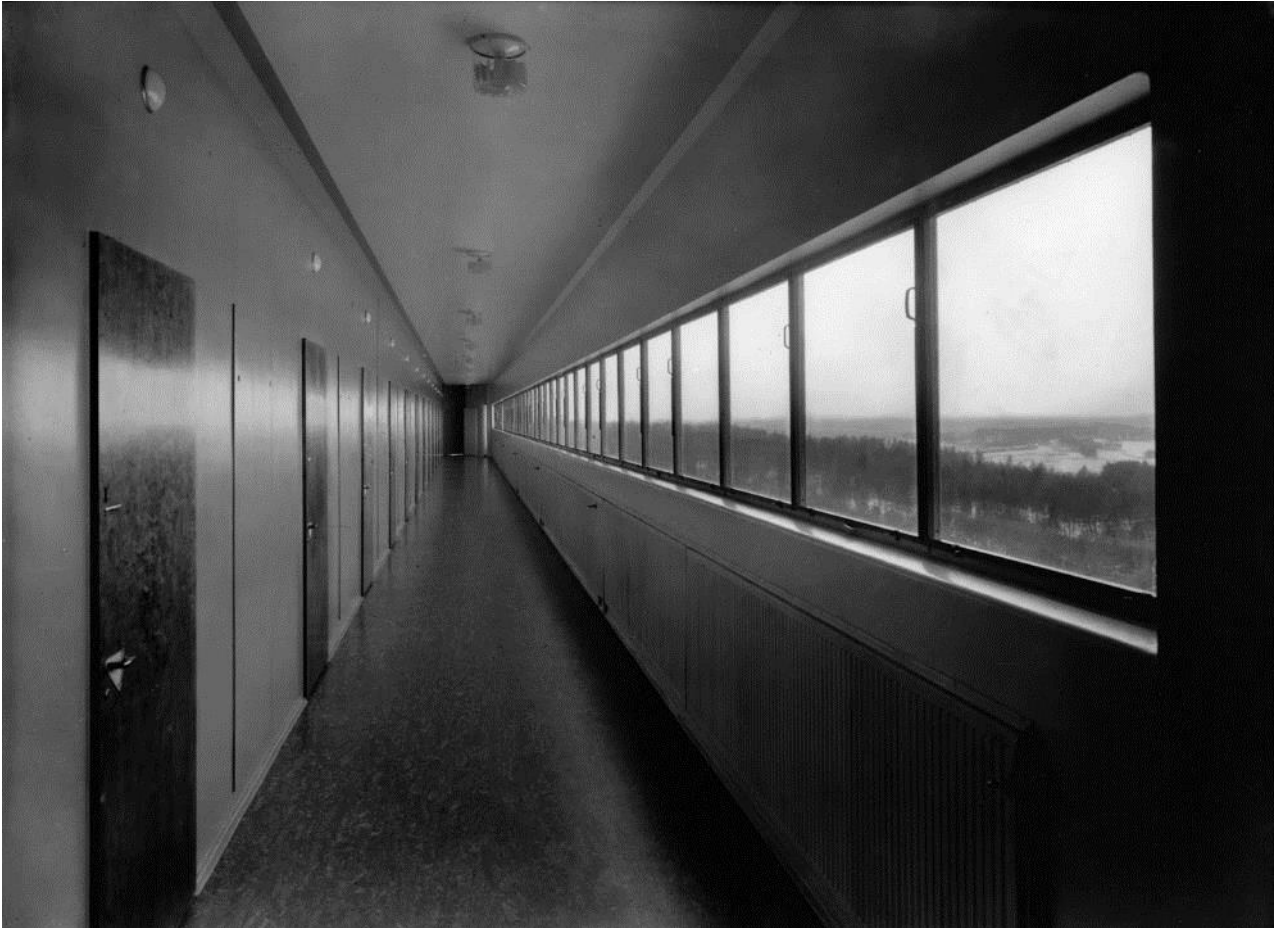
One of the wards (probably sixth according to the view from window). The wall with doors was painted in rich a tone and the outer wall in neutral color of off white. Below is a view today from the sixth floor ward to the opposite direction. Notice the built in structure in the ceiling for the purpose of hiding ventilation systems and electricity cords, dating to the 1970's. AAM. Sign. 50-003-328

The ceiling of the corridor has originally been white but as seen in the picture above, there is was a diagonal molding in the corner of the colored wall and ceiling. This molding was painted with the same color as the wall. In Eino Kauria's color board the wards are marked with three colors, ochre, blue and green.

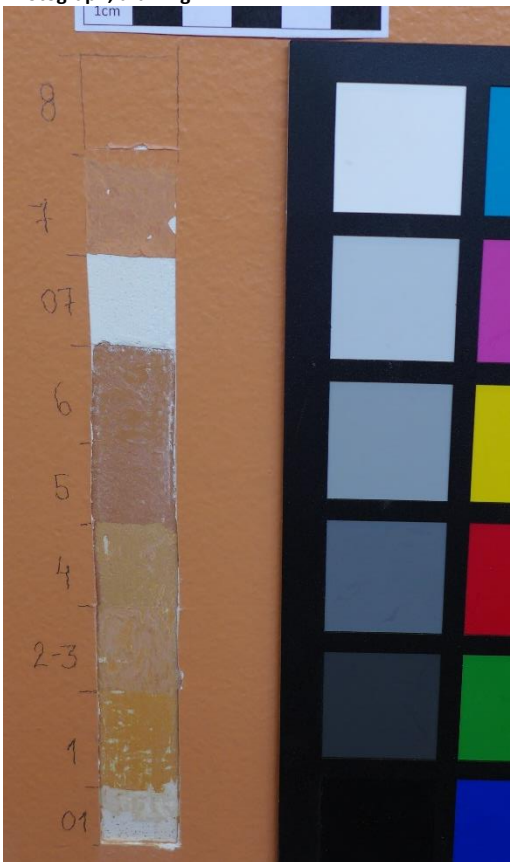
Ward, Main Hallway

Number of Sample 11	Subject Paimio Sanatorium	Building / Space / Surface Main building 1st Floor A-wing, ward's main corridor Wall with doors	
Architect, building year Alvar Aalto, 1929-33	Researcher, date Elina Riksman, June-Dec. 2015, Alvar Aalto-foundation		
Most significant repairs and changes of the space, dates 1970's ventilation system brought casing of the pipes and electric cords in the ceiling. Doors and their sizing has changed, broader painted wooden doors have replaced the original wooden doors with lacquered surfaces. The lighting and fixtures have also been replaced.			
Photograph, drawing

Layers of Sample 00 Plaster	
		01 Beige filler	
		1 Ochre S2050-Y30R	
		2 -3 Reddish browns 3020 – Y40R	
		4 Brown 3030-Y20R	
		5 Reddish dark brown 4020-Y60R	
		6 Brown 4030-Y30R	
		07 White light weight filler	
		7 Red 3020-Y60R	
Observations, remarks, e.g. pigment, adhesive, type of paint, material analysis: 1st layer is oil based paint.		8 Orangey red 2040-Y60R (nearest possible shade)

Technique used to make and take Samples, Circumstance in site, Lighting: Carved color steps on surface, crater technique, daylight + fluorescent lamps	Color chart in use: NCS Teknos 2004 Color codes are written without the NCS prefix.	Type of Sample, Place of Storage: Cross-section sample 11, Alvar Aalto Foundation Helsinki. Scale 1mm.	Floor plan, Location of Sample

The cross section sample no. 11 taken from this ochre wall, broke into three parts. The bottom picture of this sample shows the undermost plaster, the middle one shows the original base filler as a brown layer, the white base coat and the first two orange paint layers. The surface is presented in the top picture where a light weight white filler layer is visible.

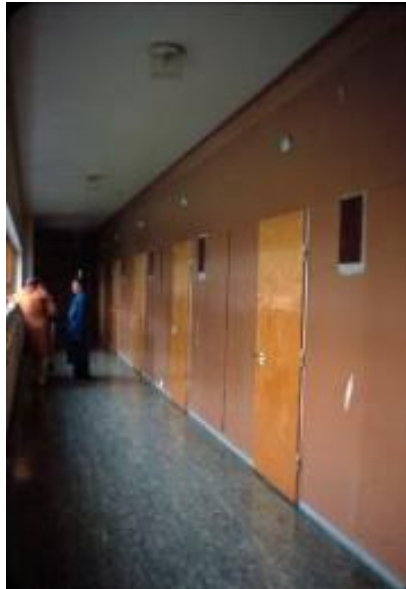
Photo: Av 5375_26. The status of one of the wards before the 1970's renovation. Notice the color and pattern of the linoleum flooring.

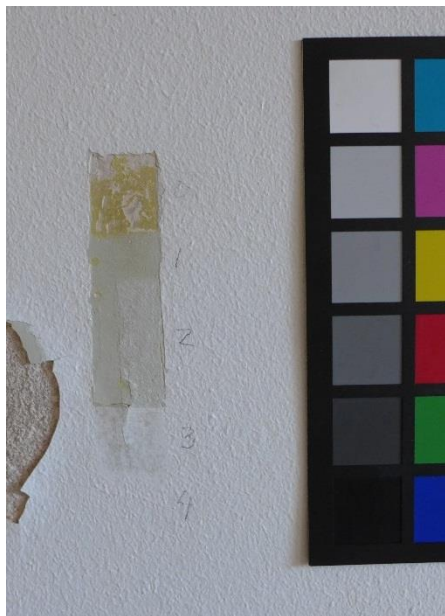
Jamb / Cheek of Door

Number of Sample 52	Subject Paimio Sanatorium	Building / Space / Surface Main building Ground Floor A wing Museum room (former patient room left untouched in the 1970's renovation) Jamb of door (cheek of door)	
Architect, building year Alvar Aalto, 1929-33	Researcher, date Elina Riksmán, June-Dec. 2015, Alvar Aalto-foundation		
Most significant repairs and changes of the space, dates Patients' rooms have been fully renovated during 1970's but this Museum room was left to resemble the original 1930's look of a patient room. No hospital technique (i.e. different types of gases) or surfaces, HVAC-technique or furniture were redone. Original ceiling radiator was left (still functioning) and ceiling painted. Wallcoverings and flooring were left as they were, a Enso-cardboard covering on one wall and linoleum flooring. Original furniture and light fixtures were put to place.			
<p>Photograph, drawing THIS EXCAVATION WAS MADE DURING ANOTHER RESEARCH YEAR 2000 (Katja Aaltonen).</p>

Layers of Sample 00 Plaster

0 Filler	
		01 Yellow paint, base coat?	
		1 Grey paint S1005-G75Y	
		2 White paint S0505-G60Y	
		3 White S0601-Y21R	
		4 S0500-N	
Observations, remarks, e.g. pigment, adhesive, type of paint, material analysis: 1 Öljymaali			
Technique used to make and take Samples, Circumstance in site, Lighting: Carved color steps on surface, crater technique, daylight + fluorescent lamps	Color chart in use: NCS Teknos 2004 Color codes are written without the NCS prefix.	Type of Sample, Place of Storage: Cross-section sample 52, Alvar Aalto Foundation Helsinki. Scale 500µm.	Floor plan, Location of Sample
