**PAIMIO SANATORIUM
CONSERVATION MANAGEMENT PLAN
2016**

Publisher
Alvar Aalto Foundation

The overall goal of the CMP is to guide the future use, care and conservation of the Paimio Sanatorium. The objective in preparing of this CMP has been to produce documents that bring together already existing historical records of the building, including defining of architectural features, physical analysis and the knowledge of the buildings performance over time to create a long-term strategy for decision-makers, contractors and users regarding conservation and maintenance.

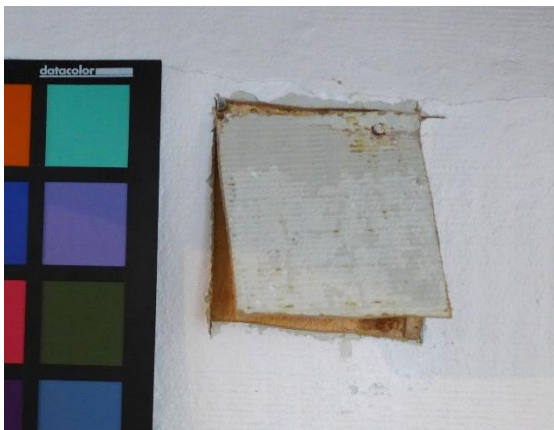
Enso card board was a Finnish wall treatment that was easy to apply and which gave instantly smooth paintable surfaces. It had its own distinctive texture that can be seen in the pictures below. The museum room wall's card board is the last fragment of Enso board in Paimio. Katja Aaltonen made an excavation on the wall board of museum room during the year 2000 research to define the original colors of the wall.

The undermost color was S1005-G30Y, a greenish grey.

Enso card board fragment excavated in Museum room in the year 2000 research.

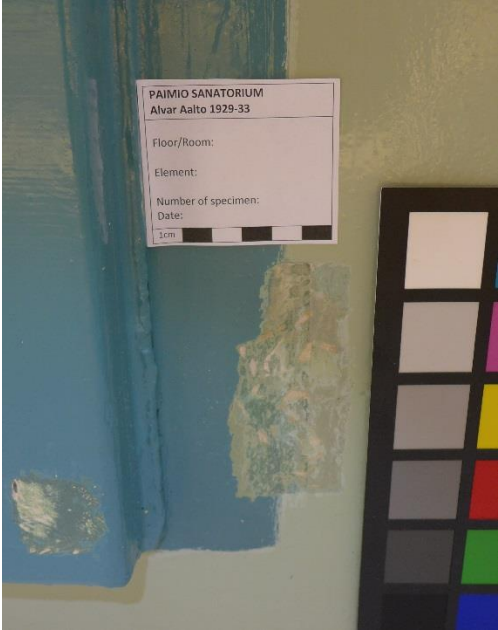
Ceiling Radiator's Lining

Number of Sample 4.1	Subject Paimio Sanatorium	Building / Space / Surface Main building 1 st Floor Dining hall Ceiling radiator, dark color rim lining the radiator	
Architect, building year Alvar Aalto, 1929-33	Researcher, date Elina Riksmann, June-Dec. 2015, Alvar Aalto-foundation		
Most significant repairs and changes of the space, dates The counter desk for distributing food 1970's. Vinyl flooring 1970's. Window frames have been treated (sandblasted?) during 1948 renovation (repair and paint instructions dating 1948).			
Photograph, drawing

Layers of Sample 00 Iron (Radiator)	
		01 Filler	
		1 Dark green paint 6020-G10Y or 6020-G

2	
		3	
		4	
Observations, remarks, e.g. pigment, adhesive, type of paint, material analysis:			
Technique used to make and take Samples, Circumstance in site, Lighting: Carved excavations on surface, daylight + fluorescent lamps	Color chart in use: NCS Teknos 2004 Color codes are written without the NCS prefix.	Type of Sample, Place of Storage: Cross section sample 4.1. Alvar Aalto Foundation, Helsinki. Scale 500µm.	Floor plan, Location of Sample

Cross section sample no. 4.1. from the dark color rim surrounding the ceiling radiators.

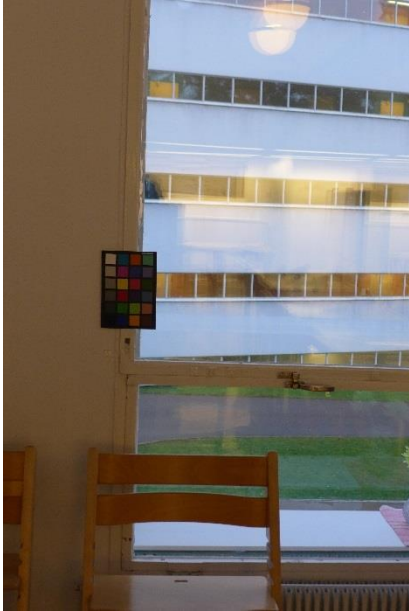
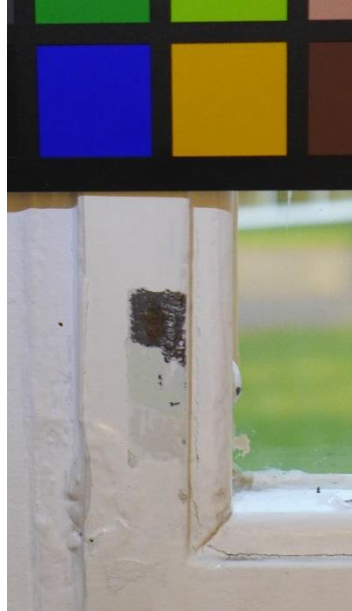
The Window Frames of Dining Hall

The iron window frames have apparently been sanded clean in the 1948 renovation. This is shown in the written order given to the painters at the time. It is highly possible that the window frames have been sand blasted again some times after 1948 renovation, due to their material, iron. The excavation from year 2000 showed only three layers + the newest white paint, the bottom one being base coat for metallic materials.

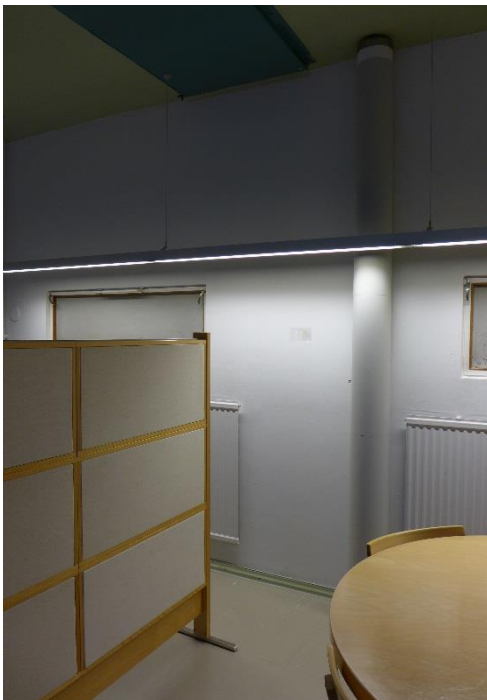
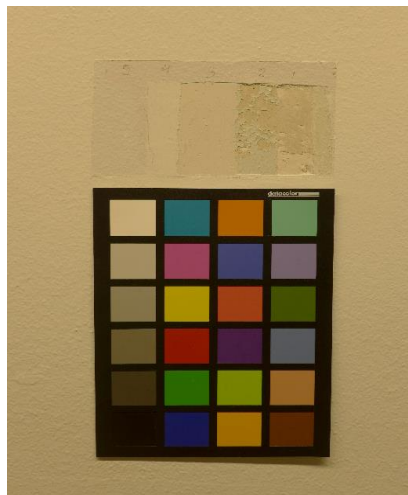
The Walls of Dining Hall

The small craters excavated and the cross section samples showed that the walls have had a neutral coloring through its history. The year 2000 color researcher Katja Aaltonen had made one large excavation on the north wall (the low wall under dropped ceiling). This excavation has deteriorated during 15 years so confirmations were therefore made. The excavation shows neutral tones of white, beige and light green color.

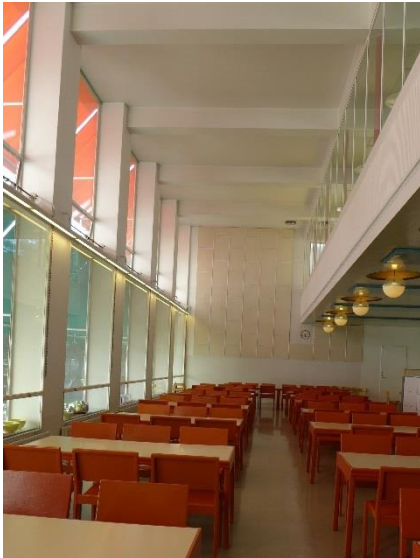
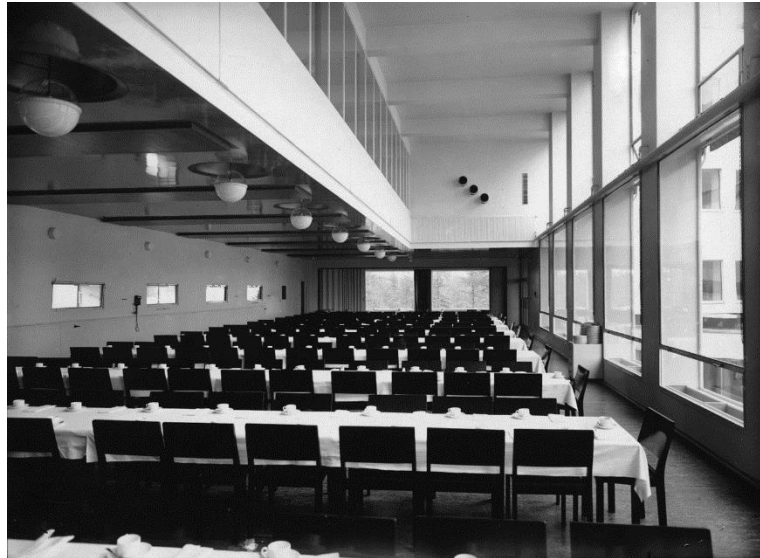
The Dining Hall Ceiling, Samples 102, 104, 105

The high section of the dining hall ceiling rises to almost 6 meters and is divided with supporting concrete beams. The black and white photos stating the original coloring, show that there has not been any other original coloring then white. To see if the beams had had any other coloring in any other point in history, cross section samples were taken from the ceiling and its beams. No such results were found in the three cross section samples

The sample 105 taken from the bottom of a supporting beam shows that the bottom yellow filler layer is covered with modern looking light weight white filler. It tells that the ceiling has probably been stripped from previous paint layers in recent decades.

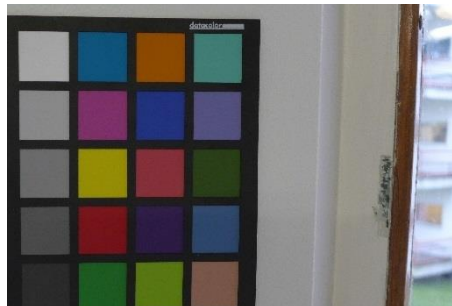
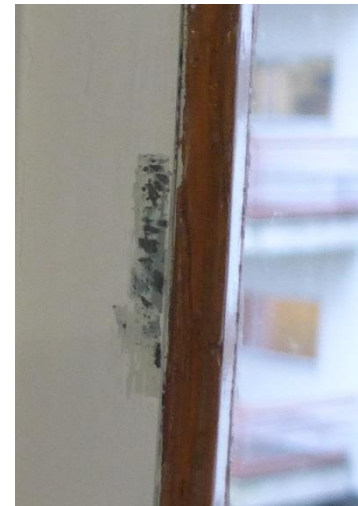
The Lounge's Window Frame

The iron frames showed only few layers, and as the dining hall windows, these windows have also been stripped from paint during and after 1948 renovation. The excavation was made in the year 2000 color research by K.Aaltonen.

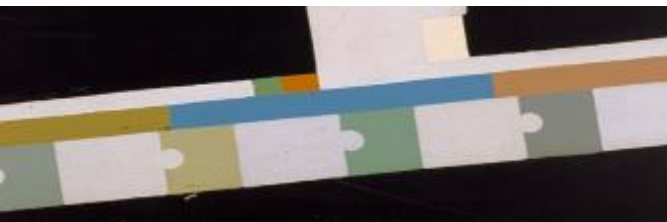
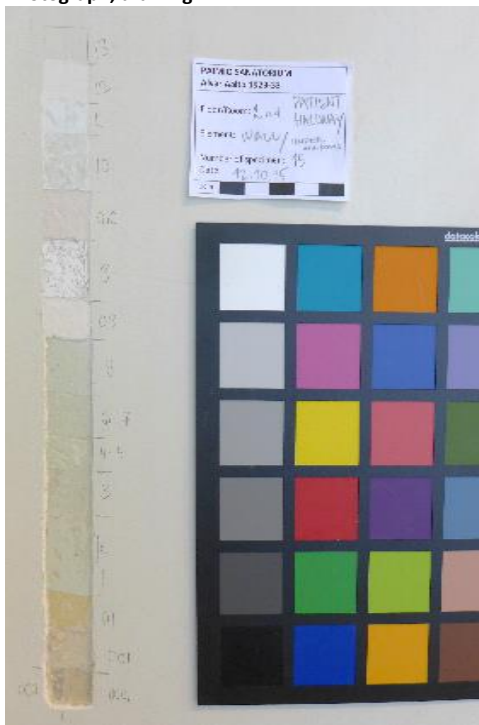
North Wall

Number of Sample -	Subject Paimio Sanatorium	Building / Space / Surface Main building 1 st Floor A wing, main corridor Wall with windows, to north	
Architect, building year Alvar Aalto, 1929-33	Researcher, date Elina Riksmann, June-Dec. 2015, Alvar Aalto-foundation		
Most significant repairs and changes of the space, dates 1970's ventilation system brought casing of the pipes and electric cords in the ceiling. Doors and their sizing has changed, broader painted wooden doors have replaced the original wooden doors with lacquered surfaces. The lighting and fixtures have also been replaced.			
Photograph, drawing

Layers of Sample 000 Plaster	
		0001 Filler	
		001 Consolidating cotton canvas with oil filler	
		01 Yellow filler	
		1 Greenish grey 1005-G50Y

010 Filler 10 Light green 1005-G20Y	
		11 White 0300-N	
Observations, remarks, e.g. pigment, adhesive, type of paint, material analysis: 1st layer oil paint.		12 White 0502-Y	
		13 White 1002-Y	
Technique used to make and take Samples, Circumstance in site, Lighting: Carved color steps on surface, crater technique, daylight + fluorescent lamps	Color chart in use: NCS Teknos 2004 Color codes are written without the NCS prefix.	Type of Sample, Place of Storage: Cross-section sample, Alvar Aalto Foundation Helsinki	Floor plan, Location of Sample

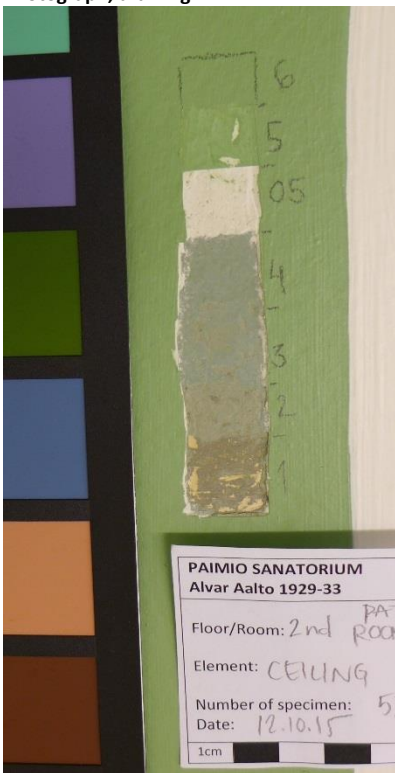
Patient Room Ceiling

Number of Sample 53	Subject Paimio Sanatorium	Building / Space / Surface Main building 1 st Floor Patients' room 203 Ceiling	
Architect, building year Alvar Aalto, 1929-33	Researcher, date Elina Riksmann, June-Dec. 2015, Alvar Aalto-foundation		
Most significant repairs and changes of the space, dates Patient rooms have been fully renovated during 1970's as the hospital technique (i.e. different types of gases, electricity) and all of the surfaces, HVAC-technique and furniture were redone. Original ceiling radiators were removed and ceilings painted (but not hidden under dropped ceiling structures). Wallcoverings and flooring were replaced. Original furniture was removed.			
<p>Photograph, drawing</p>

Layers of Sample 00	
		01 Filler	
		1 Grey 6502-G

Observations, remarks, e.g. pigment, adhesive, type of paint, material analysis:			
Technique used to make and take Samples, Circumstance in site, Lighting: Carved color steps on surface, crater technique, daylight + fluorescent lamps	Color chart in use: NCS Teknos 2004 Color codes are written without the NCS prefix.	Type of Sample, Place of Storage: Cross-section sample 53, Alvar Aalto Foundation Helsinki. Scale 500 µm.	Floor plan, Location of Sample

The ceiling of the patient room 203 has an original layer of grey paint that is also found in the Kauria color board. The sample no. 53 was broken in half. It shows more layers that was possible to excavate in situ. The bottom layers are shown in the picture below and the surface with thick white light weight filler in the picture above.

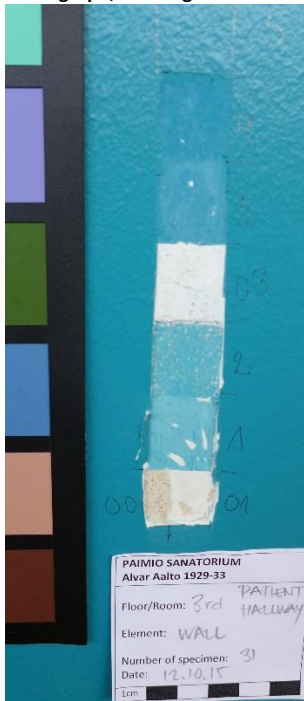
Ward, Main Corridor

Number of Sample 31	Subject Paimio Sanatorium	Building / Space / Surface Main building 2 nd Floor Patient wing, main hallway Wall (the wall with the doors to patient rooms)	
Architect, building year Alvar Aalto, 1929-33	Researcher, date Elina Riksmann, June-Dec. 2015, Alvar Aalto-foundation		
Most significant repairs and changes of the space, dates 1970's ventilation system brought casing of the pipes and electric cords in the ceiling. Doors and their sizing has changed, broader painted wooden doors have replaced the original wooden doors with lacquered surfaces. The lighting and fixtures have also been replaced.			
Photograph, drawing

Layers of Sample 00 Plaster	
		01 white light weight filler	
		1 Blue 2040-B20G

Technique used to make and take Samples, Circumstance in site, Lighting: Carved color steps on surface, crater technique, daylight + fluorescent lamps	Color chart in use: NCS Teknos 2004 Color codes are written without the NCS prefix.	Type of Sample, Place of Storage: Cross-section sample 31, Alvar Aalto Foundation Helsinki. Scale 500 µm.	Floor plan, Location of Sample

The ward's main corridors colored wall shows less layers than other ward corridors have shown. The bottom one found stated a blue color. The sample no. 31 broke in to two parts: the surface is seen in the picture above, and the bottom layers below. The undermost layer is white, porous, light weight filler that obviously is not the original 1930's oil filler used, but a layer from later renovation.

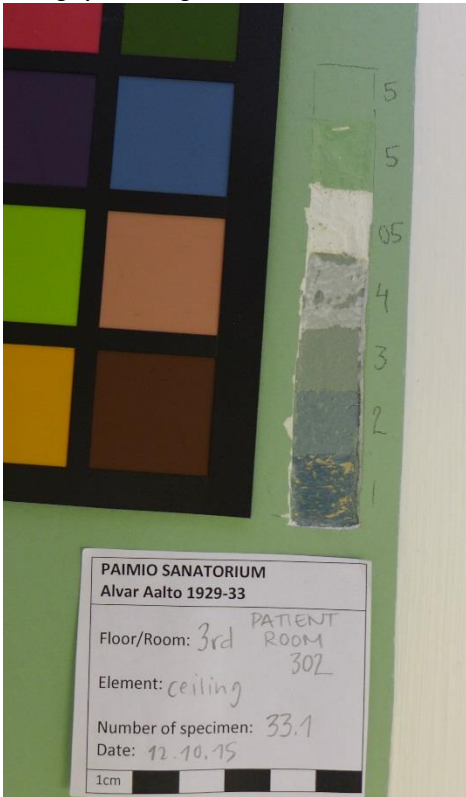
Patient Room Ceiling

Number of Sample 33.1	Subject Paimio Sanatorium	Building / Space / Surface Main building t Floor 2 nd Floor Patient room Ceiling	
Architect, building year Alvar Aalto, 1929-33	Researcher, date Elina Riksmann, June-Dec. 2015, Alvar Aalto-foundation		
Most significant repairments and changes of the space, dates Patient rooms have been fully renovated during 1970's as the hospital technique (i.e. different types of gases, electricity) and all of the surfaces, HVAC-technique and furniture were redone. Original ceiling radiators were removed and ceilings painted (but not hidden under dropped ceiling structures). Wallcoverings and flooring were replaced. Original furniture was removed.			
Photograph, drawing

Layers of Sample 00 Plaster	
		01 Filler, yellow oil based	
		1 Blue 5020-B10G

Observations, remarks, e.g. pigment, adhesive, type of paint, material analysis: oil paint			
Technique used to make and take Samples, Circumstance in site, Lighting: Carved color steps on surface, crater technique, daylight + fluorescent lamps	Color chart in use: NCS Teknos 2004 Color codes are written without the NCS prefix.	Type of Sample, Place of Storage: Cross-section sample, 33.1. Alvar Aalto Foundation Helsinki. Scale 500µm.	Floor plan, Location of Sample

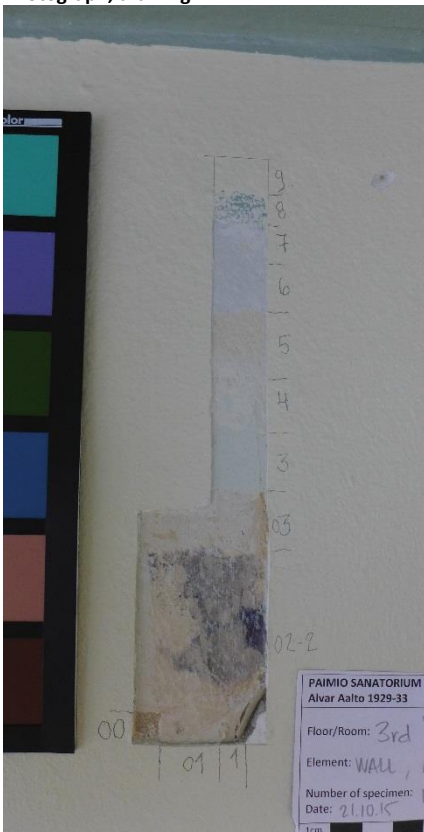
North Wall

Number of Sample 112.	Subject Paimio Sanatorium	Building / Space / Surface Main building t Floor 3 rd Floor Reading room North wall		
Architect, building year Alvar Aalto, 1929-33	Researcher, date Elina Riksmann, June-Dec. 2015, Alvar Aalto-foundation			
Most significant repairs and changes of the space, dates HVAC-remodeling in the 1970's renovation brought the dropped ceiling structures that hide ventilation pipes and electric cords. Original rubber flooring has been changed to a vinyl floor.				
<p>Photograph, drawing</p>

Layers of Sample 00 Plaster		
		01 0505-Y30R light beige		
		1 Beige 1005-Y20R		
		02-2 Black 9000-N and 0505-Y30R (?)		
		03 White base coat 1002-Y50R		
		3 Light green (hecker technique, oil) 1005-G50Y		
		4 Light yellow 0507-Y		
		5 Beige (hacker technique) 0907-G90Y		
		6 Light grey 1500-N		
Observations, remarks, e.g. pigment, adhesive, type of paint, material analysis: 1oil paint		7 White

8 Green 3010-G20Y		
		9. Yellow 1010-G90Y		
Technique used to make and take Samples, Circumstance in site, Lighting: Carved color steps on surface, crater technique, daylight + fluorescent lamps	Color chart in use: NCS Teknos 2004 Color codes are written without the NCS prefix.	Type of Sample, Place of Storage: Cross-section sample, Alvar Aalto Foundation Helsinki	Floor plan, Location of Sample

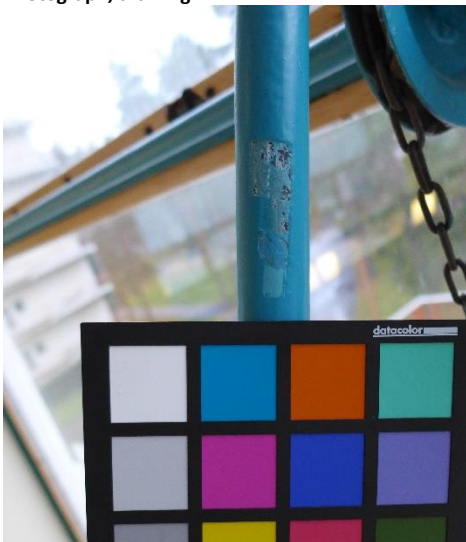
Iron Frame Windows Giving to West

Number of Sample	Subject Paimio Sanatorium	Building / Space / Surface Main building t Floor 2 nd Floor Reading room Iron windows (to west)	
Architect, building year Alvar Aalto, 1929-33	Researcher, date Elina Riksmann, June-Dec. 2015, Alvar Aalto-foundation		
Most significant repairs and changes of the space, dates HVAC-remodeling in the 1970's renovation brought the dropped ceiling structures that hide ventilation pipes and electric cords. Original rubber flooring has been changed to a vinyl floor.			
<div>Photograph, drawing</div>

Layers of Sample 00 Iron	
		01 base coat, light beige	
		1 Blue 3030-B30G

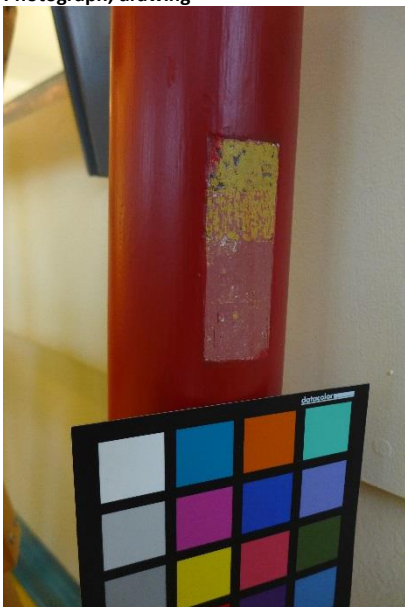
Number of Sample	Subject Paimio Sanatorium	Building / Space / Surface Main building t Floor 3 rd Floor reading room Columns lining the windows giving to south and dining hall	
Architect, building year Alvar Aalto, 1929-33	Researcher, date Elina Riksmann, June-Dec. 2015, Alvar Aalto-foundation		
Most significant repairs and changes of the space, dates HVAC-remodeling in the 1970's renovation brought the dropped ceiling structures that hide ventilation pipes and electric cords. Original rubber flooring has been changed to a vinyl floor.			
Photograph, drawing

Layers of Sample 00 Iron	
		1 Red 1580-Y80R

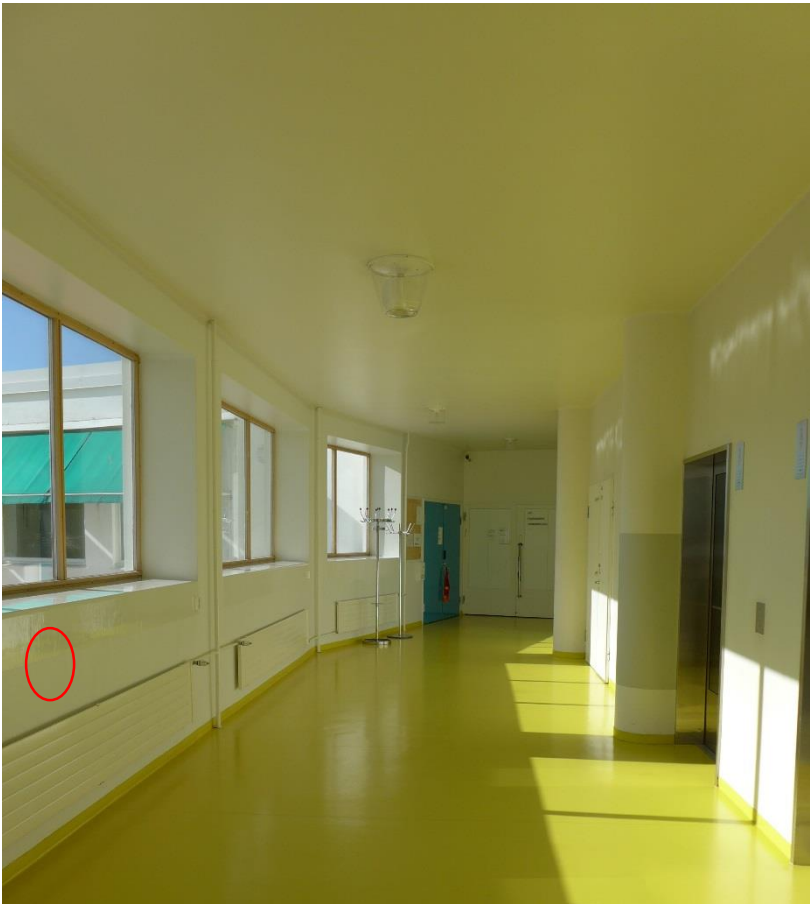
The main corridors through out the main building had the same coloring. The sample no. 84 shows the general situation of the walls surrounding corridors, a palette of neutral tones through decades, as the undermost layers are white.

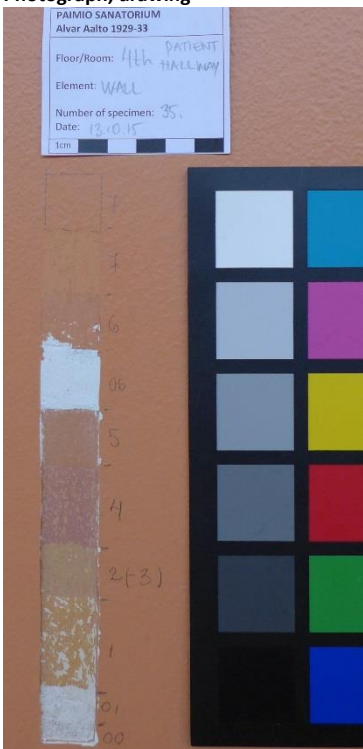
Patient Ward, Main Hallway

Number of Sample 35	Subject Paimio Sanatorium	Building / Space / Surface Main building 4 th Floor Patient wing, main hallway Wall (the wall with doors leading to patient rooms)	
Architect, building year Alvar Aalto, 1929-33	Researcher, date Elina Riksmann, June-Dec. 2015, Alvar Aalto-foundation		
Most significant repairments and changes of the space, dates 1970's ventilation system brought casing of the pipes and electric cords in the ceiling. Doors and their sizing has changed, broader painted wooden doors have replaced the original wooden doors with lacquered surfaces. The lighting and fixtures have also been replaced.			
Photograph, drawing

Layers of Sample 00 Plaster	
		01 Filler	
		1 Orange, ochre 2040-Y30R

Technique used to make and take Samples, Circumstance in site, Lighting: Carved color steps on surface, crater technique, daylight + fluorescent lamps	Color chart in use: NCS Teknos 2004 Color codes are written without the NCS prefix.	Type of Sample, Place of Storage: Cross-section sample 35. Alvar Aalto Foundation Helsinki.	Floor plan, Location of Sample

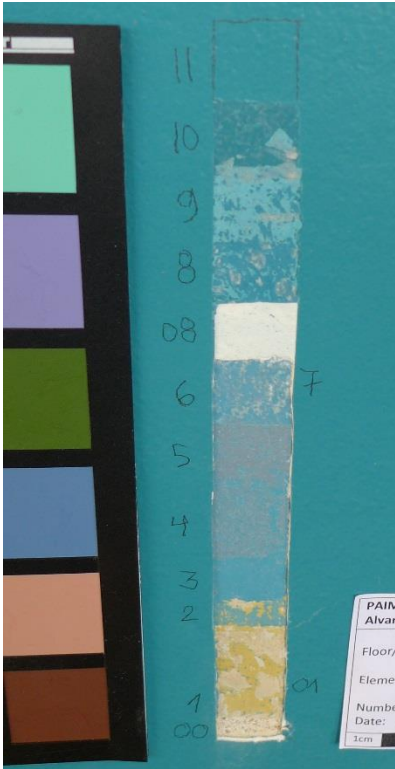
Patient Wing, Main Corridor

Subject Paimio Sanatorium 79	Building / Space / Surface Main building 5 th Floor		
Researcher, date Elina Riksmán, June-Dec. 2015, Alvar Aalto- foundation	Patient wing, main corridor Wall (wall with doors leading to patient rooms)		
Most significant repairs and changes of the space, dates Patient rooms have been fully renovated during 1970's as the hospital technique (i.e. different types of gases, electricity) and all of the surfaces, HVAC-technique and furniture were redone. Original ceiling radiators were removed and ceilings painted (but not hidden under dropped ceiling structures). Wallcoverings and flooring were replaced. Original furniture was removed.			
Photograph, drawing

Layers of Sample 00		
	01 Filler		
	1 Yellow, oil paint, 1040-Y10R

9 Light blue 1040- B20G		
	10 Petrol Blue 4550-B20G		
	11 Blue 3050-B30G		
Color chart in use: NCS Teknos 2004 Color codes are written without the NCS prefix.	Type of Sample, Place of Storage: Cross-section sample 79, Alvar Aalto Foundation Helsinki. Scale 500 µm.		Floor plan, Location of Sample

The sample no. 79 was broken into two parts, the undermost layers shown here below. The cross section sample clearly shows a rather thick yellow paint layer that has been painted on white filler. This same undermost yellow layer is also found in the ward walls in 2nd and 5th floors. See second floor ward wall for further details addressing the yellow paint.

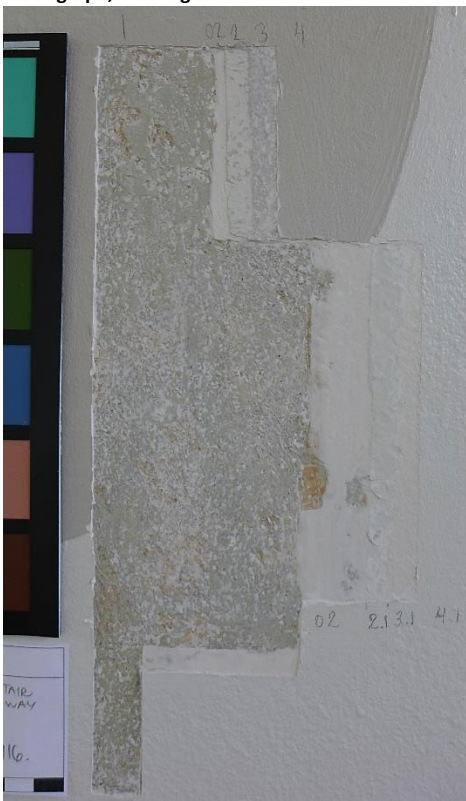
Main Staircase, Wall Behind Stair Handrail

Number of Sample 117	Subject Paimio Sanatorium	Building / Space / Surface Main building 6th Floor Main staircase Wall, an area of grey paint on white painted wall.	
Architect, building year Alvar Aalto, 1929-33	Researcher, date Elina Riksmann, June-Dec. 2015, Alvar Aalto-foundation		
Most significant repairs and changes of the space, dates Main stair has had a few changes. The flooring has been changed from the original yellow rubber flooring to new material. The last change of flooring was made only in the 1990's. Walls have been painted. The main stair's middle handrail has had a recent change as clear screens were attached between railings to protect visiting children. Hand railings are original on both sides of stairs. No dropped ceiling structures have been installed, ceilings of main stairway have only been painted during many renovations.			
Photograph, drawing

Layers of Sample, WHITE AREA 00 Plaster

02 Filler	
		2.1 White 1002-G50Y	
		3.1 White 1002-Y50R	
		4.1 White 0300N	
		Layers of sample. GREY AREA 00 plaster	
		1 Grey 2005-G80Y or 3005-G80Y

Observations, remarks, e.g. pigment, adhesive, type of paint, material analysis: Grey undermost paint: oil paint.		02 Filler	
		2 White 0500-N	
		3 Grey 1502-Y50R	
		4 Grey 1502-Y	
Technique used to make and take Samples, Circumstance in site, Lighting: Carved color steps on surface, crater technique, daylight + fluorescent lamps	Color chart in use: NCS Teknos 2004 Color codes are written without the NCS prefix.	Type of Sample, Place of Storage: No sample.	Floor plan, Location of Sample

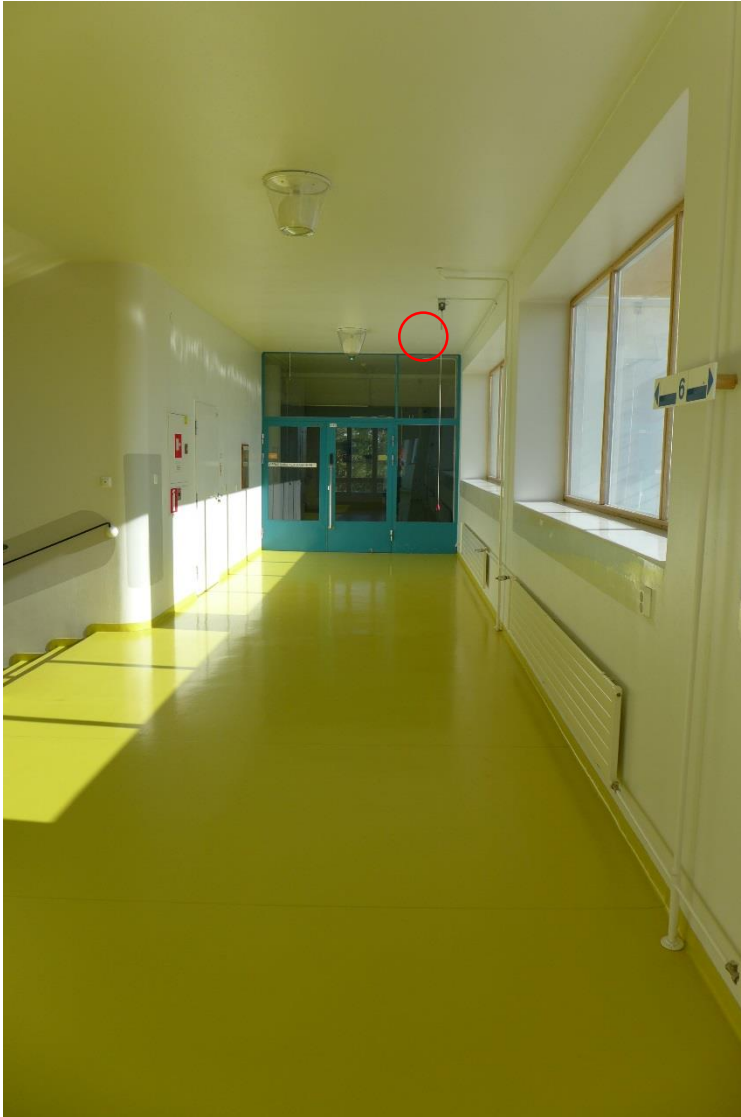
The ceilings of main staircase corridors were researched throughout the floors from ground floor to 5th by taking cross section samples. All samples showed white and beige neutral colors. Below are three exsamples from the cross section samples taken from the ceilings of main halls in each floor.

The fifth floor main staircase. The spot were cross section sample was taken.

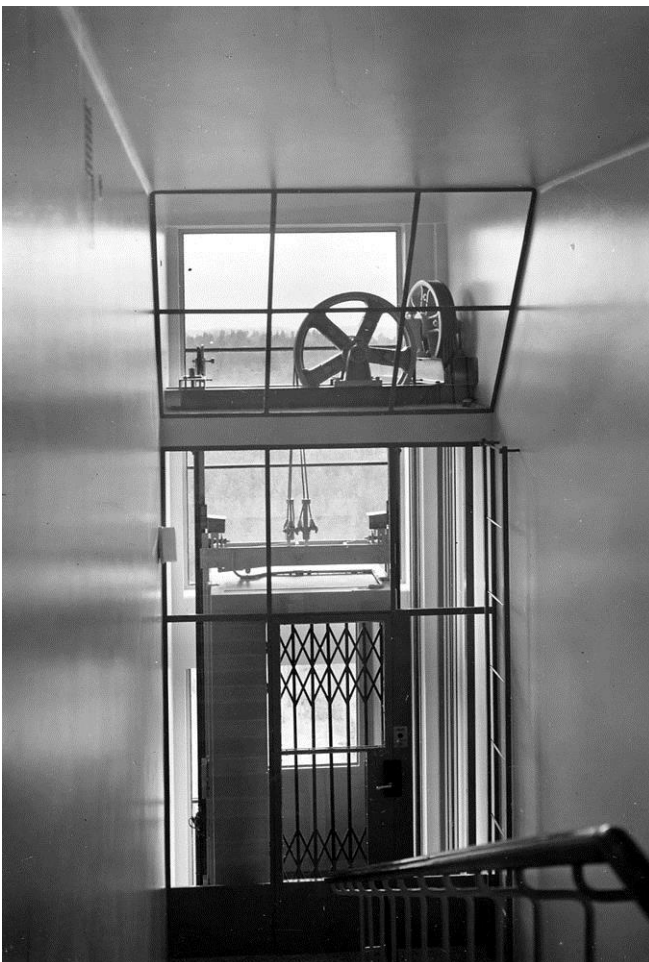
The original elevator in the west end of the ward wing is still in its place. The Elevator car and technique are well preserved and fully functioning. The elevator is still in use, if not daily, but by the tourist groups that visit the main building. They ride it down from the scenery balconies down to the first floor ward. The elevator shafts west wall is mainly glass, hence the nickname Scenic elevator.

Original look of the elevator. AAM. Sign. 50-003-

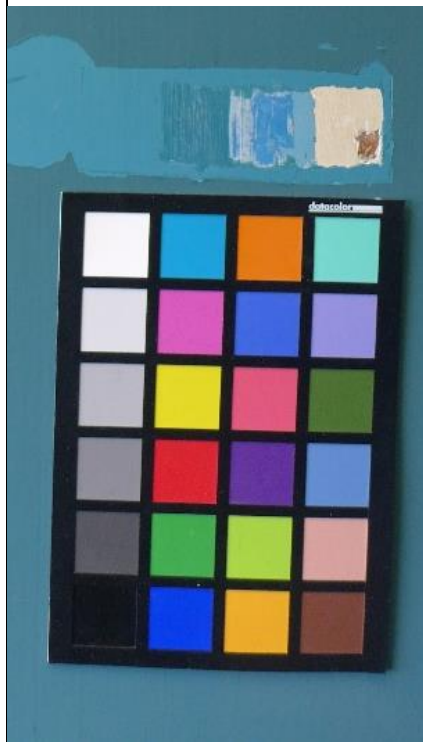
Elevator Car

Number of Sample	Subject Paimio Sanatorium	Building / Space / Surface Main building The west elevator of wards The elevator car walls The elevator car walls RESEARCH POINT MADE IN YEAR 2000 COLOR RESEARCH	
Architect, building year Alvar Aalto, 1929-33	Researcher, date June-Dec. 2015, Alvar Aalto- foundation		
Most significant repairments and changes of the space, dates The elevator car is original. The ceiling light fixture of the elevator has been changed at some point. The front wall surrounding of every floor elevator door was originally made of glass. It was been changed to metal board. The button board inside the car has also been changed.			
Photograph, drawing		Layers of Sample

00	
		0	
		1 White 1010-Y10R, base coat	
		2 Blue 2030-B10G	
		3 Blue 3040-B10G	
		4 White base coat	
		5 Teal blue	
		6 Teal blue	
Observations, remarks, e.g. pigment, adhesive, type of paint, material analysis:		7

8	
		9	
		10	
Technique used to make and take Samples, Circumstance in site, Lighting: Carved color steps on surface, made 2000 by Katja Aaltonen, daylight + fluorescent lamps	Color chart in use: NCS Teknos 2004 Color codes are written without the NCS prefix.	Type of Sample, Place of Storage: -	Floor plan, Location of Sample

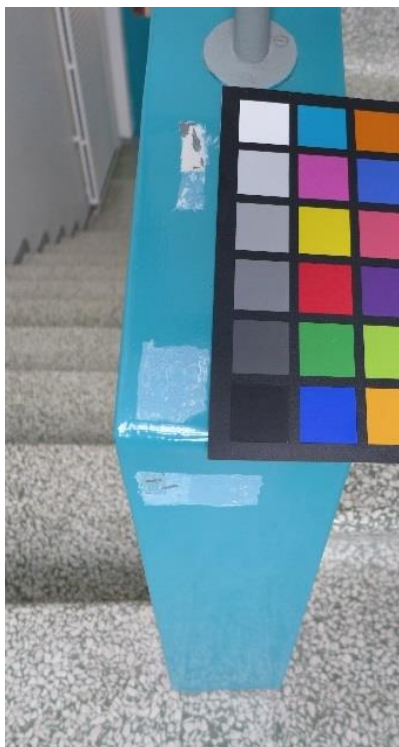
Number of Sample	Subject Paimio Sanatorium	Building / Space / Surface Main building 3rd Floor Ward The West Staircase The handrail, metallic base RESEARCH POINT MADE IN YEAR 2000 COLOR RESEARCH	
Architect, building year Alvar Aalto, 1929-33	Researcher, date June-Dec. 2015, Alvar Aalto- foundation		
Most significant repairments and changes of the space, dates The elevator car is original. The ceiling light fixture of the elevator has been changed at some point. The front wall surrounding of every floor elevator door was originally made of glass. It was been changed to metal board. The button board inside the car has also been changed.			
Photograph, drawing

Layers of Sample 00 Metal	
		0	
		01 White 1010-Y30R, base coat	
		1 Blue 3040-B30G

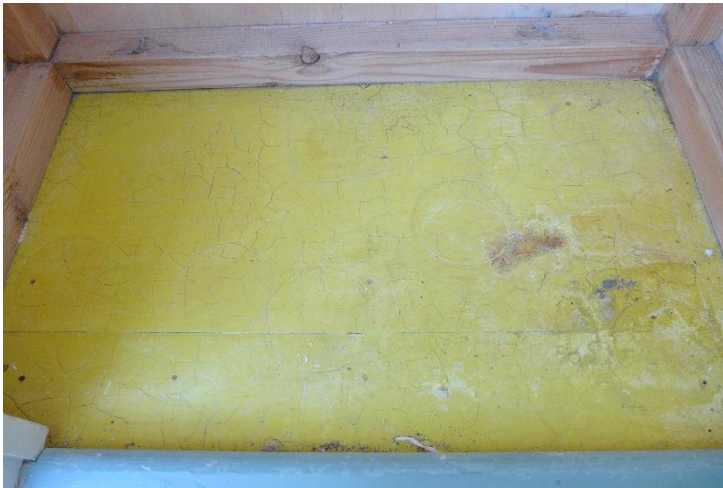
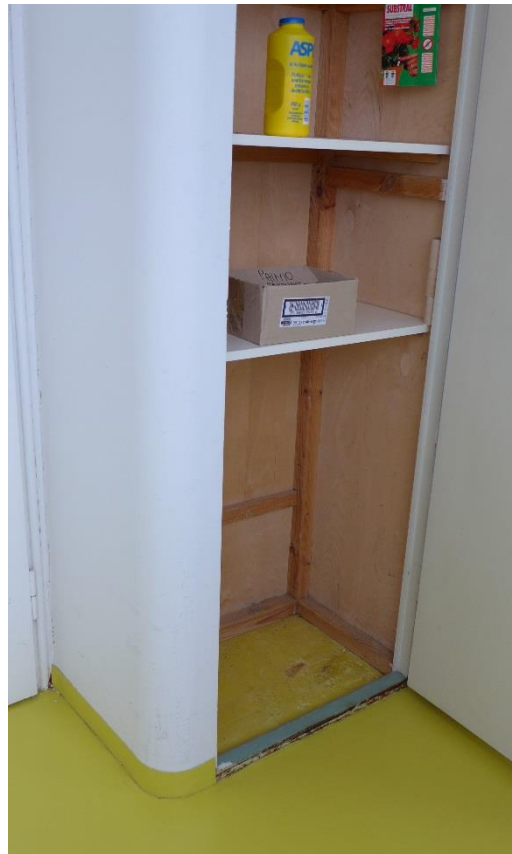
The yellow flooring was originally specially made, a hue that was not available in catalogs. In an interview from 1986 Eino Kauria tells that soon after the order for the yellow flooring was made, Aalto had some grave second thoughts about the color yellow. At that point it was impossible to cancel the order. According to Kauria, Aalto himself stated that the chosen yellow color was a mistake.

The original fragment of yellow flooring in comparison to the renewed flooring surrounding the cupboard.

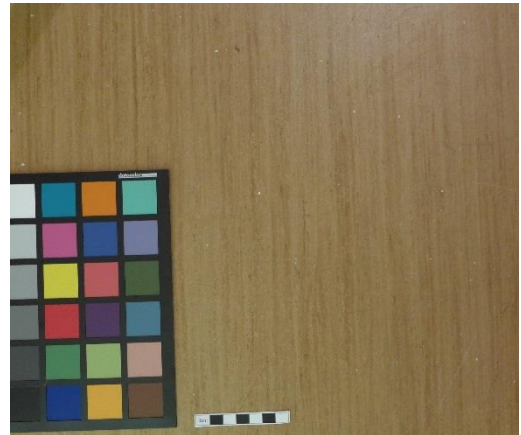
Other Floor Fragments

Other flooring fragments beside the original yellow, found in Paimio main building, have no resembles to the marmoleum patterned linoleum floorings seen in the photographs that present the original state of the dining hall, lounge or ward corridors. This brown linoleum at the middle, left, found in a drought lobby of a balcony in second floor main building, has somewhat heavy but straight pattern, and it is presumably a later linoleum from 1940's or 1950's. The same flooring, in a better condition is found in the second floor of former engine room for the cinematography technique.

The two floor samples seen below were found inside old cupboards in the hospital's staff building from the 1950's (by architect Lauri Sipilä). The fragments have been used for covering the cupboard shelves. The red sample shows some resembles to the original 1930's type of linoleum with marmoleum pattern. Green flooring sample covering another cupboard shows a slightly more modern pattern and material. The green fragment is probably from the 1950's.

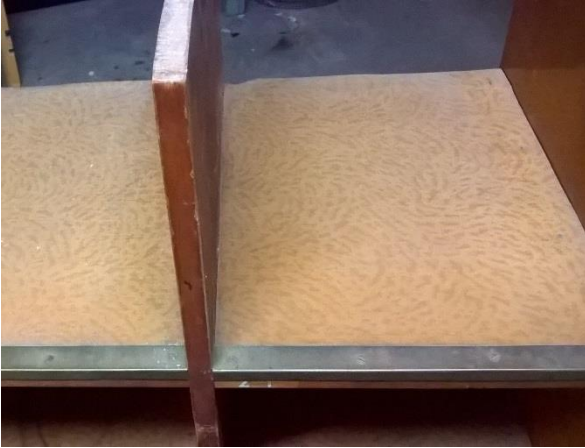
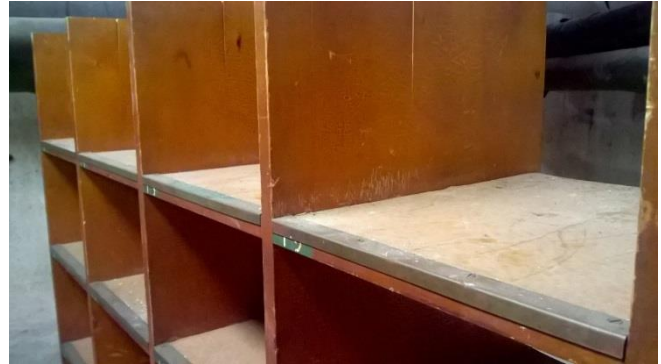
The linoleum type flooring was also used to protect some heavy duty furniture like the original shoe shelves that were originally situated in the entrance hall. The flooring matt seems to have a pattern typical in 1940's so it has likely been installed during the 1948 renovation to cover up some detrition of the shelves. This flooring has not been found in any other location in the main building nor in the other buildings in the hospital area. nor shown in any photographs found.

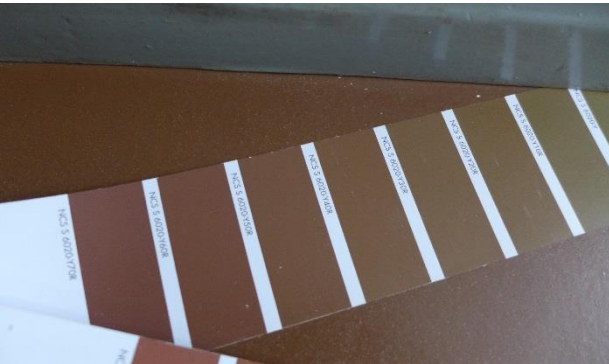
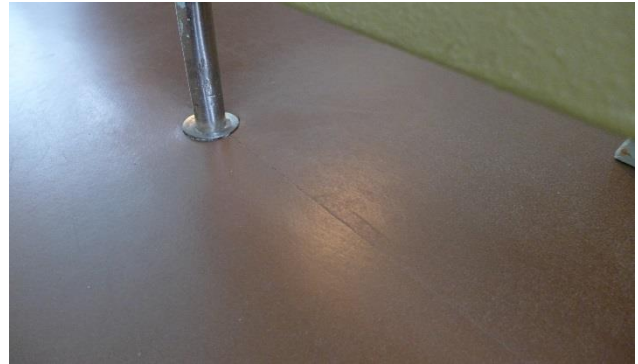
Museum Room Flooring Today

The deep brown linoleum flooring of the ground floor museum room showed at the left, is probably not the original flooring of a patient room as it is in such good, resilient condition and shows vibrant uniform color throughout the room. The color code of this flooring is something between the two NCS color codes

NCS S 6020-Y50R and 6020 Y60R.

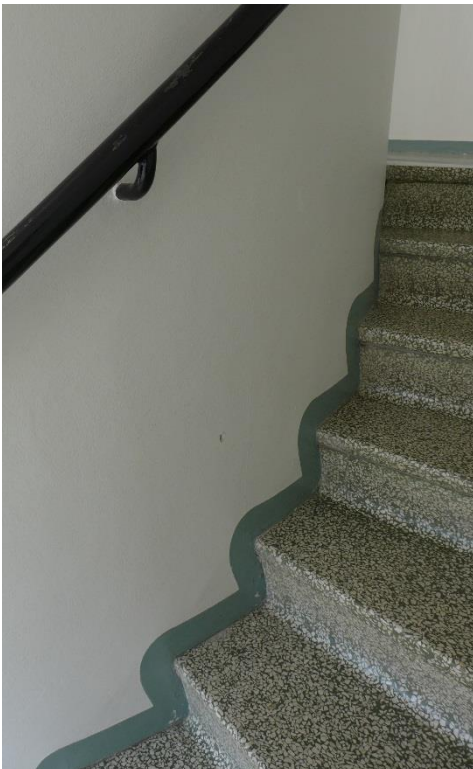
The mosaic concrete steps of these stairs were pre-produced modules and they were installed on site. The color of all three stairs was the same: the base concrete mixture had a deep color of green with 3mm to 15mm sized white stone grains. The NCS color codes for the green are

The stairs climbing around the chimney of C-wing.

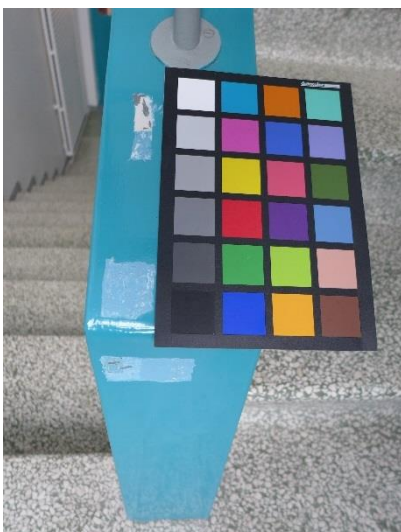
The staircase with panoramic lift, in the west end of the wards.

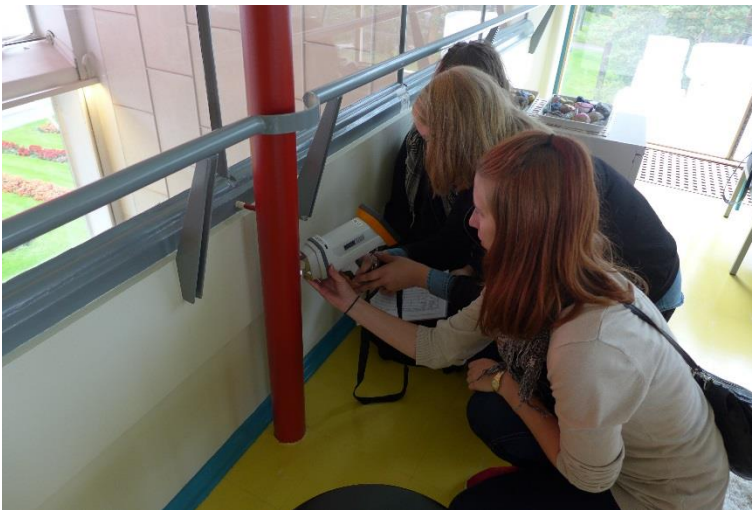
The X-ray Fluorescence (XRF) measurements were made in selected research points in the reading room of second floor and in the museum room of ground floor. Mainly first layers were measured to achieve data from the assumed first and original layers of paint. The aim was to gather data from paints to find out if these materials contained toxic elements as Lead (Pb) or Arsen (As).

The conservation students from Metropolia University of Applied Sciences measure Reading room columns with the guidance of chemist and lecturer Krista Hackzell (in front).

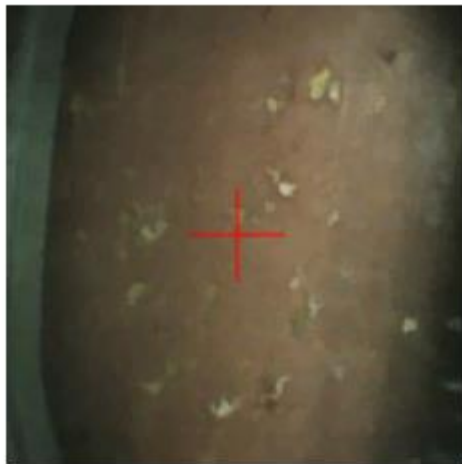
Reading room, red iron columns, third layer, red

Nimi	Luokka		Päivämäärä		Kellonaika		Kesto
kirjasto punainen	Soil_LE_FP		7.9.2015		15.06.03		20,5 s
3 krs punainen							
Alkuaine	Zn ppm	S ppm	Ti ppm	Pb ppm	Si ppm	Ba ppm	Ca ppm
	343118	90489	57583	50054	34118	31350	29420
±	692	782	304	475	1496	907	323
Alkuaine	Cl ppm	Fe ppm	V ppm	Sr ppm	Mn ppm	Ta ppm	Co ppm
	28197	17650	14593	4985	1332	629	260
±	471	254	1276	72	169	143	70
Vertailunäyte:

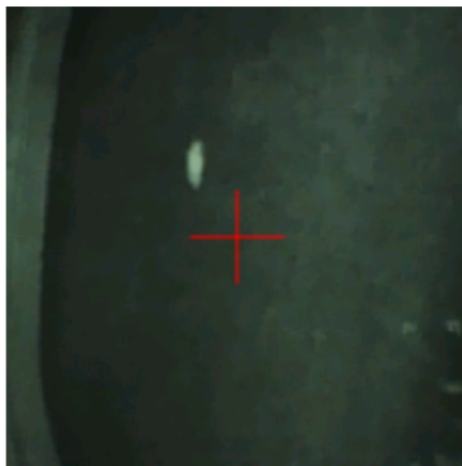
Museum room, jamb of door, undermost layer

Nimi museo huone 1. karmi 0	Luokka Soil_LE_FP		Päivämäärä 7.9.2015		Kellonaika 16.09.19		Kesto 20,6 s
Alkuaine	Fe ppm	S ppm	Pb ppm	Mg ppm	Cl ppm	Si ppm	Al ppm
	227355	214687	103671	54941	47720	28100	11194
±	713	814	427	7833	455	788	1440
Alkuaine	Ca ppm	K ppm	Zn ppm	P ppm	Ti ppm	Mn ppm	Cd ppm
	10175	8522	4561	1702	899	723	703
±	181	233	71	222	54	96	69
Alkuaine	Tl ppm	Se ppm	Rb ppm	Zr ppm			
	602	234	115	76			
±	49	21	17	18			
Vertailunäyte:

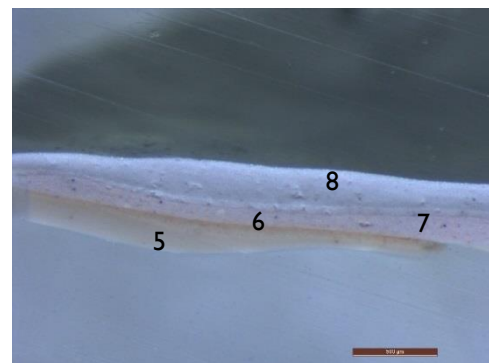
Cross section sample 126 shows white undermost paint layer. The samples broke into two pieces presented in the pictures above. Scale 500μm.

7The ceiling of the lobby has always been painted white according to the cross section sample 126.

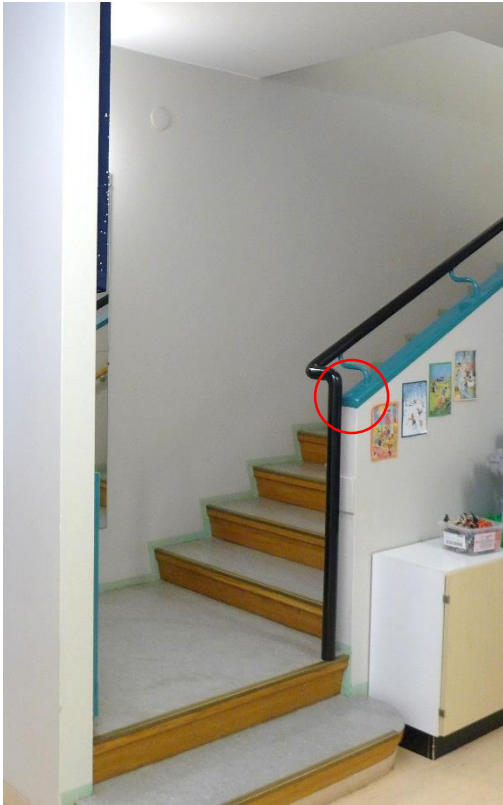
The cross section sample 129 showed the light blue original paint coat of the hand railing. The black wooden hand rail had three black layers of paint, original being also black.

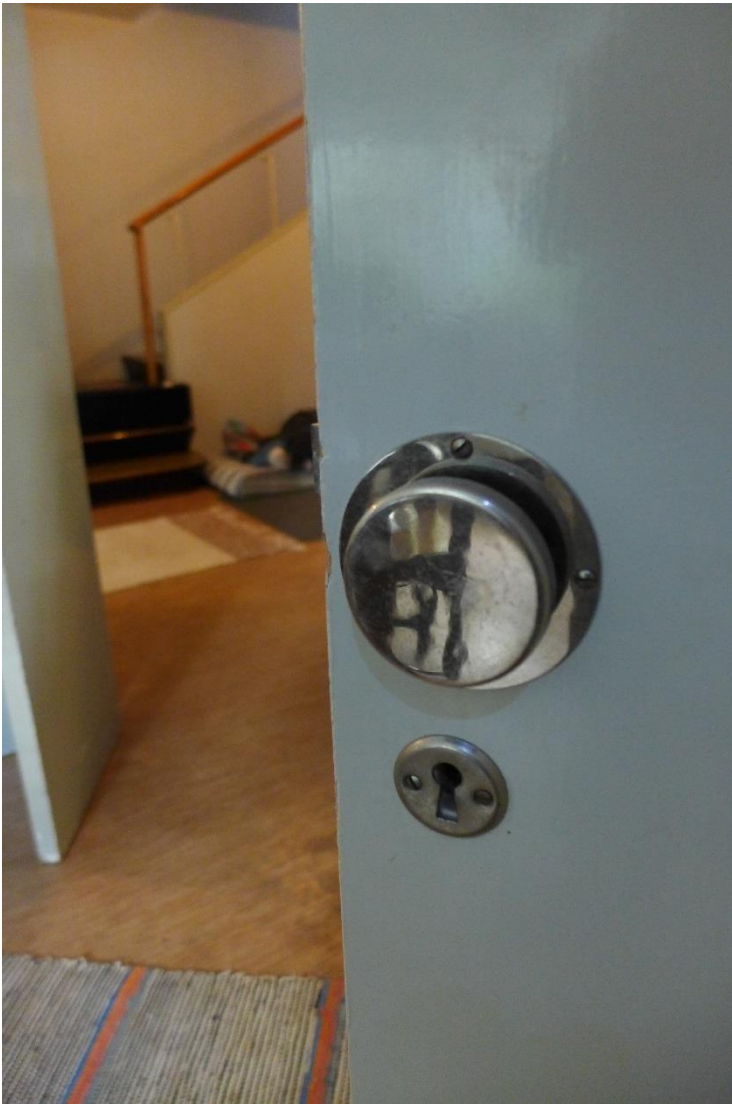
A detail of the original sliding door between the lobby and living room.

Sample 142. Lobby wall, taken behind the sliding door in the photograph at left. Scale 1mm.

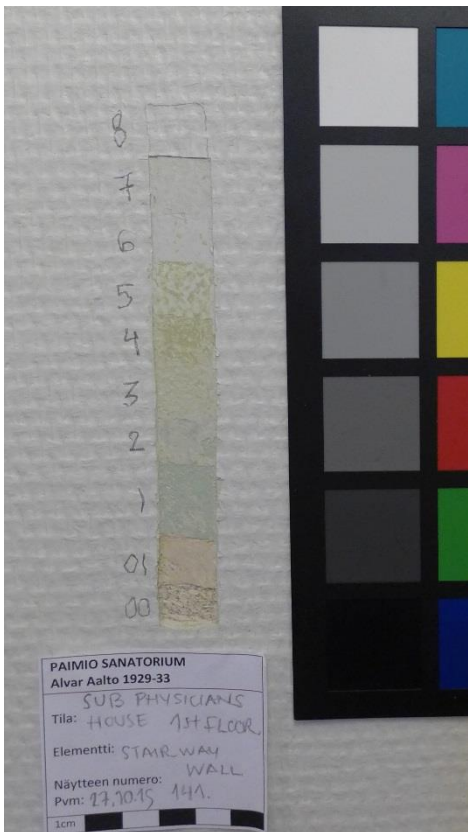
Sample 141. Stairway wall. Scale 1mm. Smaller picture presents the undermost layers.

The wall of the stair way seems to have the same undermost layers as the lobby wall (sample 142). The first layers are light blue.

Layers of Sample 00 Chalsium based Plaster	
		01 Filler	
		1 Paint light blue 1510-G	
		2 Paint White 0804-G20Y	
		3 Paint Light yellow paint 1015-G90Y	
		4 paint Beige 3020-Y	
		5 Paint Yellow 0502-Y	
		6 White	
		7 Glue of the glassfiber netting/Beige? 1510-G90Y Latex	
		8 White paint + glass fiber net, latex	
Observations, remarks, e.g. pigment, adhesive, type of paint, material analysis:

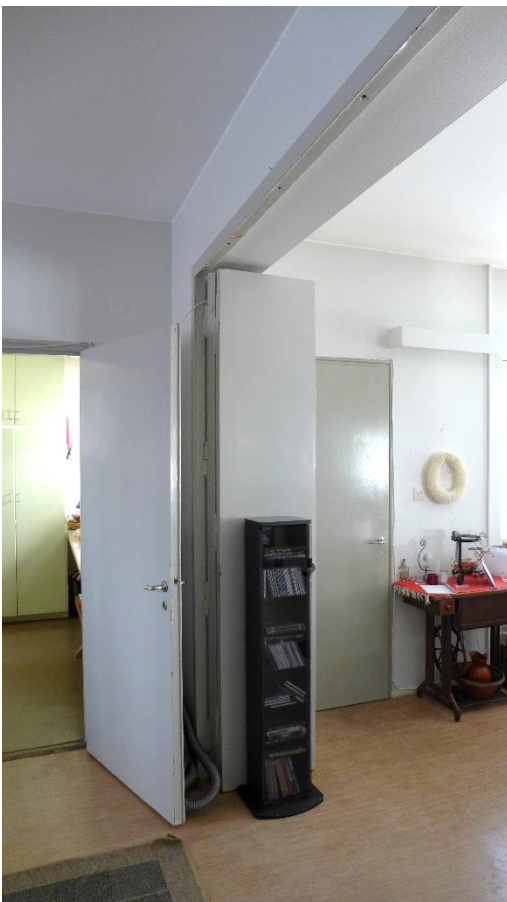
Floors of living and dining room are heavily patterned linoleum. Notice the large original folding doors dividing the rooms.

The flooring of Sub Physician's apartment today is linoleum. It is possible that some of the floorings are original. As no photographs nor maintenance documents of these apartments and their floors have been found, there are no proof of the originality of these floors.

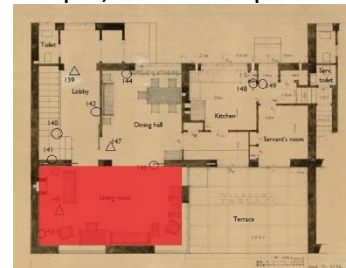
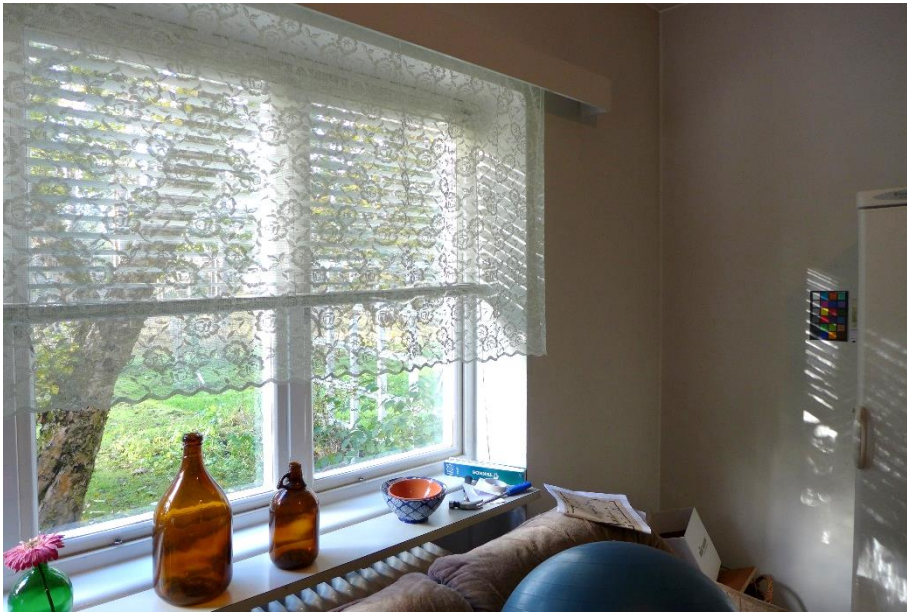
'As the picture below shows, the original living room wall color in one of the apartments has had a rich coloring. The difference between ceiling's white and the wall color is notable. It is possible that the second layer found in excavation (see picture in previous page chart), green, is the original color of the living room walls. The opposite side of the room showed same layers in carved crater excavations.
