**PAIMIO SANATORIUM
CONSERVATION MANAGEMENT PLAN
2016**

Publisher
Alvar Aalto Foundation

The overall goal of the CMP is to guide the future use, care and conservation of the Paimio Sanatorium. The objective in preparing of this CMP has been to produce documents that bring together already existing historical records of the building, including defining of architectural features, physical analysis and the knowledge of the buildings performance over time to create a long-term strategy for decision-makers, contractors and users regarding conservation and maintenance.

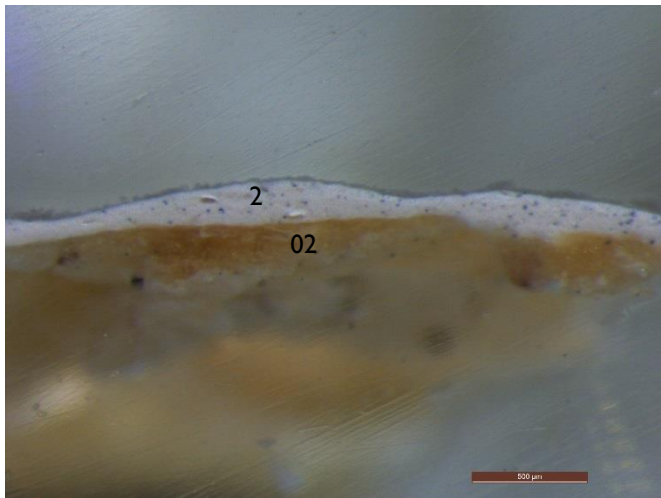
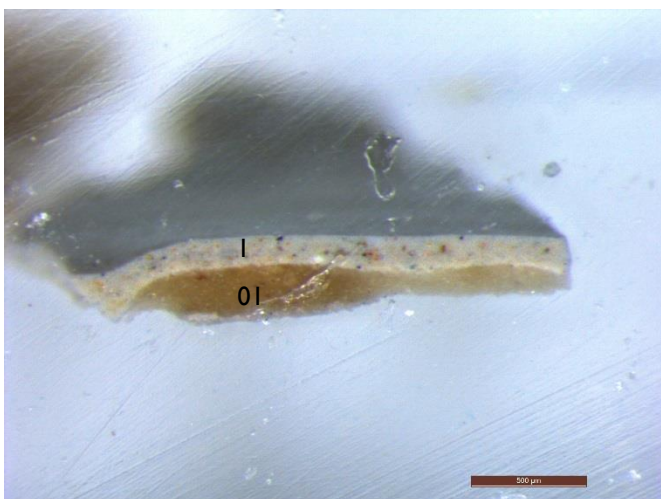
Dining room wall

The dining room ceiling shows warm white paint layer as the undermost layer. Paint layers have particles of pigment showing clearly in cross section sample. The sample broke into two parts. The upper part is presented above.

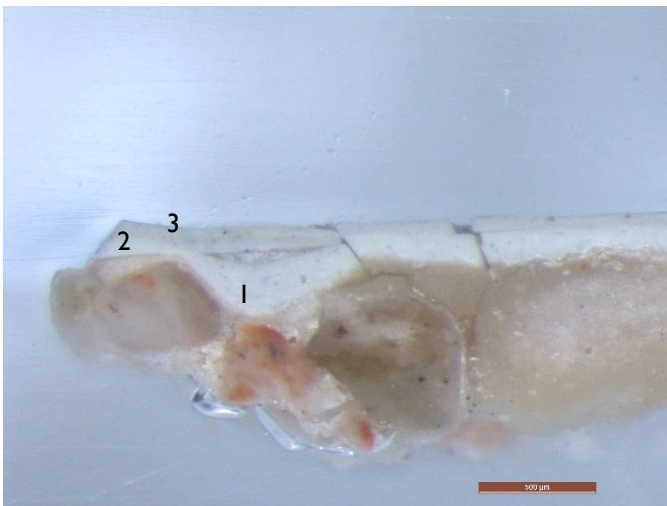
Undermost paint layer in the dining room is light green. The sample 144 does not have the same rich colors of green as the living room wall sample 143.

Sample 144. Dining room wall by the window. Scale 500µm. Sample broke in two parts, below are the undermost layers.

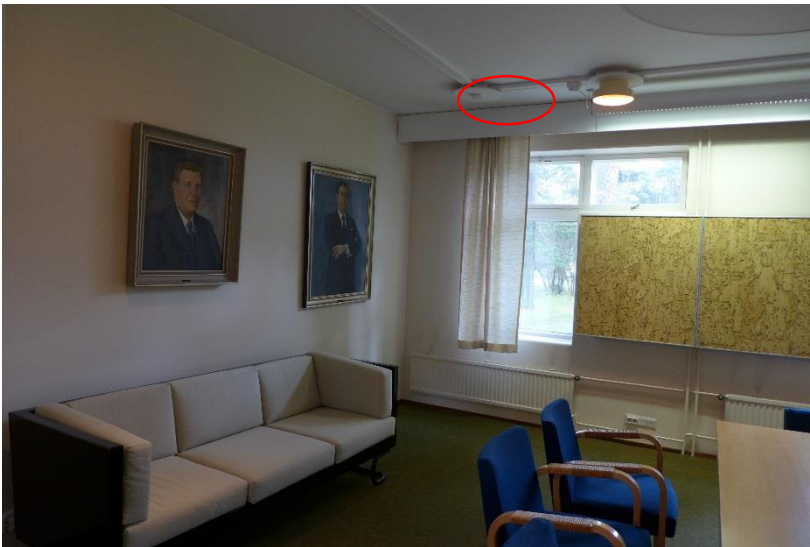
Ground floor Family apartment, bedrooms

Sample 150 from former bedroom ceiling shows a cream white undermost layer.

Sample 156 from bedroom wall facing east has a white undermost layer. No excavations were made in this floor.

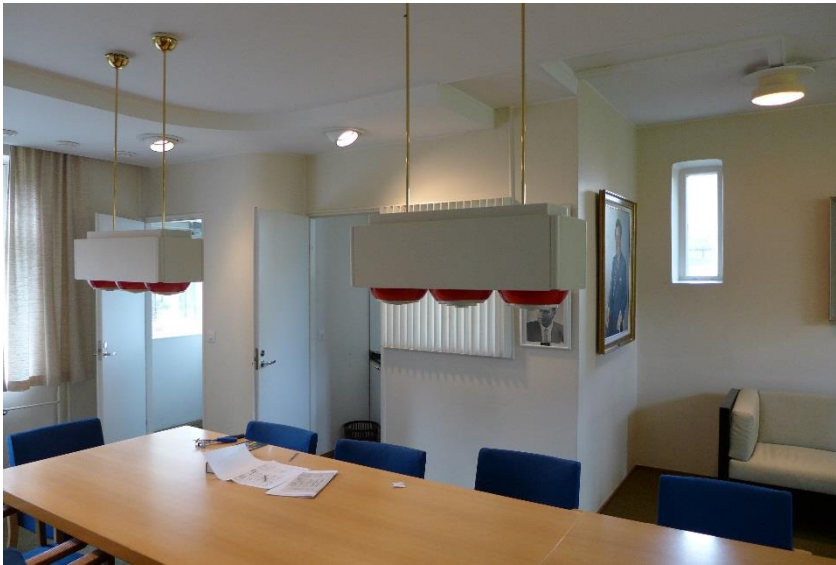
Ground floor, Family apartment: kitchenette and living room ceiling

The former kitchenette cubicle seen in the picture at left, has gone through some changes in the 1980's renovation from staff housing to office space. It is the only one left of the kitchen cubicles in the staff house. The samples were taken from another point of the house, but from a similar spot. The results are white paint layers as undermost layers on both ceilings.

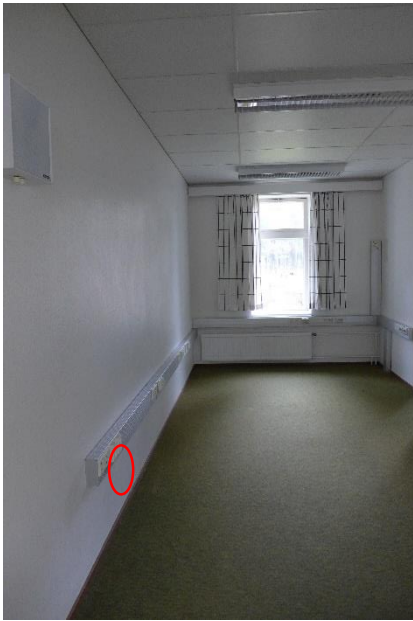
Frist floor, studio apartment walls

The first layers of the samples gathered from walls of upstairs studio apartments show undermost layer of filler that seems original. The second layer (marked "01?") seems like a filler as well. This is the impression one gets from both samples. The undermost layers are all white or cream white. That has probably been the main original color of studio apartment walls.

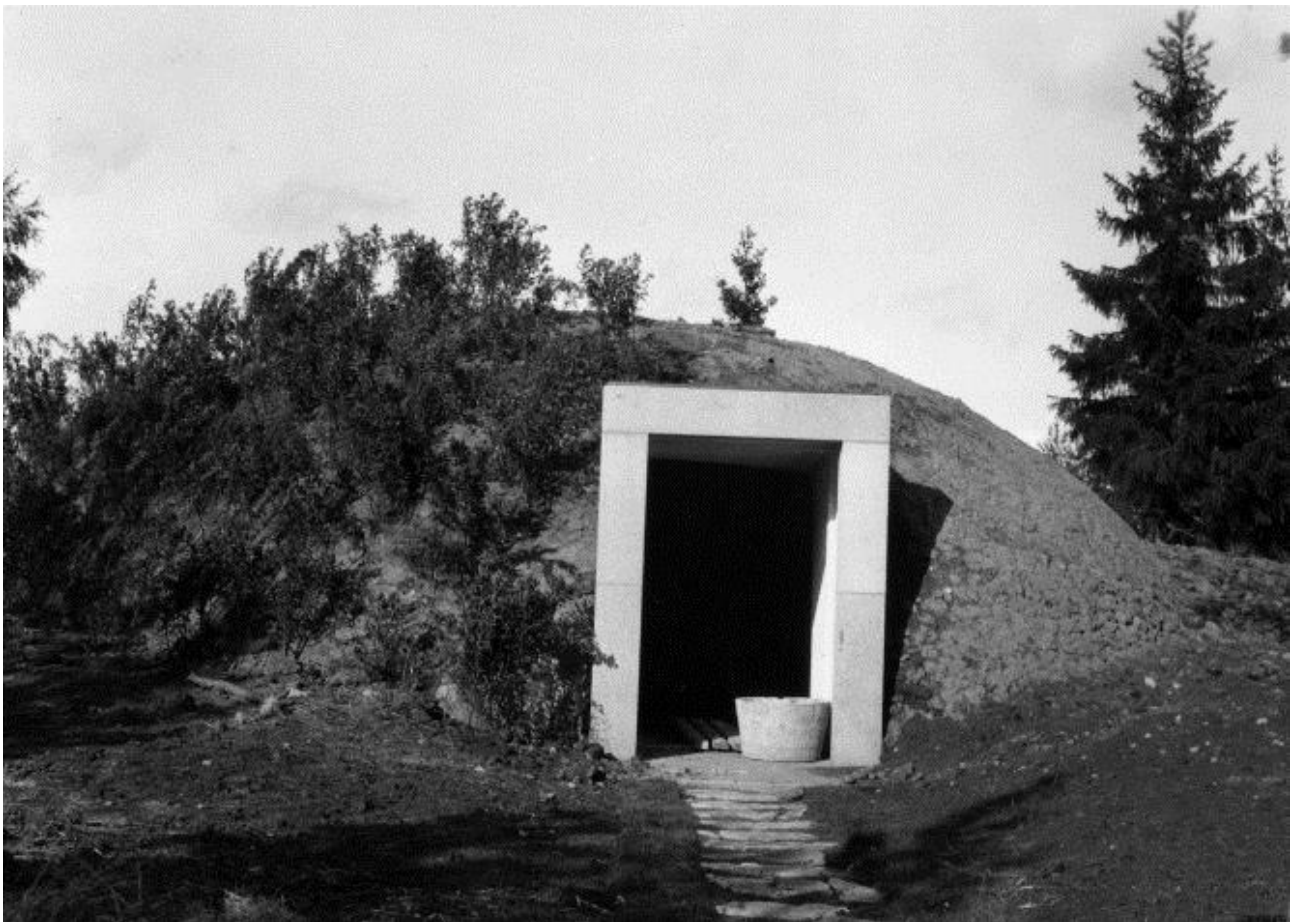
The Rose cellar in its original state, covered with soil and rose bushes. AAM 50-003-25 I

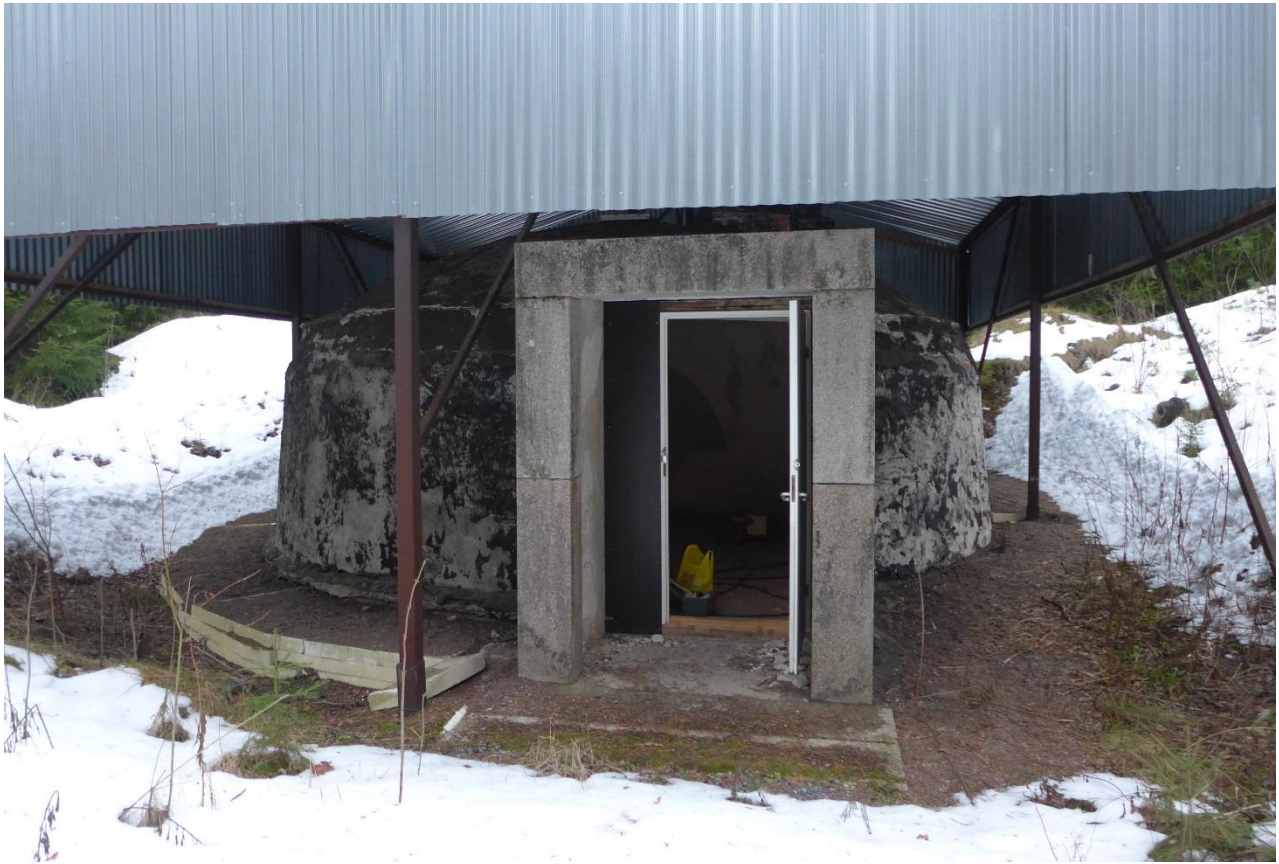
The state of Rose cellar today. The masses of soil covering the dome have been removed. The original moisture insulation, the black tar-like coating has been scraped down to ensure further drying of the structure. The cellar has been covered with a temporary shelter to protect it from rain and subzero temperatures during 2005. The original door has been removed, stored and replaced by a temporary door. An underground drain has been installed around the dome to gather most of the water from the ground.

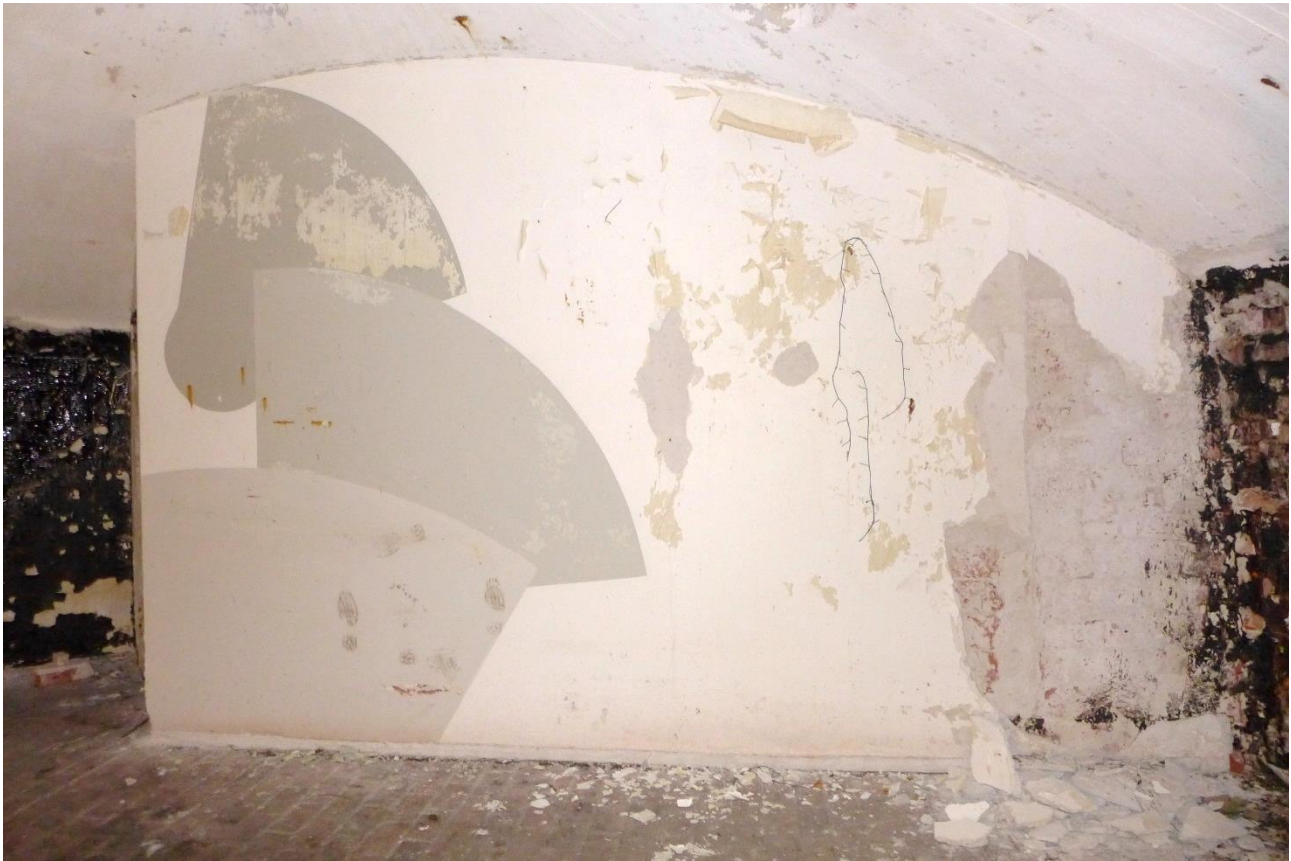
The current state of the Rose Cellar mural. August 2015. The presumed original redbrick floor is now revealed after the peeling of concrete flooring. Black tar-like watertight coating has also been stripped partly to enhance the drying process of the water damaged wall structures.

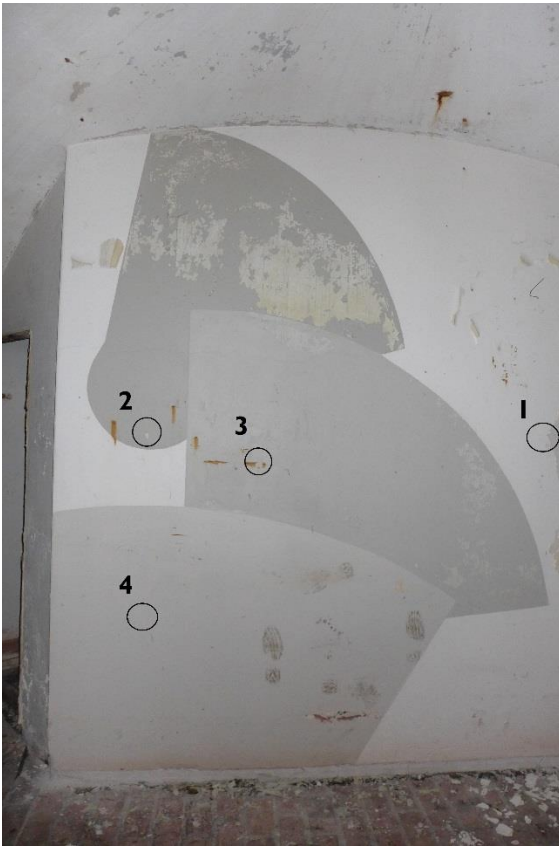
The cross section samples taken from the mural of Rose cellar.

The cross section samples gathered from the Rose cellar mural show three light colored layers. Sample number 1 shows light cream or yellow layers, as the bottom layer there seems almost nonexistent.

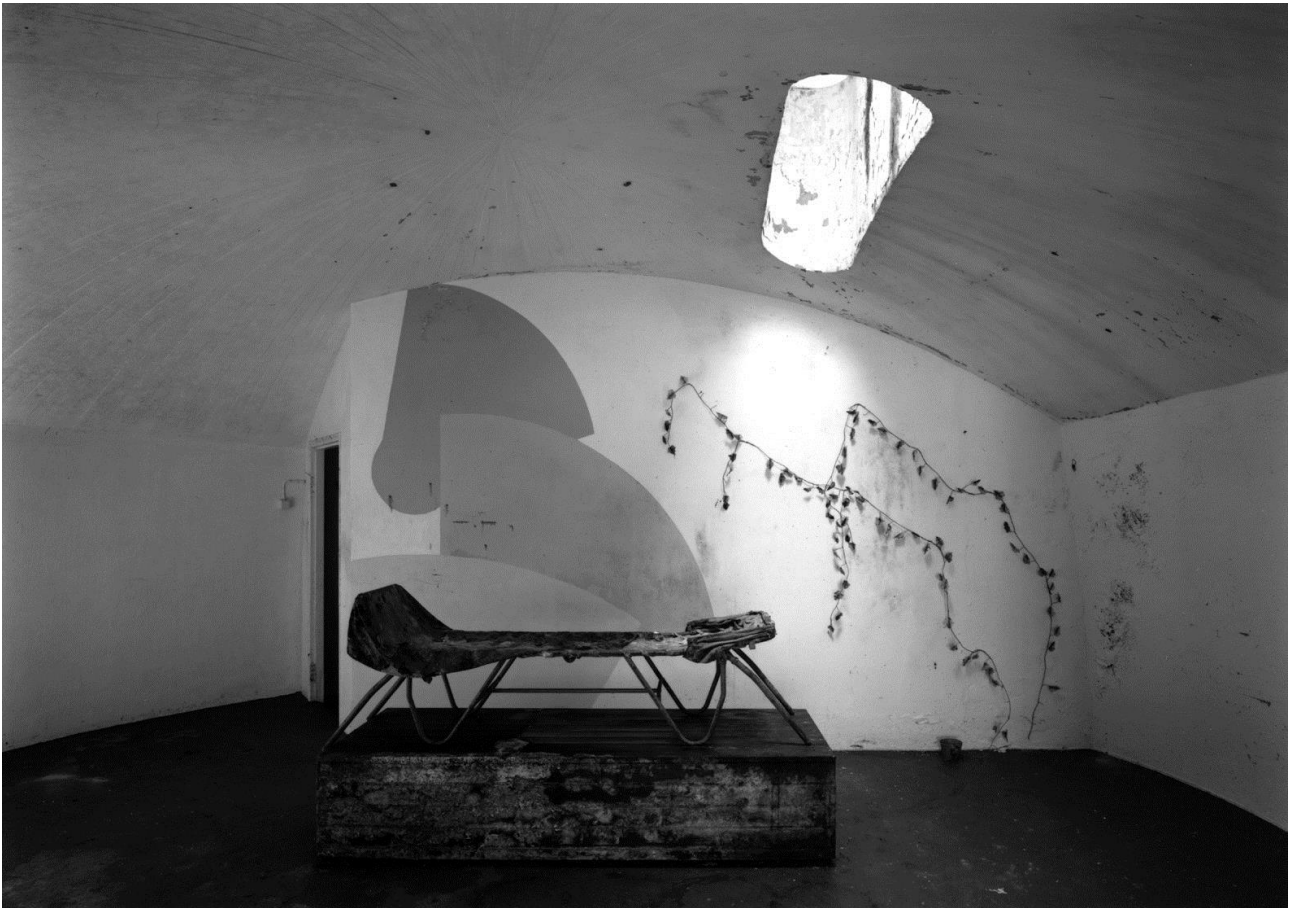
The Rose cellar in 1986. The now demolished concrete floor of Rose cellar is seen here. Kauria's original mural has been painted over at this stage. The vine on the mural wall is plastic. The catafalque standing in the center was made of wood and apparently painted.⁷ AAM. Sign L776.
