**Management Plan for Preserving
the Yoyogi National Stadium as a Living Heritage**

**Japan Sport Council
June 2019**

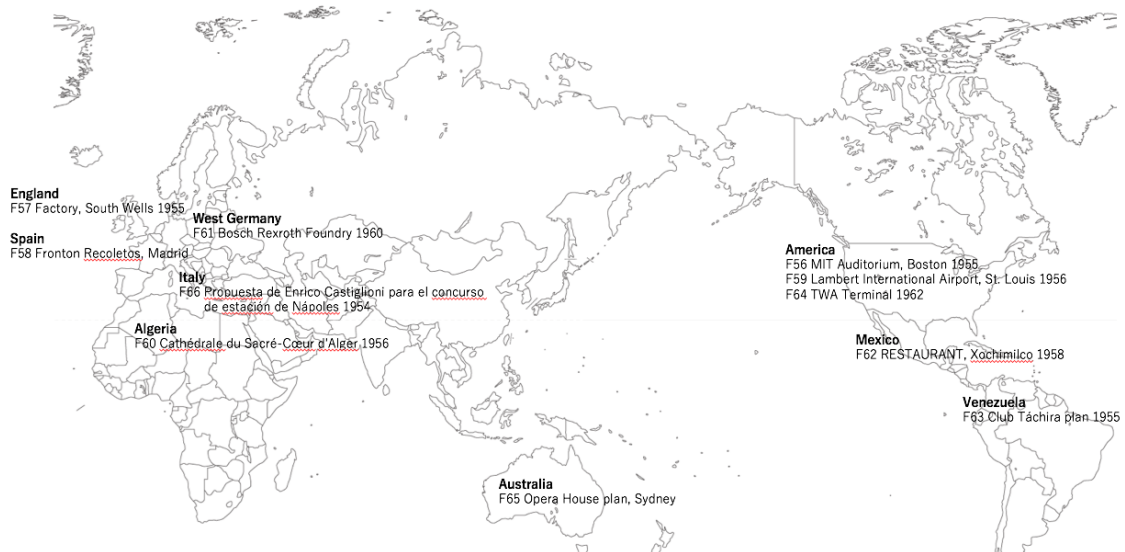
Kawaguchi is the chief engineer of Yoyogi Gymnasium in 1964. He made the distribution map of Suspension Structures and Shell Structures in 1966.01.

Distribution of suspended shell structures designed by Mamoru Kawaguchi in the world (January 1966)

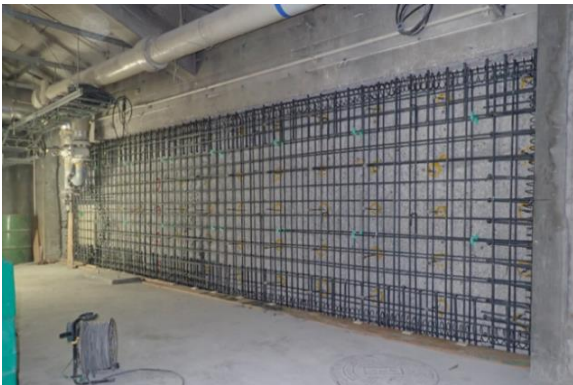
Photo 2-1 Wall repair (thickening the wall by newly adding a bearing wall)

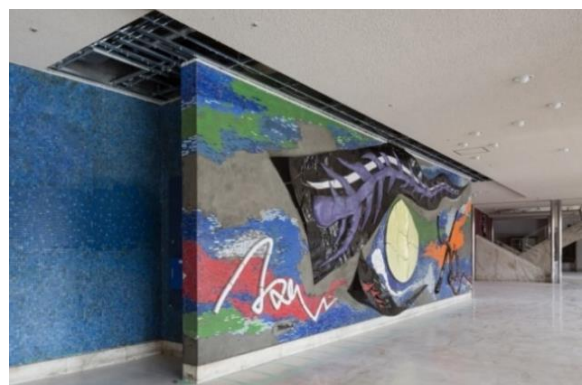
Photo 2-2 Wall repair (Reinforcing a concrete block wall)

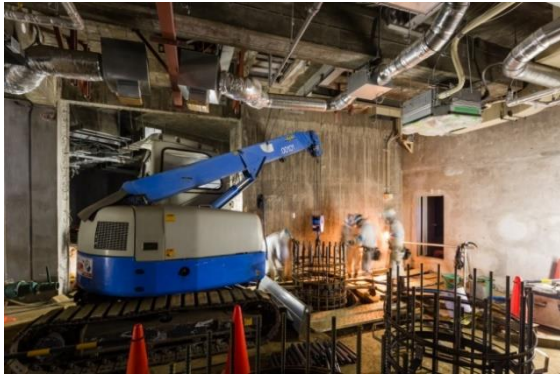
Photo 2-3 Pile installment and base reinforcement work

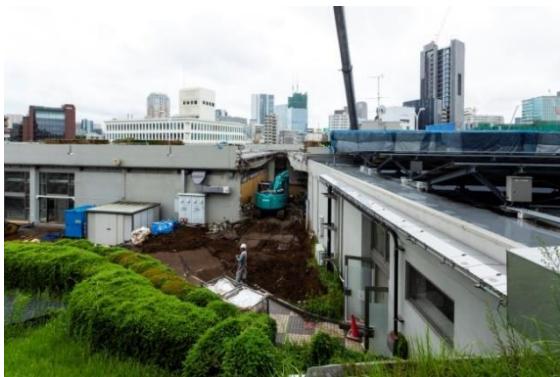
Photo 2-7 Restructuring the building frame of the area around the pool and connecting spaces

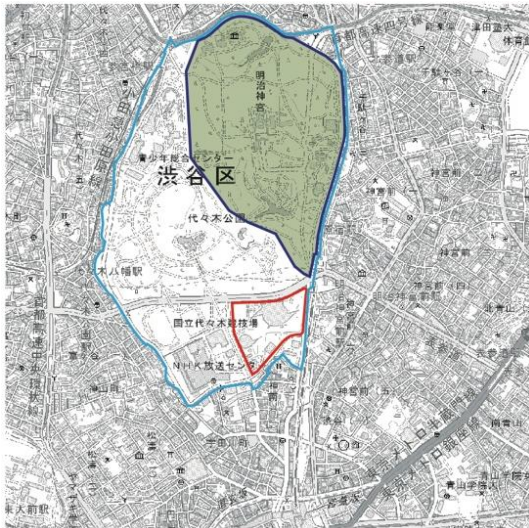
<p>Yoyogi Park and Meiji Jingu are designated as category II Scenic Districts, and Meiji Jingu is designated as a category I Scenic District. Meiji Jingu is also designated as a special green space conservation area. Activities are regulated in a special green space conservation area.</p>

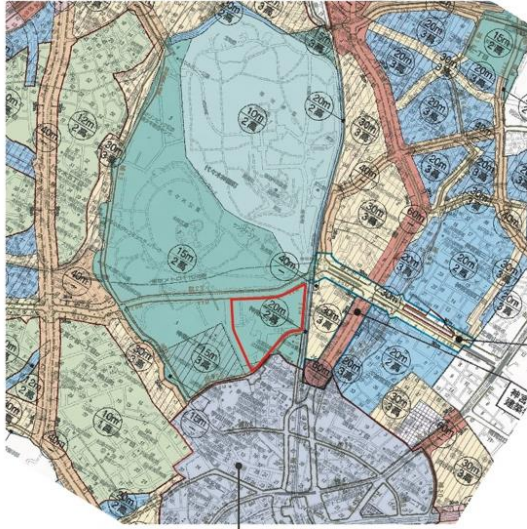
The site is designated as a category II height district (maximum height 20m). There is no height limit in the southern area of the site.

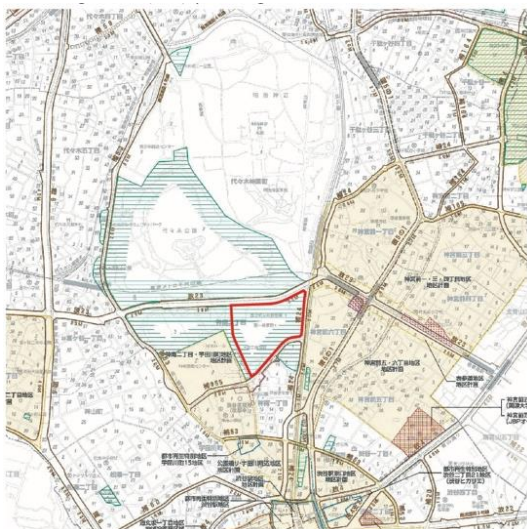
The site of Yoyogi Stadium is included in the public park designated by city planning. However, the area is regulated by Urban Park Law, because the site is not opened as a park.

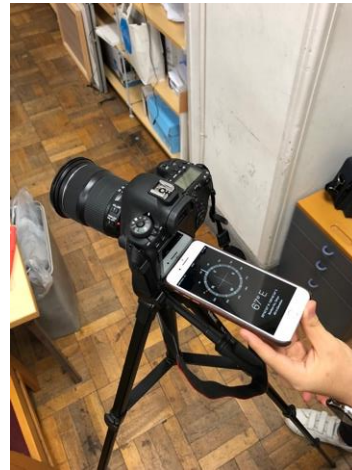
Fig. 3-7 Measurements for photographing directions

First, 1) photograph the Yoyogi Stadium from the specified viewpoints. At the same time, record the positions, orientations, and elevations of the photographing points (Fig. 3-7) create a 3D model by referencing the planar shapes and height of planned new buildings based on the available development plans of the surrounding area. Set the viewpoints using 3D software based on the positions, orientations, and camera angles recorded in 1) and generate the perspective views of the model created. 3) Collate the photographs taken in 1) with the perspectives generated in 2) to create composite images. Finally, 4) check and adjust the front-rear relationship of objects in the images.

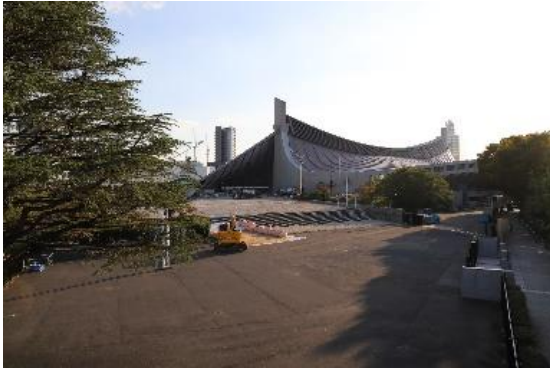
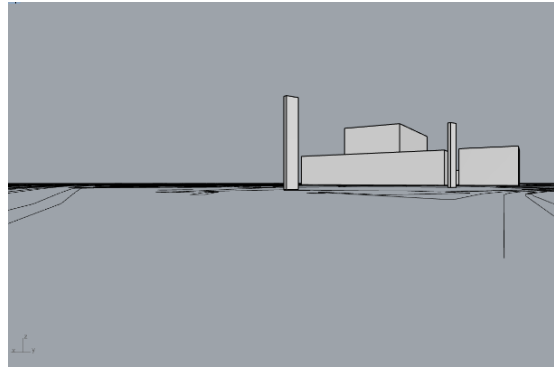
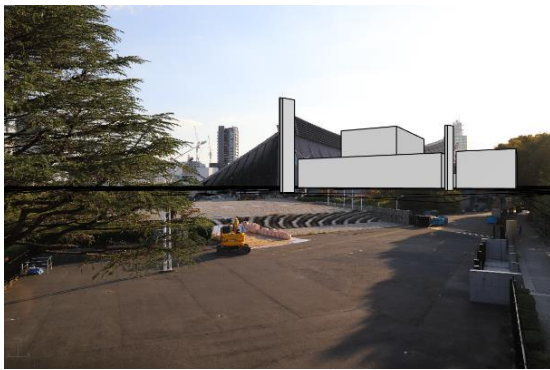
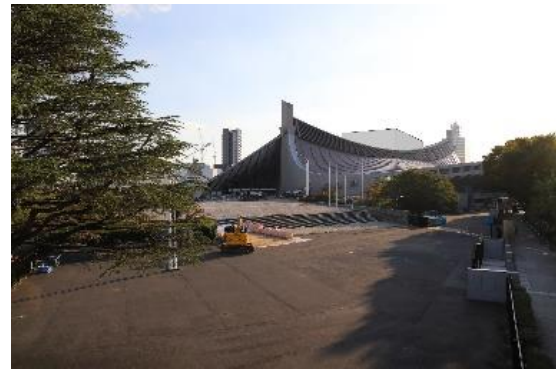
Fig. 3-8 Procedure for creating landscape simulation

① Taking photos and recording photographing positions and orientations

② Creating the 3D model

③ Collating photographs and the 3D model

④ Adjusting the front-rear relationship of objects in the images

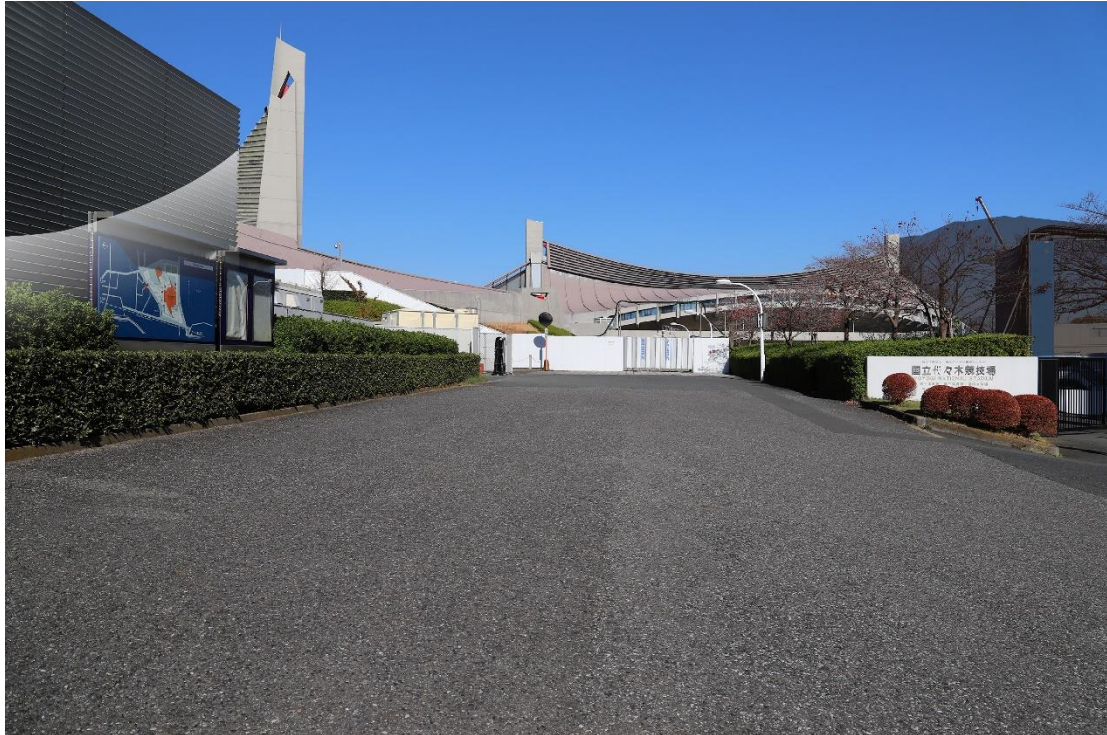
Fig. 3-9 (a) Landscape simulation

The simulation view Fig. 3-9 (a) is what would be immediately visible after passing through the Shibuya Gate along the path used by athletes and distinguished guests to access the site. The first and second gymnasiums are visible in their entirety along the approach axis line, though the second gymnasium is partially

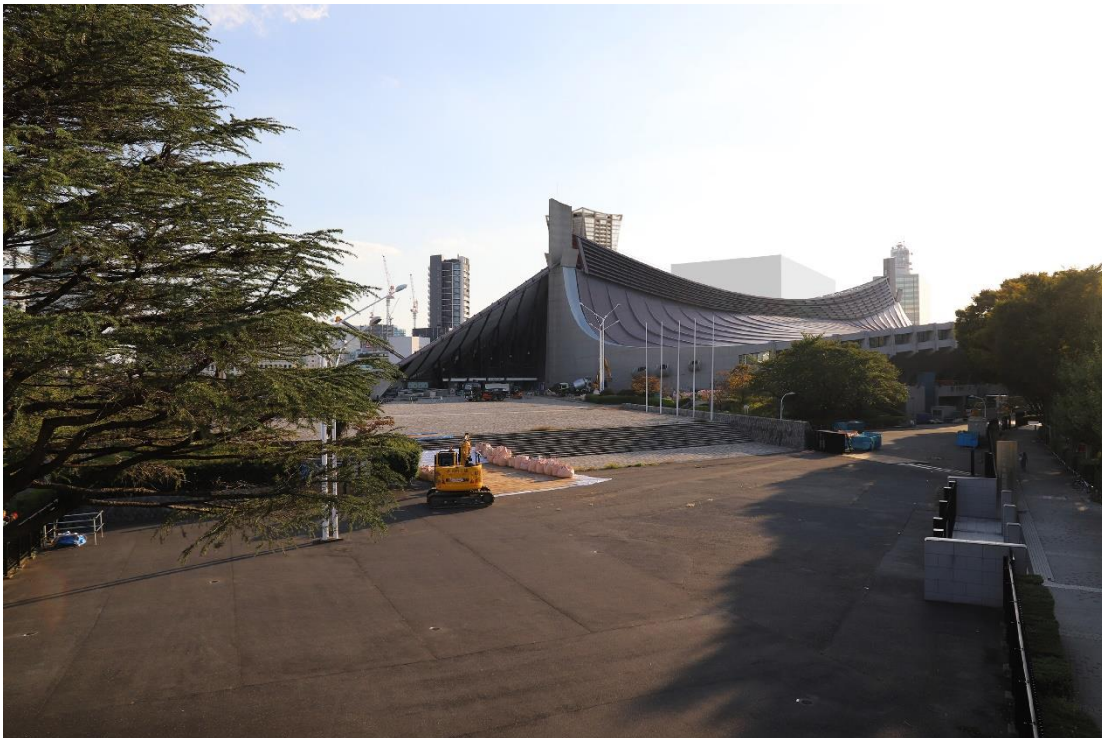
Fig. 3-12 (a) Landscape simulation

The landscape simulated Fig. 3-12 (a) is the view from the pedestrian overpass on the traffic line approaching the stadium from Harajuku Station. Many spectators will take this approach for stadium events. The second gymnasium is hidden behind the first gymnasium, but the structural components—such as the main pillars and cables of the first gymnasium—are highly visible, and the suspended roof and its characteristic curve are also clearly visible. In the background are 1) recently completed high-rise condominiums (La Tour Jinnan 1

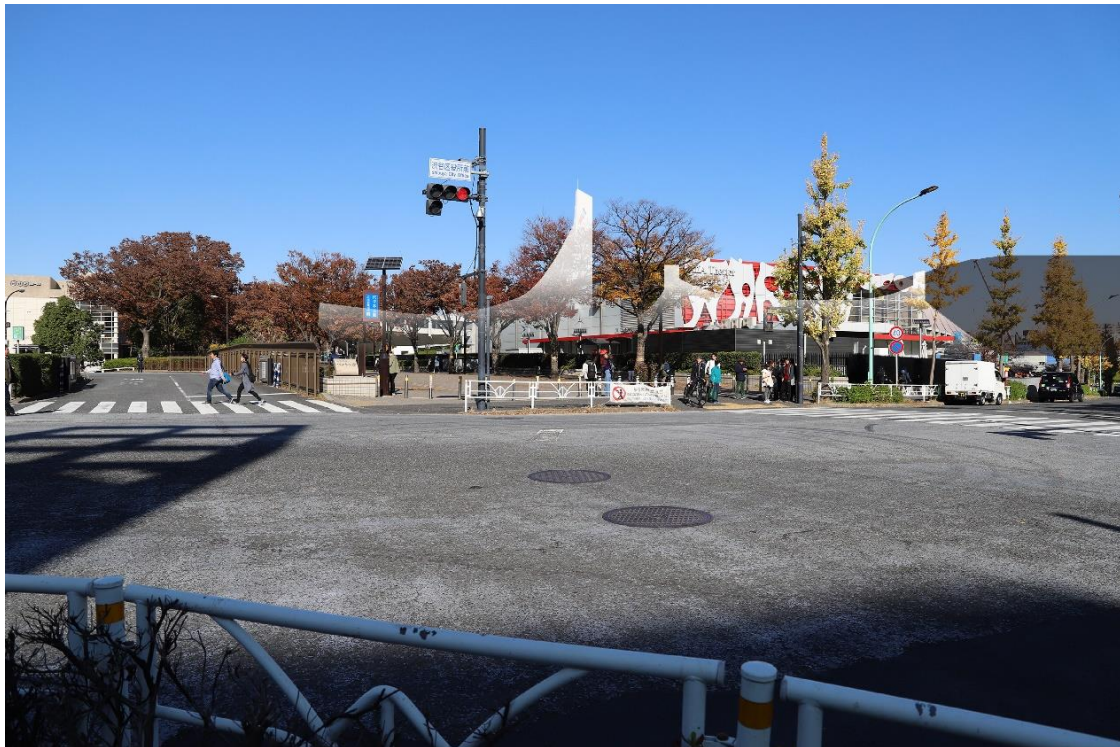
Fig. 3-15 (a) Landscape simulation

The simulated view Fig. 3-15 (a) is the northward view when standing at the southwest corner of the intersection (in front of the Shibuya Public Hall, currently being rebuilt). Similar to the view from viewpoint A, the development in the Jingumae area to the right of the first gymnasium may affect the visibility of its outline. The temporary building shown in the photo at the northeast corner of the

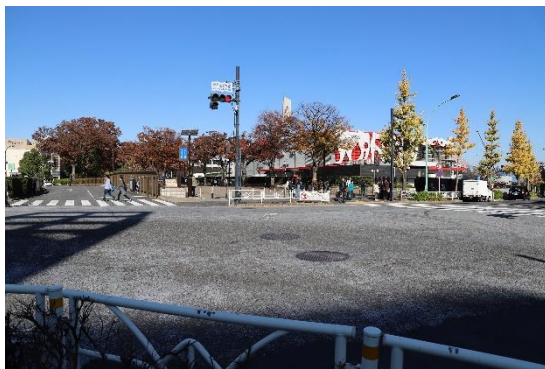
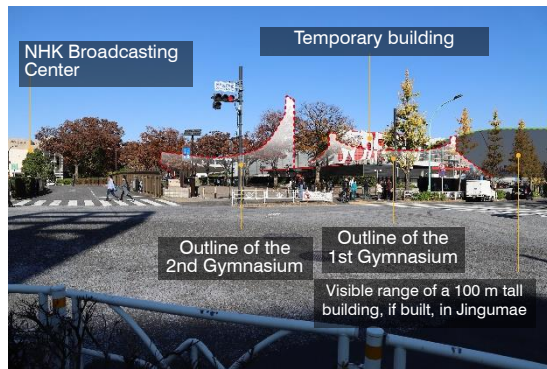
Fig. 3-16 (b) Current view (November 2018)

Fig. 3-17 (c) Elements of the view

intersection was nonexistent when the gymnasium was completed. The building was removed in April 2019, and another new temporary building has been constructed which is blocking much of the view of both gymnasiums, and the open and gently sloping landscape of the gathering place connecting the two gymnasiums at the time of completion is hardly visible.

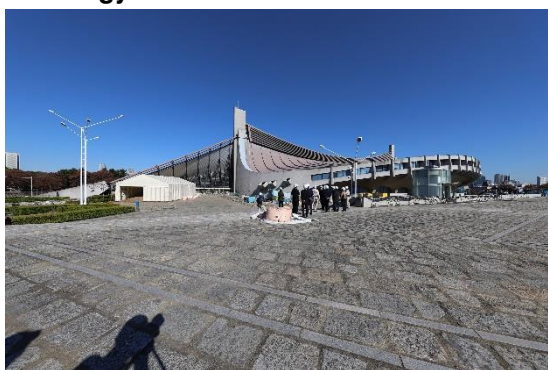
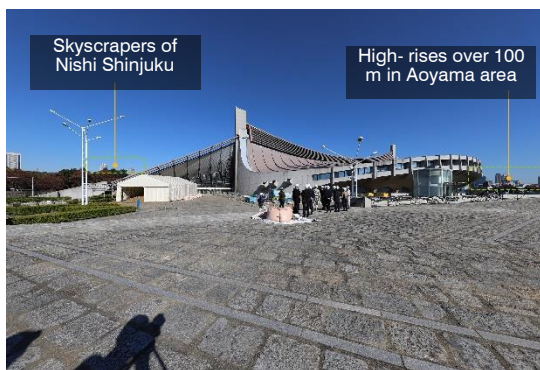
Fig. 3-19 (b) Current view (November 2018)

Fig. 3-20 (c) Elements of the view

This is the view from the promenade, an open space, where the entrances to the first and second gymnasiums face each other and point toward the center of Tokyo. Because the viewpoint has been set very close to the building, a wide field angle is necessary to view the entire building. The view from this point only includes the first gymnasium, with the entire gymnasium and shapes of respective elements clearly visible. Visible in

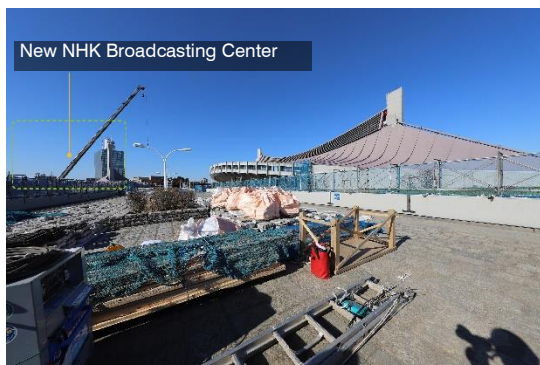
Fig. 3-22 (c) Elements of the view

This is the view when standing in the promenade; it is the same as viewpoint D except for looking westward (Tokyo fringe area), with a wide field of view to include most of the two gymnasiums. Behind the first gymnasium is the Meiji Jingu site; therefore, development of the surrounding area is not expected to affect the view of the gymnasium significantly,
