# Illustrated Glossary

## Technician Training for the Maintenance of In Situ Mosaics

The Getty Conservation Institute

Institut National du Patrimoine

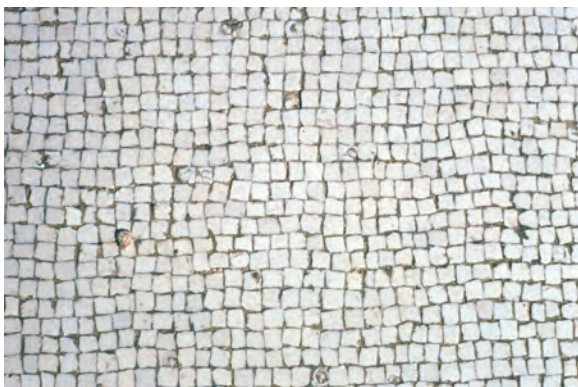
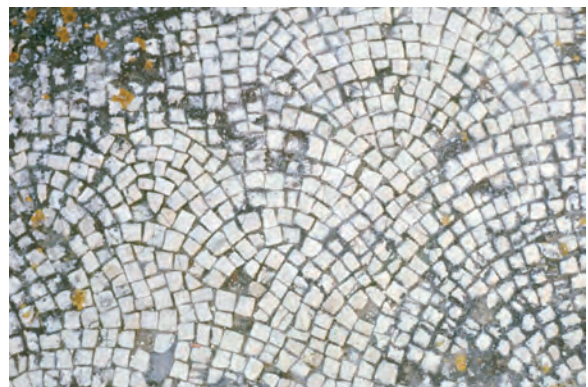
### Monochrome opus tessellatum

Pavement made of small, regularly shaped, usually quadrangular, elements (generally 4 to 20 millimetres wide) placed side by side in rows. These elements, called tesserae, are obtained by cutting different materials such as stone (often marble or limestone), ceramic or glass.

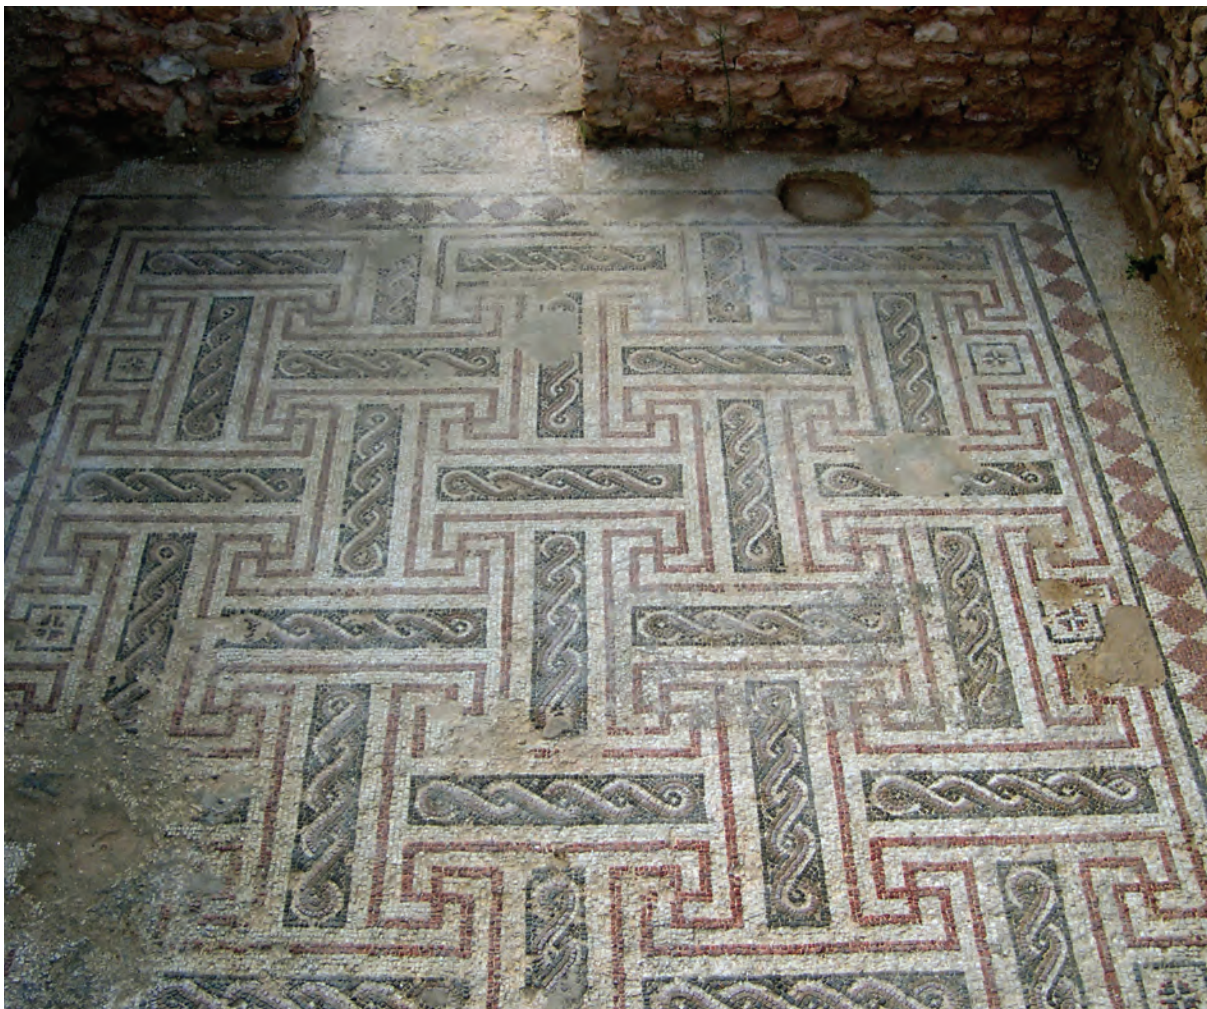
**Polychrome geometric opus tessellatum**

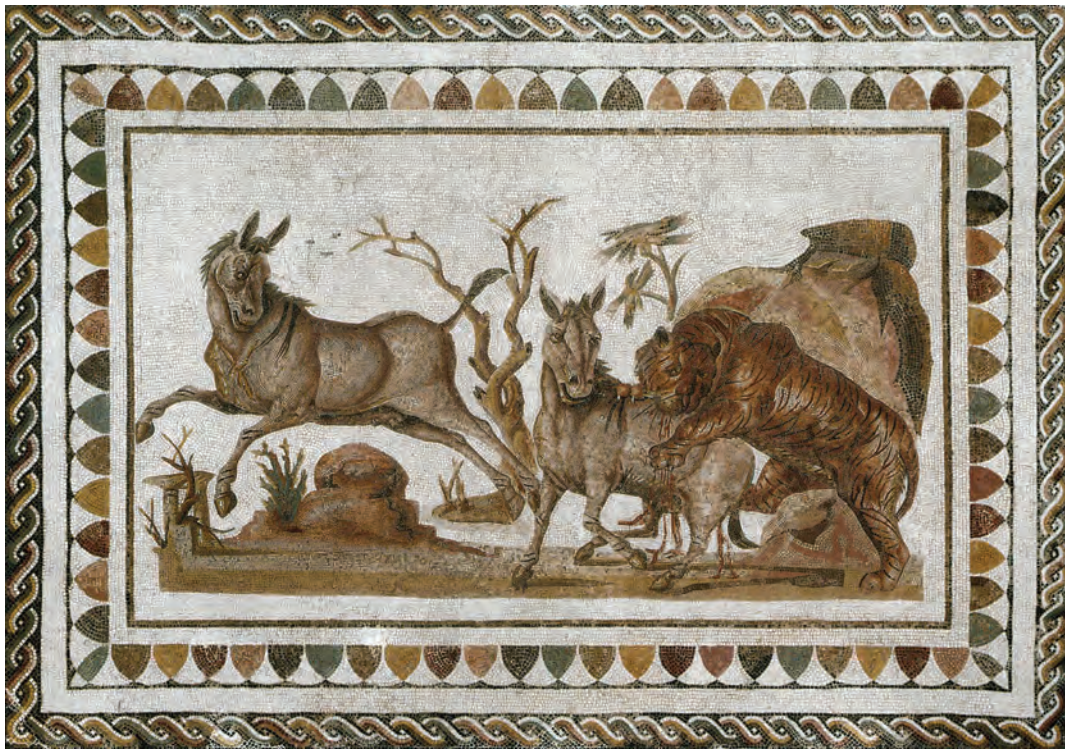
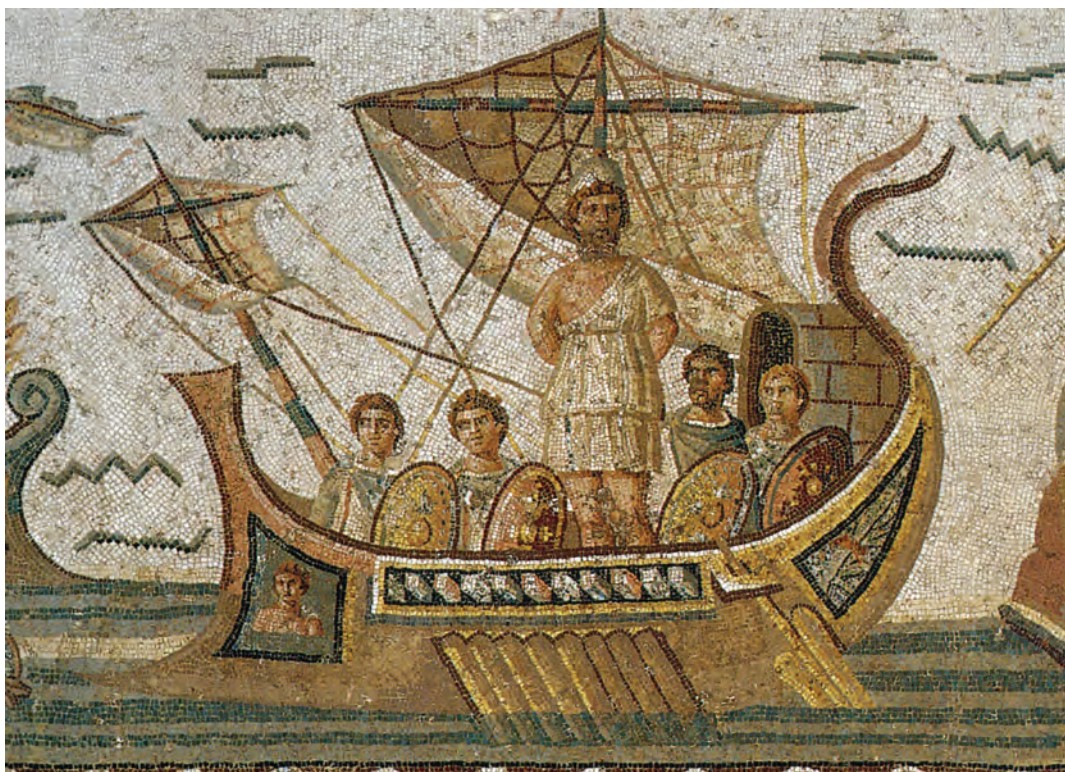
**Polychrome figurative opus tessellatum**

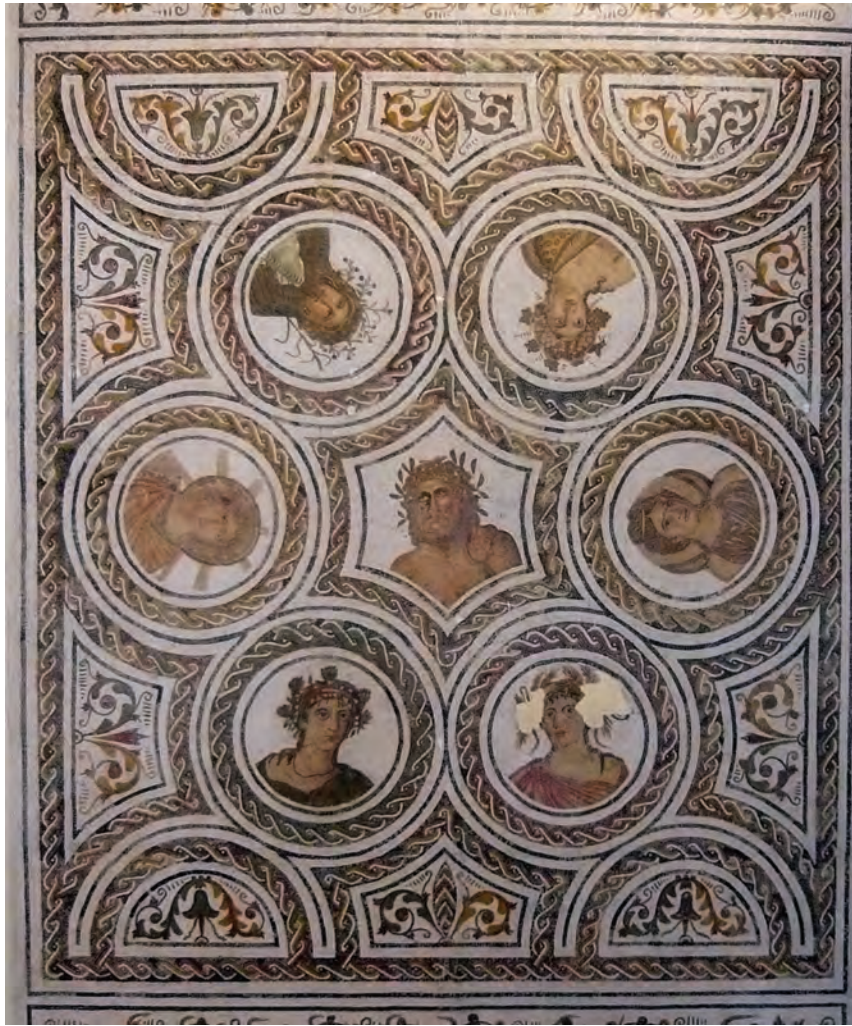
**Polychrome geometric and figurative opus tessellatum**

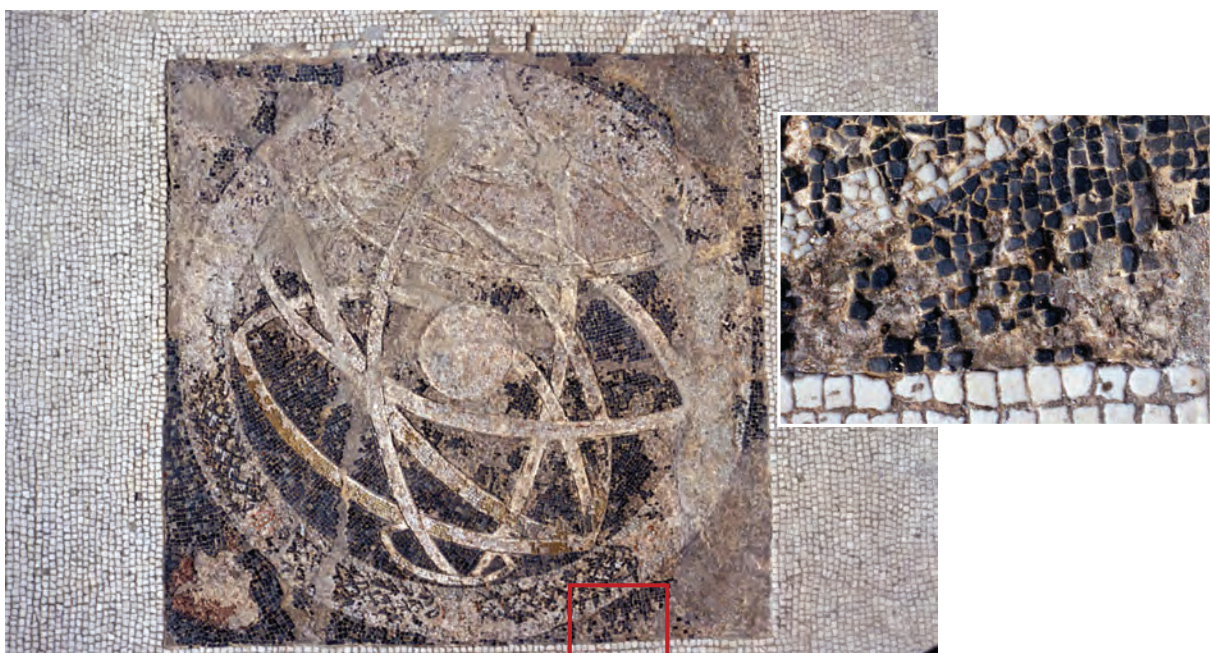
A small mosaic panel (usually less than a square meter) made in *opus vermiculatum* and inserted in a mosaic pavement (or sometimes on a vertical surface) is called an *emblema*. It is generally made separately on a stone slab or large ceramic tile in a workshop prior to the making of the mosaic into which it is inserted. This type of mosaic was also made as a portable work of art, independent from any building.

### Emblema in opus vermiculatum

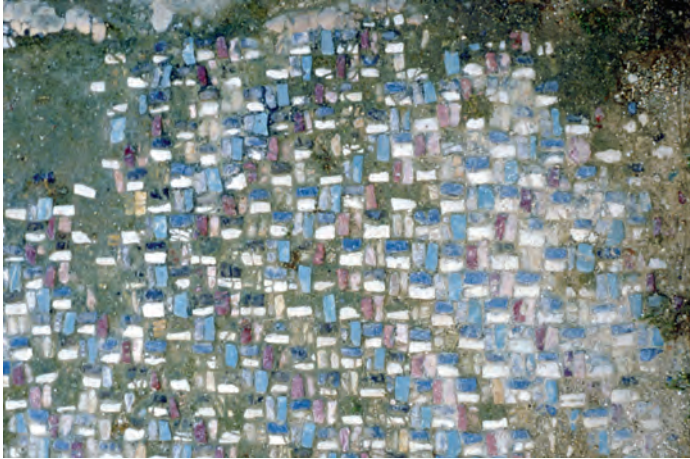
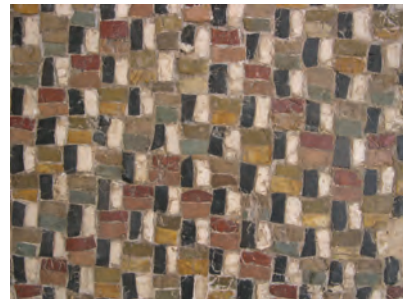
## PSEUDO-FIGLINUM

Type of *opus tessellatum* pavement made of stone tesserae of different colors, all of the same size and rectangular shape. As with *opus figlinum* (page 14), the placement of the tesserae creates a visual impression of a basket weave pattern.

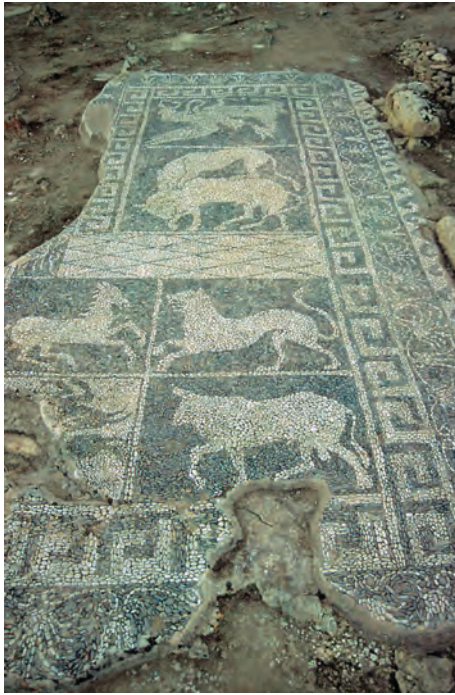
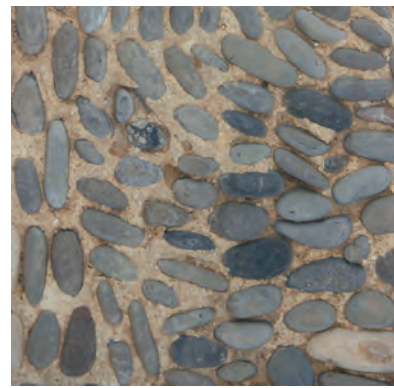
## PEBBLE MOSAIC

Pavement, generally bi-chrome, more rarely polychrome, made of natural pebbles of different sizes and placed on their edge, side by side, to create figures or geometric motifs.

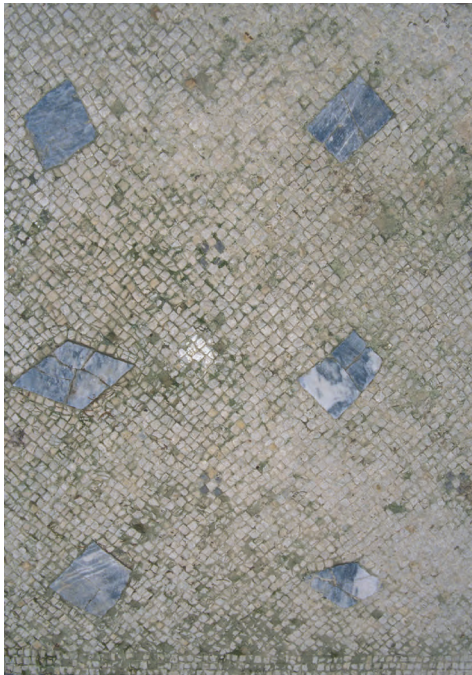
### Opus scutulatum with white background

Pavement combining an *opus tessellatum* background, frequently monochrome, and small stone slabs, often in fragments, generally aligned in rows. The slabs are of different forms, colors, and dimensions.

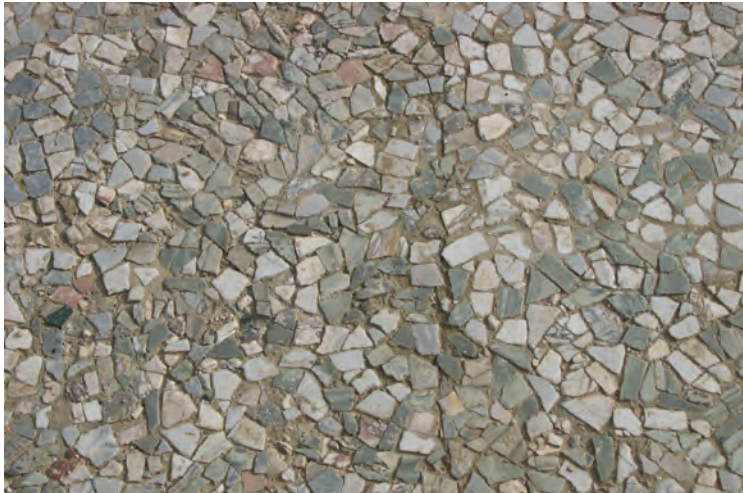
## OPUS SEGMENTATUM

Pavement made of stone slab fragments, most commonly marble, of different colors, cut in irregular shapes and placed side by side without creating any geometric or figurative motif.

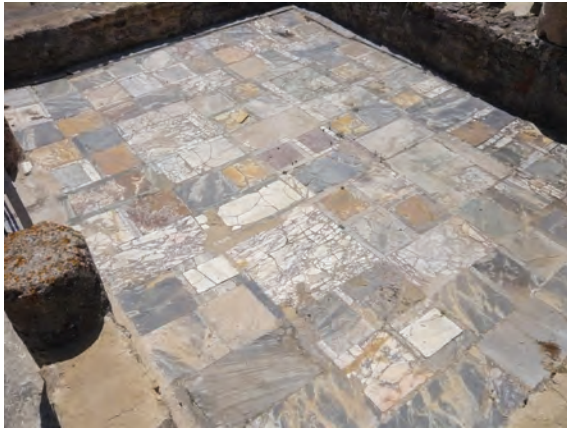
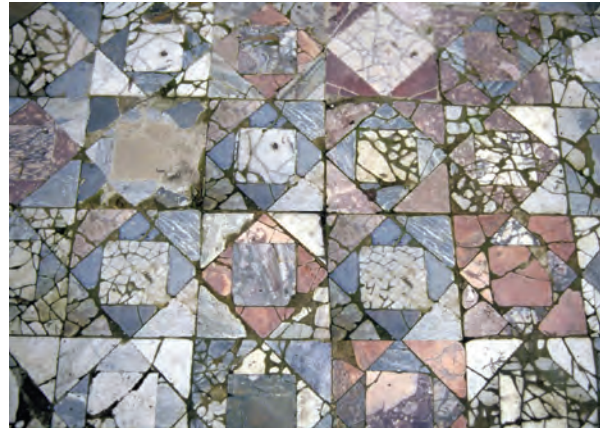
## OPUS SECTILE

Pavement made of stone slabs, most commonly of different colored marble, cut in regular shapes and placed side by side to create a geometric pattern or figurative motif.

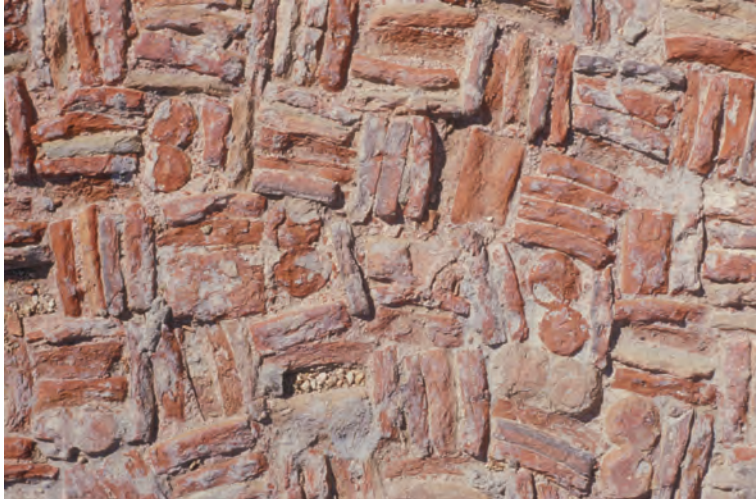
## OPUS FIGLINUM

Pavement usually made of same-sized rectangular ceramic fragments, inserted on their smaller side and assembled together in groups of a few elements. The orientation of adjacent groups is alternated so that their juxtaposition creates the visual impression of a basket weave pattern.

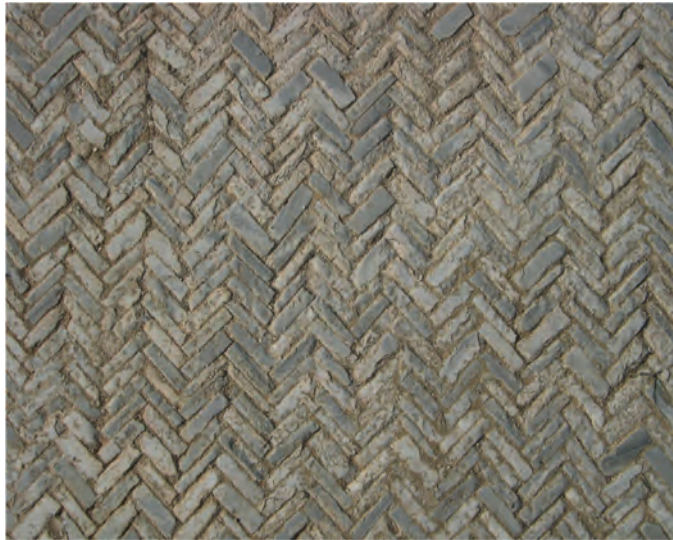
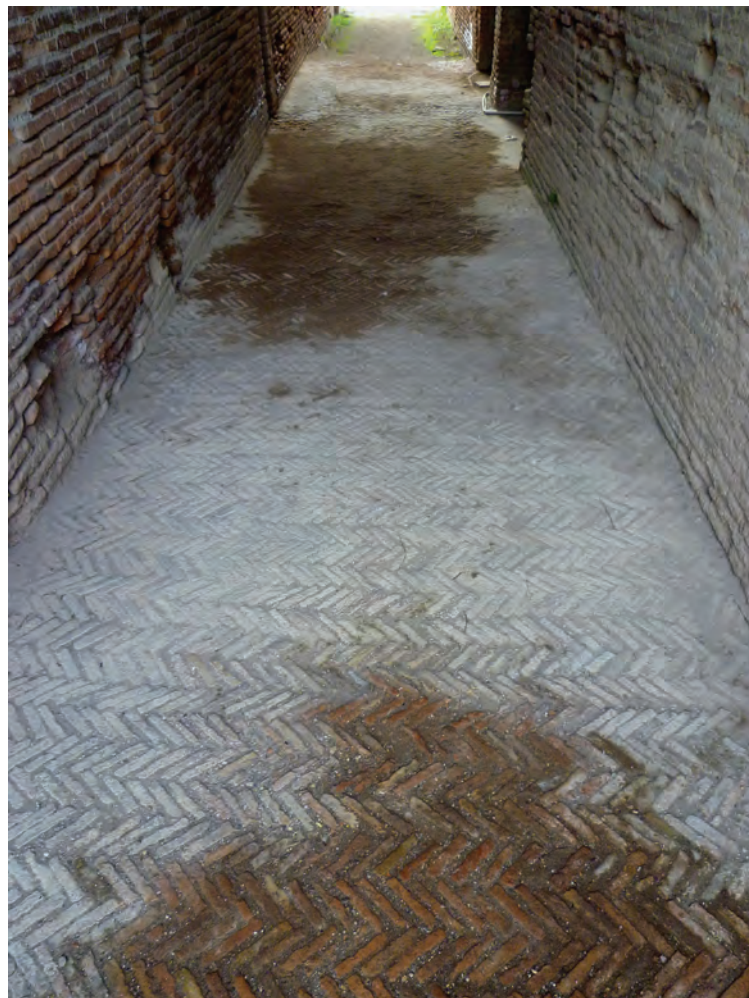
## OPUS SPICATUM

Pavement made of ceramic elements, usually of the same size and rectangular shape, arranged in a herringbone pattern.

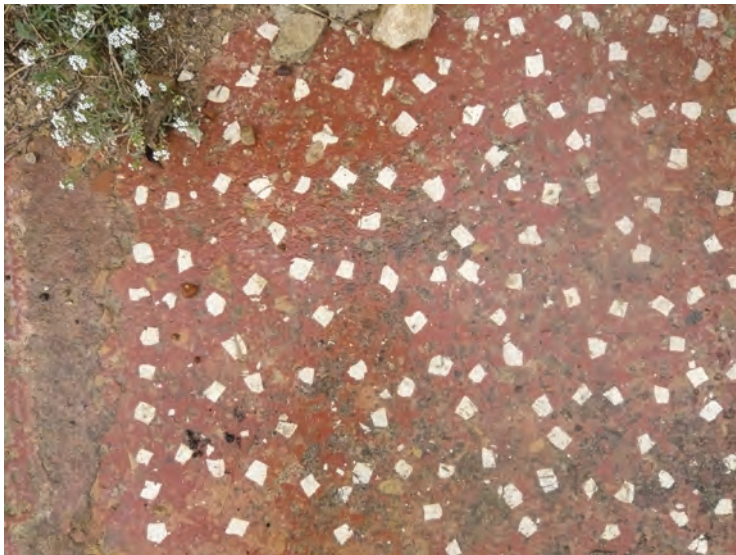
### Opus signinum using randomly placed tesserae

Pavement made of lime mortar mixed with ceramic fragments into which quadrangular tesserae or small stone fragments are inserted, either randomly or to form geometric designs.

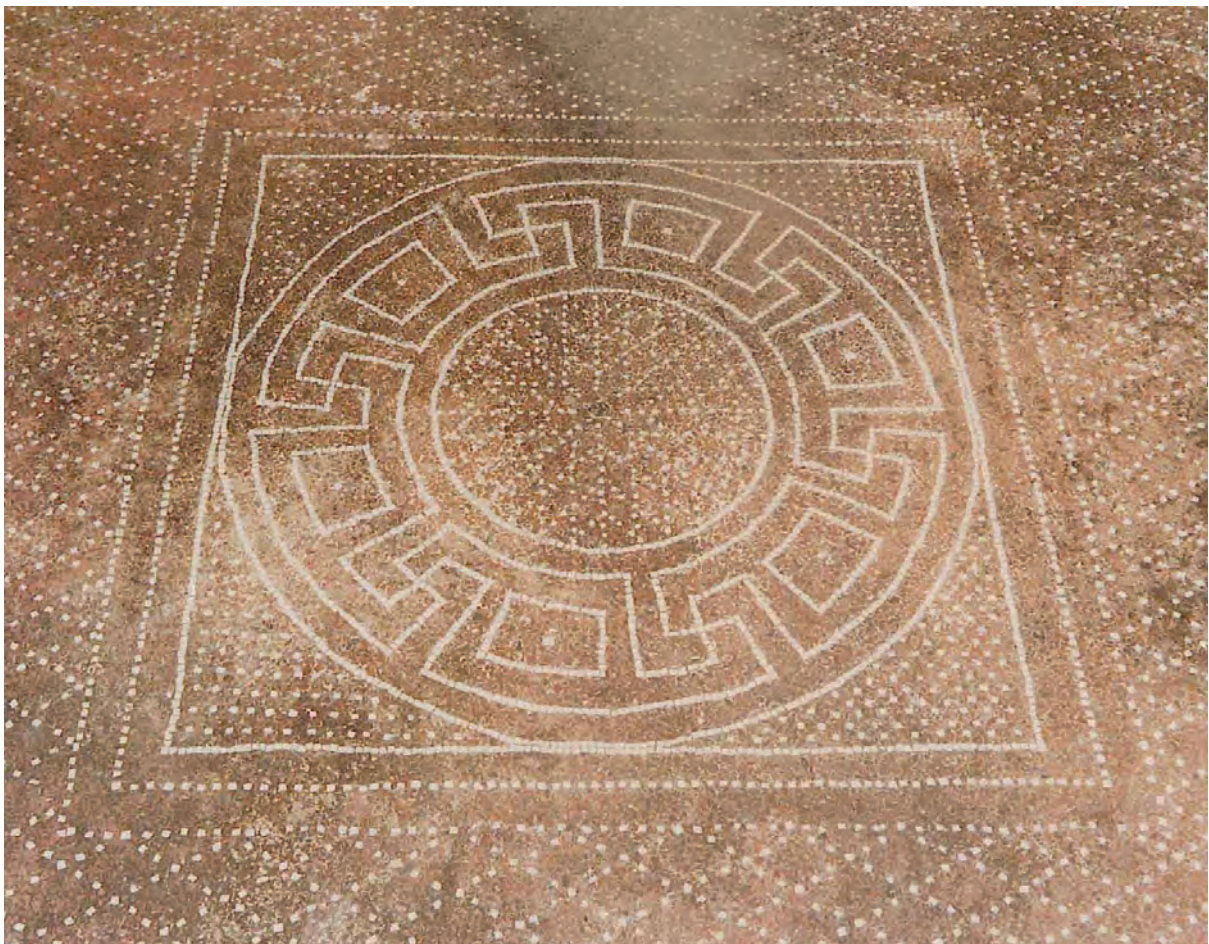
**Opus signinum using tesserae to form geometric designs**

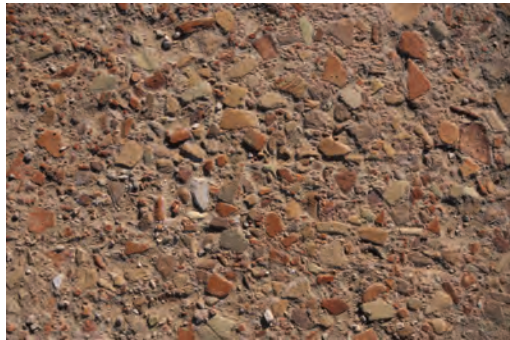
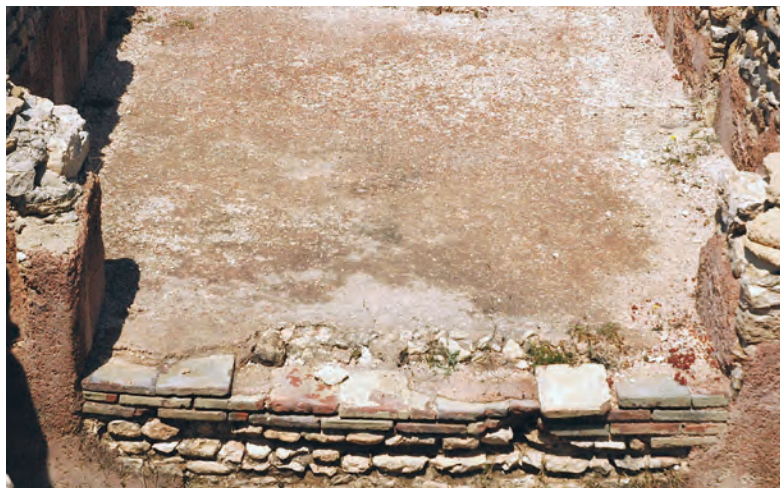
### Cocciopesto

Pavement made of lime mortar mixed with ceramic or stone fragments without the insertion of other elements.

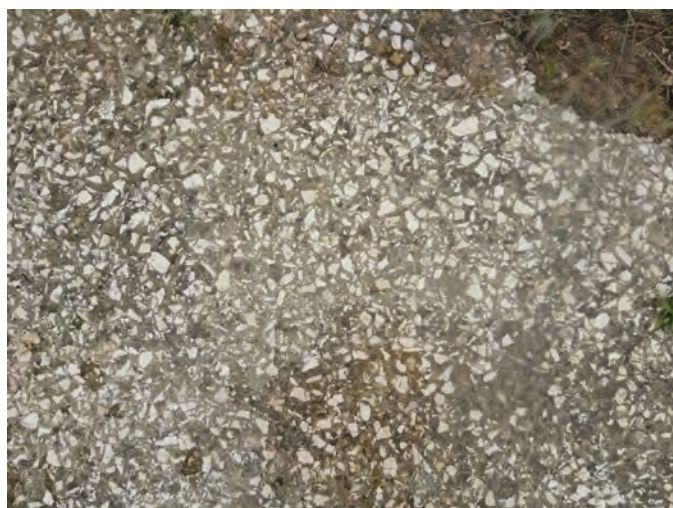
### Mortar pavement with stone fragments

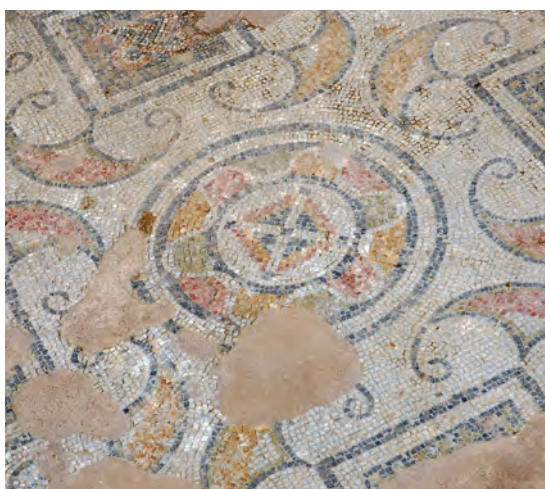
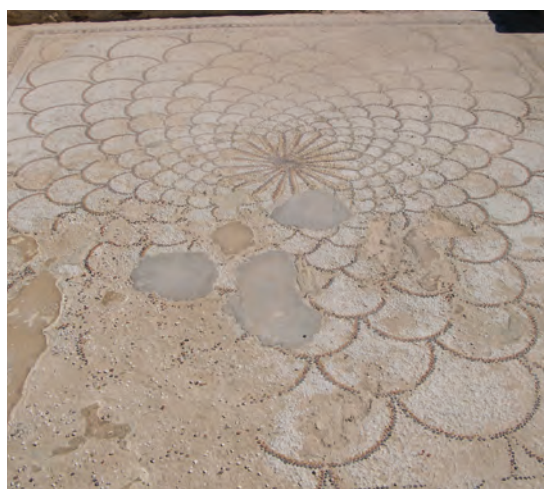
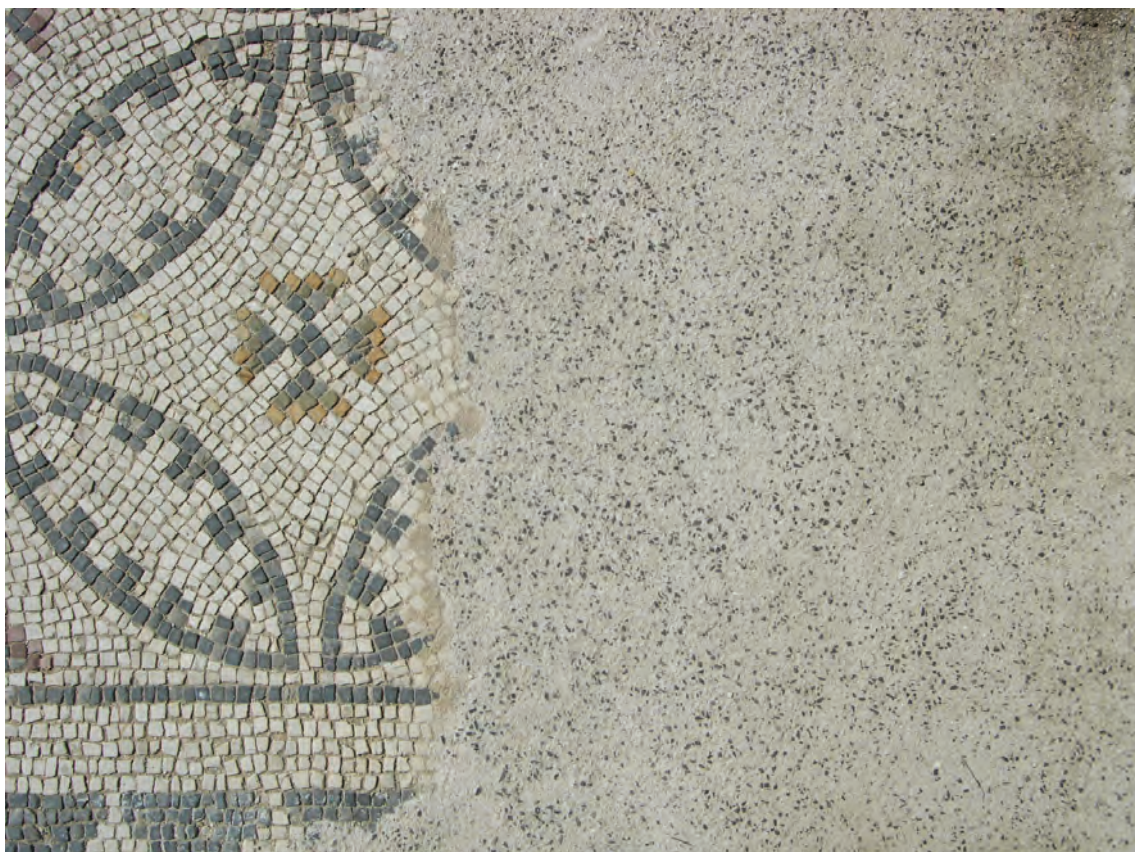
**Lacuna fill:** An area of the pavement where the original tessellatum is missing and has been replaced with a repair mortar.

In addition to the tessellatum, a lacuna fill can also be used to fill loss in preparatory layers below.

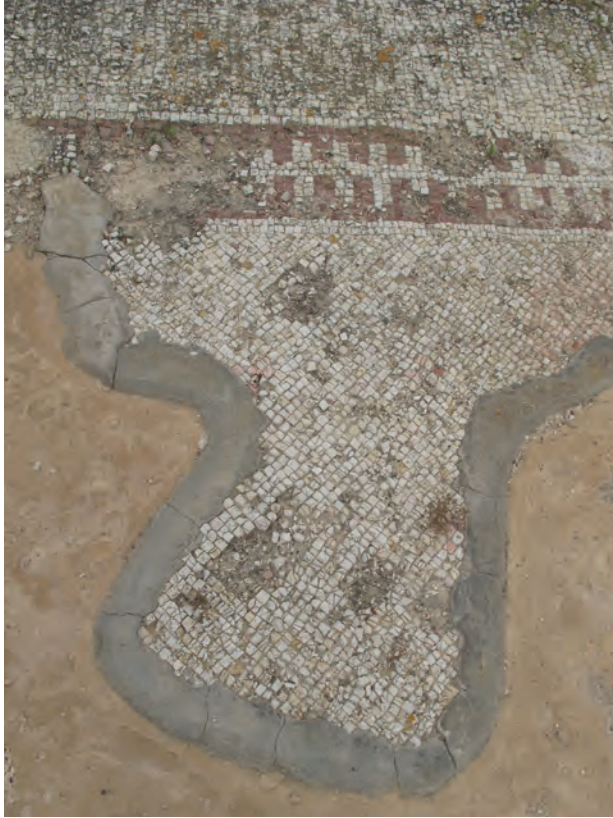
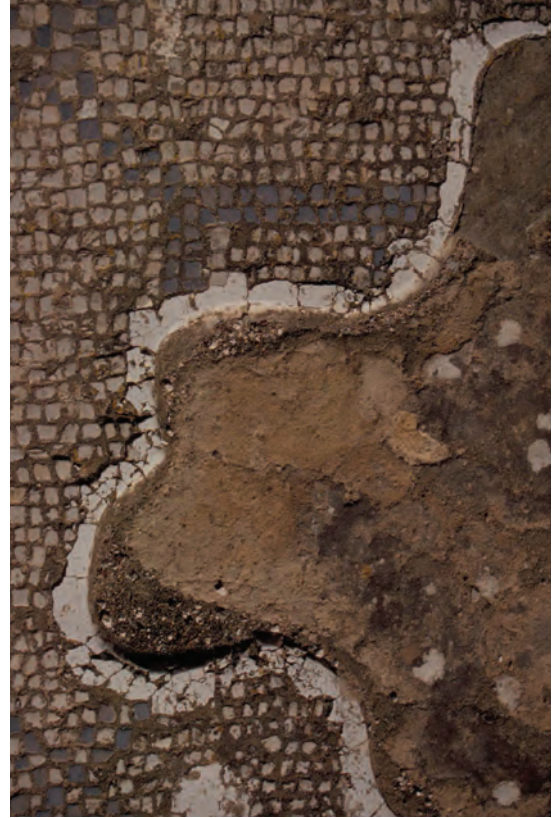
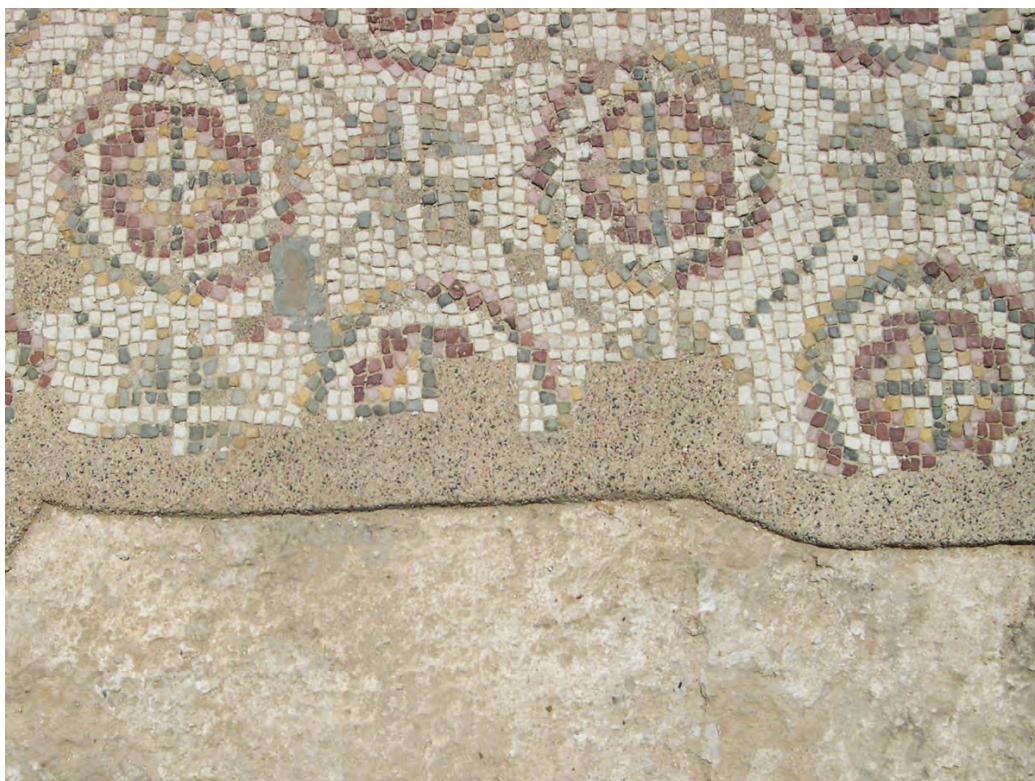
**Edging repair:** An area of the pavement where part of the mosaic is missing and the edge of the mosaic has been contained and supported on the side by applying a layer of repair mortar along it.

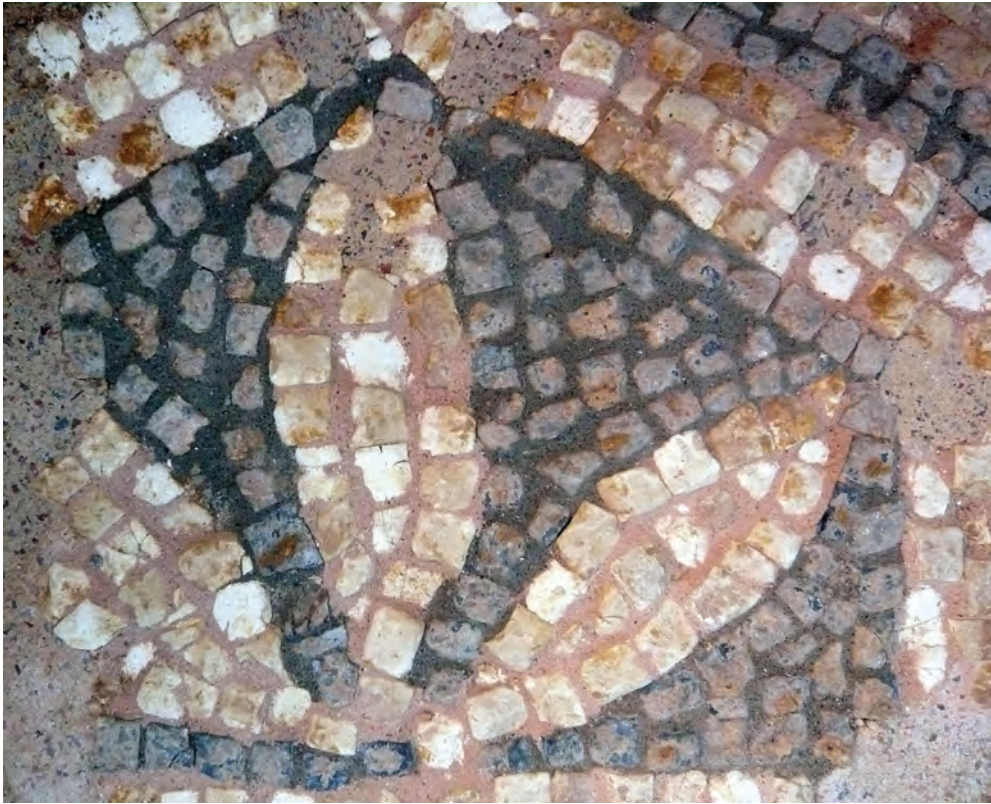
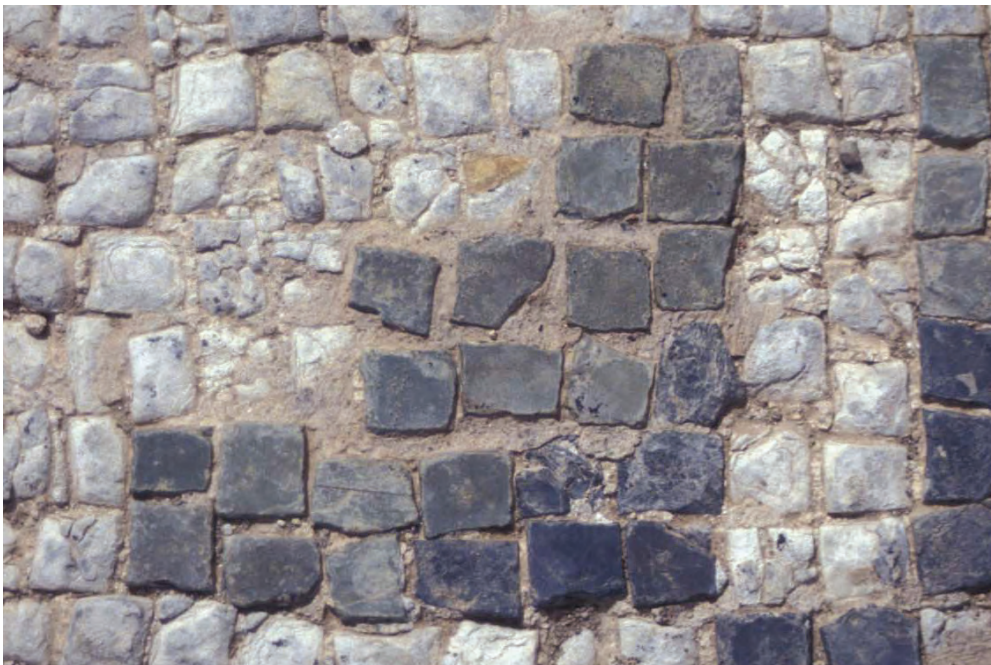
**Filling of interstices between tesserae:** An area where the original mortar in the interstices between the tesserae is missing, and has been replaced with a repair mortar.

Mortar filling of interstices between tesserae (diagonal lines)

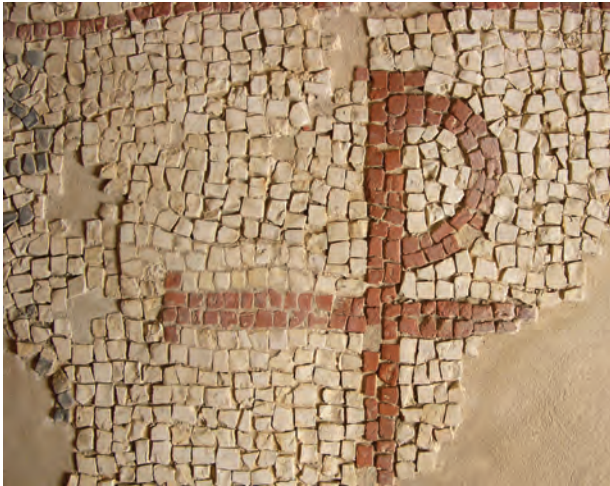
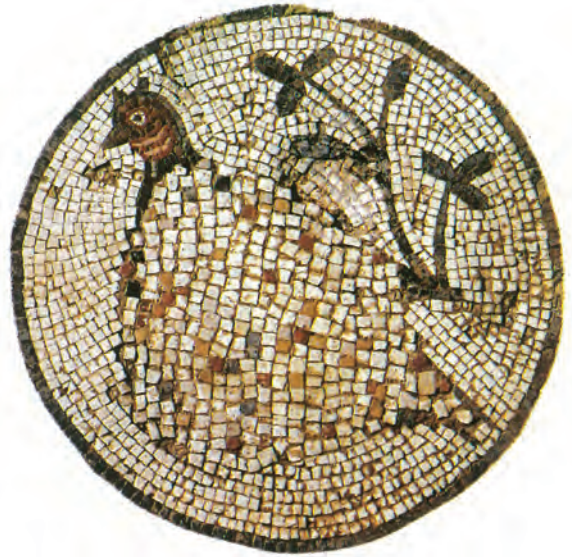
**Reintegration with tesserae:** An area of the pavement where a tessellatum lacuna has been filled with original tesserae which have been reused, or with new tesserae.

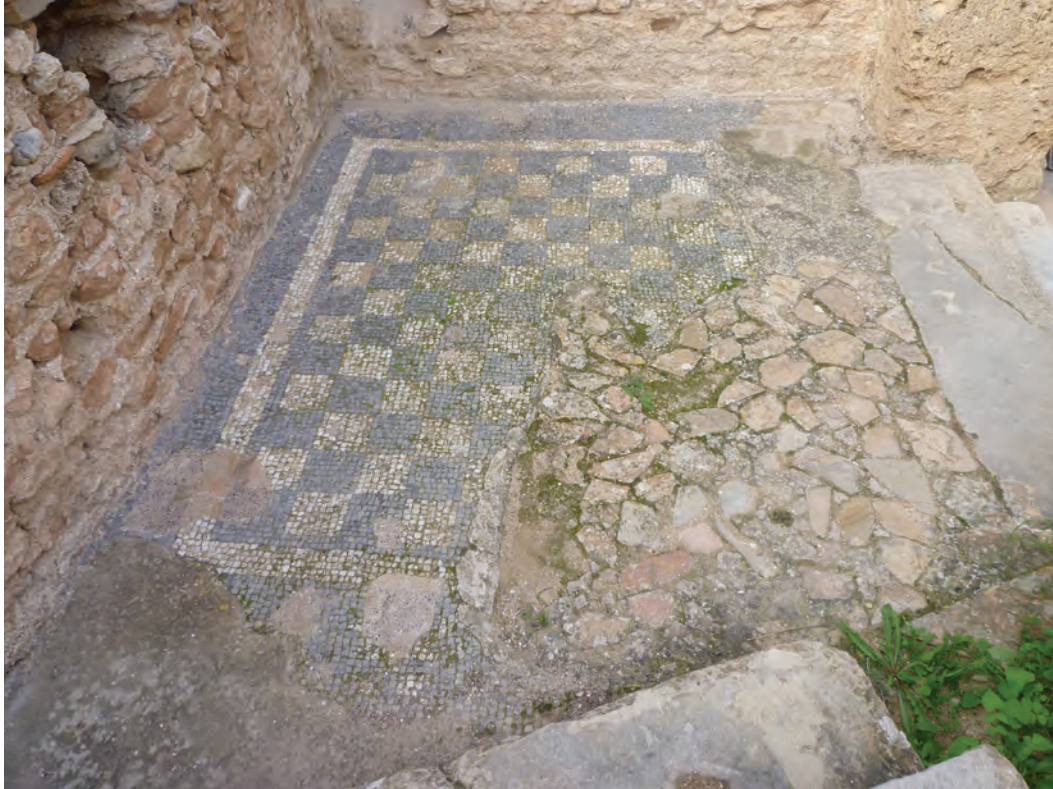
**Reintegration with pieces of stone, brick or other materials:** An area of pavement where a tessellatum lacuna has been filled with a layer of mortar, on the surface of which are inserted slabs or fragments of stone, ceramic, or brick.

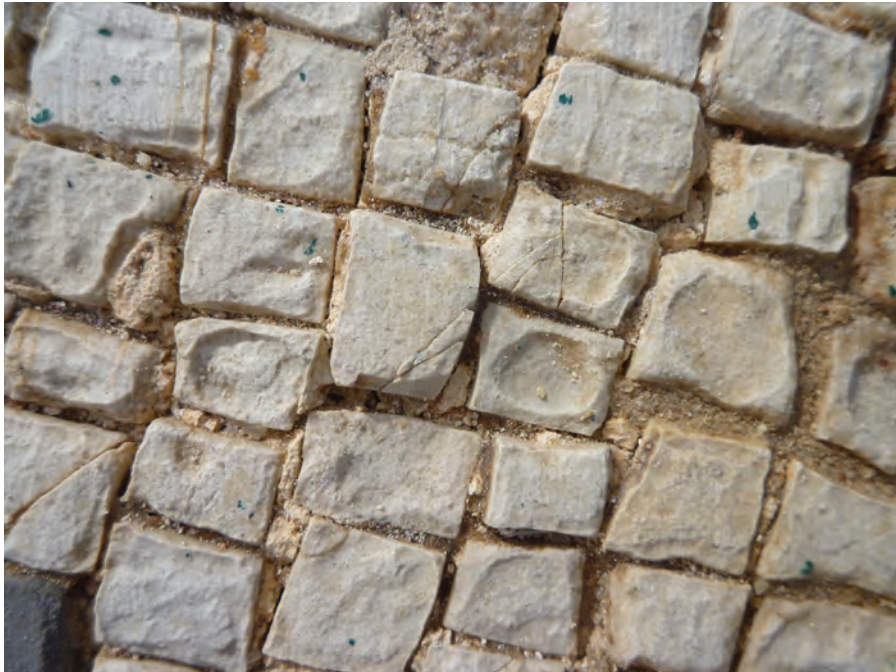
**Chemical cleaning:** Visible effects of the application of chemicals used to clean the tessellatum, such as whitening, pitting, etc.

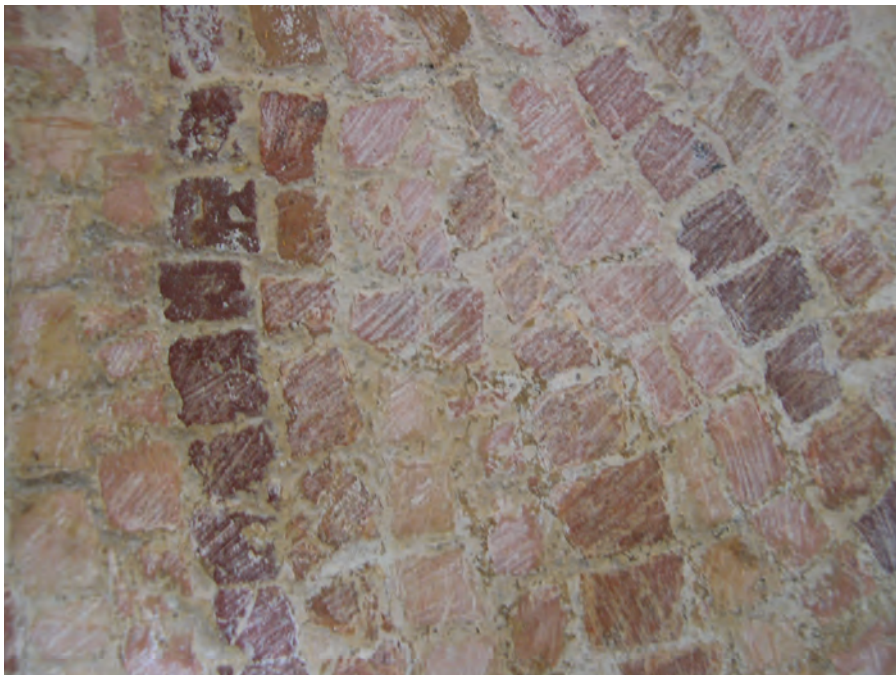
**Mechanical abrasion:** Presence of marks left by abrasive tools or materials used to make the surface of the tessellatum flat and smooth again.

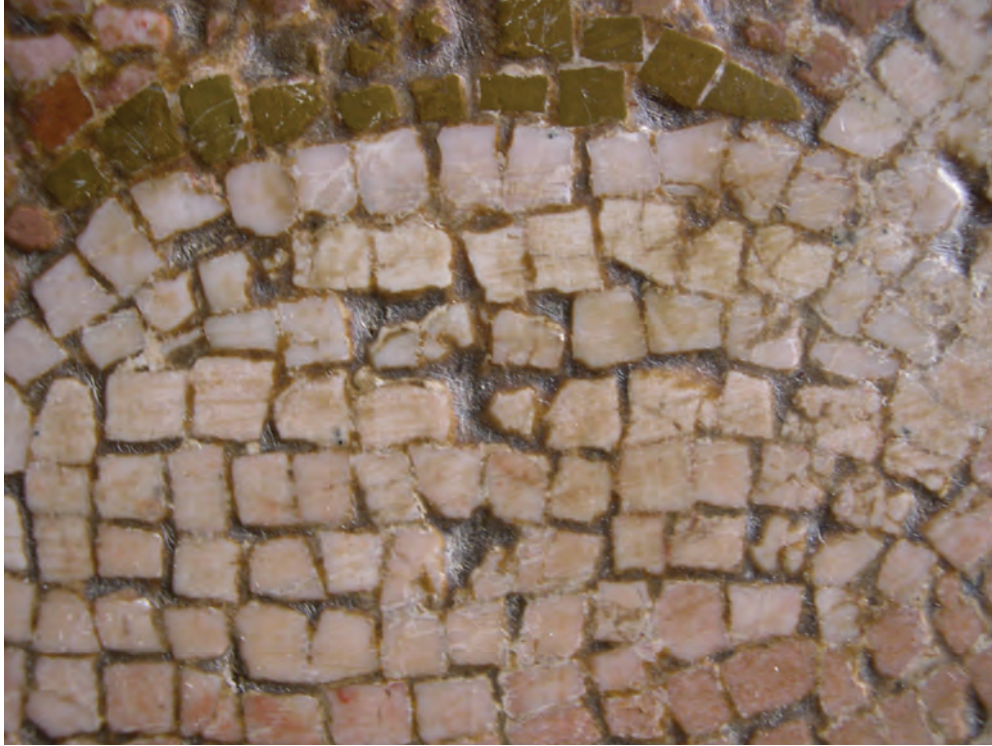
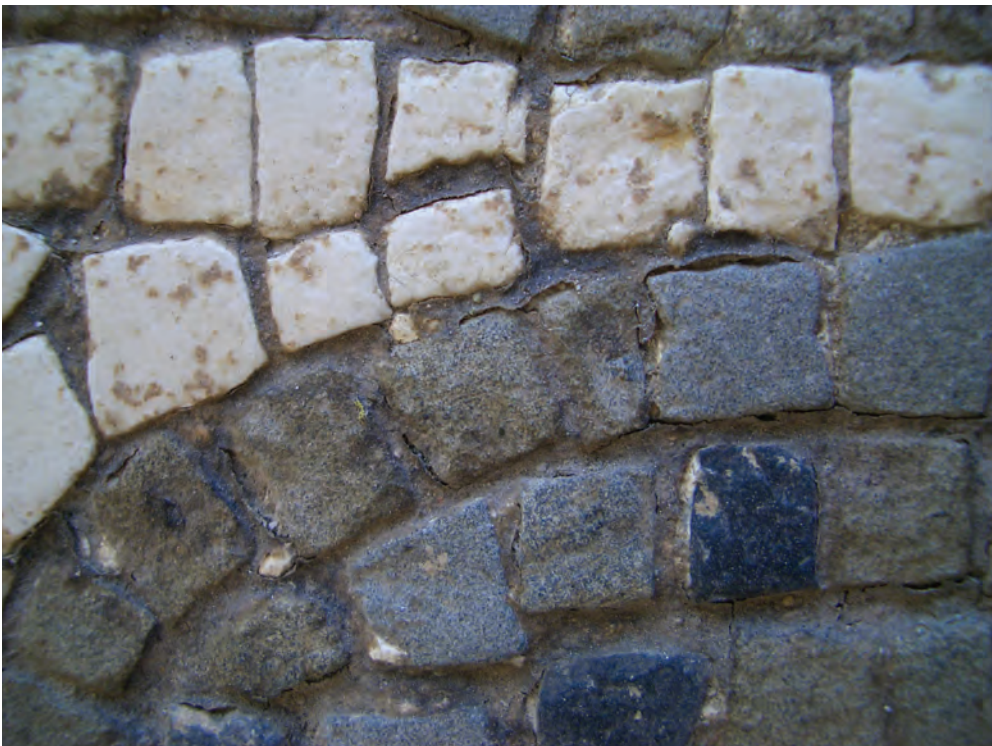
**Application of a surface product:** Presence on the surface of the tessellatum of natural or synthetic products, such as wax or resin, applied to protect the surface and/or enhance the colors of the tessellatum.

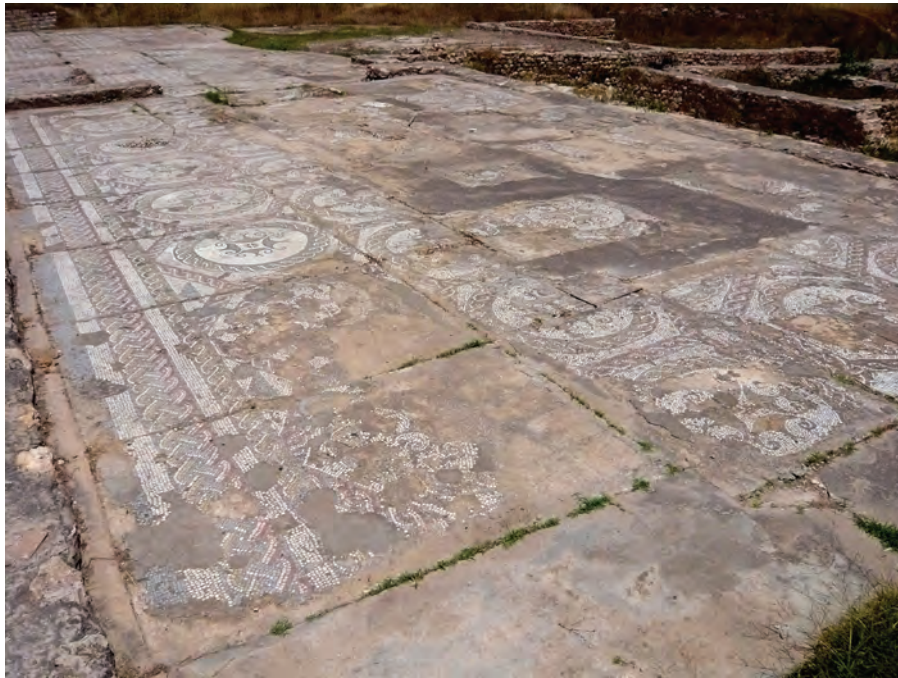
**Reinforced concrete support:** The part of the mosaic which was detached from its preparatory layers, in sections or in one piece, and then re-laid on a new backing made of cement-based mortar reinforced with steel bars, generally laid out as a grid.

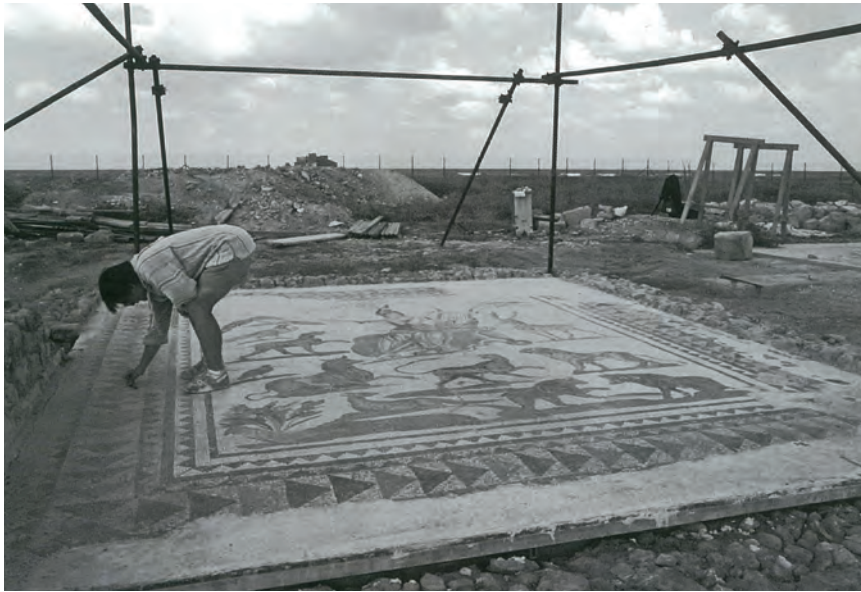
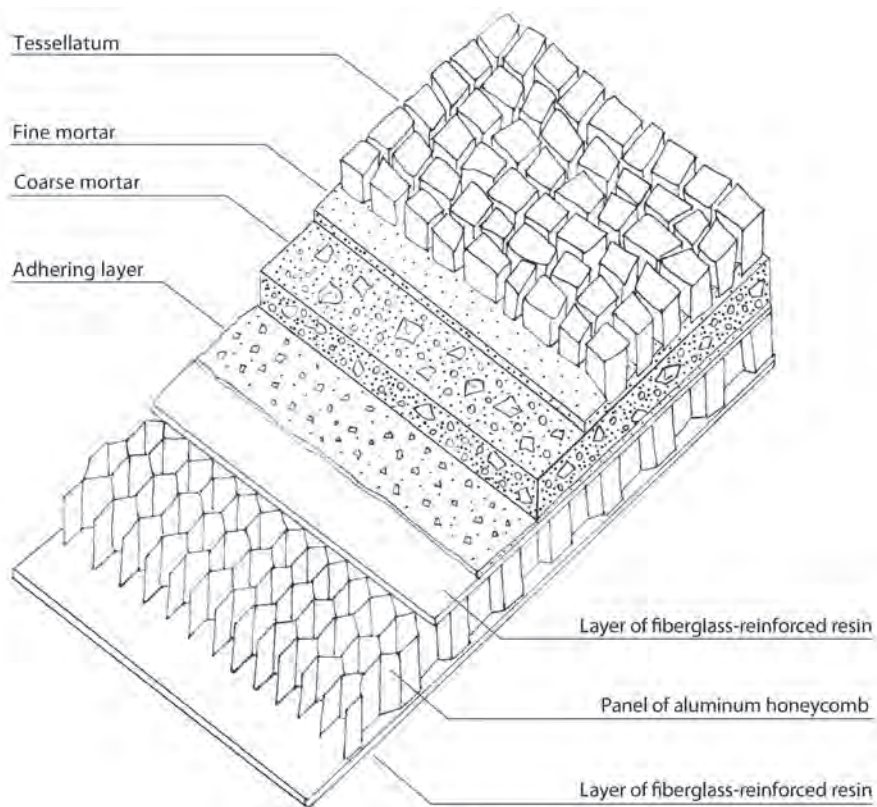
**Modern synthetic materials support:** The part of the mosaic which was detached from its preparatory layers, in sections or in one piece, and then re-laid in situ on a new backing made of synthetic materials. A common support is made from an aluminum honeycomb panel sandwiched between two layers of resin reinforced with fiberglass.
