# Illustrated Glossary

## Technician Training for the Maintenance of In Situ Mosaics

The Getty Conservation Institute

Institut National du Patrimoine

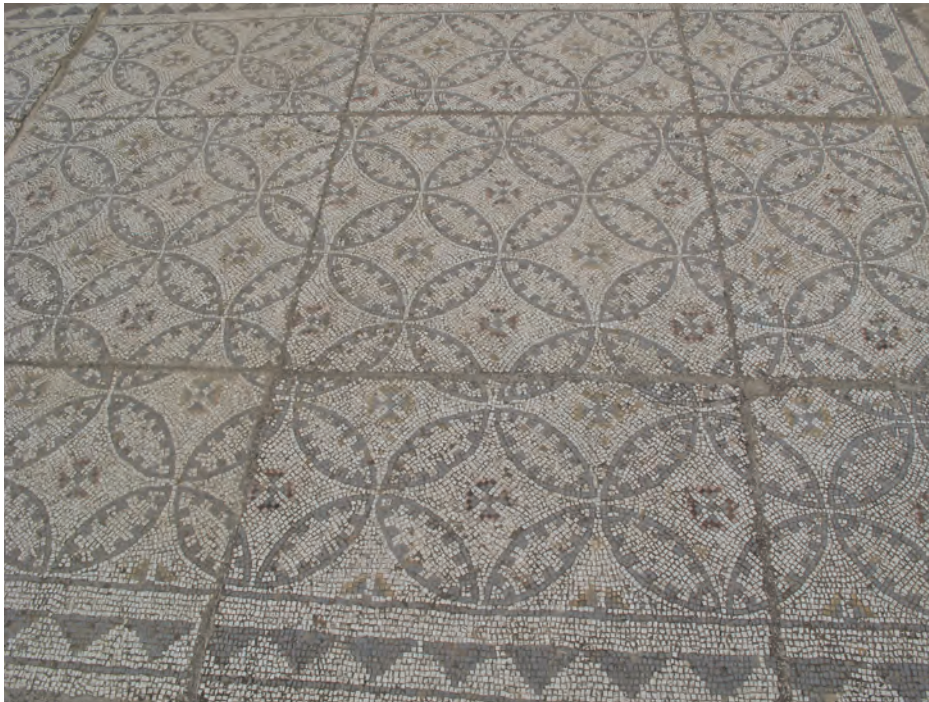
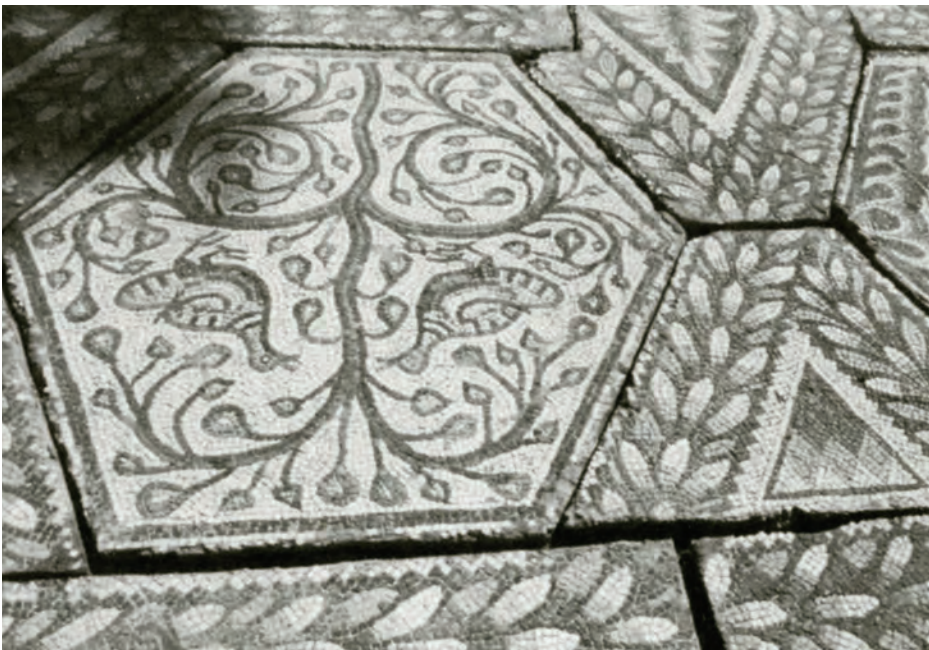
The outer edges of each section of a mosaic that has been cut, lifted, re-laid on a modern support and replaced in situ.

The cutting lines may follow the mosaic's decorative design (bottom photo), or they may not (top photo). The joints between the panels are generally filled with materials such as mortar (top photo) or tesserae to restore the continuity of the mosaic surface.

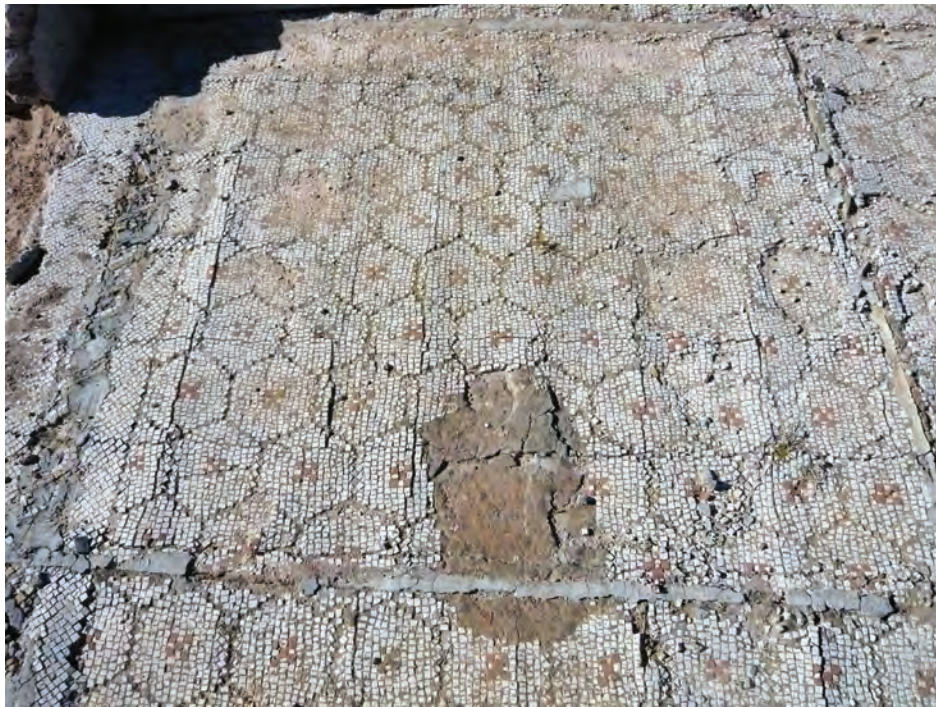
## **PRESUMED LOCATION OF THE METAL REINFORCEMENTS OF THE SUPPORT PANELS**

Probable location of the steel bars which structurally reinforce the support panels of a re-laid mosaic. The bars, positioned within the concrete panels, are not necessarily visible, but their presence may be suspected, for example, due to a surface deformation. In the bottom photo, the position of the steel bars is indicated with red lines.

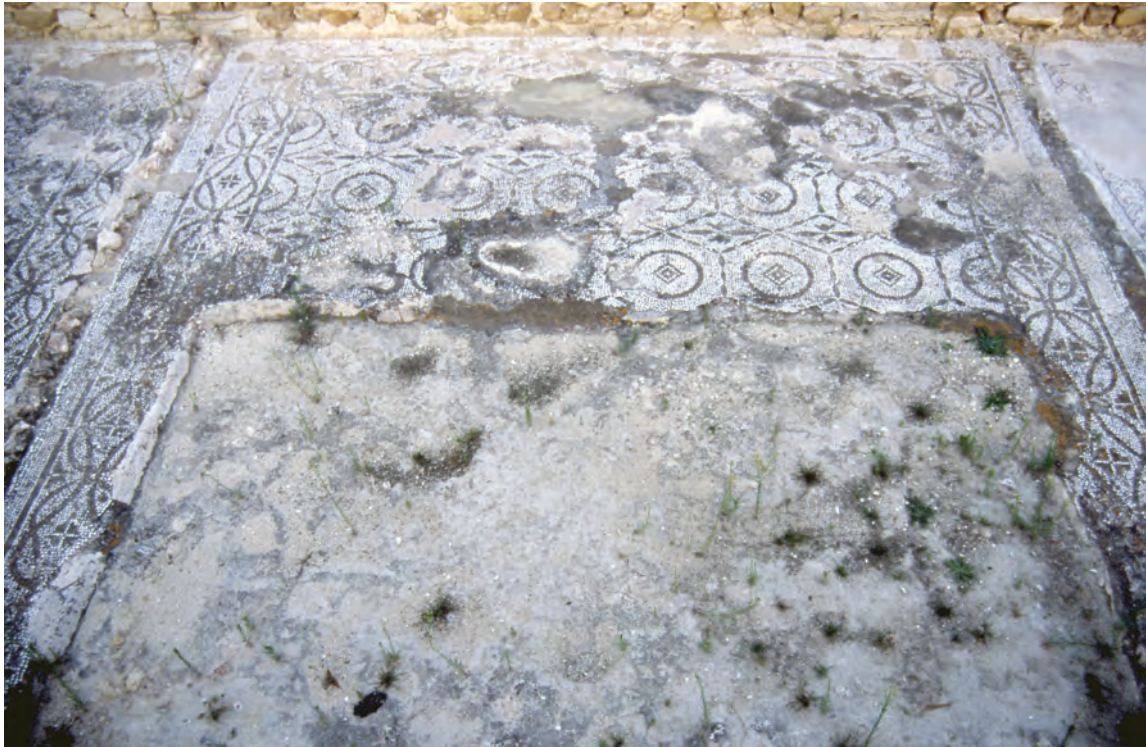
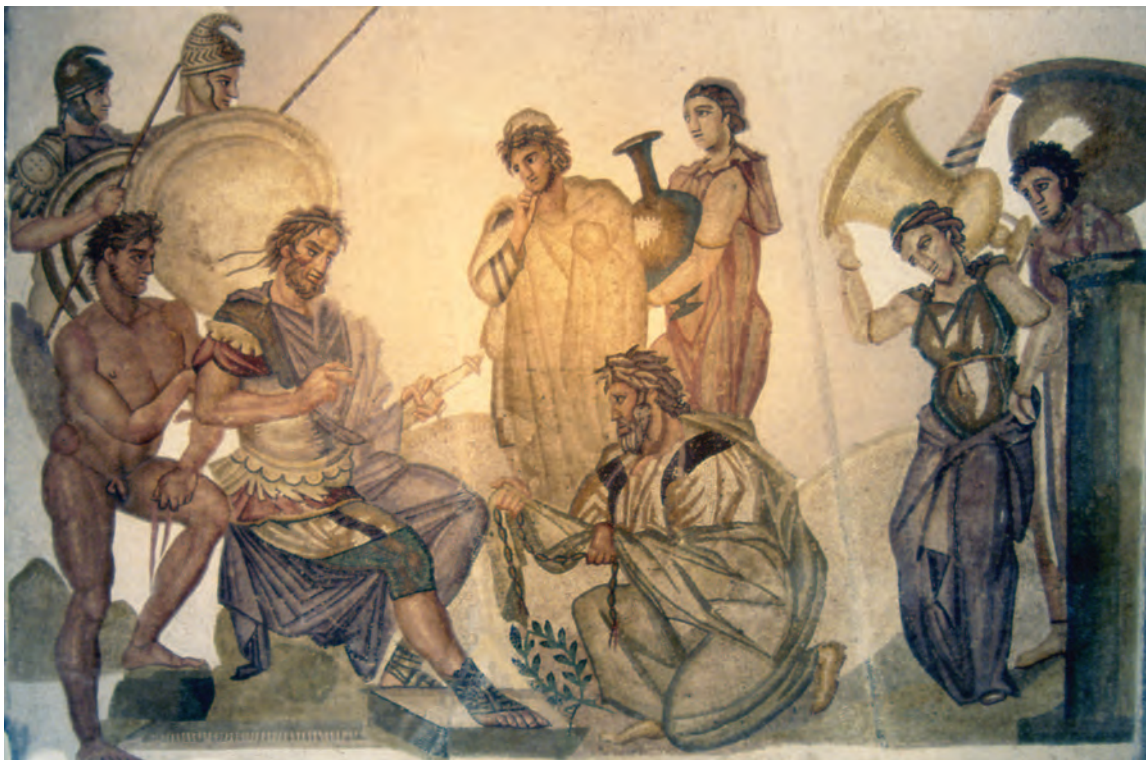
The section of the mosaic surface that has been detached from the rest of the mosaic and removed from its place of origin (top photo) to be kept in a museum (bottom photo), or in storage.

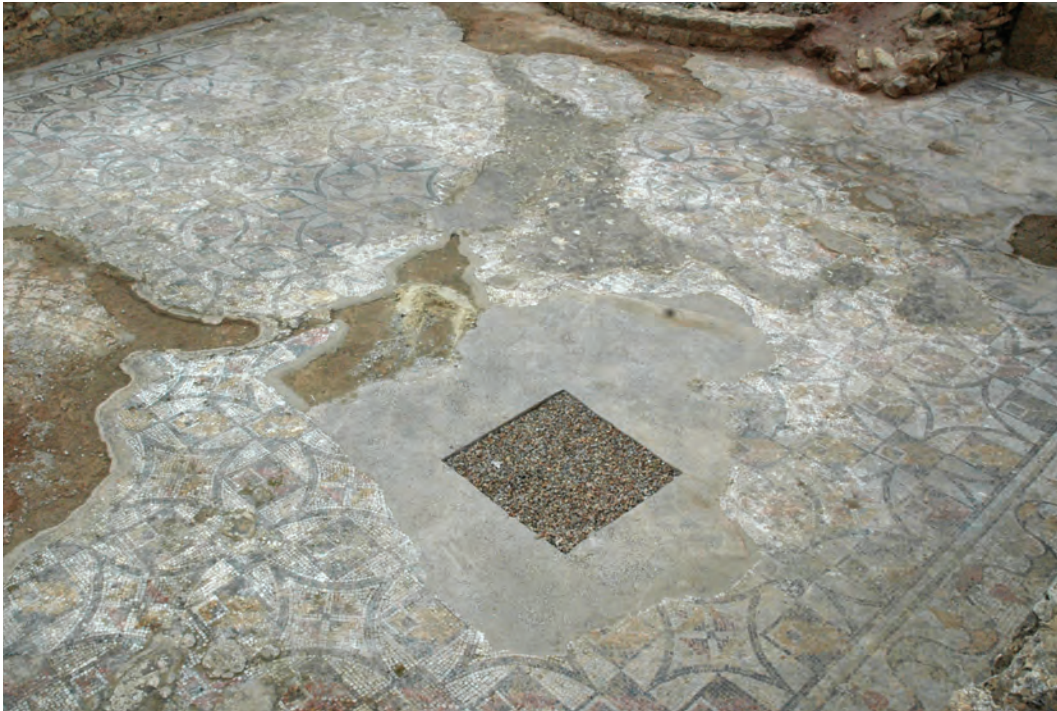
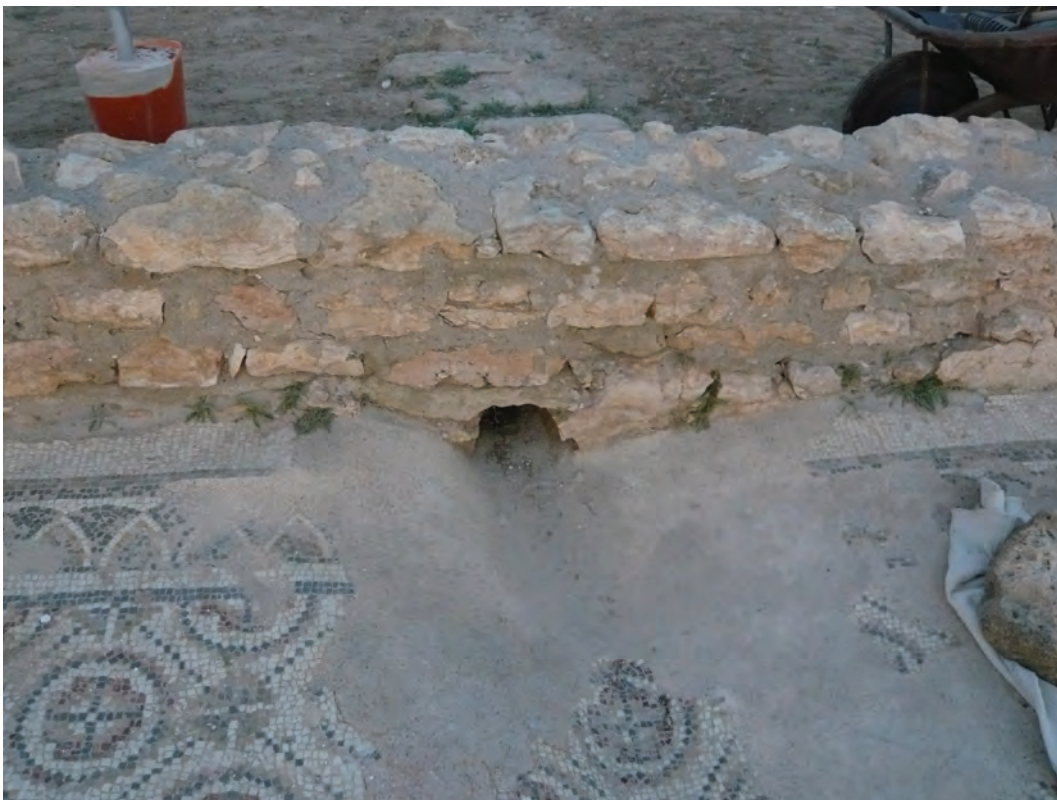
System created to drain water away from the surface of the mosaic, such as a drainage pit (top photo), or channel or an opening in a wall adjacent to the mosaic (bottom photo).

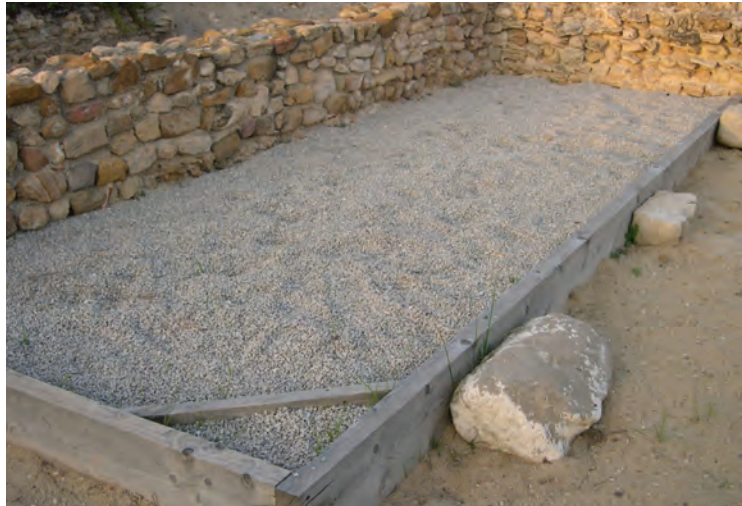
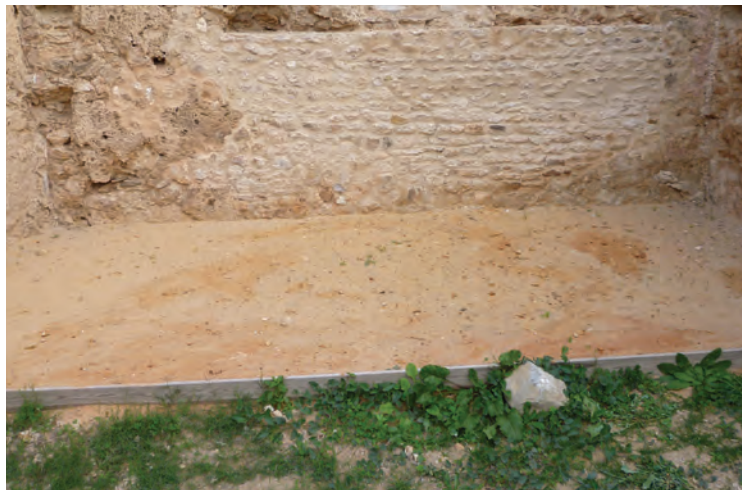
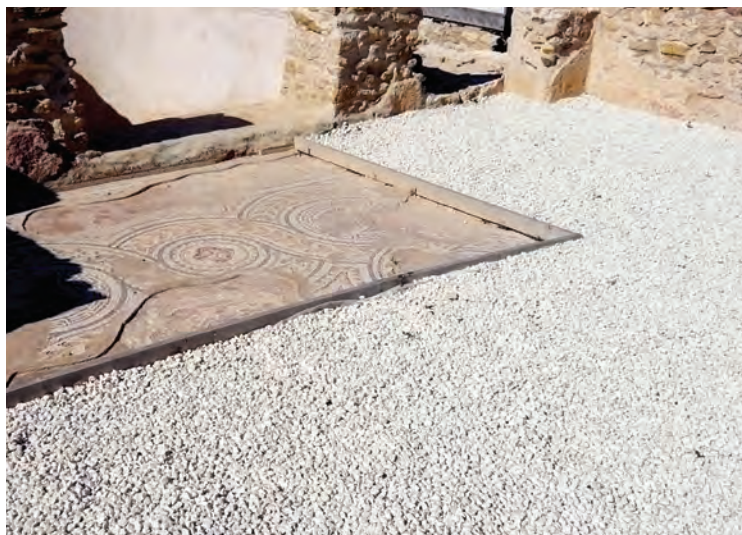
The part of the mosaic which has been re-covered by using fill materials such as sand (middle photo) and gravel (top and bottom photos) to protect it.

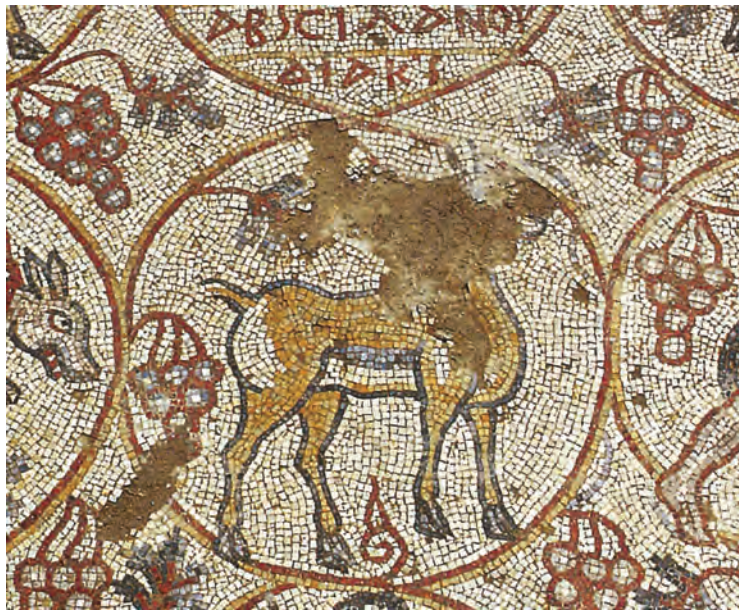
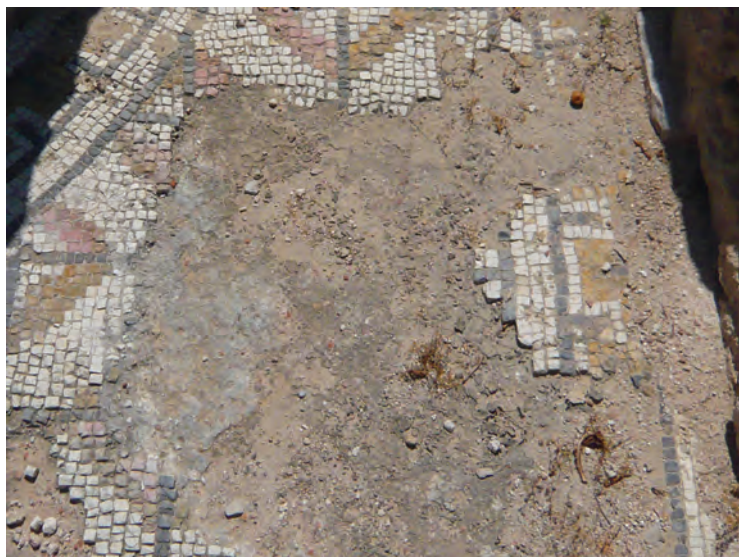
An area of a mosaic where the tessellatum is missing.

Different levels of lacunae in a mosaic

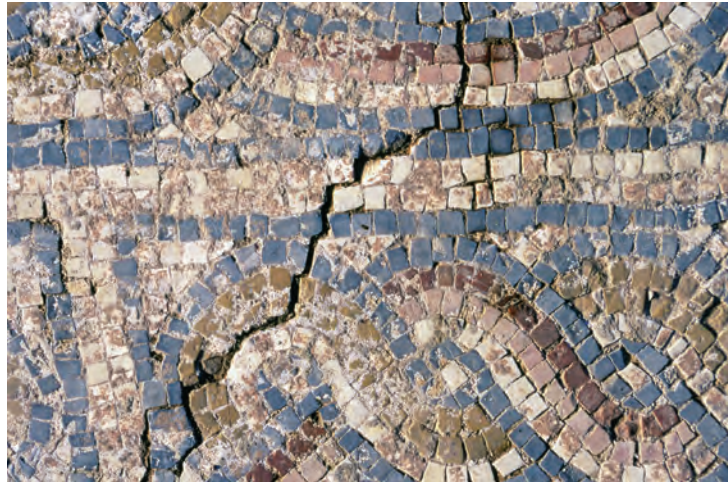
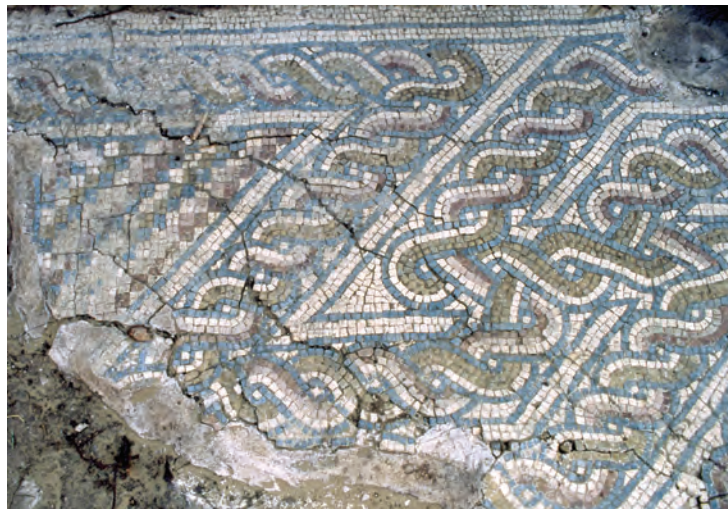
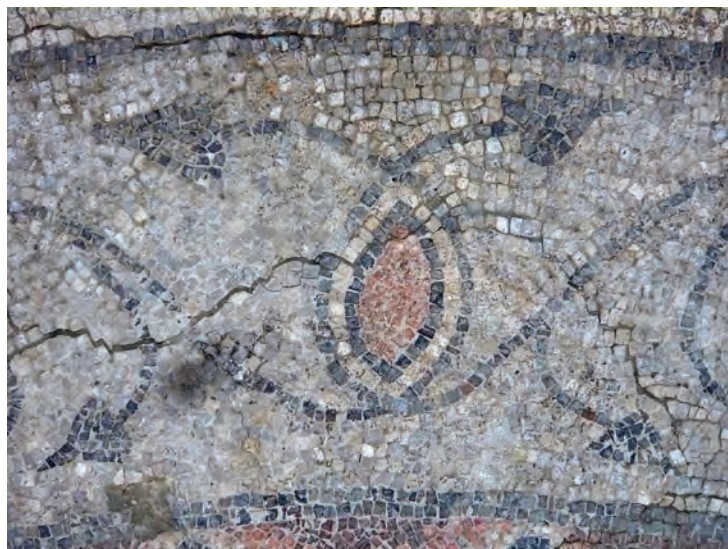
A linear break that is visible on the surface of the mosaic and may also penetrate into its lower layers.

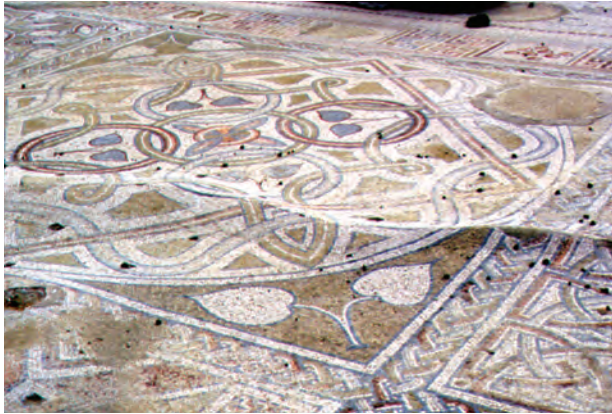
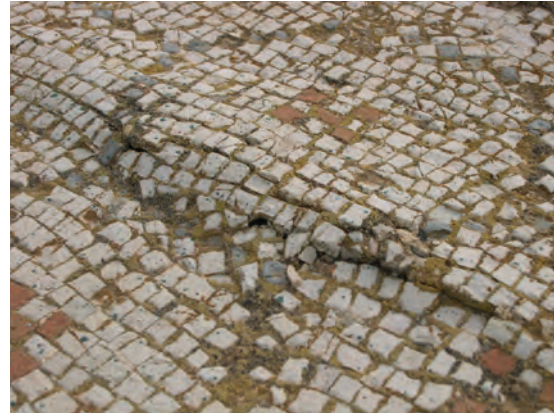
## BULGE

An upward deformation of the mosaic above its original surface level.

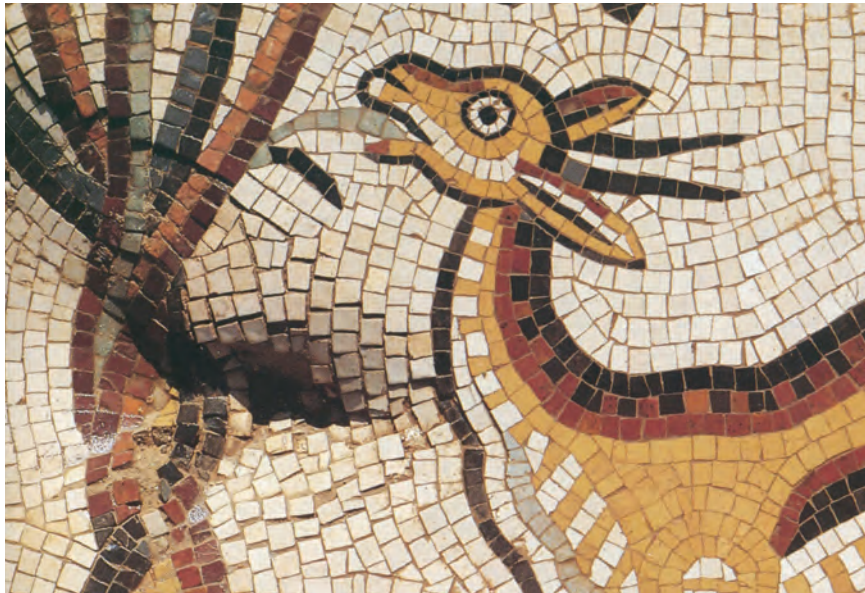
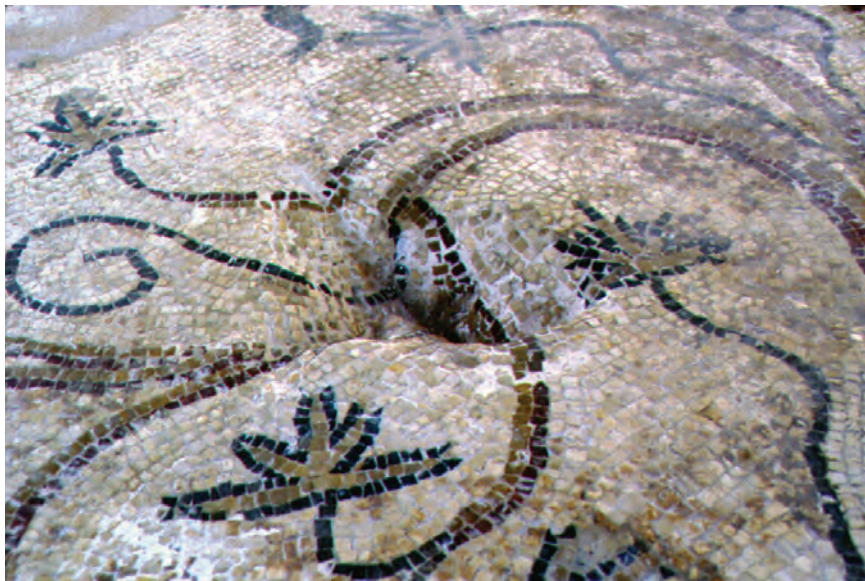
## DEPRESSION

A downward deformation of the mosaic below its original surface level.

Depression

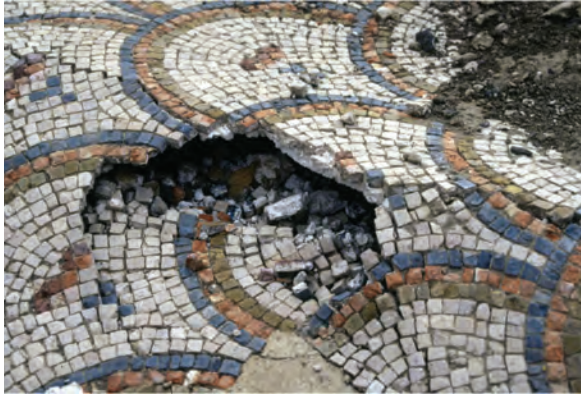
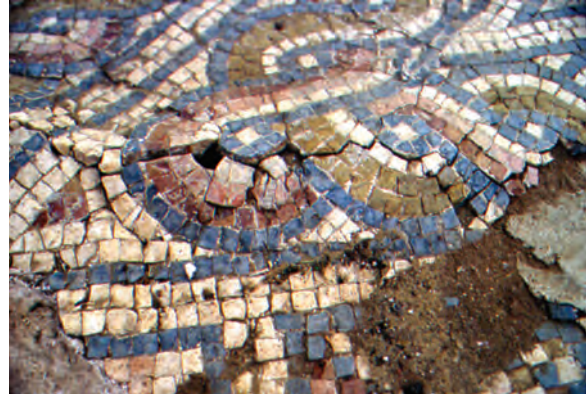
## DETACHMENT BETWEEN MOSAIC LAYERS

Separation or void between two layers of the mosaic. A detachment is generally not visible and can be detected by the corresponding hollow sound produced when the surface of the mosaic is tapped.

Detachment with bulging

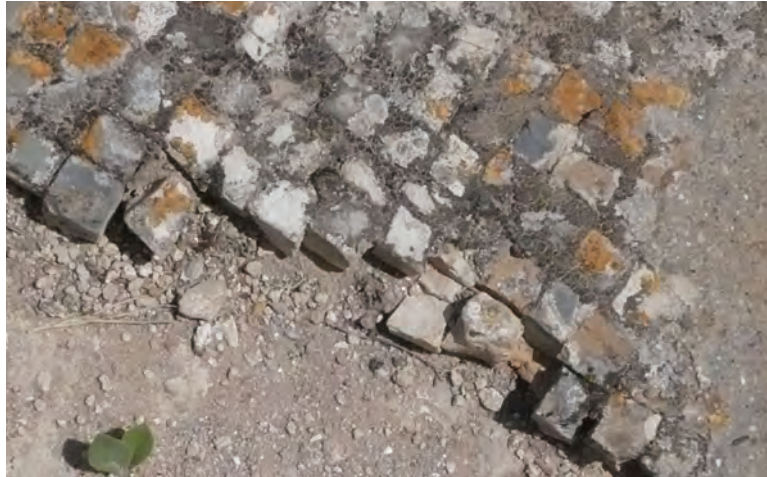
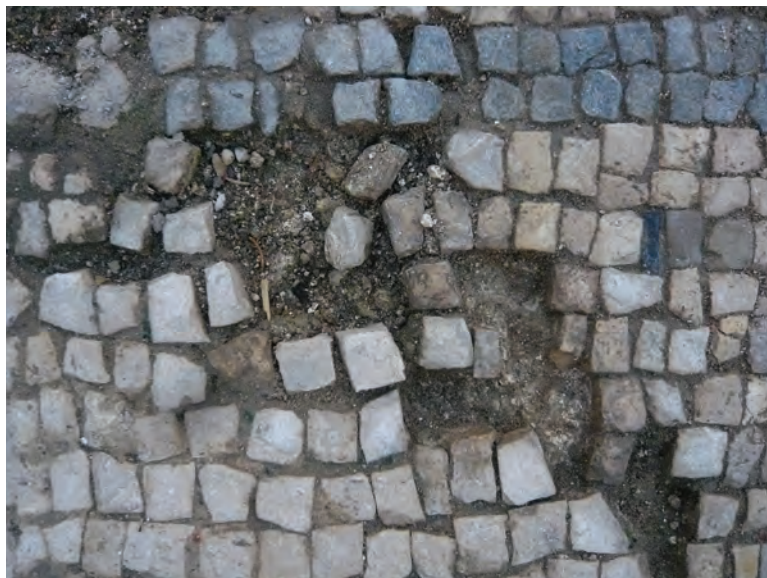
A tessera which is still in its original location, but which is no longer adhered to the bedding layer, and, as a result, moves when lightly touched.

Detached tesserae from the bedding layer and with a change of their original position (middle)

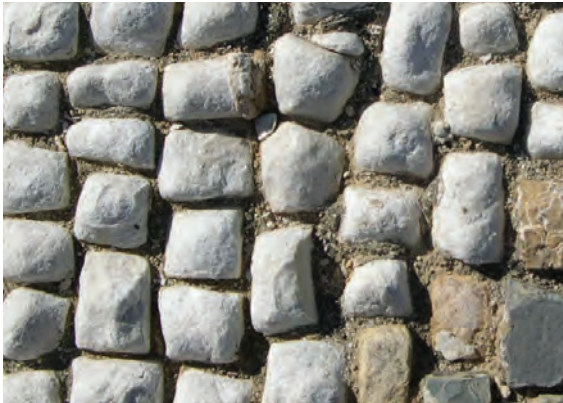
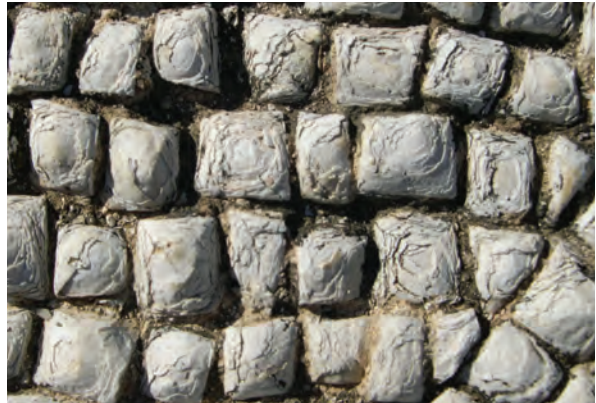
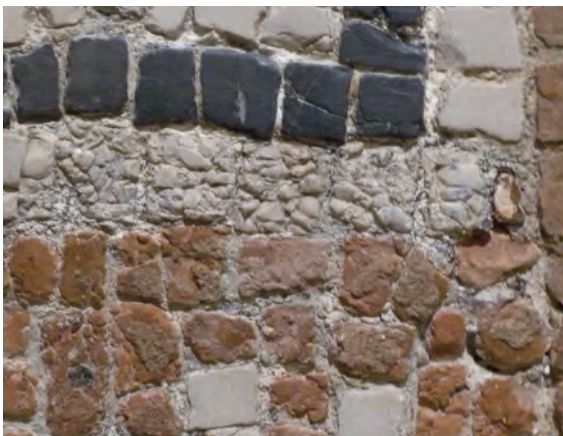
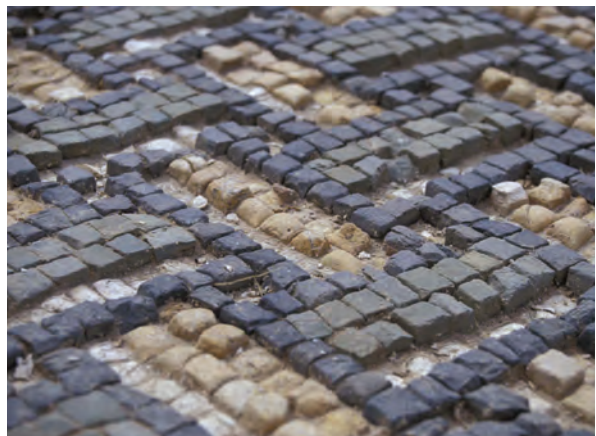
Tessera which is no longer in good condition. A deteriorated tessera can be broken, fractured, eroded, or otherwise damaged.

Disaggregation of tesserae

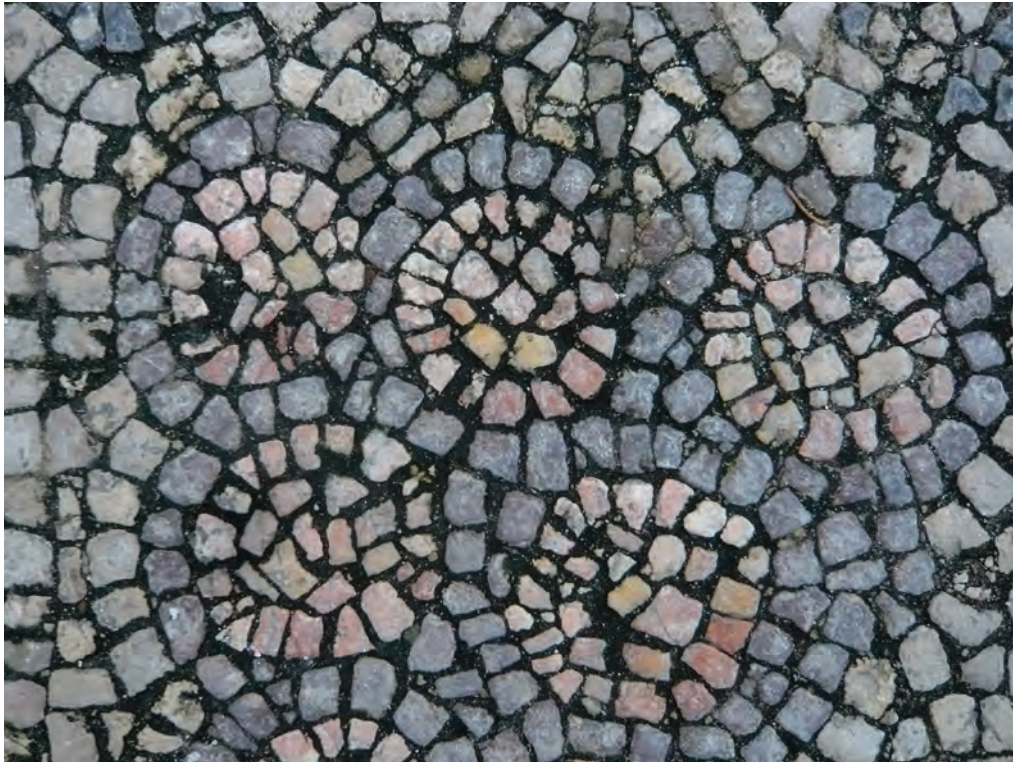
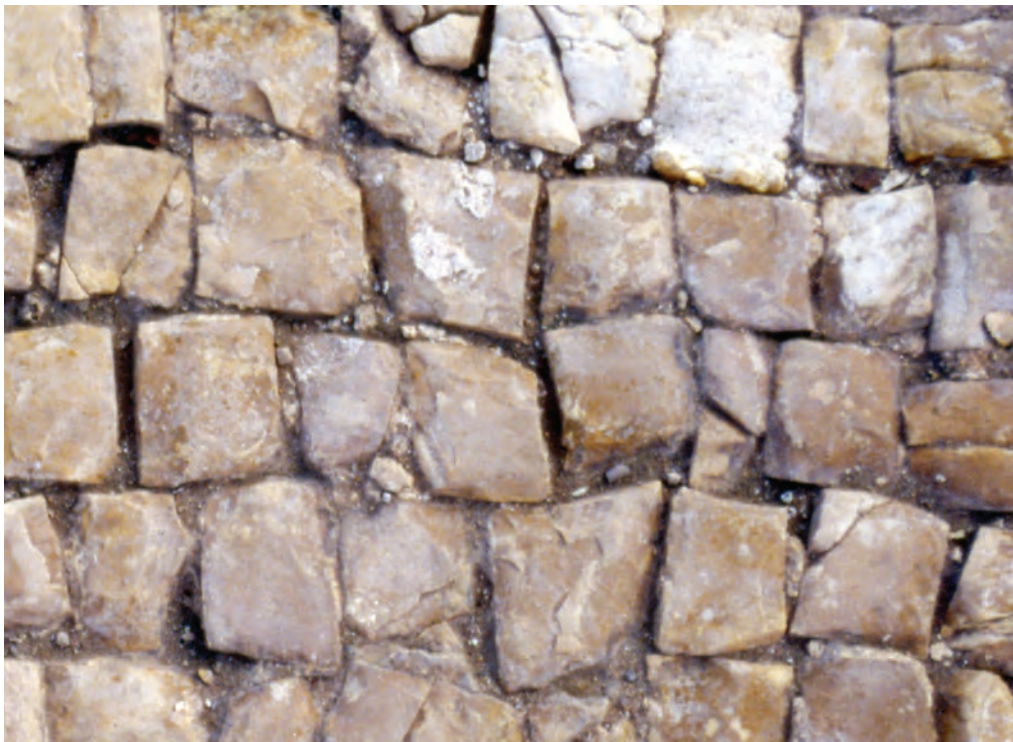
Mortar located in the interstices between the tesserae which is lost or no longer in good condition.

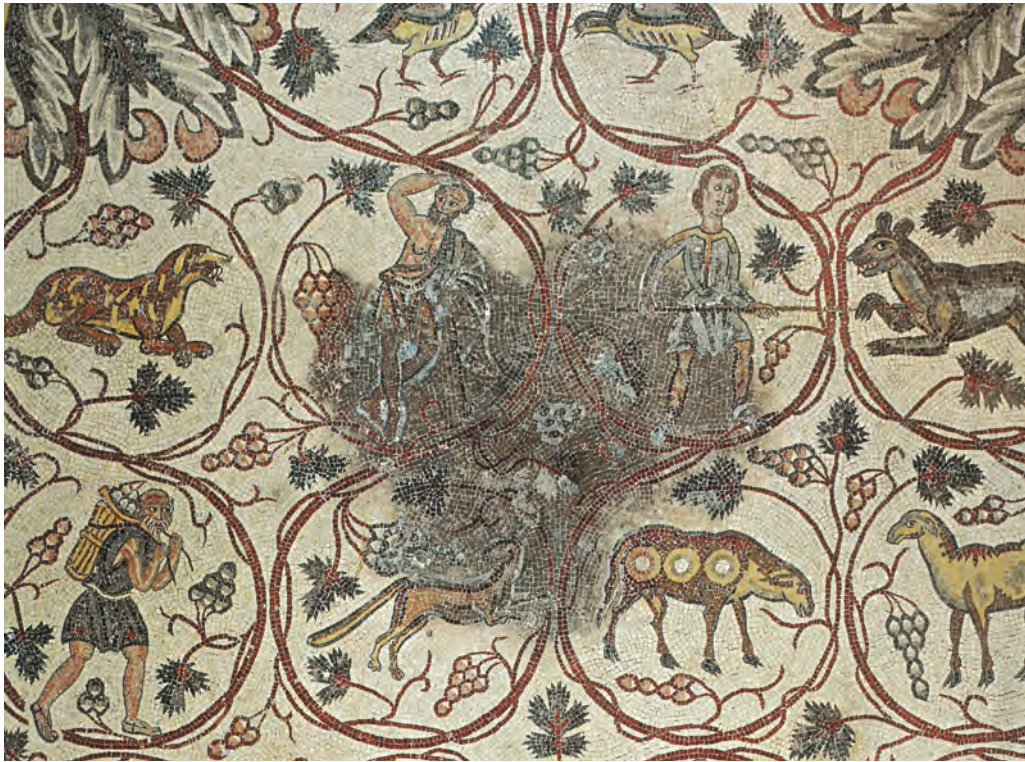
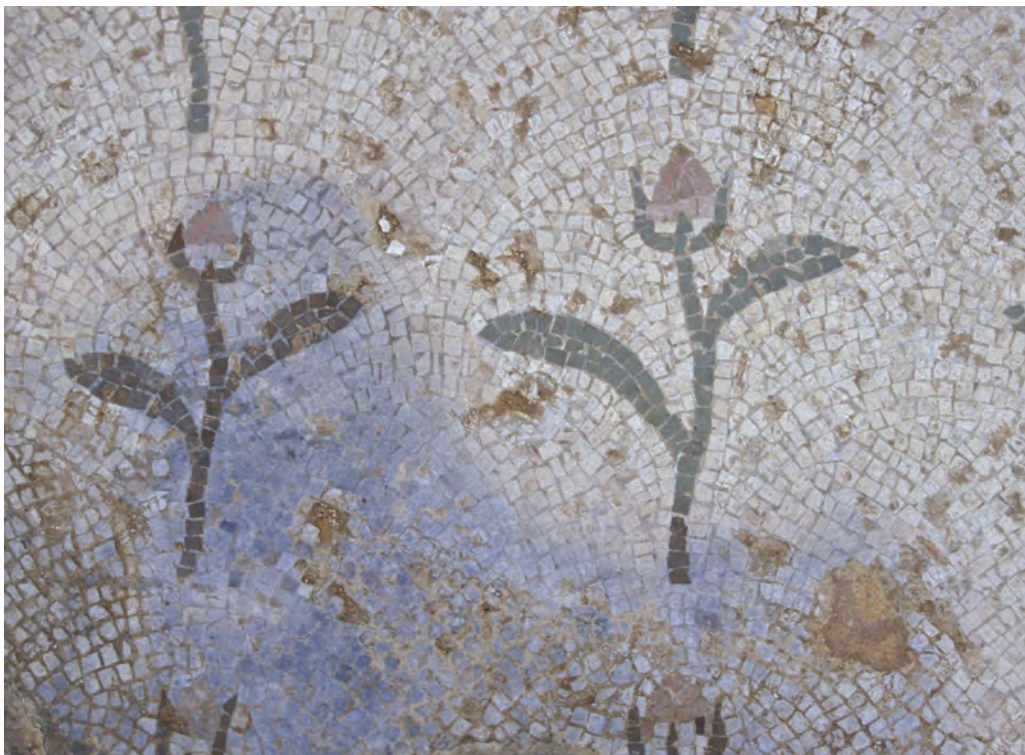
Localized change in color of the mosaic surface.

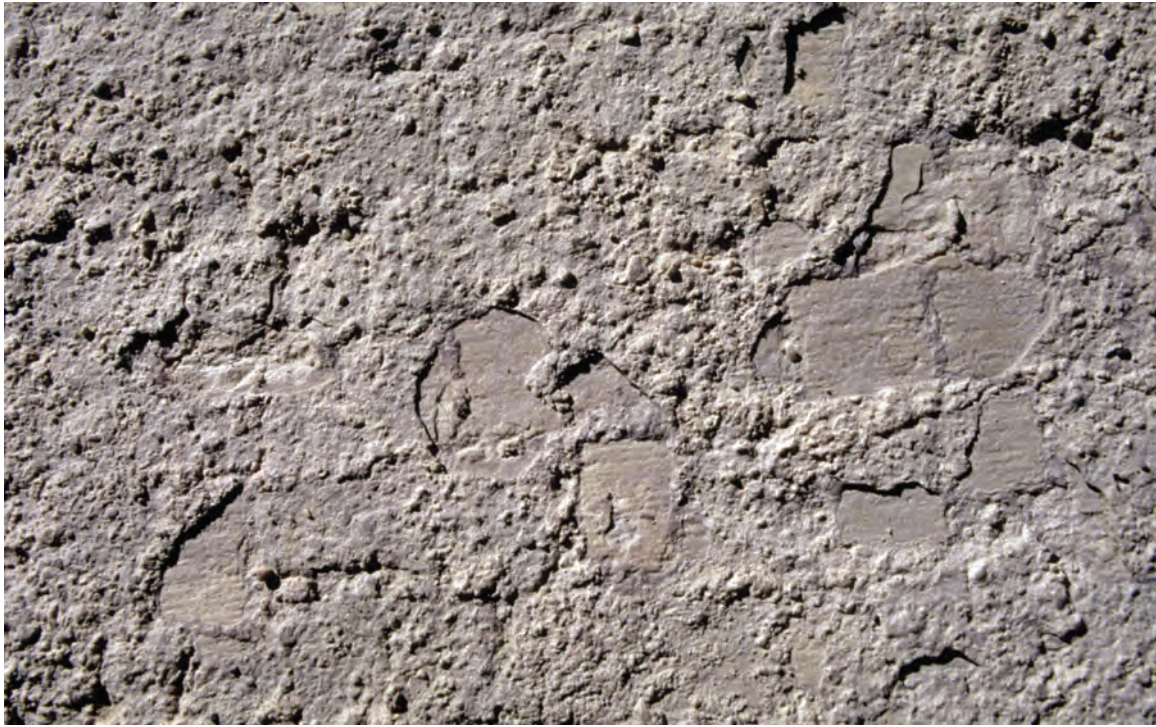
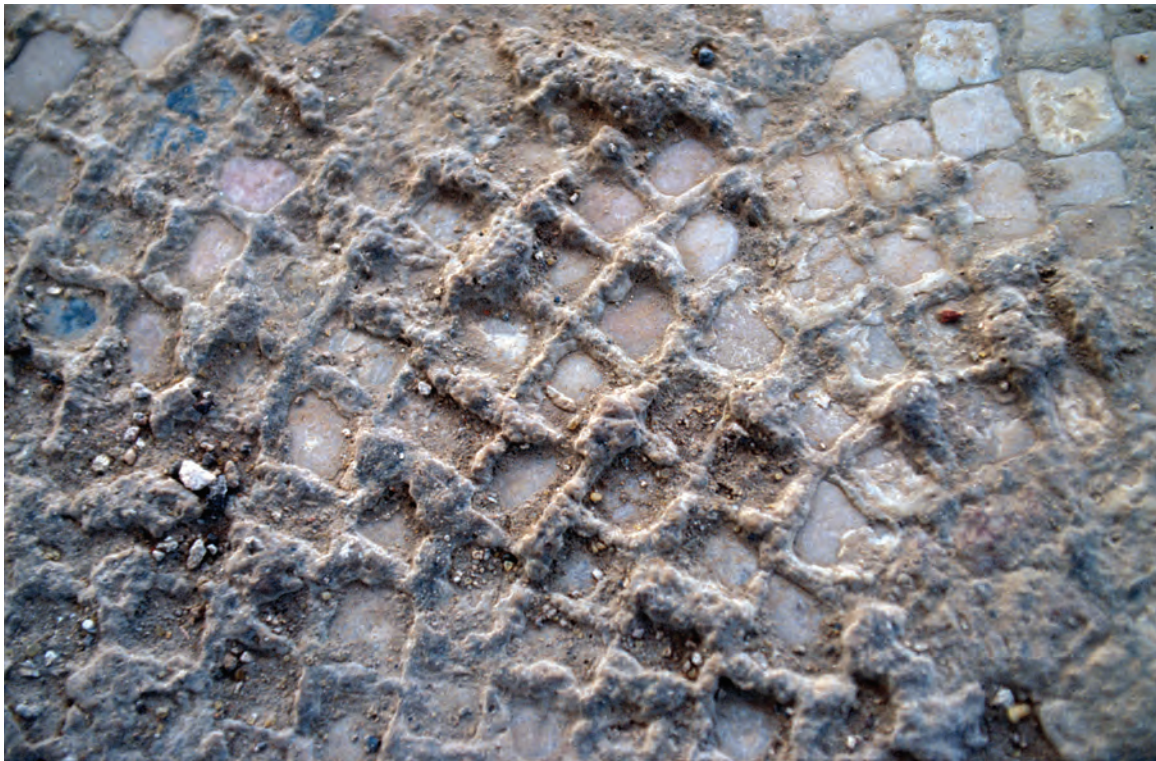
Mineral crust of variable thickness and area, that is often hard and compact, located on the surface of the mosaic.

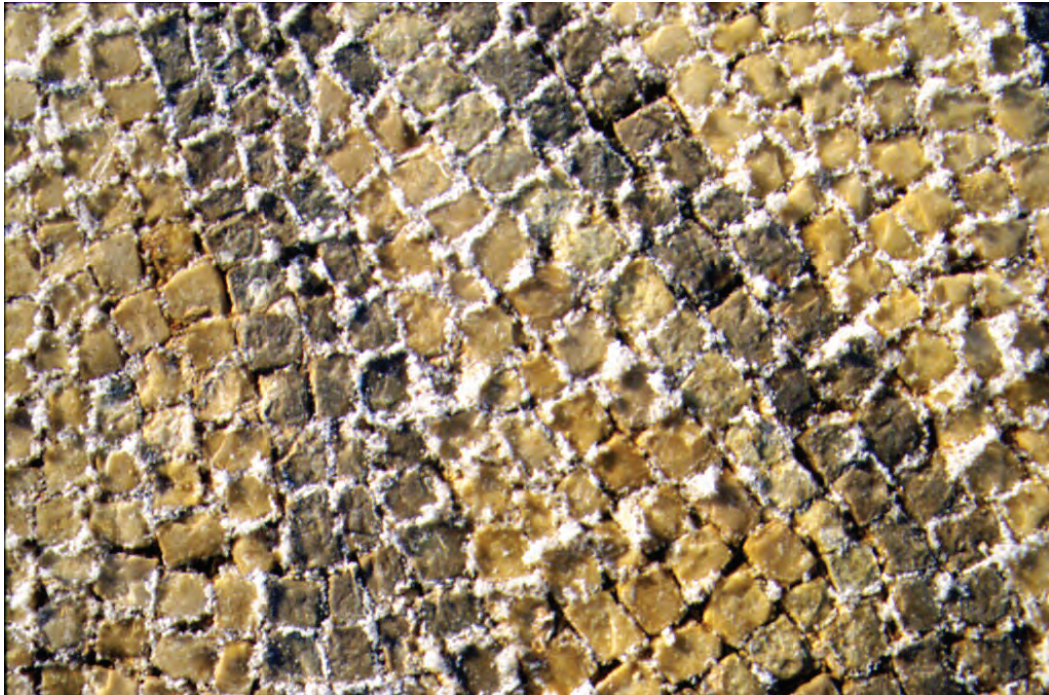
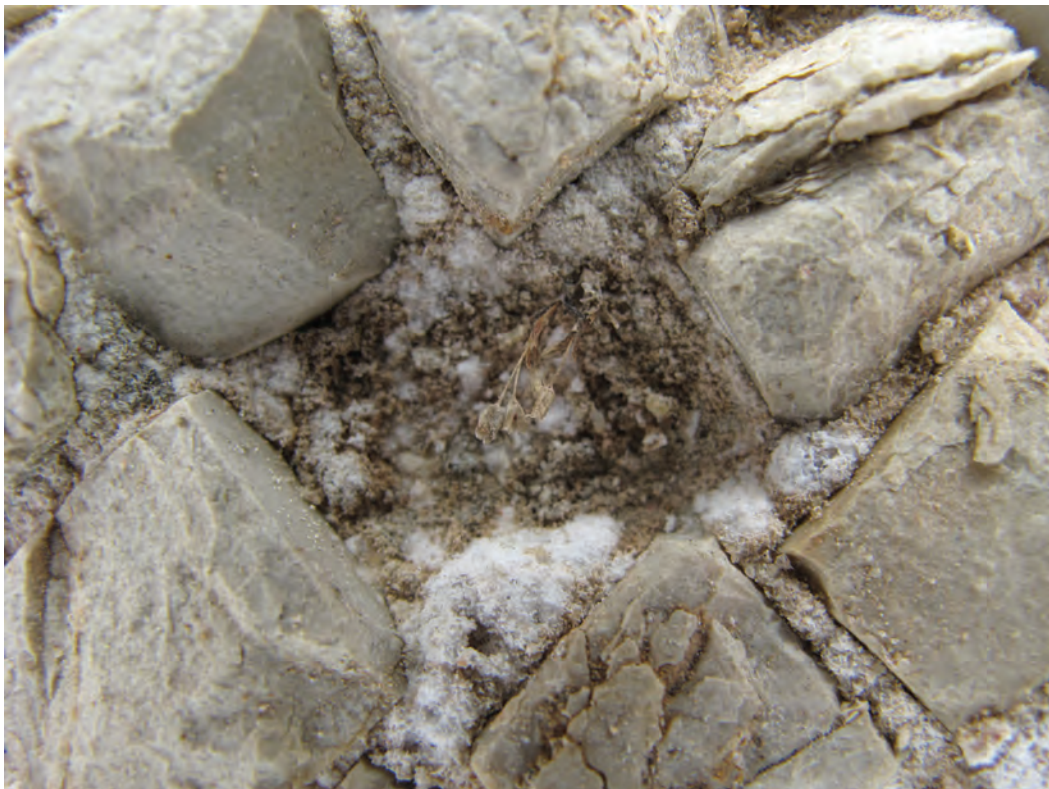
Generally a white and crystalline substance, which adheres loosely to the mosaic surface, and is powder-like or whisker-like in appearance.

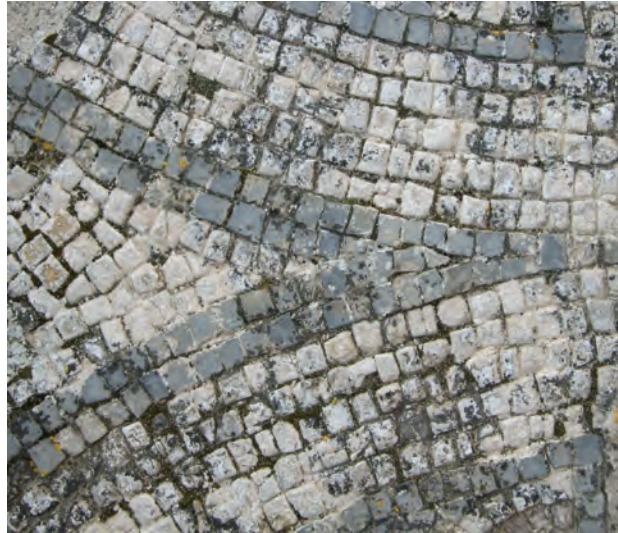
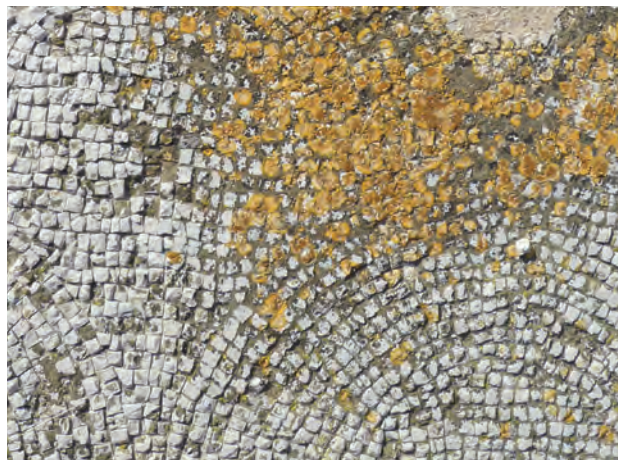
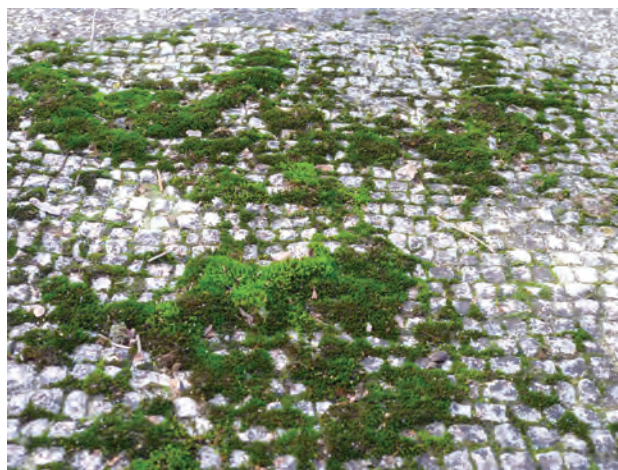
#### MICRO-ORGANISMS

Small organisms varying in color and shape, alive or dead, such as algae (top photo), lichens (middle photo), or mosses (bottom photo) that adhere to the mosaic surface.

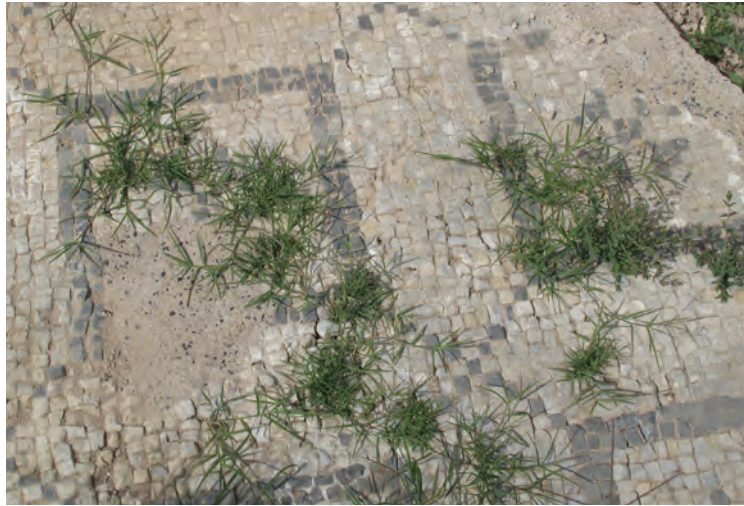
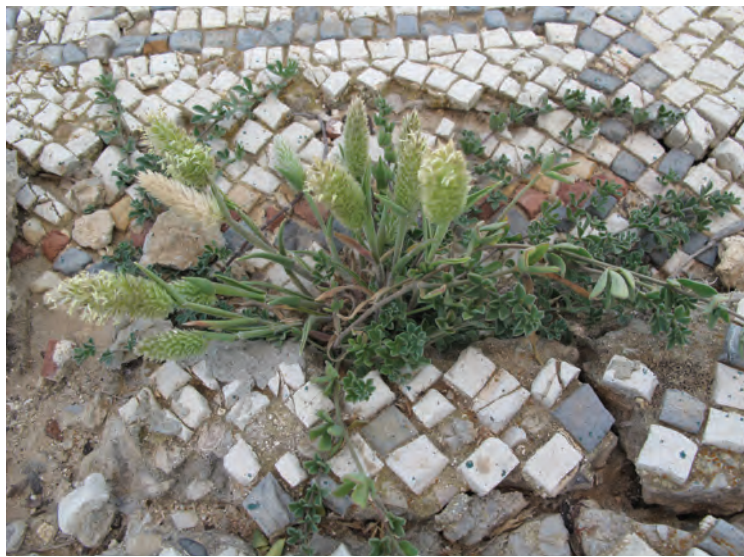
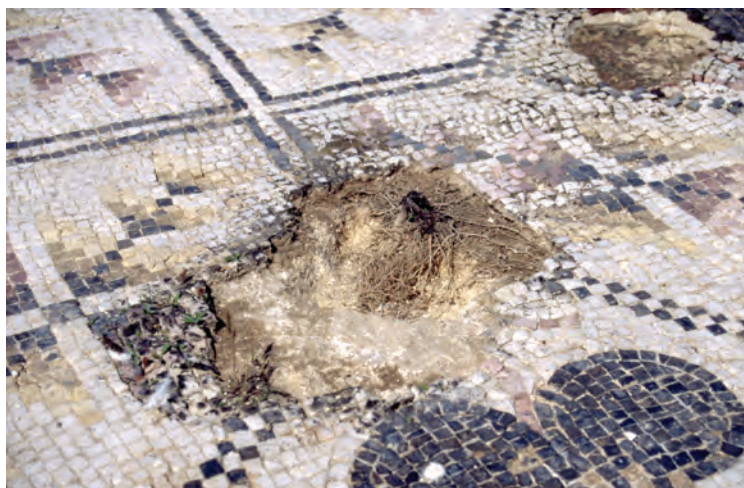
## VEGETATION

Plants such as grasses, weeds, bushes, as well as trees and their associated roots growing under, inside, or on top of the mosaic.

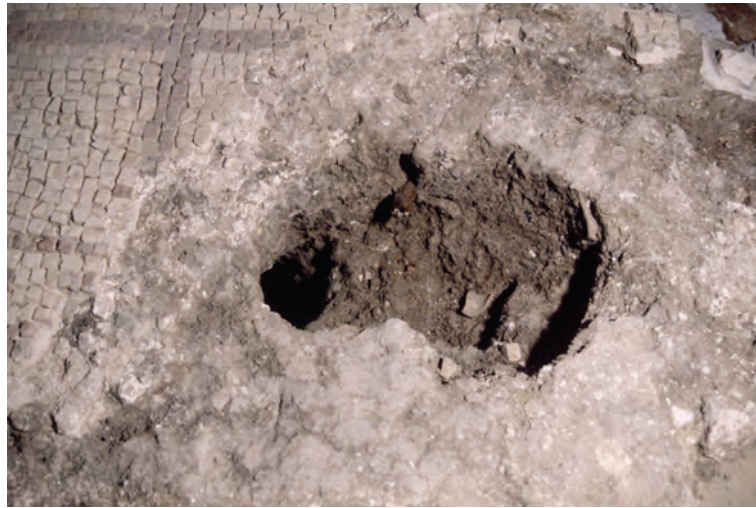
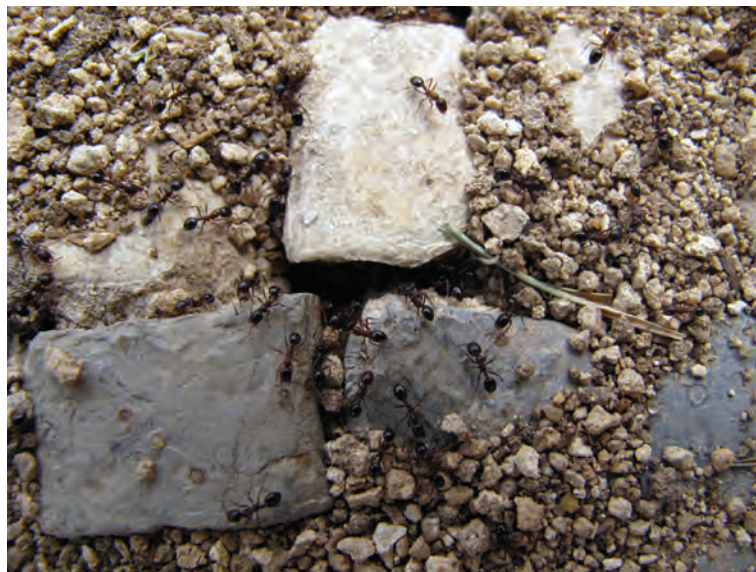
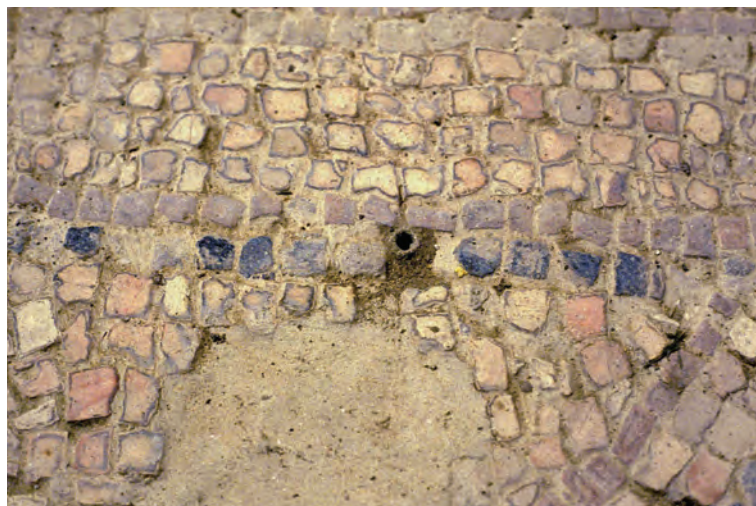
An area of the mosaic where insects or other animals have burrowed.
