# Illustrated Glossary

## Technician Training for the Maintenance of In Situ Mosaics

The Getty Conservation Institute

Institut National du Patrimoine

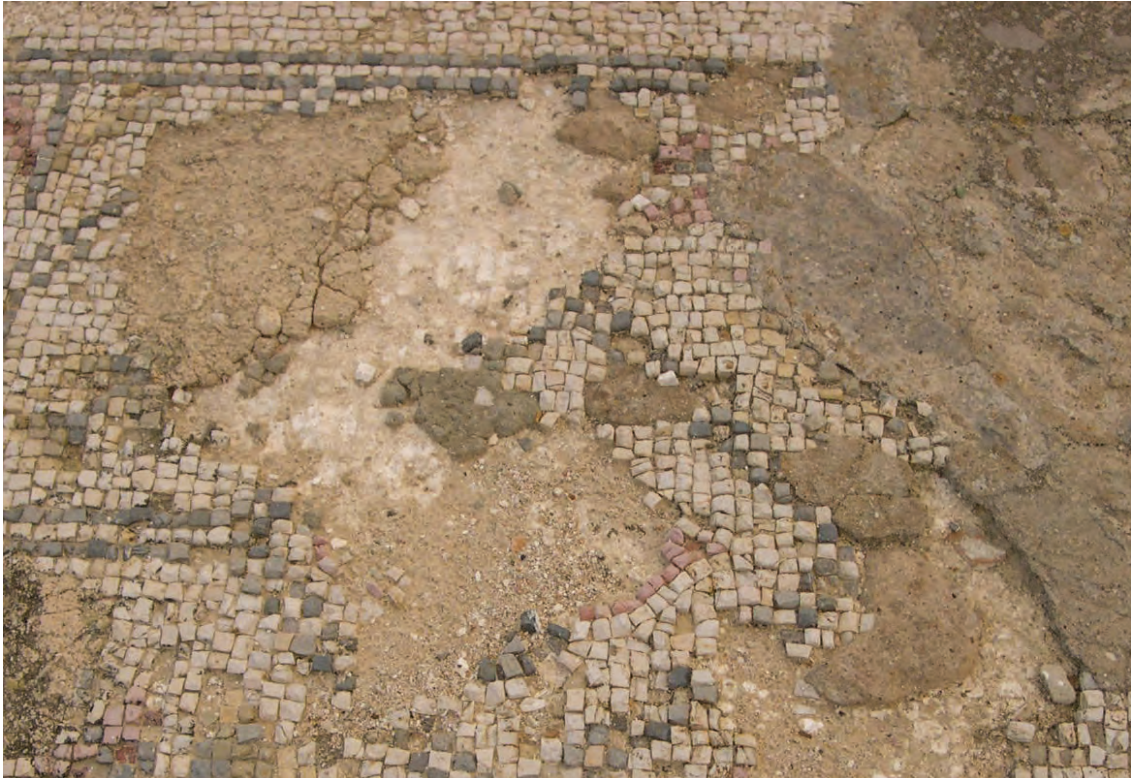
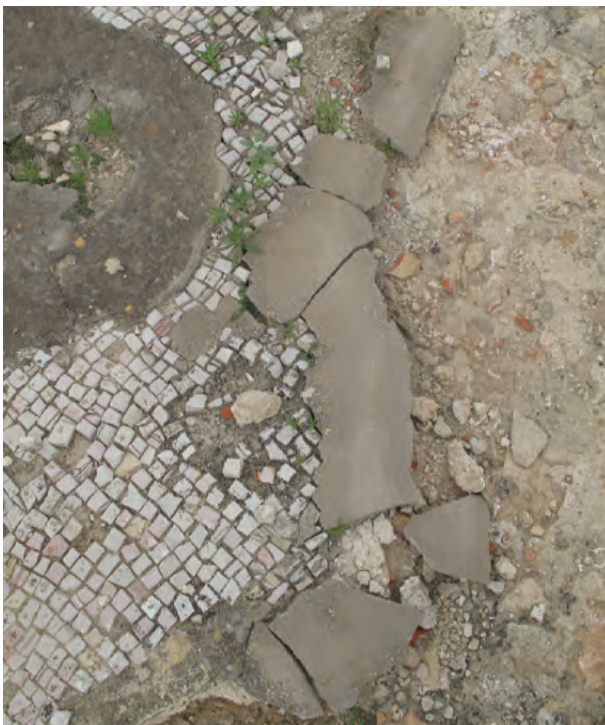
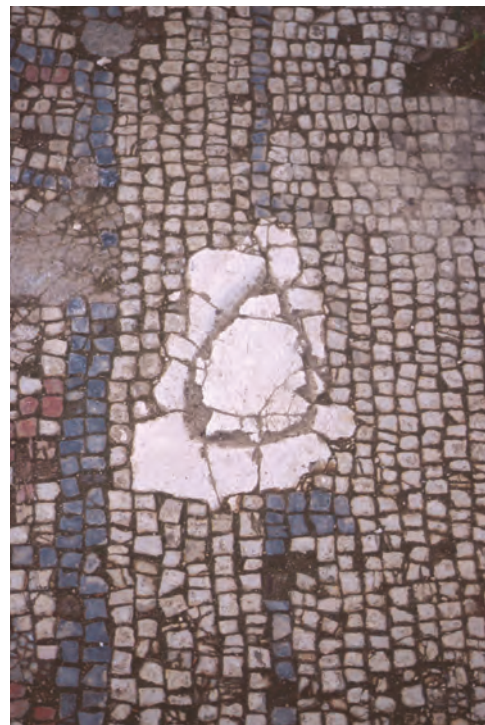
**Lacuna fill or edging repair or mortar fill between tesserae** in poor condition, presenting cracks, erosion or other types of damage.

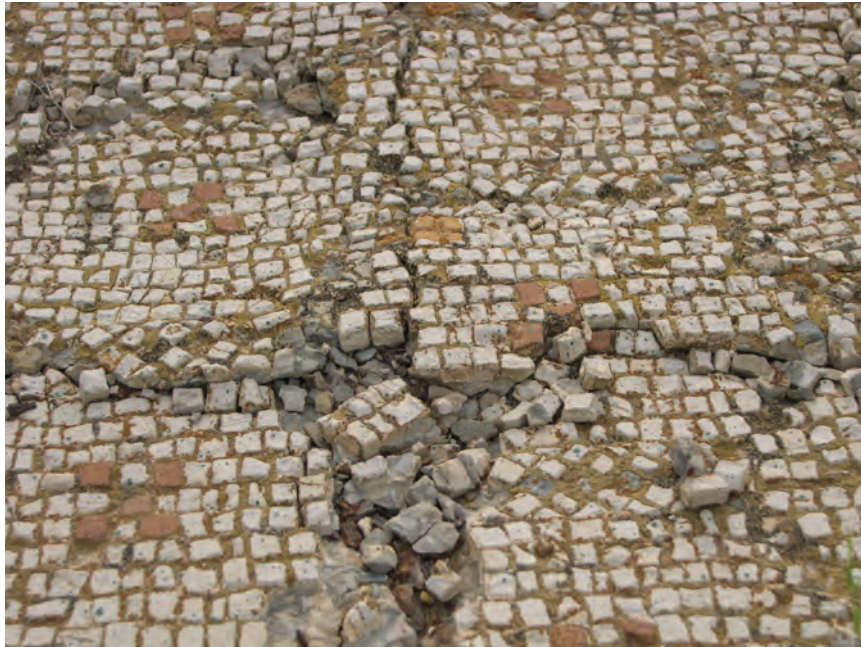
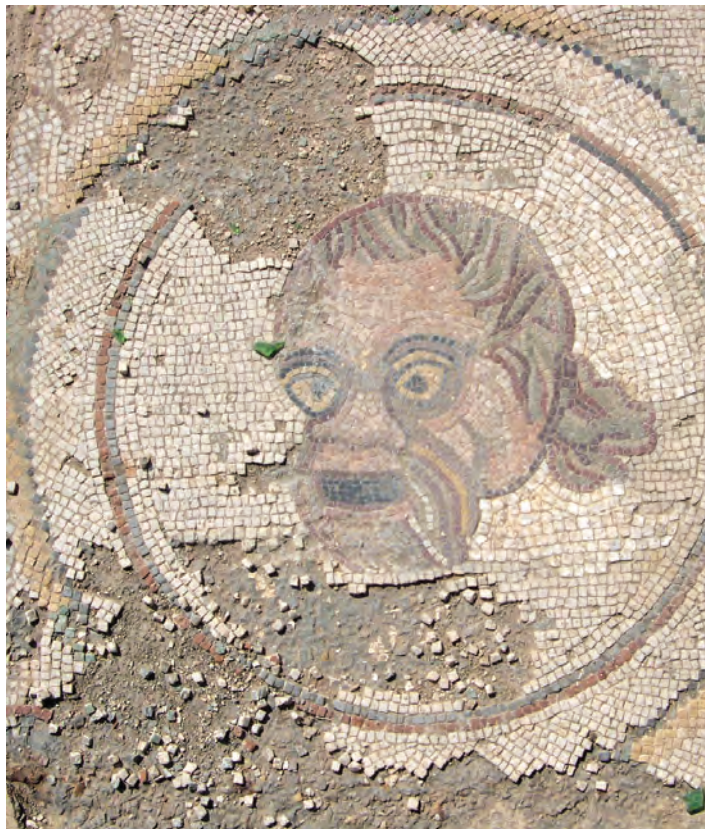
A tessera already reset during a previous intervention, which is no longer adhered, or a detached tessera of a section of the mosaic that has been lifted and re-laid on a new support.

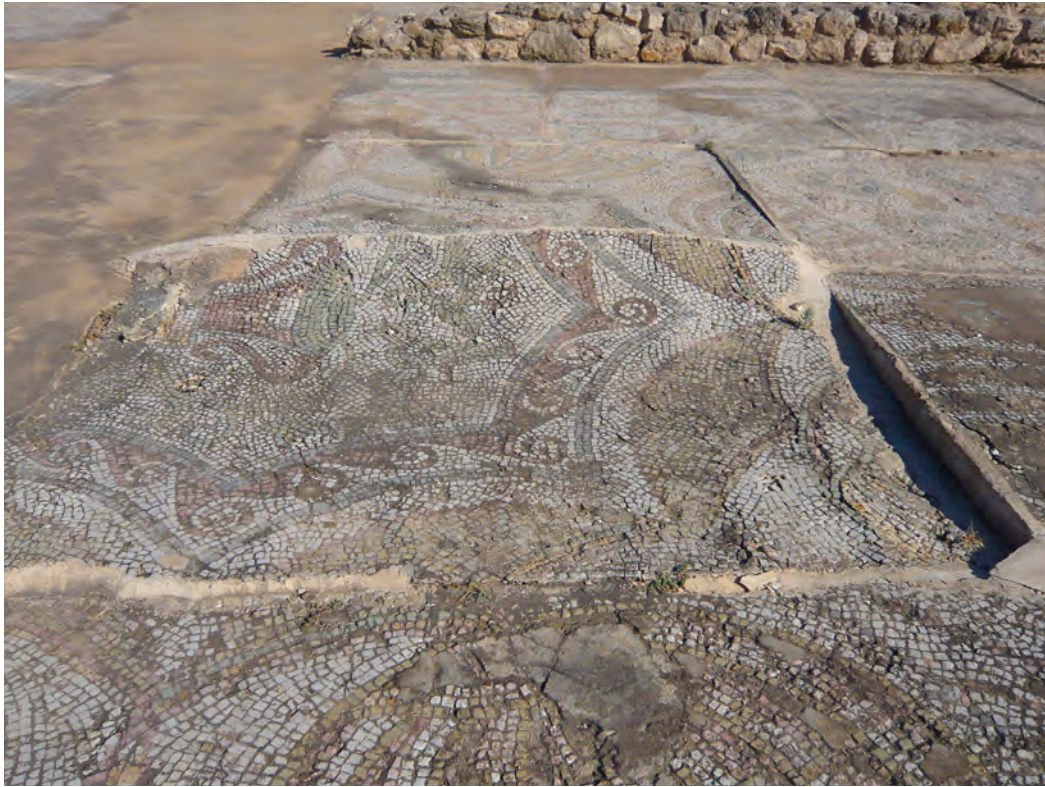
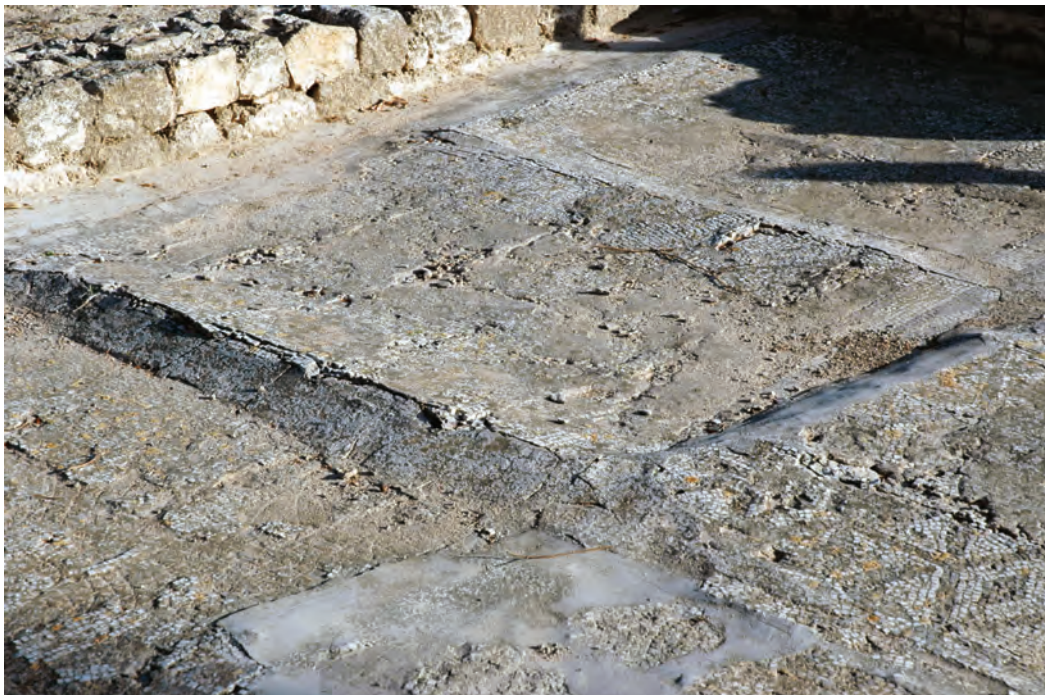
**Deformed support panel:** Modern support panel of a re-laid mosaic whose shape has changed, part of its surface being located above or below its original level.

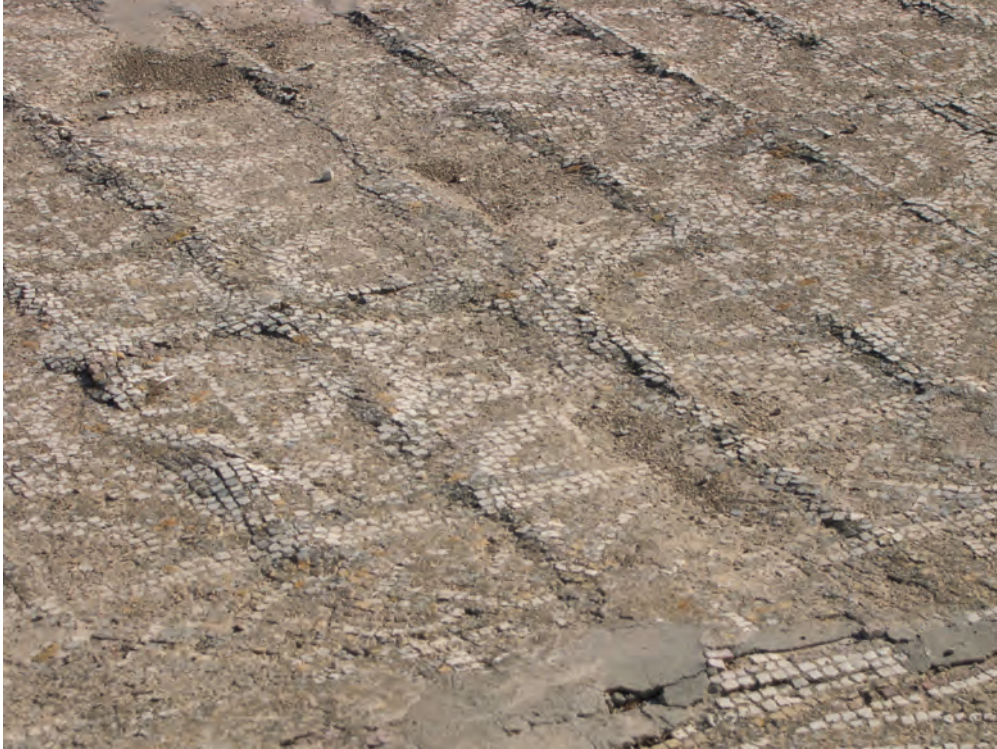
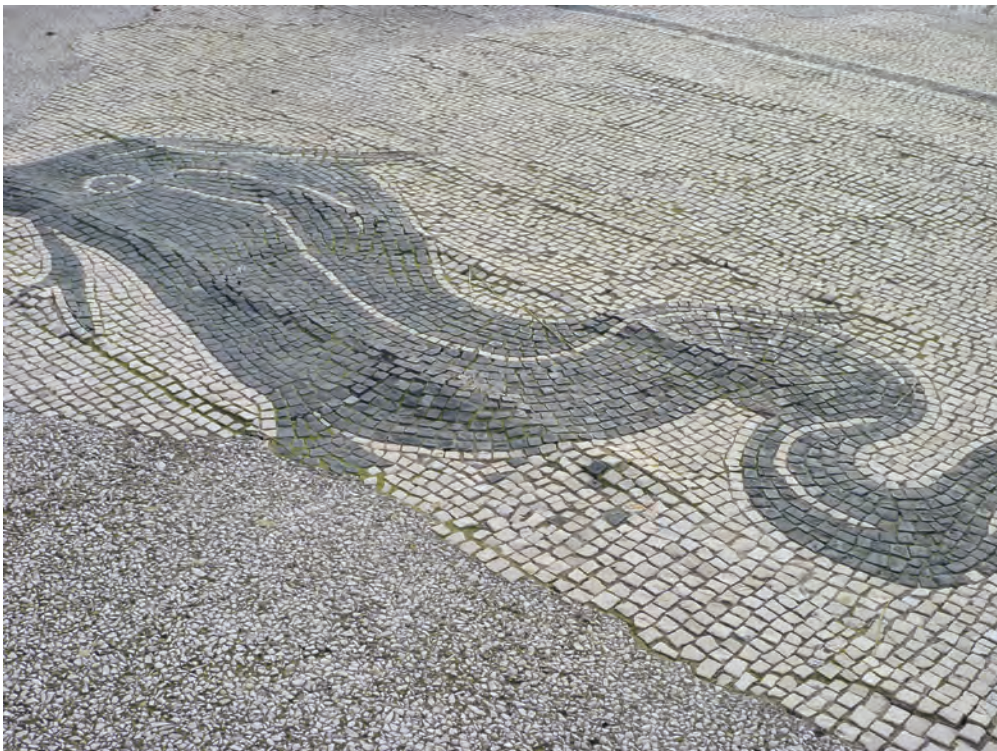
**Detachment between the tessellatum and the support panel:** Separation of the tesserae layer of a modern support panel of a re-laid mosaic. A detachment is often accompanied by a bulge visible on the surface.

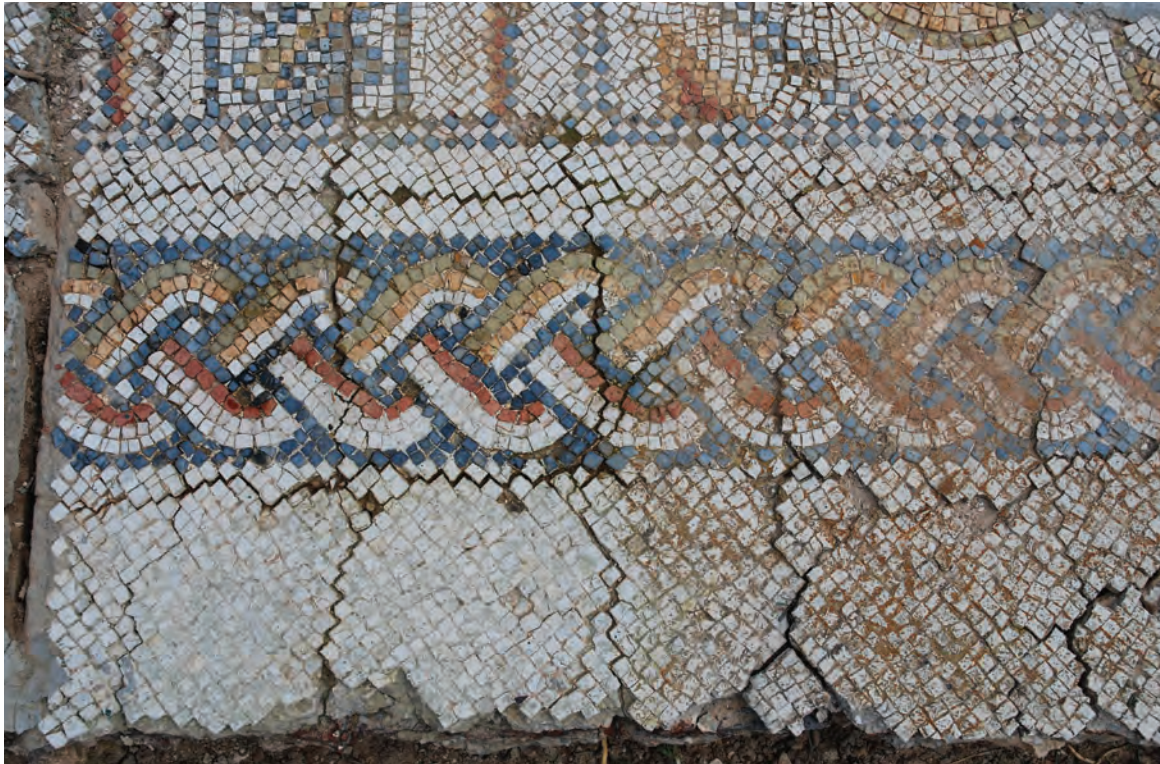
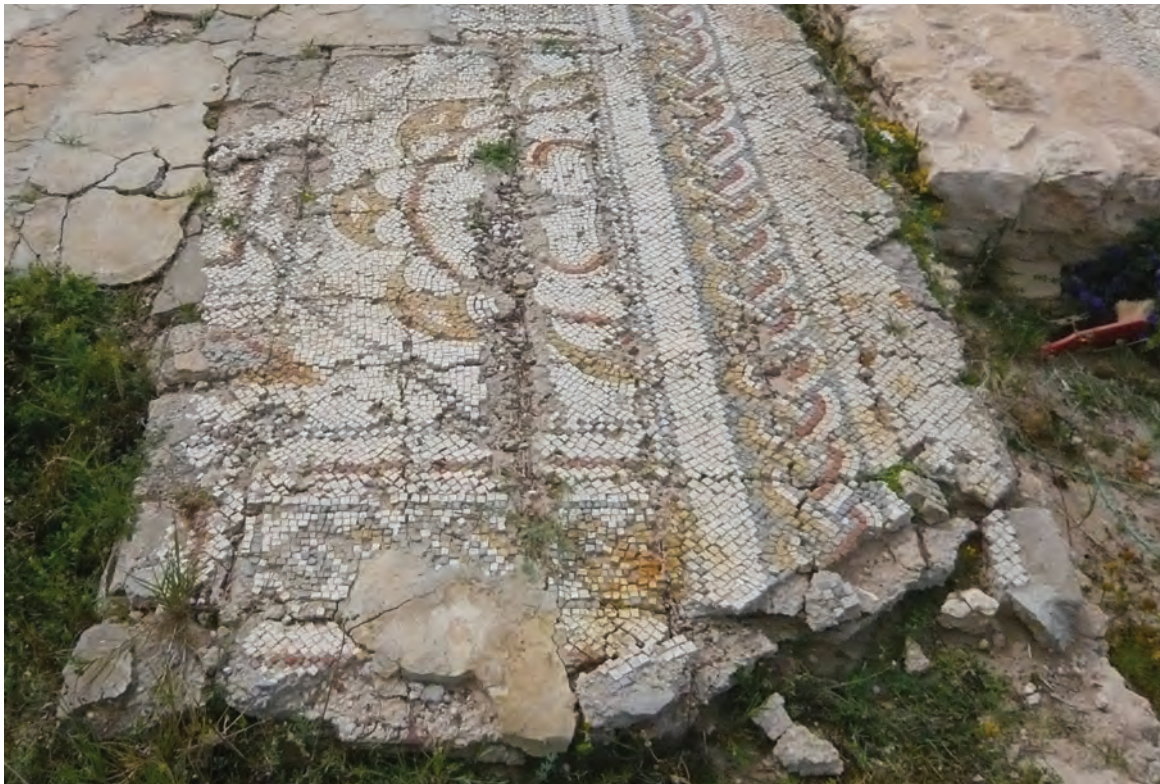
**Crack in support panel:** Linear break in the modern support panel of a re-laid mosaic that can traverse all or only part of its thickness.

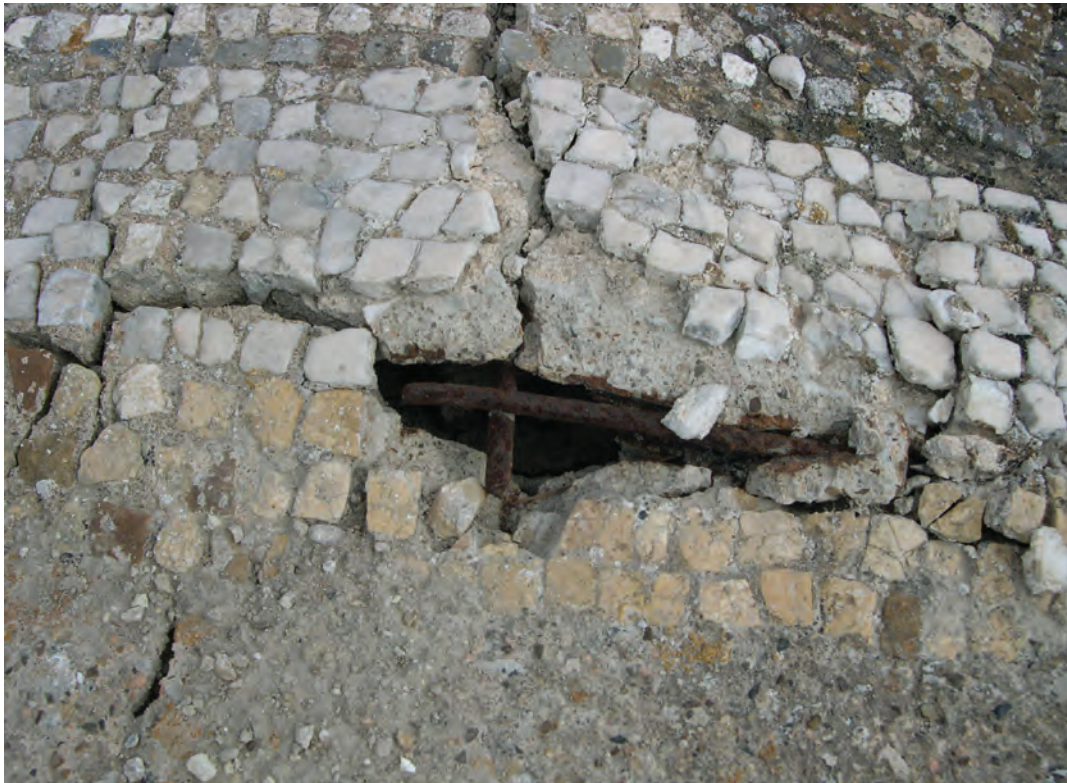
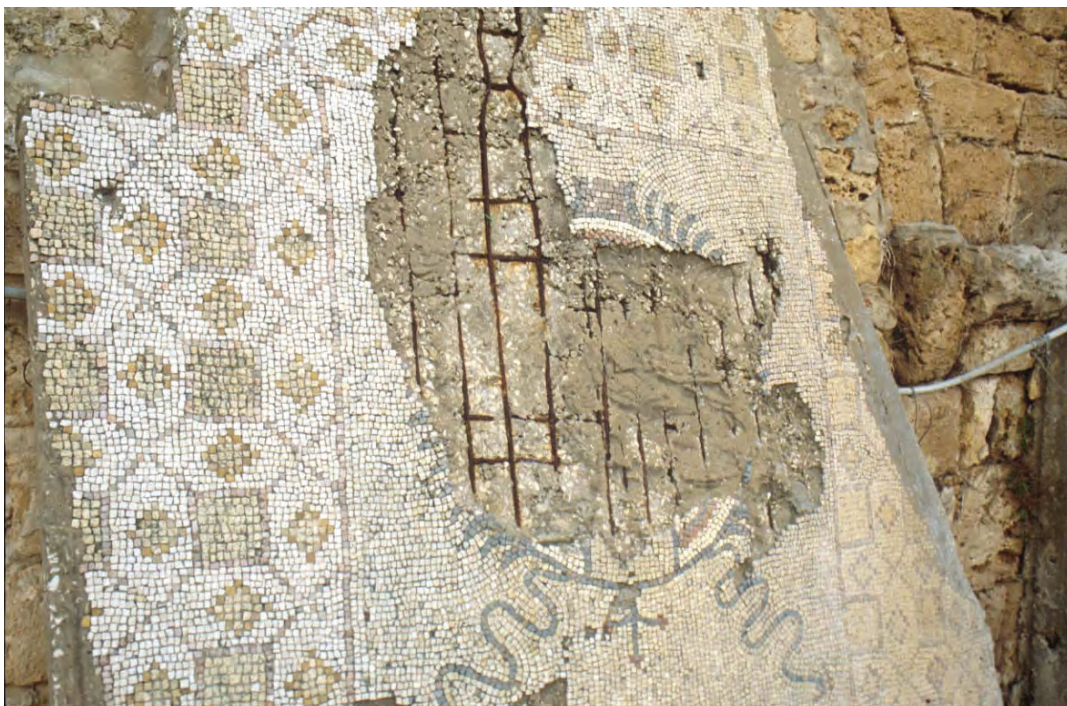
Structural reinforcement in the new support of a re-laid mosaic that is in poor condition.
