# 第85窟的保存

# Preserving Cave 85

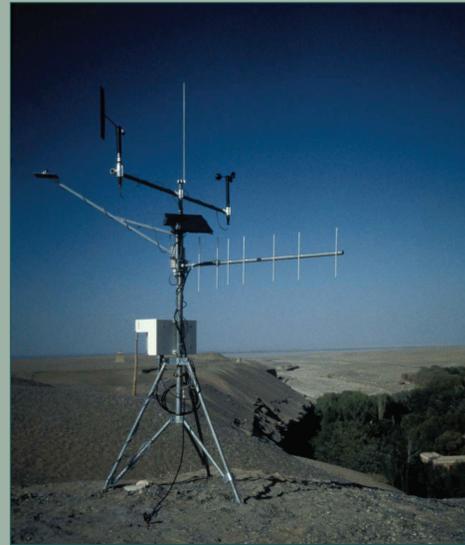
莫高窟崖顶设置有全自动气象站可监测降雨强度与雨量、空气温度、相对湿度、风速和风向等气象因子。  
A weather station at the top of the cliff measures rainfall intensity and amount, air temperature, relative humidity, and wind speed and direction.

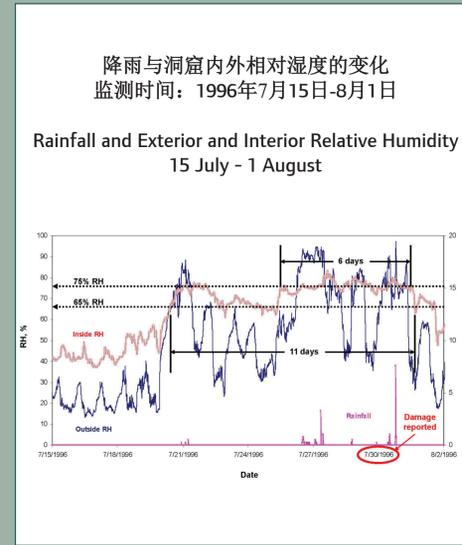
1996年在一段时期的降雨后，第85窟窟顶壁画脱落（图上底部的粉红色线条显示了降雨强度）。降雨对相对湿度的影响很大。比较一段时期的降雨前后相对湿度的变化。  
Collapse of painted plaster from the ceiling in 1996 followed a period of rainfall (pink lines at base of graph indicate rainfall intensity). The effect of rain on the relative humidity (RH) is dramatic. Compare the RH before and after the major period of rain.

尽管莫高窟处于沙漠的环境中，当地还是会降雨。降雨虽然罕见，还是会使窟内相对湿度升高至危险的阶段。相对湿度的突然升高会激活盐分，引发壁画病害。  
Despite the desert setting it does rain at the site. These rain events, though rare, can cause the relative humidity to rise to dangerous levels inside the caves. The rise in relative humidity can activate salts leading to deterioration of the wall paintings.

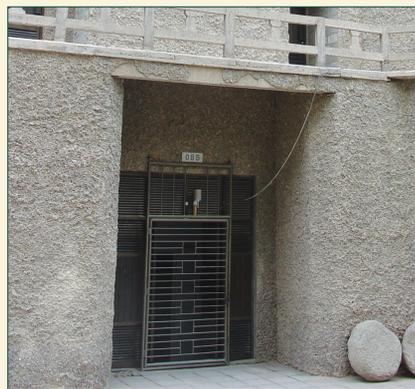
第85窟入口。  
The entrance door to Cave 85.

环境控制措施可以有效地减缓与盐分有关的病害发生。特别是在降雨期间，关闭洞窟的门可以降低窟内外空气的交换率，从而保持窟内湿度的稳定。

Environmental control measures are effective in slowing salt-related deterioration. Keeping the door to the cave closed reduces air exchange between the interior and the outside climate, thus maintaining stable humidity conditions in the cave, particularly during periods of rain.

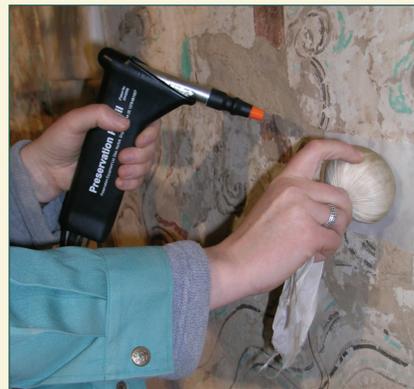
鉴于泥质地仗的脆弱状况和壁画对水的高度敏感，降低可溶盐只能限于局部选定的区域。使用超声波加湿器配合吸水棉纸可以用来吸收表面及表面下的盐分。  
Reduction of soluble salts was limited to select areas given the fragile condition of the earthen plaster and the water sensitive painting. An ultrasonic humidifier was used with absorbent tissue to absorb surface and subsurface salts.

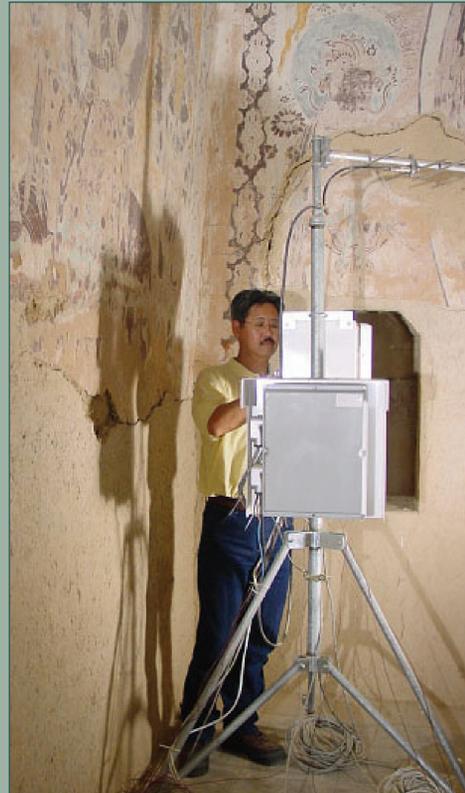
在第85窟内部也监测温度和相对湿度。相对湿度高于67%时，壁画中的盐分就会从空气中吸收水分，因此将窟内相对湿度保持在该数值以下是保存洞窟的关键。  
Monitoring of temperature and relative humidity was also undertaken inside the cave. Above 67% relative humidity salts absorb moisture from the air. Keeping the humidity below this value is key to preserving the cave.

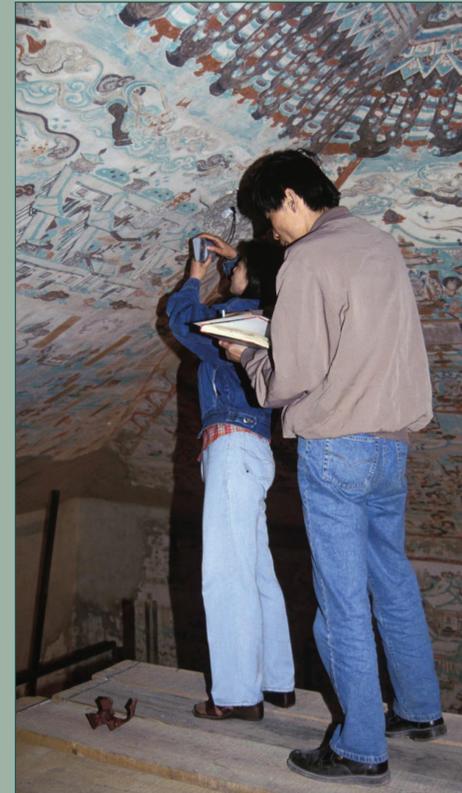
定期下载洞窟内不同位置监测探头所收集的数据。  
Data was regularly downloaded from monitoring probes at various locations throughout the cave.

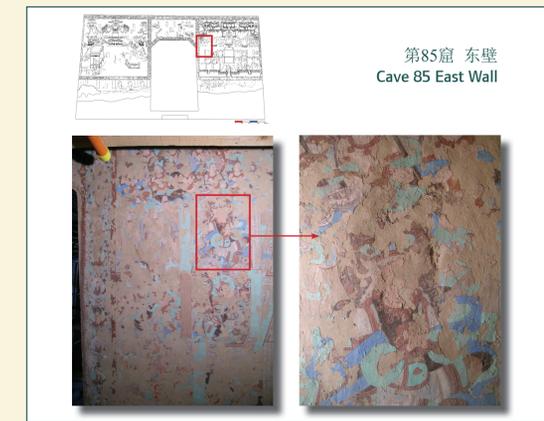
选择壁画区域进行定期现状监测。  
Areas of the wall painting were selected for regular monitoring of condition.

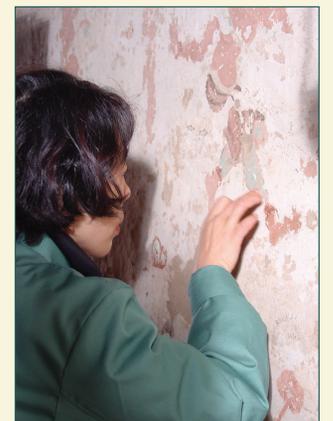
在监测期间对监测区域进行肉眼检查和拍照。  
Areas are checked and photographed during these periods of monitoring.
