Lessons Learned: Reflecting on the Theory and Practice of Mosaic Conservation

Learning from Past Interventions: Evaluation of the Project to Conserve the Orpheus Mosaic at Paphos, Cyprus

Martha Demas, Thomas Roby, Neville Agnew, Giorgio Capriotti, Niki Savvides, and Demetrios Michaelides

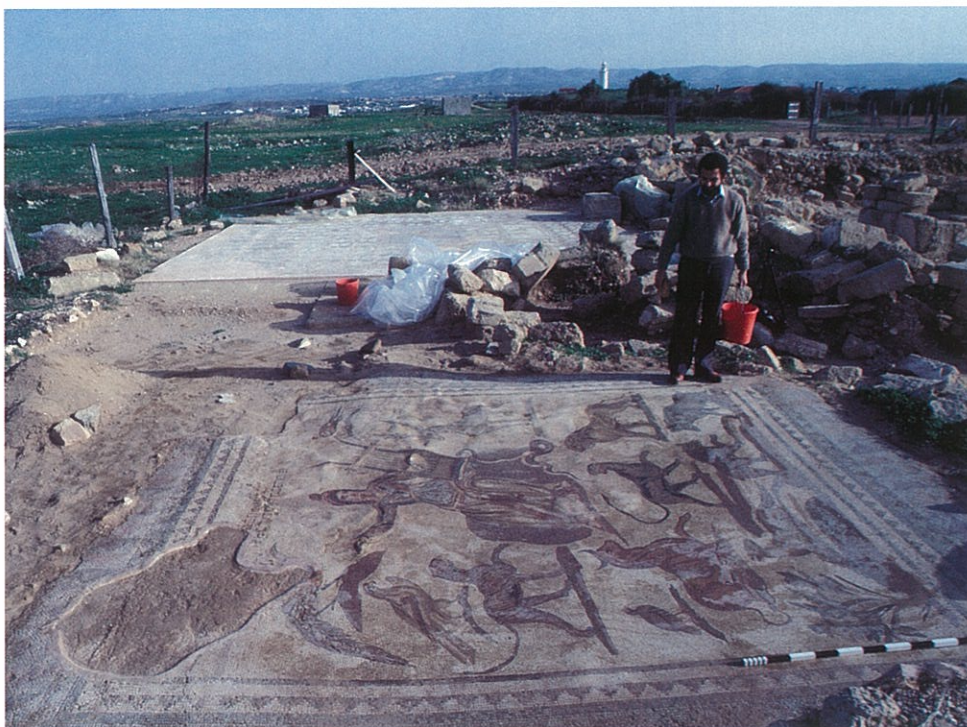
of Antiquities, Cyprus.² It suffered from root intrusion that resulted in a few large lacunae and dislocation and loss of tesserae along the top part of the mosaic, destruction of its edges from ancient robbing of the walls of the room, subsidence caused by the presence of earlier structures below the mosaic, which became more pronounced as the subsoil dried out following excavation, and lack of cohesion of the mortar of the bedding layer (fig. 1) (Michaelides 1991).

FIGURE 1 Orpheus mosaic (foreground) prior to being lifted in 1988, with the Amazon and Heracles mosaic (background) already partially lifted and relaid. Photo by Guillermo Aldana 1998.
© J. Paul Getty Trust.

For these reasons, particularly lack of cohesion and subsidence of the bedding layers, and in line with common practice of the Cypriot Department of Antiquities, the Orpheus mosaic was to be conserved through lifting and re-laying. The technique of rolling the *tessellatum* on a large wooden cylinder (or drum) was selected because the mosaic was largely intact, without structural cracking, was accessible to large machinery, and, most important, could be lifted as a single intact, pictorial composition. The project began in 1988, under the general direction of Paolo Mora, as consultant to the GCI, and entailed three main components: lifting and re-laying of the mosaic, training of conservators in the technique, and temporary sheltering of the mosaic (see Stanley-Price 1991 for details of the project implementation, participants, and costs).

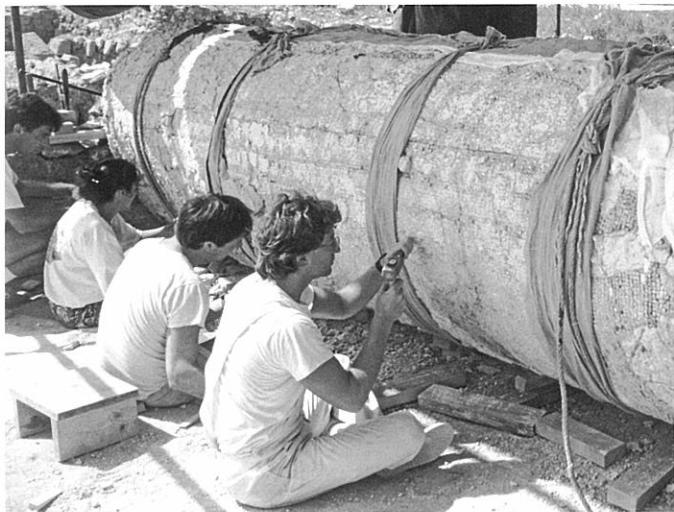
FIGURE 2 Mortar being removed from the back of the Orpheus mosaic while it is rolled on the drum. Photo by Paolo Pastorello 1998. © J. Paul Getty Trust.

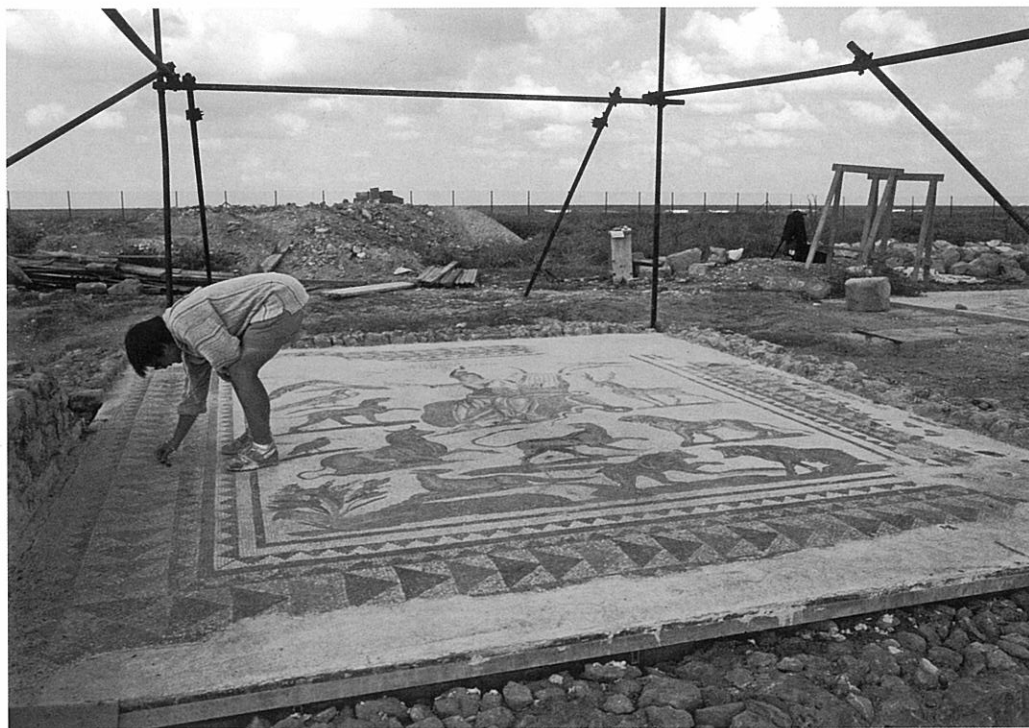
Figure 3 shows the mosaic on its Aerolam® panel after it was relaid in its original position.

FIGURE 3 Orpheus mosaic on the Aerolam® panel relaid in its original position but before final cleaning, filling of lacunae, and rebuilding of the surrounding walls of the room. Photo by Guillermo Aldana 1989. © J. Paul Getty Trust.

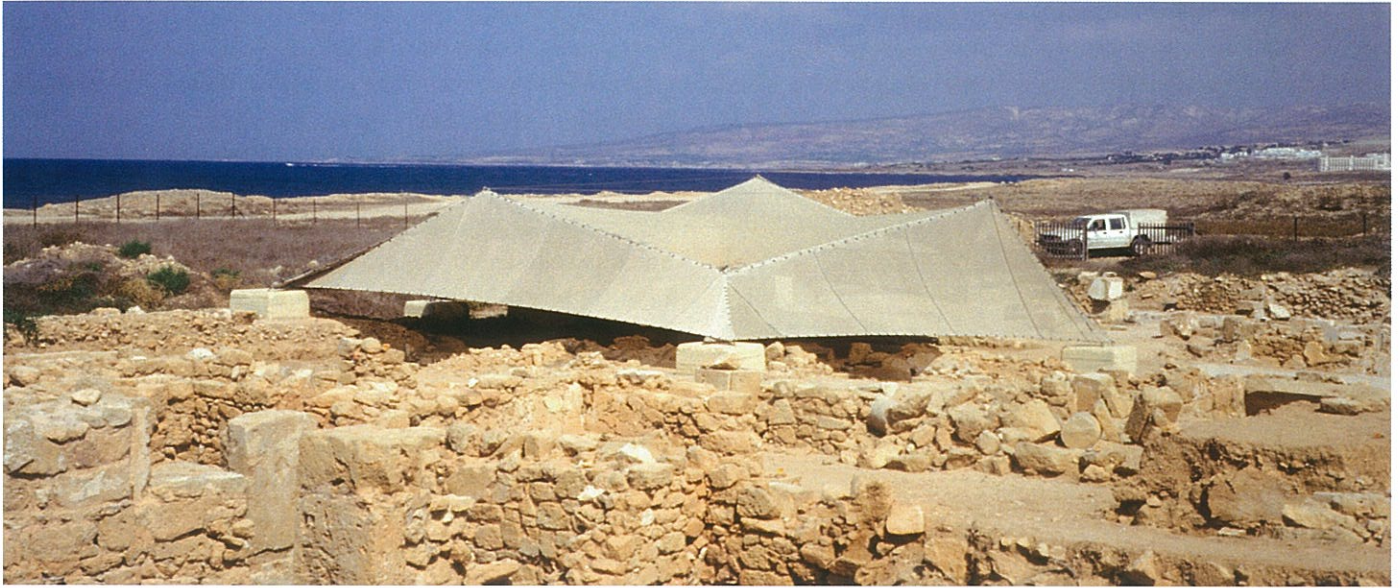
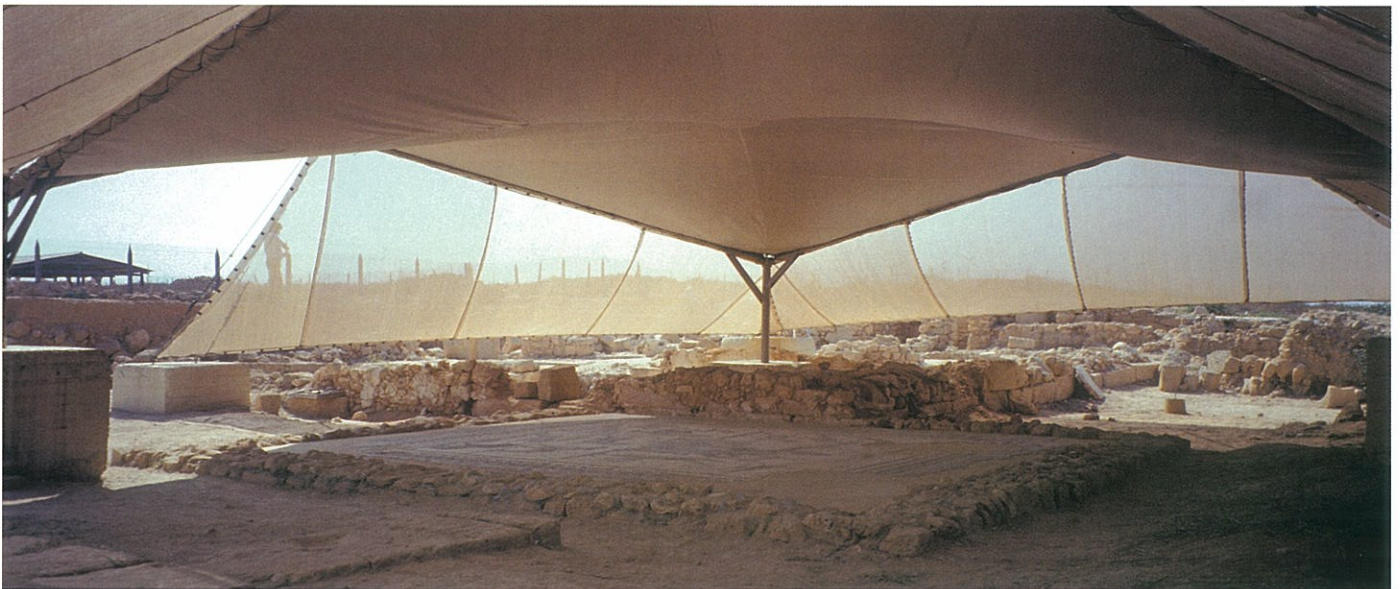
The construction of a shelter to protect the Orpheus mosaic was a later addition to the original project objectives (fig. 4). It arose out of a GCI initiative to develop a lightweight, modular, and temporary shelter for protection of archaeological sites. The so-called hexashelter began as an experimental design by Neville Agnew that was field-tested and evaluated in 1988 at Fort Selden, New Mexico (Agnew and Coffman 1991; Agnew et al. 1996). In 1989 it was decided to apply the prototype to protect the Orpheus mosaic temporarily (no more than five years) pending permanent sheltering and site

FIGURE 4A, B The “hexashelter,” a modular system designed as temporary protection for the Orpheus mosaic, as seen from the exterior (a) and interior (b). Photos by Martha Demas 1992.

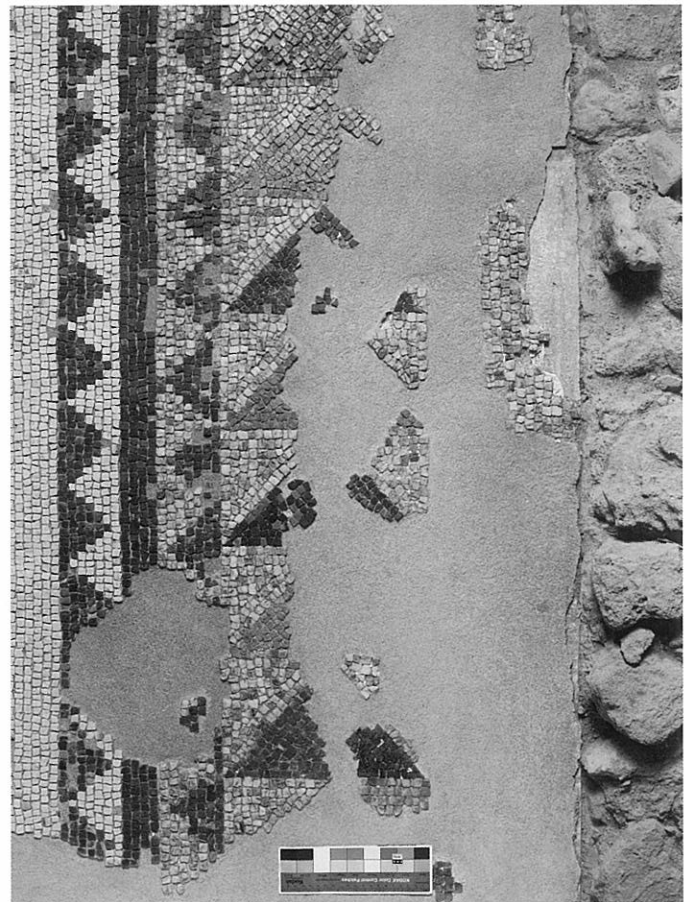
- loss of tesserae: approximately seventy-five tesserae had been lost since 1989, most from border areas

(mainly those embedded in polyester resin after re-laying in 1989) (fig. 5), as well as a few loose or detached tesserae;

FIGURE 5 Loss of tesserae that had been embedded in polyester resin soon after the re-laying; loss of infill mortar is visible on the right. Photo by Vassos Stylianos 2004. © J. Paul Getty Trust.

With the exception of the loss of tesserae, these are correctable problems. Certainly the overall good state of preser-

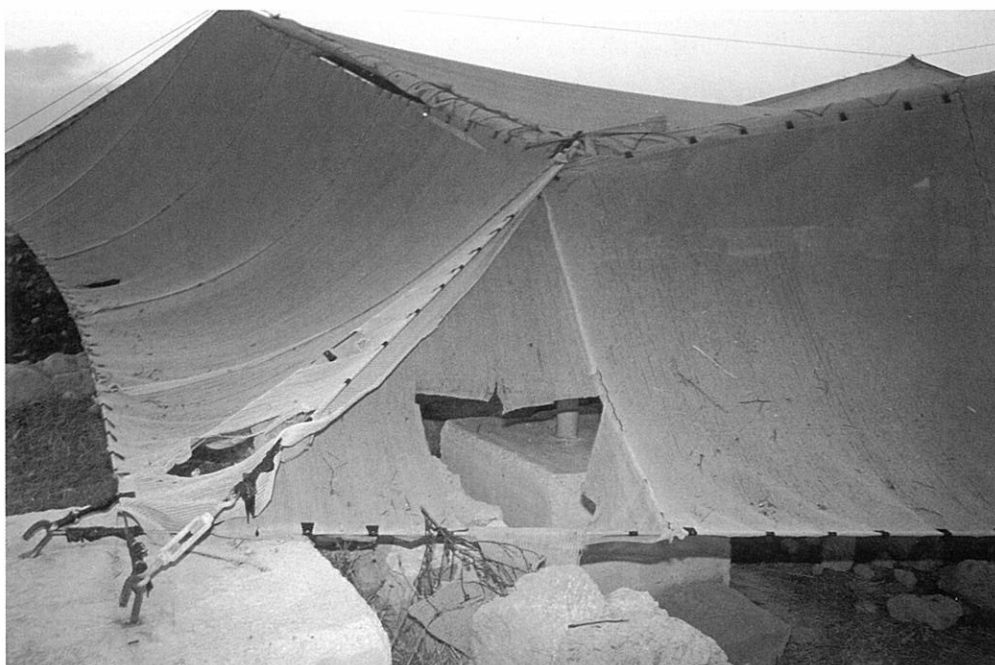
FIGURE 6 The covering materials of the hexashelter had severely degraded by 2004, fifteen years after the shelter was erected. Photo by Martha Demas 2004. © J. Paul Getty Trust.

Nor did the project have any impact on the authorities responsible for the site; indeed, an unintended consequence of the project may have been to encourage the notion that because the mosaic was relaid on an isolating support, it required little or no maintenance. Certainly little was done over the fifteen years to maintain or monitor the mosaic, its setting, and its shelter (fig. 6).

- 12 The lightweight materials of the shelter (an impermeable membrane and a permeable woven fabric) held up far beyond their intended life but were severely degraded by the time of the assessment in September 2004. The Department of Antiquities attempted to repair the membrane in late 2004, but unsuccessfully, as during winter storms in 2005 rainwater was observed falling on the mosaic and pooling. The membrane developed a large tear, necessitating its removal in February 2006. The Orpheus mosaic has since been reburied, pending construction of the permanent shelters.

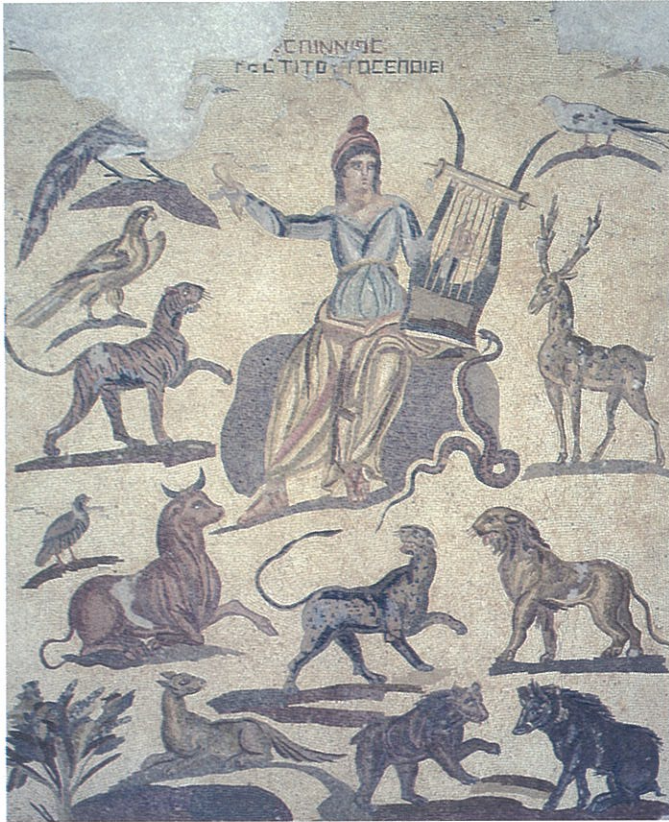
FIGURE 7 The Orpheus mosaic after re-laying on its new support in 1989 (before infilling lacunae) retains aspects of artistic and historic value—artistic composition, iconography, and attribution—that are most prized in mosaics. Photo by Guillermo Aldana 1989. © J. Paul Getty Trust.

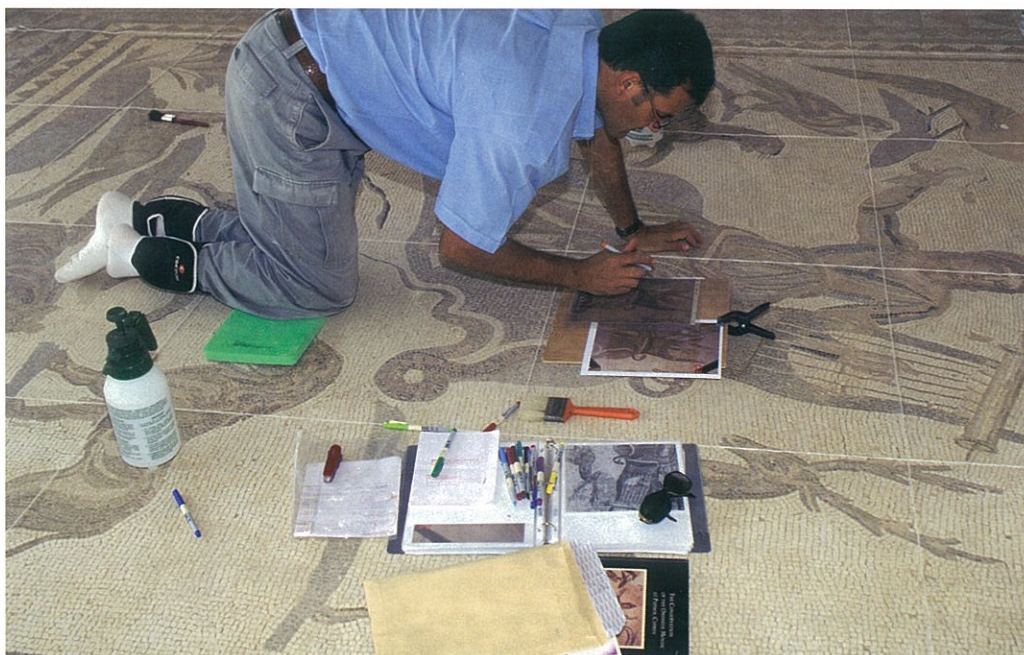
FIGURE 8 Graphic recording of the condition of the Orpheus mosaic in 2004, used for comparison with documentation undertaken in 1988 before re-laying and in 1989 after re-laying. Photo by Neville Agnew 2004. © J. Paul Getty Trust.
