A Collection Climate Control System for an Ethnographic Storage of a Museum in North of Brazil

Shin Maekawa, PhD, PE
Member ASHRAE

Franciza Toledo, PhD

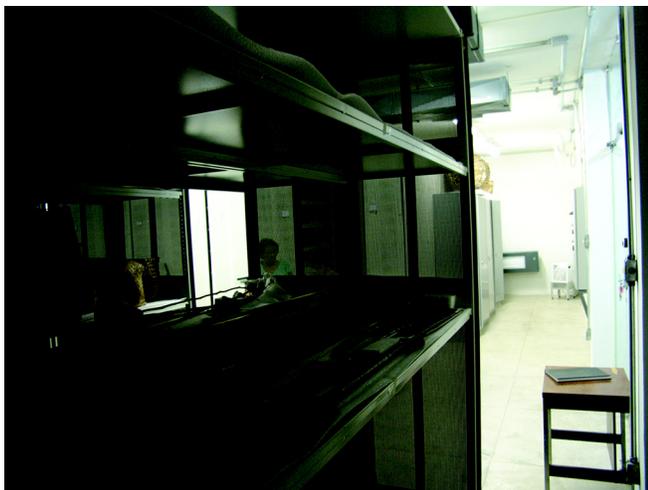
Figure 3 Side panels of a compact shelving system are made of perforated plate in order to allow air flow through the panel even in closed positions.

Compact shelving systems and chests made of steel with a baked enamel finish were positioned in the storage to provide the maximum use of the space while the ventilating air could circulate through as well as around them. Side panels of the compact shelving system were fabricated with perforated steel sheets to allow air circulation through them even at closed positions (Figure 3). Drawers of the two chests also had large

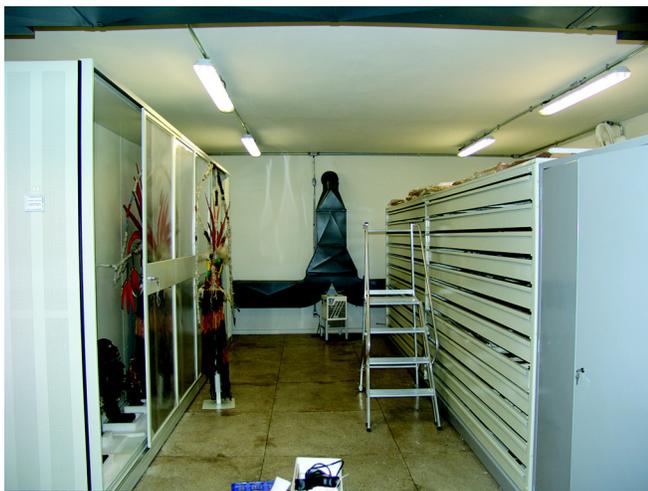
Figure 4 Drawers have gaps between drawers in order to allow air flow even in closed conditions.

gaps between them to promote good air circulation, even in the closed position (Figure 4).
